1. Report No. FHWA/TX-0-1401-1	2. Government Accession No.	3. Recipient's Catalog No.	
4. Title and Subtitle Bending Fatigue Response of Grouted Stay Cables		5. Report Date July 2008

Bending Fatigue Response of Grouted Stay Cables

CTR Research Report:	1401-1
Report Date:	July 2008
Research Project:	0-1401
Research Project Title:	Determination of Fatigue Damage in Stay Cables
Sponsoring Agency:	Texas Department of Transportation
Performing Agency:	Center for Transportation Research at the University of Texas at Austin

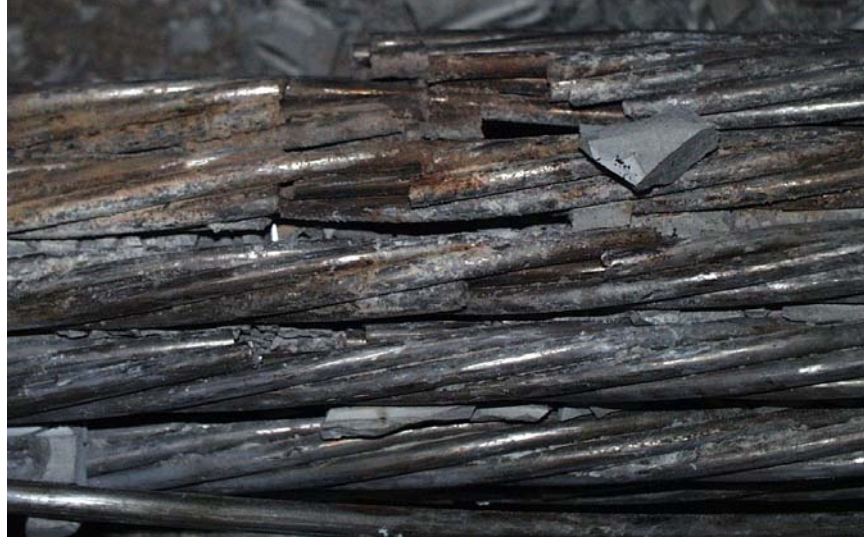
At midspan, wire breaks in the inner layers of strands were more common, especially when most of the wires in the outer layer fractured. Corroded fretting product was often observed in the vicinity of the wire breaks (Figure 3.9). The amount of observed corrosion tended to increase as the number of wire breaks increased.

Figure 3.9 Corroded Fretting Product on Surface of Strand at Midspan – Specimen 12

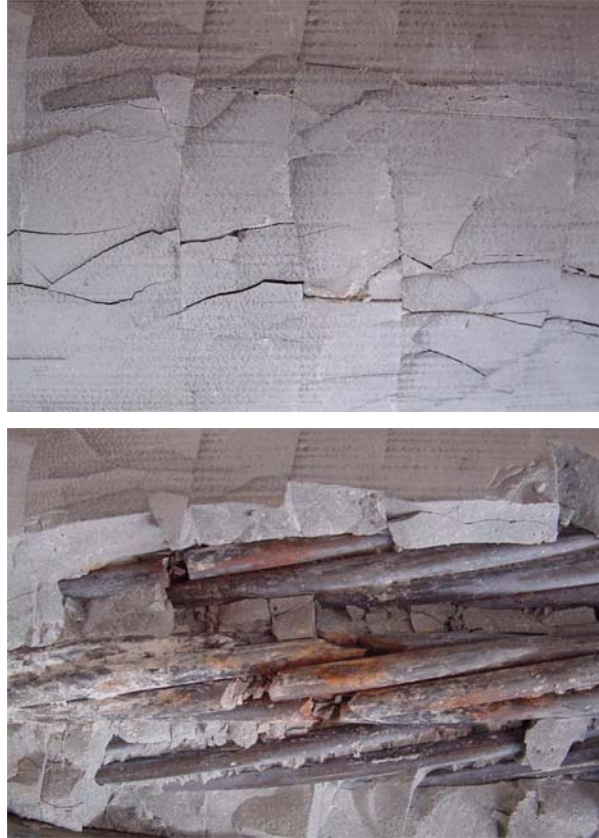
Figure 3.11 Longitudinal Cracks in Grout, Corrosion of Strand, and Wire Breaks near Midspan of Specimen 1

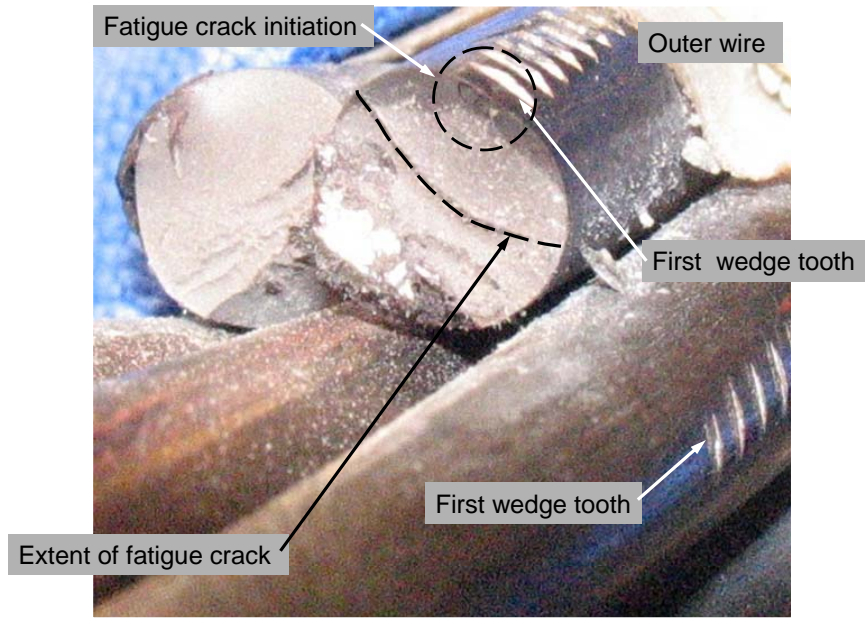
Figure 3.22 Isolated Fatigue Failure at Wedge

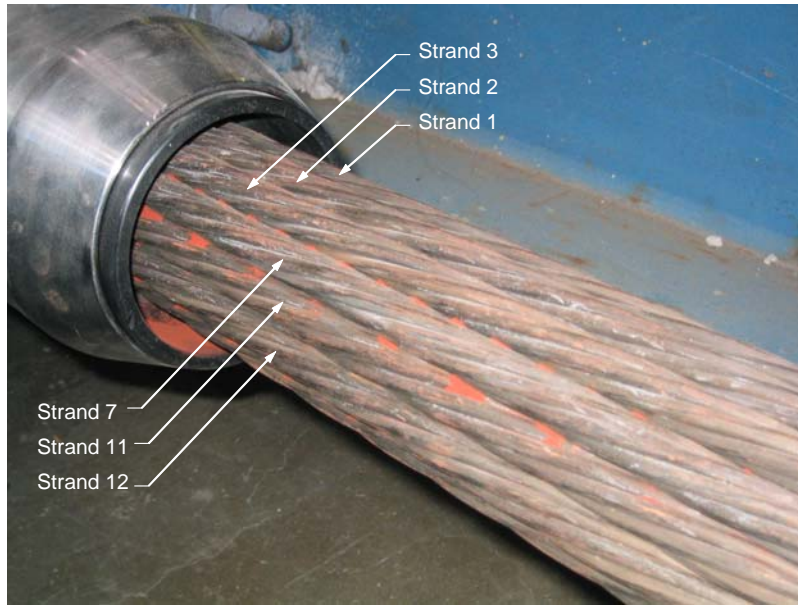
Specimen 8 was ungrouted, but strain gages were not attached to the strands. During construction, one of the interior strands from the middle row was caught between two of the exterior strands near the tension ring at the deck end (Figure B.38). The strands were not crossed, but the misalignment caused extensive fretting between adjacent strands near the tension ring.

Figure B.38 Misalignment of Strands at Deck Tension Ring – Specimen 8

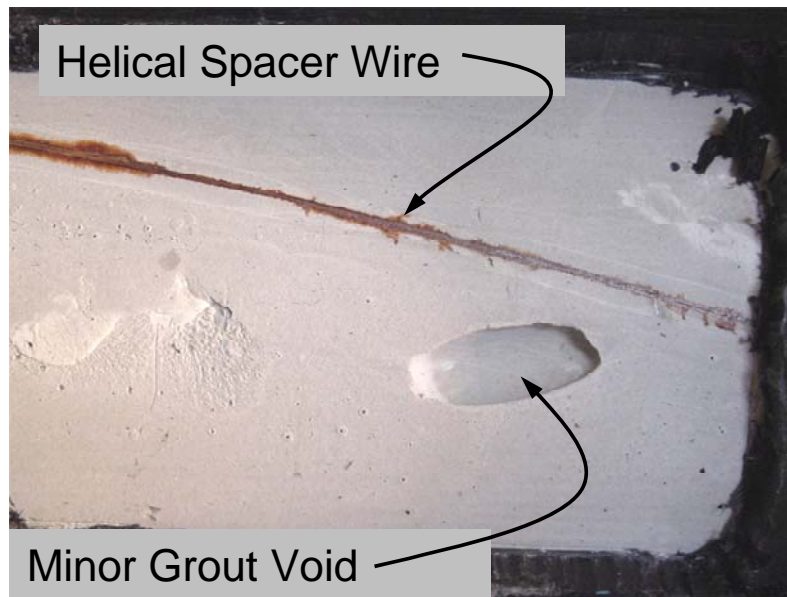
The grout in the rest of the specimen was homogeneous and only minor surface defects were observed. The defects were often very close to the helical spacer wire as shown in Figure D.5. Orange surface corrosion was found on some locations at the very outside of the helical spacer wire where it was in contact with the PE pipe.

Figure D.5 Grout Surface Defect and Corrosion on Spacer Wire – Specimen 1

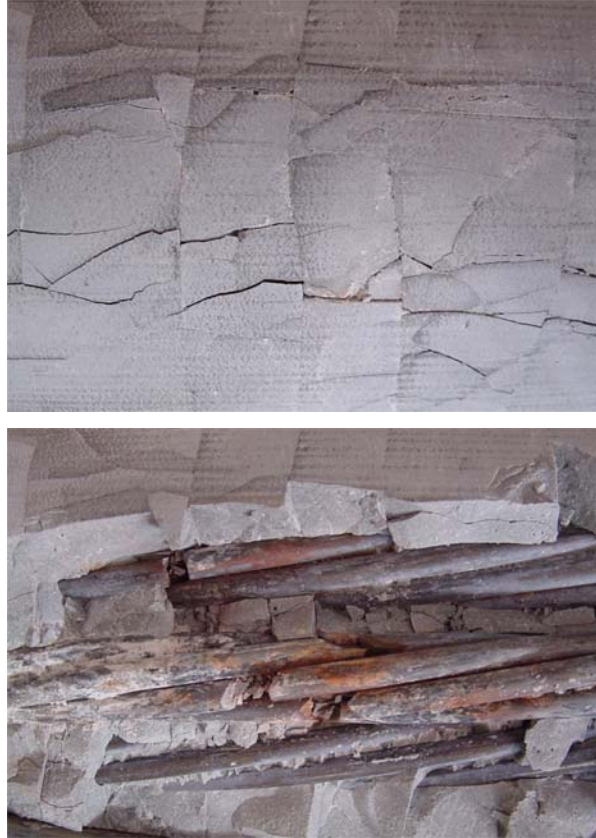
Figure D.8 Longitudinal Cracks in Grout, Corrosion of Strand, and Wire Breaks near Midspan of Specimen 1

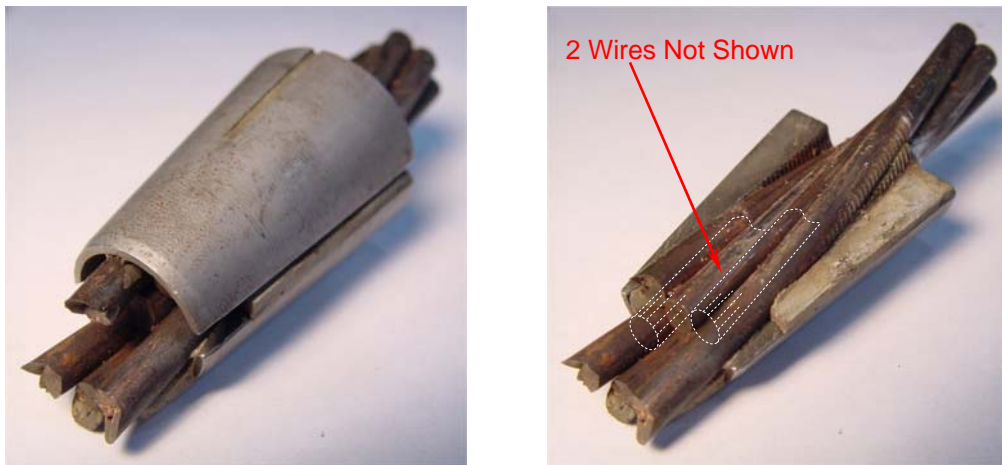
Figure D.25 Opened Wedges and Wire Fractures for Strand 2 near Tower Anchor Head – Specimen 2

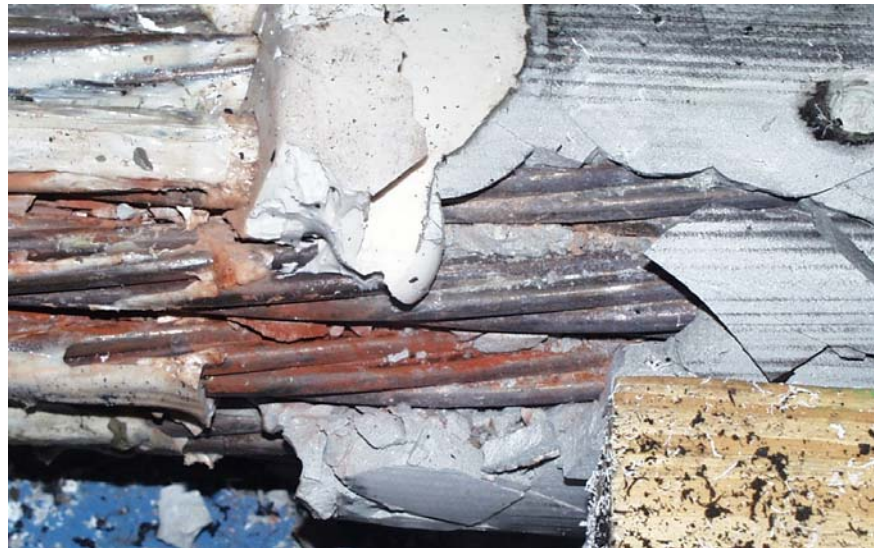
Figure D.51 Corrosion Product Observed at Interface between Caulk and Grout in Specimen 5

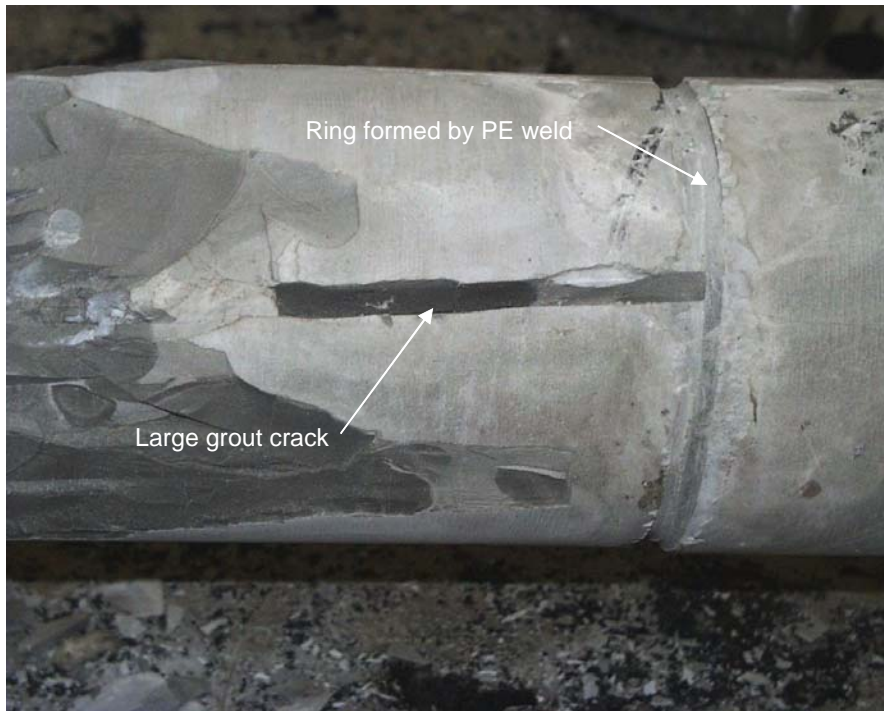
Figure D.57 Large Grout Crack near Deck Anchorage – Specimen 6

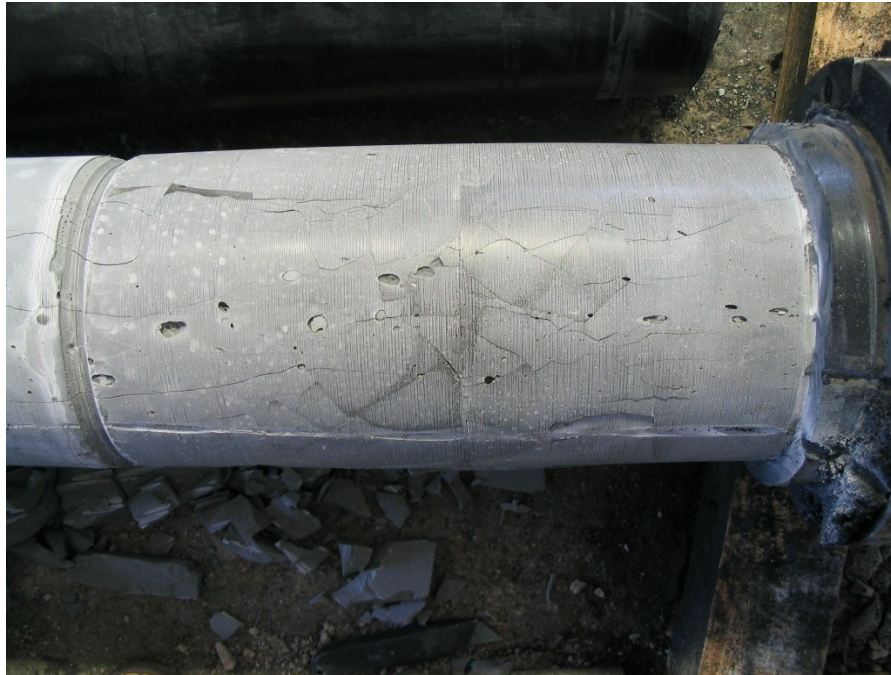
Figure D.72 Condition of Grout at Tower End - Specimen 7

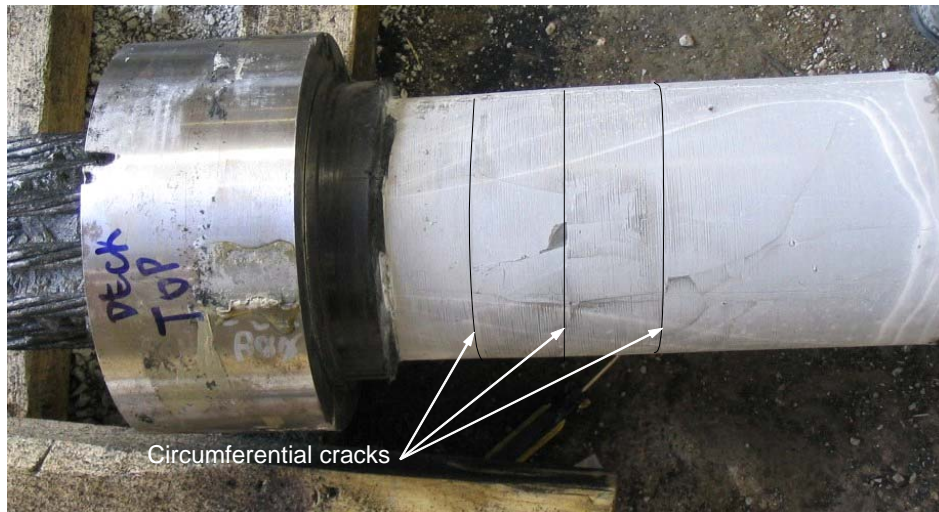
Figure D.73 Condition of Grout near Deck Anchor Head Immediately after Removing Polyethylene Pipe – Specimen 7

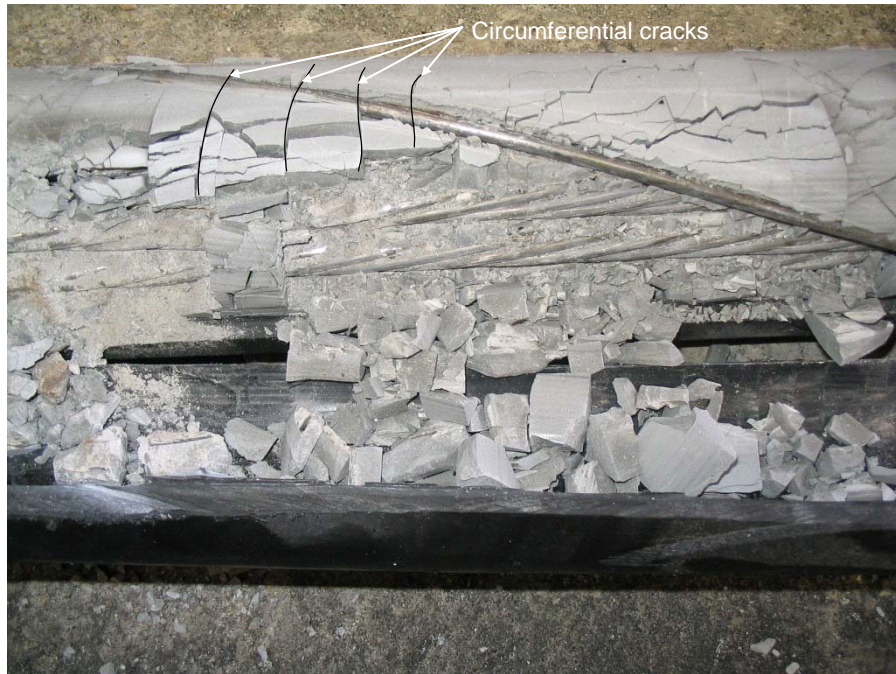
Figure D.75 Condition of Grout under Load Point – Specimen 7

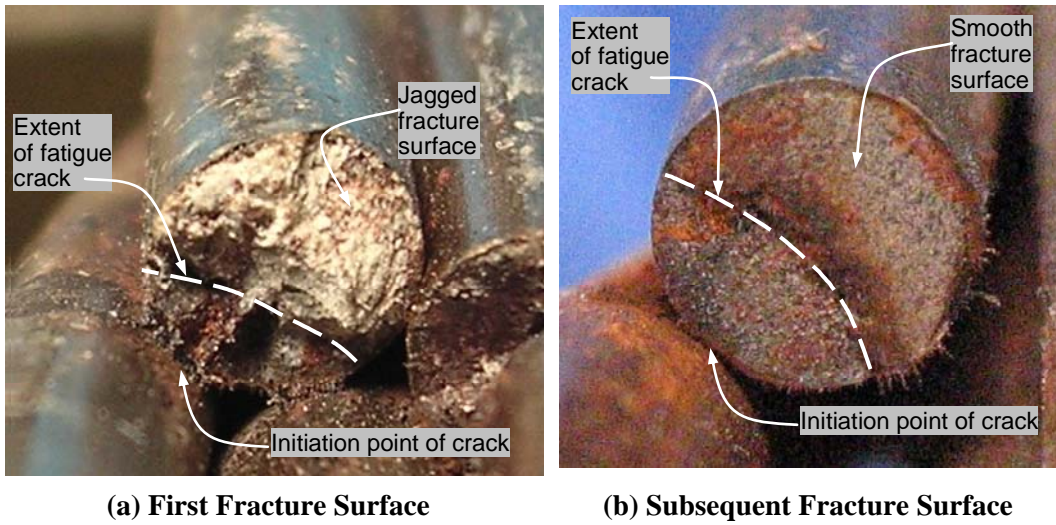
Figure D.81 Two Wire Breaks in the Same Wire near the Tower End – Specimen 7

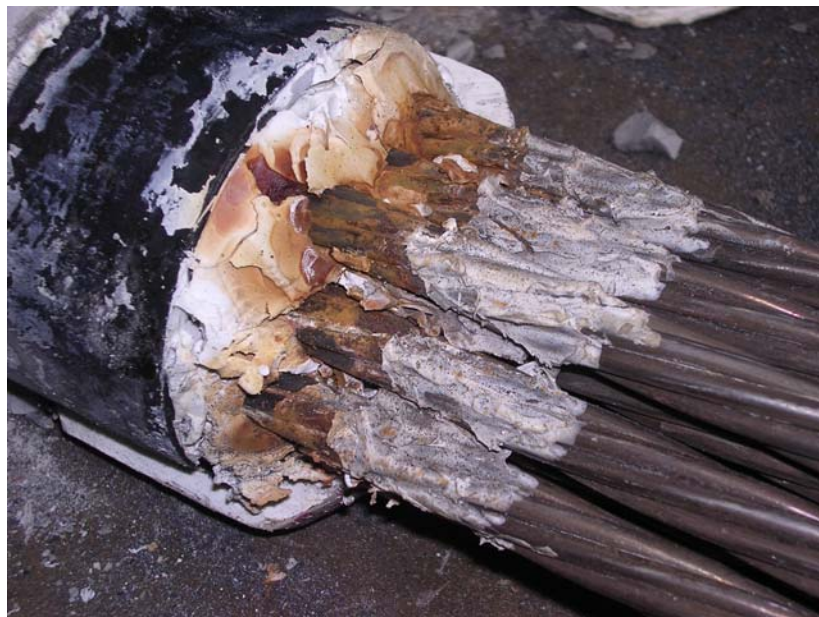
Figure D.93 Corrosion Product Observed at Interface between Caulk and Grout in Specimen 8

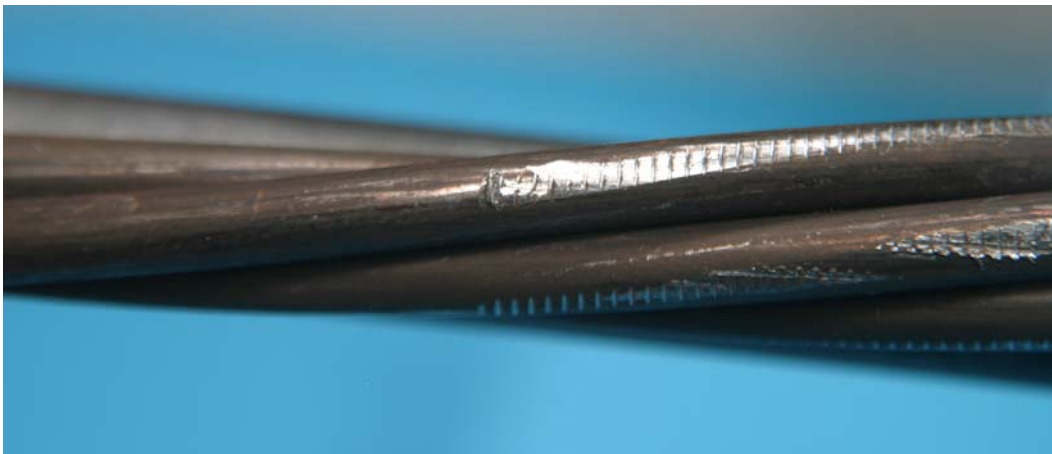
Figure D.97 Scraping of Strand Due to Stressing at Tower End – Specimen 8

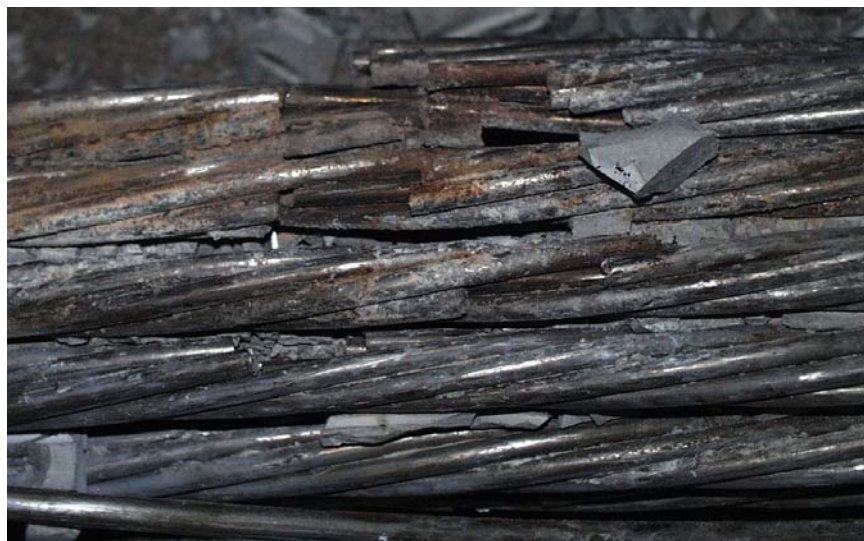
Figure D.148 Corroded Fretting Product on Surface of Strand at Midspan – Specimen 12

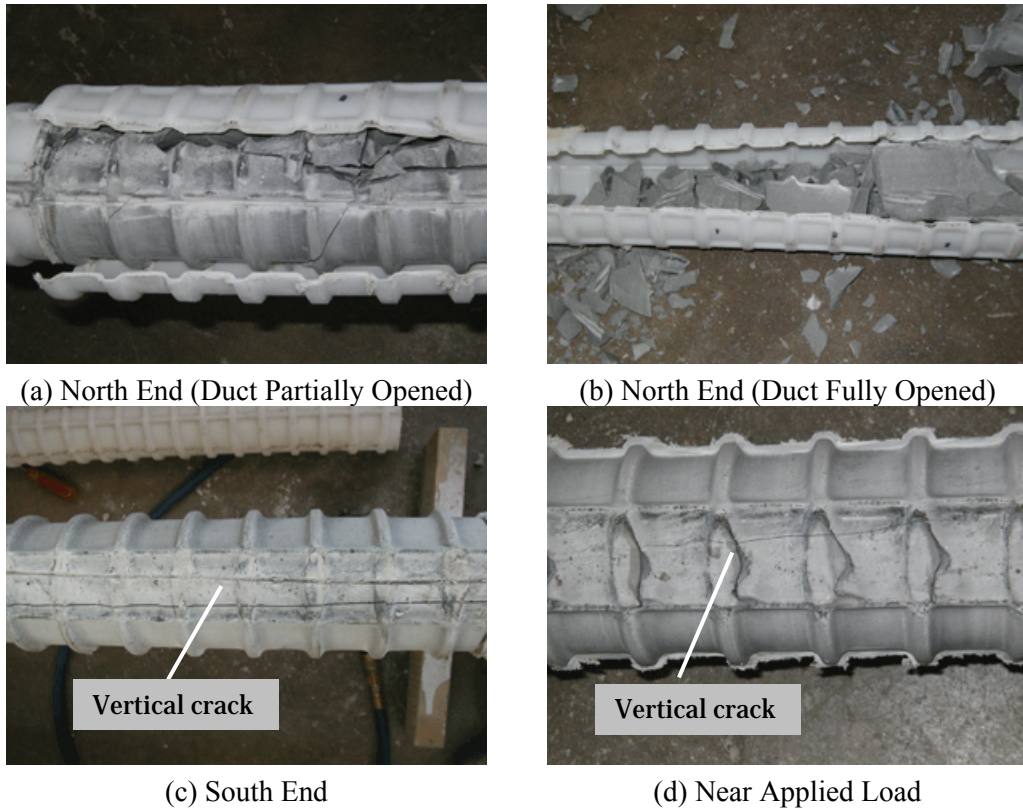
Figure E.23 Observed Condition of Grout – Specimen 3
