6. Performing Organization Code	
7. Author(s) L. S. Memberg, R. E. Klingner, and T. J. Fowler				8. Performing Organization Report No. Research Report 0-1857-4

9. Performing Organization Name and Address Center for Transportation Research The University of Texas at Austin 3208 Red River, Suite 200 Austin, TX 78705-2650				10. Work Unit No. (TRAIS)

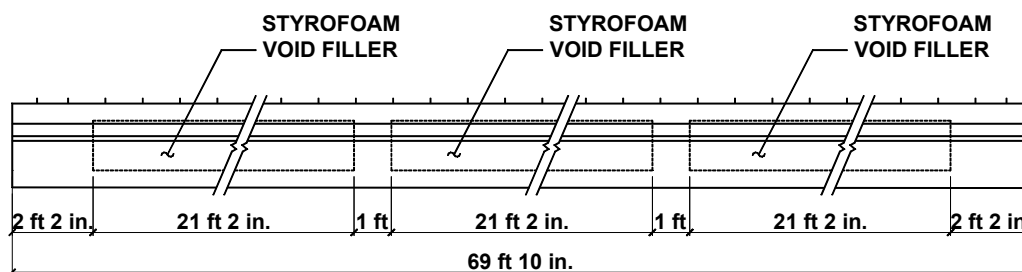
**Figure 3.1: Side view of box girders**

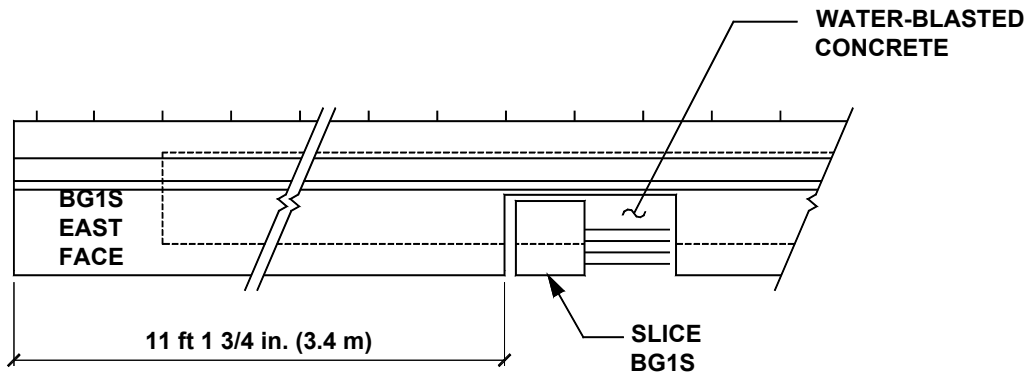
Figure 3.8: Location of slice from Girder BG1S

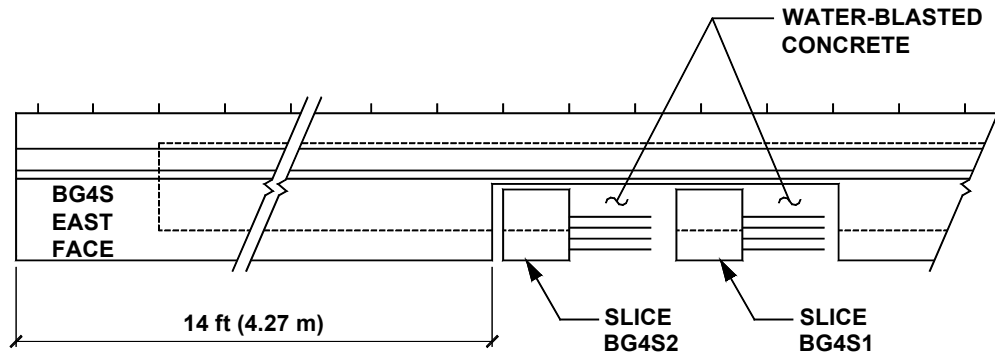
**Figure 3.10: Location of slices from Girder BG4S**

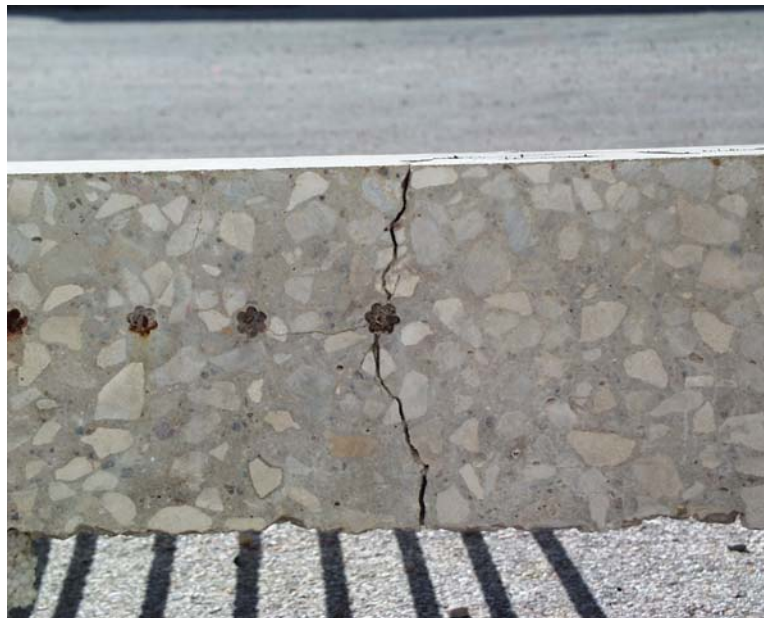
**Figure 3.11: Crack through Strand 9L in back face of Slice BG1S**

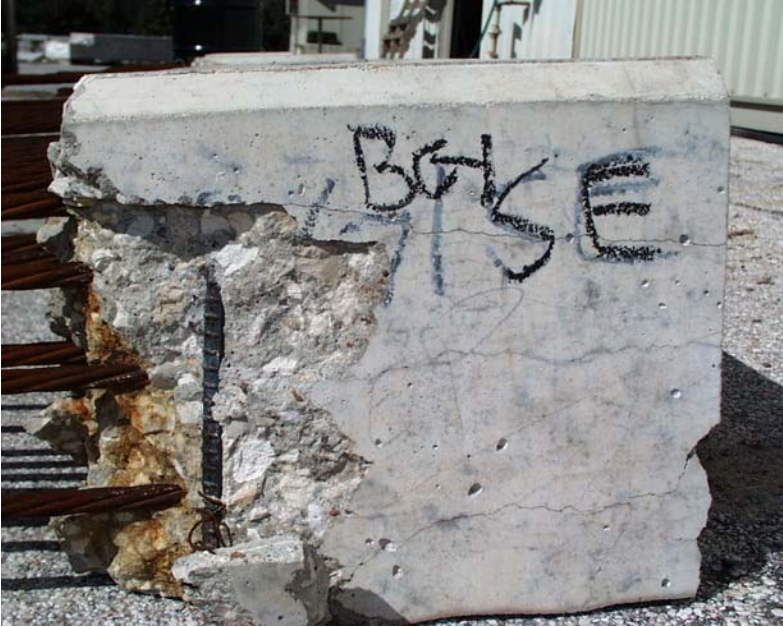
**Figure 3.12: Cracking on left face of Slice BG1S**

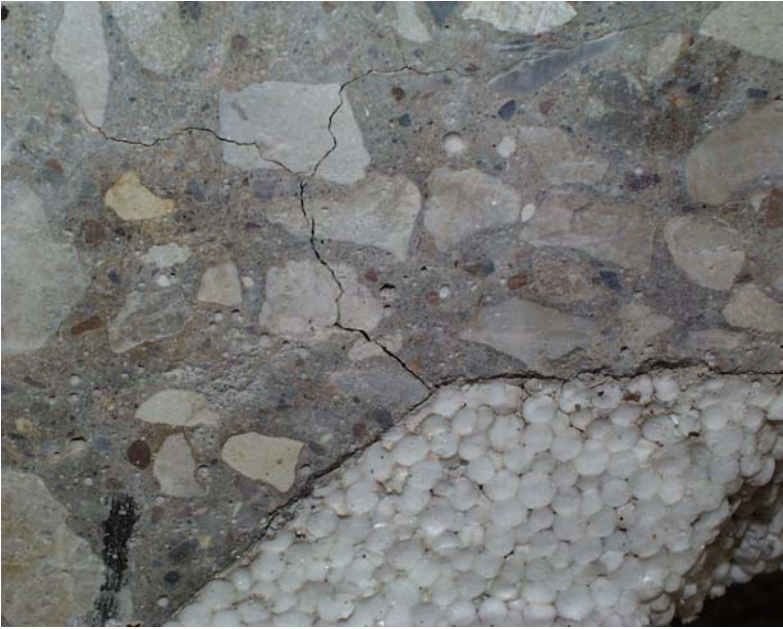
**Figure 3.13: Cracks at left inner corner of Slice BG1S**

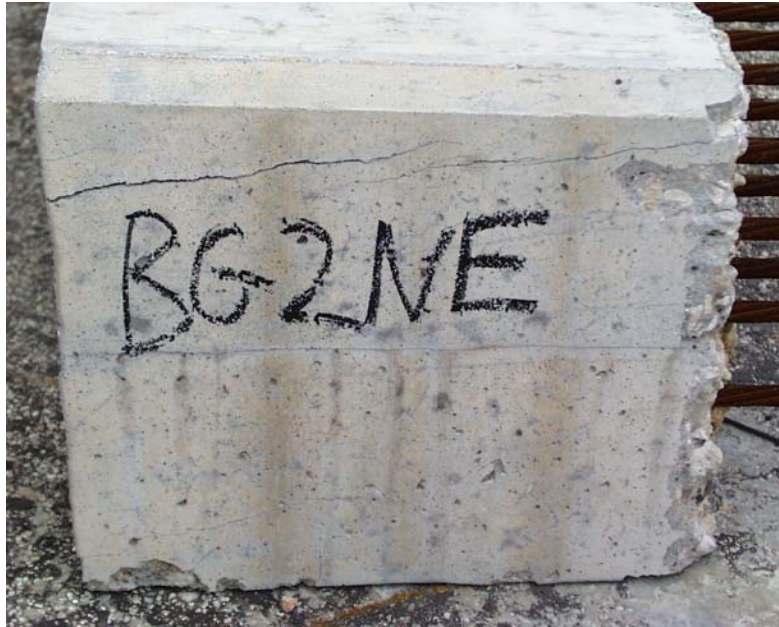
**Figure 3.14: Cracking on right face of Slice BG2N**

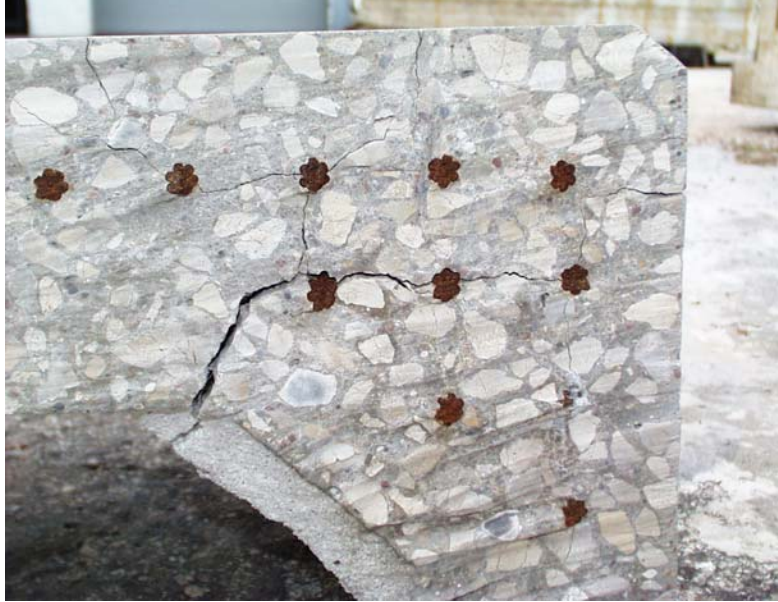
**Figure 3.15: Large cracks in back face of Slice BG2N**

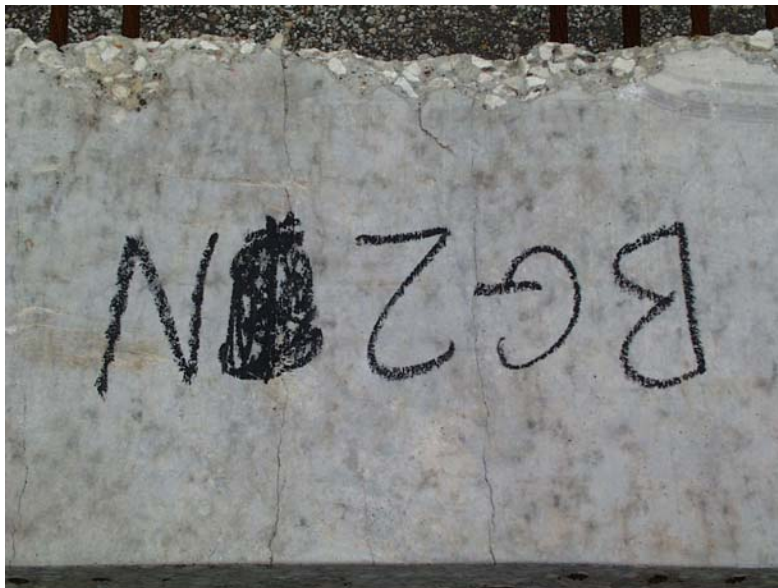
**Figure 3.16: Cracking on middle of bottom face of Slice BG2N**

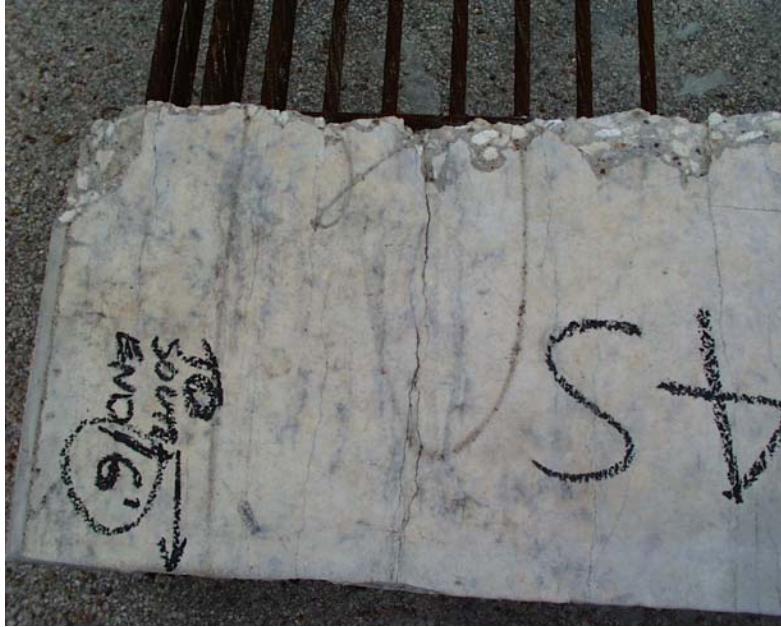
**Figure 3.17: Cracking on bottom face of Slice BG4S1**

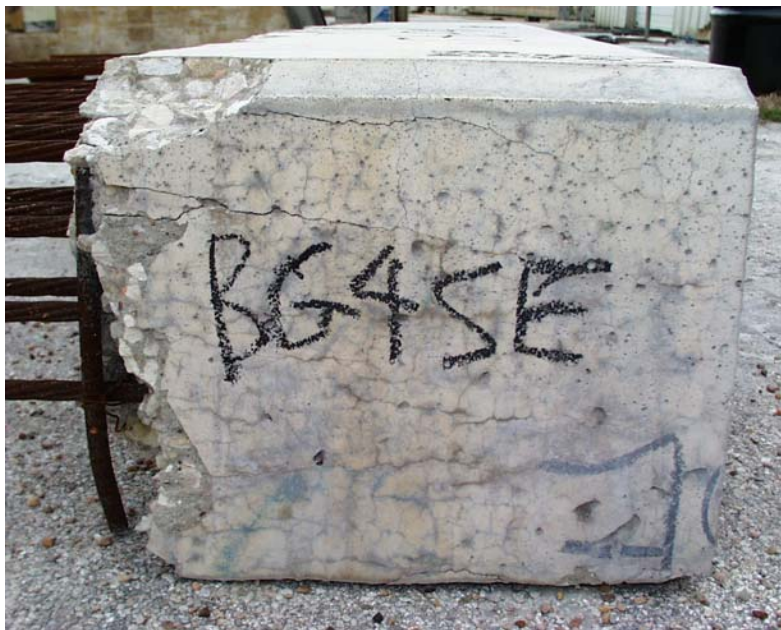
**Figure 3.18: Cracking on left face of Slice BG4S1**

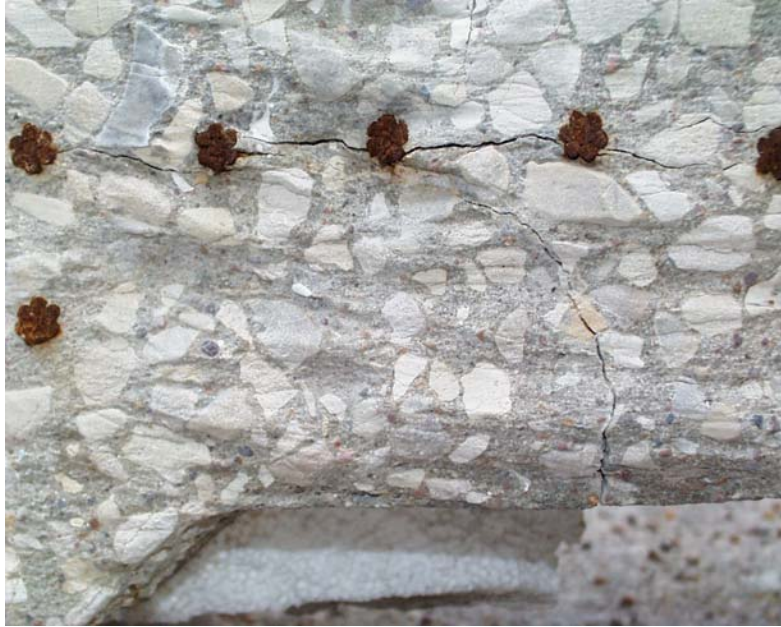
**Figure 3.19: Damage to cross section of Slice BG4S1 (back face)**

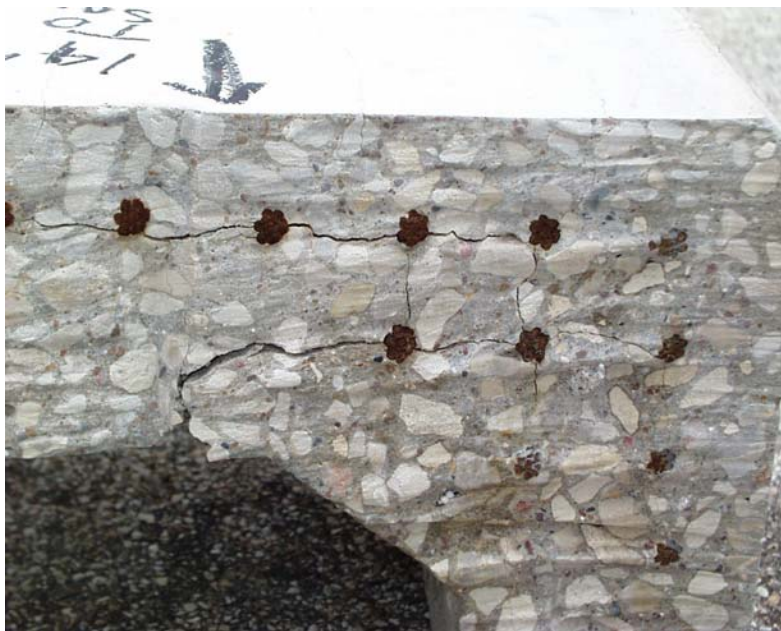
**Figure 3.20: Cracking in back face of Slice BG4S2**

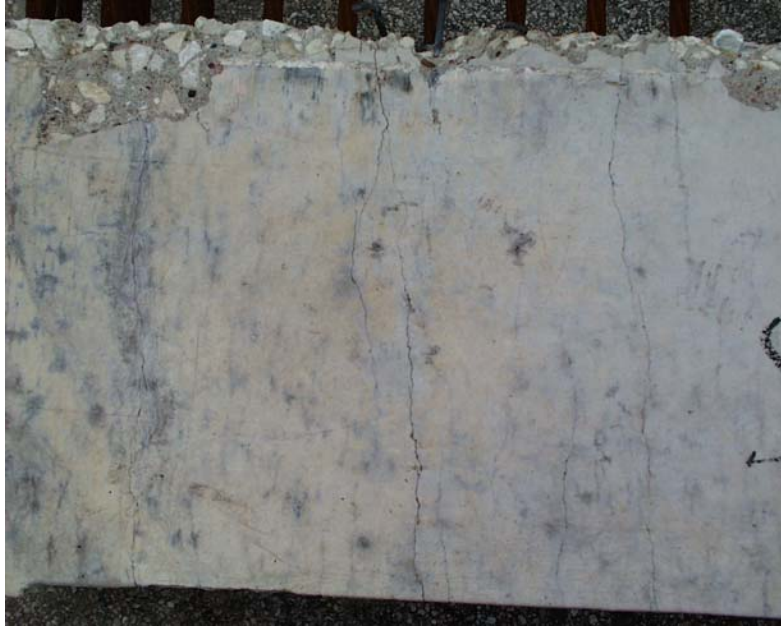
**Figure 3.21: Cracking on bottom face of Slice BG4S2**

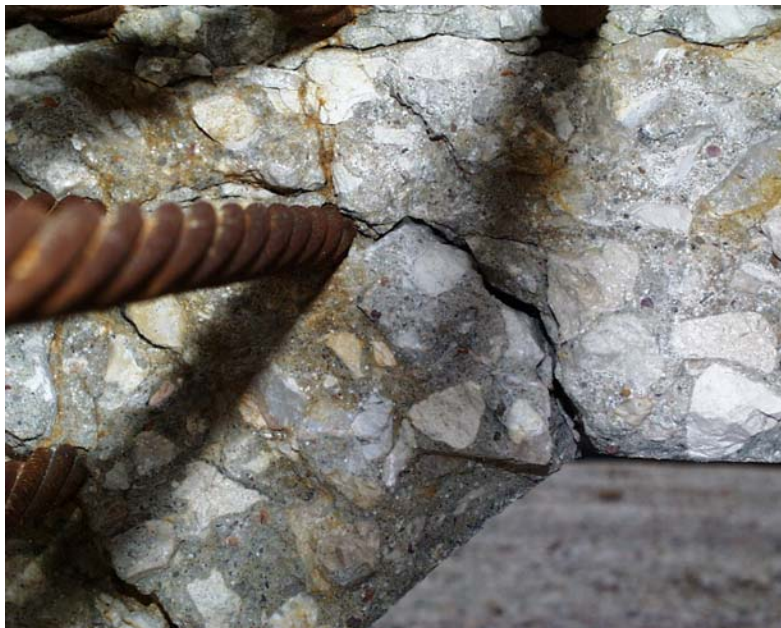
**Figure 3.22: Front view of right inside corner of Slice BG4S2**

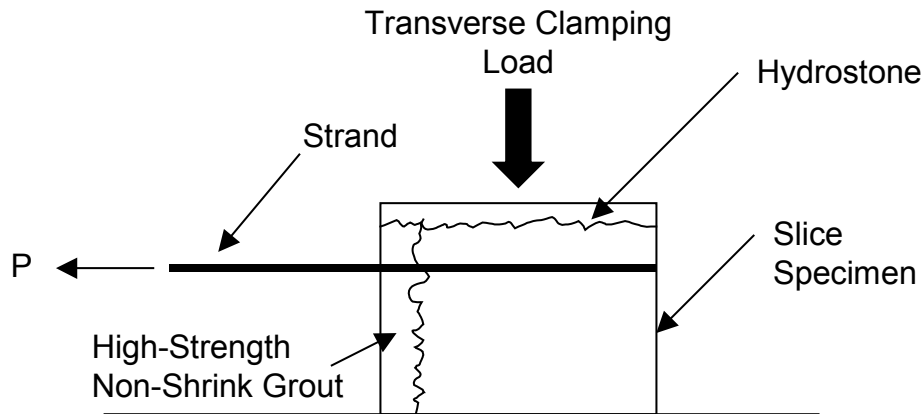
Figure 3.23: Test setup to mimic service conditions in a solid end block

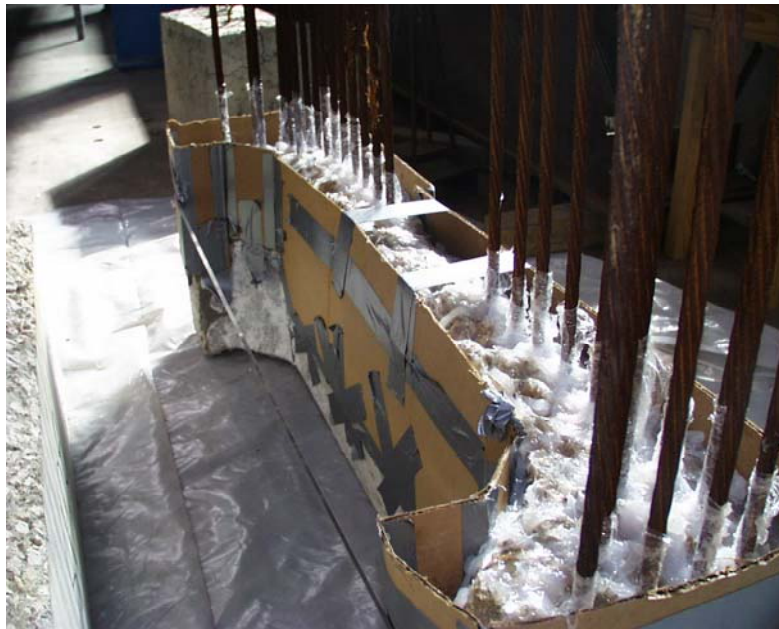
**Figure 3.24: Cardboard formwork used for front face**

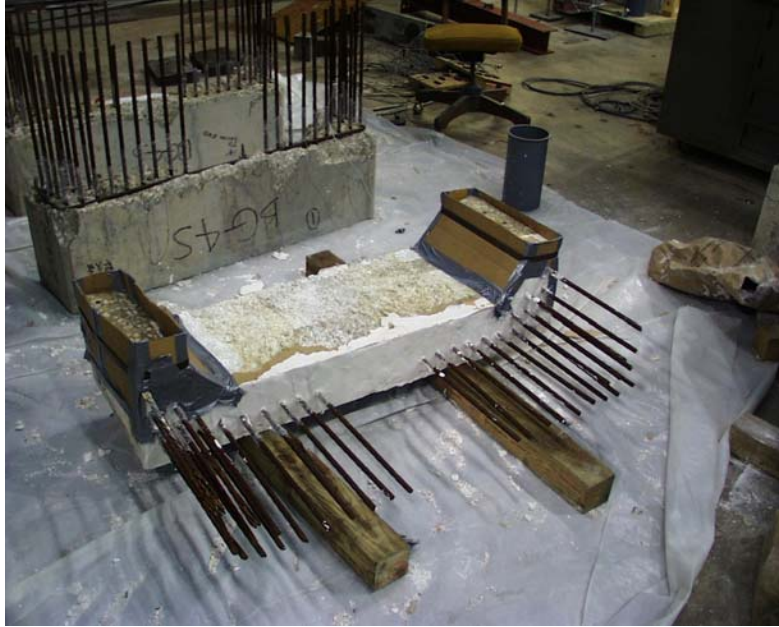
**Figure 3.25: Formwork for web sections**

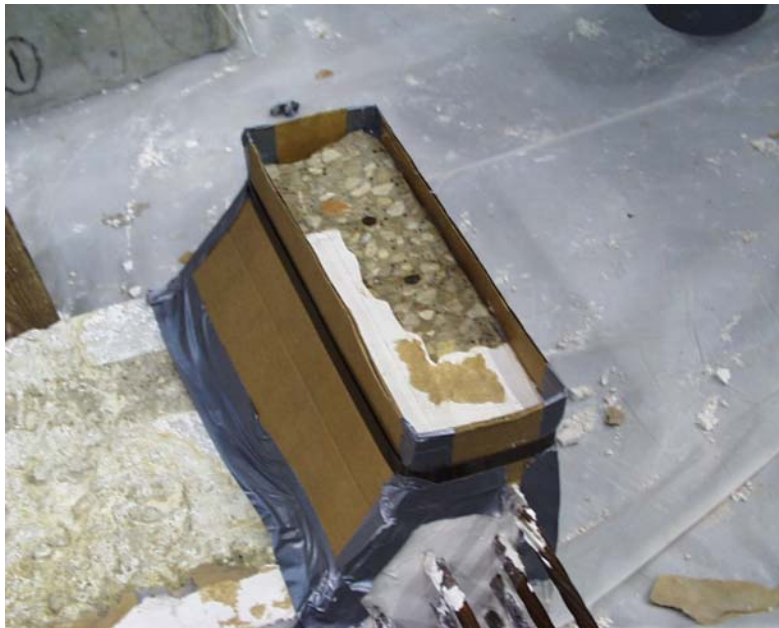
**Figure 3.26: Cardboard formwork for top of web**

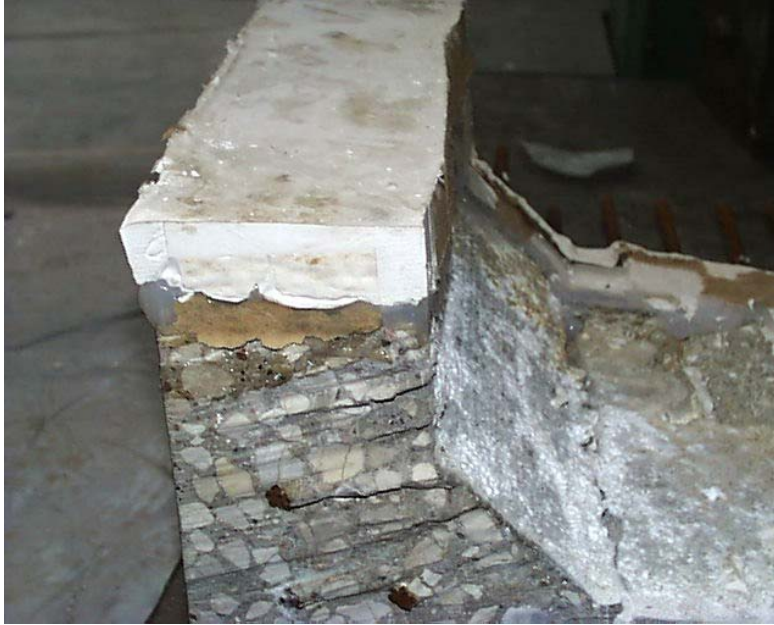
**Figure 3.27** Level Hydrostone bearing surface on top of web section

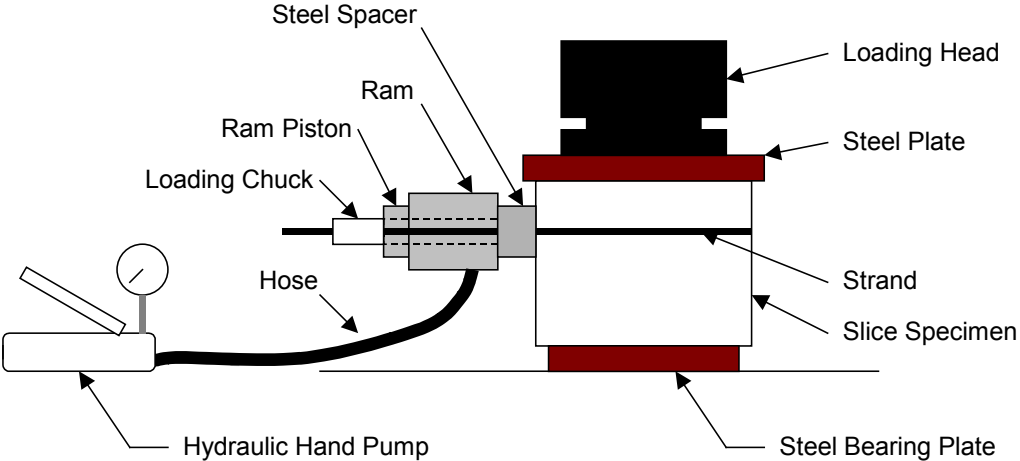
**Figure 3.28: Schematic drawing of test setup**

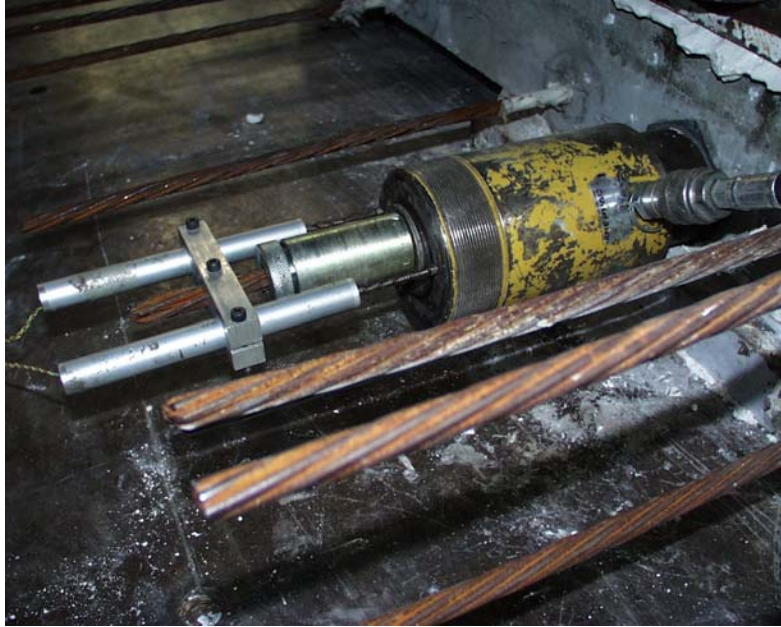
**Figure 3.33: Linear potentiometers at loaded end**

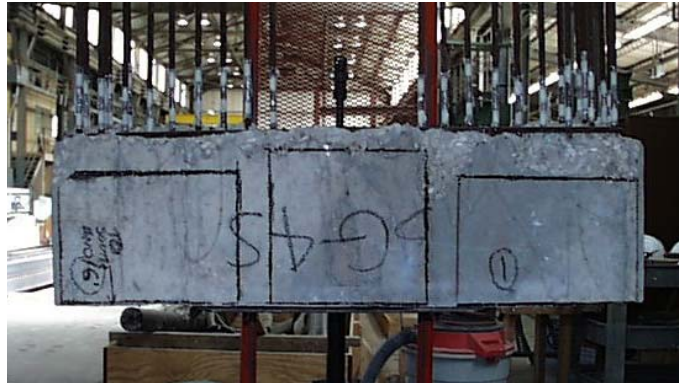
**Figure 3.36: Representative areas for bottom face damage indices**

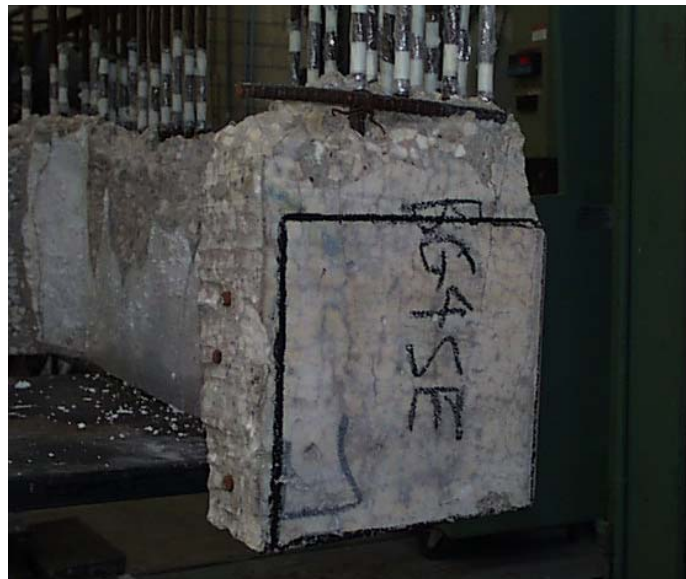
**Figure 3.37: Representative square for left side damage index**

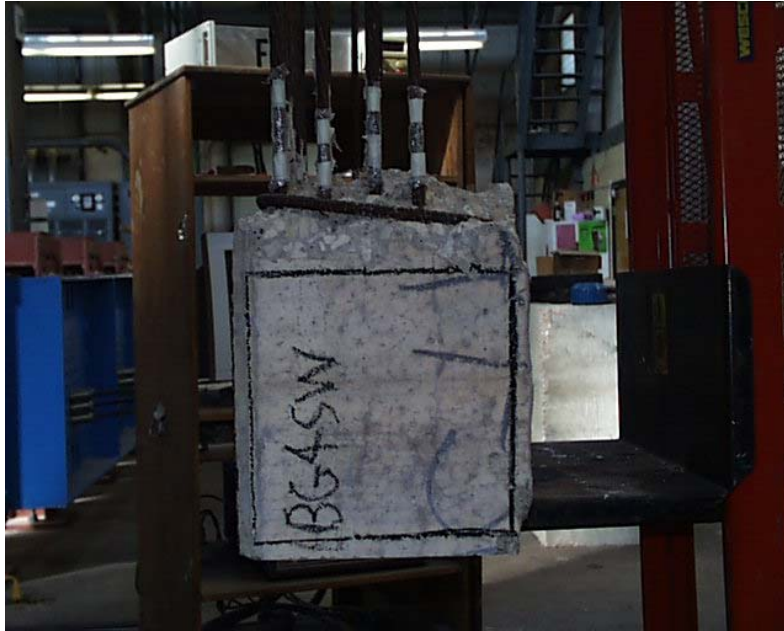
**Figure 3.38: Representative square for right side damage index**

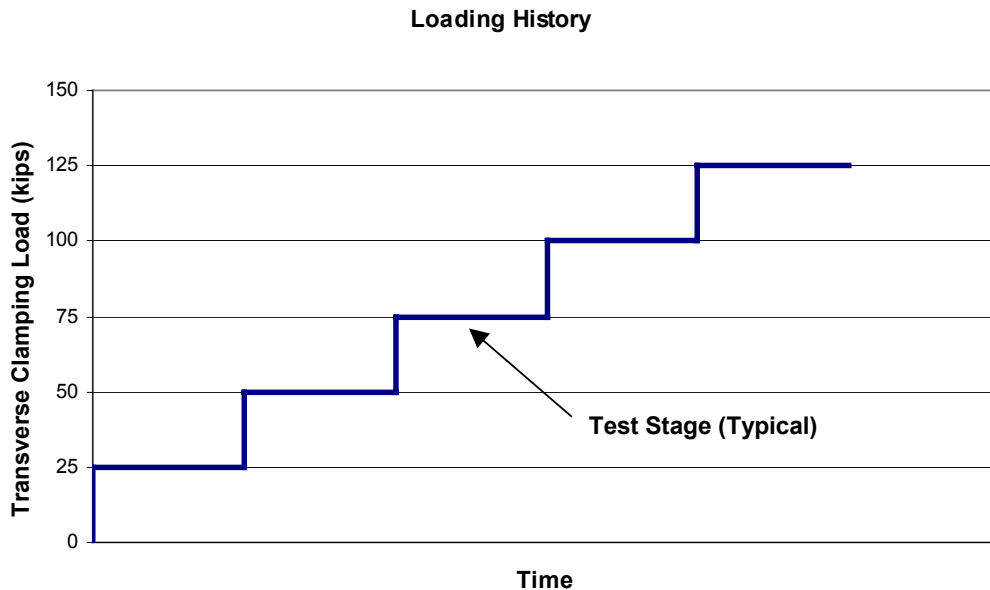
**Figure 4.1: Loading history for strand-pullout tests**

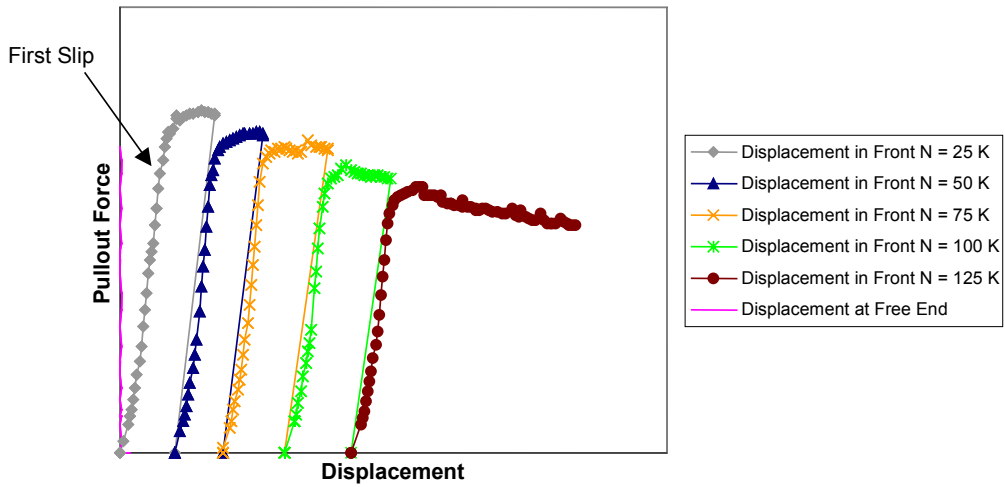
**Figure 4.3: Identifying first slip without reliable free-end data**

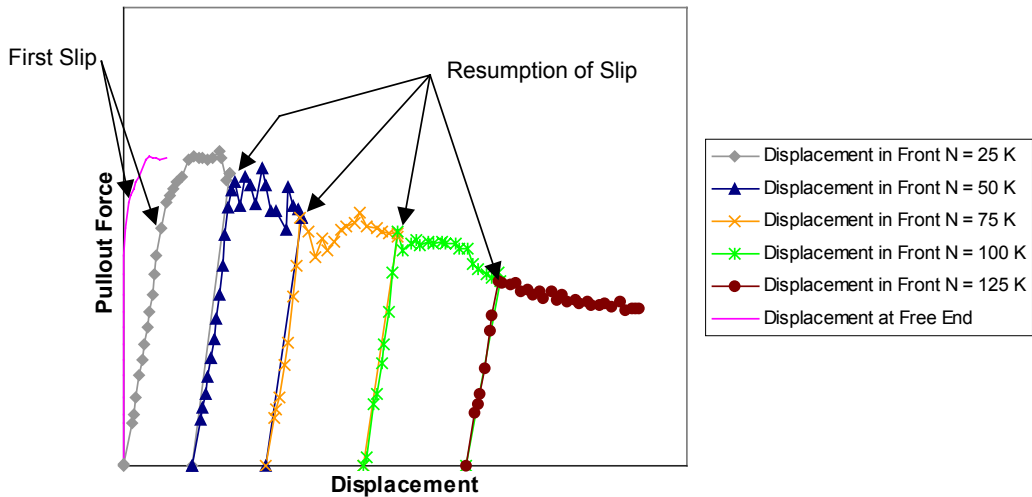
**Figure 4.4: Identifying resumption of slip without reliable free-end data**

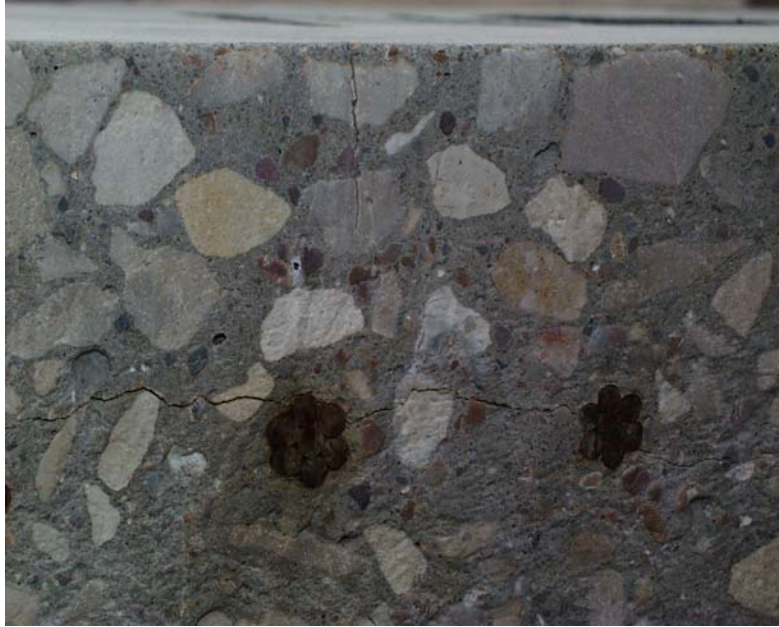
**Figure 4.5: Back view of Strand BG2N\_8L (right) and Strand BG2N\_9L (left)**

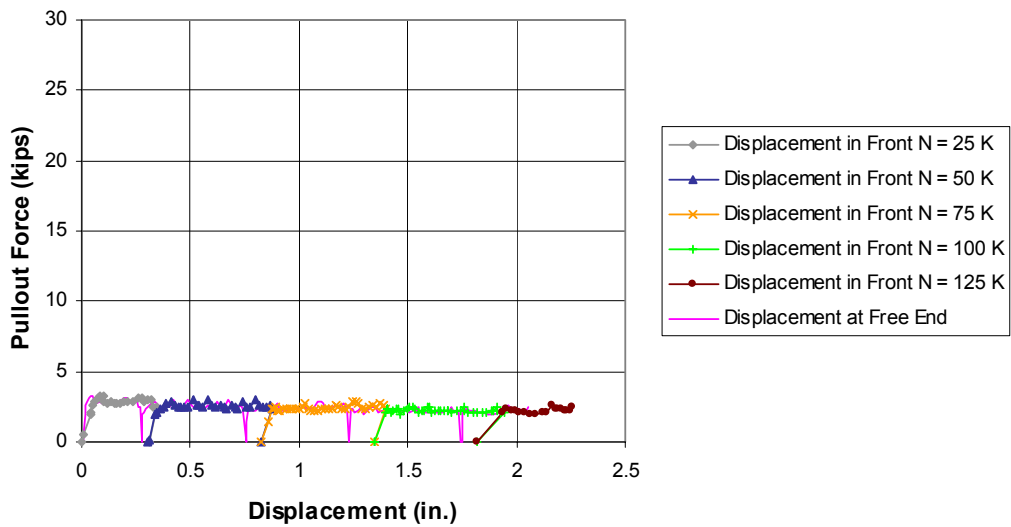
**Figure 4.6: Load-displacement Relationship for Strand BG2N\_8L**

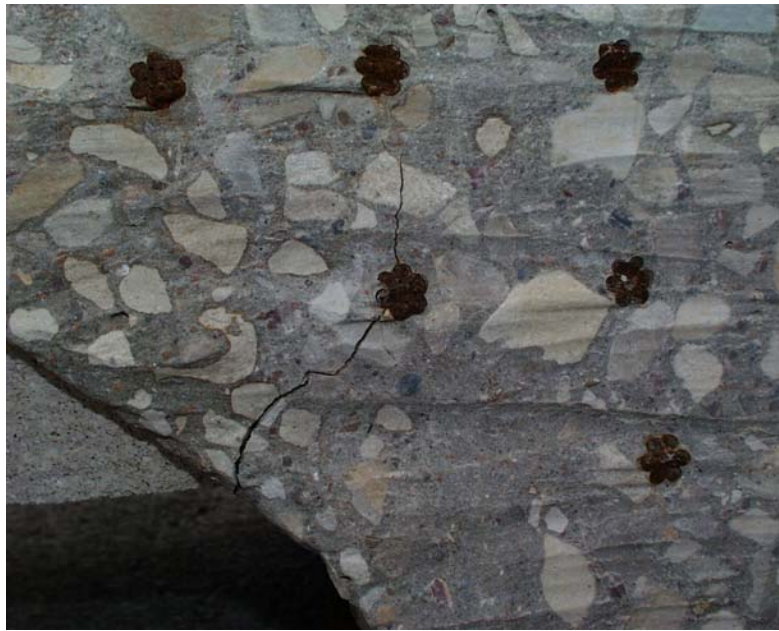
**Figure 4.7: Crack in back of Slice BG4S1 at Strand 17R (Center)**

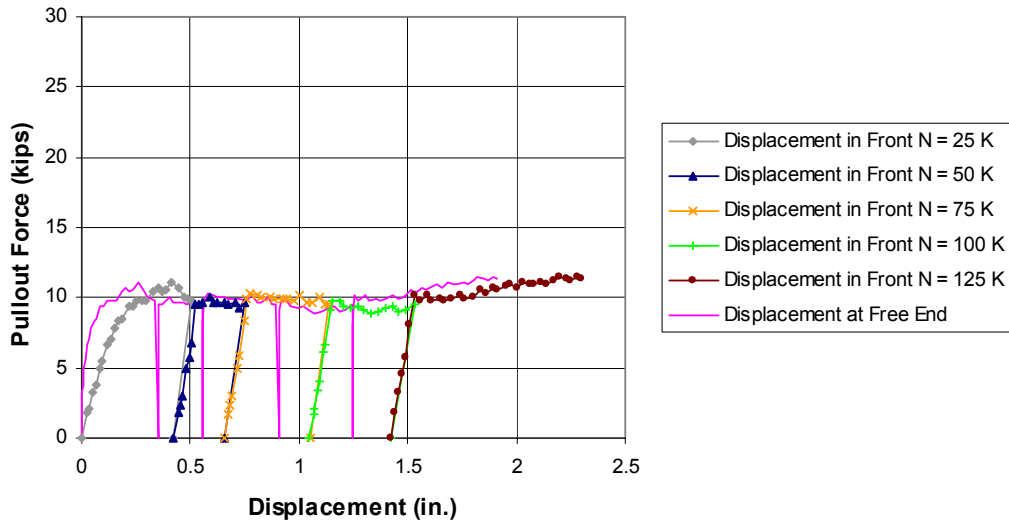
**Figure 4.8: Load-displacement Relationship for Strand BG4S1\_17R**

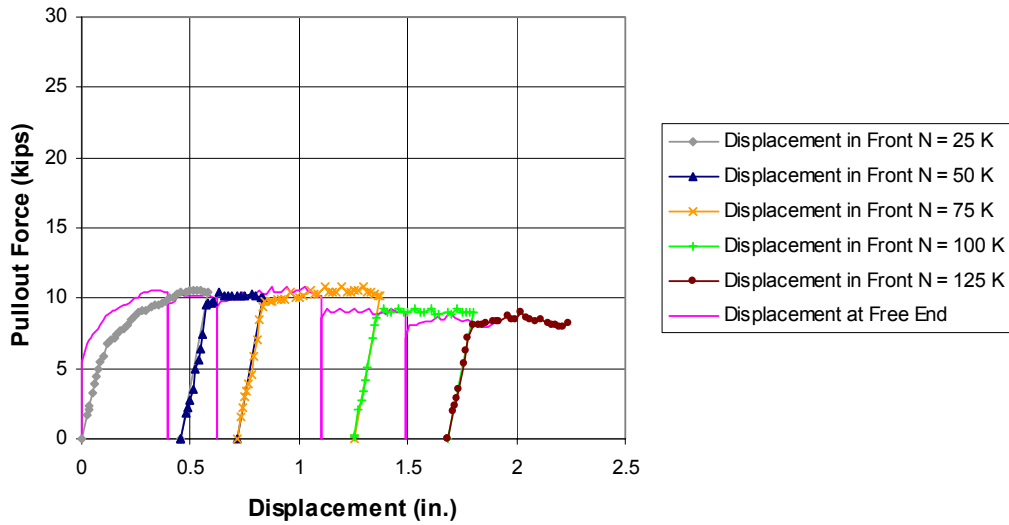
**Figure 4.9: Load-displacement Relationship for Strand BG4S2\_1L**

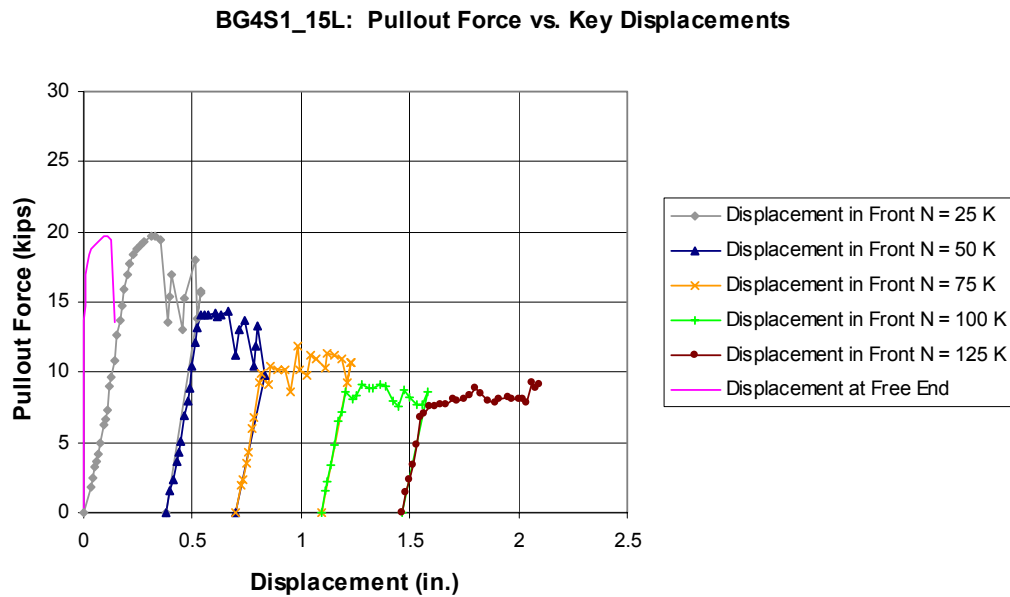
**Figure 4.10: Load-displacement Relationship for Strand BG4S1\_15L**

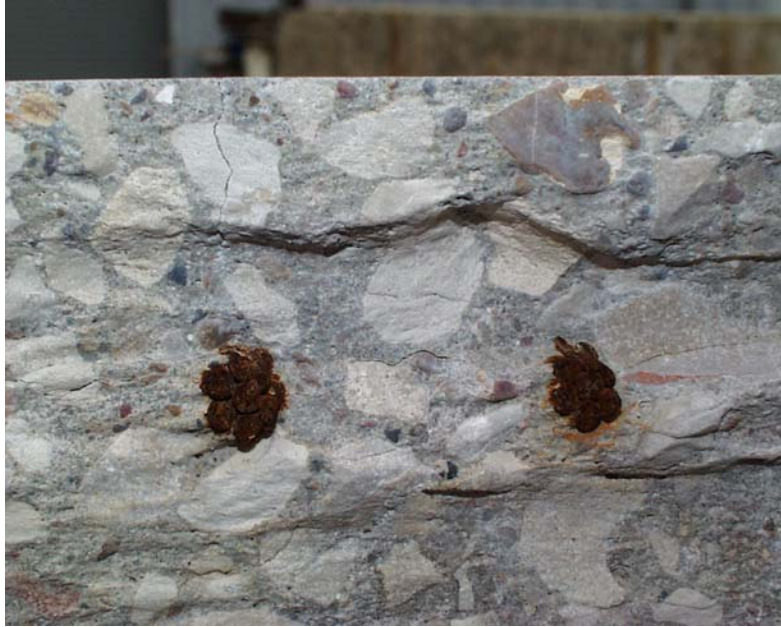
**Figure 4.11: Back view of Strand BG4S1\_4R (right) and Strand BG4S1\_5R (left)**

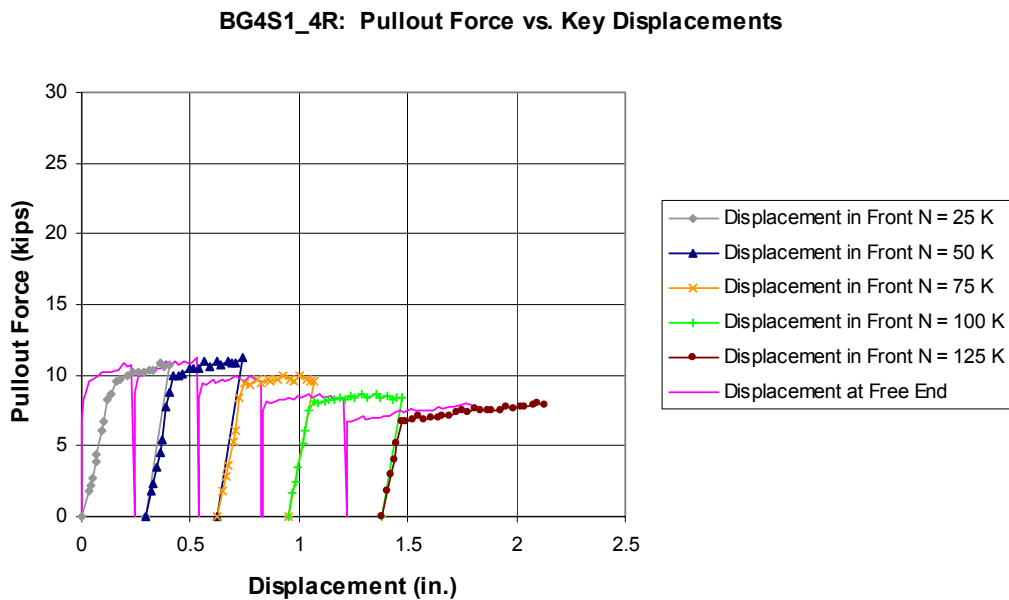
**Figure 4.12: Load-displacement Relationship for Strand BG4S1\_4R**

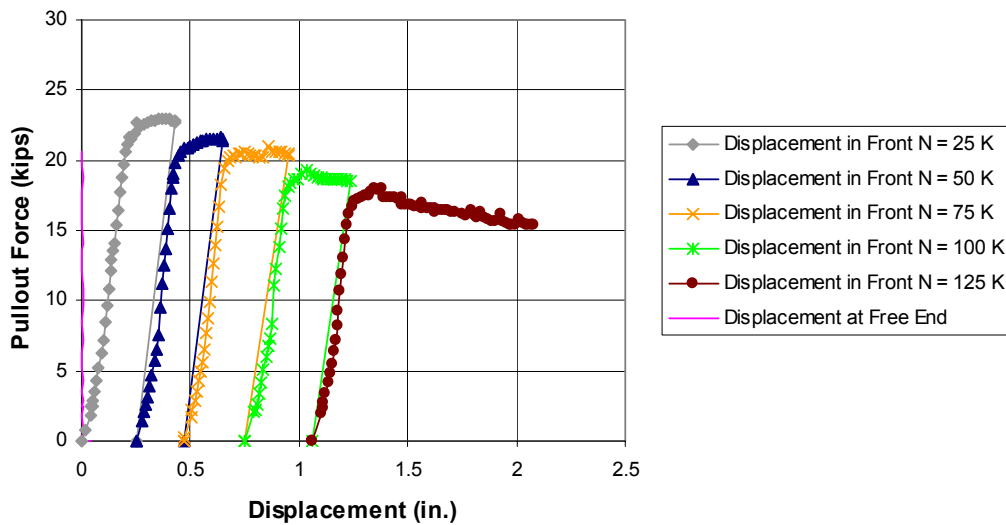
**Figure 4.13: Load-displacement Relationship for Strand BG2N\_9R**

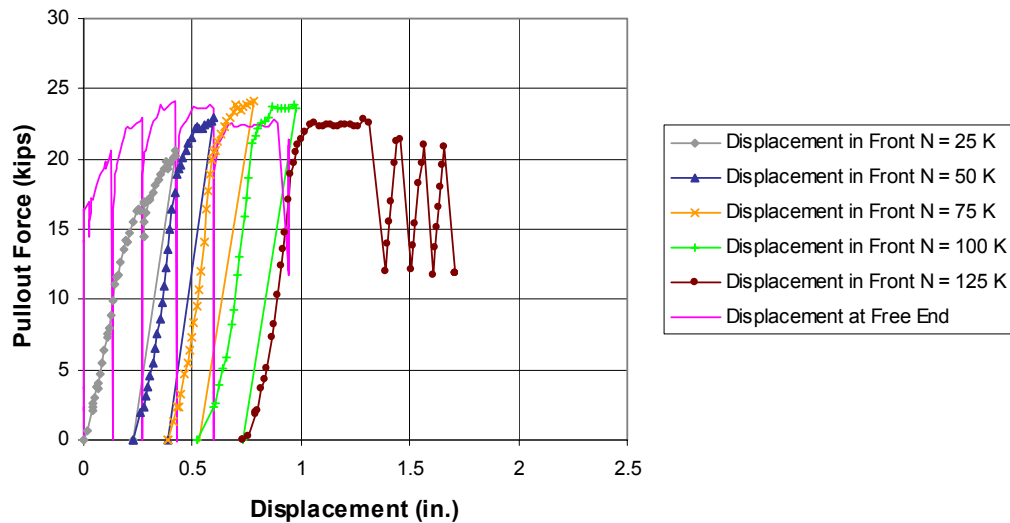
**Figure 4.14: Load-displacement Relationship for Strand BG1S\_13R**

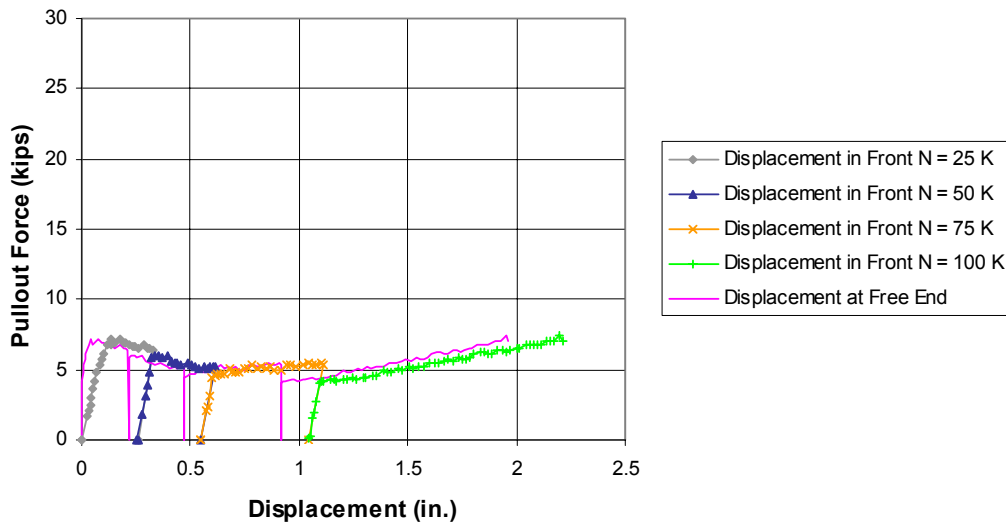
**Figure 4.15: Load-displacement Relationship for Strand BG2N\_2R**

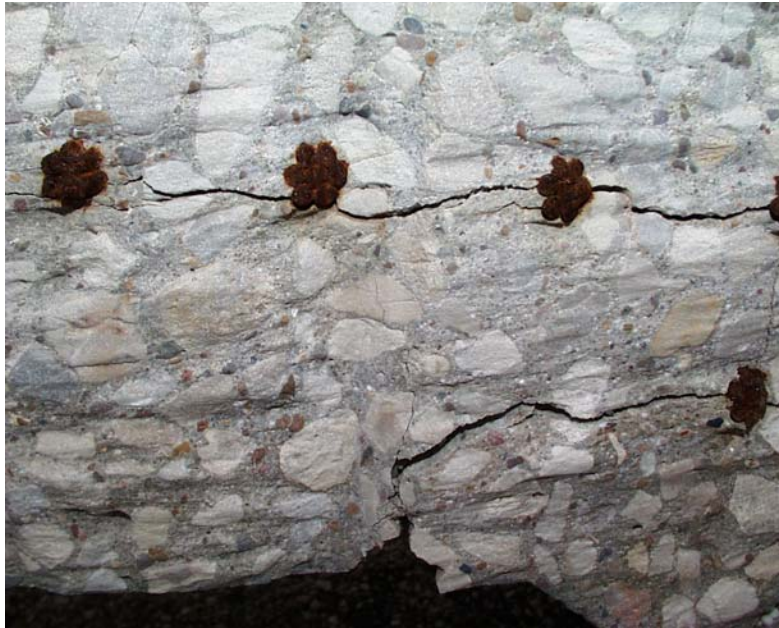
**Figure 4.16: Back View of Strand BG4S2\_5R (Top Row, Second From Left)**

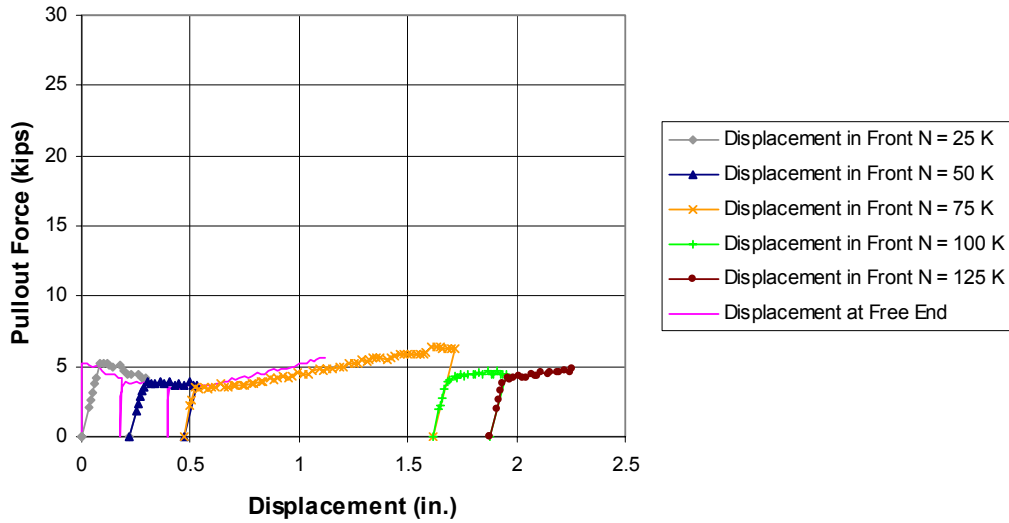
**Figure 4.17: Load-displacement Relationship for Strand BG4S2\_5R**

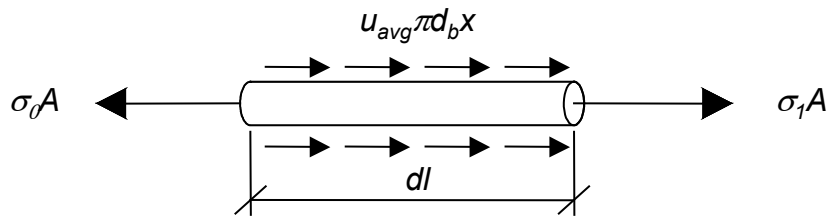
**Figure 5.2: Free-body diagram of a smooth bar in concrete**

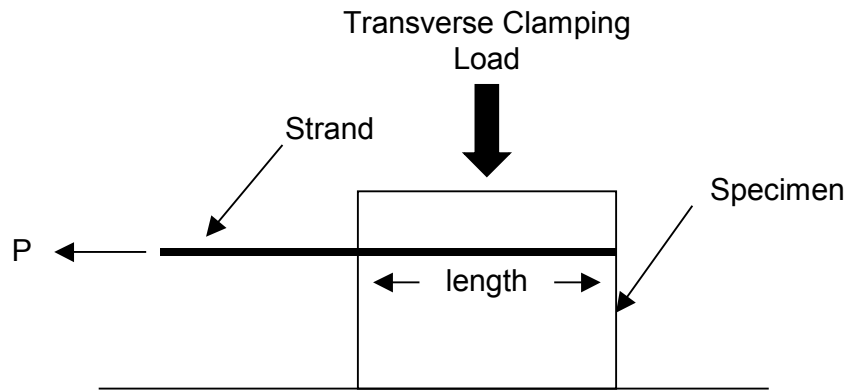
**Figure 5.3:** Experimental setup used to determine  $u_{avg}$

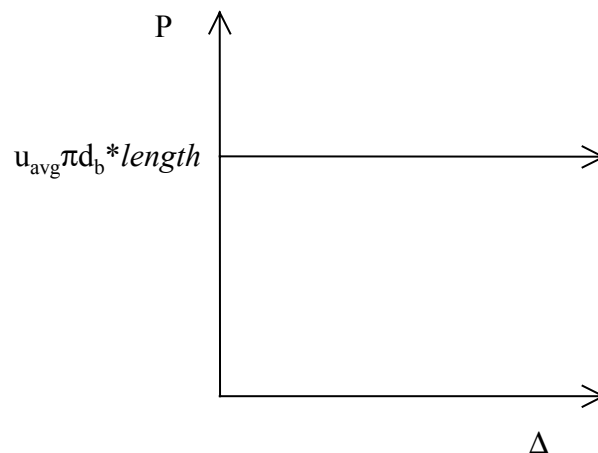
**Figure 5.4:** Load-displacement relationship assuming uniform bond stress

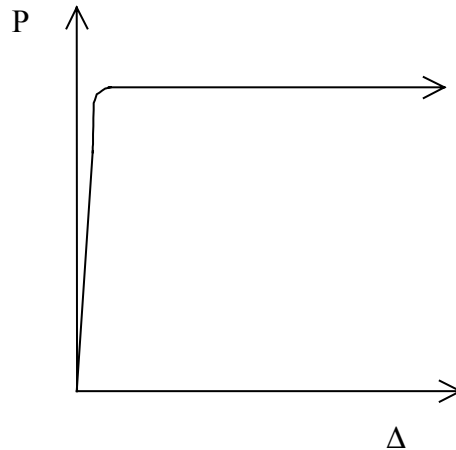
**Figure 5.5: Approximate load-displacement relationship for bond mechanism**

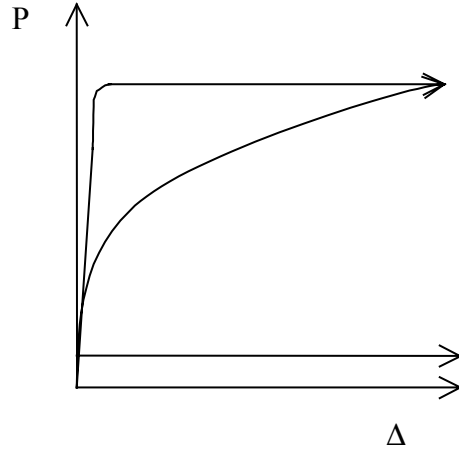
**Figure 5.9: Superposition of the three independent mechanisms**

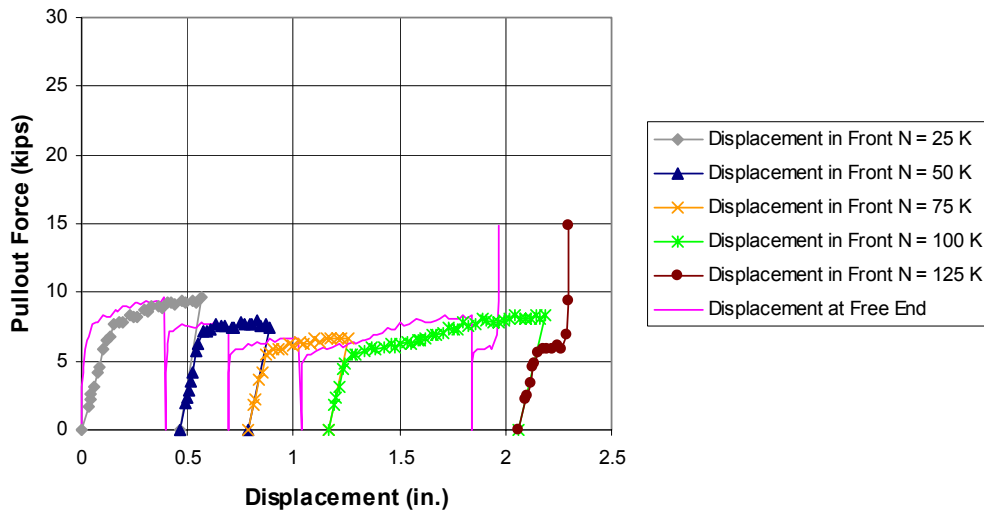
**Figure 5.10: Load-displacement Relationship for Strand BG4S2\_17R**

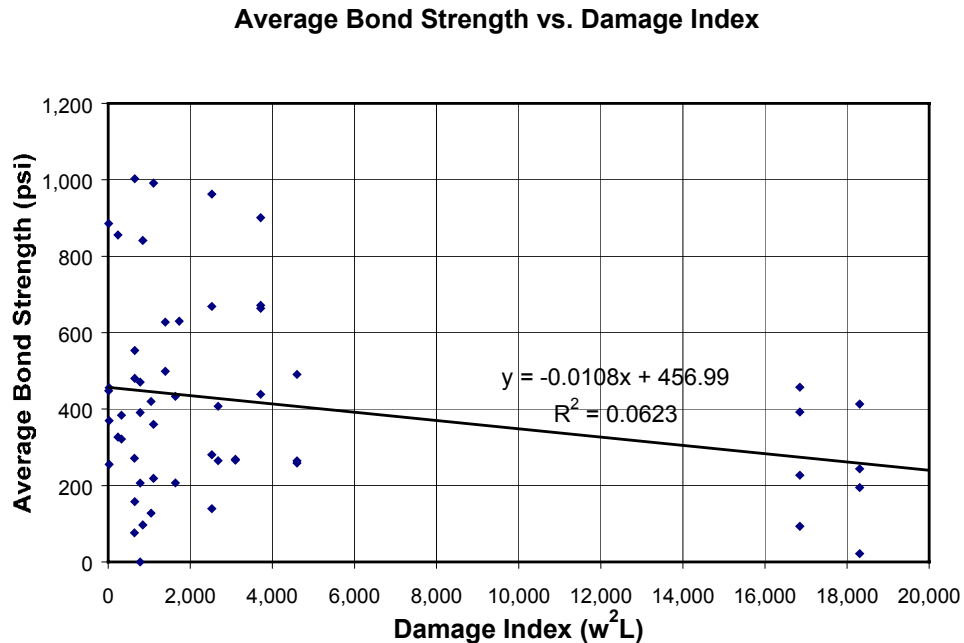
**Figure 5.11: Average bond strength vs. damage index for strand-pullout tests**
