6. Performing Organization Code	
7. Author(s) L. S. Memberg, R. E. Klingner, and T. J. Fowler				8. Performing Organization Report No. Research Report 0-1857-4

9. Performing Organization Name and Address Center for Transportation Research The University of Texas at Austin 3208 Red River, Suite 200 Austin, TX 78705-2650				10. Work Unit No. (TRAIS)

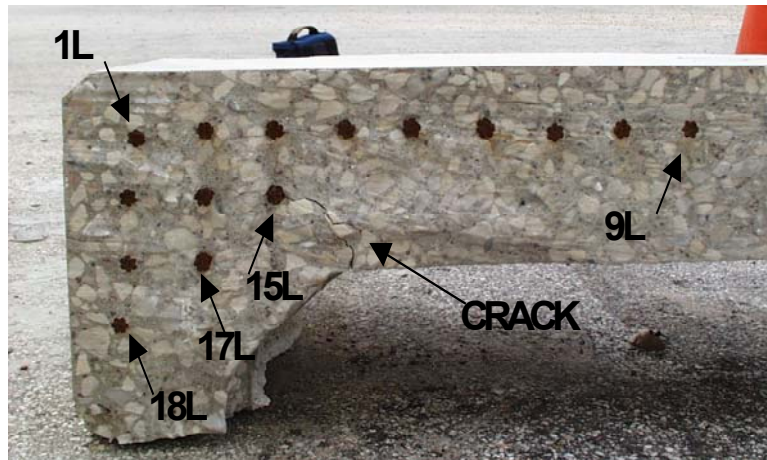
**Figure 5.12: Cracking in back face of Slice BG4S2**

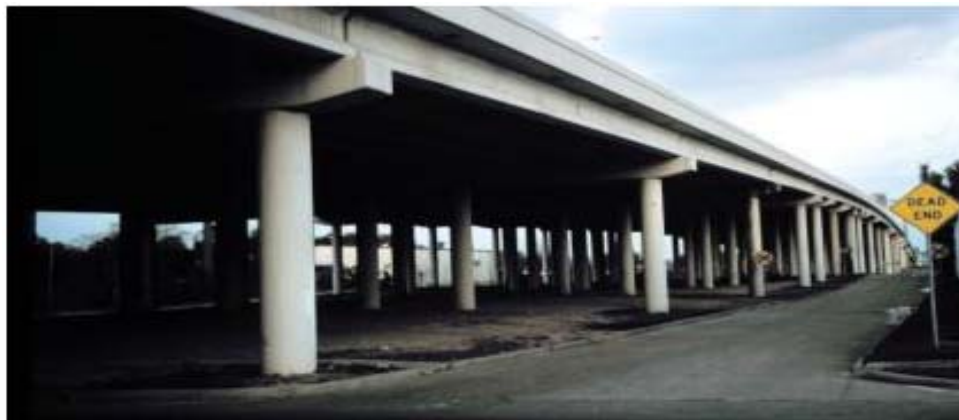
**Figure 6.1: I-10 over AT & SF RR in Beaumont, Texas (facing east)**

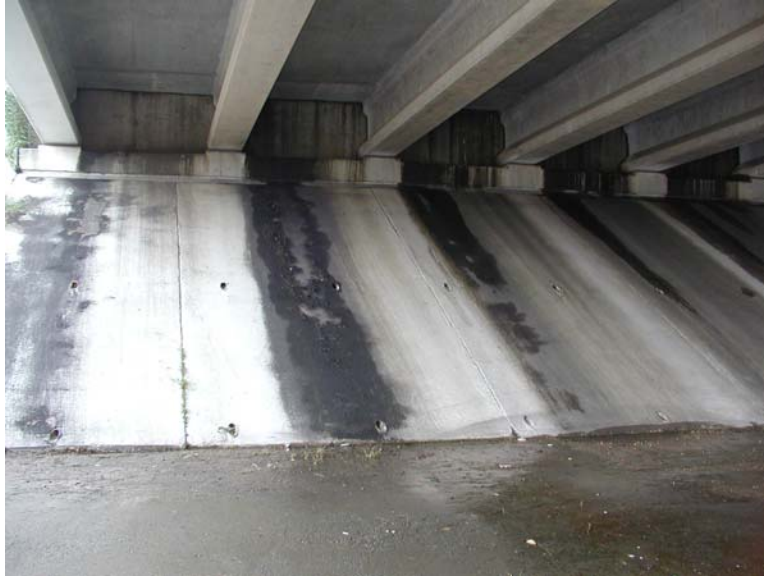
**Figure 6.2: Overview of West Abutment of I-10 structure in Beaumont, Texas**

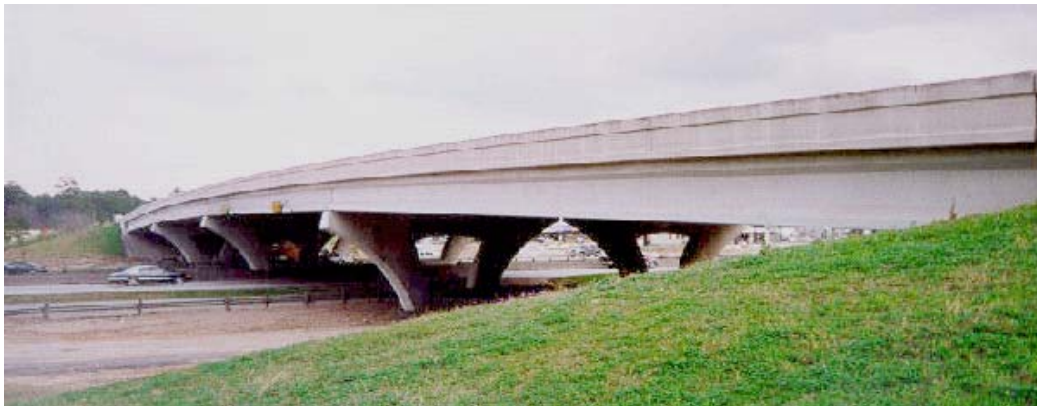
**Figure 6.5: Robinson Road over I-45 in The Woodlands, Texas**

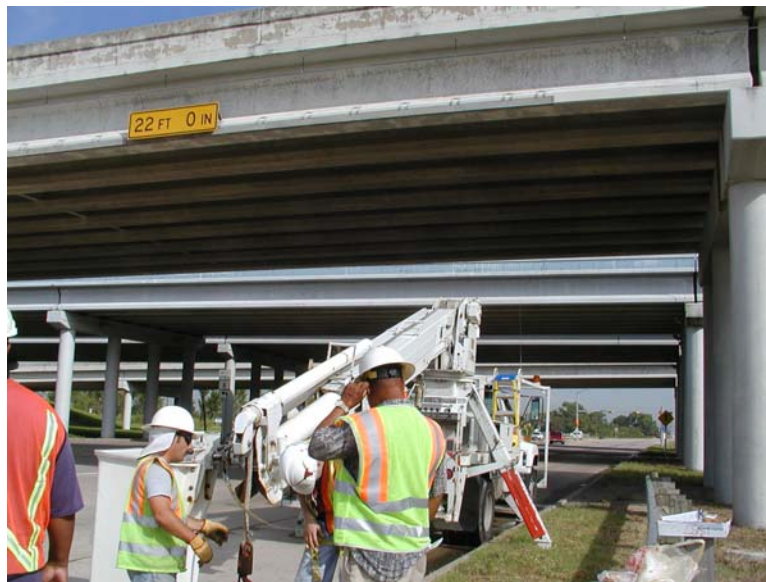
**Figure 6.7: Beltway 8 over State Highway 3, Houston, Texas (facing north)**

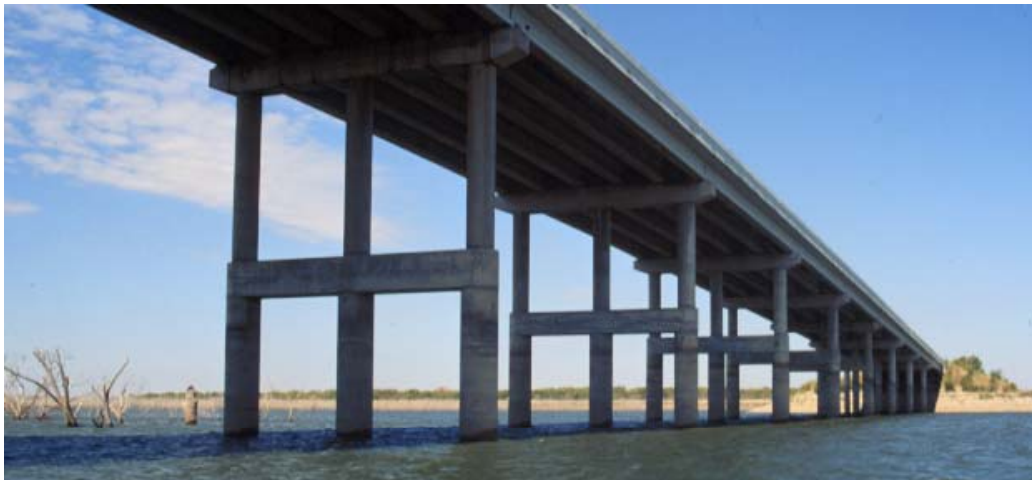
**Figure 6.9: FM 1929 over the Lake Ivie Reservoir in Concho, Texas (facing west)**

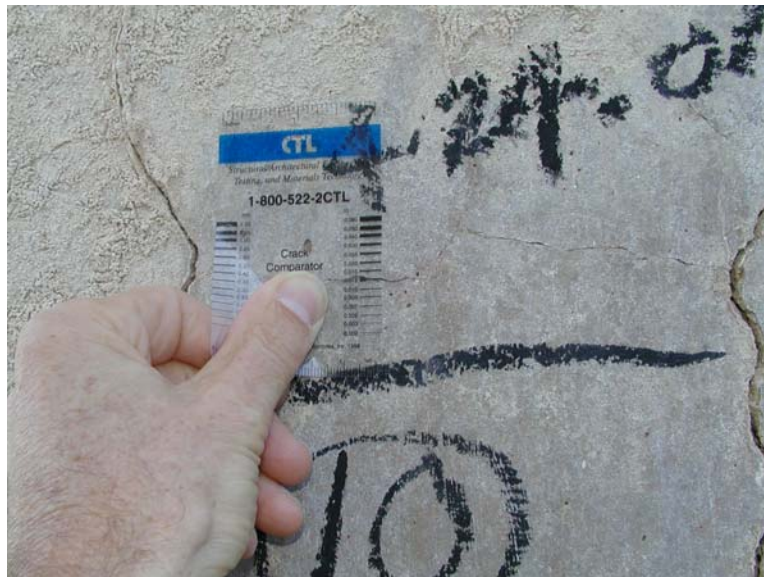
Figure 6.10: Crack comparator card

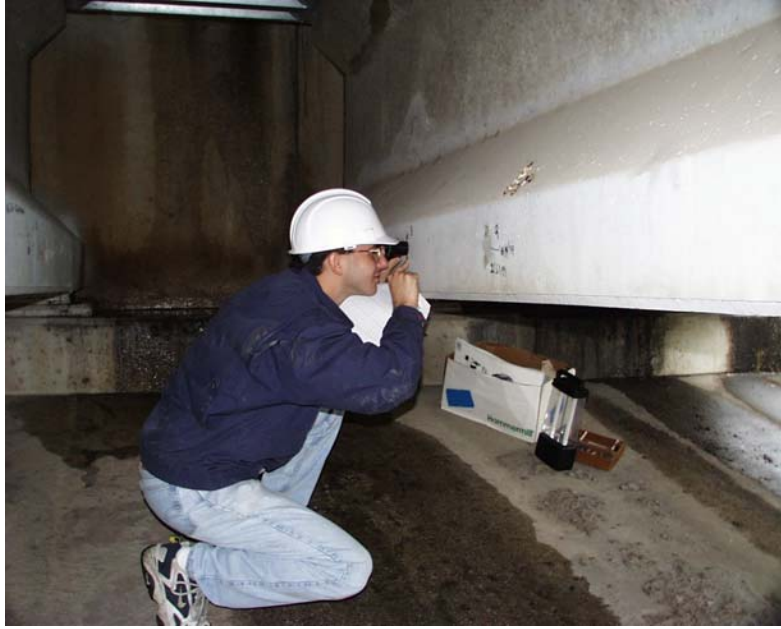
**Figure 6.11: Measuring crack widths with optical scope**

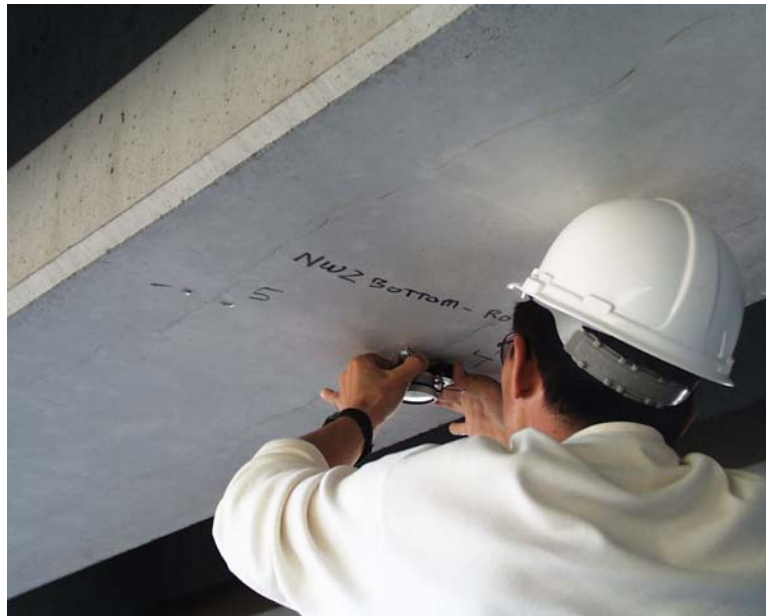
**Figure 6.12: Taking readings with Demec gauge**

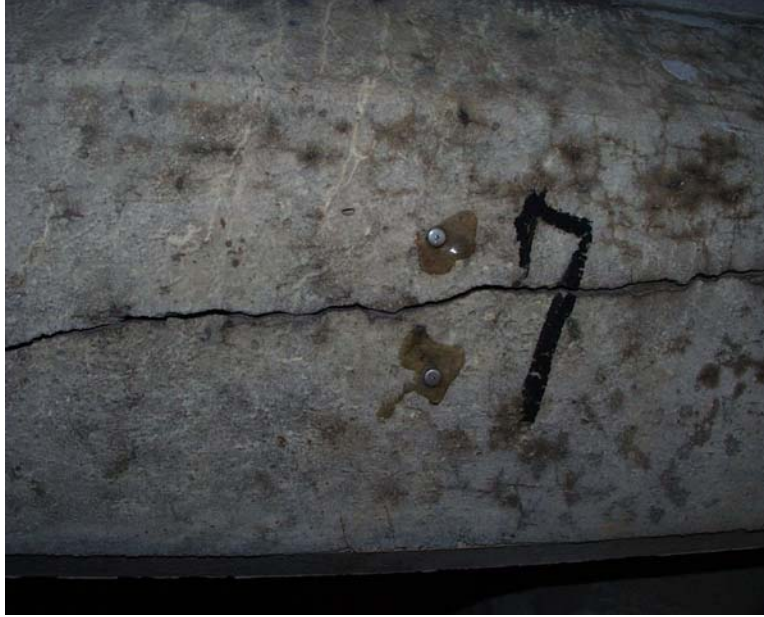
**Figure 6.13: One set of Demec discs for monitoring crack width**

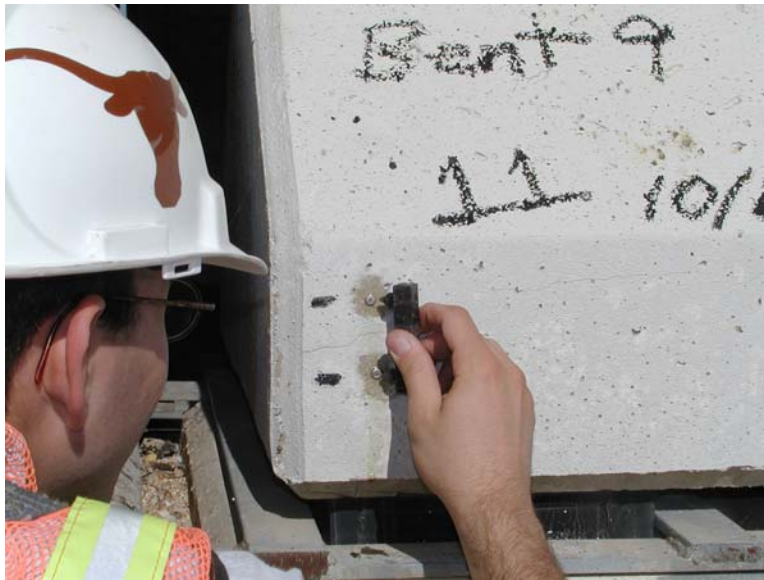
**Figure 6.14: Holding set of Demec discs in place with reference bar**

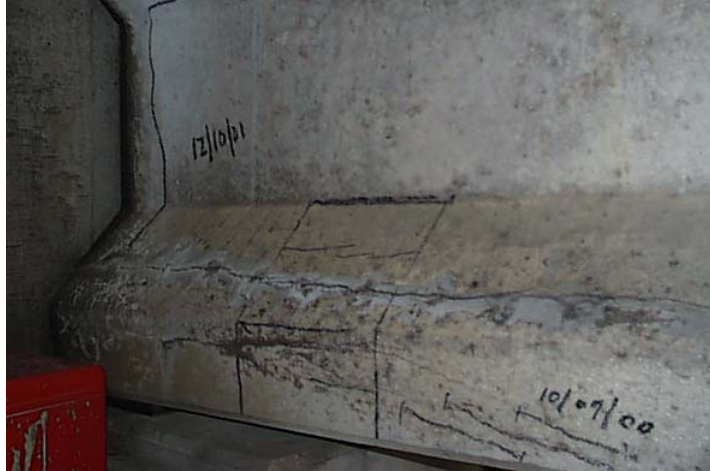
**Figure 6.15: Representative areas used for crack ratios, I-10 structure**

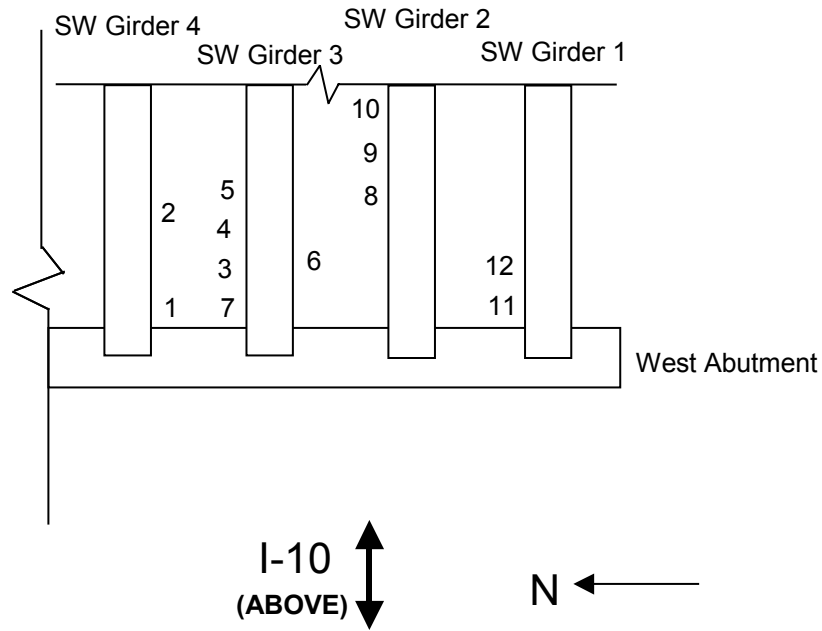
**Figure 7.2:** Schematic of crack-measurement locations on I-10 structure (plan view)

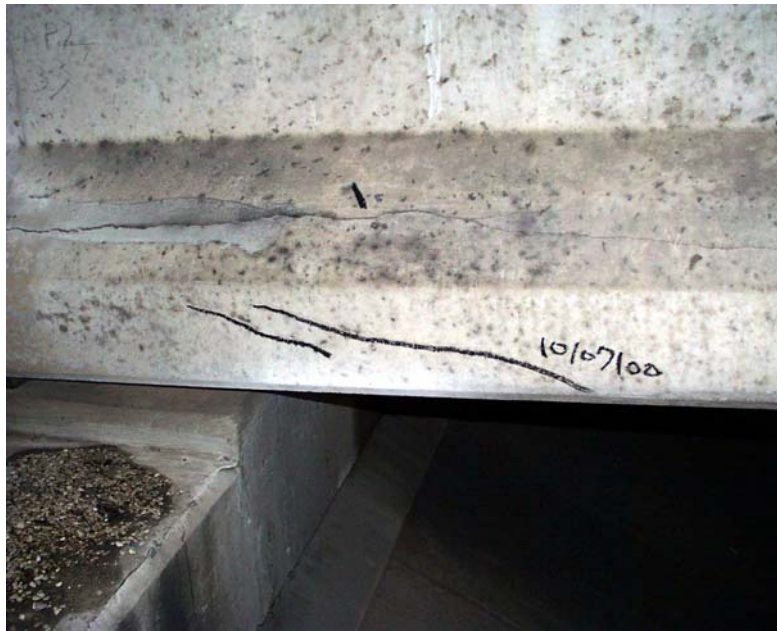
**Figure 7.3:** New diagonal cracks on I-10 SW Girder 4, Face 5 (10/7/00)

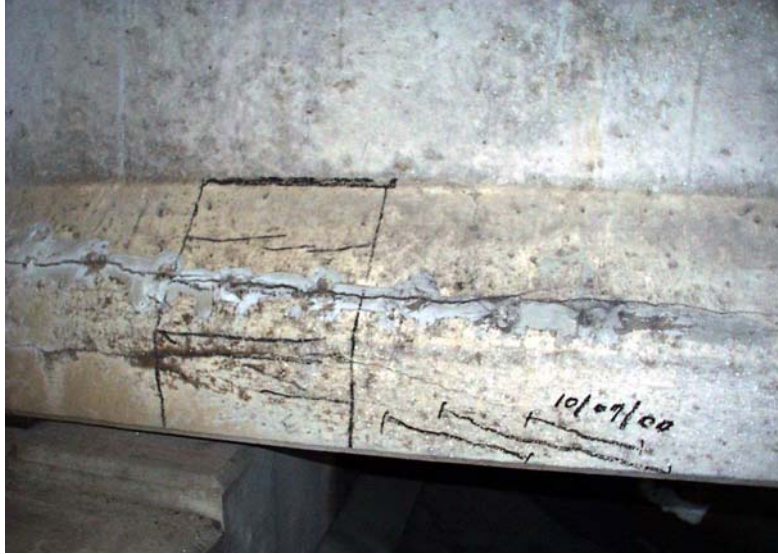
**Figure 7.4: Representative areas on I-10 SW Girder 2, south face (10/7/00)**

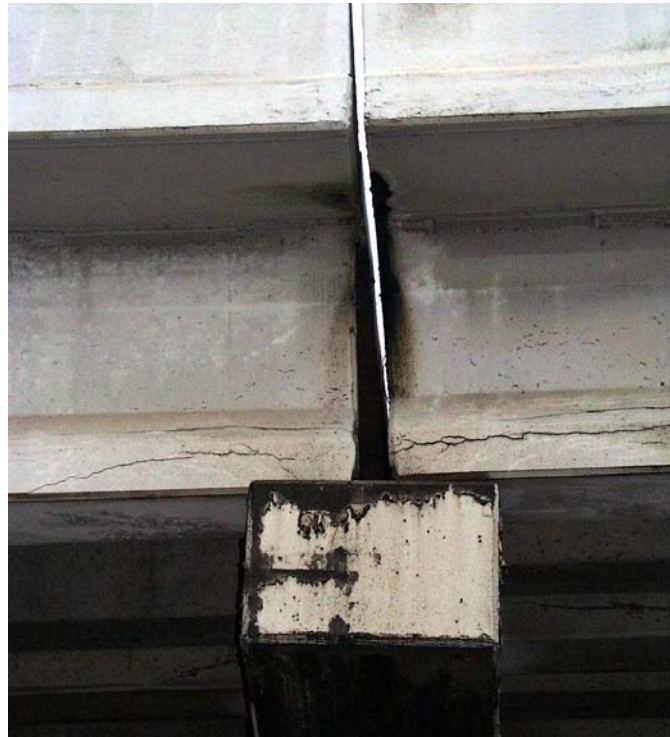
**Figure 7.5: Cracks at first bent east of west abutment, I-10 (10/7/00)**

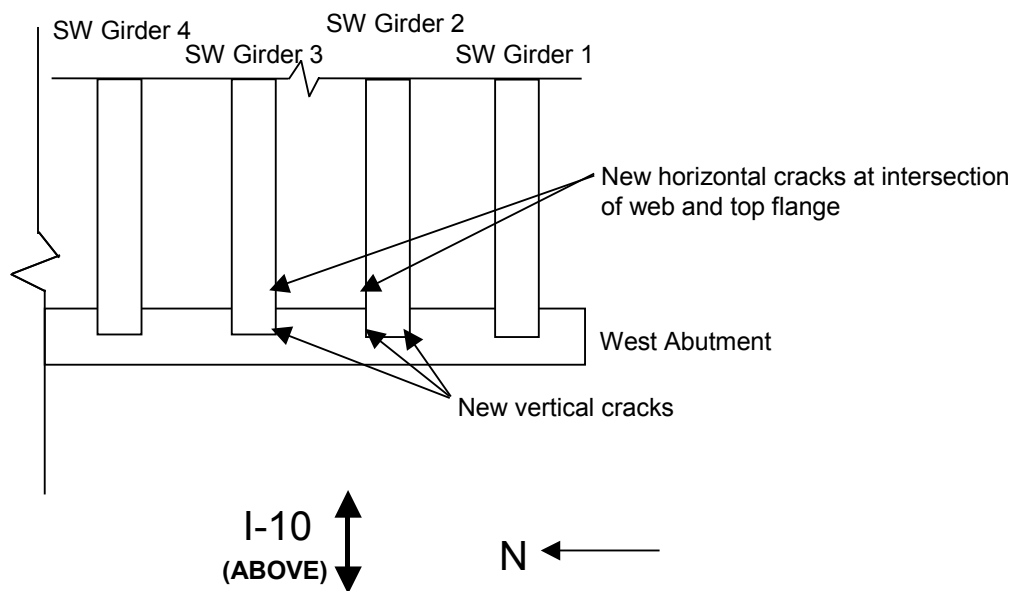
**Figure 7.6: Location of new cracks on I-10 structure (plan view) (12/10/01)**

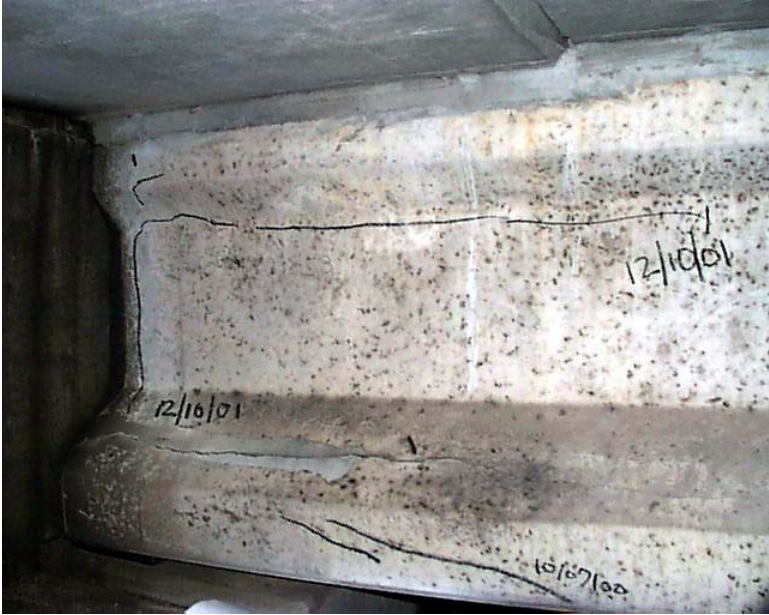
**Figure 7.7:** New cracks on south face of SW Girder 3 at west abutment, I-10 (12/10/01)

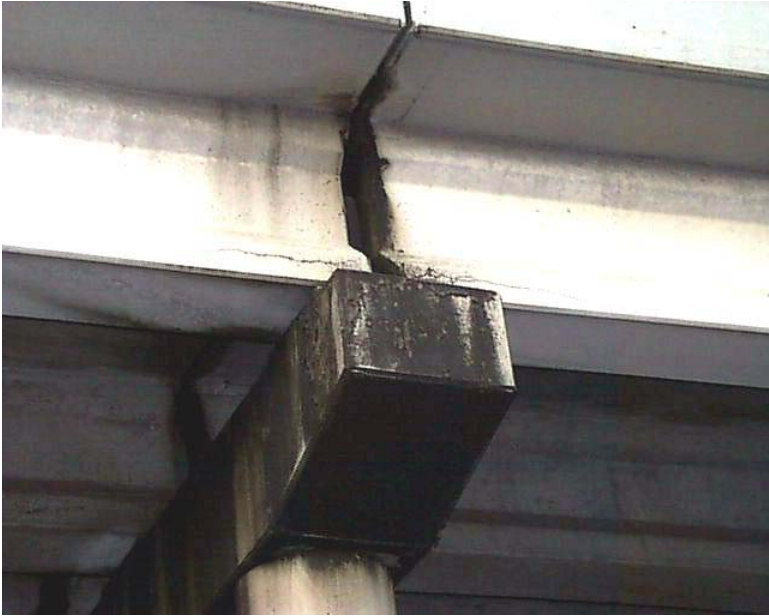
**Figure 7.8:** Cracks at first bent east of west abutment, I-10 (12/10/01)

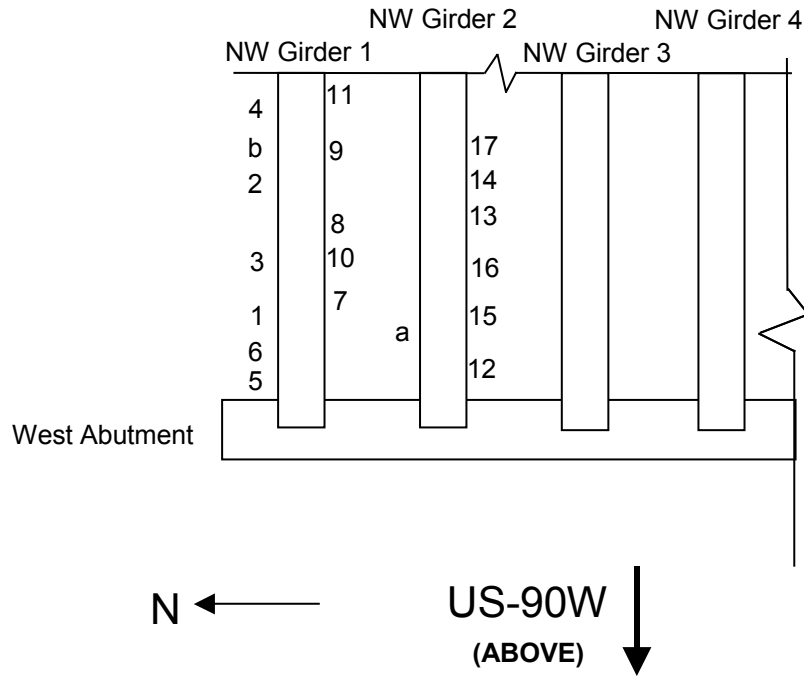
**Figure 7.9: Schematic of crack-measurement locations on US-90 structure (plan view)**

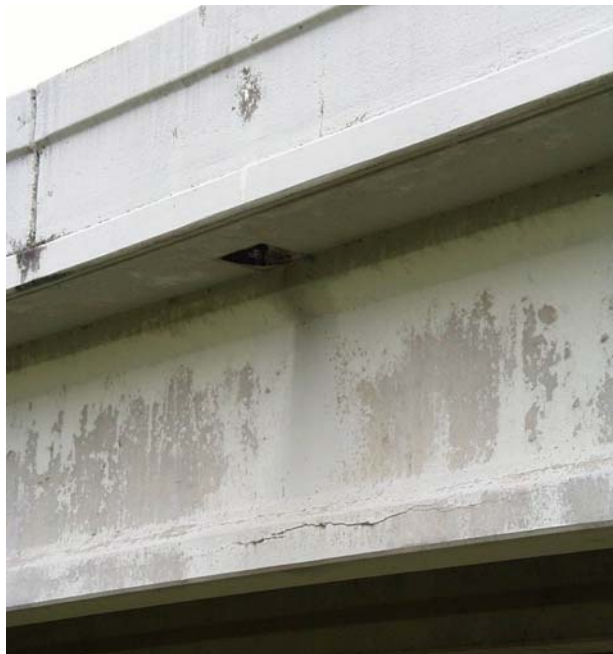
**Figure 7.10: Typical crack under drain at US-90 structure (10/6/00)**

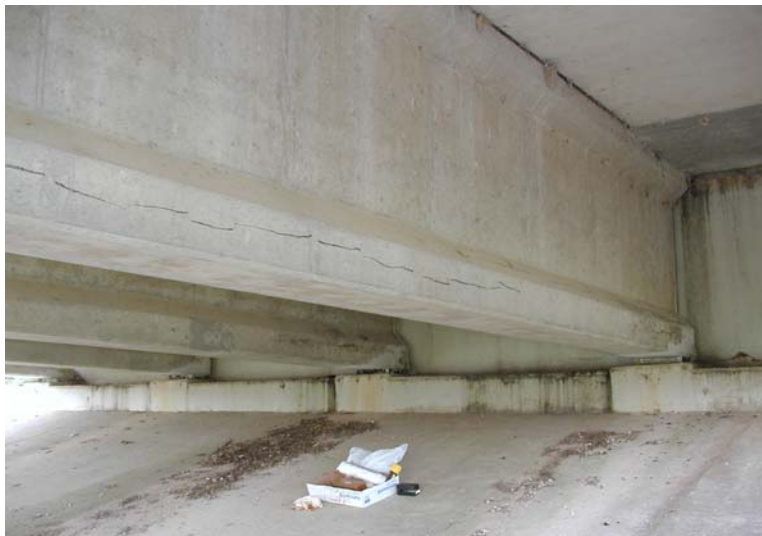
**Figure 7.11: Extension of existing cracking on north surface (Face 5) of NW Girder 2, US-90 (6/22/01)**

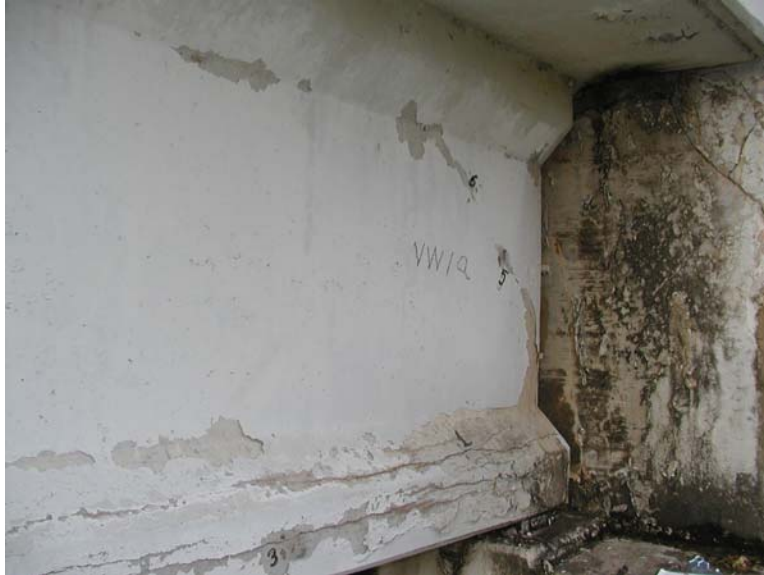
**Figure 7.12: Cracks at end of NW Girder 1, US-90 (6/22/01)**

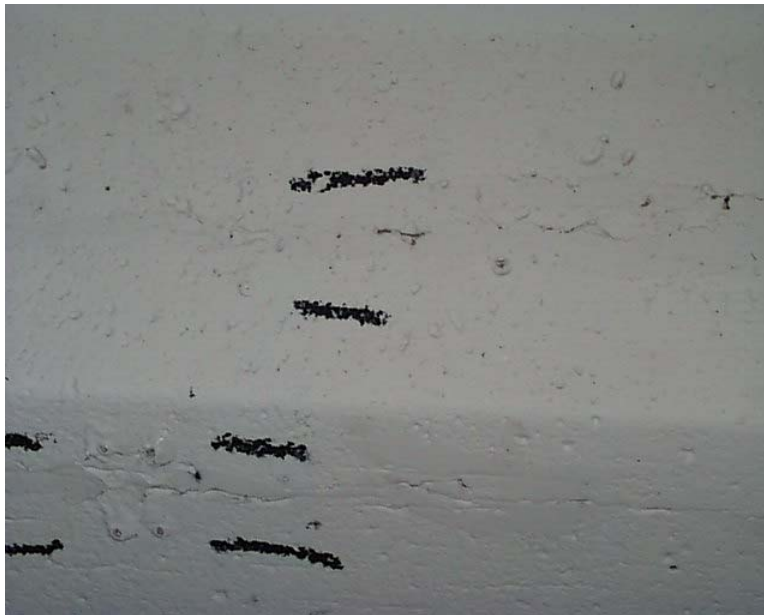
**Figure 7.13: Close-up view of Point 10 (bottom, left pair of Demec discs) and Point 8 (top), US-90 (12/11/01)**

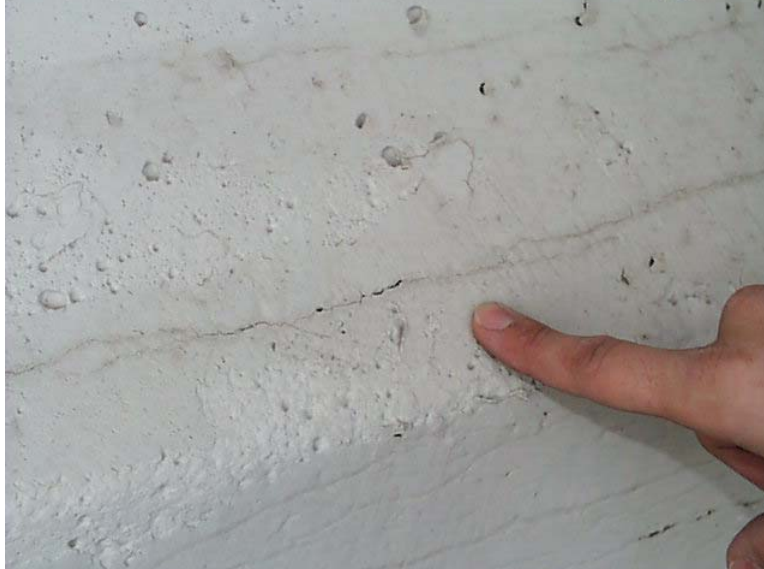
**Figure 7.14: Apparent cracking through sealant, US-90 (12/11/01)**

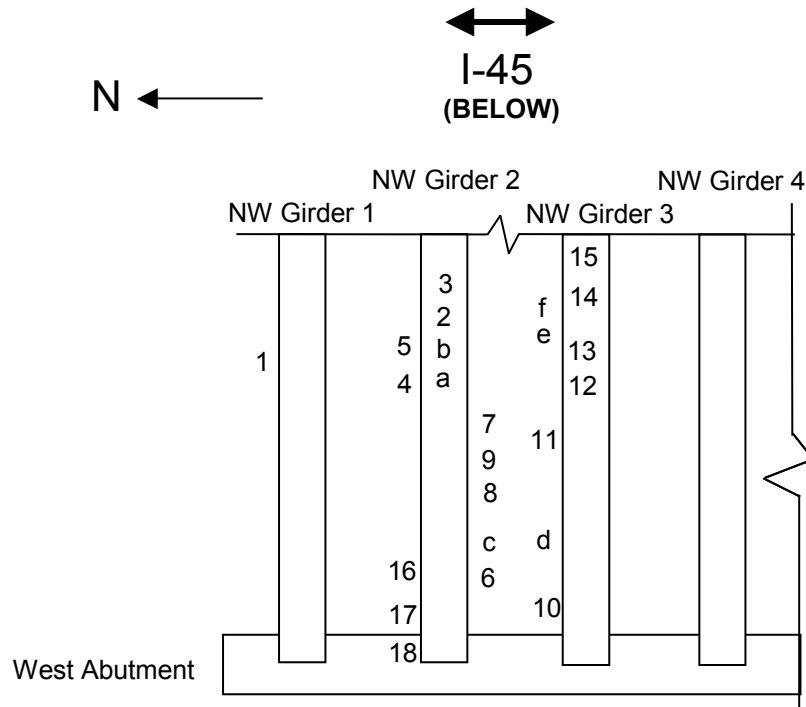
**Figure 7.15: Schematic of crack-measurement locations on Robinson Road structure (plan view)**

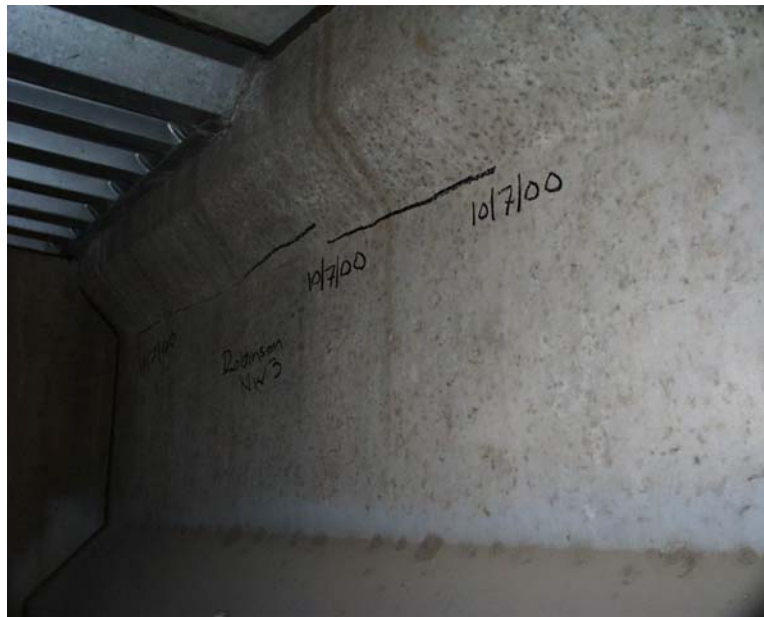
**Figure 7.16: Extension of new cracking on south face of NW Girder 3, Robinson Road (10/7/00)**

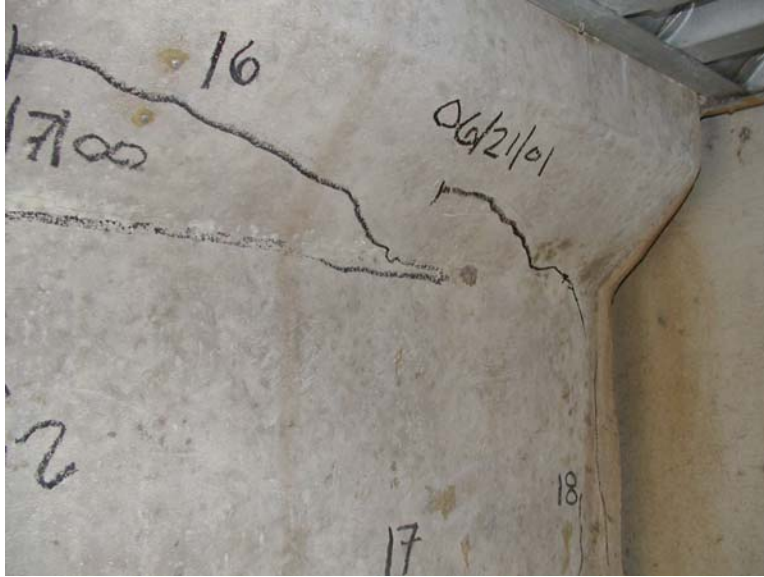
**Figure 7.17: Extension of cracking on NW Girder 2, Robinson Road (6/21/01)**

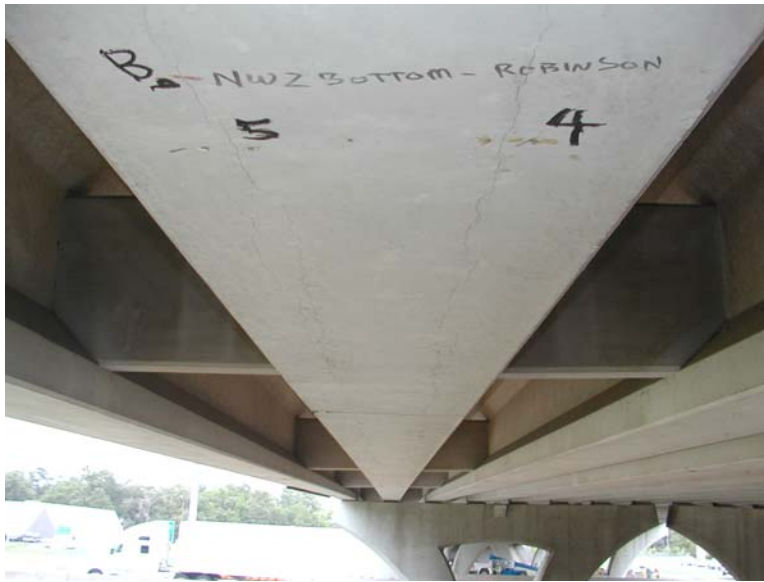
**Figure 7.18: Extension of cracking on underside of NW Girder 2, Robinson Road (6/21/01)**

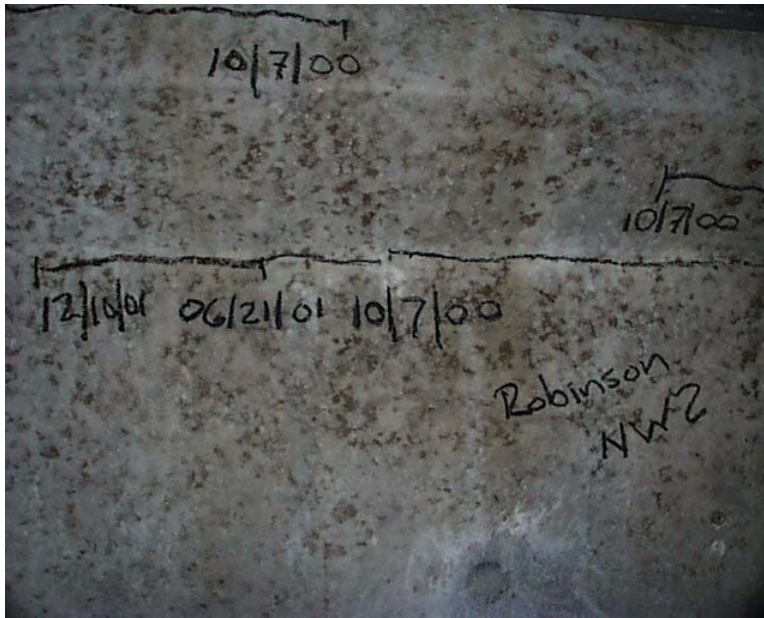
Figure 7.19: Extension of cracking on north surface of NW Girder 2, Robinson Road, at west abutment (12/10/01)

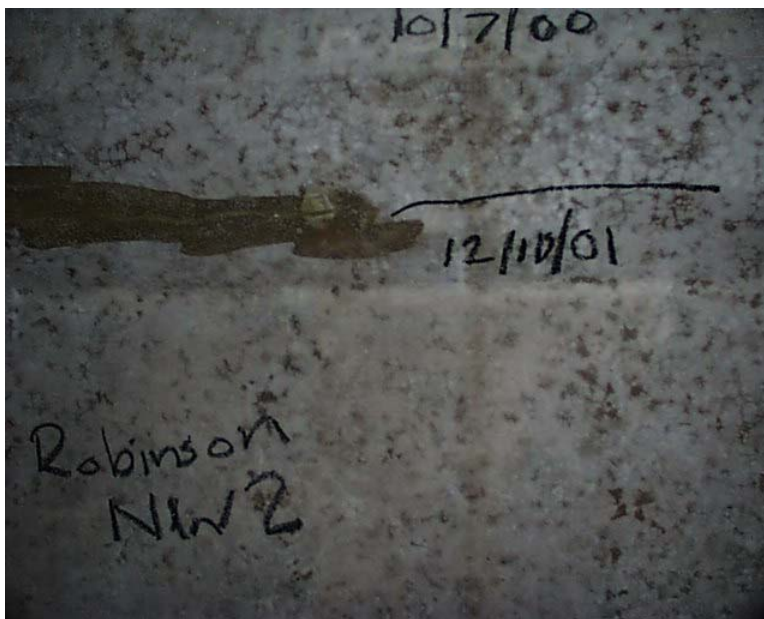
Figure 7.20: Extension of cracking past sealant on south surface of NW Girder 2, Robinson Road, at west abutment (12/10/01)

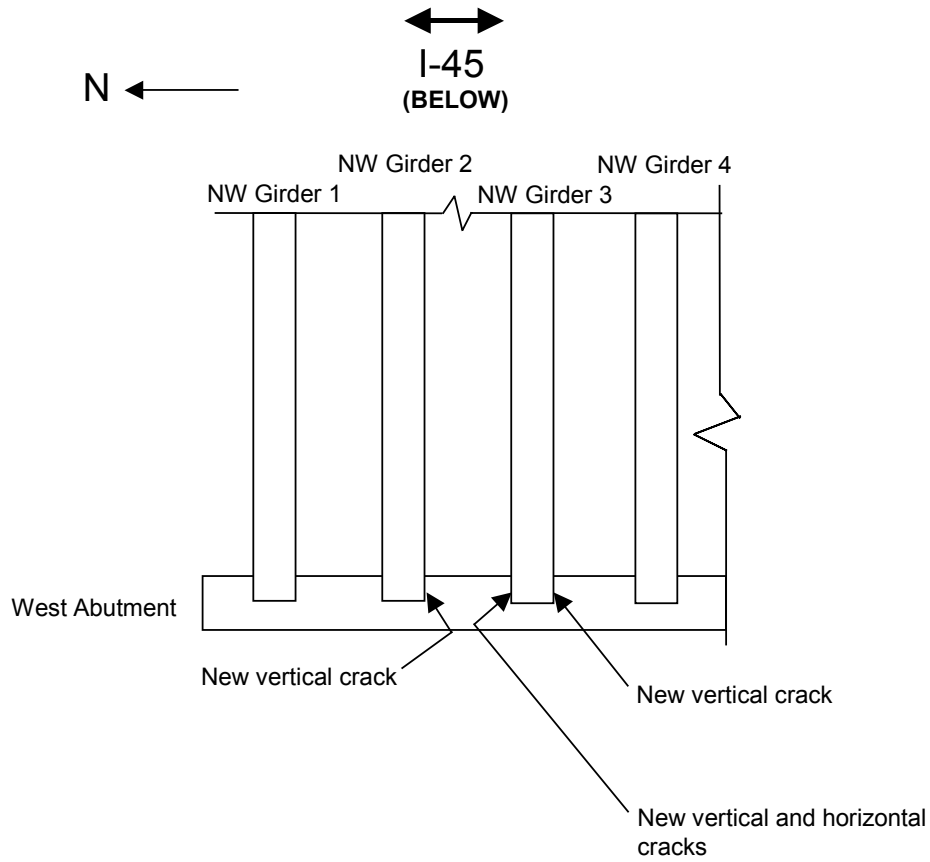
**Figure 7.21: Location of new cracks on Robinson Road structure (plan view) (12/10/01)**

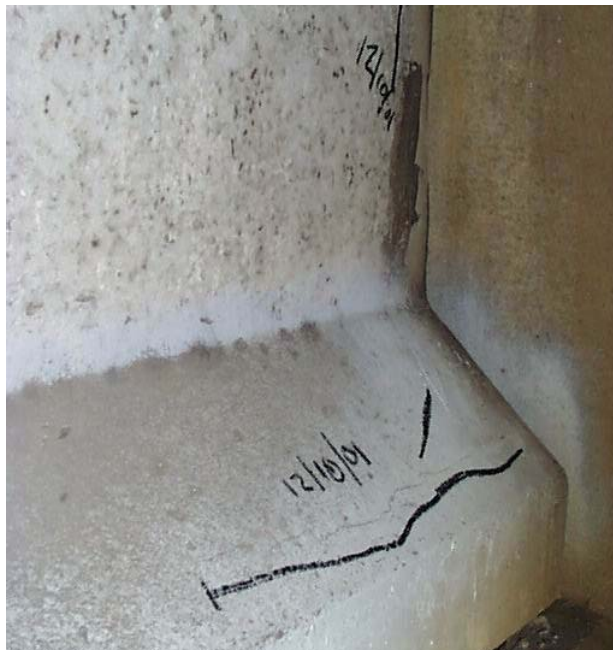
**Figure 7.22: New cracks on north surface of NW Girder 3, Robinson Road, at west abutment (12/10/01)**

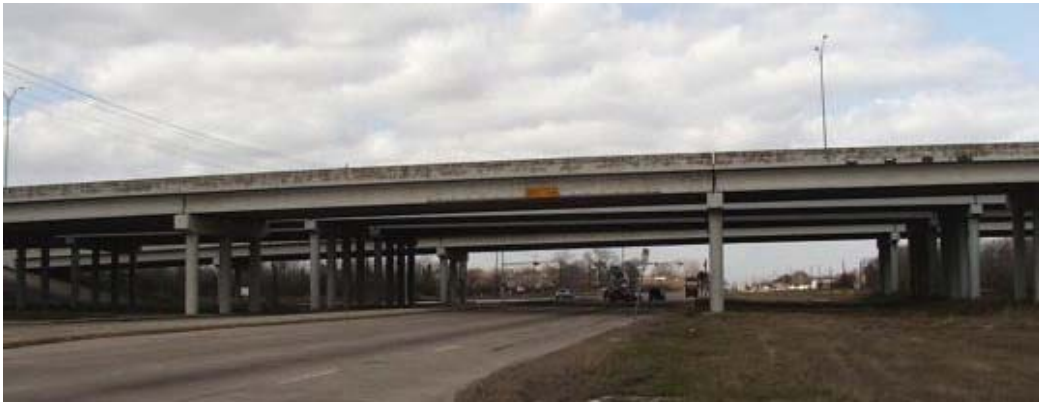
Figure 7.23: Overview of Beltway 8 over State Highway 3 (facing north)

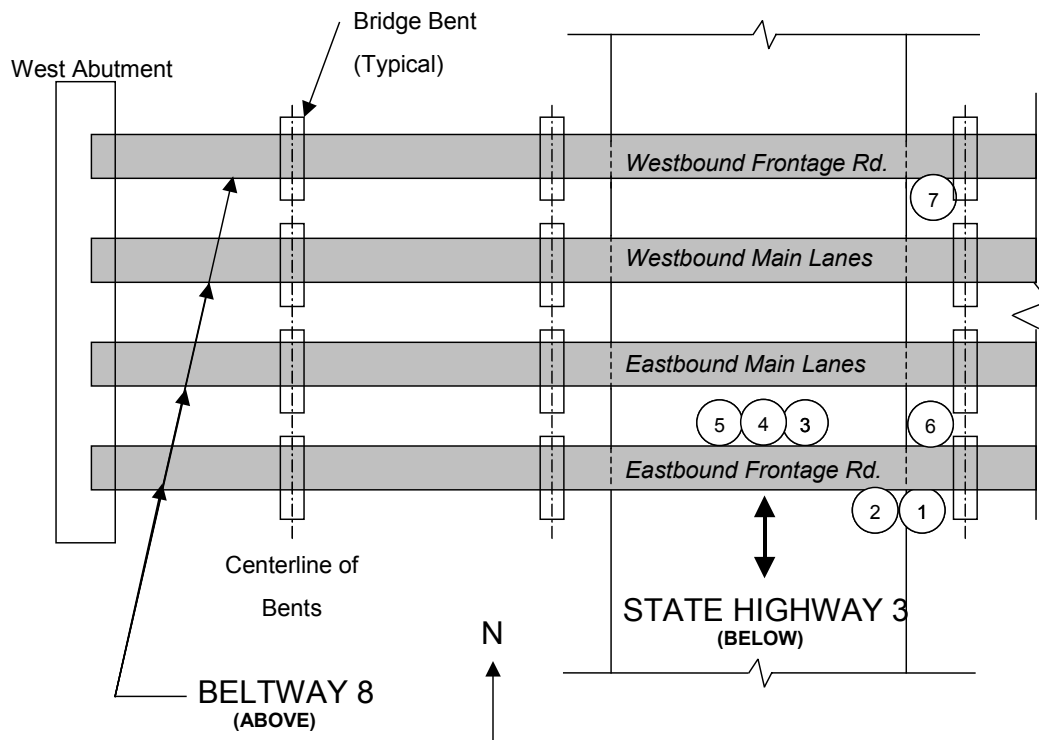
Figure 7.24: Schematic of crack-measurement locations on Beltway 8 structure (plan view)

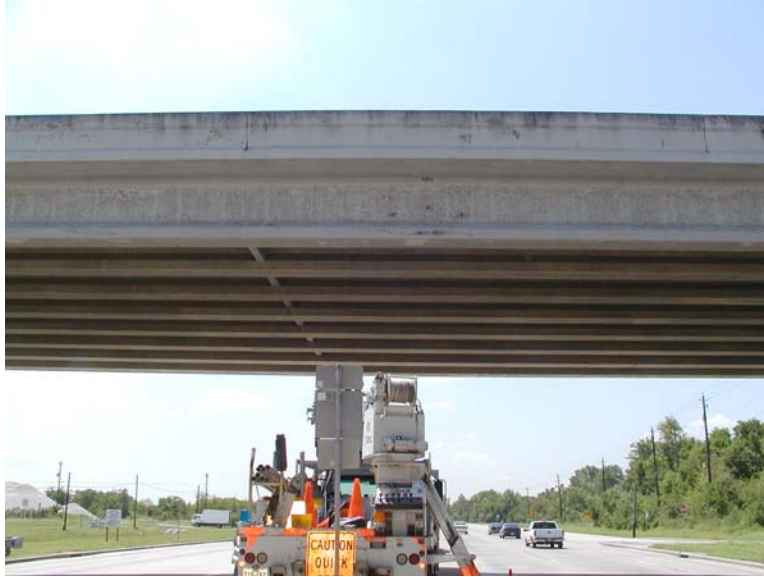
**Figure 7.25: Overall view of Points 3-5, Beltway 8 (facing south) (6/22/01)**

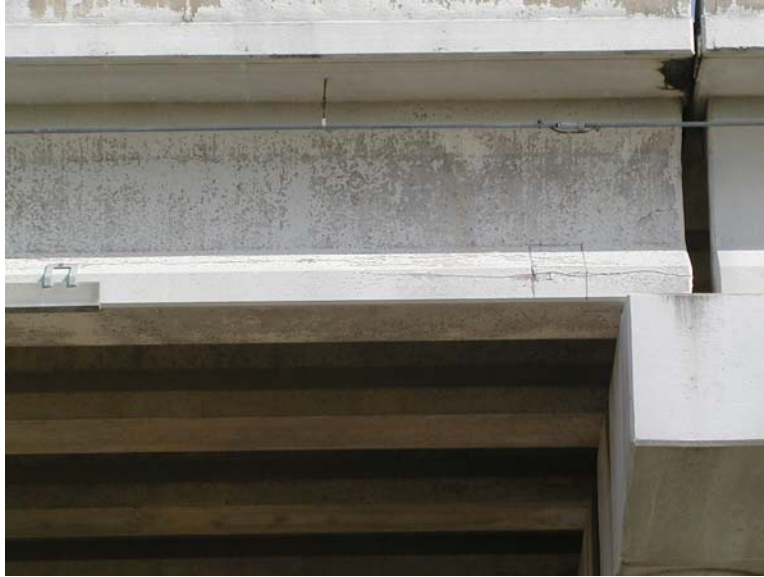
**Figure 7.26:** Overall view of Point 1, Beltway 8 structure (facing north) (6/22/01)

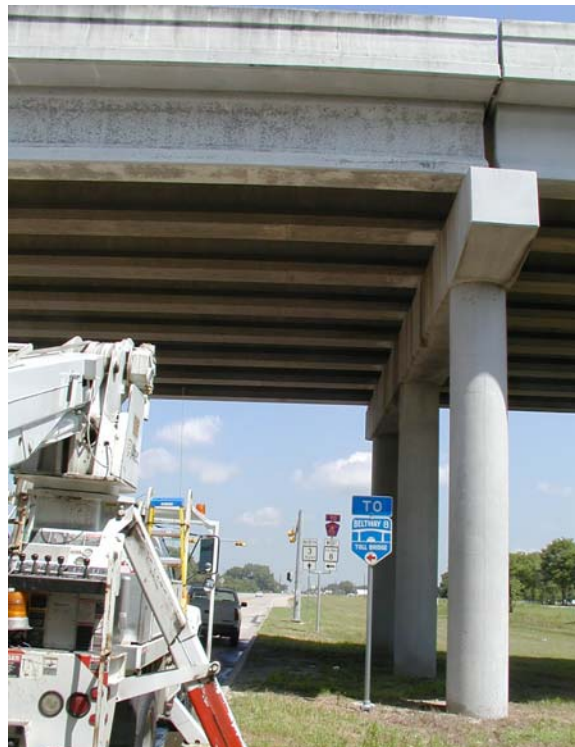
**Figure 7.29: Overall view of Point 7, Beltway 8 structure (facing north) (6/22/01)**

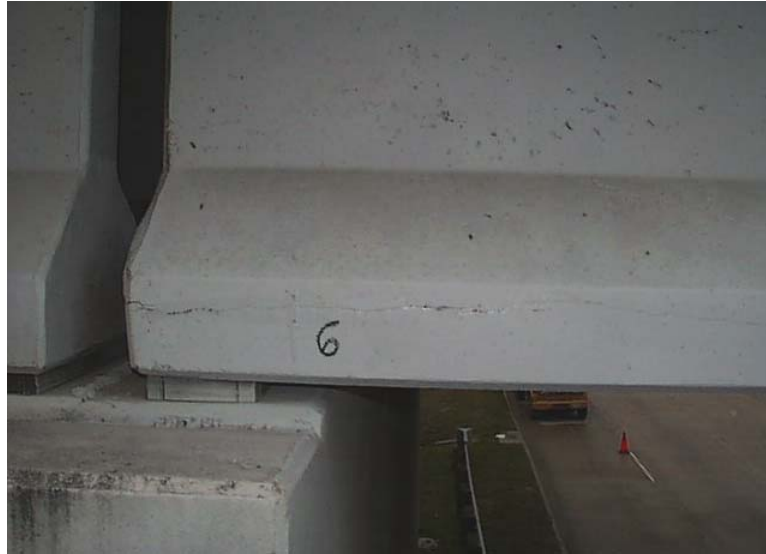
**Figure 7.30: Cracking near Point 6, Beltway 8 structure (12/11/01)**

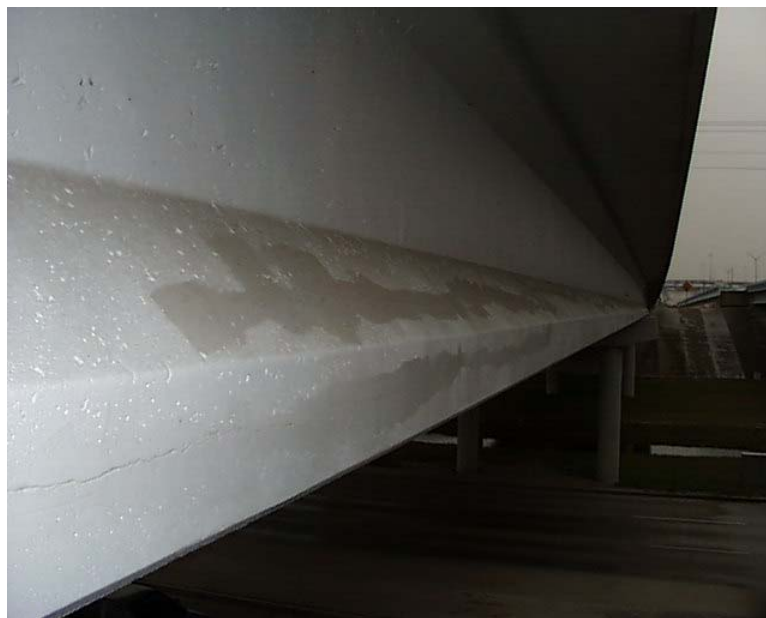
**Figure 7.31: Sealed cracks along girder flange near Point 6, Beltway 8 structure (12/11/01)**

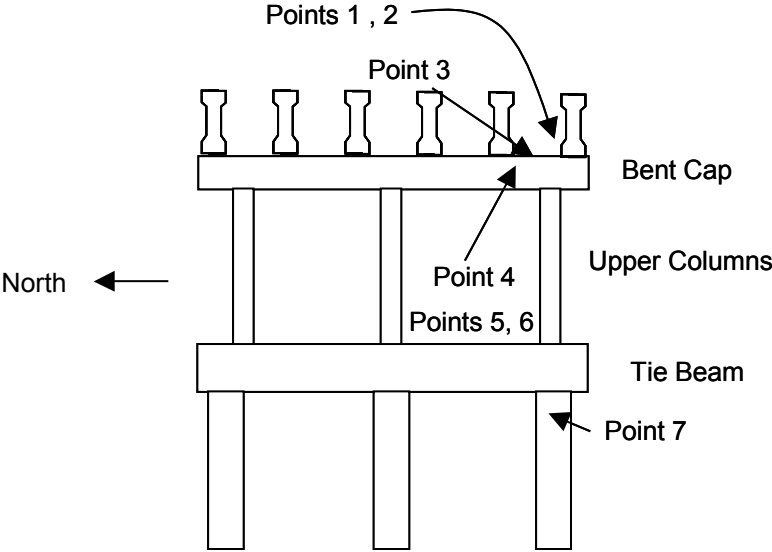
**Figure 7.35: Schematic drawing of crack-measurement locations on Bent 5**

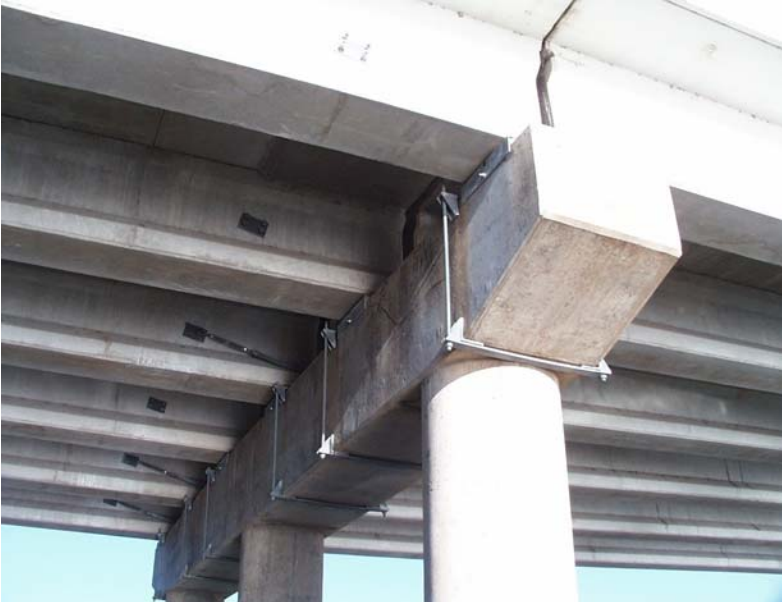
**Figure 7.36: Overall view of Bent 5 (facing north)**

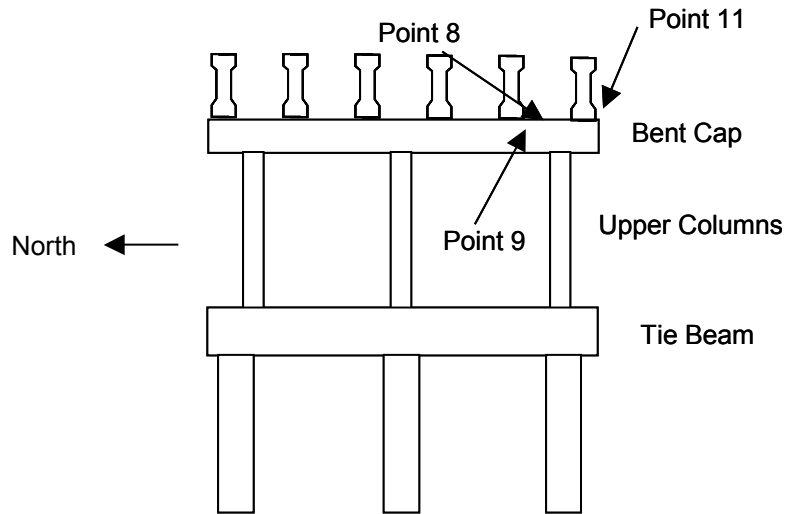
**Figure 7.37: Schematic drawing of crack-measurement locations on Bent 9**

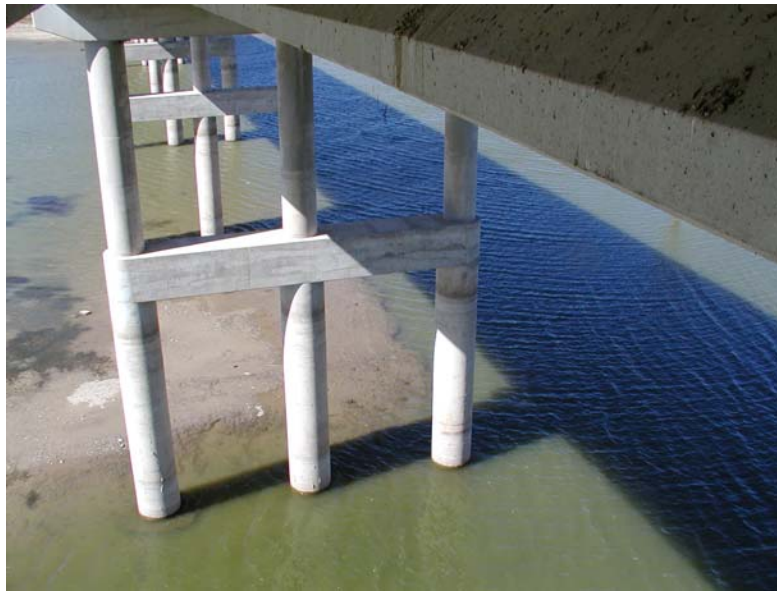
**Figure 7.38: Overall view of Bent 9 (facing west)**

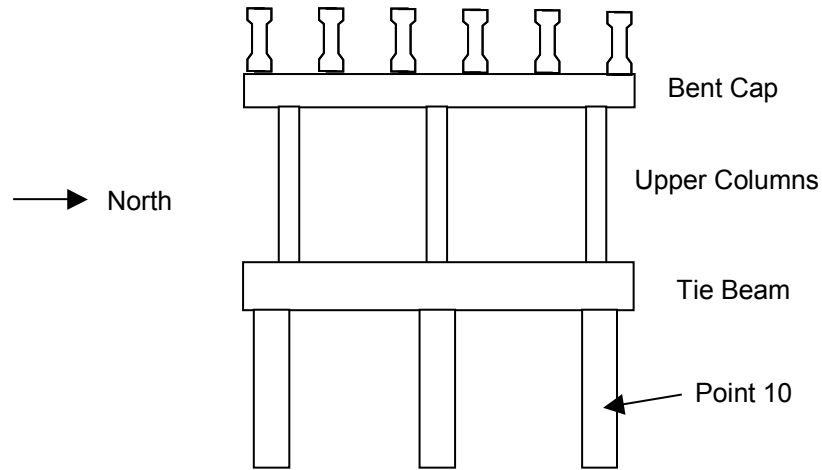
**Figure 7.39: Schematic drawing of crack-measurement location on Bent 11**

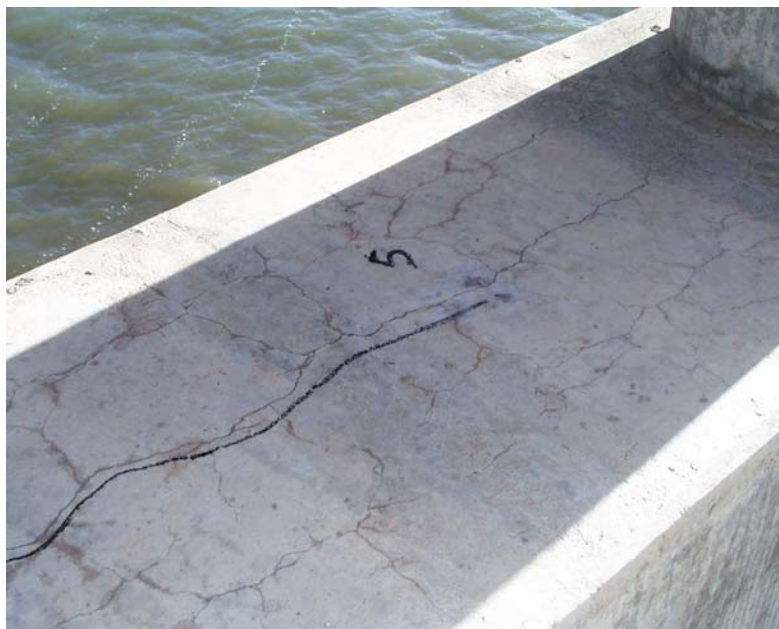
**Figure 7.40: Map cracking on tie beam, Bent 5 (12/18/00)**

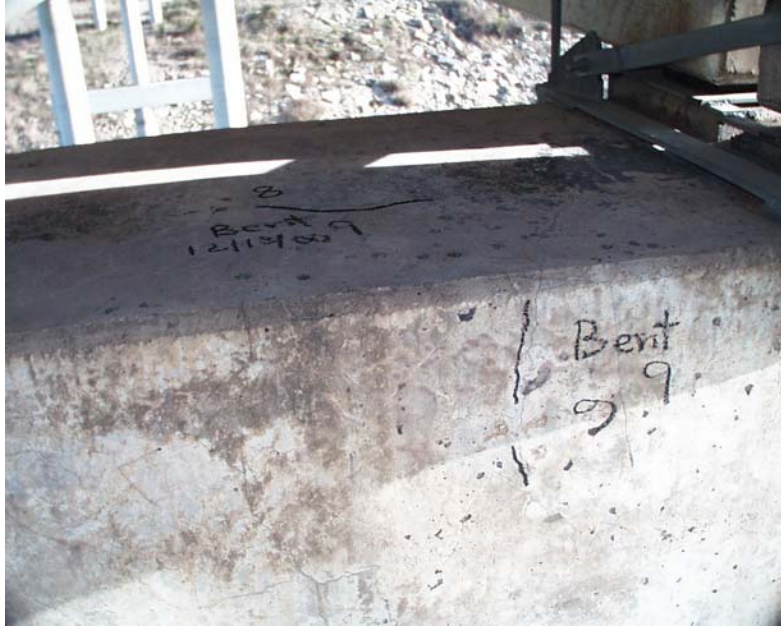
**Figure 7.41: Cracking on bent cap, Bent 9 (12/18/00)**
