6. Performing Organization Code	
7. Author(s) L. S. Memberg, R. E. Klingner, and T. J. Fowler				8. Performing Organization Report No. Research Report 0-1857-4

9. Performing Organization Name and Address Center for Transportation Research The University of Texas at Austin 3208 Red River, Suite 200 Austin, TX 78705-2650				10. Work Unit No. (TRAIS)

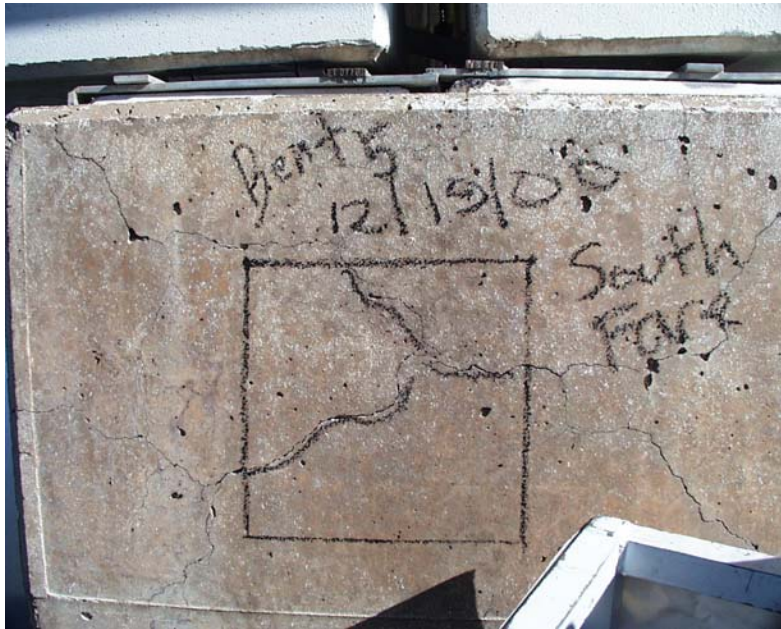
**Figure 7.42: 12 in. (0.31 m) square on south end of bent cap, Bent 5 (12/19/00)**

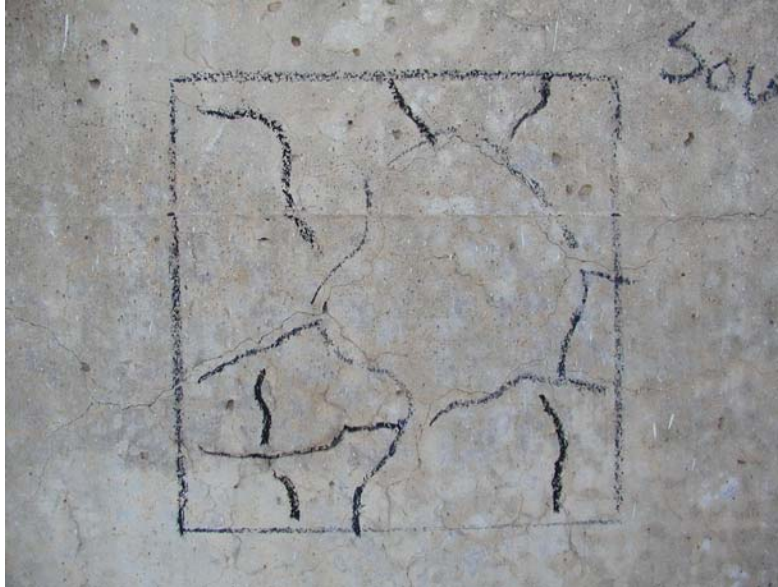
**Figure 7.43:** 12 in. (0.31 m) square on south end of bent cap, Bent 9 (4/24/01)

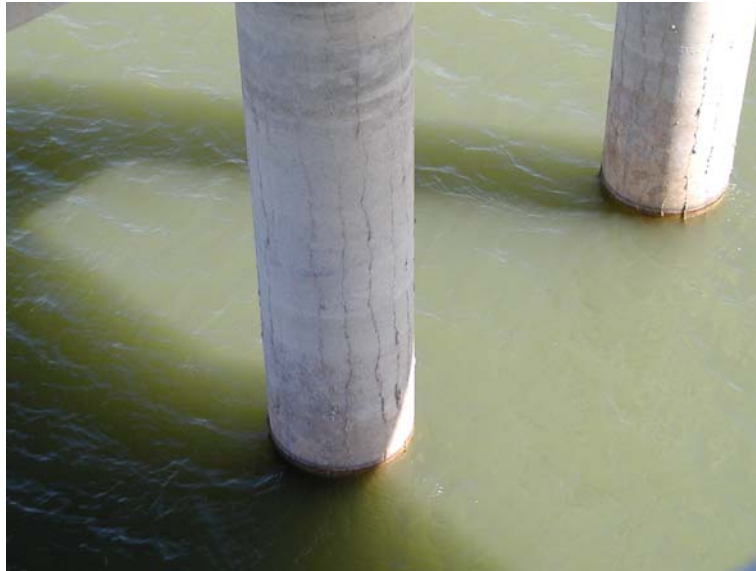
**Figure 7.44:** Example of column cracking near waterline of Bent 5 (4/24/01)

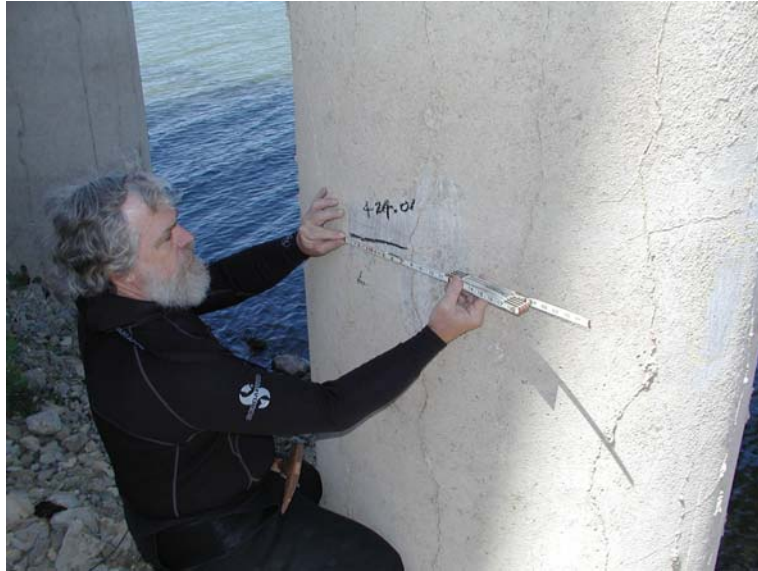
**Figure 7.45: Example of column cracking near waterline of Bent 11 (Point 10) (4/24/01)**

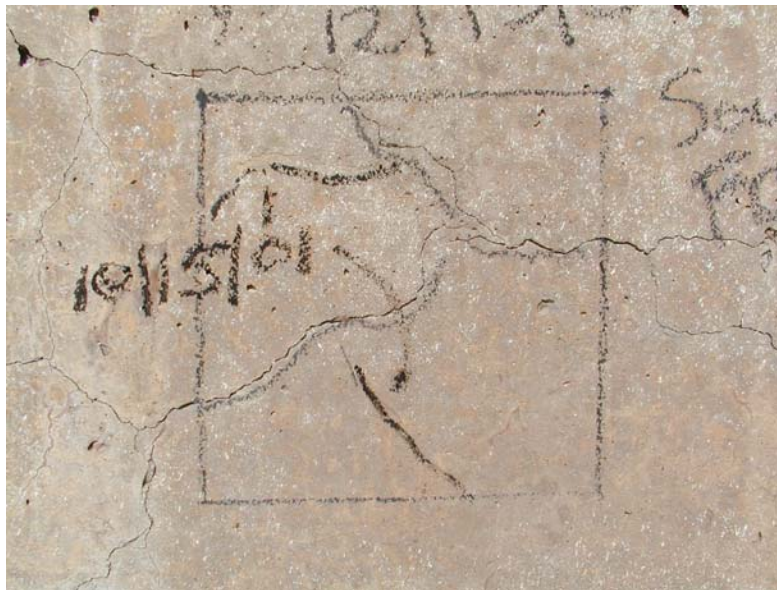
**Figure 7.46: New cracks on 12 in. (0.31 mm) square on south end of bent cap, Bent 5 (10/15/01)**

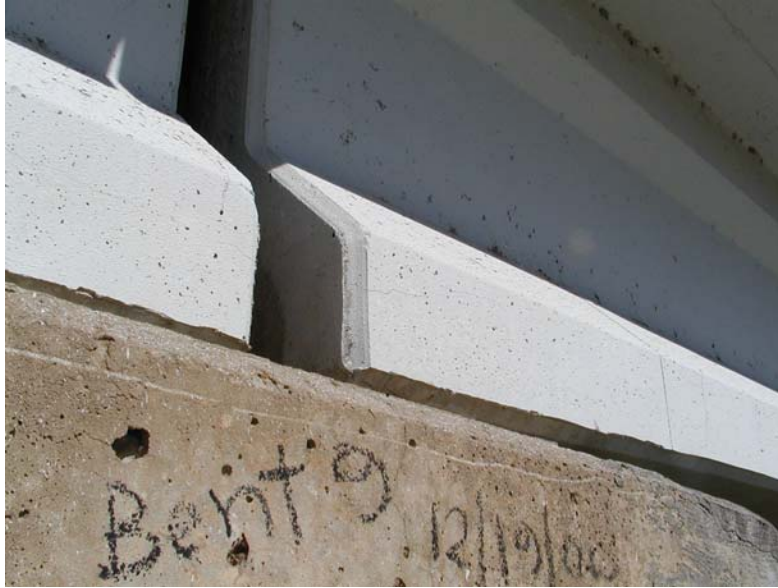
**Figure 7.47: New cracks on exterior faces of south girders at Bent 9 (10/15/01)**

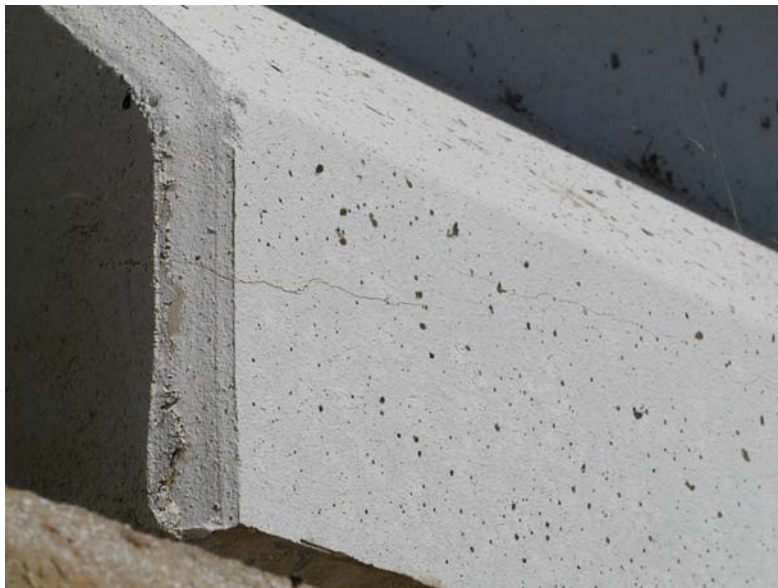
**Figure 7.48: Close-up of new cracks on south girder at Bent 9 (10/15/01)**

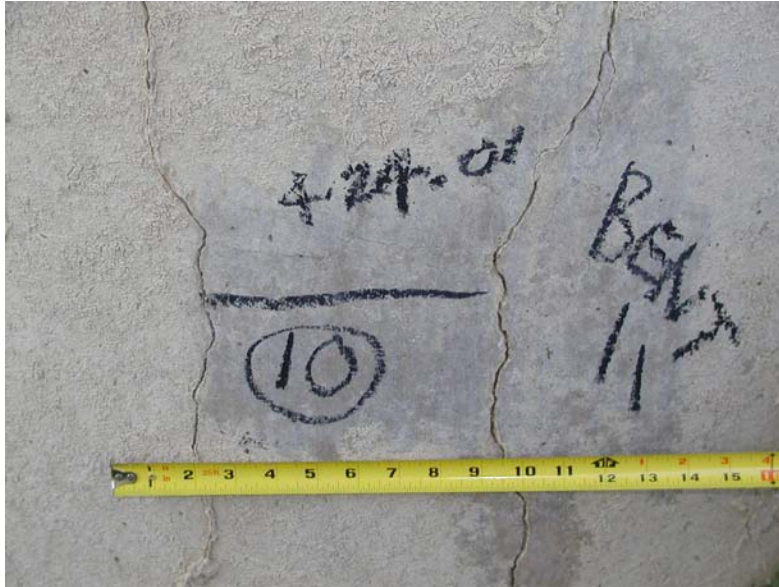
**Figure 7.49: Column cracking at Point 10 near waterline, Bent 11 (10/15/01)**

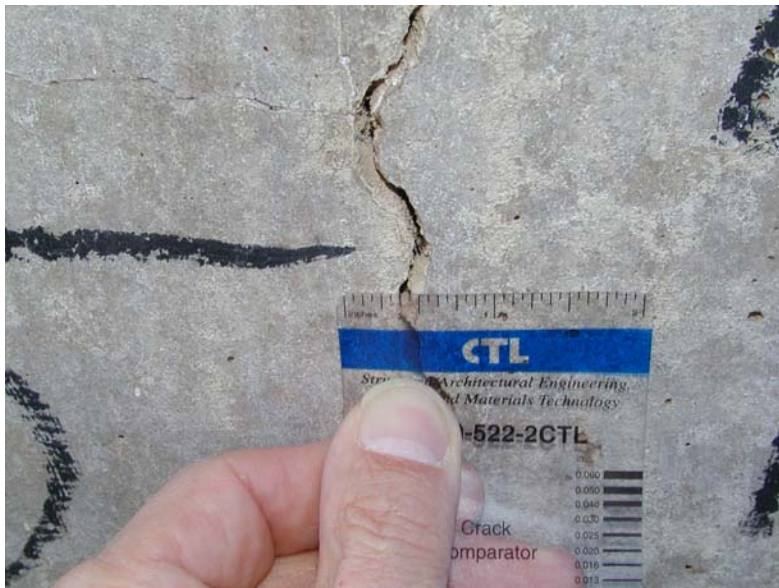
**Figure 7.50: Close-up of vertical cracking at Point 10 near waterline, Bent 11 (10/15/01)**

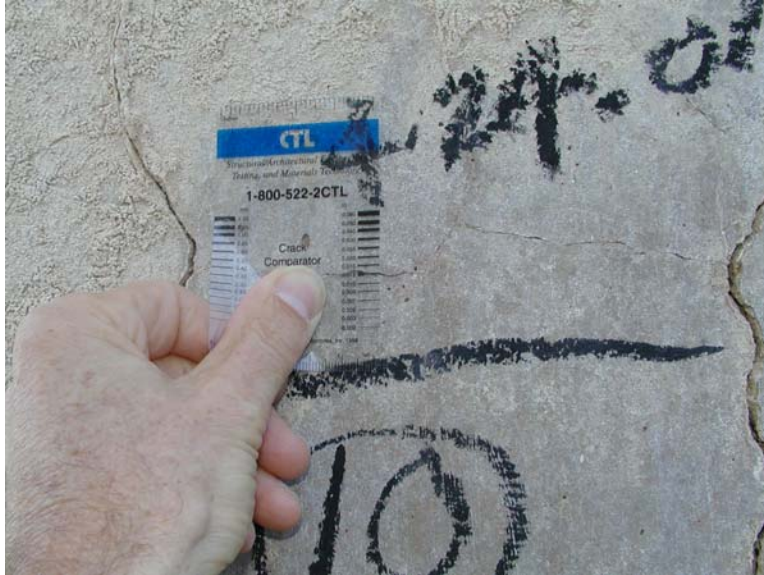
Figure 7.51: Close-up of horizontal crack at Point 10 near waterline, Bent 11 (10/15/01)

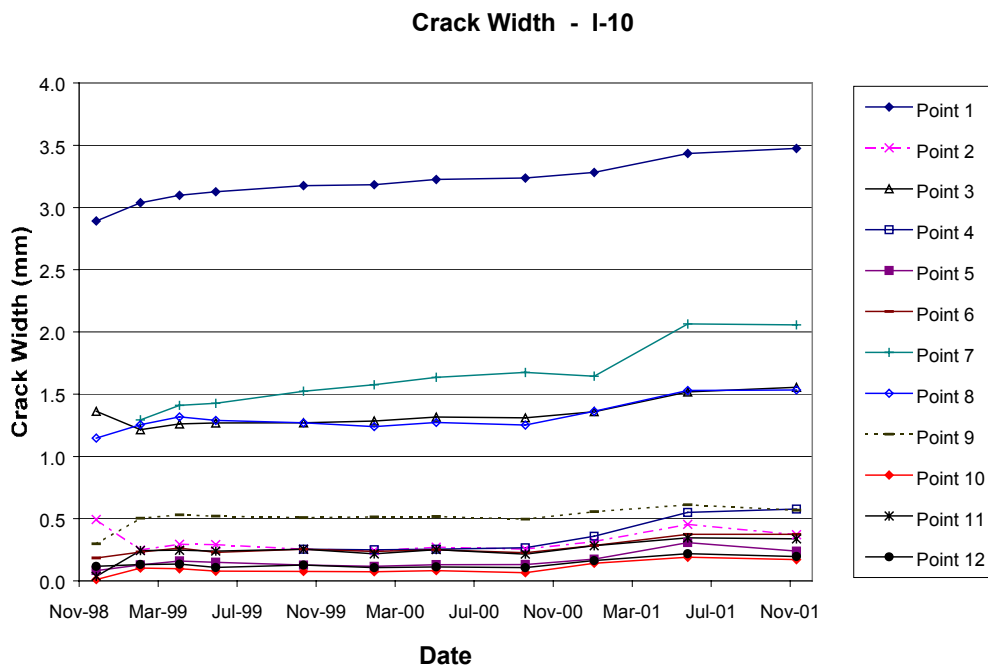
Figure 7.52: Crack width over time for I-10 structure

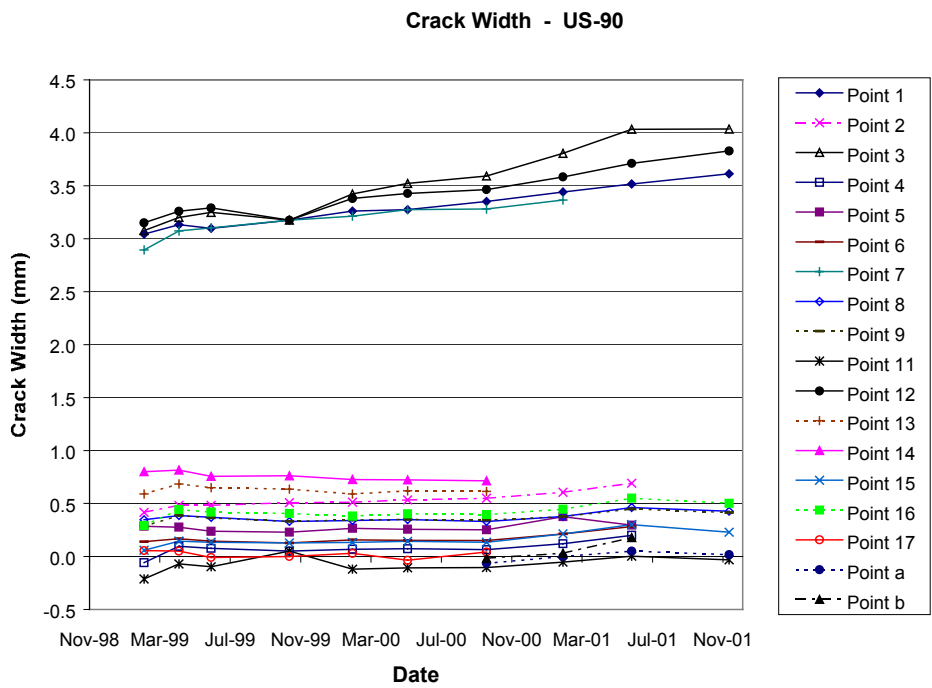
Figure 7.53: Crack width over time for US-90 structure

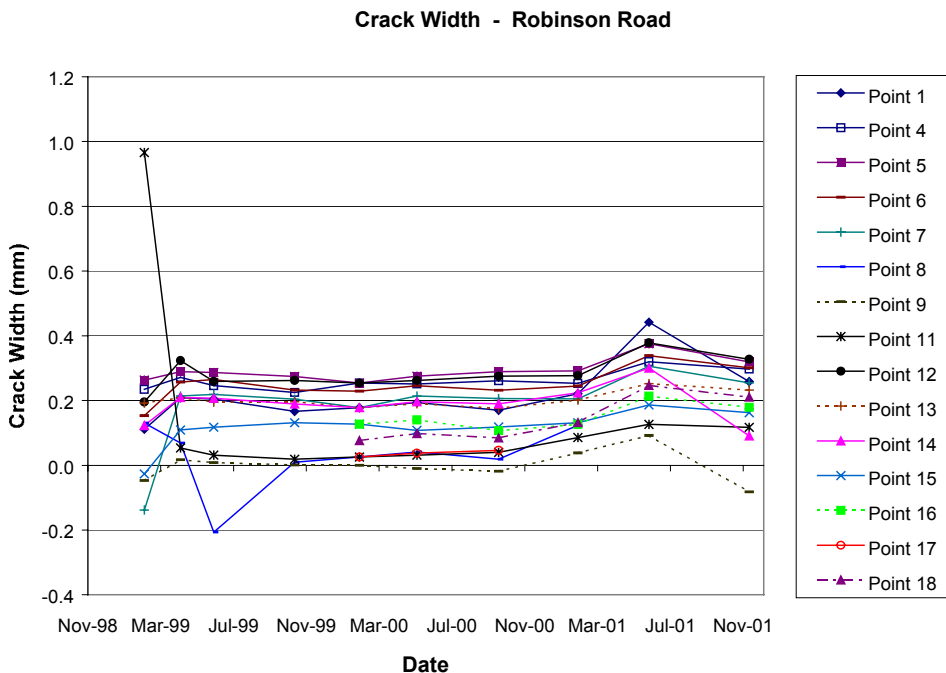
**Figure 7.54: Crack width over time for Robinson Road structure**

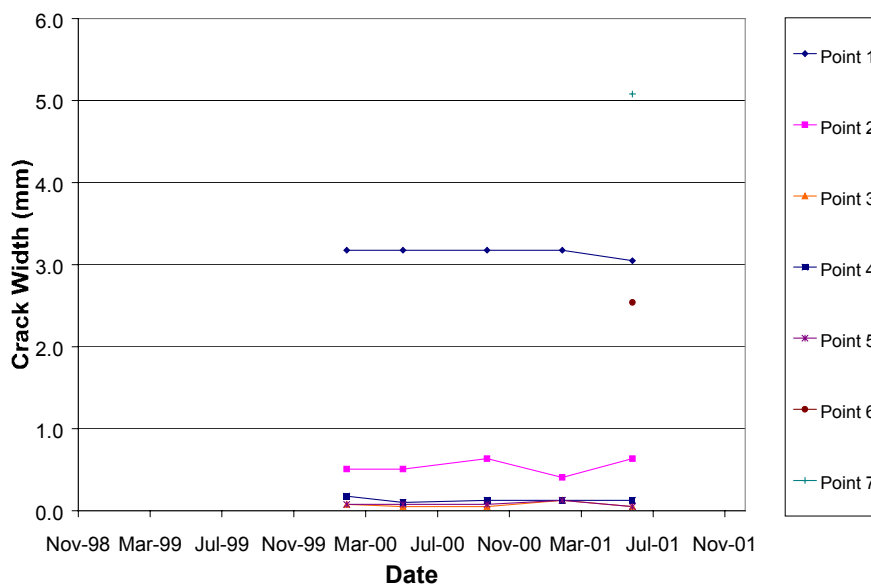
**Figure 7.55: Crack width over time for Beltway 8 structure**

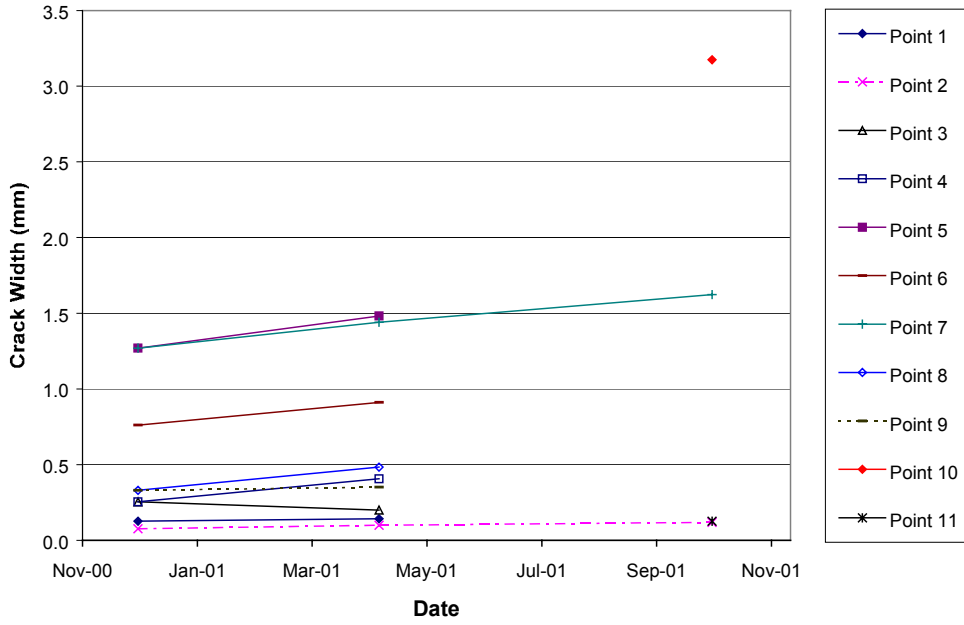
**Figure 7.56: Crack width over time for FM 1929 at Lake Ivie**

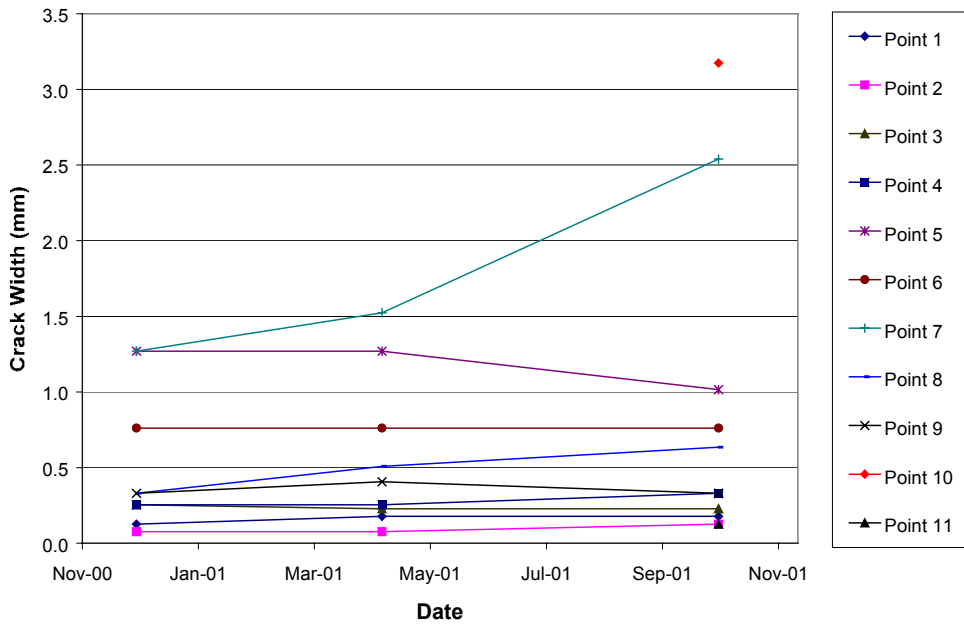
**Figure 7.57: Crack comparator readings over time for FM 1929 at Lake Ivie**

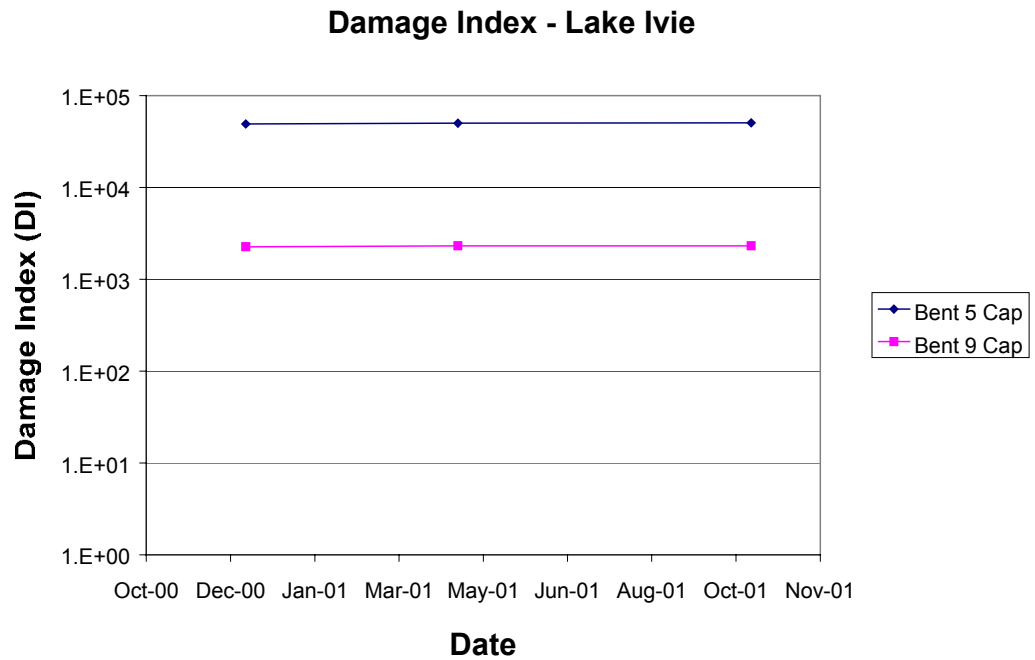
**Figure 7.58: Damage Index over time for FM 1929 at Lake Ivie**

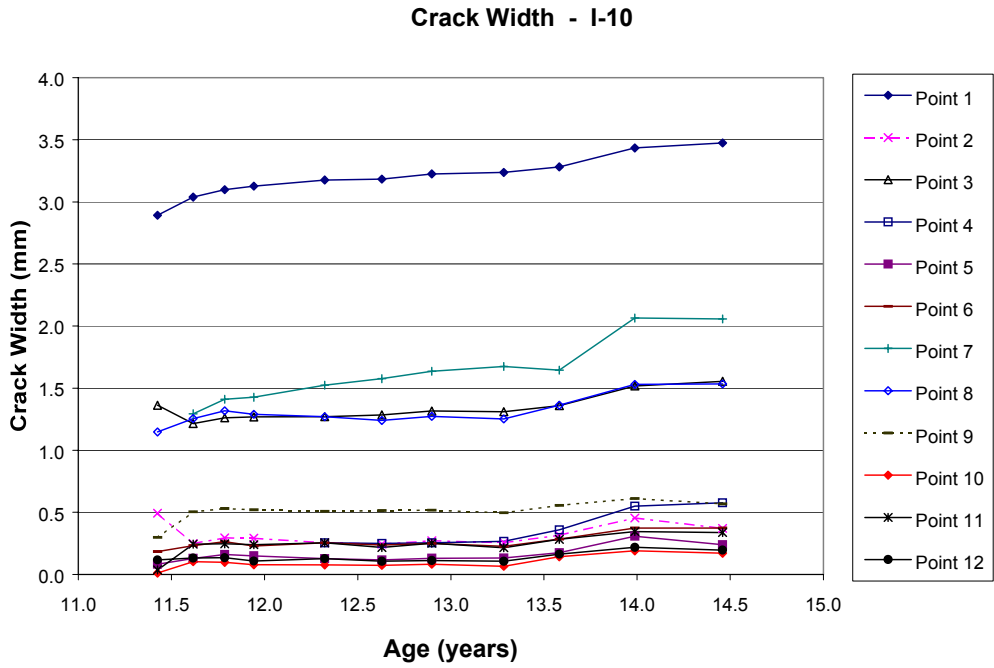
**Figure 8.1: Crack width versus age of girder for the I-10 structure**

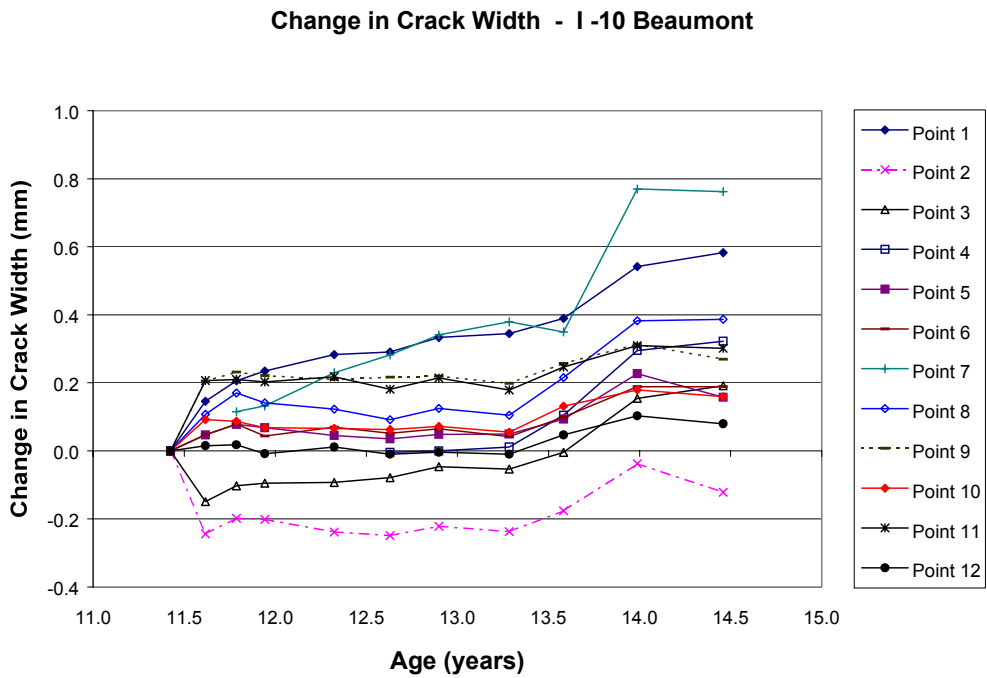
**Figure 8.2: Change in crack width versus age of girder for the I-10 structure**

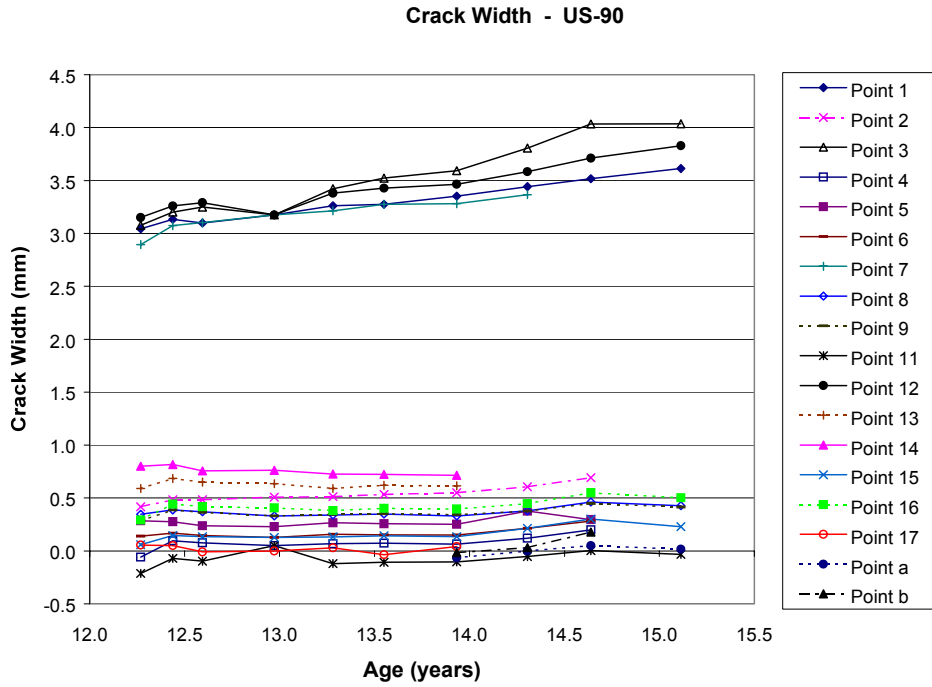
**Figure 8.3:** Crack width versus age of girder for the US-90 structure

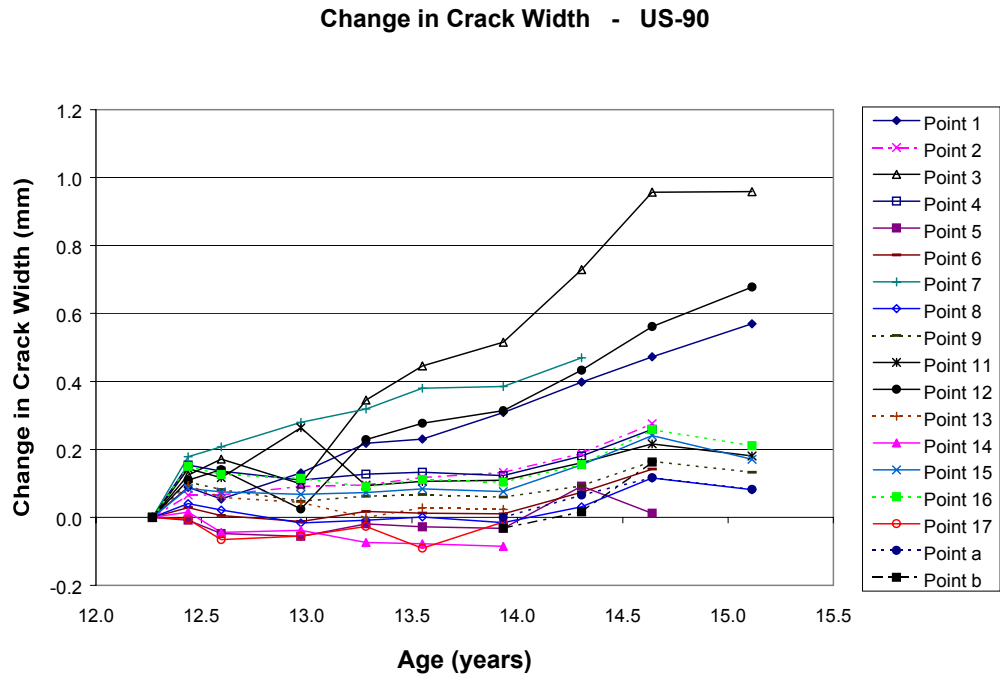
**Figure 8.4:** Change in crack width versus age of girder for the US-90 structure

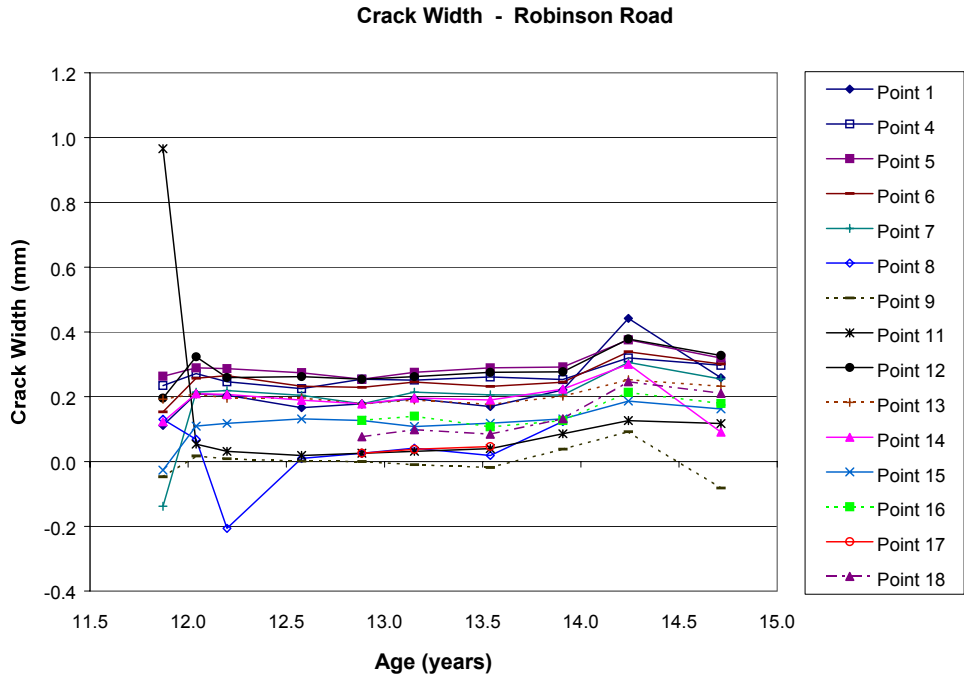
Figure 8.5: Crack width versus age of girder for the Robinson Road structure

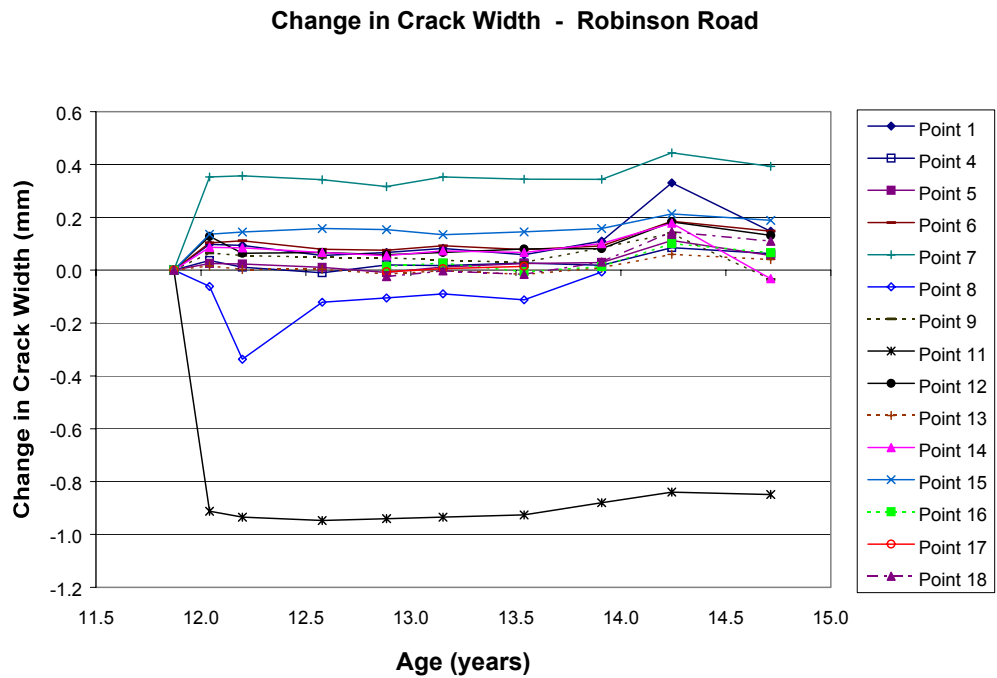
Figure 8.6: Change in crack width versus age of girder for the Robinson Road structure

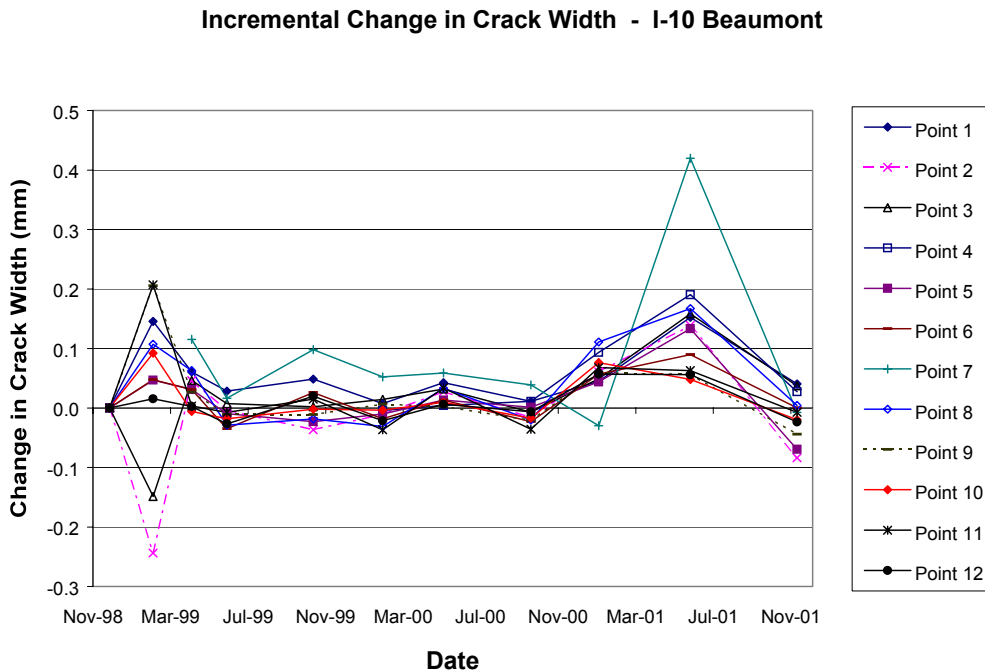
**Figure 8.7: Incremental change of crack width versus age of girder for the I-10 structure**

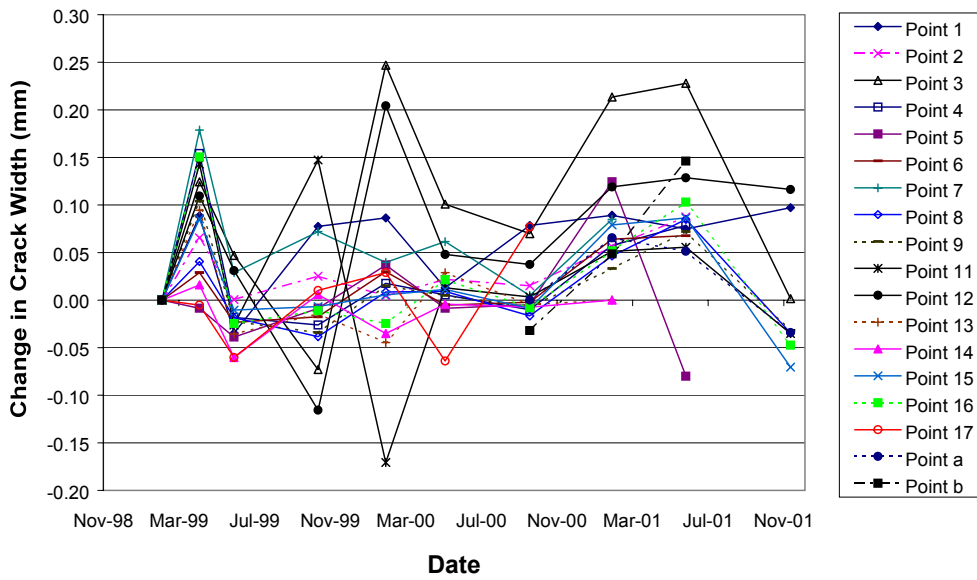
**Figure 8.8: Incremental change in crack width versus age of girder for the US-90 structure**

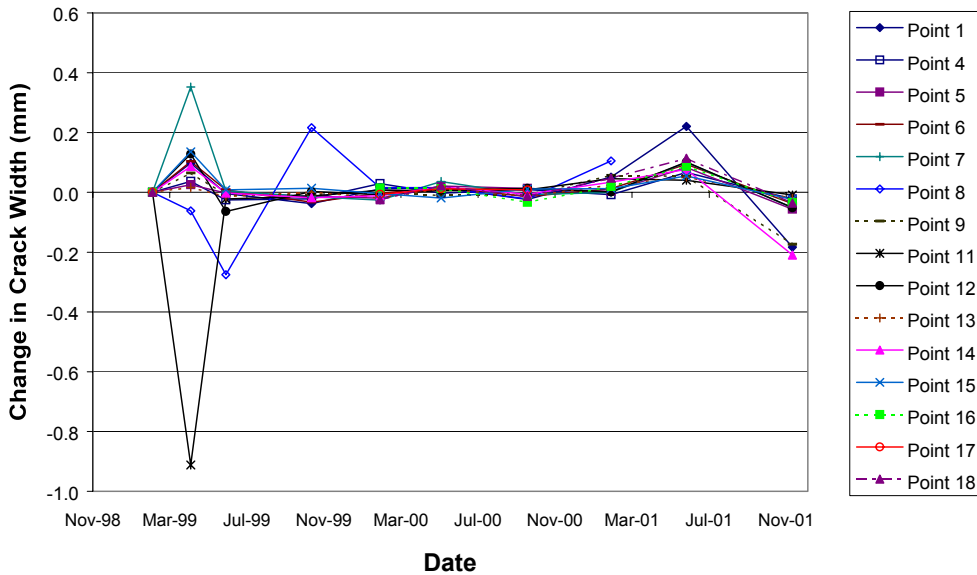
**Figure 8.9: Incremental change in crack width versus age of girder for the Robinson Road structure**

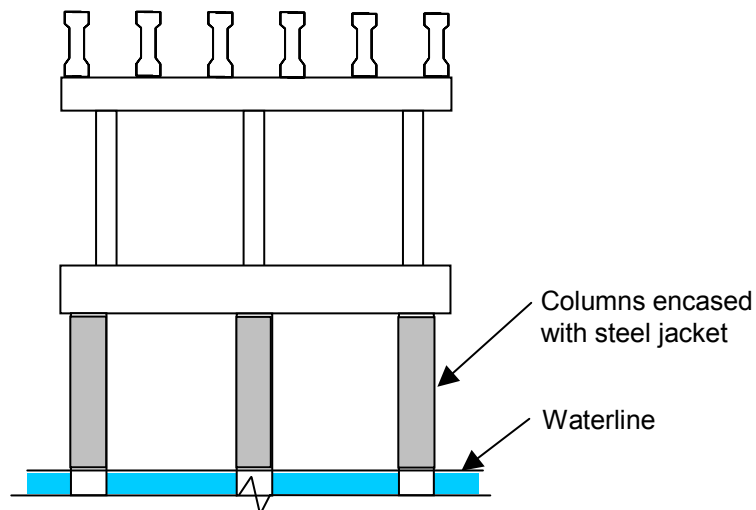
**Figure 9.1: Steel jacket around bent columns**

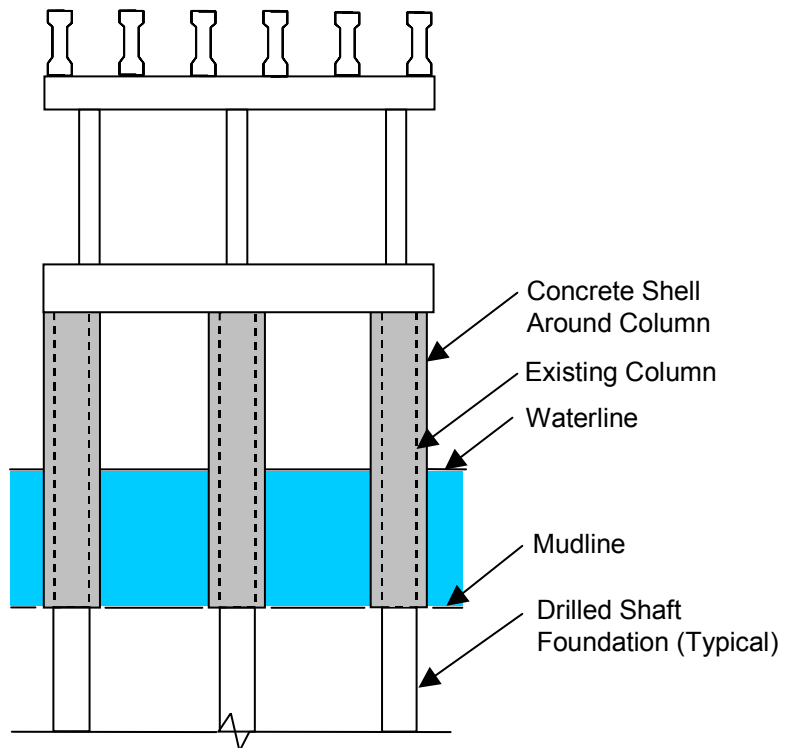
**Figure 9.2: Concrete shells poured around bent columns**

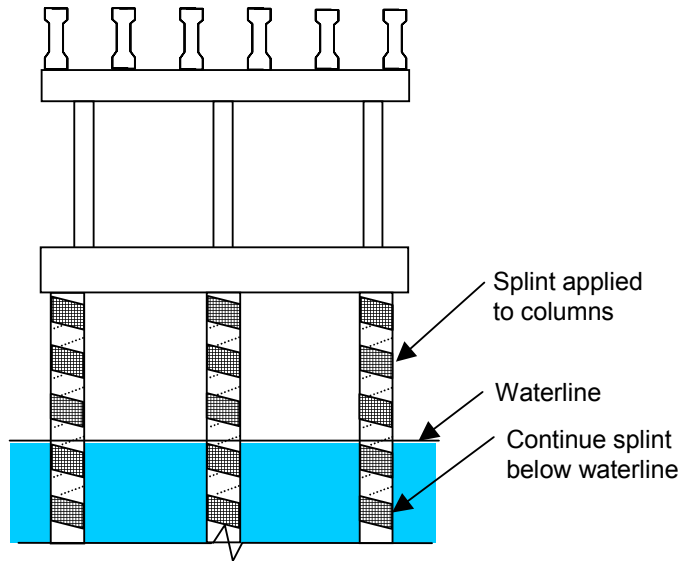
**Figure 9.3: Splints installed on bent columns**

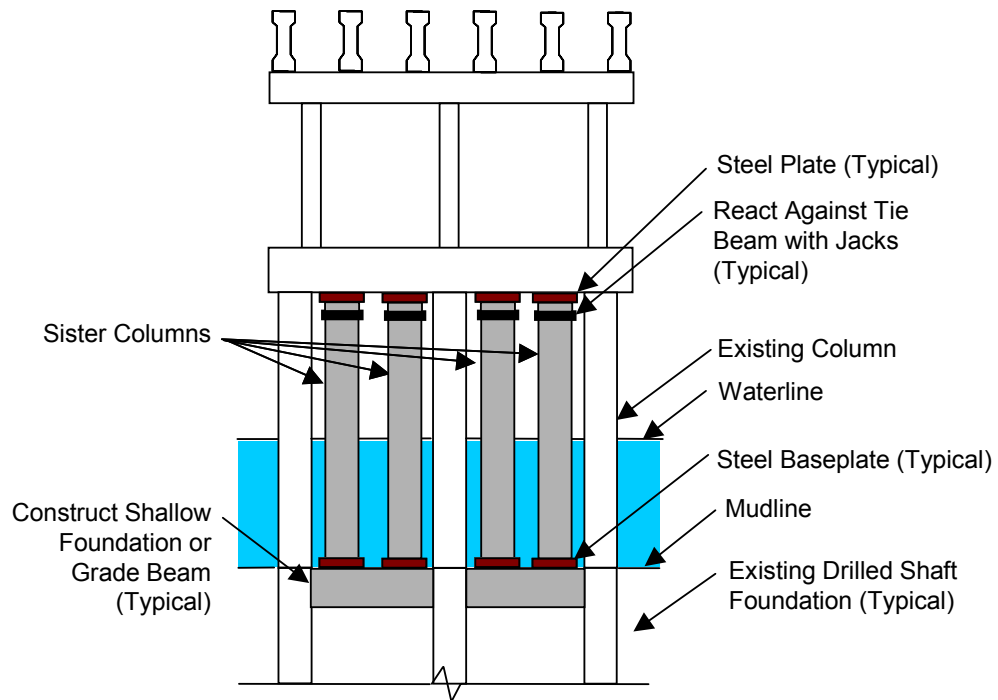
**Figure 9.4: Sister columns installed at bent**

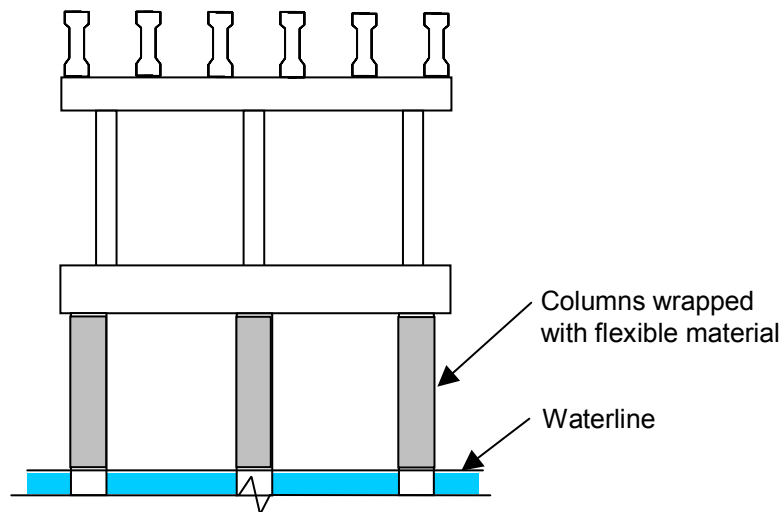
**Figure 9.5: Flexible wrap around bent columns**

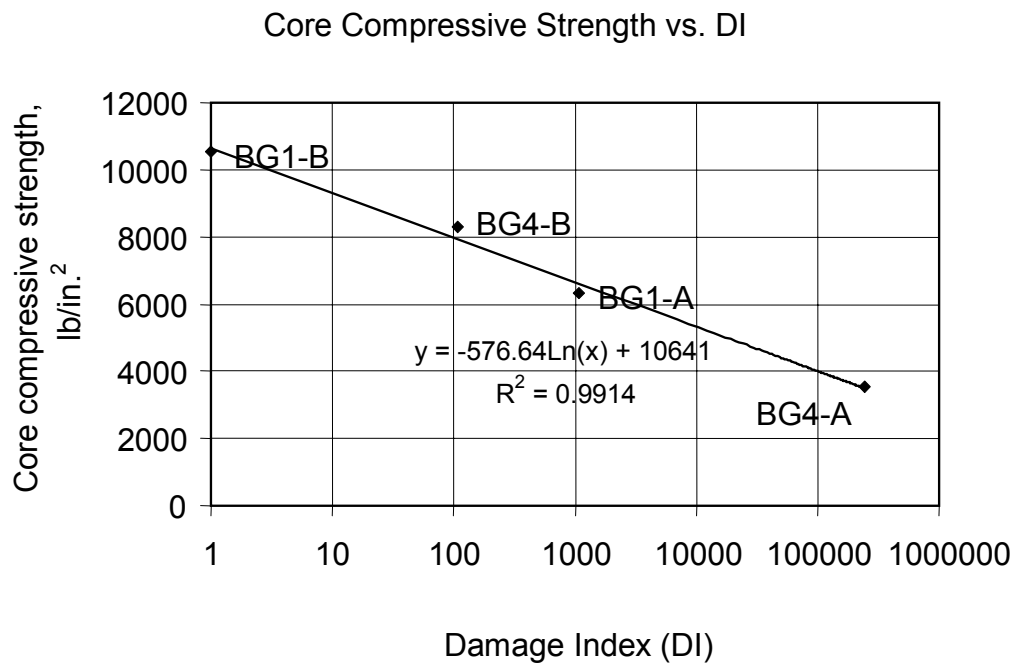
**Figure 9.7: Concrete compressive strength of cores from box girders versus damage index (Boenig 2000)**

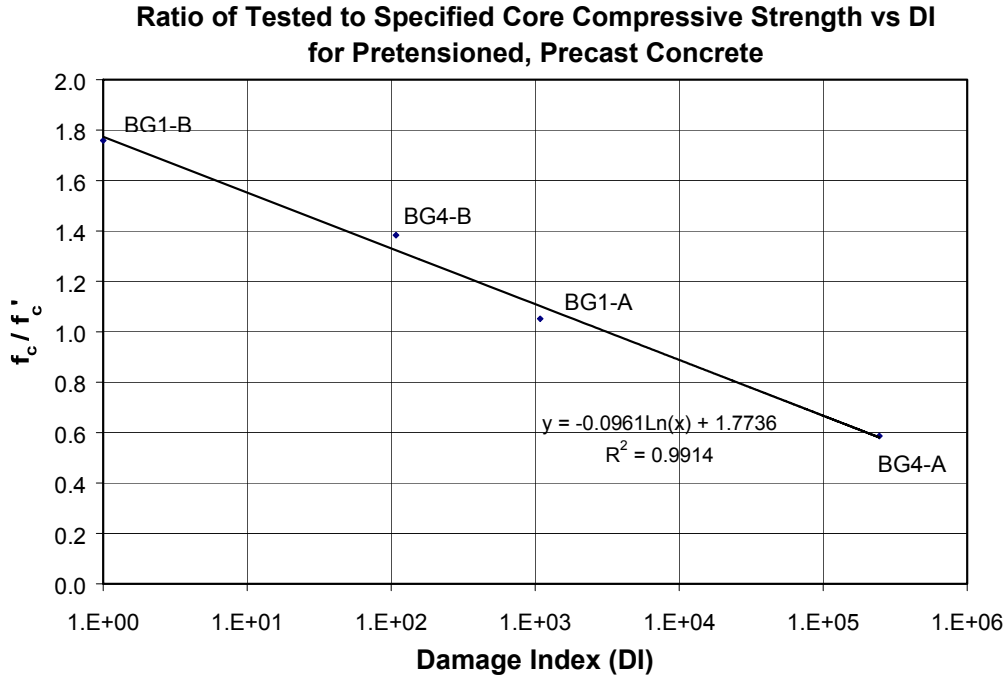
**Figure 9.8: Ratio of tested to specified concrete compressive strength versus damage index for pretensioned, precast concrete**

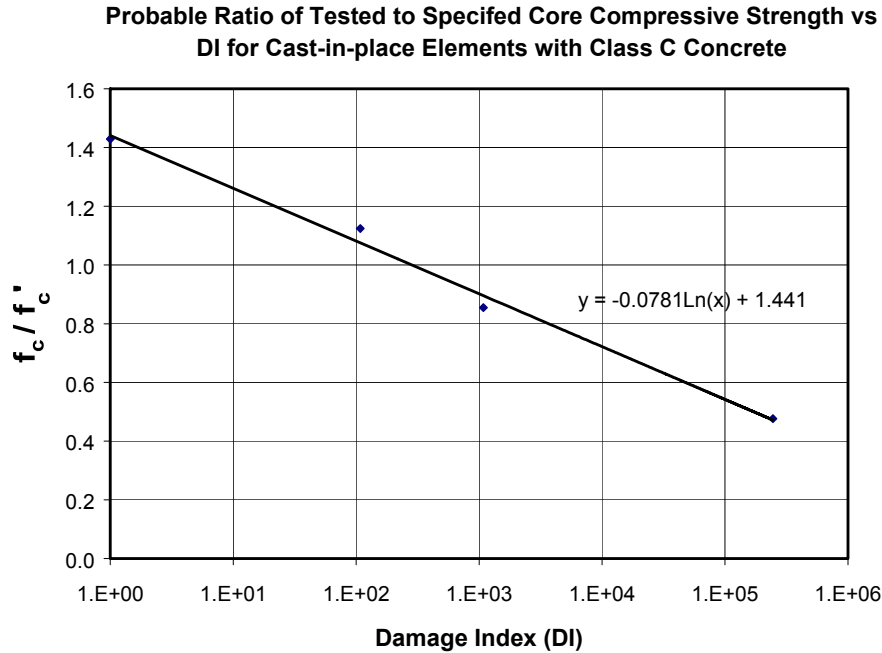
**Figure 9.9: Probable ratio of actual to specified concrete compressive strength versus damage index for cast-in-place elements with Class C concrete**

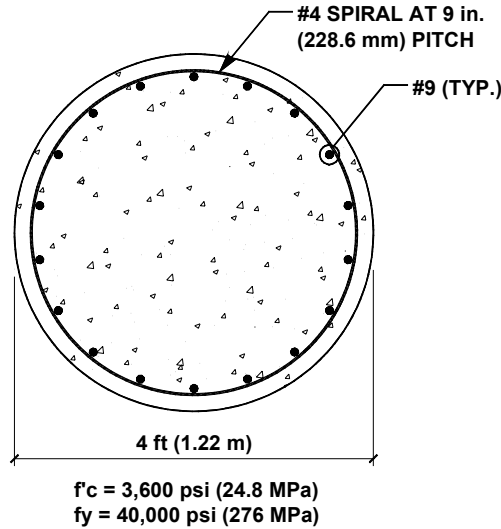
**Figure 9.10: Cross-section of lower column in Bent 5, Lake Ivie structure**

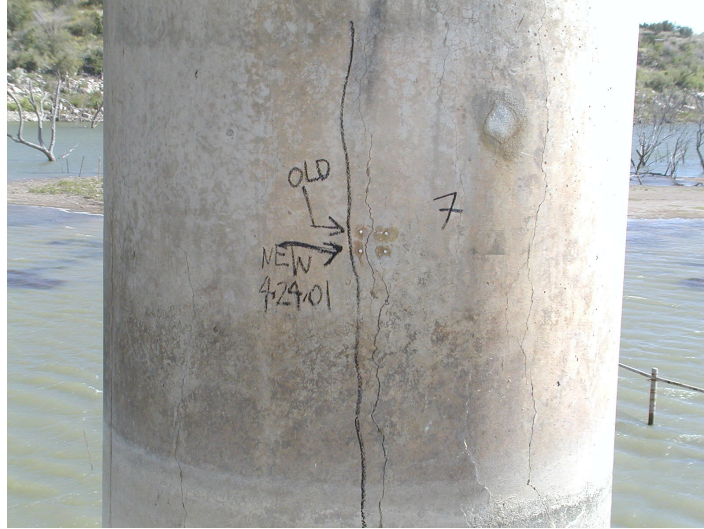
**Figure 9.11: Typical vertical cracking on south lower column of Bent 5 (10/15/01)**

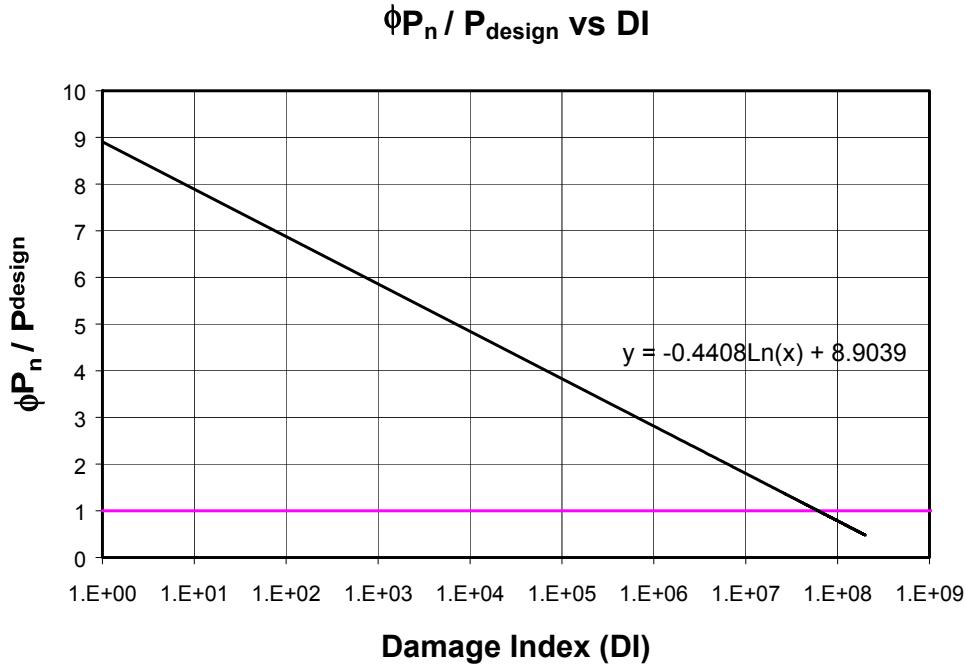
**Figure 9.12: Ratio of design axial capacity to design axial load versus damage index, south column, Bent 5, Lake Ivie**

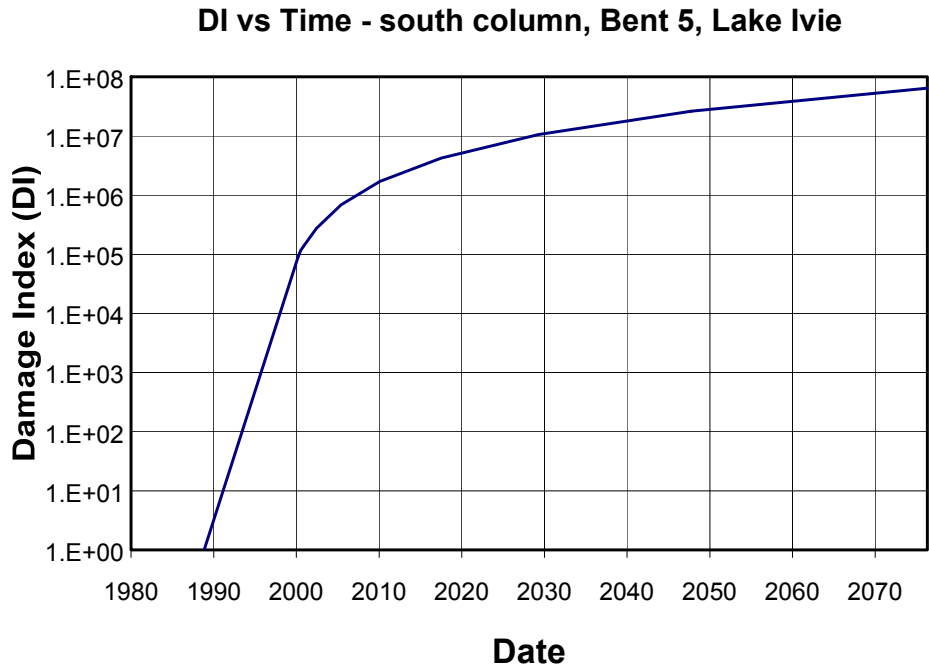
Figure 9.13: Predicted Damage Index versus time for south column, Bent 5, Lake Ivie

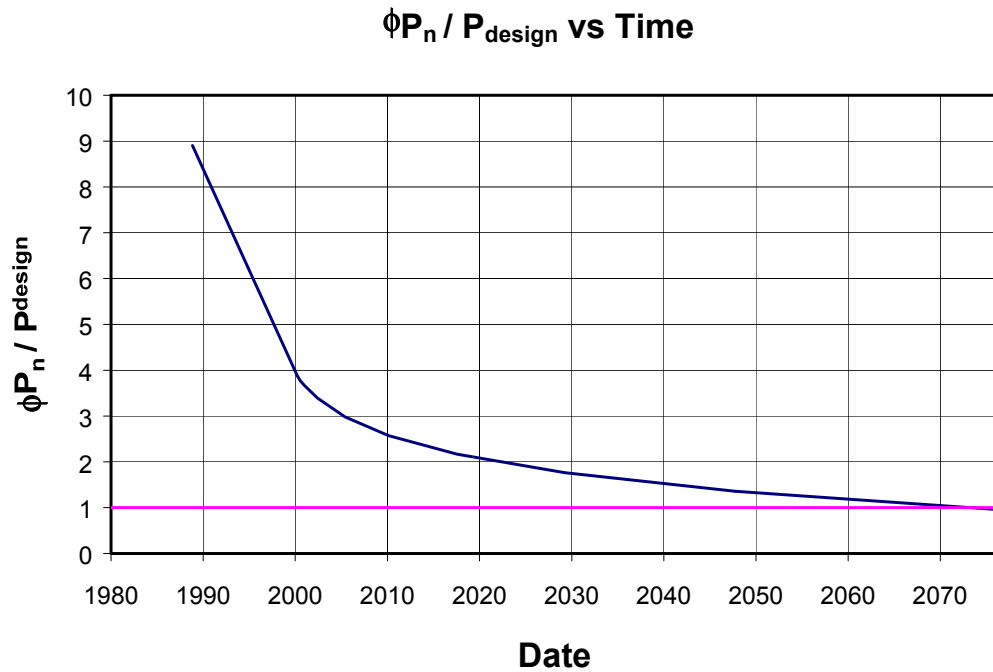
Figure 9.14: Predicted ratio of axial capacity to design axial load versus time, south column, Bent 5, Lake Ivie

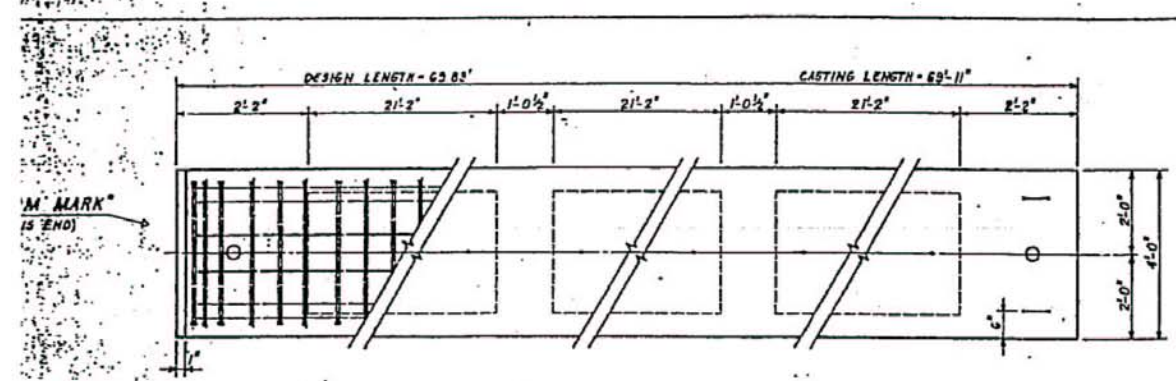
## **Appendix A: Fabrication Details of Box Girders**
