**STUDIES ON DAMAGE AND CORROSION PERFORMANCE OF
FABRICATED EPOXY-COATED REINFORCEMENT**

Research Report 1265-1

Structural Integrity of Epoxy-coated Bars
Research Project 3-5-91/3-1265

January 1993

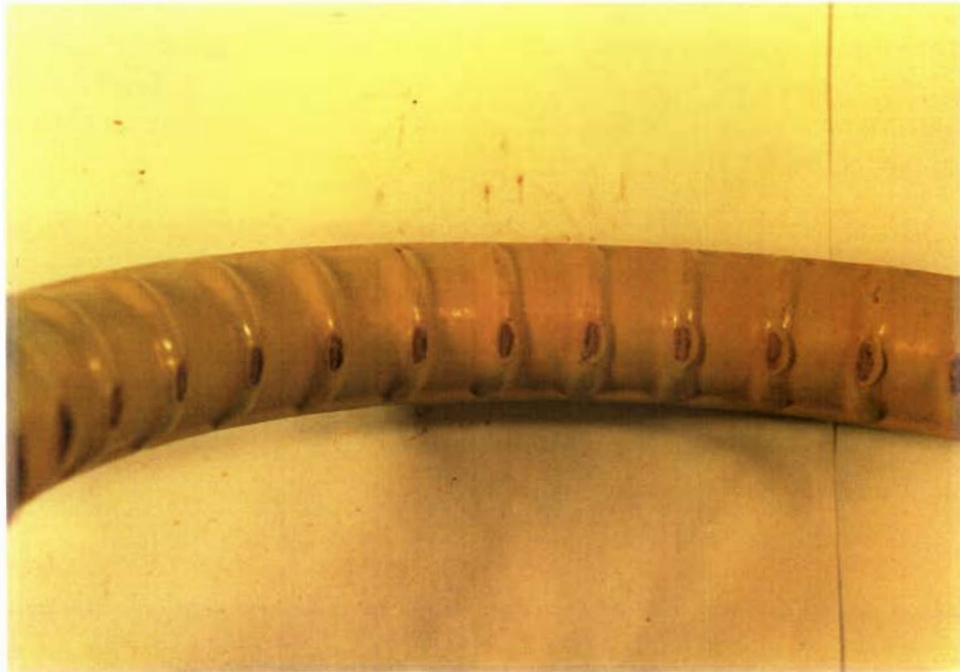
Figure 3.3 Comparison of damage induced by different bending operations.

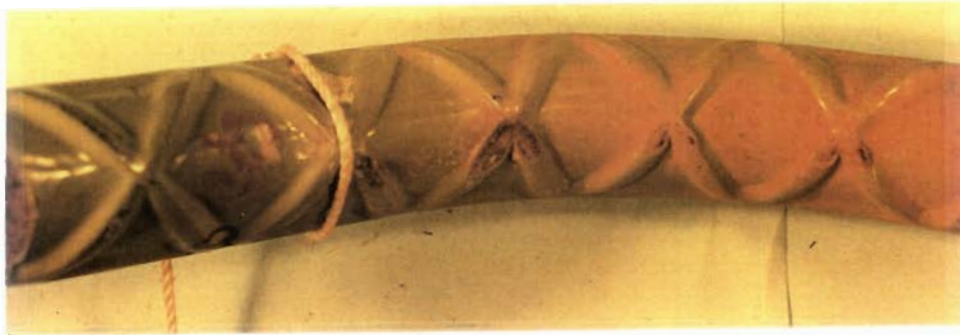
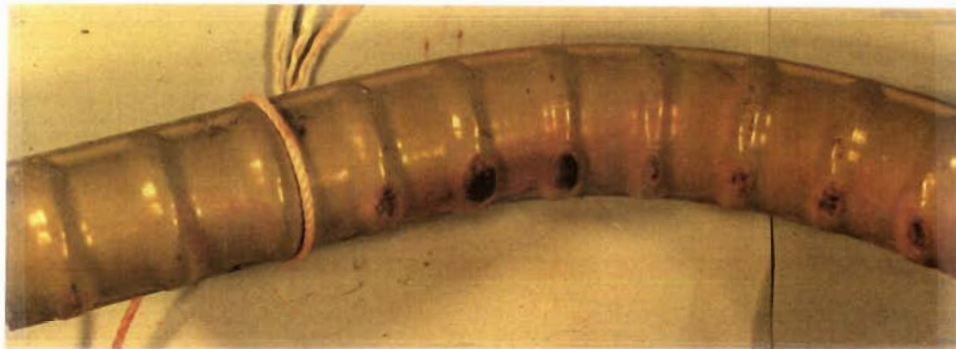
Figure 3.8 Corrosion in the damaged areas on the inside portions of bends

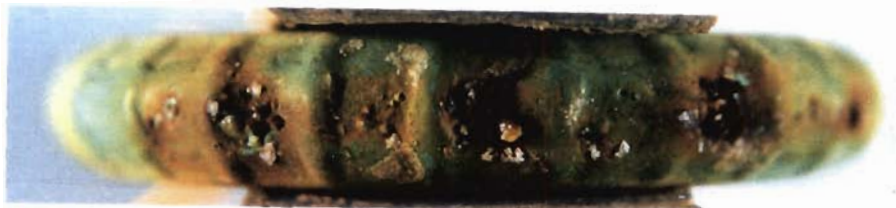
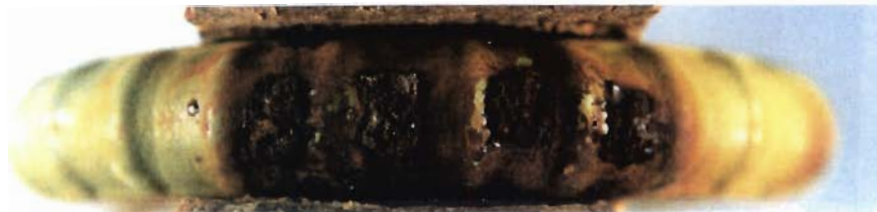
Figure 3.9 Typical corrosion observations of bars in series C and D.

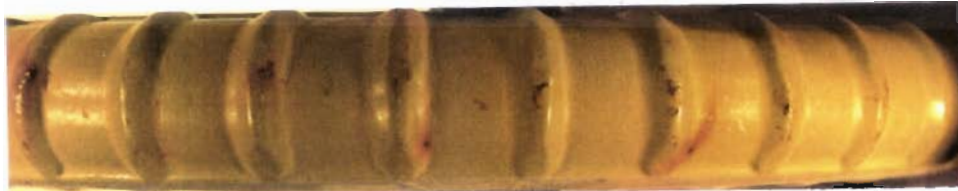
(b) #8 bar (B6 group)

Figure 3.12 Corrosion on hairline cracks on bars with parallel deformations.

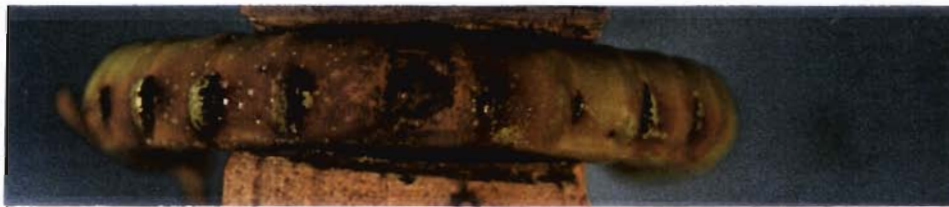
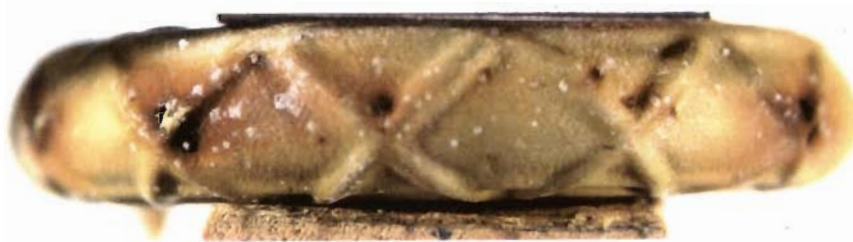
Figure 3.13 Comparison of corrosion on hairline cracks on bars with different deformations.

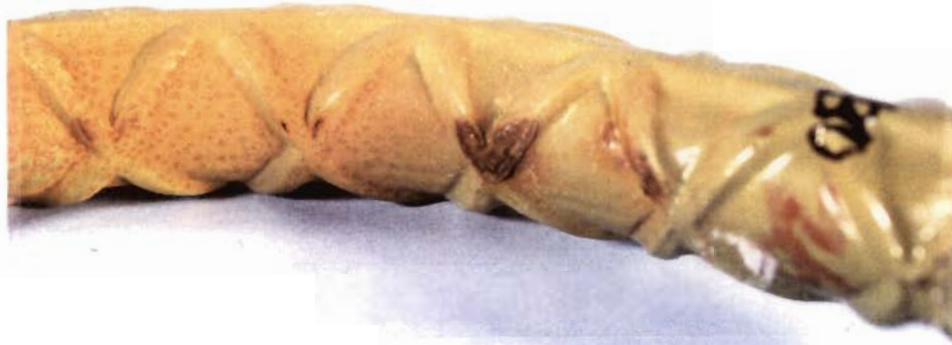
Figure 3.15 Comparison of corrosion on the inside portion of bend for different introduced damage on the outside portion.

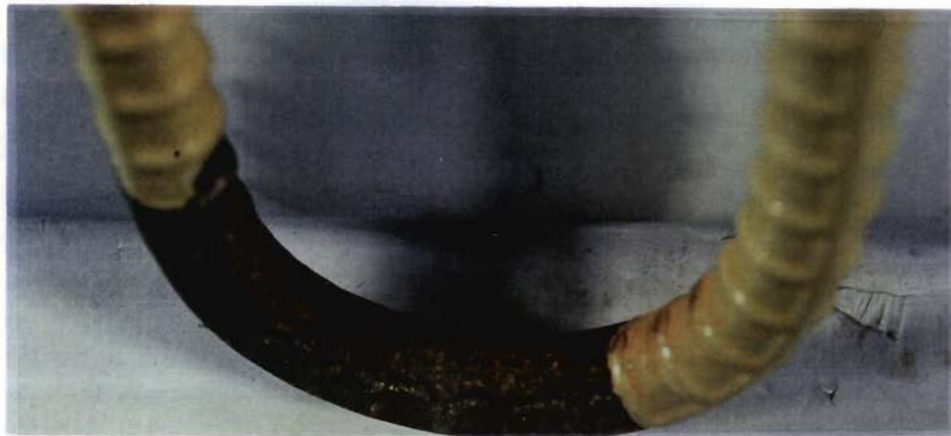
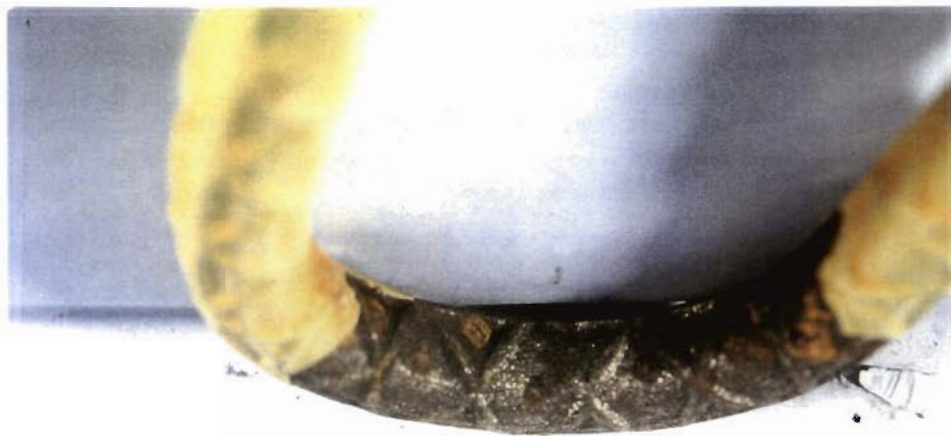
Figure 3.18 Corrosion progression on the inside of bends.

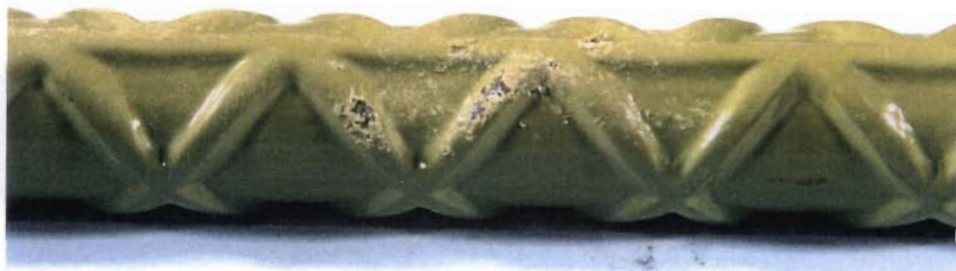
Figure 4.12 Damage due to vibration on the bottom side bars in the column specimen.

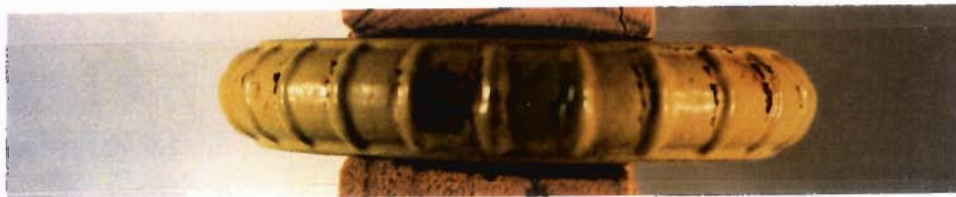
Figure 5.2 Deterioration of exposed areas on #4 bar with parallel deformations.

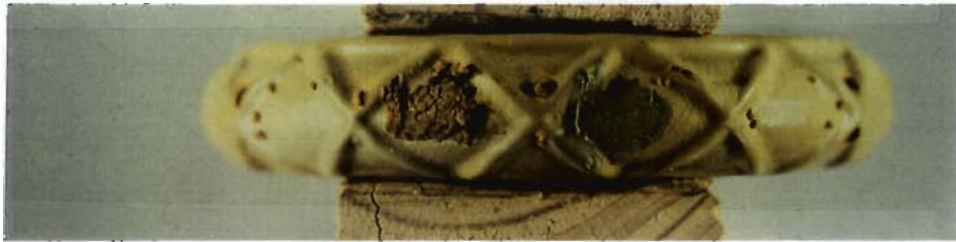
Figure 5.3 Deterioration of exposed areas and holidays on #4 bar with cross deformations.

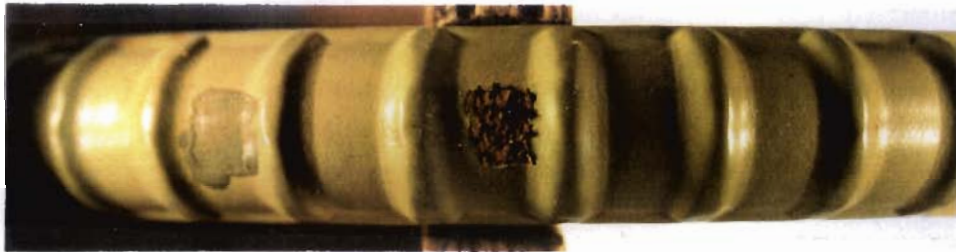
5.3.2 #8 Bars. No visible signs of deterioration were observed on any #8 bar where the damaged area was patched. However, damage on a few holidays was evident especially on bars with cross deformations. In addition, a considerable amount of rust was seen on the exposed steel areas (see Figures 5.4 and 5.5). Minor deterioration occurred on the damaged areas on the inside of bends.

Figure 5.4 Deterioration of exposed areas on #8 bar with parallel deformations.

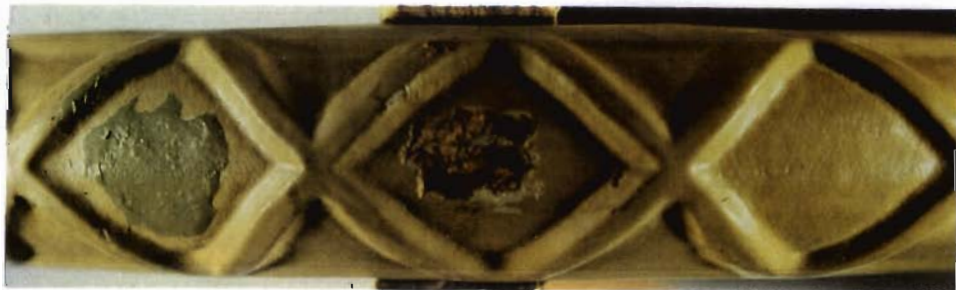
Figure 5.5 Deterioration of exposed areas on #8 bar with cross deformations.
