**CORROSION PERFORMANCE OF EPOXY-COATED
REINFORCEMENT-BEAM TESTS**

Research Report No. 1265-4

STRUCTURAL INTEGRITY OF EPOXY-COATED BARS

Texas Department of Transportation

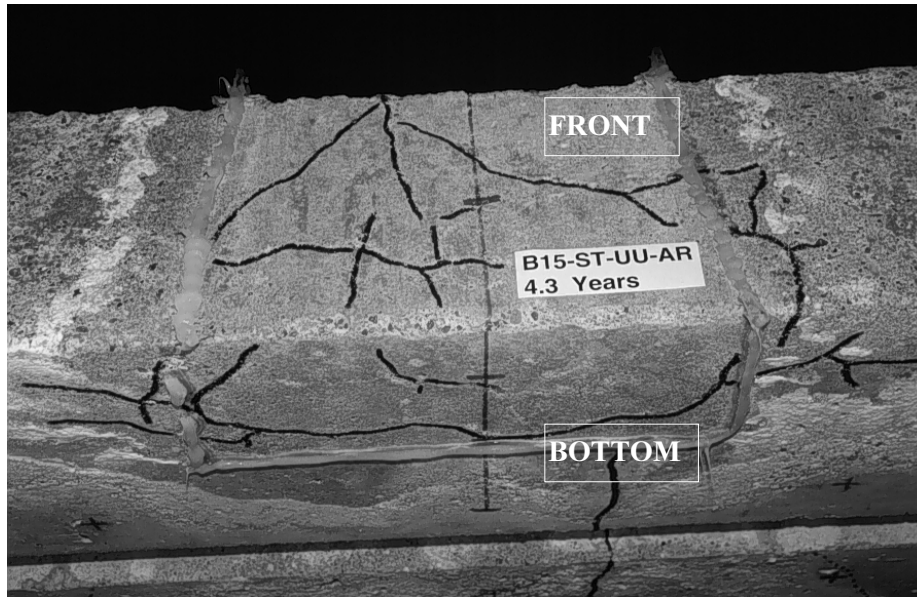
Figure 2.29 Surface cracking on previously uncracked beam B15 (front and bottom surfaces as in exposure).

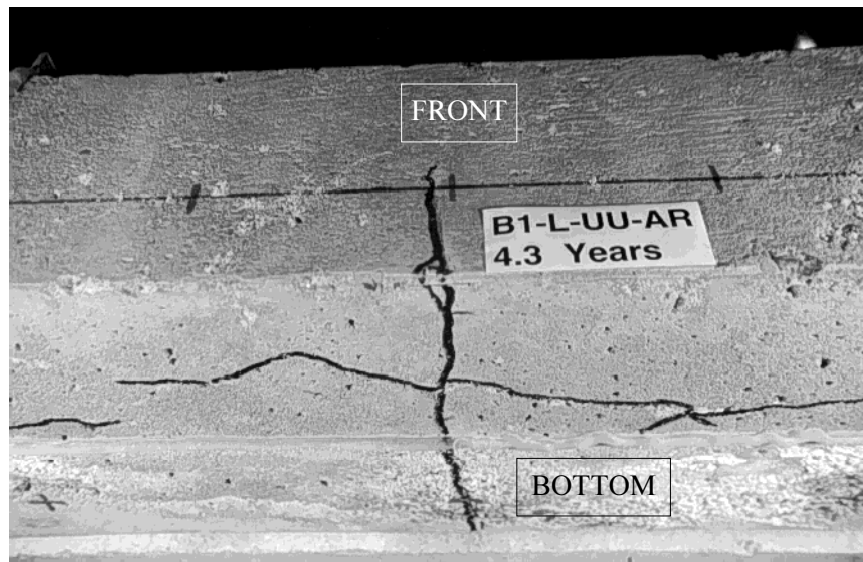
about 2.4 years. No evidence of rust was found around the crack. The crack was characteristic of a flexural crack but the beam was intended to be uncracked and no permanent load was applied. It may be that during handling, a load was accidentally applied.

Figure 2.31 Cracking on initially uncracked, unloaded beam B1 (front and bottom surfaces as in exposure).

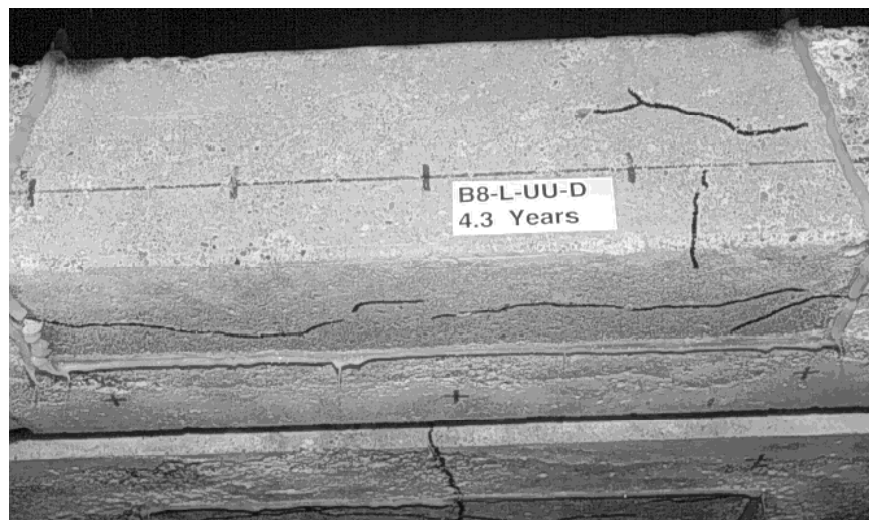
A series of short cracks developed on the bottom surface within the wet zone (Figure 2.32). Such cracks were detected at about 3.6 years of exposure and their orientation was parallel to the longitudinal beam axis. The cracks were narrow (0.10 to 0.15mm wide).

Figure 2.32 Cracking on non-precracked beam B8.

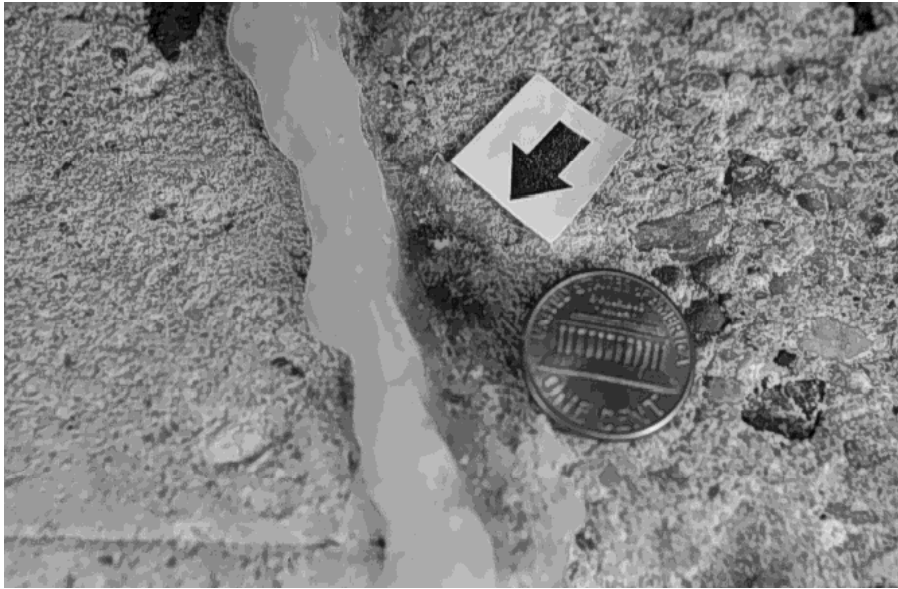
A spot with rust deposits formed on the front surface just outside the wet zone, close to the location of the lower coated bar (Figure 2.33). The rust spot was first observed at about 2.4 years of exposure. The rust spot grew from about 12mm² up to 50mm² at the end of 4.3 years. A small reddish-brown spot close to the upper black bar was observed at midspan on the top surface at about 2.4 years. The spot gradually faded and was not visible at the end of exposure.

Figure 2.33 Rust spot just outside wetted region on beam B12.

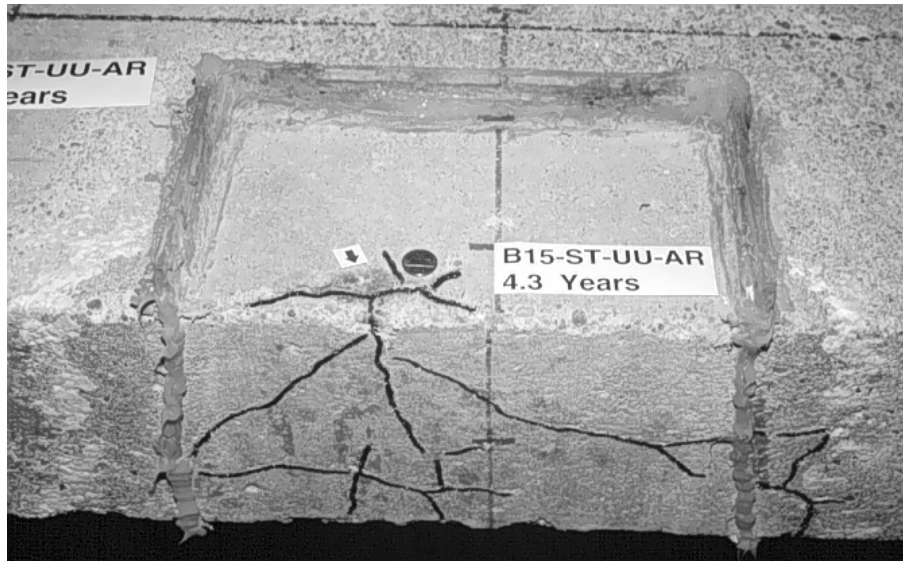
Figure 2.35 Random cracking on front surface of beam B15.

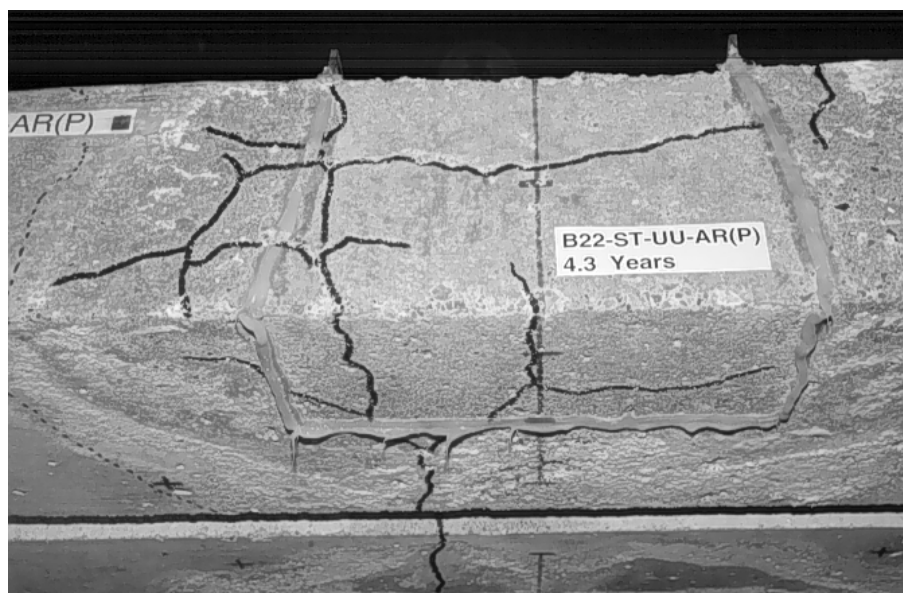
After 2.7 years of exposure, a crack developed on the front surface, inside the wet zone, extending from top to bottom, perpendicular to the beam axis and adjacent to the left boundary (Figure 2.36). Maximum crack width measured was 0.15mm. The crack continued to grow and an extension on the front surface was observed at 3.6 years. The crack extended from the vertical crack further into the wet zone, parallel to the beam axis at the mid-height of the front surface. Additional crack extensions were observed. Maximum crack widths were 0.10mm.

Figure 2.36 Random cracking on non-precracked beam B22.

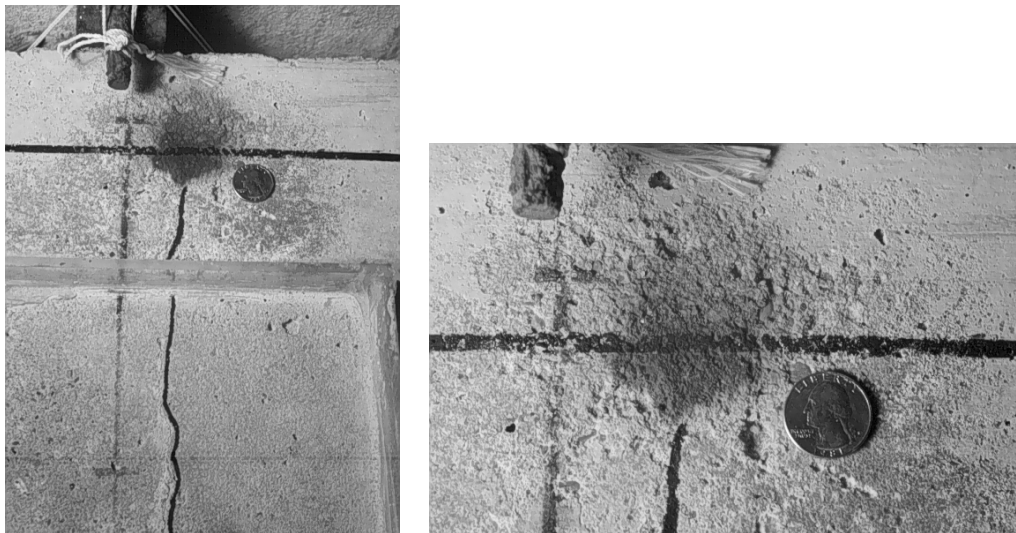
A small dark-brown spot was observed on the top surface, outside the wet zone (just to the left of wet zone, near the front surface), at about 2.7 years of exposure. Another small dark stain was detected on the bottom surface, outside the wet zone (8.5cm to the left of midspan), at about 2.2 years.

Figure 2.37 Rust spot on top surface of beam B17 at black bar location at midspan.

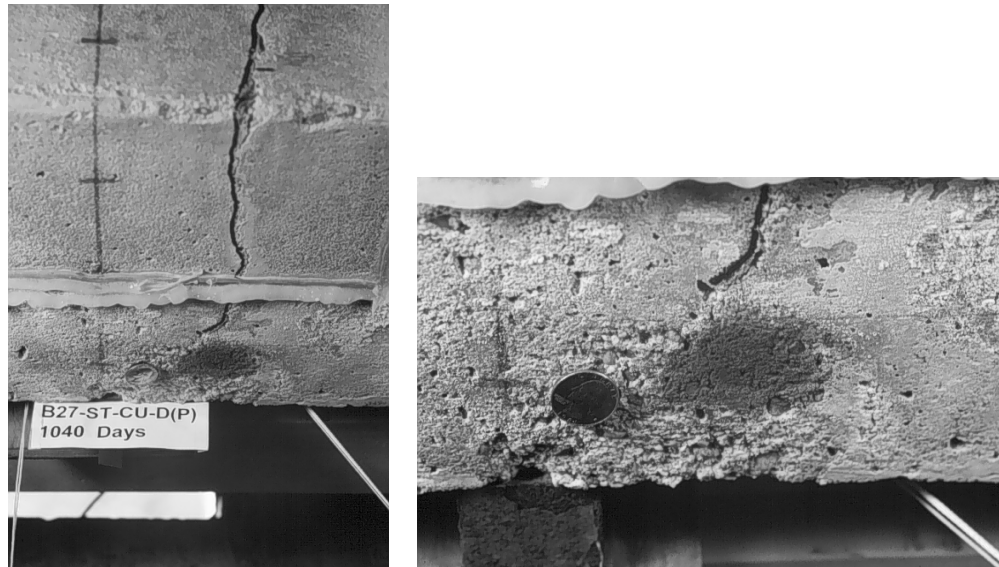
A rust spot of circular shape formed on the bottom surface of the beam, outside the wet zone, at the end of the flexural crack induced by the stirrup, close to the black bar location (Figure 2.38). The rust stain was first spotted at about 1.8 years of exposure and measured 7cm². Its size gradually increased with time up to 2.4cm² at 2.5 years, with no significant increases in size thereafter.

Figure 2.38 Large rust spot on bottom surface of beam B27 at black bar location at midspan.

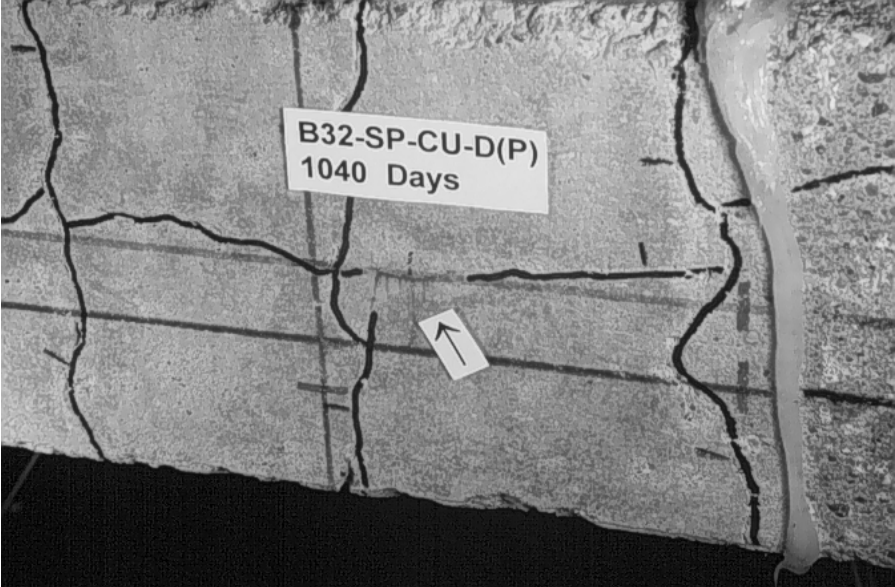
Figure 2.39 Horizontal cracking on front surface of beam B32.

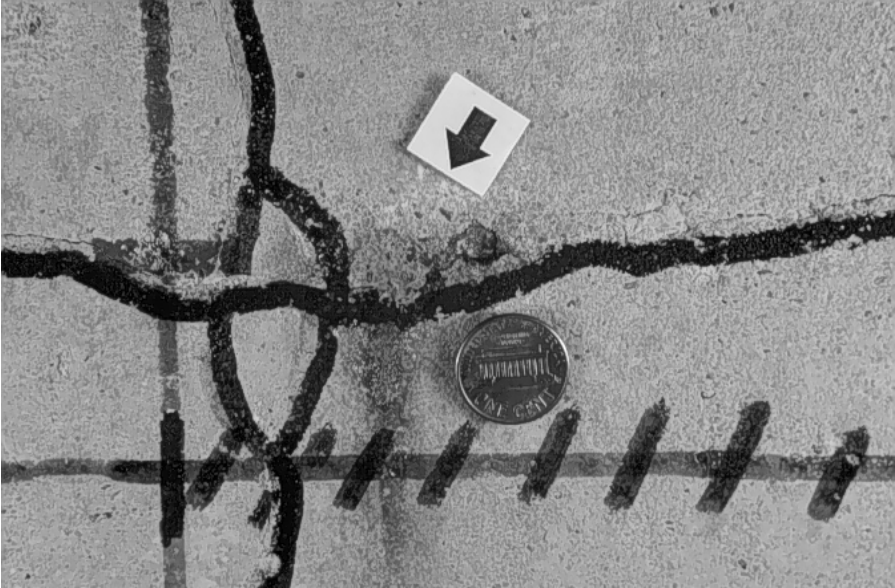
Rust exuded from a horizontal crack and an adjacent vertical crack at the front surface of the beam within the wet zone, just to the right of midspan. The exudation of rust along with downward flow of solution during the wet cycle left a rust stain below the horizontal crack (Figure 2.40). Rust along the crack extended 2cm along the horizontal crack and 2.7cm along the vertical crack. Rust staining increased up to a size of 4cm² at about 3.6 years of exposure. The rust stain seemed to dissipate with subsequent wet cycles.

Figure 2.40 Rust exuding through cracks on front surface of beam B32.

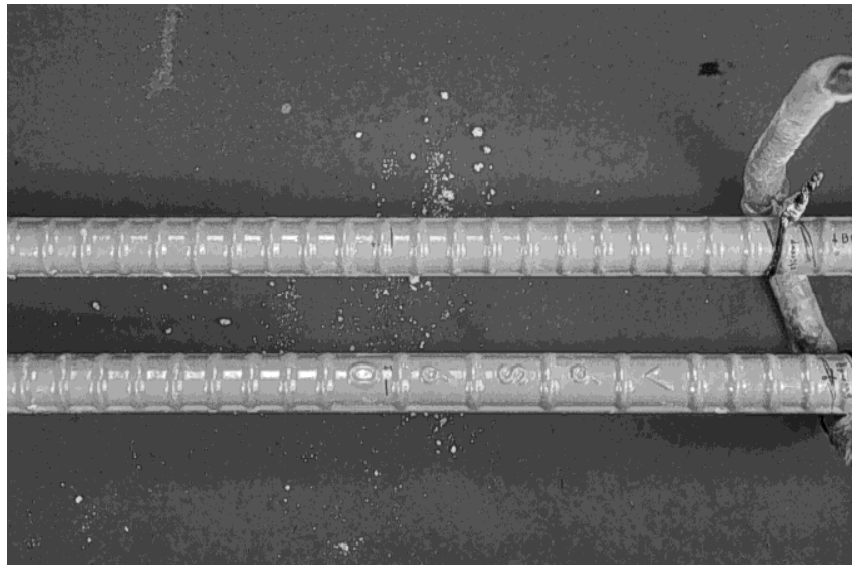
Figure 2.47 Longitudinal coated bars of beam B1 after 4.3 years of exposure.

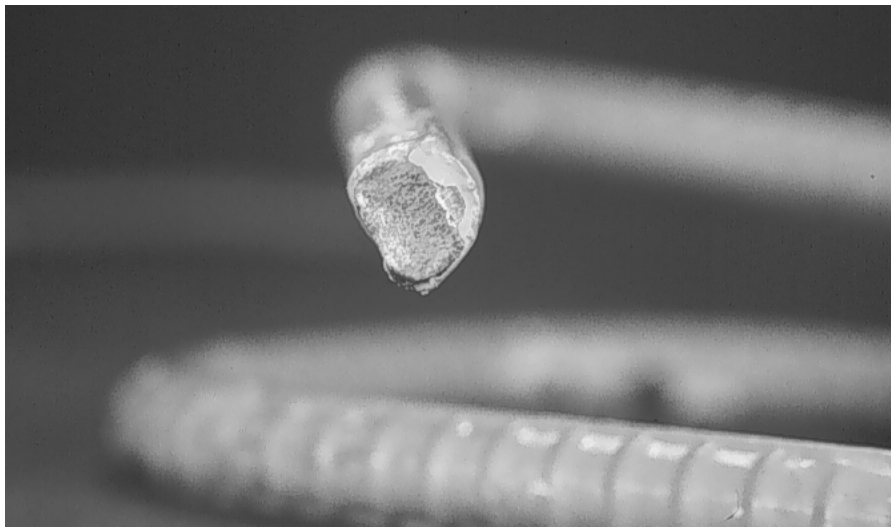
Figure 2.57 Patch at bar end of a stirrup hook that broke during autopsy (beam B23) after 4.3 years. Metallic surface beneath the patch was uncorroded.

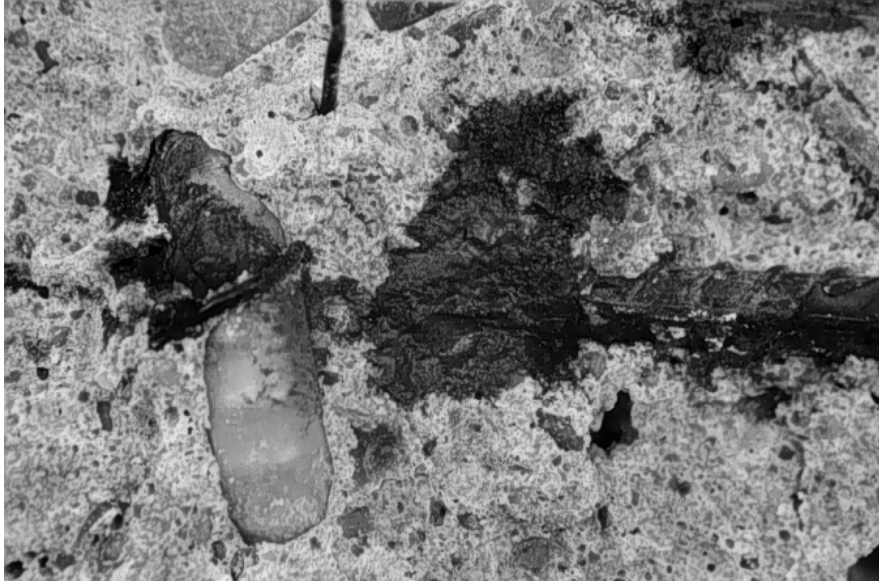
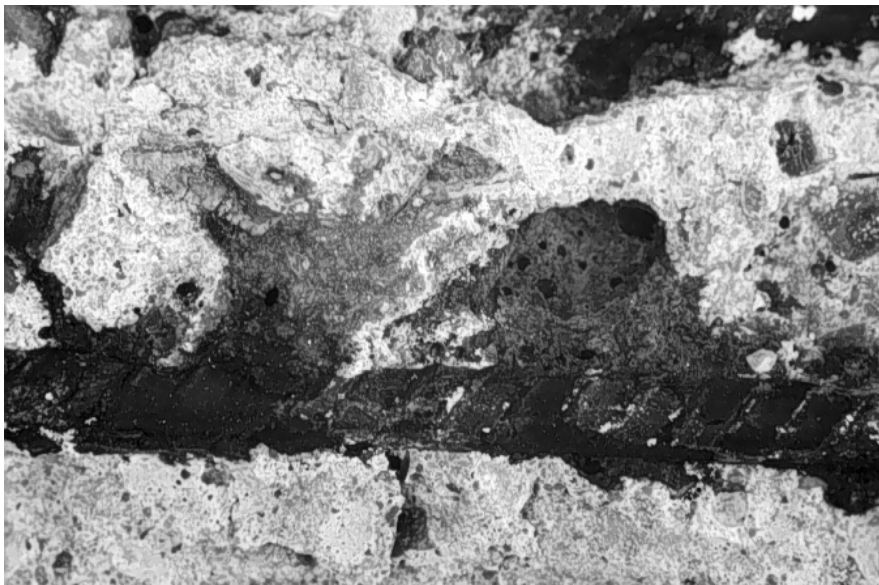
Figure 2.64 Severe pitting and loss of cross section on uncoated bars near crack locations after 4.3 years.

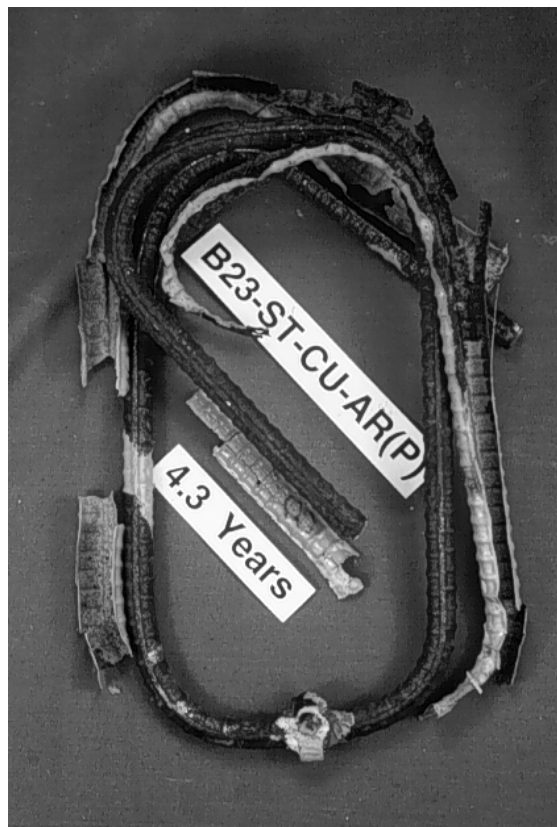
Coating debonded extensively at stirrups, as can be seen in Figure 2.71. Coating was very easy to remove at the least corroded portions of the stirrups. It could be lifted up integrally, without breaking or falling apart in small pieces. Coating was less easily removed at the most corroded portions of the stirrups, where it came off in smaller pieces due to its very thin and deteriorated condition. Adherence of rust products to the coating also contributed to the higher degree of difficulty. Because of these factors, coating removal at stirrups was generally time-consuming.

Figure 2.71 Coating extensively debonded on stirrups after 4.3 years.

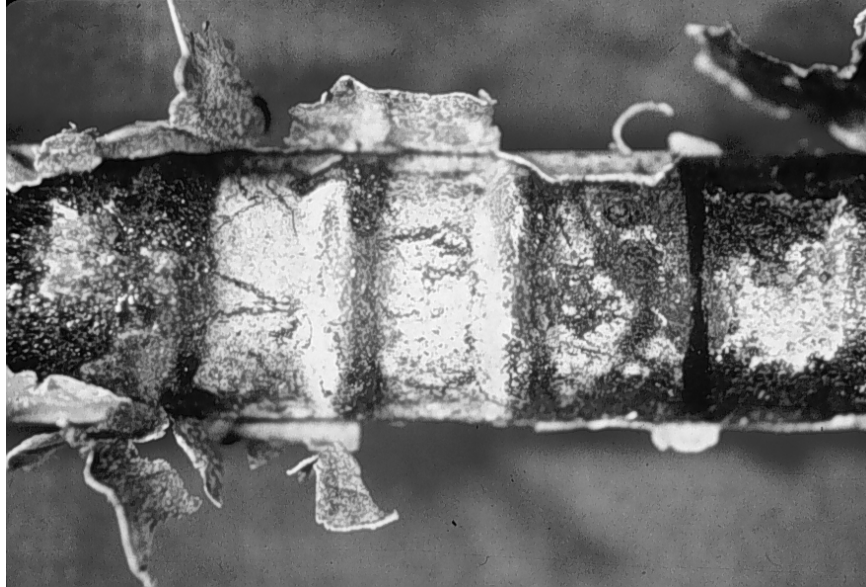
Occasionally, a clear-trapped solution was found underneath the coating. The solution dried quickly upon exposure to the atmosphere leaving a white residue that turned brown as shown in Figure 2.75. Except for the bars that exhibited considerable pitting as mentioned above, steel corrosion was generally superficial without significant metal loss.

Figure 2.75 White residue of dried solution trapped beneath coating.

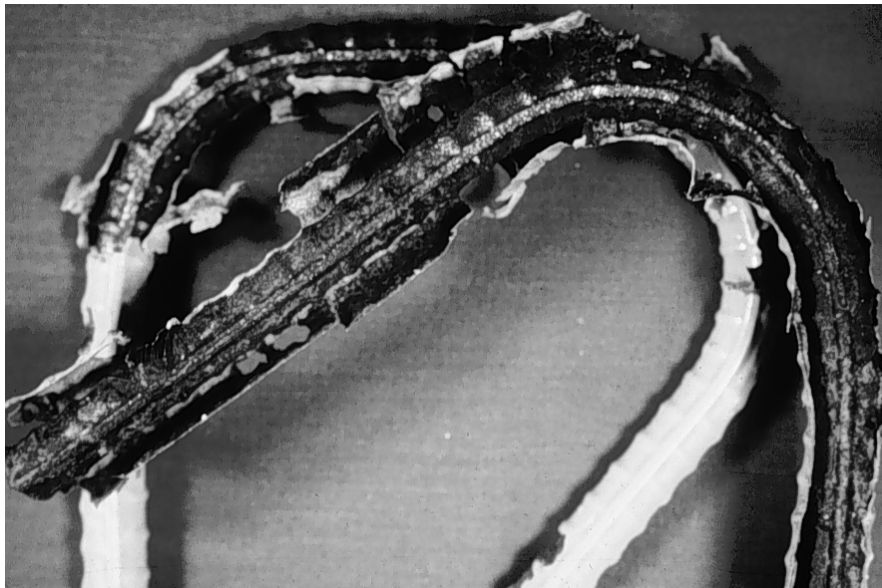
Many of the stirrups exhibited moderate to widespread underfilm corrosion starting from the hook ends and from defects on both the inside and outside of bends. The metal underneath the coating, including patching, appeared dull and darkened with some brown rust spotting. A rust layer was observed particularly on stirrup parts closest to a crack or lower concrete surface. Corrosion was also obvious around points of contact between stirrup and uncoated bars. Slight pitting was observed along the continuous ribs of some stirrup legs. Stirrup surface rusting ranged from minor to severe but without significant localized loss of bar section. Figure 2.76 shows an example of undercutting on a stirrup specimen with 3% patched damage.

Figure 2.76 Example of undercutting on stirrup with 3% patched damage after one year of exposure.

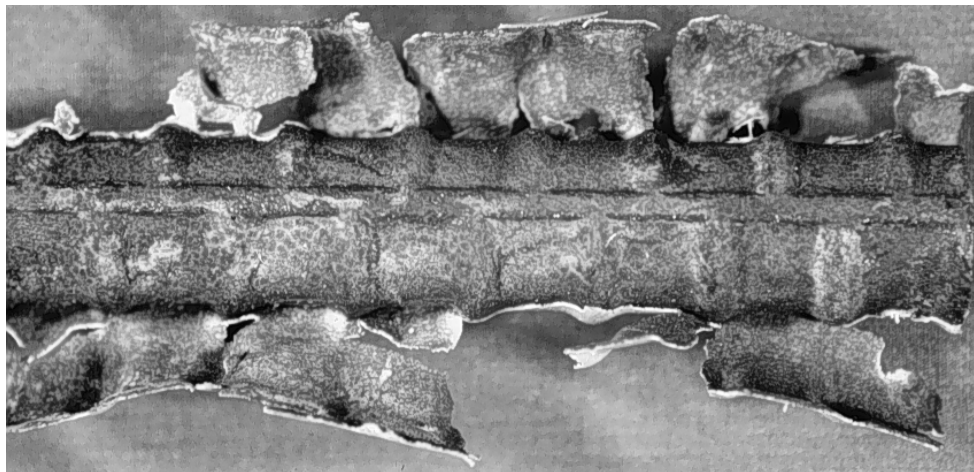
For bar ends at splice zones, a black corrosion product covered up to about 70% of bar surface area at the lower side. The maximum undercutting length was about 165mm (6.5in.) from the cut end as shown in Figure 2.77. Again, corrosion was light without significant metal loss.

Figure 2.77 Undercutting along splice bar at patched cut end after one year of exposure.

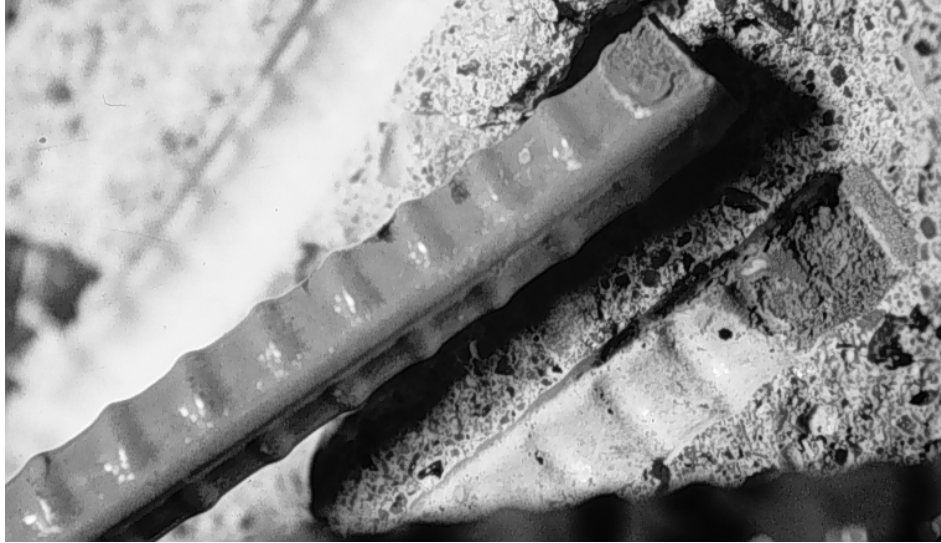
The stirrup trace did not have a similar distinct pattern. There were some voids distributed along the stirrup legs and concrete was not as glossy as it appeared on top of the longitudinal bars. Figure 2.89 shows an example of a stirrup trace in concrete. An interesting observation was that the patching material used at the coating plant to repair stirrup ends remained on the stirrup imprint in concrete as shown in Figure 2.90.

Figure 2.90 Patching material observed on stirrup imprint in concrete.

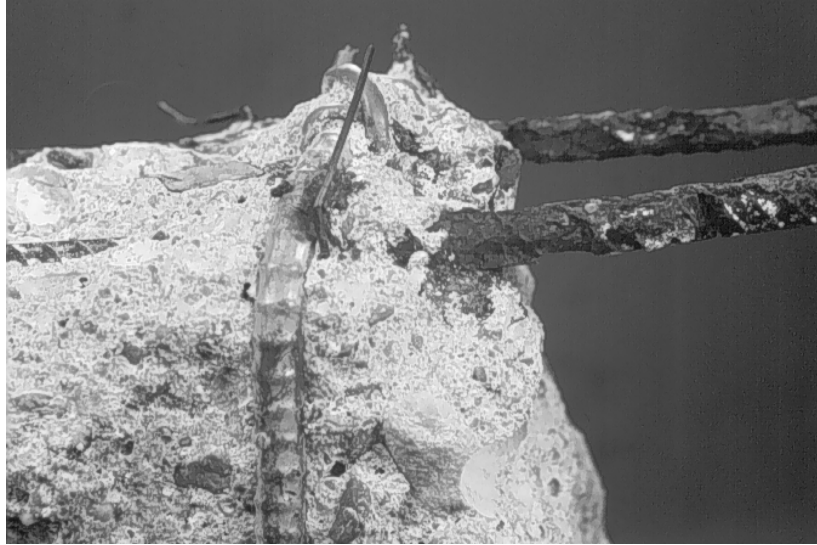
Figure 3.9 *Pitting corrosion of uncoated bars at crack location (beam B25).*

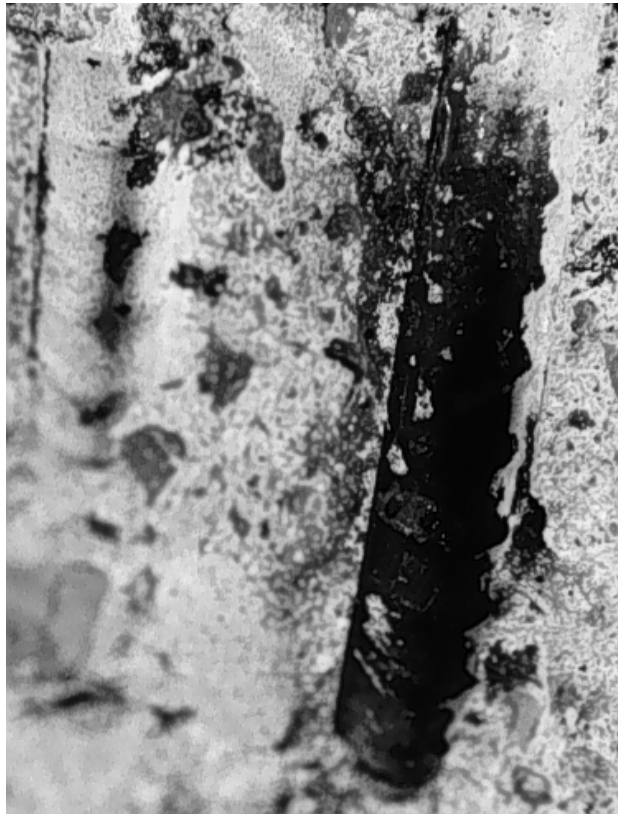
Figure 3.10 Stirrup trace in concrete adjacent to crack after one year.

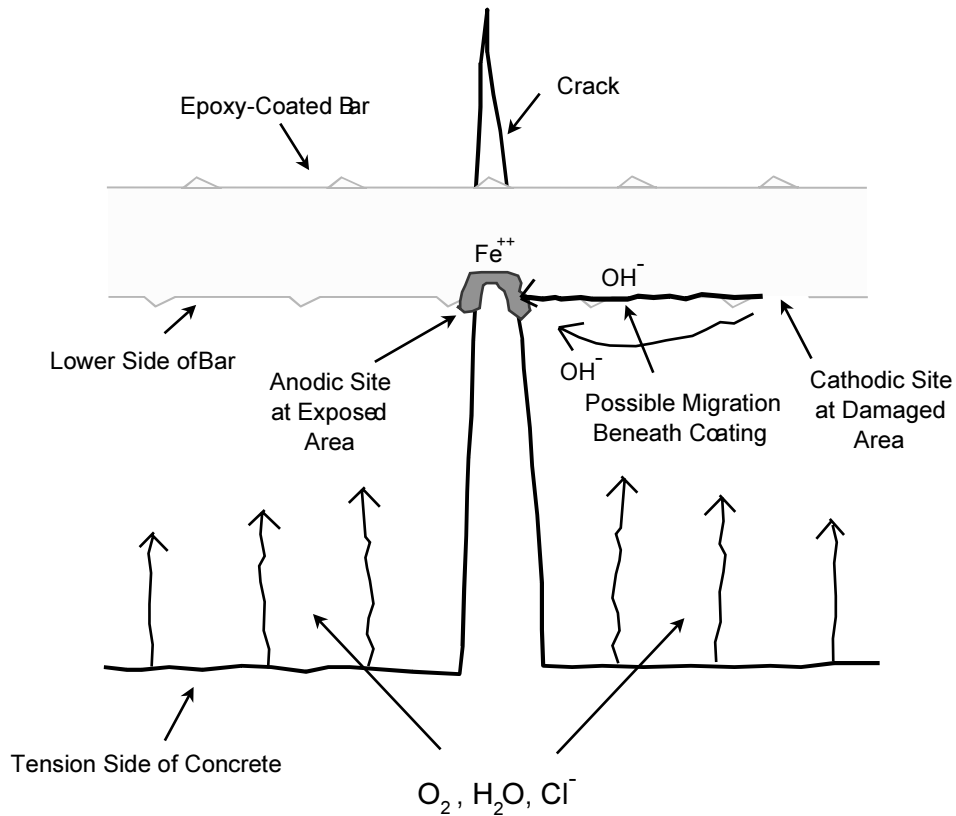
Figure 3.18 Pitting corrosion on coated bar at crack location.

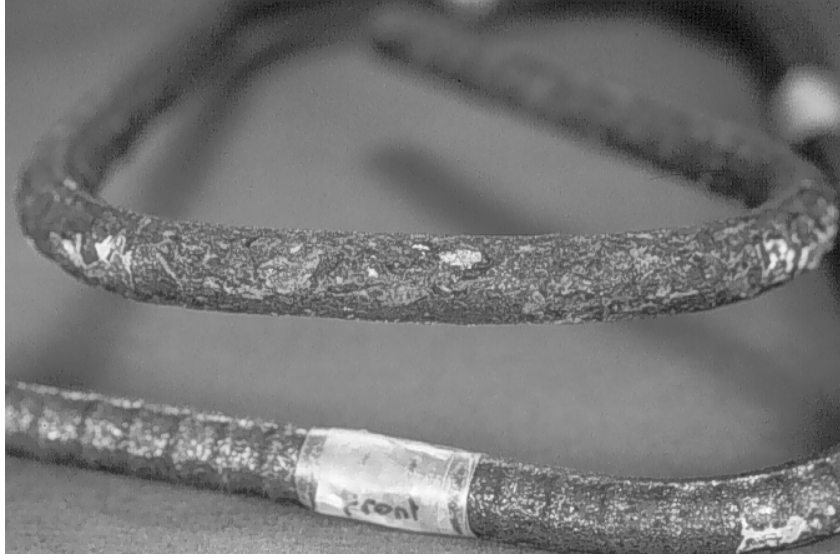
Figure 3.24 Stirrup leg near the beam front surface (top in photo) is corroded while stirrup hook is mottled (bottom in photo) (Beam B32).

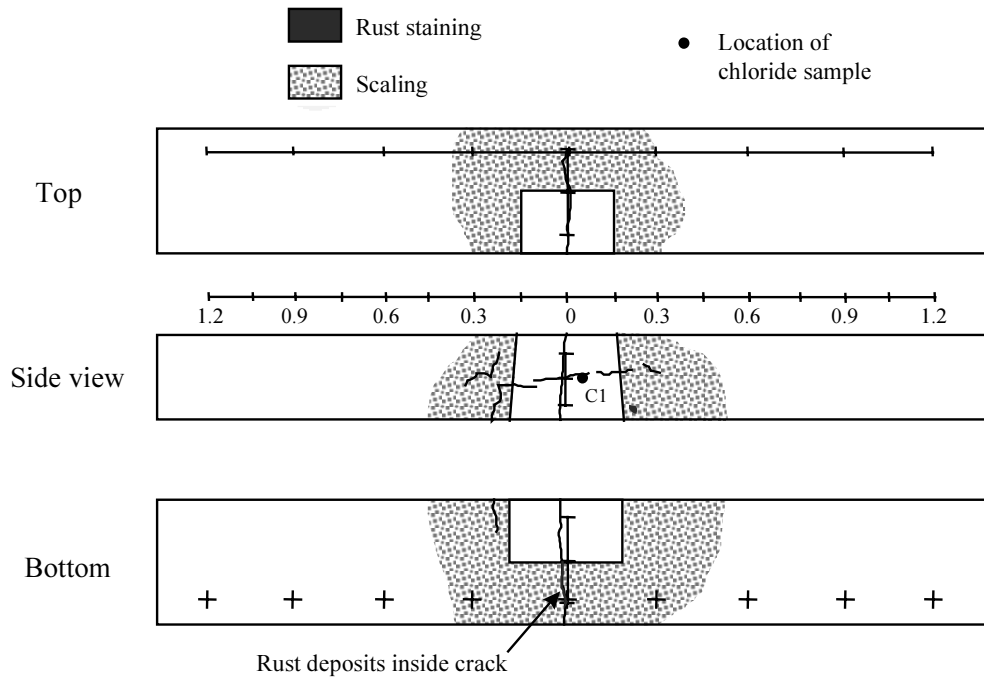
Figure A.49 Surface condition of beam B19-ST-CL-AR after 4.3 years of exposure.

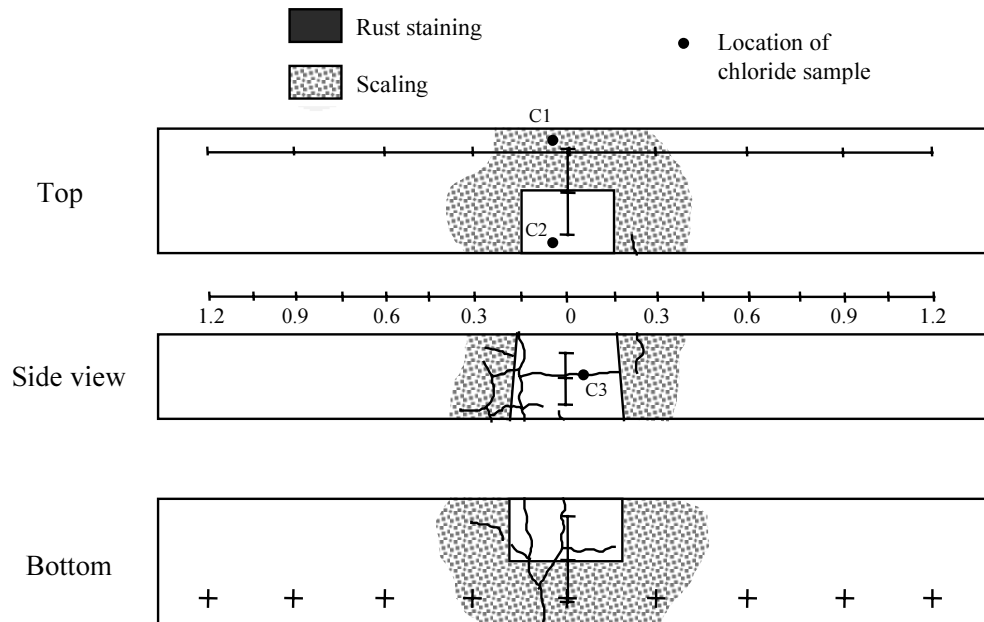
Figure A.50 Surface condition of beam B22-ST-UU-AR(P) after 4.3 years of exposure.

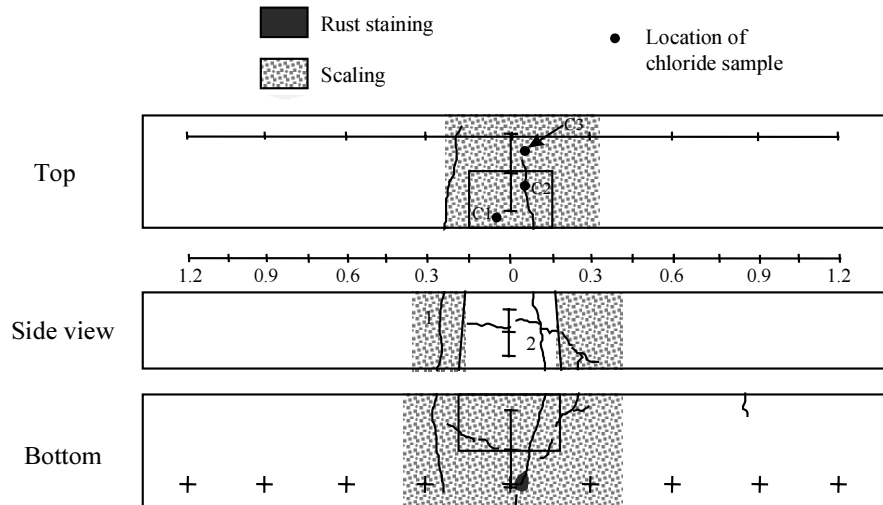
Figure A.51 Surface condition of beam B23-ST-CU-AR(P) after 4.3 years of exposure.

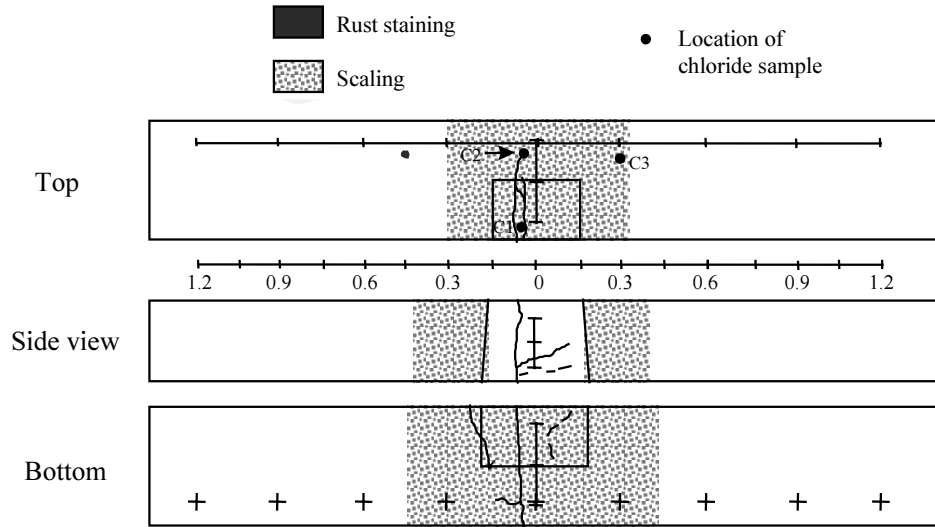
Figure A.52 Surface condition of beam B25-ST-CL-AR(P) after 4.3 years of exposure.

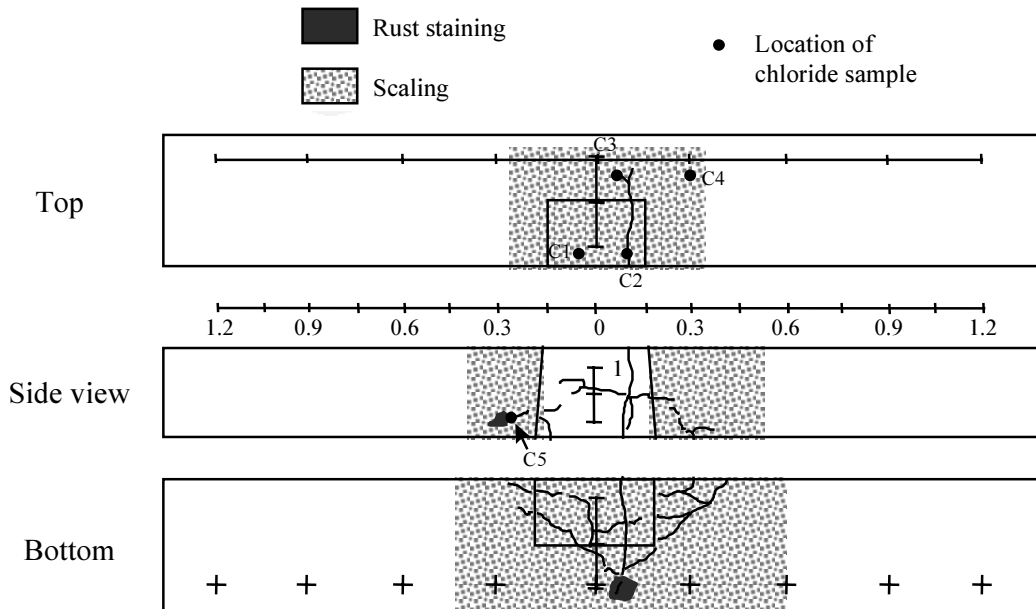
Figure A.53 Surface condition of beam B27-ST-CU-D(P) after 4.3 years of exposure.

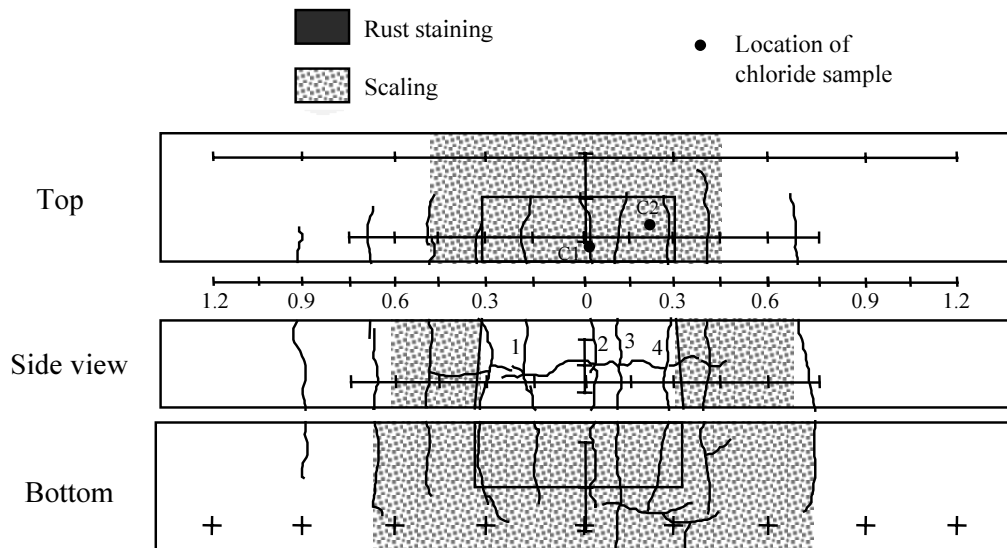
Figure A.54 Surface condition of beam B30-L/ST-CU-D(P) after 4.3 years of exposure.

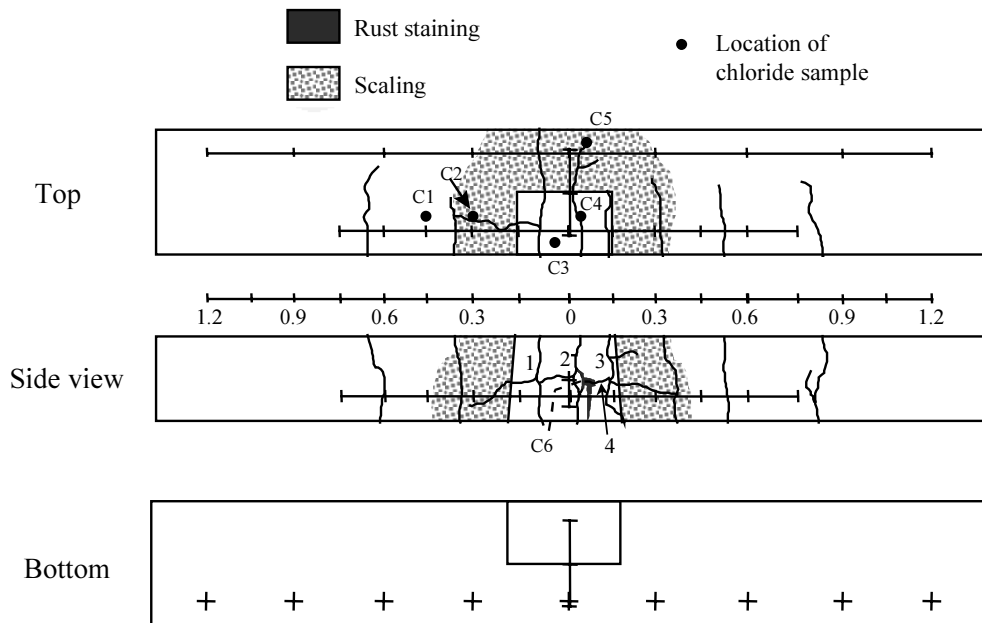
Figure A.55 Surface condition of beam B32-SP-CU-D(P) after 4.3 years of exposure.

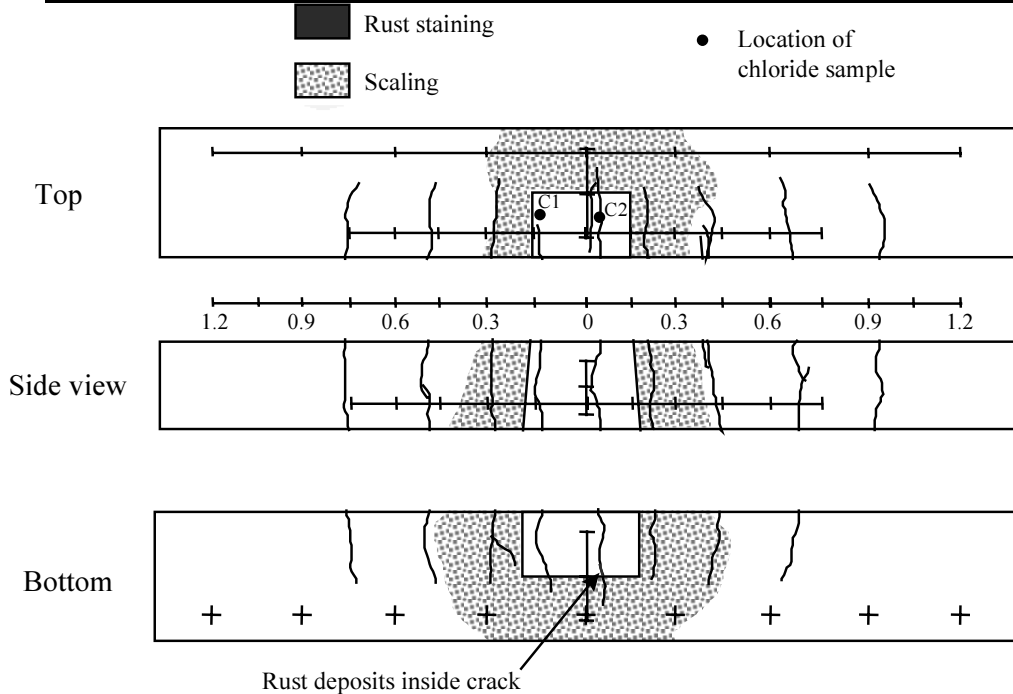
Figure A.56 Surface condition of beam B34-SP-CL-D(P) after 4.3 years of exposure.
