REPAIR OF EPOXY-COATED REINFORCEMENT

Research Report No. 1265-5

STRUCTURAL INTEGRITY OF EPOXY-COATED BARS

Texas Department of Transportation

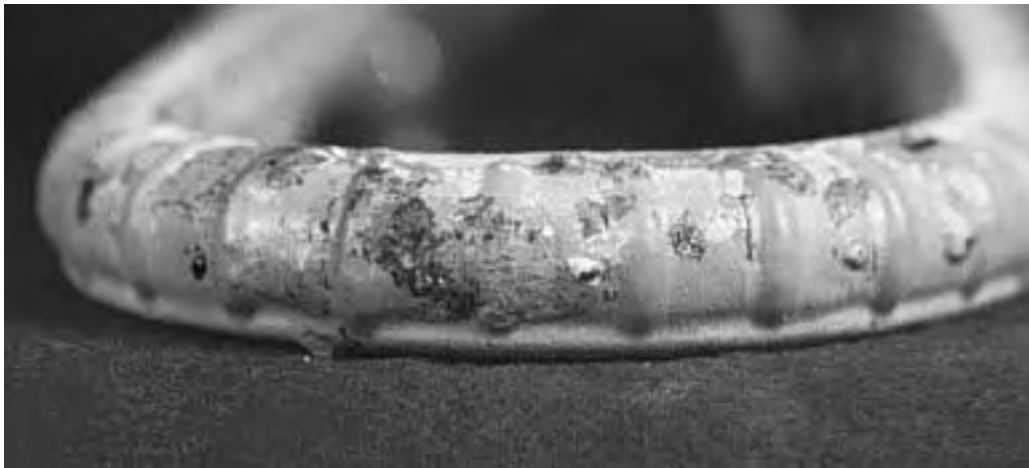
Figure 1.1 Corrosion of patched area of #4 epoxy-coated bar (macrocell study).

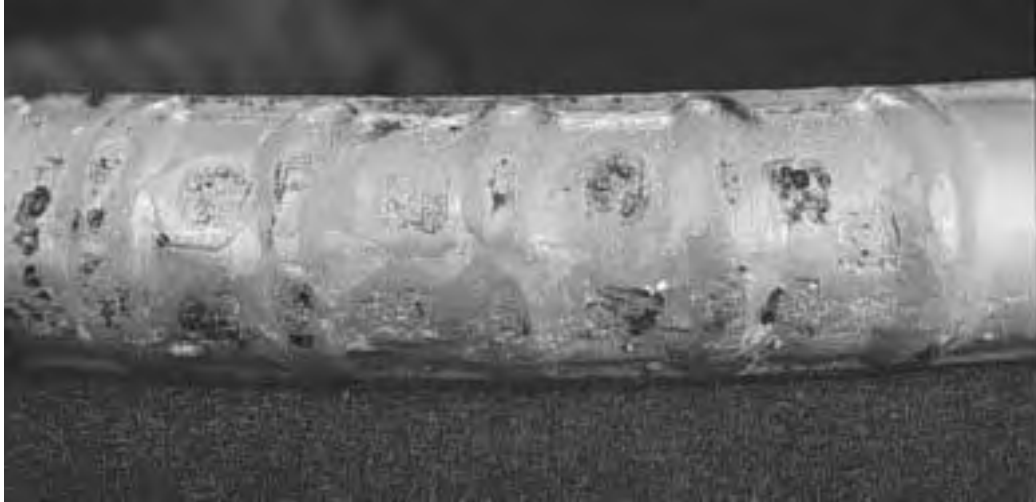
Figure 1.2 Corrosion of patched areas at outside bend on #8 bar with damaged coating greater than 2% (macrocell study).

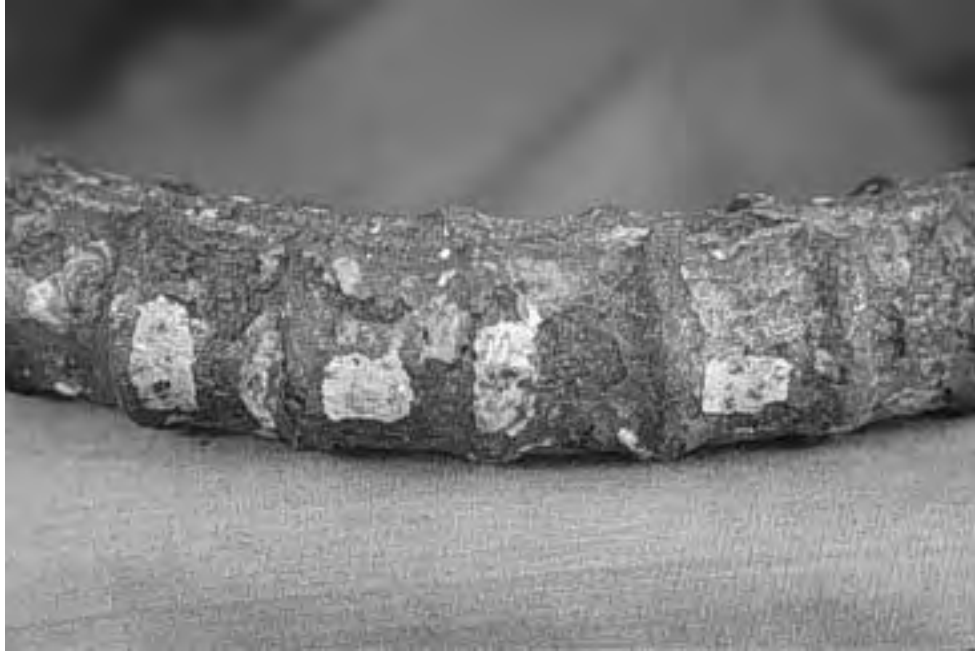
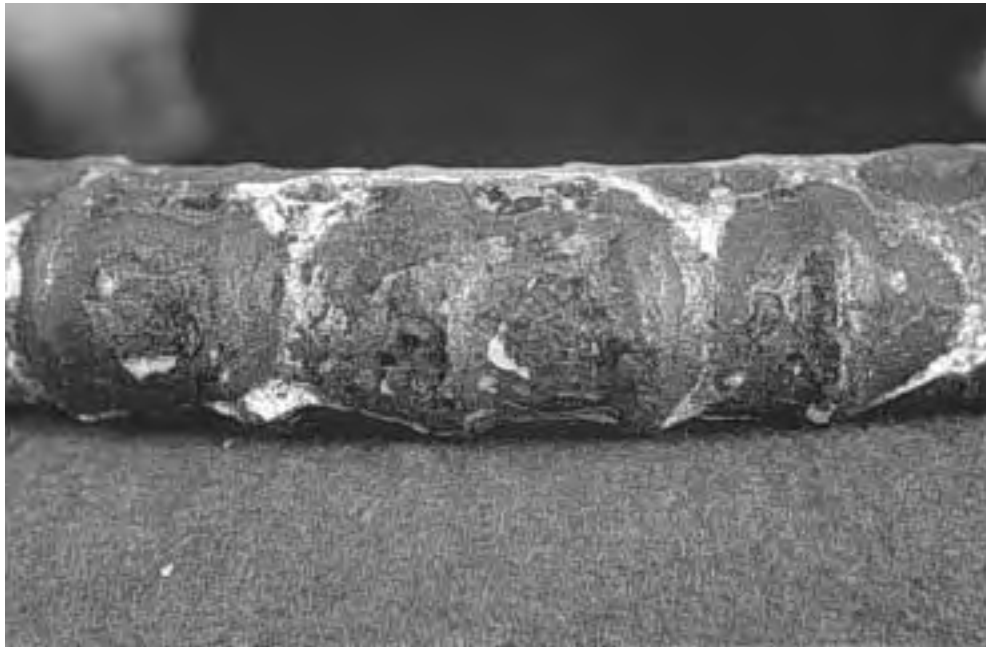
(a) Patched bar, outside bend.

(b) Bar with unpatched damage at outside bend.

Figure 1.3 Comparison of steel corrosion under the coating at outside bend of bars with damaged coating, with and without repair (macrocell study).

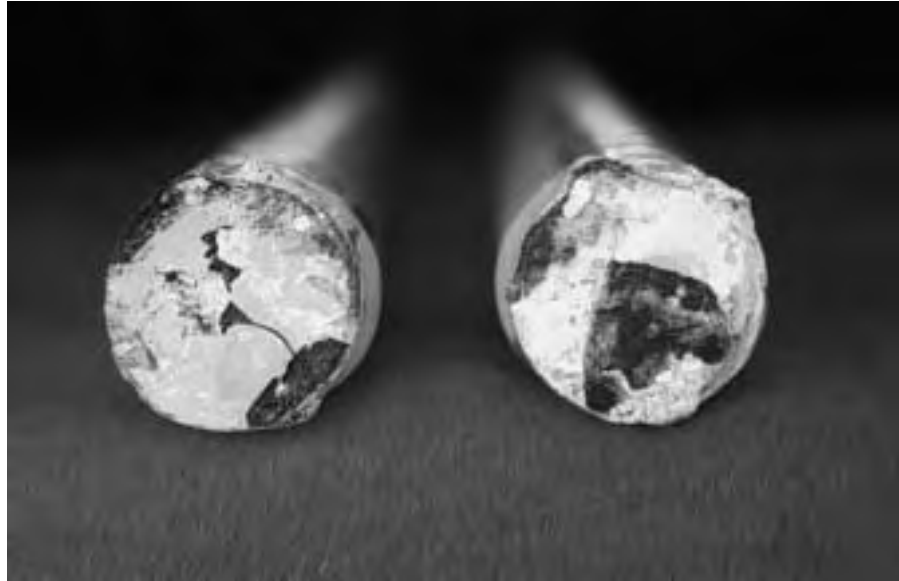
Patched bar ends were particularly vulnerable to corrosion. Patched cut ends at spliced bars in beam specimens experienced uniform dark corrosion beneath the patch, and coating debonding with underfilm corrosion progressed along the bar up to a distance of about 20 to 24 cm from the patched ends (Figures 1.4 and 1.5). When bar patched ends coincided with a crack location, corrosion was initiated and chloride solution penetrated and migrated underneath the coating. Corrosion of patched ends has been observed by others.⁶

Figure 1.4 Patch at ends of spliced bars broke during autopsy, exposing a dark corroded surface after 4.3 years of exposure (beam study).

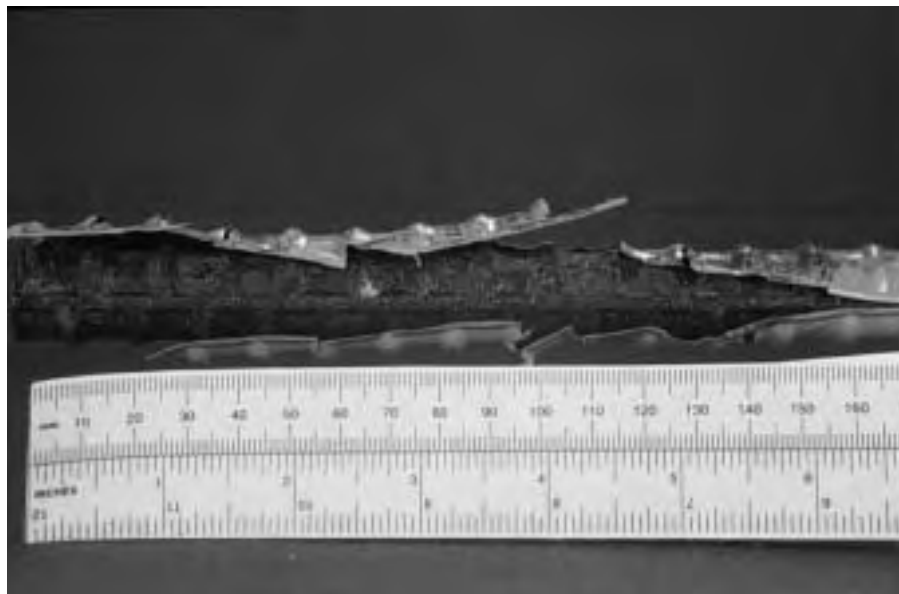
Figure 1.5 Coating debonding with underfilm corrosion of spliced bar within the wetted region after 4.3 years of exposure (beam study).

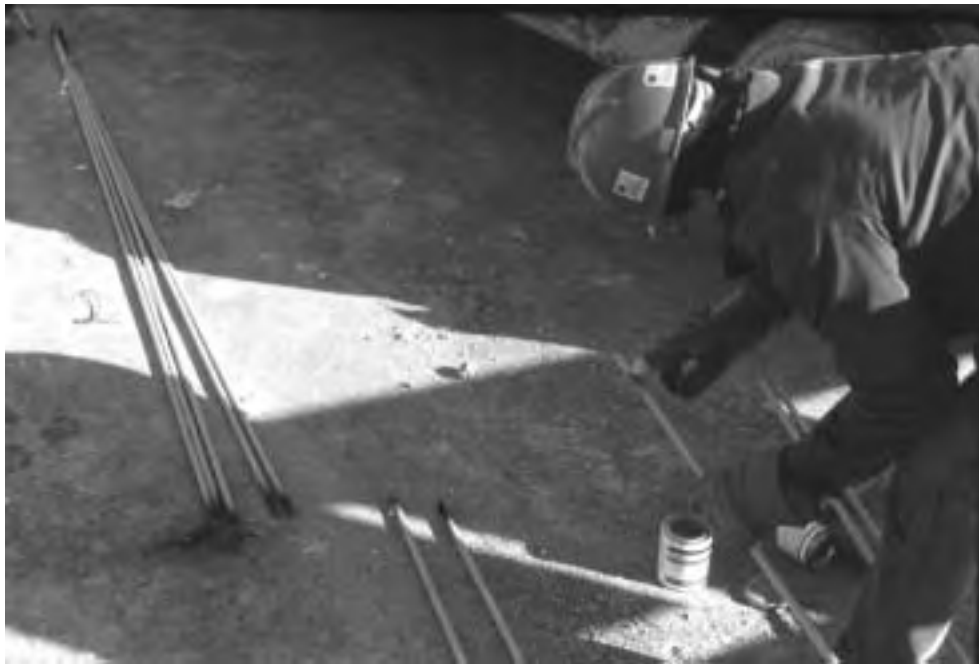
Figure 1.6 Improper field practice: Epoxy coated bars were flame cut and, immediately thereafter, bar ends are being touched up by hand.

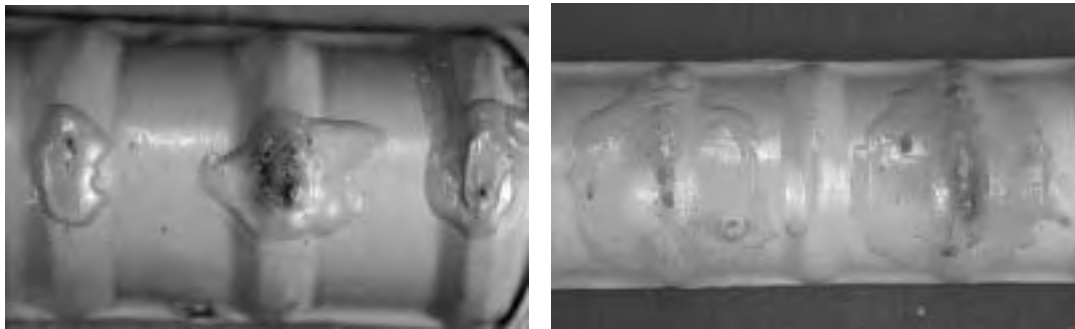
(a) Corrosion of patched area on bar deformation. (b) Rust stains on repaired areas on bar deformations.

Figure 3.1 Corrosion of patched areas on bar surface.

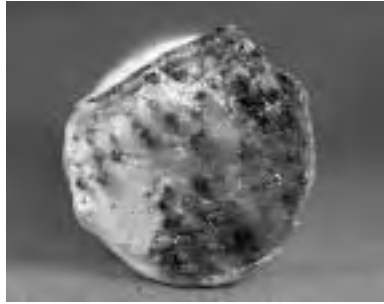
(a) Corrosion of patched end (shear-cut).

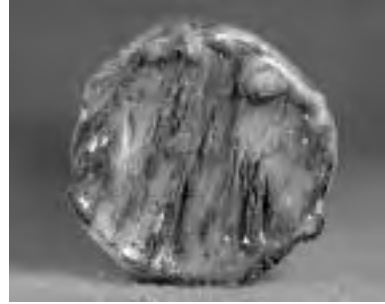
(b) Corrosion of patched end (torch-cut).

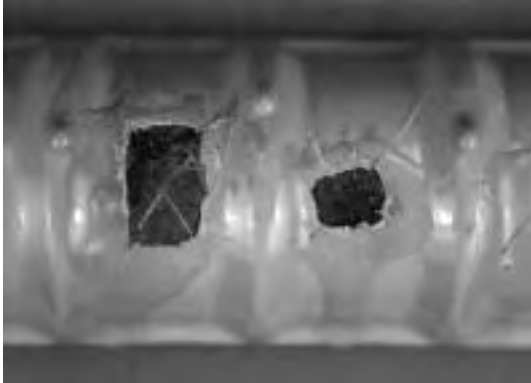
(a) Corrosion of steel surface underneath patch on damaged areas.

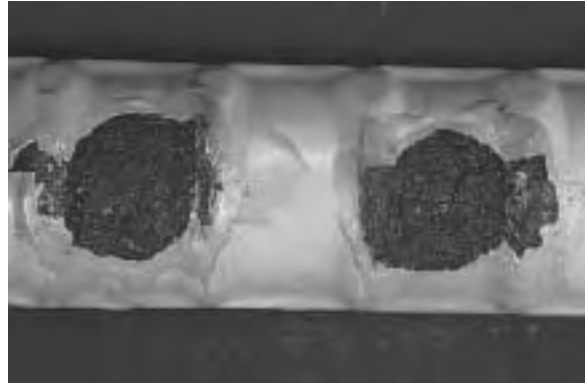
(b) Corrosion of steel surface beneath patched areas.

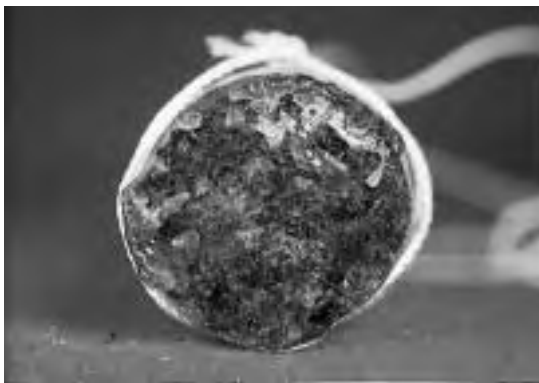
(a) Corrosion of bar end surface underneath the patch.

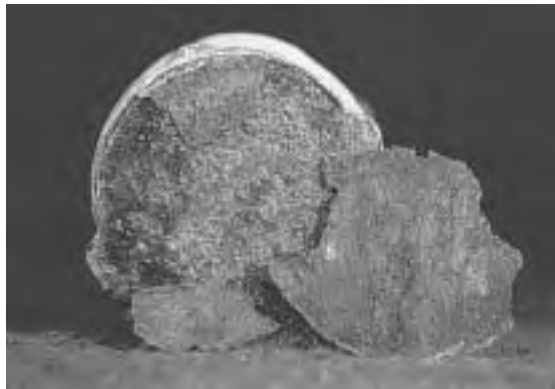
(b) Rust layer beneath patch.

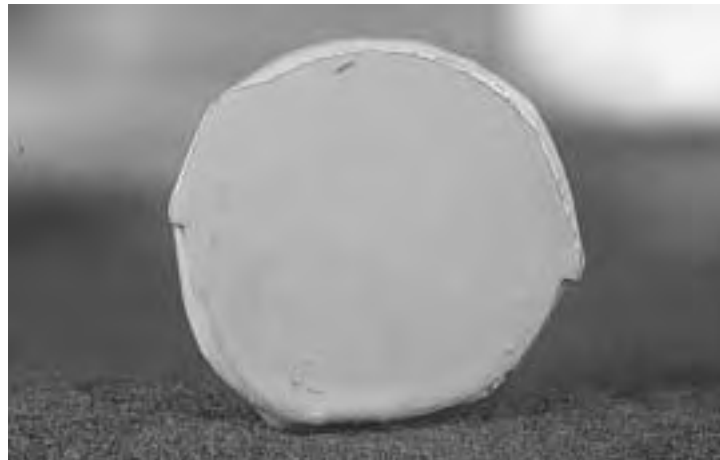
Figure 3.6 Visible steel due to very thin patch around perimeter edge on bar end.

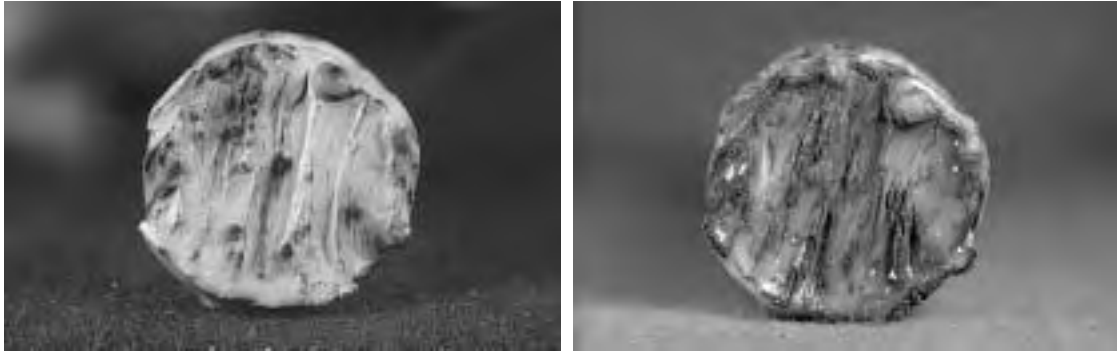
(a) Appearance after 53 days of immersion in 3.5% salt solution. (b) Appearance after 200 days of immersion.

Figure 3.7 Corrosion of flame-cut and patched bar ends.

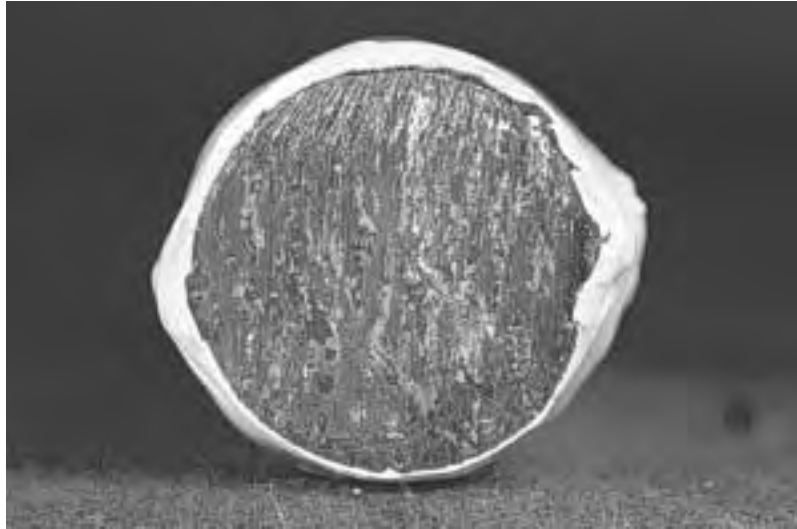
Figure 3.8 Good corrosion performance of bar end surface uncleaned before patching after 200 days of exposure to 3.5% NaCl solution.

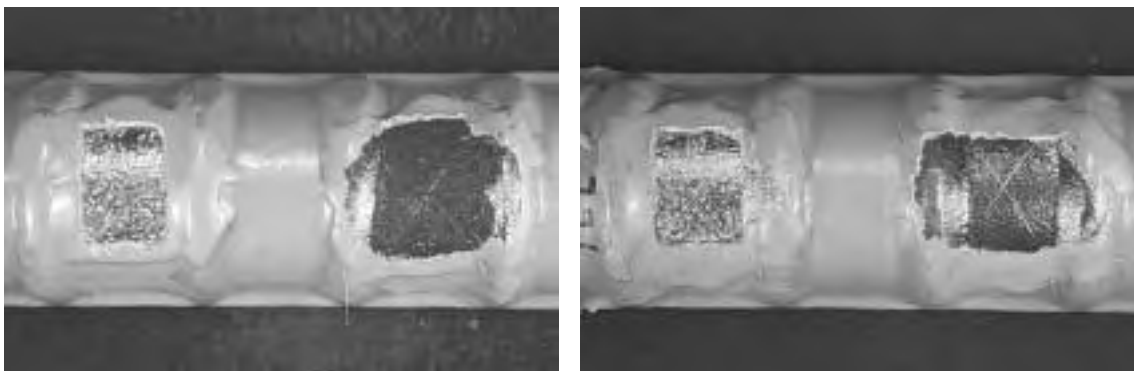
(a) Good adhesion and no corrosion on left area. Poor adhesion with surface corrosion on right area.

(b) Uncorroded areas with good adhesion (left area) and poor adhesion (right area).

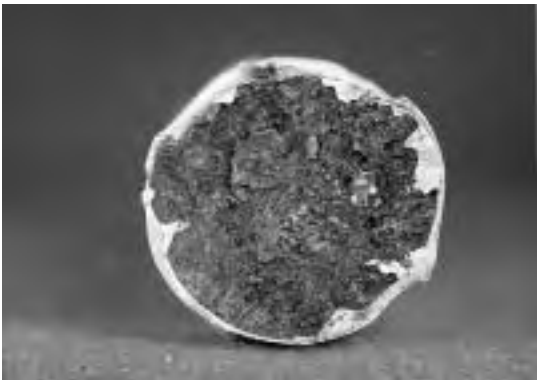
(e) Rating 5.

observed over more than 90% of patch surface area. Patch adhesion to steel surface was poor. See Figure 3.10(e) for an example of extensive corrosion.

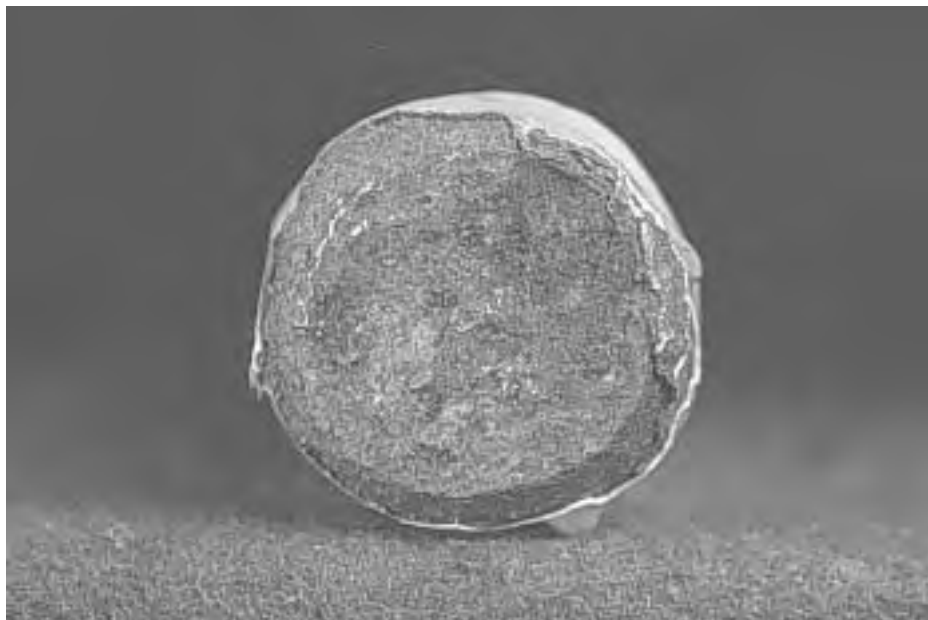
Figure 3.18 Corrosion of bar end surface that was specially cleaned before patch application.

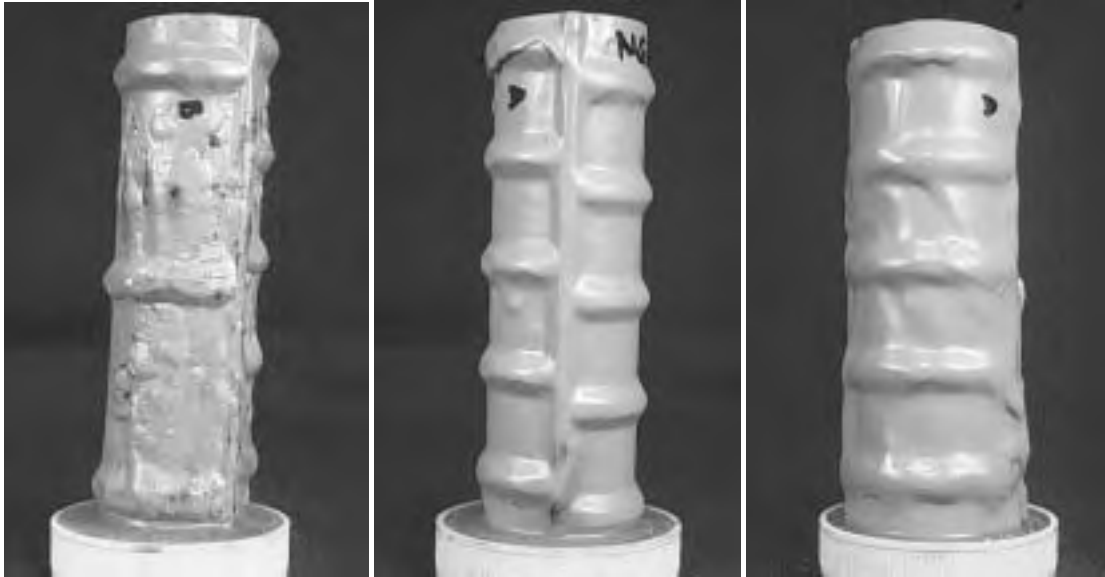
ranged from good to poor at non-corroded areas in all specimens. Finally, specimens coated with patching material *C* did not exhibit any rust spots or staining on the coating surface. The patch was clean and shiny [Figure 4.4(c)]. The steel surface underneath the coating was in extremely good condition (Figure 4.5). Coating removal required chiseling but practically no coating residues were left on the metallic surface. Observed corrosion agreed with EIS and polarization resistance measurements.

Figure 4.4 Surface condition of specimens coated with patching materials *A*, *B*, and *C* after 100 days in 3.5% NaCl solution.

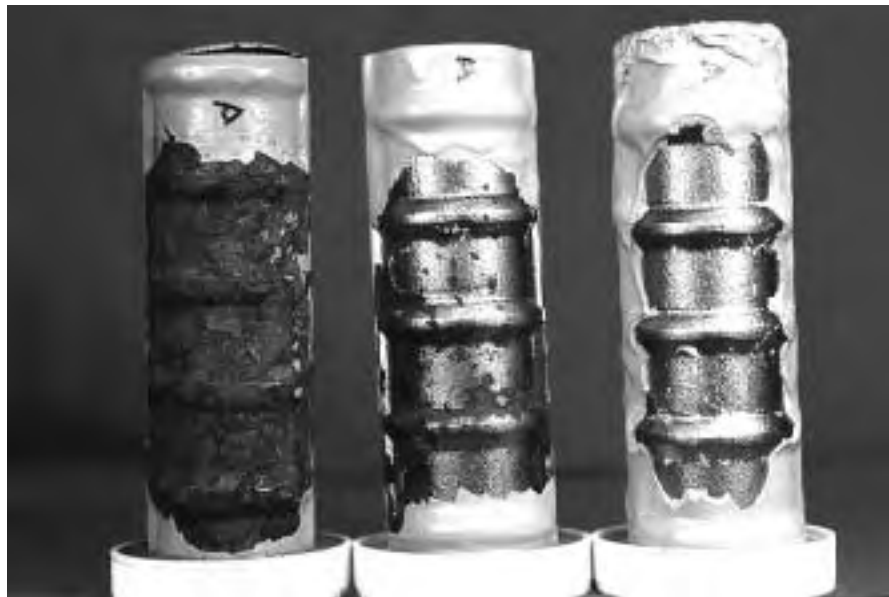
Figure 4.5 Steel surface condition underneath patching materials *A*, *B*, and *C* after 100 days in 3.5% NaCl solution.
