EVALUATION OF FAILURE IN BRIDGE EXPANSION JOINT RAILS

Research Report Number 1309-1F

This report summarizes the investigation into the cause of failures of strip seal expansion joints at the US 83 and US 281 interchange at McAllen, Texas. The investigation was made at the request of the Texas Department of Transportation. The interchange of US 83 and US 281 at McAllen, Texas, opened in December of 1993, is composed of four unidirectional ramps (1, 2, 3, 4). Each of the ramps uses a mix of simple span AASHTO girders and continuous steel girders. The supporting substructure includes both concrete and steel bent cap systems with concrete piers. Concrete systems are inverted tee bents, hammerhead or tee piers and concrete beam straddle bents. Decking for all of these structures is 8-inch reinforced concrete with a design strength of 24.8 MPa (3600 psi). Concrete mixes for the deck were standard TxDOT S class mixes with a maximum aggregate size of 38 mm (1-1/2 inches). All ramps have vertical grade and most are in horizontal curves with super elevation.

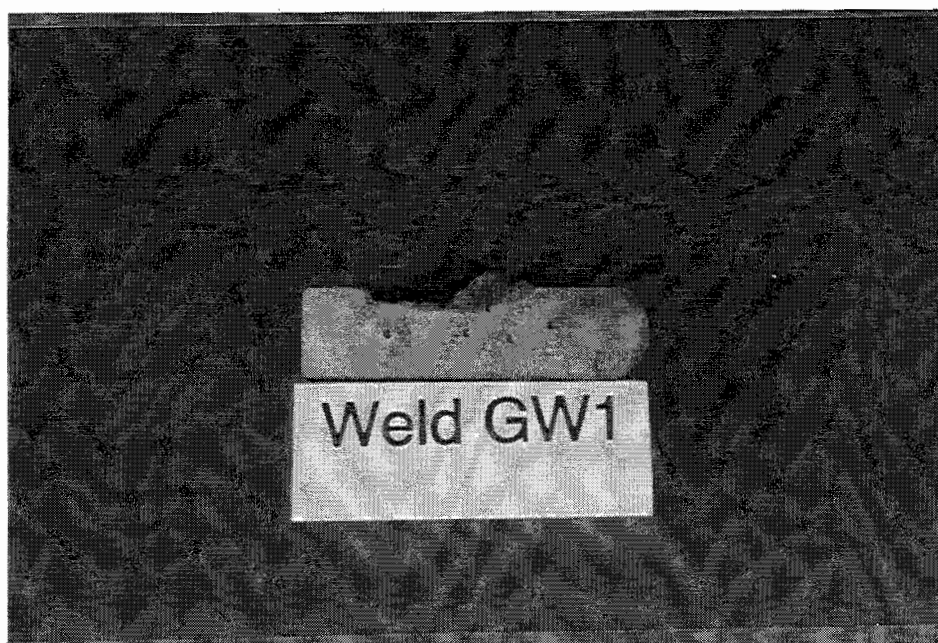
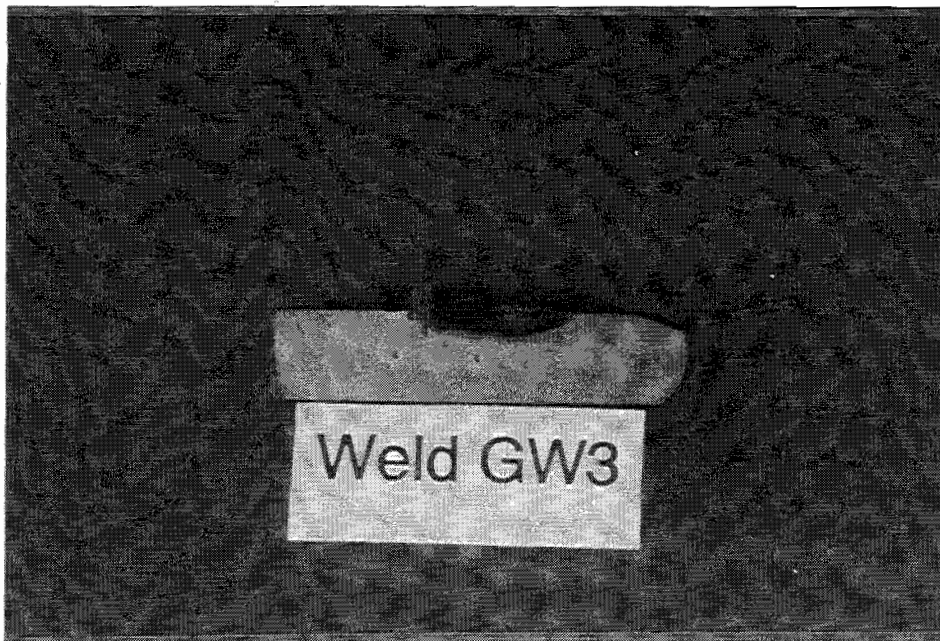
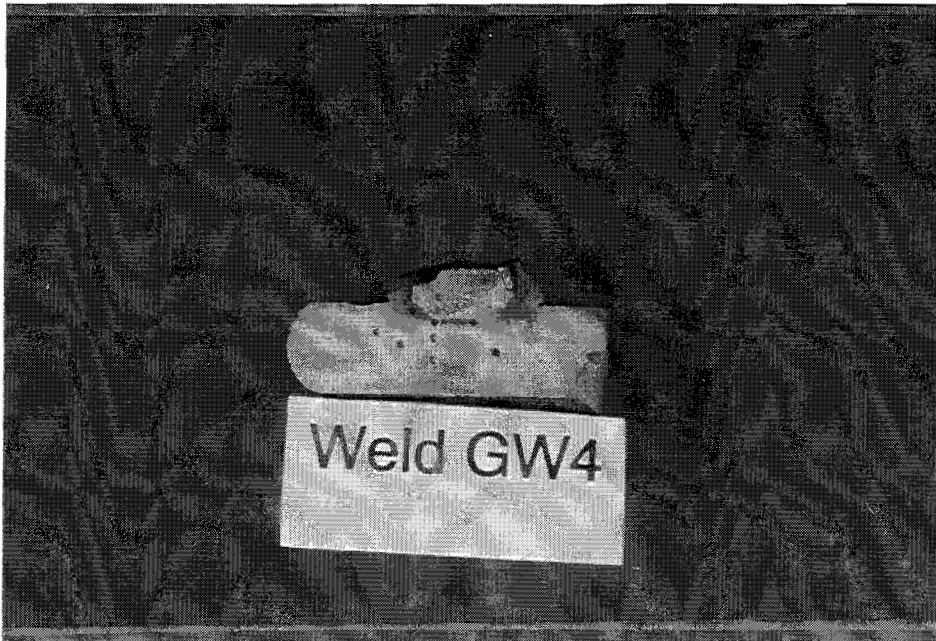
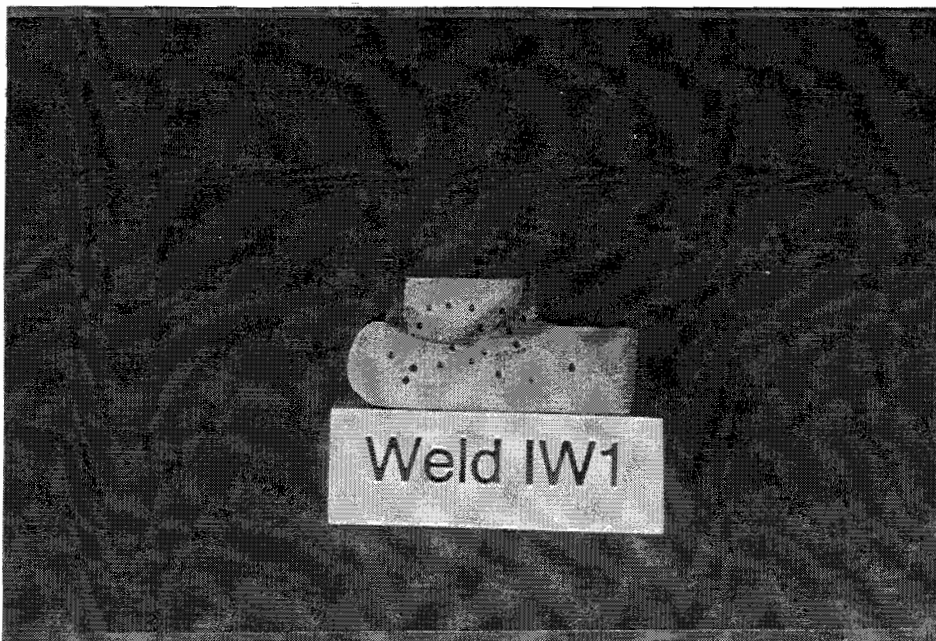
Sections were then cut through the rail welds for etching. Each specimen was cut, ground, polished and then etched with a Ferric Chloride solution. This solution made the macrostructure of the weld clearly discernible. Figures 16 through 24 show the etched specimens. Etching showed the welds to be of consistent quality and to be free of any harmful flaws. The welds indicated that stud guns used for placing these studs were properly calibrated and operated consistently.

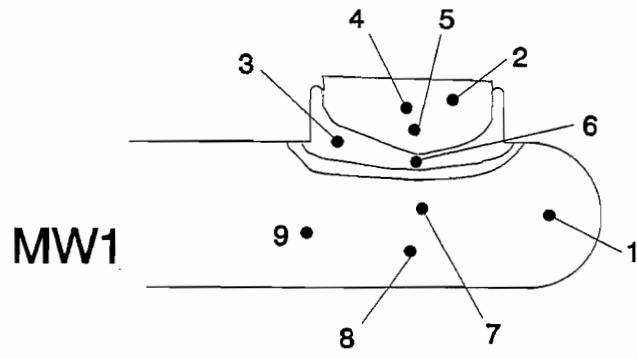
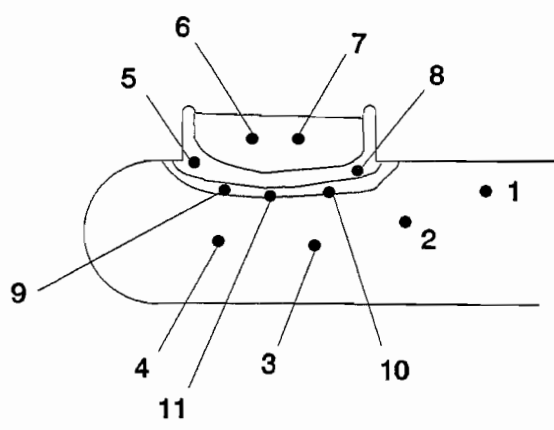
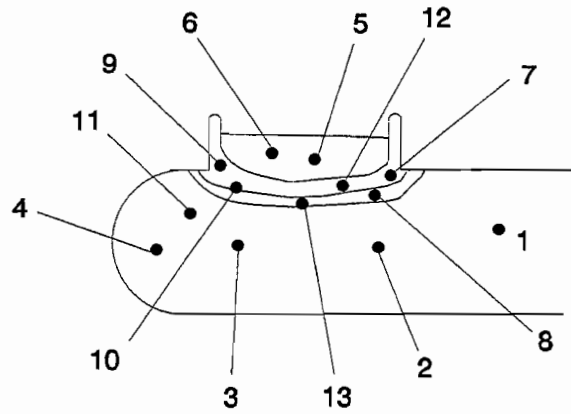
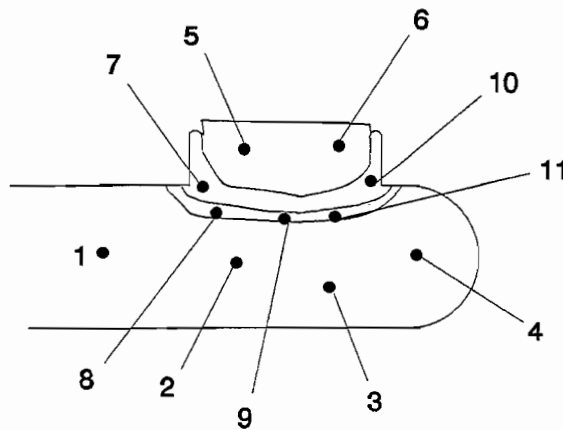
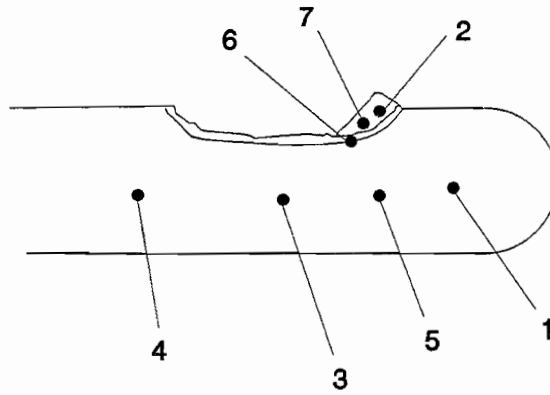
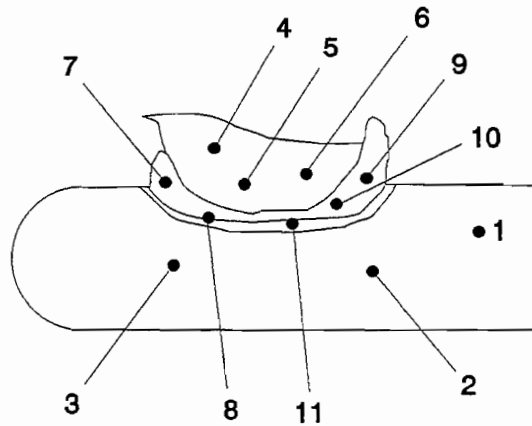
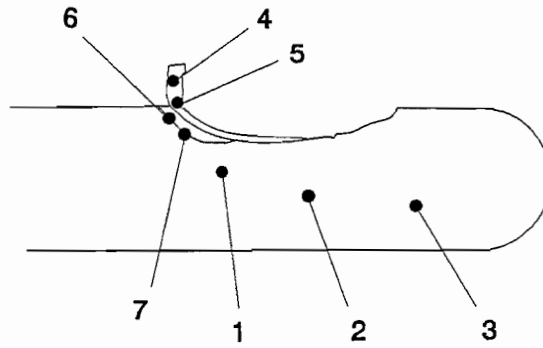
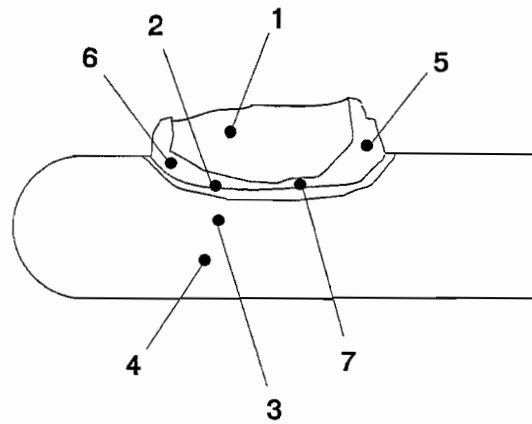
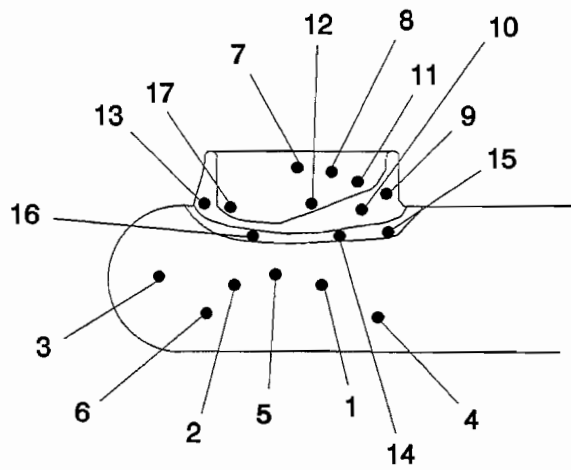
After etching, each of the sections was subjected to hardness testing. Hardness testing was used to see if the welding process caused a significant change in the rail or stud strength. All these tests were performed using the Rockwell C scale. The decision to report the Rockwell C scale (R_c) over the Rockwell B scale (R_b) for specimens was based on testing using both scales. Testing using the R_b scale worked well for the base metal but was inconclusive for the weld metal and heat affected zone due to the high hardness of the material. Use of the R_c scale worked well for the weld metal and heat-affected zones and some readings for the base metal were below the recommended range for the C scale. Extrapolations required for the R_c scale were not as large as those needed to use the R_b scale, thus the R_c scale was chosen. Mappings of the hardness testing and results are shown in Figures 25-33. The numbered location is shown in the figure with the hardness reading given in the table directly below the figure. The abbreviations listed for each of the areas are:

The average results of hardness tests on the samples are shown in Table 2. These results show some hardening of the base metal in the heat affected zone but not enough to cause a brittle weld. The ductility of the welds was confirmed by the bend over tests performed in the field.

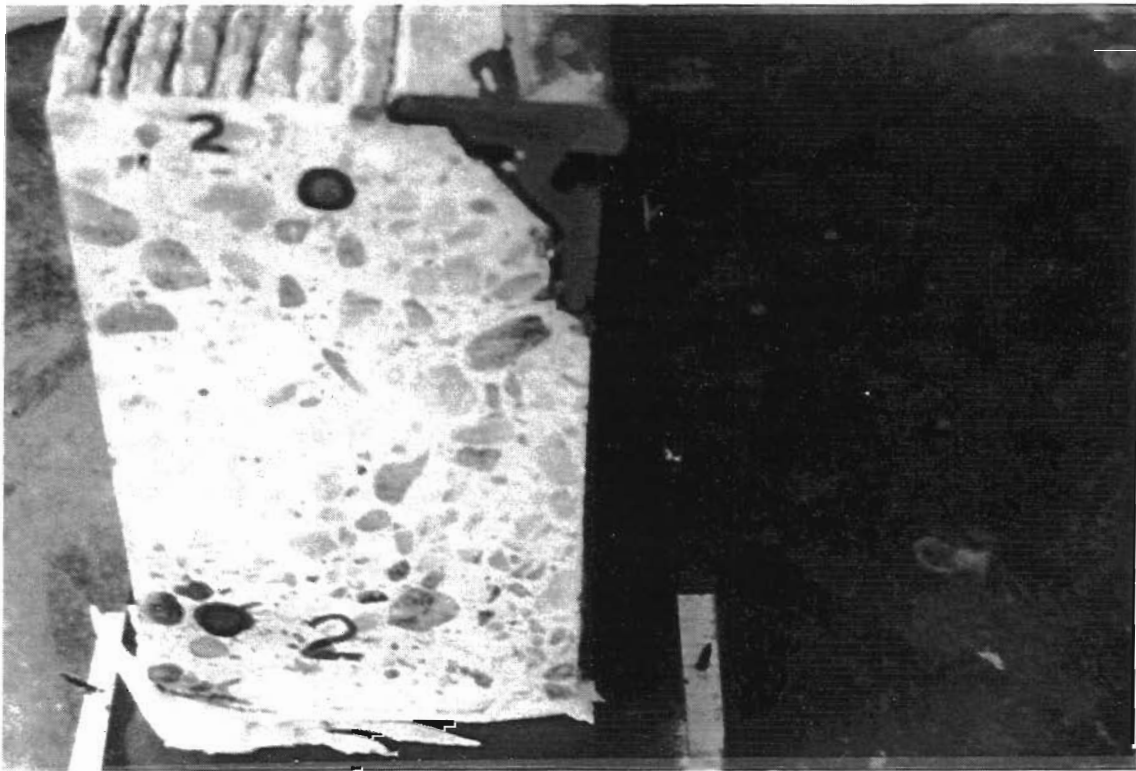
The specimen that arrived at the Ferguson Lab is shown in Figures 34 and 35 (front and end view). Inspection of the block immediately showed a lack of complete concrete consolidation. This lack of concrete consolidation was illustrated by the presence of voids at both ends of the specimen (Faces 2 and 3) as well as voids along the lower lip of the rail. Figures 36 and 37 identify these voids and quantify their depth. Another feature of the block, which was symptomatic of the failed joints in McAllen was the close proximity of the reinforcing steel to the rail. Figure 37 shows a bar along Side 3 which is touching the rail and Figure 36 illustrates the close proximity of the transverse bar to the rail lip. This close arrangement of the bar and rail was also present at Ramp 3, Pier 22. Presence of these bars close to the rail causes the rail and reinforcing bar to act as a filter. Filtering action by the rail and reinforcing bar catches large aggregate and prevents it from flowing underneath the rail. The "caught" aggregate increases the filtering and impedes the flow of smaller aggregate and cement paste under the rail which ultimately leads to voids. Once these preliminary observations were complete a portion of the rail was removed, from the section.

Figure 34 Front view of roadway section

Figure 35 End view of roadway section

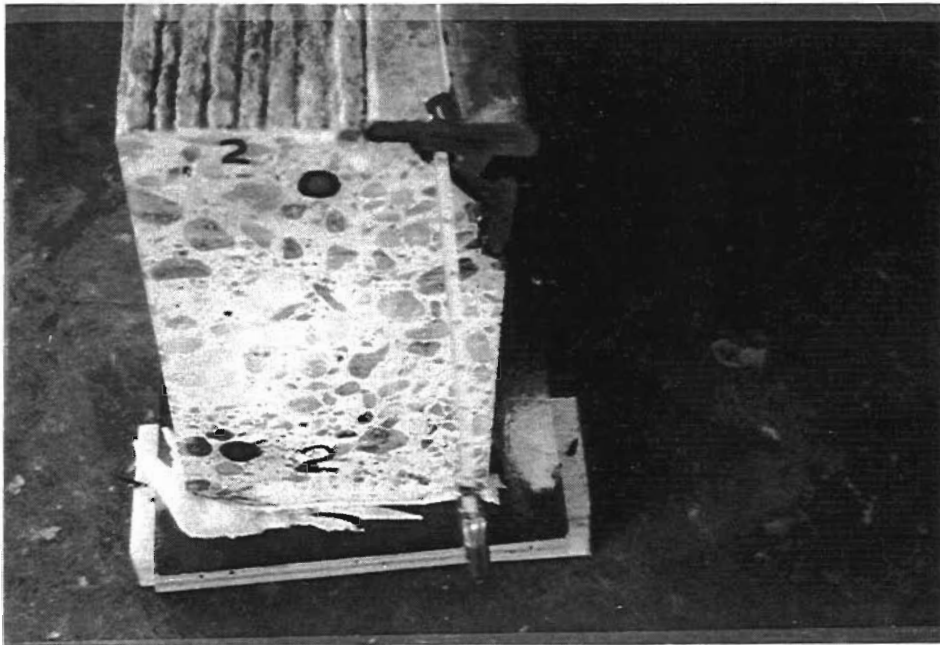
Figure 36 Approximately 2-in. void along end 2 and note reinforcing bar location (round dot)

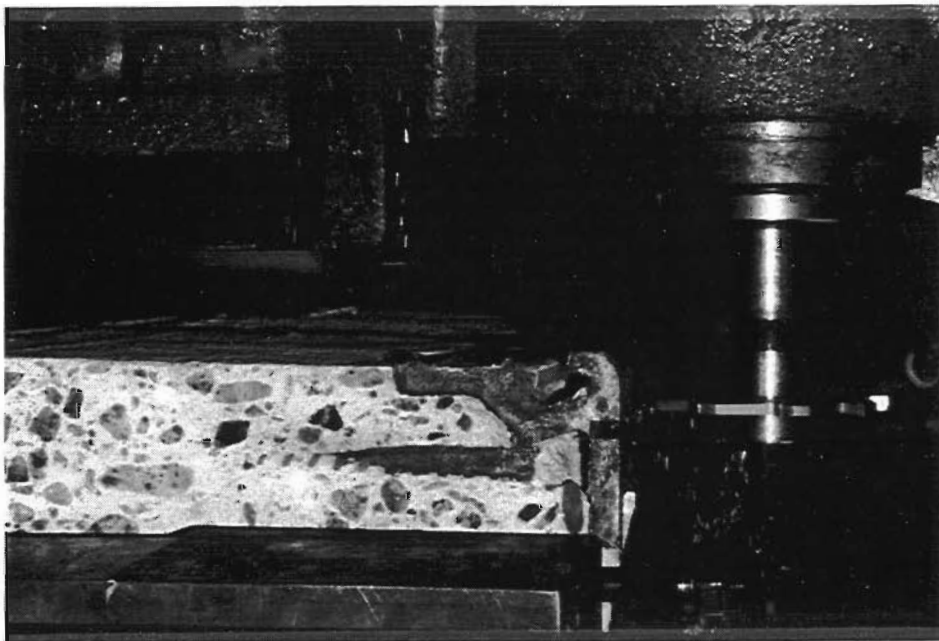
Figure 37 Void at end 3 also vertical reinforcing bar

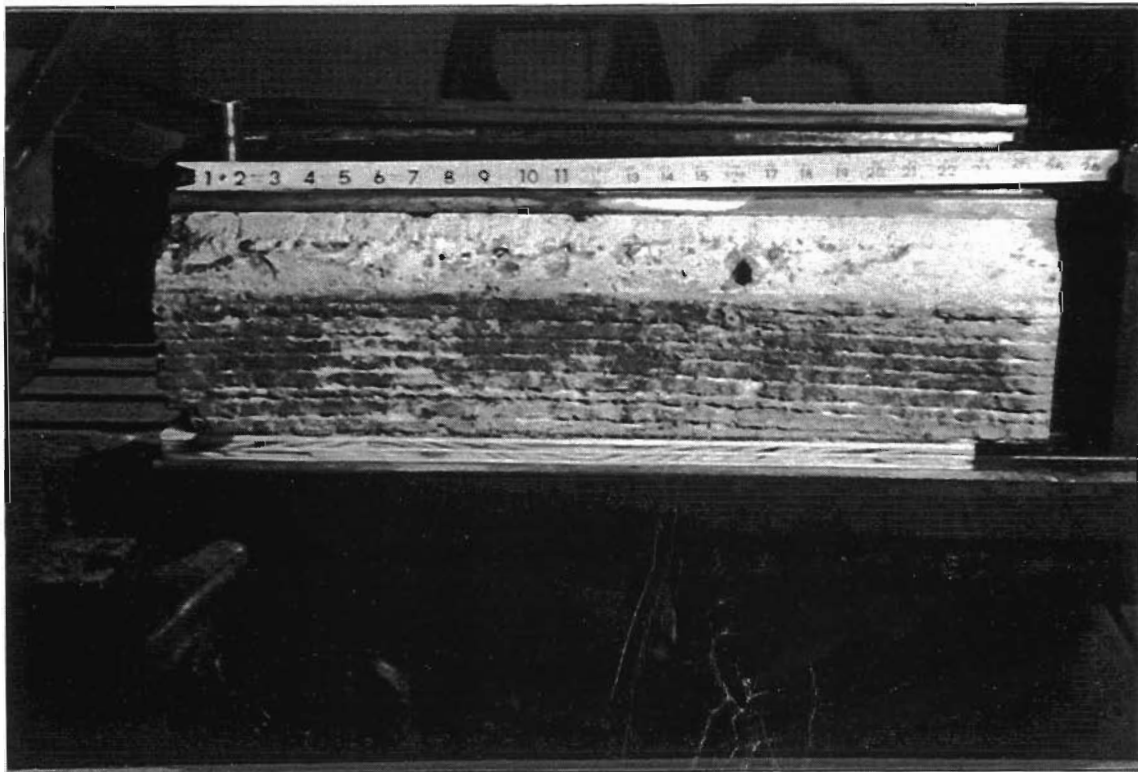
Complete removal of the rail was not necessary to check for proper concrete consolidation. Instead, the corner section of the rail was removed. The corner section of the rail was of prime interest. Field observations had shown a correlation between lack of concrete in this area and stud failure. In order to remove the corner section of the rail two cuts were made in the rail section. The location of these cuts are shown in Figure 38. By choosing these two lines for cutting the most rail material could be removed without cutting at a stud weld. To perform these cuts the block was moved to a horizontal milling machine and anchored in place. Cuts were then made in the rail using a 102 mm (4-in.) by 6.4 mm (1/4-in.) carbide tipped cutting blade. Figures 39 and 40 show the block in the mill during the cutting of the second side of the rail. An Accu-Lube mist cooling system was used to minimize any contamination of the specimen due to cooling of the cutting blade. Upon completion of the second cut it was realized that a stud connected to the top lip of the rail had failed. This allowed for a more complete removal of the rail as illustrated in Figure 41 with one lip of the rail present.

Figure 41 Rail section removed note lack of rail along roadway (raked) surface

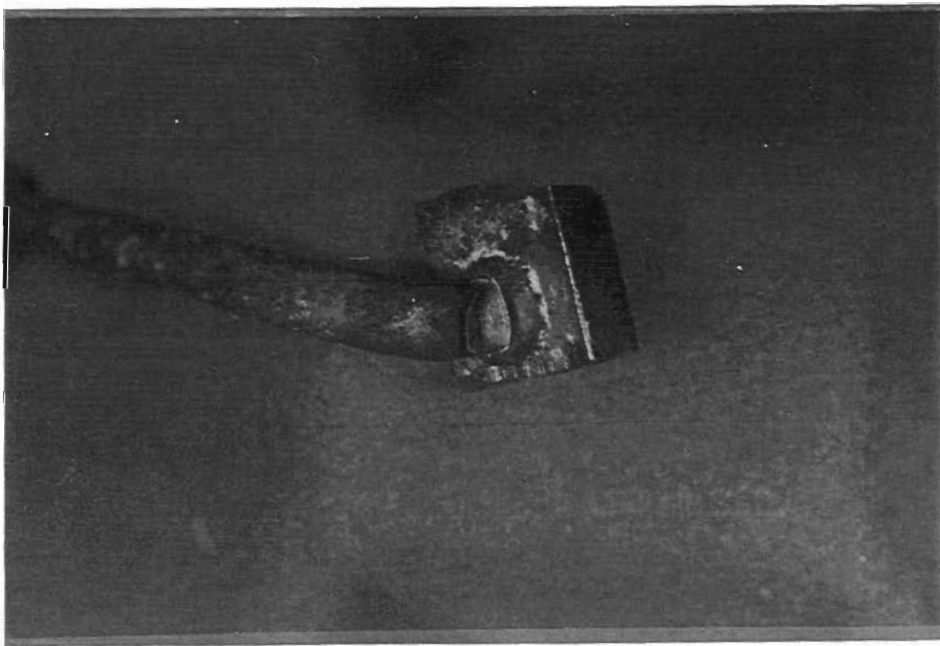
Before excavation of the stud, the excess rail on both sides of the stud was removed from the block. It was also noted that the area near the base of the stud had a void. This void is shown in Figures 47 and 48. The stud was excavated as shown in Figures 49 and 50. Excavation revealed that there was a small open area around the base of the stud. After completely exposing the stud it was removed from the block by cutting the reinforcing bar shown in Figure 50. The removed stud was then placed in a vise and the stud was bent over using a hammer. This bending over of the stud was done to test the soundness of the stud weld. The stud failed in this test and revealed an interesting fracture surface. By examining the fracture surface, Figures 51, 52 and, 53, it is apparent that the smooth semicircular region is a fatigue crack propagating through the stud. This type of crack would ultimately lead to failure of the stud. Figure 54 shows the orientation of the stud, fatigue crack, rail and roadway.

Figure 51 Failure surface of excavated stud

Figure 52 Failure surface of excavated stud

Figure 53 Failure surface of excavated stud

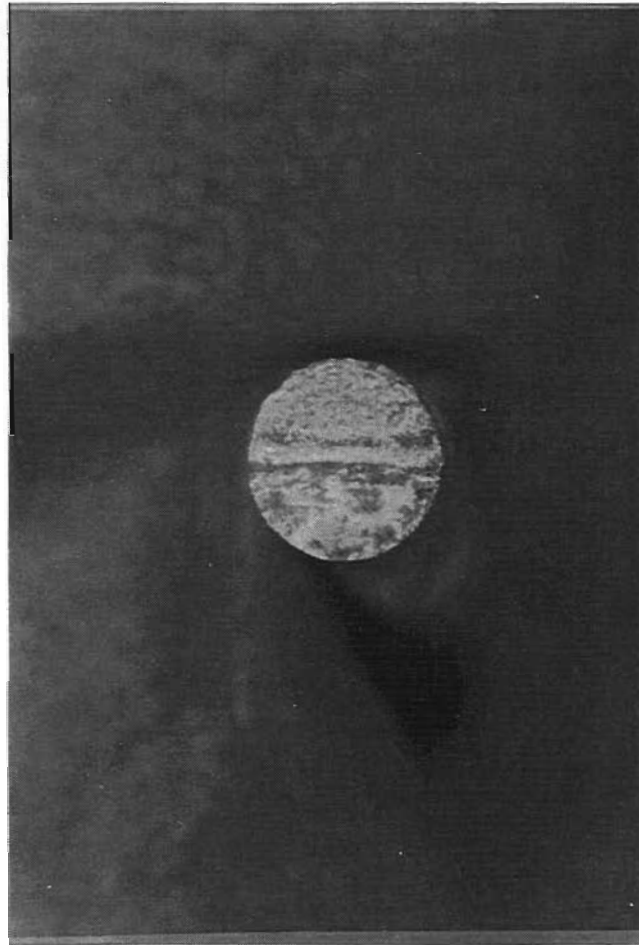
region tangent to the bend. The embedded section of the stud was removed from the specimen and the fracture surface examined. Figure 56 shows the fracture surface of the embedded stud. The failure surface has a slight crowning with the peak being in a straight line across the middle of the section. This fracture surface also appears to be a fatigue induced failure, due to cyclical bending of the section.

Figure 56 Fracture surface of second removed stud
