**EVALUATION AND REPAIR OF IMPACT-DAMAGED PRESTRESSED
CONCRETE BRIDGE GIRDERS**

Research Report No. 1370-3F

Research Project 0-1370

MAY, 1996

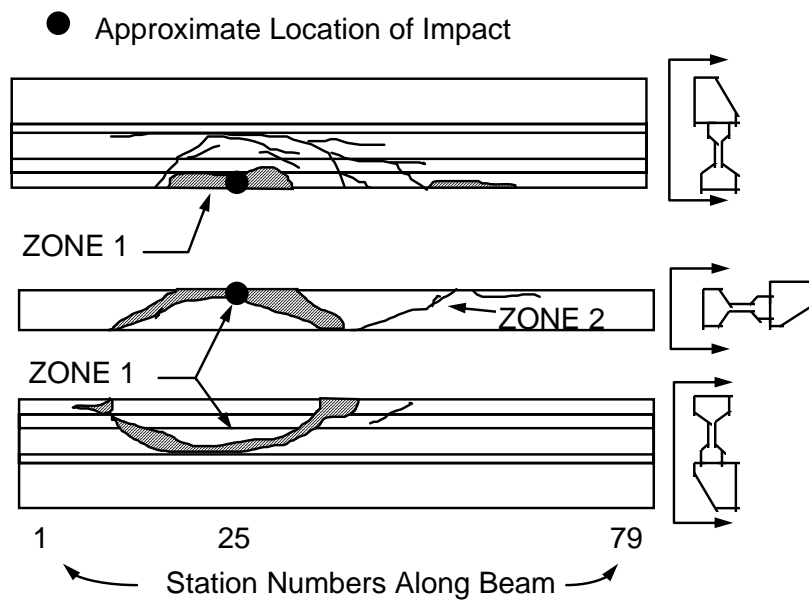
Figure 4-5 Schematic of impact damage of Steck Girder

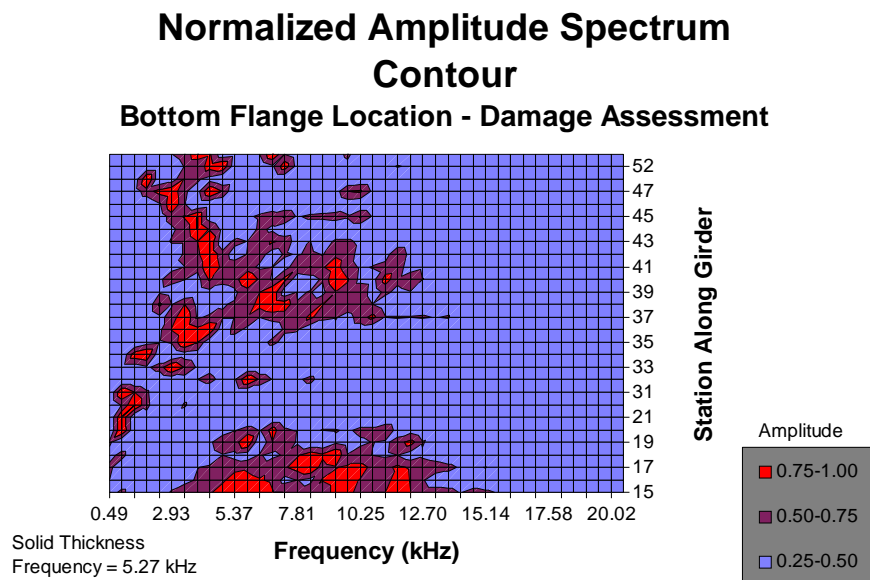
For global assessment purposes a contour of the normalized amplitude spectra along the bottom flange on both sides of the member was constructed using the results from each individual sampling location. These contour plots shown in Figures 4-21 and 4-22 reveal the nature of the damage to the flange on a global basis. It should be noted that on the impacted face between stations 19 and 35 and on the nonimpacted face between station 33 and 43 there was such severe damage to the concrete in the bottom flange that no data were able to be recorded. This lack of data is evident in each the contour plot. No clear pattern of response exists in the contour plots for the bottom flange on each side of the girder which is an indication on a global level that there appears to be damage within the flange of the member throughout the entire sampling range with the exception of a few locations that exhibit peak amplitudes near the solid thickness frequency of 5.27 kHz as already discussed (Figure 4-17).

Figure 4- 21 Global damage assessment using impact echo - bottom flange location - impacted side of girder

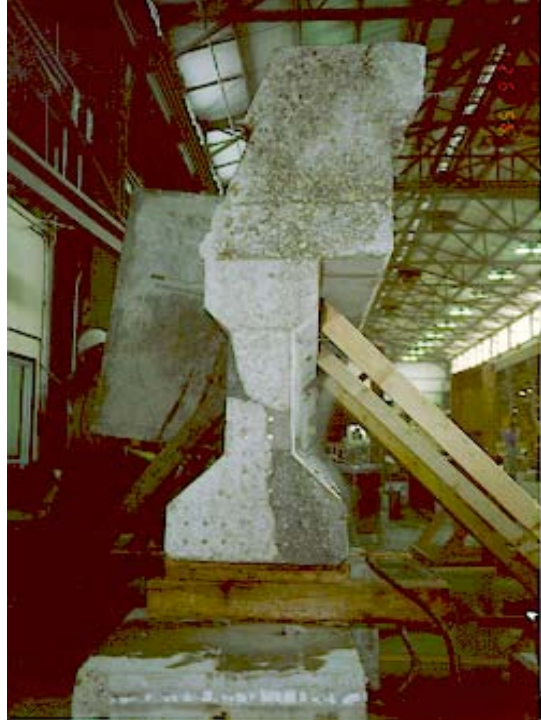
The most evident observation from these photographs is that the low pressure epoxy injection system combined with the internal injection procedure was effective at sealing and filling the remaining internal cracks and voids following the concrete patching. Figure 5.40 and Figure 5.41 clearly reveal the depth of epoxy penetration when using the low pressure injection system and internal injection ports. The void space within the web of the member was completely filled with epoxy at this location (Figure 5.40). It is also evident from the close-up photographs that, for the most part, the hand-applied materials bonded to the concrete substrate around the perimeter of the patches. In some locations where the bond appeared questionable, the injected epoxy was able to penetrate and fill any spaces that existed around the patch perimeter.

Figure 5- 38 Photograph showing saw-cut section while girder is still in place

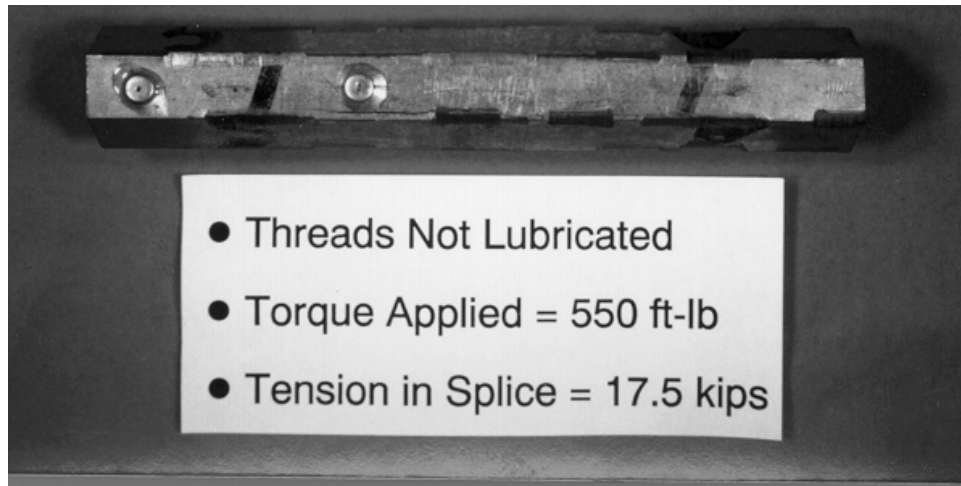
When the external threads were cleaned with a wire wheel and then lubricated, the required torque was closer to the expected value; tensioning of the splice was more reliable and much safer to install when the threads were lubricated. At an applied torque of 250 lb.-ft. (339 N-m) the induced tension was measured to be 25 kips (111 kN). Figure 6.12 shows the exterior of the turnbuckle after the test with lubricated threads. It is evident from the results that if the Grab-It™ splice assembly is to be used safely and reliably, the threads must

Figure 6-11 *Grab-It™ cable splice — exterior of turnbuckle - dry threads - torque proof test*

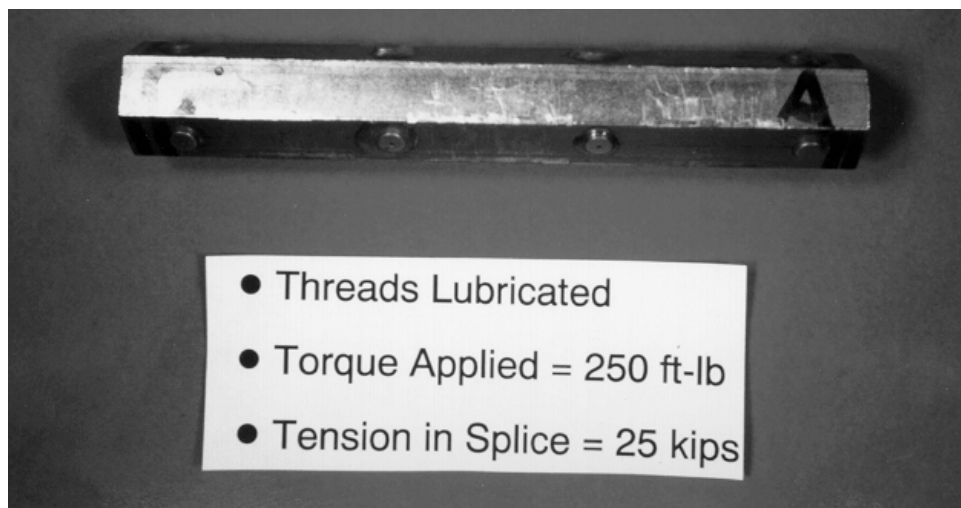
The thrust bearings that were intended to isolate the rotation of the splice from the strand did not work as intended. The bearings at each end of the splice sleeve did not work properly and therefore did not isolate

Figure 6-12 *Grab-It™ cable splice — exterior of turnbuckle - lubricated threads, torque proof test*

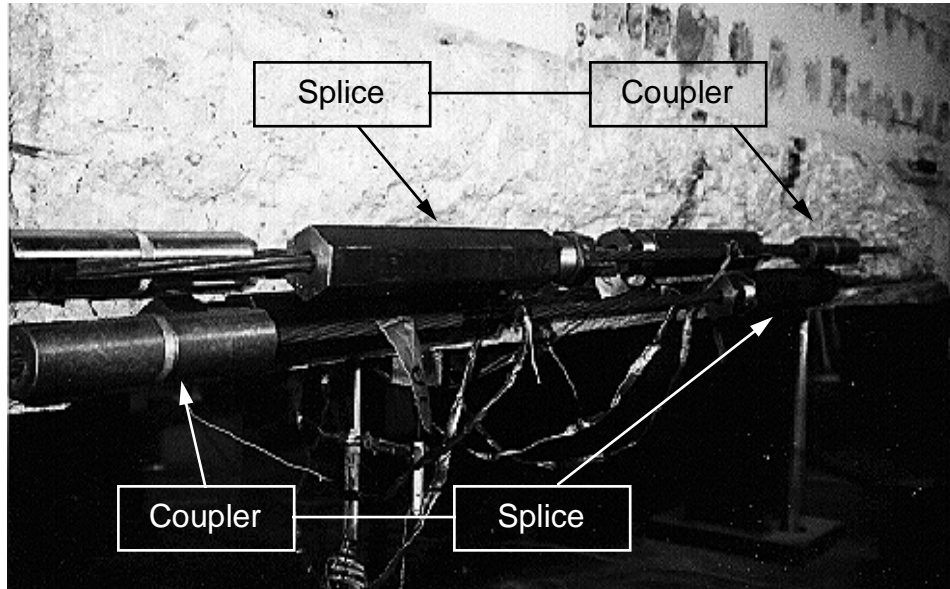
Figure 6- 17 Completed repair of severed strands using the Alberta splice

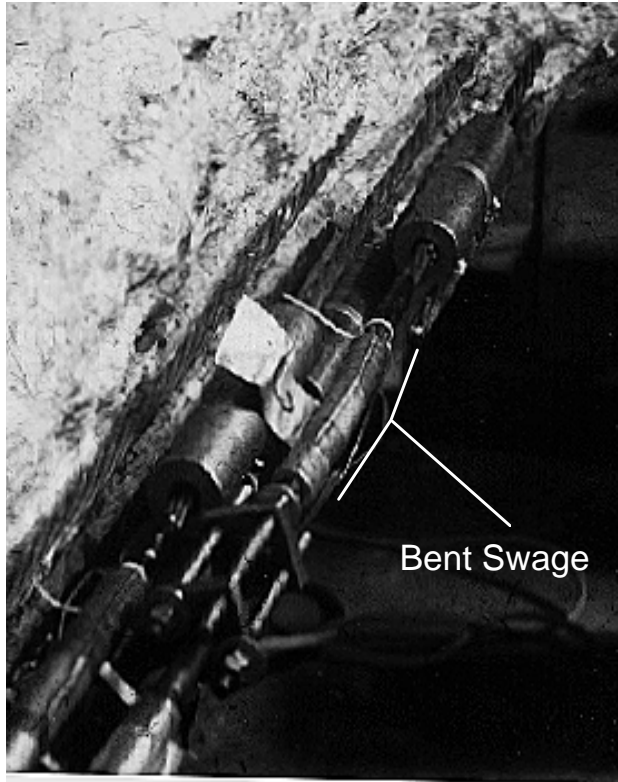
Figure 6- 34 Photograph of out of shape swage installed on tendon #2.

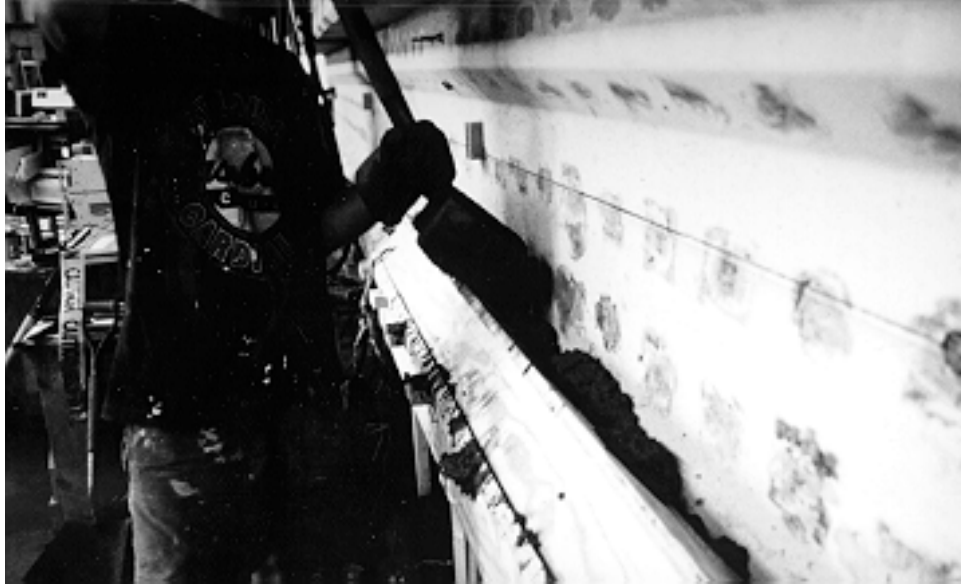
Figure 6- 68 Placement of 928 Fast Patch — final phase of repair — Steck girder

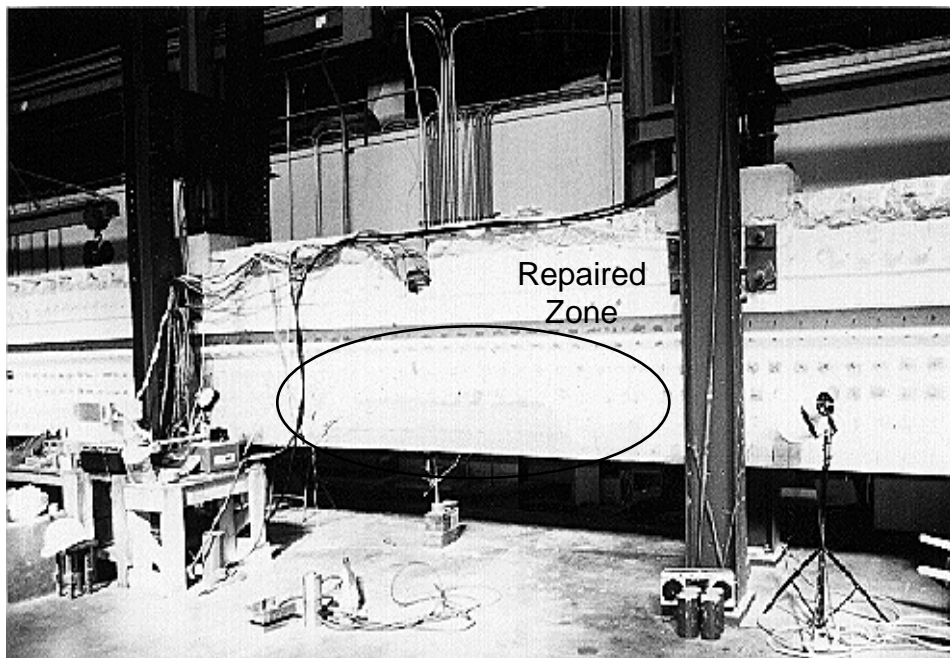
Figure 6- 69 Completed repair — final phase — Steck girder

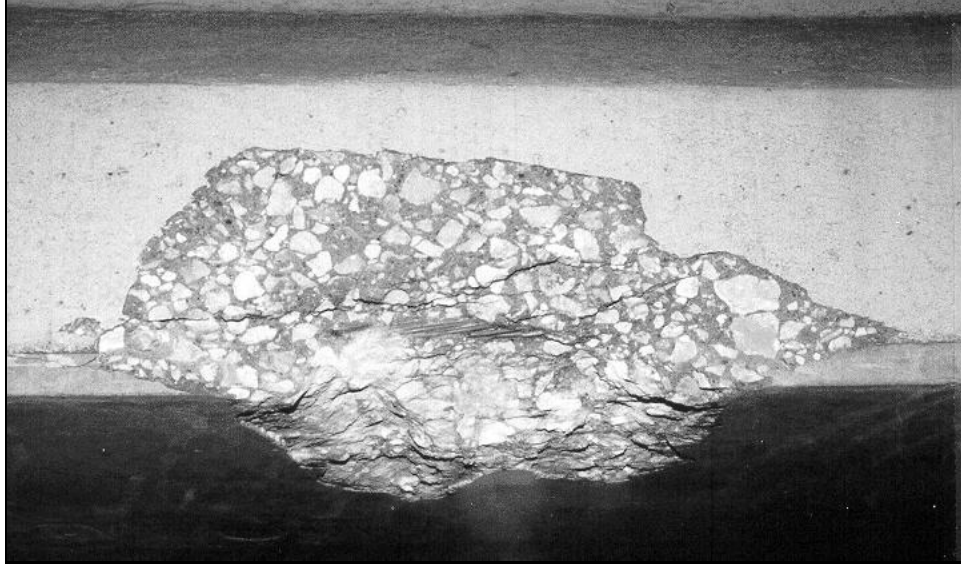
Figure 7- 4 Spalled flange area

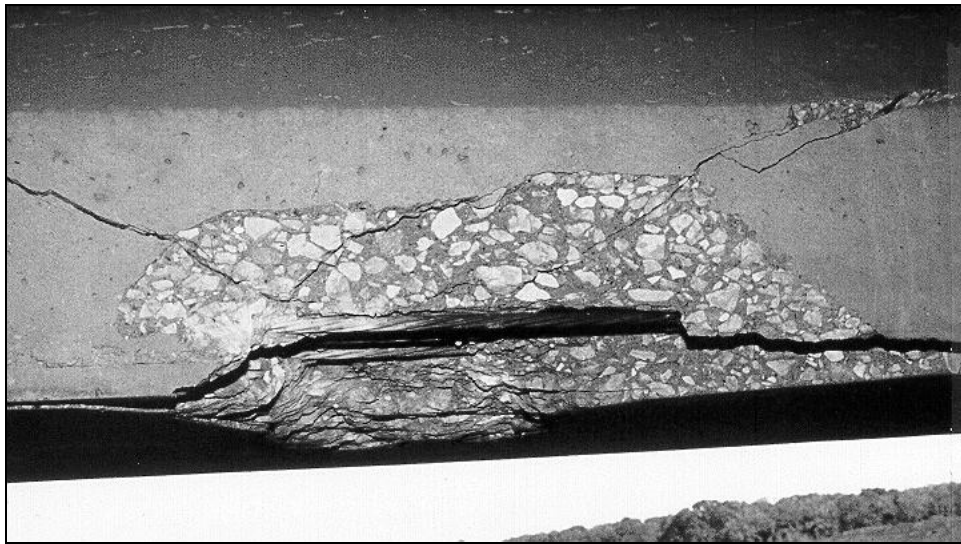
Figure 7- 5 Side-splitting concrete damage resulting from vehicle impact

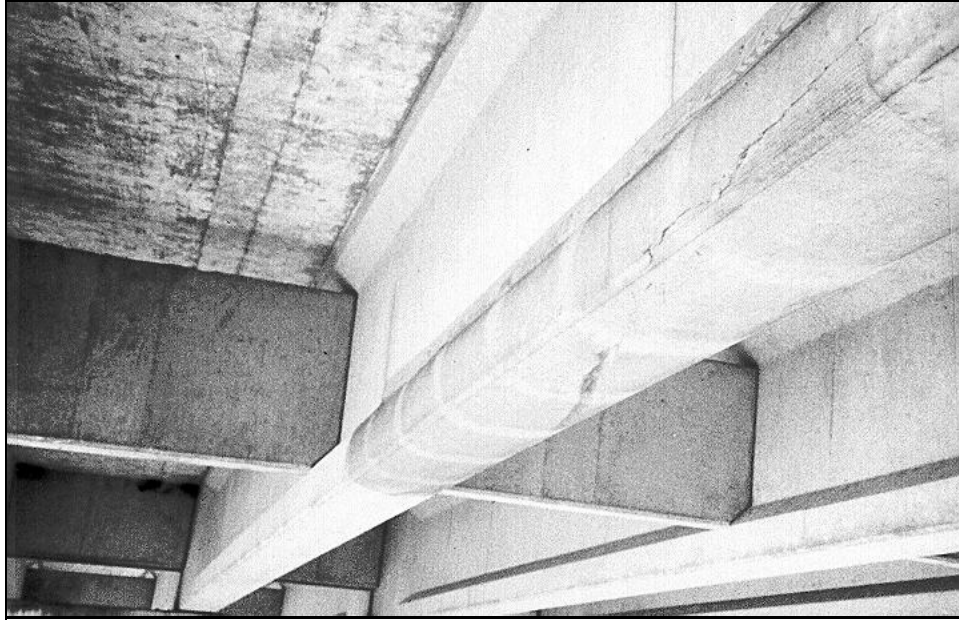
Figure 7- 6 Concrete damage where the diaphragm acts as a reaction for transverse impact loading

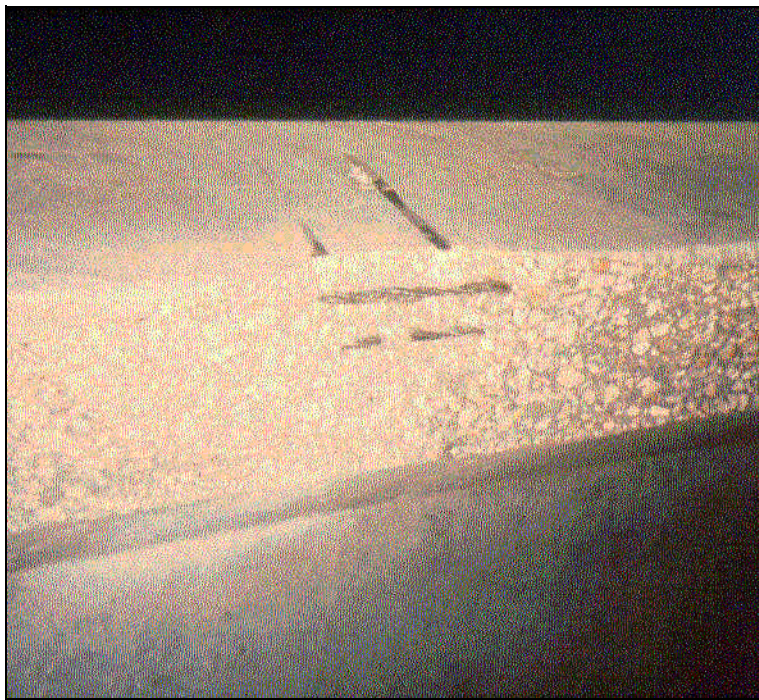
Figure 7- 7 Typical loss of concrete side cover

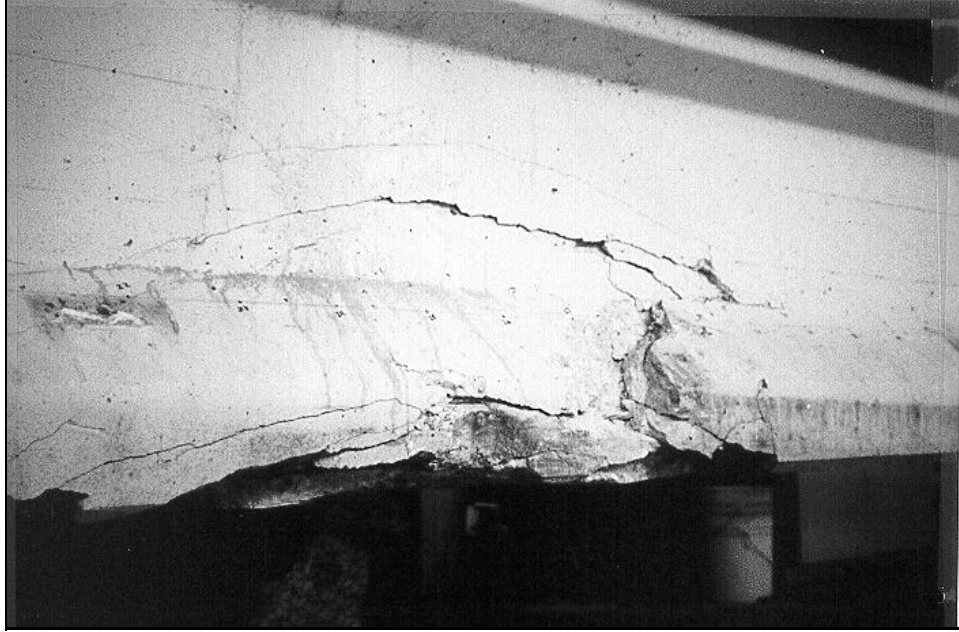
Figure 7- 8 Example of side impact damage to concrete

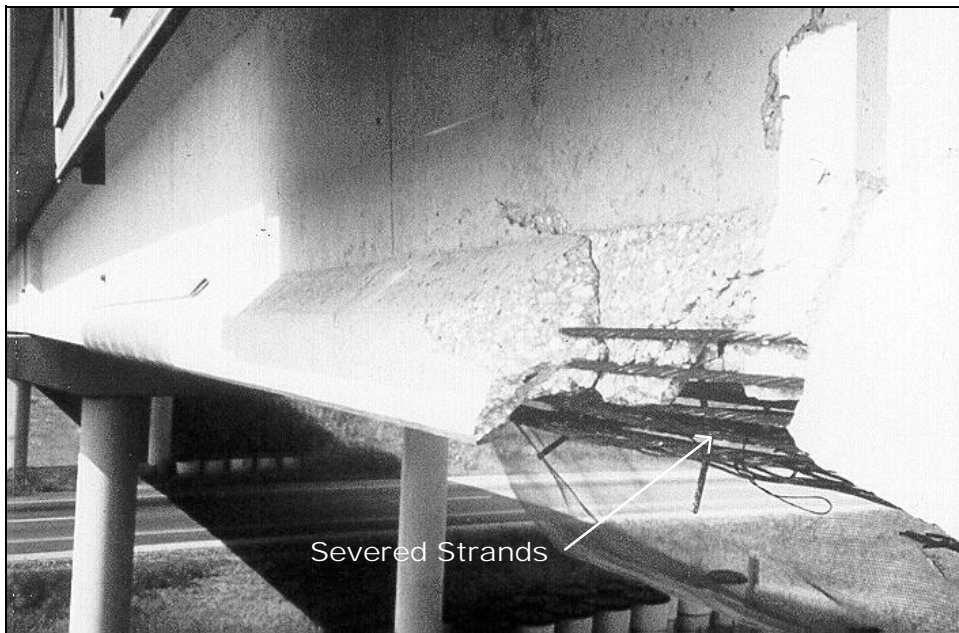
Figure 7- 9 Large volume loss of concrete cross section

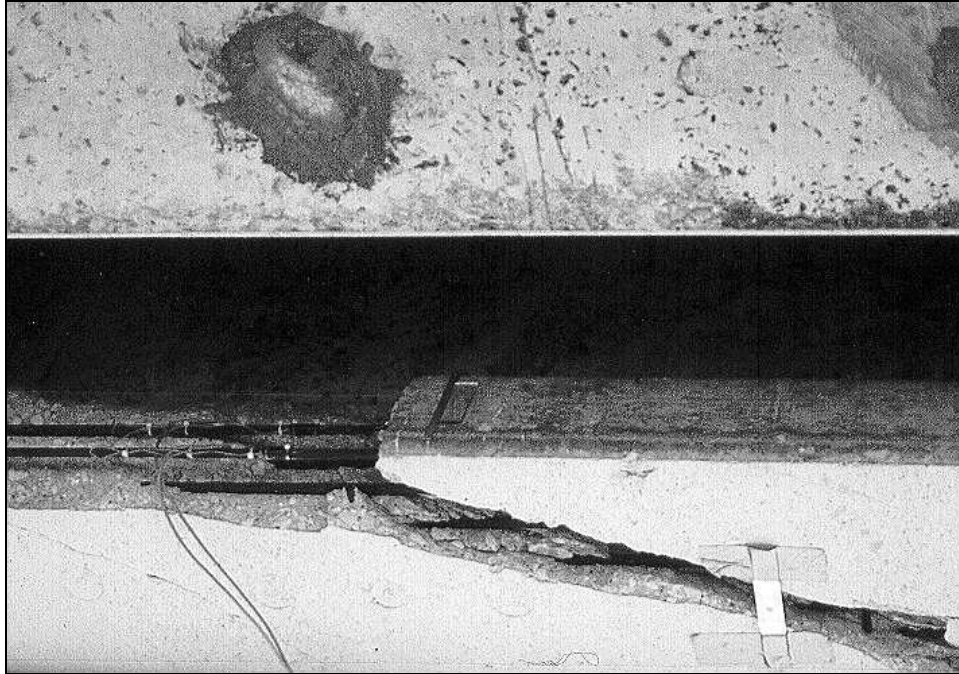
Figure 7- 11 Example of an offset section of the damaged girder

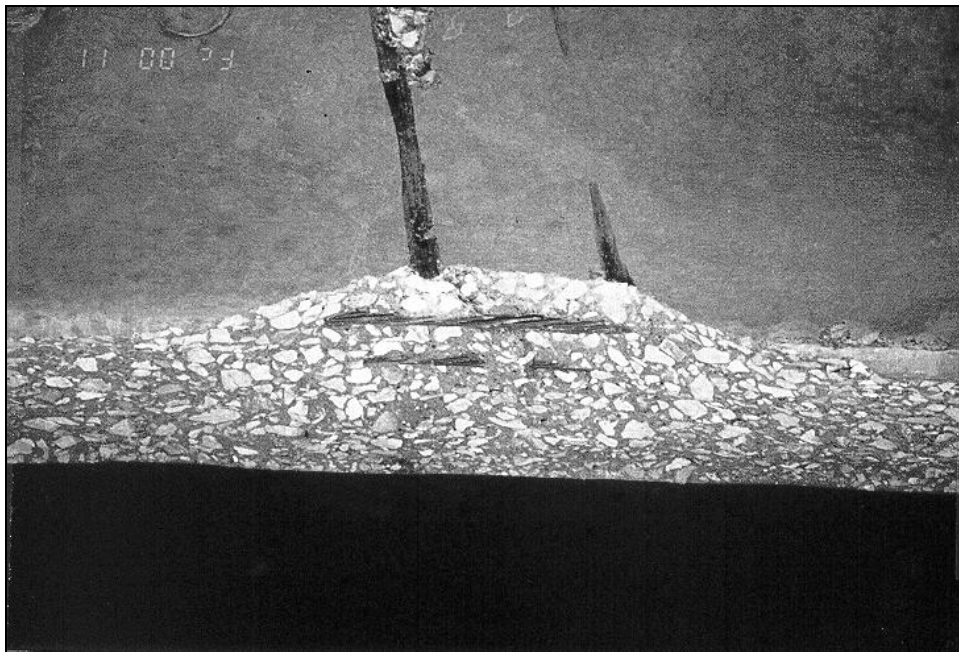
Figure 7- 12 Minor exposure of prestressing tendon

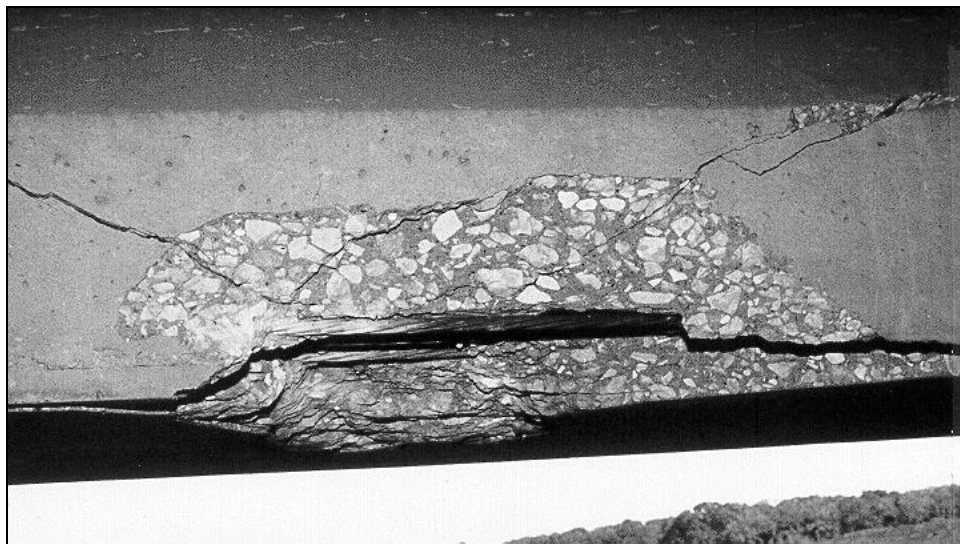
Figure 7- 13 Moderate exposure of prestressing strand with an embedded item of unknown origin

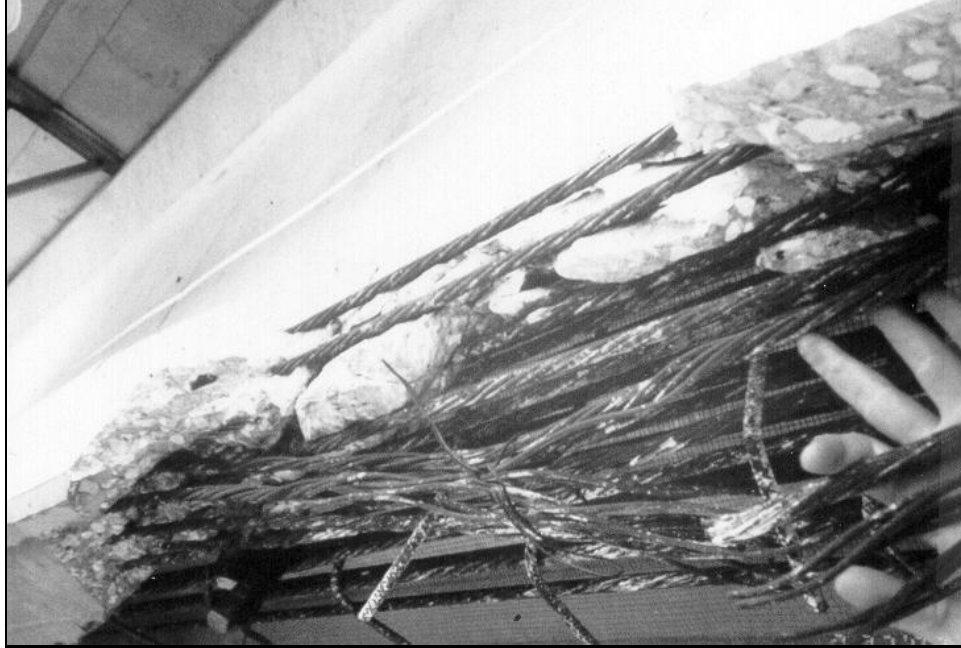
Figure 7- 14 Misalignment and complete severing of strands
