1. Report No. FHWA/TX-96/1479-2F/1340-1F		2. Government Accession No.		3. Recipient's Catalog No.	
4. Title and Subtitle TESTING NOTCHED ENDS OF PRESTRESSED CONCRETE BOX BEAMS: FINAL LETTER REPORT ON PROJECTS 1479 AND 1340				5. Report Date December 1994

TESTING NOTCHED ENDS OF PRESTRESSED CONCRETE BOX BEAMS

Research Report 1479-2F/1340-1F

FINAL REPORT ON PROJECT 0-1479

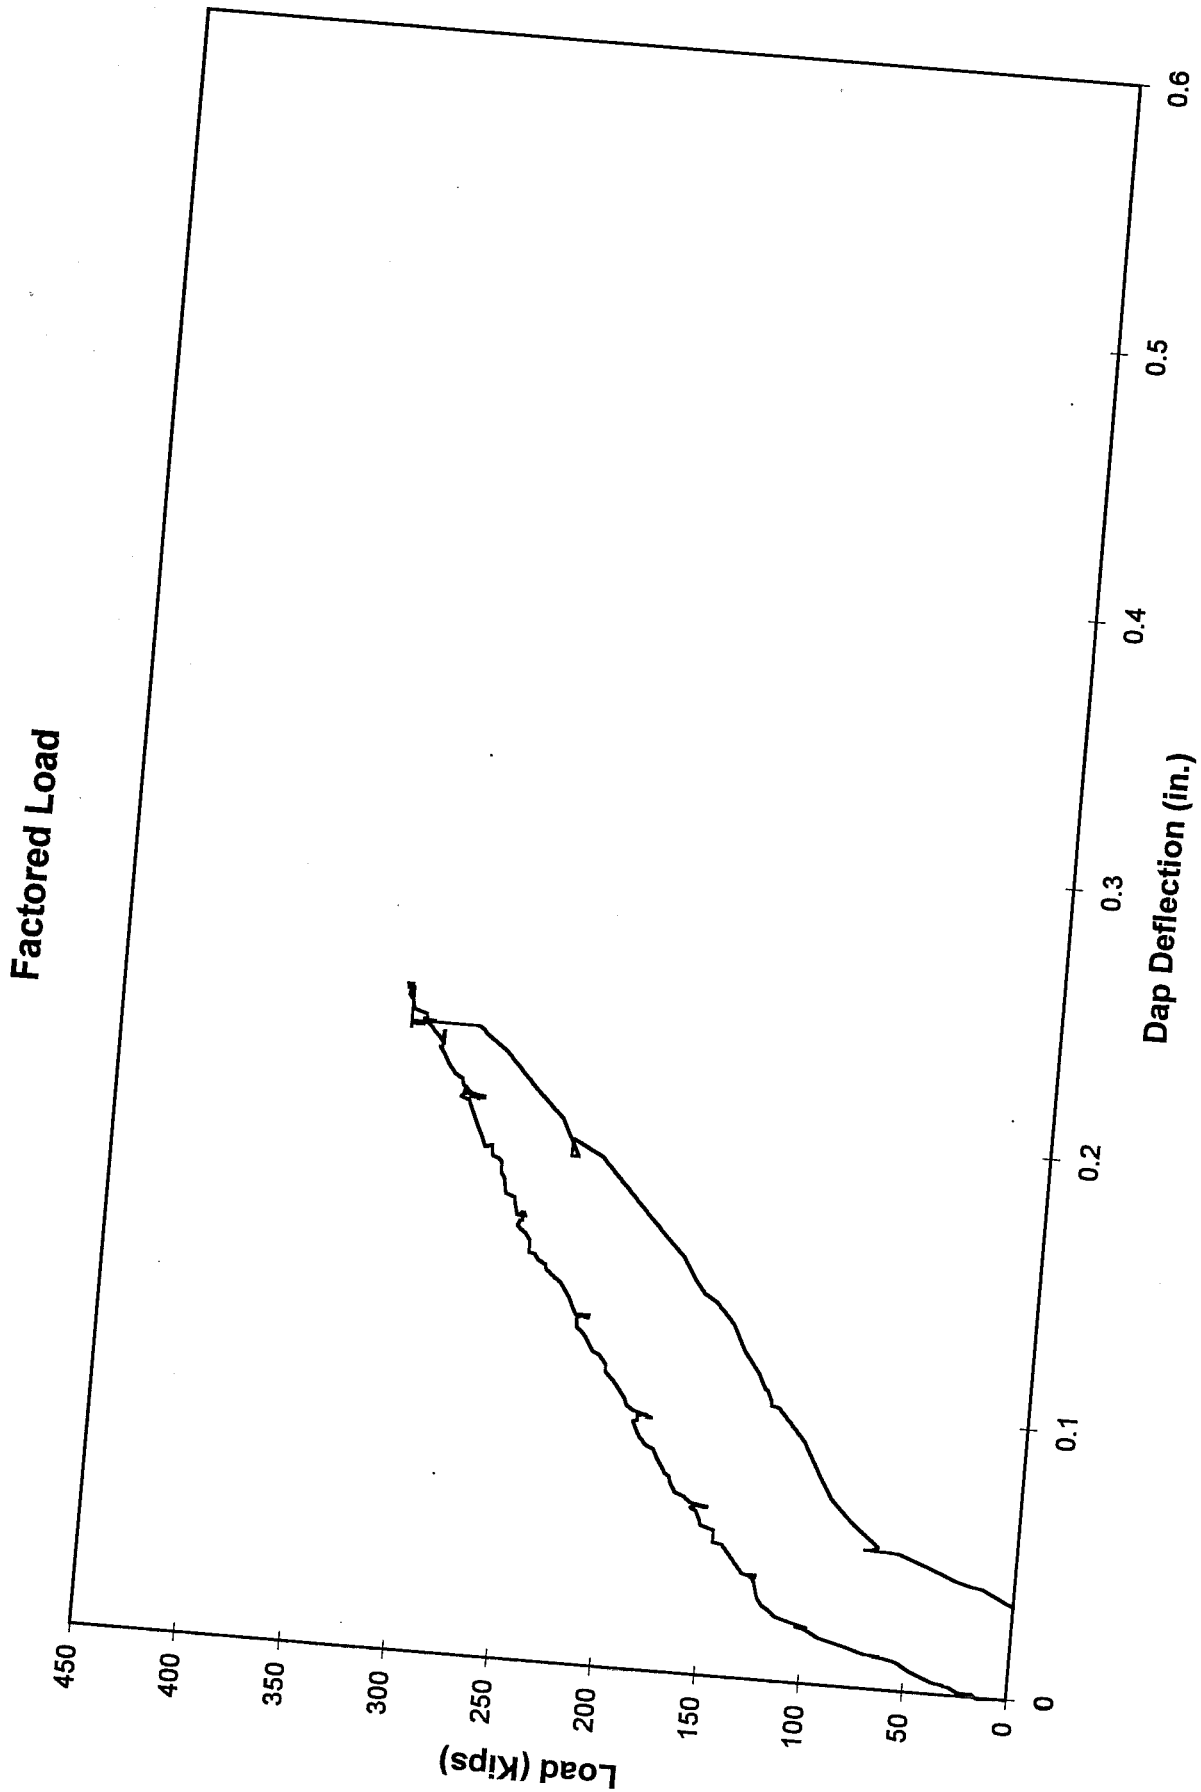
Figure 3 Load vs. Dap Deflection / Factored Load Test

The response of the beam to loading during the two tests is illustrated in Figures 3 and 4 using plots of load versus dap deflection (beam-end deflection minus deflection of the box end adjacent to the dap). Figure 3 clearly indicates stiffness reductions due to cracking and then yielding of reinforcement at approximately 530 kN (120 kips) and 1500 kN (340 kips). Opening of diagonal cracks at the dap/beam interface is illustrated in Figure 5 for the second test. The displacement transducer was unable to precisely record the small crack width at the dap during the factored load test.

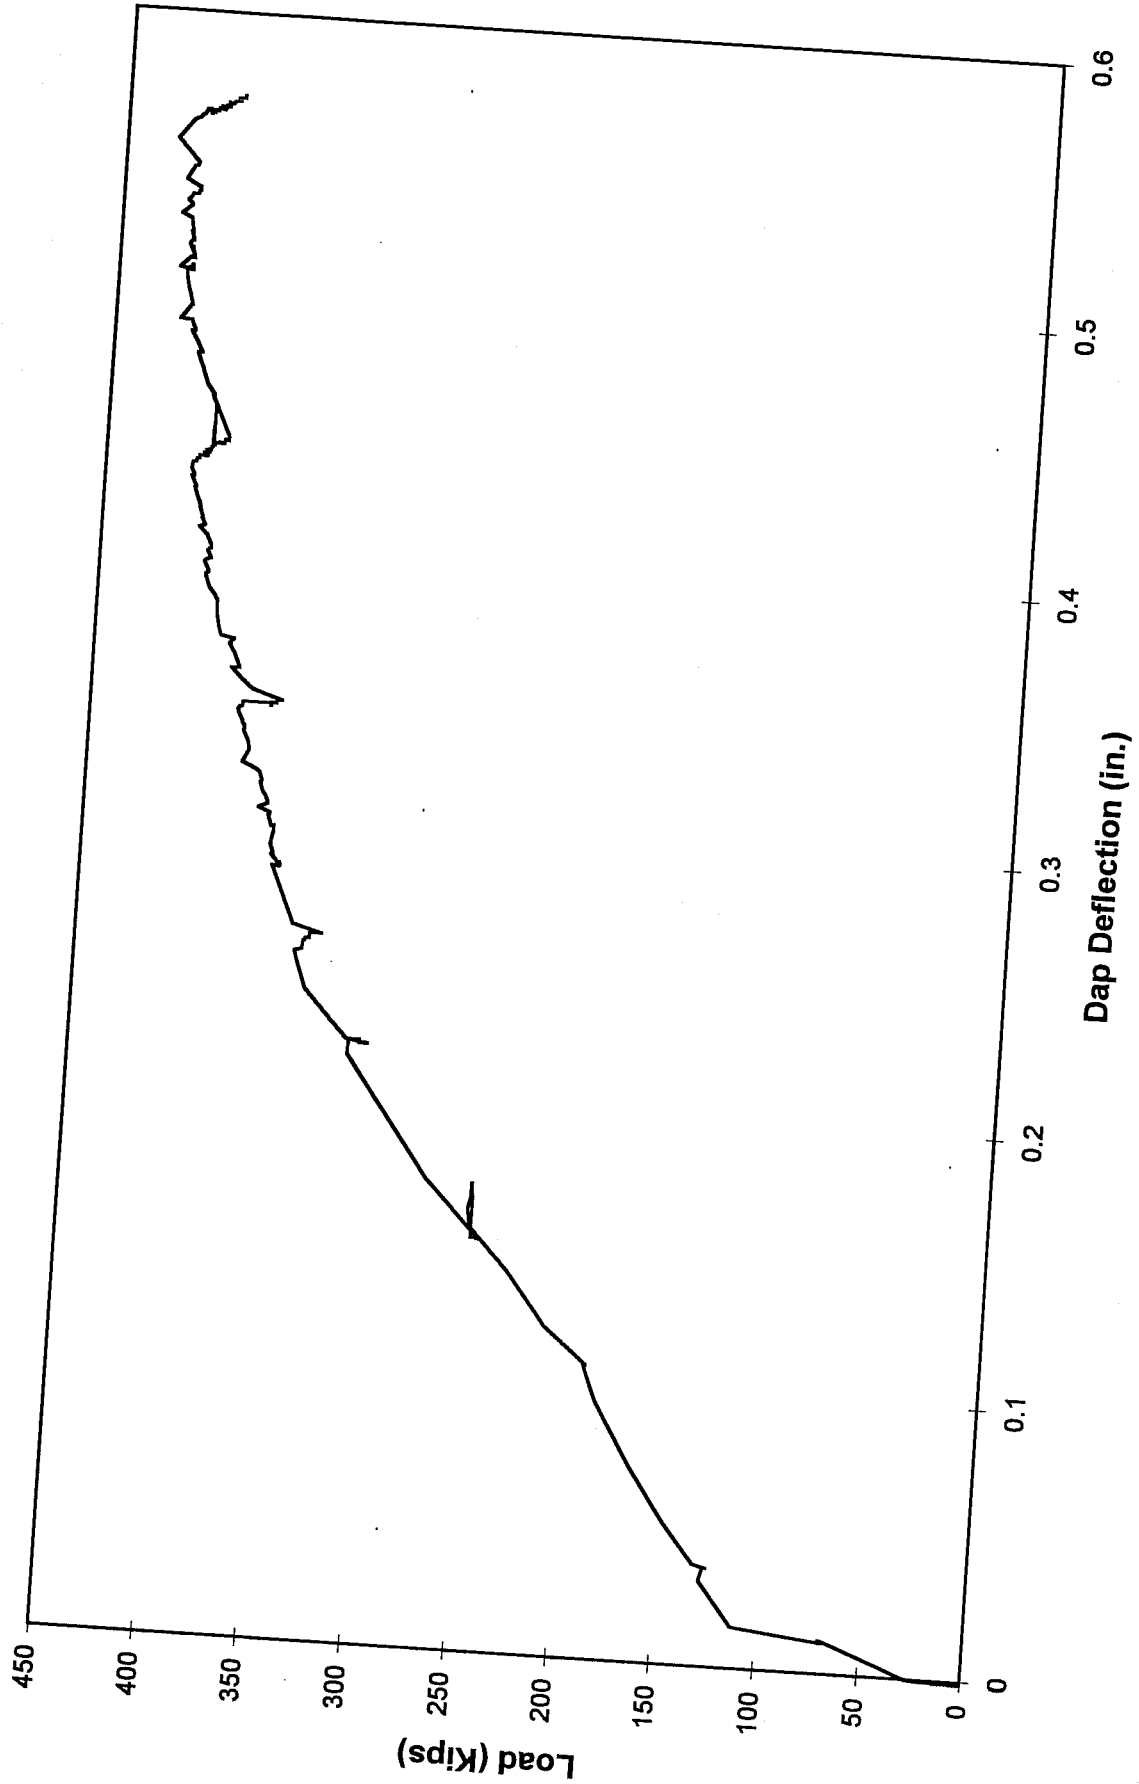
Figure 4 Load vs Dap Deflection / Ultimate Strength Test

Although the diagonal crack in the dapped-end region was the primary concern at the beginning of this investigation, it is interesting that strength of the beam was ultimately controlled by the diagonal cracks that initiated in the beam webs then propagated into and through the bottom flange. These cracks intersected the prestressing strands inside the required development length and resulted in slip of the strands. Initial slip of the strands

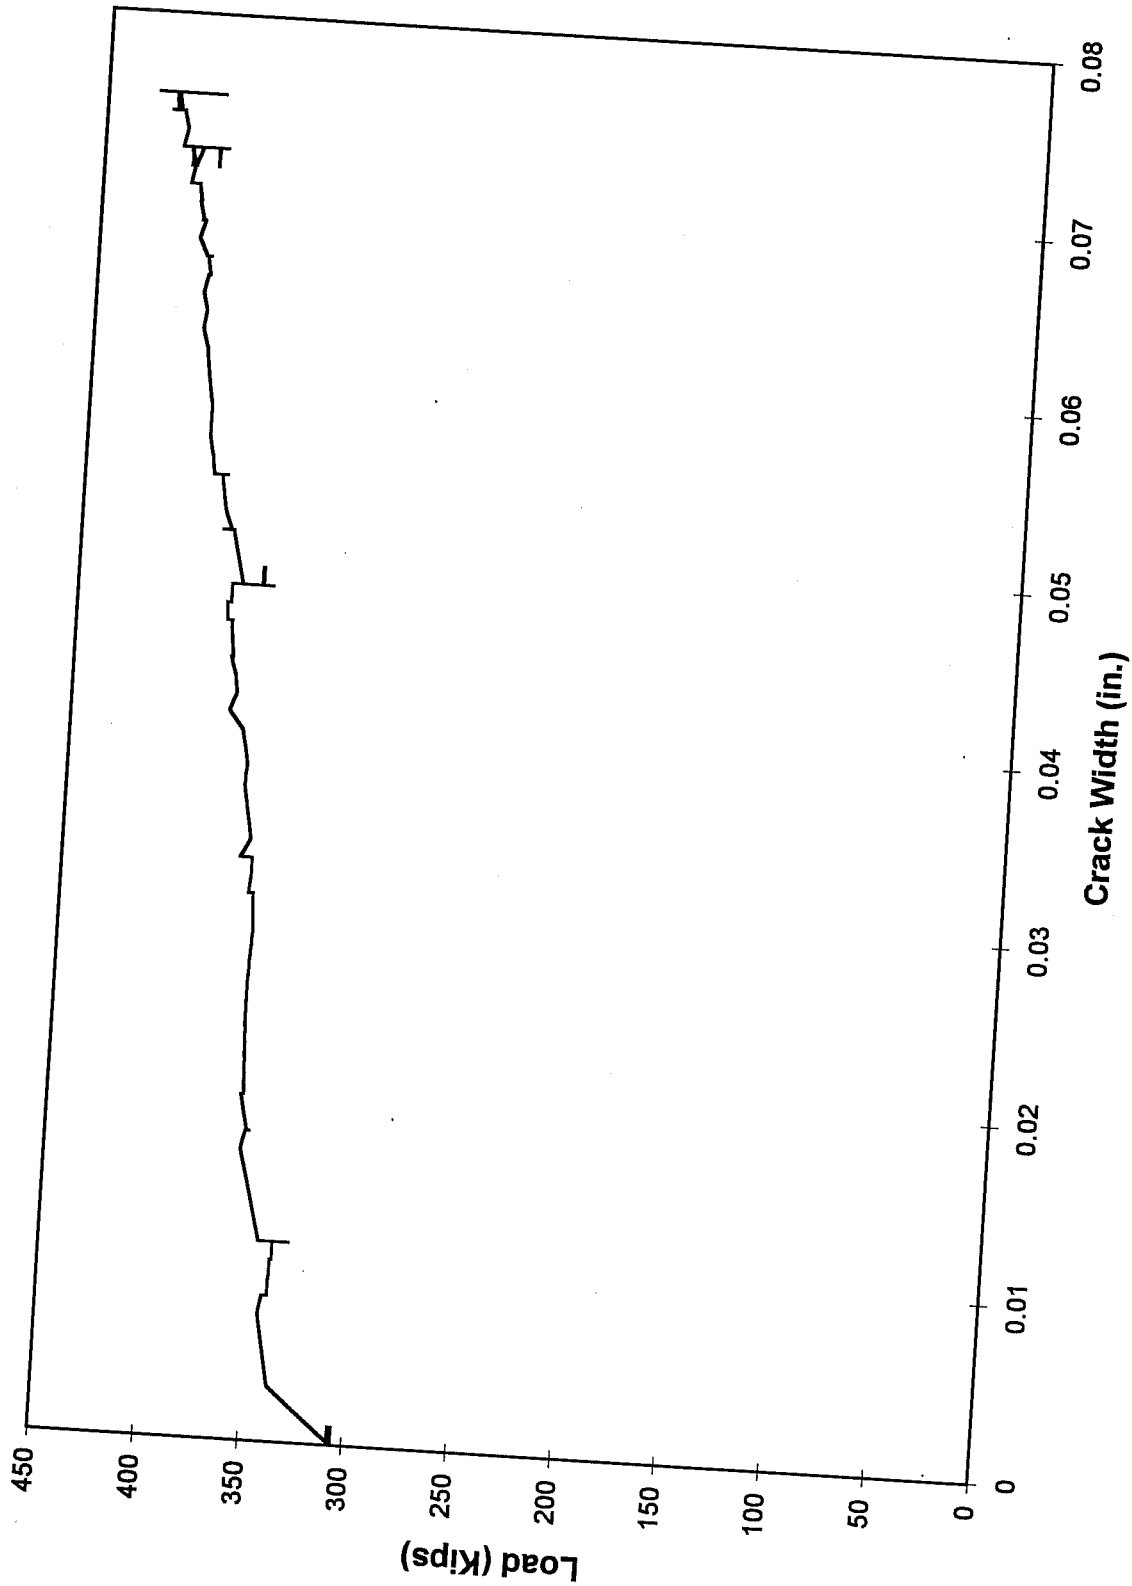
Figure 5 Crack Openings at Beam/Dap Interface for Ultimate Strength Test

At conclusion of the FL test, the largest crack in the dapped end was approximately 0.25 mm (0.01 in.) wide. Diagonal cracks in the webs of the girder developed during the test and were approximately aligned between the steel crosshead and the bottom corner of the beam. The largest of these was approximately 0.05 mm (0.002 in.) wide. During the test to failure, the largest diagonal crack in the dapped end increased to 2.5 mm (0.1 inches) and the largest diagonal cracks in the beam webs increased to 1.4 mm (0.055 in.) in width. Diagonal web cracks extended into the bottom flange of the box girder near conclusion of the FL test. These cracks extended further and ultimately passed completely through the bottom flange during the second test. Note that the measurements presented in Figure 5 do not agree with the dapped-end crack widths presented above because the gage was not oriented perpendicular to the crack where the crack width measurement was made (using a crack width comparator), and also more than one crack is located within the gage length.

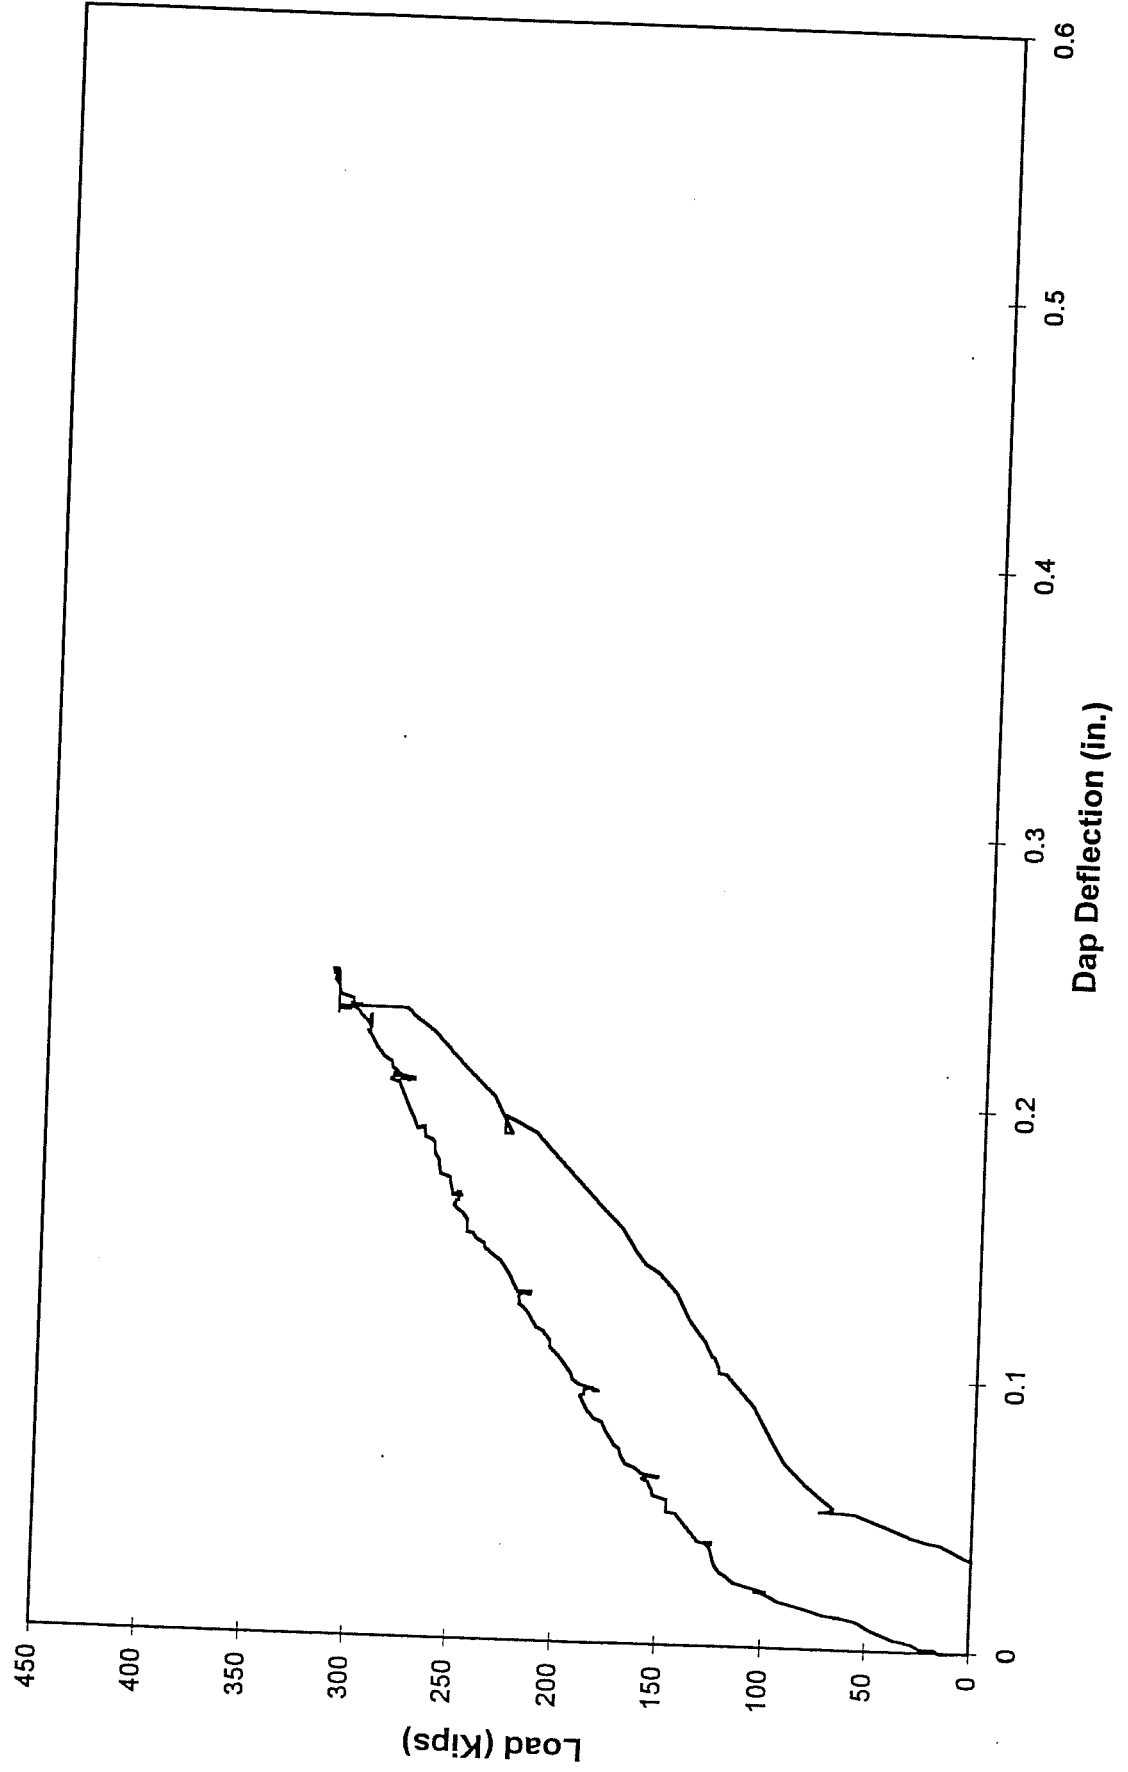
Figure 3 Load vs. Dap Deflection / Factored Load Test

The response of the beam to loading during the two tests is illustrated in Figures 3 and 4 using plots of load versus dap deflection (beam-end deflection minus deflection of the box end adjacent to the dap). Figure 3 clearly indicates stiffness reductions due to cracking and then yielding of reinforcement at approximately 530 kN (120 kips) and 1500 kN (340 kips). Opening of diagonal cracks at the dap/beam interface is illustrated in Figure 5 for the second test. The displacement transducer was unable to precisely record the small crack width at the dap during the factored load test.

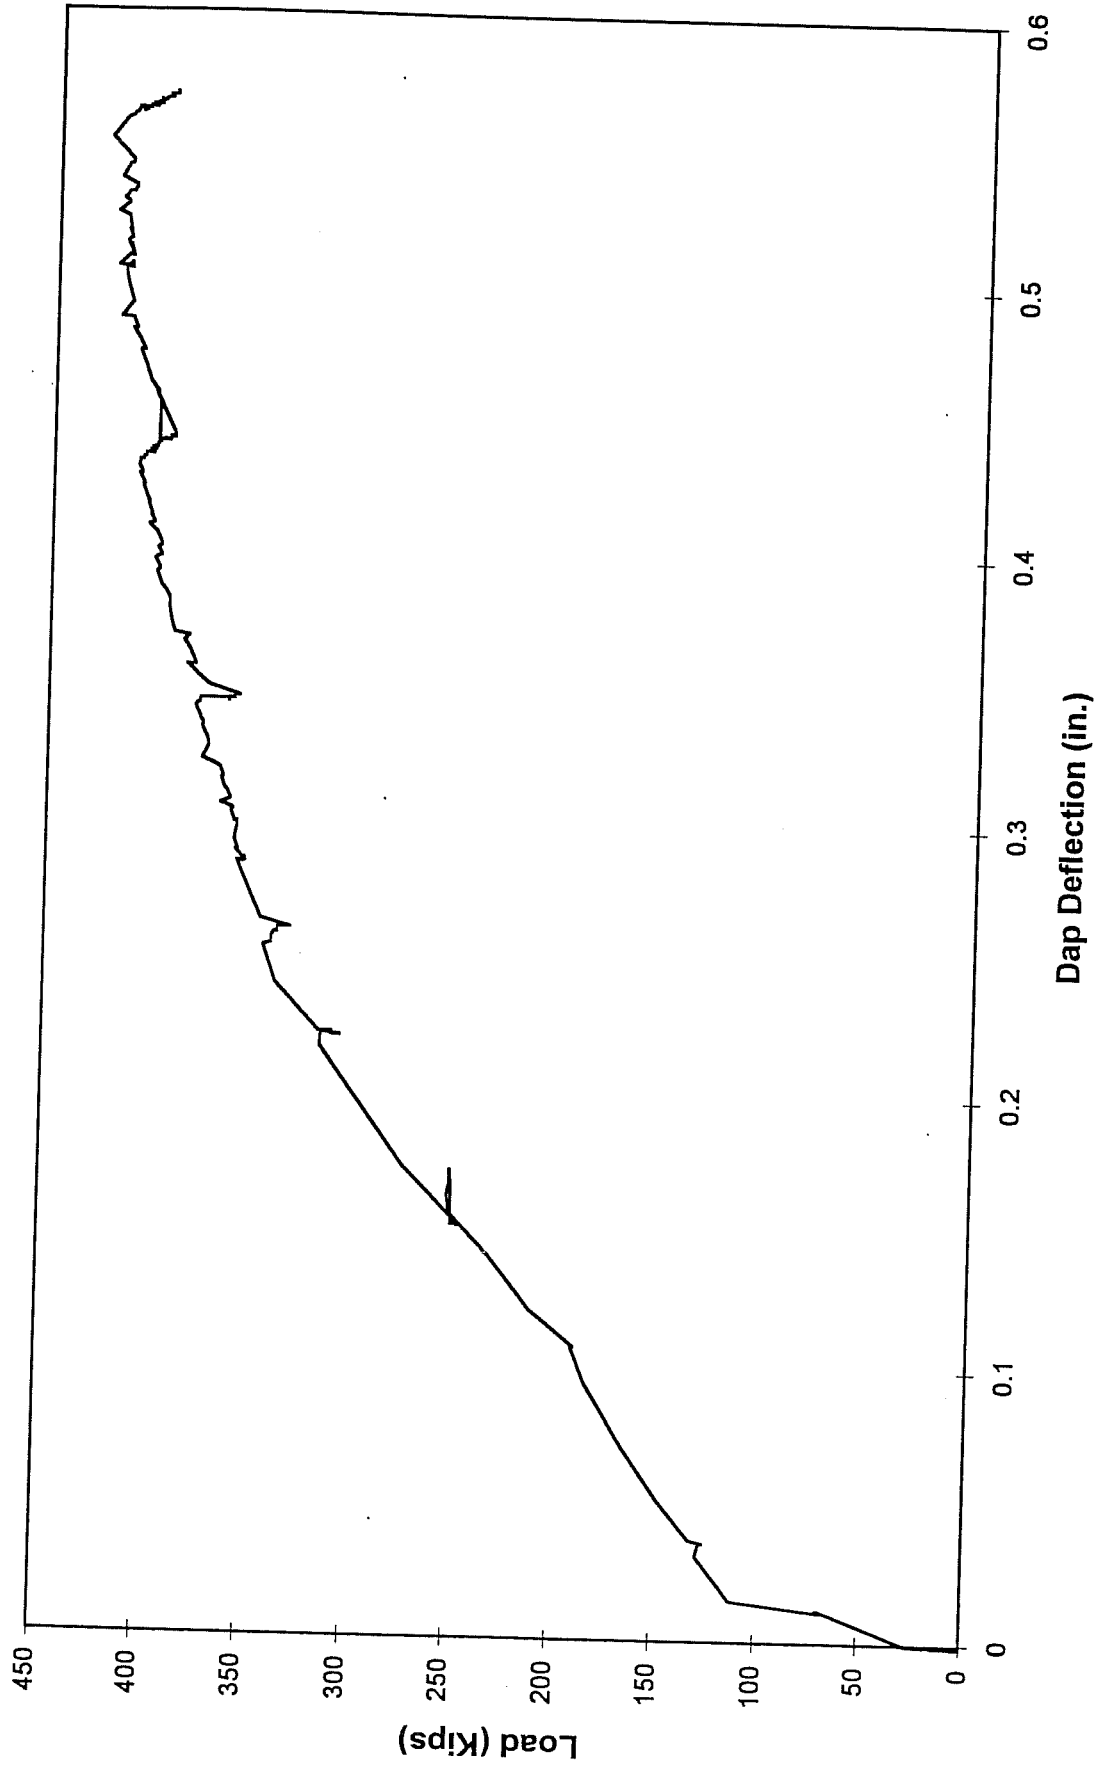
Figure 4 Load vs Dap Deflection / Ultimate Strength Test

Although the diagonal crack in the dapped-end region was the primary concern at the beginning of this investigation, it is interesting that strength of the beam was ultimately controlled by the diagonal cracks that initiated in the beam webs then propagated into and through the bottom flange. These cracks intersected the prestressing strands inside the required development length and resulted in slip of the strands. Initial slip of the strands

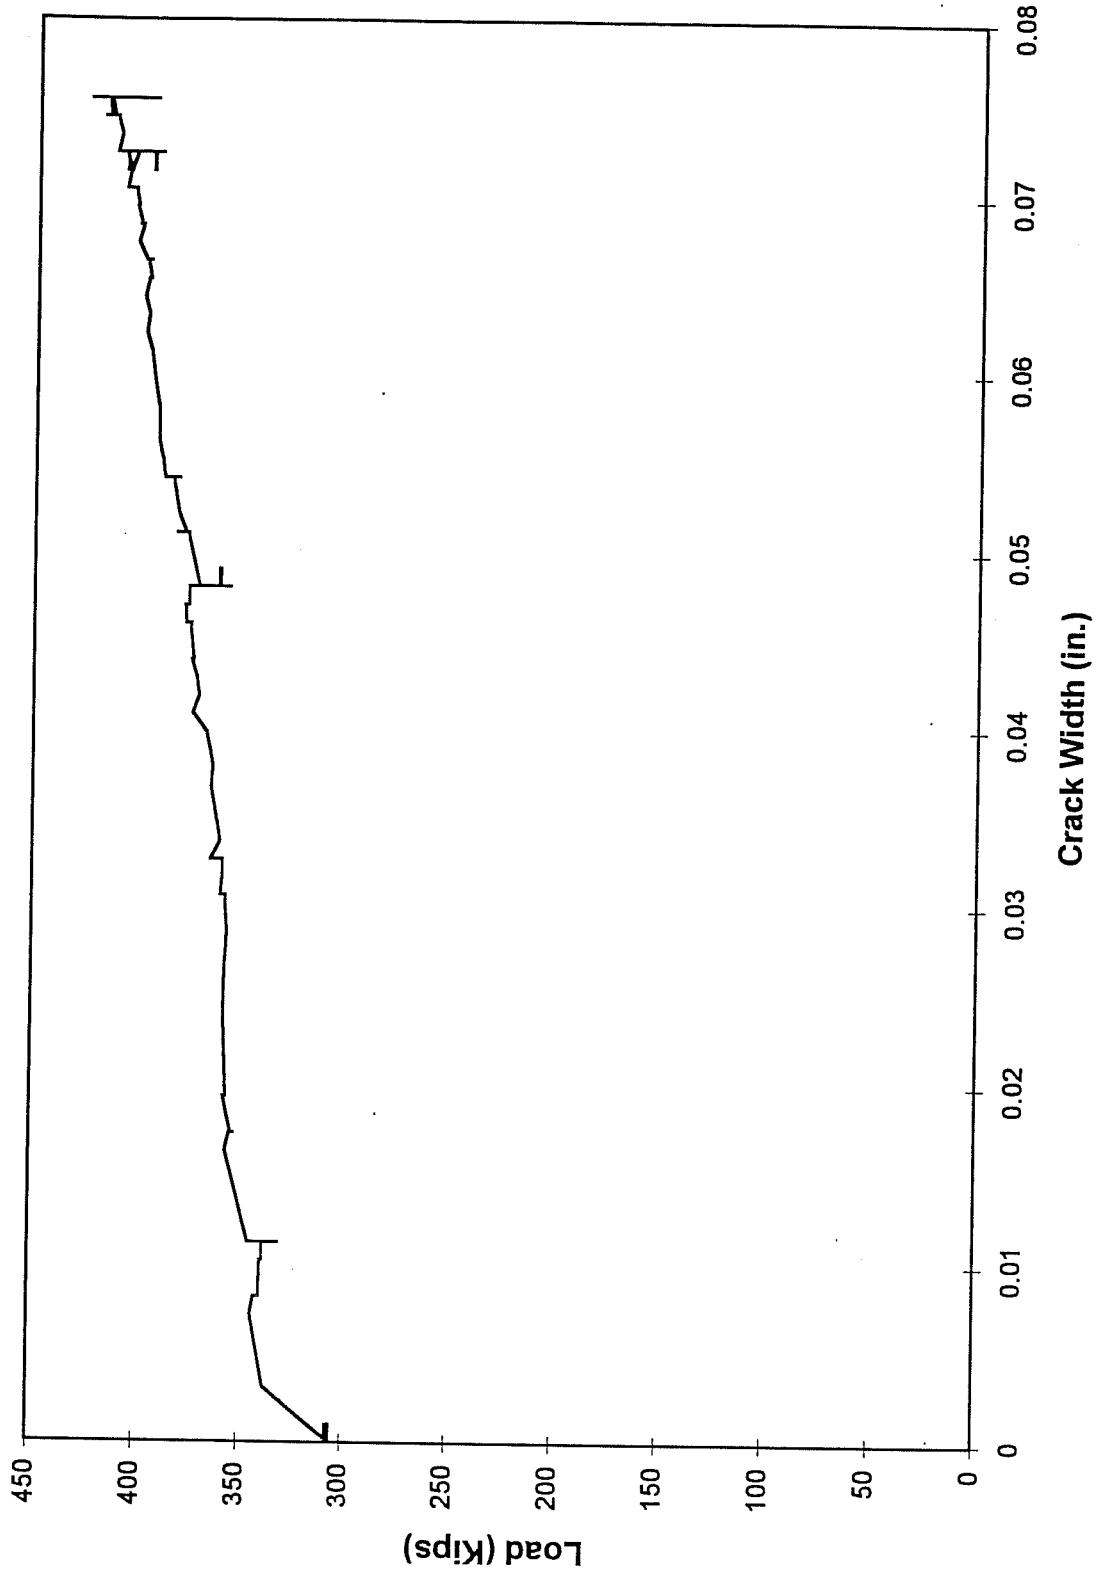
Figure 5 Crack Openings at Beam/Dap Interface for Ultimate Strength Test

At conclusion of the FL test, the largest crack in the dapped end was approximately 0.25 mm (0.01 in.) wide. Diagonal cracks in the webs of the girder developed during the test and were approximately aligned between the steel crosshead and the bottom corner of the beam. The largest of these was approximately 0.05 mm (0.002 in.) wide. During the test to failure, the largest diagonal crack in the dapped end increased to 2.5 mm (0.1 inches) and the largest diagonal cracks in the beam webs increased to 1.4 mm (0.055 in.) in width. Diagonal web cracks extended into the bottom flange of the box girder near conclusion of the FL test. These cracks extended further and ultimately passed completely through the bottom flange during the second test. Note that the measurements presented in Figure 5 do not agree with the dapped-end crack widths presented above because the gage was not oriented perpendicular to the crack where the crack width measurement was made (using a crack width comparator), and also more than one crack is located within the gage length.

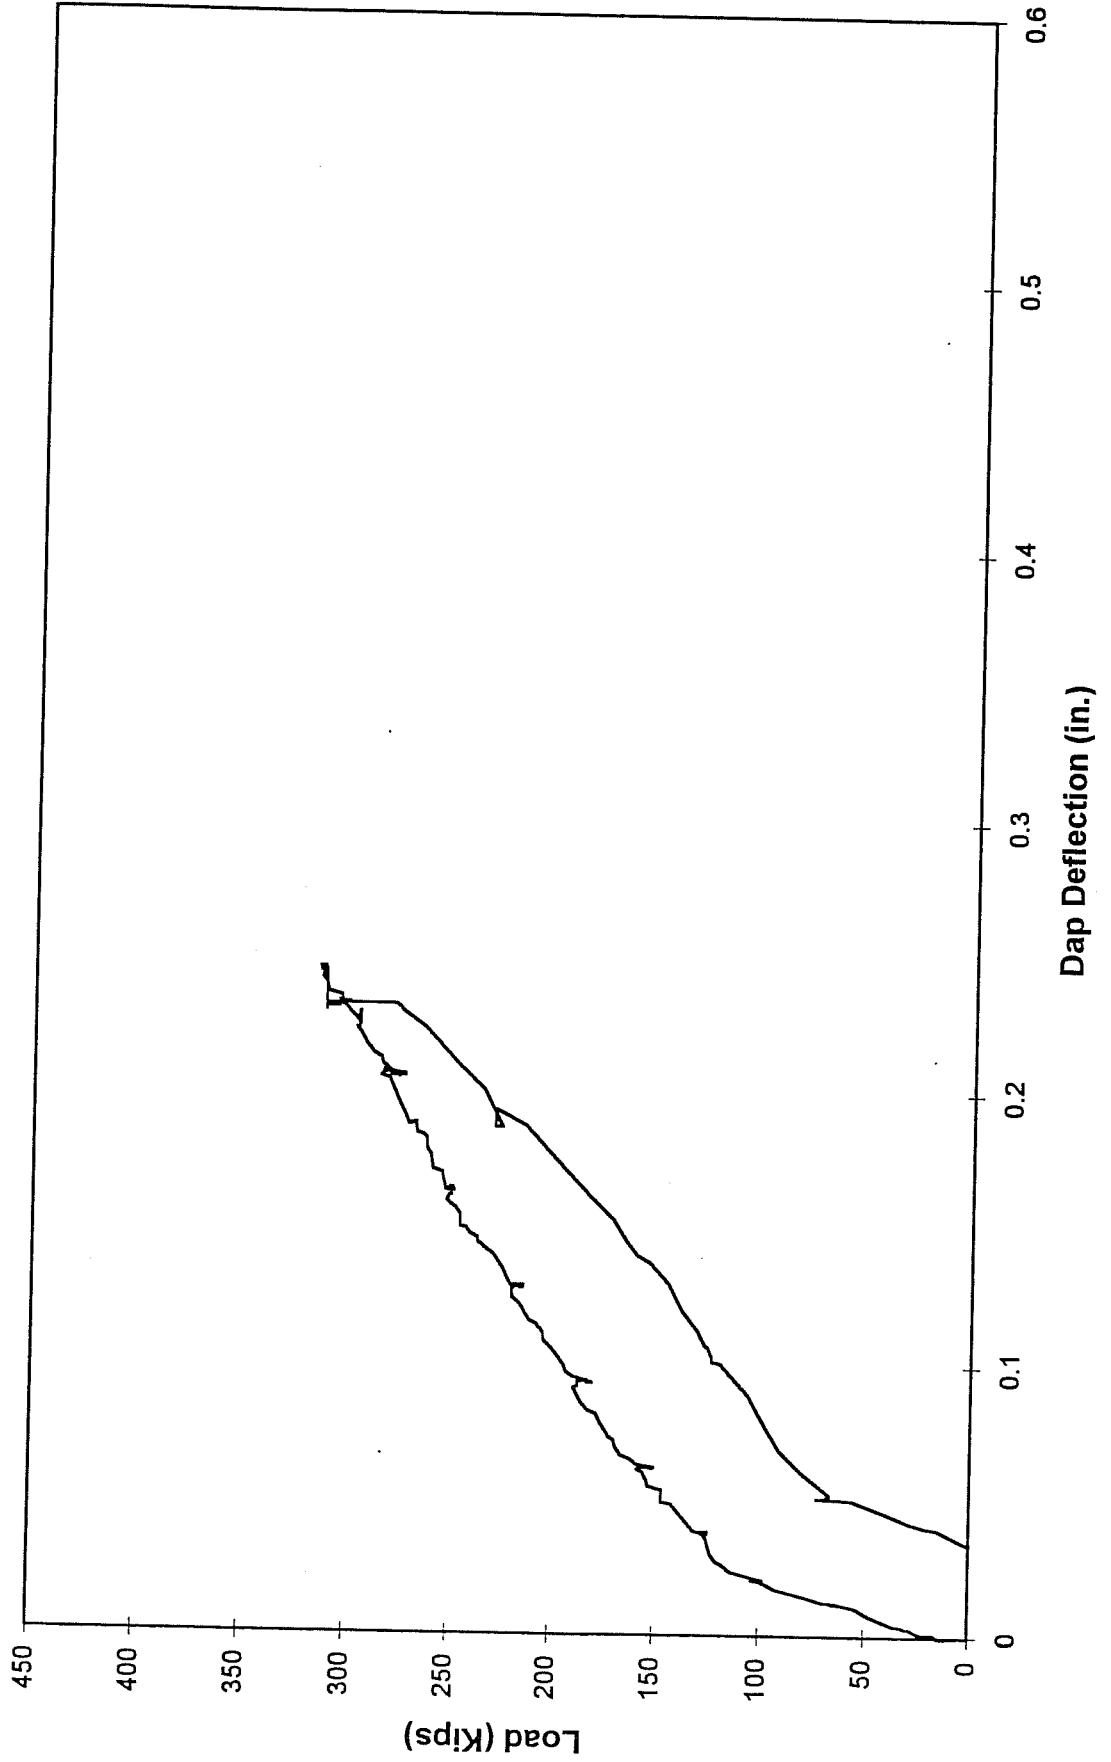
Figure 3 Load vs. Dap Deflection / Factored Load Test

The response of the beam to loading during the two tests is illustrated in Figures 3 and 4 using plots of load versus dap deflection (beam-end deflection minus deflection of the box end adjacent to the dap). Figure 3 clearly indicates stiffness reductions due to cracking and then yielding of reinforcement at approximately 530 kN (120 kips) and 1500 kN (340 kips). Opening of diagonal cracks at the dap/beam interface is illustrated in Figure 5 for the second test. The displacement transducer was unable to precisely record the small crack width at the dap during the factored load test.

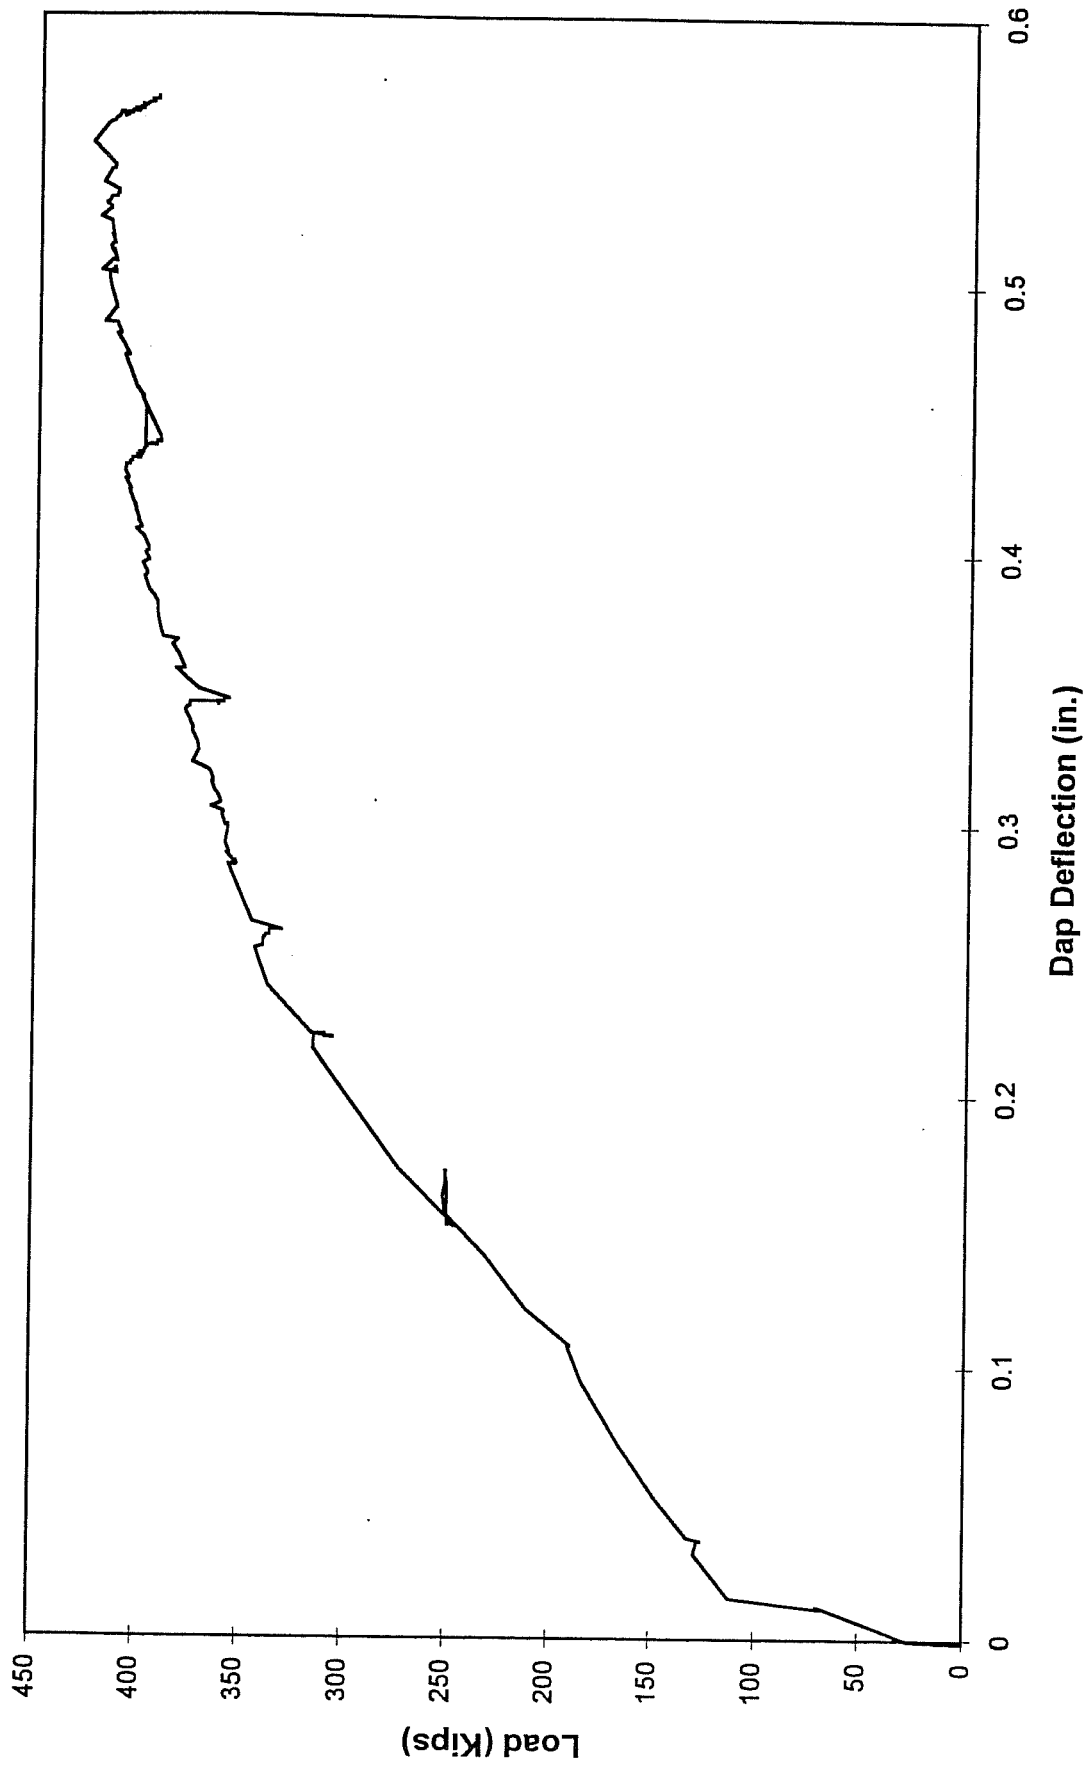
Figure 4 Load vs Dap Deflection / Ultimate Strength Test

Although the diagonal crack in the dapped-end region was the primary concern at the beginning of this investigation, it is interesting that strength of the beam was ultimately controlled by the diagonal cracks that initiated in the beam webs then propagated into and through the bottom flange. These cracks intersected the prestressing strands inside the required development length and resulted in slip of the strands. Initial slip of the strands

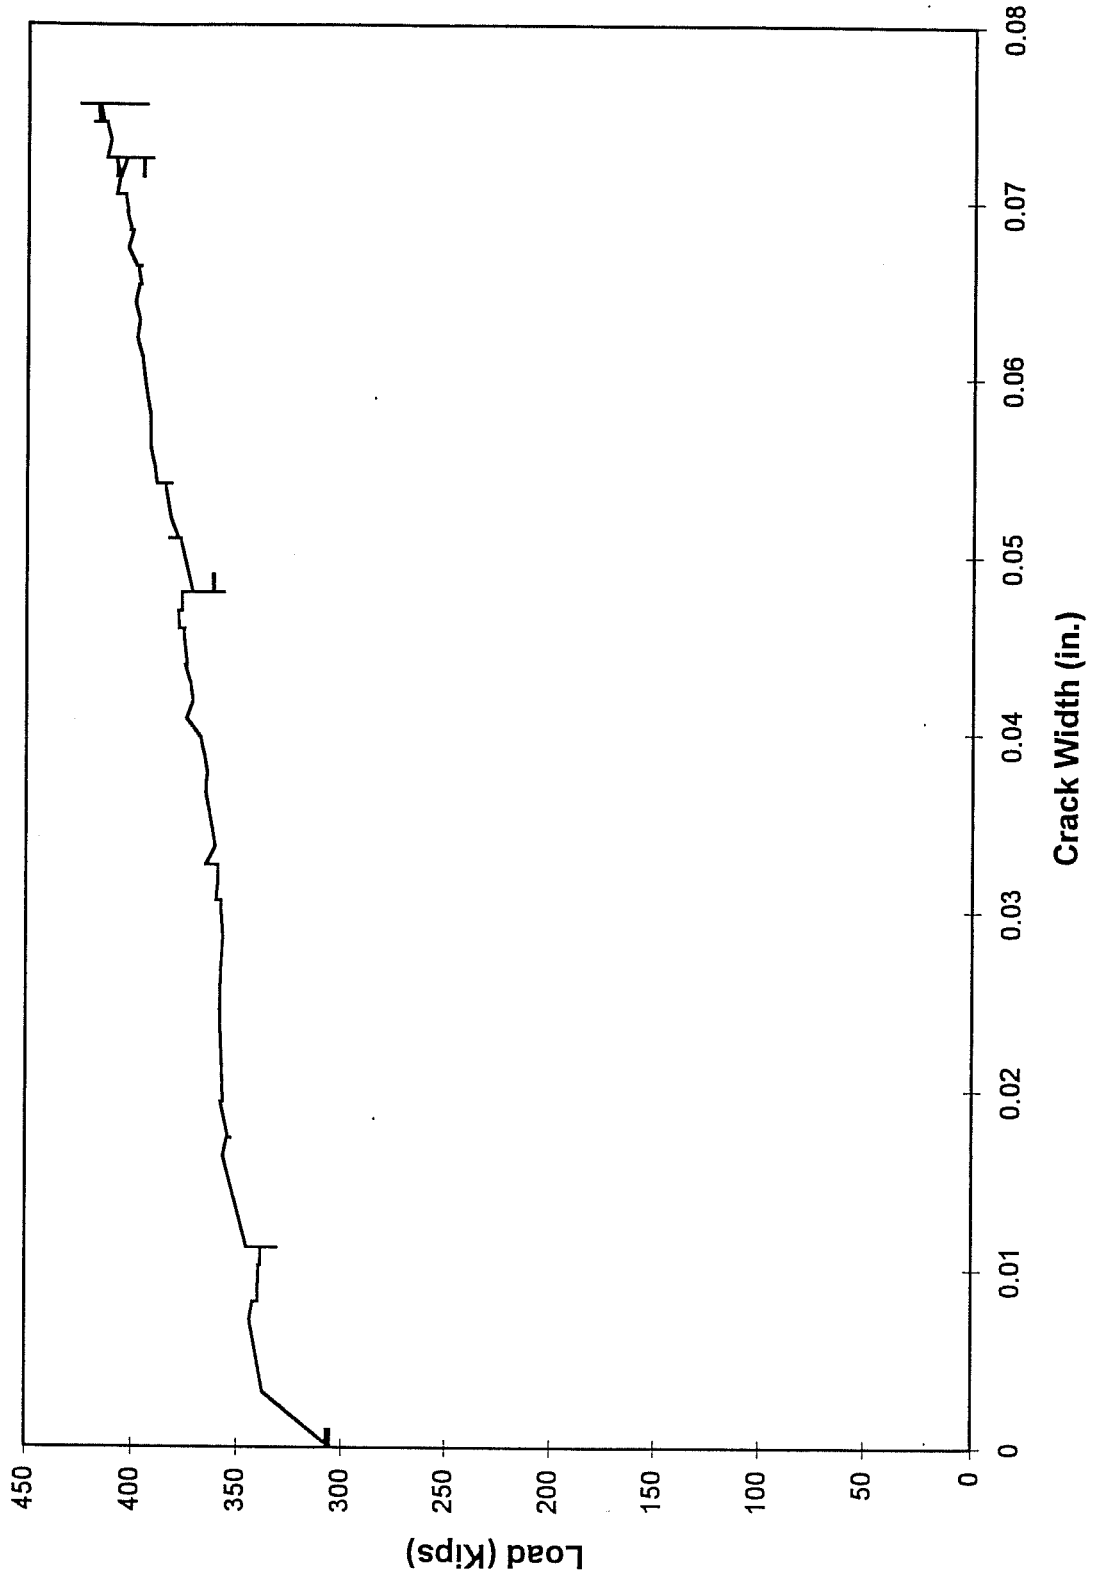
Figure 5 Crack Openings at Beam/Dap Interface for Ultimate Strength Test

At conclusion of the FL test, the largest crack in the dapped end was approximately 0.25 mm (0.01 in.) wide. Diagonal cracks in the webs of the girder developed during the test and were approximately aligned between the steel crosshead and the bottom corner of the beam. The largest of these was approximately 0.05 mm (0.002 in.) wide. During the test to failure, the largest diagonal crack in the dapped end increased to 2.5 mm (0.1 inches) and the largest diagonal cracks in the beam webs increased to 1.4 mm (0.055 in.) in width. Diagonal web cracks extended into the bottom flange of the box girder near conclusion of the FL test. These cracks extended further and ultimately passed completely through the bottom flange during the second test. Note that the measurements presented in Figure 5 do not agree with the dapped-end crack widths presented above because the gage was not oriented perpendicular to the crack where the crack width measurement was made (using a crack width comparator), and also more than one crack is located within the gage length.
