**PMFSEL 90-2
DECEMBER 1990**

TESTS OF HIGHLAND WAREHOUSE ROOF JOISTS

**PHIL M. FERGUSON STRUCTURAL ENGINEERING LABORATORY
Department of Civil Engineering / Bureau of Engineering Research
The University of Texas at Austin**

December 1990

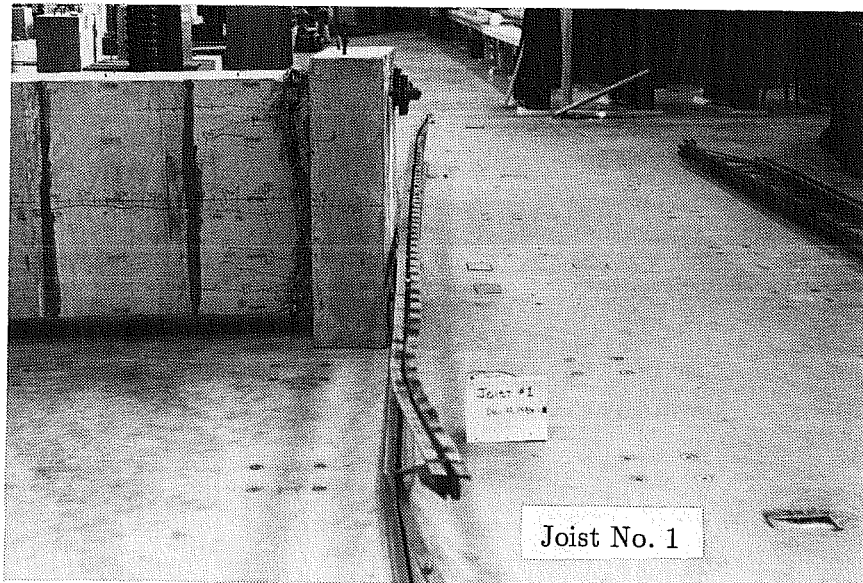
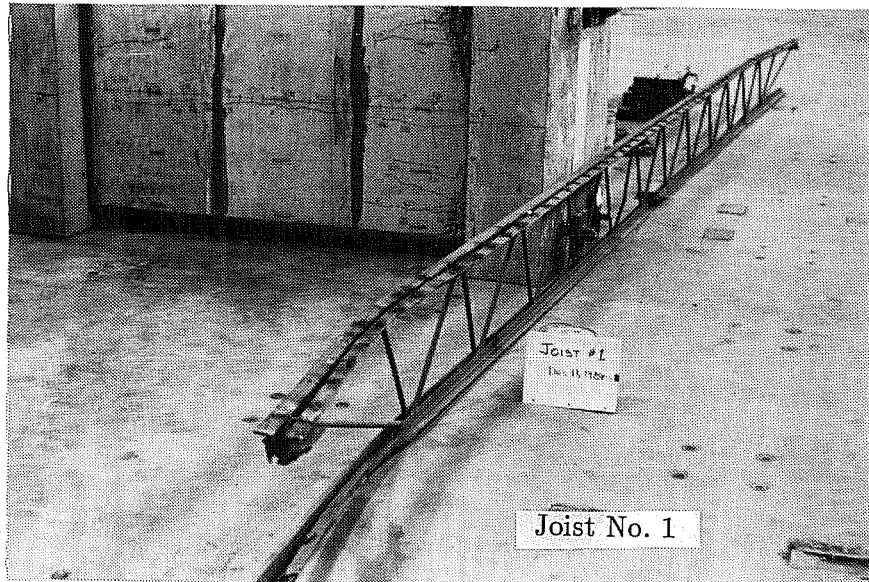
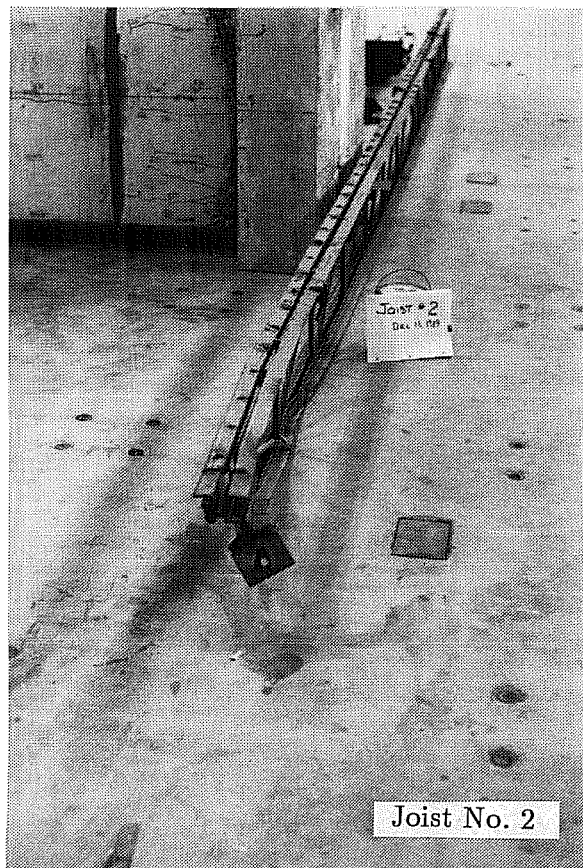
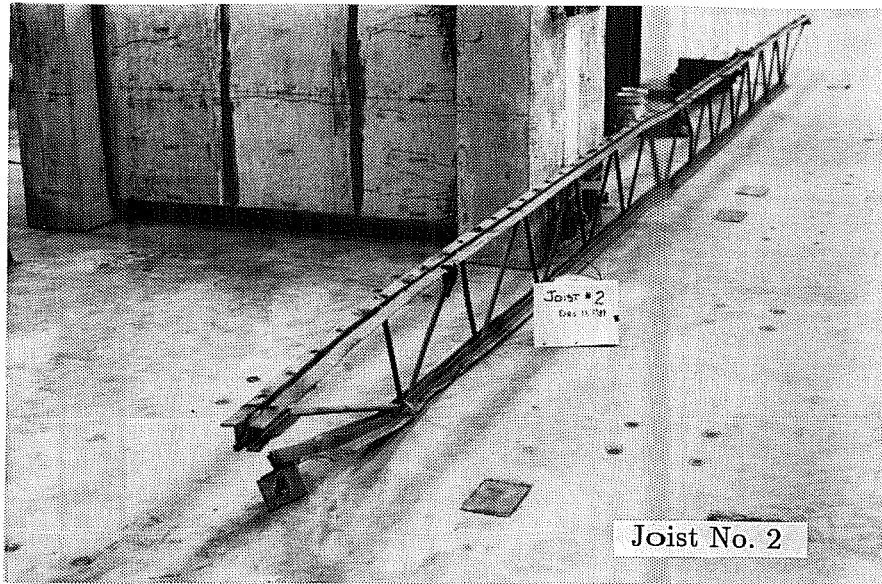
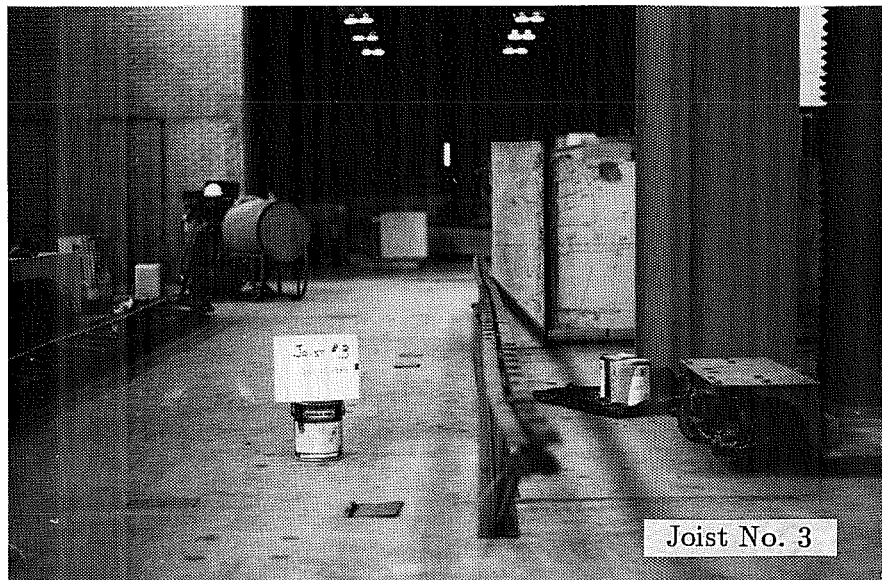
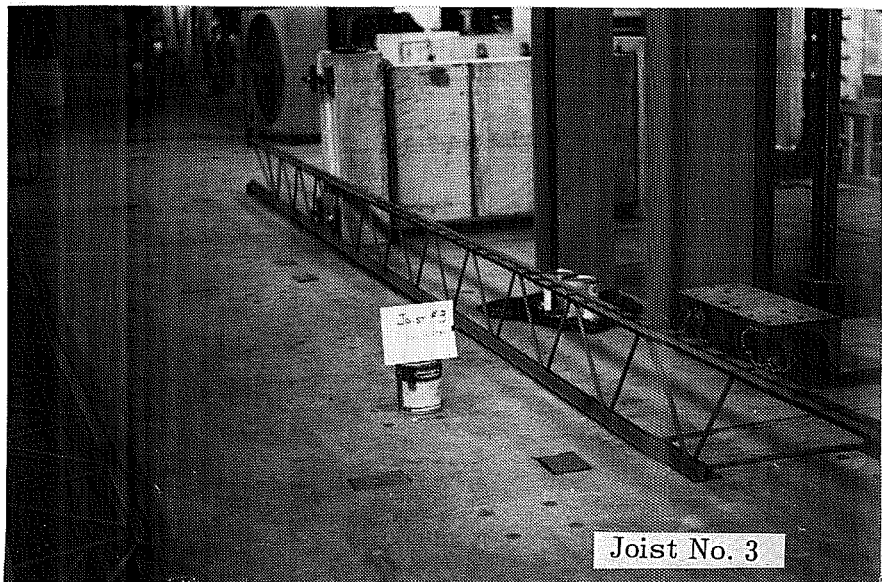
Fig. 2.17 Photographs of Joists as Received at Ferguson Lab

The three test joists were salvaged from the Highland warehouse roof system after the collapse. The joists were delivered to Ferguson Laboratory on December 8, 1989. As delivered, all three joists showed significant damage. Photographs of each joist, as received at Ferguson Lab, are provided in Fig. 2.17. Overall, Joist No. 1 appeared to be most damaged, and Joist No. 3 appeared to be least damaged.

As can be seen in the photographs, each of the joists were laterally bent out of shape. Most of this deformation was concentrated at the joist ends. The lower chord extensions were severely damaged on Joist Nos. 1 and 2. In addition to the overall deformations, the individual angles in the chord members were twisted at several locations. No severe deformations, with the exceptions noted below, were observed in the diagonals.

As received, the joists were too deformed for testing. The large lateral deformations did not permit the joists to fit within the test setup. Further, testing of a severely distorted joist could not be expected to provide a meaningful representation of the strength or controlling failure mode of an undamaged joist. For these reasons, limited repairs were undertaken on the joists prior to testing. First, the severely distorted lower chord extensions were cut off of Joist Nos. 1 and 2. An attempt was then made to straighten out each of the joists by applying out of plane forces to the joists. In some cases, individual members were heated with a torch to facilitate straightening. Although this operation straightened out the joists by removing the largest lateral deformations, the joists still showed significant lateral distortions. It was not possible to completely straighten the joists prior to testing. The three lateral guides within the test frame were used to further straighten the joists.

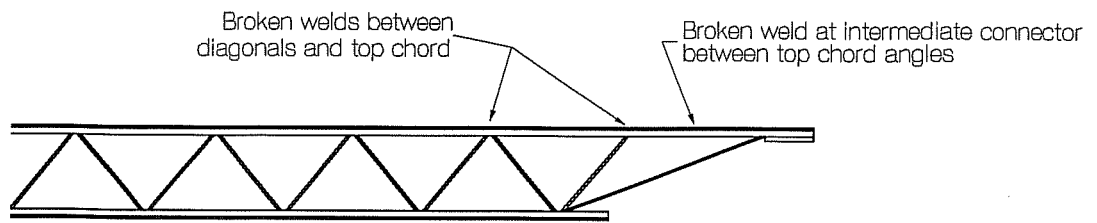
Fig. 2.18 Location of Broken Welds Found on Joist No. 1
After Straightening

After the straightening operation was completed on Joist No. 1, several broken welds were observed in the joist. These broken welds were at the north end of the joist, at the locations indicated in Fig. 2.18. It is not known when these welds were broken. It is noted, however, that the broken welds were in a severely distorted region of the joist. This region was subject to large lateral forces during the straightening of the joist. It is therefore possible that the welds were broken while straightening the joist. One of the broken welds between the diagonals and the top chord was deemed critical to the joist's load carrying capacity. Consequently, the broken welds indicated in Fig. 2.18 were repaired prior to testing of the joist.

Note: Broken welds discovered after joist straightening.
Broken welds were repaired prior to testing joist

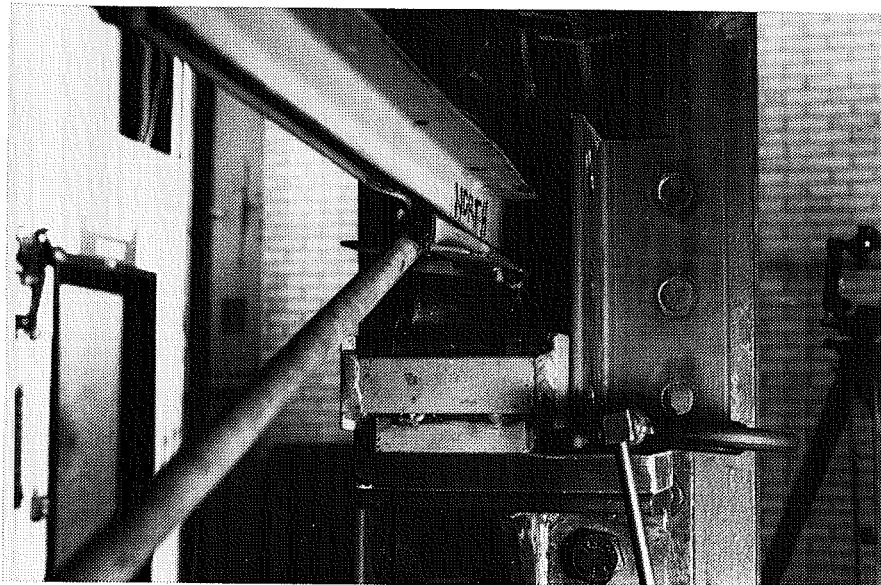
Fig. 2.19 North End of Joist No. 2 Prior to Testing

A broken weld was also observed in Joist No. 2, also after the straightening operation was completed. This broken weld was at an intermediate connector in the top chord, near midspan. This weld was not repaired prior to testing. Based on the observed behavior of Joist No. 2 during testing (described in Chapter 3), this broken weld had no effect on the joist.

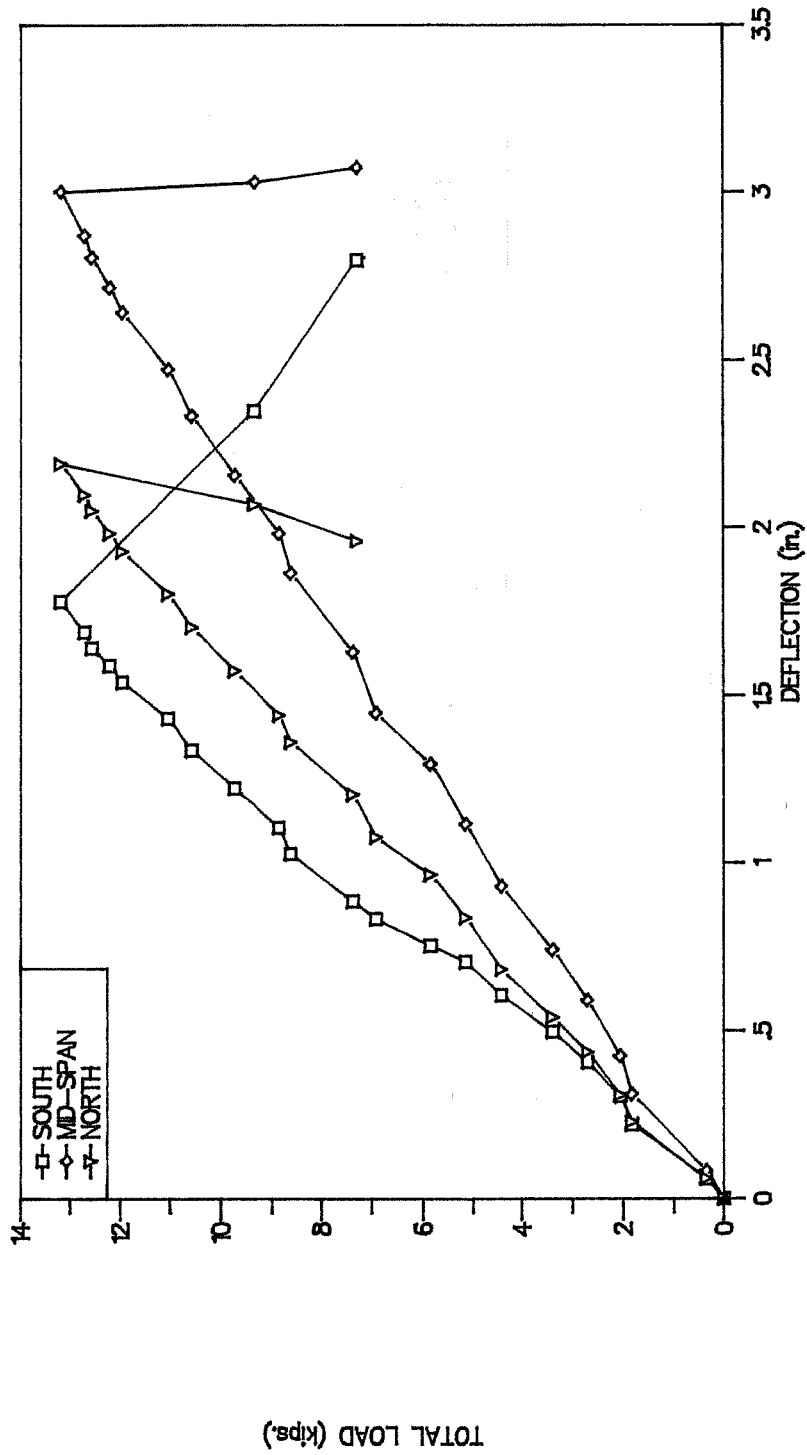
Fig. 3.1 Joist No. 1 - Load vs. Displacement

The plot of load versus displacement for Joist No. 1 is shown in Fig. 3.1. The peak load held by this joist was 13,200 lbs., at which point the midspan deflection was measured at 3.01 inches. At the peak load, the first compression diagonal at the south end of the joist buckled. This was followed almost immediately by buckling of the next compression diagonal at the south end. The location of the buckled diagonals are indicated in Fig. 3.8. Photographs of the buckled diagonals are provided in Fig. 3.2. Both diagonals buckled primarily out of the plane of the joist. After all load was removed from the joist, the first compression diagonal at the south end had a residual out-of-straightness of approximately 1.75 inches at midlength. The residual out-of-straightness of the second compression diagonal that buckled was approximately 1 inch.

Prior to achieving the peak load, the load-displacement plot for Joist No. 1 (Fig. 3.1) shows some irregular areas where the displacements increased somewhat suddenly. These occurred at about 2000 lbs. and again at about 9000 lbs. It is believed that these increased displacements corresponded to slip in the joist end supports. The 5" x 5" x 1/2" support angles, bolted to the W10 x 33 support members likely slipped a small amount. During the test, sudden noises were heard from the supports, which indicated the likelihood of slip. For the remaining two joist tests, the connections were tightened, and no additional slipping occurred. The small slip of the end supports did not affect the strength of Joist No. 1, although the measured displacements were increased.

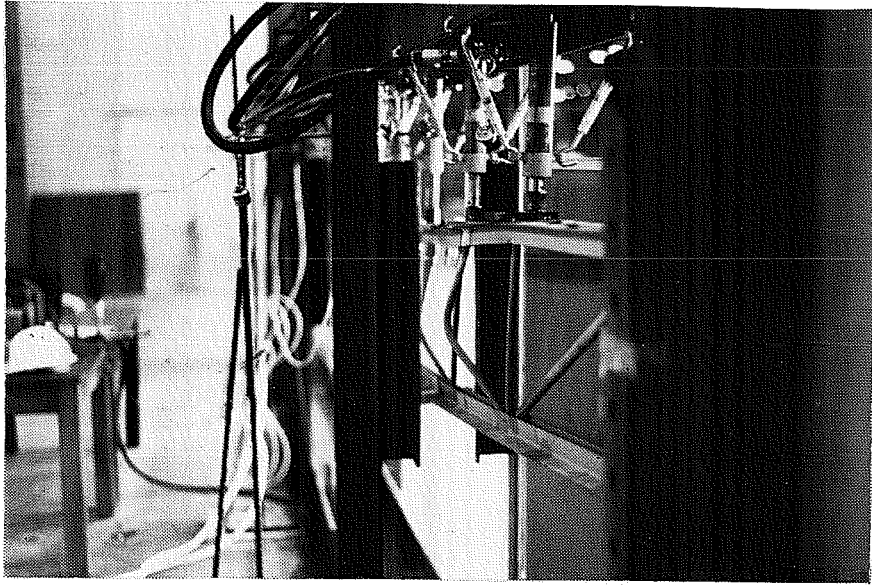
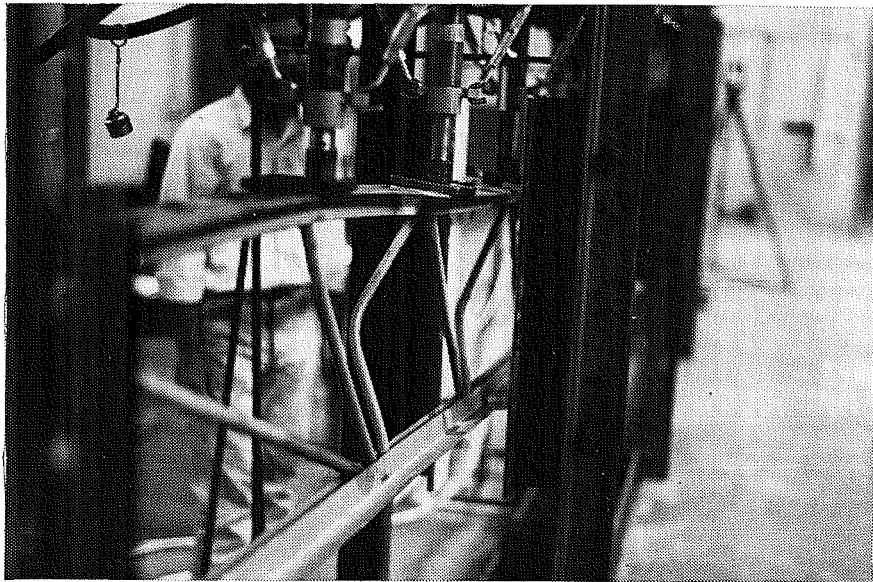
Fig. 3.2 Joist No. 1 – After Testing

Each joist failed by buckling of compression diagonals near the joist end. In Joist No. 1, the first two compression diagonals at the south end buckled out of the plane of the joist. In Joist No. 2, the first compression diagonal at the north end buckled out of the plane of the joist. In Joist No. 3, the first compression diagonal at the north end buckled in the plane of the joist. Upon continued loading, the second compression diagonal at the north end also buckled in the plane of the joist. There was also evidence of buckling of the lower chord extension in the plane of the joist for Joist No. 3.

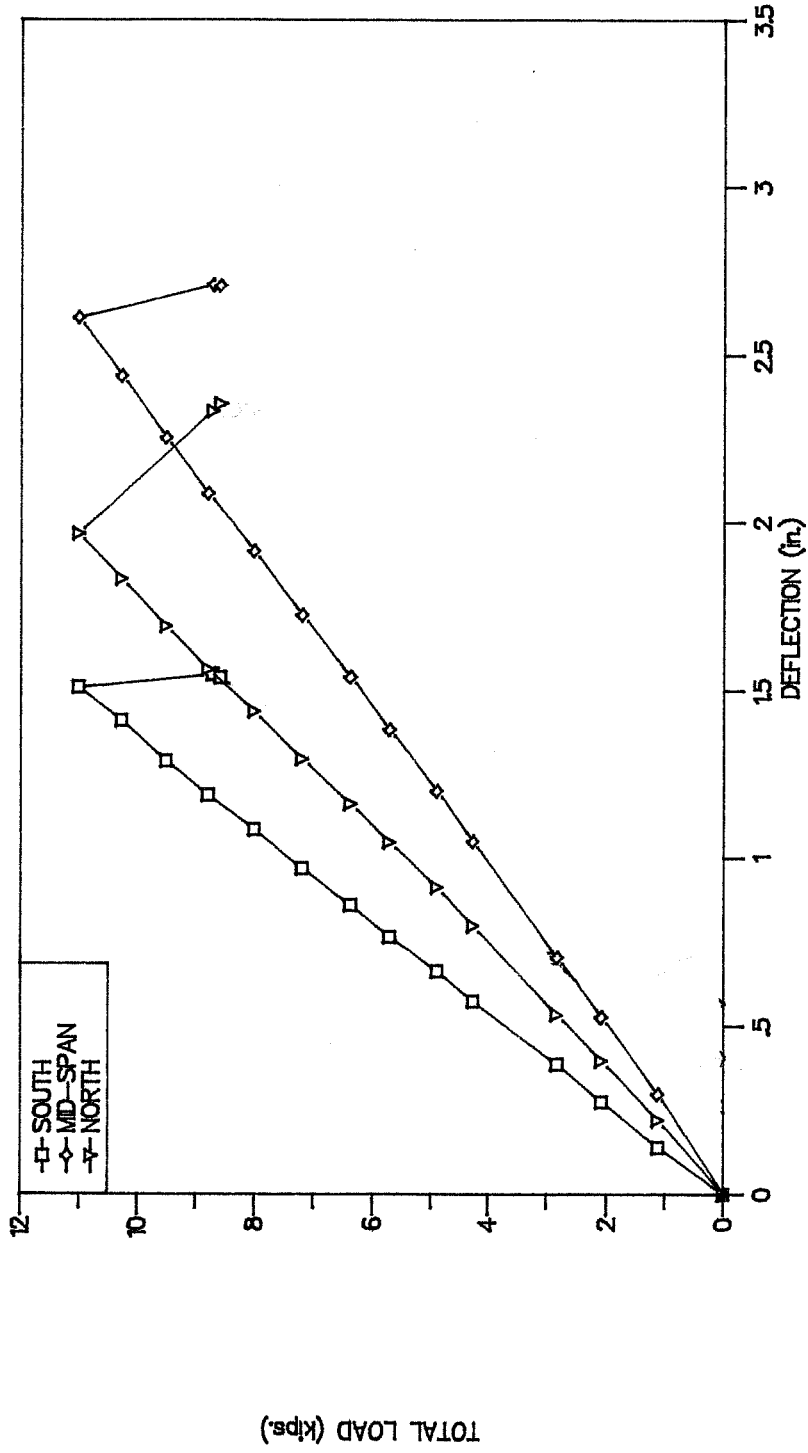
Fig. 3.3 Joist No. 2 - Load vs. Displacement

The plot of load versus displacement for Joist No. 2 is shown in Fig. 3.3. The peak load held by this joist was 11,100 lbs., at which point the midspan deflection was measured at 2.63 inches. At the peak load, the first compression diagonal at the north end of the joist buckled. Unlike Joist No. 1, no other members buckled. The location of the buckled diagonal is indicated in Fig. 3.8, and photographs of the failure are in Fig. 3.4. The diagonal buckled primarily out of the plane of the joist, with a similar buckled shape as occurred with Joist No. 1. As with Joist No. 1, the diagonal retained a permanent buckled shape after unloading of the joist at the end of the test.

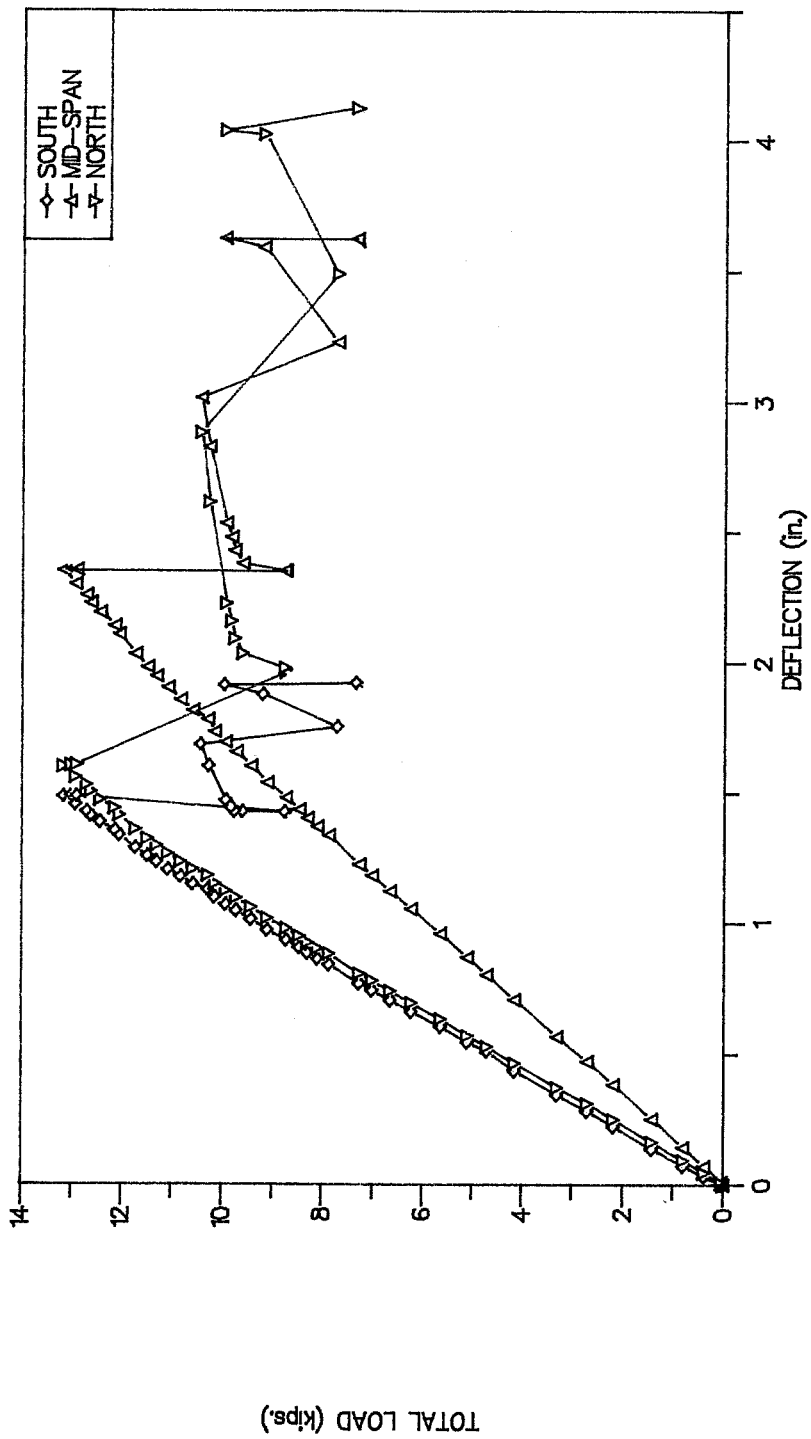
Fig. 3.5 Joist No. 3 -Load vs. Displacement

The plot of load versus displacement for Joist No. 3 is shown in Fig. 3.5., and a plot of load versus the vertical reaction measured at the south end of the joist is in Fig. 3.6. The peak load held by this joist was 13,200 lbs., at which point the midspan deflection was measured at 2.37 inches. At the peak load, the first compression diagonal at the north end of the joist buckled. This diagonal buckled primarily in the plane of the joist.

The maximum midspan deflection measured for Joist No. 3 was significantly lower than for the other two joists, due to the stiffening effect of the lower chord extension.

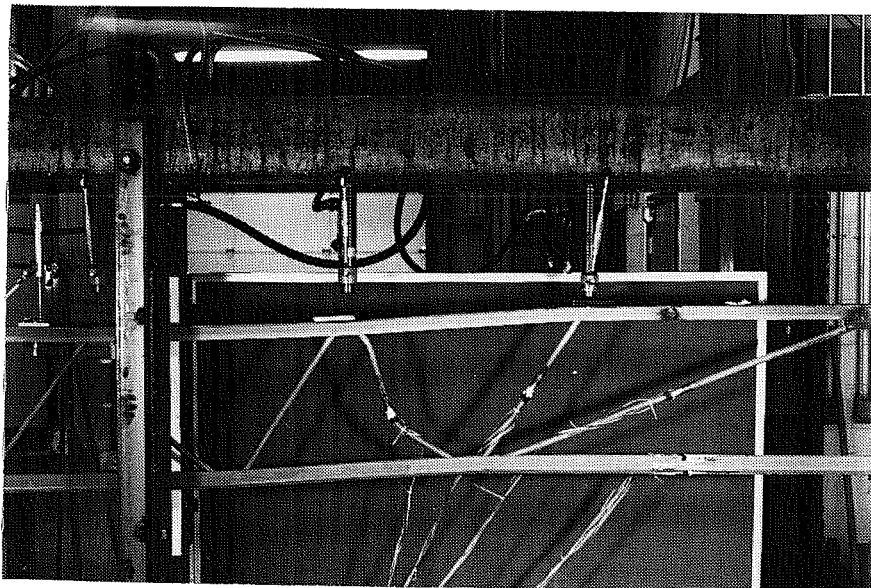
Fig. 3.7 Joist No. 3 – After Testing

After the first diagonal buckled, the load supported by the joist dropped to about 8700 lbs. At this point, loading of the joist was resumed. The load on the joist increased to approximately 10,500 lbs., at which point the second compression diagonal at the north end of the joist buckled. Again, the direction of buckling was primarily in the plane of the joist. After the second diagonal buckled, loading was again resumed. However, the hydraulic rams at the north end of the joist were fully extended shortly after the loading was resumed, and the test was terminated.

Figure 3.8 shows the location of the buckled diagonals in Joist No. 3. A photograph of the buckled diagonals is provided in Fig. 3.7. Both diagonals retained a permanent buckled shape after unloading of the joist at the end of the test.
