# **REHABILITATION OF EXISTING REINFORCED CONCRETE BUILDINGS IN MEXICO CITY**

## **Case Studies**

**PMFSEL 96-3**

**Ferguson Structural Engineering Laboratory  
The University of Texas at Austin**

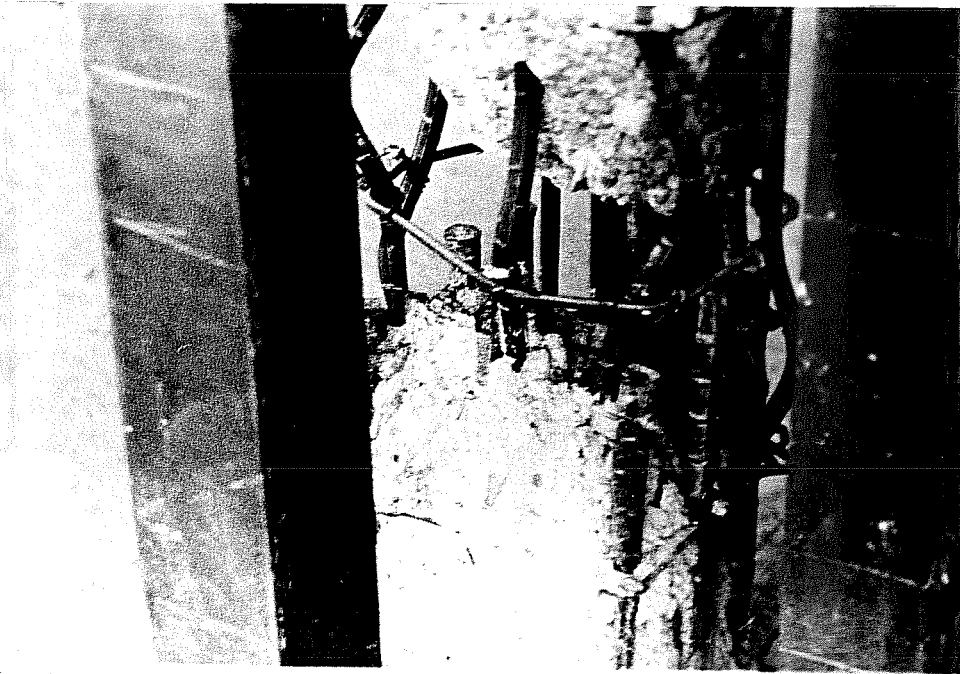
Figure 5- A3 Excessive splicing of reinforcement

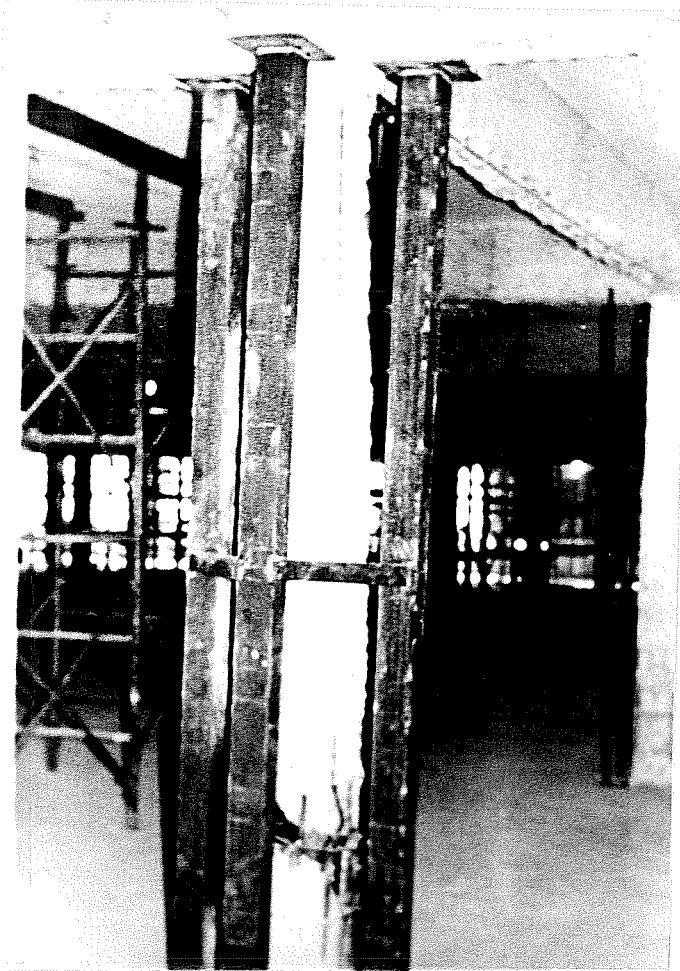
The most damaged columns in the second floor were located at 2B and 6B (see Fig. 5-A1). These columns spalled and reinforcing bars were exposed (Figs. 5-A3 and 5-A4). Some other columns in the same floor had cracks larger than 1 mm. The damage in the second floor columns was due primarily to the restraint provided by the brick infills which produced a short column effect (Fig. 5-A5). Excessive bar splicing at the same location resulted in failure at that section (Fig. 5-A3), and lack of confinement by transverse reinforcement allowed bar buckling and failure. No beam or slab damage was found.

Figure 5- A4 Failed column

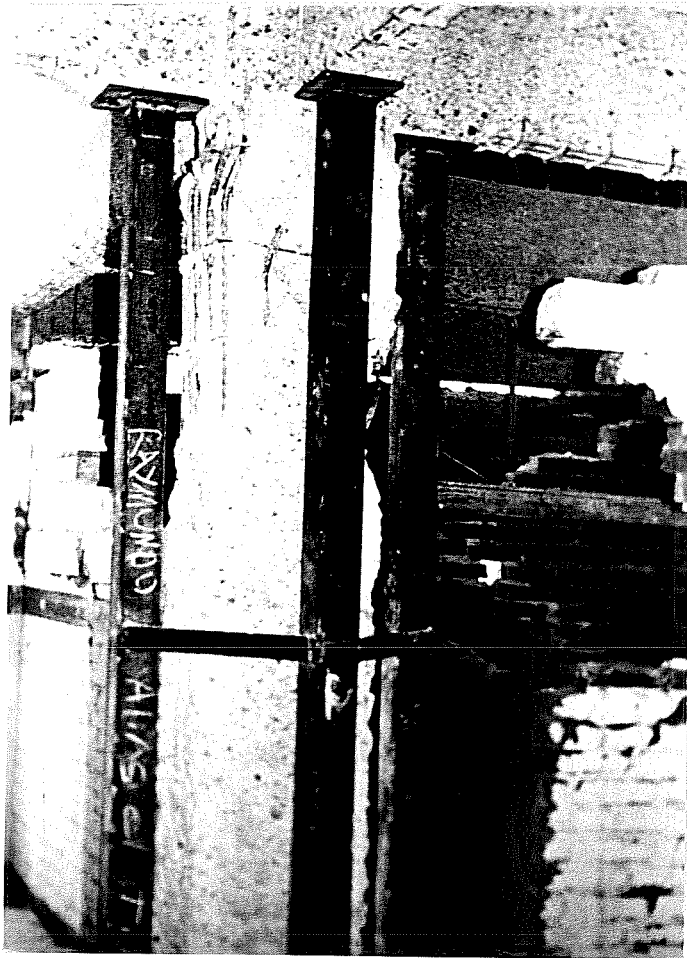
Figure 5- A5 Short column failure

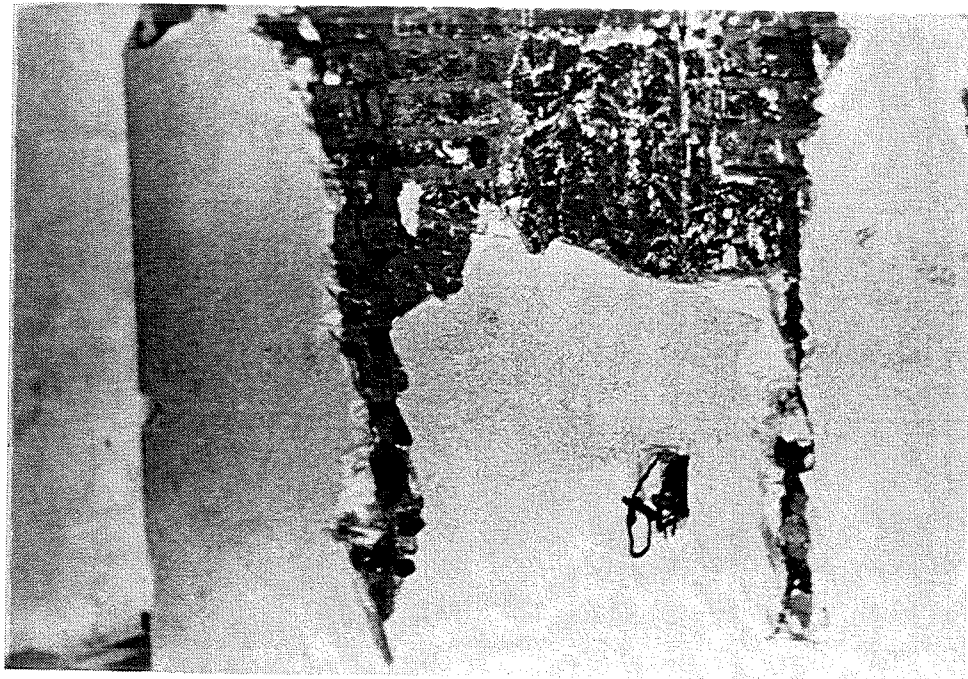
Figure 5- E3 Damage to walls

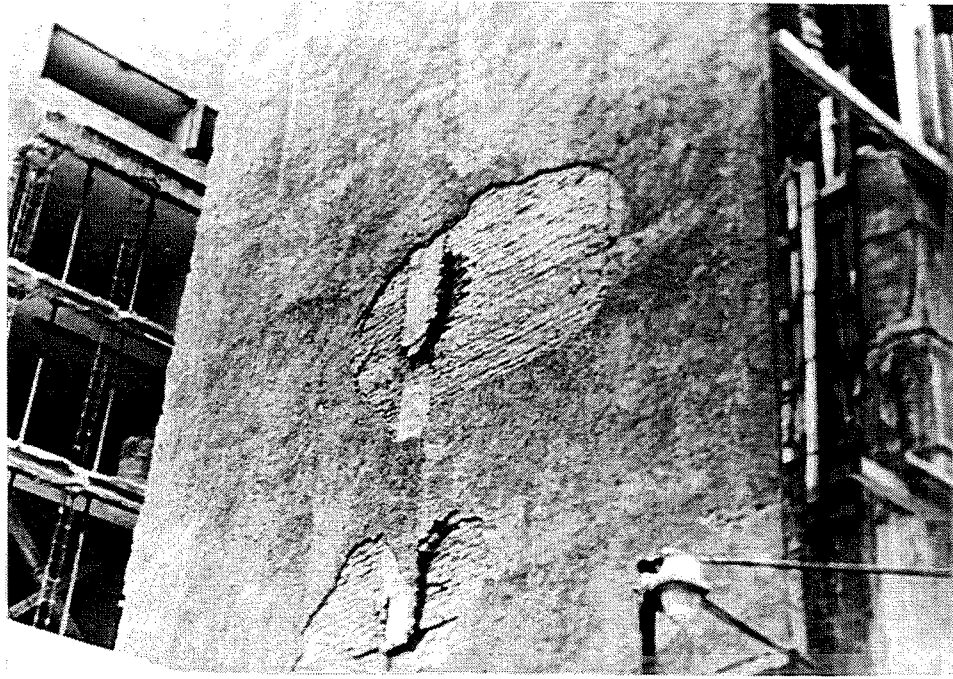
*Figure 5- E4 Damage to exterior wall on line A*

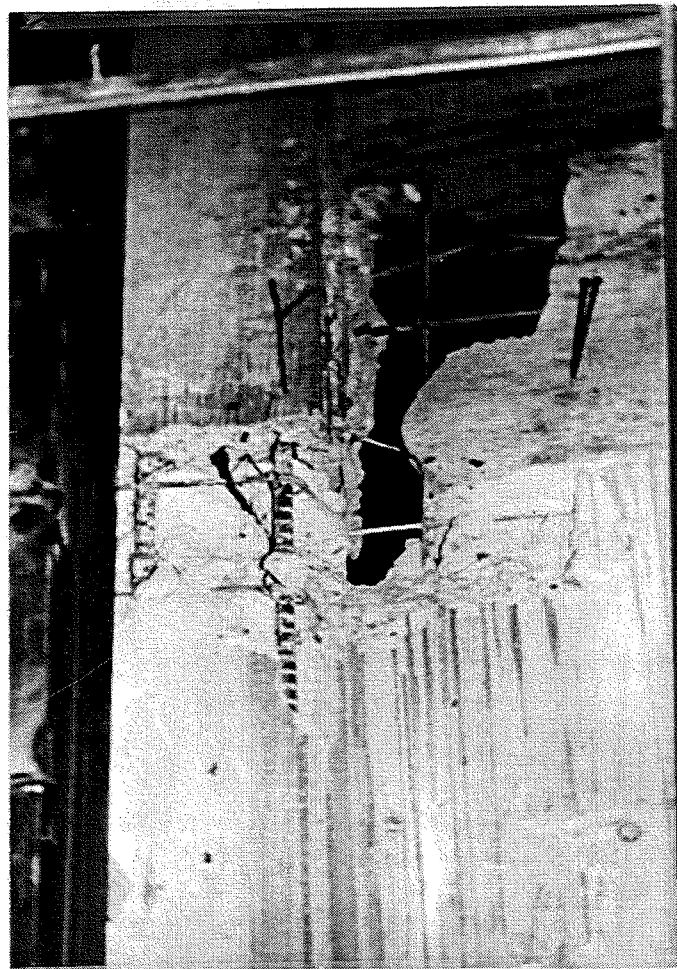
Figure 5- F5 Typical damage to boundary columns

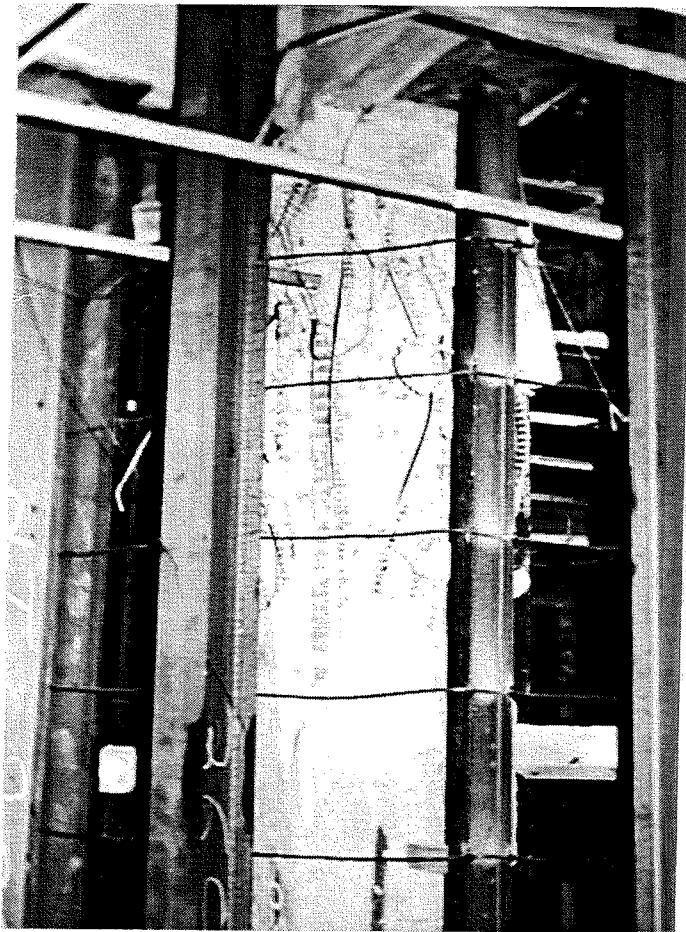
*Figure 5- F6 Damage to column C-5*

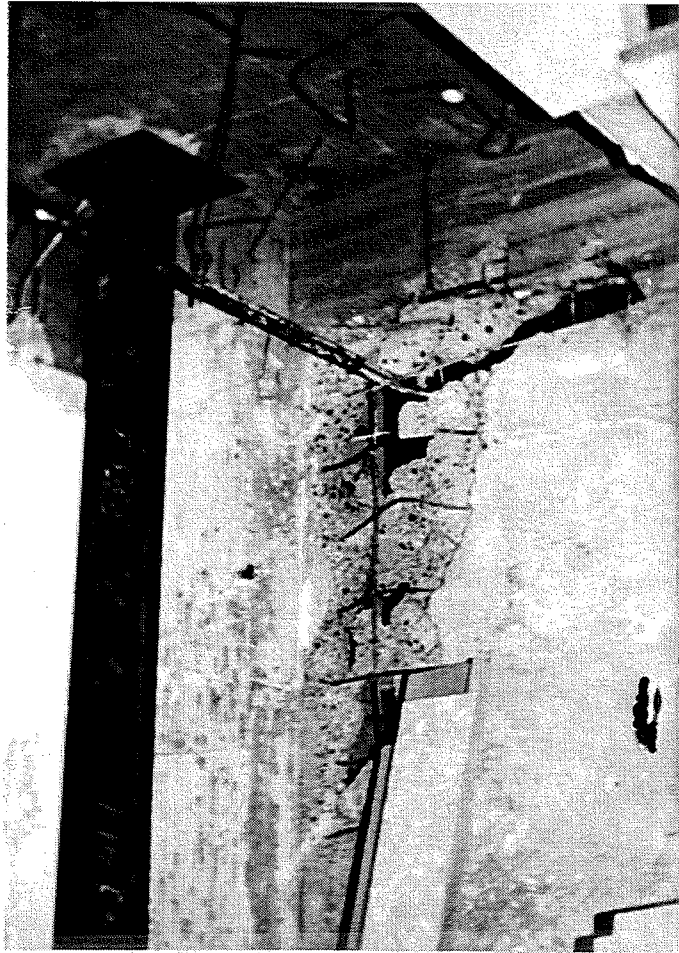
*Figure 5- F7 Damage in concrete walls*

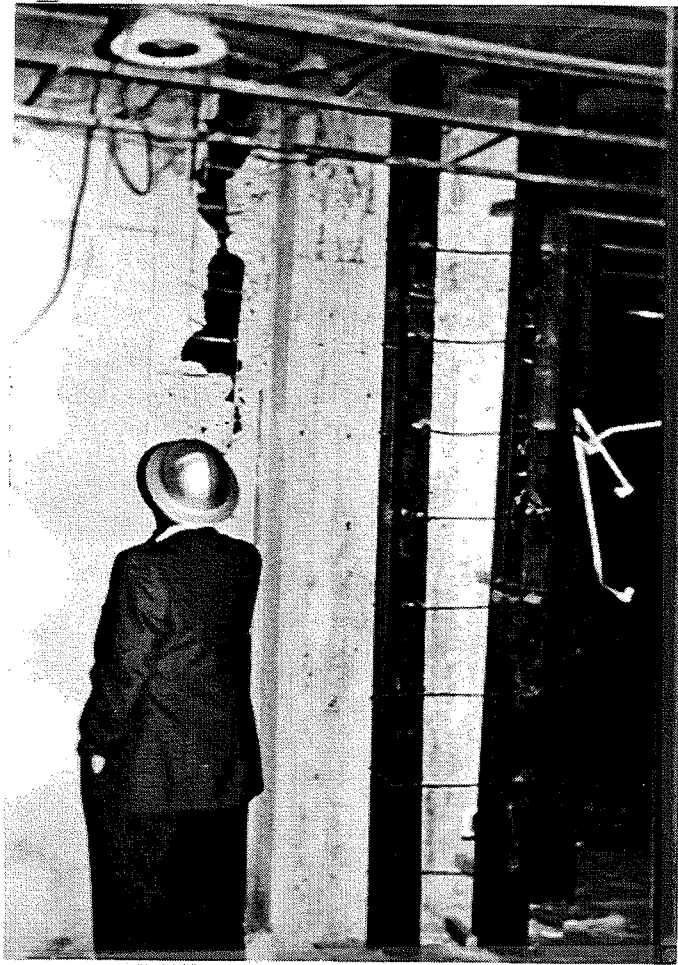
*Figure 5- F8 Damage in concrete walls*

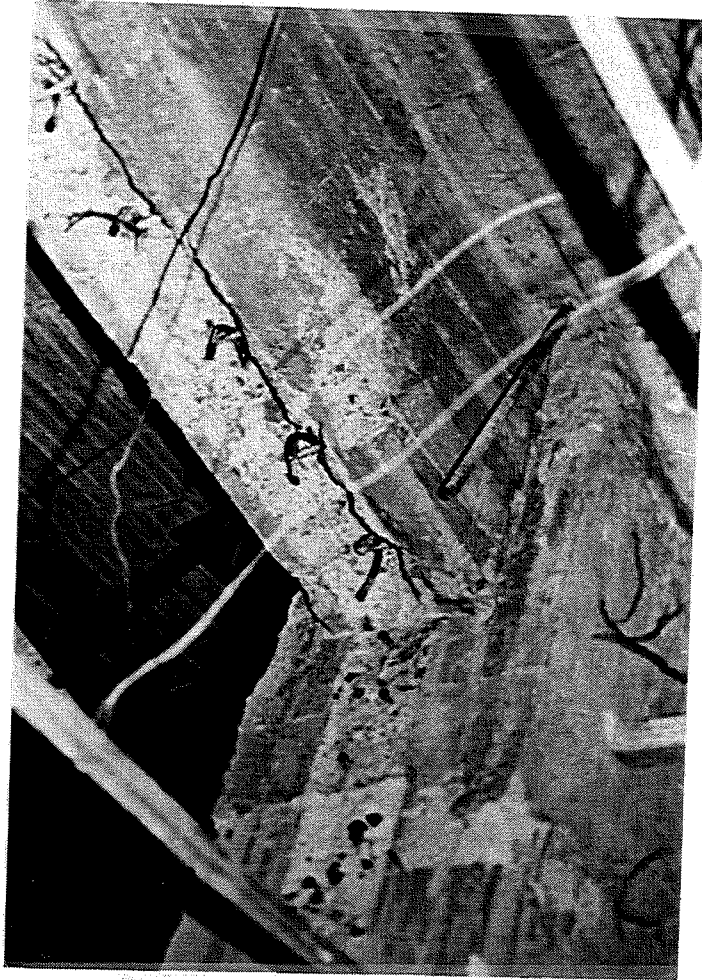
*Figure 5- F9 Deficient wall-beam anchorages*

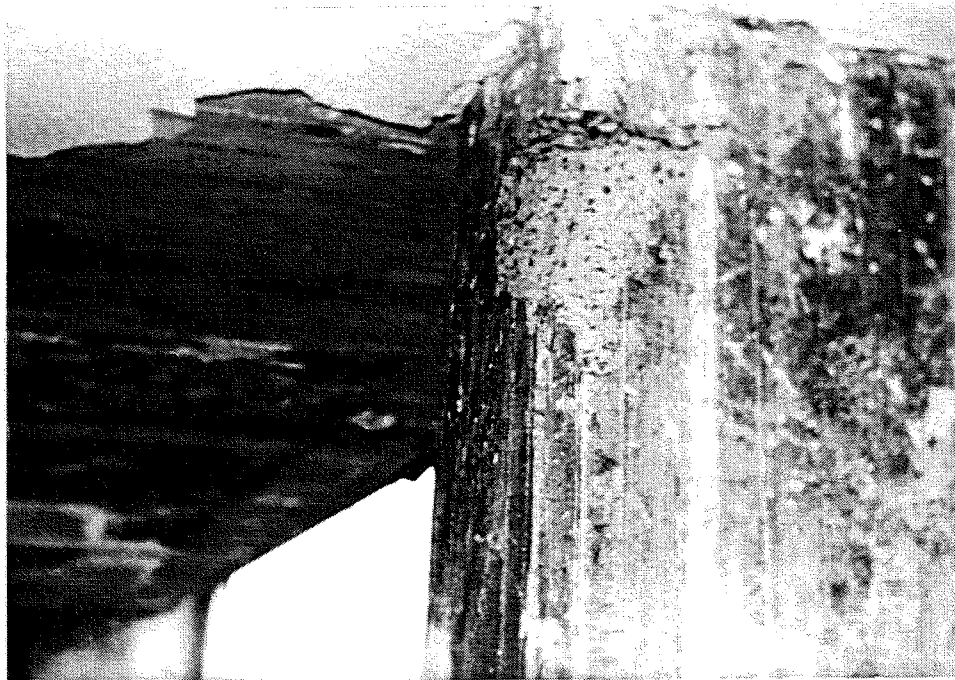
Figure 5- G3 Damage at slab-column joint

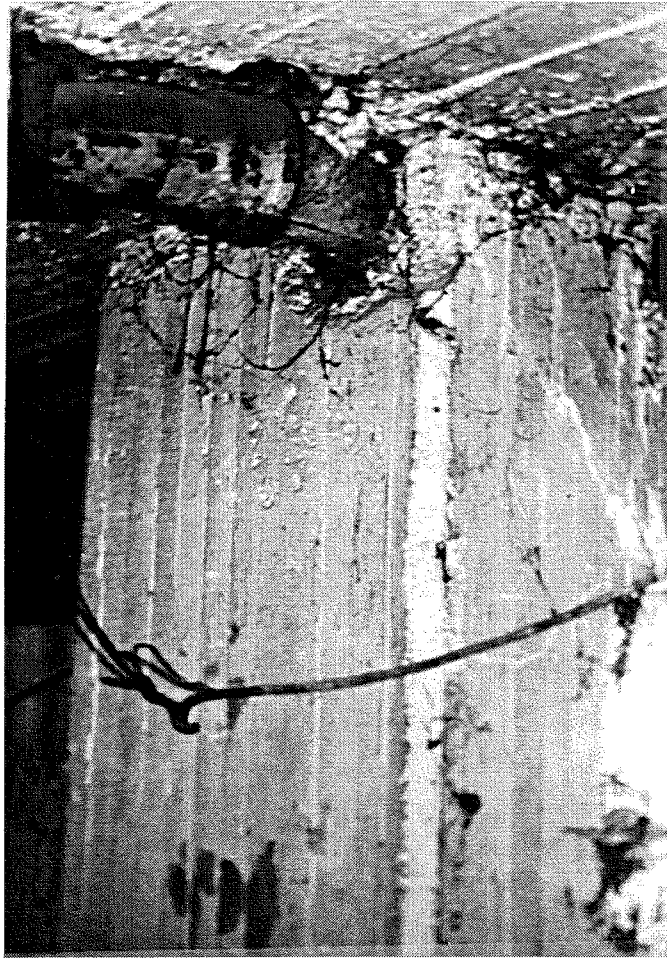
*Figure 5- G4 Cracks in column at sewer pipe location*

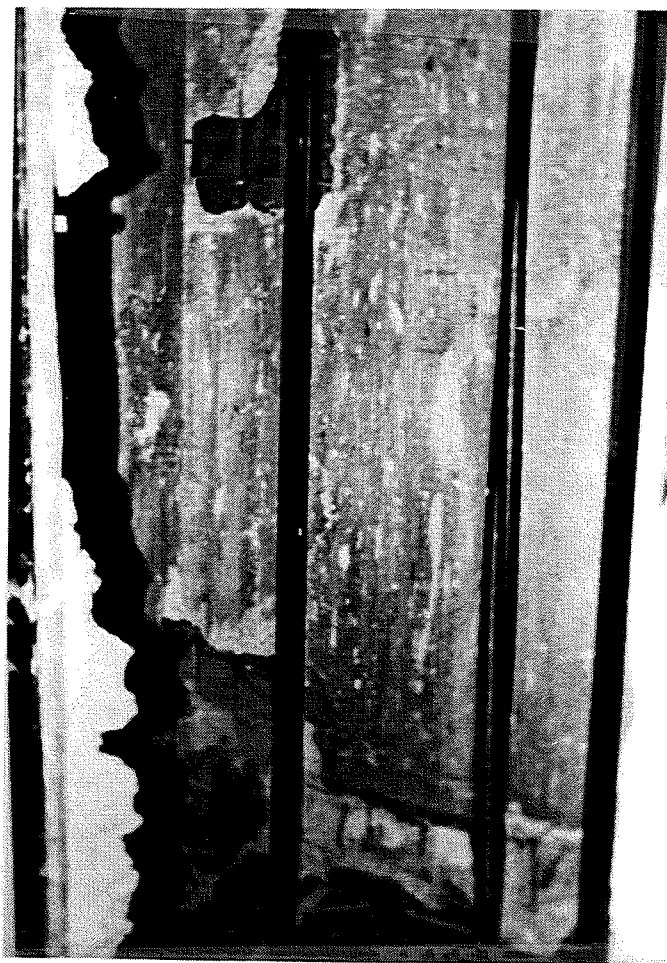
*Figure 5- G5 Exposed reinforcement in concrete wall*

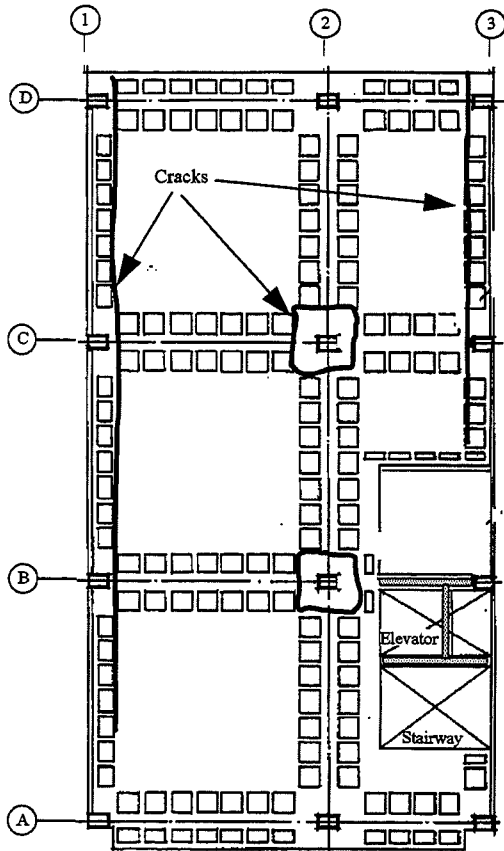
Figure 5-6 Crack pattern in waffle slab

The waffle slab was repaired with epoxy injection. The cracks were injected with resins by placing tubes along the cracks and injecting the resins, as shown in Figures 5.G12 and 5.G13.

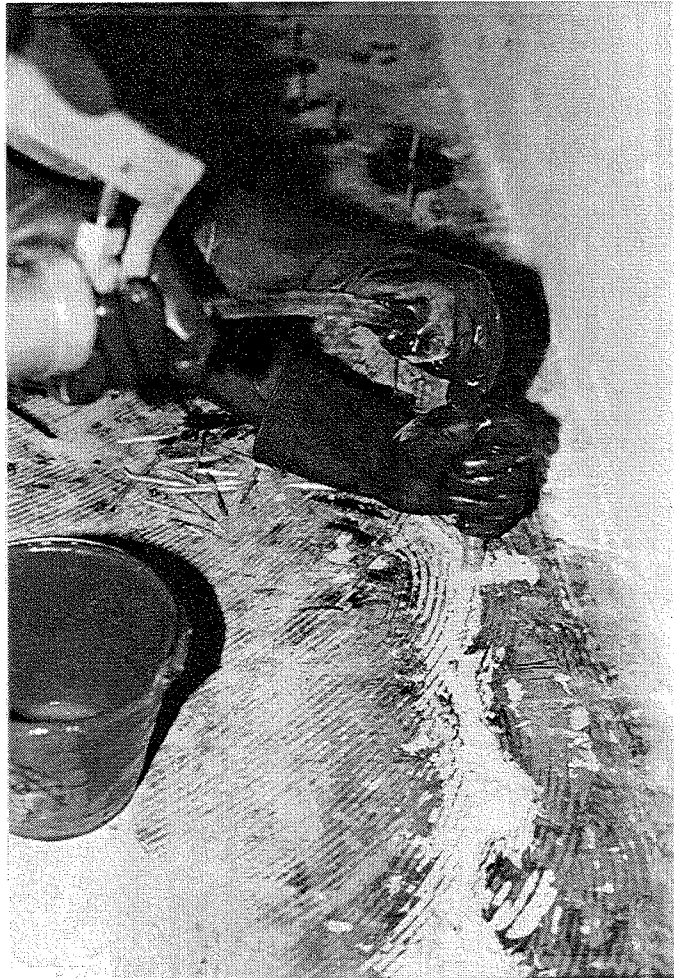
*Figure 5- G12 Epoxy injection in waffle slab cracks*

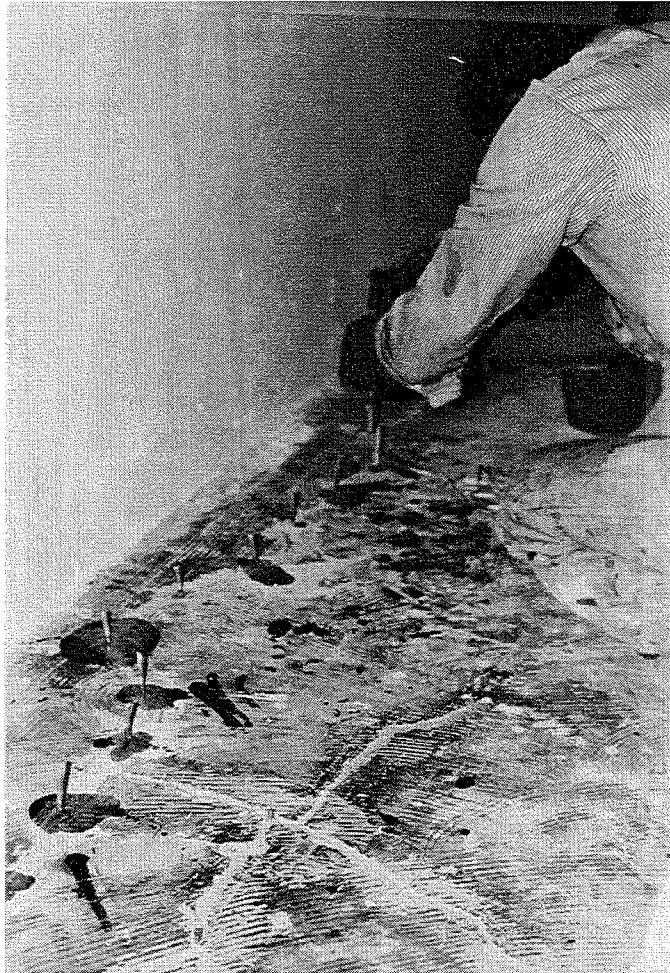
*Figure 5- G13 Injections in waffle slab cracks*

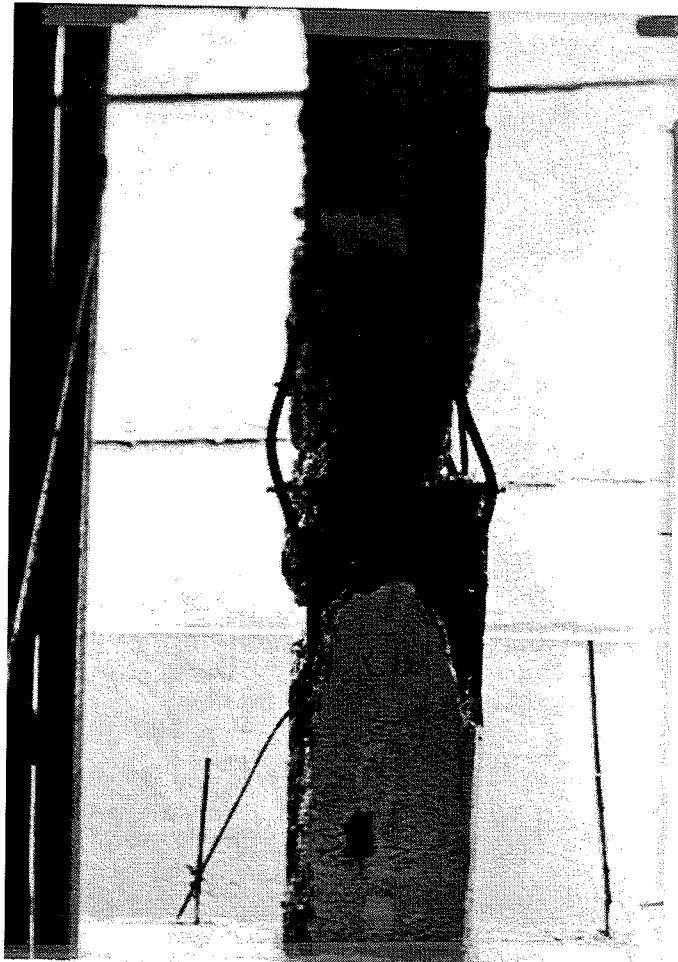
*Figure 5- H3* Damage in column D-3

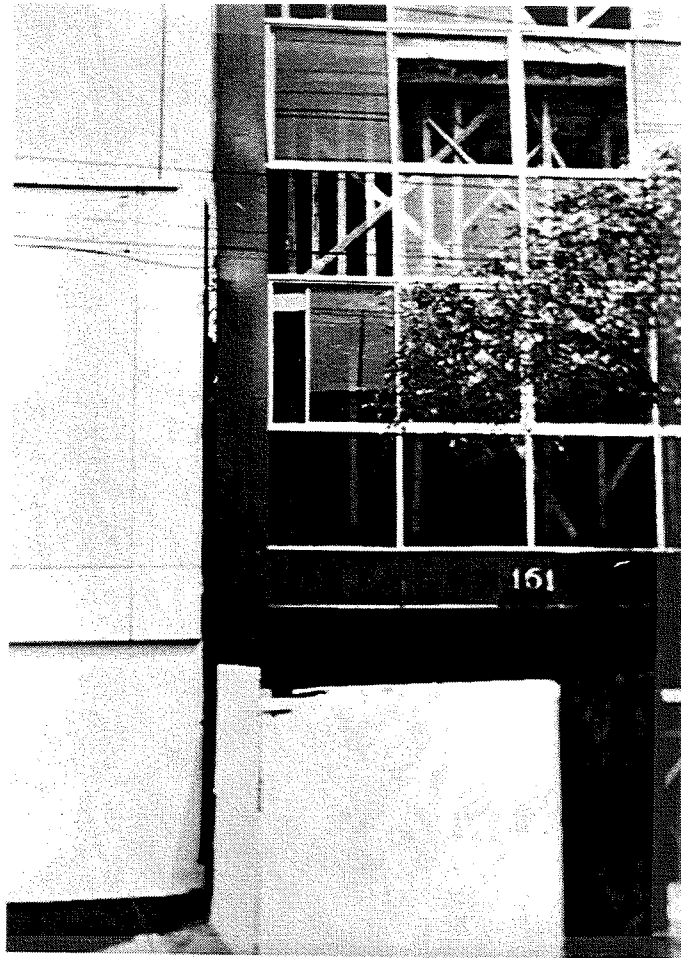
*Figure 5- H4 Pounding with adjacent building*

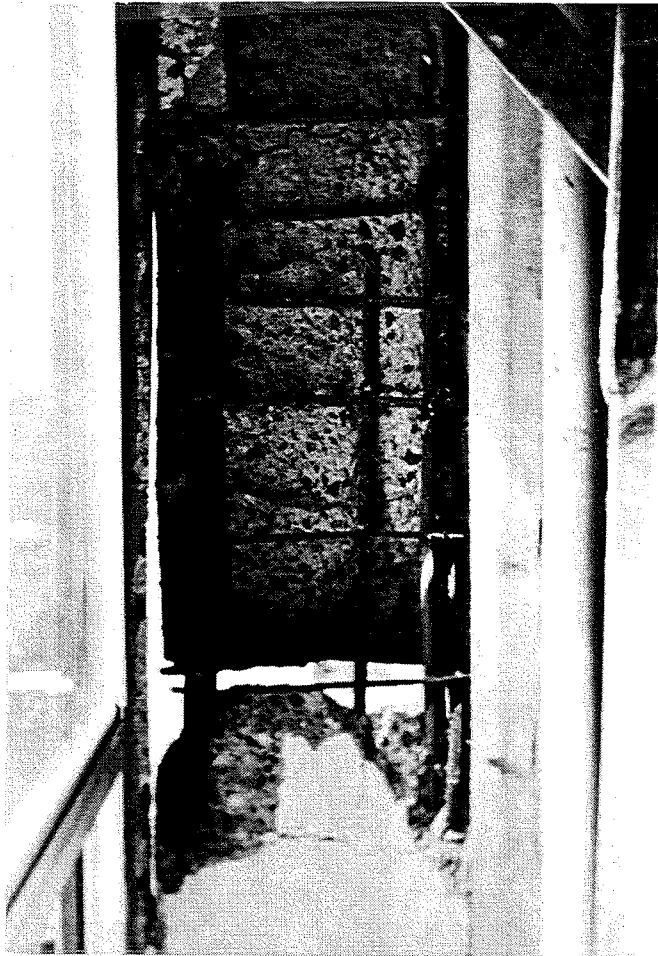
*Figure 5- H5 Damage in column A-1 due to pounding with adjacent building*

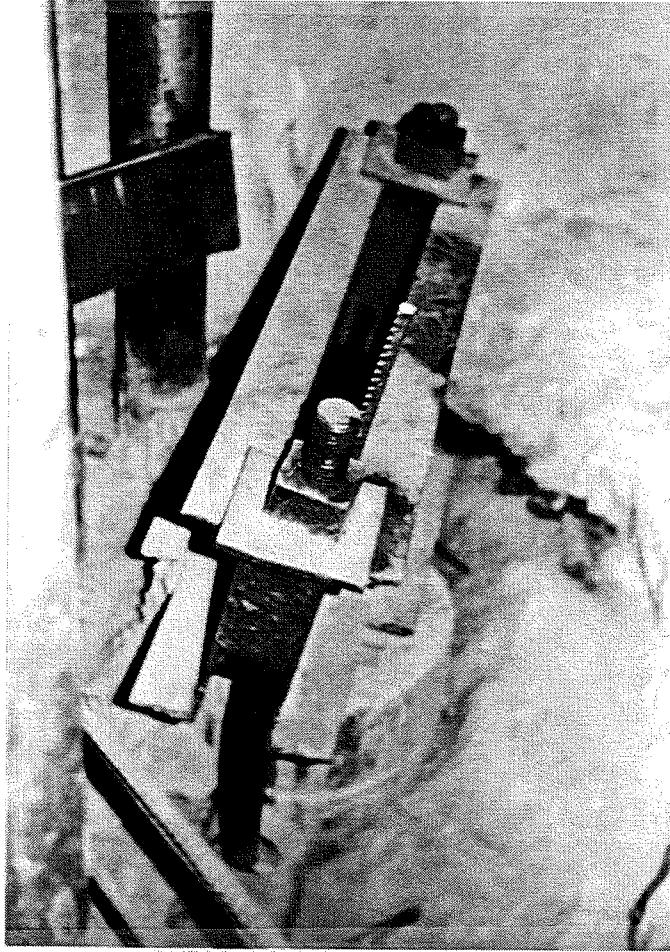
*Figure 5-14 Damaged anchor rods in control pile caps*
