**Effects of Wrapping Chloride Contaminated Concrete with Fiber
Reinforced Plastics**

Emily Wason Berver, B.S.C.E.

Thesis

The University of Texas at Austin

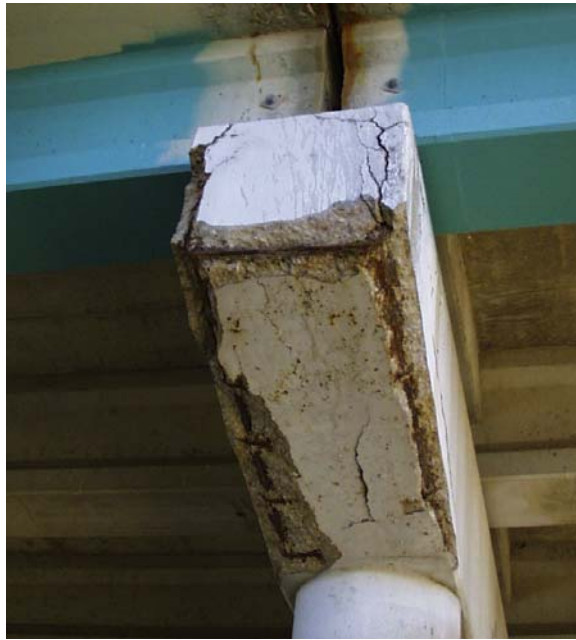
Figure 1.1 Corrosion damage to a bridge bent.

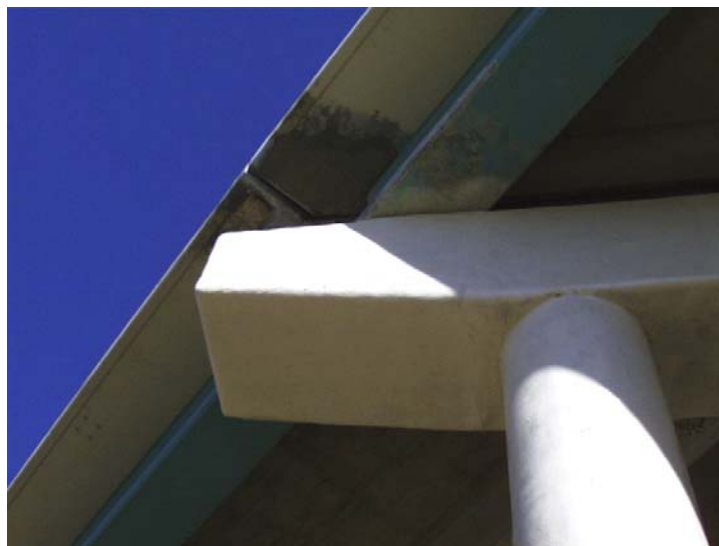
Figure 1.2 Bridge bent and column wrapped with FRP after repair of corrosion damage.

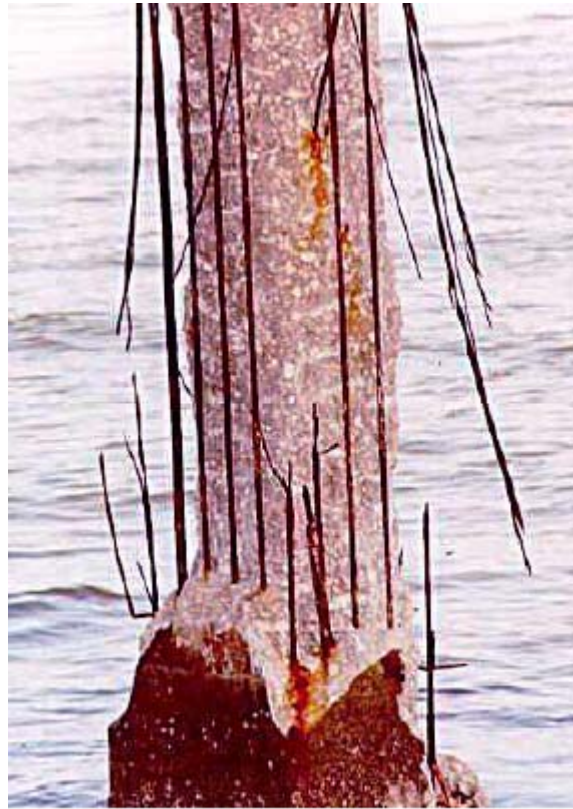
On the Bryant Patton Bridges in Florida, it was found that fiberglass jackets applied to bridge piles in a marine environment had accelerated the corrosion process. Capillary action allowed moisture to rise from the submerged portion of the pile, but the fiberglass jacket prevented the concrete from drying out. The combination of moisture and the high levels of chlorides in the unrepaired portions of the pile resulted in severe damage due to corrosion, as seen in Figure 3.3 (Sohanghpurwala and Scannell 1994).

Figure 3.3 Concrete pile that had previously been repaired with a fiberglass jacket.

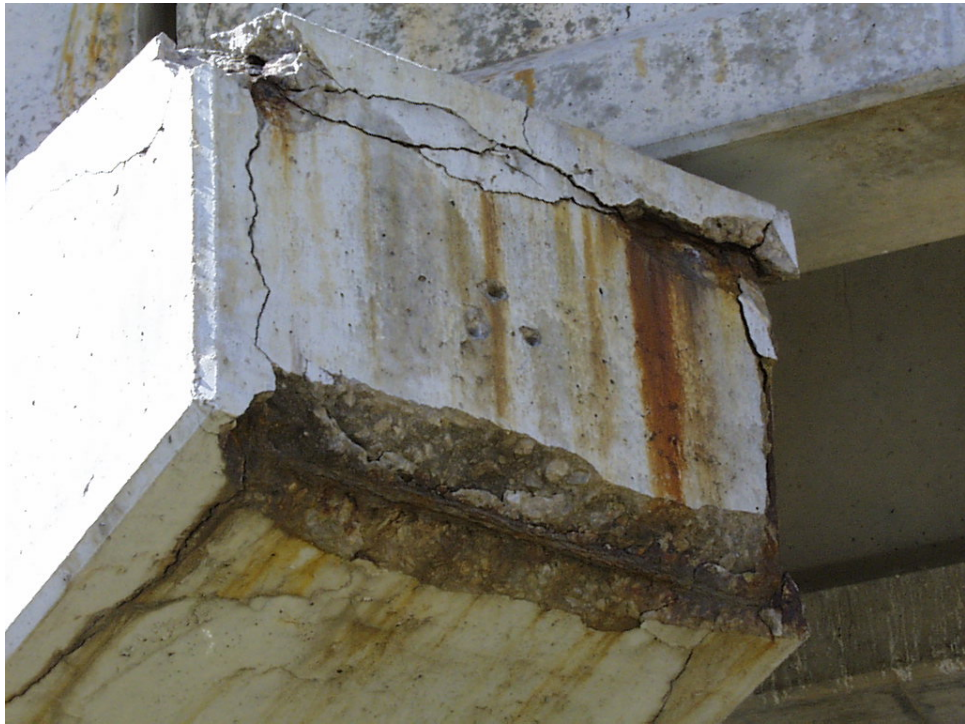
The bridges were experiencing severe damage due to corrosion. The damage consisted of cracking, spalling, and delamination of the concrete cover on the downstream portions of the bents, and also on some of the columns. Figures 5.8 to 5.10 show typical corrosion damage found on the substructure. The damage correlated with the drainage paths for water on the bridge deck. The bents had a slight slope so that water ran to the lower end as shown in Figs. 5.8 and 5.9.

Figure 5.8 Damage to an endcap of Structure #5.

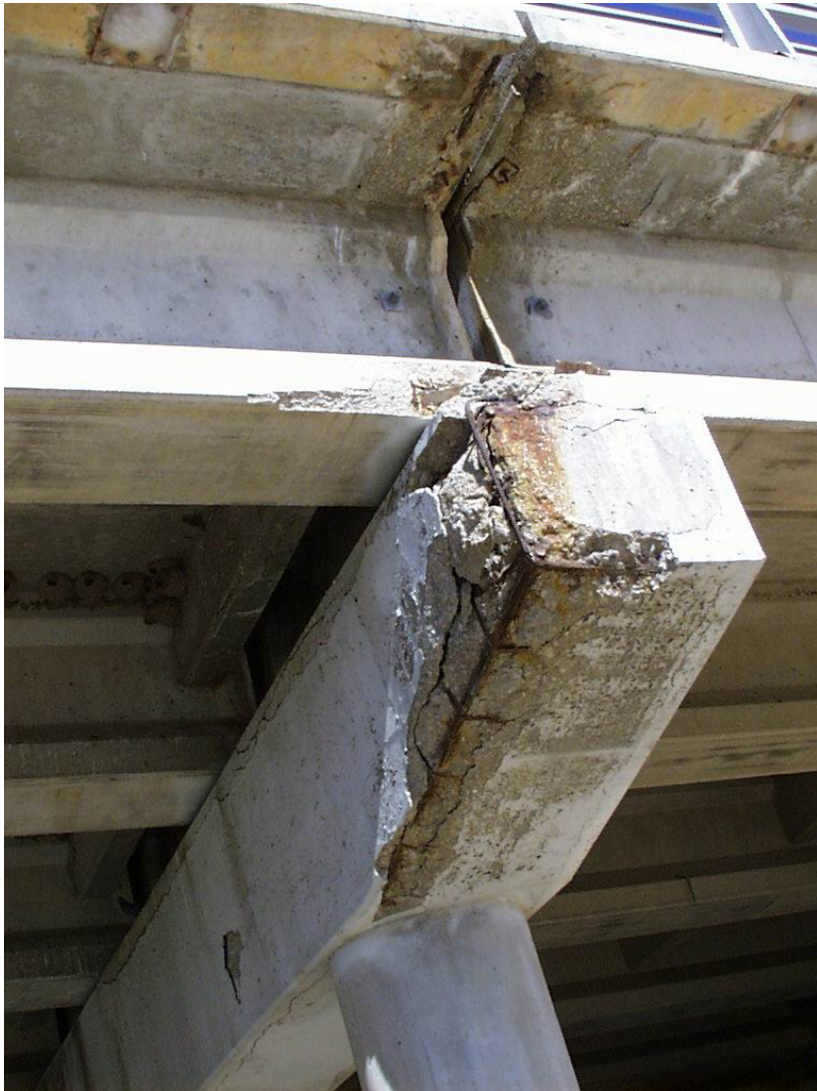
Figure 5.9 Delamination on an endcap of Structure #8.

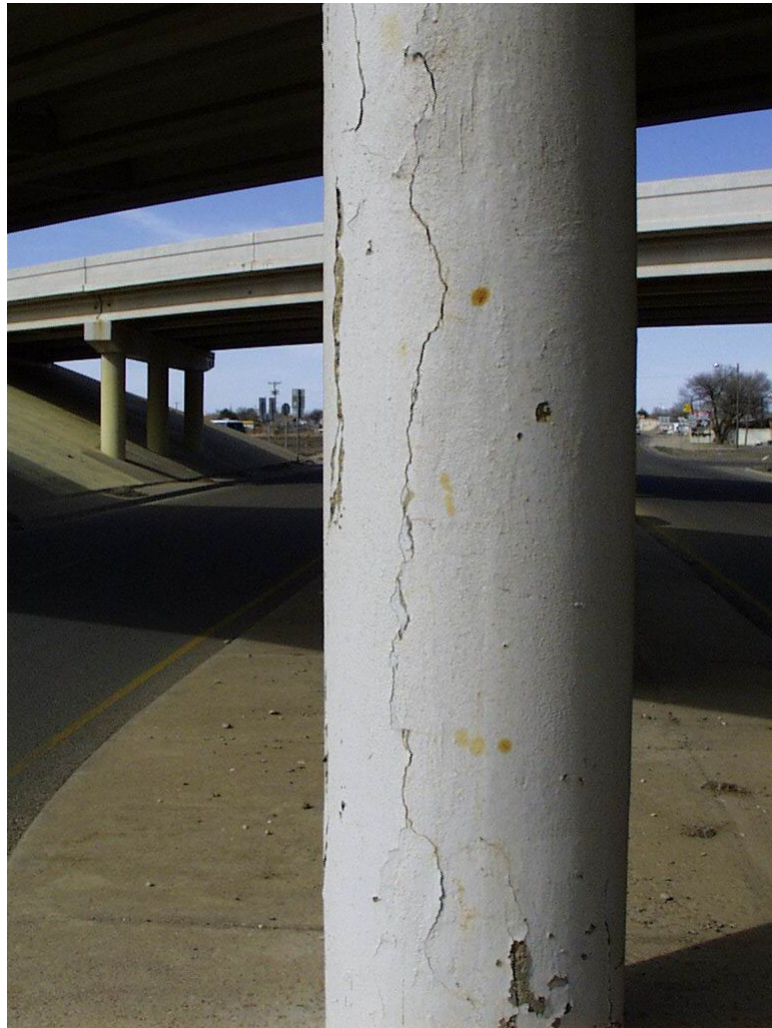
Figure 5.10 Cracking on column of Structure #12.

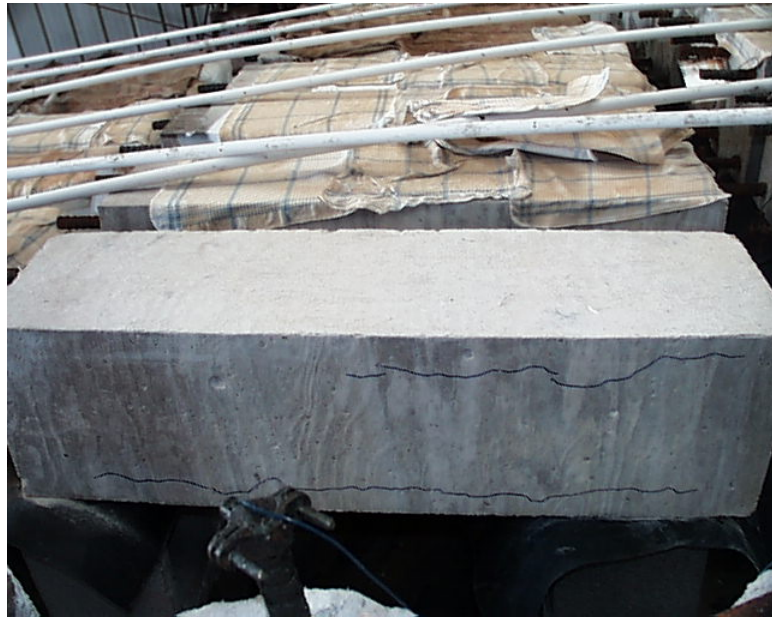
Readings were taken after every four wet/dry cycles for the wrapped specimens during the exposure period. Readings were taken after every cycle for the unwrapped specimens for the first year and a half of monitoring. After eighteen months of exposure, it was well established that corrosion was taking place in the unwrapped specimens. The readings indicated a high probability that corrosion was taking place. In addition, cracks were forming parallel to the reinforcing in specimens that were not cracked prior to exposure, as illustrated in Figure 6.2. After eighteen months of exposure, readings were taken after every four cycles on all of the specimens. Linear polarization testing was performed on the cylinders in Group B in order to compare results with the amount of corrosion activity found in the specimen after it was opened.

Figure 6.2 Longitudinal cracks forming on an uncracked specimen.

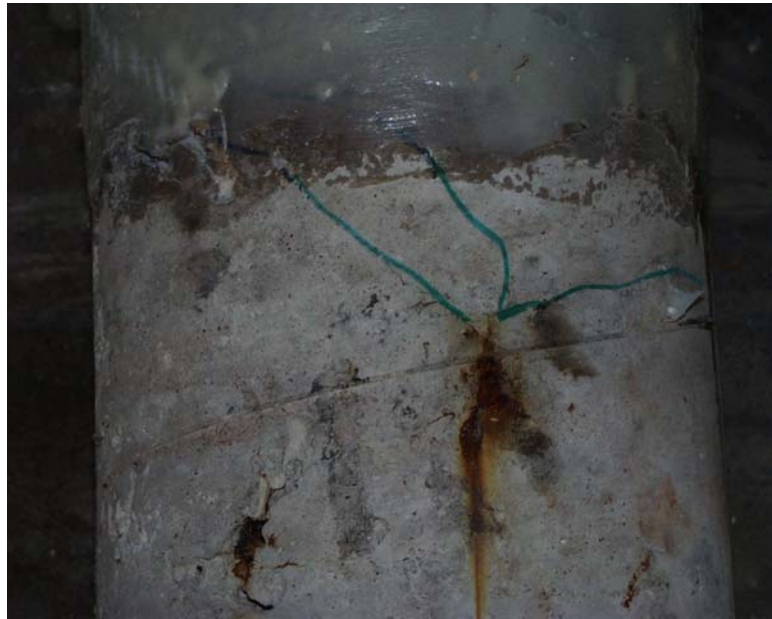
The results from the linear polarization tests indicate that severe corrosion is taking place in most of the specimens. Specimen CC3 was the only specimen to fall into the moderate corrosion rate level. From visual observations of the specimens, there were no outward signs of corrosion activity on the middle portions of CC3 and CNC10. There was minimum cracking on CC3, and CNC10 did not have the cast-in-chlorides. The lower portion of CNC10 showed signs of corrosion activity as seen in Figure 6.10. Rust stains were visible at both locations on specimen CC6, and in the splash zone of CC5.

Figure 6.10 Evidence of corrosion activity in the splash zone of specimen CNC10.

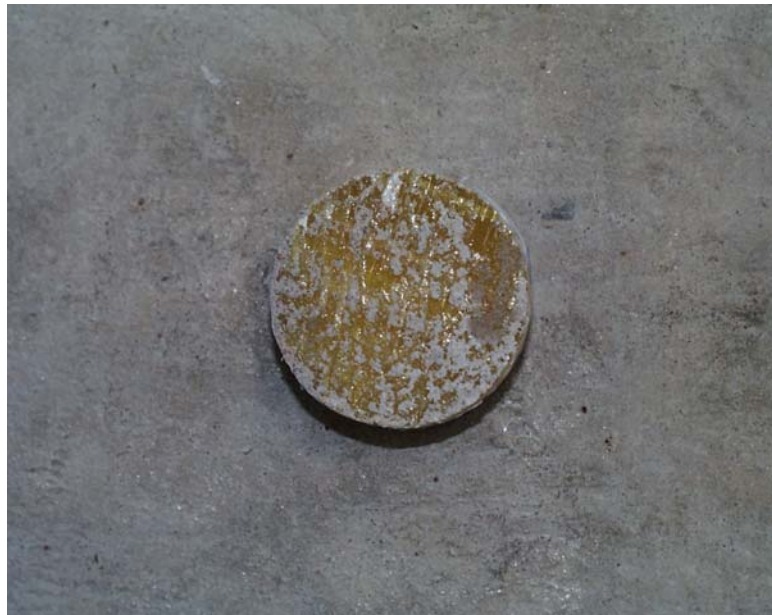
most of the specimen. The top face had the most severe exposure, so it is reasonable that the tensile strength was lower. The upstream end was most likely to have moisture seep under the wrap, which may have resulted in the failure at the epoxy bond in that location. The differences in failure strength are also possibility due to the fact that concrete is not an isotropic material. In addition, the low failure strength in the substrate during test #1 may have also been caused by cracks in the specimens. The difference in values of failure stress does indicate that there is some variation in the adhesion of the FRP wrap to the concrete surface.

Figure 6.12 Failure at the epoxy/concrete interface on Test #2.

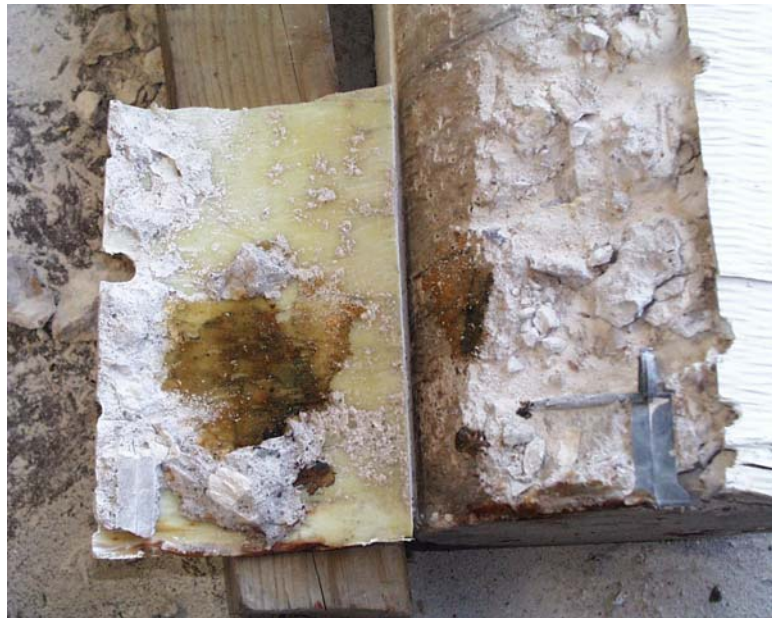
Corrosion activity appeared less severe on the specimens that were treated with the Sika™ Ferrogard 903. Corrosion activity in specimen CNC19, which was not treated with the corrosion inhibitor, was found on the stirrups throughout the splash zone even though the specimen was not cracked prior to exposure. Corrosion activity in specimens CNC13 and CNC14, which were treated with the corrosion inhibitor, was near the crack locations. Very little corrosion activity was found in the uncracked portions of CNC13.

Figure 6.13 Moisture trapped beneath the surface in the splash zone of specimen CNC14.

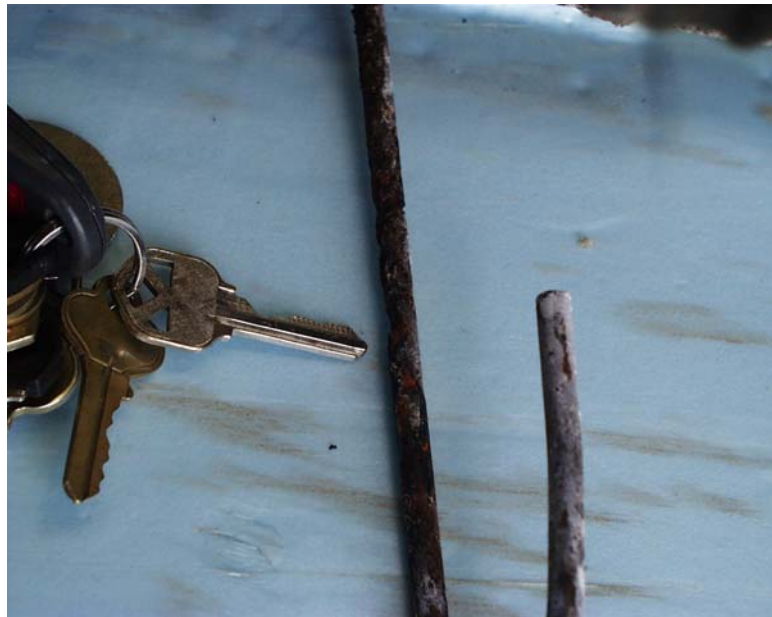
Moisture was found trapped beneath the wrap for two of the fully wrapped specimens, CC6 and RNC6. No moisture was found in specimen CC5, even though it was fully wrapped. Corrosion activity near the location of trapped moisture was greater than in other areas of the specimen. Specimen RNC6 experienced section loss in the stirrup due to the trapped moisture as shown in Figure 6.14.

Figure 6.14 Section loss on the upstream stirrup of specimen RNC6.

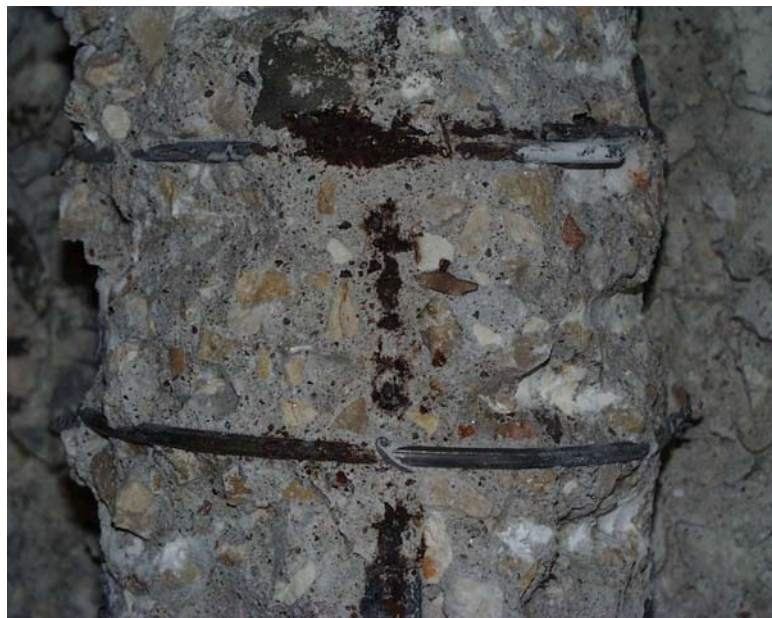
zone in encapsulated concrete. Figure 6.15 shows the corrosion activity found in the top portion of specimen CC5. A macrocell also formed between the uncontaminated concrete and the repair material in RNC6, but the corrosion activity was not as extensive. This was most likely due to fact that the existing concrete did not contain chlorides.

Figure 6.15 Macrocell formation in the top portion of specimen CC5.

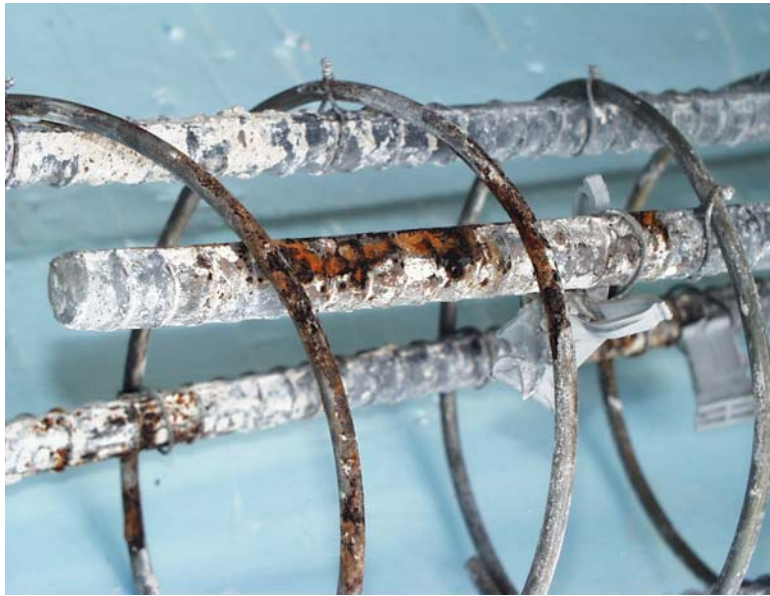
Figure 6.16 Steel reinforcing of CNC10 with a corrosion rate of 3.86 mpy.

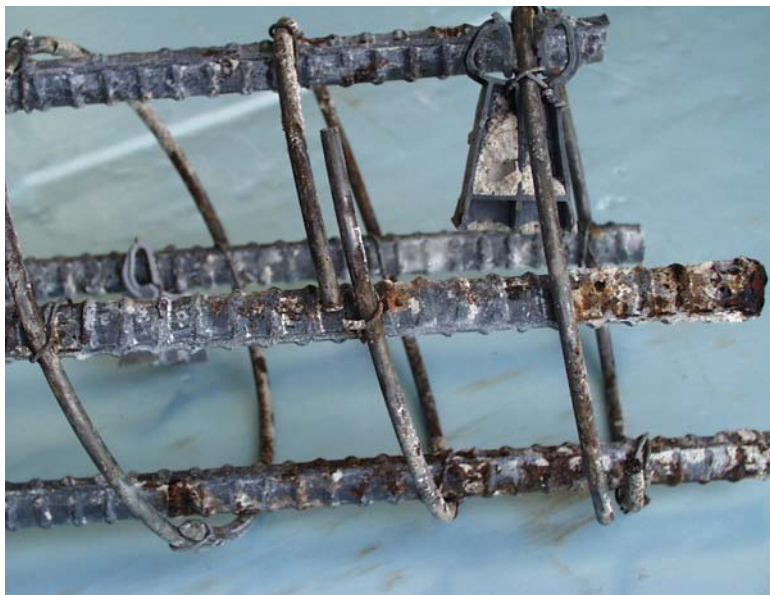
Figure 6.17 Steel reinforcing of CC6 with a corrosion rate of 1.41 mpy.

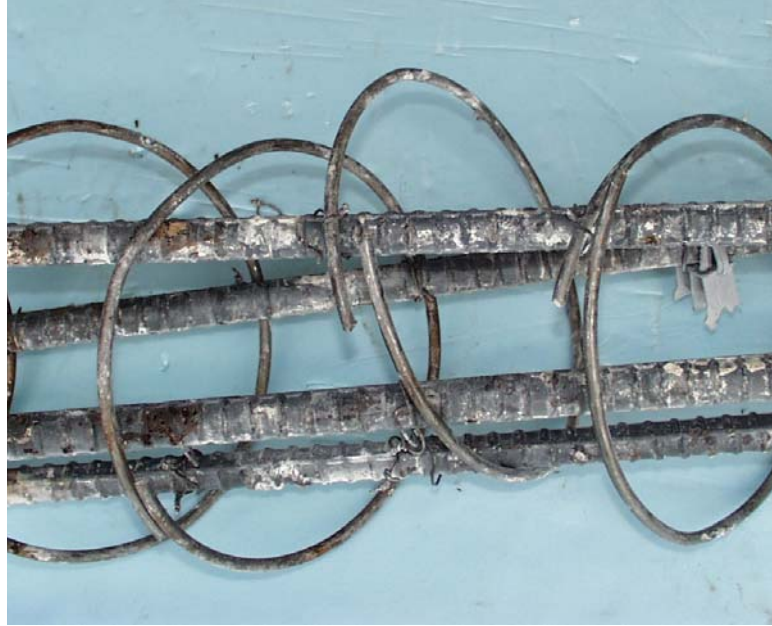
Figure 6.18 Steel reinforcing of CC3 with a corrosion rate of 0.34 mpy.

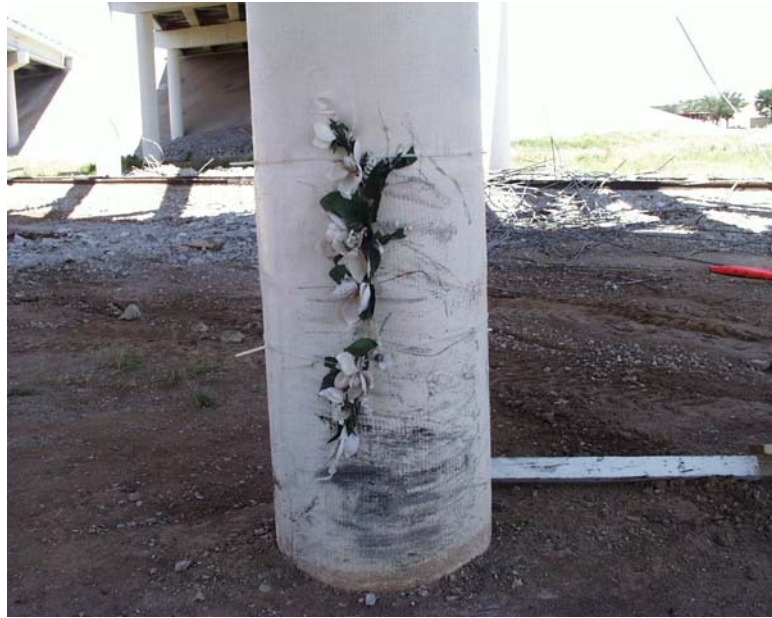
Figure 7.7 Vehicular collision damage on column of Structure #2.

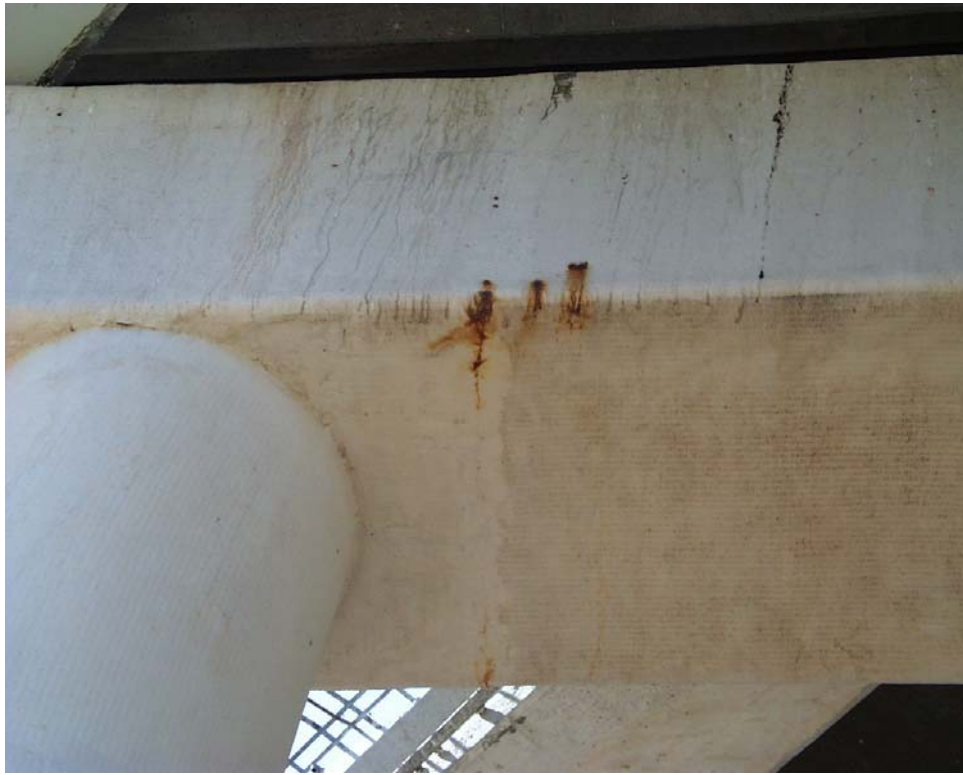
Figure 5.8 Rust stains on bent of Structure #1.
