**EVALUATION OF LONGITUDINAL CRACKING  
IN END REGIONS OF PRETENSIONED BOX BEAMS**

**Craig Morgan Chamberlain, B.S.C.E.**

**THESIS**

The University of Texas at Austin

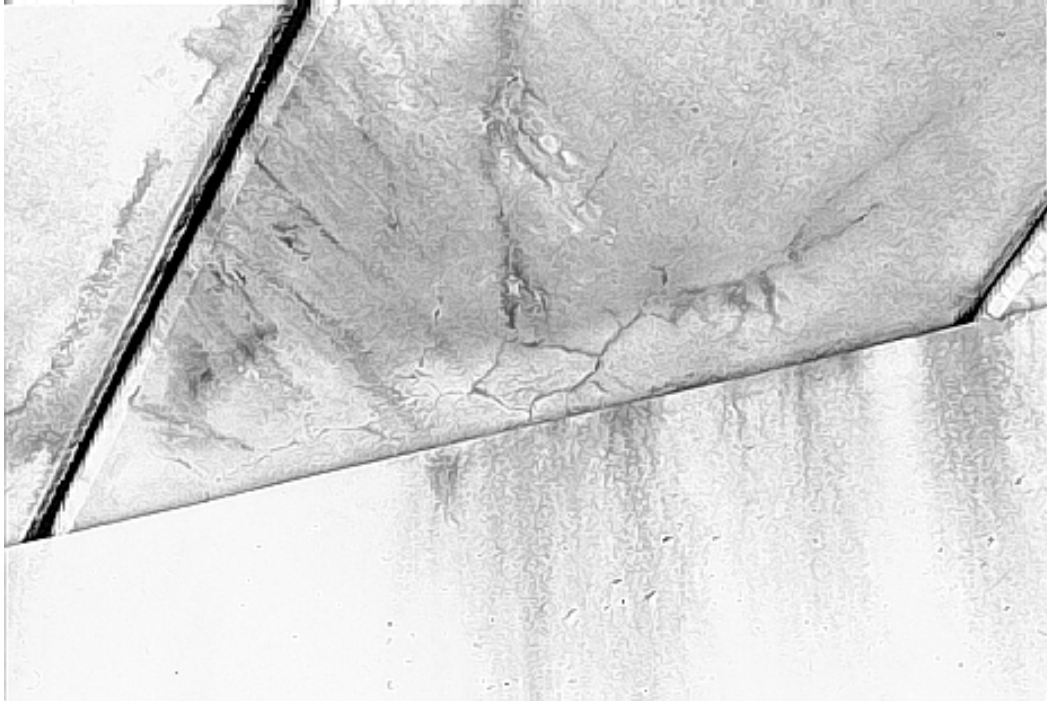
A prime example is the Hicks Road Overpass along U.S. Highway 287 in Tarrant County near Fort Worth, Texas. Constructed in 1976 with roadways to supplement the existing vehicular capacity, the overpass recently came under close scrutiny by Texas Department of Transportation (TxDOT) officials because of unusual cracking patterns in the bottom flange near the supports of many beams in the superstructure. The orientation and propagation of cracks in the bottom flange has perplexed officials. Cracks propagated along the bottom flange in a diagonal fashion, flaring from the central portion of the bottom flange near the support toward the webs of the box girder. Figure 1.1 shows an example of the observed cracking.

Figure 1.1: Cracking in bottom flange of box girder near support

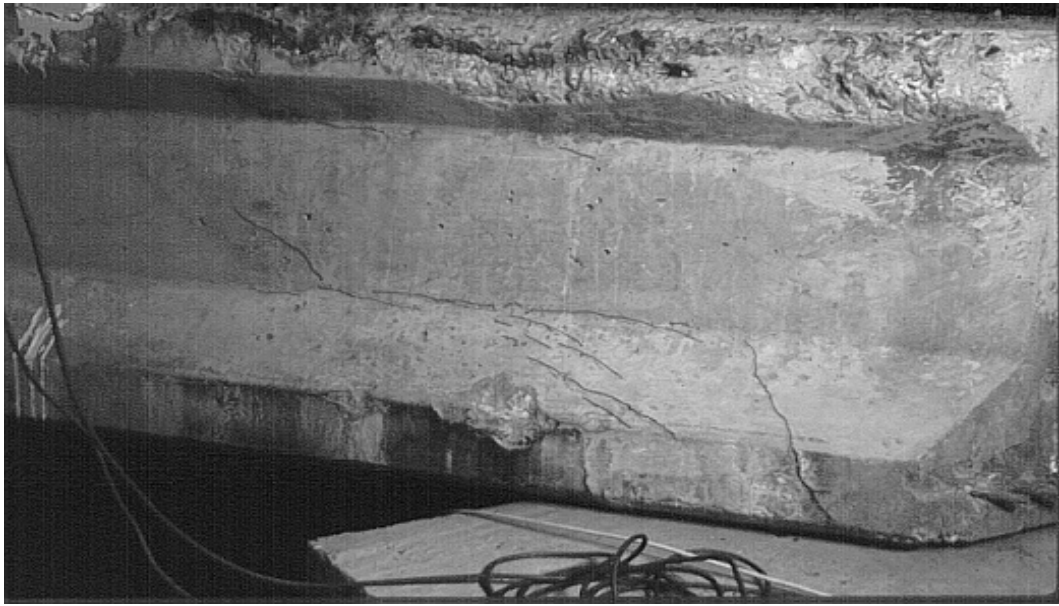
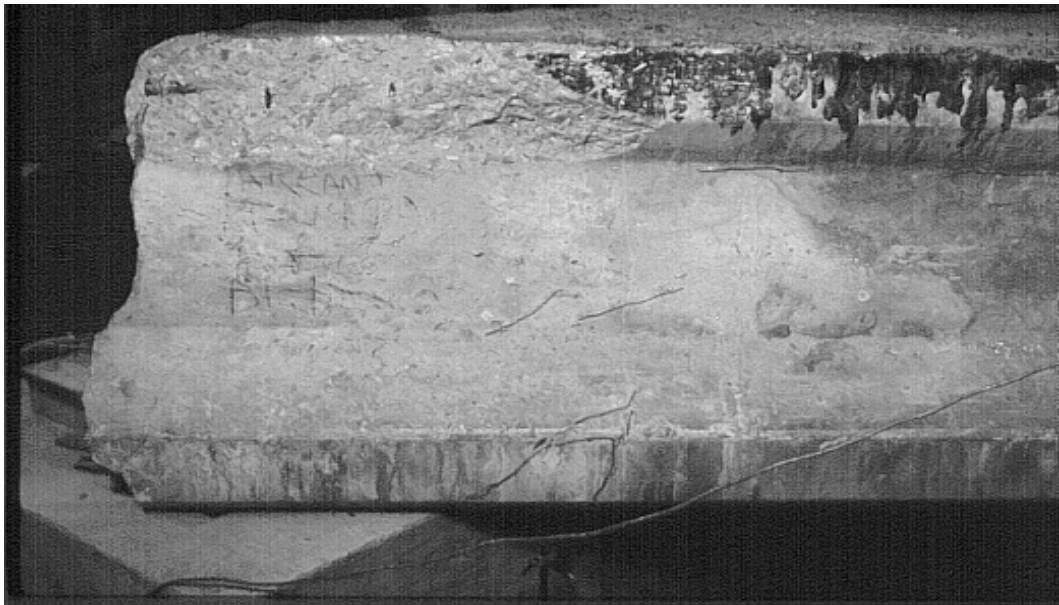
Prior to testing, existing cracks were marked on the box beam with a red felt-tip marker. Figures 3.4 and 3.5 show this cracking in the web and bottom flange on both sides of the beam. These figures also display some of the existing damage to the girder prior to testing.

Figure 3.4: Pretest Cracking of West Face of Box Beam 3 - Test 1

Figure 3.5: Pretest Cracking of East Face of Box Beam 3 - Test 1

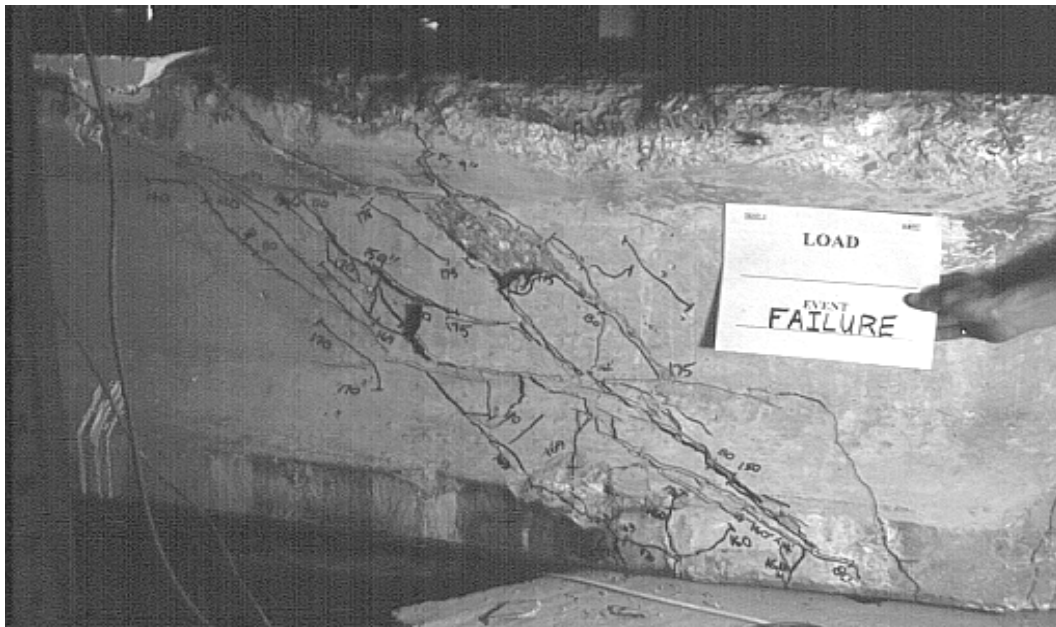
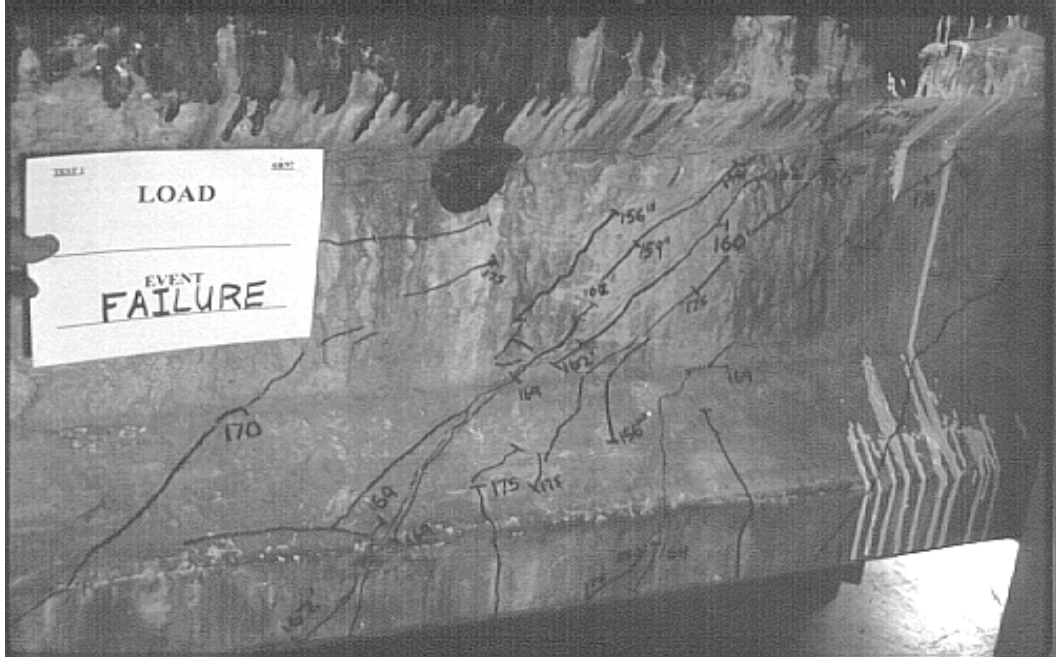
Upon loading of the girder, cracks began forming in the West web first. It should be noted that web shear cracks opened at loads substantially lower (80 to 90 kip level) than computed cracking loads, suggesting that the cracks already existed and were opened by the applied loads. After substantial web-shear cracking in this web, the East web began to experience web-shear cracks as well. All web-shear cracks originated in the hollow, box section before propagating into the solid end diaphragm. Figures 3.6 and 3.7 illustrate the cracking and spalling in each web at failure. Note the well-defined “band” of cracks from the spreader-beam to the support on the West side of the beam. The maximum crack width in this web at failure was approximately  $\frac{1}{4}$  inch.

Figure 3.6: Cracking and Spalling at Failure on West Face of Box Beam 3

Figure 3.7: Cracking and Spalling at Failure on East Face of Box Beam 3

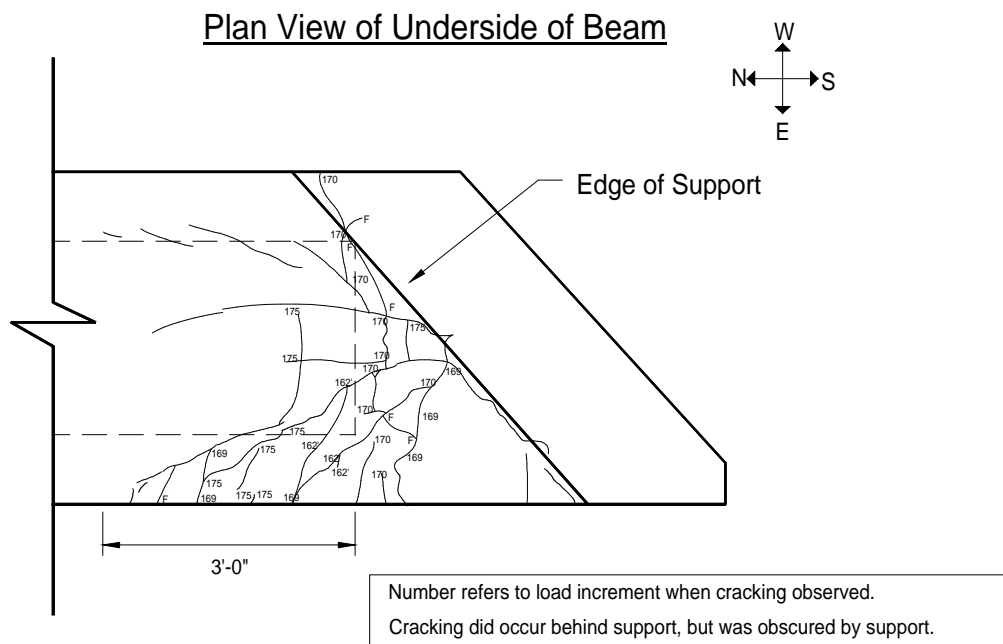
Cracking of the underside of the box beam is mapped in Figure 3.8. Some of these cracks did not originate during the testing; they existed before testing. Only one crack at the 169 kip load level appeared to propagate from an existing crack and flare out toward the edge of the beam as previously observed in many of the box beams. The remaining cracks were caused by slip of the pretensioned strands, and propagation of the shear-flexure cracks on the East side of the girder. Cracks in this region were also observed to widen as testing proceeded, with the existing crack on the East underside reaching 0.1 inch.

Figure 3.8: Crack Map of Beam Bottom Flange - Test 1

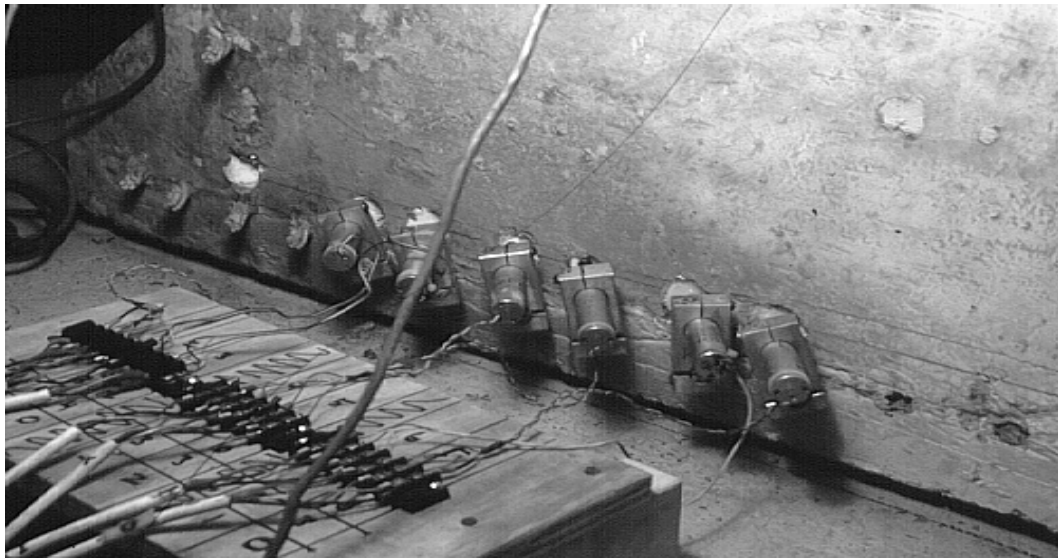
increased as the test progressed and reached 0.015 inches for Strand #4 at the final load step of 230.5 kips. As described earlier, testing was discontinued here when the specimen failed. Large slips were recorded for most of the strands when failure occurred. The linear potentiometer on Strand #1 fell off at failure because of the severe slip experienced by the strand. Figure 3.10 shows a photograph of the twisting of the strands and gages during slip at failure of Strands #1-7. The maximum slip recorded by the linear potentiometer was 0.44 inches for Strand #2, but the slip on Strand #1 (where the gage fell off the strand) likely exceeded this value. Figure 3.11 displays the maximum slip for each monitored strand.

Figure 3.10: Rotation of Strand Slip Gages at Failure of Box Beam 5 - Test 2

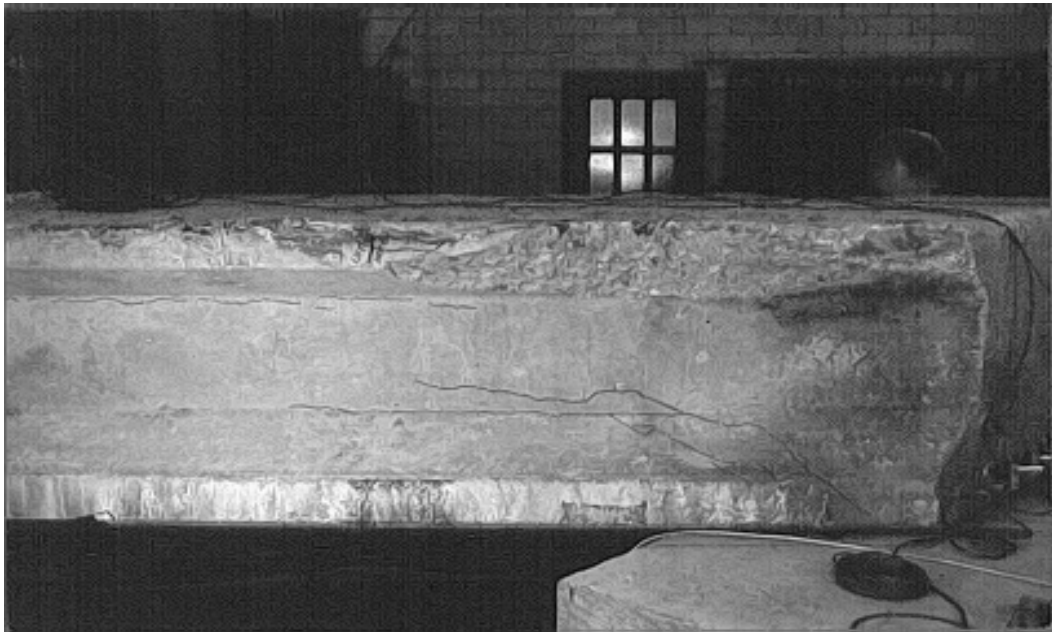
Test 2 developed web-shear cracks, flexure-shear cracks, flexural cracking, and splitting cracks on the underside of the beam. All cracks noted prior to any loading were again marked with a red felt-tip pen, and pretest cracks for the West face are illustrated in Figure 3.12. Pretest cracks were not visible on the East face of the girder.

Figure 3.12: Pretest Cracking of West Face of Box Beam 5 - Test 2

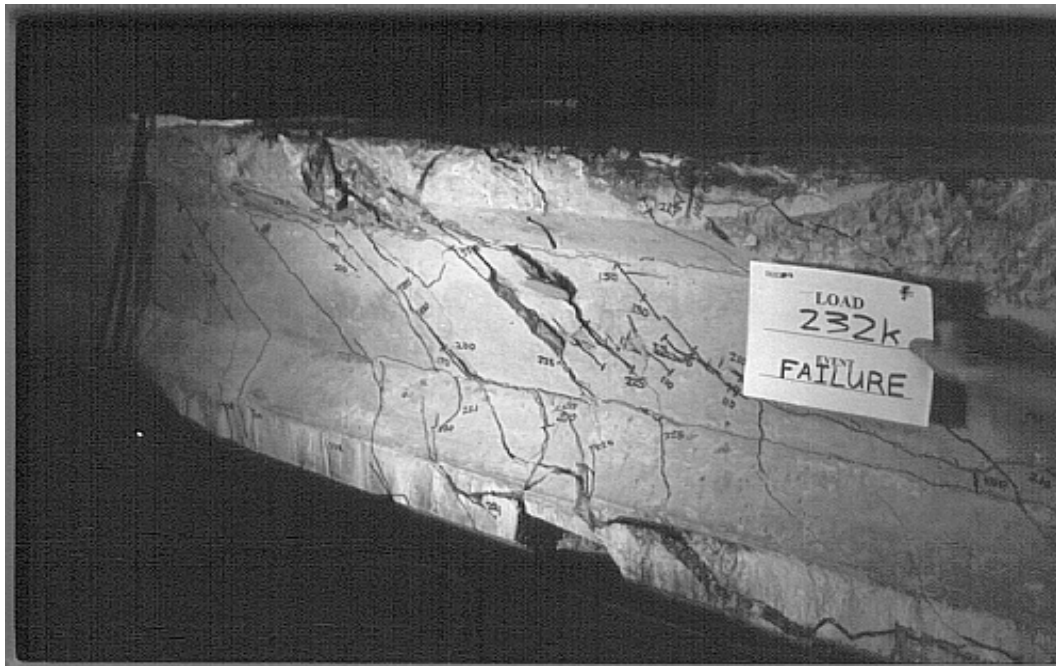
Web-shear cracks were first visible on the specimen on the West side of the beam, and at 120 kips an existing crack began to widen and propagate. The original width of this crack was approximately three thousandths of an inch, but faulting became apparent at 180 kips. Just before failure the crack width had reached nearly six hundredths of an inch. From this first crack, a well-distributed “mesh” of web-shear cracks formed during the test. At failure (232 kips) crushing formed in the region of the web-shear cracking. Figure 3.13 shows a photograph of the West side of the beam at failure where concrete crushing in the web and flanges was prevalent.

Figure 3.13: Concrete Crushing on the West Face at Failure of Box Beam 5

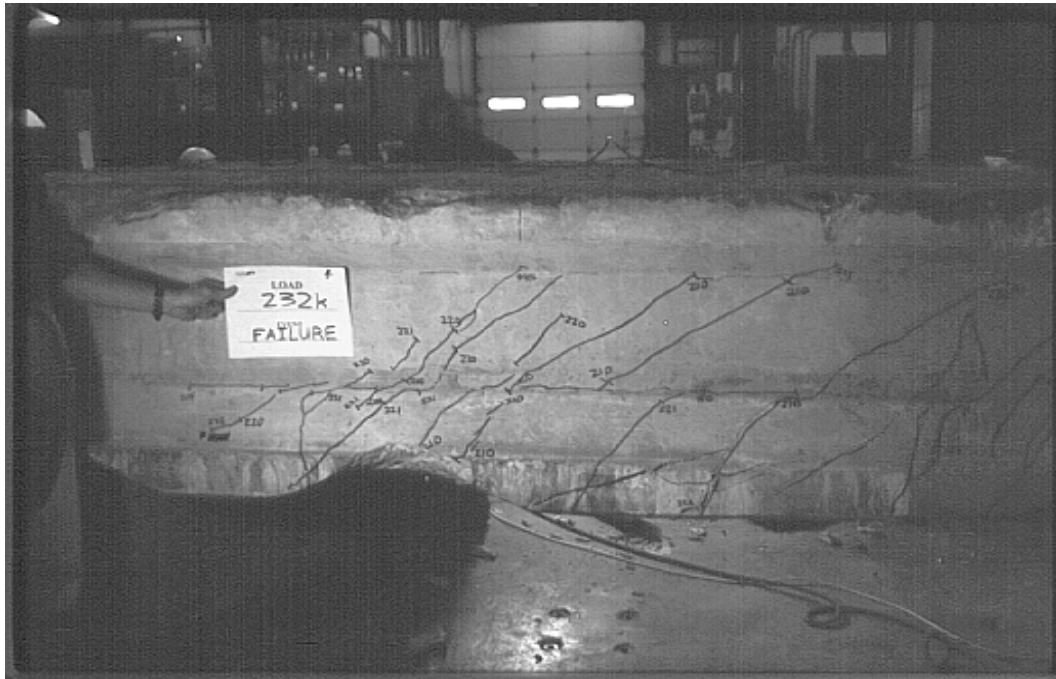
Flexure-shear cracks were also visible during this test. Many of these cracks propagated from flexural cracks that developed in the bottom flange. This cracking was visible on both sides of the beam at 200 and 210 kips. The cracks propagated from the region of web-shear cracking to the closest point of load application. Figure 3.14 shows a photograph of the East side of the beam at failure where flexure-shear cracking was prevalent.

Figure 3.14: Cracking Pattern at Failure on East Face of Box Beam 5

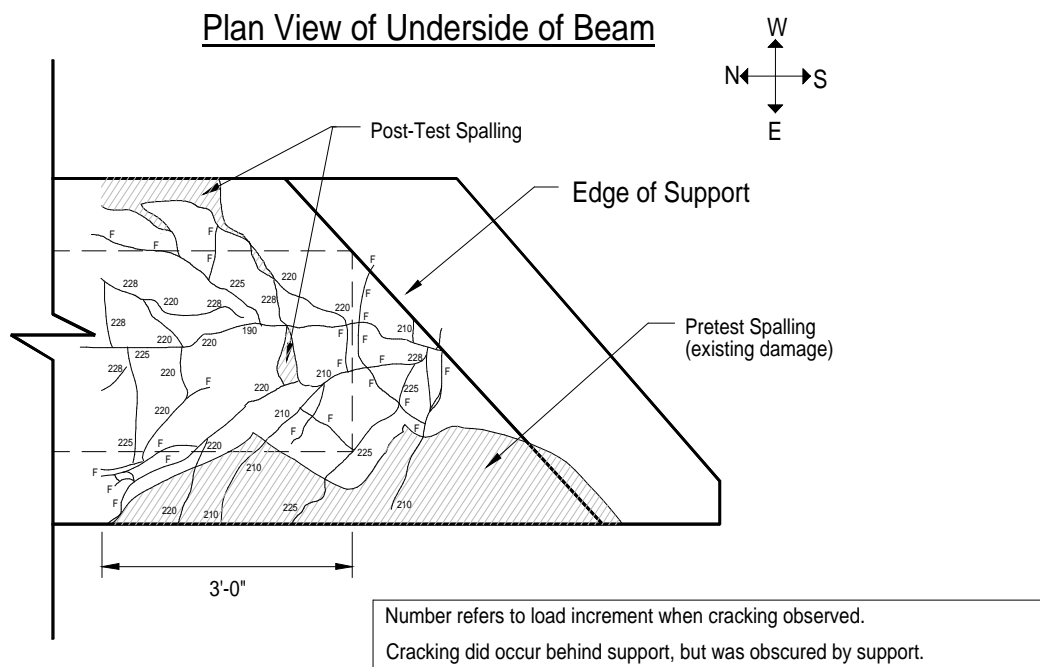
Figure 3.15 shows a crack map of the underside of the beam. Unlike Test 1, these cracks were observed to propagate during loading. Multiple diagonal, flaring cracks, as well as extensions of existing cracks were evident. The first, new cracks appeared at the 210 kip load level and were observed to extend at each load step beyond this. Faulting and spalling of concrete occurred in this region. The three other types of cracking mentioned in this section joined with these cracks on the underside of the girder.

Figure 3.15: Crack Map of Beam Bottom Flange - Test 2

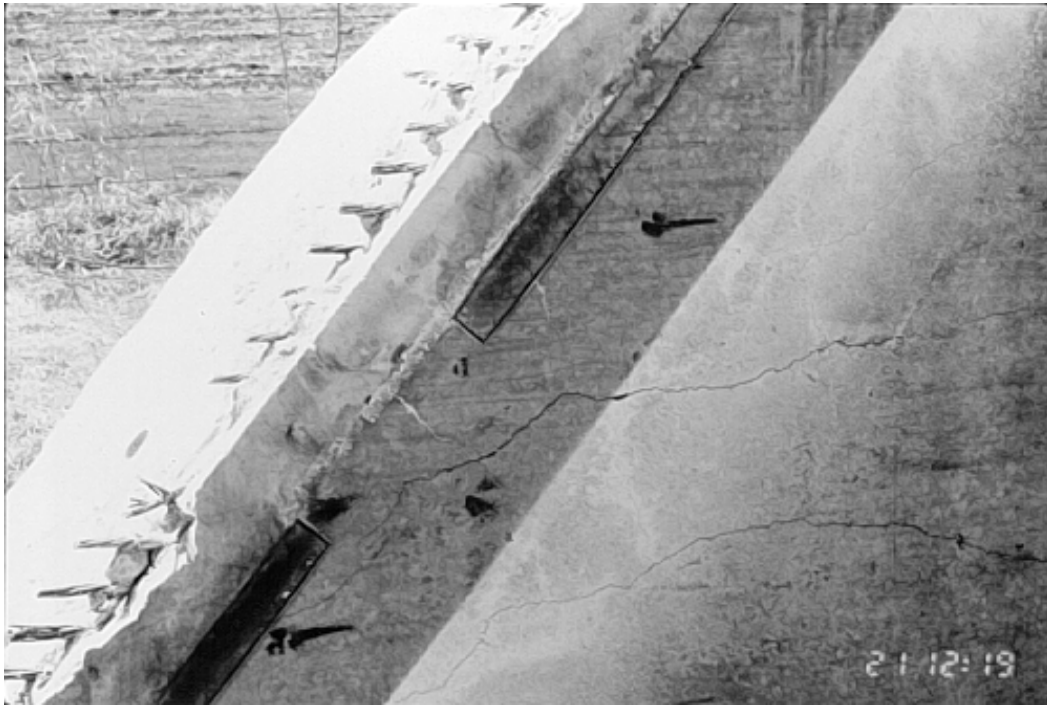
On August 13, 1996, M. Sansalone, R. Poston, and K. Kesner performed Impact-Echo testing [3] on the end regions of an 85-foot box girder that was also removed from the Hicks Road Overpass but stored in a TxDOT maintenance yard in South Austin. The bottom flange of the girder contained some of the most extensive cracking observed in any of the girders (see Figure 3.16).

Figure 3.16: Cracking of 85-foot Box Beam used for Impact-Echo Testing

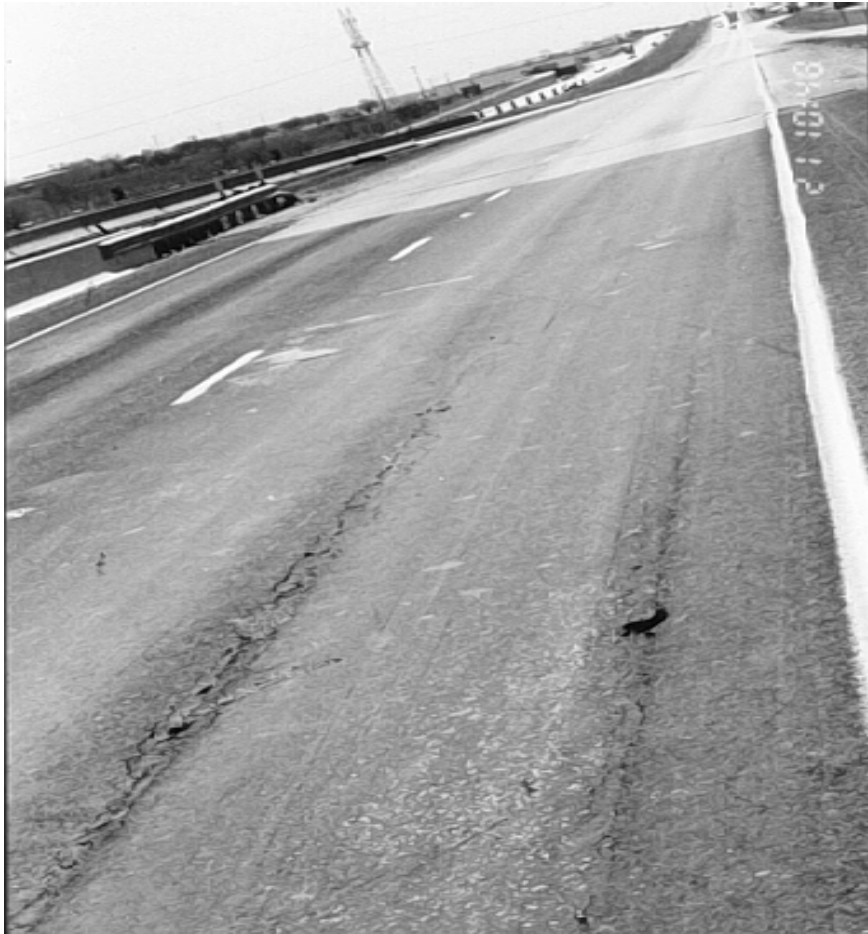
Figure 4.2: Longitudinal Cracks in Wearing Surface of Bridge Deck

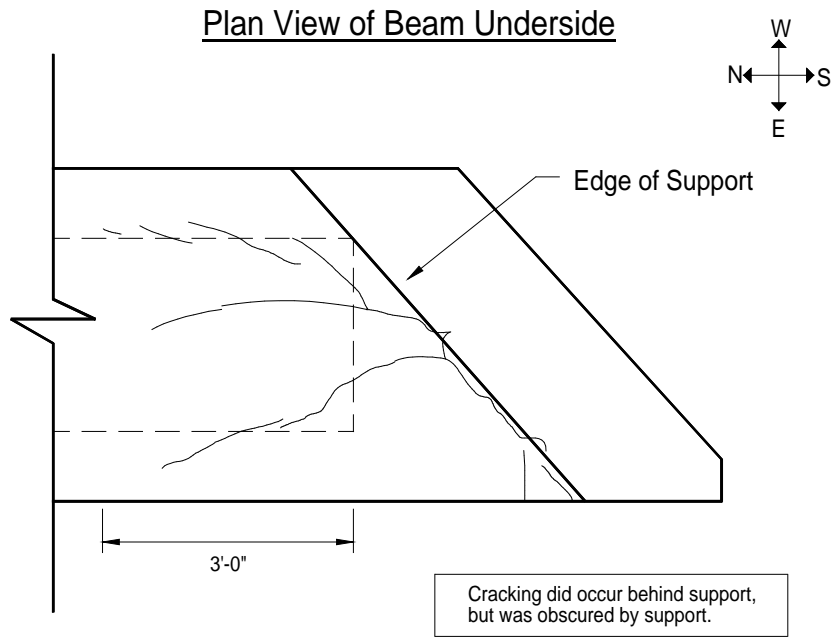
Figure D1: Pretest Cracking in Bottom Flange of Box Beam 3 - Test 1

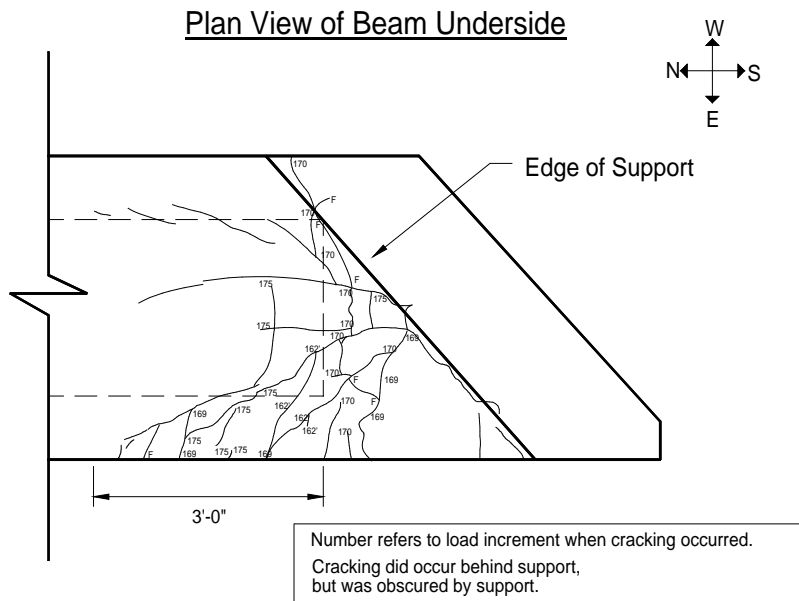
Figure D2: Post-test Cracking in Bottom Flange of Box Beam 3 - Test 1

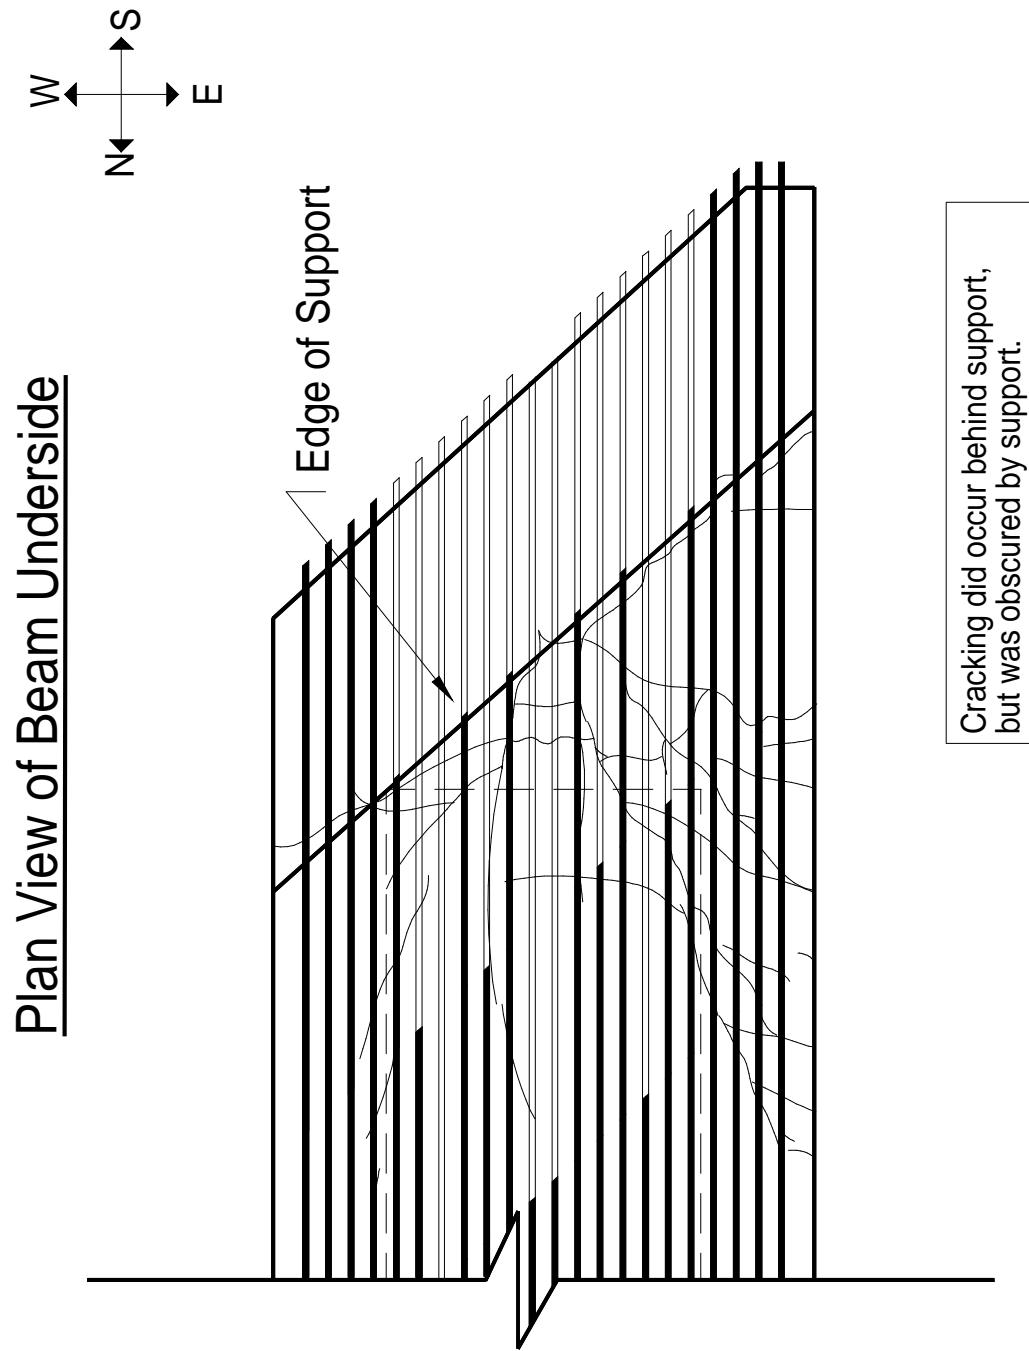
Figure D3: Post-test Cracking on Bottom Flange of Box Beam 3 - Test 1 w/ superimposed pretensioned steel

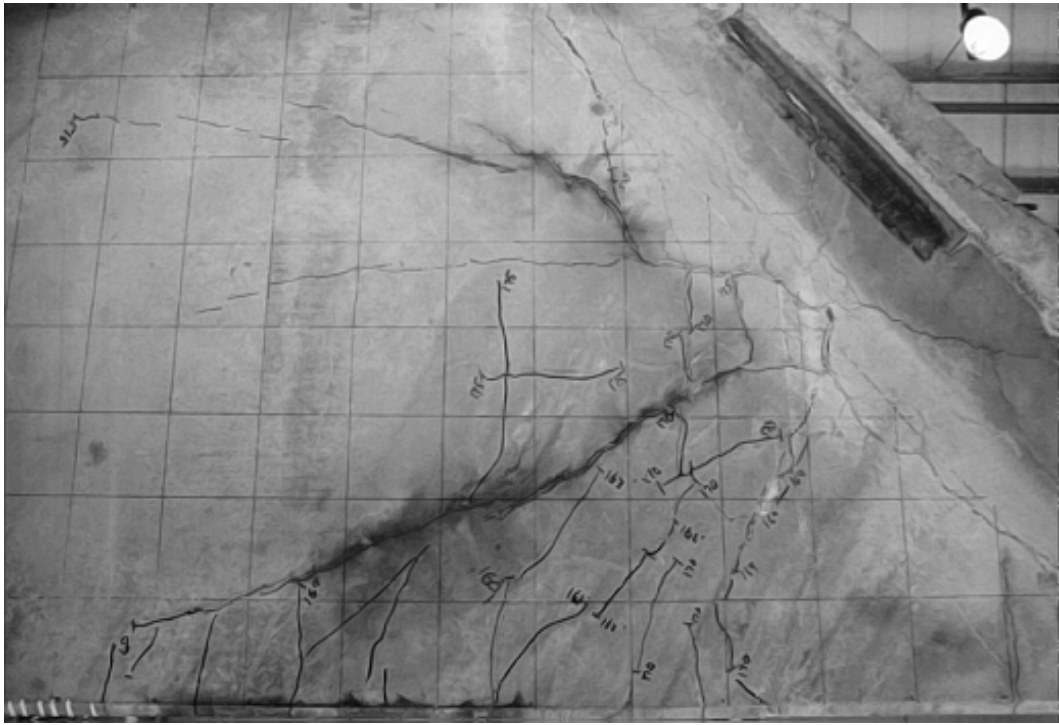
Figure D4: Photograph after Testing of Beam Underside, Box Beam 3 - Test 1

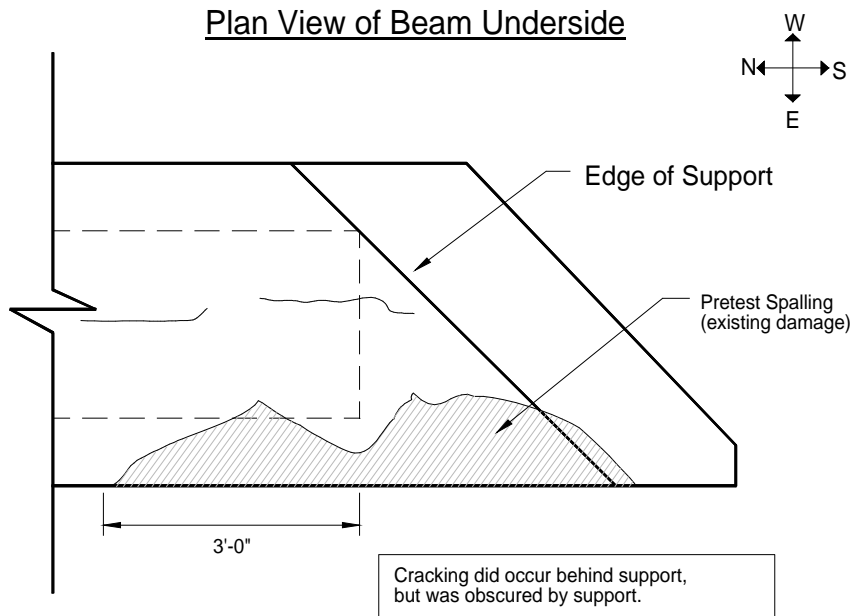
Figure D5: Pretest Cracking in Bottom Flange of Box Beam 5 - Test 2

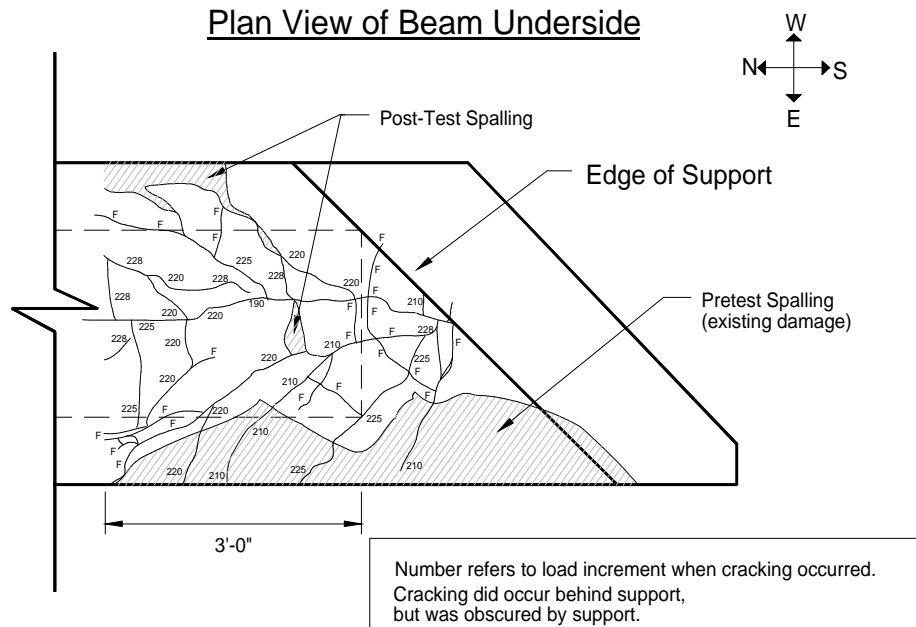
Figure D6: Post-test Cracking in Bottom Flange of Box Beam 5 - Test 2

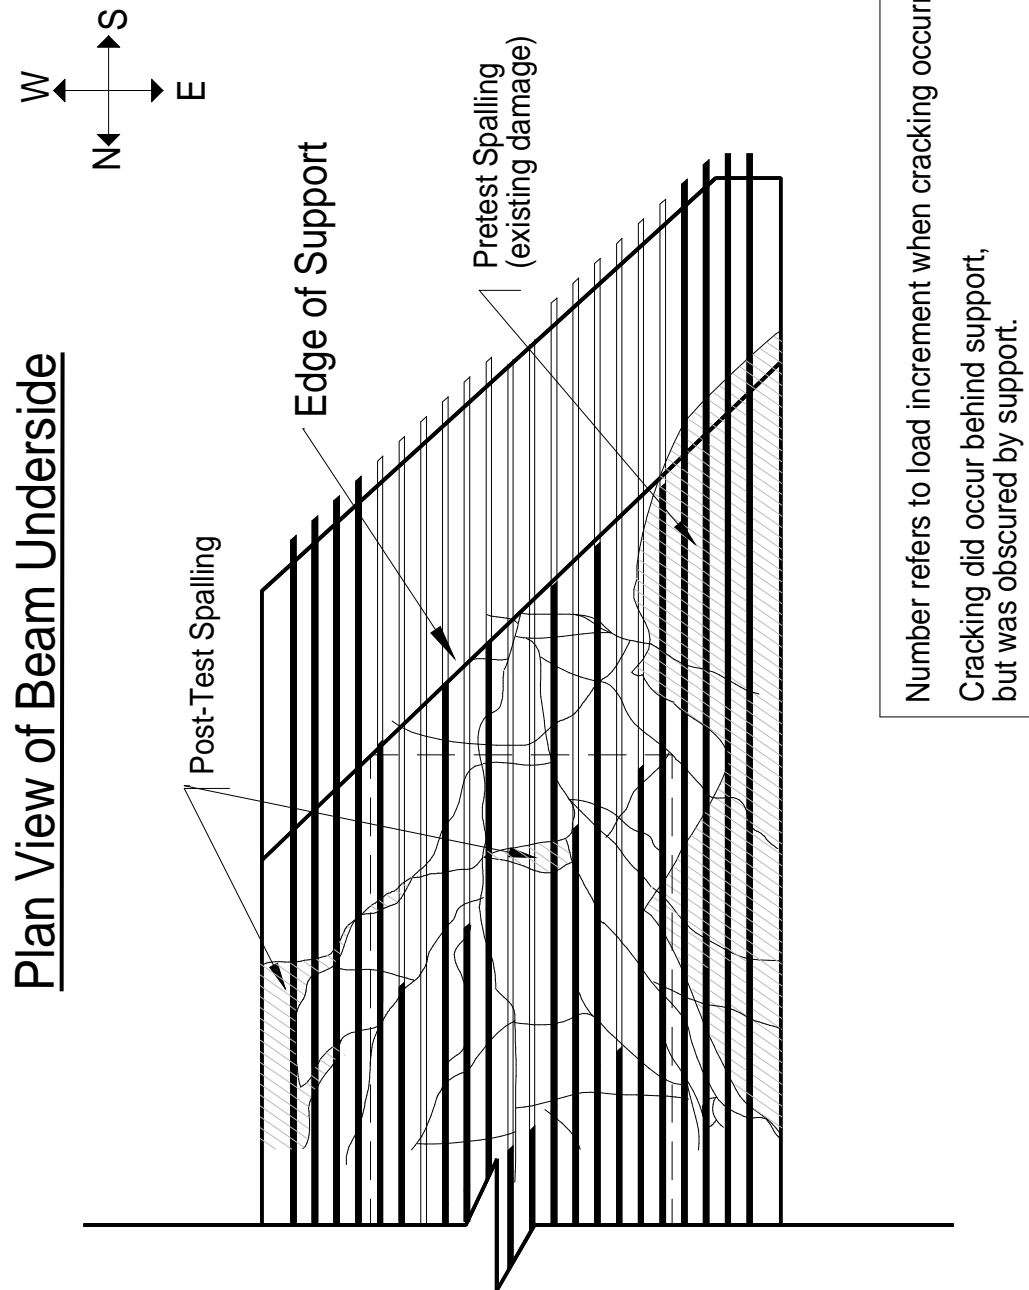
Figure D7: Post-test Cracking in Bottom Flange of Box Beam 5 - Test 2 w/ superimposed pretensioned steel

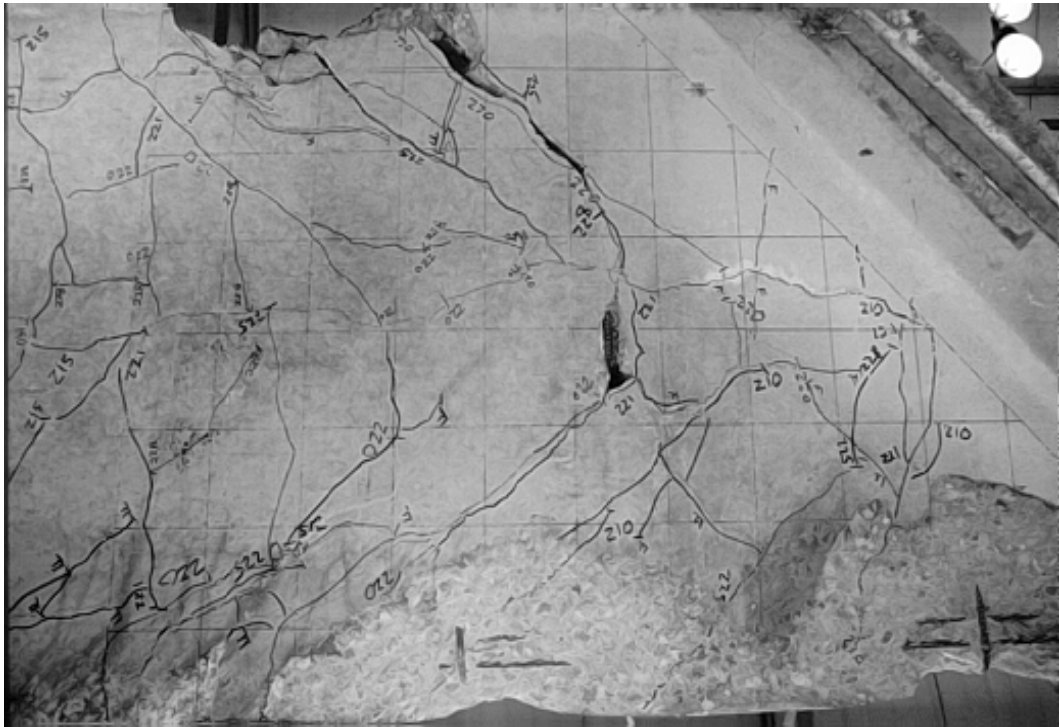
Figure D8: Photograph after Testing of Beam Underside, Box Beam 5 - Test 2

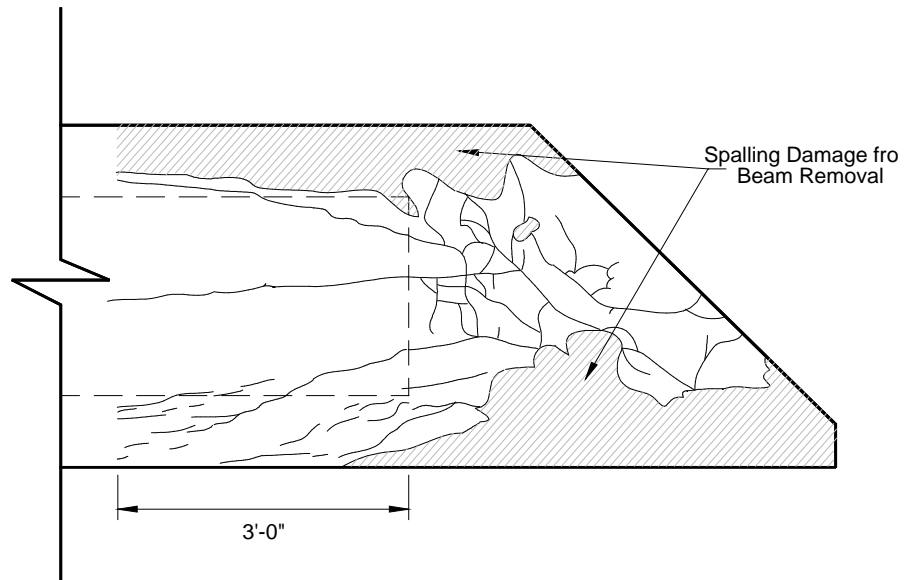
Figure D9: Cracking in Bottom Flange of Box Beam 3 - Untested End

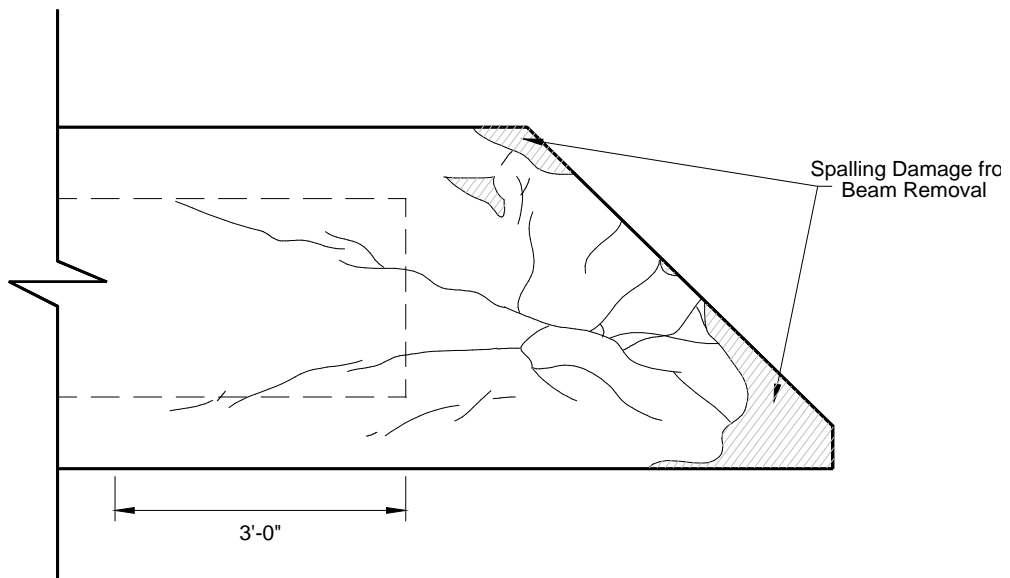
Figure D10: Cracking in Bottom Flange of Box Beam 5 - Untested End

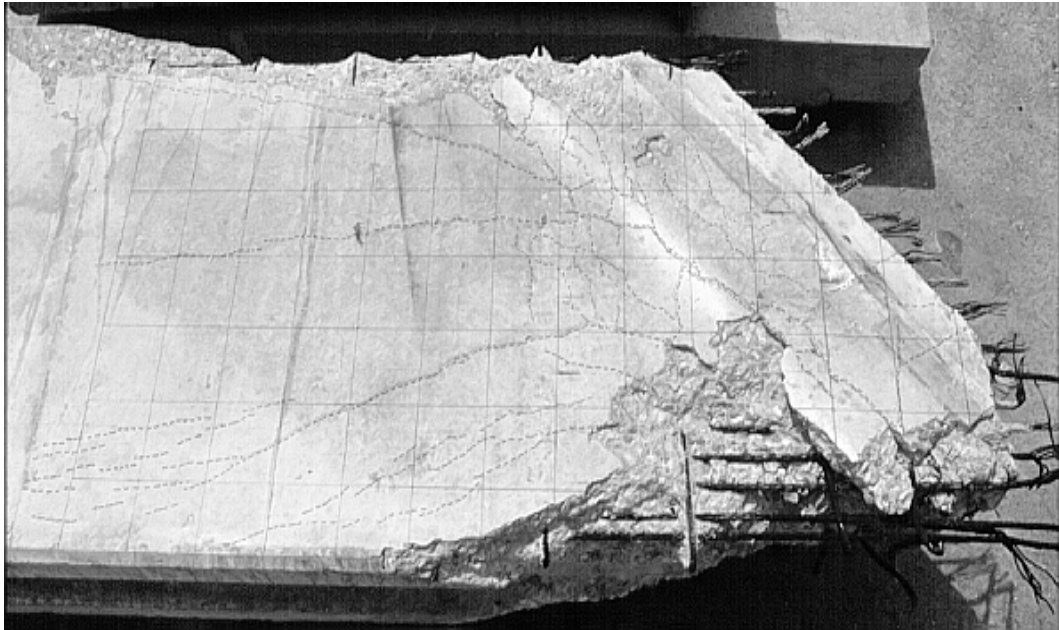
Figure D11: Photograph of Beam Underside, Box Beam 3 - Untested End

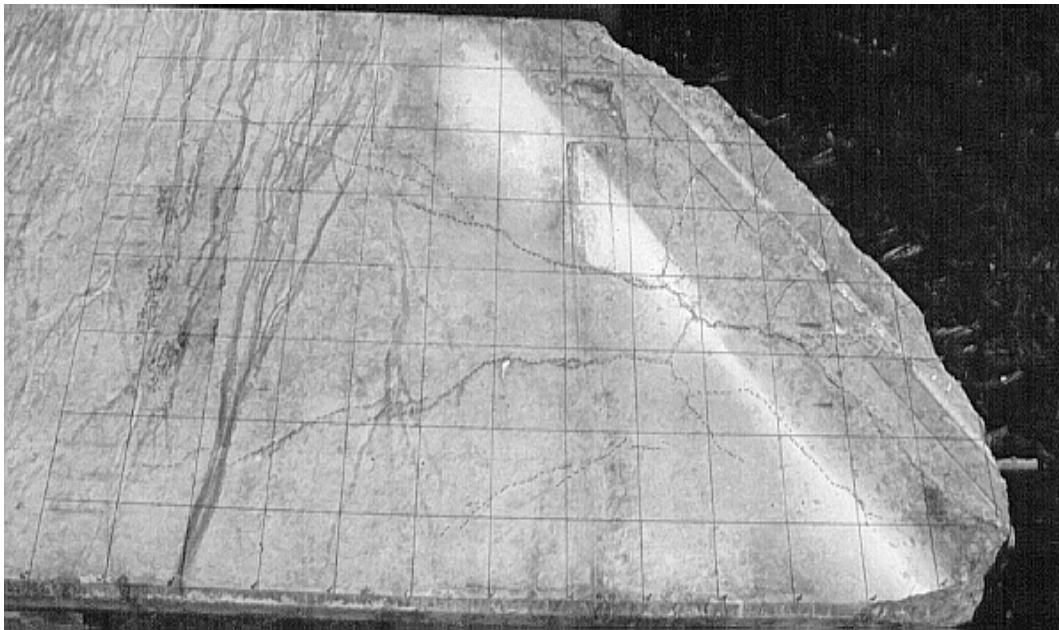
Figure D12: Photograph of Beam Underside, Box Beam 5 - Untested End
