**Durability Evaluation of Post-Tensioned Concrete Beam Specimens
After Long-Term Aggressive Exposure Testing**

Thesis

Master of Science in Engineering

The University of Texas at Austin

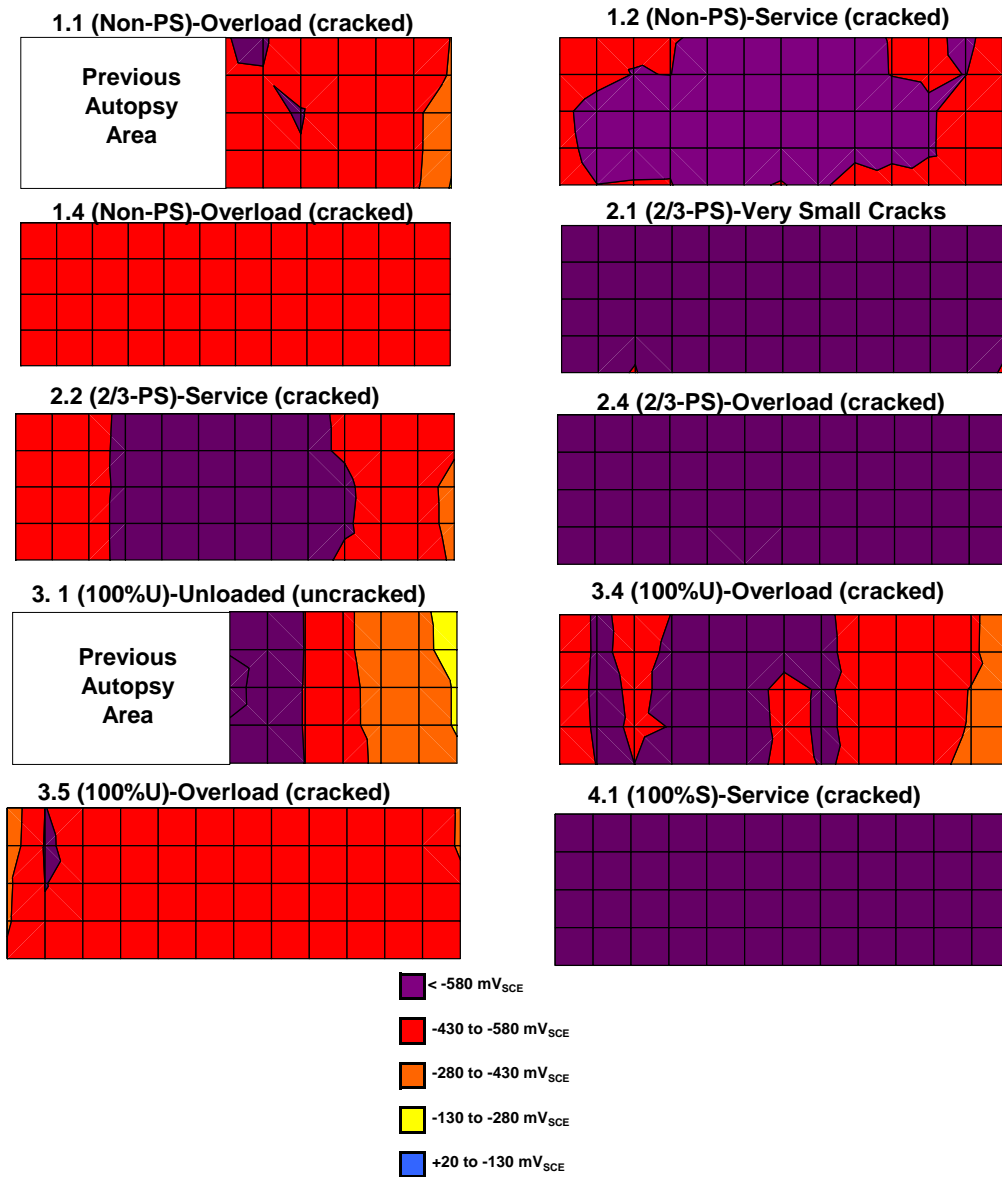
Figure 4.1: Half-Cell Potential Contours at 3107 Days for Phase I Beams

All Phase I specimens show high probabilities of corrosion. Only a small area of beam 3.1 falls in the uncertain range, while the rest of the beam shows a high probability of corrosion. Based on the -280 mV threshold for 90% probability of corrosion, the half cell data can also serve as a means to estimate the time of initiation of corrosion. This is done by examining the most negative monthly reading for each specimen. The estimated time to initiation of corrosion for the Phase I specimens is shown in Figure 4.2.

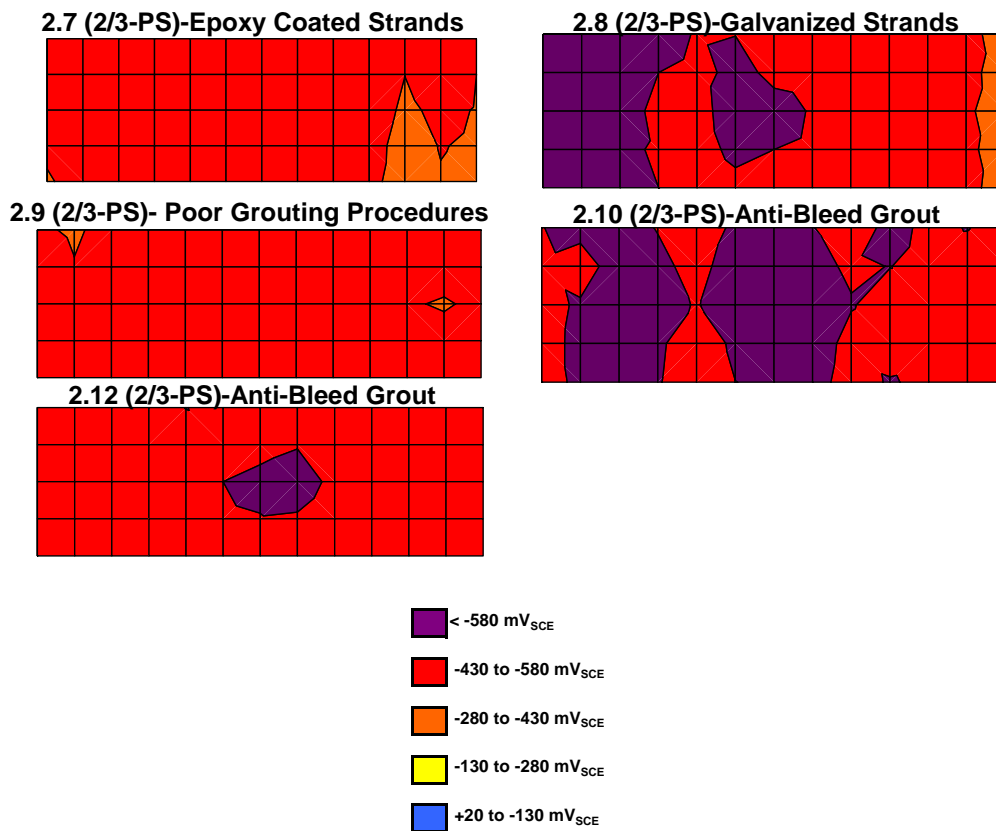
Figure 4.3: Half-Cell Potential Readings at 2894 Days for Phase II Beams

All Phase II beams had high probabilities of corrosion at the end exposure testing. The time to initiation of corrosion for the Phase II beams is shown in Figure 4.4

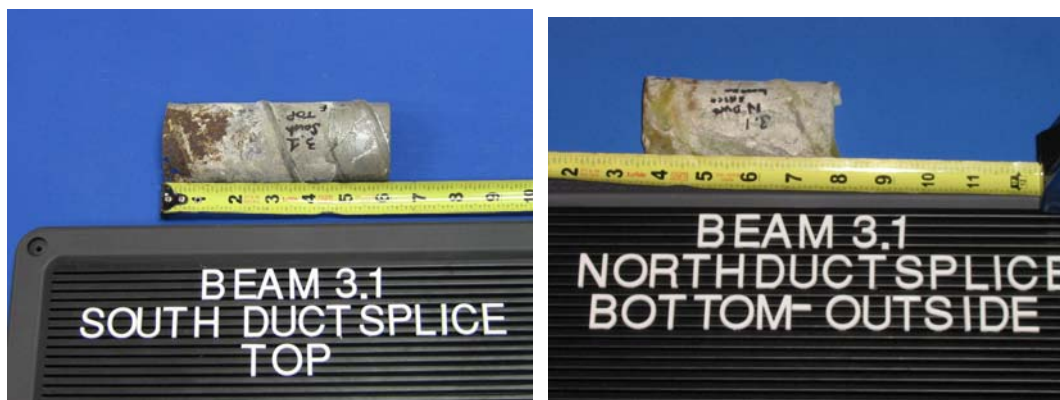
Since the splices of the ducts were at the beam centerline, only half of the splice remained from each duct to be autopsied. The remaining half of each splice was removed during the previous autopsies. The south duct industry standard splice had small holes and pitting on both the top and bottom near the cut face of the beam. Pitting was observed on the inside of both splice halves as well. The north duct heat shrink splice had discoloration on the inside surface where duct corrosion had taken place. Otherwise, no other discoloration or corrosion deposits were seen on the heat shrink splice. Both splices are shown in Figure 5.44.

Figure 5.44: Beam 3.1 Duct Splices-South Duct Industry Standard Splice (Left) and North Duct Heat Shrink Splice (Right)

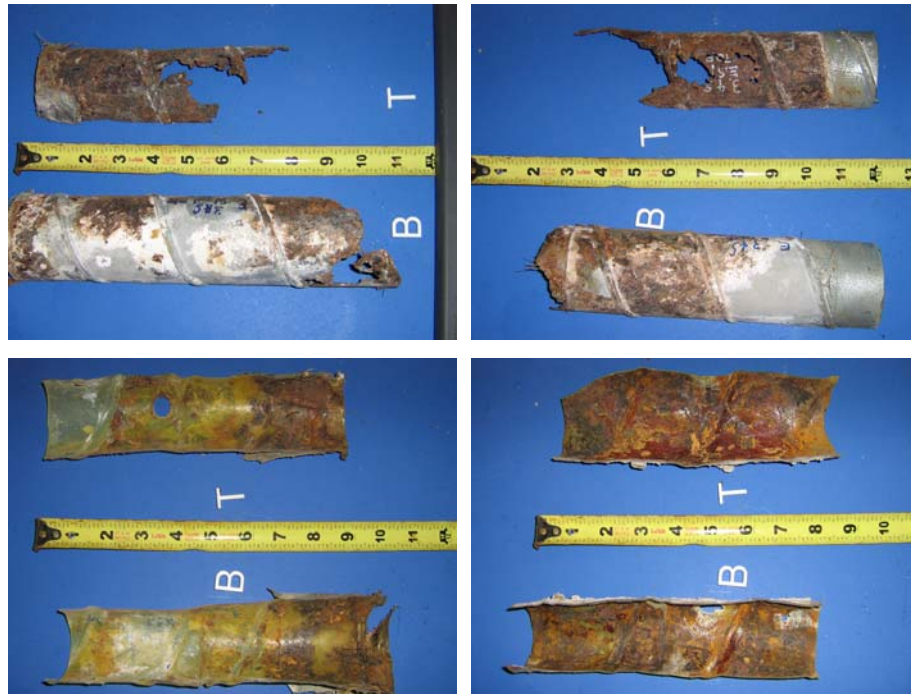
Figure 5.49: Beam 3.4 Duct Splices-South Duct "Damaged" Industry Standard Splice (Top Left) and "Undamaged" Splice (Top Right), North Duct "Damaged" Heat Shrink Splice (Bottom Left) and "Undamaged" Splice (Bottom Right)

standard splice or the heat shrink splice. The south duct was used to test the industry standard splice, with the west-most splice damaged in the form of poor duct taping. The north duct was used to test the heat shrink splice, with the west splice damaged in the form of a 1-in. tear at the seam between the two duct portions. For both ducts each splice was 18 in. either to the west or east of the beam centerline. Upon autopsy, the “damaged” industry standard splice on the south duct was found to be severely corroded. Half of the top portion of the splice was corroded away, with pitting and holes on the remaining portion. The bottom portion of the duct was also severely pitted in some areas, with one end corroded away directly beneath the splice. Pitting was also found on the insides of both the top and bottom halves of the splice. Pitting and holes were also found in the duct directly beneath the splice. The corrosion damage to the “undamaged” splice was similar, but no holes were found on the bottom portion. Holes and pitting were found in the duct portion directly beneath this splice. Both heat shrink splices on the north duct had corrosion deposits on their inside surfaces. The “damaged” splice had smaller deposits on it, while the duct beneath was pitted. The “undamaged” splice had more deposits, and pitting and holes were observed on the duct directly beneath it. The splices are shown in Figure 5.49. Note that the circular hole in the “damaged” heat shrink splice is due to the drilling of chloride samples.

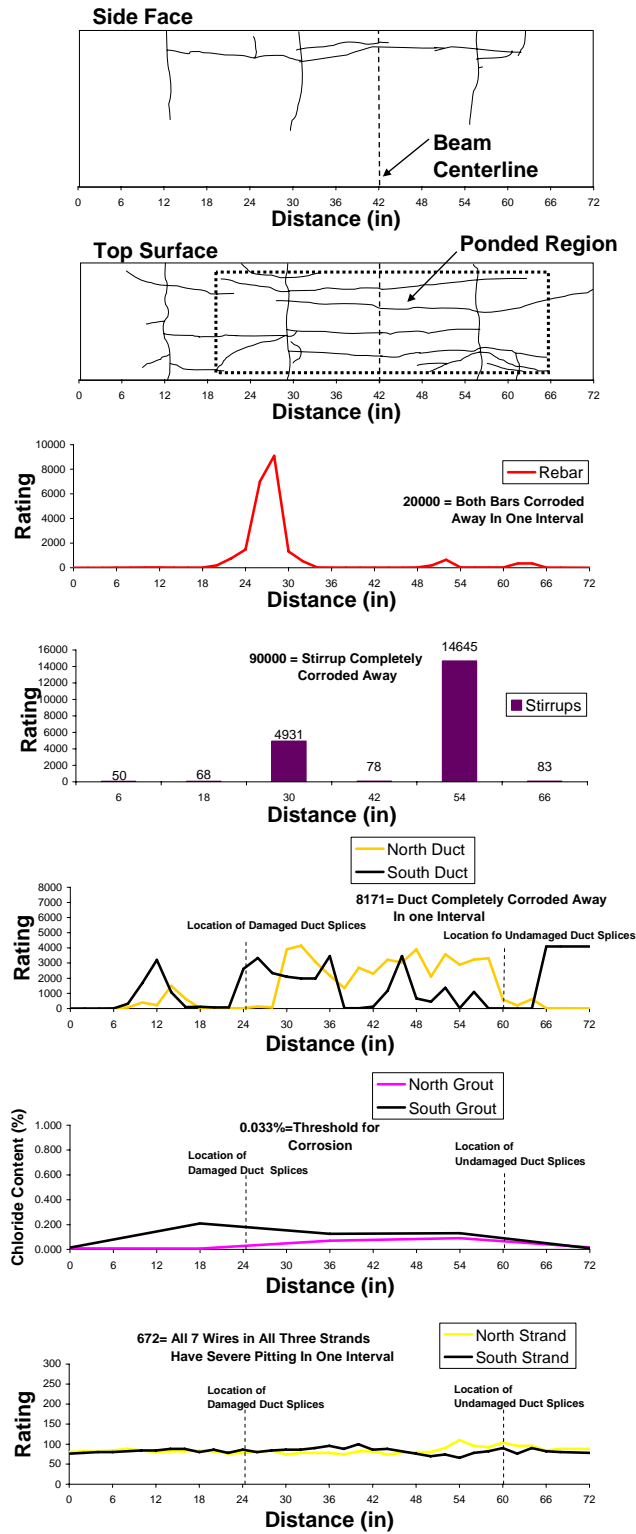
Figure 5.50: Beam 3.4-Crack Patterns and Corrosion Rating Graphs

From the plots in Figure 5.50, there is no overall trend between either strand damage or chloride content when comparing the data in the vicinities of the “damaged” or “undamaged” splices in both ducts. It is likely that the severe duct corrosion made the damage to the splices insignificant as the ducts began to corrode away.

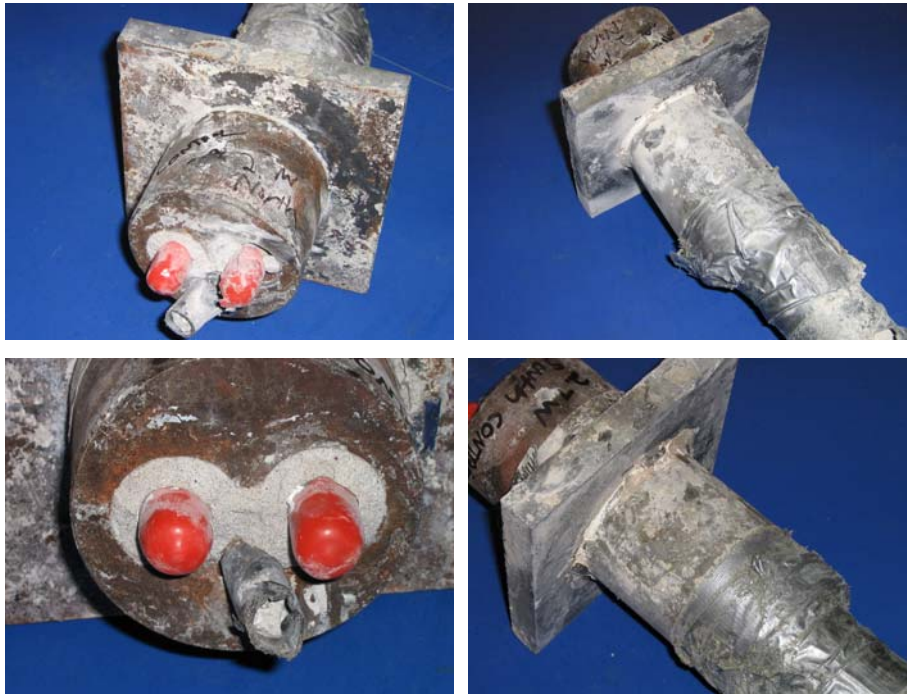
Figure 5.72: Beam 2.7 West End Anchorages After Removal (Controls): North Duct Anchorage (Top, Left and Right), and South Duct Anchorage (Bottom, Left and Right)

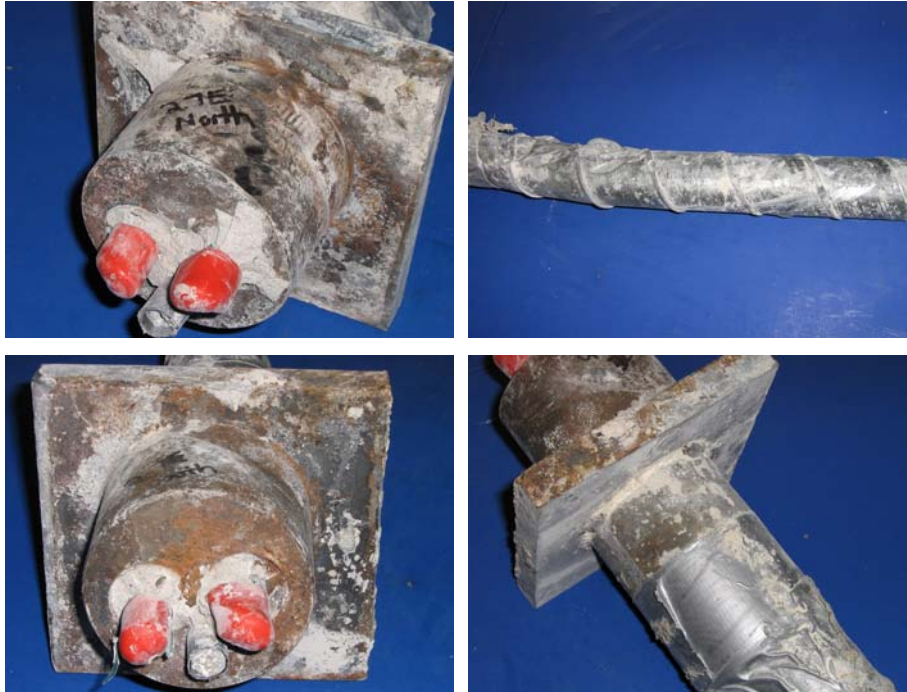
Figure 5.74: Beam 2.7 East End Anchorages (Dripped End): North Duct Anchorage (Top, Left and Right), and South Duct Anchorage (Bottom, Left and Right)

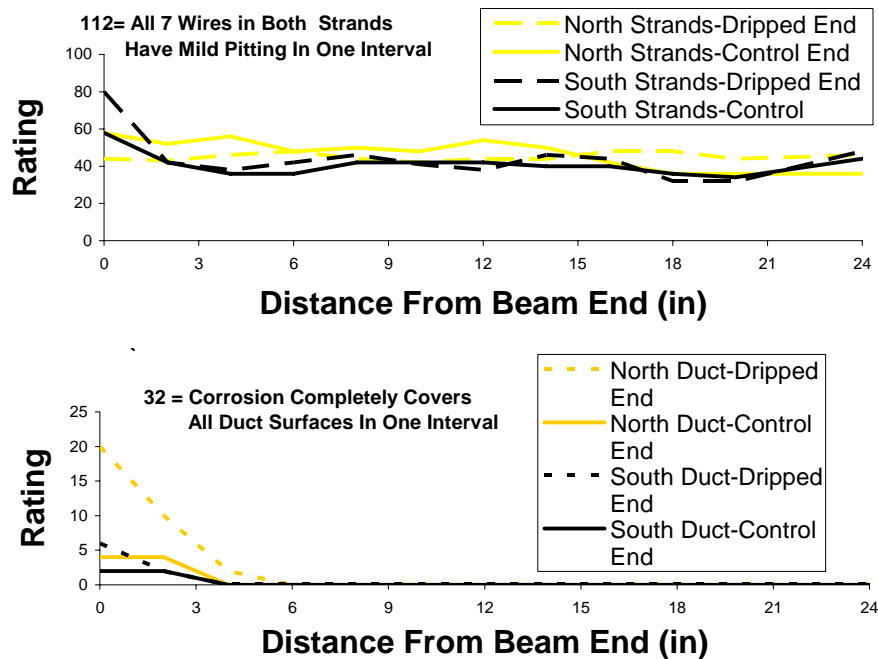
Figure 5.76: Beam 2.7-Corrosion Rating Graphs for Anchorages

In Figure 5.76, the corrosion ratings for both the ducts and strand for the west end and east end anchorages are shown plotted together for comparison. Note that “Distance From Beam End” is the distance from the respective end of the beam for each respective anchorage. Because the corrosion from the center of the beam spread to both anchorages, in order to detect any corrosion caused by the end dripper the data from the dripped end is compared to the control end to see if there is any increase in corrosion between the two. Thus it is assumed that the corrosion from the center of the beam had an equal effect on both ends of the beam.

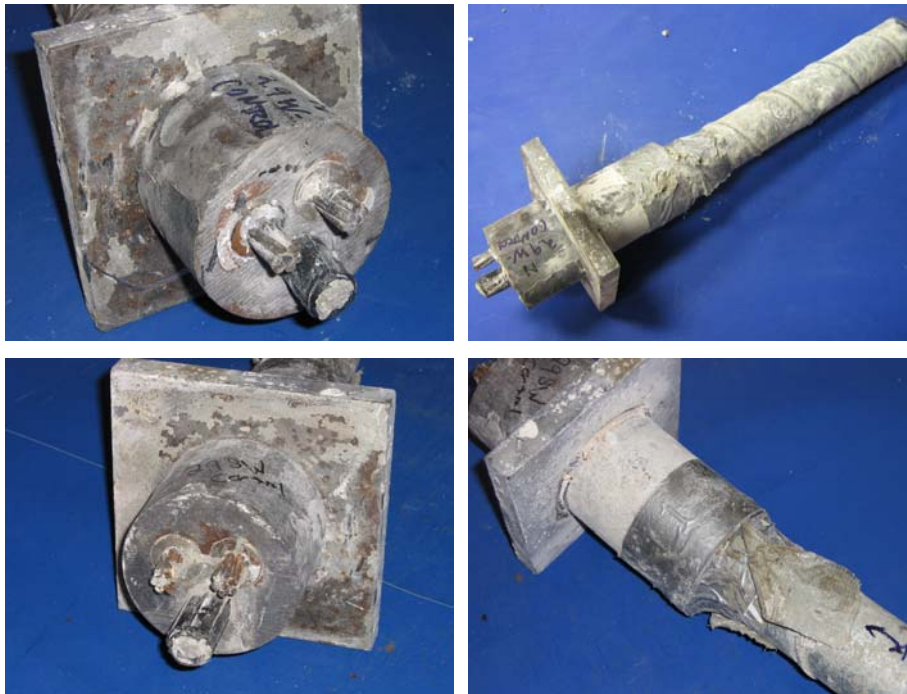
Figure 5.90: Beam 2.9 West End Anchorages (Controls) After Removal-North Duct Anchorage (Top, Left and Right), and South Duct Anchorage (Bottom, Left and Right)

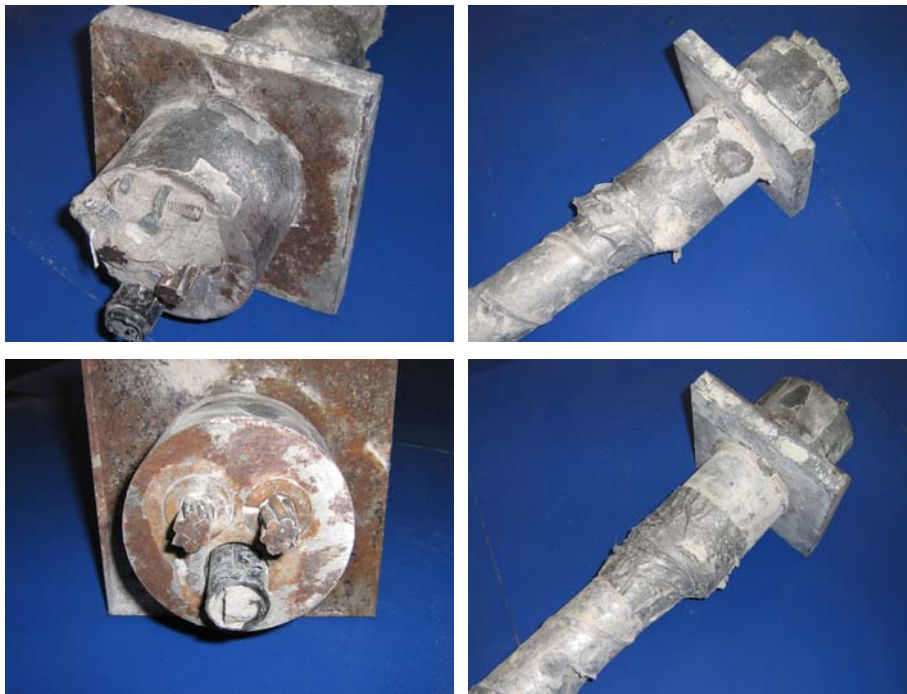
Figure 5.92: Beam 2.9 East End Anchorages (Dripped End)-North Duct Anchorage (Top, Left and Right), and South Duct Anchorage (Bottom, Left and Right)

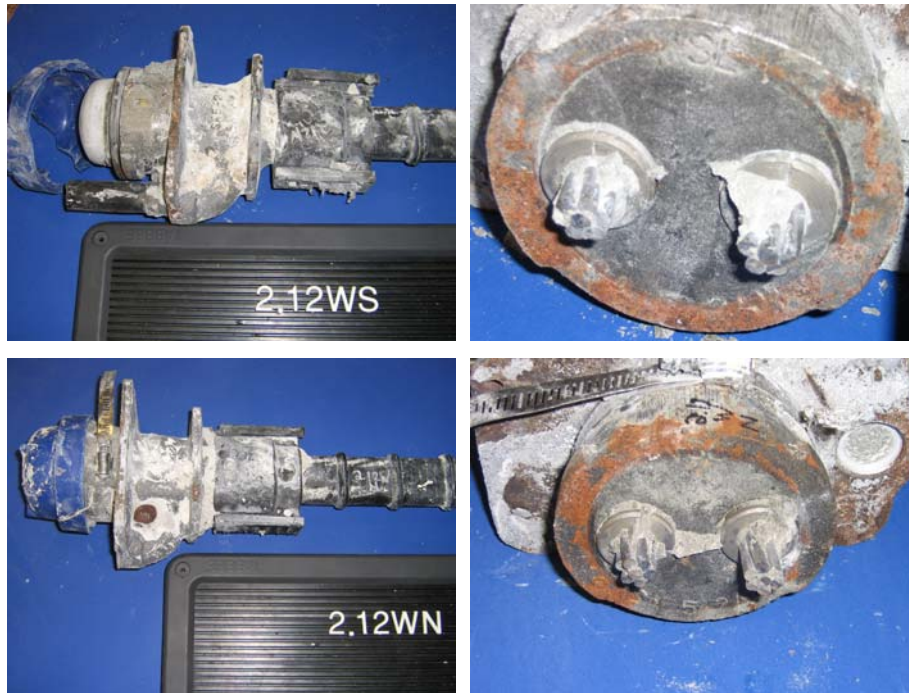
Figure 5.108: Beam 2.12 West End Anchorages (Control End)-South Duct Anchorage (Top, Left and Right) and North Duct Anchorage (Bottom, Left and Right)

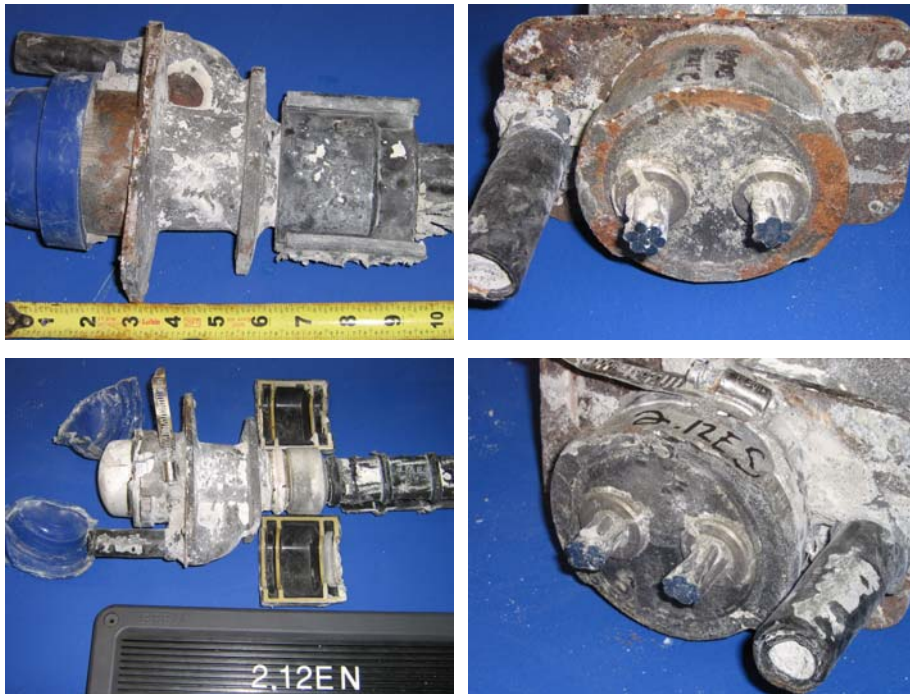
Figure 5.111: Beam 2.12 East End Anchorages (Dripped End)-South Duct Anchorage (Top, Left and Right), and North Duct Anchorage (Bottom, Left and Right)
