**Assessment of Long-Term Corrosion Resistance of Recently Developed  
Post-Tensioning Components**

**Thesis**

The University of Texas at Austin

**August, 2012**

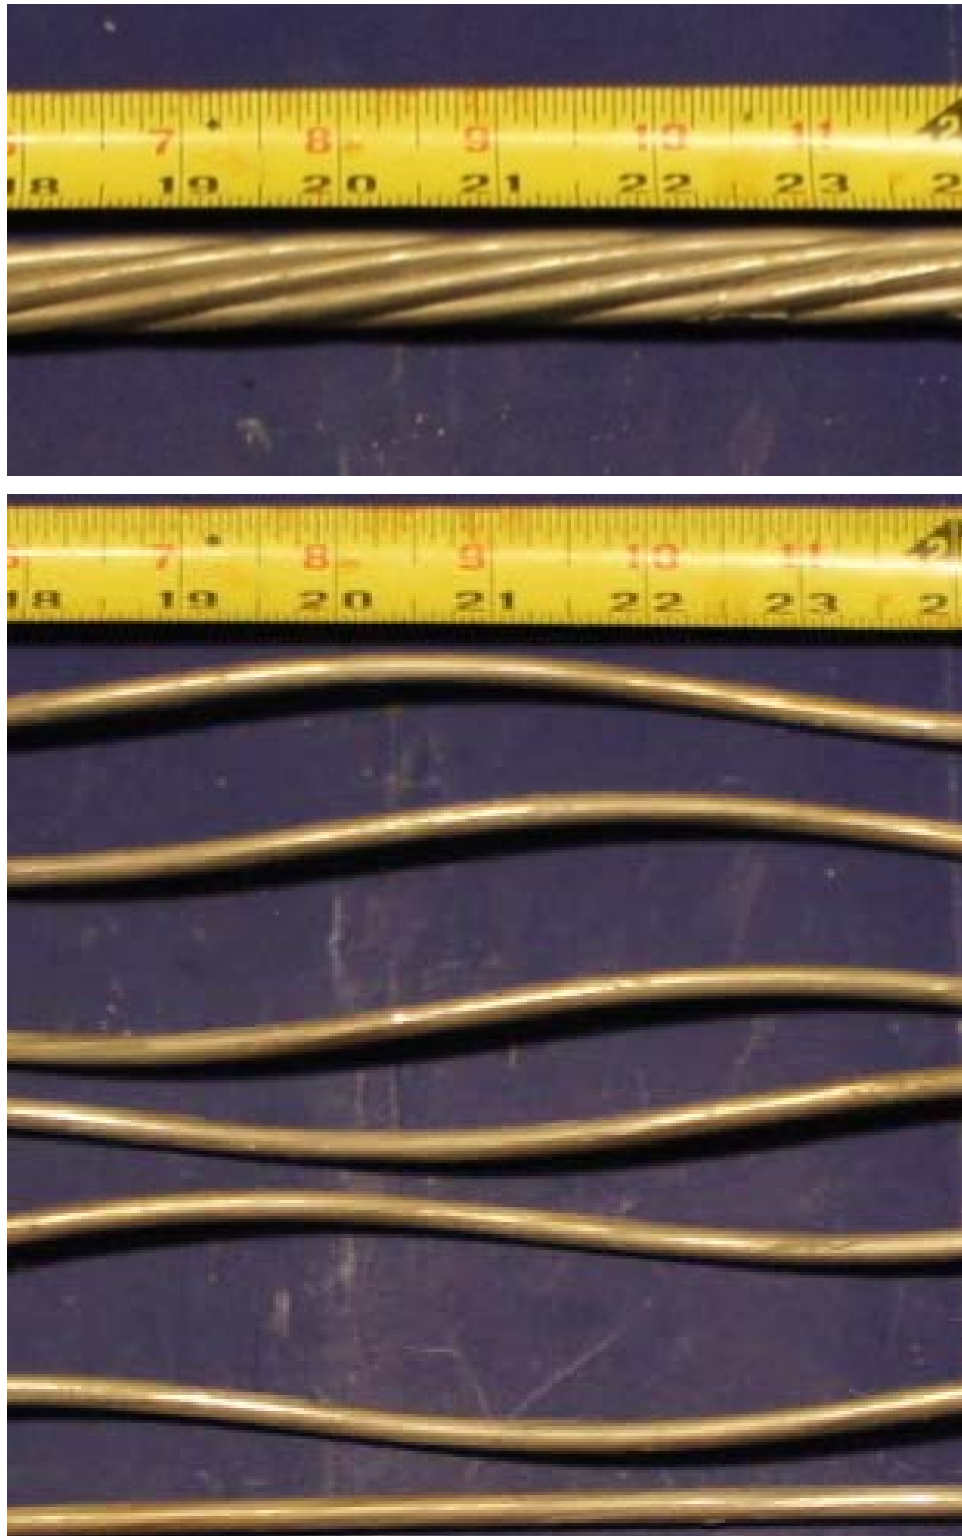
Figure 6.19 shows the condition of a typical strand and the condition of an unraveled strand. Figure 6.20 shows the corrosion ratings for the strands and Table 6.6 shows the summary of the corrosion ratings for the strands.

*Figure 6.19: Typical Strand (Left) and Unraveled Strand (Right) from Specimen 1.1*

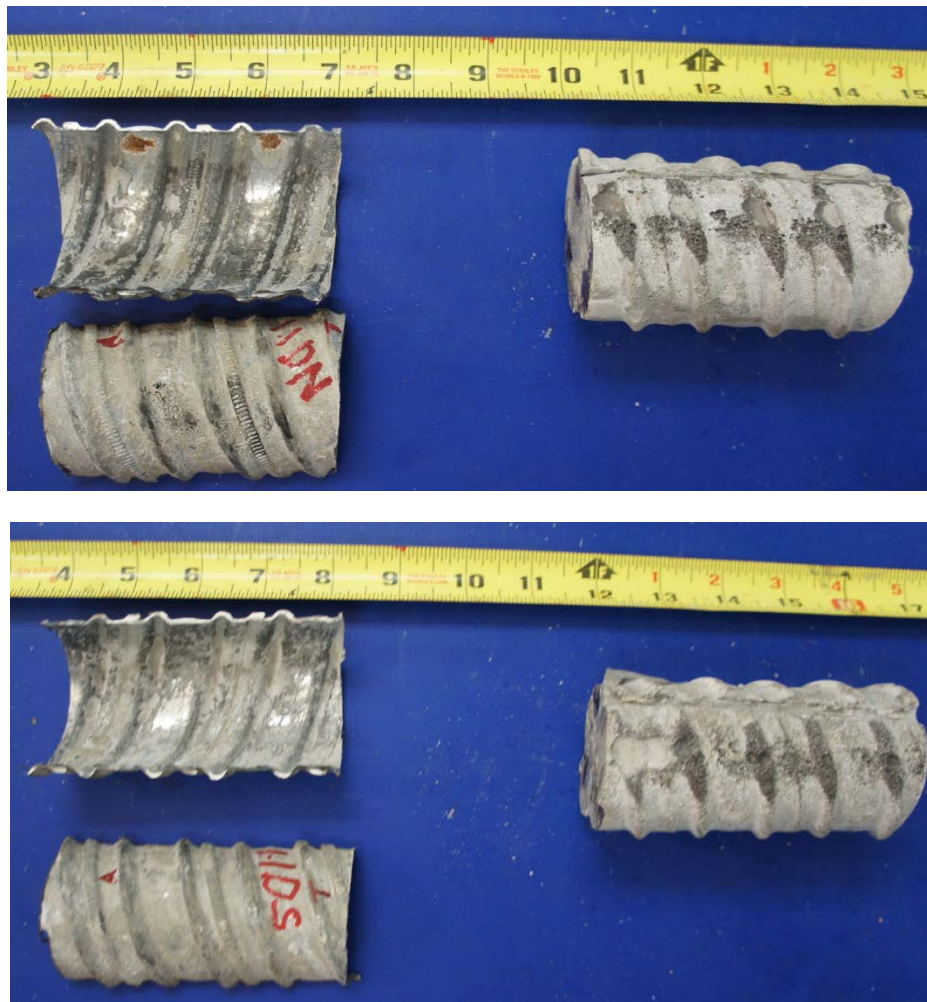
The grout from the north and south dead end tendons had no visible transverse or longitudinal cracks. The grout from both tendons had voids and signs of “bubbling” in the area of the flutes of the ducts along the length of the top surface (Figure 6.22). The grout from both tendons showed signs of segregation along the length of the anchorage region. Figure 6.22 shows grout and the ducts from the north and south anchorage region.

**Figure 6.22: Dead End North Tendon Duct and Grout (Top) and Dead End South Tendon Duct and Grout (Bottom) from Specimen 1.1**

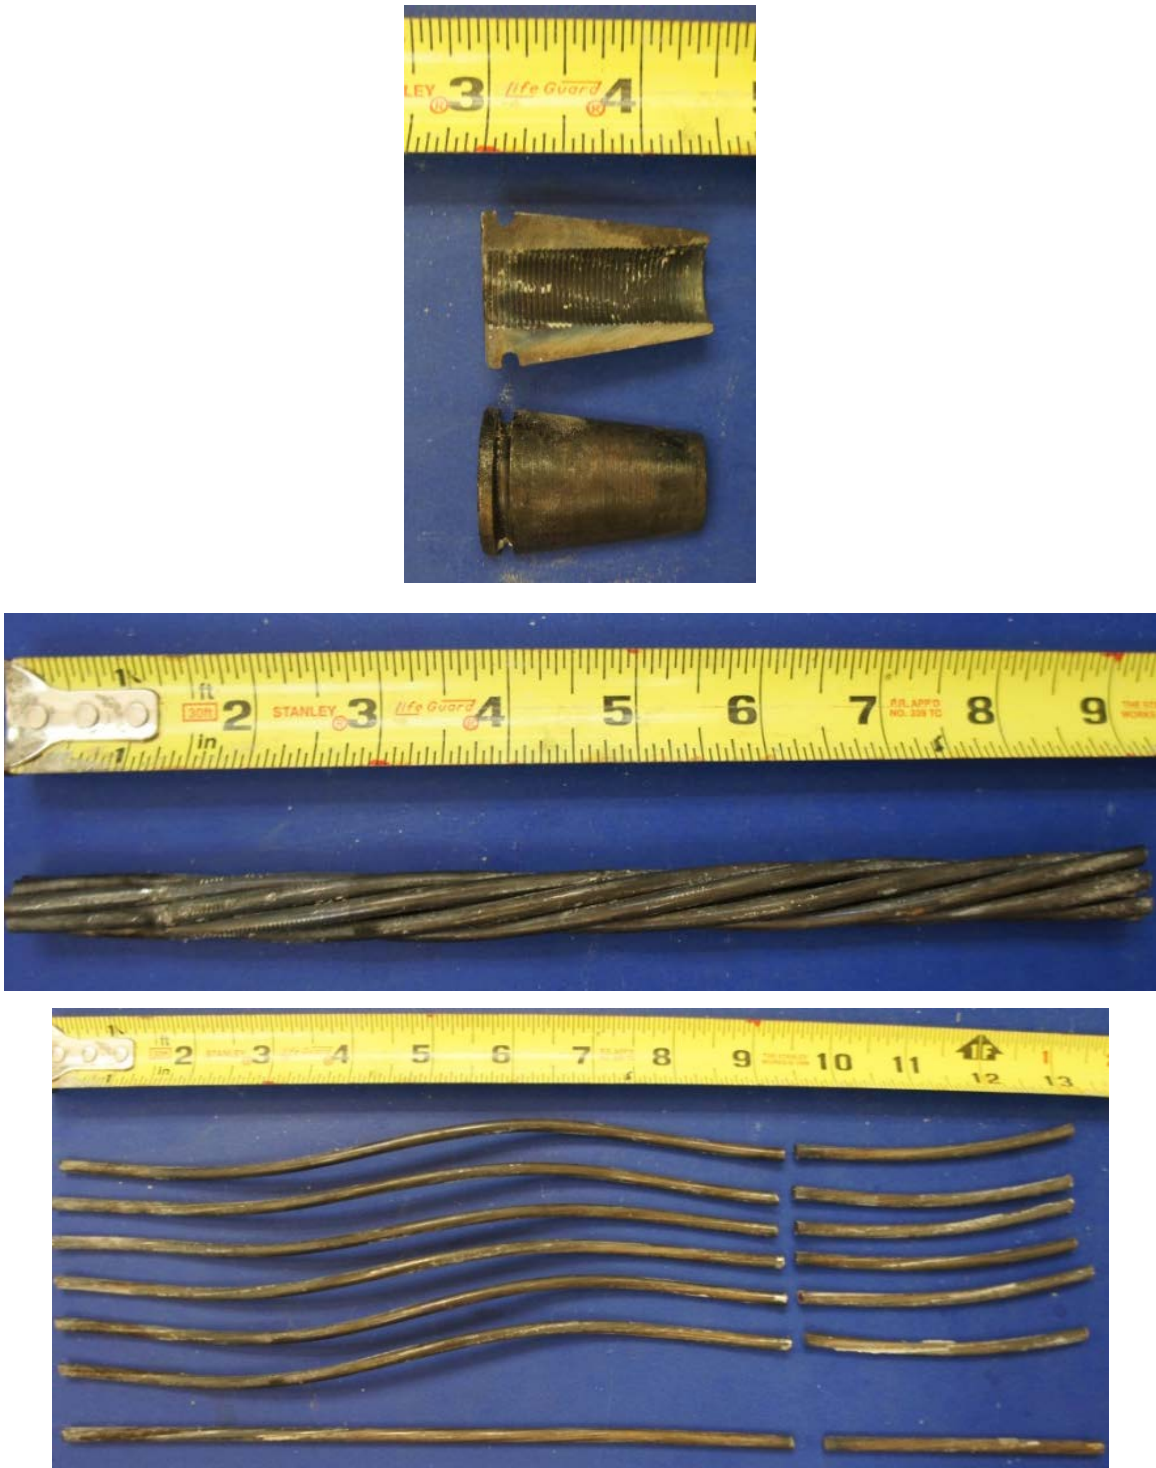
The outer wires of the strands from the dead end of the north and south tendon had discoloration and light corrosion over the length of the stands. The inner wires had light corrosion over the total length of the strand. The wedges were intact and showed no visible signs of corrosion. Figure 6.23 shows a typical wedge, strand and an unraveled stand. Figure 6.24 shows the corrosion ratings for the anchorage region strands and Table 6.7 shows the summary of the corrosion ratings for the anchorage region stands.

*Figure 6.23: Typical Wedge (Top), Strand (Middle), and Unraveled Strand (Bottom) for the Dead End Anchorage Region of Specimen 1.1*

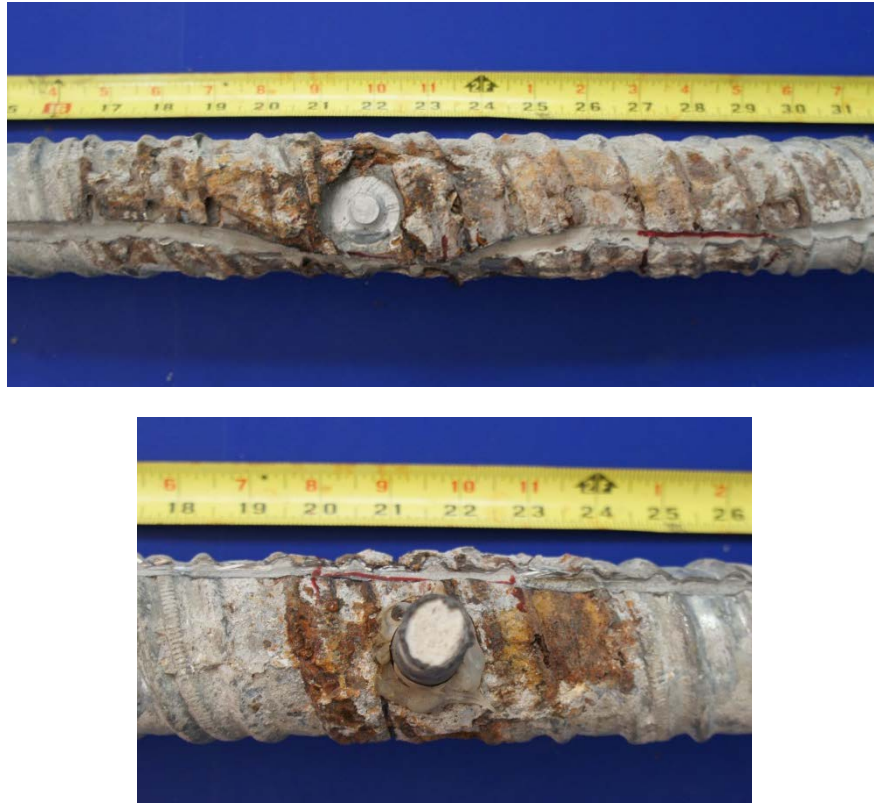
Both the north and south ducts had localized severe corrosion damage. This damage resulted in holes in the ducts. The top of the north duct had a large hole at midspan (Figure 6.29). The bottom of the north duct had a hole at midspan and pitting in the intervals adjacent to the hole. The top inner surface of the north duct had light corrosion on one interval and discoloration on intervals without holes. The bottom inner surface of the north duct had evidence of light corrosion on seven intervals scattered along the length of the duct. The top of the south duct had a large hole at midspan (Figure 6.29). The bottom of the south duct had a small hole at midspan and pitting in the adjacent intervals. The top inner surface of the south duct had a few intervals with light corrosion. The bottom inner surface of the south duct had no visible signs of corrosion. The holes experienced by both the north and south ducts indicate that voids in the grout had formed along the top of the duct. Figure 6.32 shows the corrosion ratings for the ducts and Table 6.8 shows the summary of the corrosion ratings for the ducts.

***Figure 6.29: Holes in Top of North (Top) and South (Bottom) of Duct of Specimen 1.3 Caused by Corrosion***

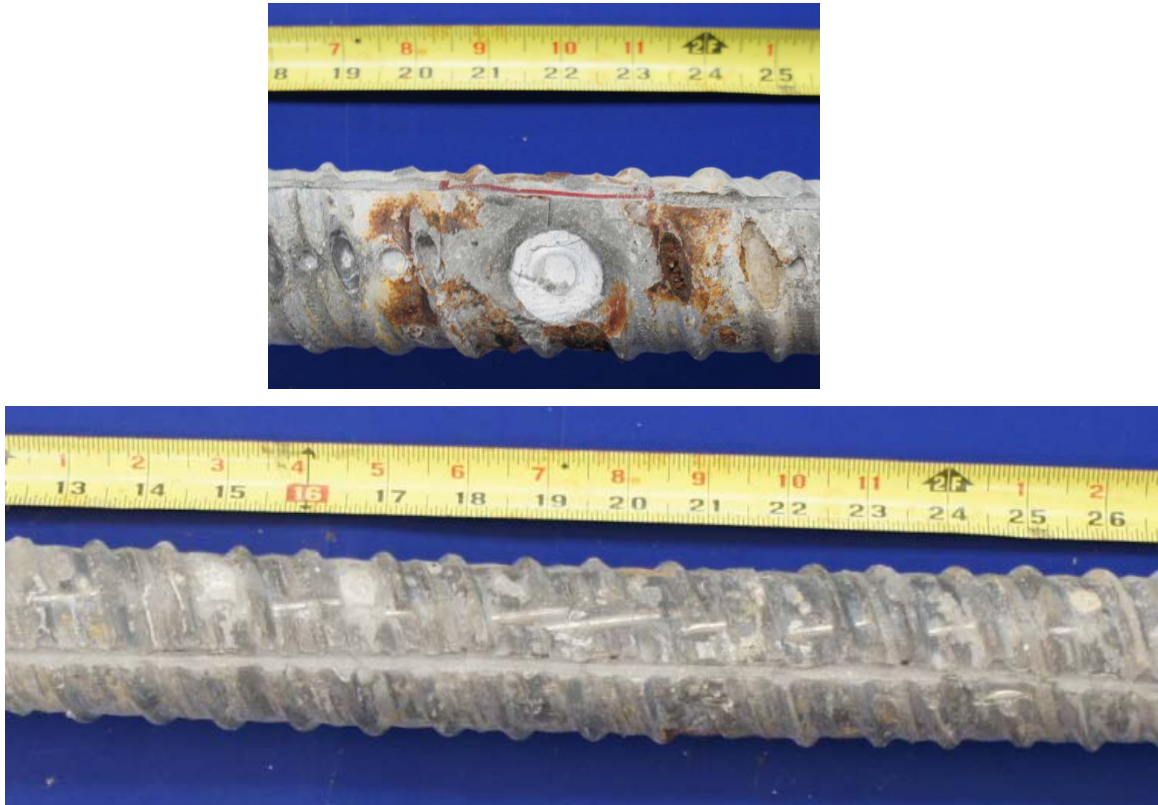
No transverse or longitudinal visible cracks were observed during examination of grout from the north and south gouts of Specimen 1.3. Staining from corrosion of the duct was observed at locations where corrosion had caused holes in the both the north and south duct (Figure 6.30). Voids in the grout were observed in the flutes at the top of both the north and south duct along the entire length of the each duct. These voids measured approximately 0.75 inch long and were as wide as the flute width of the duct (Figure 6.30). A portion of the strands at the bottom of both tendons was not entirely covered with grout at midspan of the south duct and the majority of the length of the north tendon (Figure 6.30). The coloration of the grout for both tendons was light gray at the ends and transitioned to darker gray at midspan.

***Figure 6.30: Staining on Grout from North Tendon (Top) and Exposed Strands on the Bottom of South Duct (Bottom) of Specimen 1.3***

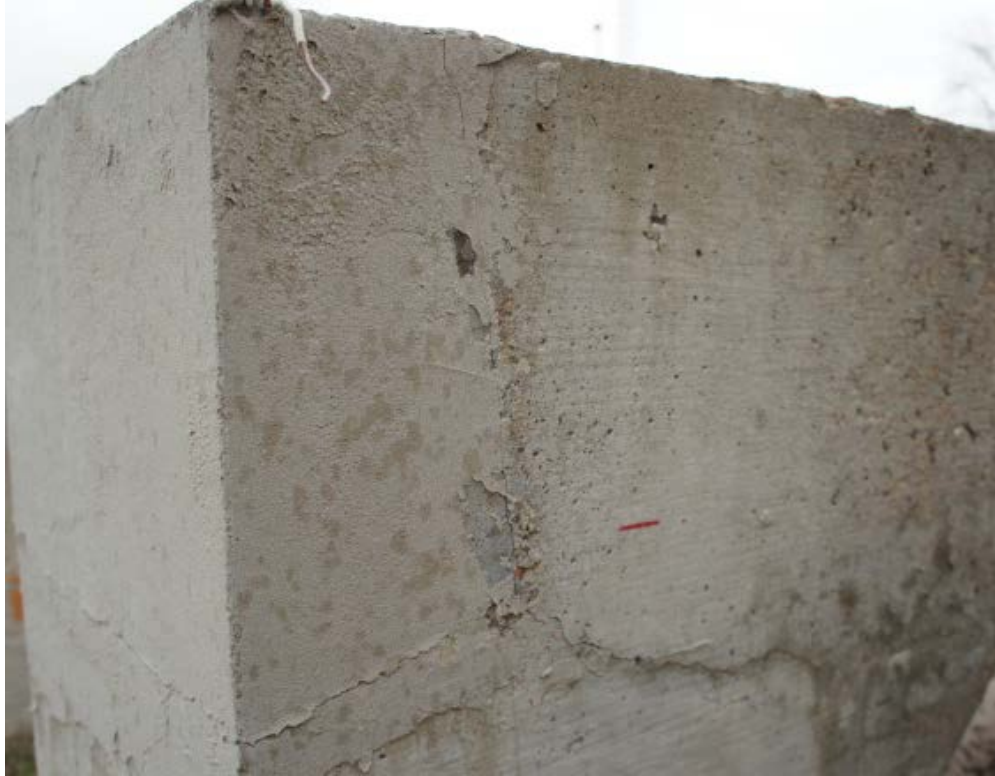
mortar in the live end anchorage pocket was separating from the concrete (Figure 6.37). This indicates that the mortar did not adhere well to the base concrete.

***Figure 6.37: Separation of the Backfill Mortar of the Live End Anchorage Pocket from the Base Concrete of Specimen 1.4***

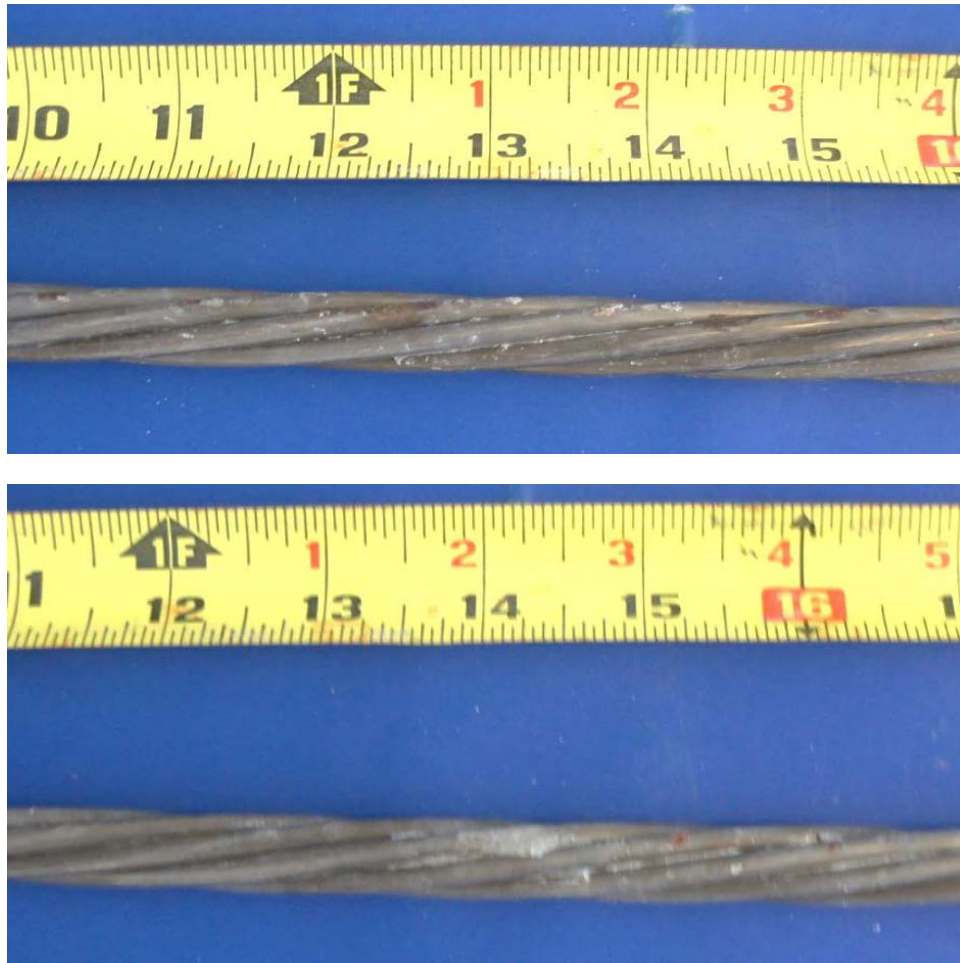
*Figure 6.43: Specimen 1.4 Moderate Corrosion on Outer Wire from a Strand in North Tendon (Top) and on Outer Wire from a Strand in South Tendon (Bottom)*

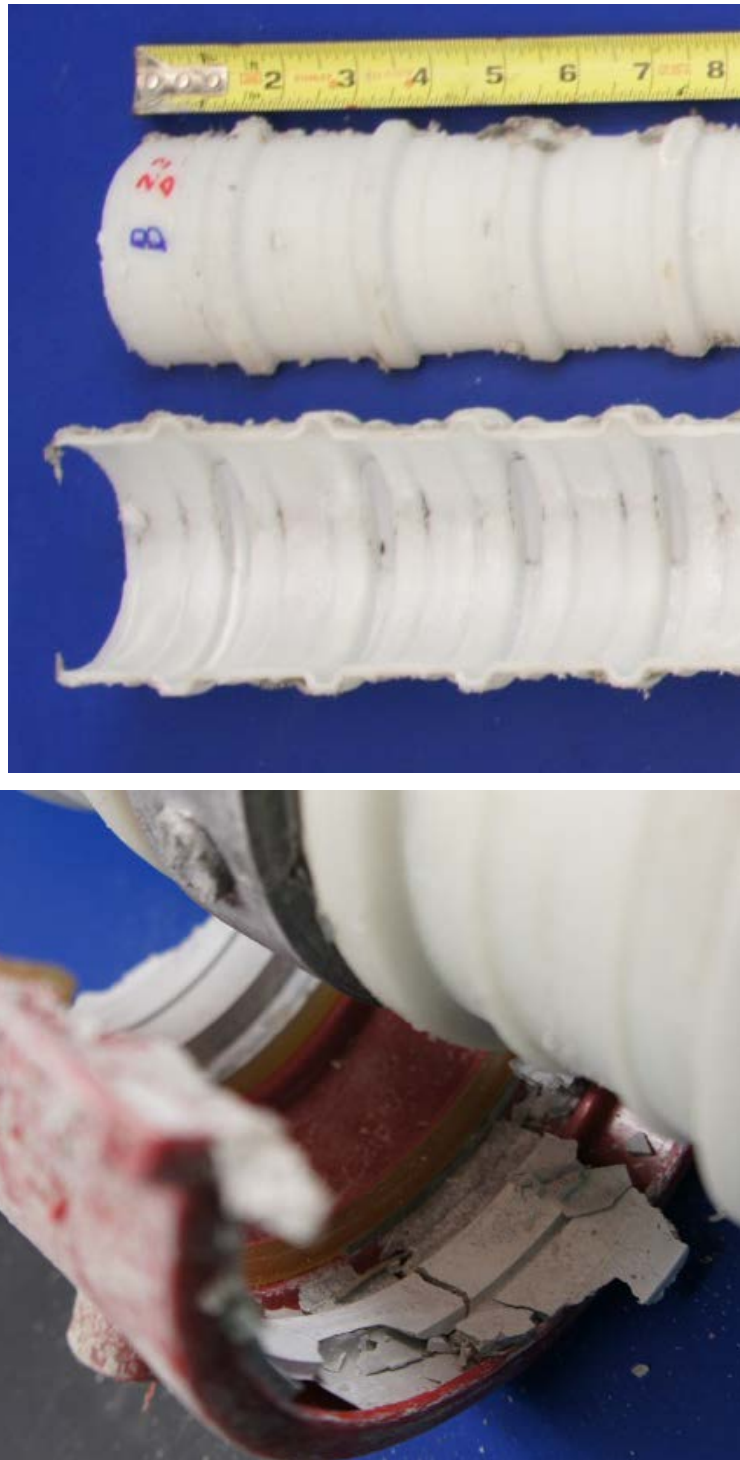
of the north duct had slight gouges on the dead end of midspan. This indicates that one or more of the strands caused damage either when the strands were being threaded through the duct or one of the strands or stands were rubbing against the north duct when the strands were being stressed. In either case, the integrity of the duct was not compromised. Indications of voids were observed on the top inner surface of the duct along the entire length (Figure 6.51). No damage was observed on the coupler. Grout was observed inside the coupler but outside the seal (Figure 6.51). This indicates that the seals of the coupler were not water tight and allowed the grout to escape from inside the duct. Thus, in reverse, it could have been a pathway for moisture, oxygen, and/or chlorides to enter the duct.

*Figure 6.51: Evidence of Voids in Grout of North Tendon (Top) and Grout inside the Coupler but outside the Seals of North Duct (Bottom) of Specimen 2.3*

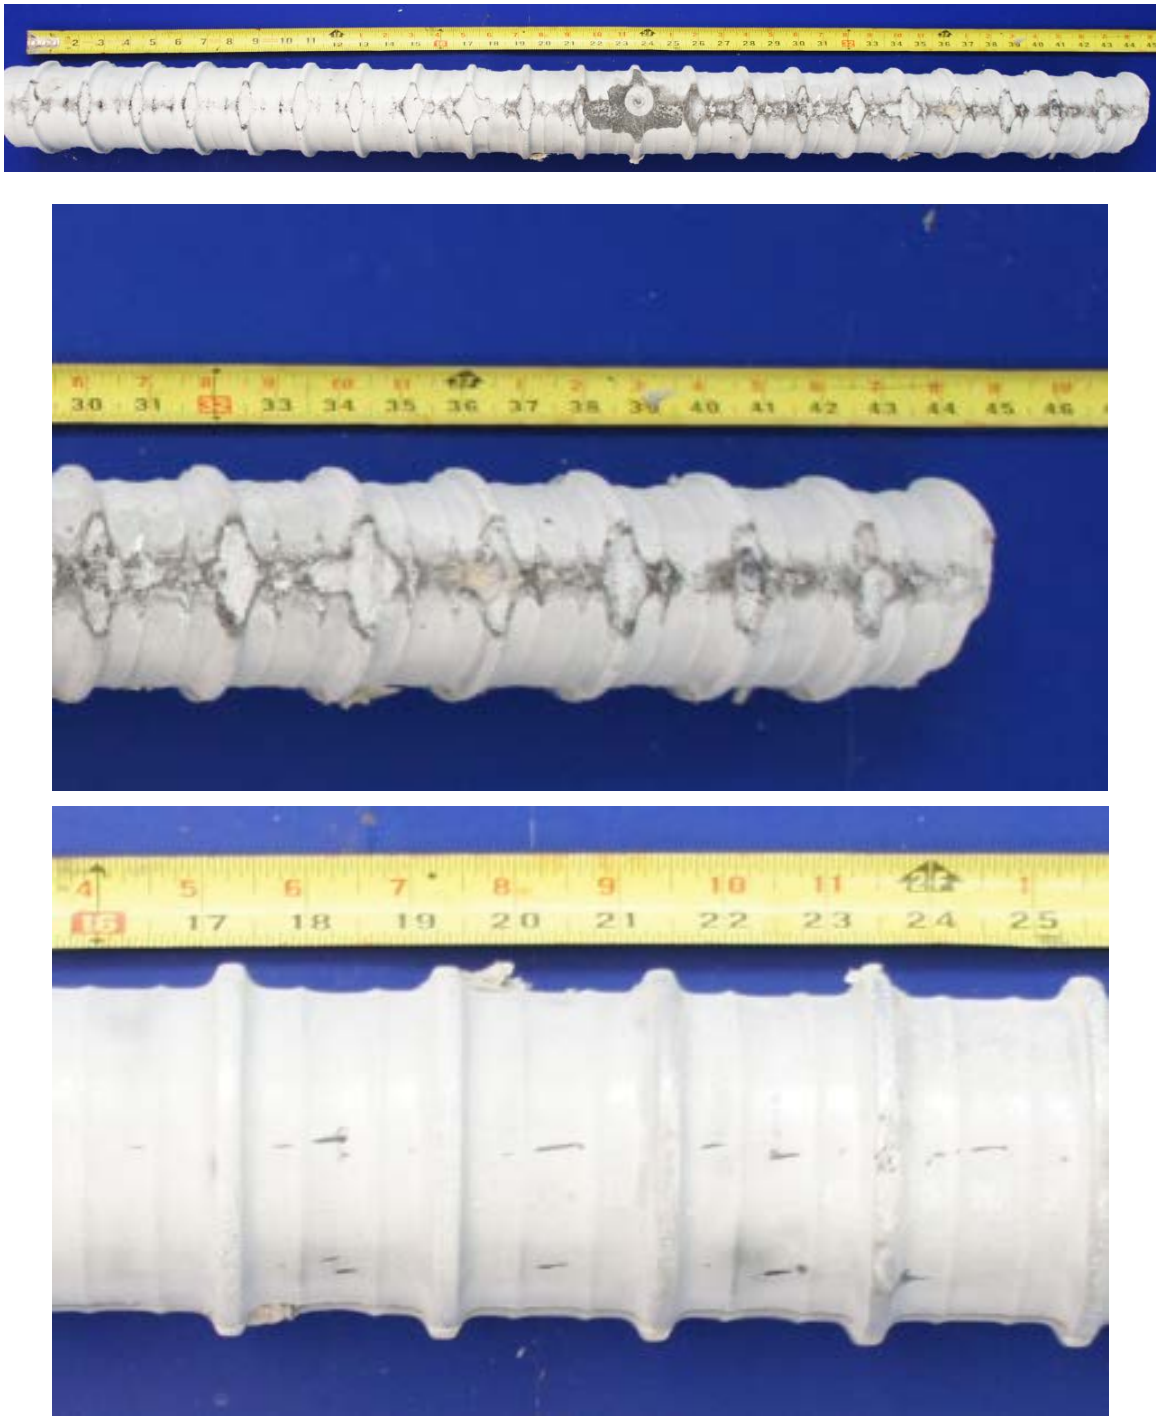
No transverse or longitudinal visible cracks were observed during examination of grout from the north and south grouts of Specimen 2.3. No staining of the grout was observed on either the north or south tendon. Small voids in the grout were observed in the flutes along the entire length of the top of both the north and south tendons (Figure 6.52). The small voids measured approximately 1.5 inch long and were as wide as the flute width. Segregation of the grout was observed on the live and dead end of both the north and south tendon (Figure 6.52). Portions of the strands were visible in the grout on the bottom of the north and south tendon (Figure 6.52).

**Figure 6.52: Voids in Grout (Top), Segregation of Grout (Middle), and Strands Visible in Grout (Bottom) in the South Tendon of Specimen 2.3**

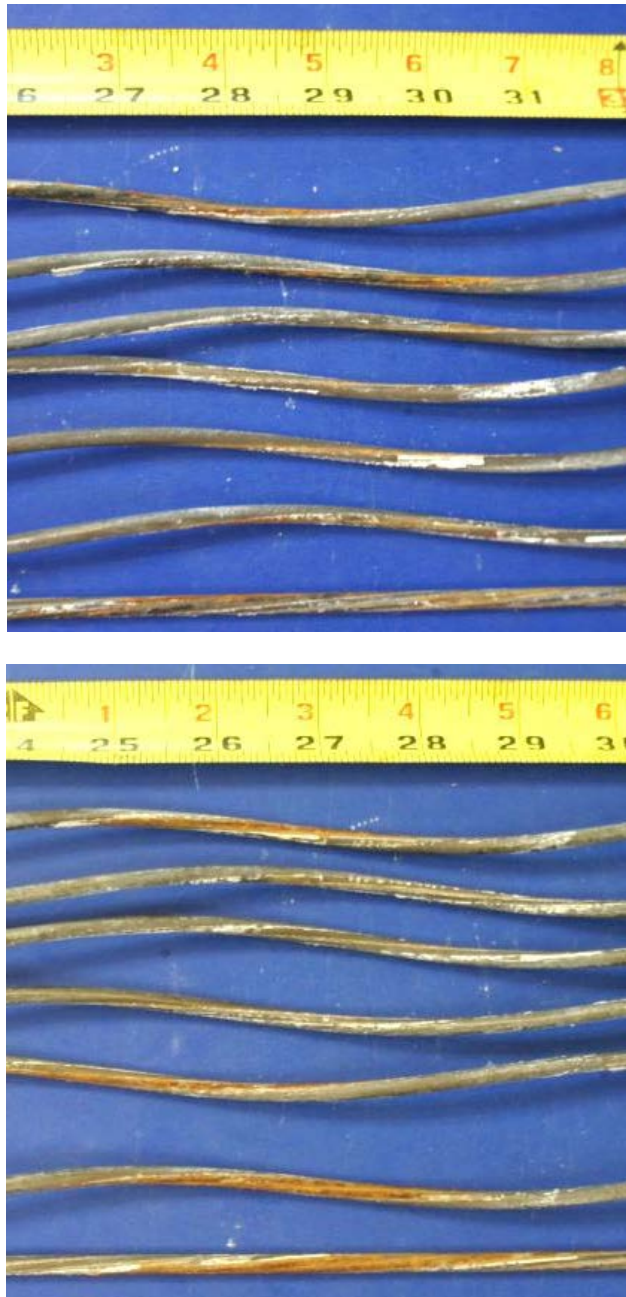
***Figure 6.53: Moderate Corrosion on Outer and Inner Wires of Strands from the North (Top) and South (Bottom) Tendon of Specimen 2.3***

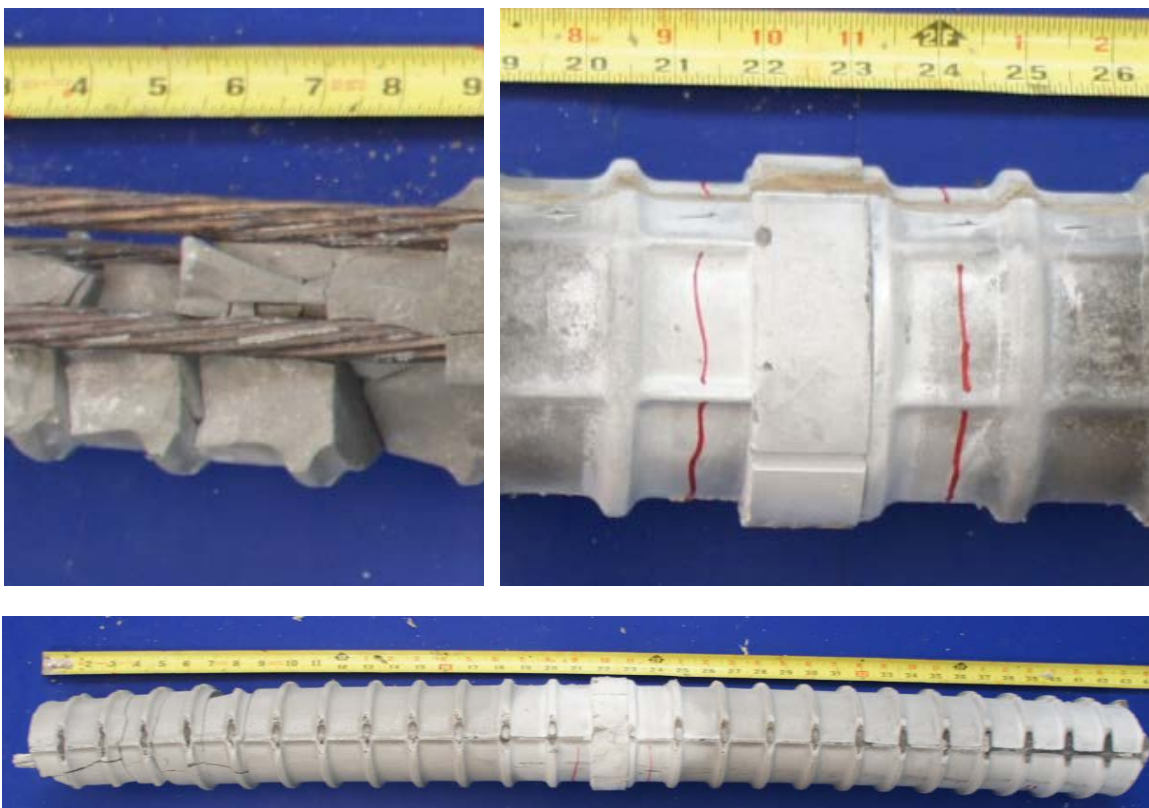
**Figure 6.65: Transverse Cracks (Top Left), White Crystalline Powder (Top Right) and Color Transition (Bottom) of Specimen 3.3 North Tendon**

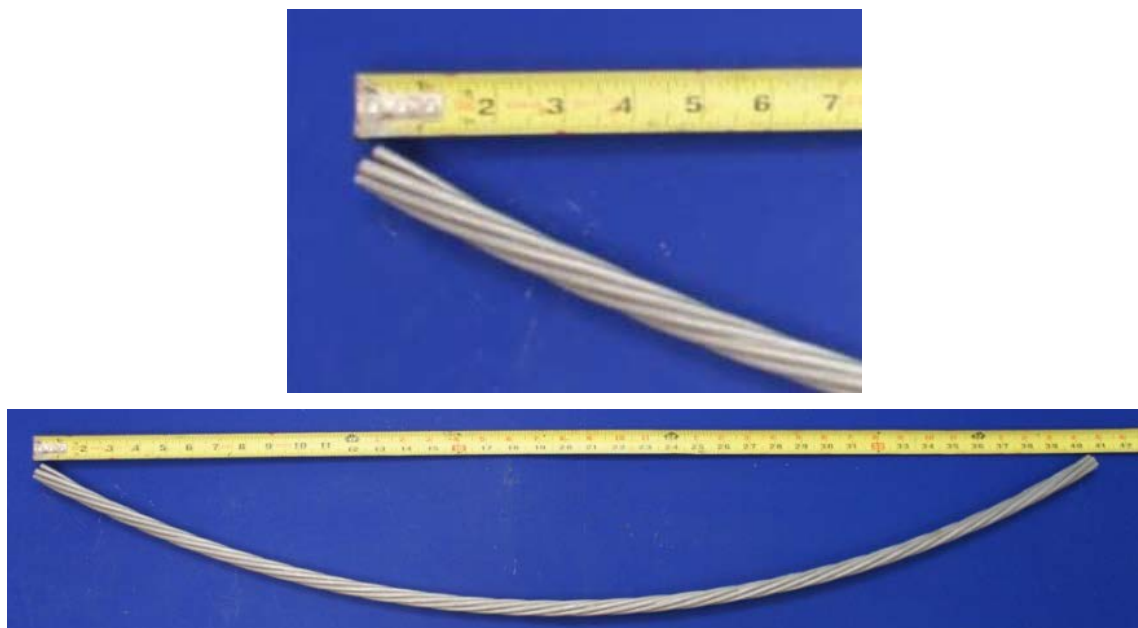
***Figure 6.78: Typical Stainless Steel Strand (Top) and Arched Strand (Bottom) from Specimen 4.1***

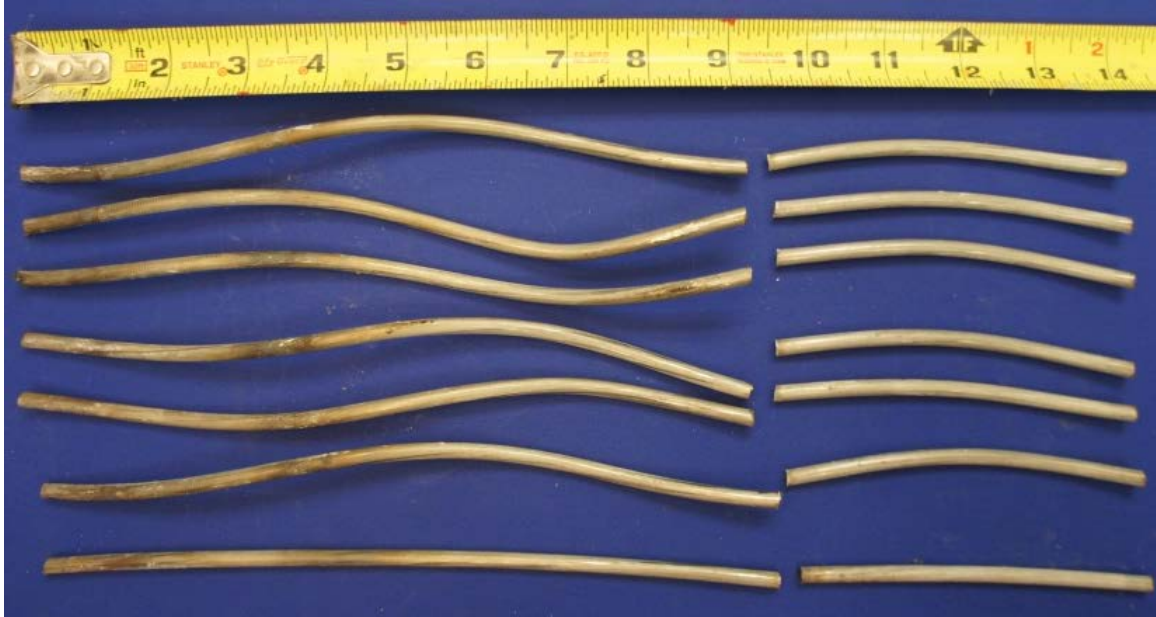
***Figure 6.81: Discoloration of Stainless Steel Wires from the South Tendon in the Dead End Anchorage of Specimen 4.1***

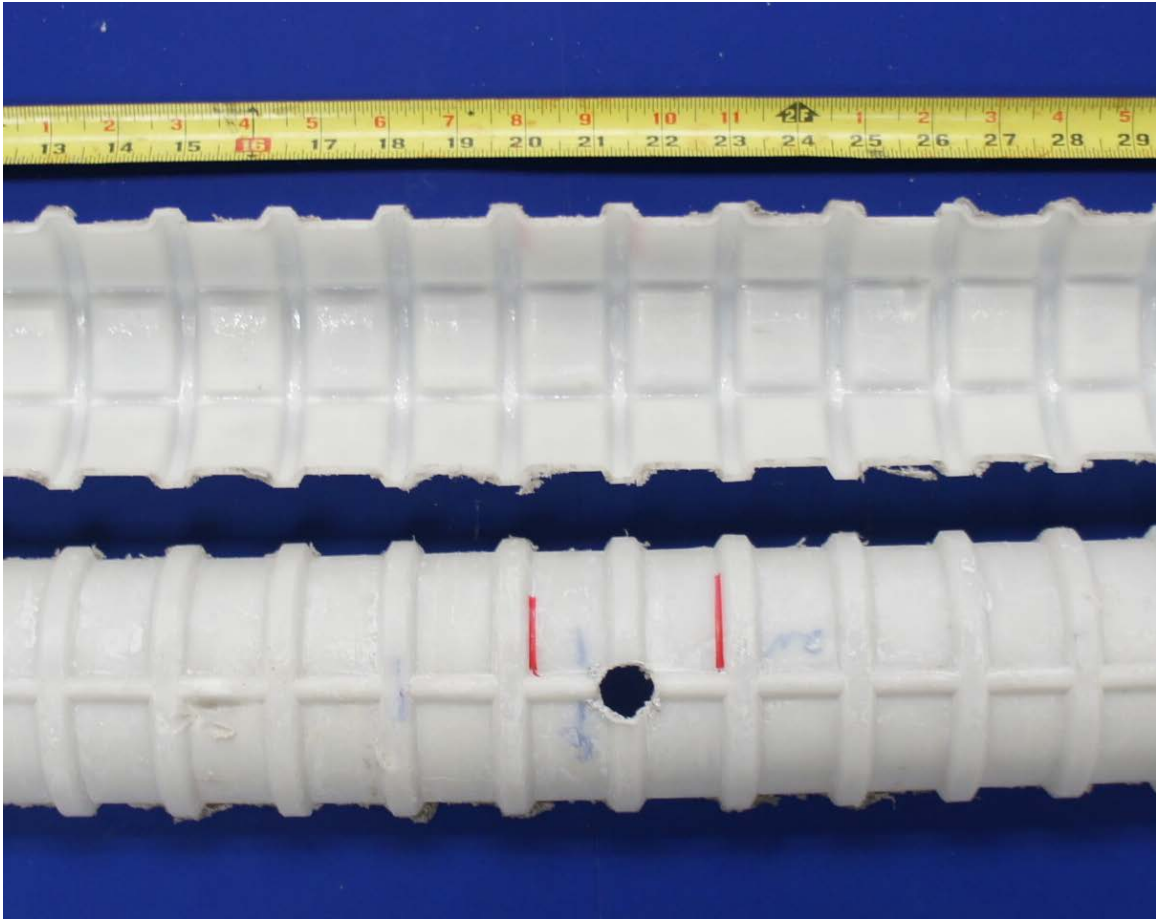
*Figure 6.100: Top Outer (Bottom) and Bottom Inner Surfaces at Midspan of the South Duct from Specimen 5.1*

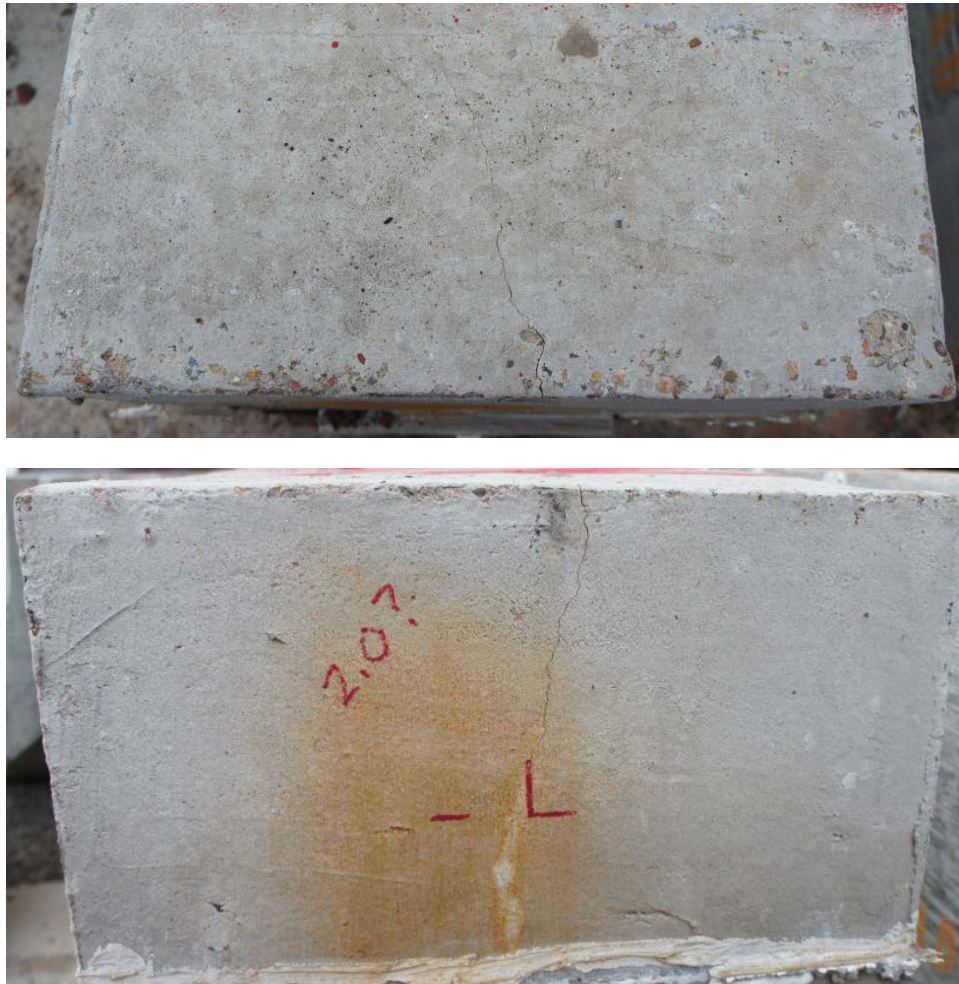
***Figure 6.129: Cracking in the Backfill Mortar of Specimen 7.2***

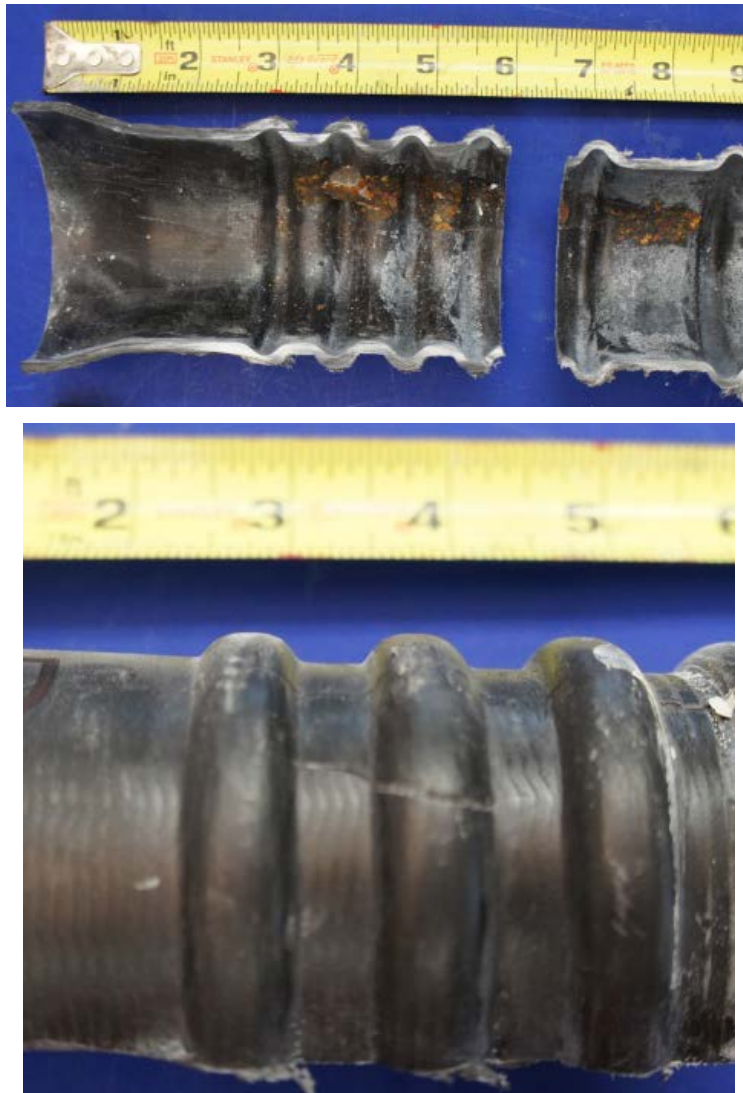
***Figure 6.134: Rust Stains on Duct (Top) and Crack in Duct (Bottom) Located at the Dead End Grout Vent of Specimen 7.2***

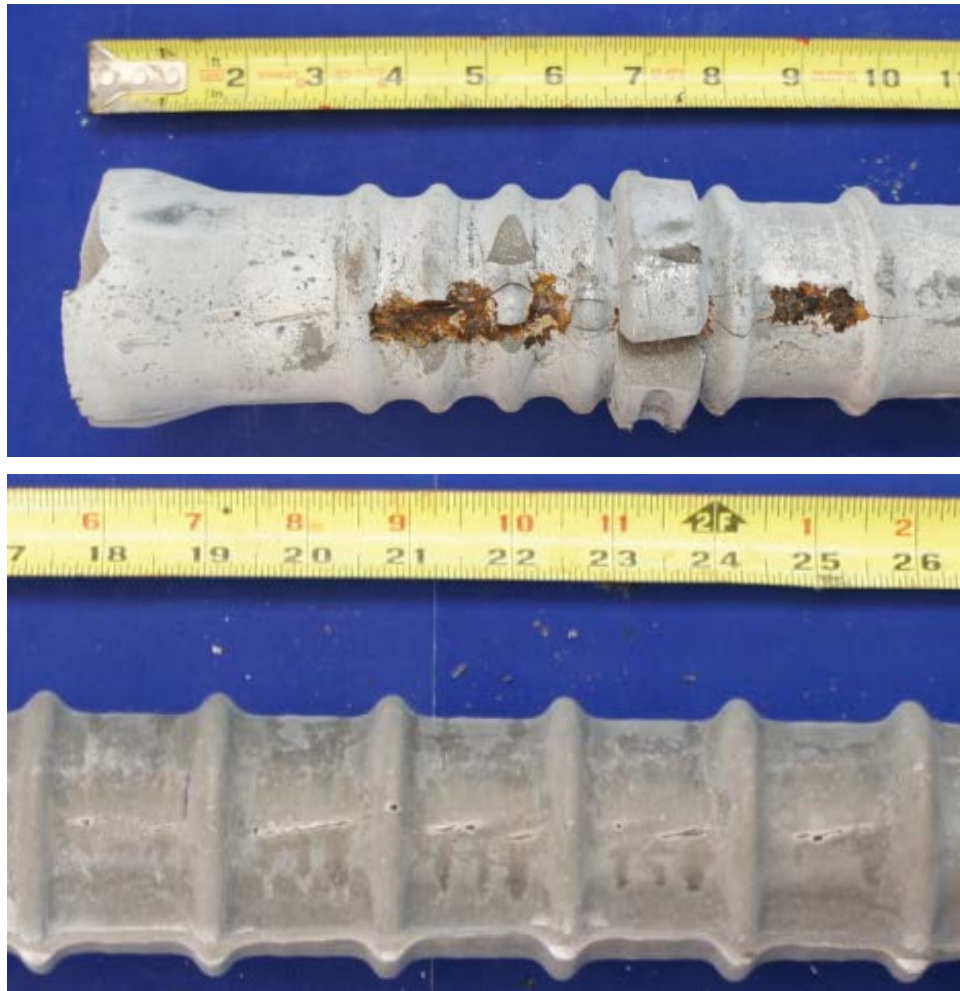
**Figure 6.135: Rust Stain and Longitudinal Cracking at the Dead End Grout Vent (Left) and Visible Wires on the bottom of the Grout (Right) of Specimen 7.2**

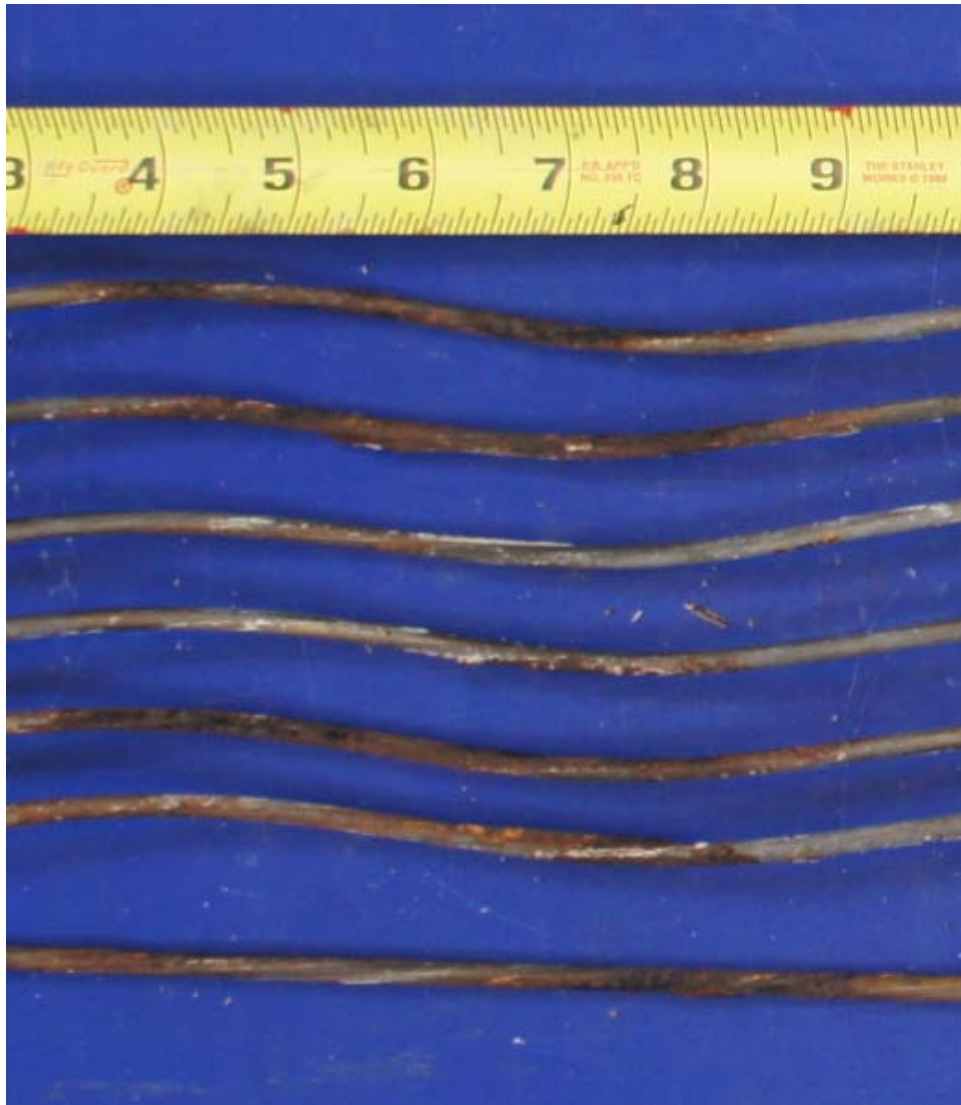
*Figure 6.136: Pitting at Dead End Grout Vent of Specimen 7.2*

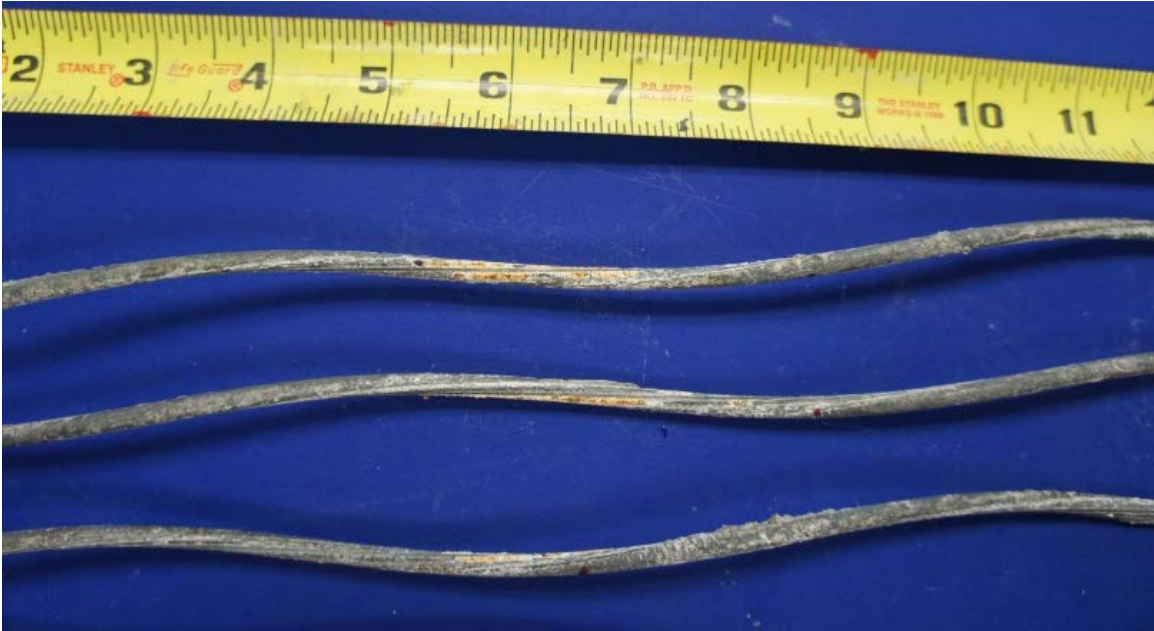
*Figure 6.158: Pitting on the Outer Wires of One Strand from Specimen 7.3*

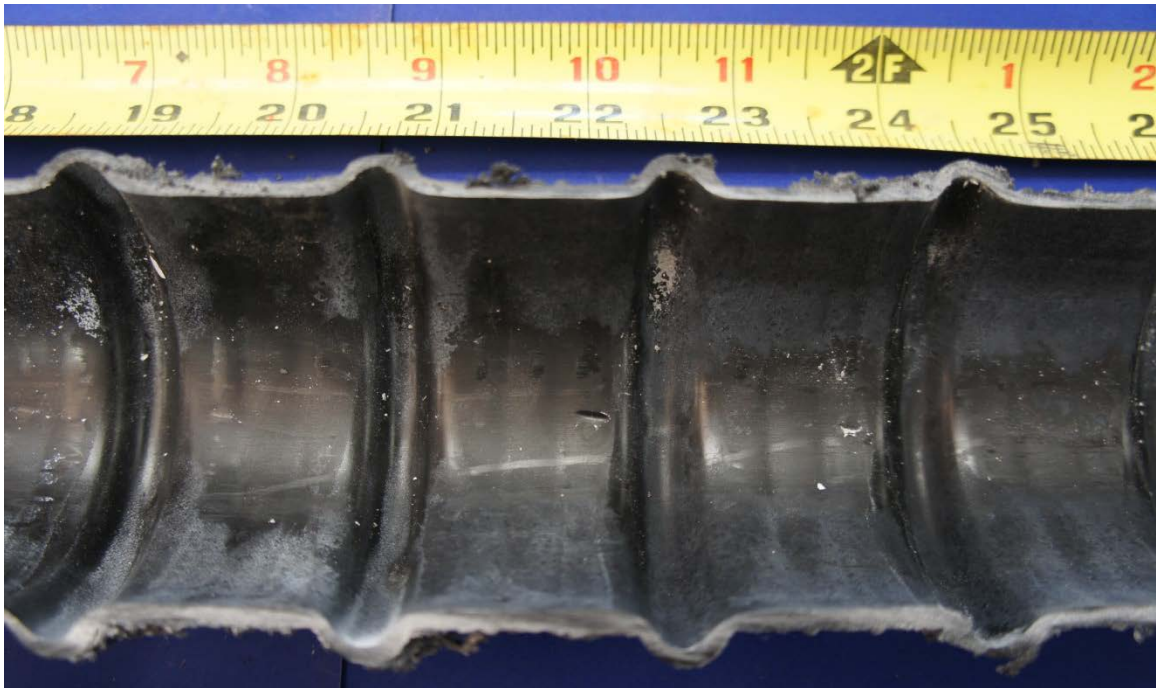
*Figure 6.168: Gouge on the Bottom Inner Surface of the Duct from Specimen 7.4*
