Larry Seth Memberg

**Bridges with Premature Concrete Deterioration: Damage Indices,
Strand-Pullout Tests, and Field Observations**

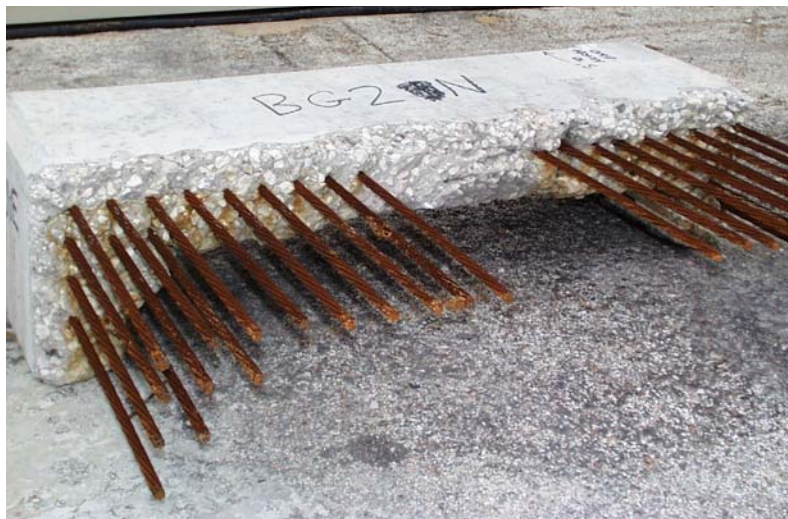
Figure 3.5: *Front view of slice cut from Girder BG2N*

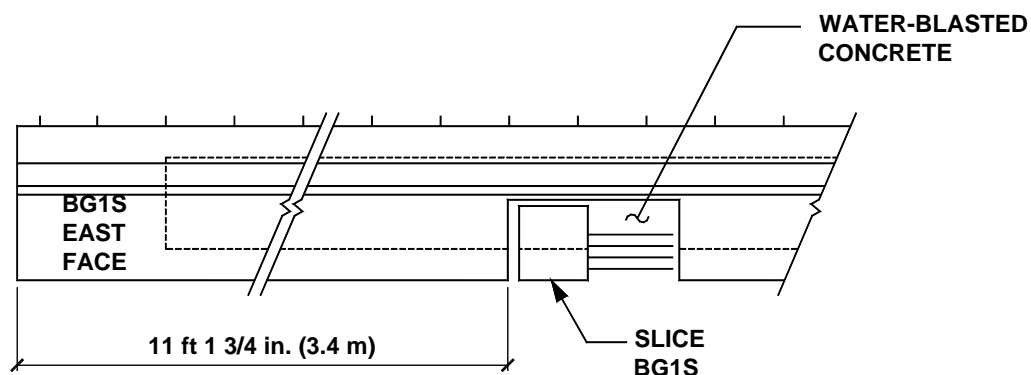
Figure 3.8: Location of slice from Girder BG1S

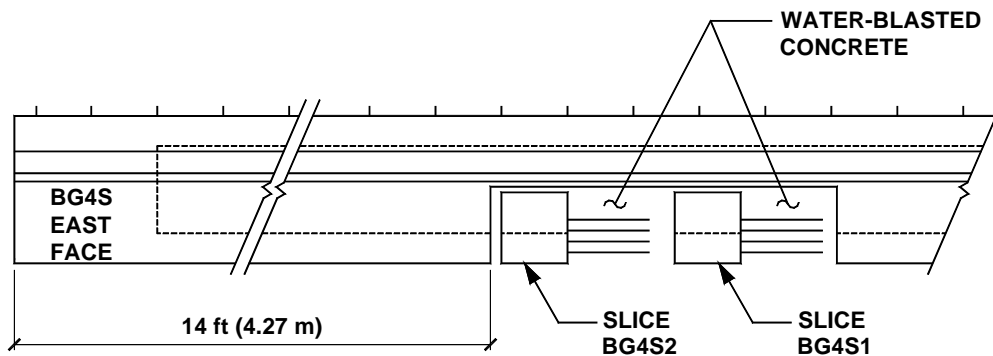
Figure 3.10: Location of slices from Girder BG4S

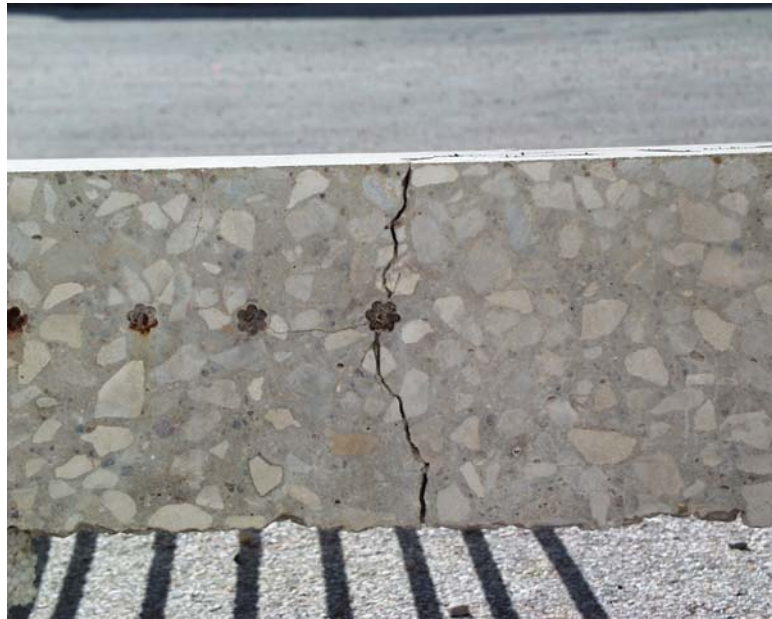
Figure 3.11: Crack through Strand 9L in back face of Slice BG1S

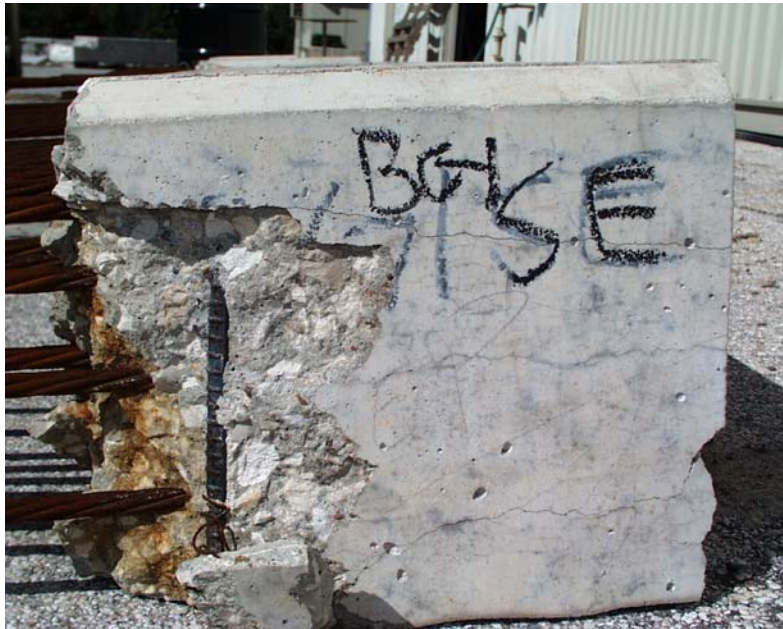
Figure 3.12: Cracking on left face of Slice BG1S

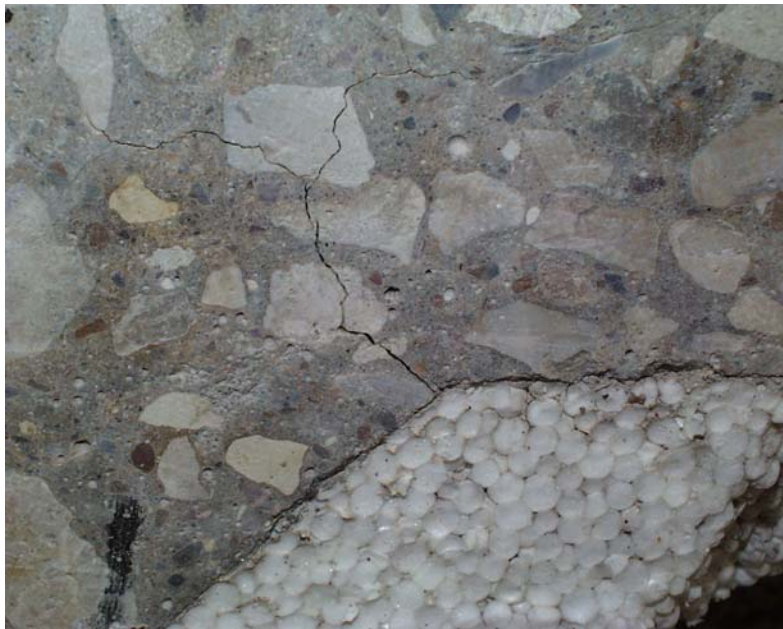
Figure 3.13: Cracks at left inner corner of Slice BG1S

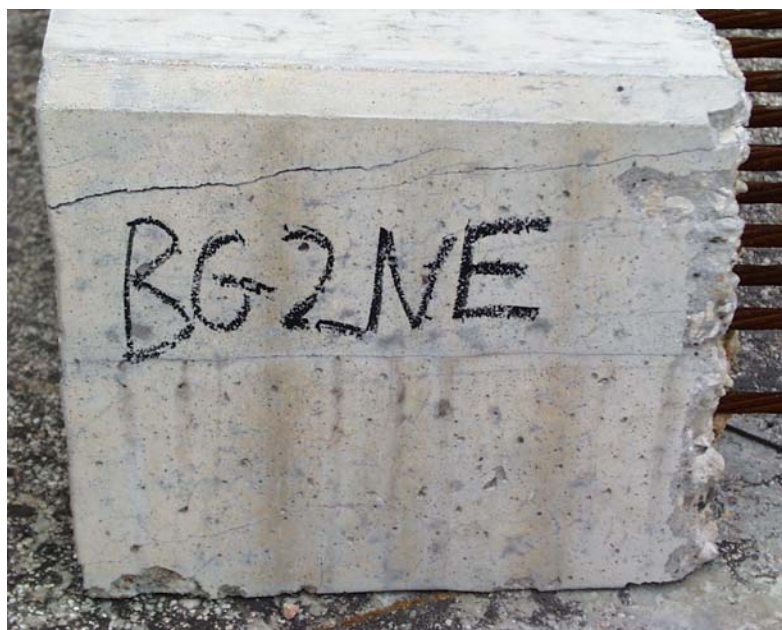
Figure 3.14: Cracking on right face of Slice BG2N

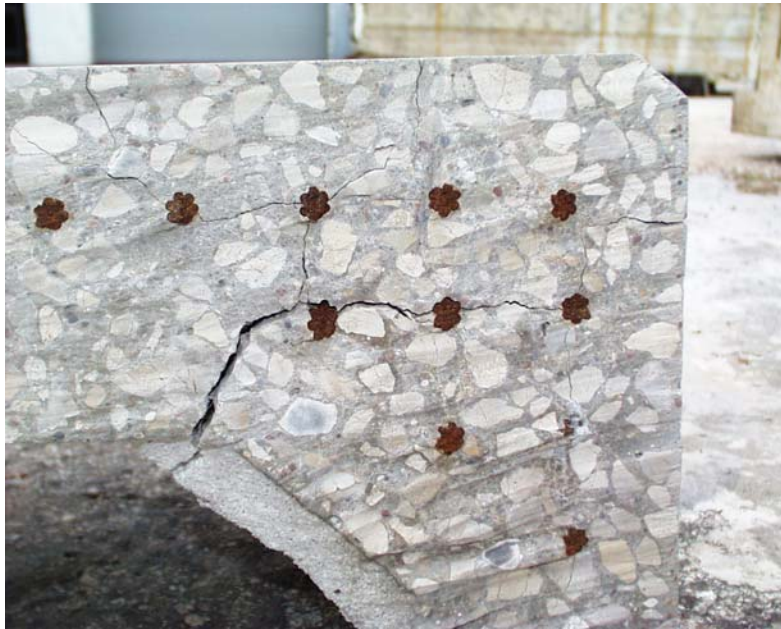
Figure 3.15: Large cracks in back face of Slice BG2N

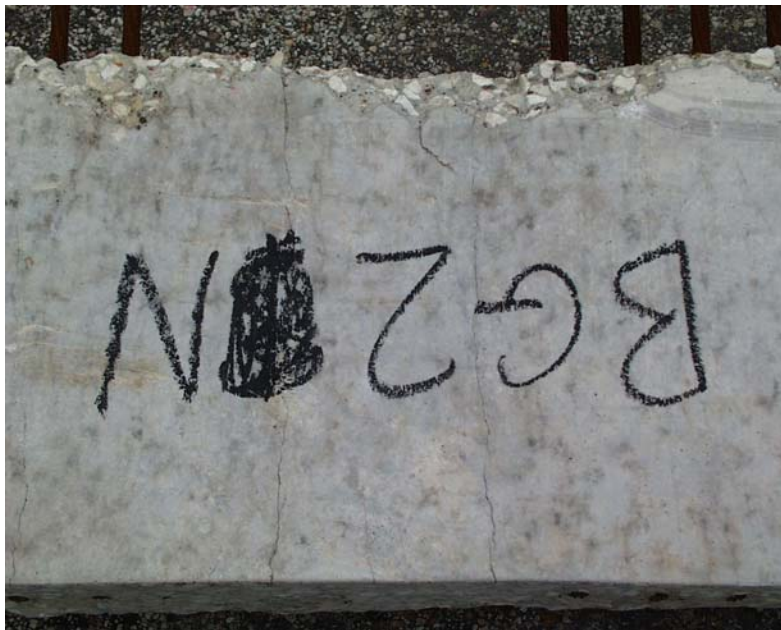
Figure 3.16: Cracking on middle of bottom face of Slice BG2N

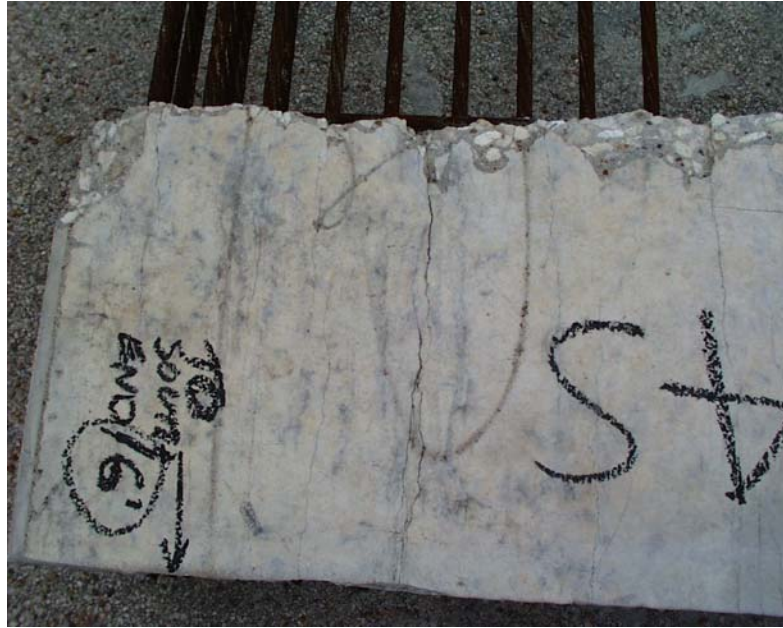
Figure 3.17: Cracking on bottom face of Slice BG4S1

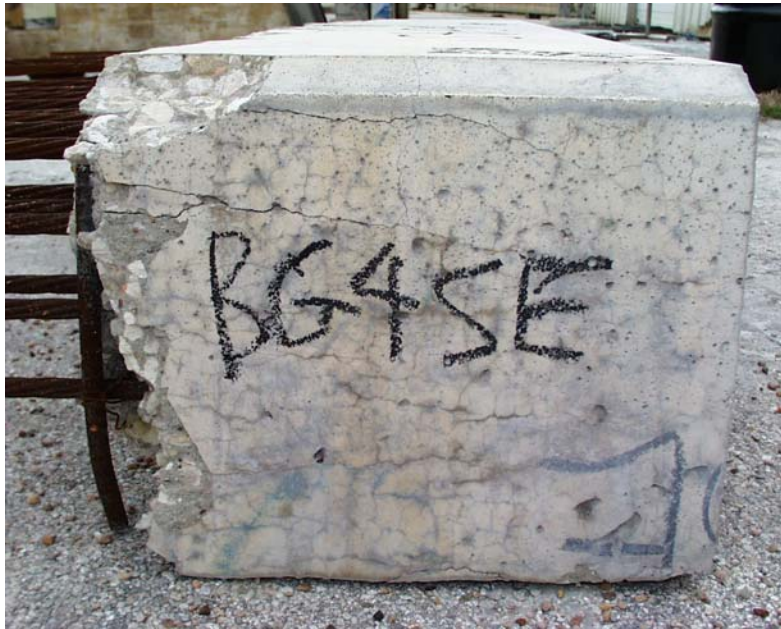
Figure 3.18: Cracking on left face of Slice BG4S1

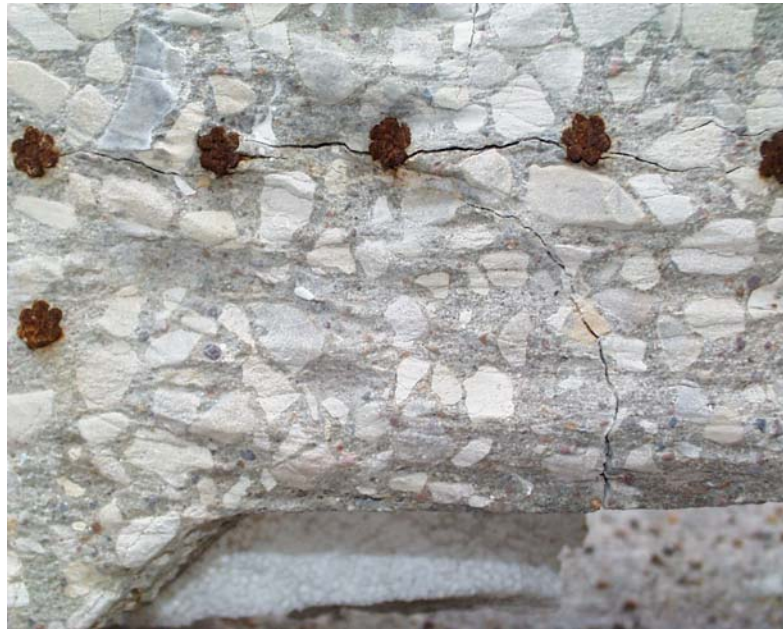
Figure 3.19: Damage to cross-section of Slice BG4S1 (back face)

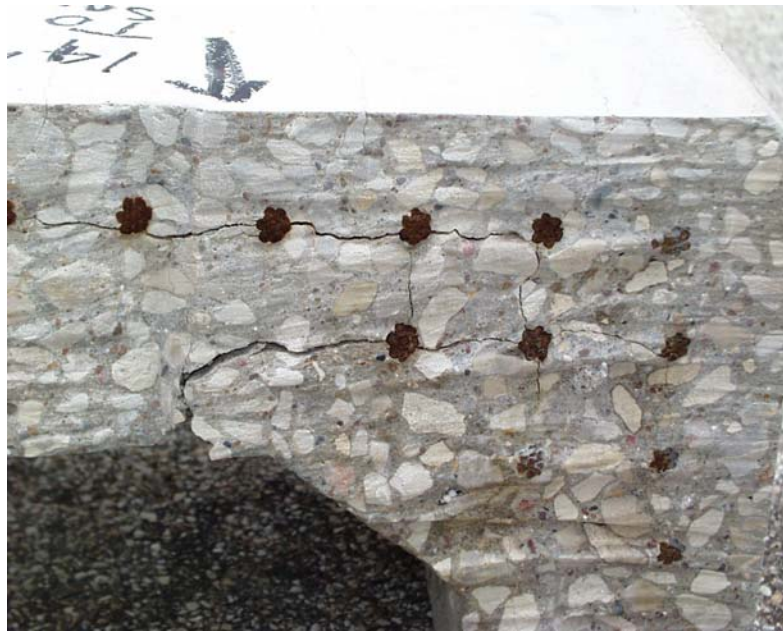
Figure 3.20: Cracking in back face of Slice BG4S2

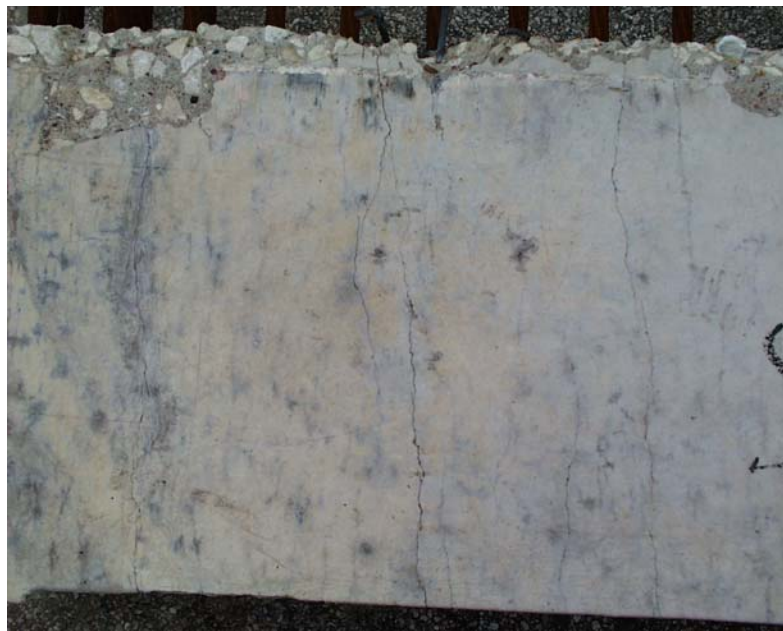
Figure 3.21: Cracking on bottom face of Slice BG4S2

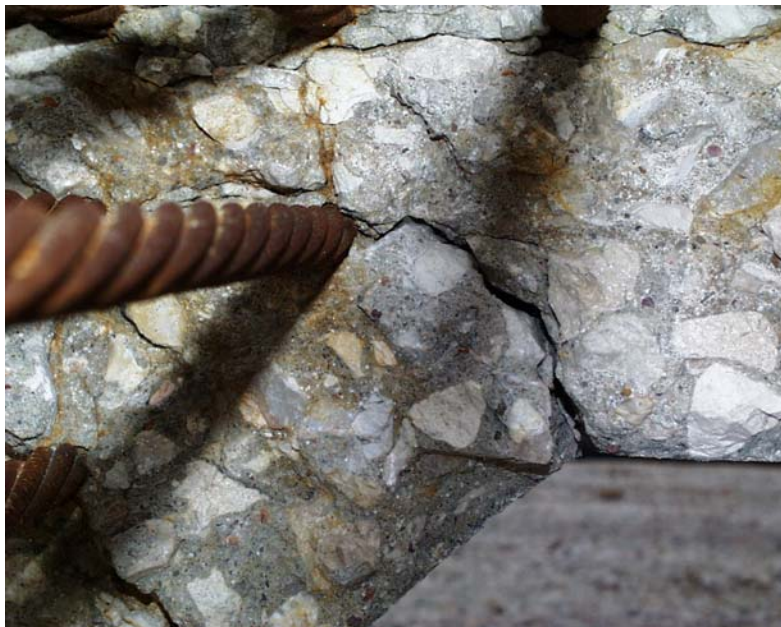
Figure 3.22: Front view of right inside corner of Slice BG4S2

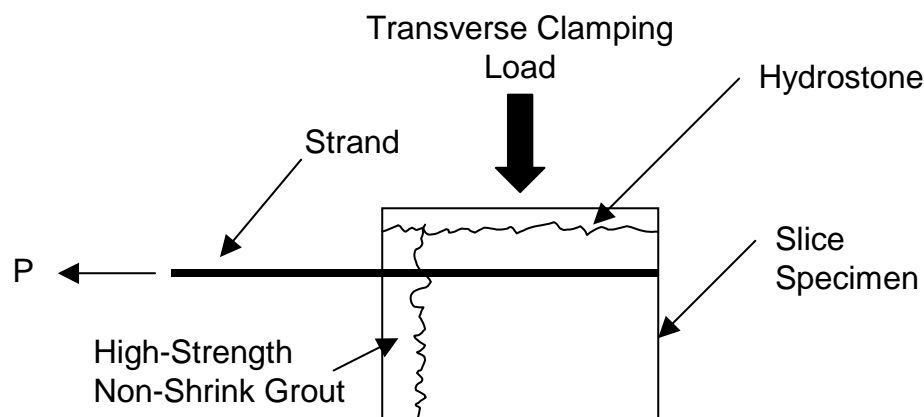
Figure 3.23: Test setup to mimic service conditions in a solid end block

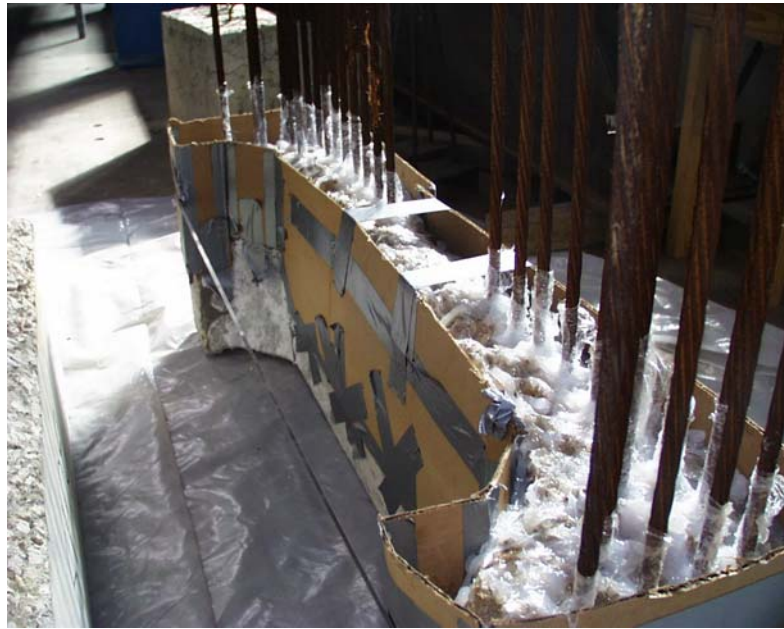
Figure 3.24: Cardboard formwork used for front face

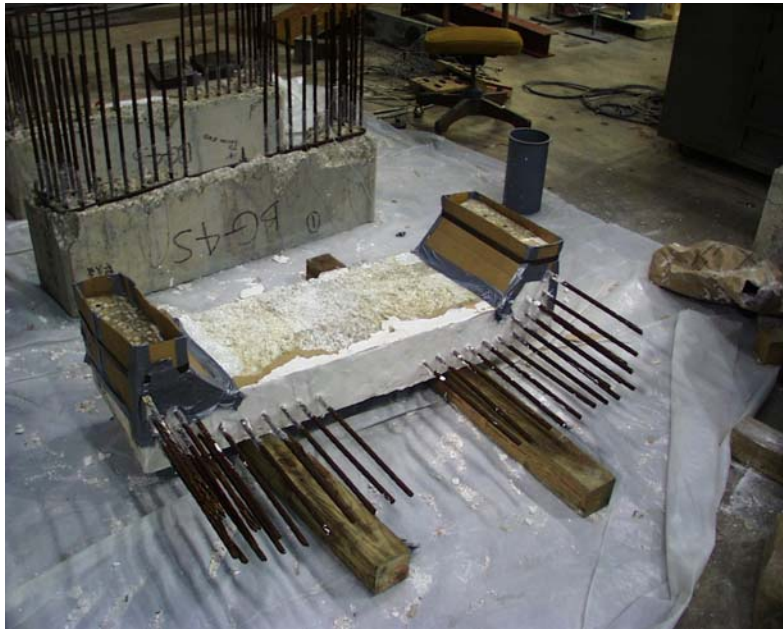
Figure 3.25: Formwork for web sections

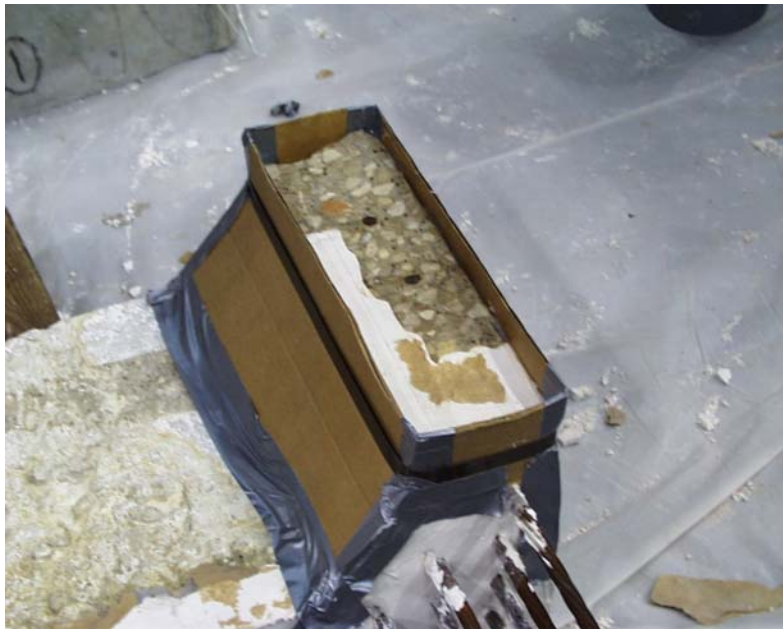
Figure 3.26: Cardboard formwork for top of web

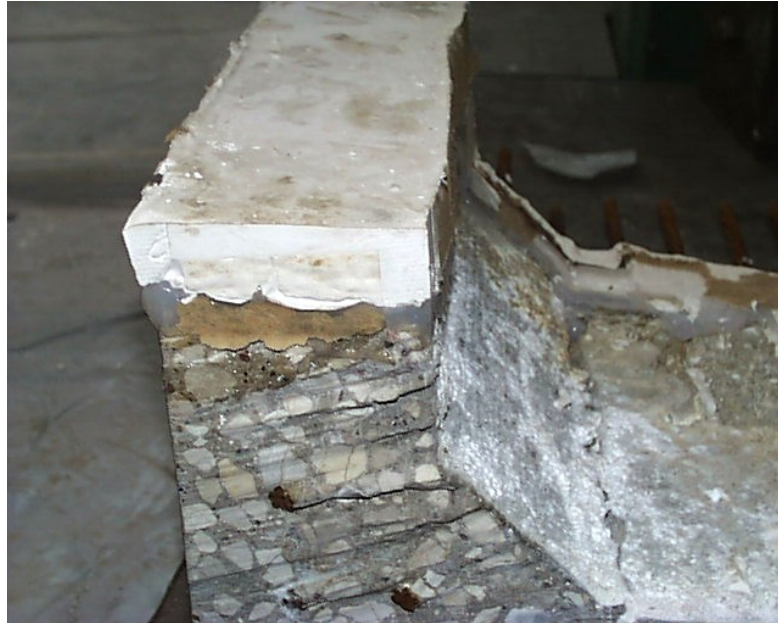
Figure 3.27 Level Hydrostone bearing surface on top of web section

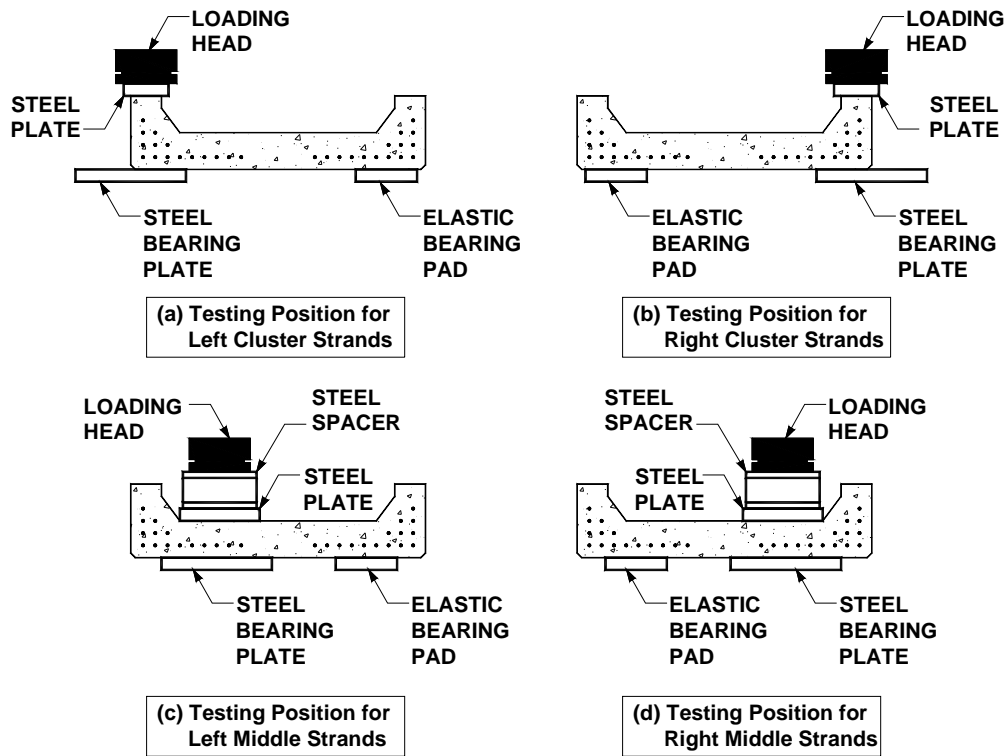
Figure 3.30: Testing positions for specimens

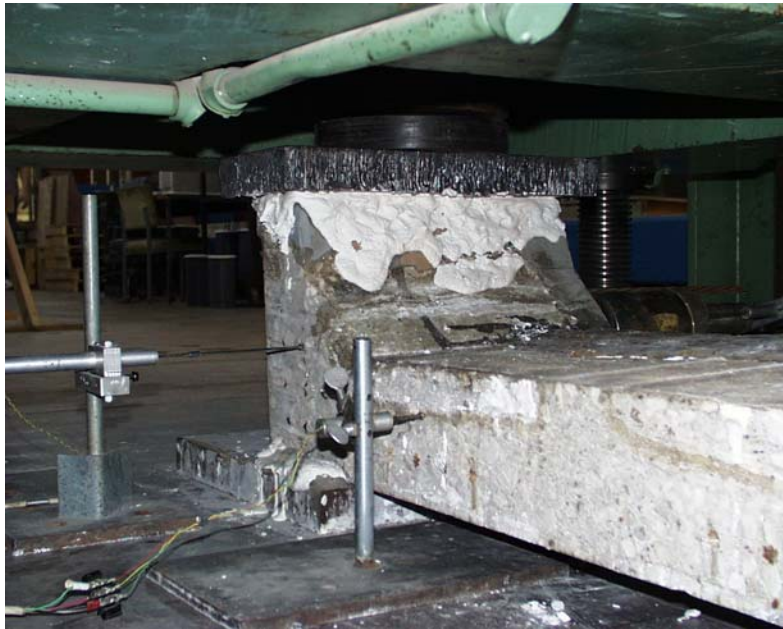
Figure 3.31: Steel plate between loading head and slice specimen

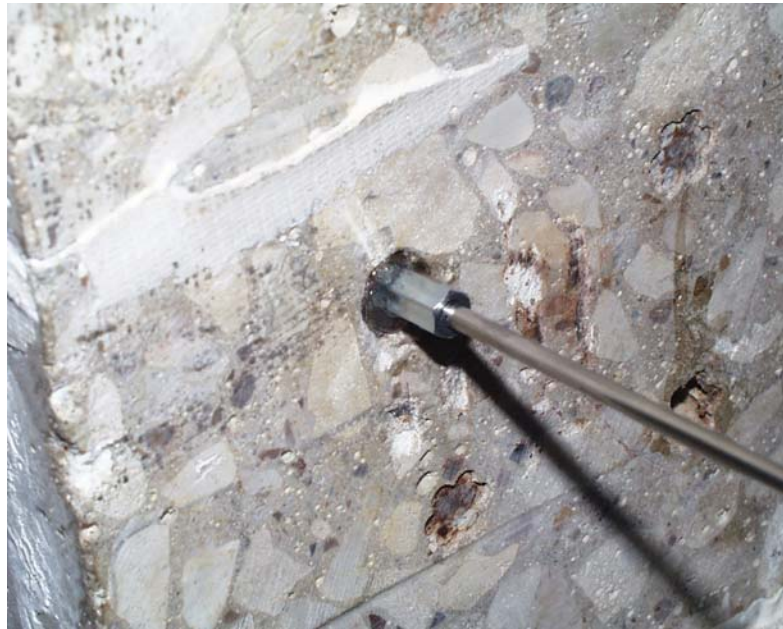
Figure 3.34: Linear potentiometer attached to back of strand

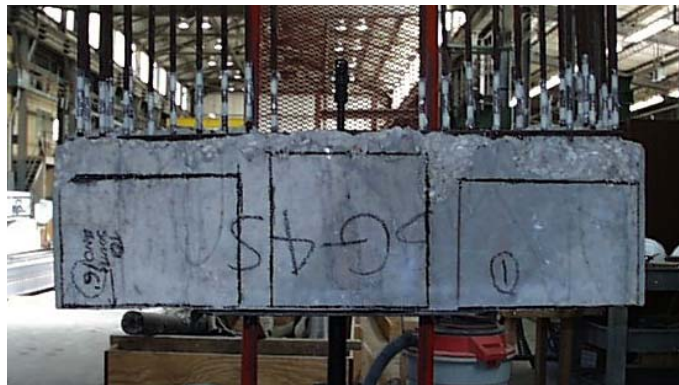
Figure 3.36: *Representative areas for bottom face damage indices*

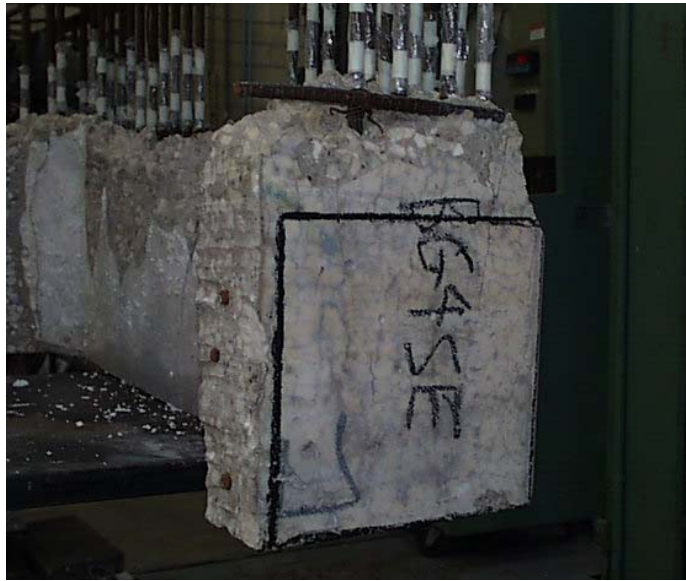
Figure 3.37: Representative square for left side damage index

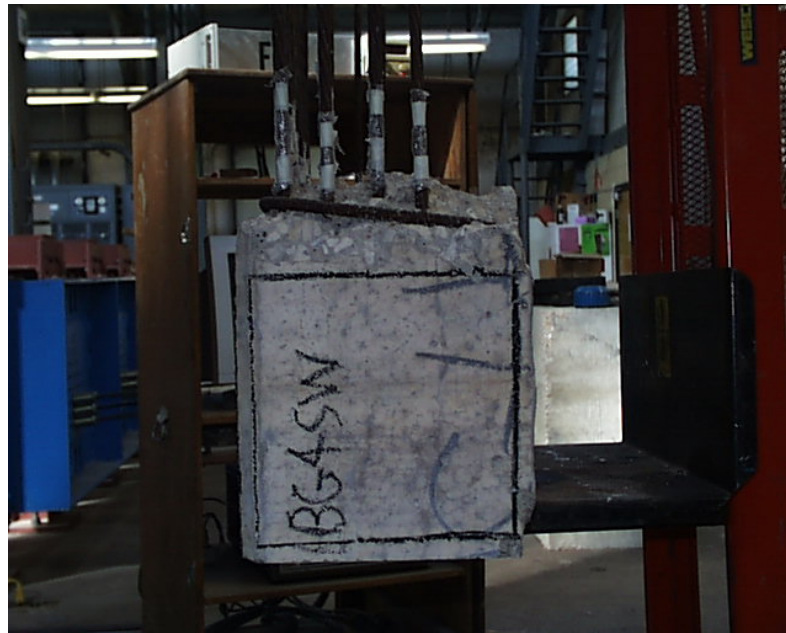
Figure 3.38: Representative square for right side damage index

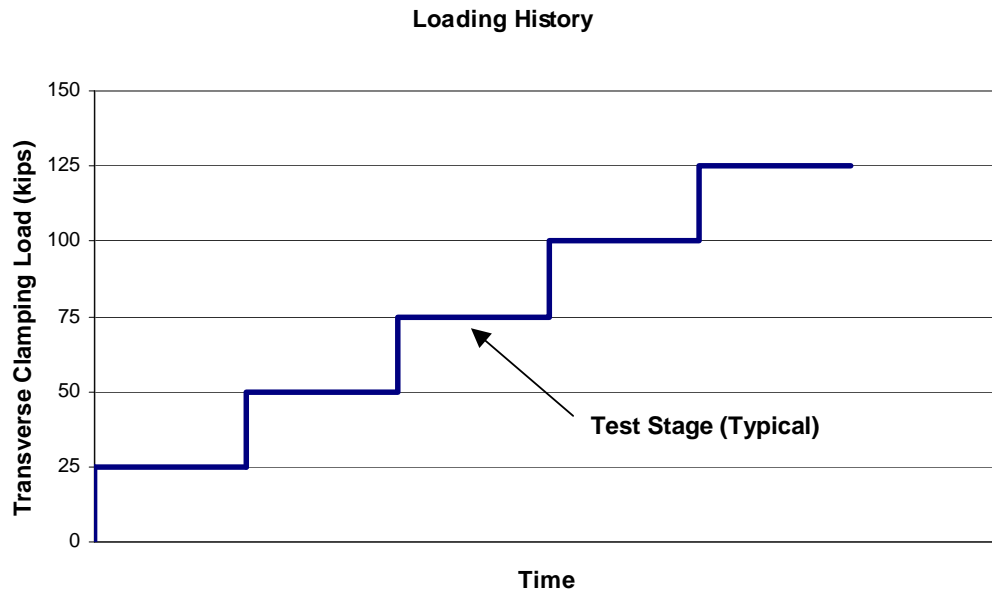
Figure 4.1: Loading history for strand-pullout tests

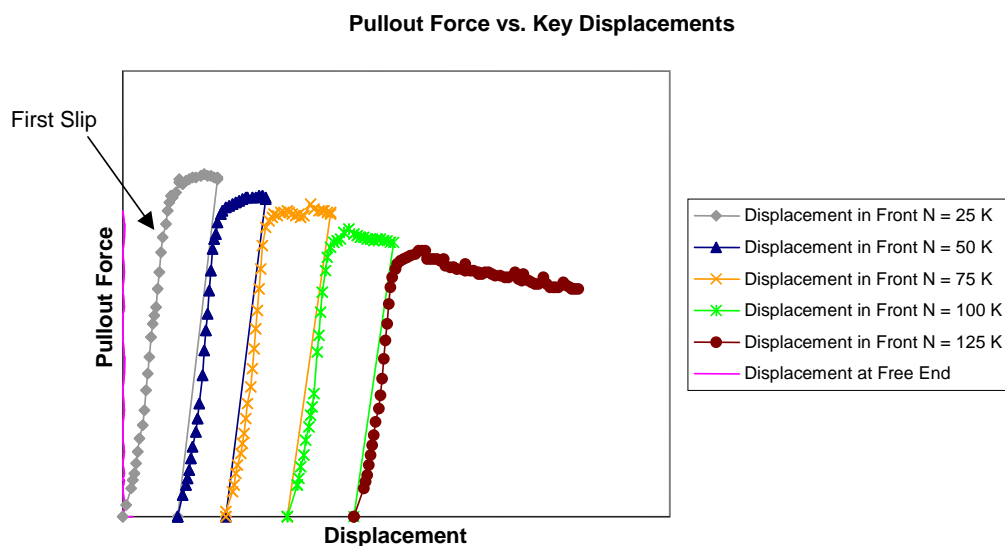
Figure 4.3: *Identifying first slip without reliable free-end data*

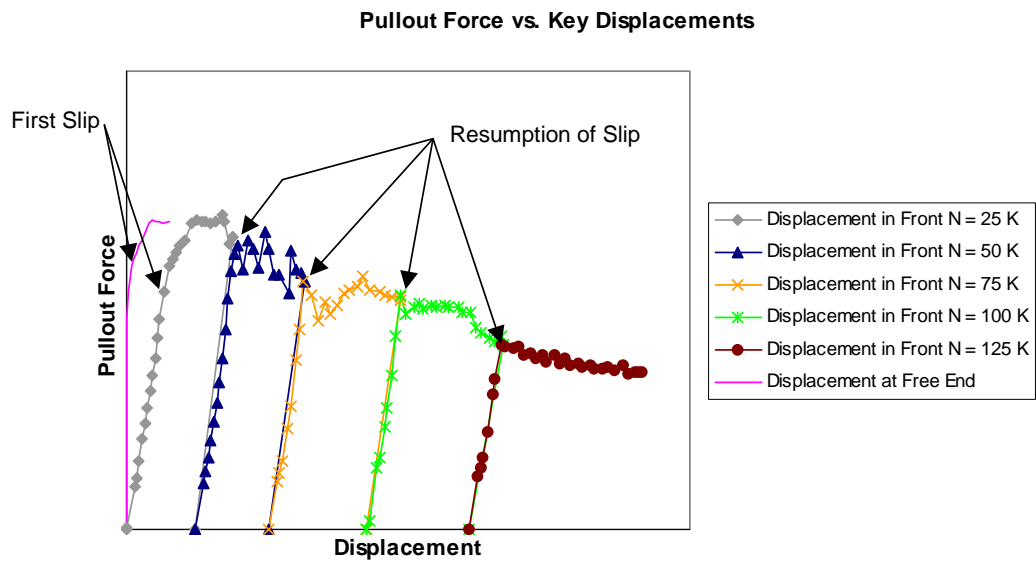
Figure 4.4: *Identifying resumption of slip without reliable free-end data*

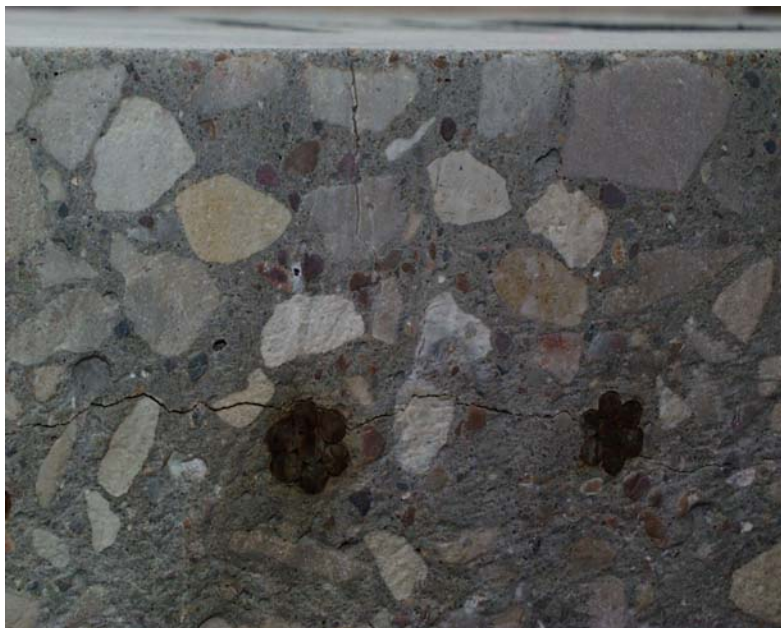
Figure 4.5: Back view of Strand BG2N_8L (right) and Strand BG2N_9L (left)

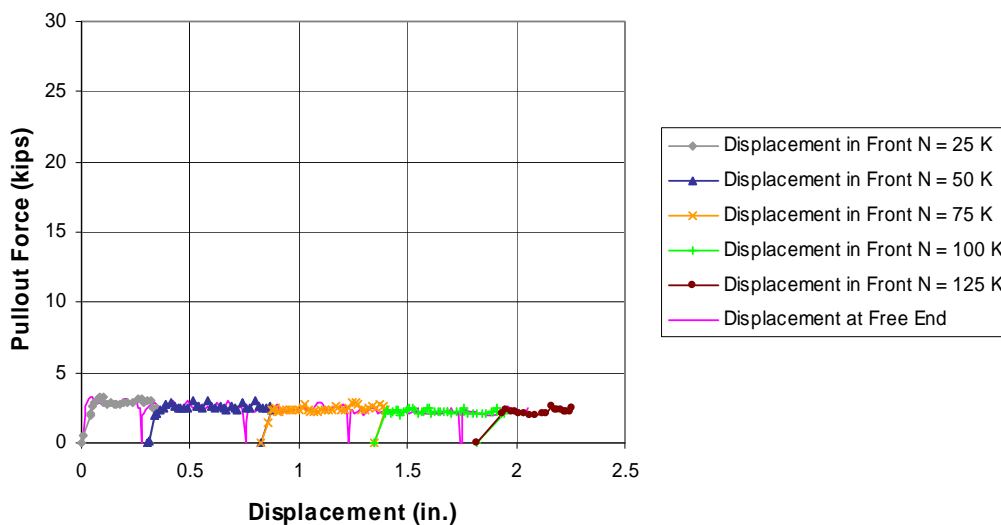
Figure 4.6: Load-displacement Relationship for Strand BG2N_8L

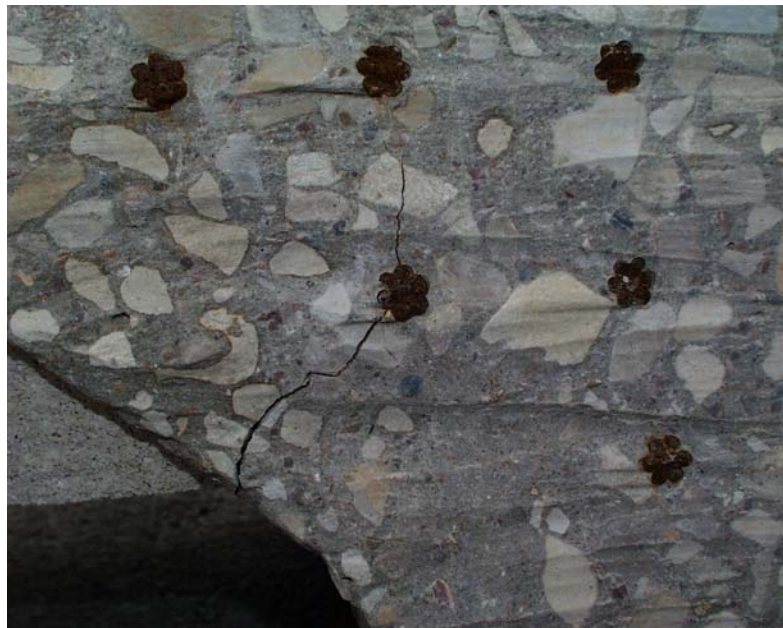
Figure 4.7: Crack in back of Slice BG4S1 at Strand 17R (Center)

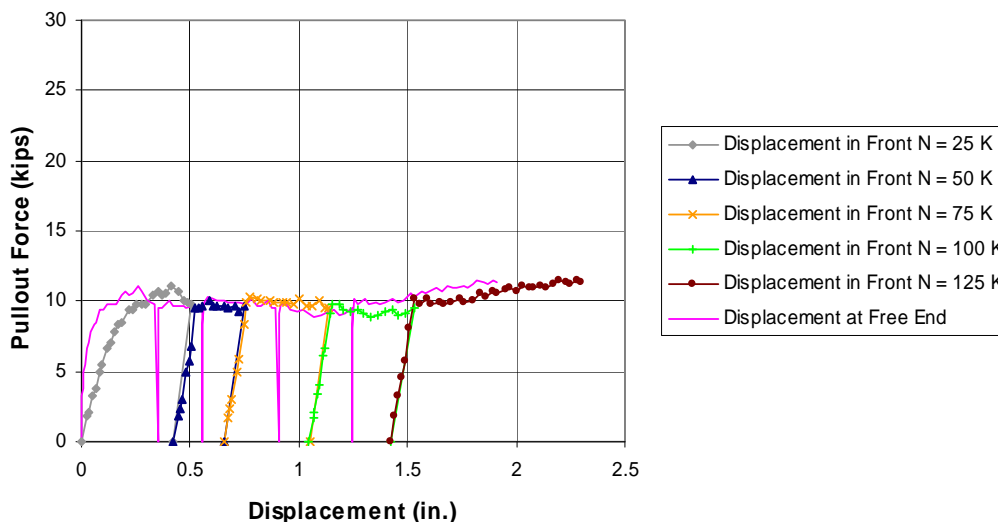
Figure 4.8: Load-displacement Relationship for Strand BG4S1_17R

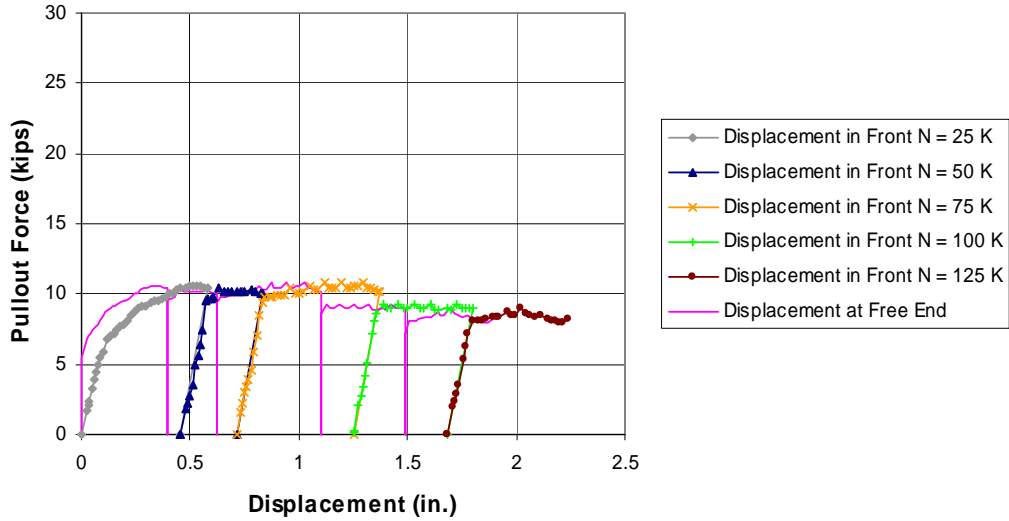
Figure 4.9: Load-displacement Relationship for Strand BG4S2_1L

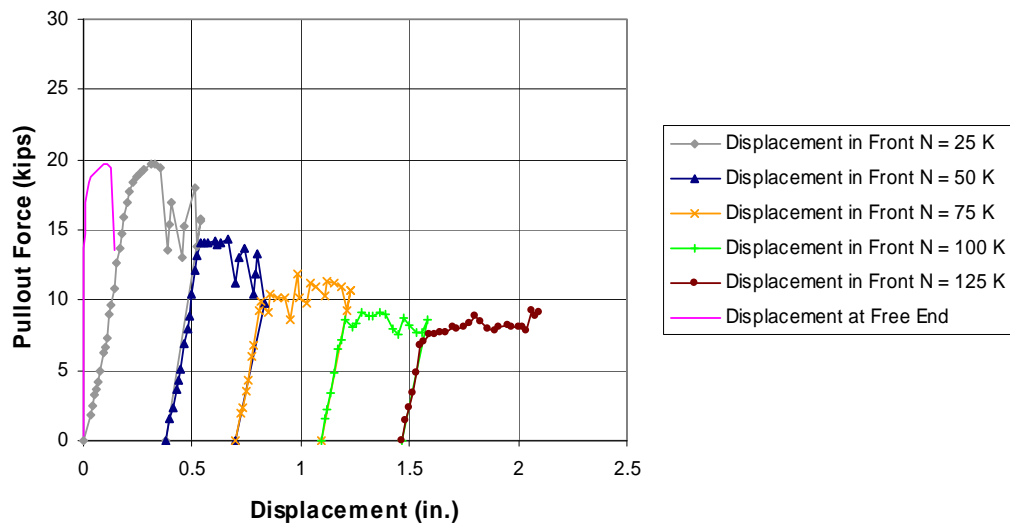
Figure 4.10: Load-displacement Relationship for Strand BG4S1_15L

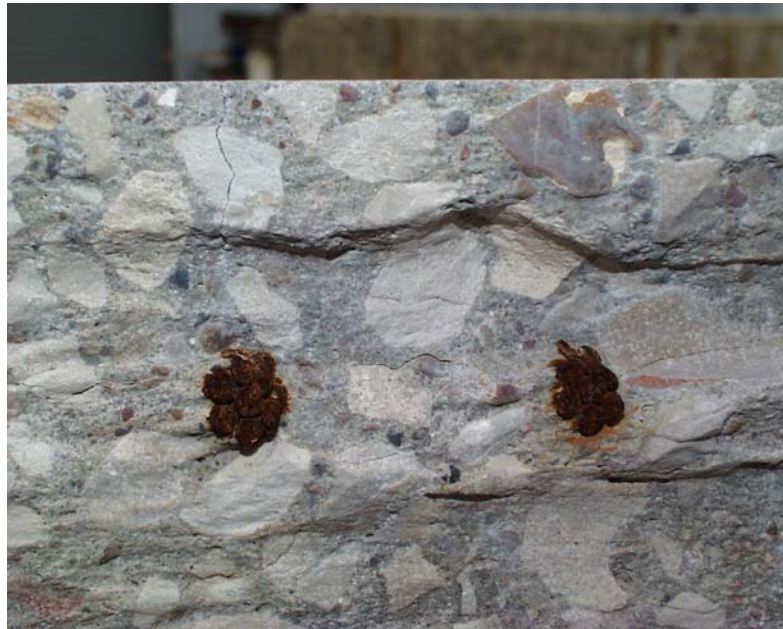
Figure 4.11: Back view of Strand BG4S1_4R (right) and Strand BG4S1_5R (left)

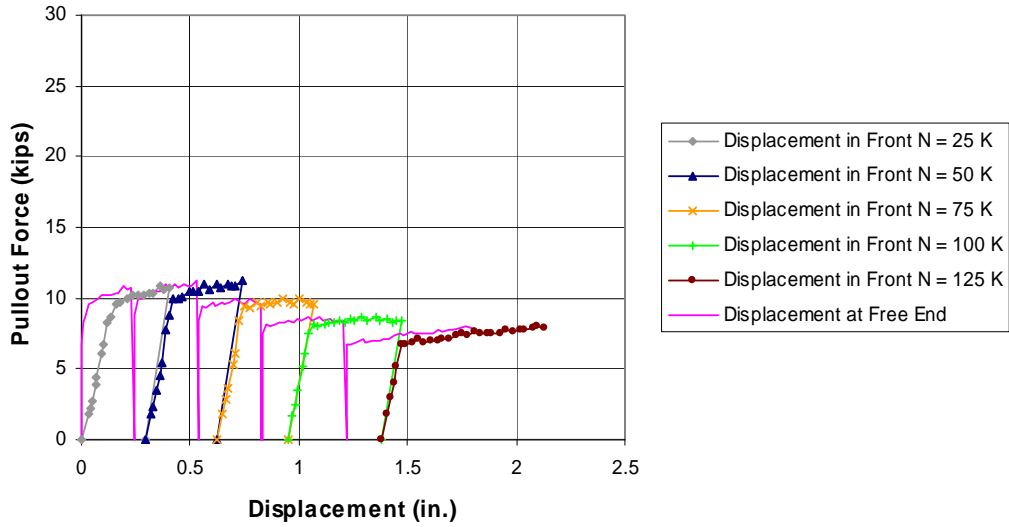
Figure 4.12: Load-displacement Relationship for Strand BG4S1_4R

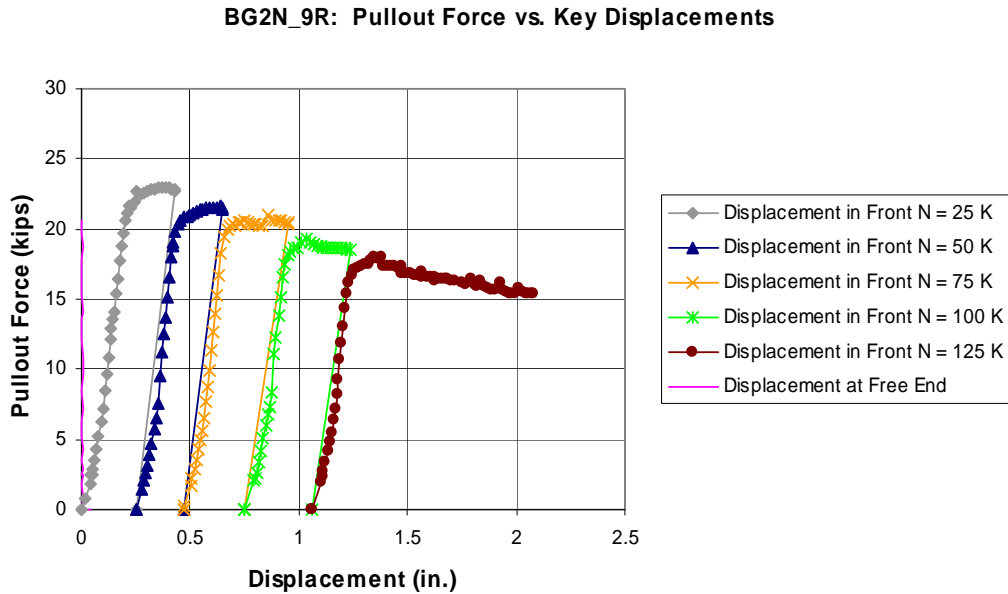
Figure 4.13: Load-displacement Relationship for Strand BG2N_9R

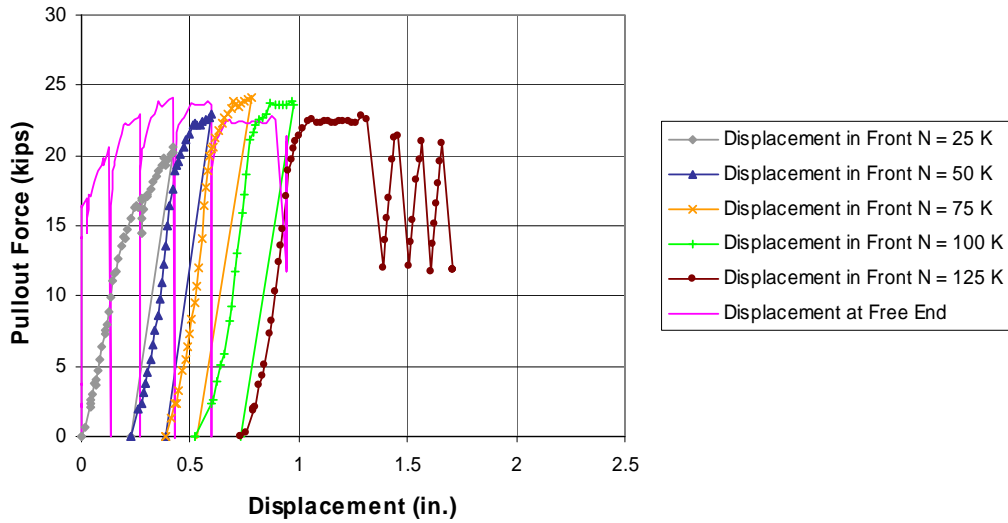
Figure 4.14: Load-displacement Relationship for Strand BG1S_13R

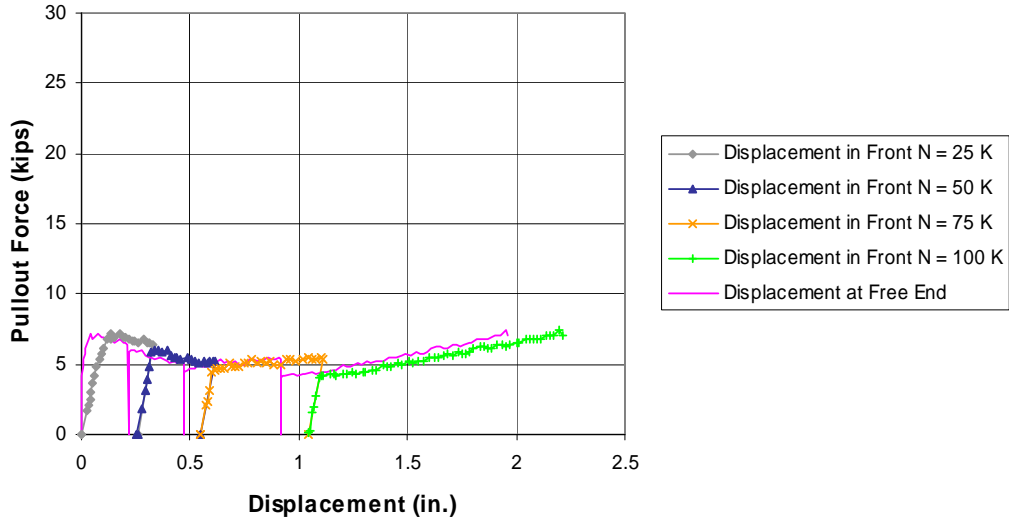
Figure 4.15: Load-displacement Relationship for Strand BG2N_2R

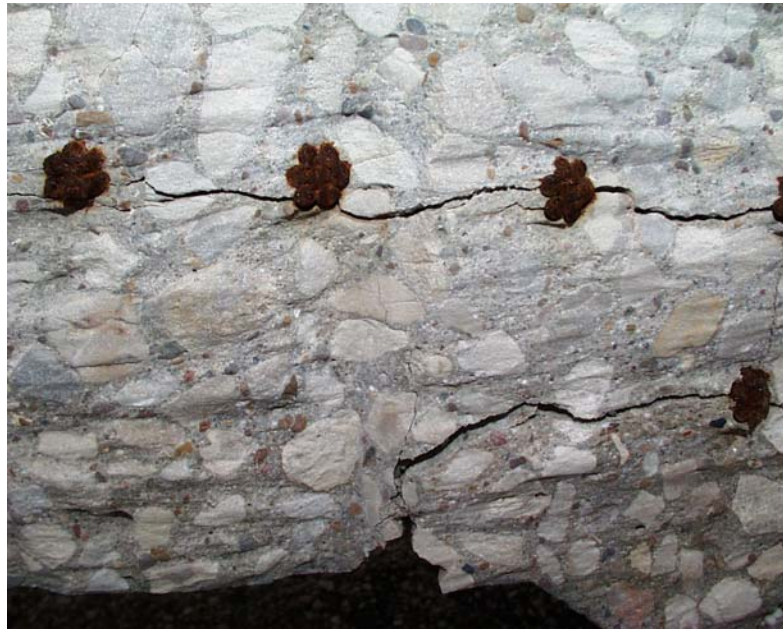
Figure 4.16: Back View of Strand BG4S2_5R (Top Row, Second From Left)

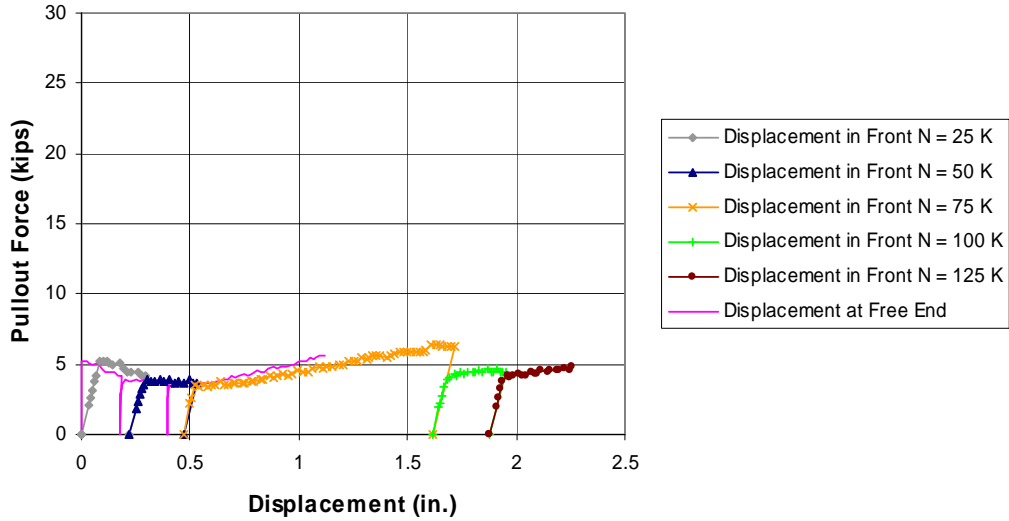
Figure 4.17: Load-displacement Relationship for Strand BG4S2_5R

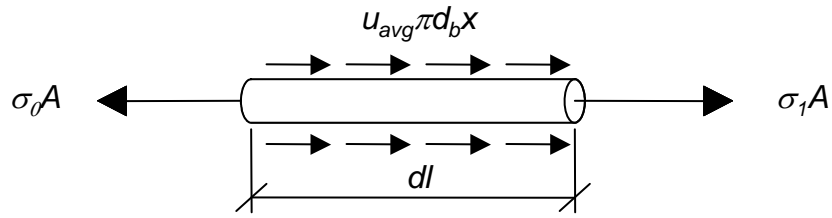
Figure 5.2: Free-body diagram of a smooth bar in concrete

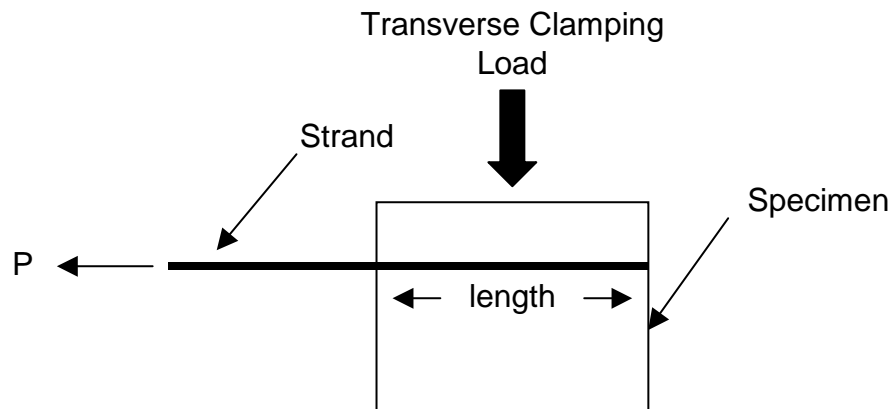
Figure 5.3: Experimental setup used to determine u_{avg}

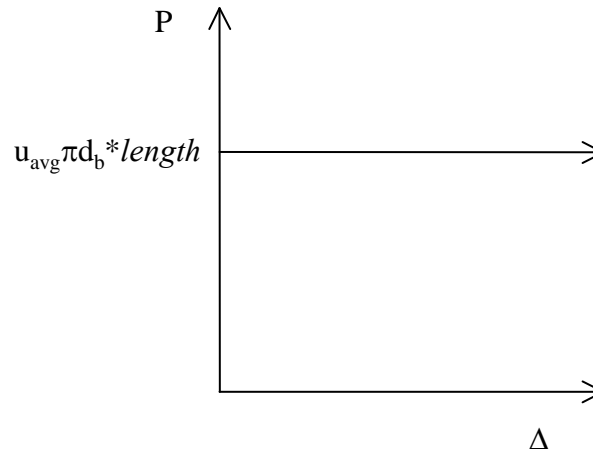
Figure 5.4: *Load-displacement relationship assuming uniform bond stress*

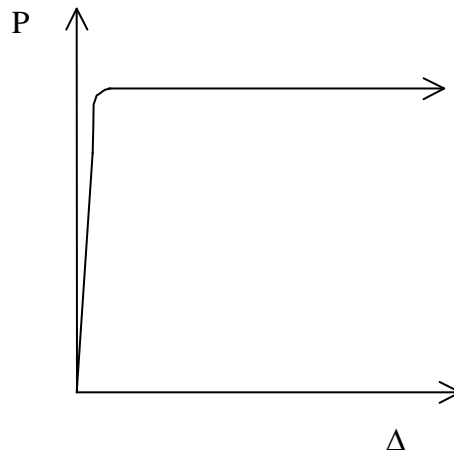
Figure 5.5: *Approximate load-displacement relationship for bond mechanism*

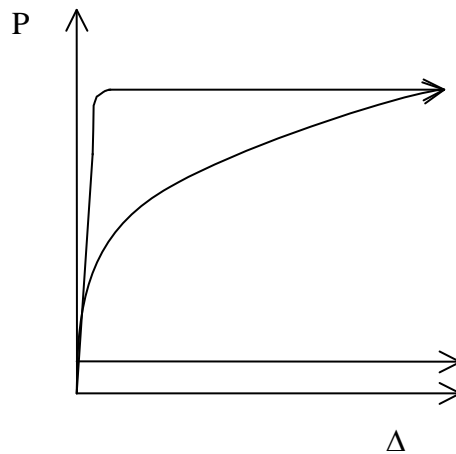
Figure 5.9: *Superposition of the three independent mechanisms*
