Larry Seth Memberg

**Bridges with Premature Concrete Deterioration: Damage Indices,
Strand-Pullout Tests, and Field Observations**

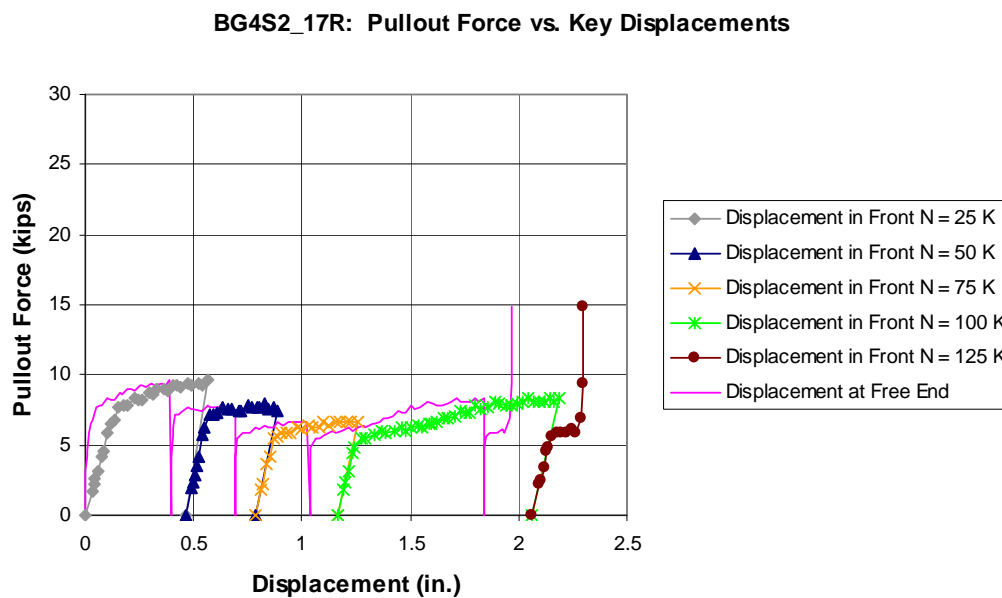
Figure 5.10: Load-displacement Relationship for Strand BG4S2_17R

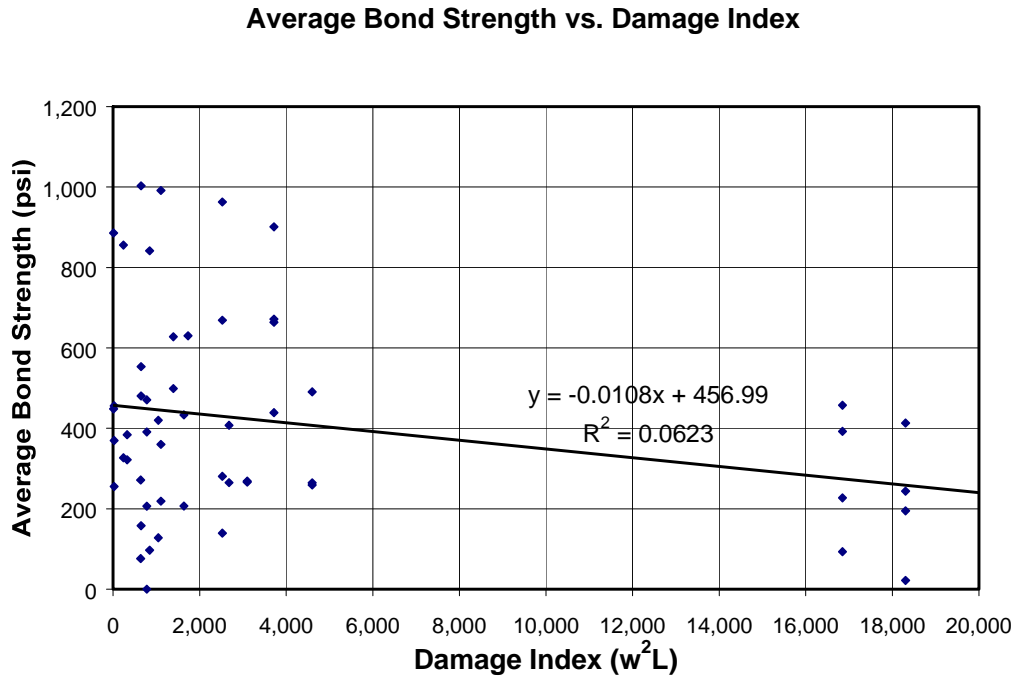
Figure 5.11: Average bond strength vs. damage index for strand-pullout tests

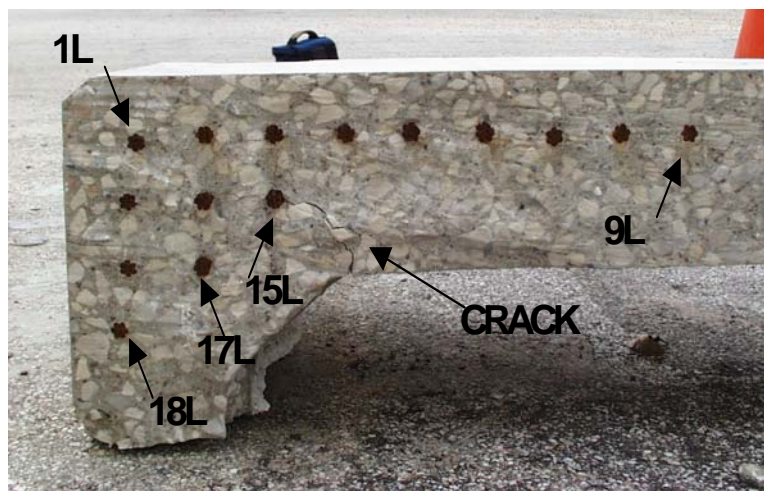
Figure 5.12: Cracking in back face of Slice BG4S2

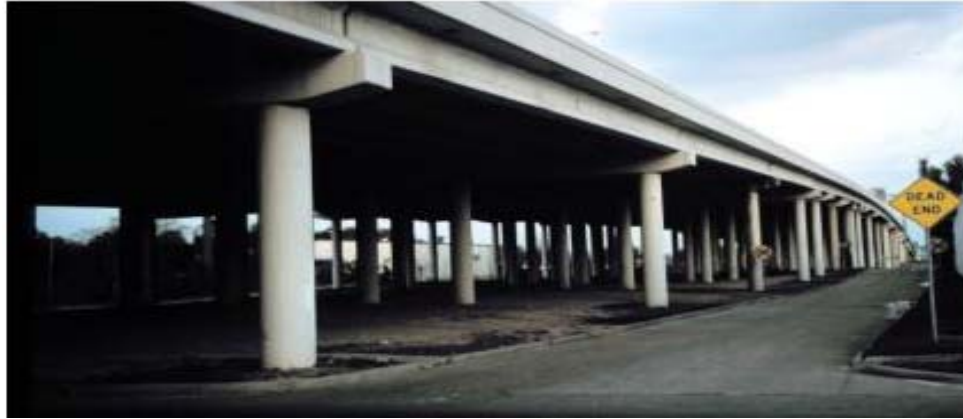
Figure 6.1: I-10 over AT & SF RR in Beaumont, Texas (facing east)

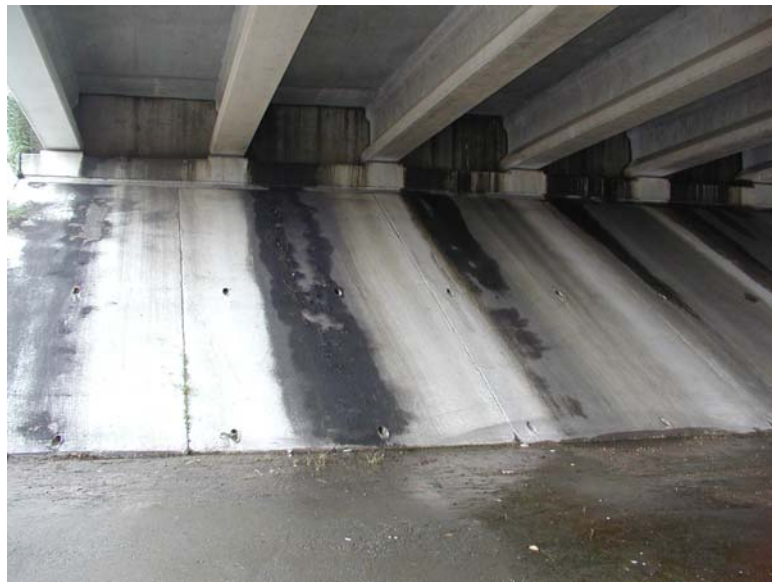
Figure 6.2: Overview of West Abutment of I-10 structure in Beaumont, Texas

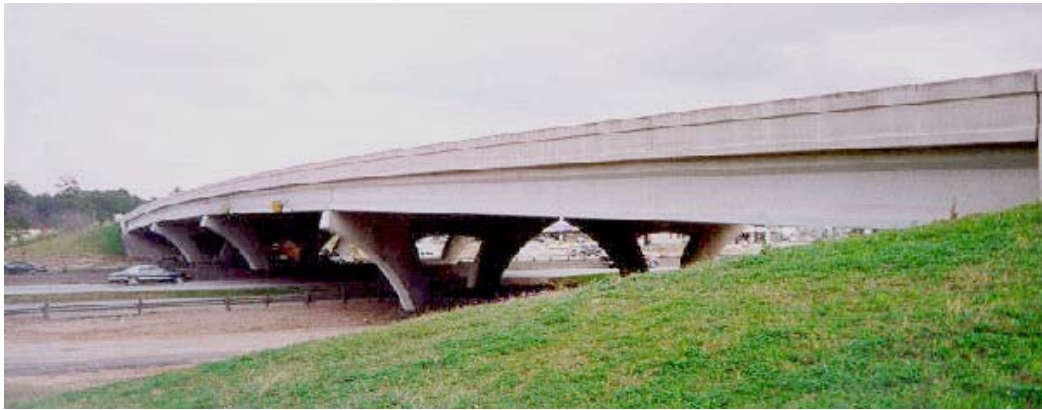
Figure 6.5: Robinson Road over I-45 in The Woodlands, Texas

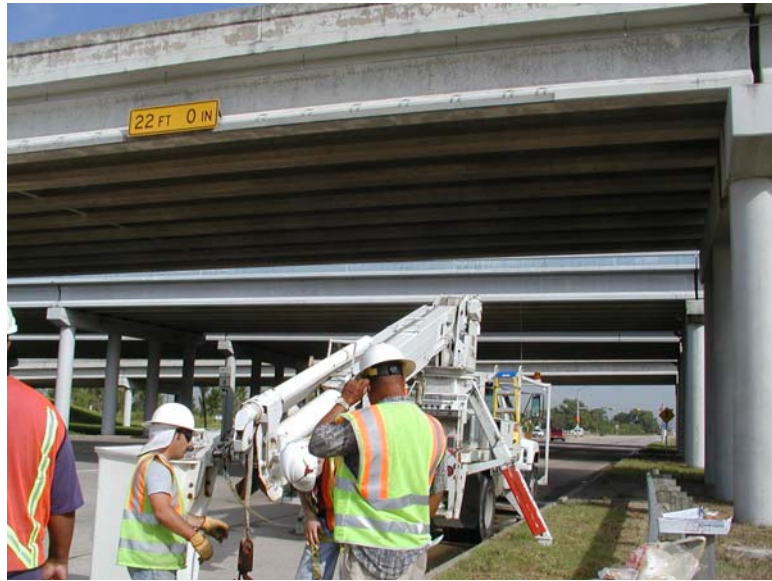
Figure 6.7: Beltway 8 over State Highway 3, Houston, Texas (facing north)

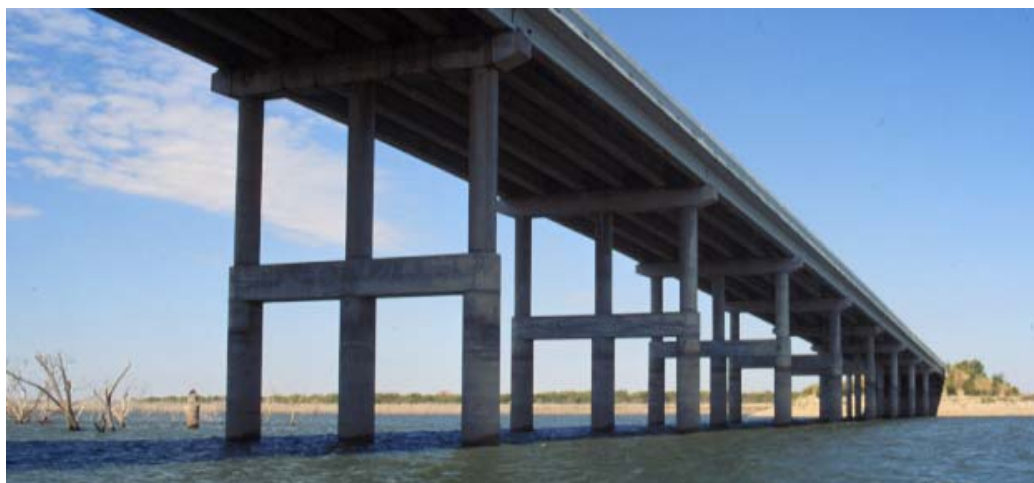
Figure 6.9: FM 1929 over the Lake Ivie Reservoir in Concho, Texas (facing west)

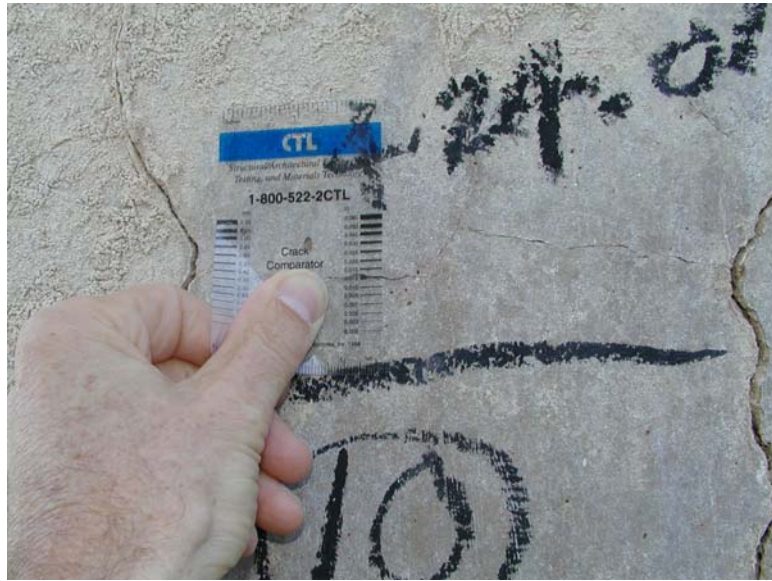
Figure 6.10: Crack comparator card

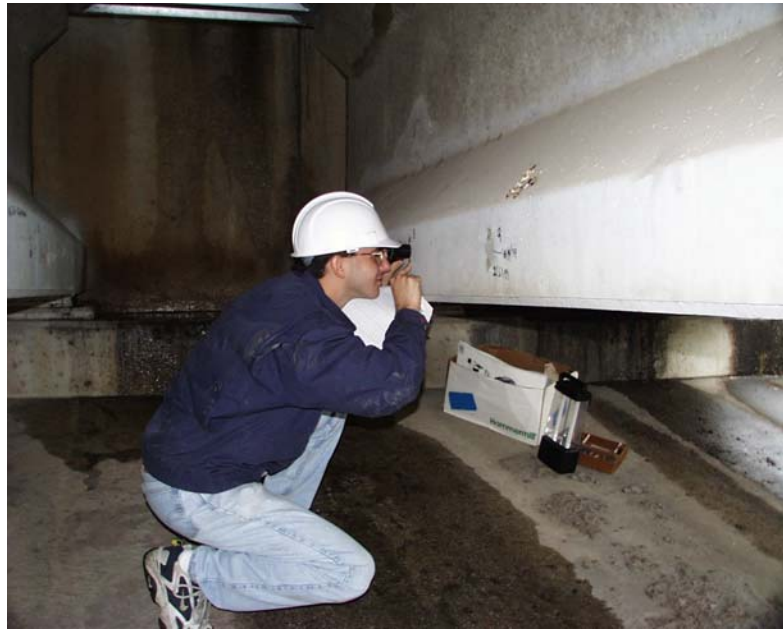
Figure 6.11: Measuring crack widths with optical scope

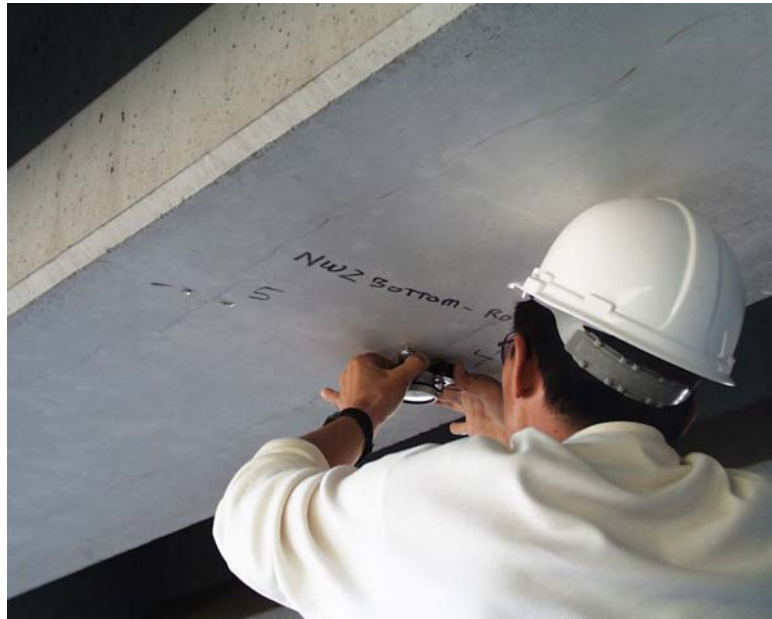
Figure 6.12: Taking readings with Demec gauge

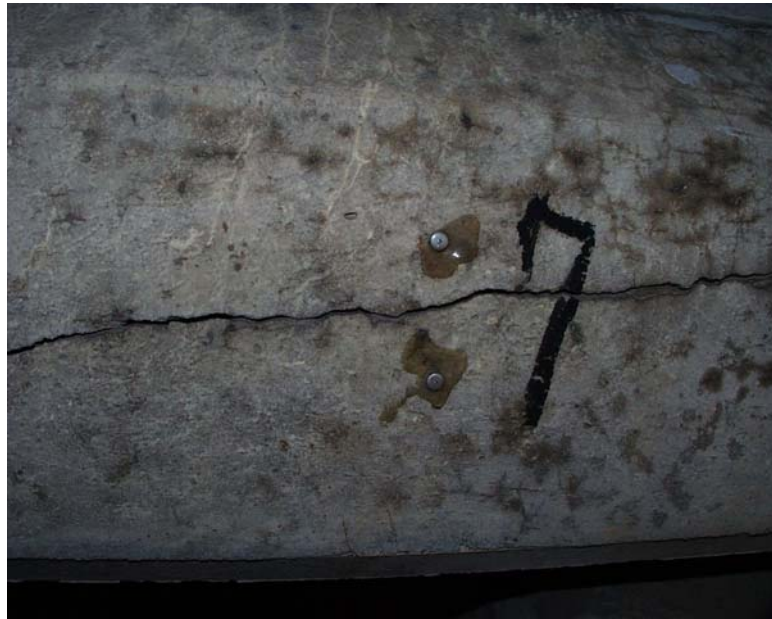
Figure 6.13: *One set of Demec discs for monitoring crack width*

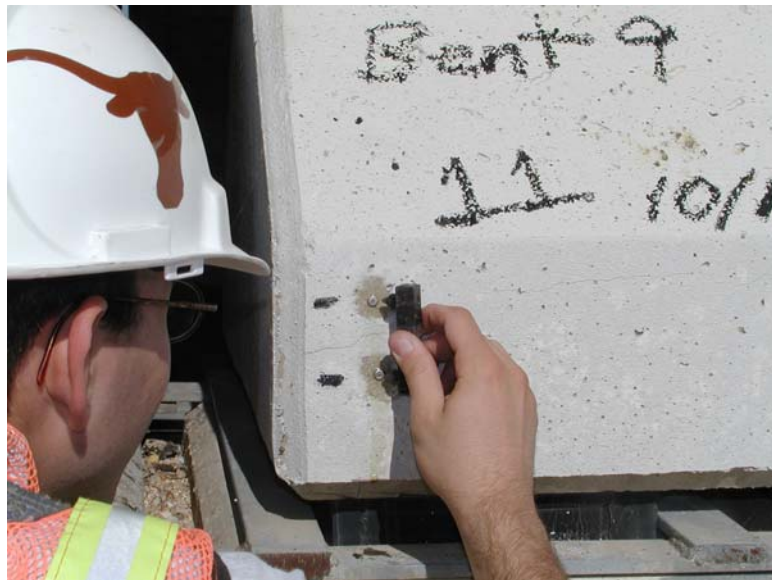
Figure 6.14: *Holding set of Demec discs in place with reference bar*

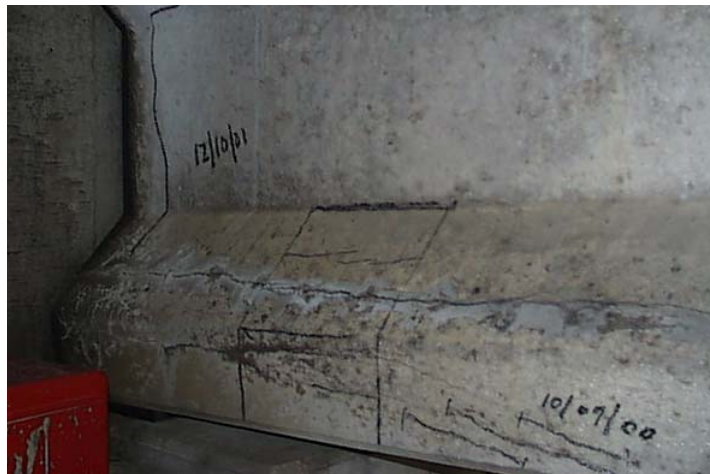
Figure 6.15: Representative areas used for crack ratios, I-10 structure

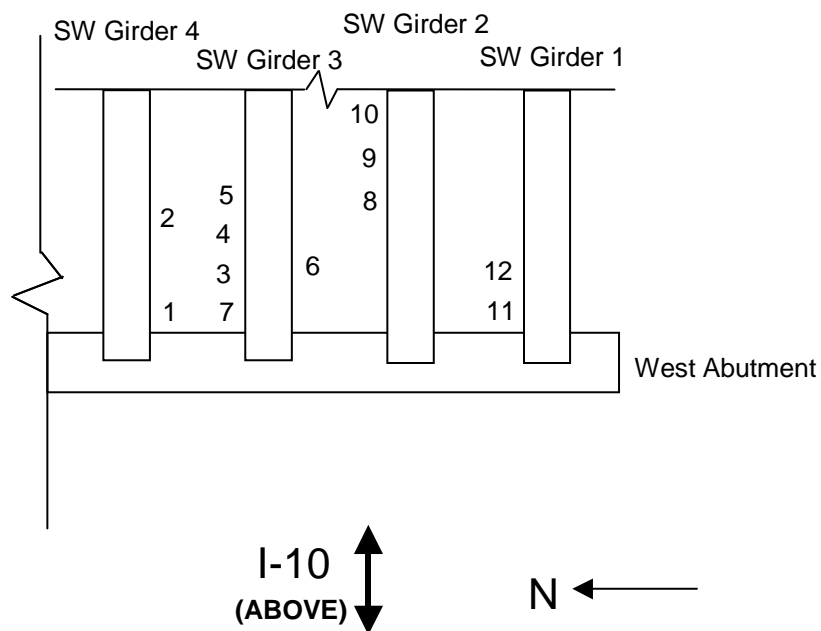
Figure 7.2: *Schematic of crack-measurement locations on I-10 structure (plan view)*

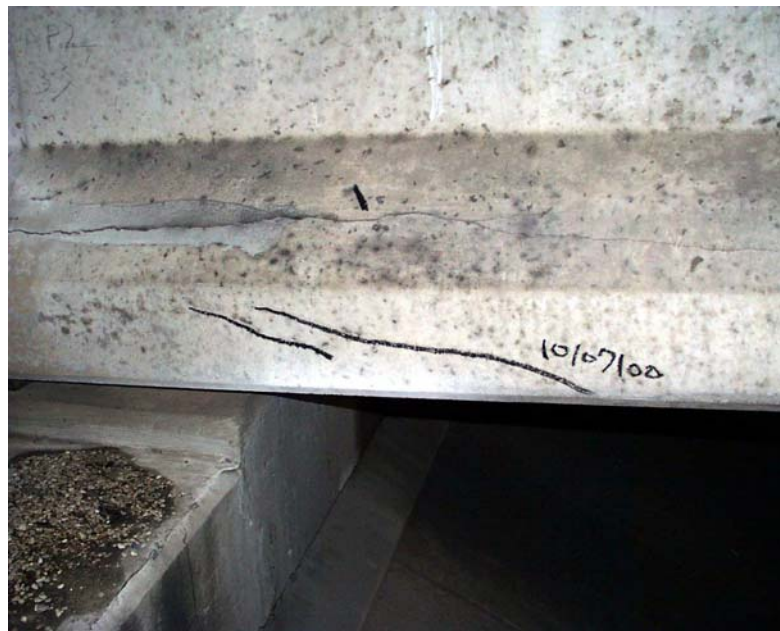
Figure 7.3: *New diagonal cracks on I-10 SW Girder 4, Face 5 (10/7/00)*

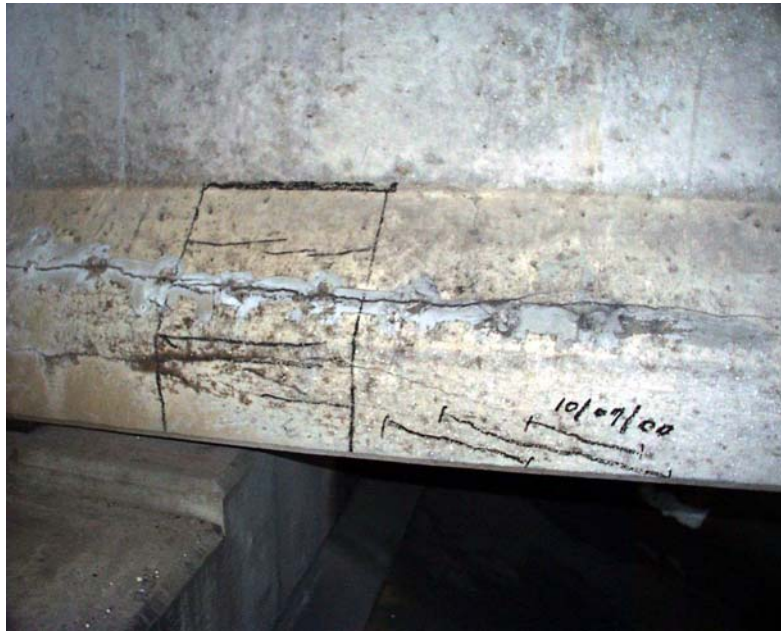
Figure 7.4: Representative areas on I-10 SW Girder 2, south face (10/7/00)

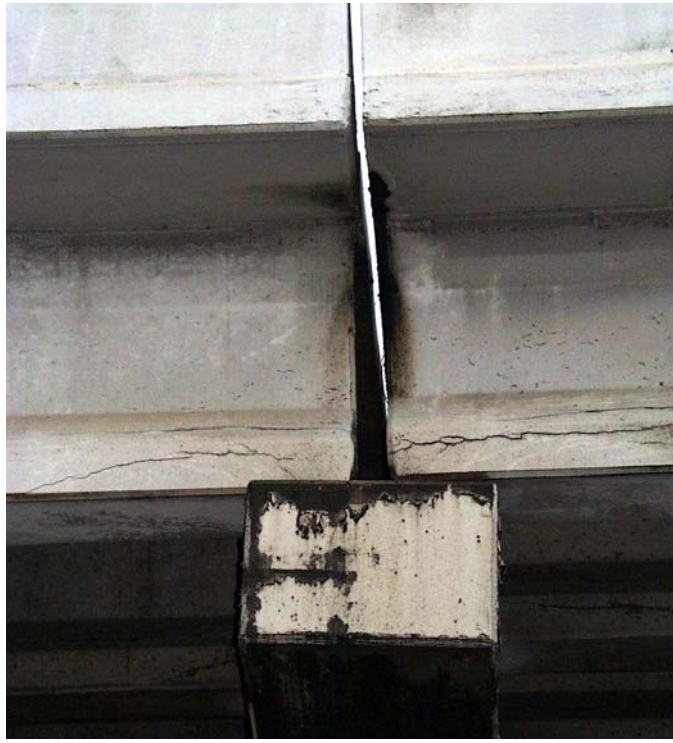
Figure 7.5: Cracks at first bent east of west abutment, I-10 (10/7/00)

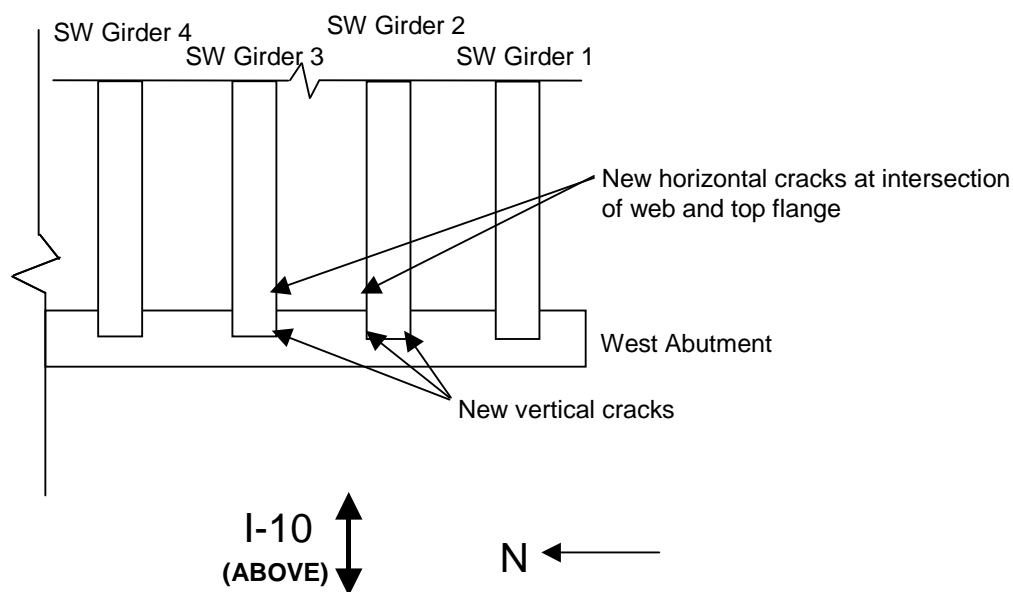
Figure 7.6: Location of new cracks on I-10 structure (plan view) (12/10/01)

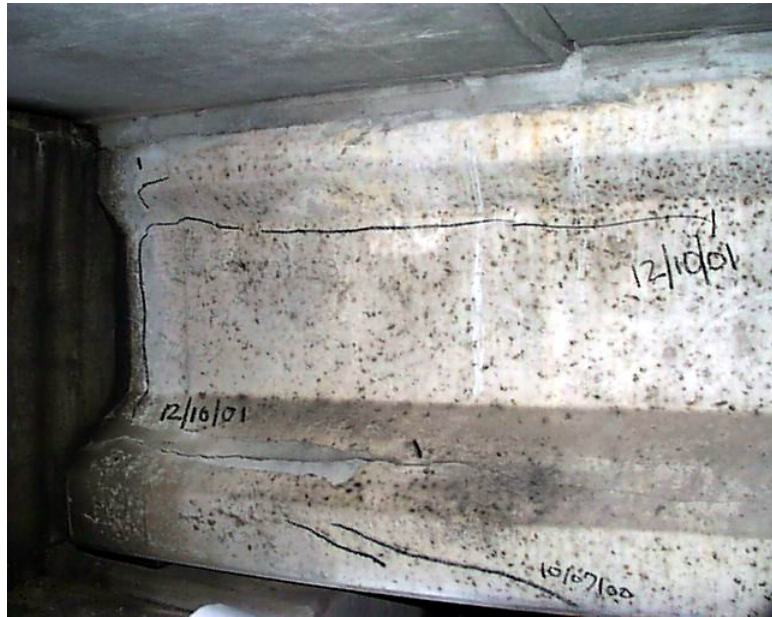
***Figure 7.7: New cracks on south face of SW Girder 3 at west abutment, I-10
(12/10/01)***

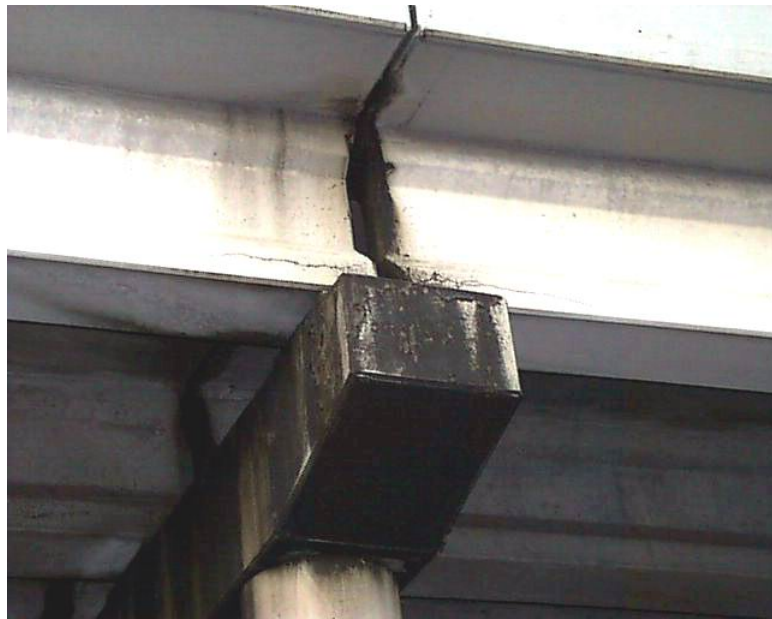
Figure 7.8: Cracks at first bent east of west abutment, I-10 (12/10/01)

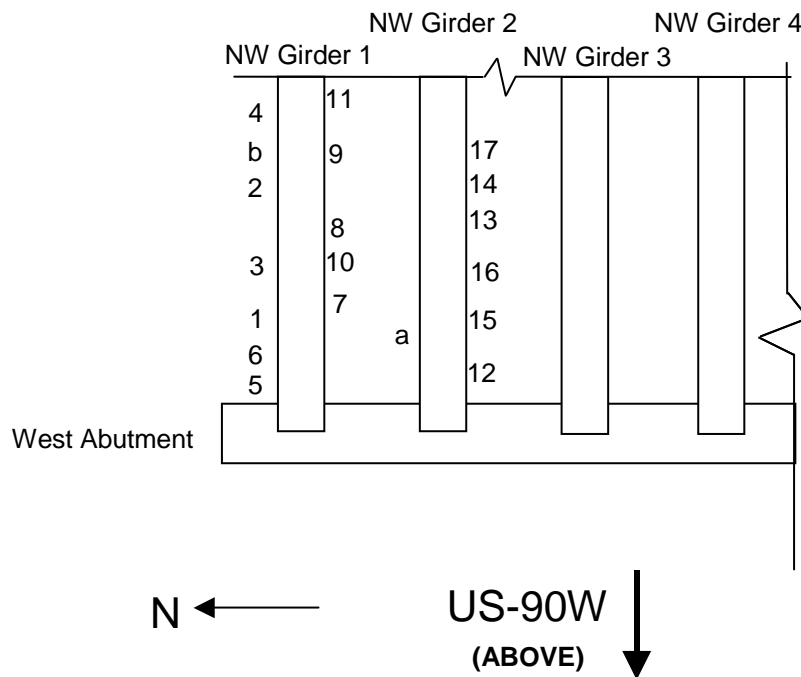
Figure 7.9: Schematic of crack-measurement locations on US-90 structure (plan view)

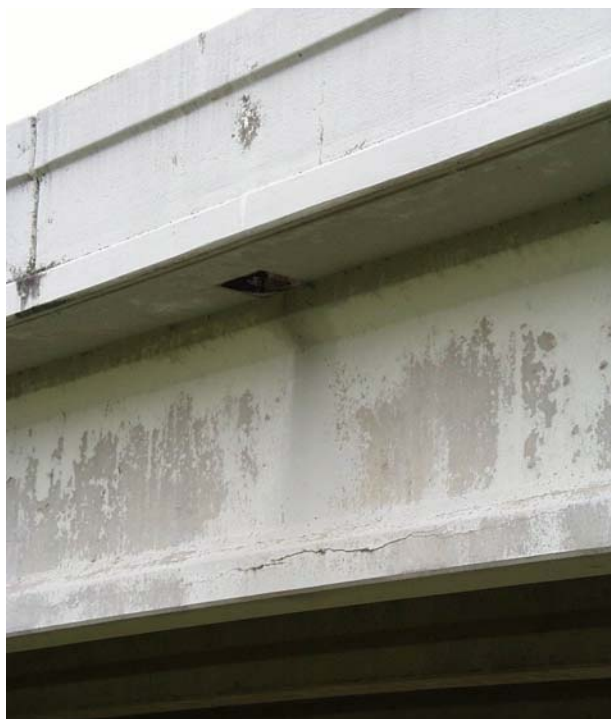
Figure 7.10: Typical crack under drain at US-90 structure (10/6/00)

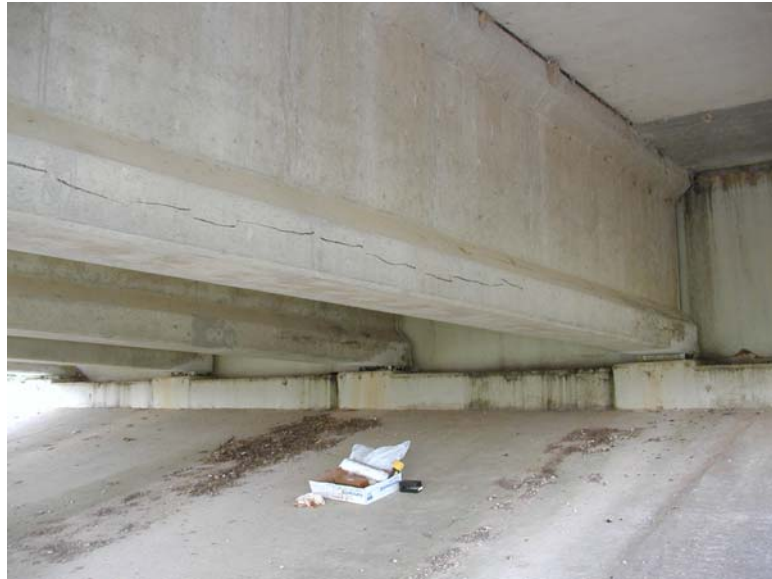
Figure 7.11: Extension of existing cracking on north surface (Face 5) of NW Girder 2, US-90 (6/22/01)

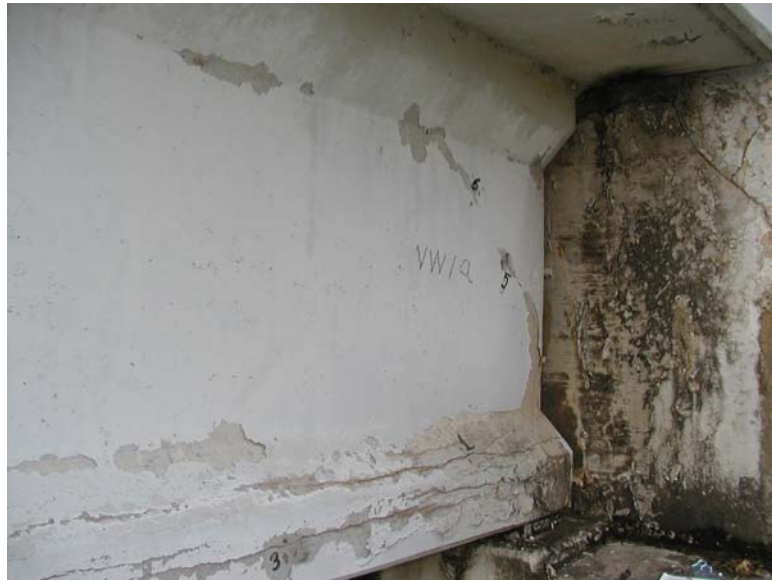
Figure 7.12: Cracks at end of NW Girder 1, US-90 (6/22/01)

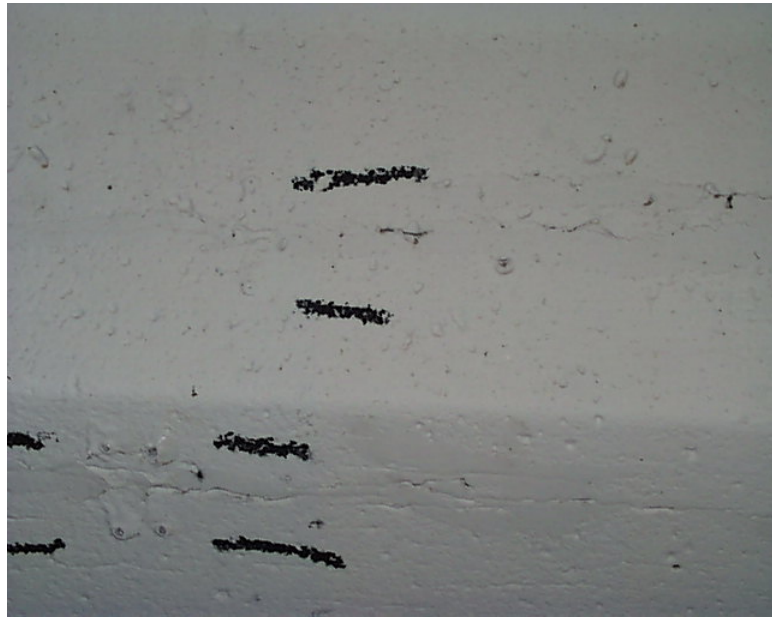
Figure 7.13: Close-up view of Point 10 (bottom, left pair of Demec discs) and Point 8 (top), US-90 (12/11/01)

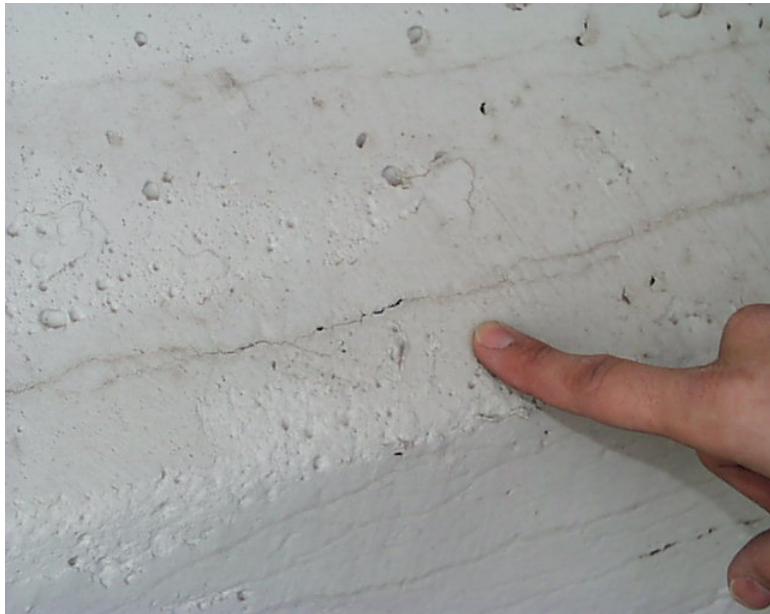
Figure 7.14: Apparent cracking through sealant, US-90 (12/11/01)

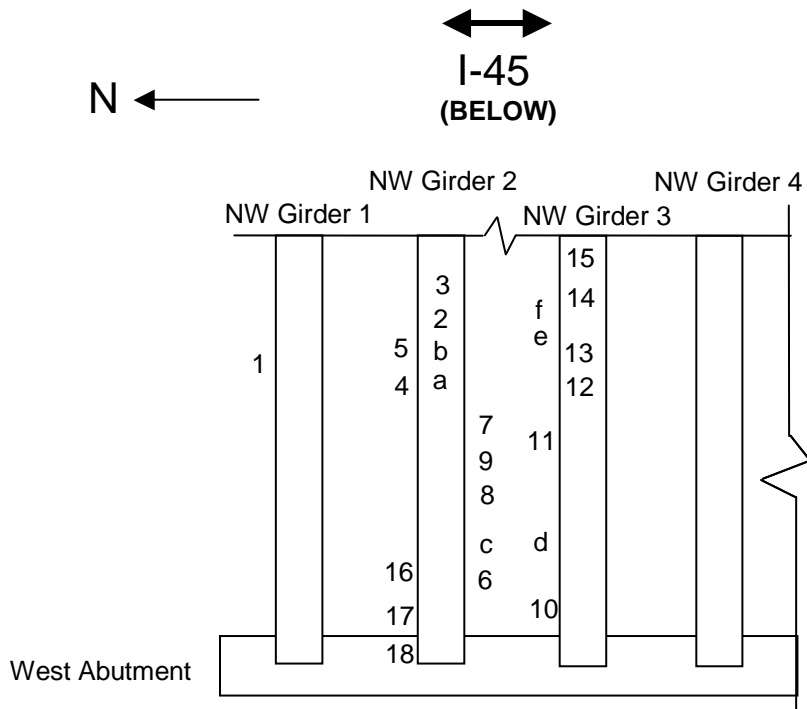
Figure 7.15: Schematic of crack-measurement locations on Robinson Road structure (plan view)

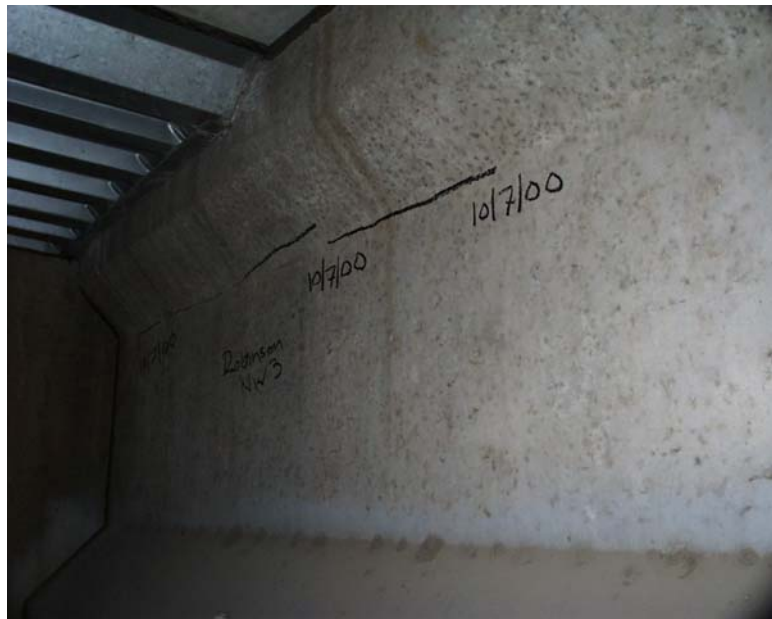
Figure 7.16: Extension of new cracking on south face of NW Girder 3, Robinson Road (10/7/00)

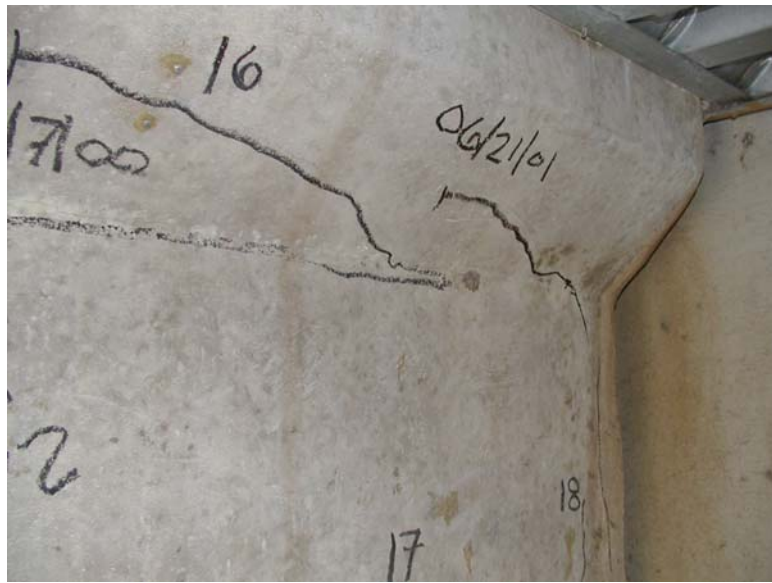
Figure 7.17: Extension of cracking on NW Girder 2, Robinson Road (6/21/01)

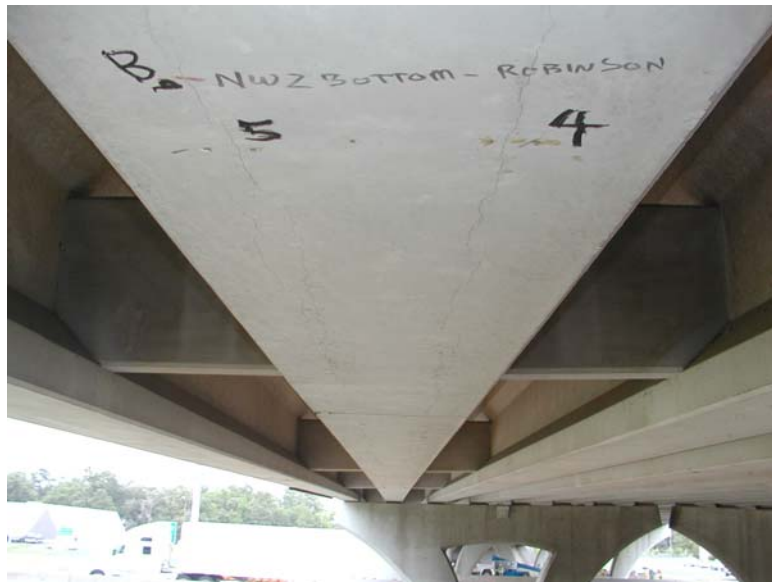
Figure 7.18: Extension of cracking on underside of NW Girder 2, Robinson Road (6/21/01)

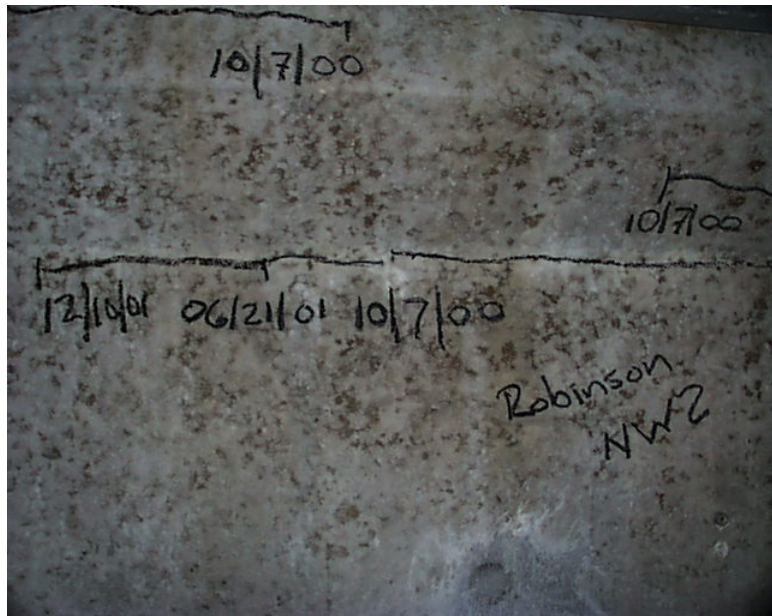
Figure 7.19: Extension of cracking on north surface of NW Girder 2, Robinson Road, at west abutment (12/10/01)

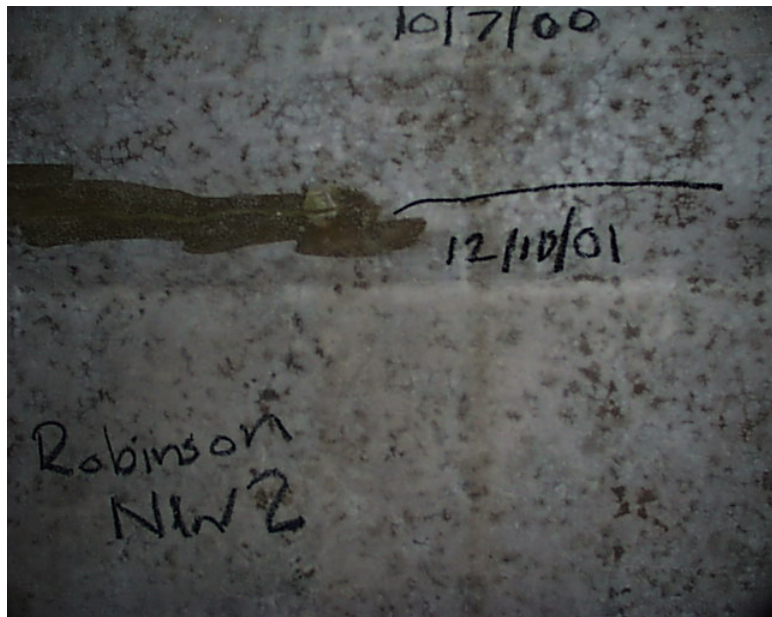
Figure 7.20: Extension of cracking past sealant on south surface of NW Girder 2, Robinson Road, at west abutment (12/10/01)

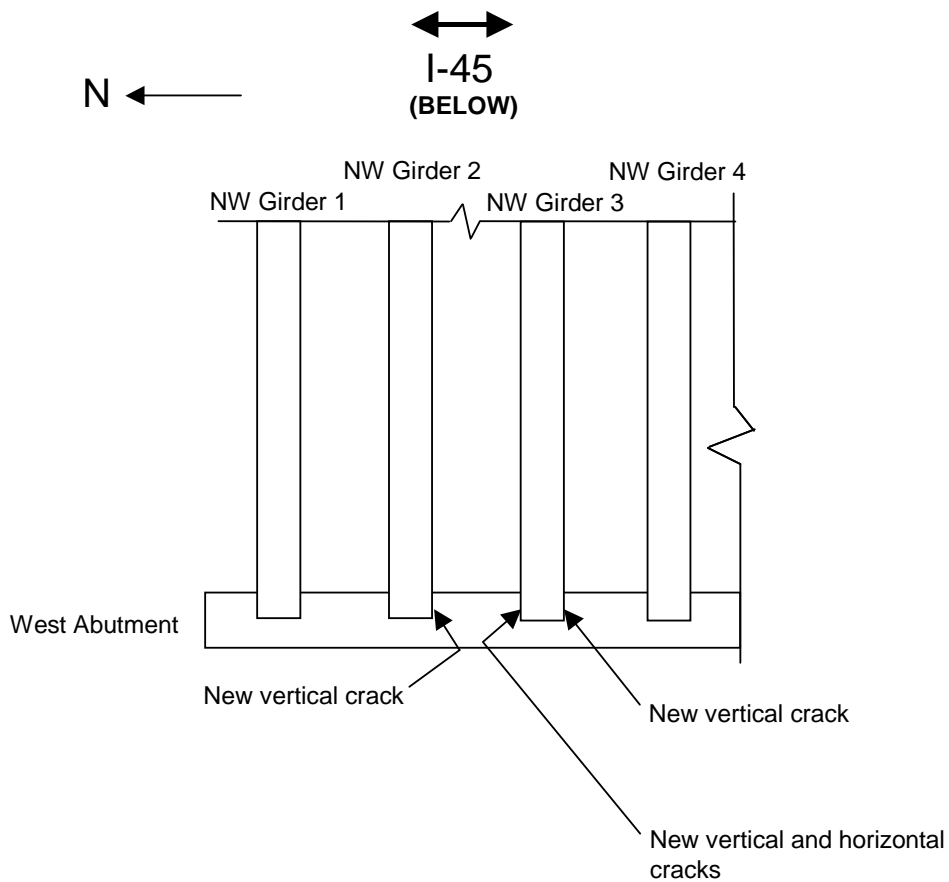
**Figure 7.21: Location of new cracks on Robinson Road structure (plan view)
(12/10/01)**

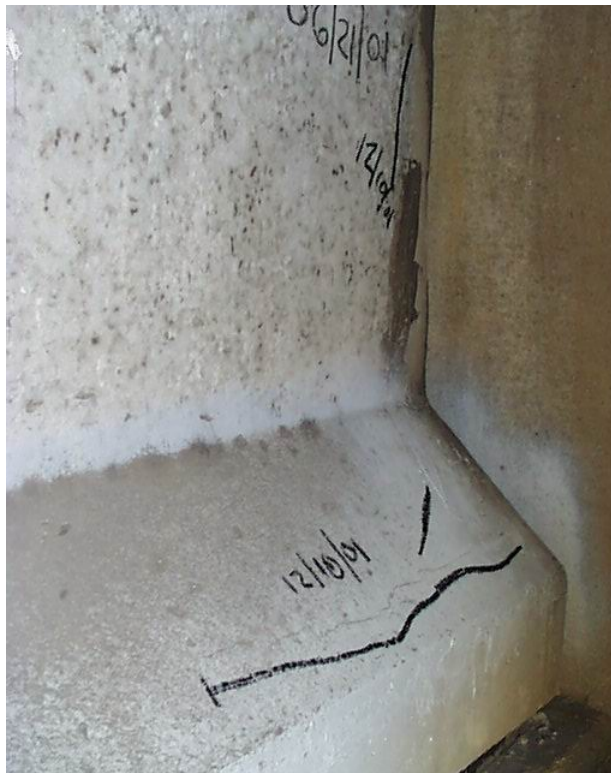
Figure 7.22: New cracks on north surface of NW Girder 3, Robinson Road, at west abutment (12/10/01)

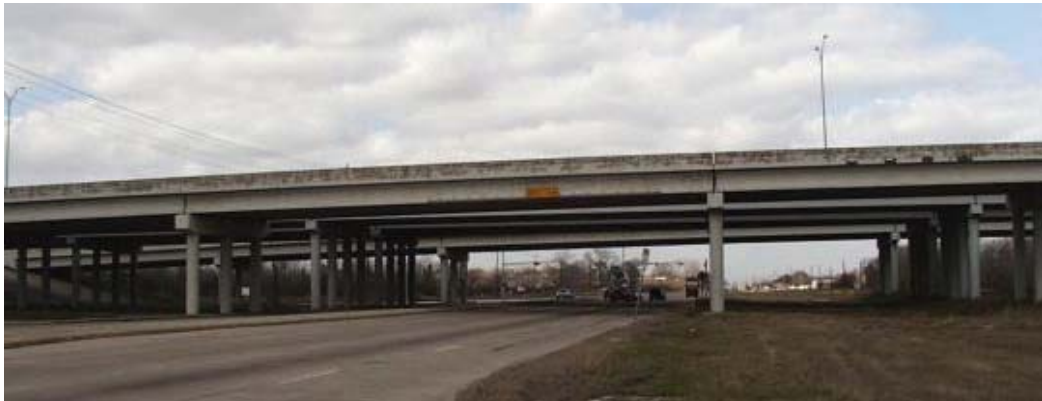
Figure 7.23: Overview of Beltway 8 over State Highway 3 (facing north)

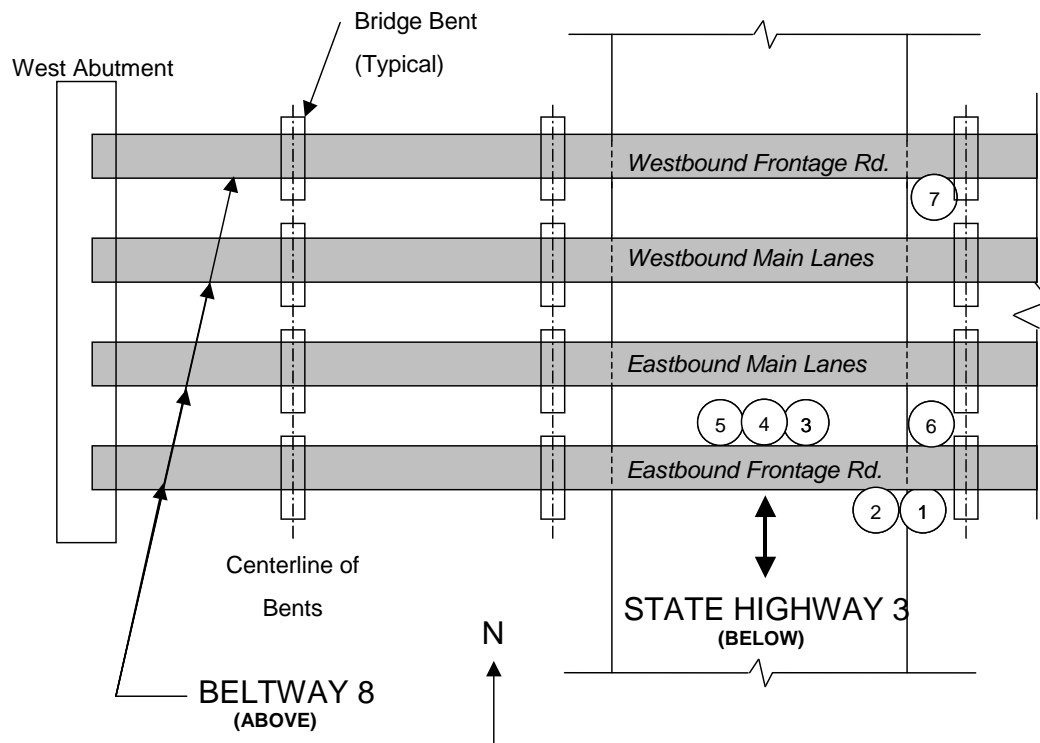
Figure 7.24: Schematic of crack-measurement locations on Beltway 8 structure (plan view)

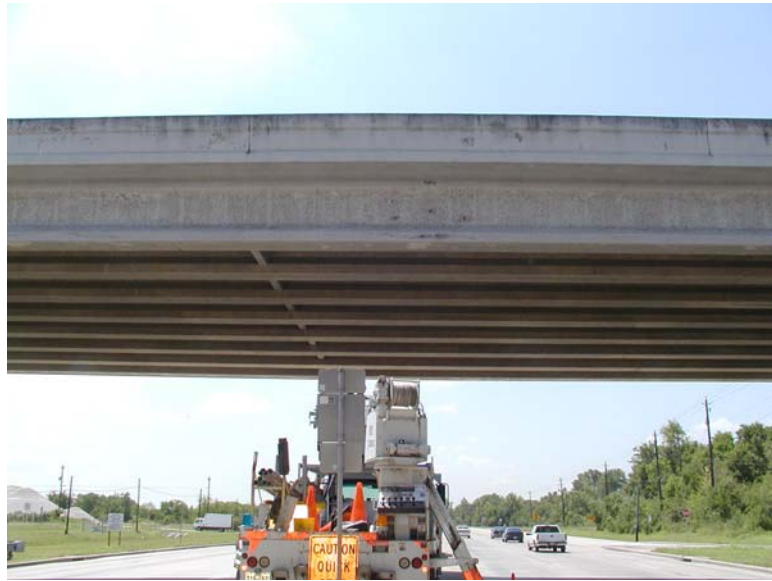
Figure 7.25: Overall view of Points 3-5, Beltway 8 (facing south) (6/22/01)

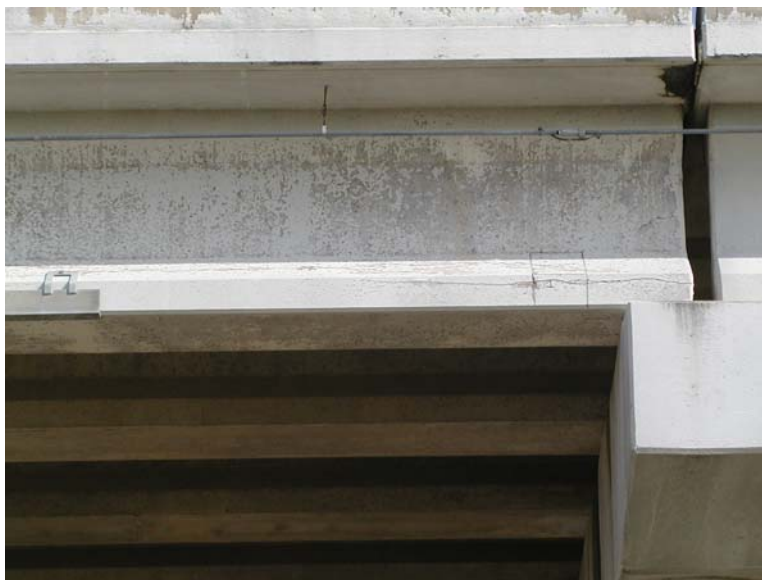
***Figure 7.26: Overall view of Point 1, Beltway 8 structure (facing north)
(6/22/01)***

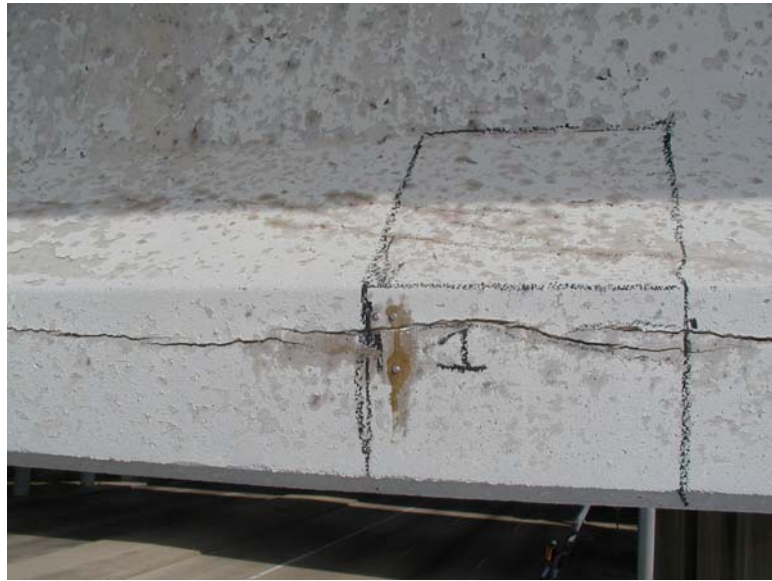
Figure 7.27: Close-up view of Point 1, Beltway 8 structure (6/22/01)

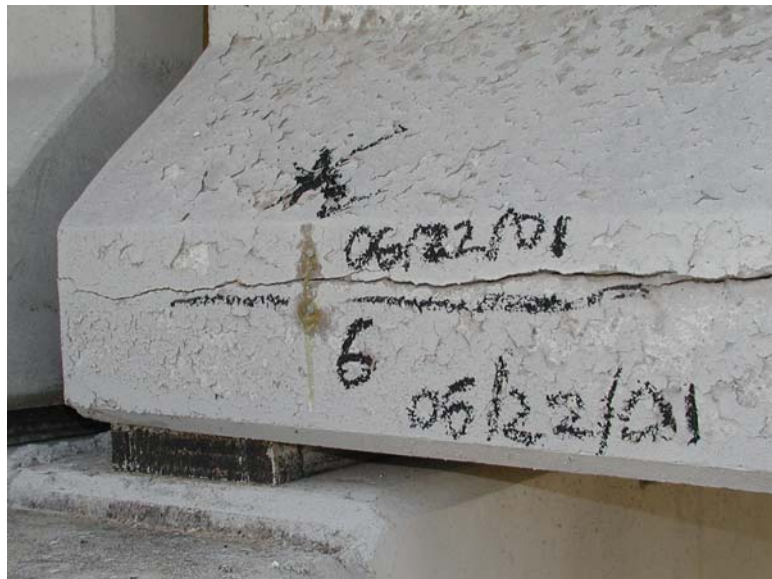
Figure 7.28: Close-up view of Point 6, Beltway 8 structure (6/22/01)

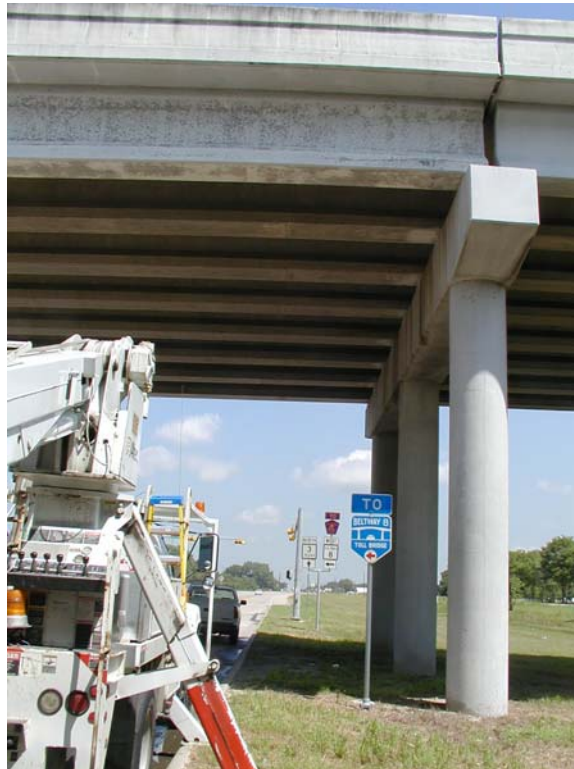
**Figure 7.29: Overall view of Point 7, Beltway 8 structure (facing north)
(6/22/01)**

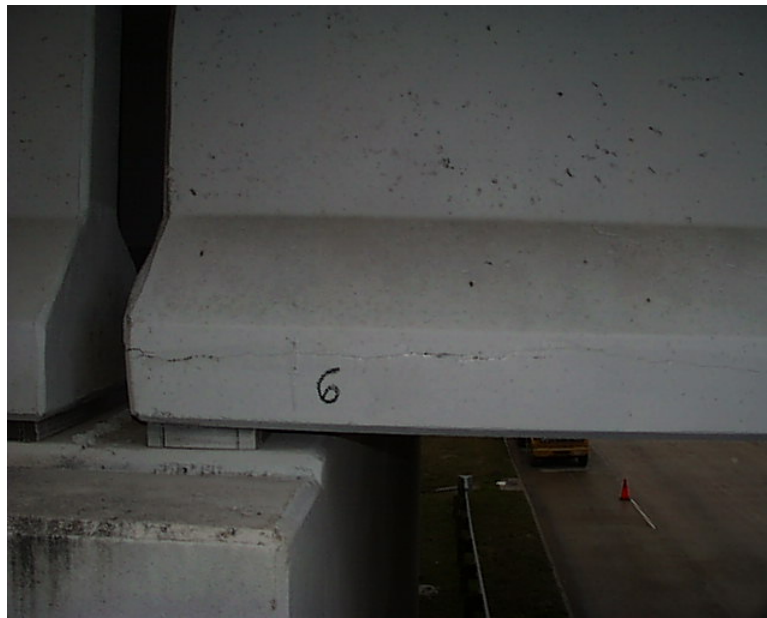
Figure 7.30: Cracking near Point 6, Beltway 8 structure (12/11/01)

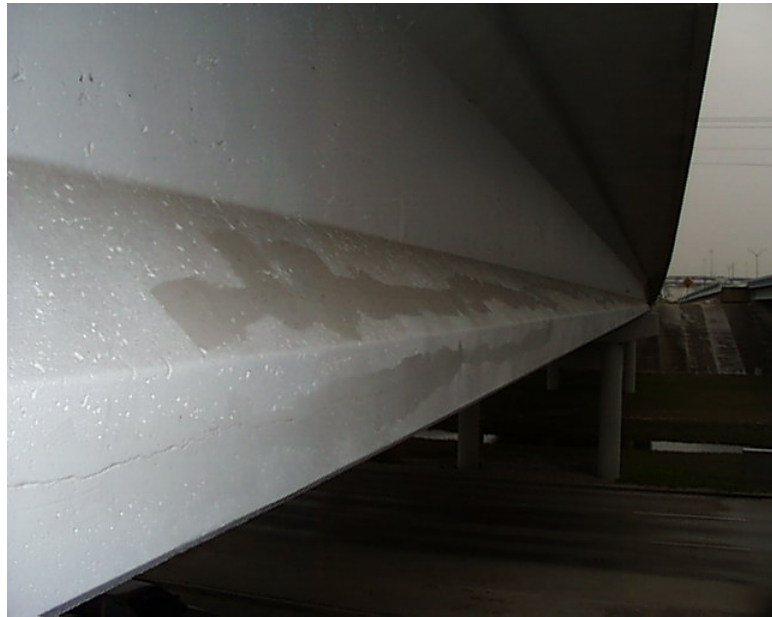
Figure 7.31: Sealed cracks along girder flange near Point 6, Beltway 8 structure (12/11/01)

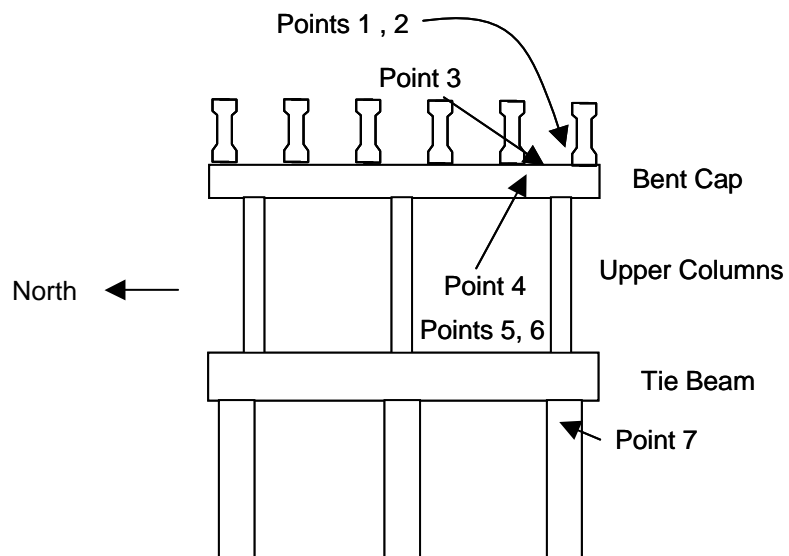
Figure 7.35: Schematic drawing of crack-measurement locations on Bent 5
