Larry Seth Memberg

**Bridges with Premature Concrete Deterioration: Damage Indices,
Strand-Pullout Tests, and Field Observations**

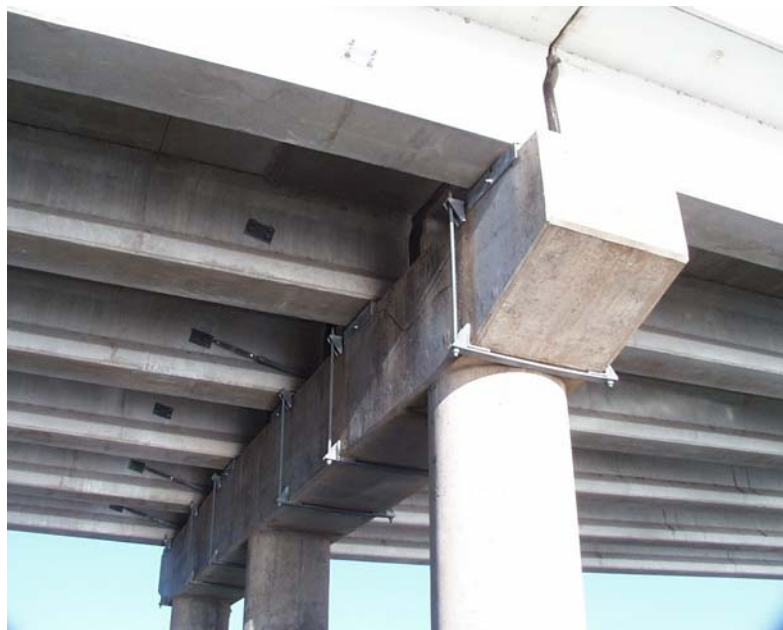
Figure 7.36: Overall view of Bent 5 (facing north)

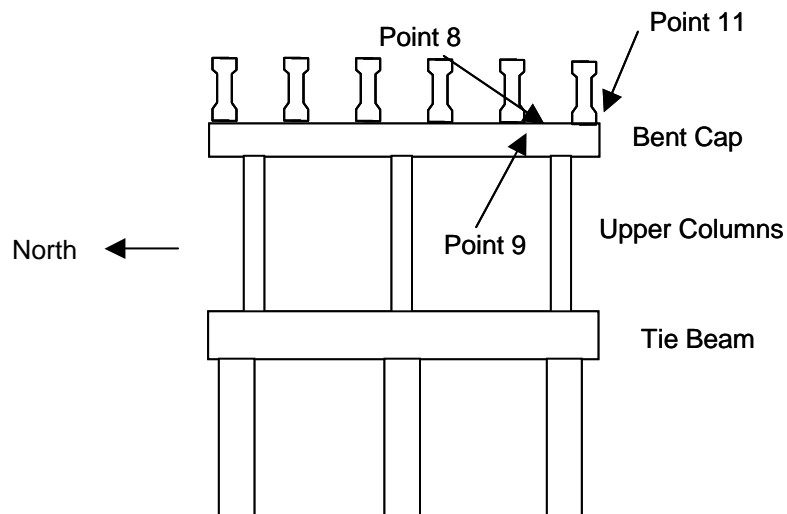
Figure 7.37: Schematic drawing of crack-measurement locations on Bent 9

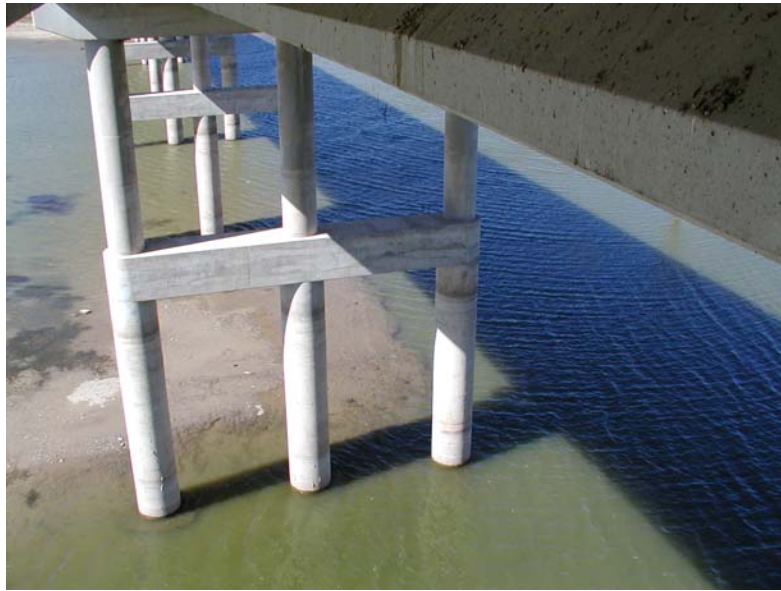
Figure 7.38: Overall view of Bent 9 (facing west)

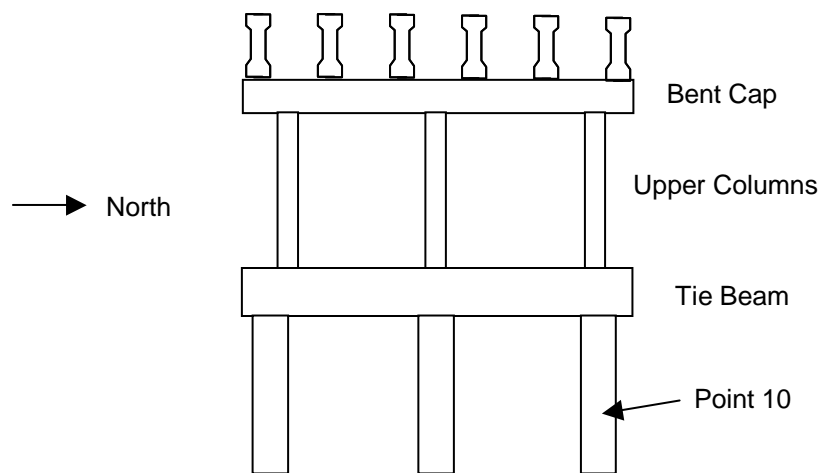
Figure 7.39: Schematic drawing of crack-measurement location on Bent 11

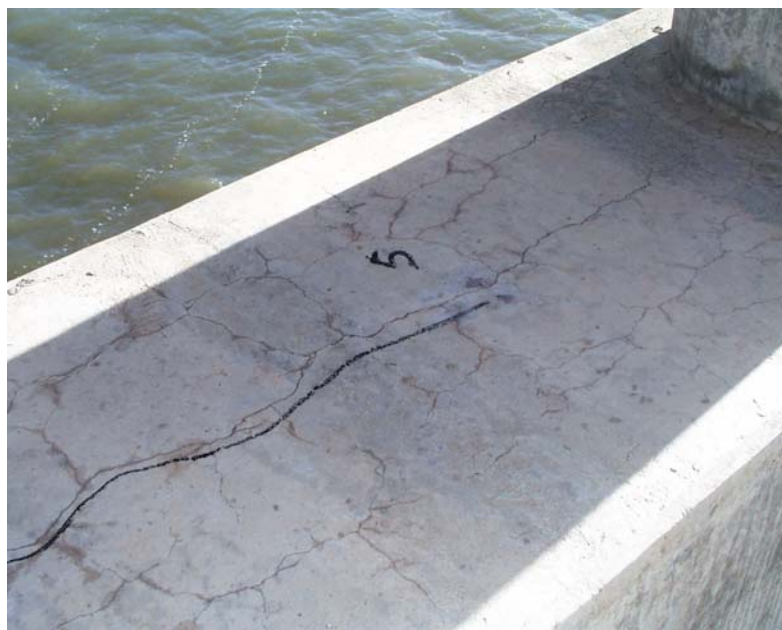
Figure 7.40: Map cracking on tie beam, Bent 5 (12/18/00)

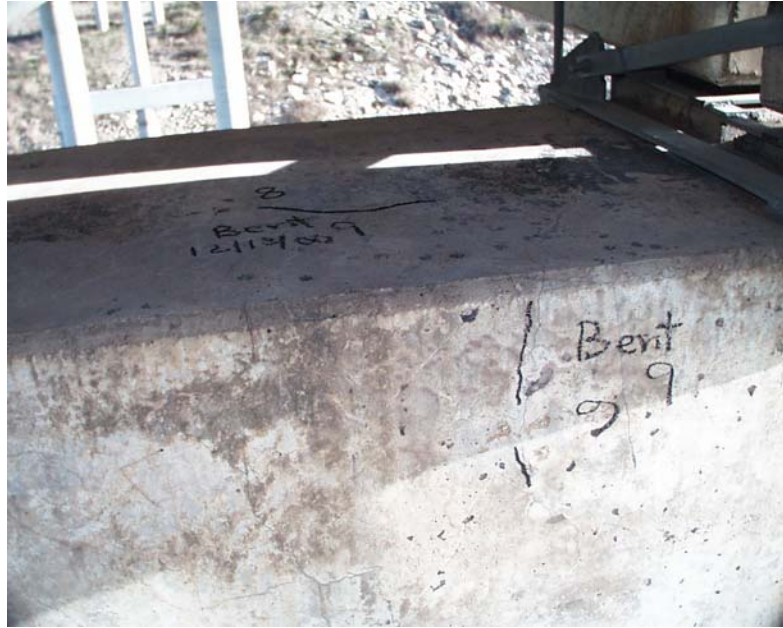
Figure 7.41: Cracking on bent cap, Bent 9 (12/18/00)

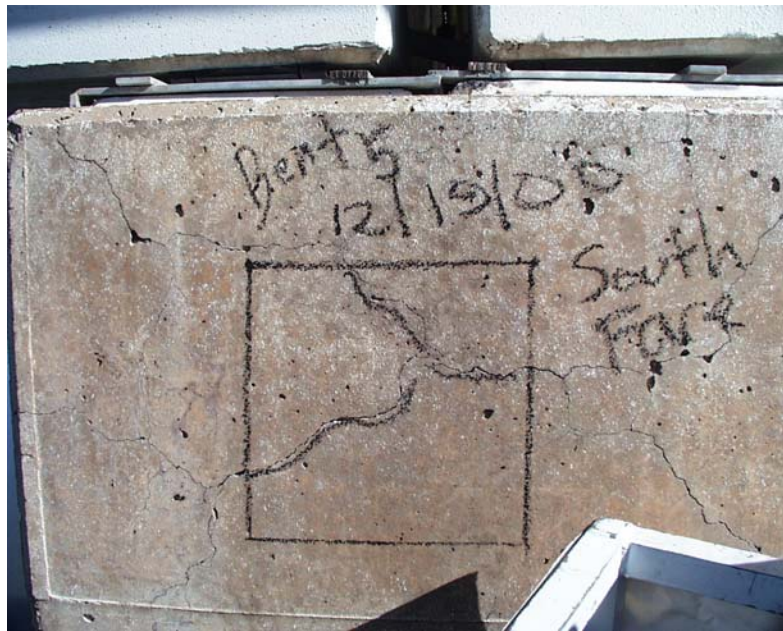
*Figure 7.42: 12 in. (0.31 m) square on south end of bent cap, Bent 5
(12/19/00)*

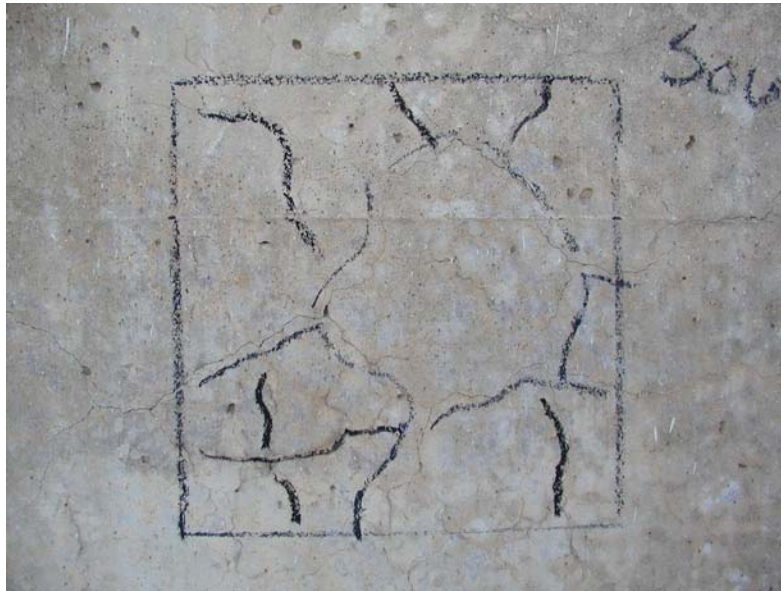
Figure 7.43: 12 in. (0.31 m) square on south end of bent cap, Bent 9 (4/24/01)

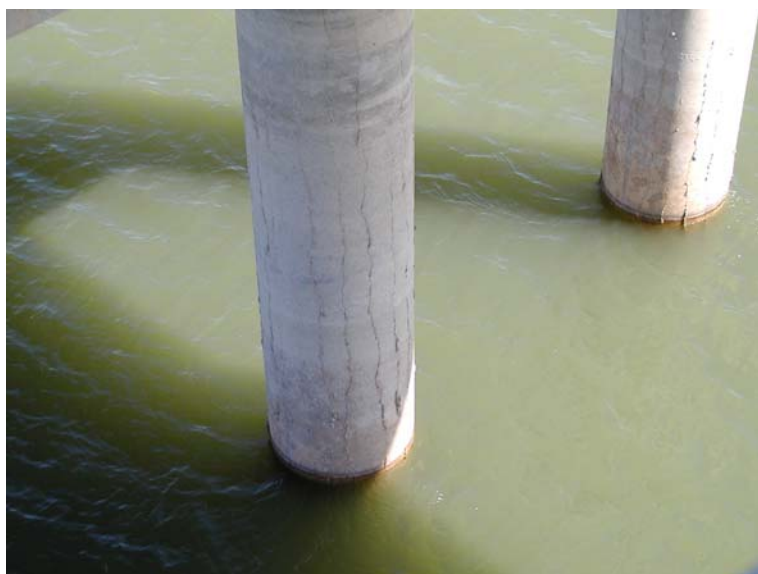
Figure 7.44: Example of column cracking near waterline of Bent 5 (4/24/01)

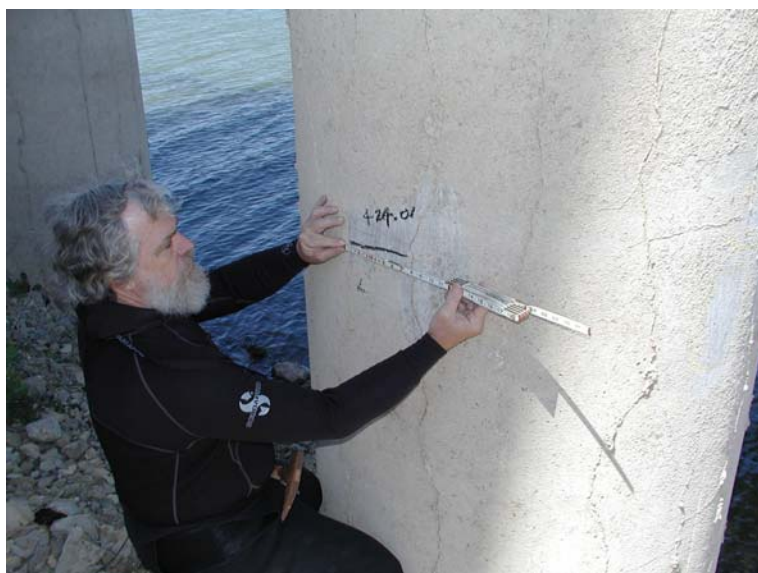
*Figure 7.45: Example of column cracking near waterline of Bent 11 (Point 10)
(4/24/01)*

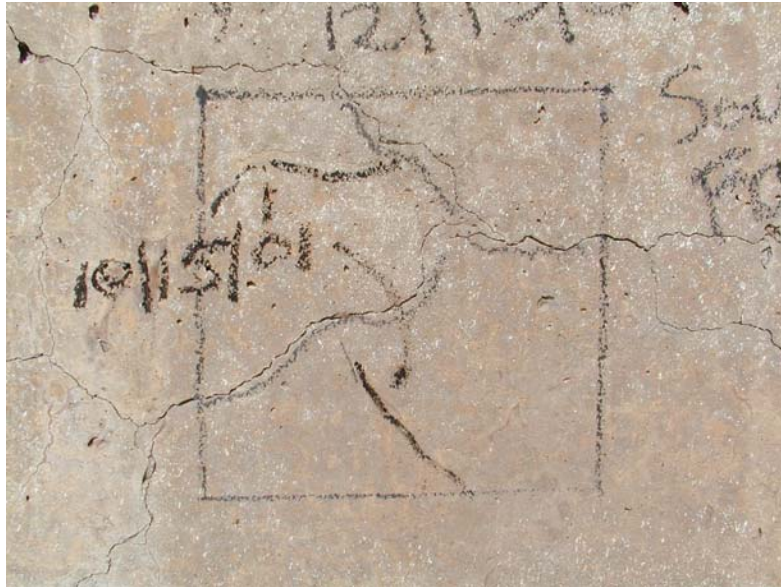
Figure 7.46: New cracks on 12 in. (0.31 mm) square on south end of bent cap, Bent 5 (10/15/01)

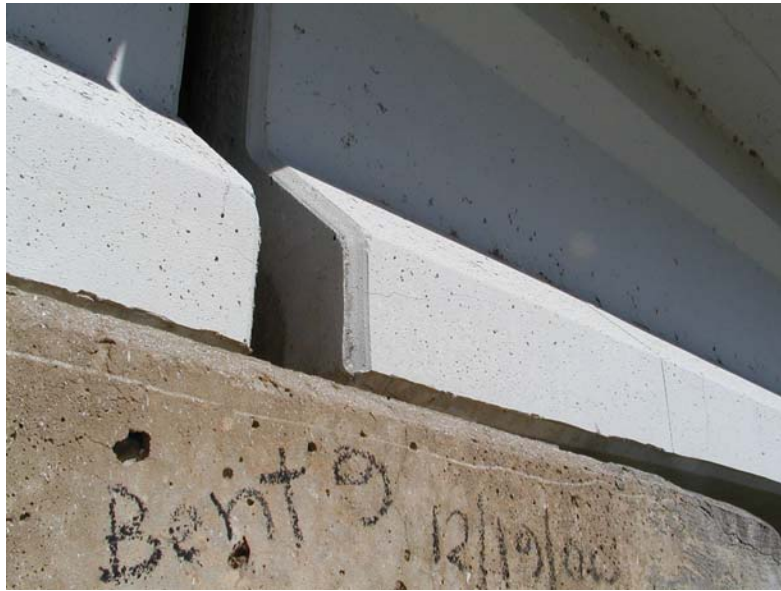
*Figure 7.47: New cracks on exterior faces of south girders at Bent 9
(10/15/01)*

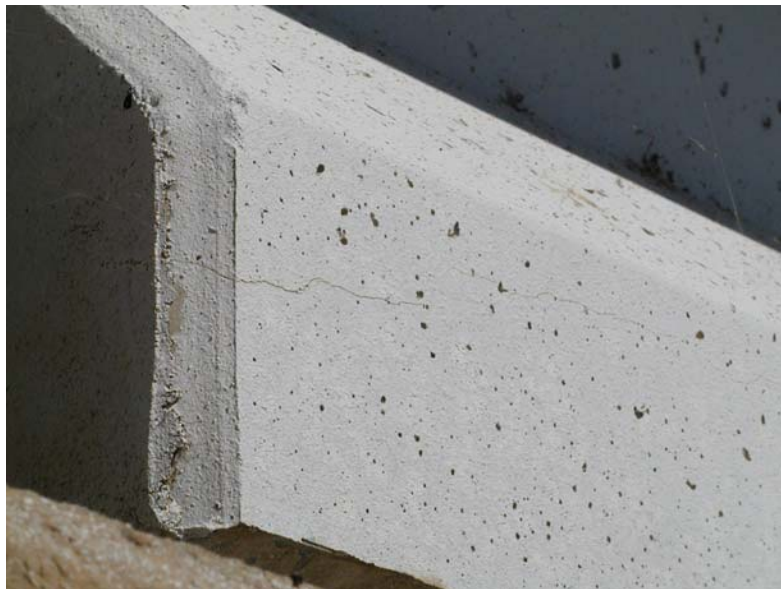
Figure 7.48: Close-up of new cracks on south girder at Bent 9 (10/15/01)

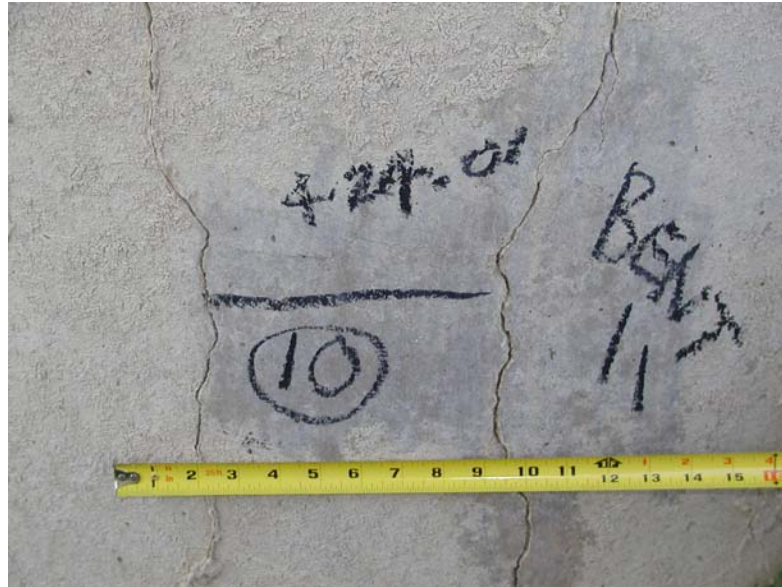
Figure 7.49: Column cracking at Point 10 near waterline, Bent 11 (10/15/01)

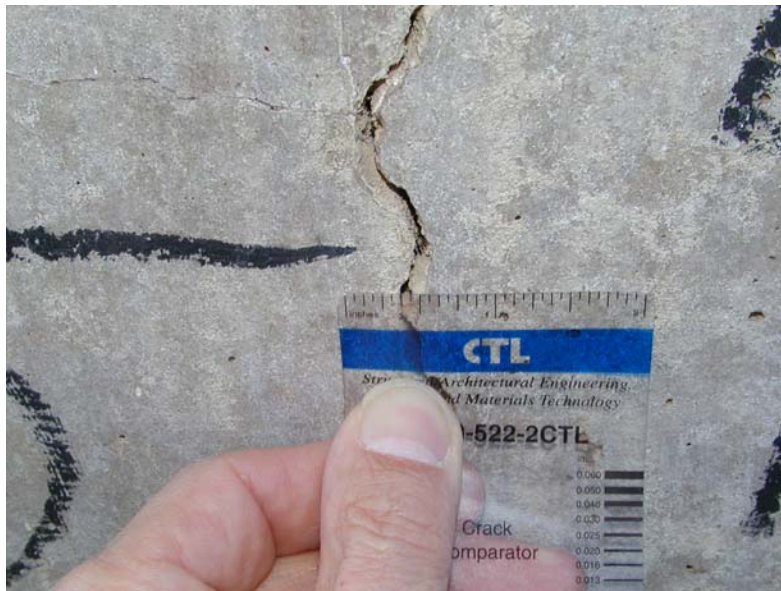
Figure 7.50: Close-up of vertical cracking at Point 10 near waterline, Bent 11
(10/15/01)

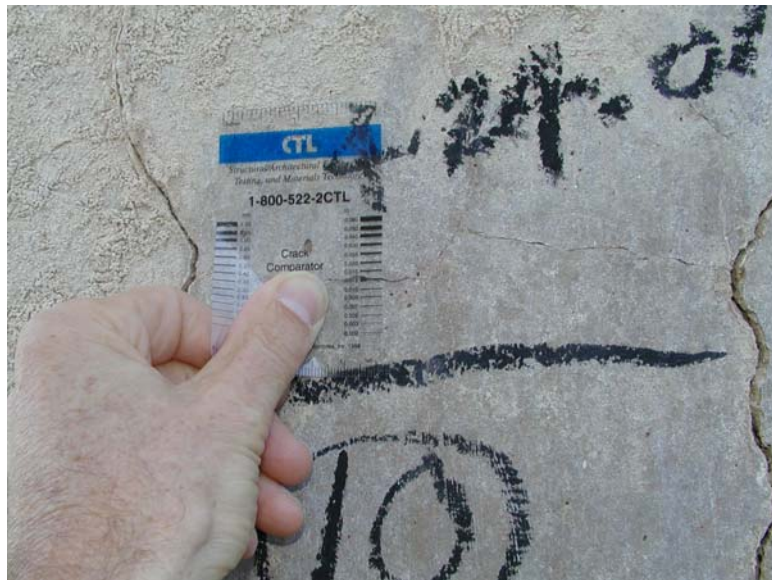
Figure 7.51: Close-up of horizontal crack at Point 10 near waterline, Bent 11
(10/15/01)

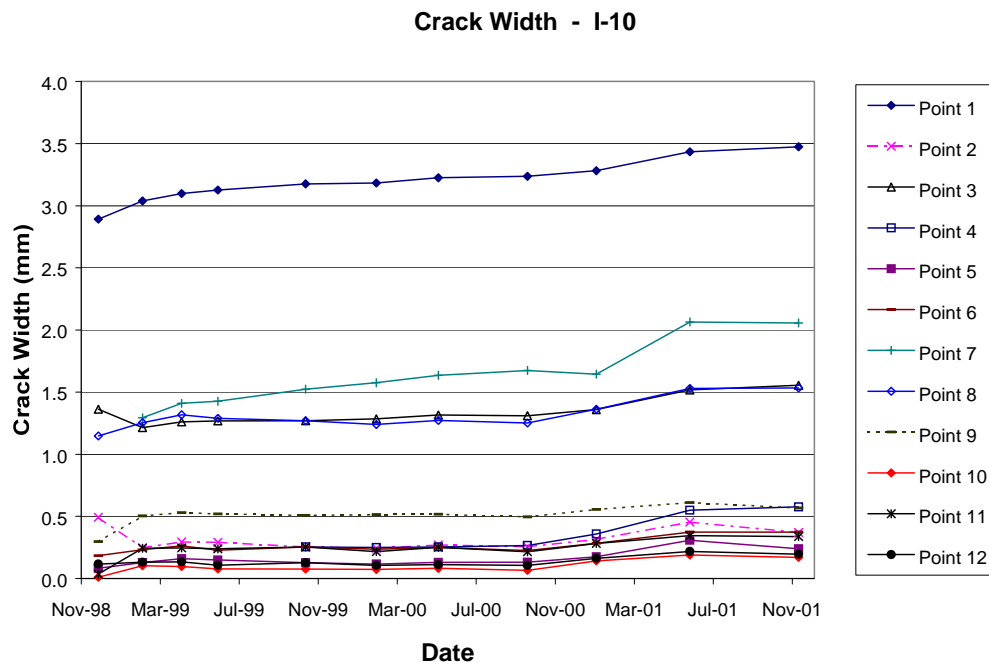
Figure 7.52: Crack width over time for I-10 structure

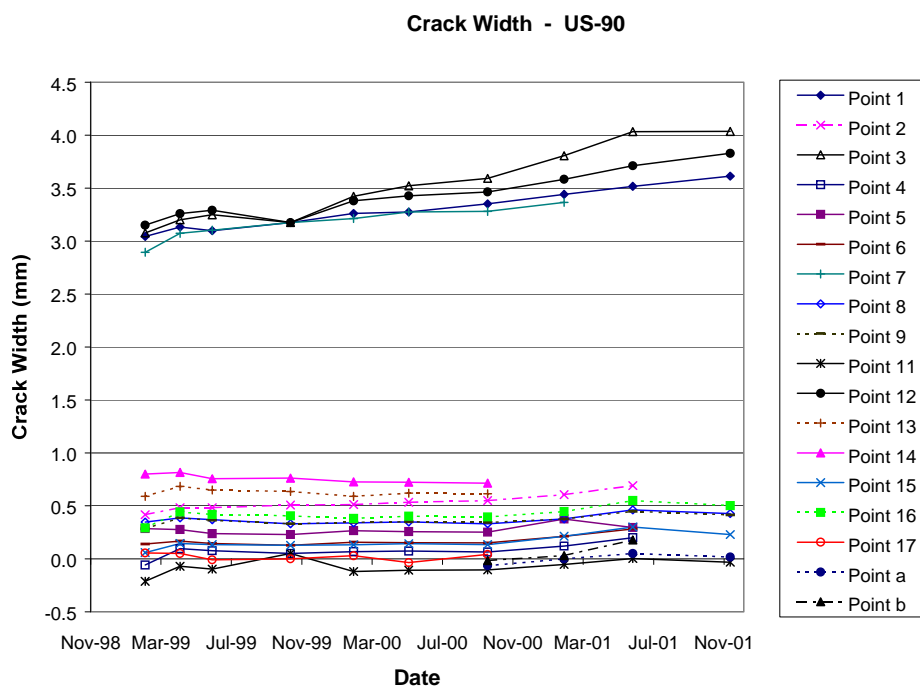
Figure 7.53: Crack width over time for US-90 structure

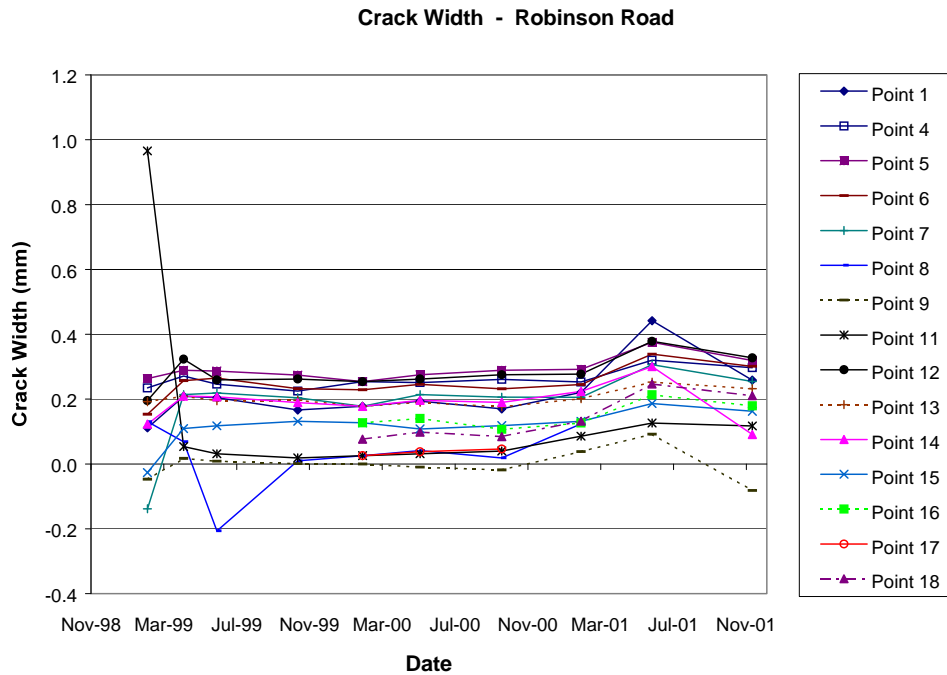
Figure 7.54: Crack width over time for Robinson Road structure

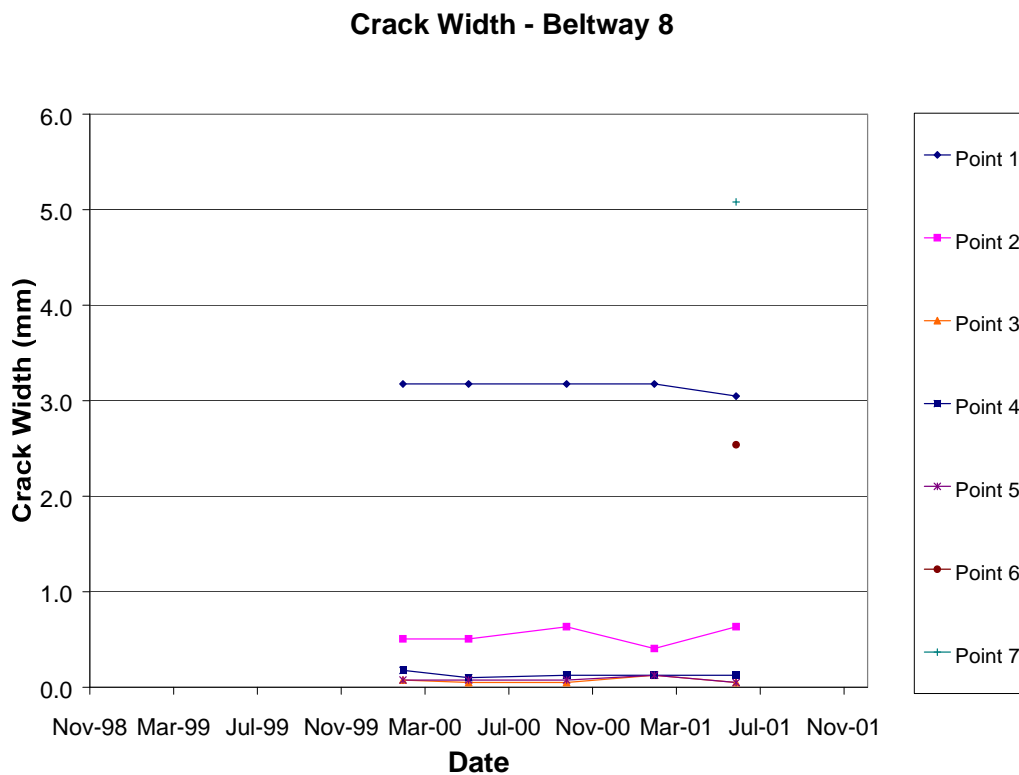
Figure 7.55: Crack width over time for Beltway 8 structure

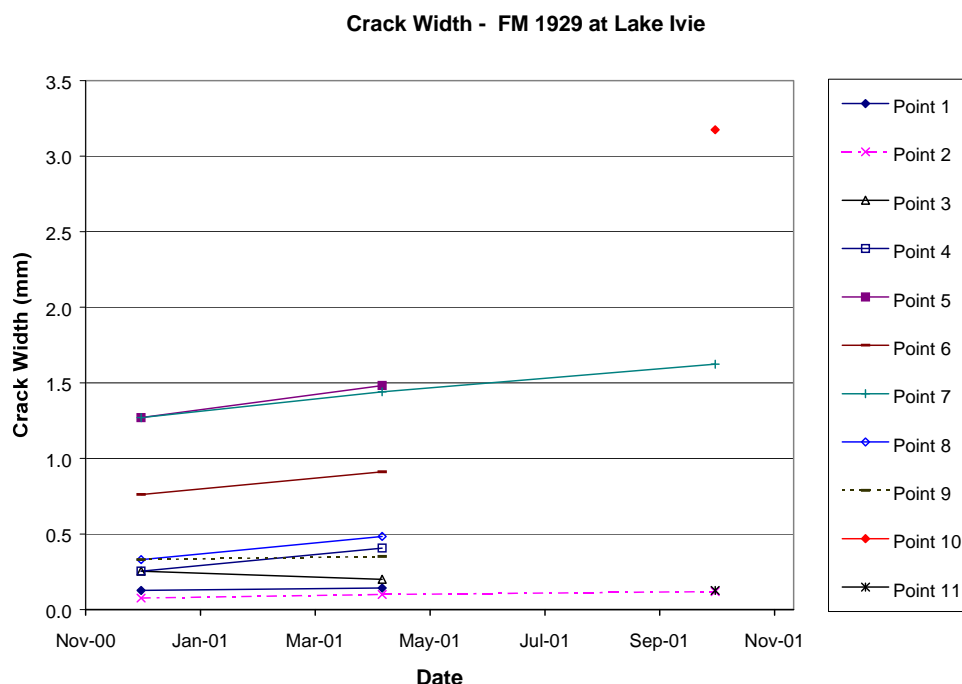
Figure 7.56: Crack width over time for FM 1929 at Lake Ivie

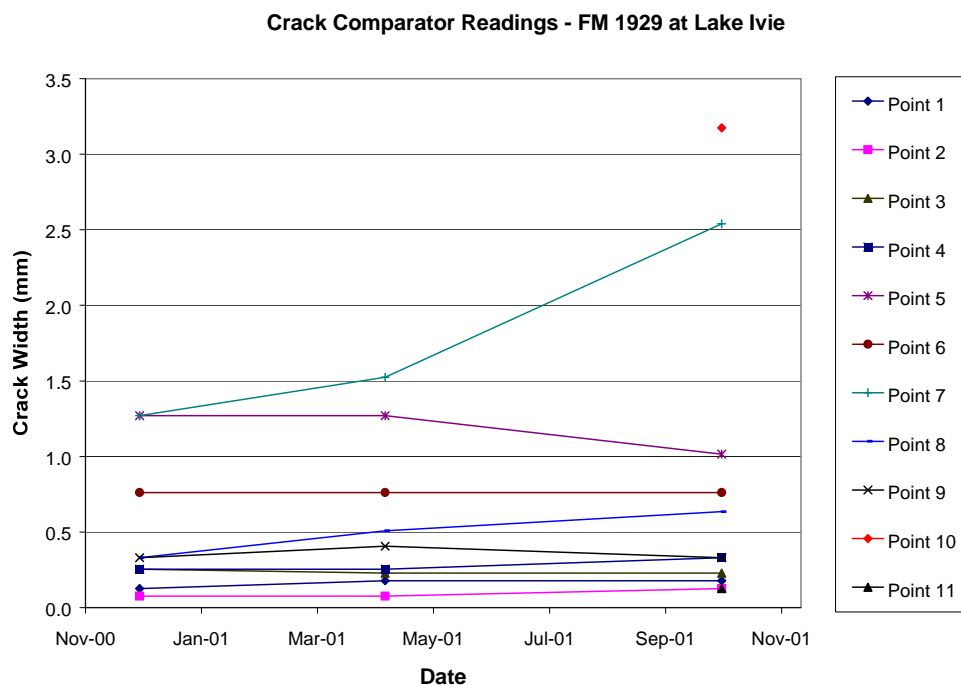
Figure 7.57: Crack comparator readings over time for FM 1929 at Lake Ivie

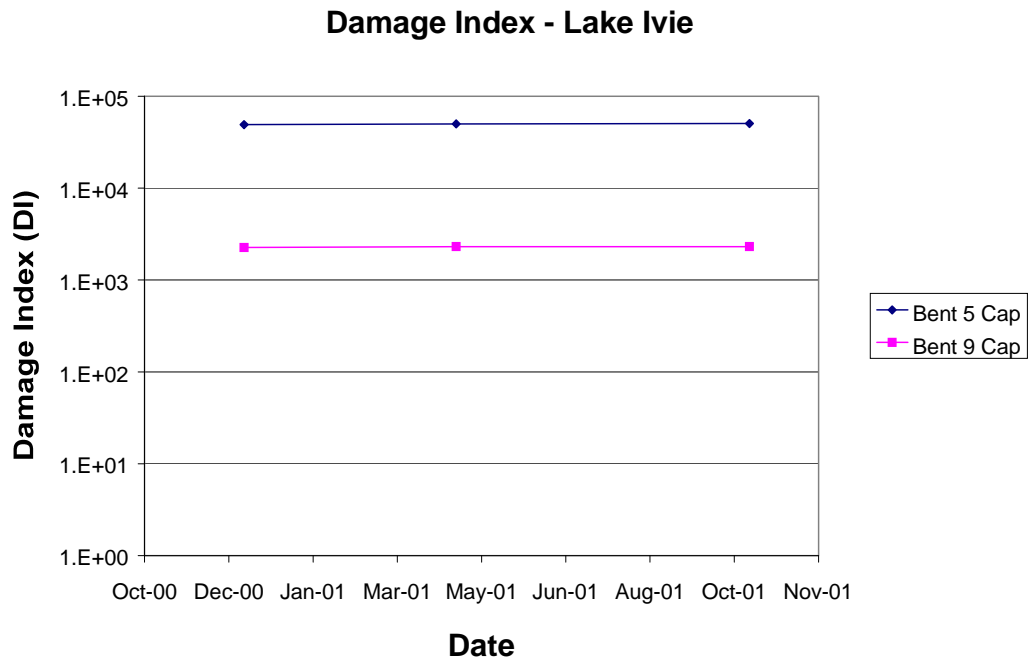
Figure 7.58: Damage Index over time for FM 1929 at Lake Ivie

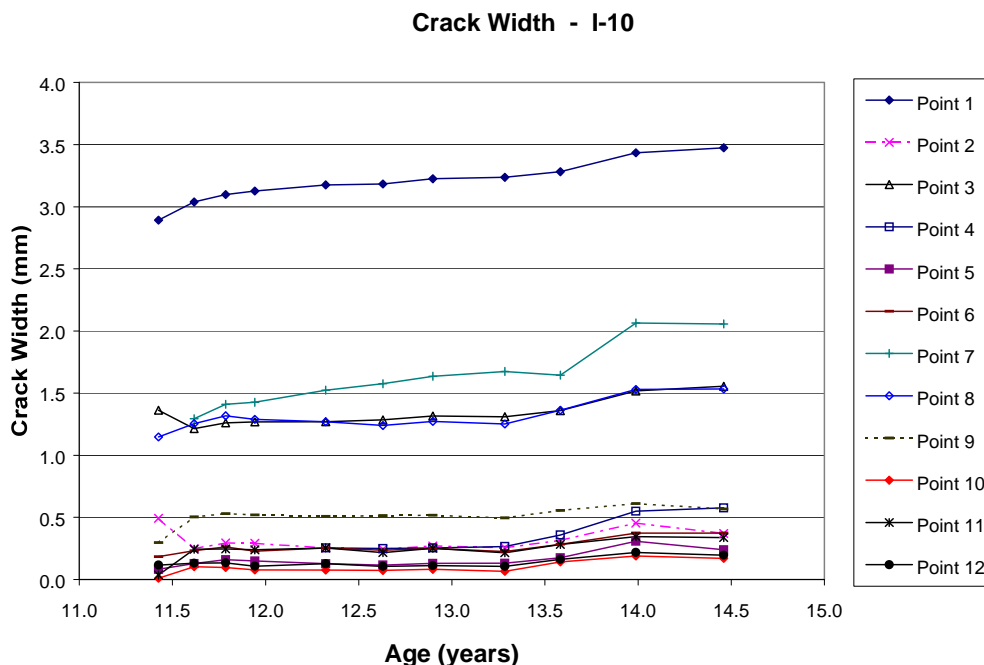
Figure 8.1: Crack width versus age of girder for the I-10 structure

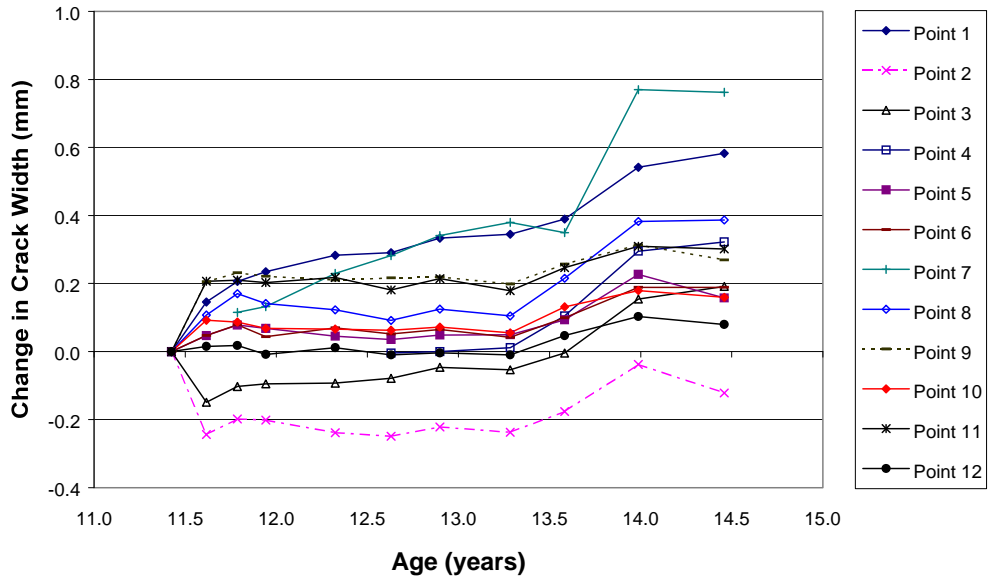
Figure 8.2: *Change in crack width versus age of girder for the I-10 structure*

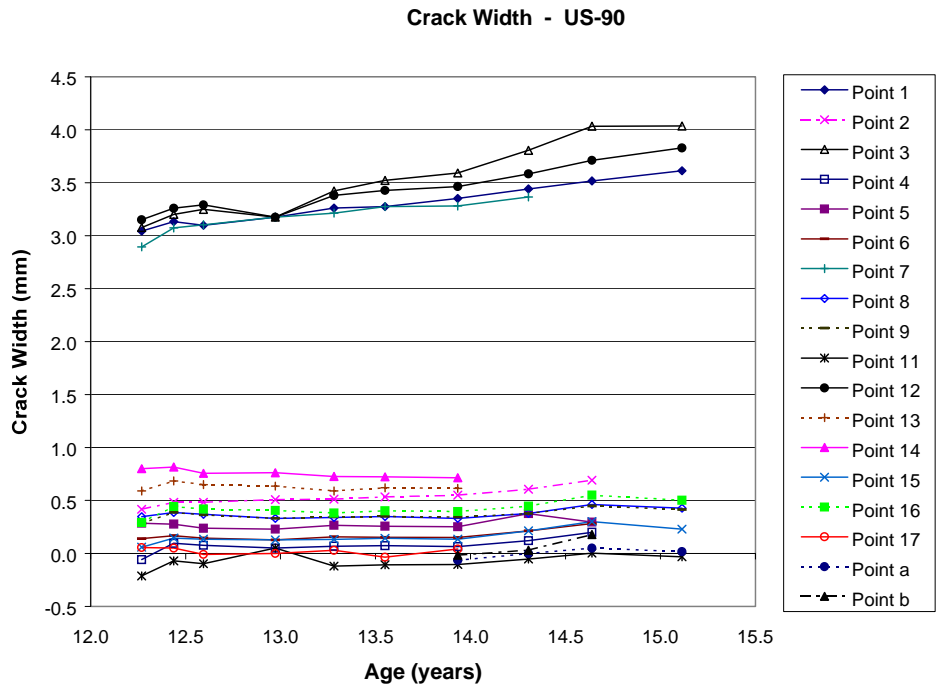
Figure 8.3: Crack width versus age of girder for the US-90 structure

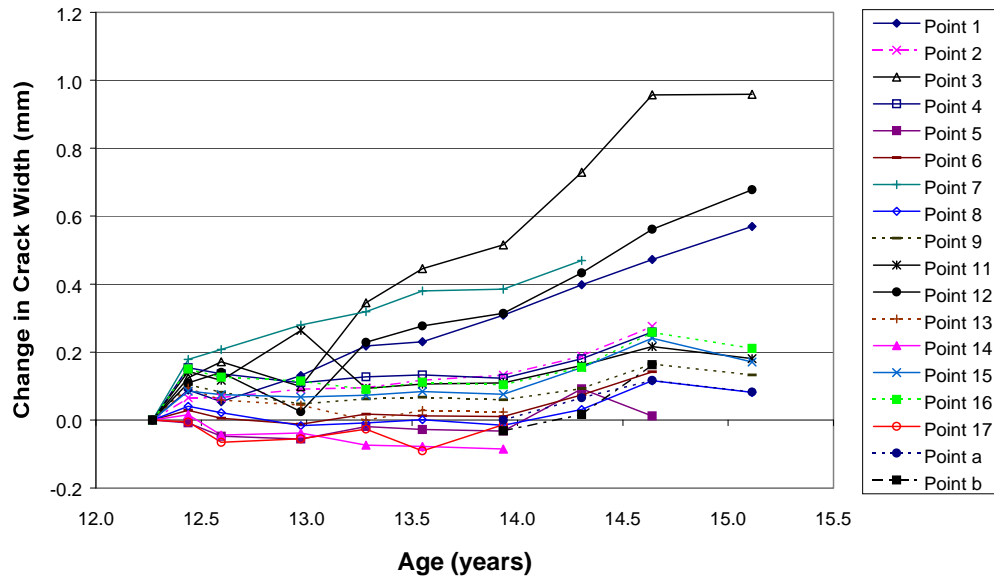
Figure 8.4: Change in crack width versus age of girder for the US-90 structure

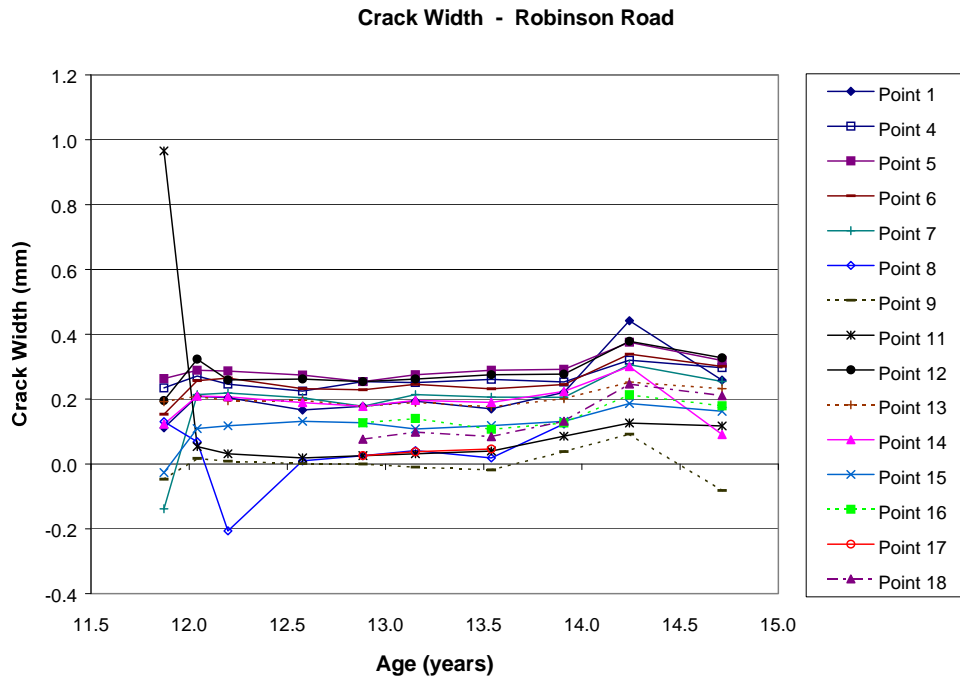
Figure 8.5: Crack width versus age of girder for the Robinson Road structure

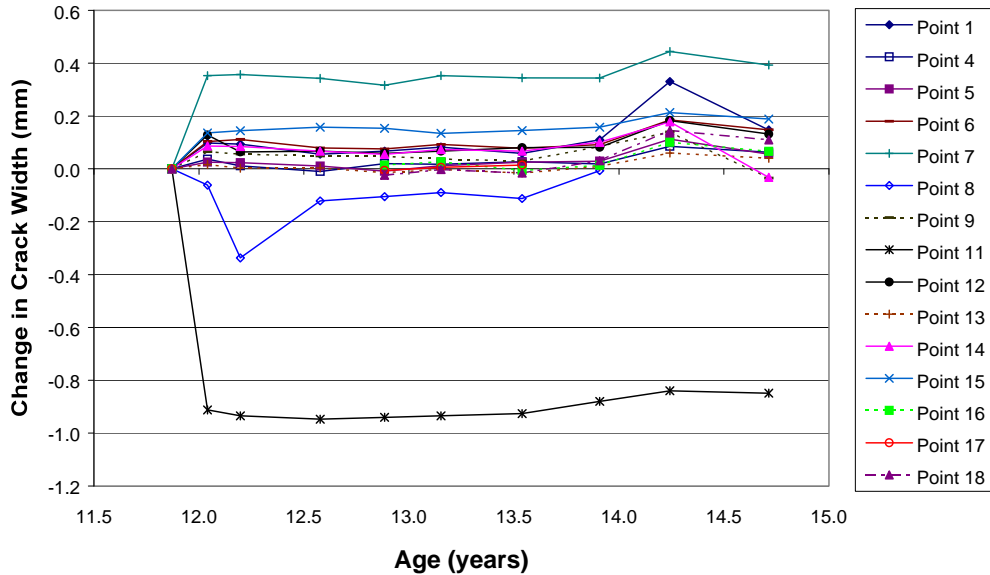
Figure 8.6: Change in crack width versus age of girder for the Robinson Road structure

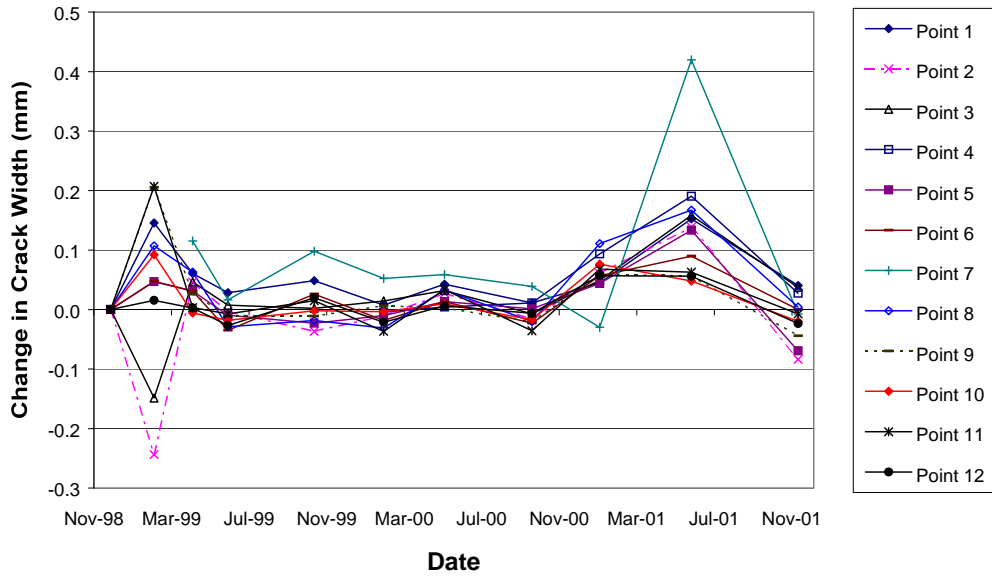
Figure 8.7: Incremental change of crack width versus age of girder for the I-10 structure

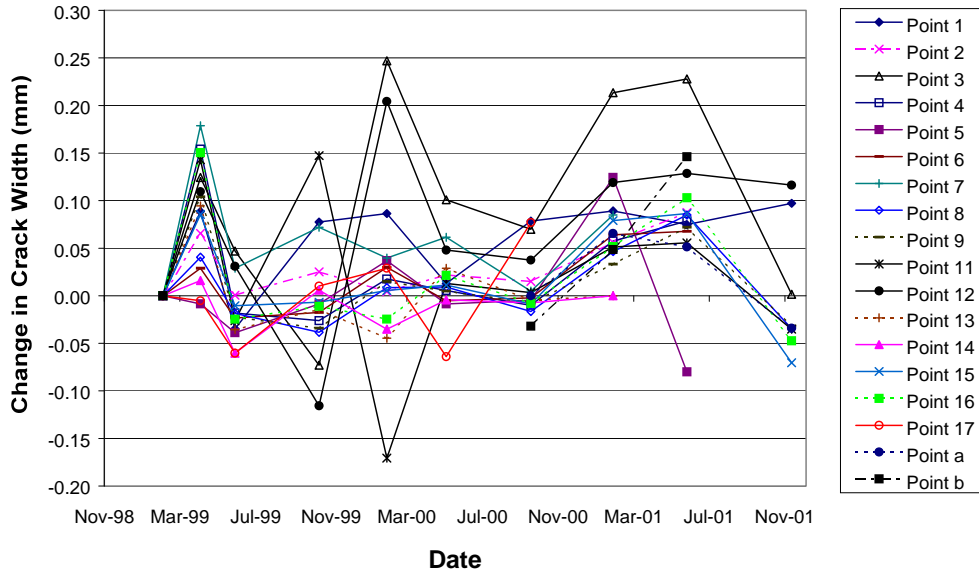
Figure 8.8: Incremental change in crack width versus age of girder for the US-90 structure

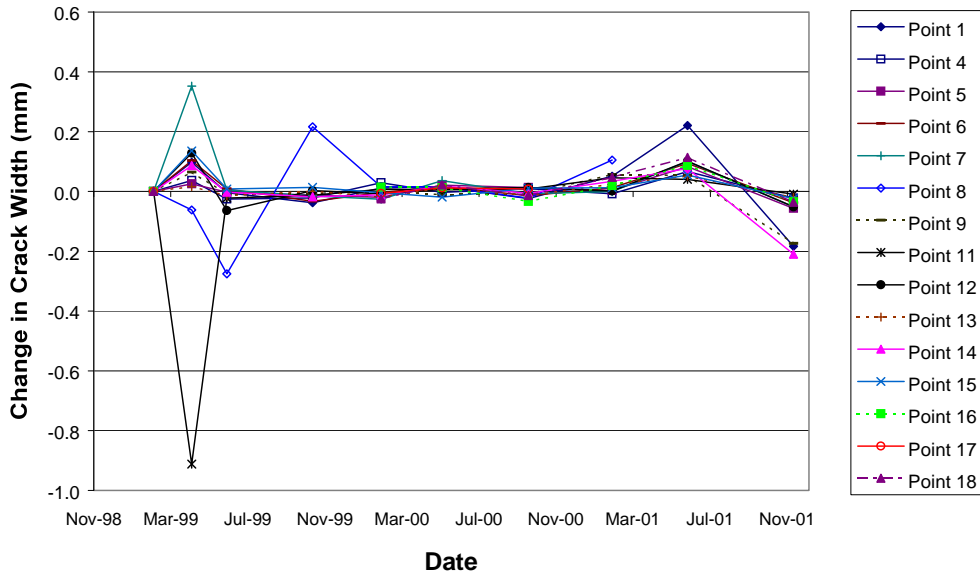
Figure 8.9: Incremental change in crack width versus age of girder for the Robinson Road structure

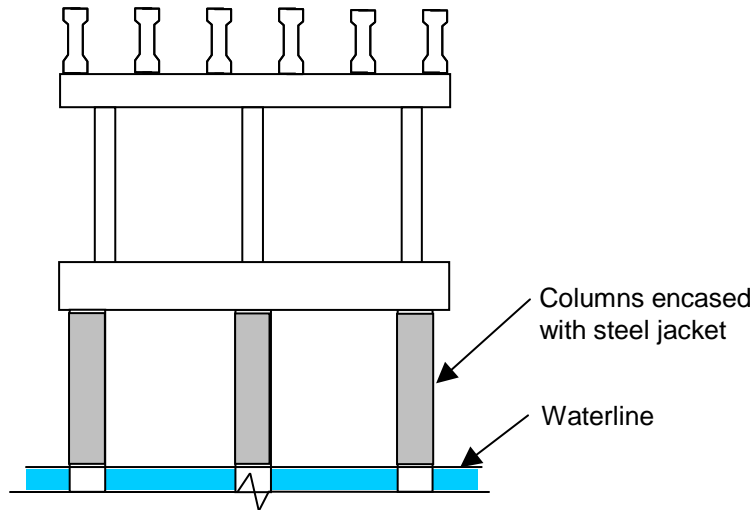
Figure 9.1: *Steel jacket around bent columns*

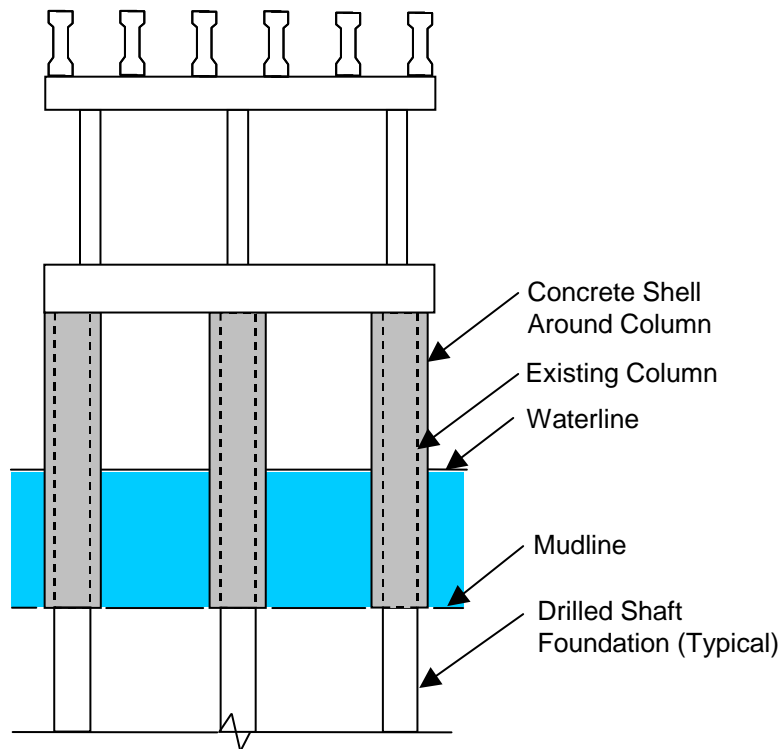
Figure 9.2: *Concrete shells poured around bent columns*

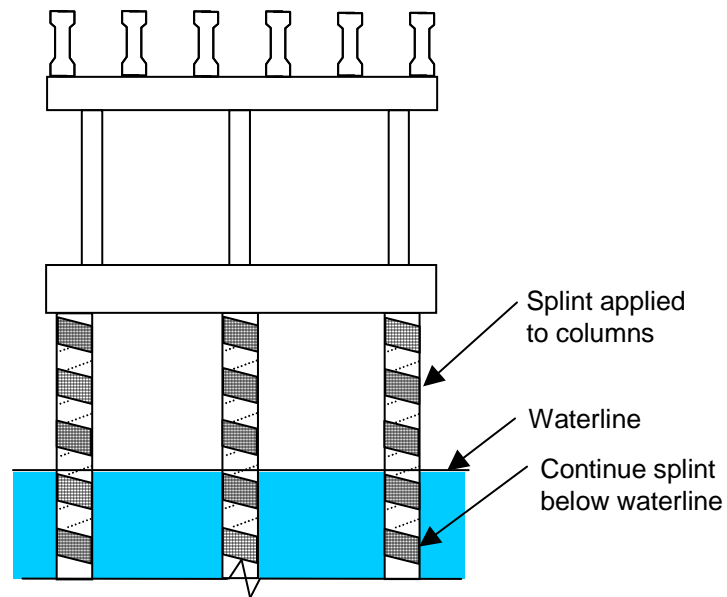
Figure 9.3: *Splints installed on bent columns*

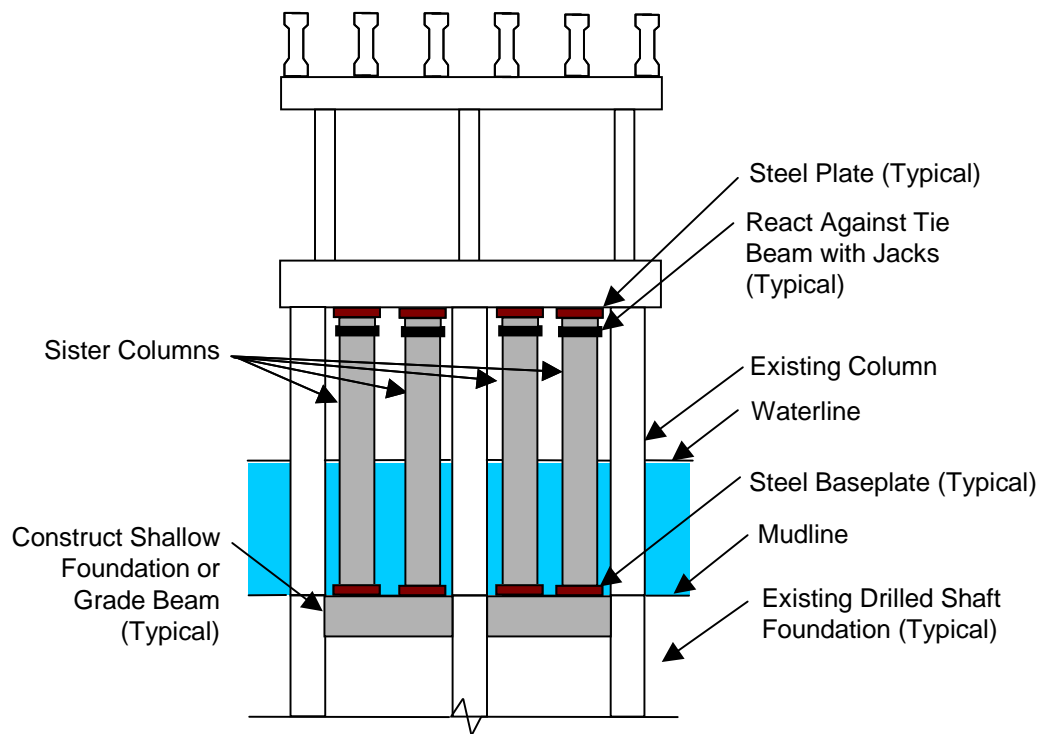
Figure 9.4: Sister columns installed at bent

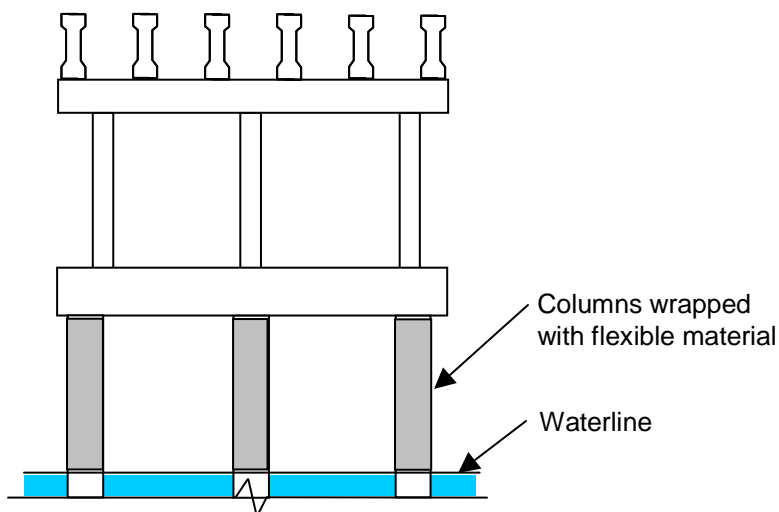
Figure 9.5: Flexible wrap around bent columns

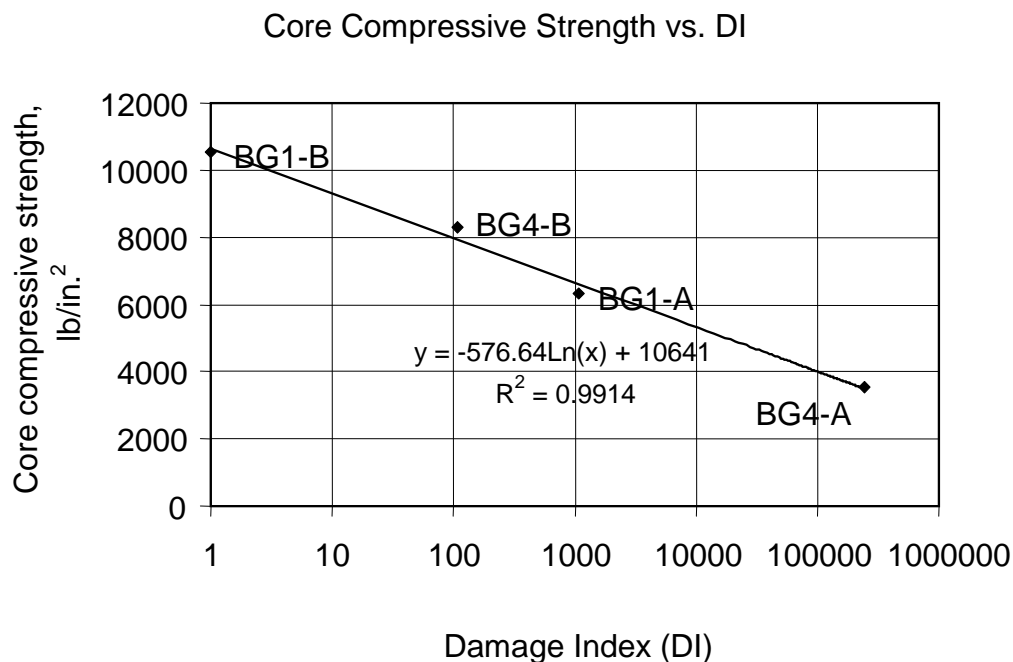
Figure 9.7: Concrete compressive strength of cores from box girders versus damage index (Boenig 2000)

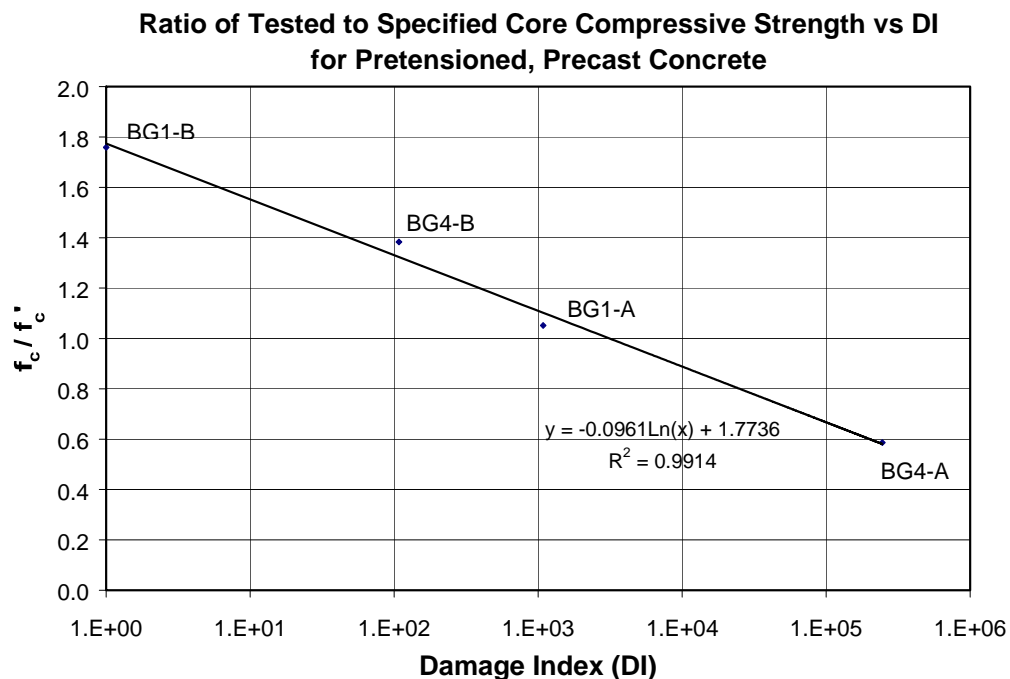
Figure 9.8: *Ratio of tested to specified concrete compressive strength versus damage index for pretensioned, precast concrete*

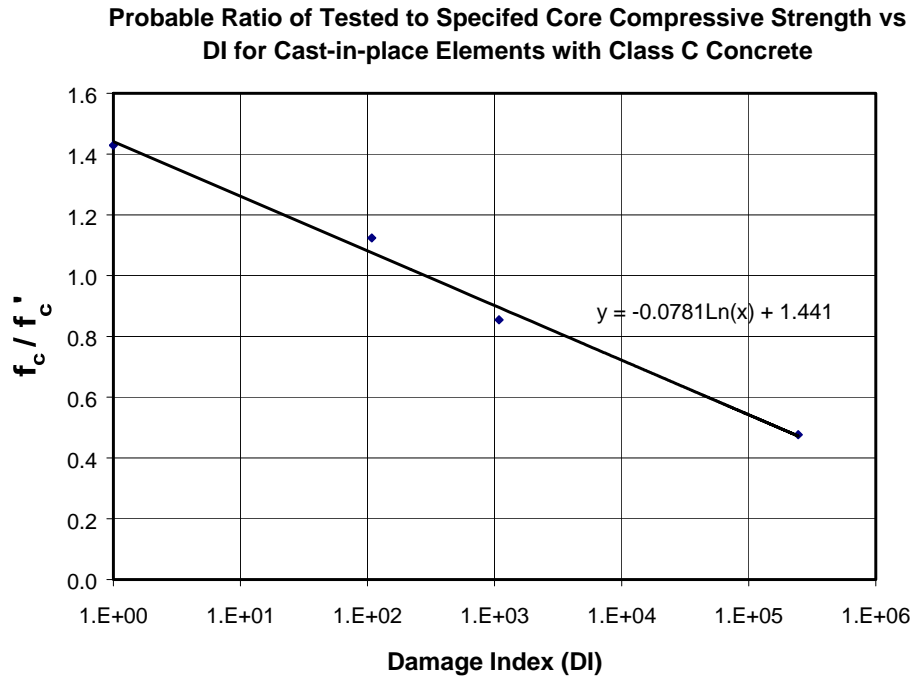
Figure 9.9: *Probable ratio of actual to specified concrete compressive strength versus damage index for cast-in-place elements with Class C concrete*

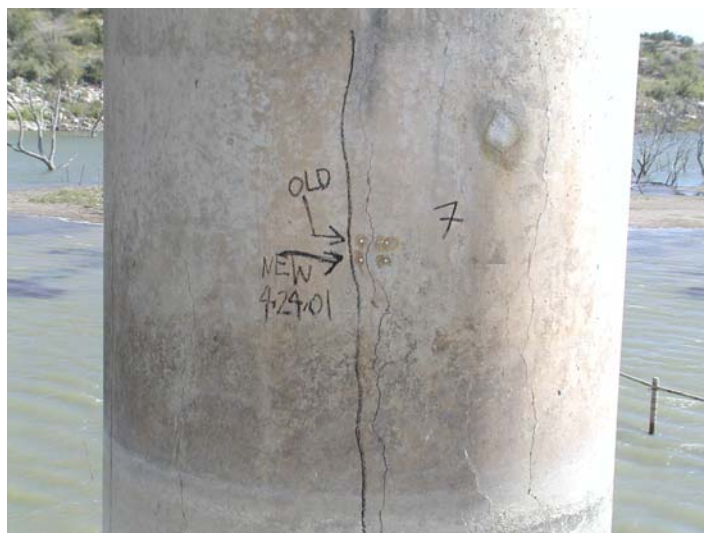
**Figure 9.11: Typical vertical cracking on south lower column of Bent 5
(10/15/01)**
