Larry Seth Memberg

**Bridges with Premature Concrete Deterioration: Damage Indices,
Strand-Pullout Tests, and Field Observations**

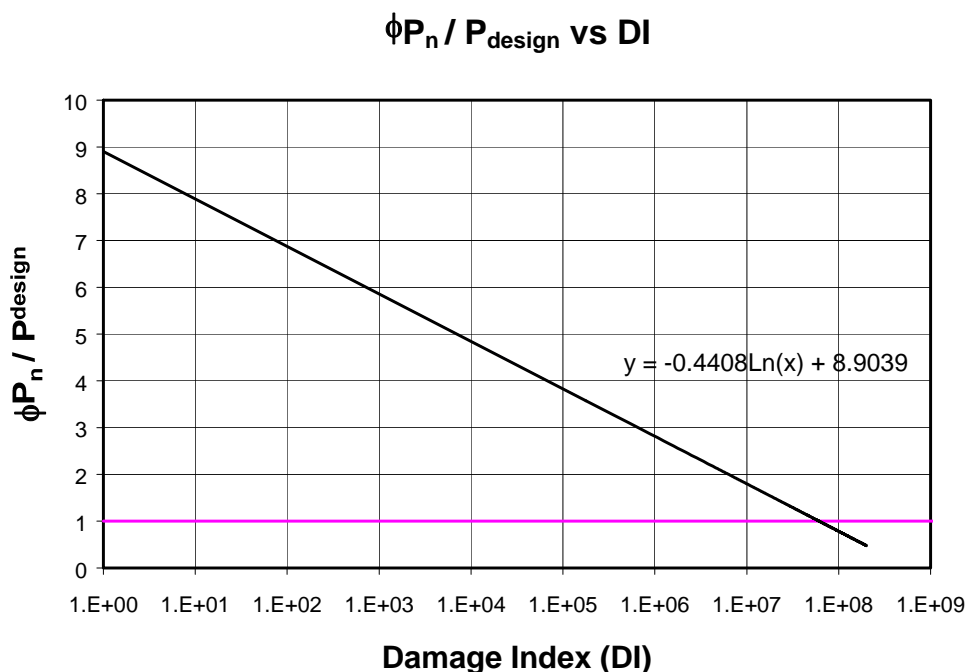
Figure 9.12: Ratio of design axial capacity to design axial load versus damage index, south column, Bent 5, Lake Ivie

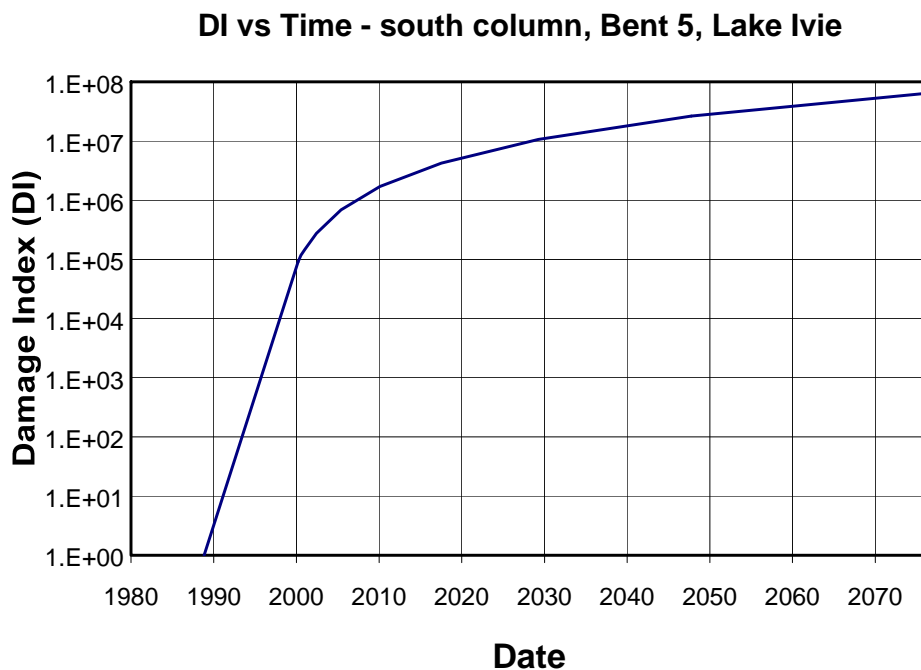
Figure 9.13: Predicted Damage Index versus time for south column, Bent 5, Lake Ivie

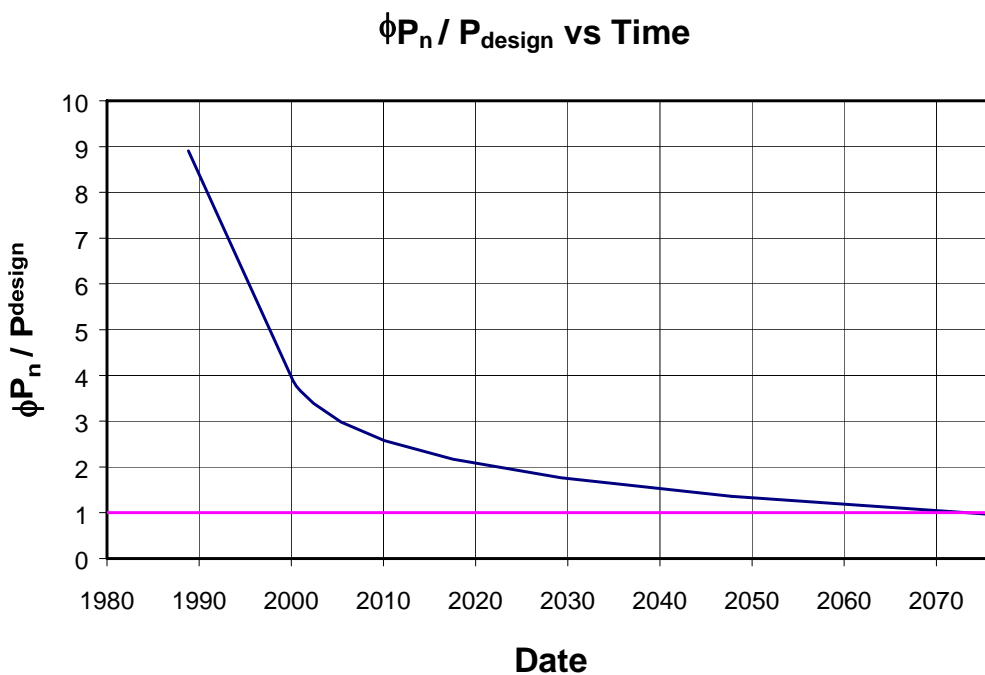
Figure 9.14: Predicted ratio of axial capacity to design axial load versus time, south column, Bent 5, Lake Ivie
