**Effect of Galvanization on the Fatigue Strength of High Mast  
Illumination Poles**

**Thesis**

The University of Texas at Austin  
May 2010

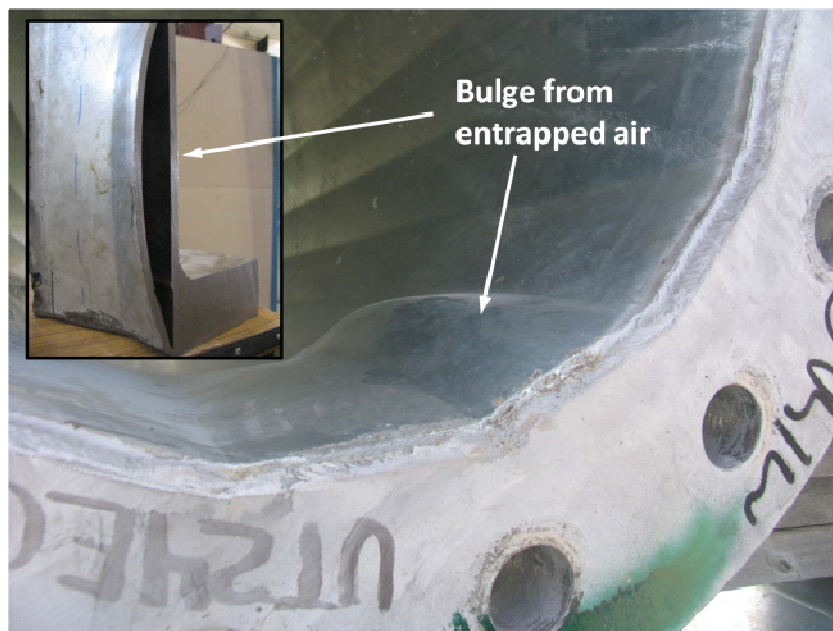
Figure 2.10 Bulge Caused by Entrapped Air between Collar and Pole (Stam, 2009)

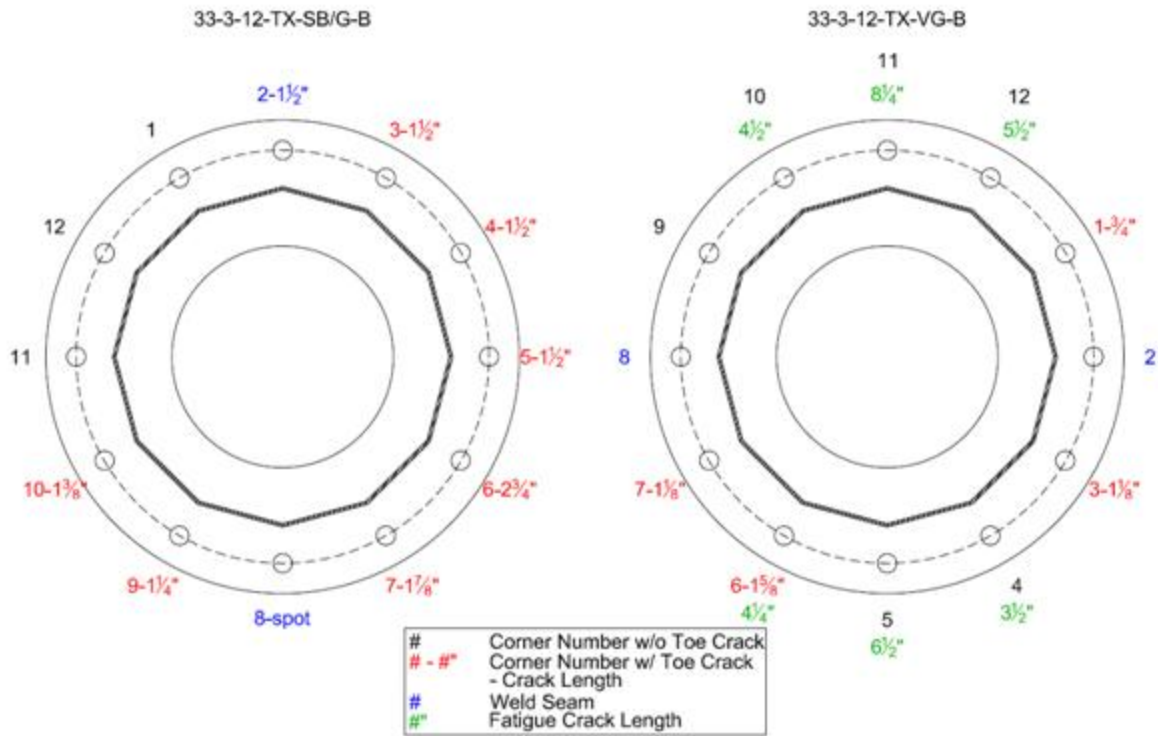
The weld repairs were only performed at bends that contained crack indications. Figure 2.11 below shows where the crack indications were on the two specimens prior to weld repair. The bend number is followed by the crack length. Specimen 33-3-12-TX-SB/G-B was initially tested prior to galvanizing. The specimen contained no fatigue cracks. The crack lengths shown were found after the specimen was galvanized.

Figure 2.11 Cracks in Weld Repair Specimens Prior to Repair

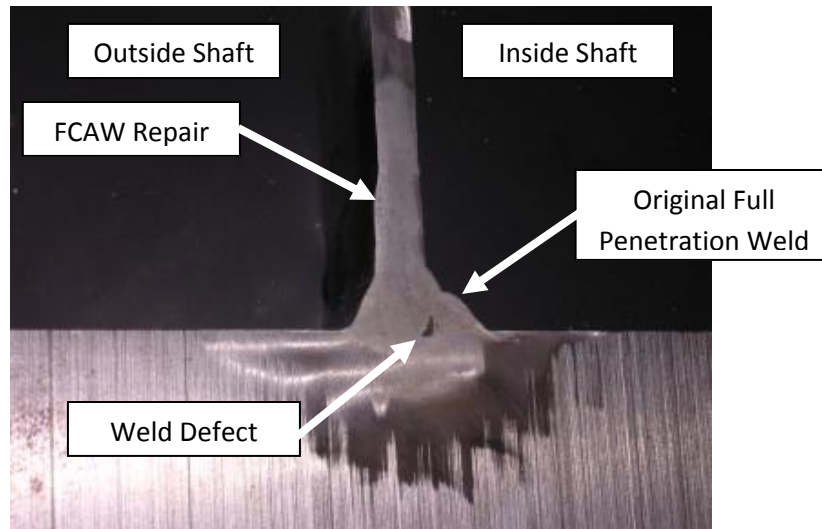
Because only one broad pass was needed to repair the weld, the weld profile on the shop repair specimen resulted in a smooth broad parabolic shape. Previous research has indicated that this interface is critical to maintaining smooth stress flow between the stiff base plate, and relatively flexible pole wall (Stam, 2009). This shape is advantageous due to the reduction of the notch effect at the transition between the toe weld and pole wall, which, in turn, leads to a lower stress increase. A picture through the cross section of a practice weld done on another sample is provided in Figure 2.13. A small weld defect from lack of fusion can be seen in this picture.

Figure 2.13 Polished Cross Section Through FCAW Repaired Weld

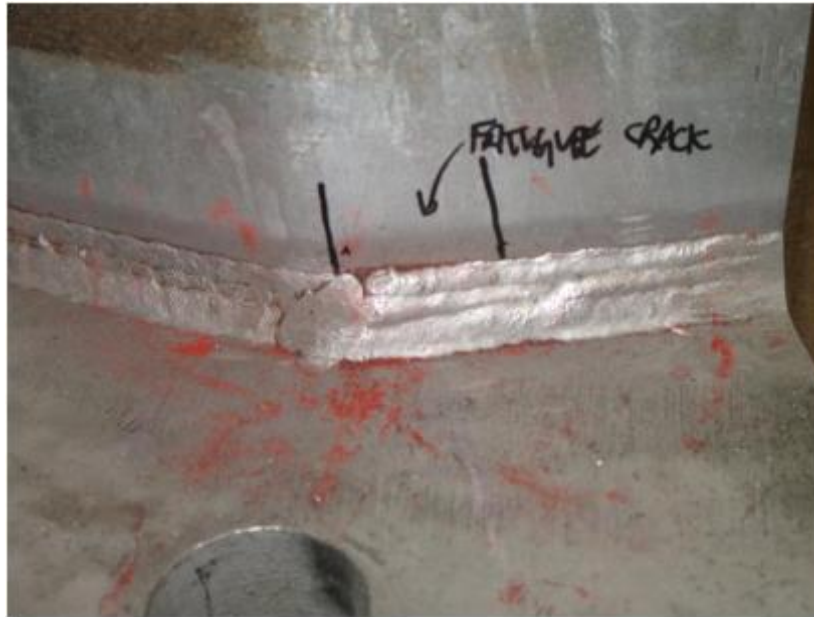
Figure 3.1 Fatigue Crack Observed Using Magnetic Particle Testing

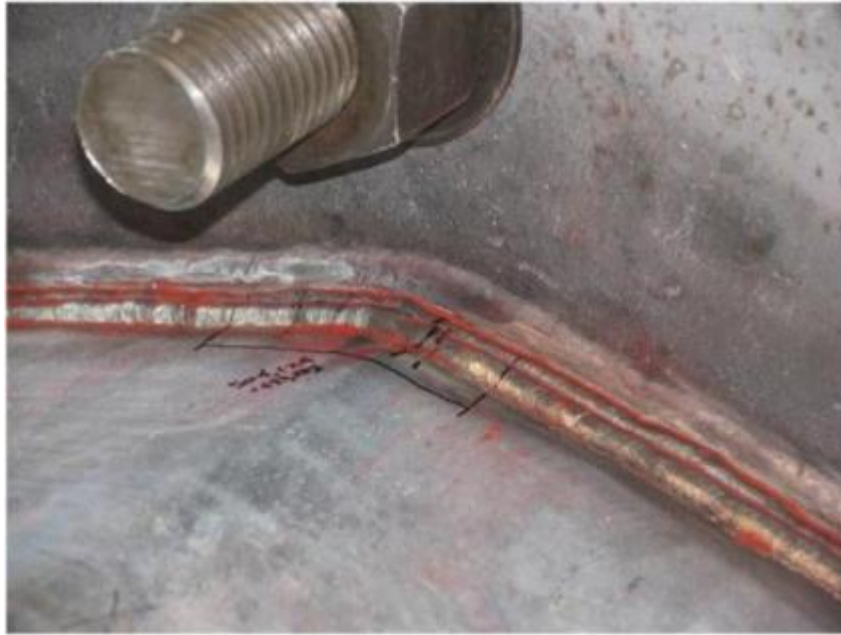
repair weld and base metal. The black lines on the base metal show the most recent fatigue crack marks observed by visual inspection. Notice the difference between these marks, and the blurred magnetic particle indications shown by the red powder.

Figure 3.2 Poor Magnetic Particle Test Reading Caused by Geometric Discontinuity

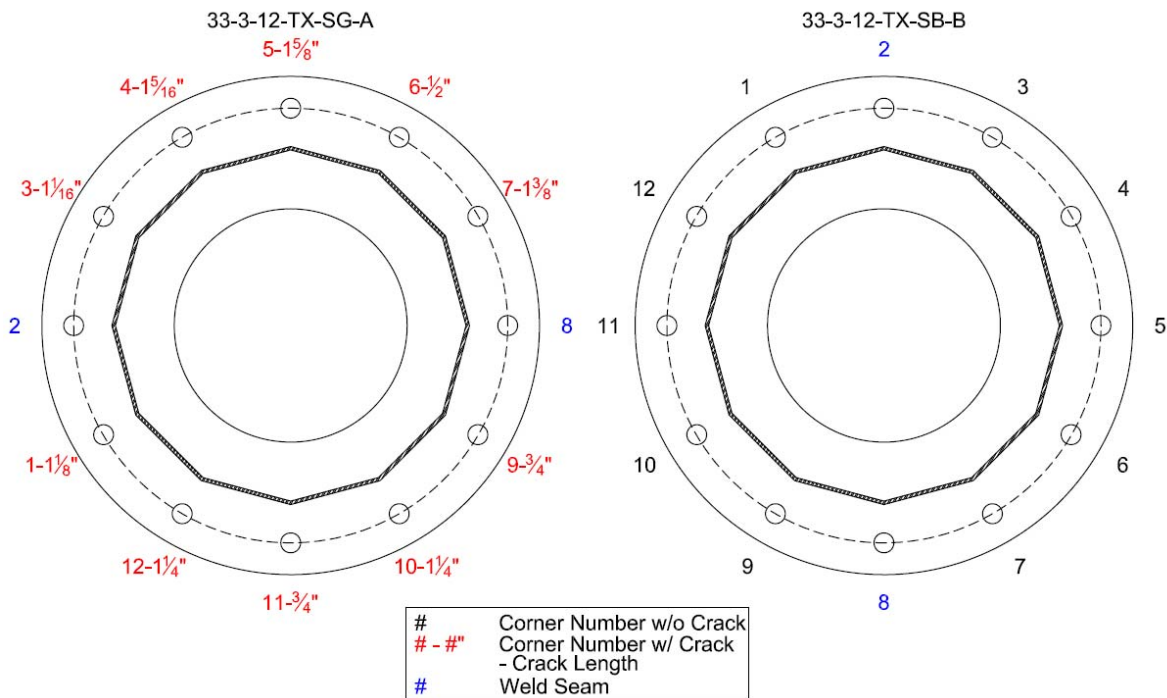
Figure 4.1 Initial Crack Locations and Lengths in Specimens 33-3-12-TX-SG-A and 33-3-12-TX-SB-B

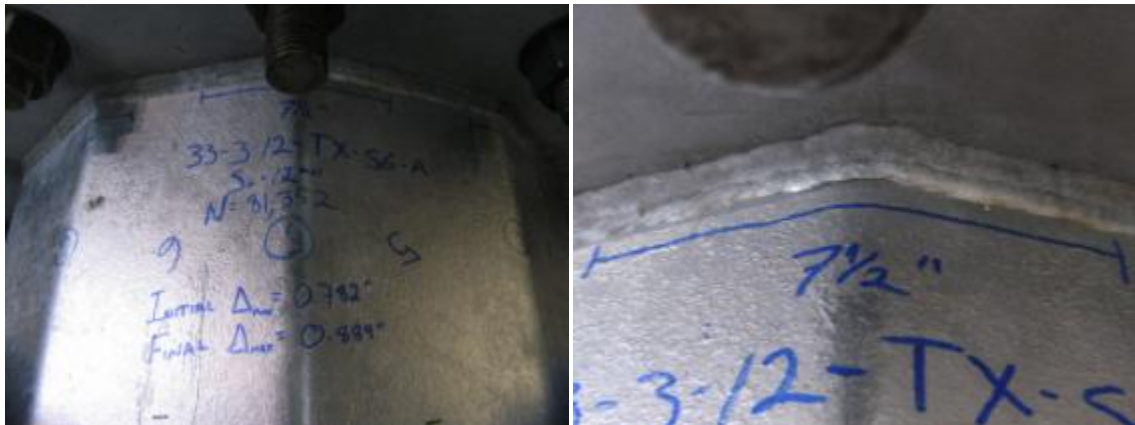
Figure 4.3 Crack Length at Bend 5 on the Galvanized Specimen after 81,326 Cycles

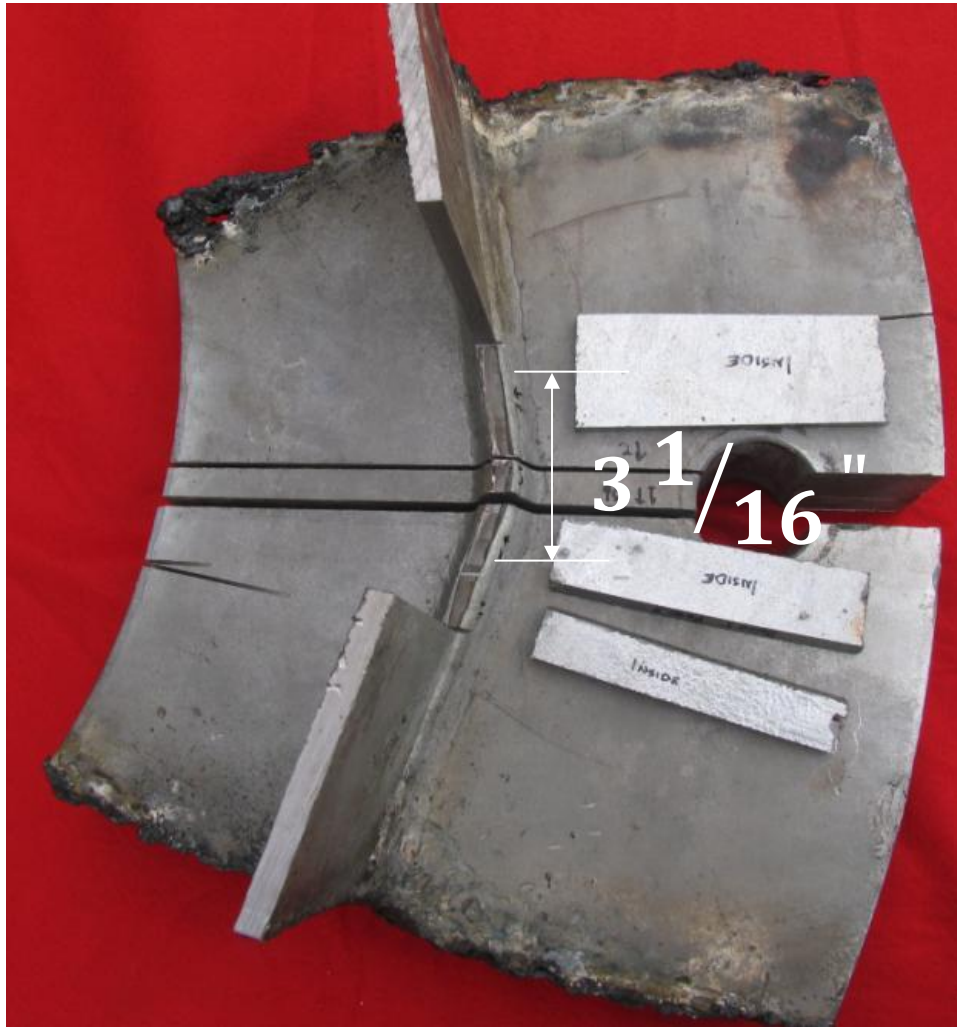
Figure 4.5 View of Bend 5 after Sectioning. Length of Observed Initial Crack is Labeled

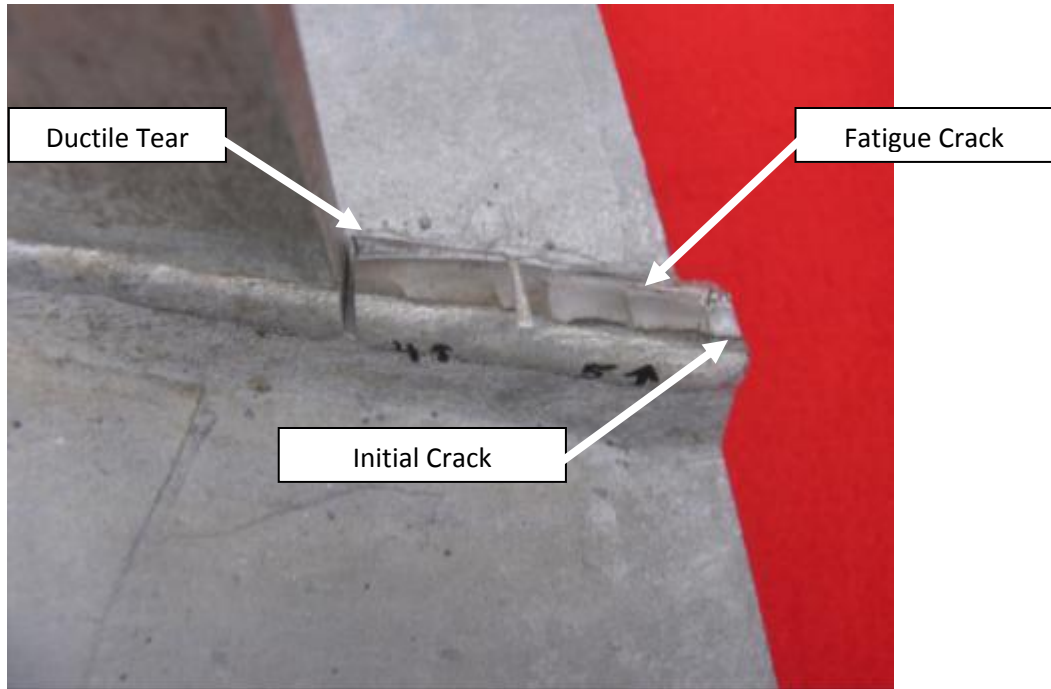
Figure 4.6 Close Up of Fracture Surface at Bend 5

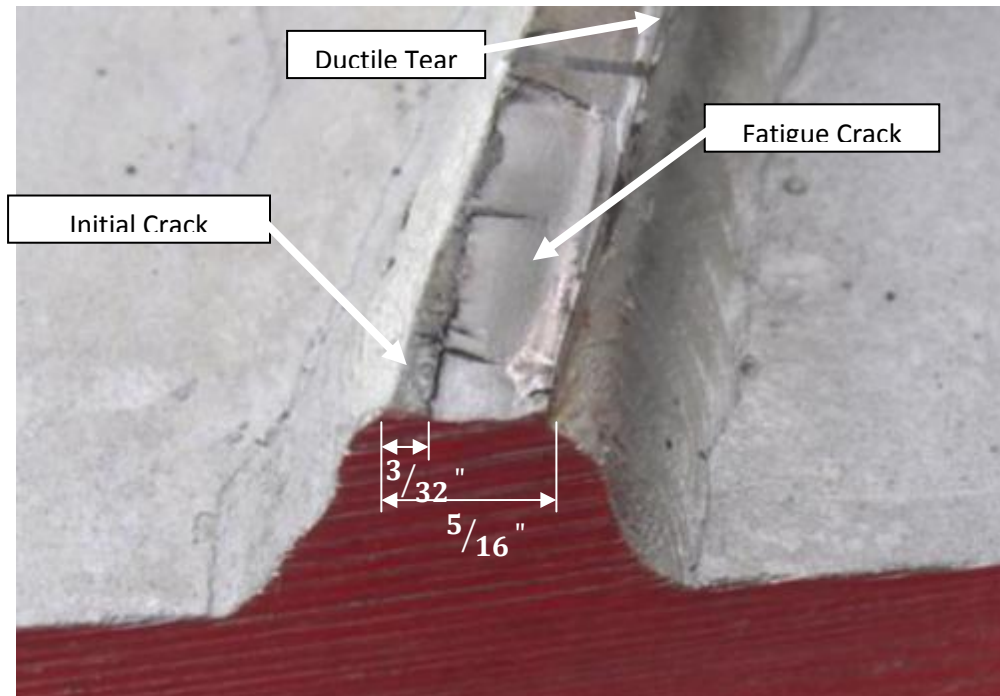
Figure 4.7 Depth of Initial Crack at Weld Toe

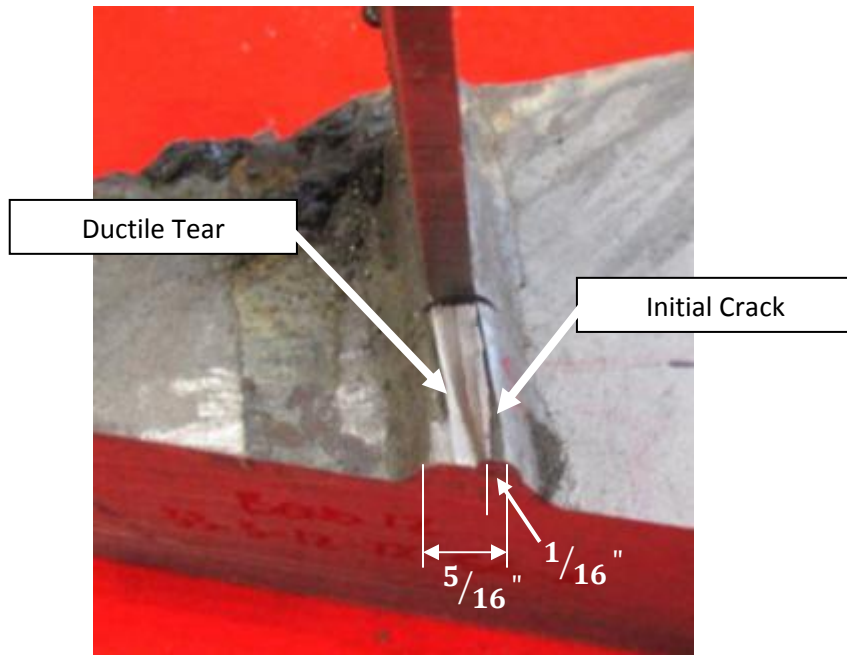
Figure 4.8 Fracture Surface at Bend 12

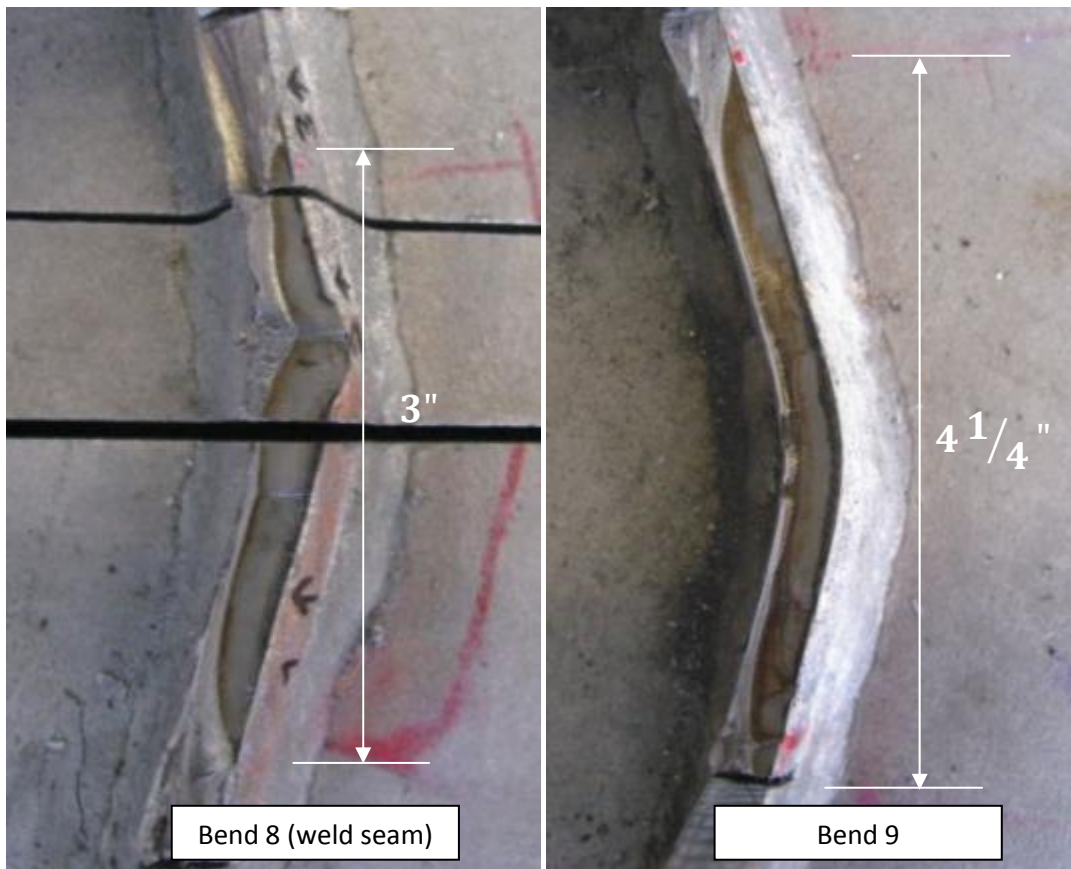
Figure 4.9 Fatigue Cracks at Bends 8 and 9

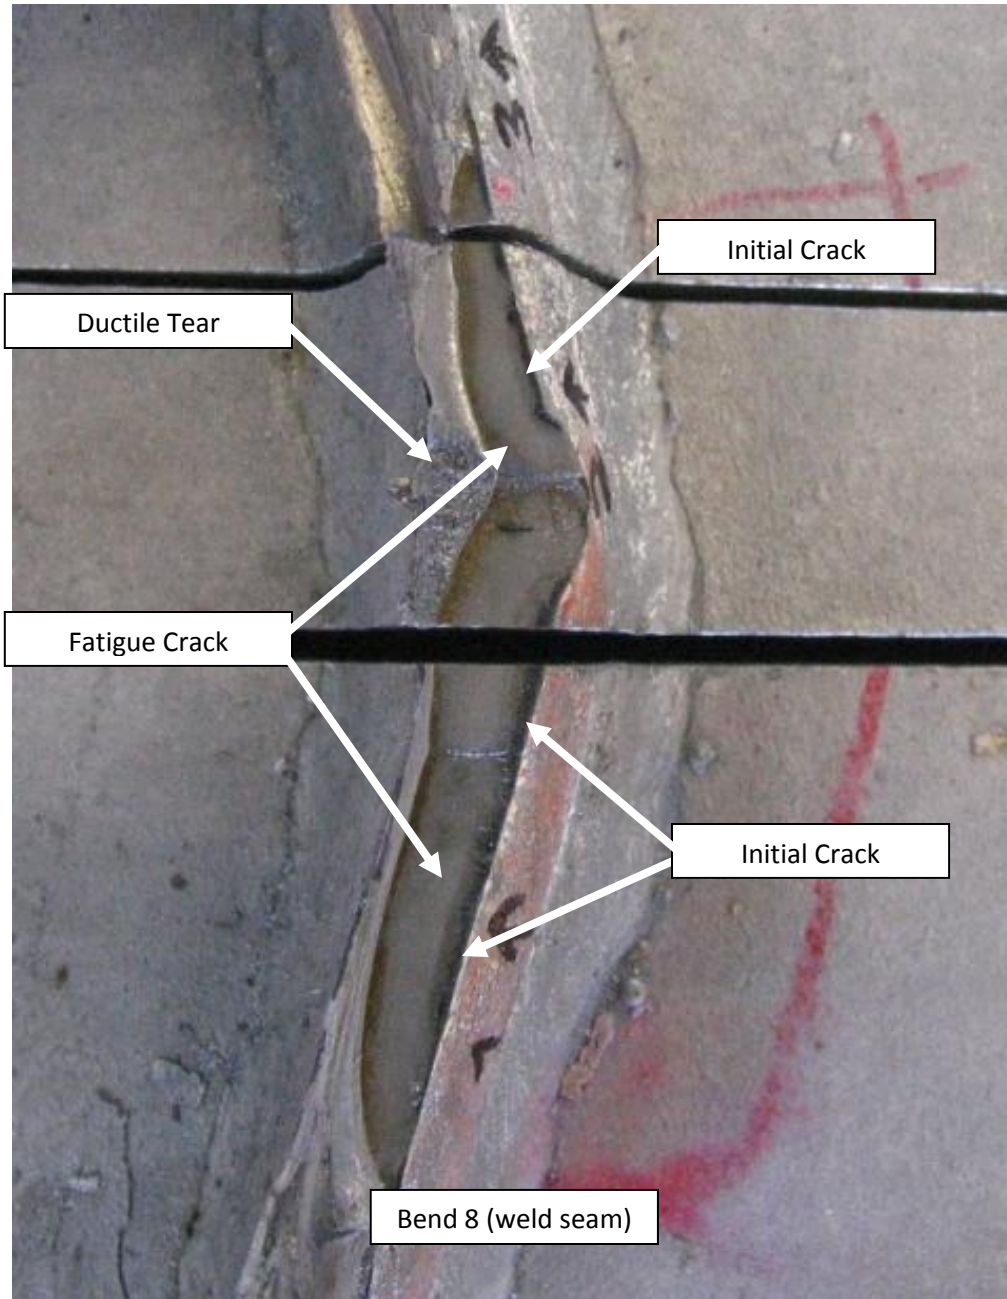
Figure 4.10 Fracture Surface of Bend 8

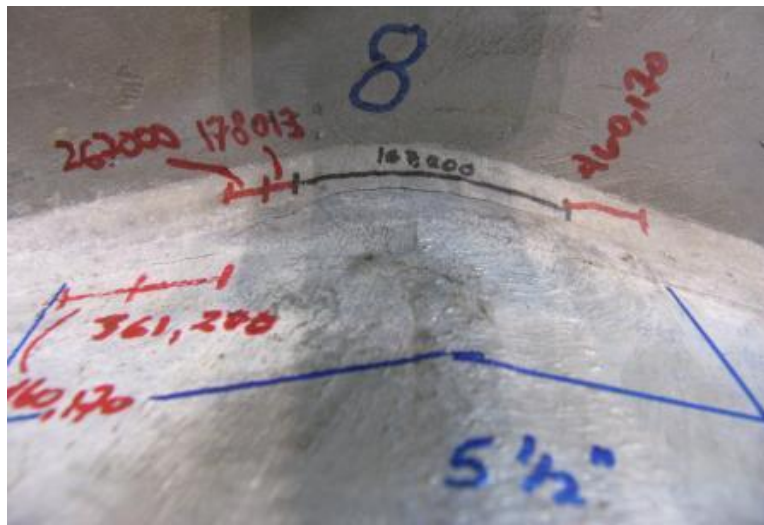
Figure 4.13 Fatigue Crack at Bend 8

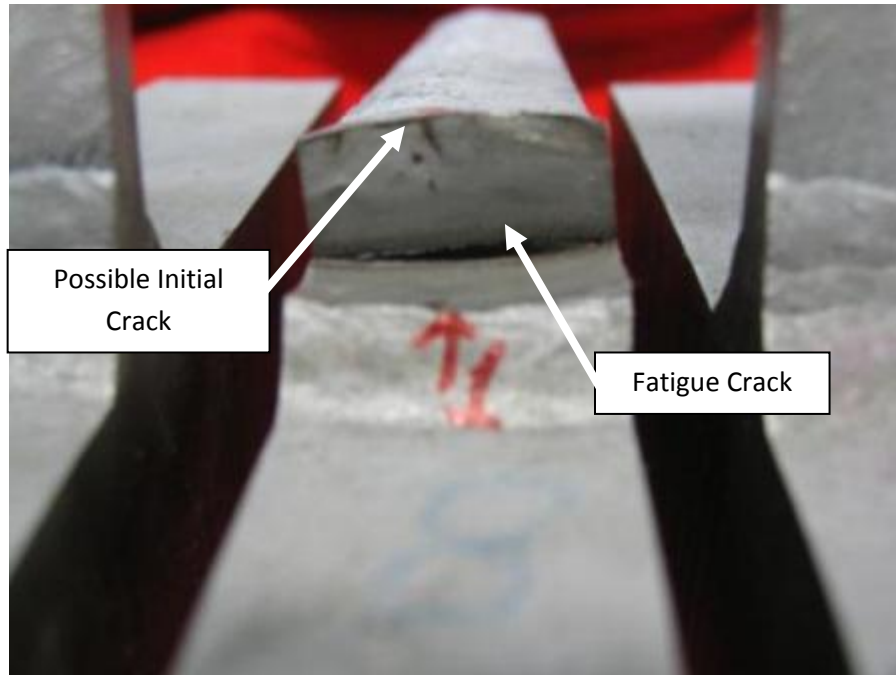
Figure 4.18 Bend 8 of Specimen 33-3-12-TX-VG-A with Fatigue Failure through Weld

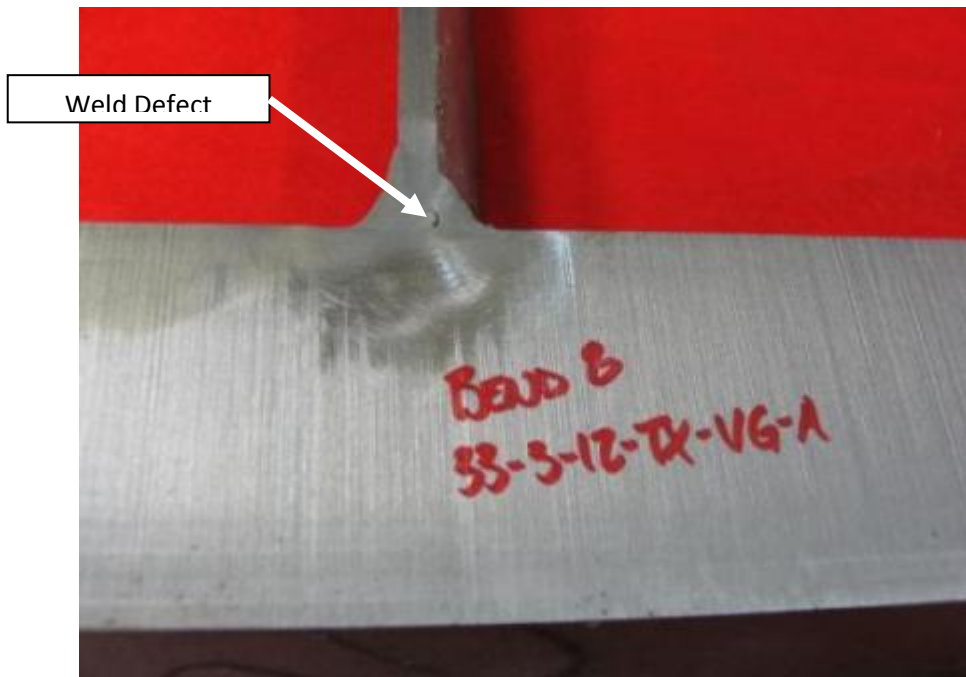
Figure 4.19 Cross Section of Bend 8 of Specimen 33-3-12-TX-VG-A Showing Apparent Weld Defect

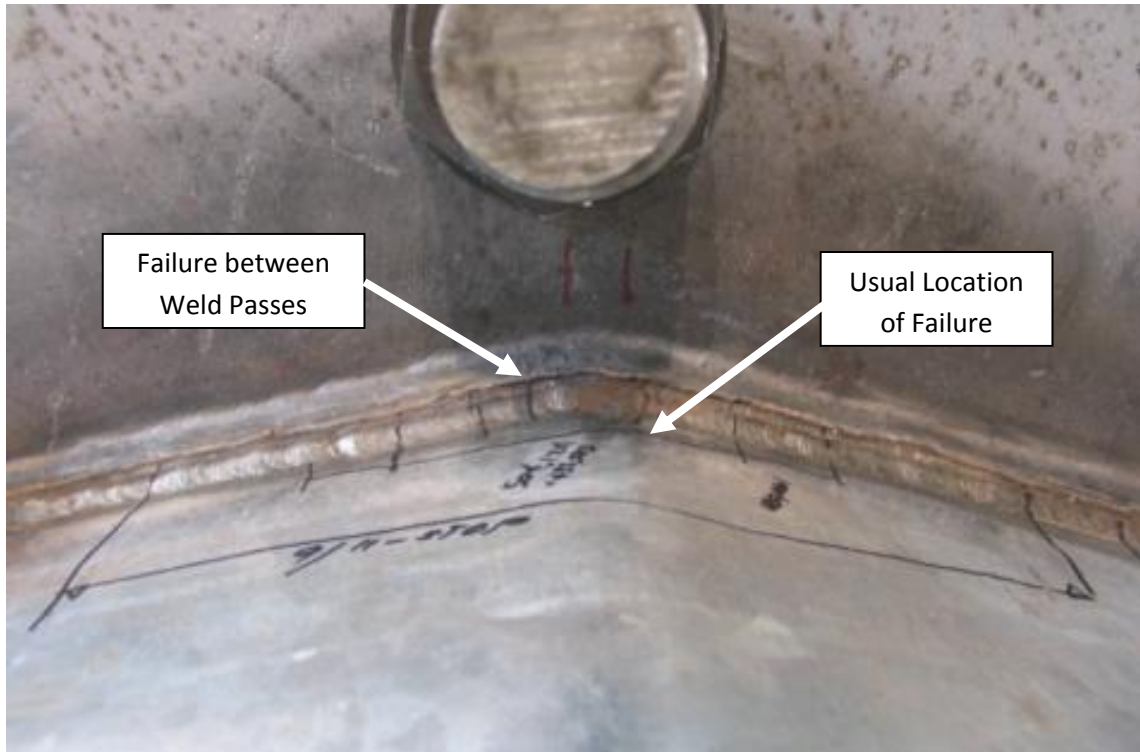
Figure 4.20 Bend 11 of Specimen Field Repair with Failure through Weld

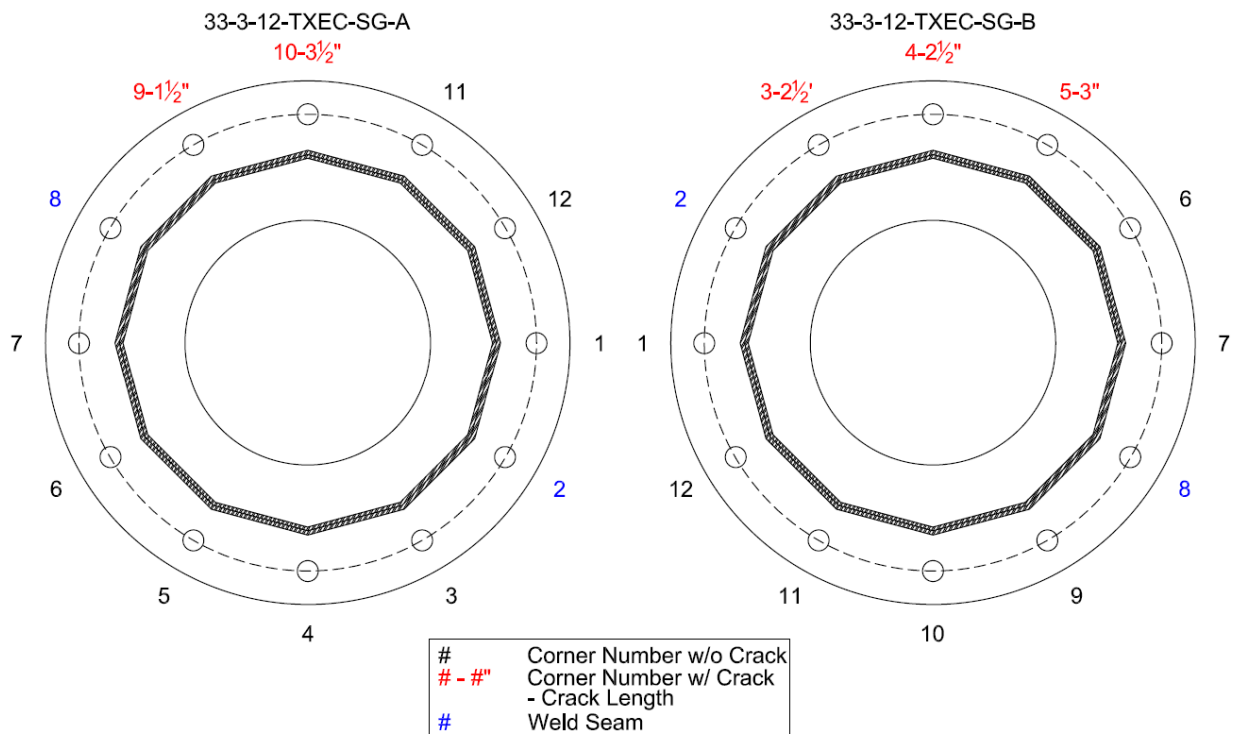
Figure 4.23 Crack Indications, Lengths, and Initial Orientation of External Collar Samples
