**Full-Scale Bending Fatigue Tests on Stay Cables**

**Thesis**

The University of Texas at Austin

**December 2001**

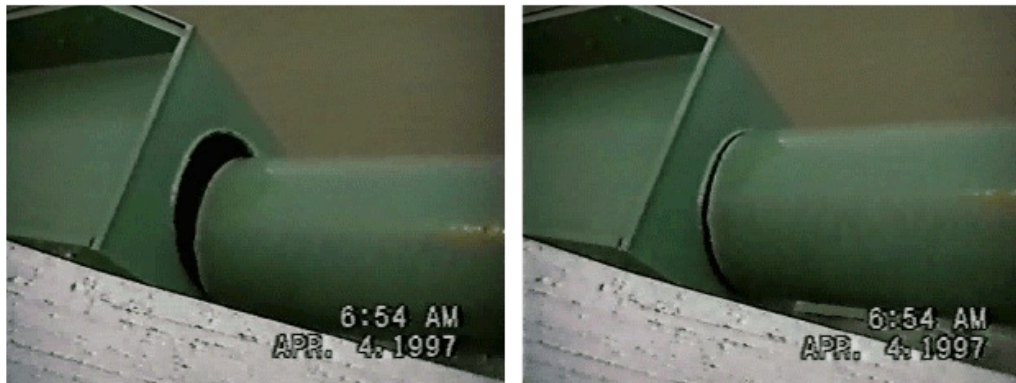
*Figure 1-6: Broken Guide Pipe*

WDP is mainly concerned with the repair of existing damage and with structural solutions to eliminate the cable vibrations. The broken guide pipes were strengthened with stiffeners, which now allow the pipe to withstand the large forces due to the cable vibrations. Note that the retrofitted guide pipes do not prevent the cable vibrations. A temporary solution to control the vibrations was the installation of cable restrainers as shown in Figure 1-7. The restrainers connect the stay cables to allow vibration energy to be transferred to adjacent stays.

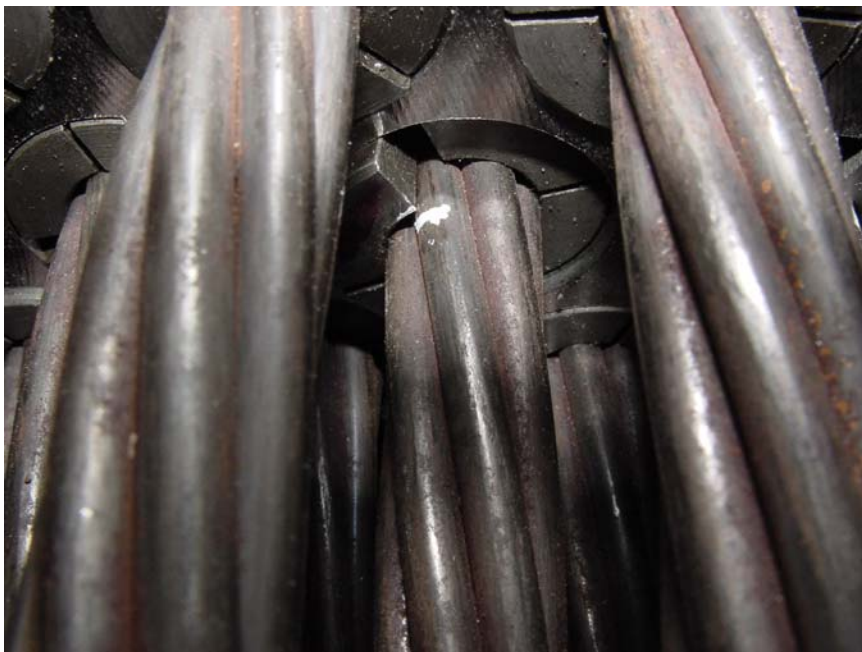
*Figure 3-31: Unequally Seated Wedges*

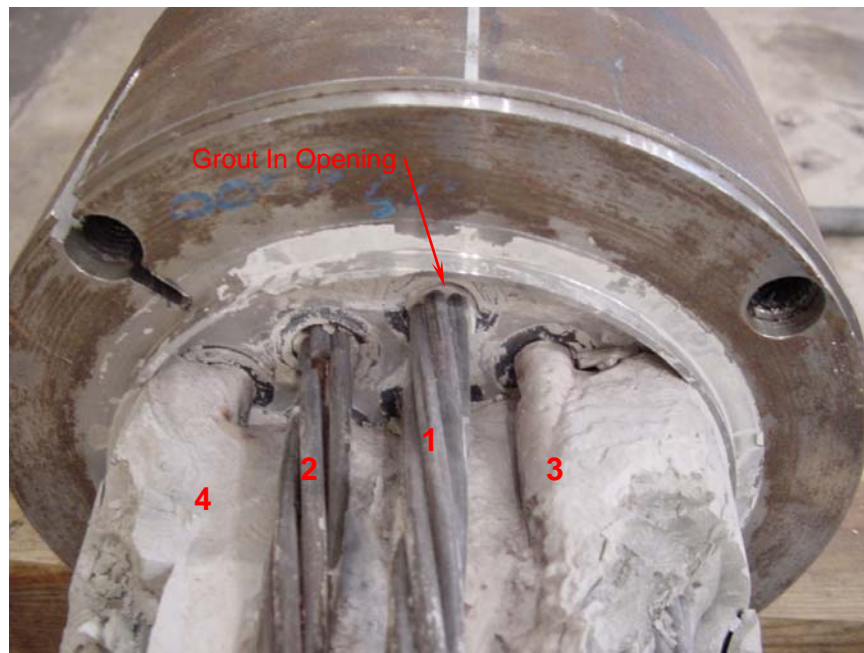
However, no significant signs of corrosion were found on the exposed strands in the grout void or on the anchor head. The surface corrosion seen in Figure 4-6 is light surface corrosion that was found on the shim plate. The location of the light corrosion would point to crevice corrosion in this area where the surfaces of the shim plate and the threaded nut are in direct contact.

*Figure 4-6: Exposed Strand within a Grout Void – Specimen #1*

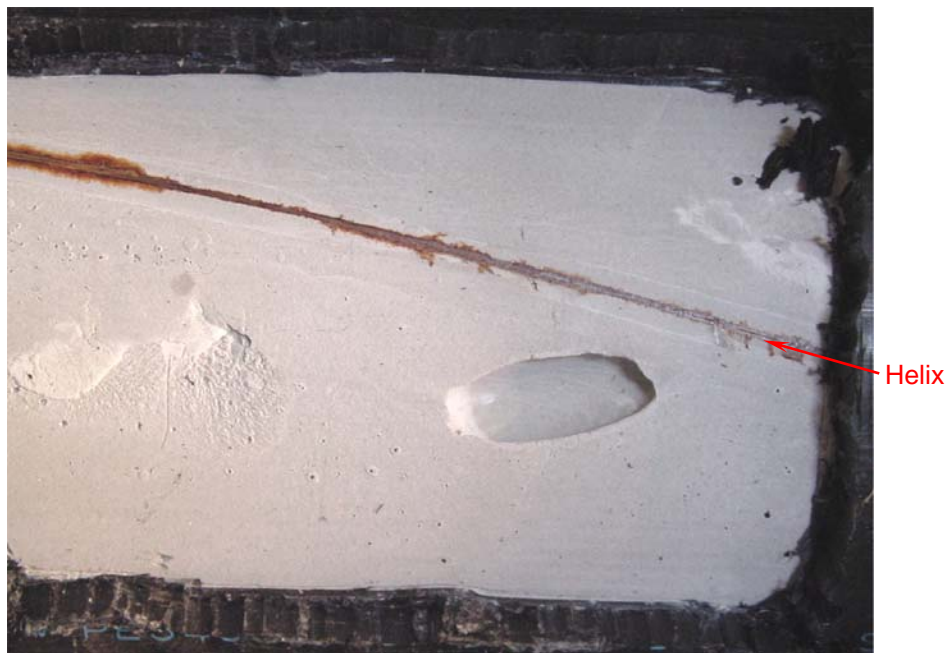
The grout in the rest of the specimen was homogeneous and only minor surface defects were found. The defects were often very close to the helical spacer wire as shown in Figure 4-7. Orange surface corrosion was found on some locations at the very outside of the helical spacer wire where it was in contact with the PE pipe.

***Figure 4-7: Grout Surface Defect and Corrosion on Helix – Specimen #1***

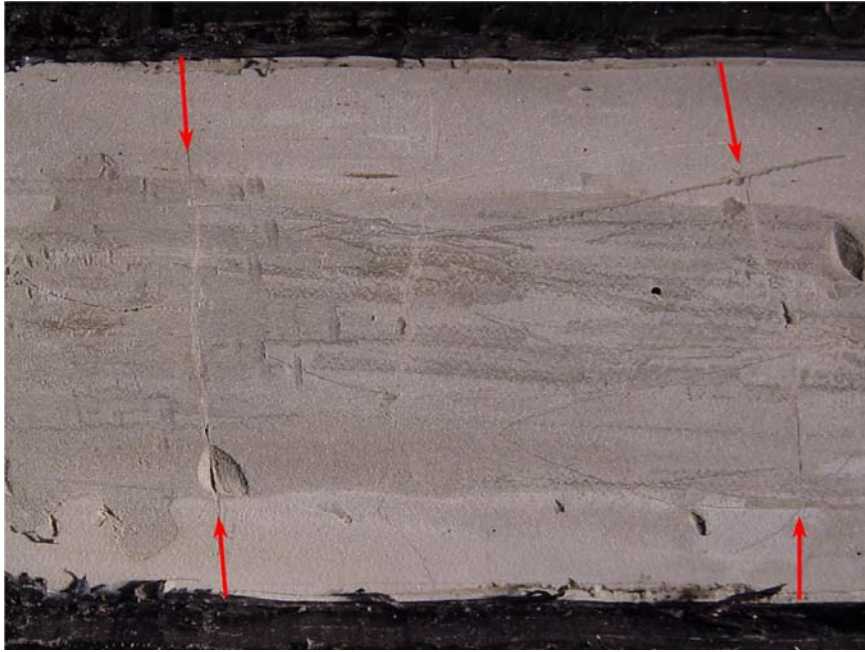
***Figure 4-8: Transverse Grout Cracks – Specimen #1***

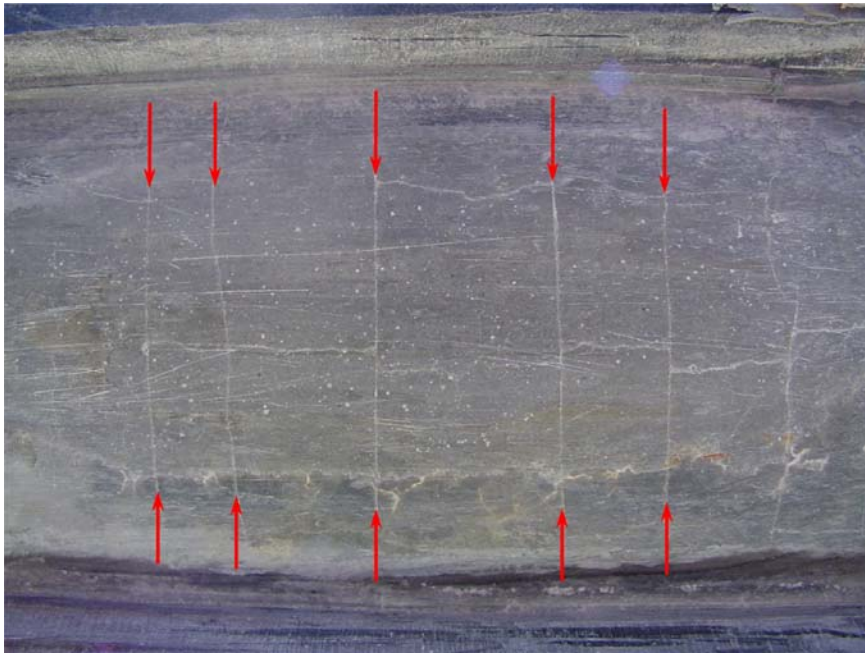
actual stay cables of the Fred Hartman Bridge, shown in Figure 4-9. Similar cracking was found in earlier investigations on stay cables (Hamilton 1995).

***Figure 4-9: Transverse Grout Cracks - Fred Hartman Bridge***

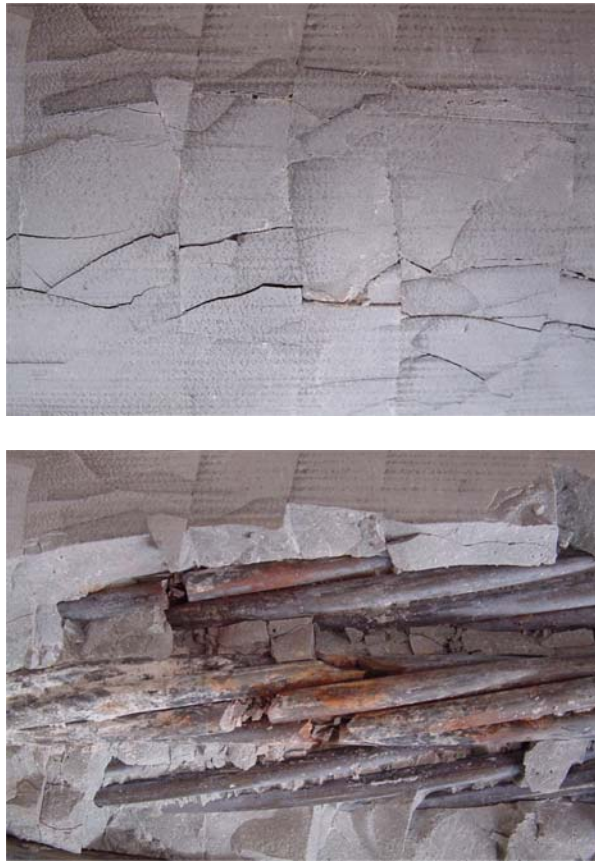
The location shown in Figure 4-10 is under the loading point at mid span of the specimen. At this location high curvature and high bending stresses occurred which might be an explanation not only for the occurrence of wire breaks, but also for the parallel cracks. Note that these cracks were seen immediately after the PE was removed, different from the shrinkage cracks described earlier.

*Figure 4-10: Longitudinal Cracks and Corresponding Wire Breaks*

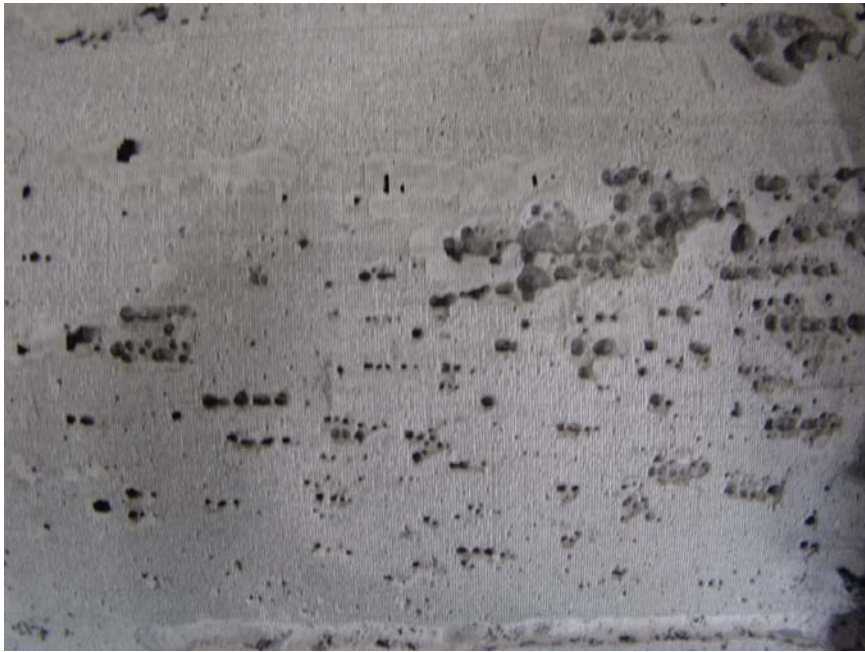
*Figure 4-11: Air Voids at the Deck Anchorage – Specimen #2*

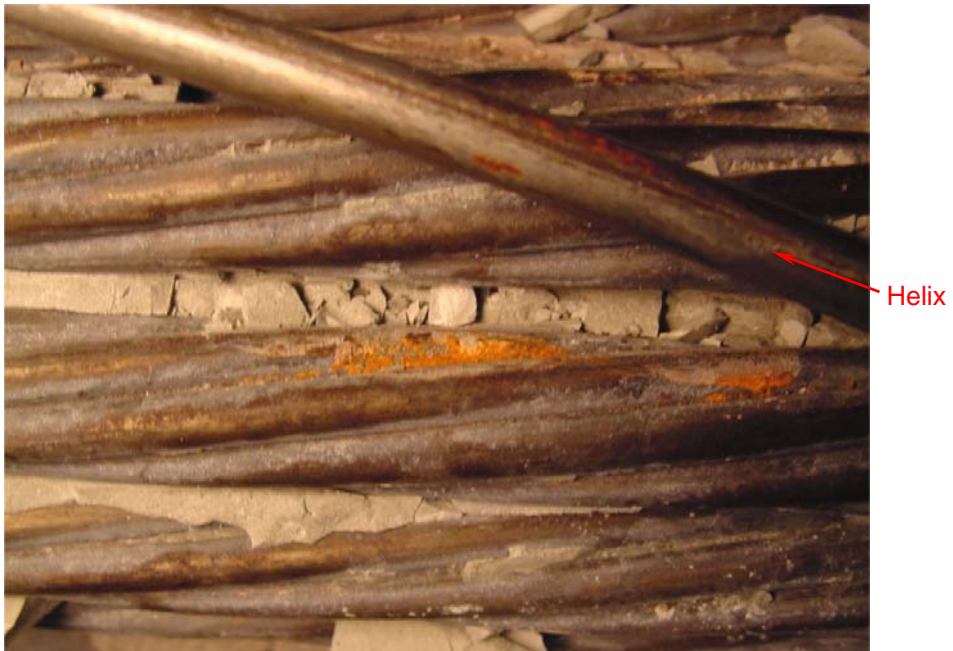
There were some localized signs of orange corrosion on some intact strands as well as some fine corrosion spots on the helical spacer wire. Figure 4-12 shows a typical spot of such strand and helix corrosion, which was found under the loading point at the side of the specimen.

*Figure 4-12: Localized Corrosion on Strand and Helix – Specimen #2*

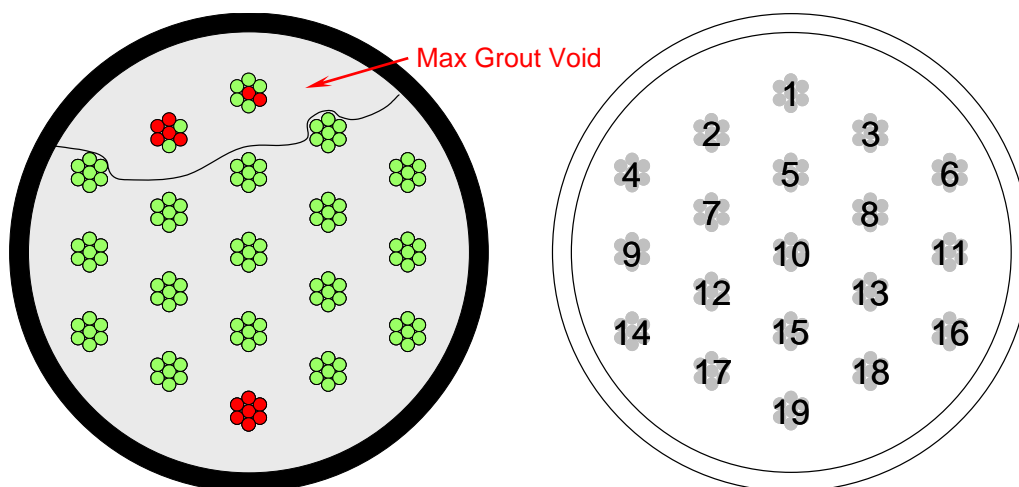
All breaks at the tower anchorage occurred within 14 in. (355 mm) of the front face of the anchor head. The 14 wire breaks occurred in strands #1, #2 and #19 – the strands that are on the top and bottom of the specimen as shown in Figure 4-15. The top and bottom fibers are expected to have the highest bending stress ranges in a bending test.

**Figure 4-15: Wire Breaks at the Tower Anchorage – Specimen #1**

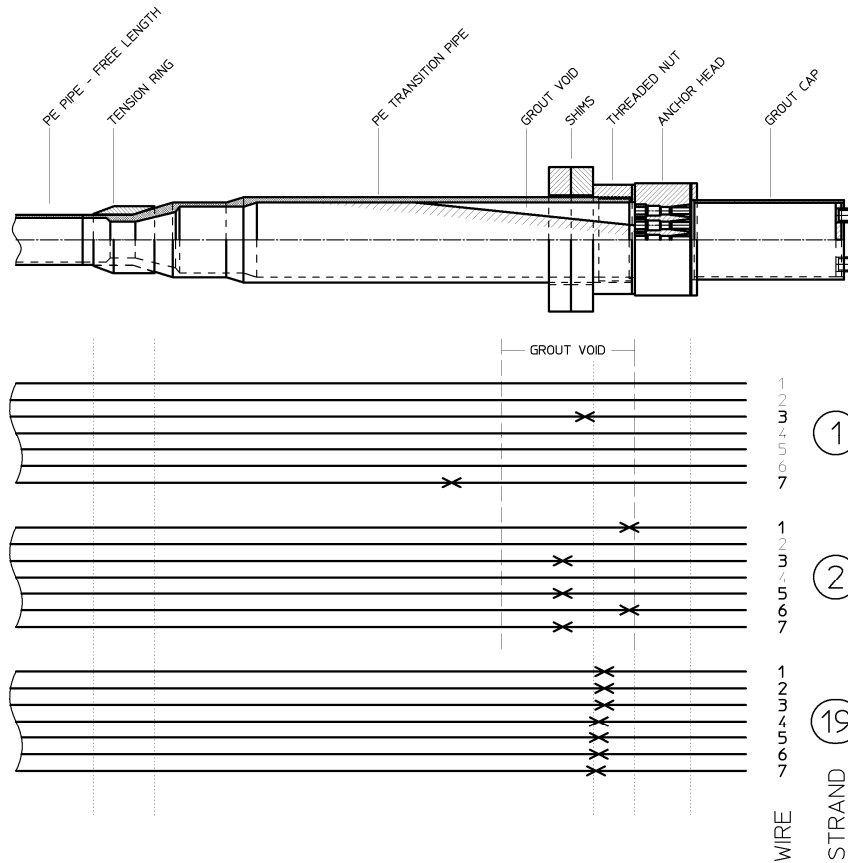
**Figure 4-17: Wire Breaks at the Tower Anchorage – Specimen #1**

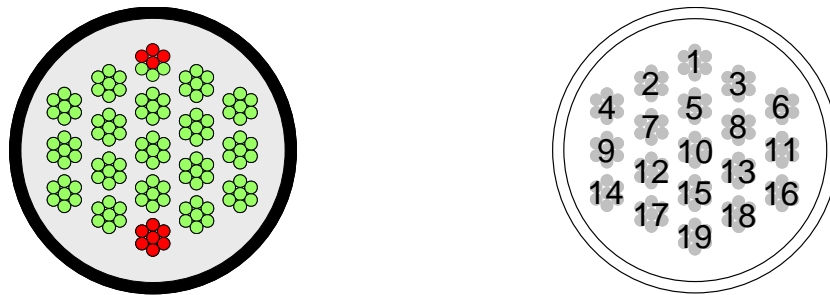
Under the loading point, the 11 wire breaks occurred on strands #1 and #19 (Figure 4-18). Interestingly, both strands also experienced fractures in the tower anchorage region. All breaks were located in a 23 in. (580 mm) window, with a bias towards the deck anchorage side (Figure 4-19).

**Figure 4-18: Wire Breaks under the Loading Point – Specimen #1**

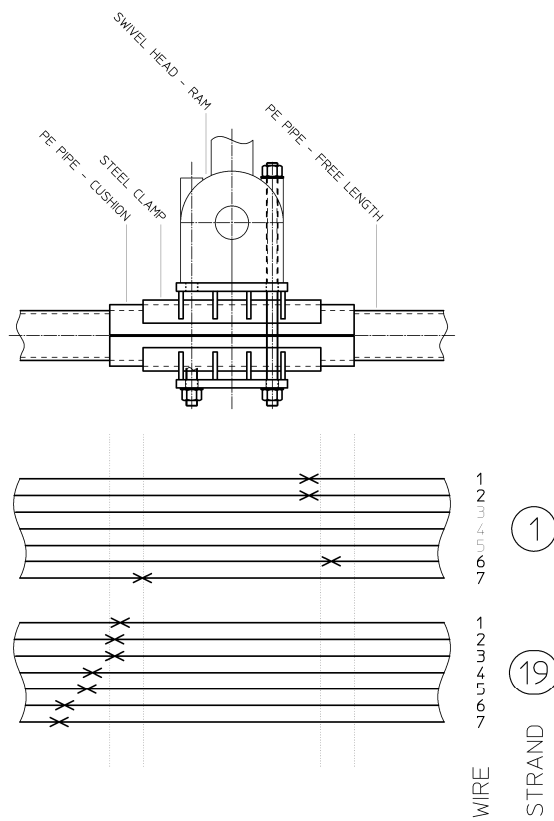
**Figure 4-19: Wire Breaks under the Loading Point – Specimen #1**

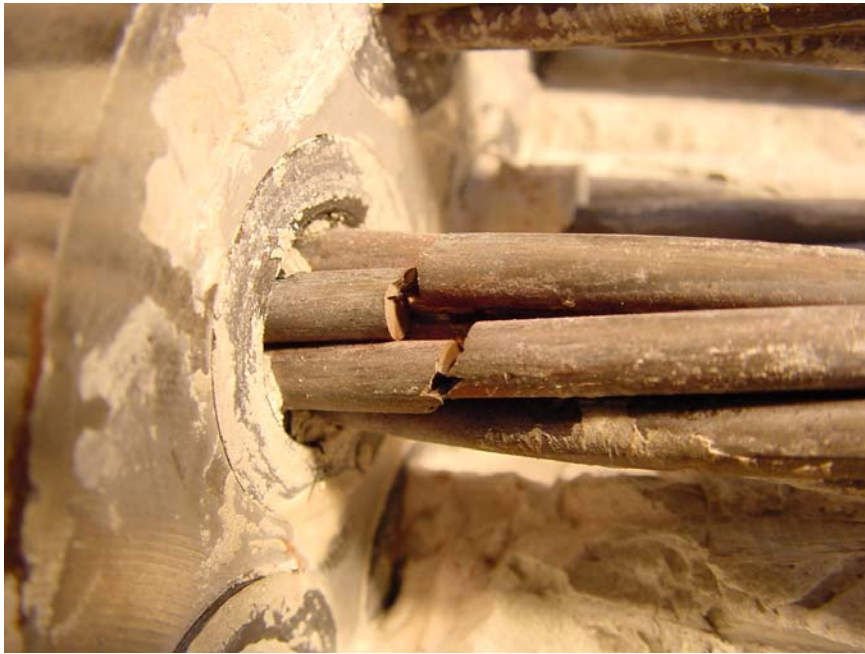
***Figure 4-20: Wire Breaks – Strand #2 – Tower Anchorage – Specimen #1***

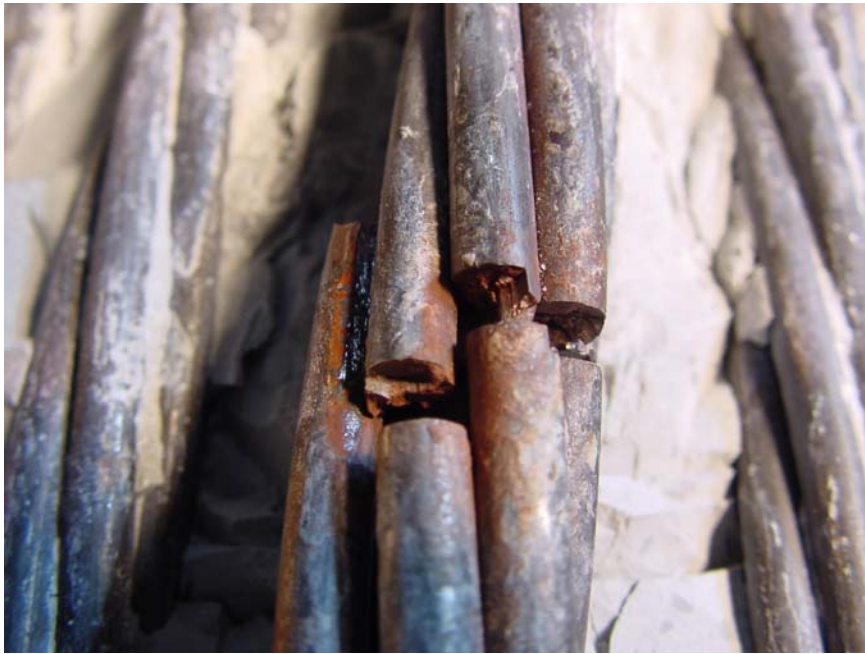
*Figure 4-21: Wire Breaks – Strand #19 – Tower Anchorage – Specimen #1*

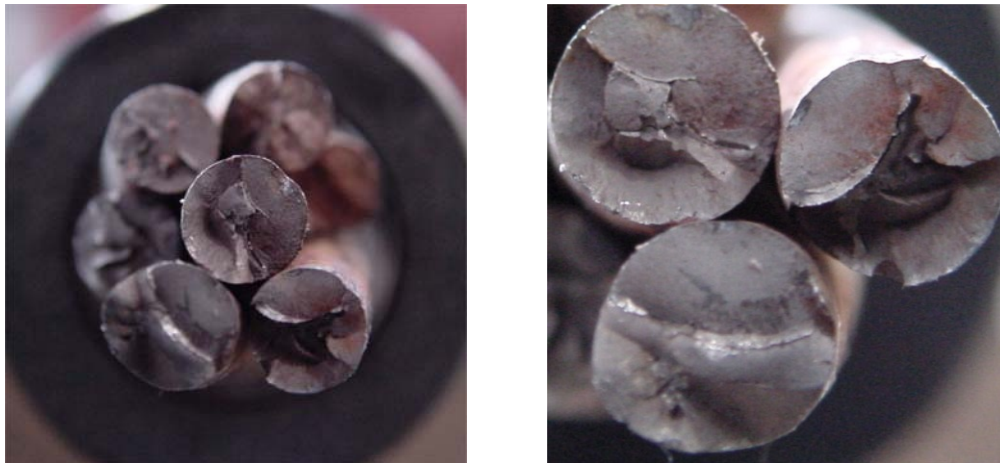
*Figure 4-22: Fracture Surface – Strand #19 – Tower Anchorage – Specimen #1*

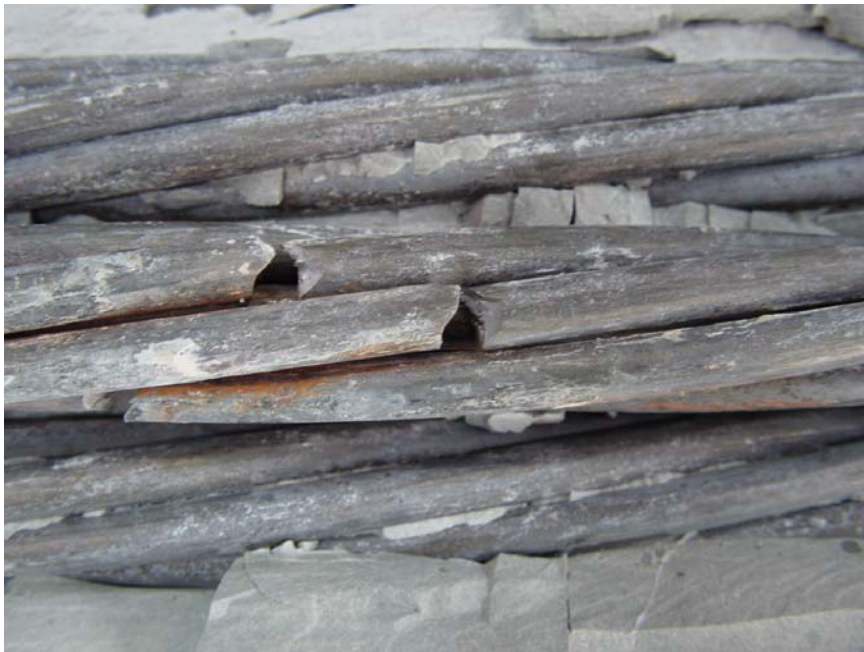
*Figure 4-23: Wire Breaks – Strand #1 – Loading Point – Specimen #1*

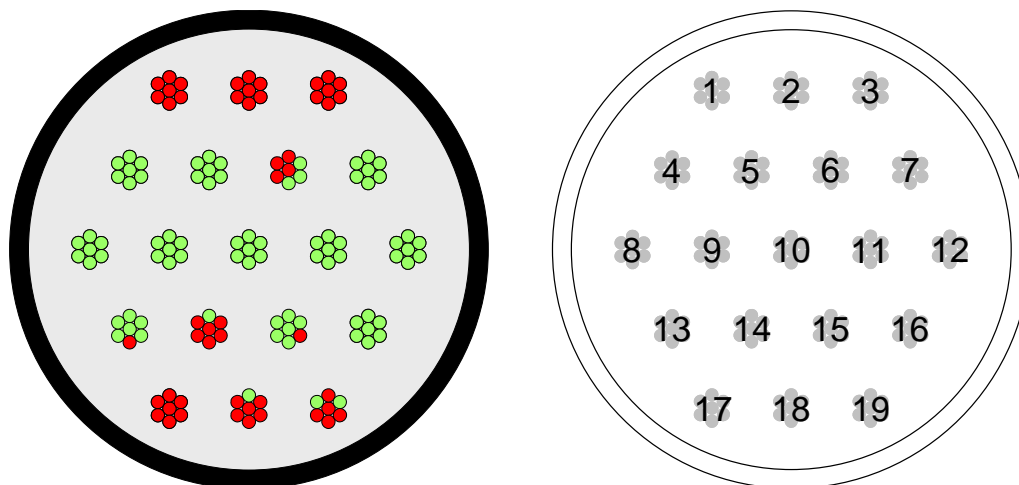
**Figure 4-26: Wire Breaks at the Tower Anchorage – Specimen #2**

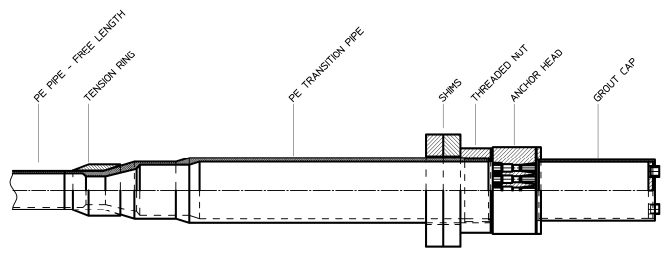
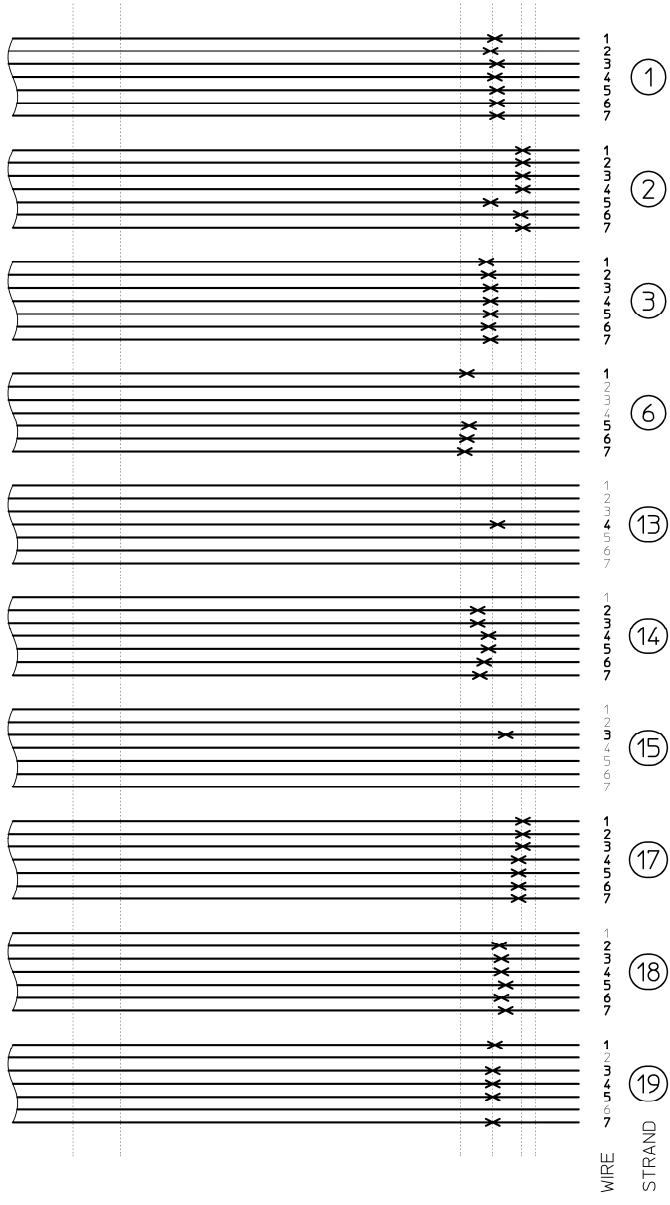
**Figure 4-27: Wire Breaks at the Tower Anchorage – Specimen #2**

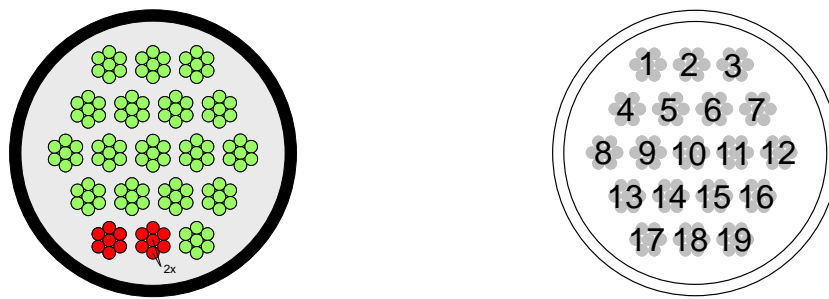
**Figure 4-28: Wire Breaks under the Loading Point – Specimen #2**

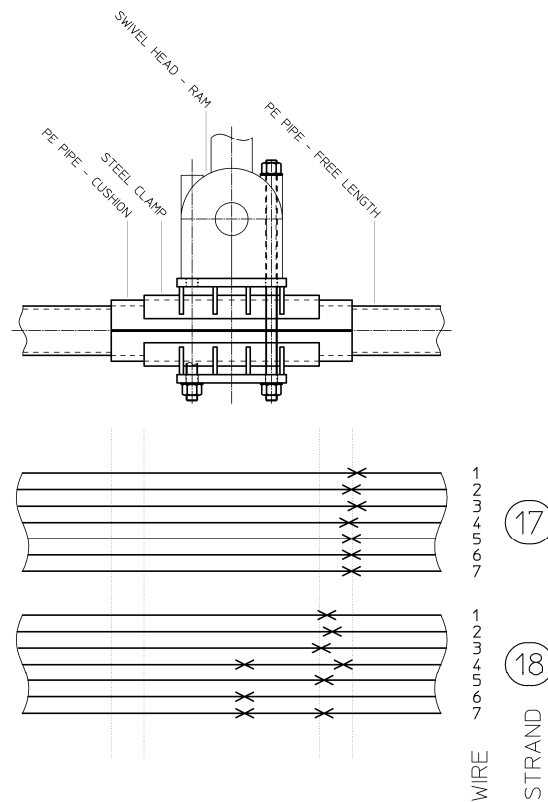
**Figure 4-29: Wire Breaks under the Loading Point – Specimen #2**

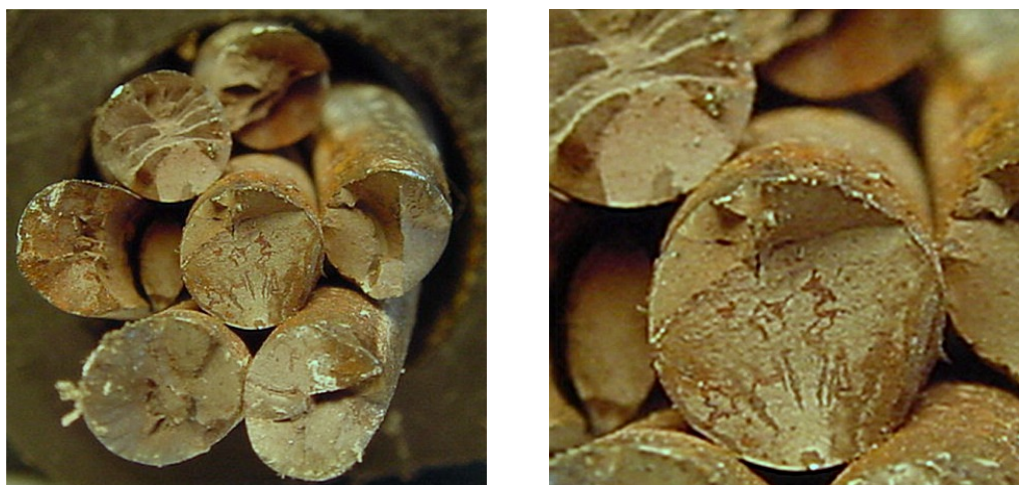
***Figure 4-30: Fracture Surfaces – Strand #1 – Tower Anchorage – Specimen #2***

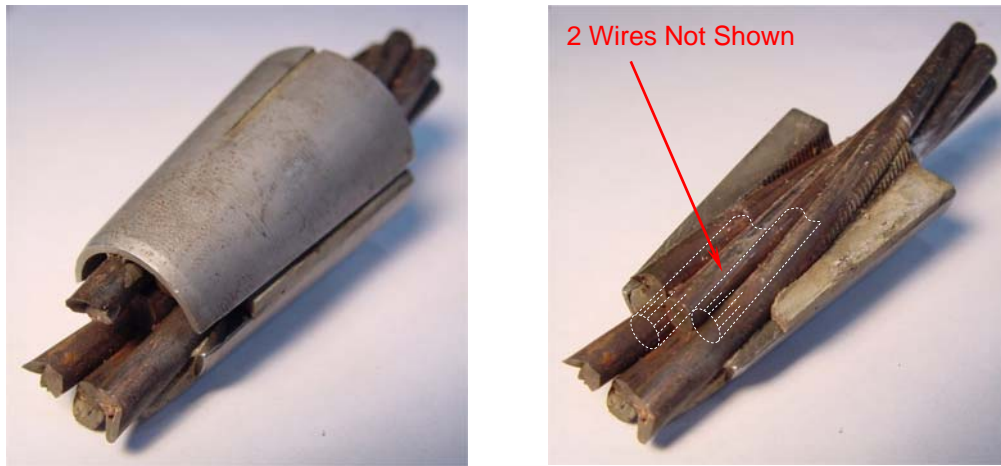
***Figure 4-31: Opened Wedges and Wire Fractures – Strand #2 – Specimen #2***

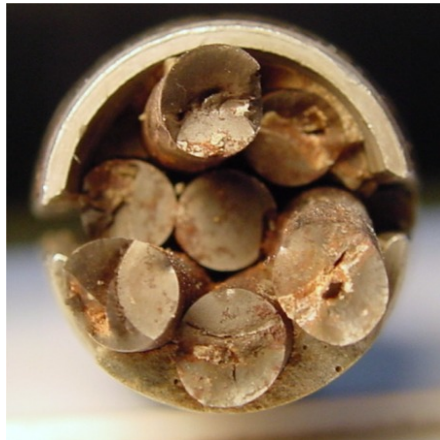
***Figure 4-32: Fracture Surfaces – Strand #2 – Tower Anchorage – Specimen #2***

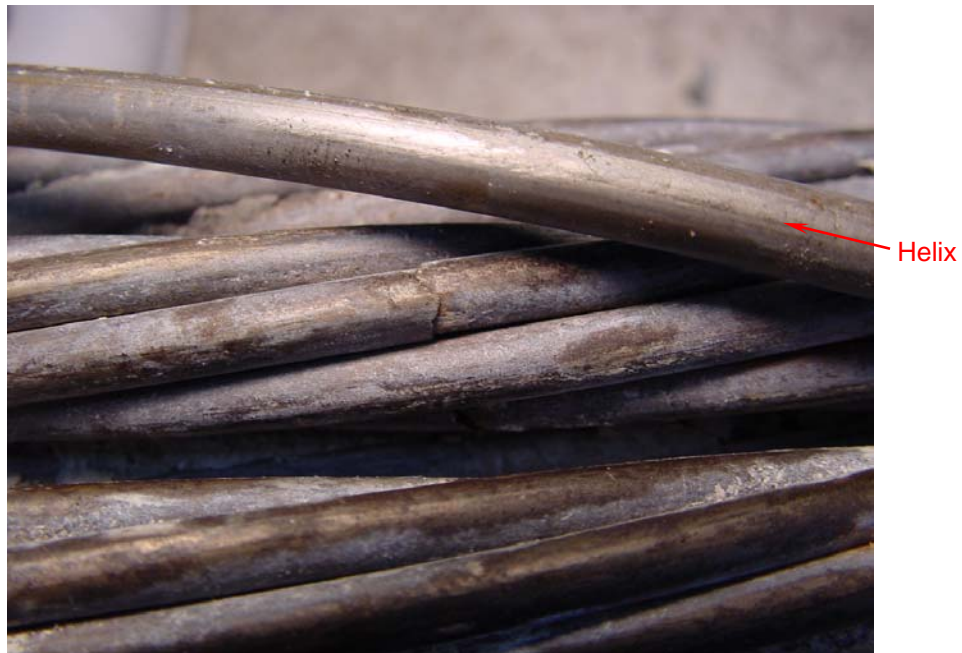
***Figure 4-33: Wire Break Close to Helical Spacer – Specimen #2***

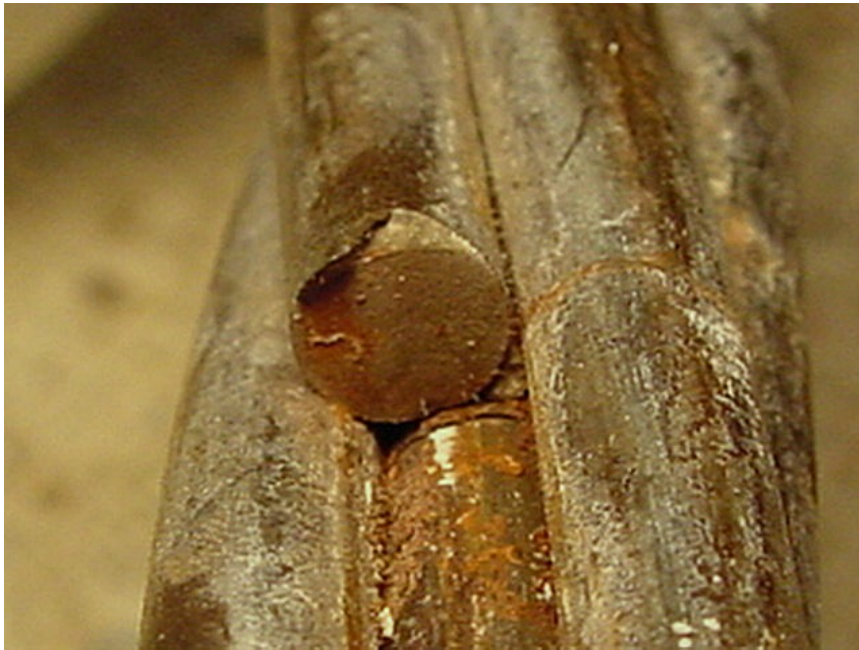
*Figure 4-34: Fracture Surface – Specimen #2*
