**EVALUATION AND REPAIR OF IMPACT DAMAGED PRE-  
STRESSED CONCRETE BRIDGE GIRDERS**

**Dissertation**

**The University of Texas at Austin**

**May 1996**

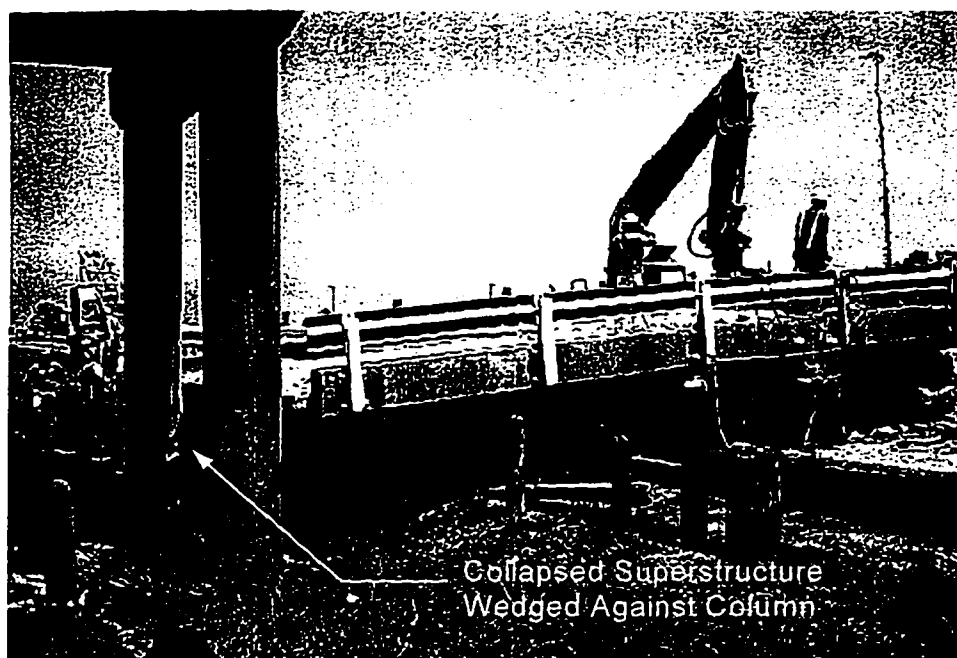
Figure 2.14 Lodging of Collapsed Structure Against Central Pier

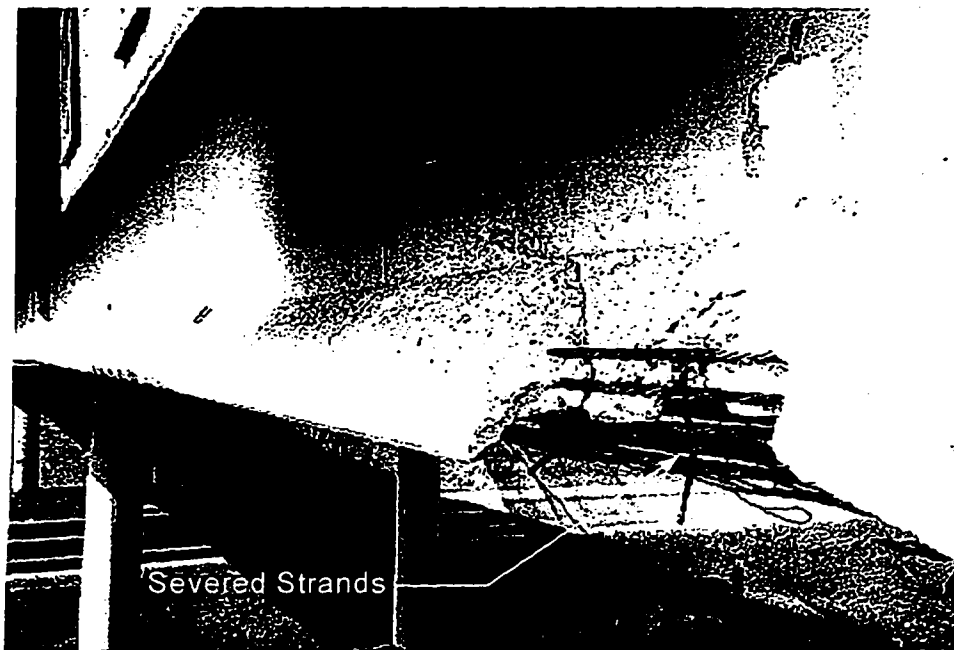
Figure 2.17 Impact Damage of Girder 1 - Waelder Bridge

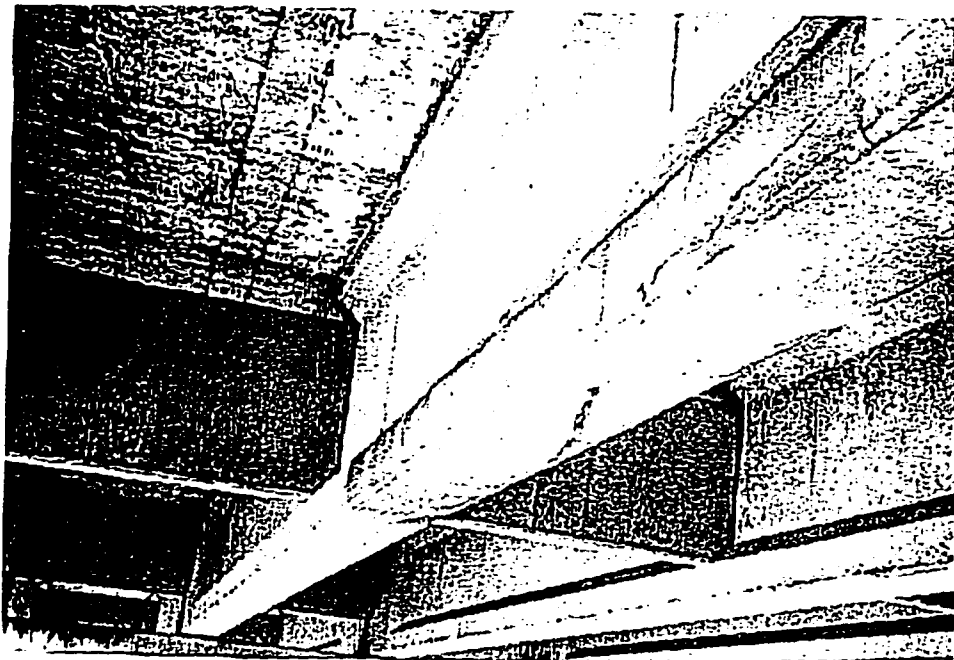
Figure 2.19 Damage to Girder 2 - Waelder Bridge

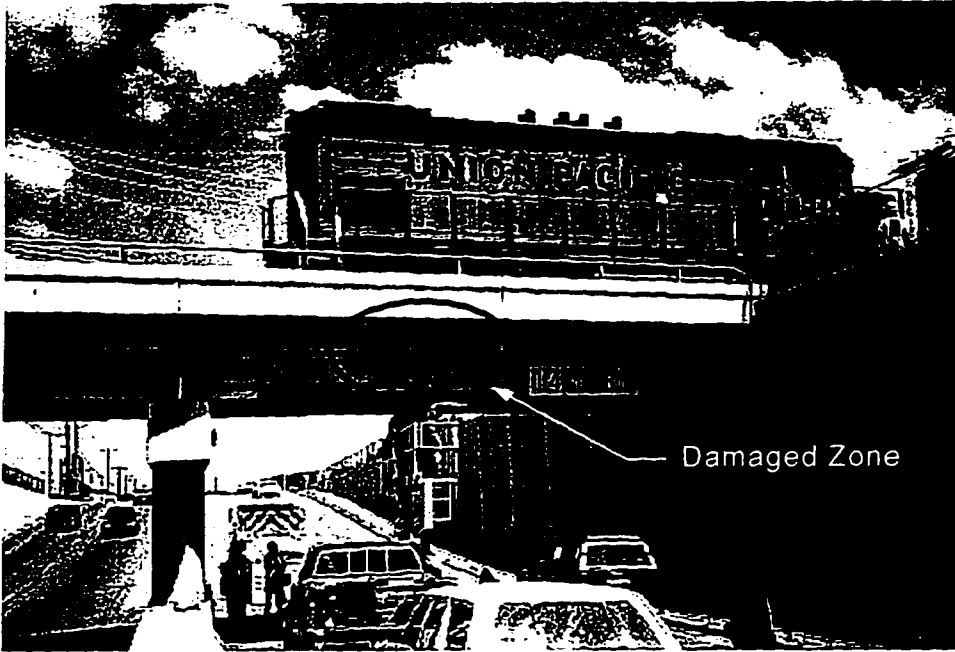
Visual observations of the impact damaged girder from the Steck bridge located all visible areas of extensive loss of cross section, cracking, misalignment, and exposure of prestressing tendons. This was done both in the field as well as after the girder was removed from the bridge and brought to the laboratory. The photograph in Figure 4.2 shows an overall view of the damaged bridge. It is evident from this photograph that the impact also caused damage to the sidewall portion of the rail bed located above the exterior girder. The sidewall sustained damage near midspan as evidenced by three cracks extending through the full height and thickness. The cracks in the sidewall all exhibited extensive staining and efflorescence at the concrete surface.

Figure 4.2 Overall View of Steck Girder In-Situ (Courtesy of the Texas Department of Transportation)

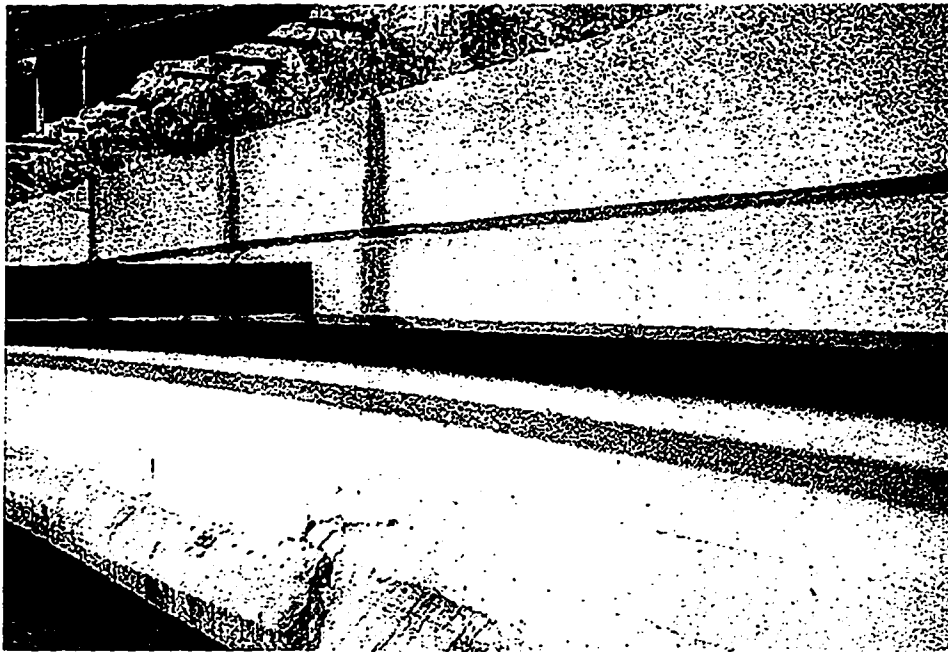
This zone of cracking is more clearly visible in the photograph shown in Figure 4.3 which was taken after the girder was removed from the bridge and brought to the laboratory. The damage on the impacted face of the girder was difficult to observe in the field; a steel angle guard, still in place after the impact, covered most of the fractured zone. Once the angle guard was removed at the laboratory, the zone of fractured concrete surrounding the direct area of impact was clearly visible as shown in Figure 4.4. Figure 4.5 shows damage on the bottom of the girder revealing exposure of several tendons on the nonimpacted side of the girder. It is quite evident from these photographs that the impact damage was very extensive.

Figure 4.3 Overall View of Steel Girder After Removal from the Bridge Structure

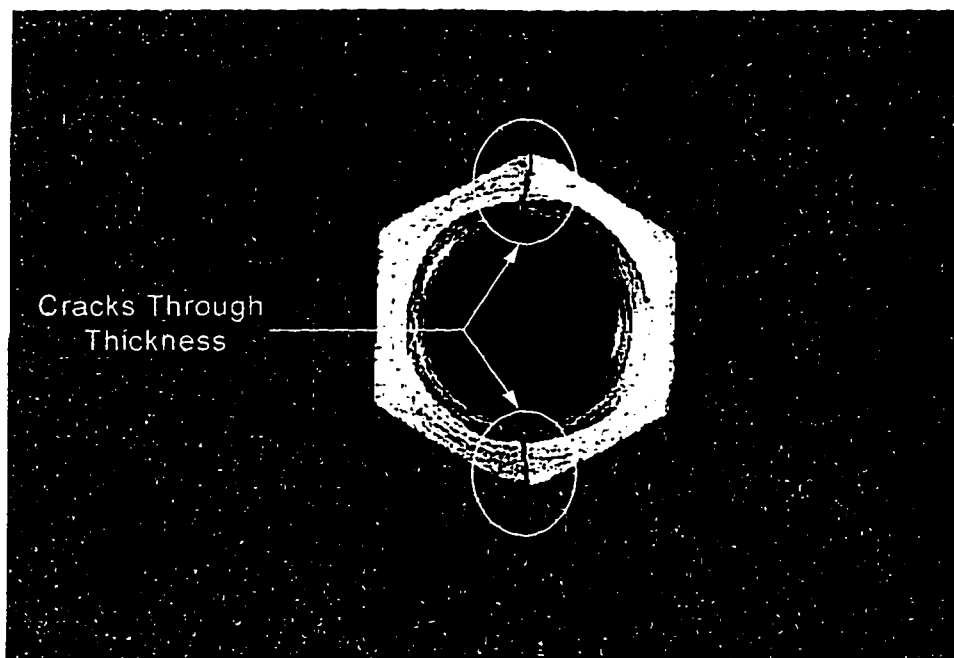
Figure 6.10 Grab-It™ Cable Splice - Cracks Through Interior Threads - Dry Threads - Torque Proof Test

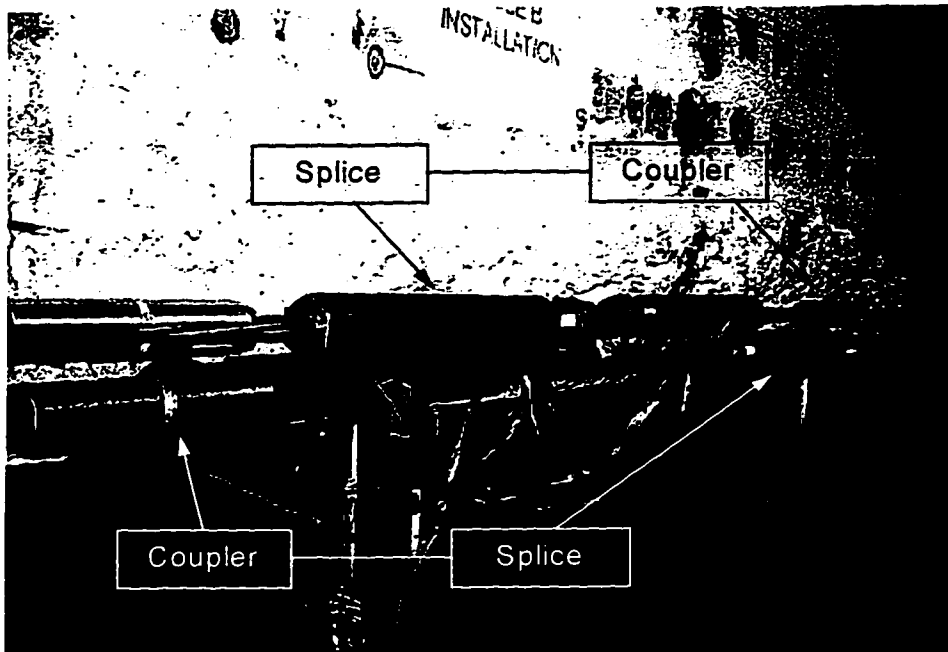
Figure 6.17 Completed Repair of Severed Strands Using the Alberta Splice

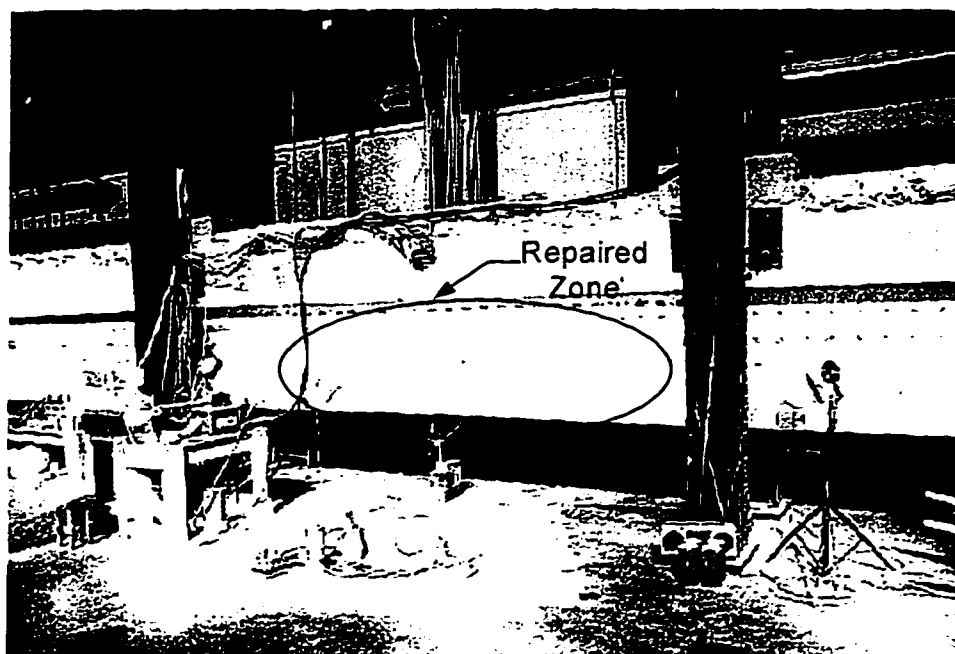
Figure 6.69 Photograph showing Completed Repair - Final Phase - Steck Girder

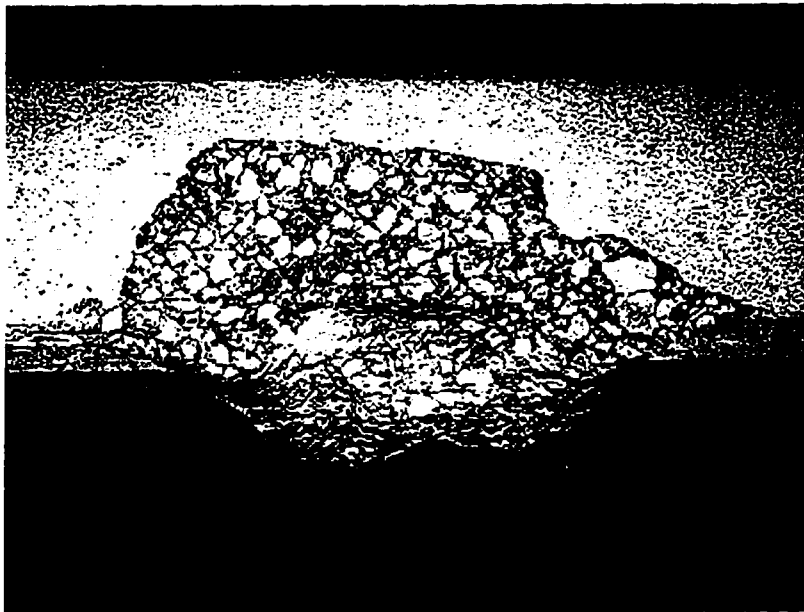
Figure 7.4 Photograph Showing Spalled Flange Area
