**REVISED PRELIMINARY DRAFT**

6. Performing Organization Code	
7. Author(s) A. Boenig, L. Fúnez, R. E. Klingner, and T. J. Fowler				8. Performing Organization Report No. Research Report 1857-1

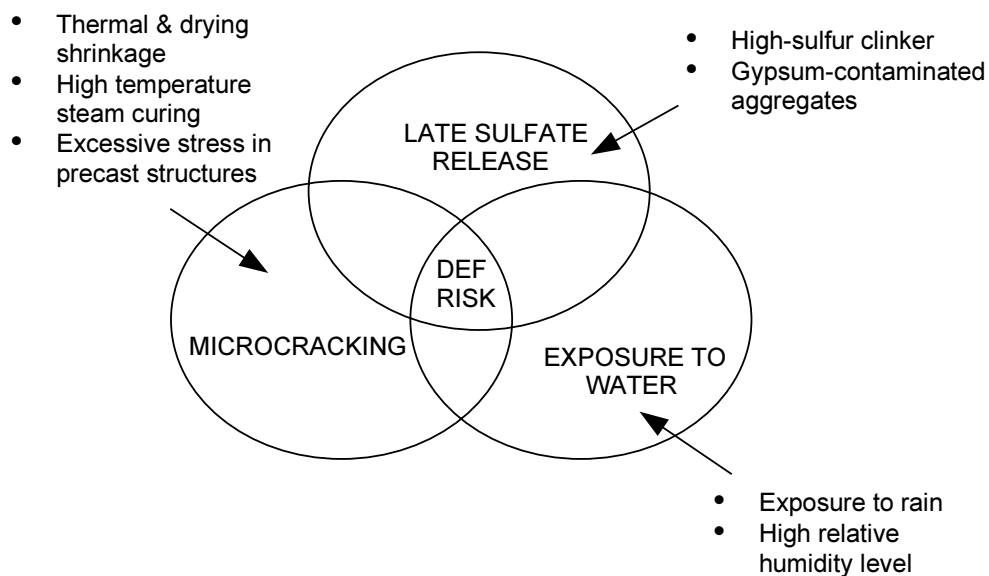
**Figure 2.1 A holistic model showing DEF-damage as a function of late sulfate release, microcracking and exposure to water, (Collepari 1999)**

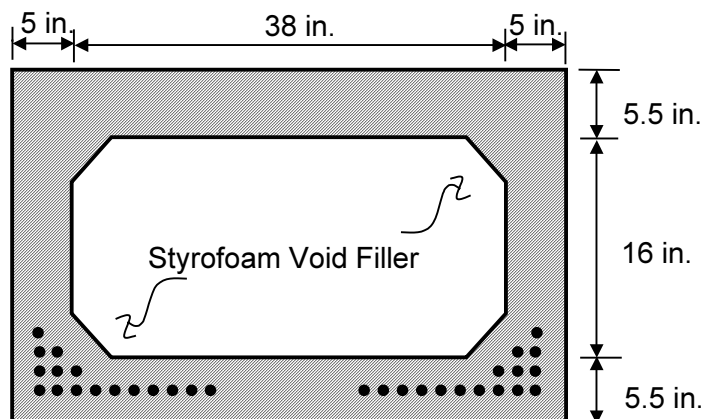
Figure 3.1 Cross section of box girders from Heldenfels Brothers, Inc. (San Marcos)

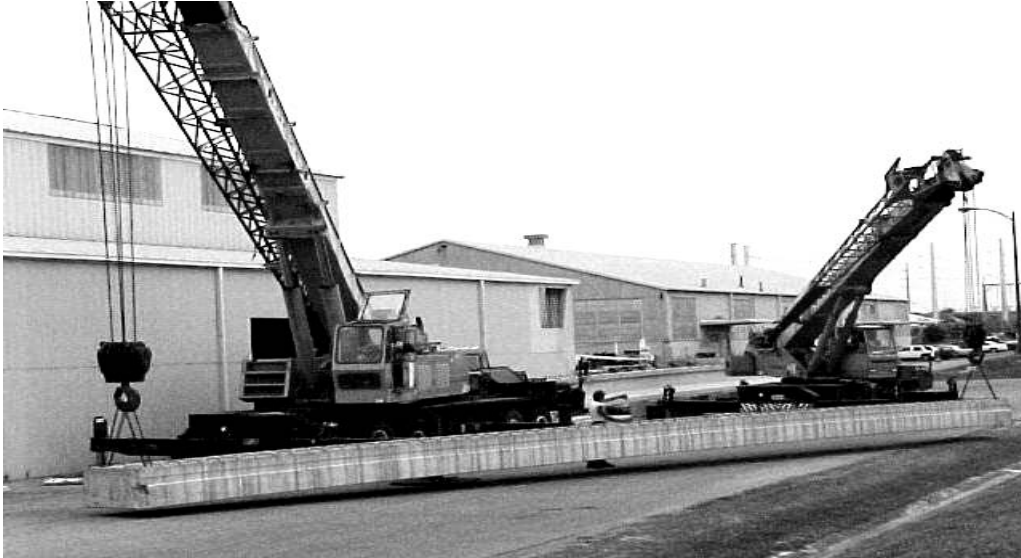
**Figure 3.2 Maneuvering BG1 into FSEL**

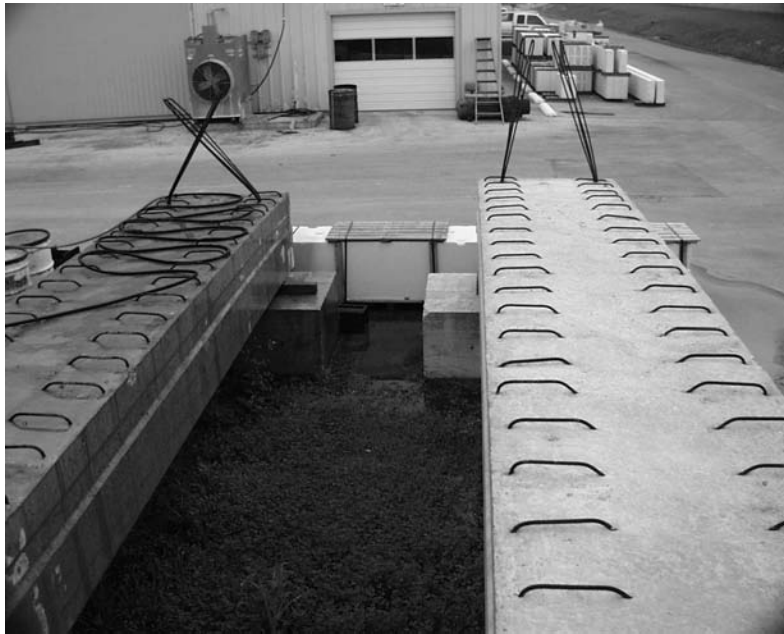
**Figure 3.3 BG3 and BG4 (wetted) outside of FSEL**

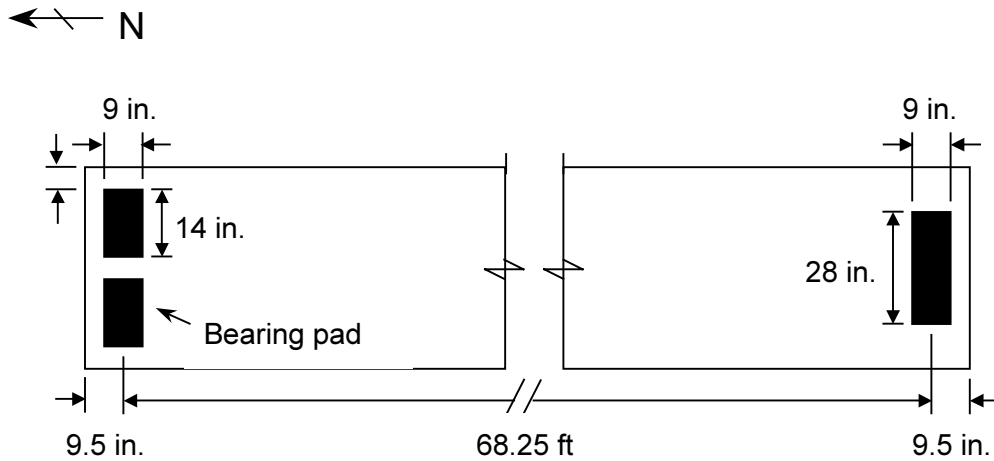
**Figure 3.6 Plan of bearing pad placement for flexure-dominated specimens**

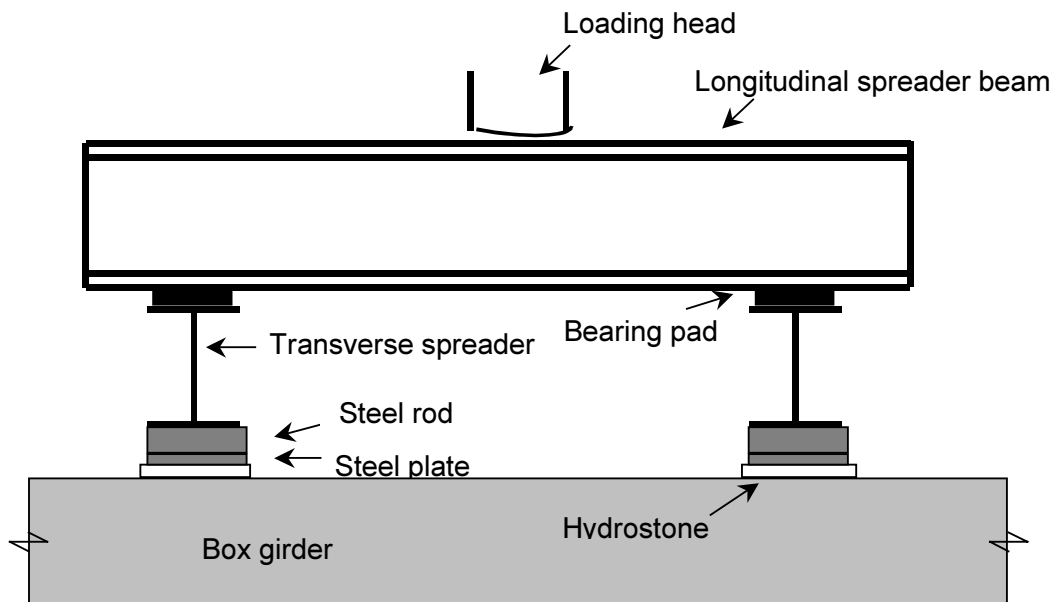
**Figure 3.7 Detail of loading setup for flexure-dominated specimens (elevation)**

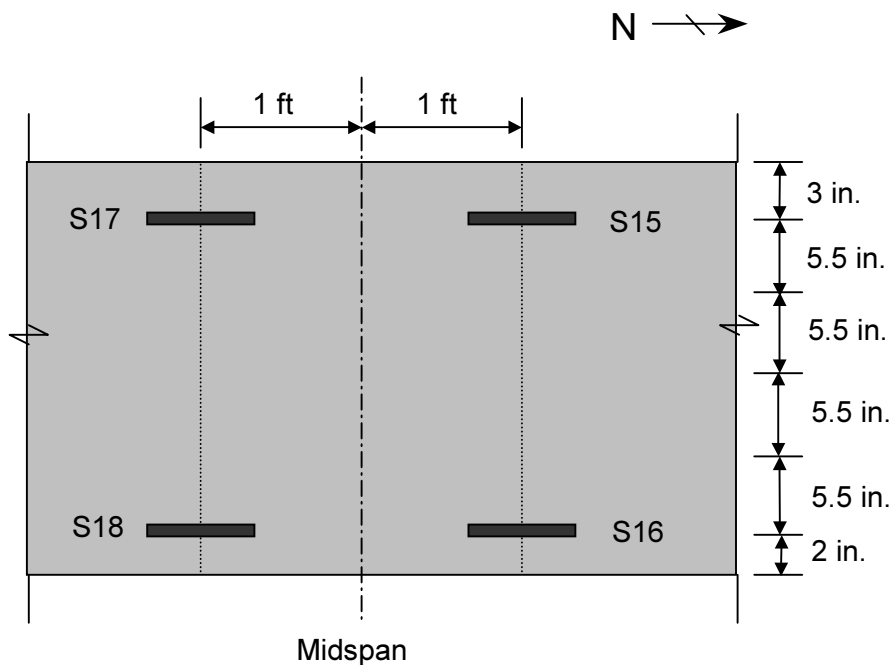
**Figure 3.13 Schematic of strain gages on east side of flexure-dominated specimens**

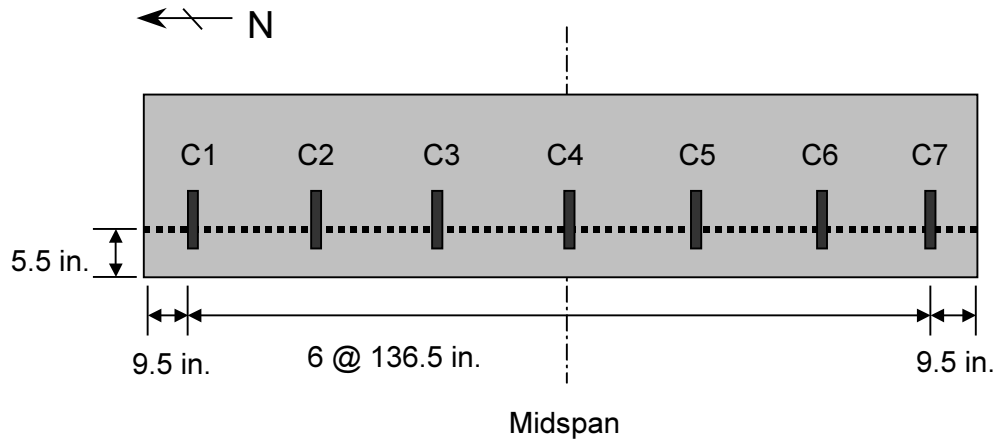
**Figure 3.14 Schematic of linear potentiometers on west face of flexure-dominated specimen along pre-existing longitudinal crack (used for tests BG1F and BG2F)**

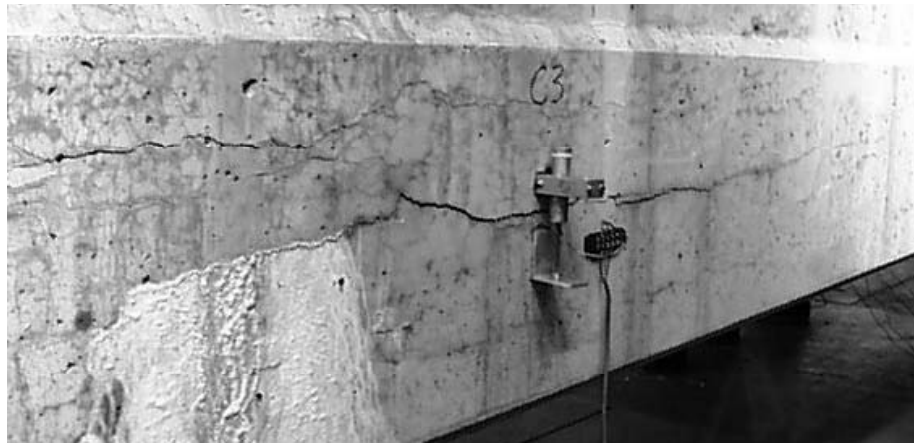
**Figure 3.15 Linear potentiometer on west face of BG4F to monitor change in width of pre-existing crack**

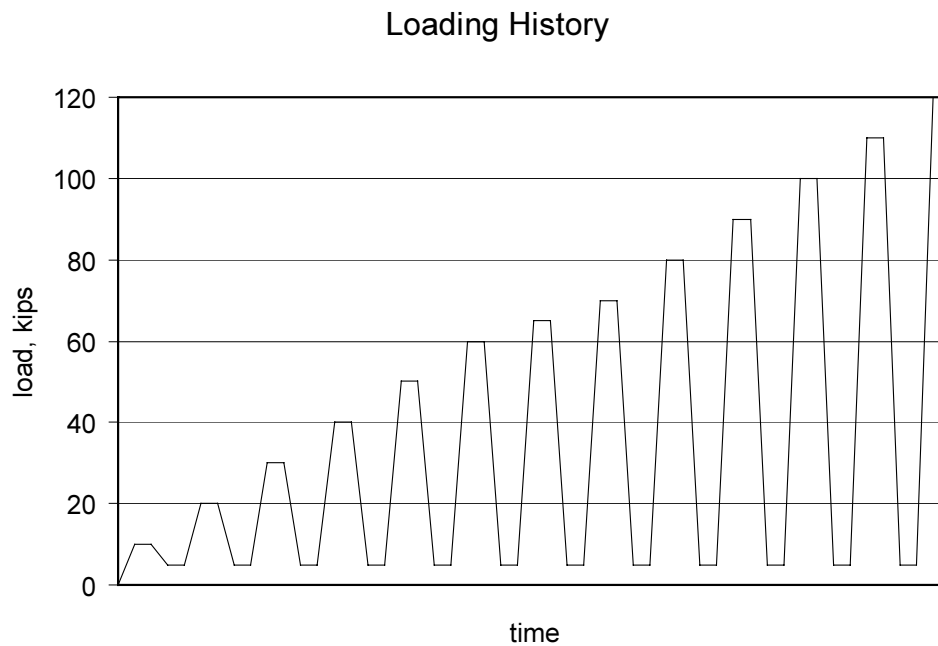
**Figure 3.17 Loading history for flexure-dominated specimens**

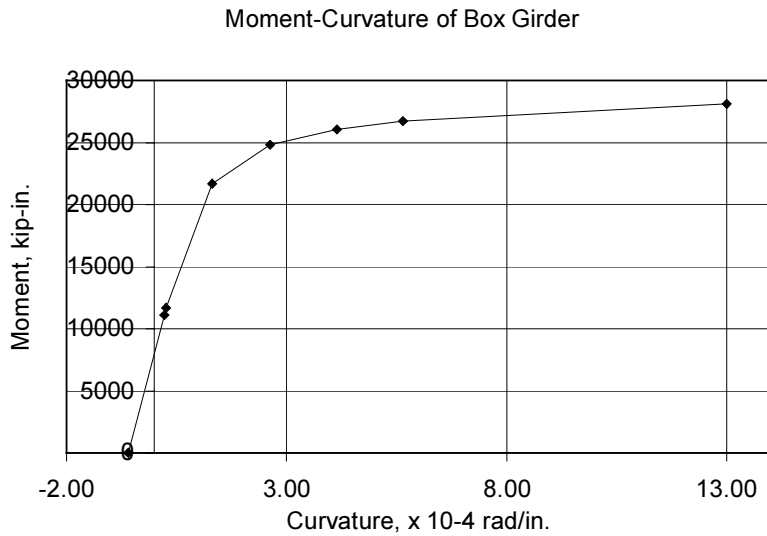
**Figure 3.18 Moment-curvature relationship predicted for box section**

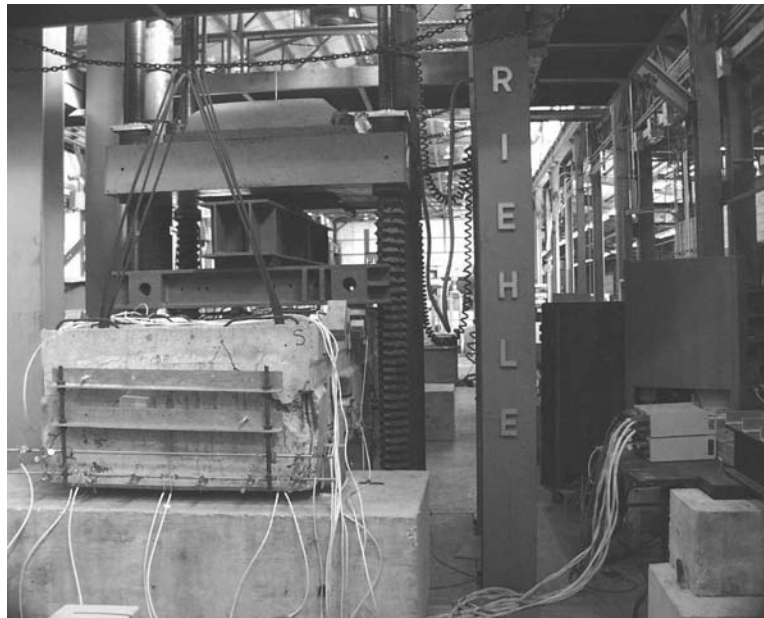
**Figure 3.20 Shear-dominated specimen in loading machine**

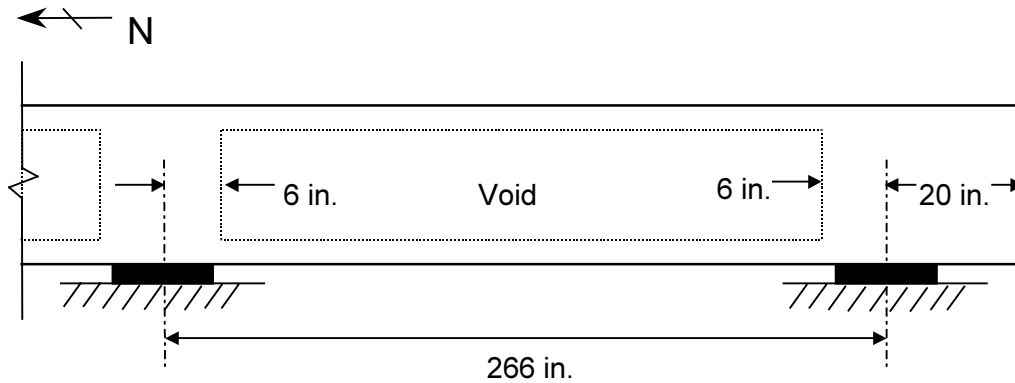
**Figure 3.21 Support conditions for Case 1**

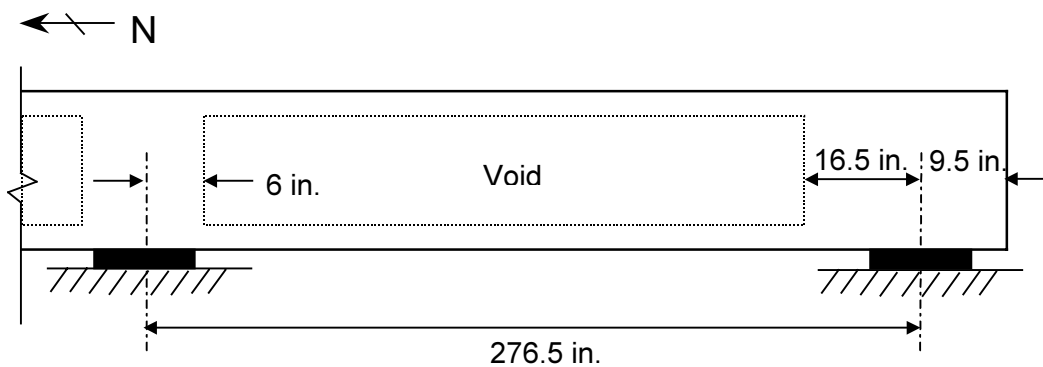
**Figure 3.22 Support conditions for Case 2**

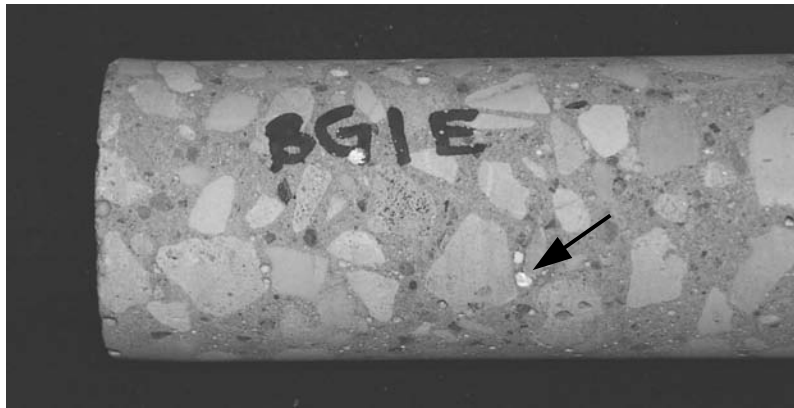
**Figure 3.29 White, soap-like substance in voids of core from end-block of BG1**

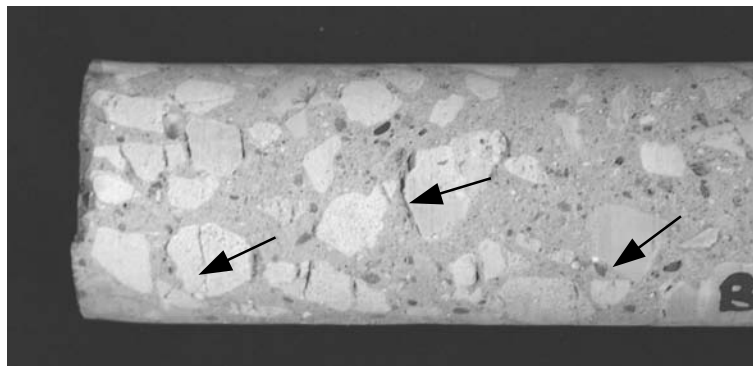
**Figure 3.30 Cracked aggregate, separation between aggregate and cement matrix, and white substance in voids of core from end-block of BG2**

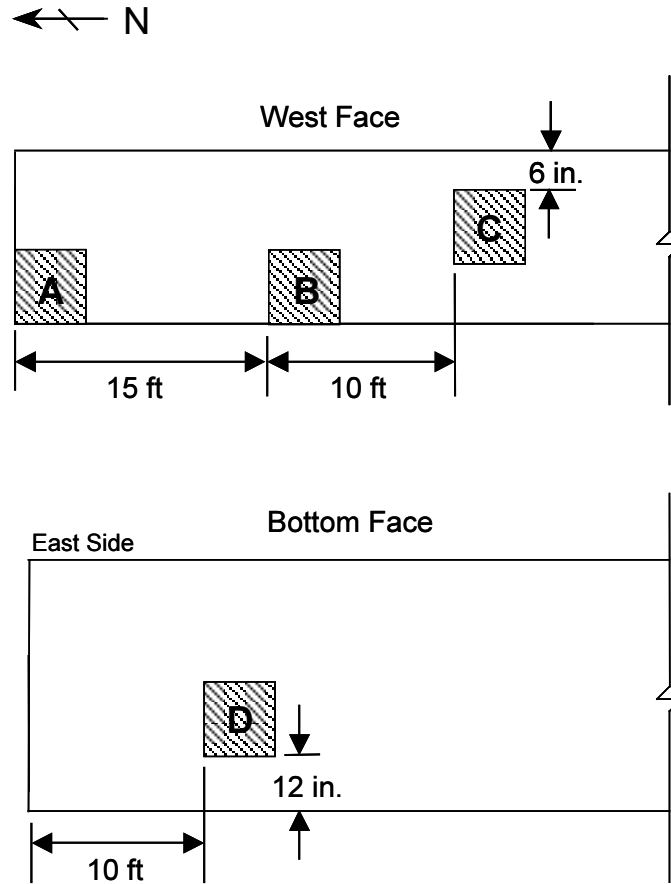
**Figure 3.32** Locations of representative squares on box girders monitored for crack growth

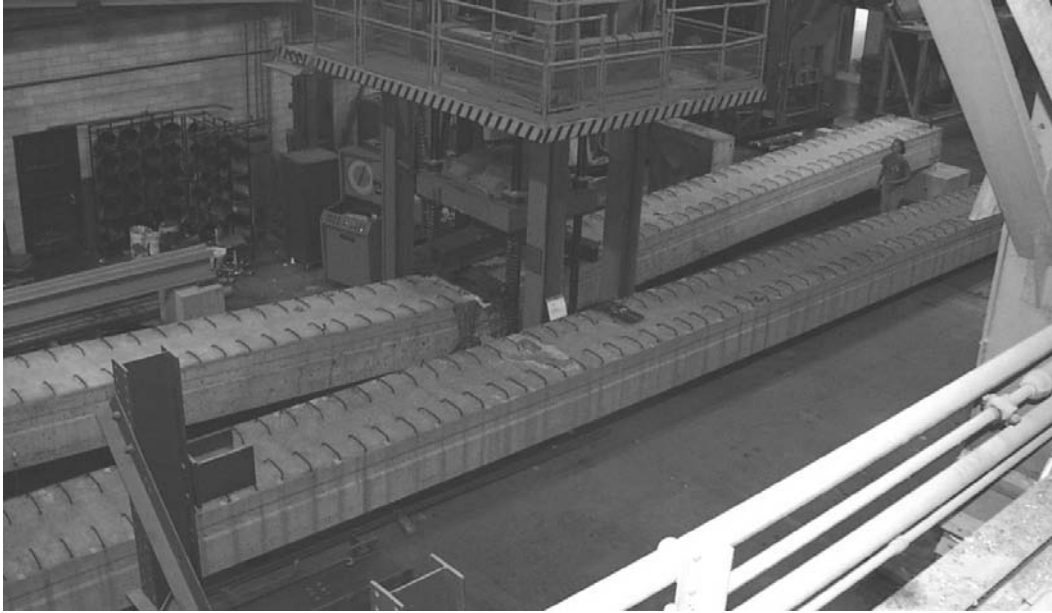
**Figure 4.1 Failure of BG1F at 118.6 kips (527 kN)**

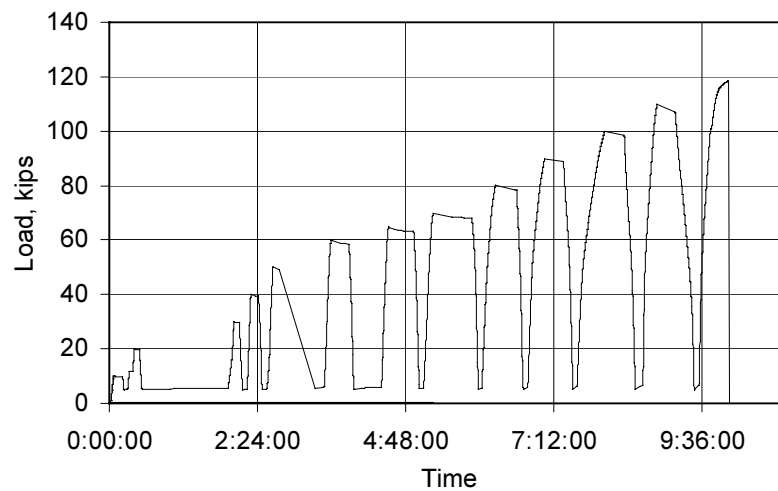
**Figure 4.2 Actual loading history of BG1F**

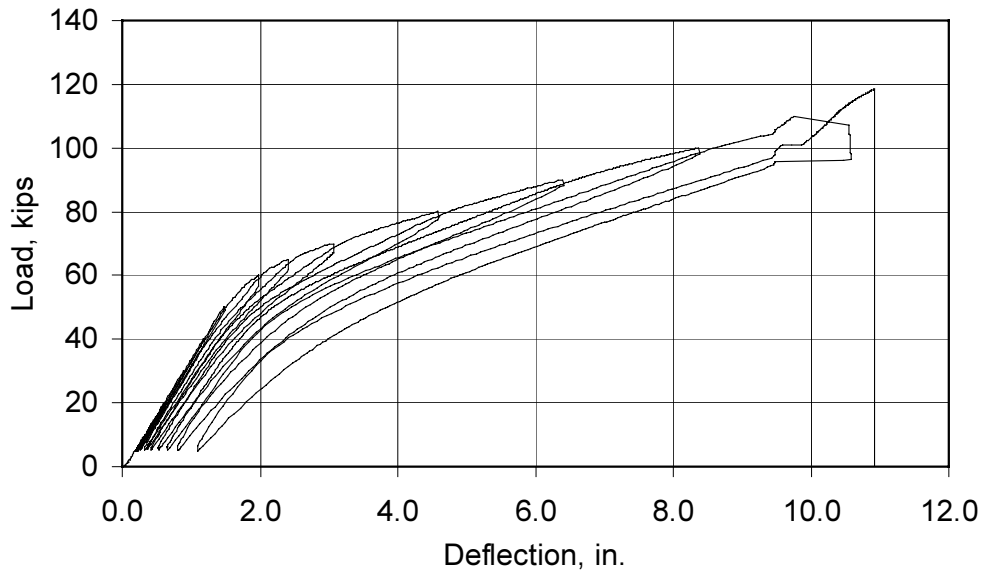
Figure 4.3 Load-deflection curve for BG1F

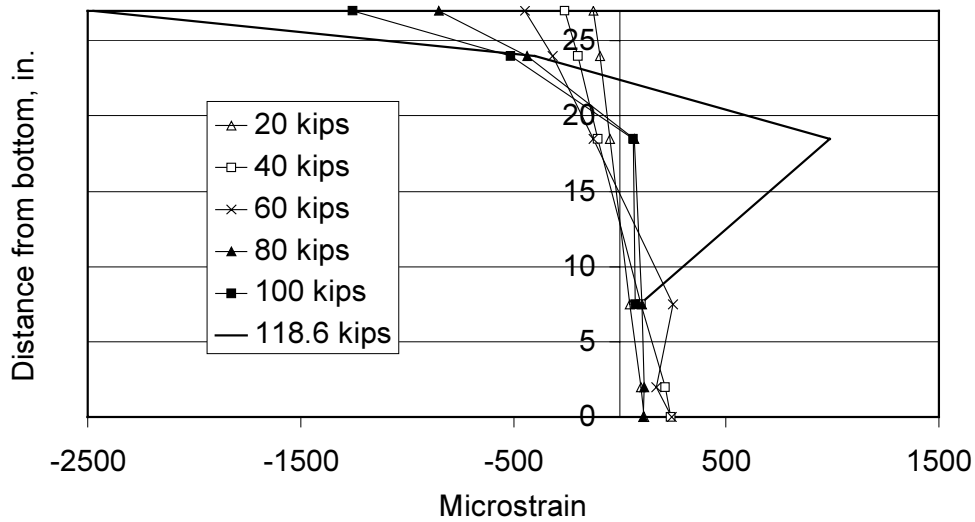
Figure 4.4 Strain gradients on BG1F, 1 ft (0.30 m) north of midspan, at discrete loads up to failure

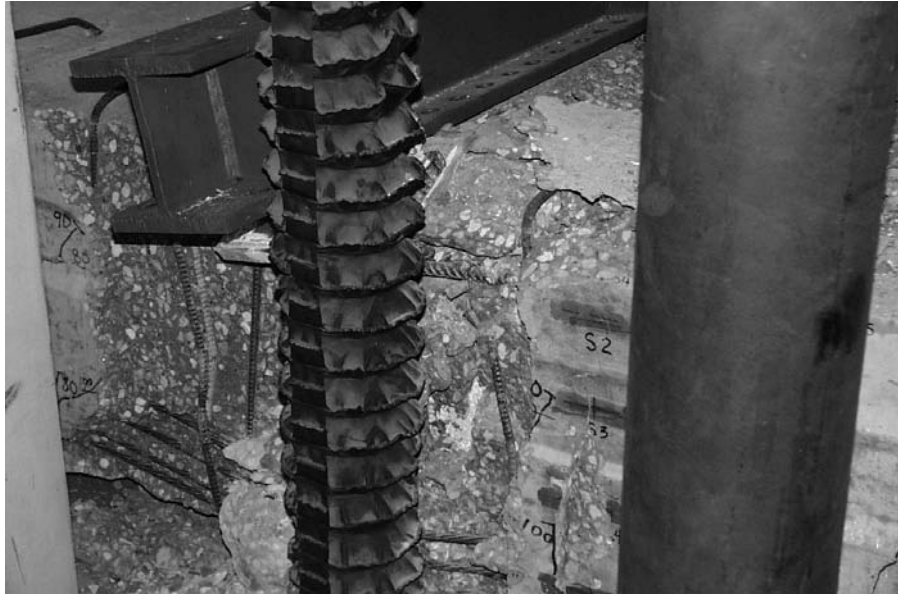
**Figure 4.5 Flexural crack through Gages S3 and S4**

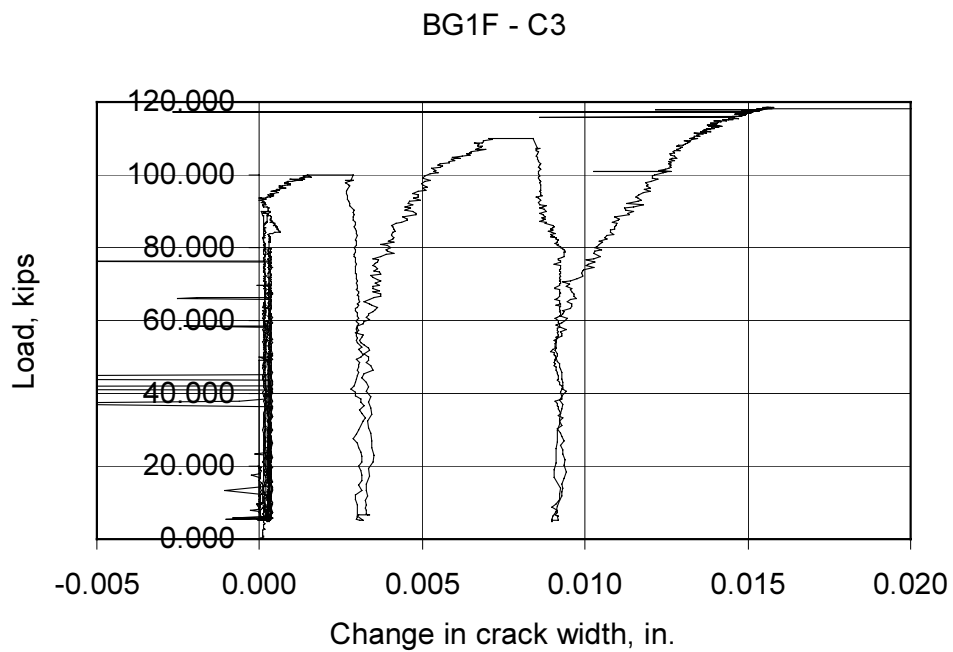
**Figure 4.6 Growth of pre-existing crack in BG1F from C3 data**

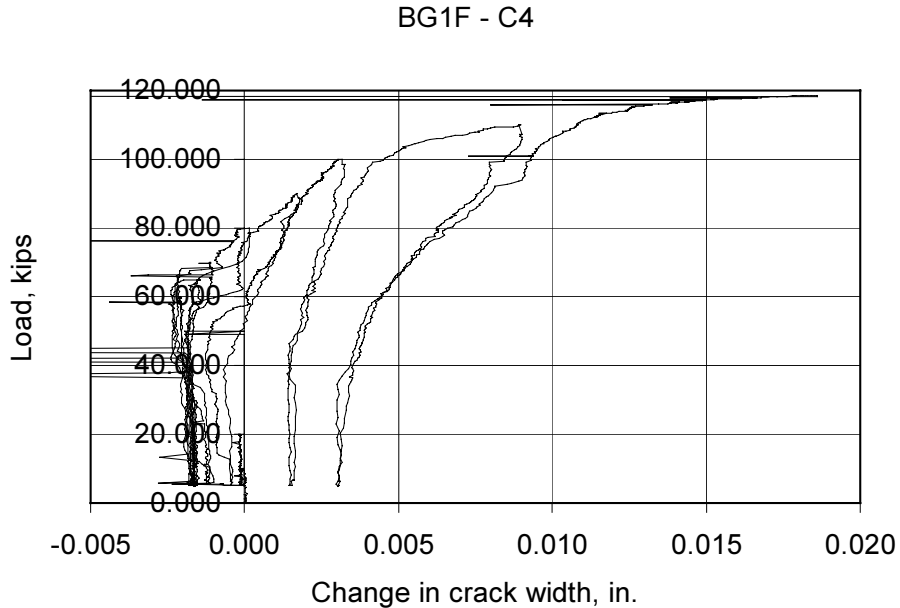
**Figure 4.7 Growth of pre-existing crack in BG1F from C4 data**

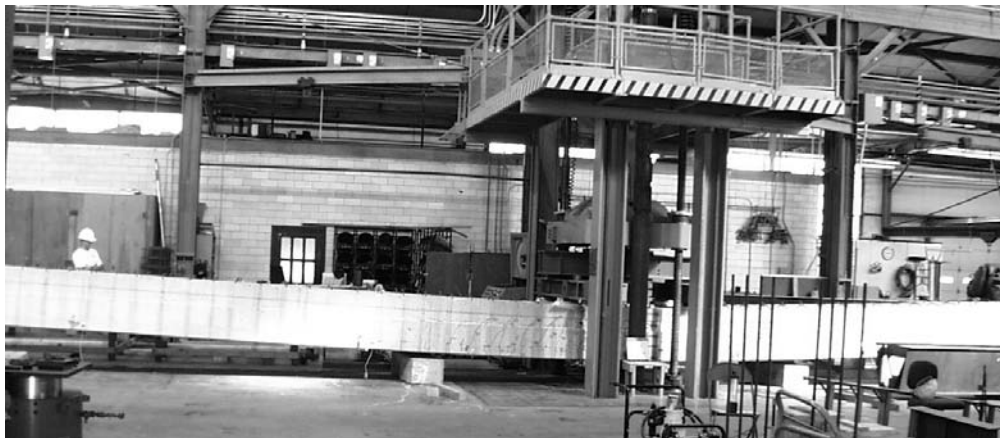
**Figure 4.8 BG2F under 110 kips (490 kN)**

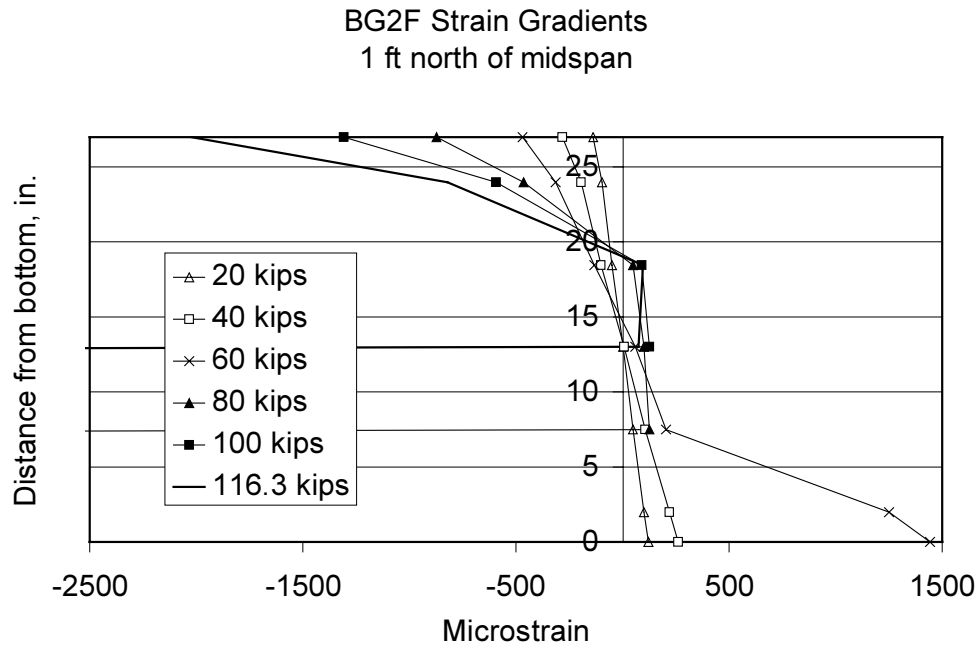
**Figure 4.11 Strain gradients on BG2F, 1 ft (0.30 m) north of midspan, at discrete loads up to failure**

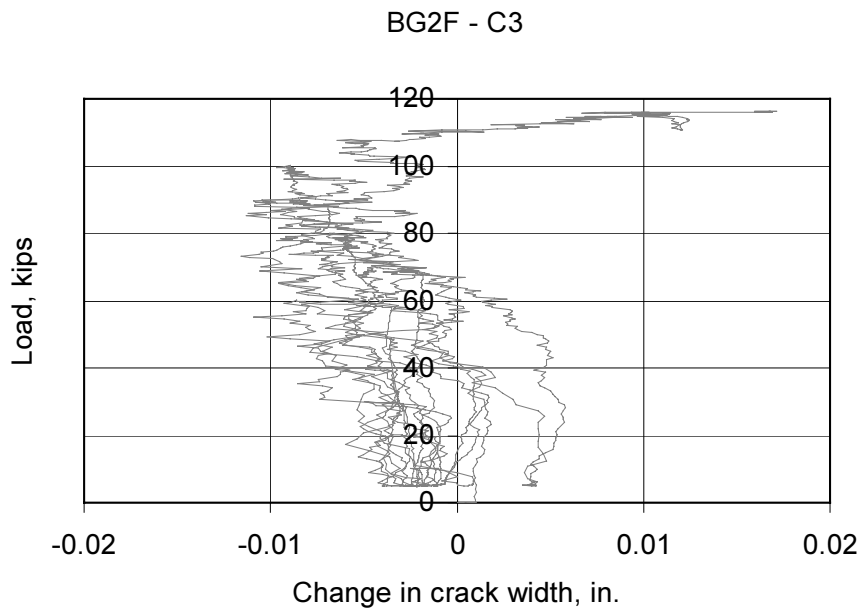
**Figure 4.12 Growth of pre-existing crack in BG2F from C3 data**

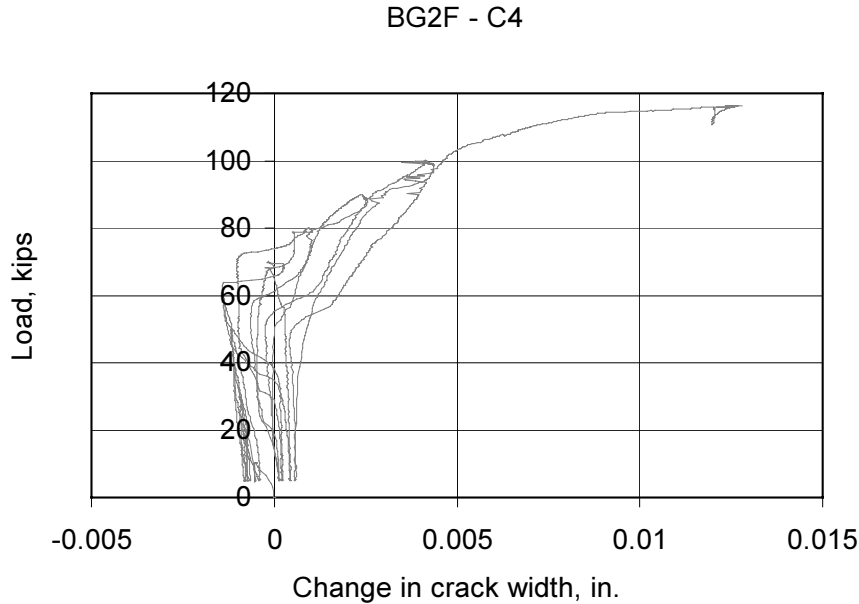
**Figure 4.13 Growth of pre-existing crack in BG2F from C4 data**

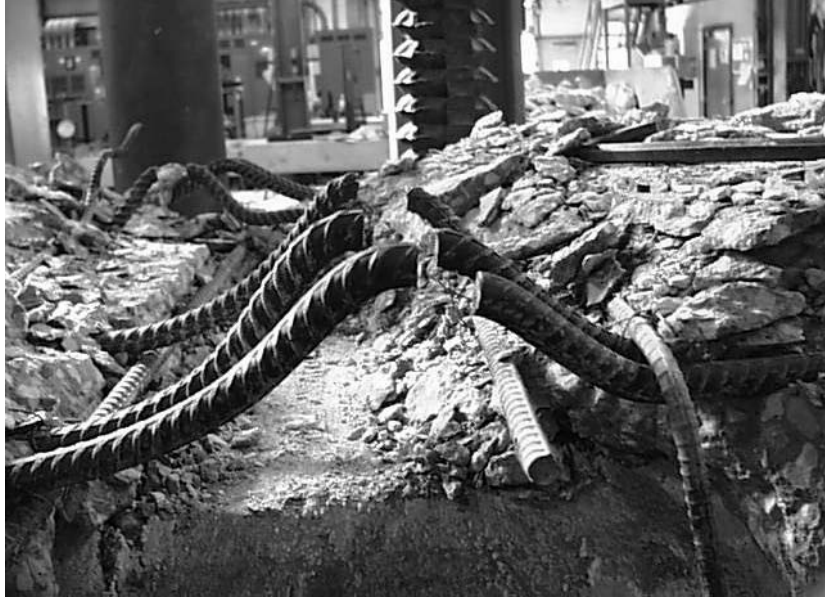
**Figure 4.14 Fractured top reinforcement in BG4F**

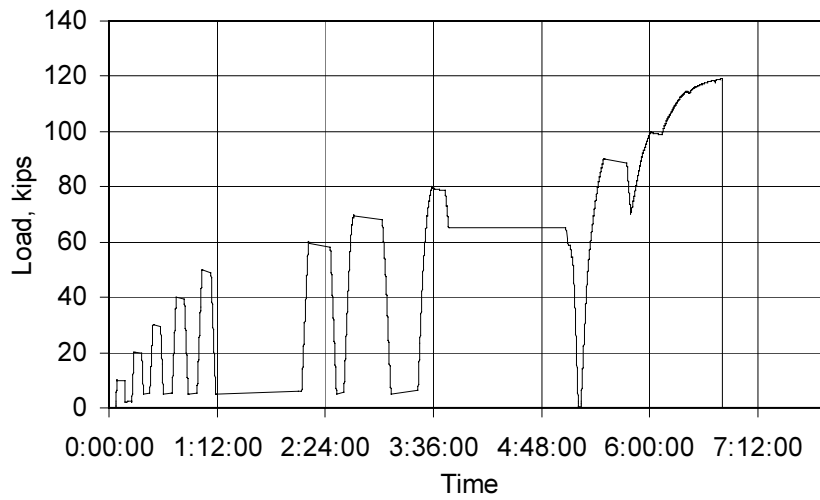
**Figure 4.15 Actual loading history of BG4F**

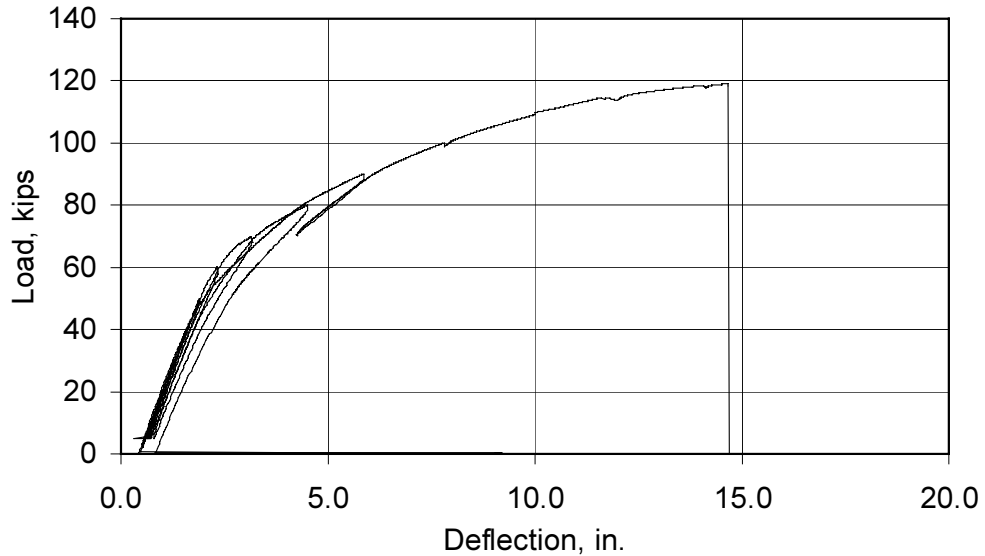
**Figure 4.16 Load-deflection curve for BG4F**

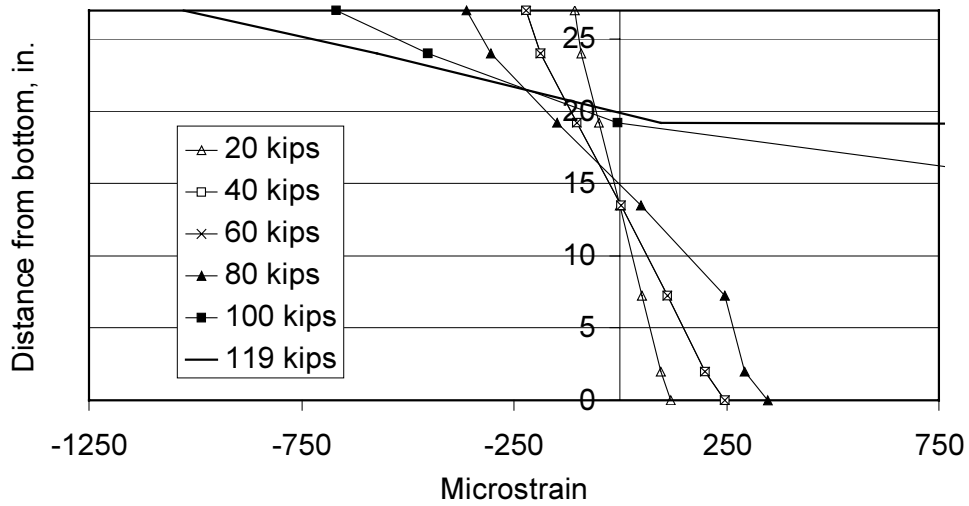
**Figure 4.17 Strain gradients on BG4F, 1 ft (0.30 m) north of midspan, at discrete loads up to failure**

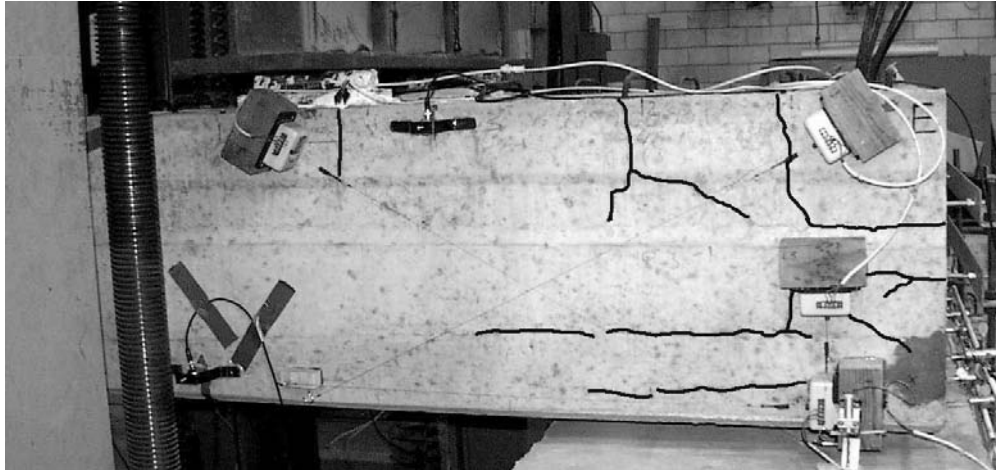
**Figure 4.18** Pre-existing cracks on the east face of BG1S

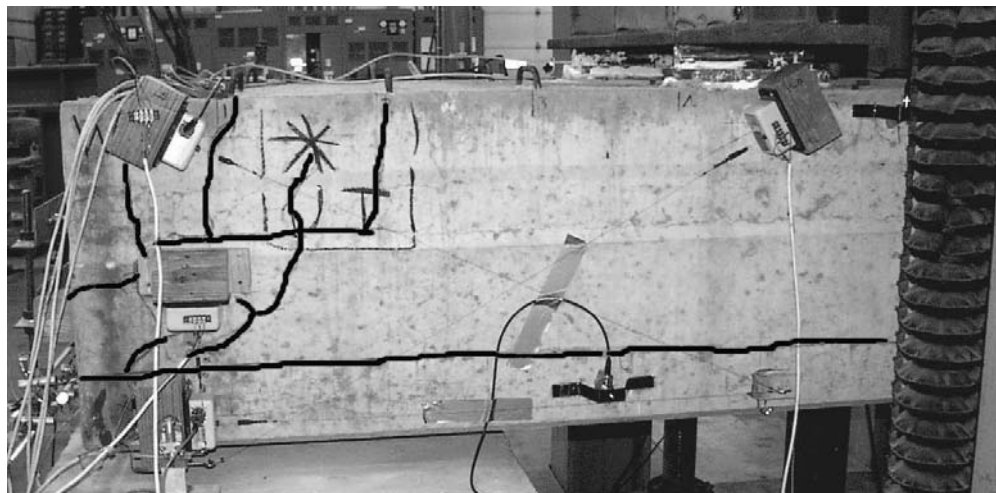
**Figure 4.19** Pre-existing cracks on the west face of BG1S

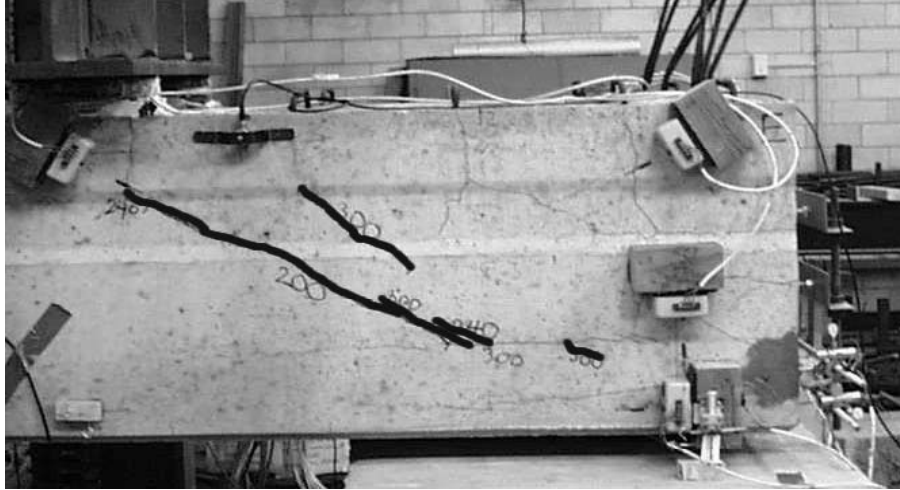
**Figure 4.20** Shear-induced cracks on the east face of BG1S under a load of 300 kips (1330 kN)

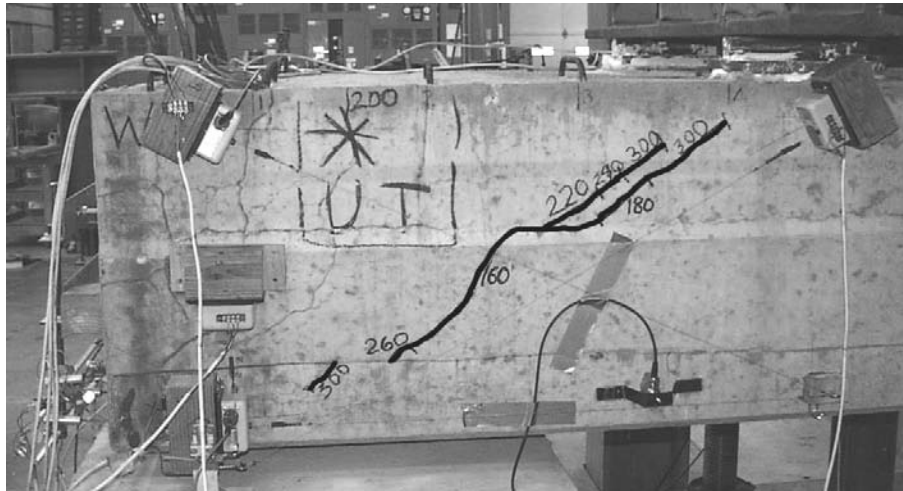
**Figure 4.21** Shear-induced cracks on the west face of BG1S under a load of 300 kips (1330 kN)

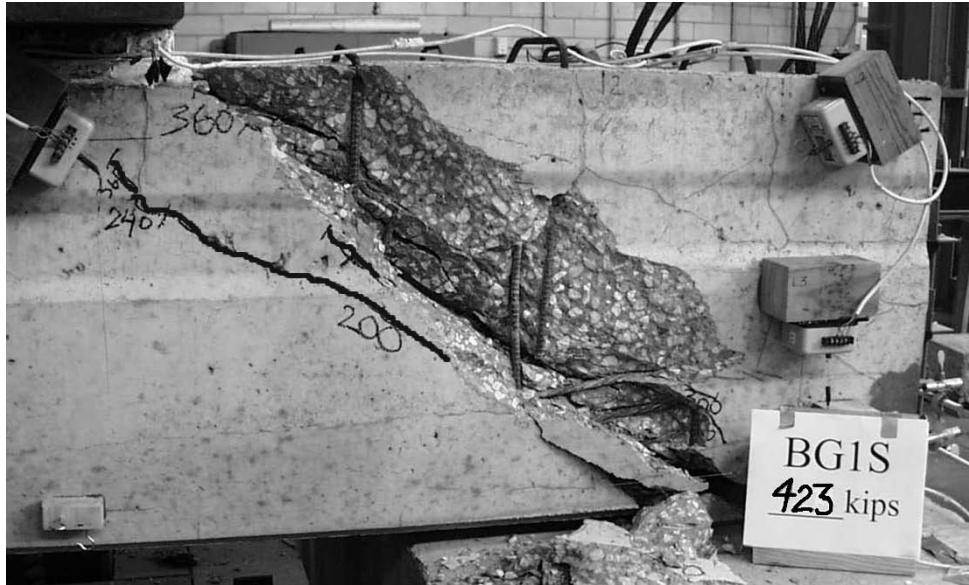
**Figure 4.22 Failure of the east face of BG1S at 423 kips (1880 kN)**

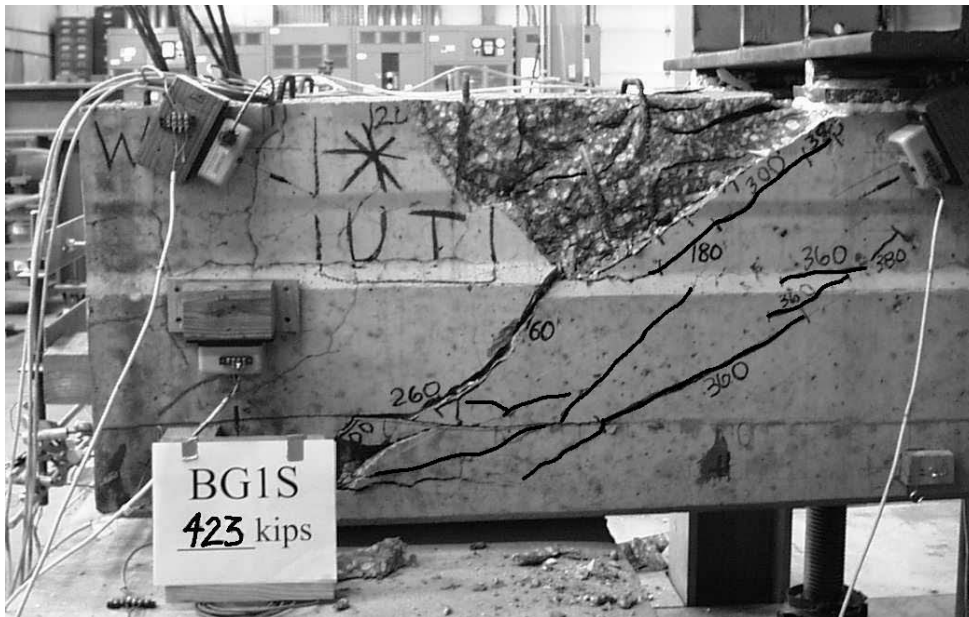
**Figure 4.23 Failure of the west face of BG1S at 423 kips (1880 kN)**

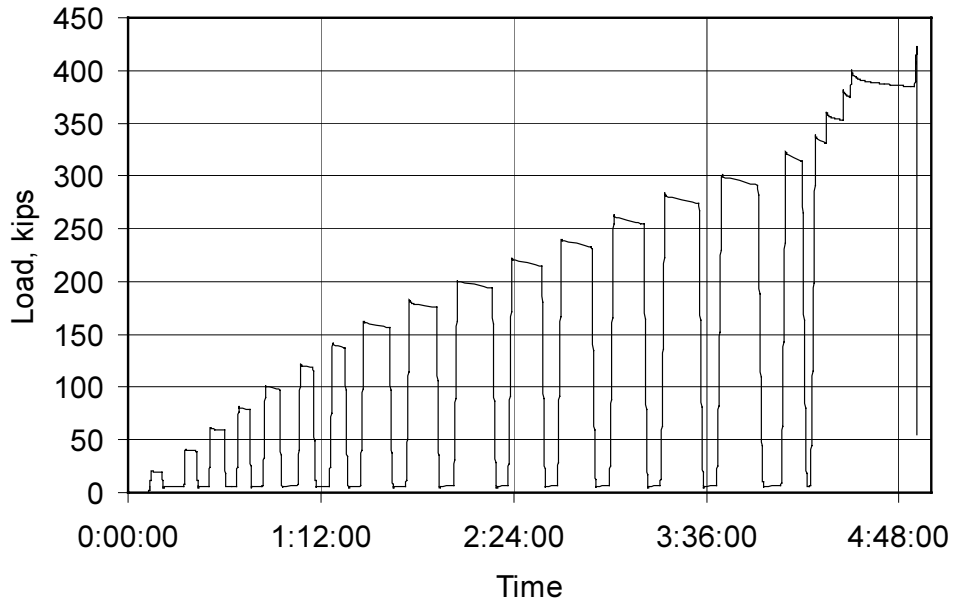
Figure 4.24 Actual loading history of BG1S

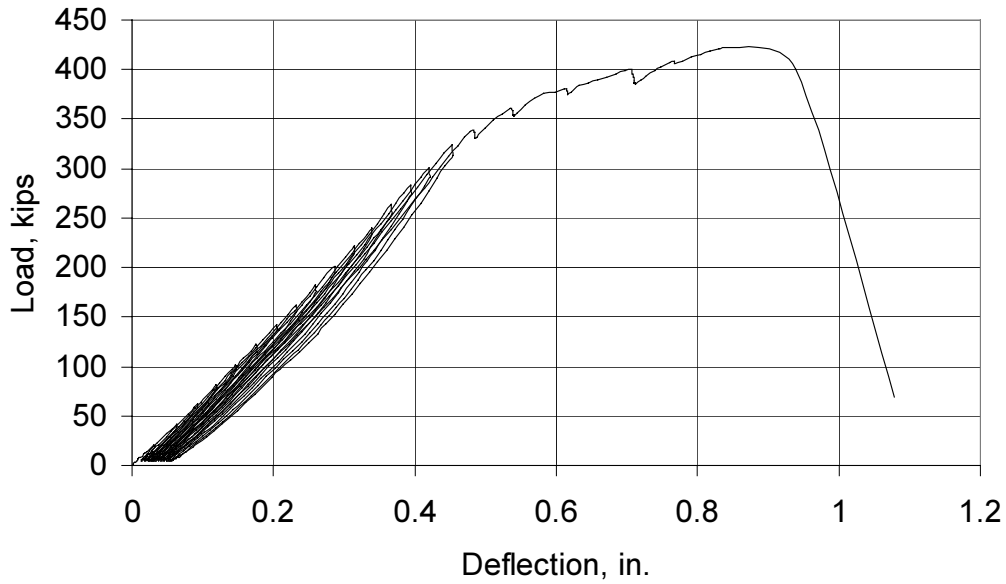
Figure 4.25 Load-deflection curve for BG1S

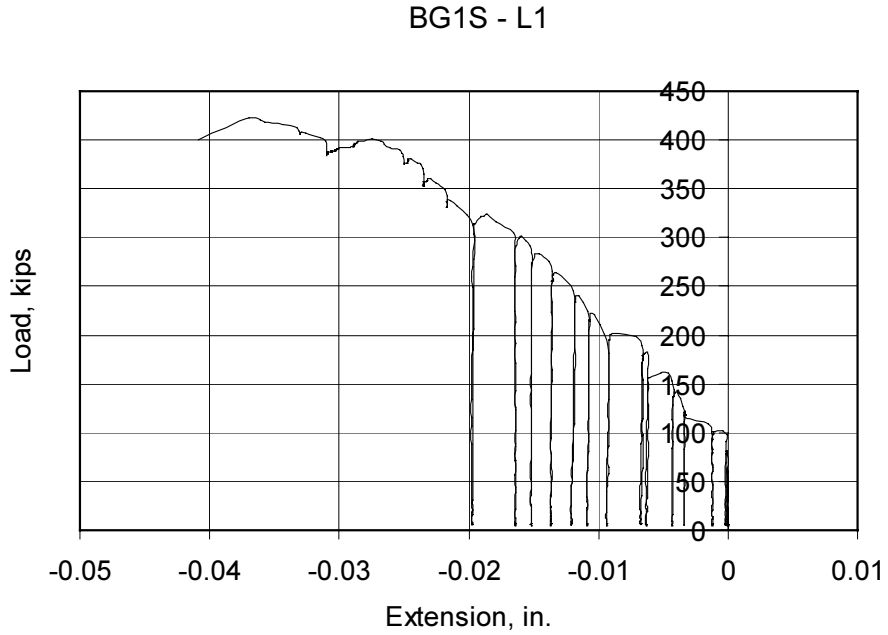
**Figure 4.26 Shortening of the compression diagonal in the west web of BG1S**

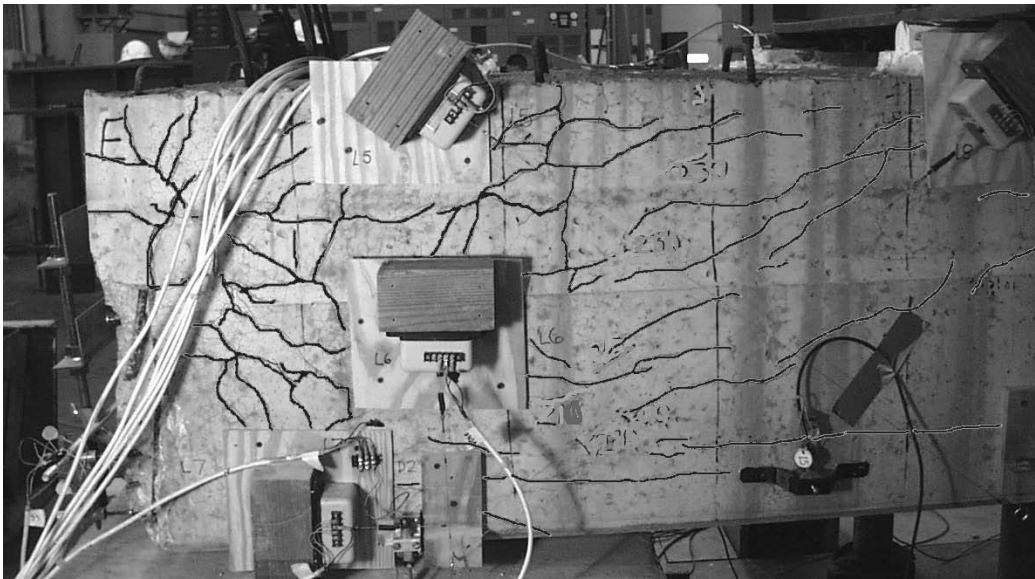
**Figure 4.28 Pre-existing cracks on the east face of BG2S**

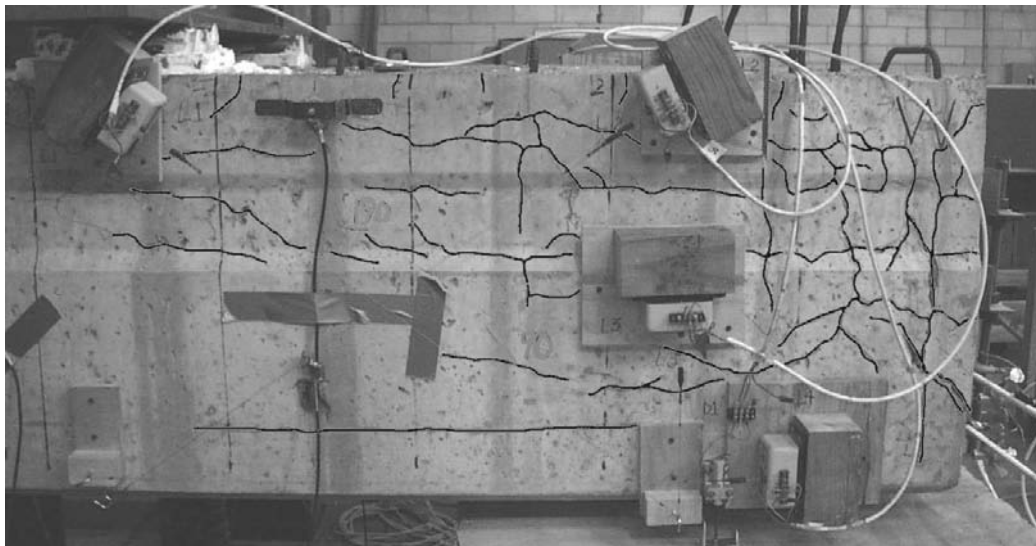
**Figure 4.29 Pre-existing cracks on west face of BG2S**

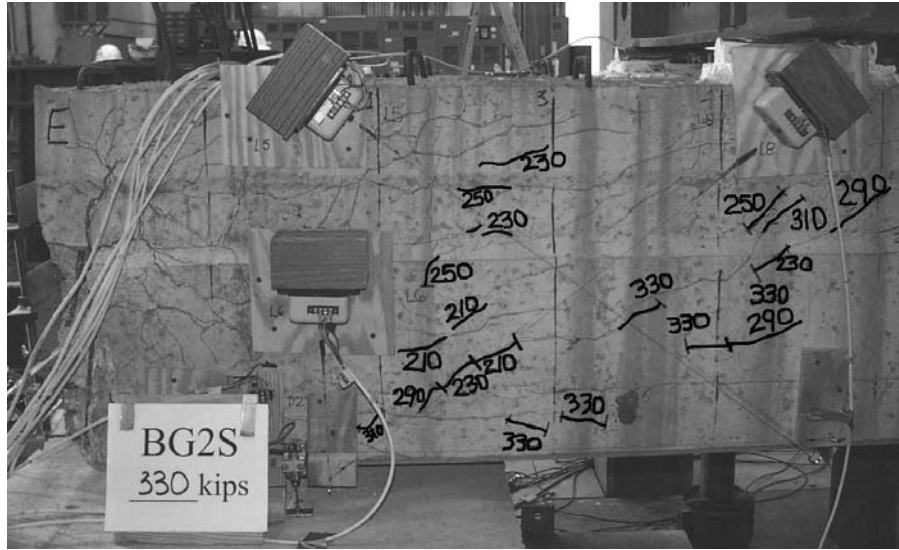
**Figure 4.30 Shear-induced cracks on the east face of BG2S under a load of 330 kips (1470 kN)**
