**REVISED PRELIMINARY DRAFT**

6. Performing Organization Code	
7. Author(s) A. Boenig, L. Fúnez, R. E. Klingner, and T. J. Fowler				8. Performing Organization Report No. Research Report 1857-1

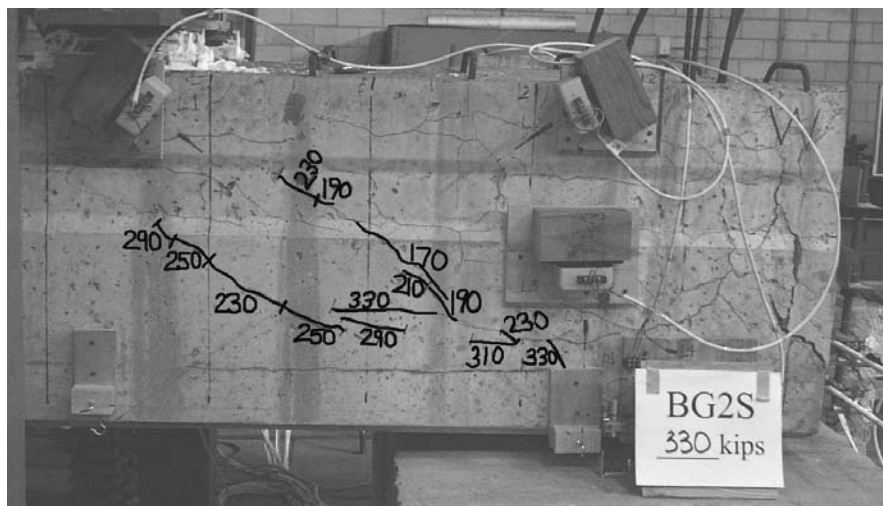
**Figure 4.31 Shear-induced cracks on the west face of BG2S under a load of 330 kips (1470 kN)**

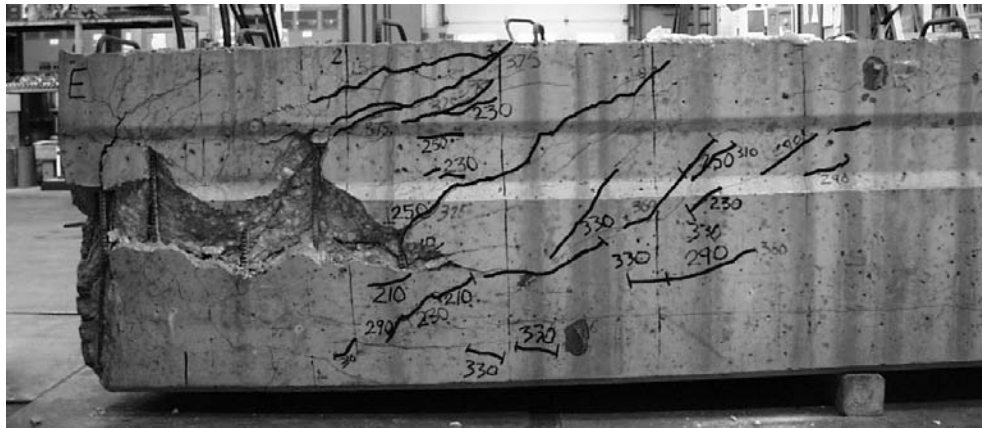
**Figure 4.32 Failure of the east face of BG2S at 358 kips (1590 kN)**

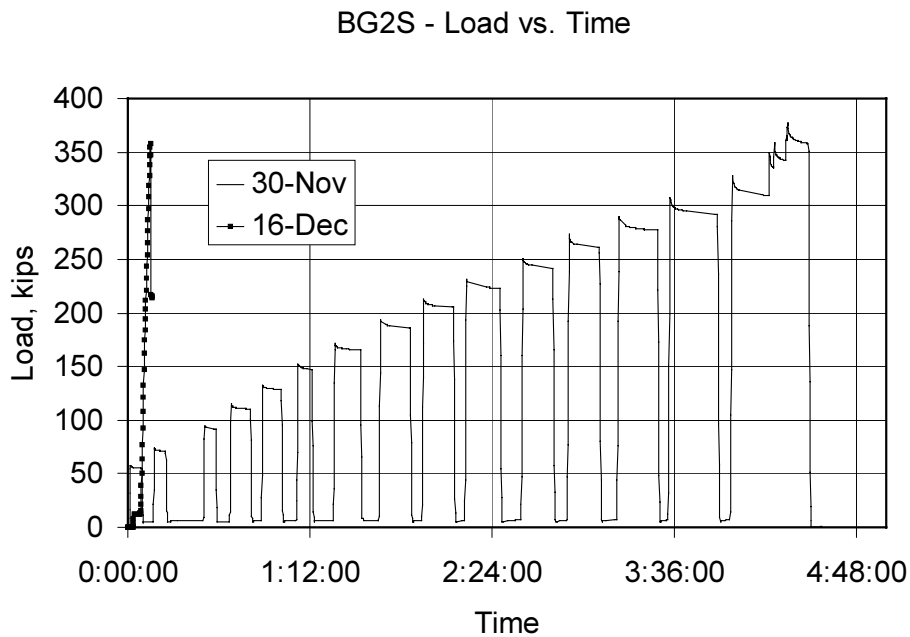
**Figure 4.33 Actual loading history of BG2S**

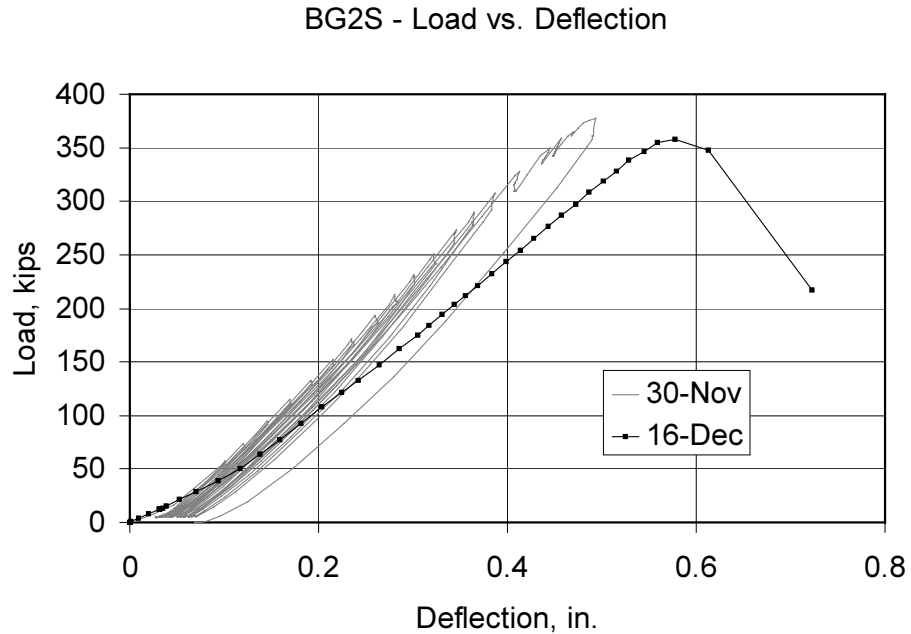
**Figure 4.34 Load-deflection curve for BG2S**

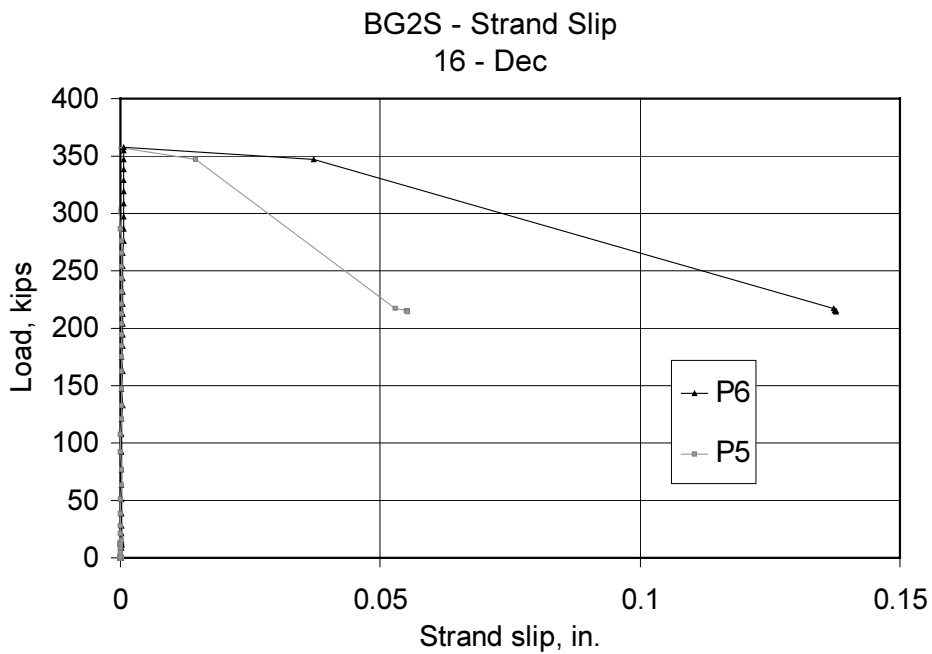
**Figure 4.35 Strand slip of BG2S**

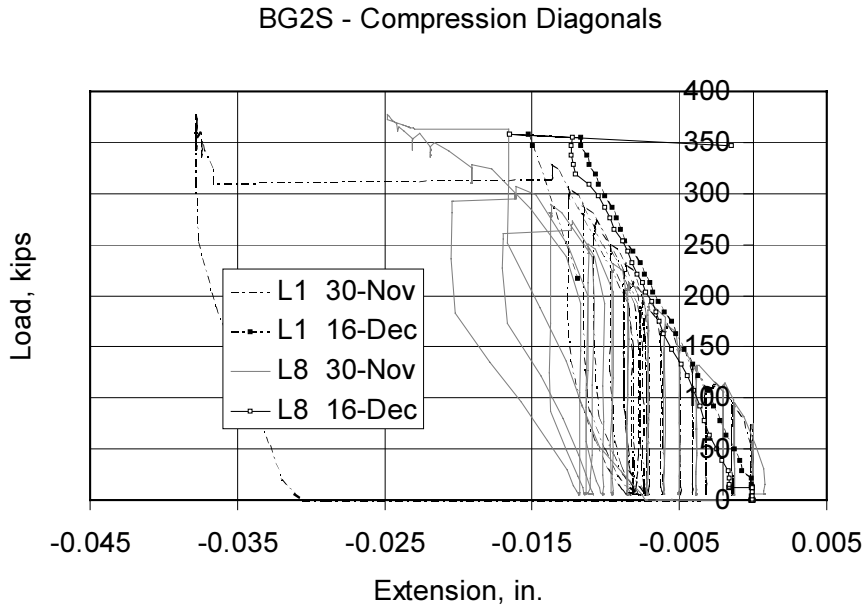
**Figure 4.36 Shortening of compression diagonals in webs of BG2S**

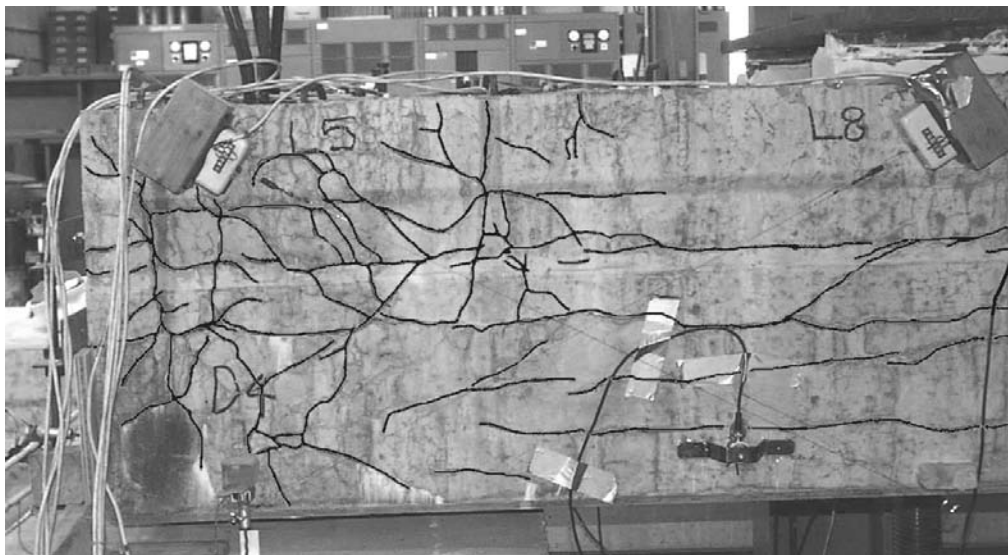
**Figure 4.39 Pre-existing cracks on the east face of BG4S**

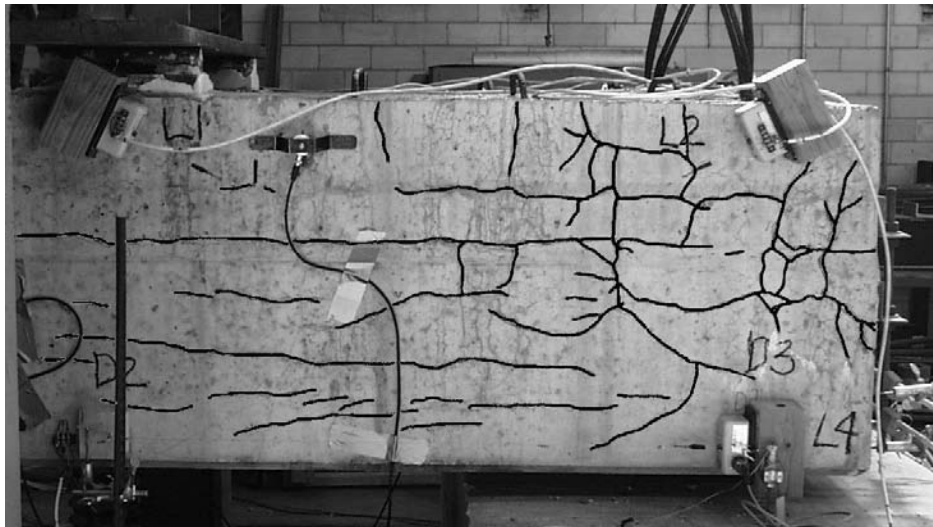
**Figure 4.40 Pre-existing cracks on the west face of BG4S**

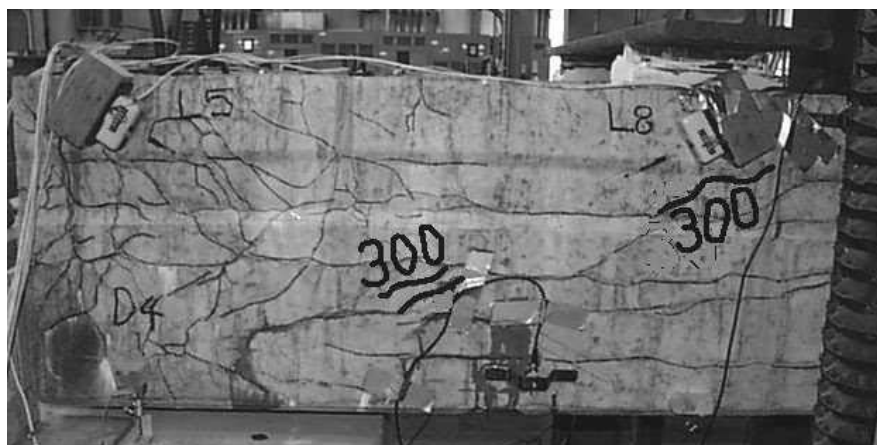
**Figure 4.41 Shear-induced cracks on the east face of BG4S under a load of 300 kips (1330 kN)**

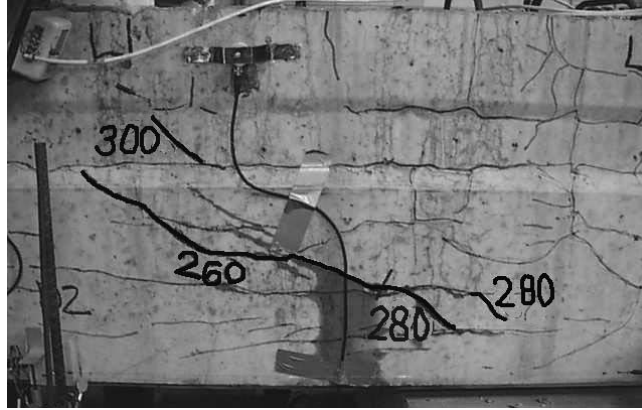
**Figure 4.42 Shear-induced cracks on the west face of BG4S under a load of 300 kips (1330 kN)**

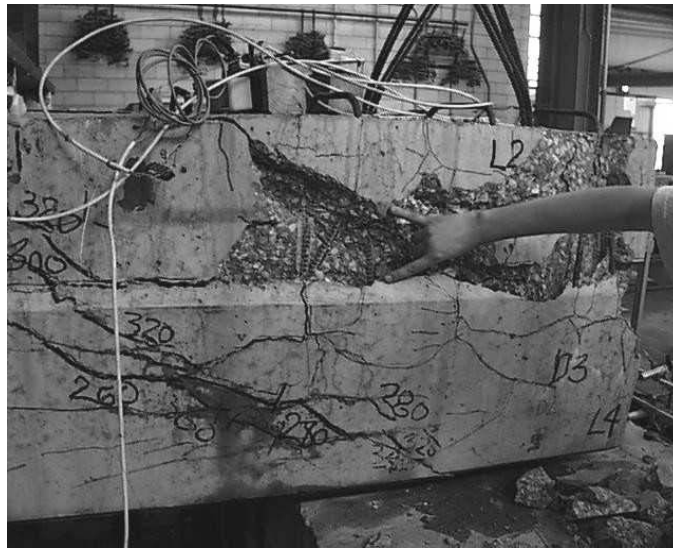
**Figure 4.43 Failure of the west face of BG4S at 361 kips (1610 kN)**

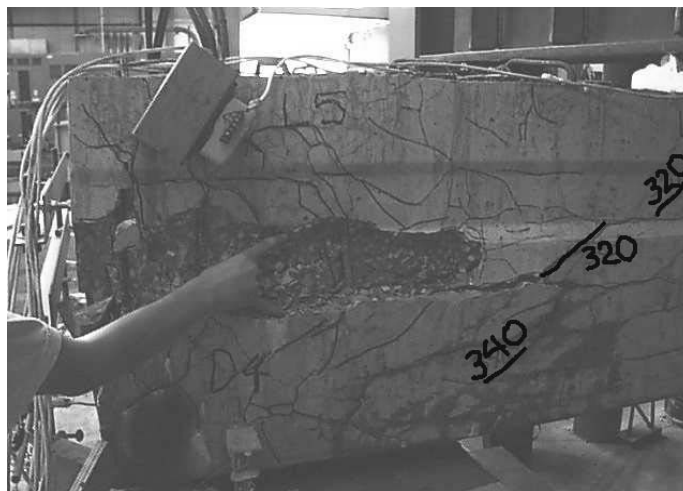
**Figure 4.44 Failure of the east face of BG4S at 361 kips (1610 kN)**

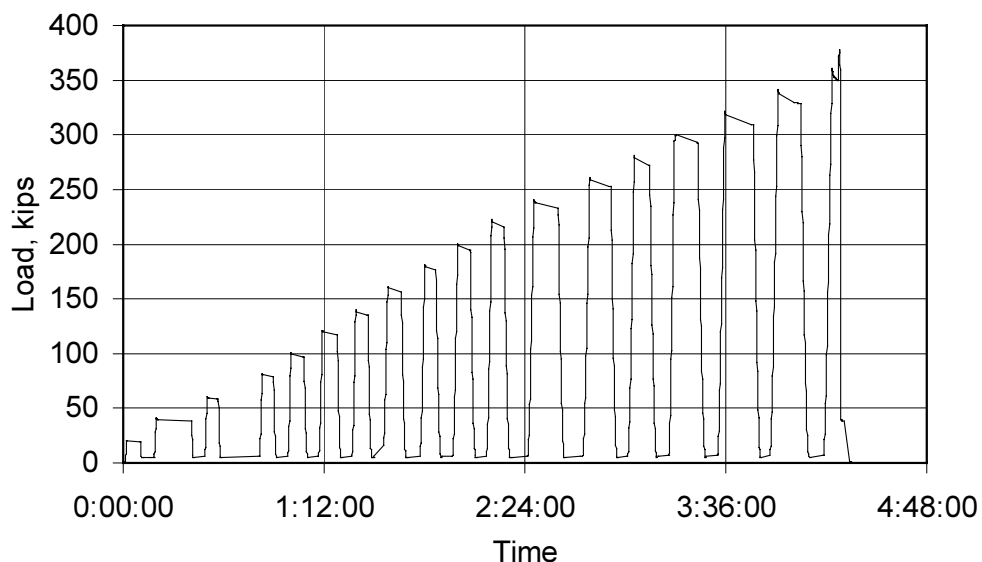
Figure 4.45 Actual loading history of BG4S

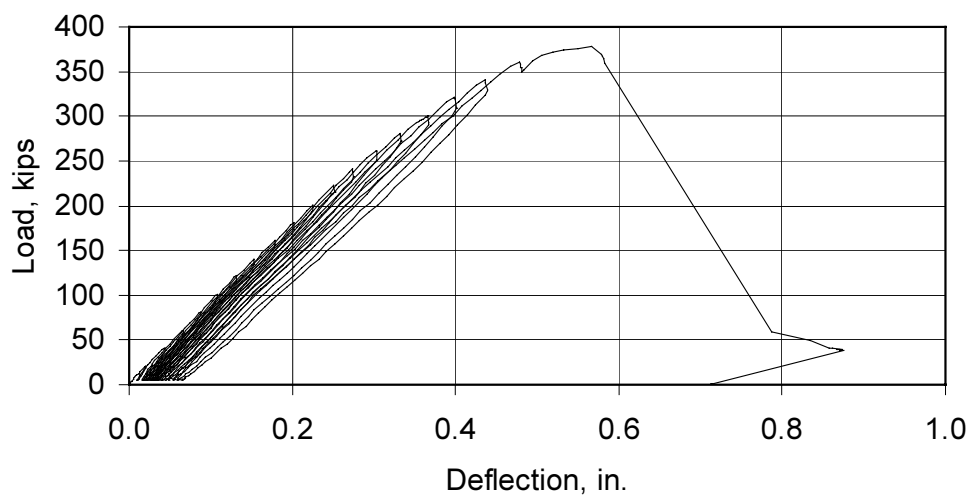
Figure 4.46 Load-deflection curve for BG4S

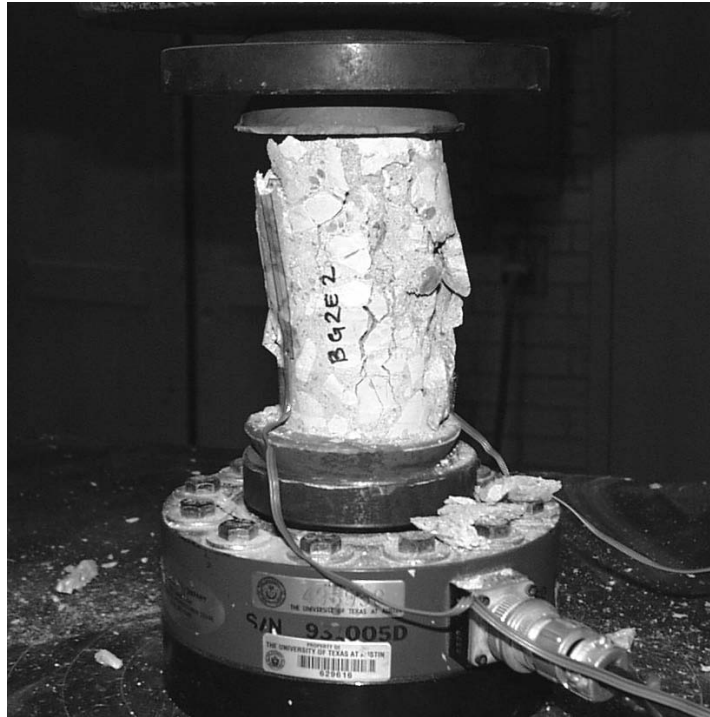
**Figure 4.51 Failure of BG2E-2, typical of more-damaged cores**

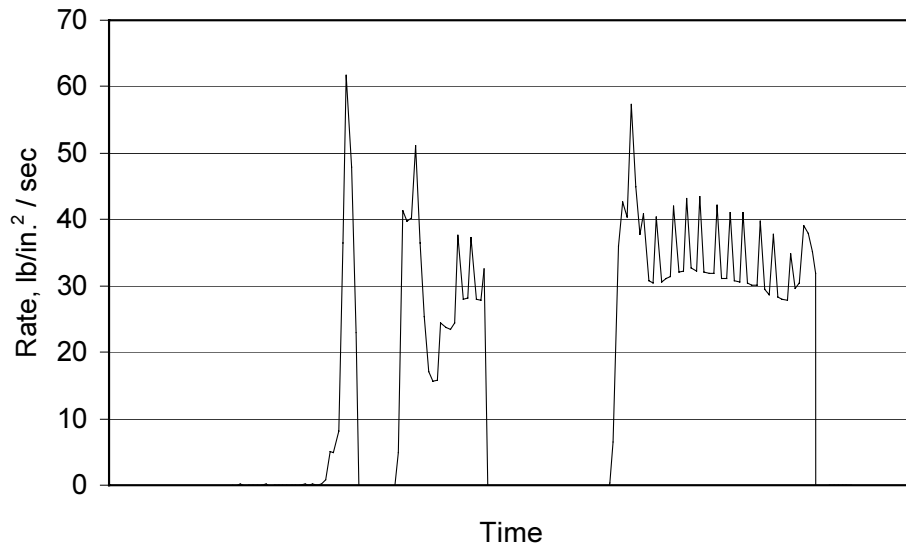
**Figure 4.52 Typical loading history of core**

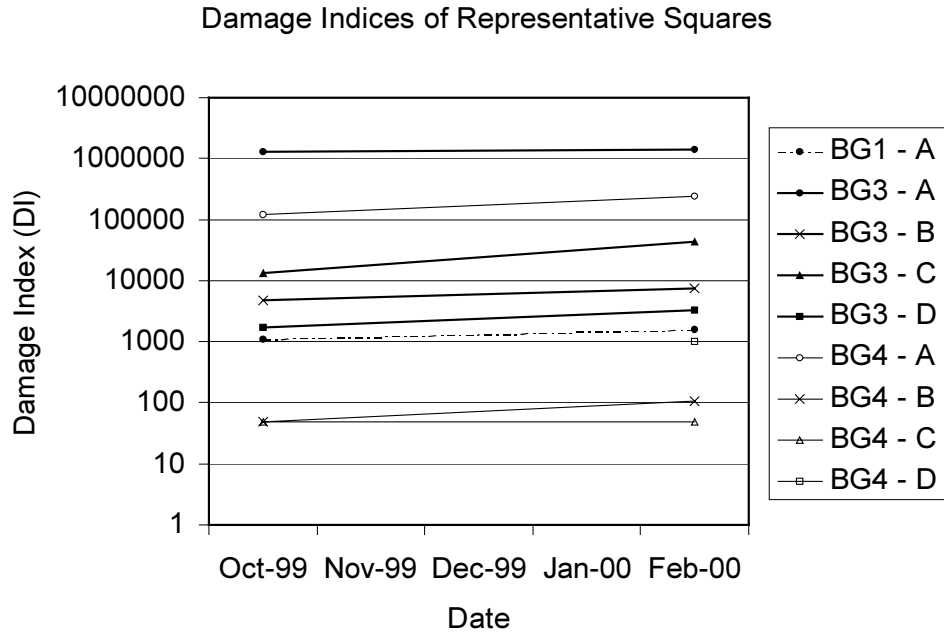
Figure 4.54 Damage Indices versus time for representative squares

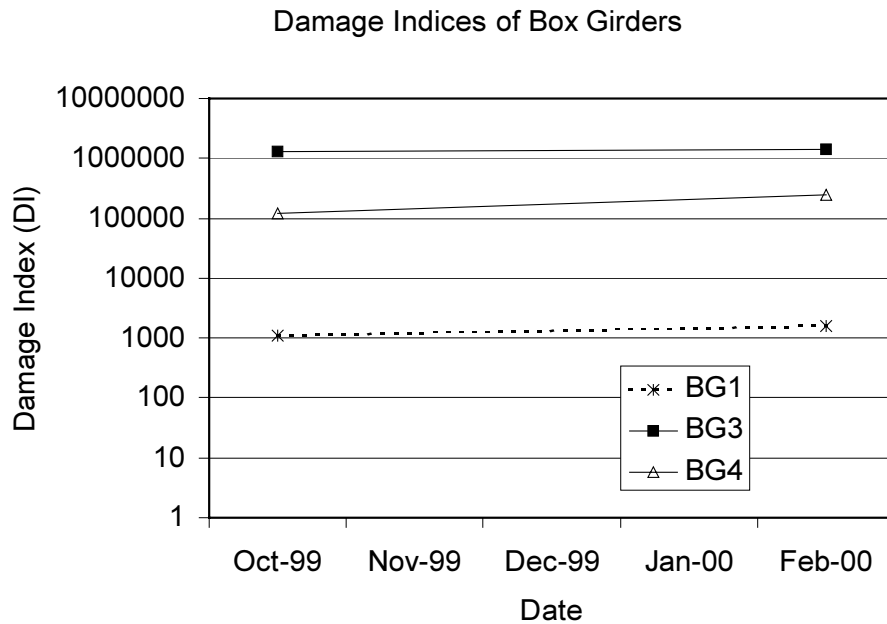
Figure 4.55 Damage Indices versus time for box girders

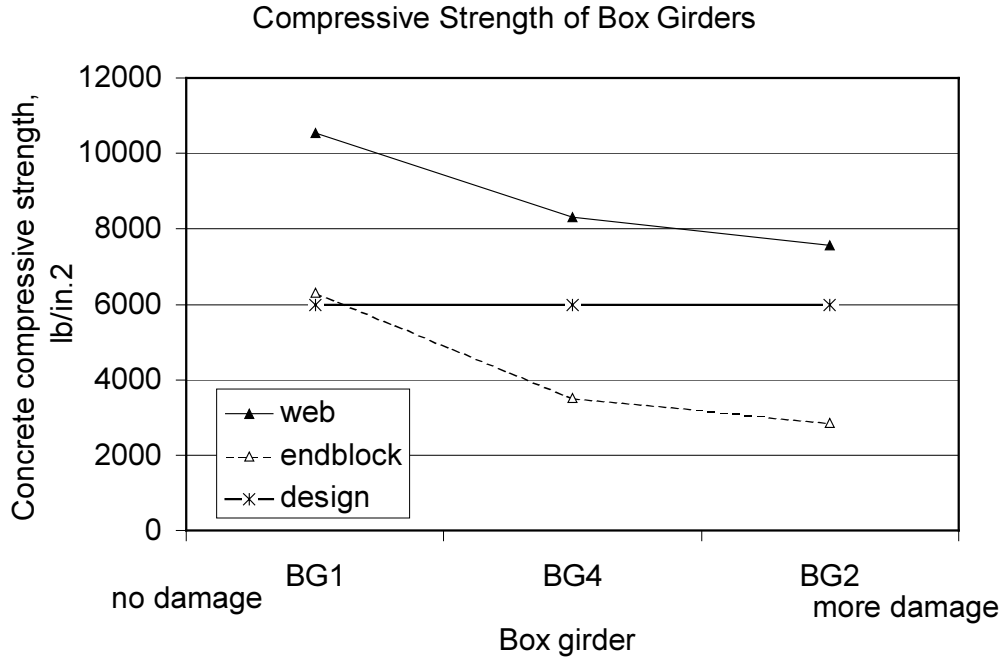
**Figure 5.4 Concrete compressive strength of cores from box girders**

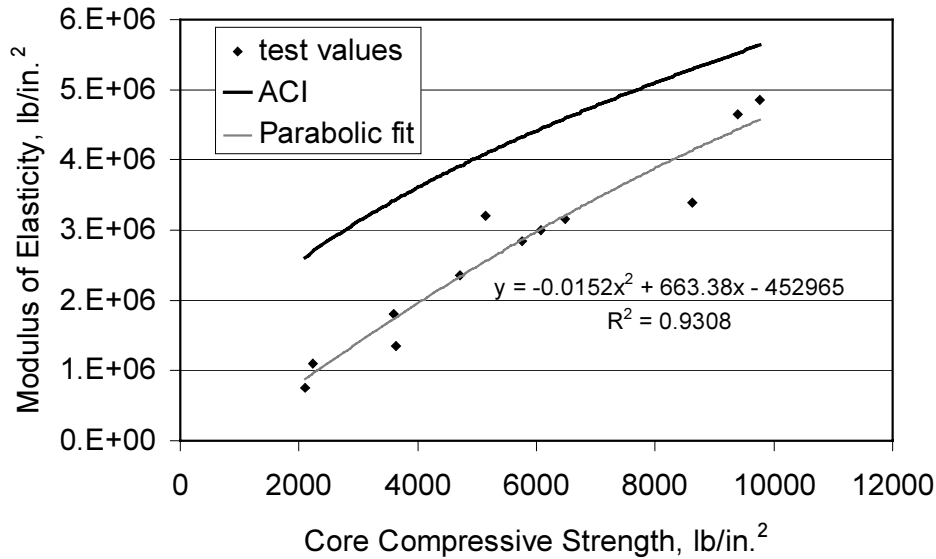
**Figure 5.6 Modulus of elasticity versus concrete compressive strength of cores from box girders**

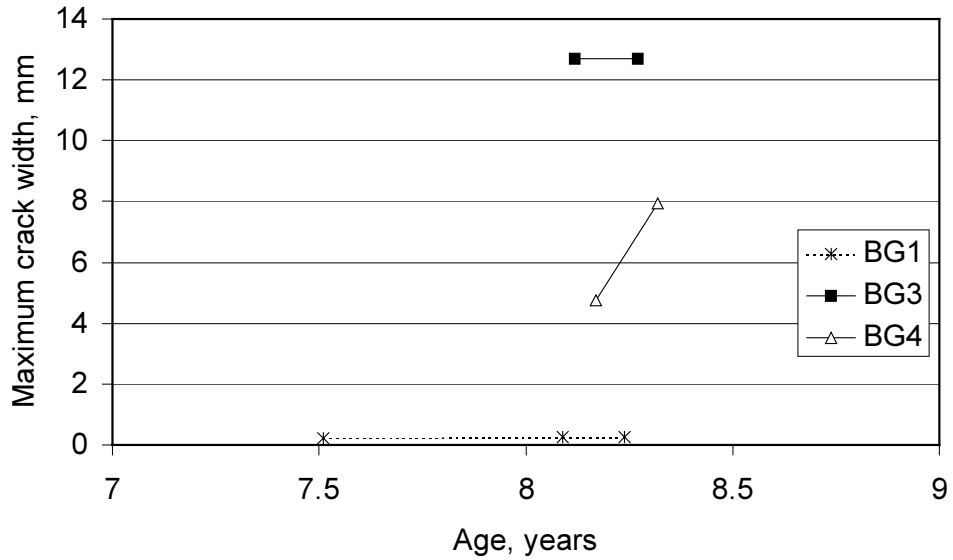
Figure 5.7 Maximum crack width versus age for box girders

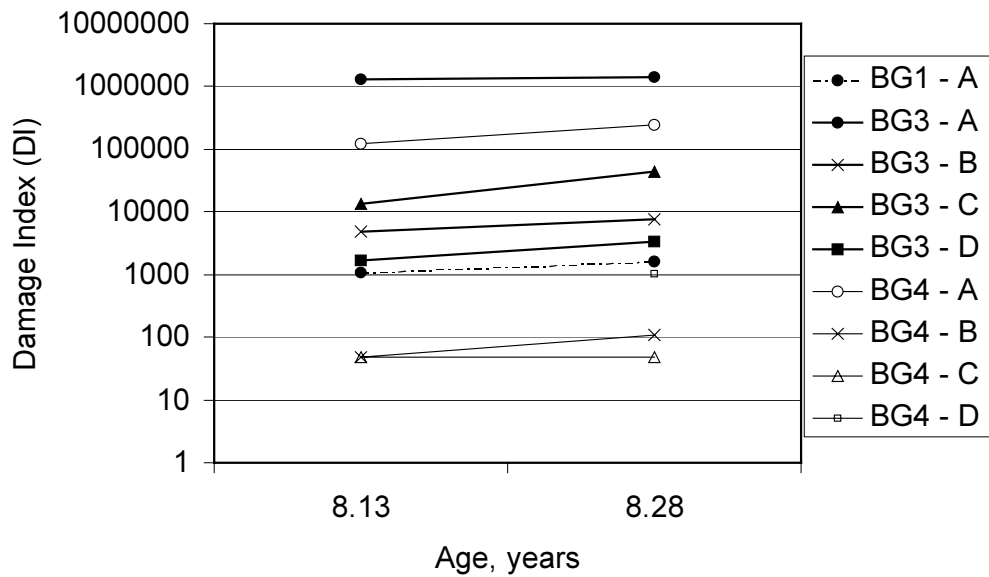
Figure 5.8 Damage Indices versus age for representative squares

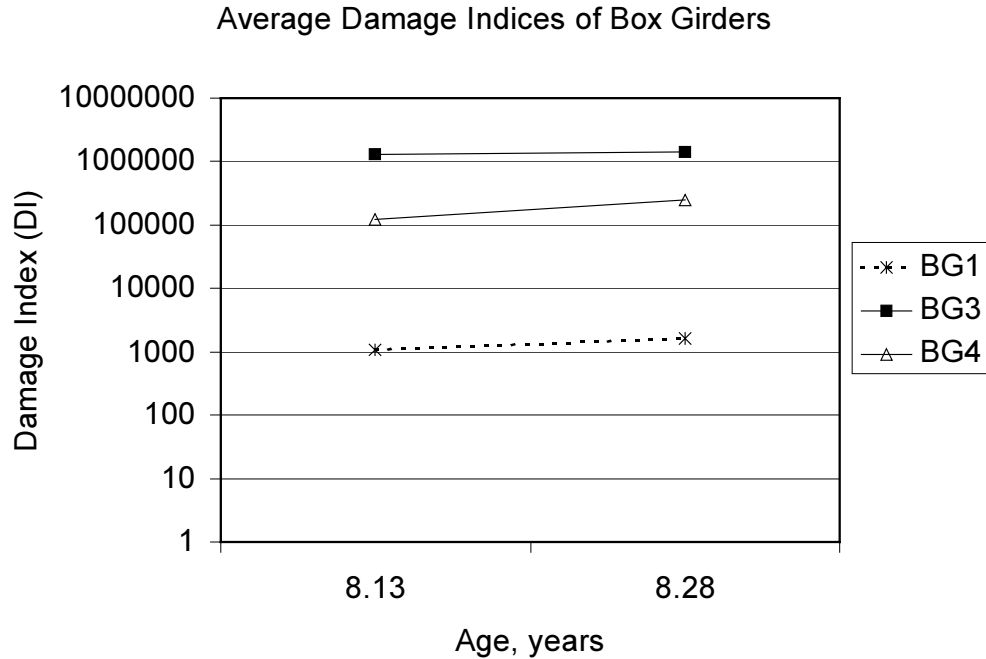
**Figure 5.9 Average damage indices versus age for box girders**

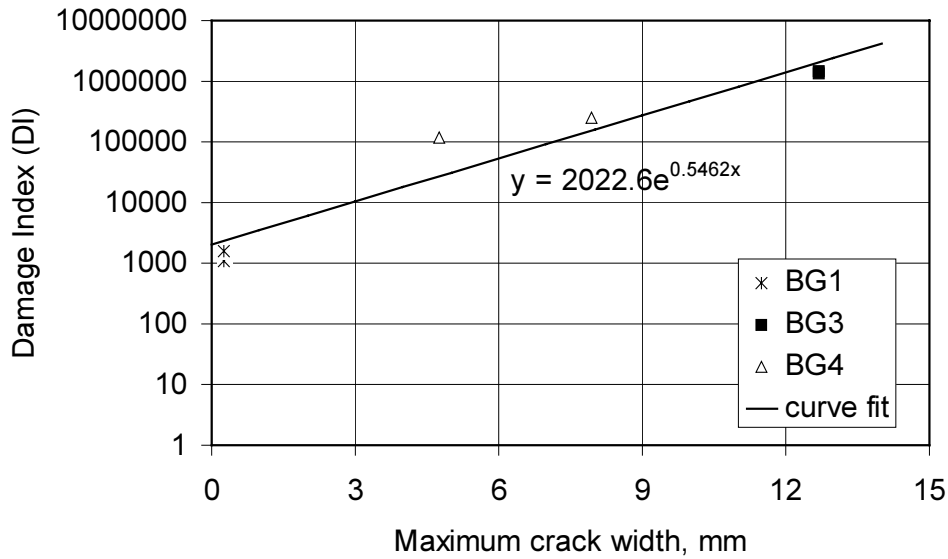
Figure 5.10 Damage index versus maximum crack width of box girders

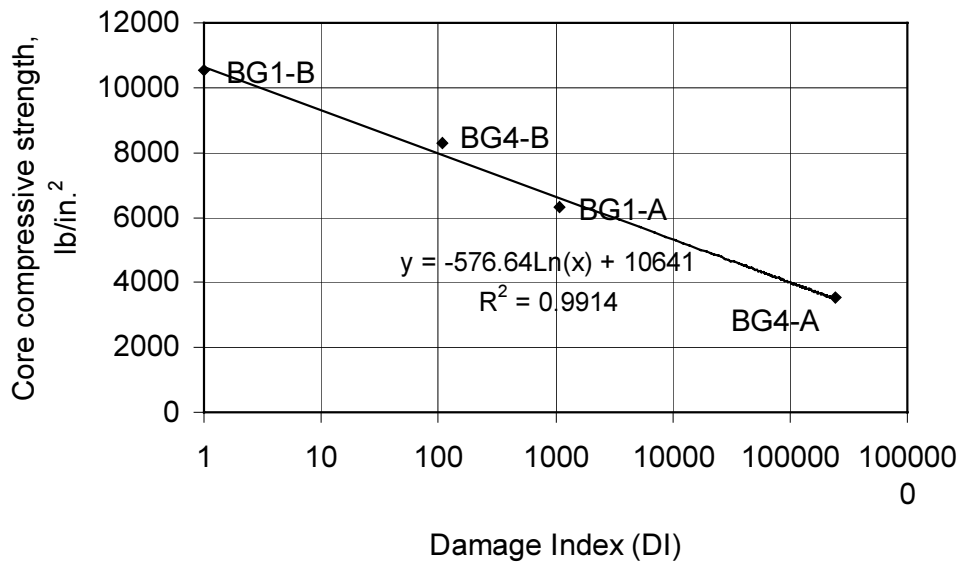
Figure 5.11 Concrete compressive strength of cores from box girders versus damage index

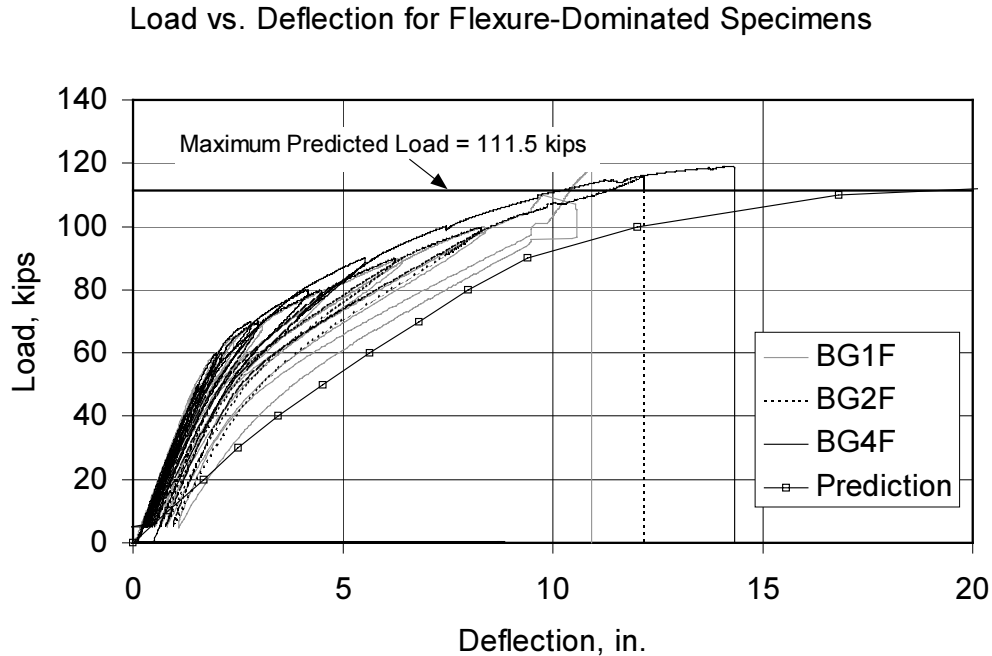
**Figure 5.12 Load-deflection curves and predicted behavior for flexure-dominated specimens**

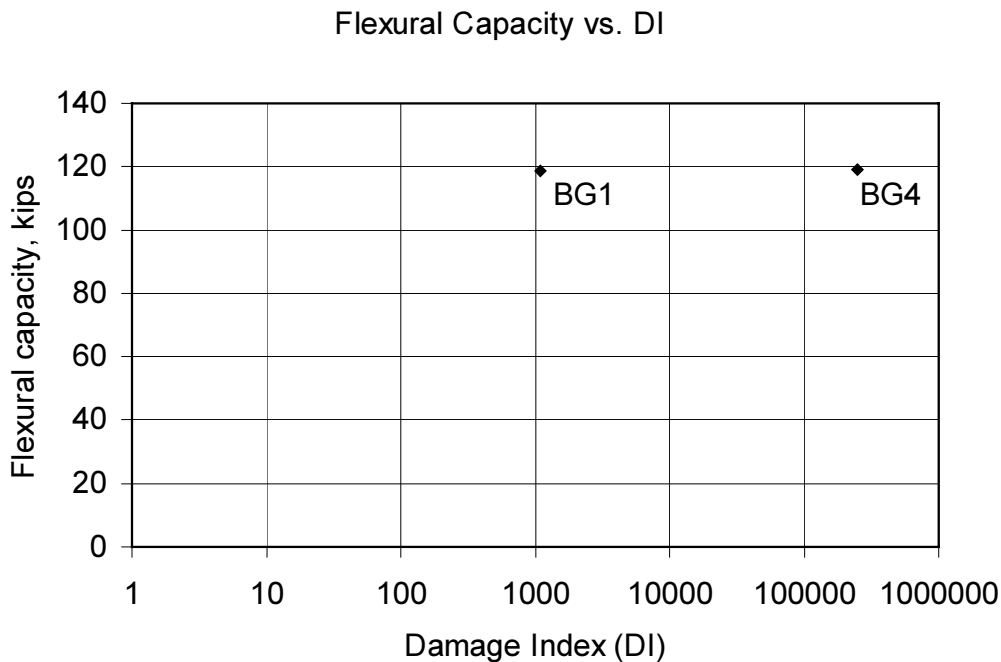
**Figure 5.13 Flexural capacity versus damage index**

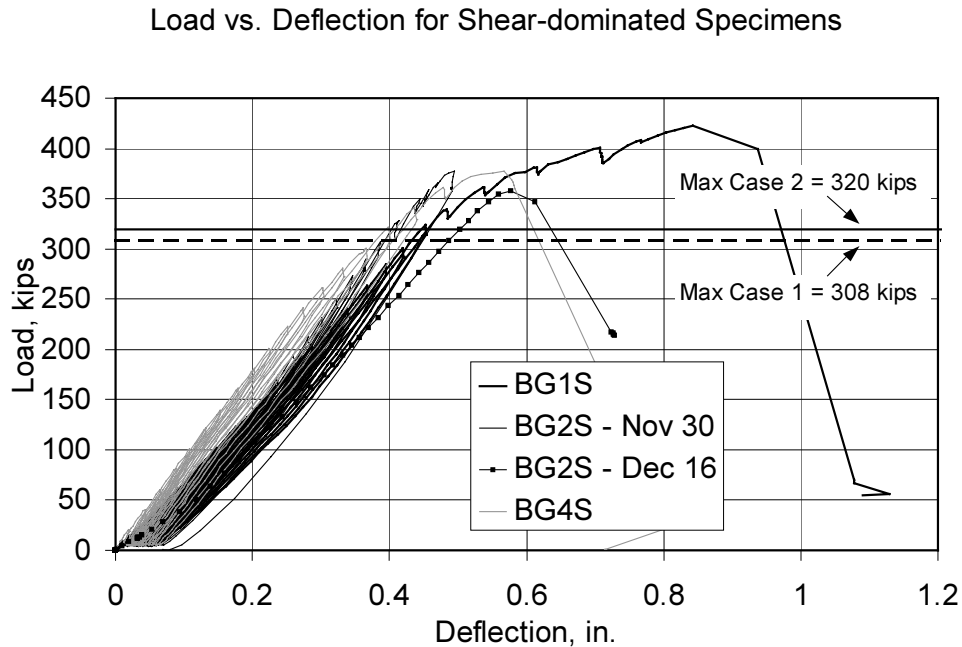
**Figure 5.14 Load-deflection curves and predicted maximum loads for shear-dominated specimens**

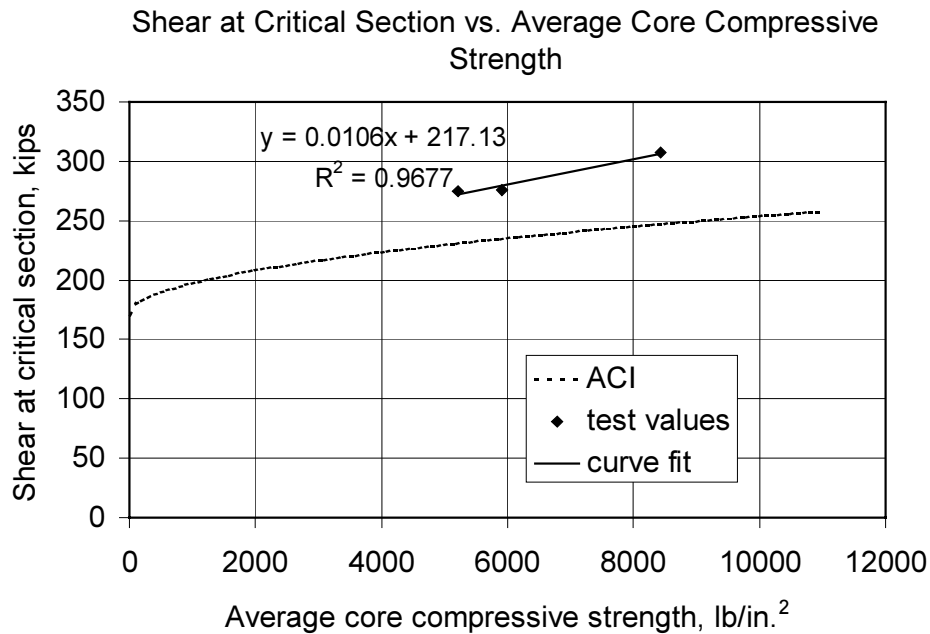
**Figure 5.15 Shear strength versus average core compressive strength**

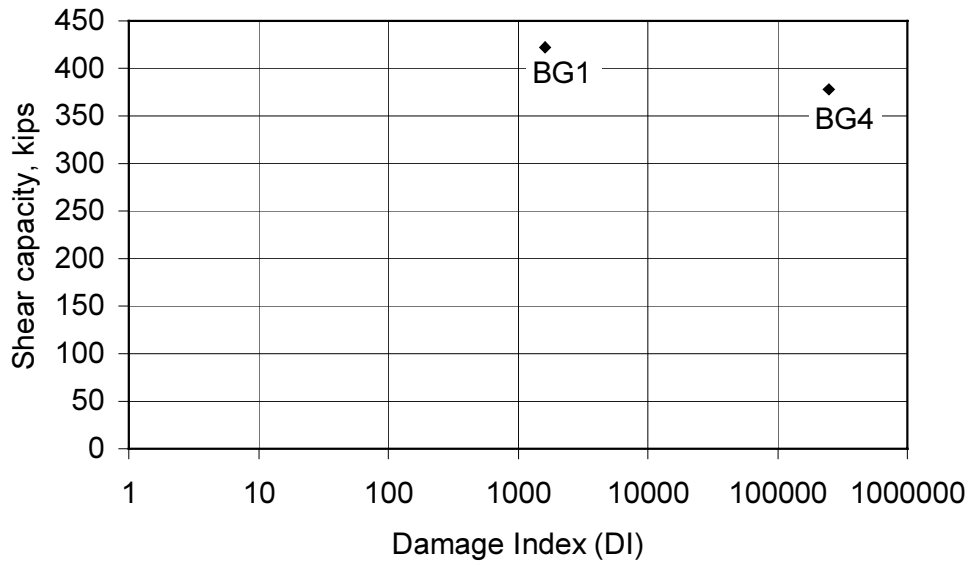
Figure 5.16 Shear capacity versus damage index

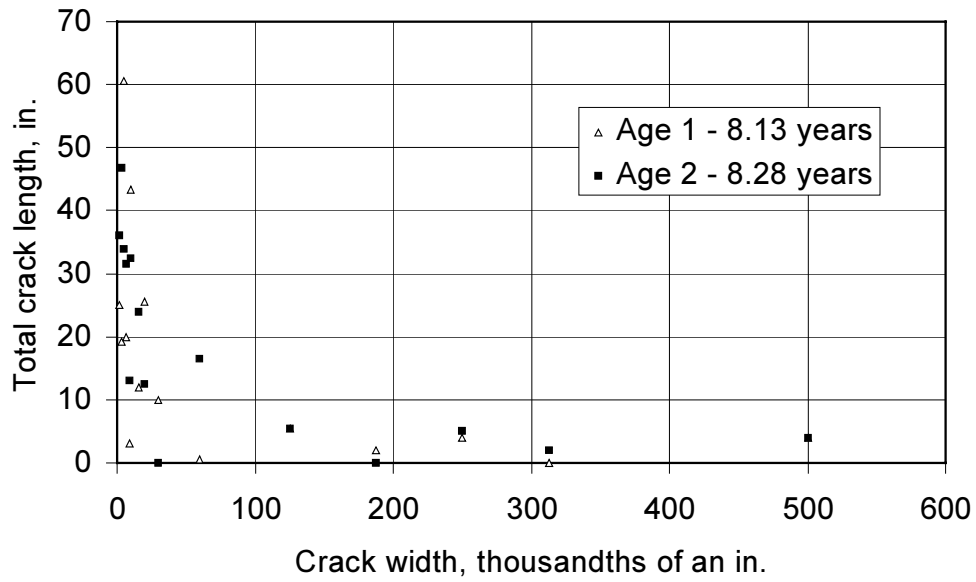
Figure 5.17 Damage histogram of box girders (US Customary units)

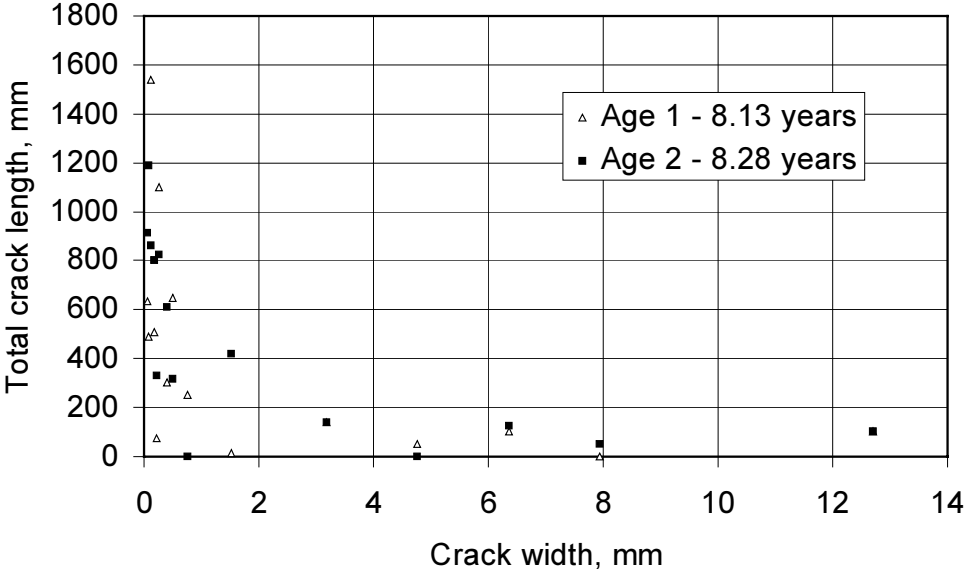
**Figure 5.18 Damage histogram of box girders (SI units)**

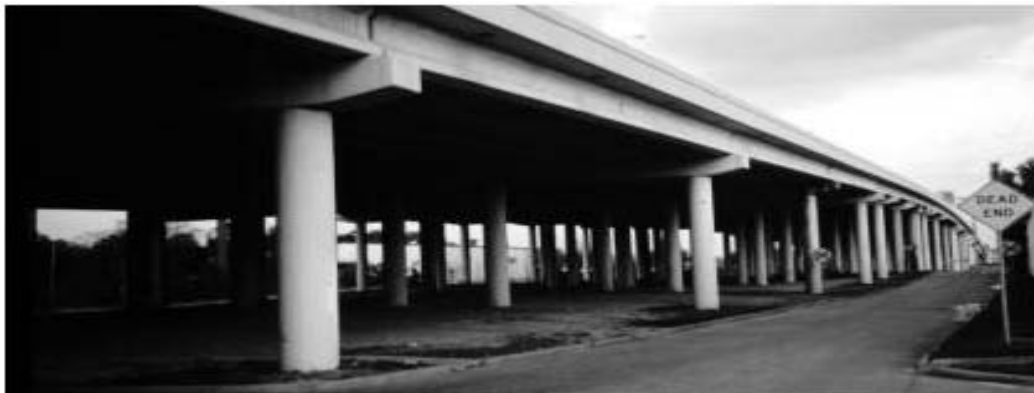
Figure 6.1 I-10 at AT & SF RR

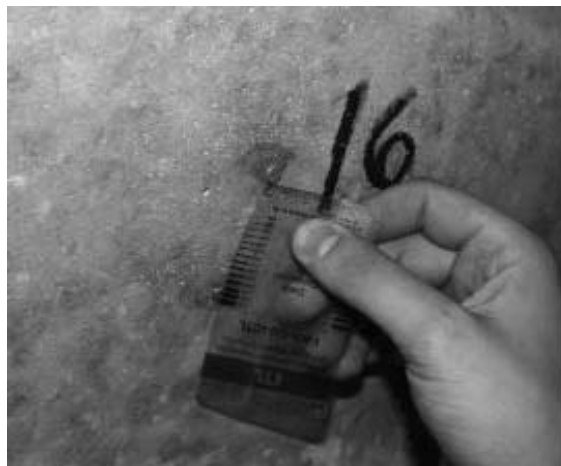
**Figure 6.6 Crack comparator**

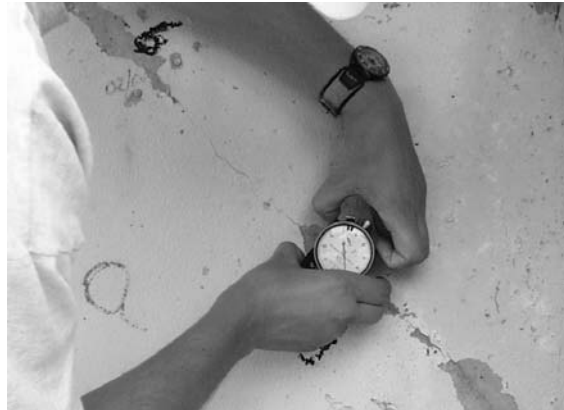
**Figure 6.7 Demec gage**

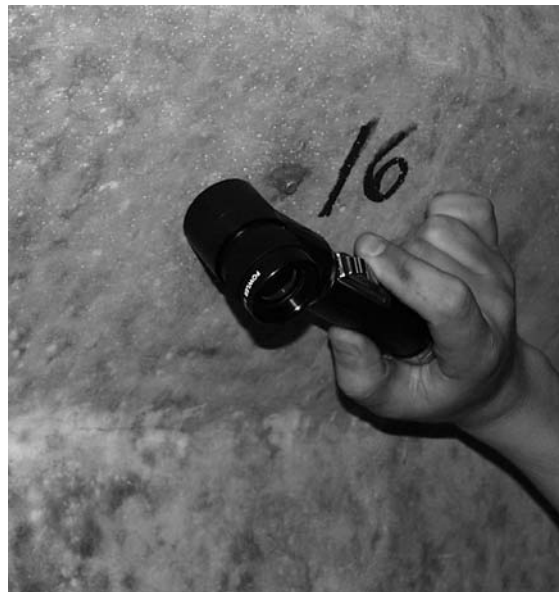
**Figure 6.8 Magnifying eye scope**

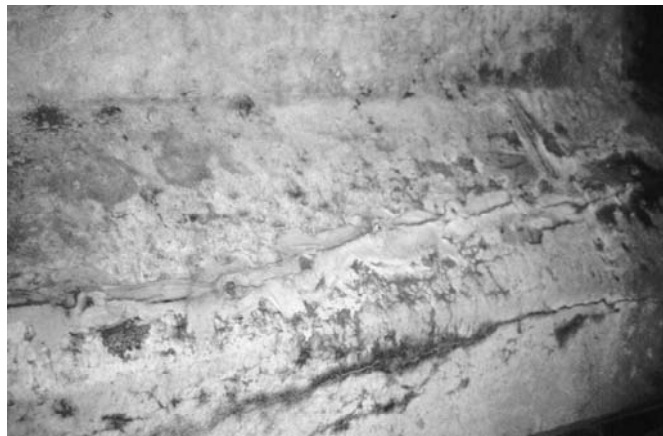
**Figure 7.3 Injected sealant on I-10 structure**

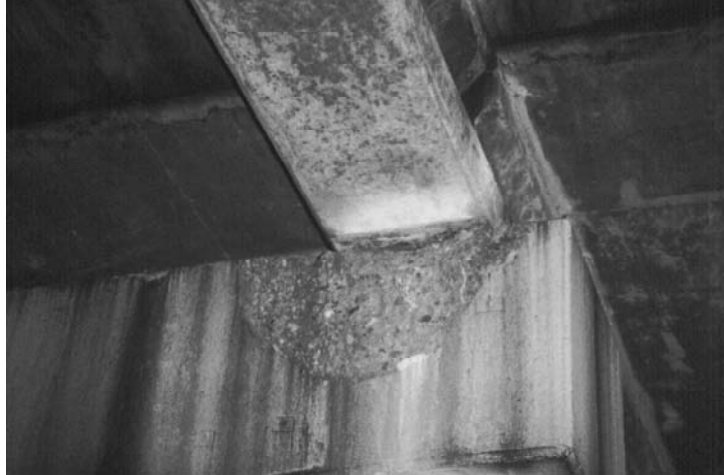
**Figure 7.4 Missing bearing pad at I-10 structure**

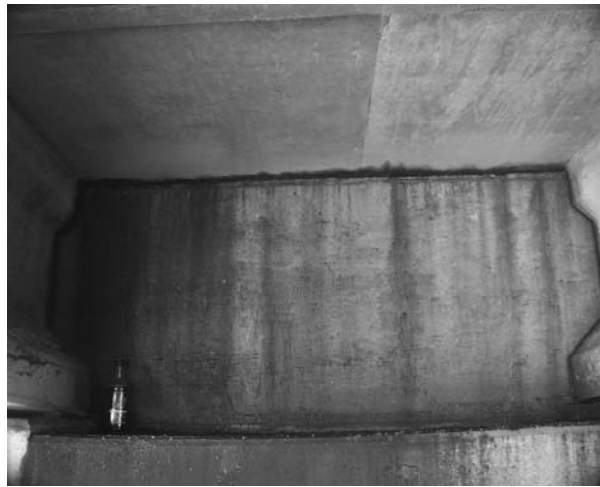
**Figure 7.5 View of west abutment between SW Girder 2 (left) and SW Girder 3 (right)**

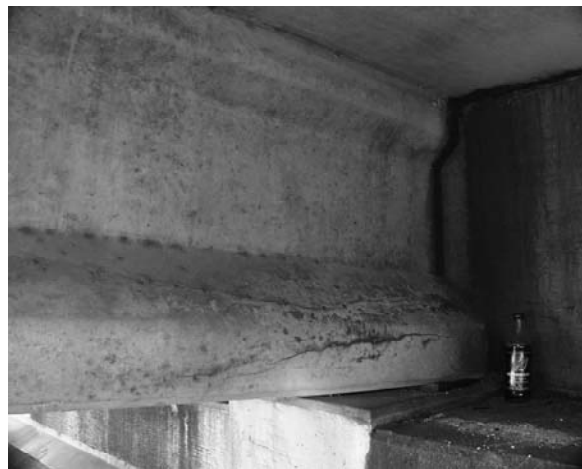
**Figure 7.6 View of greater damage to SW Girder 2**

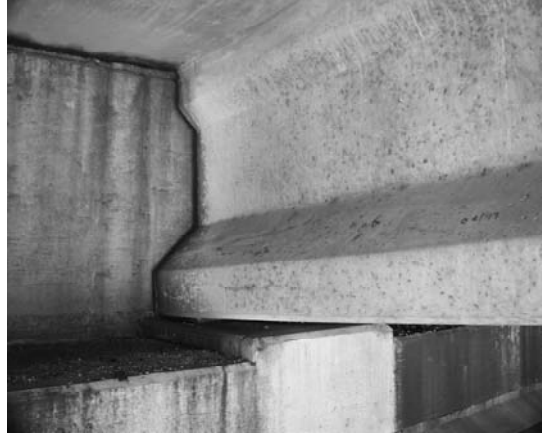
**Figure 7.7 View of lesser damage to SW Girder 3**

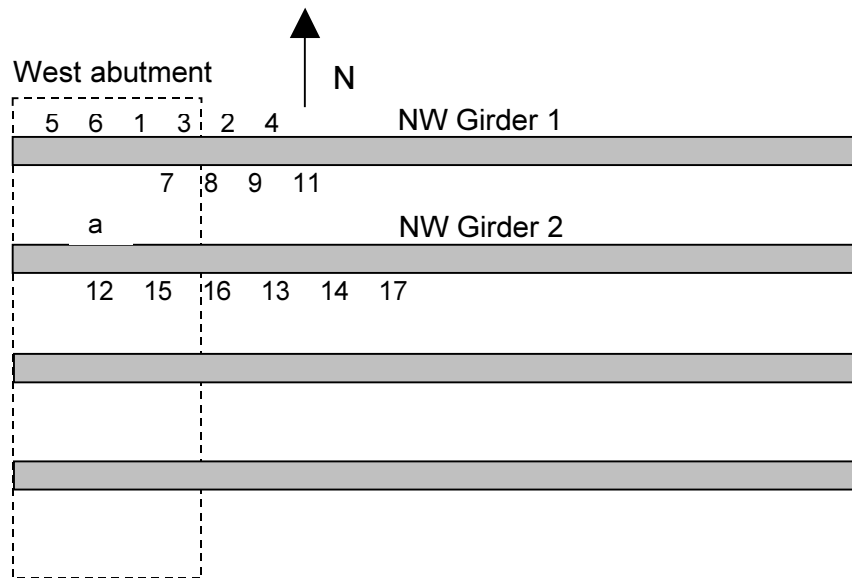
**Figure 7.8 Locations of measurement points on US-90 structure**

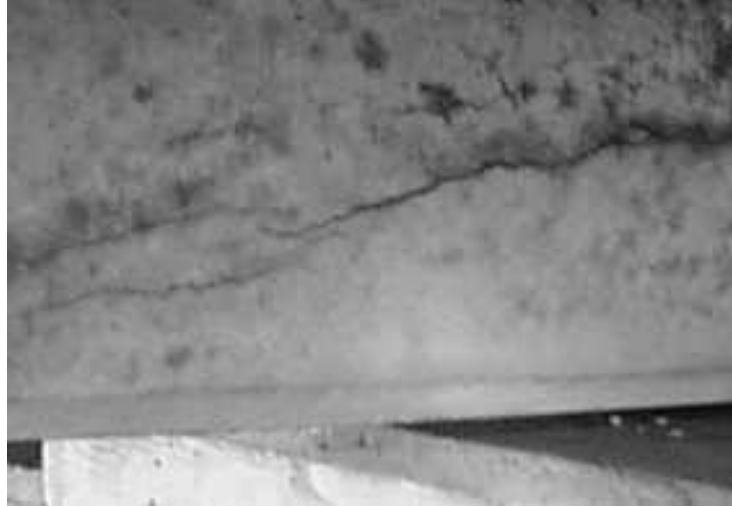
**Figure 7.9 New cracks extending past the end of the old crack**

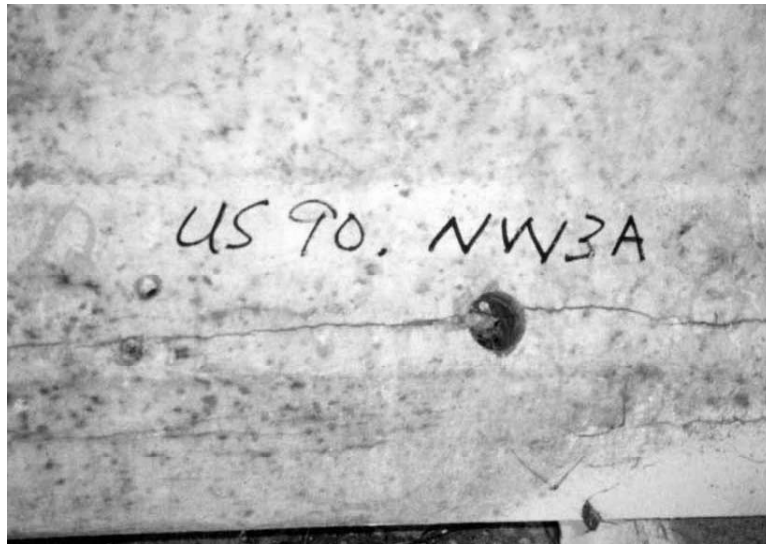
**Figure 7.10 Core removed from US-90 girder**

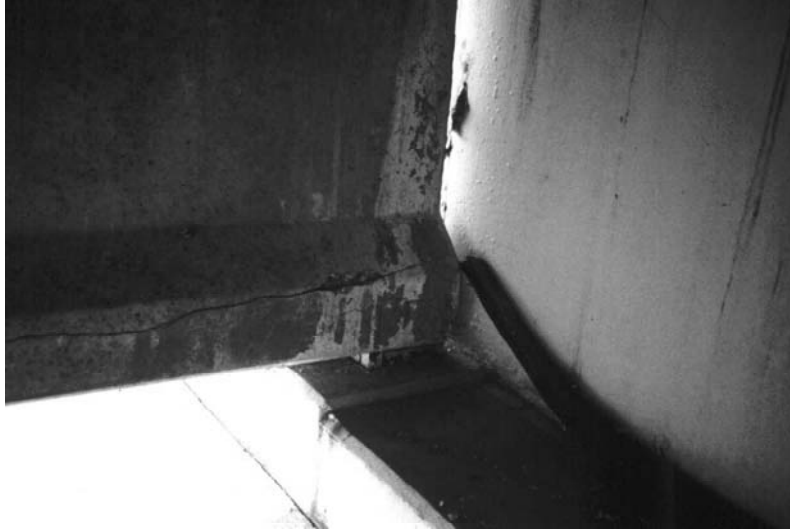
**Figure 7.11 Rubber seal dropped from joint above at west abutment of US-90 structure**

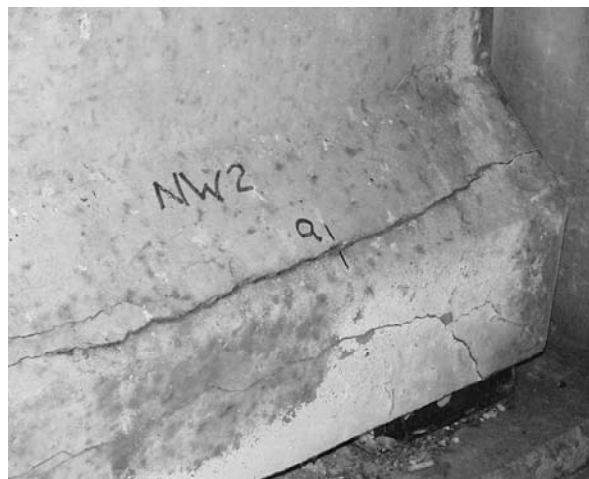
**Figure 7.12 Point “a” on NW Girder 2 of US-90 structure**

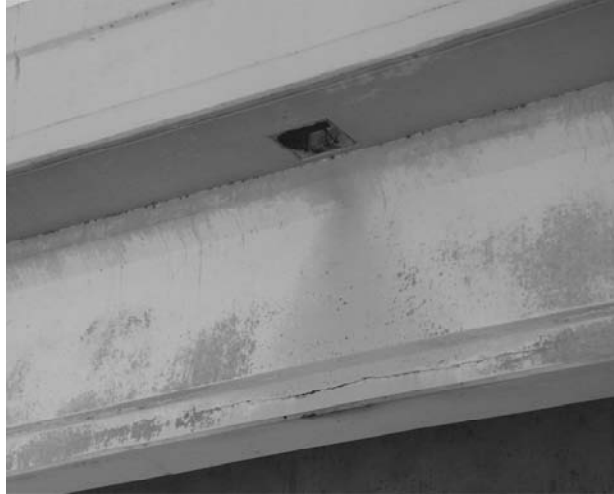
**Figure 7.13 Cracking on Face 5 of exterior girder under drain scupper**

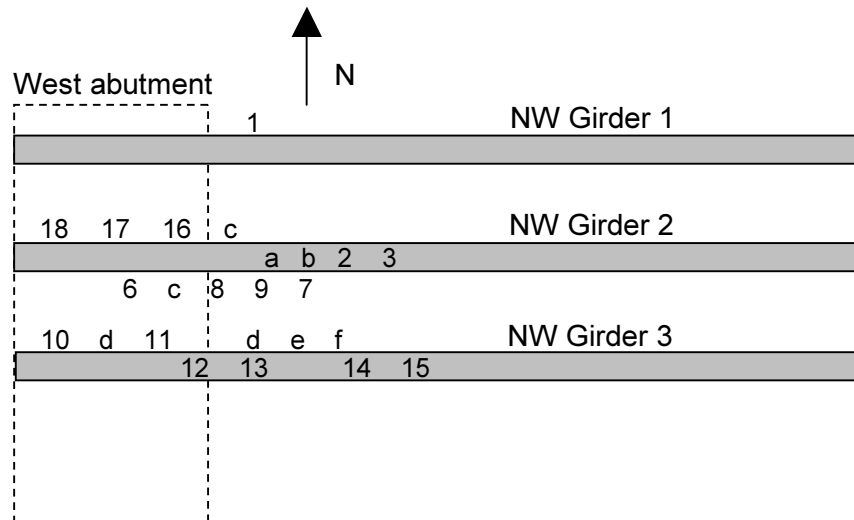
**Figure 7.14 Locations of measurement points on Robinson Road structure**
