**REVISED PRELIMINARY DRAFT**

6. Performing Organization Code	
7. Author(s) A. Boenig, L. Fúnez, R. E. Klingner, and T. J. Fowler				8. Performing Organization Report No. Research Report 1857-1

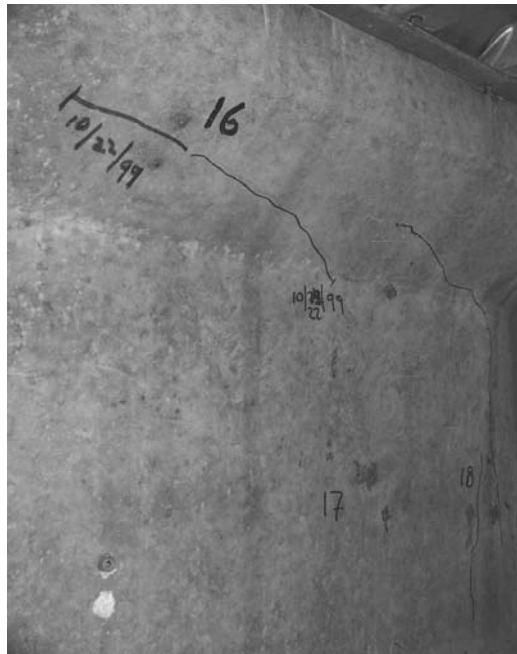
**Figure 7.15 Extension of crack on Face 2 of NW Girder 3 at Robinson Road structure**

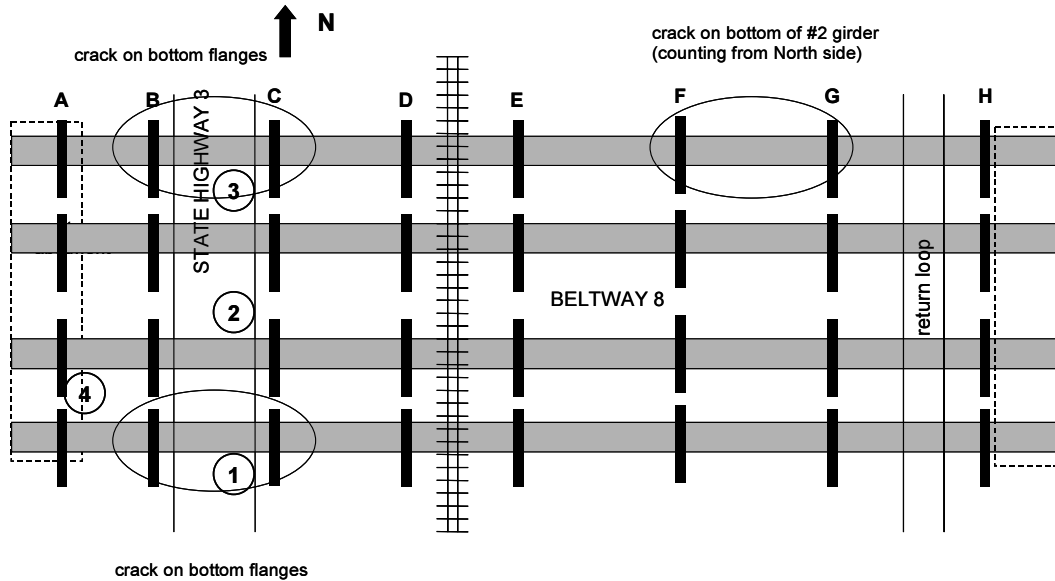
**Figure 7.16 Schematic of Beltway 8 structure**

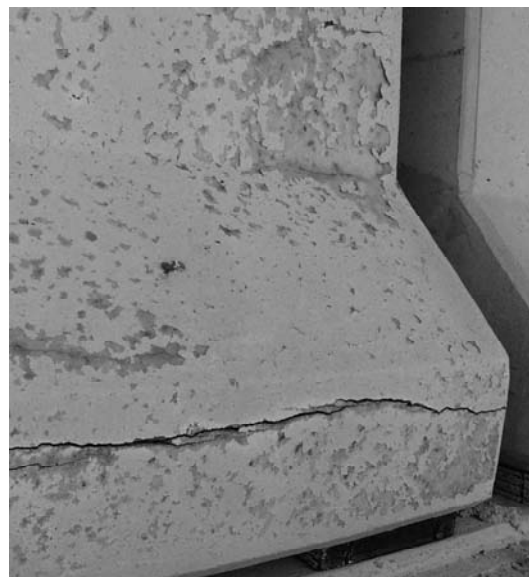
**Figure 7.17 Typical cracks on bottom flange of Beltway 8 girders**

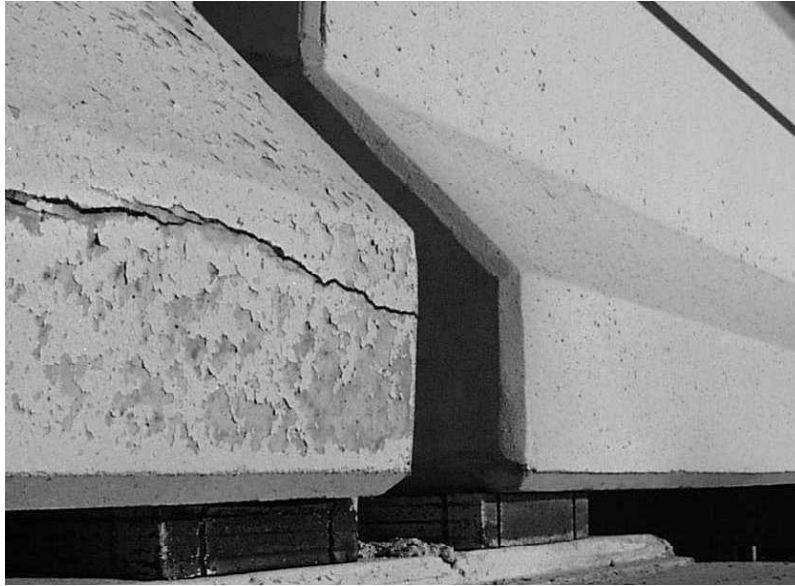
**Figure 7.18 Contrast between damaged and undamaged girders at Location 1**

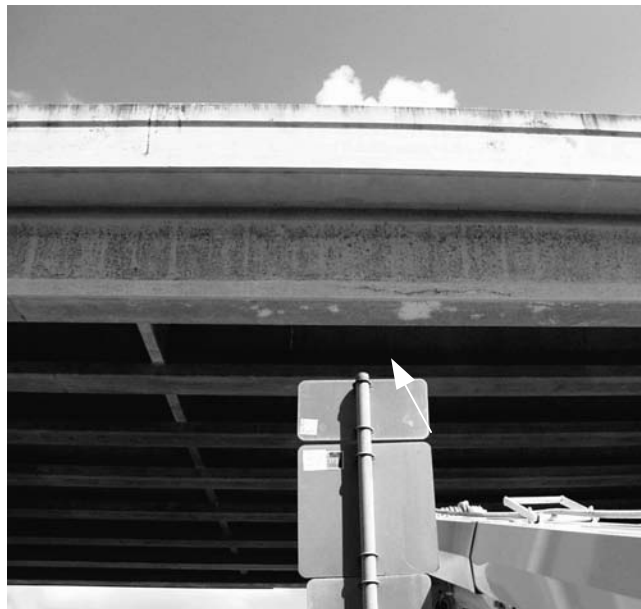
**Figure 7.19 Cracks on Face 5 of exterior girder at Location 2**

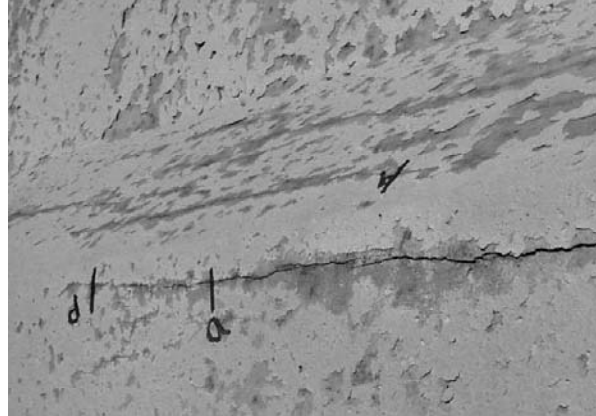
**Figure 7.20 Marked points at Location 1**

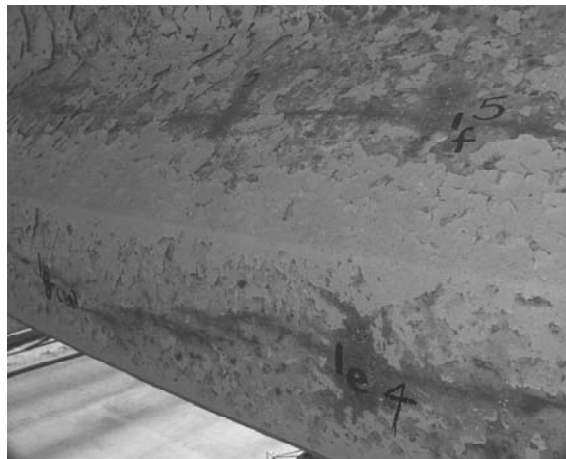
**Figure 7.21 Marked points on Faces 4 and 5 at Location 2**

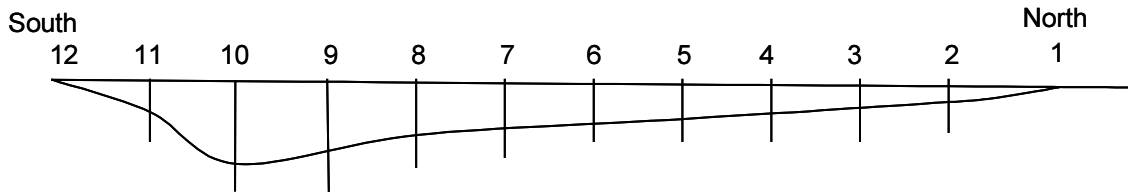
**Figure 7.22 East profile of FM 1979 structure**

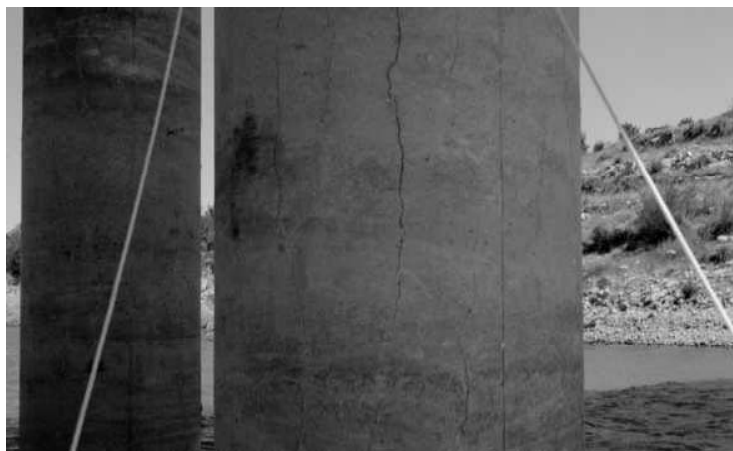
**Figure 7.24 Vertical cracking typical of Bents 9, 10 and 11 of FM 1979 structure (Bent 10)**

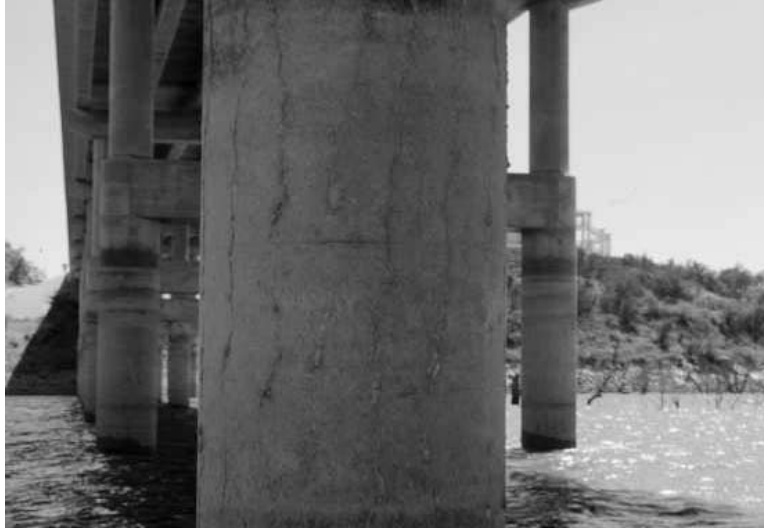
**Figure 7.25 Horizontal and vertical cracking in Bent 5 of FM 1979 structure**

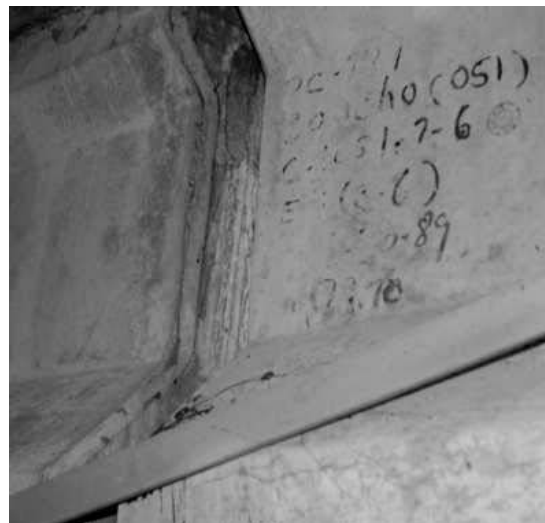
**Figure 7.26 Horizontal cracking on bottom flanges of outside girder ends (Bent 5)**

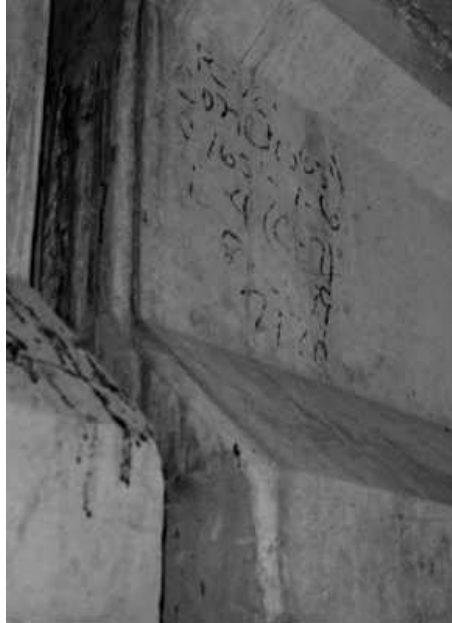
**Figure 7.27 Horizontal cracking at bottom flanges of inside girder ends (Bent 5)**

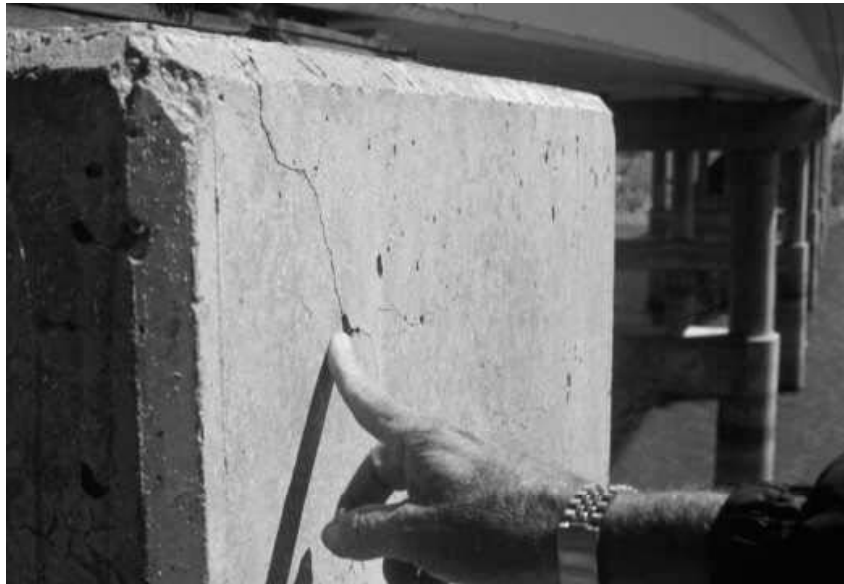
**Figure 7.28 Map cracking at ends of bent cap (Bent 5)**

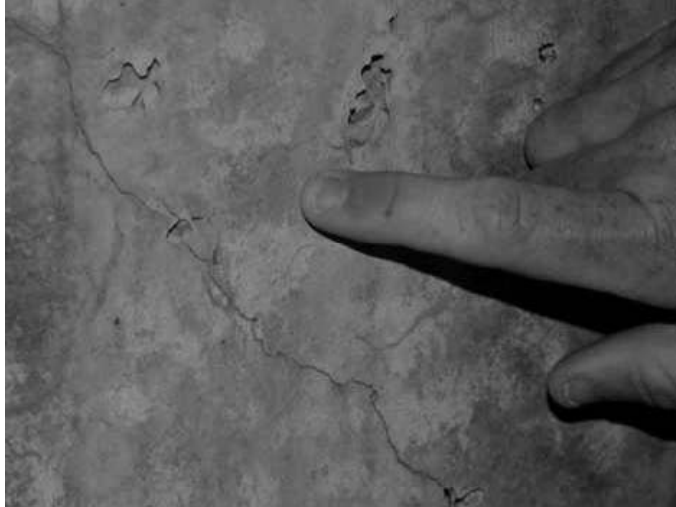
**Figure 7.29 Map cracking on side of bent cap (Bent 5)**

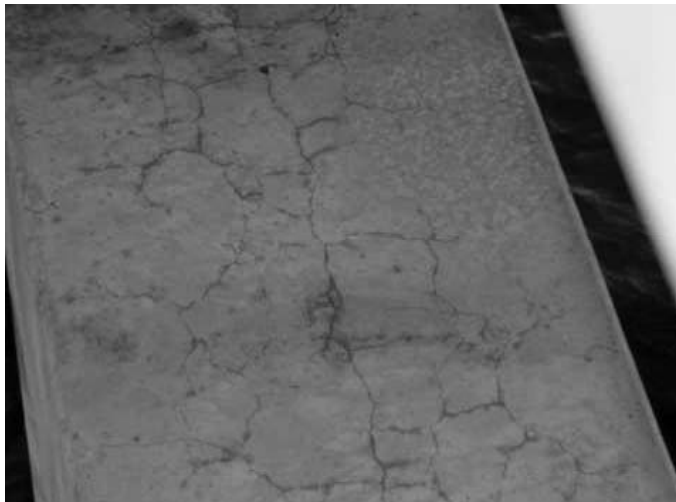
**Figure 7.30 Map cracking on upper surface of tie beam (Bent 5)**

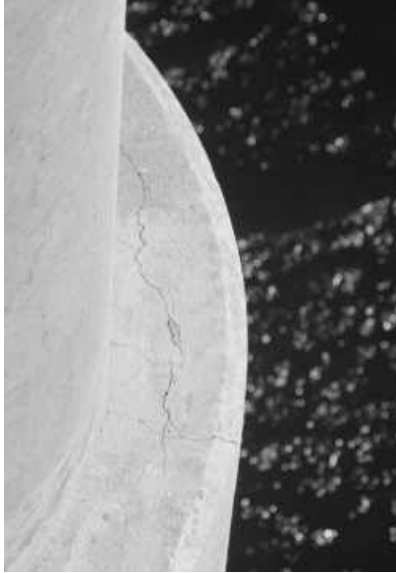
**Figure 7.31 Propagation of vertical cracks in lower column to top of tie beam (Bent 5)**

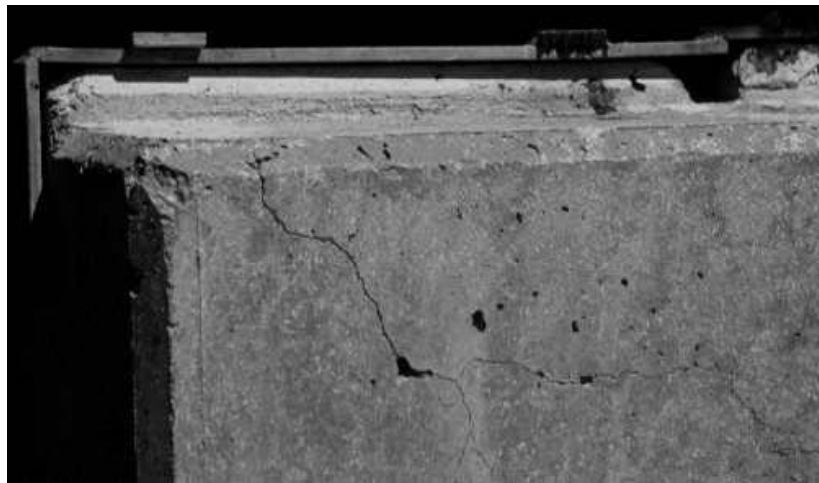
**Figure 7.32 Map cracking at ends of bent cap (Bent 9)**

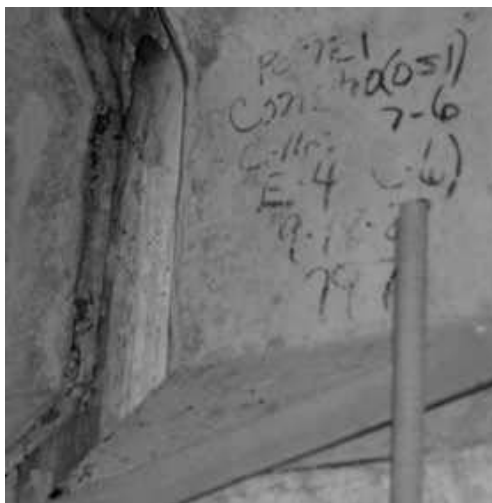
**Figure 7.33 Horizontal and map cracking at girder ends (Bent 9)**

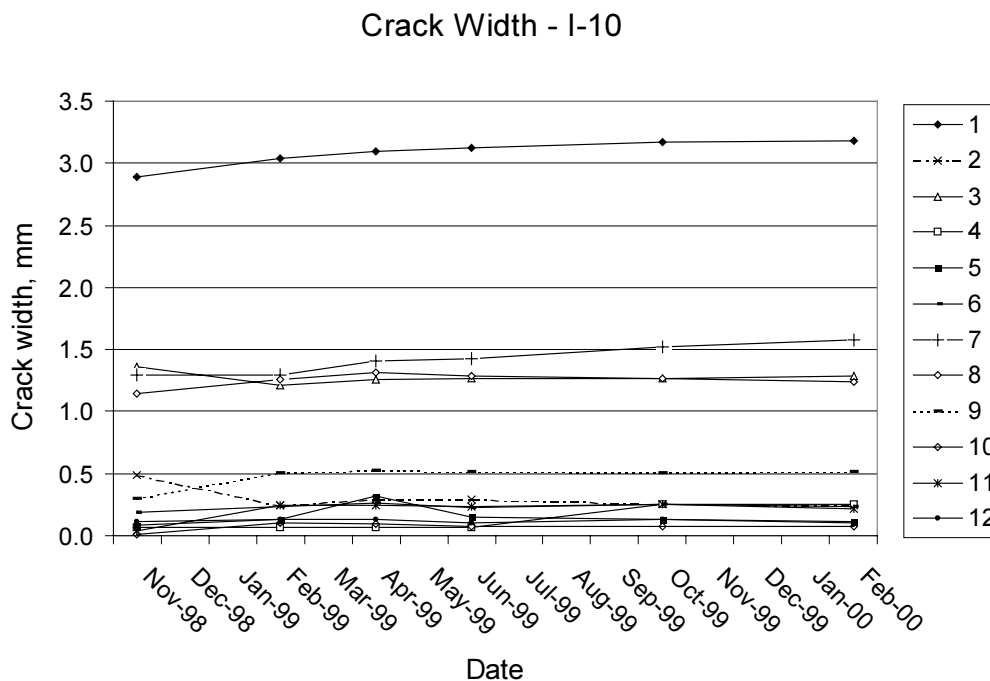
**Figure 7.34 Crack width over time for I-10 structure**

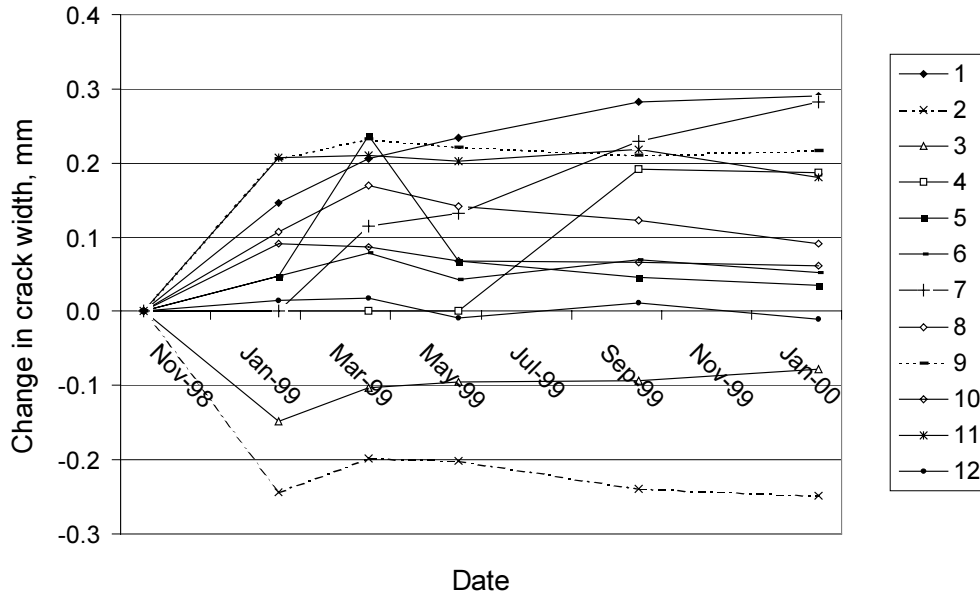
Figure 7.35 Change in crack width over time for I-10 structure

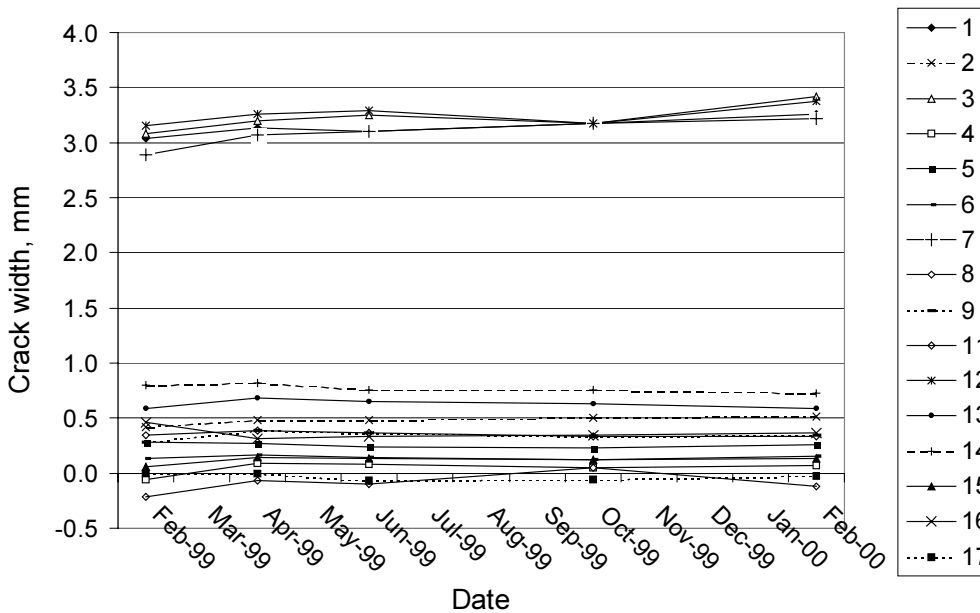
Figure 7.36 Crack width over time for US-90 structure

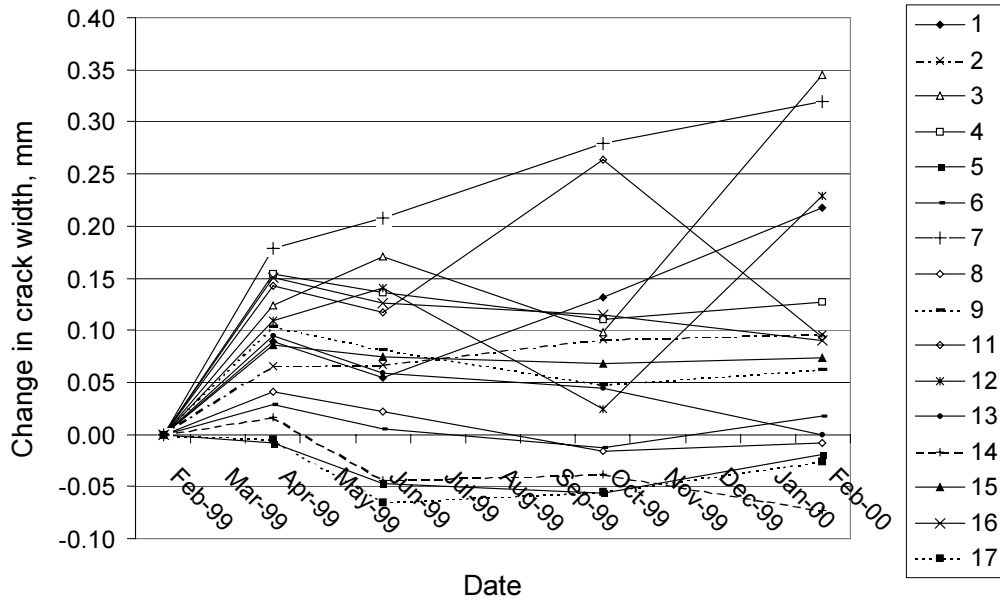
Figure 7.37 Change in crack width over time for US-90 structure

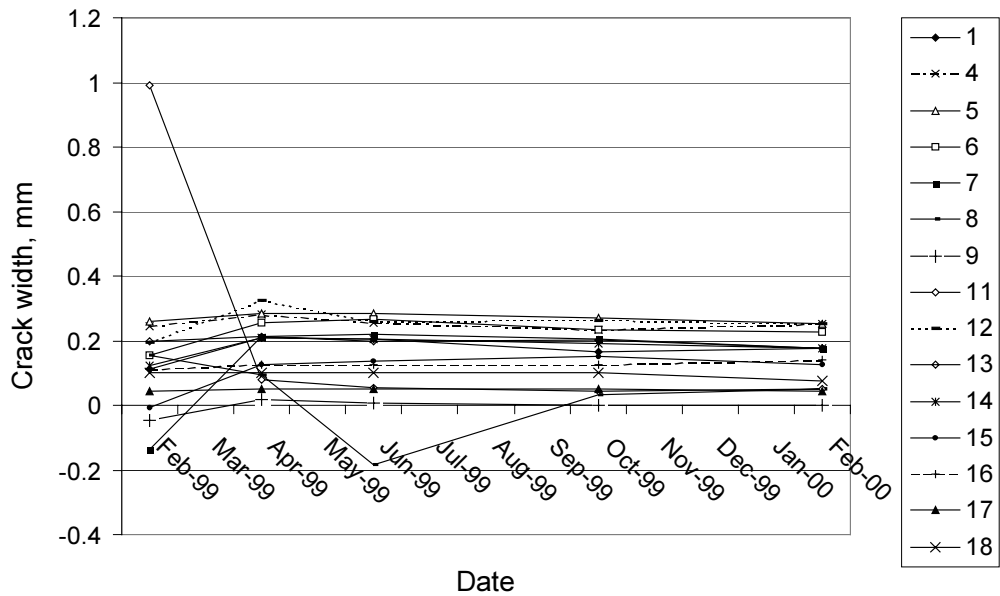
Figure 7.38 Crack width over time for Robinson Road structure

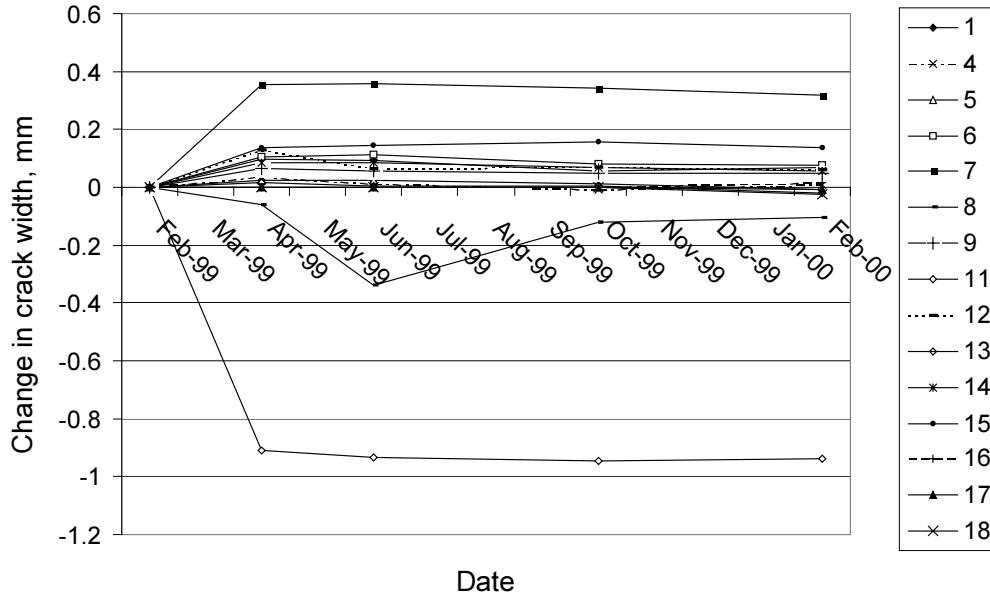
Figure 7.39 Change in crack width over time for Robinson Road structure

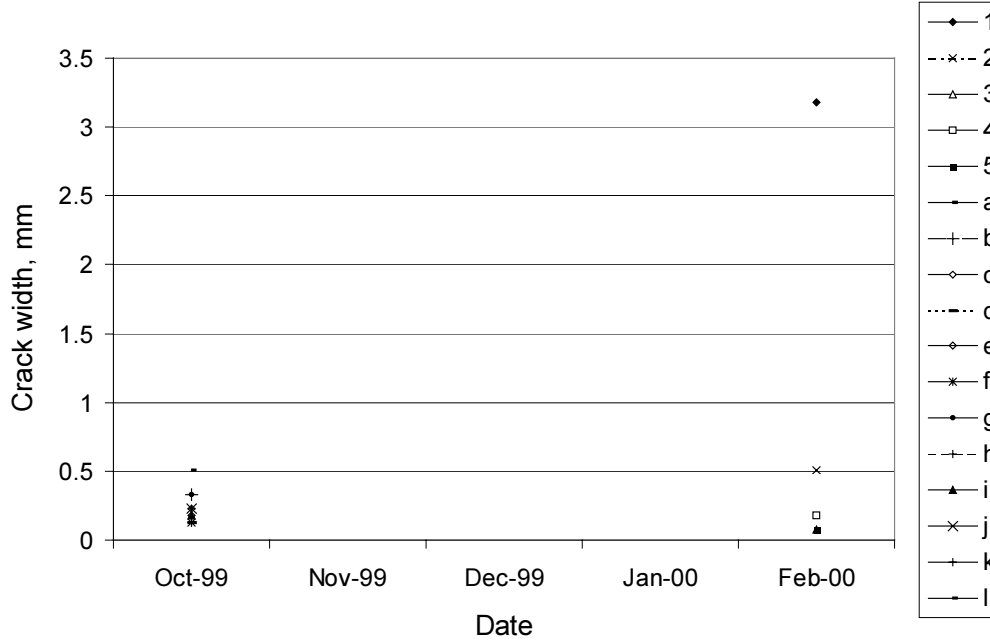
Figure 7.40 Crack width over time for Beltway 8 structure

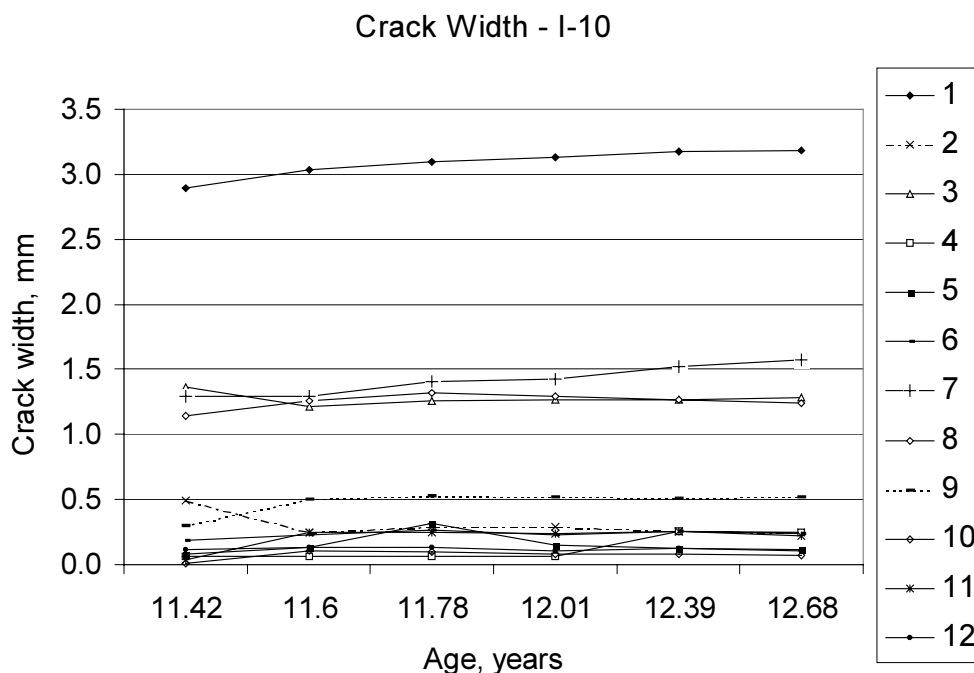
**Figure 8.1 Crack width versus age of beam for I-10 structure**

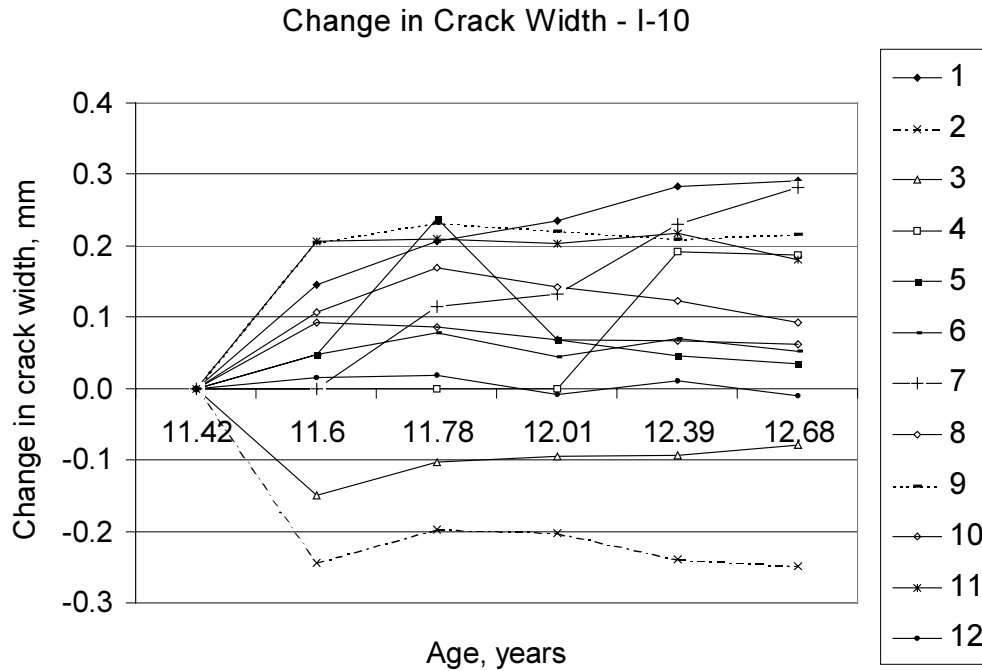
**Figure 8.2** Change in crack width versus age of beam for I-10 structure

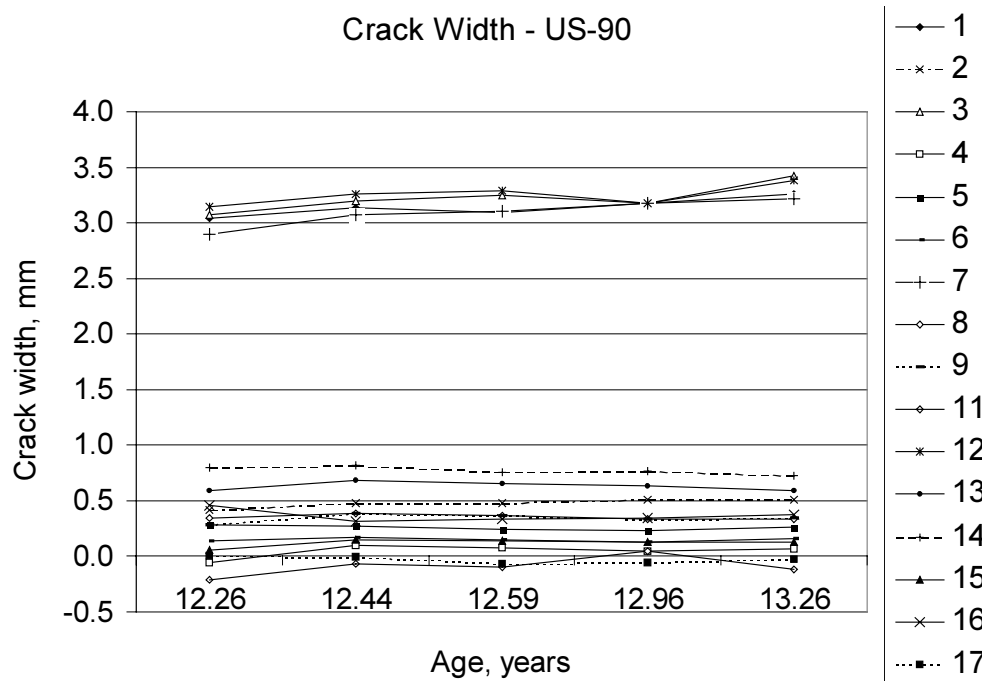
**Figure 8.3** Crack width versus age of beam for US-90 structure

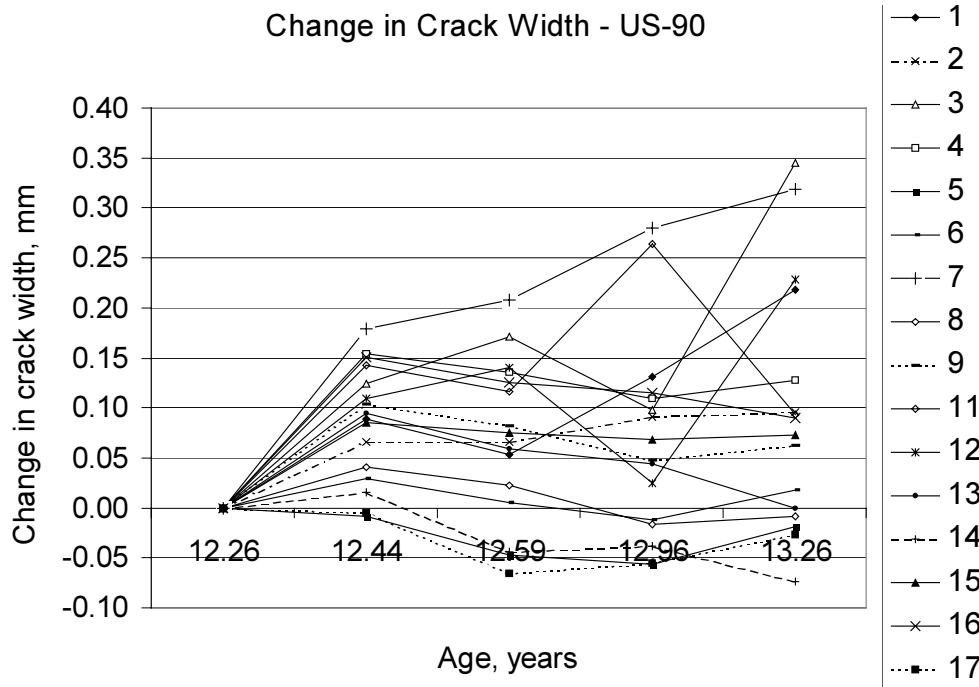
**Figure 8.4 Change in crack width versus age of beam for US-90 structure**

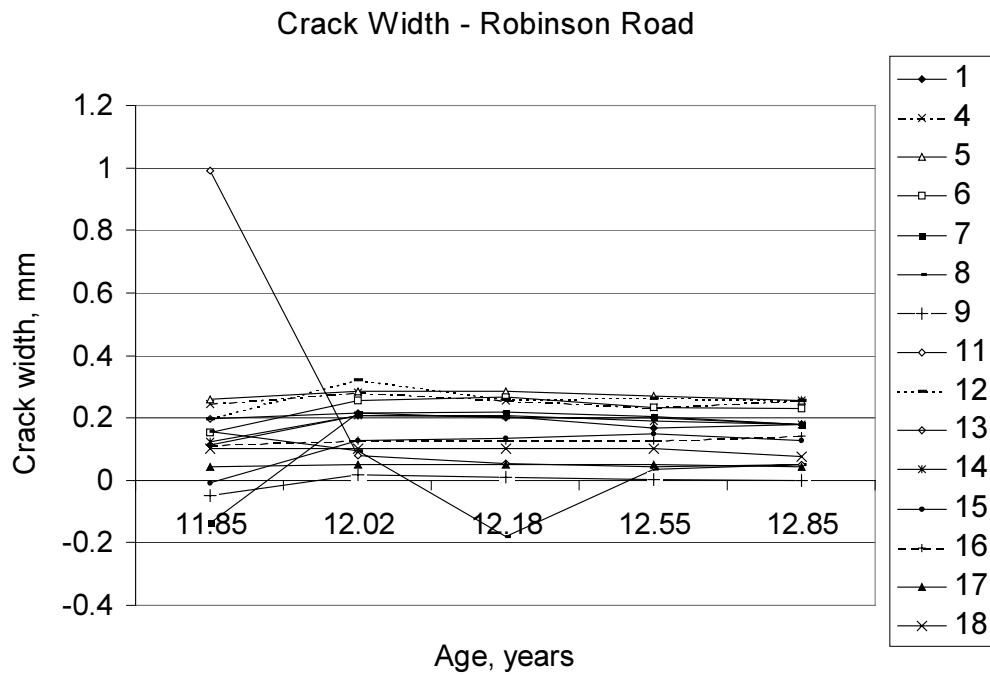
**Figure 8.5 Crack width versus age of beam for Robinson Road structure**

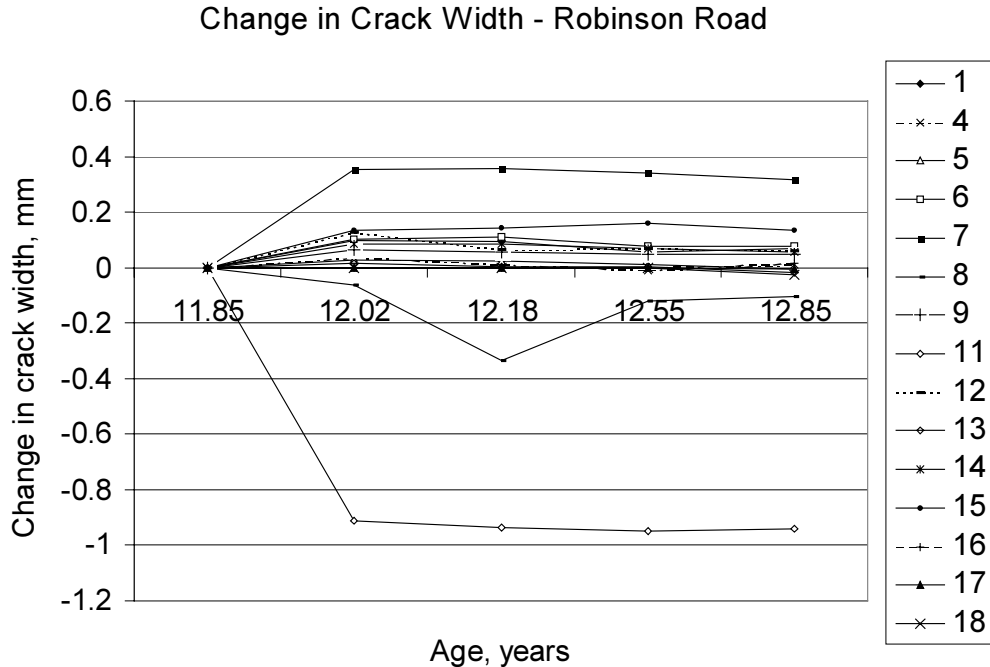
**Figure 8.6 Change in crack width versus age of beam for Robinson Road structure**

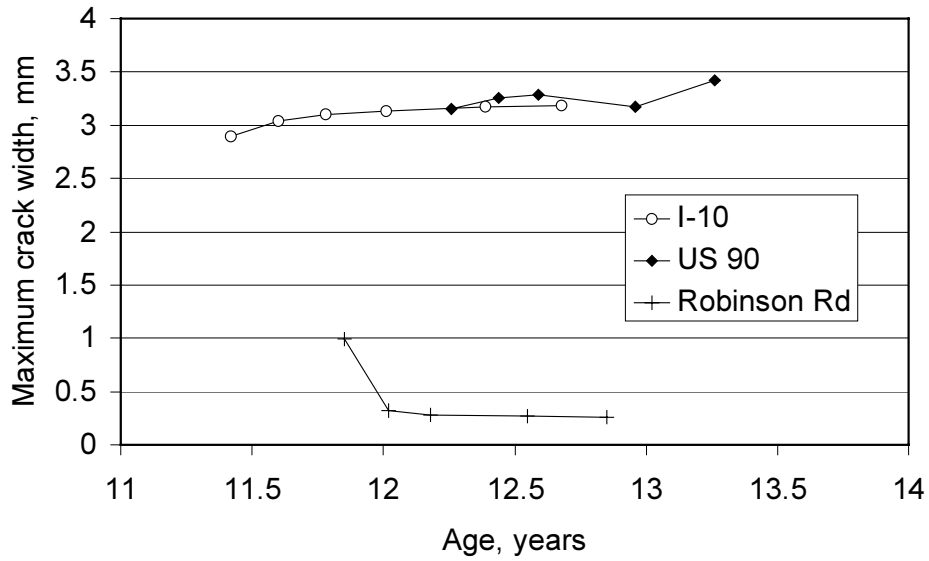
Figure 8.7 Maximum crack width of field girders

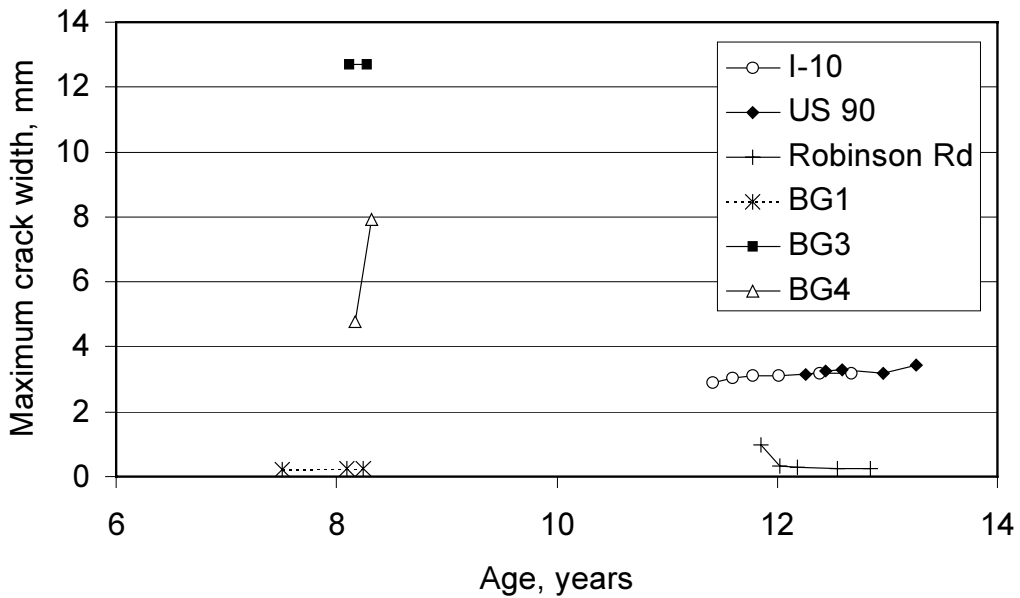
Figure 8.8 Maximum crack width of box and field girders

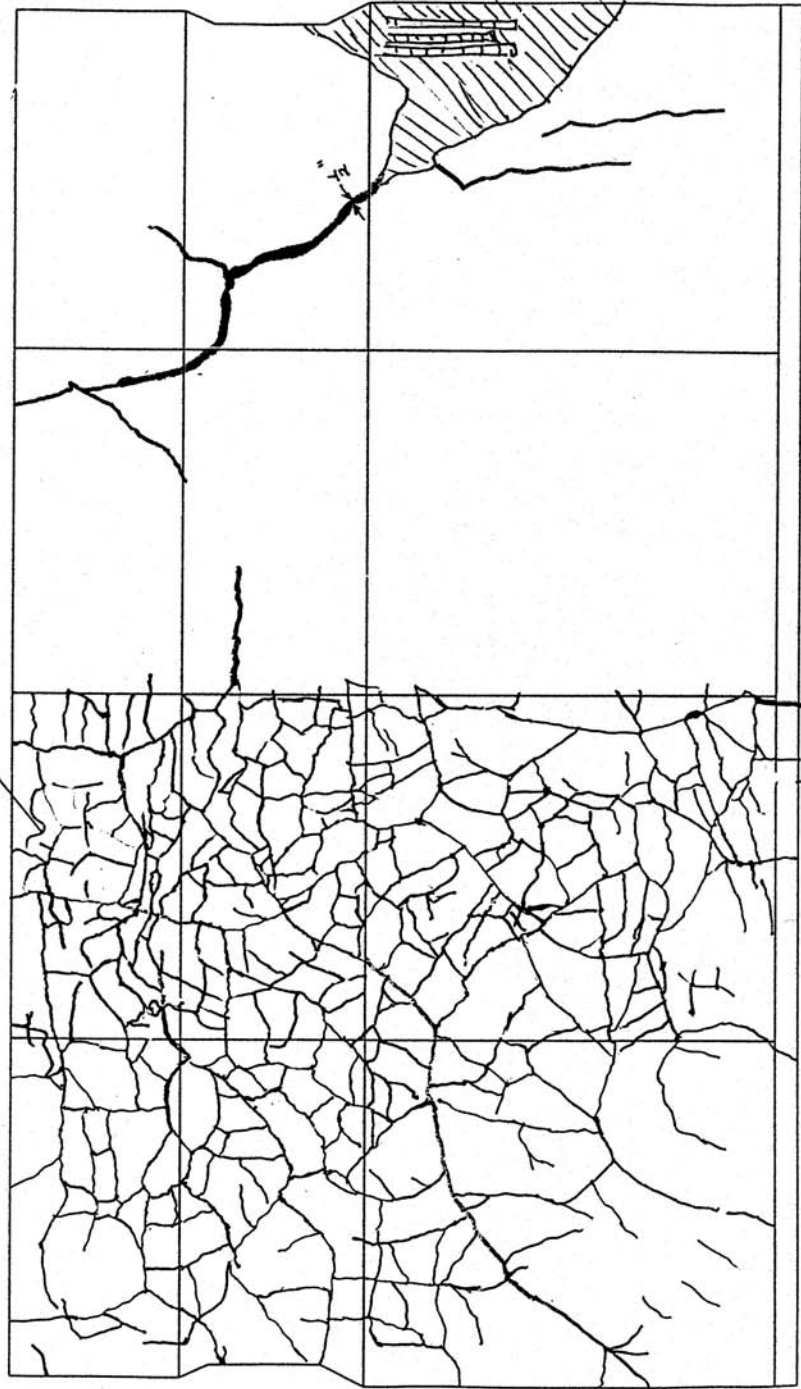
Smaller cracks typical  
of those on entire face

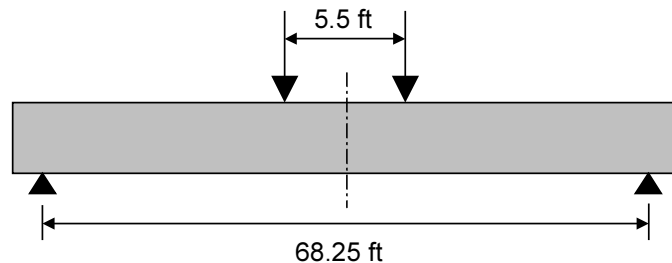
Figure D.2 Simple span of flexure-dominated specimens

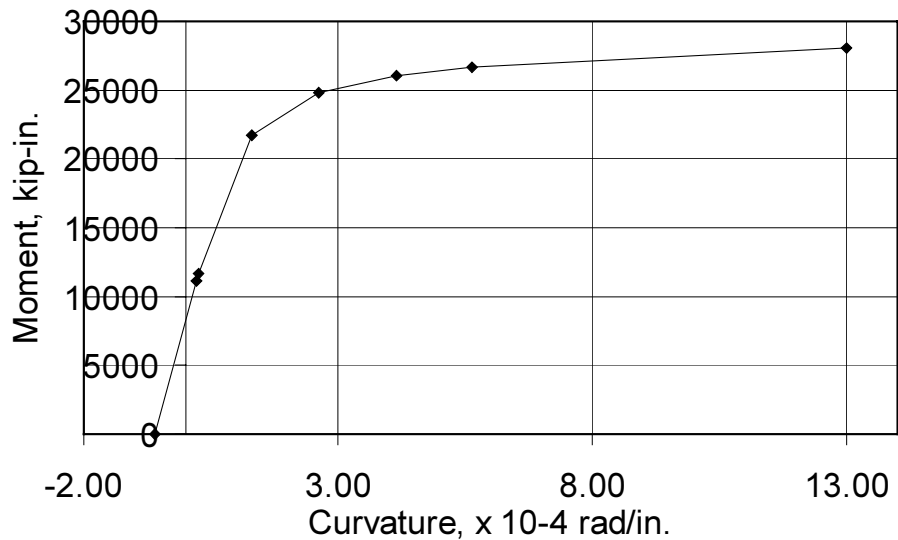
**Figure D.4 Moment-curvature of box girders**

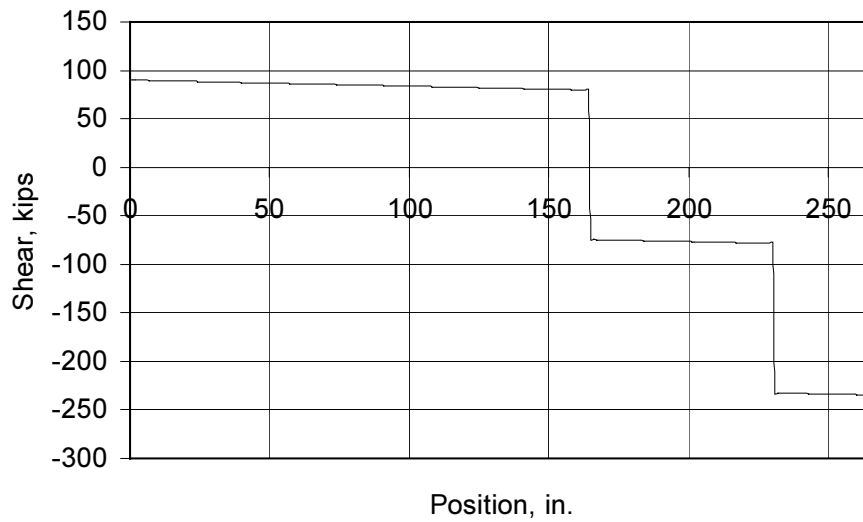
Figure D.19 Shear diagram for Case 1 loading
