Copyright
by
Anna Boenig
2000

**Bridges with Premature Concrete Deterioration:
Field Observations and Large-Scale Testing**

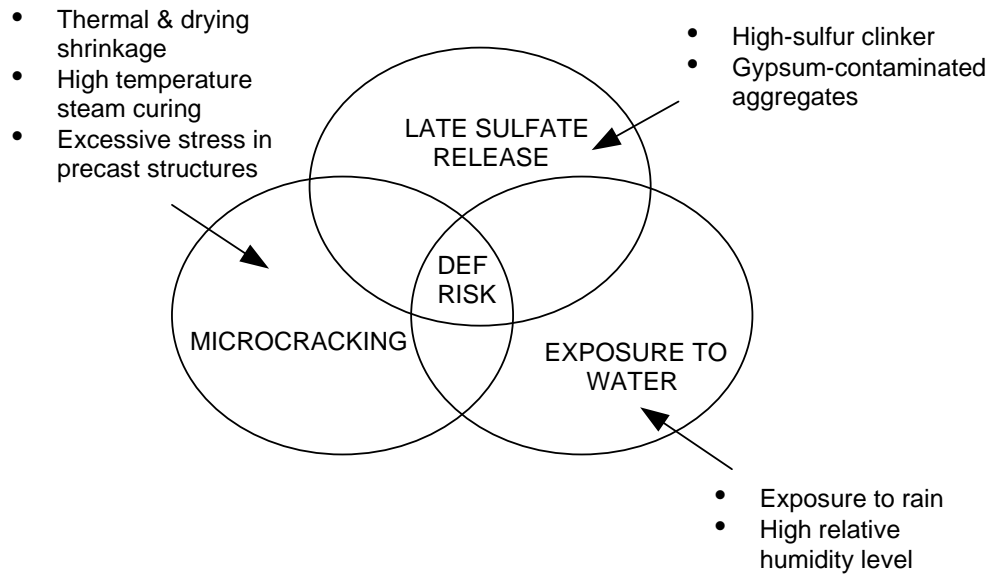
Figure 2.1 A holistic model showing DEF-damage as a function of late sulfate release, microcracking and exposure to water, (Colleparidi 1999)

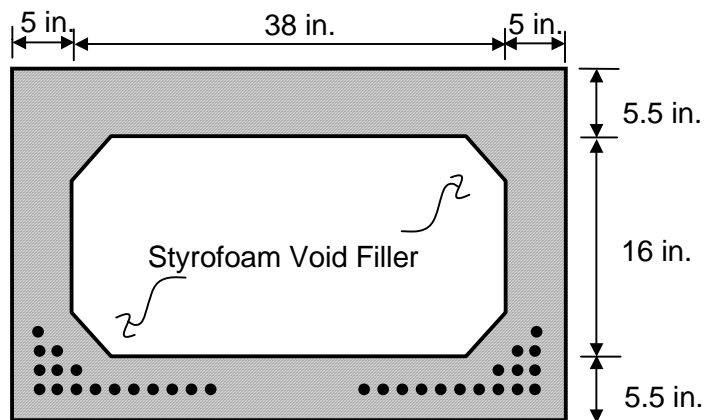
Figure 3.1 Cross-section of box girders from Heldenfels Brothers, Inc. (San Marcos)

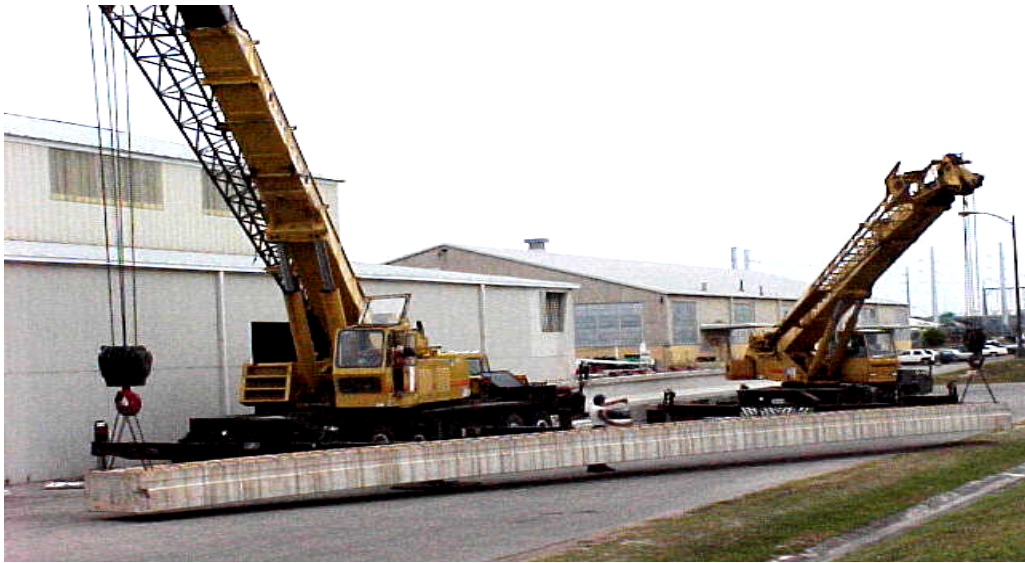
Figure 3.2 Maneuvering BG1 into FSEL

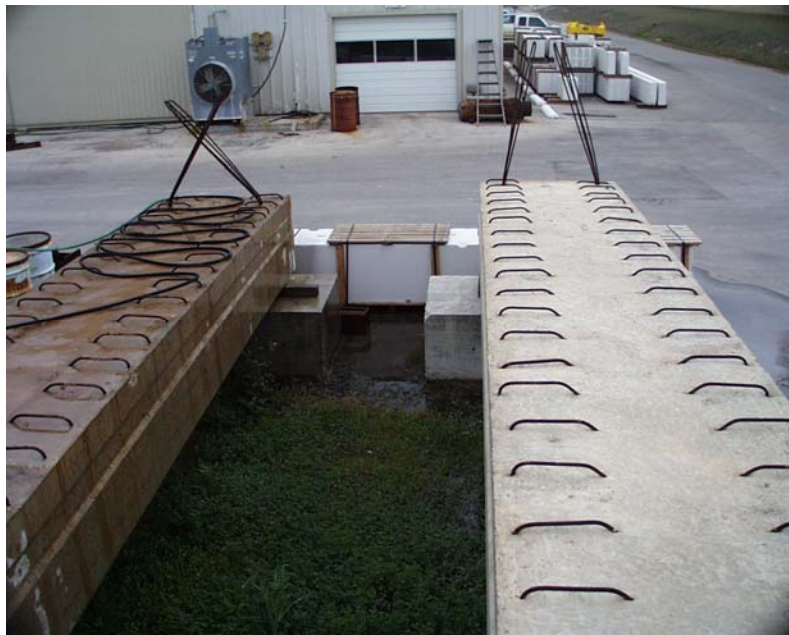
Figure 3.3 BG3 and BG4 (wetted) outside of FSEL

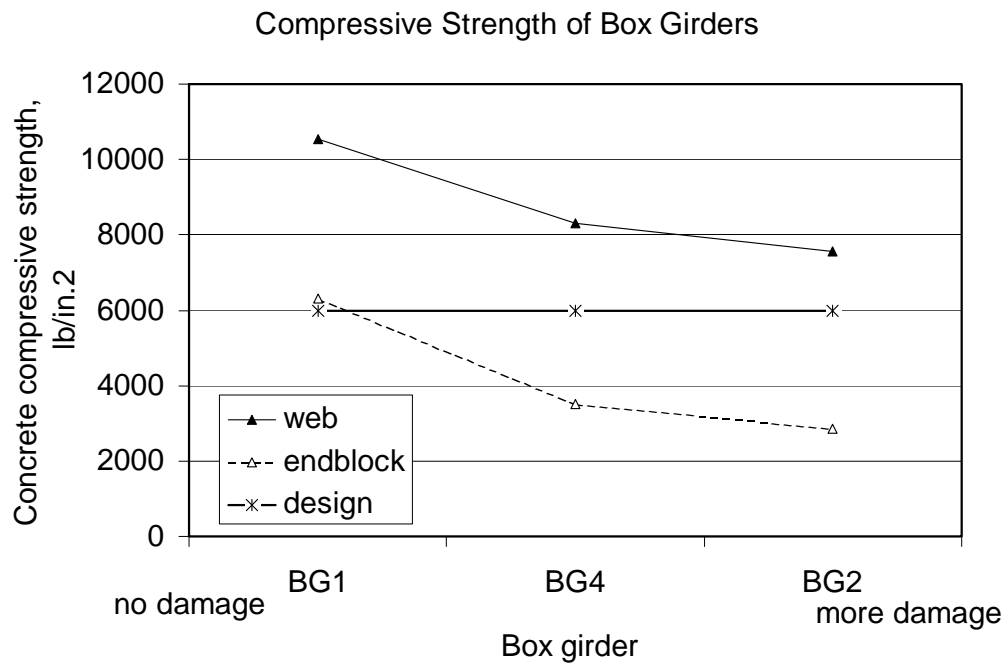
Figure 5.4 Concrete compressive strength of cores from box girders

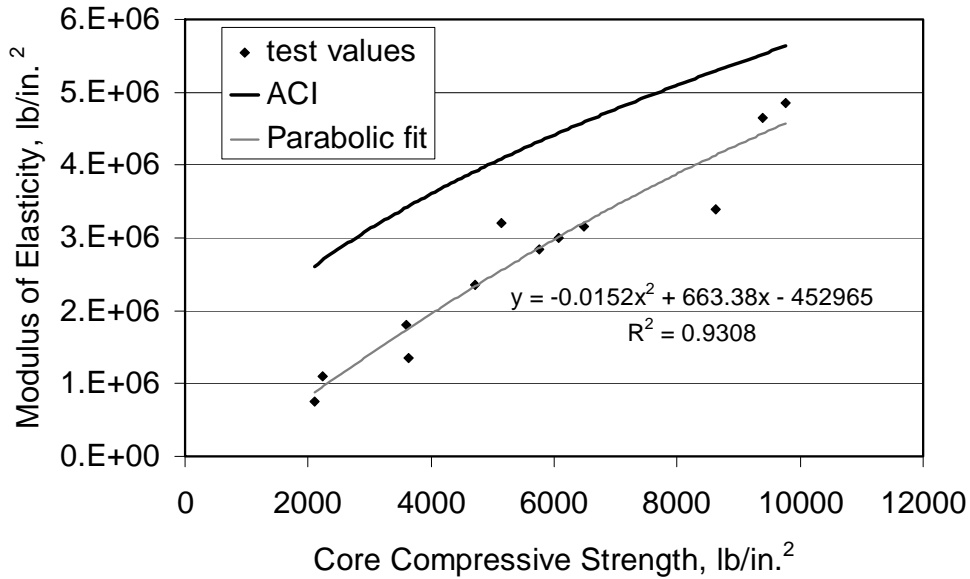
Figure 5.6 Modulus of elasticity versus concrete compressive strength of cores from box girders

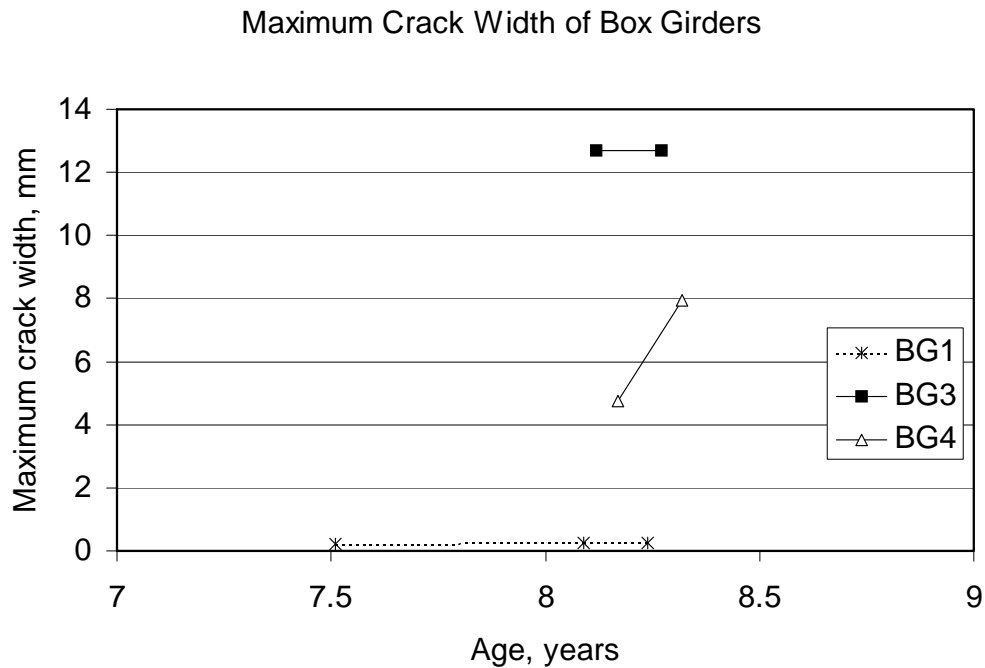
Figure 5.7 Maximum crack width versus age for box girders

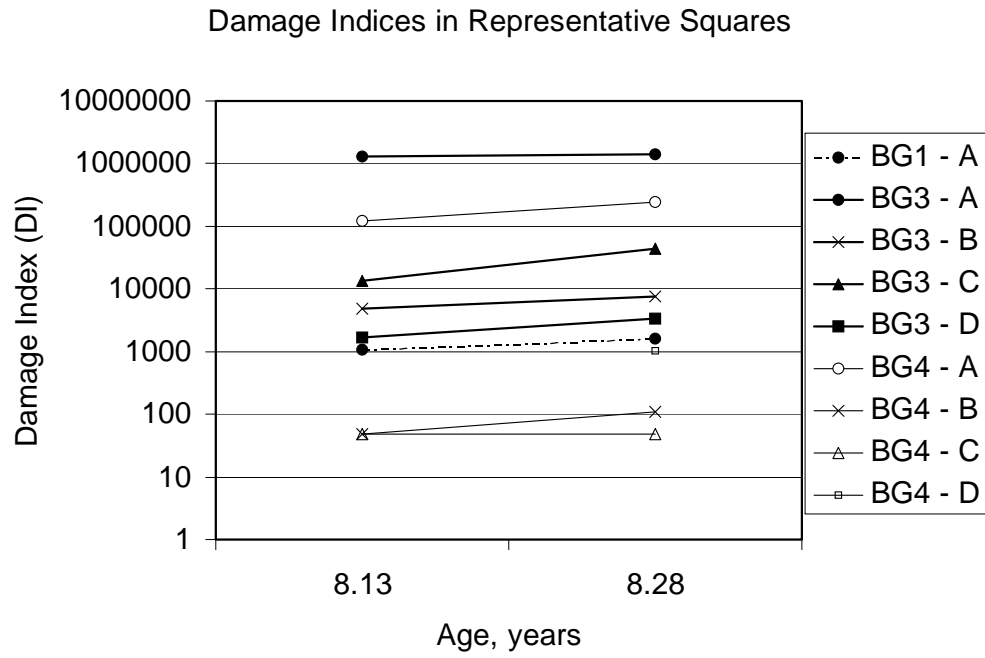
Figure 5.8 Damage Indices versus age for representative squares

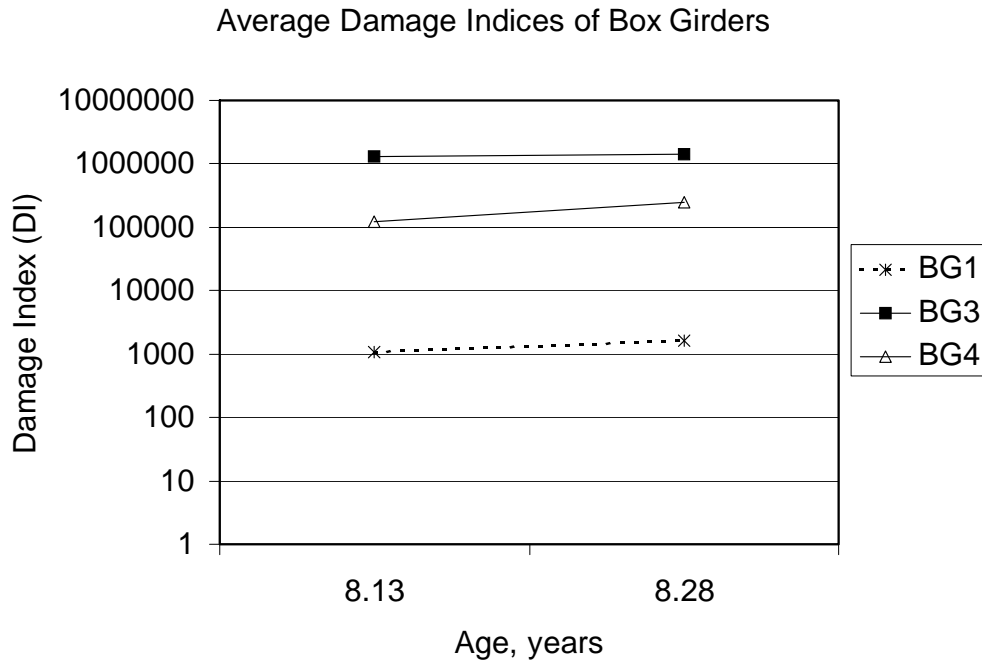
Figure 5.9 Average damage indices versus age for box girders

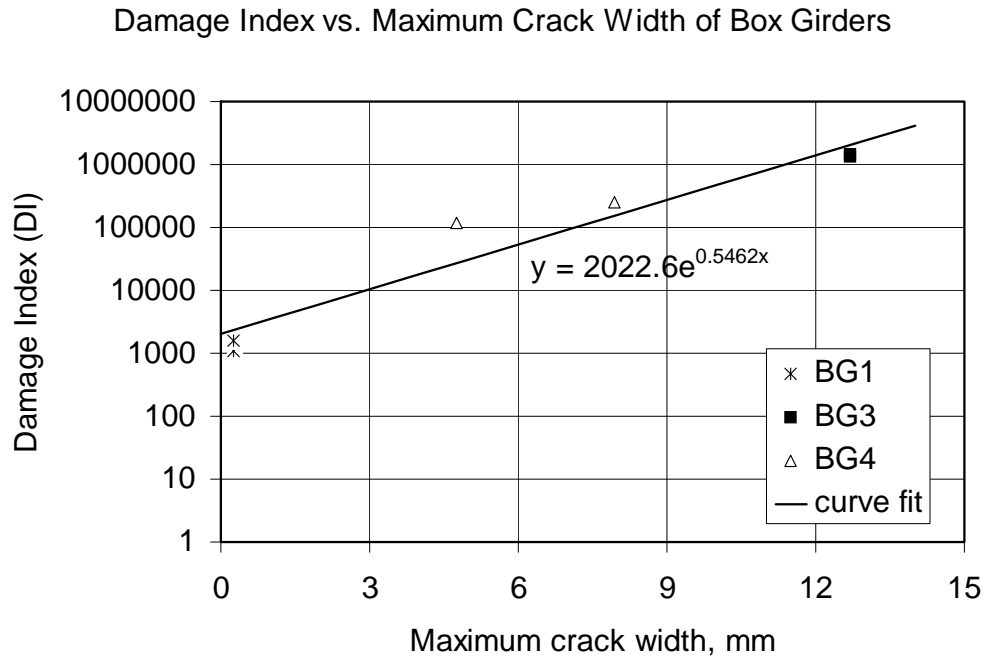
Figure 5.10 Damage index versus maximum crack width of box girders

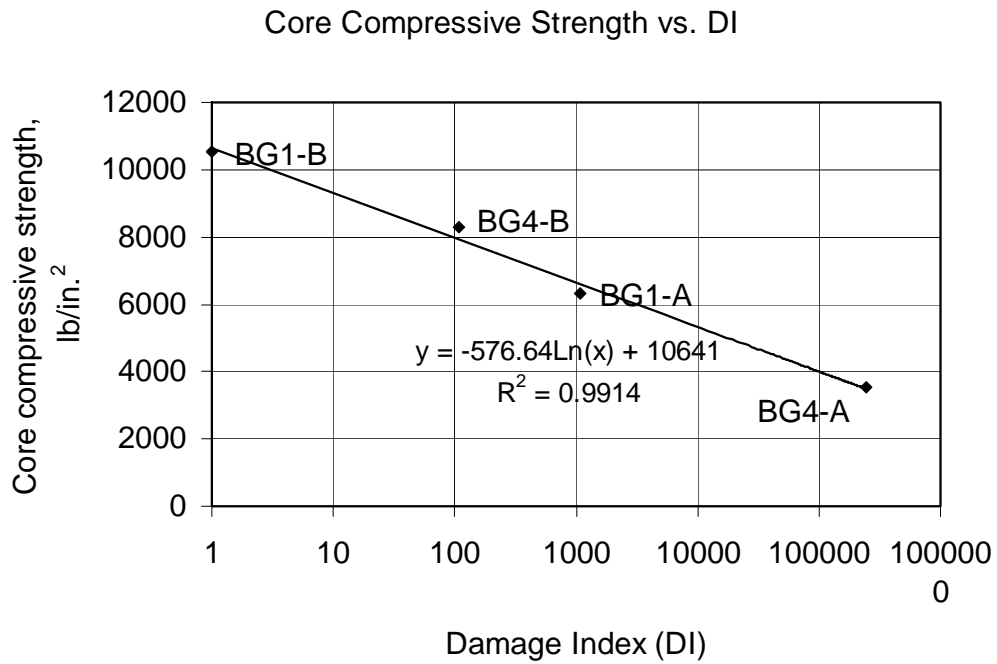
Figure 5.11 Concrete compressive strength of cores from box girders versus damage index

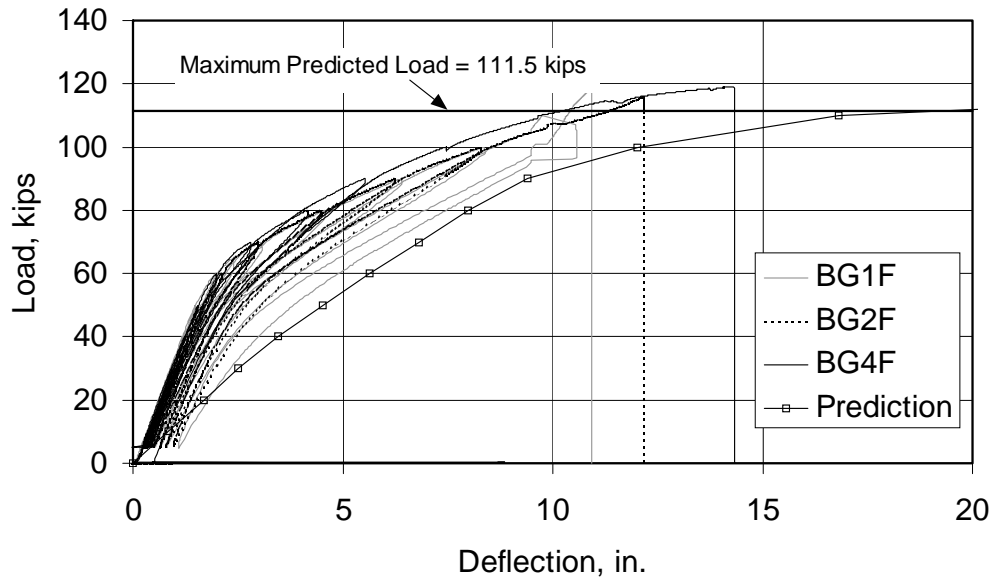
Figure 5.12 Load-deflection curves and predicted behavior for flexure-dominated specimens

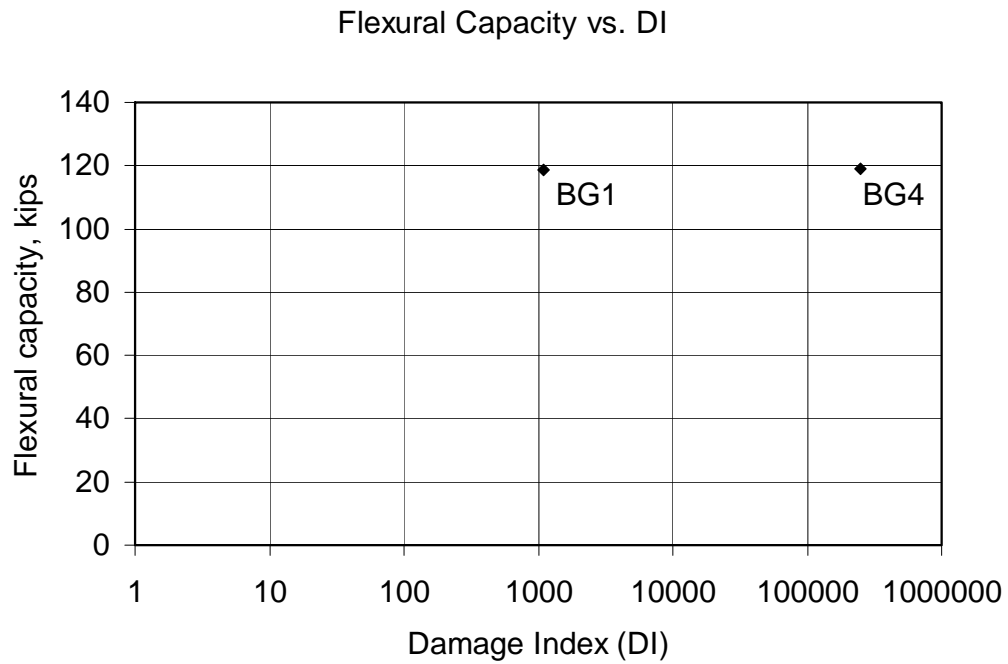
Figure 5.13 Flexural capacity versus damage index

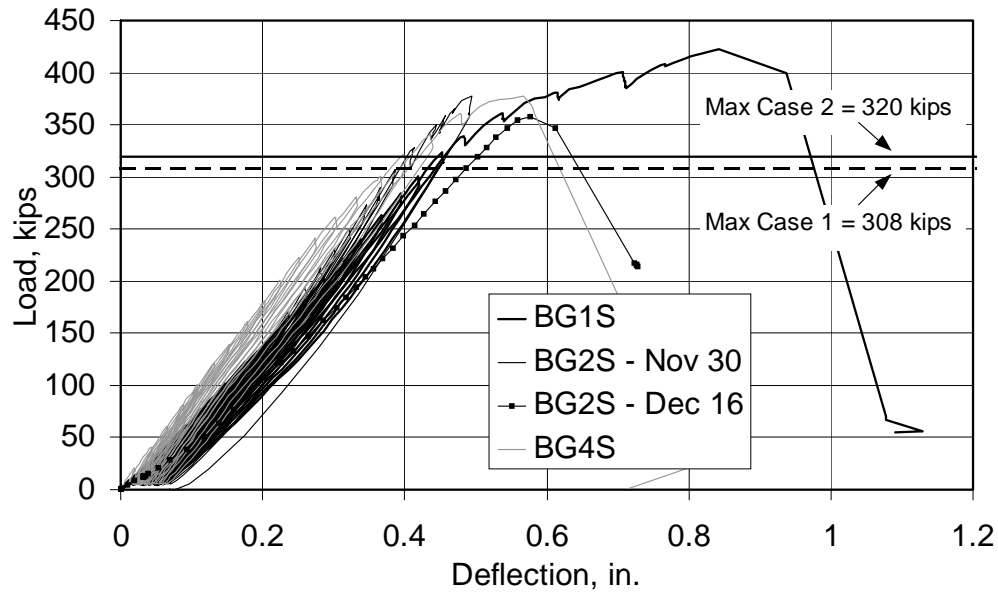
Figure 5.14 Load-deflection curves and predicted maximum loads for shear-dominated specimens

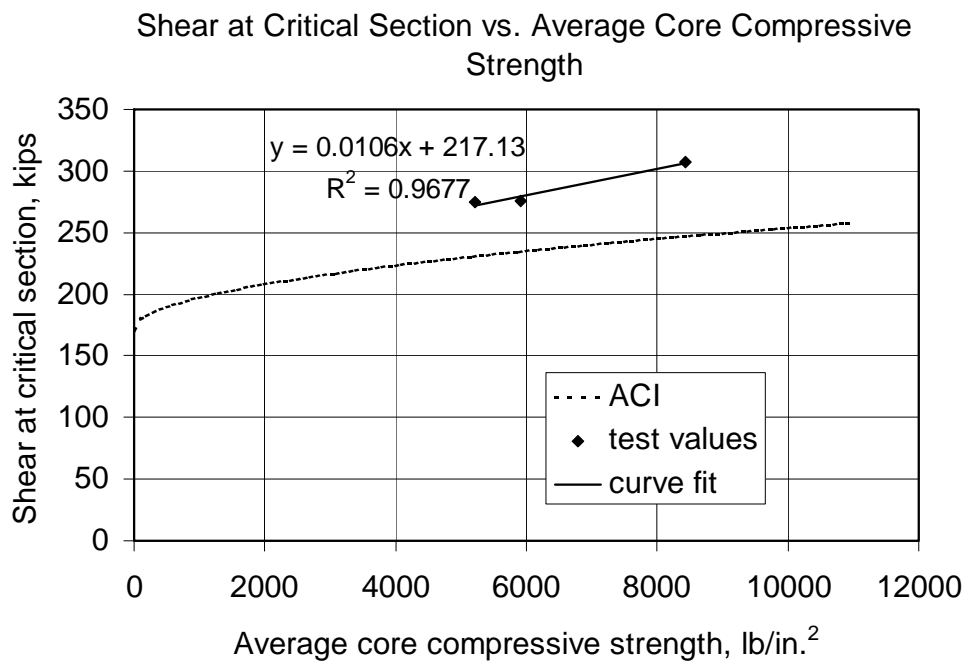
Figure 5.15 Shear strength versus average core compressive strength

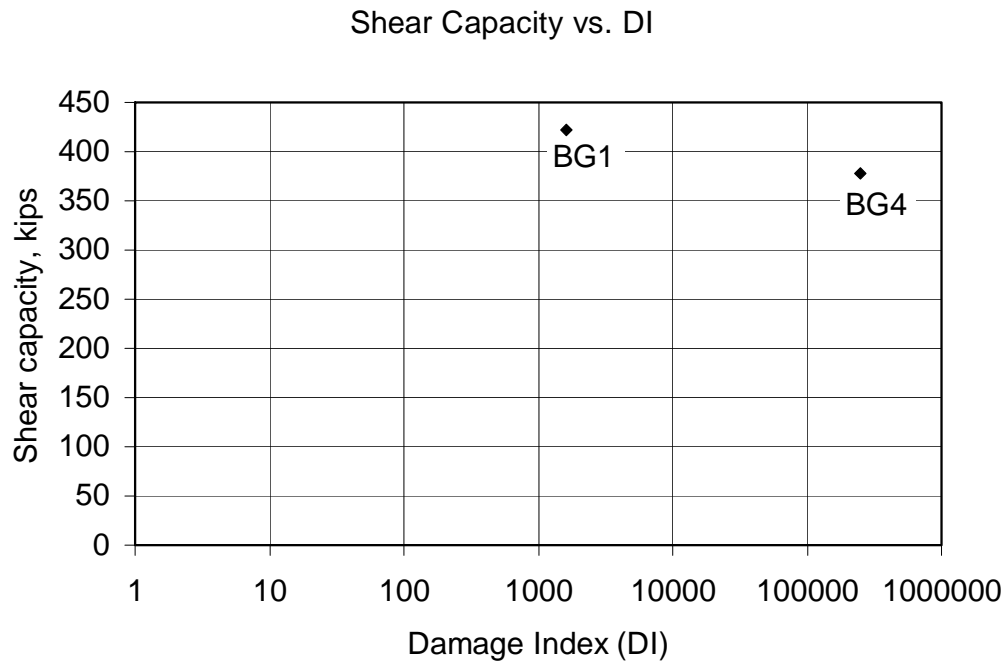
Figure 5.16 Shear capacity versus damage index

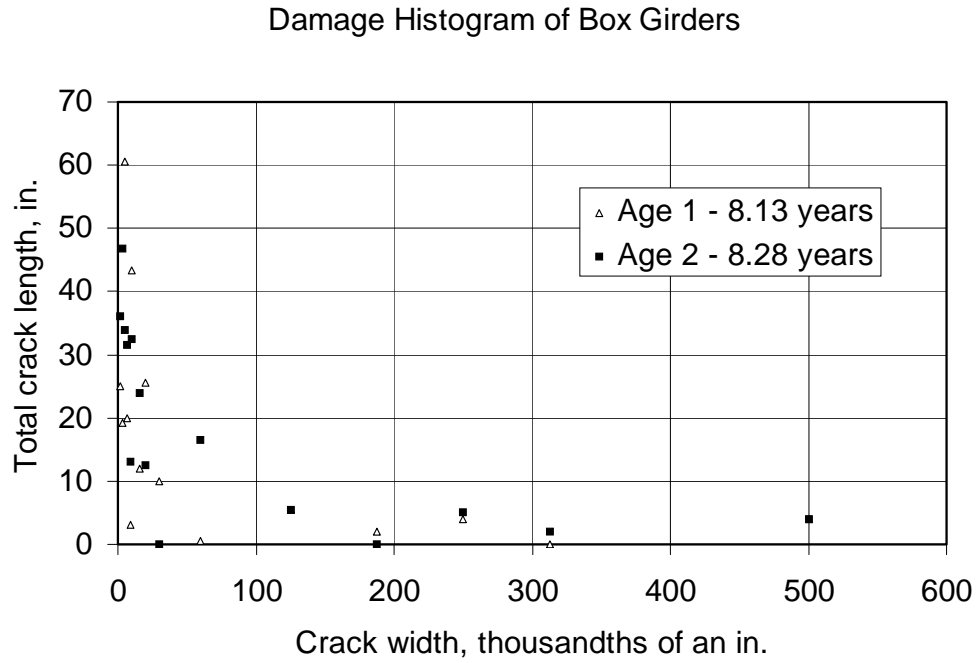
Figure 5.17 Damage histogram of box girders (US Customary units)

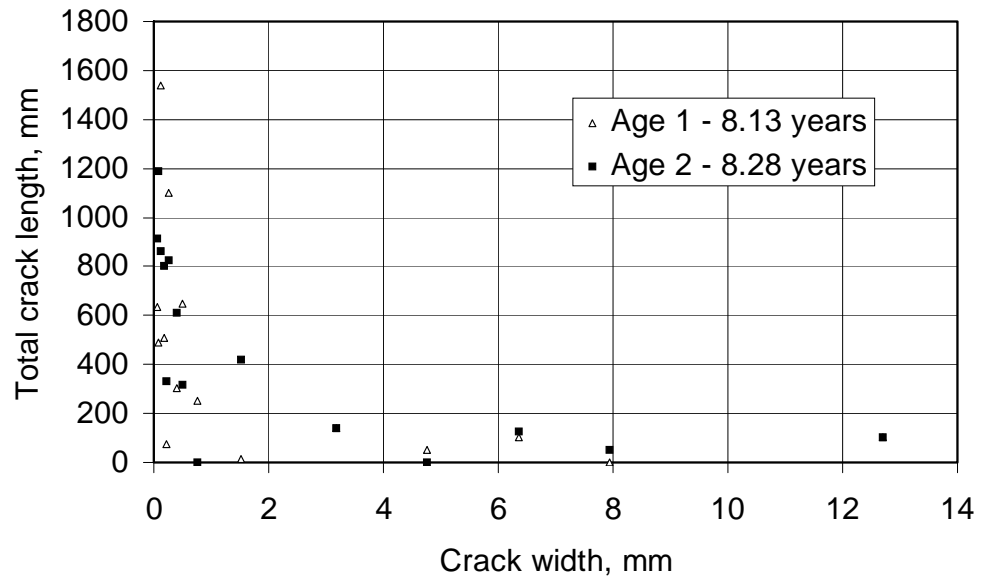
Figure 5.18 Damage histogram of box girders (SI units)

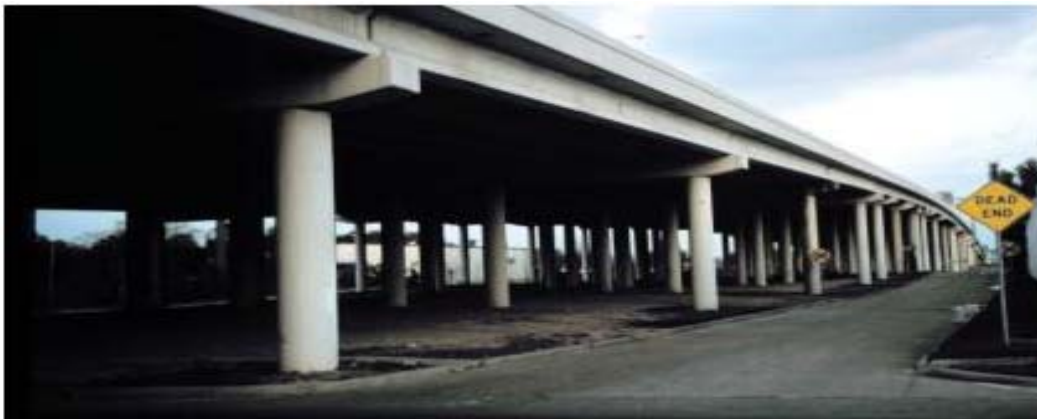
Figure 6.1 I-10 at AT & SF RR

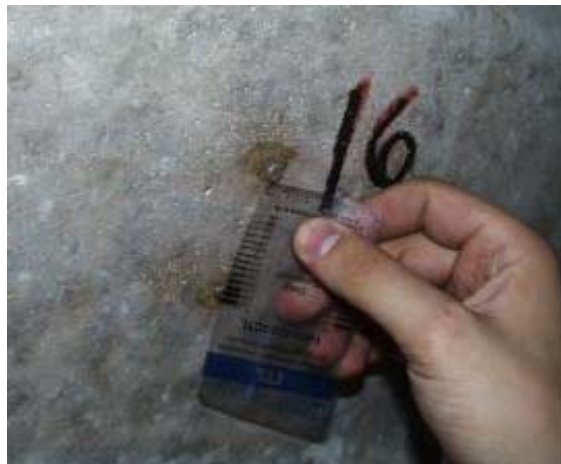
Figure 6.6 Crack comparator

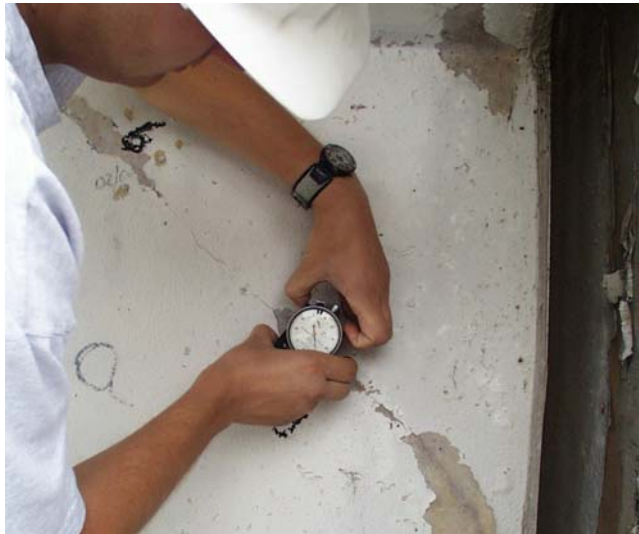
Figure 6.7 Demec gage

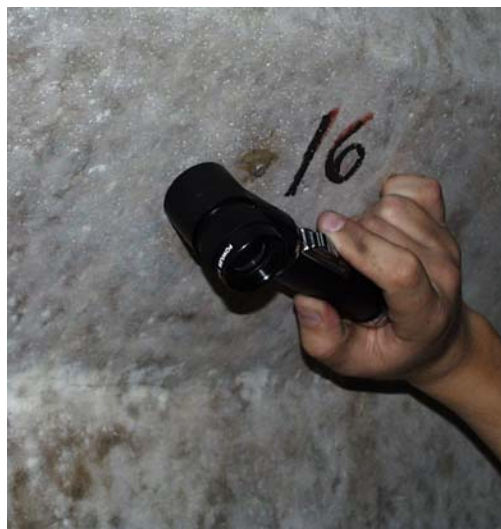
Figure 6.8 Magnifying eye scope

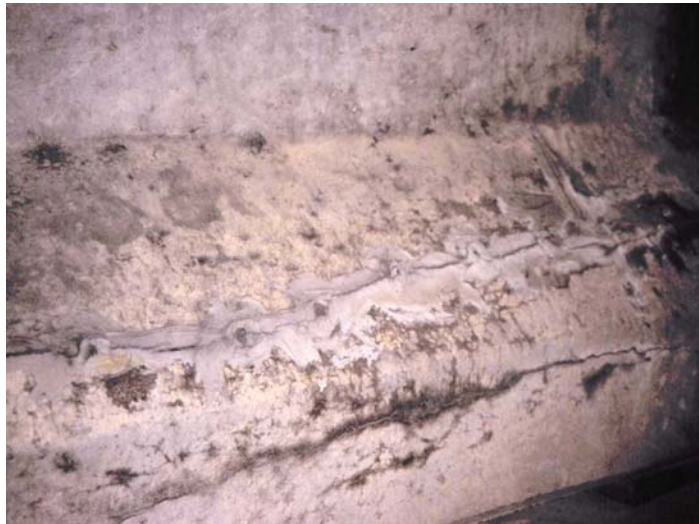
Figure 7.3 Injected sealant on I-10 structure

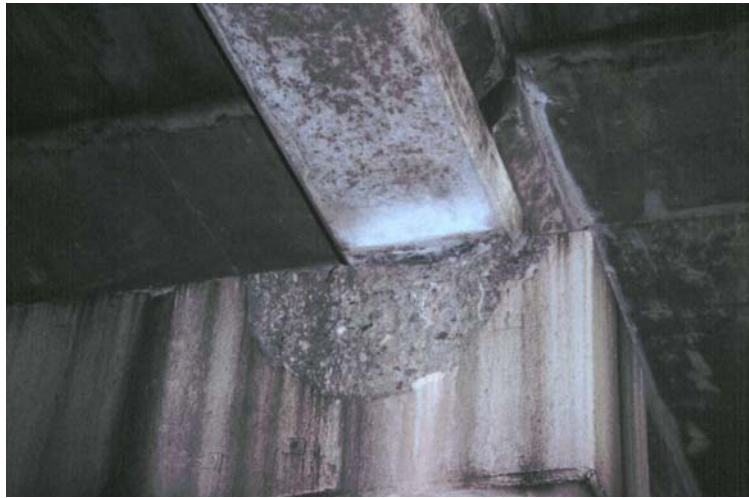
Figure 7.4 Missing bearing pad at I-10 structure

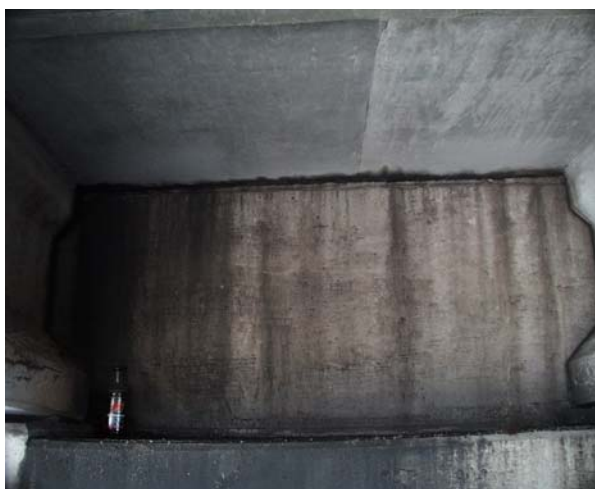
Figure 7.5 View of west abutment between SW Girder 2 (left) and SW Girder 3 (right)

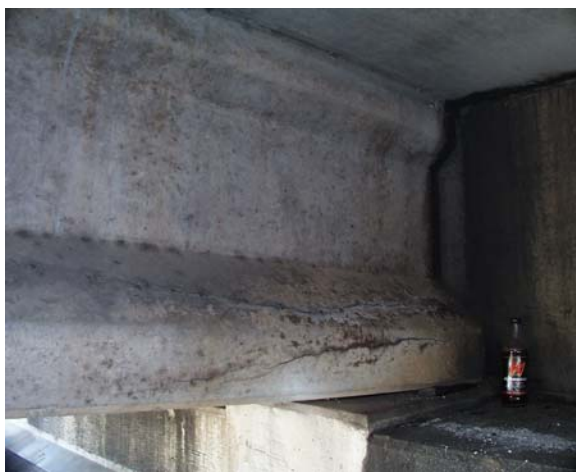
Figure 7.6 View of greater damage to SW Girder 2

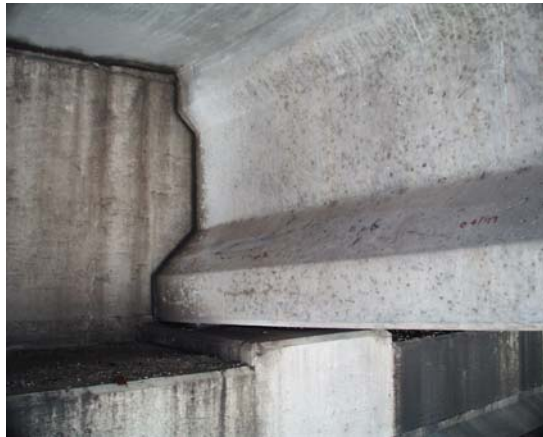
Figure 7.7 View of lesser damage to SW Girder 3

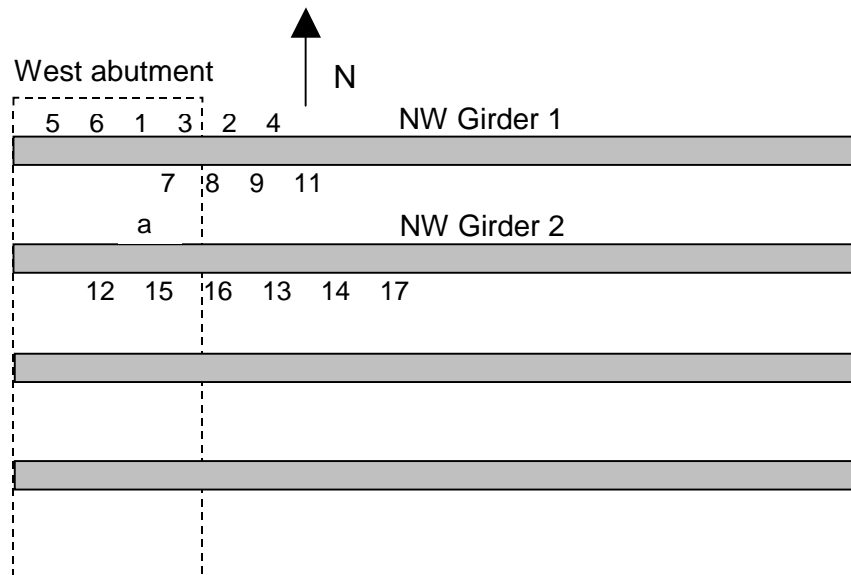
Figure 7.8 Locations of measurement points on US-90 structure

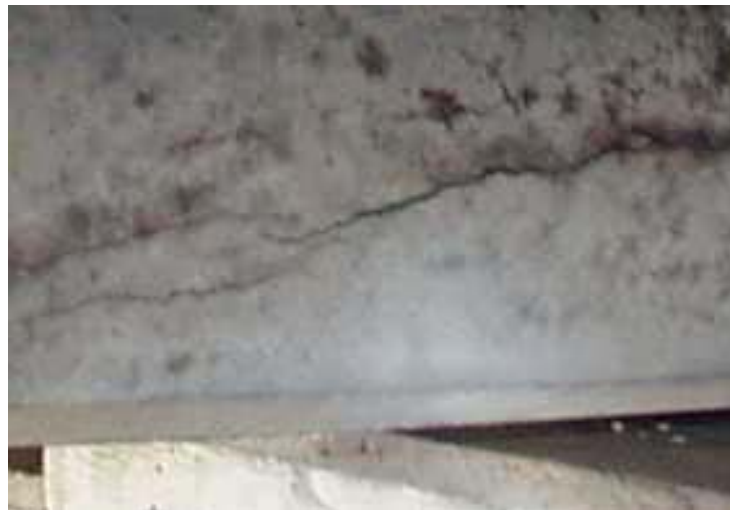
Figure 7.9 New cracks extending past the end of the old crack

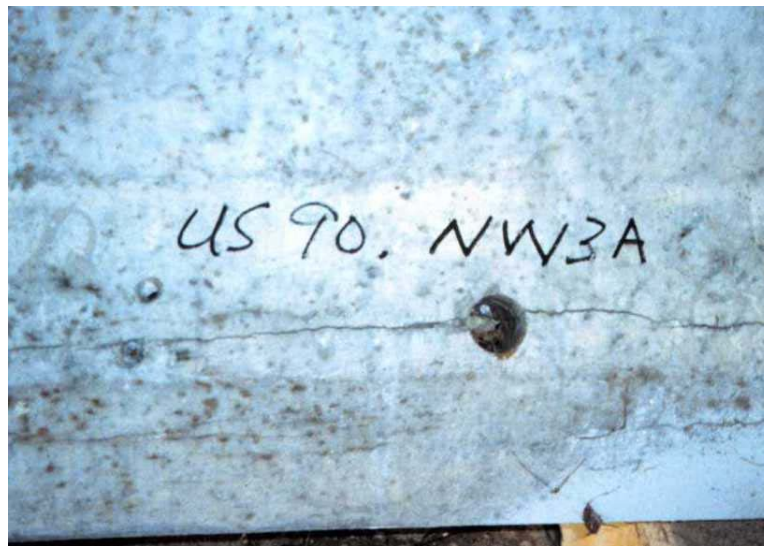
Figure 7.10 Core removed from US-90 girder

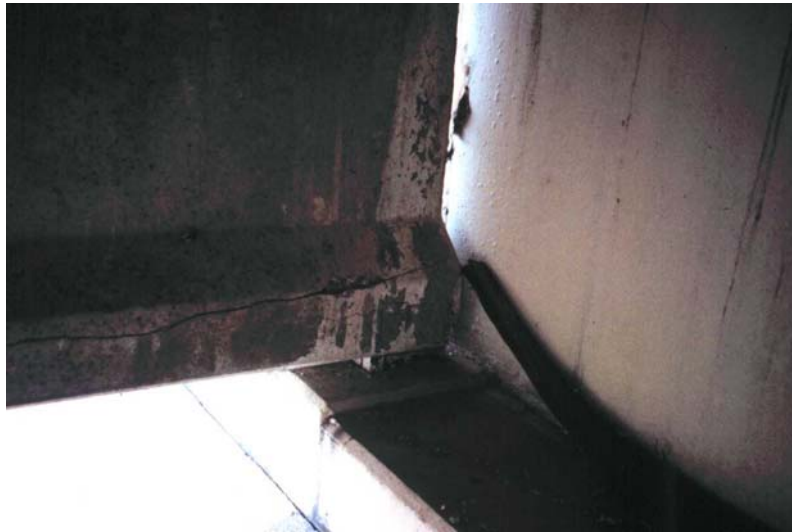
Figure 7.11 Rubber seal dropped from joint above at west abutment of US-90 structure

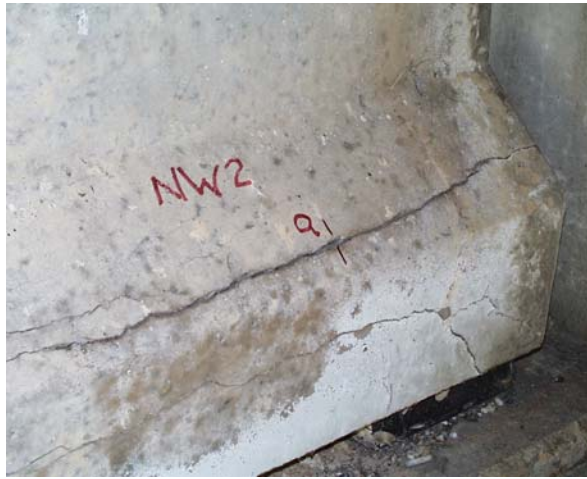
Figure 7.12 Point “a” on NW Girder 2 of US-90 structure

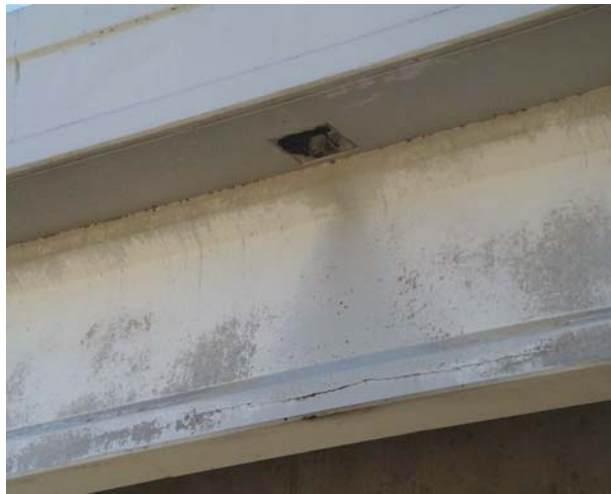
Figure 7.13 Cracking on Face 5 of exterior girder under drain scupper

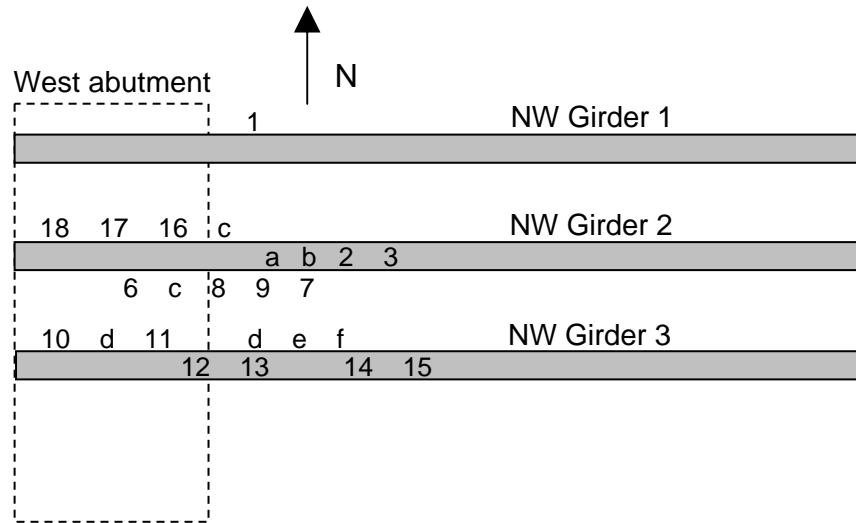
Figure 7.14 Locations of measurement points on Robinson Road structure

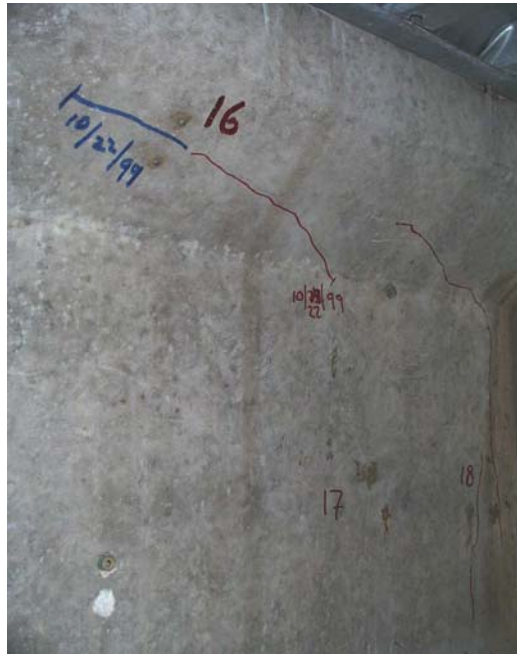
Figure 7.15 Extension of crack on Face 2 of NW Girder 3 at Robinson Road structure

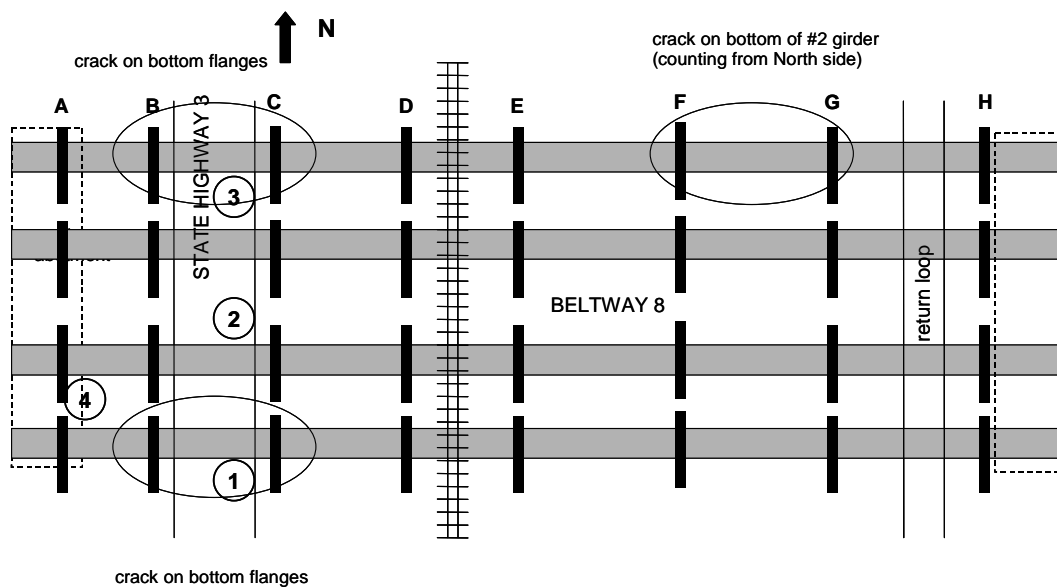
Figure 7.16 Schematic of Beltway 8 structure

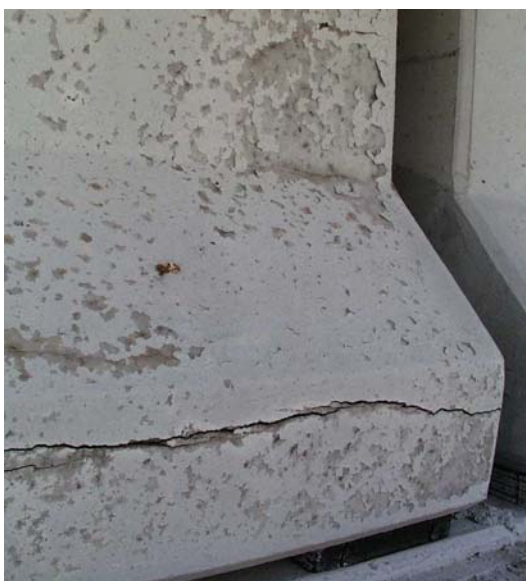
Figure 7.17 Typical cracks on bottom flange of Beltway 8 girders

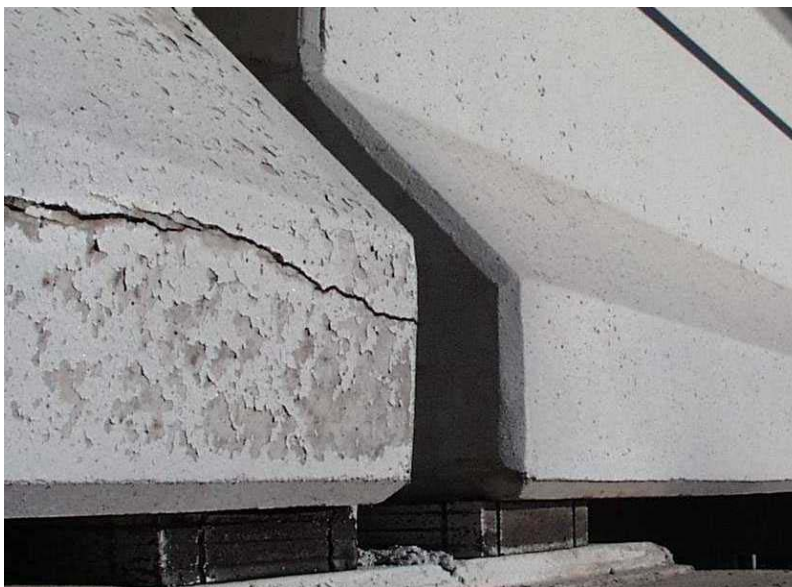
Figure 7.18 Contrast between damaged and undamaged girders at Location 1

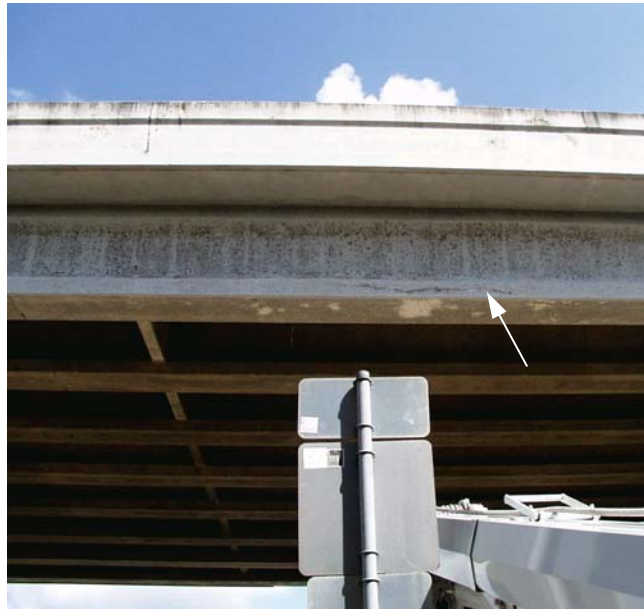
Figure 7.19 Cracks on Face 5 of exterior girder at Location 2

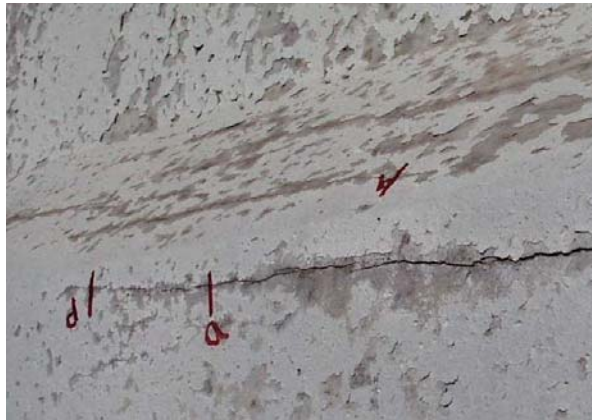
Figure 7.20 Marked points at Location 1

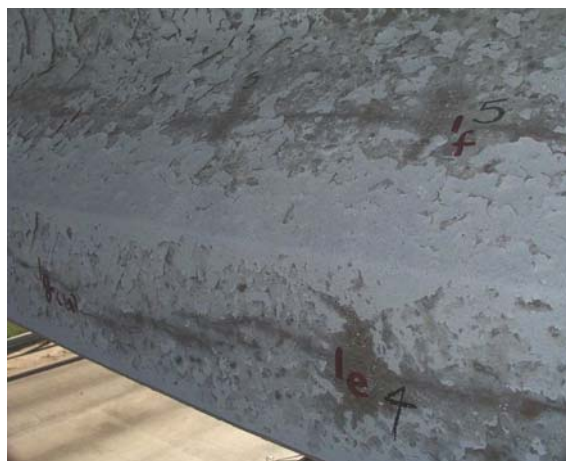
Figure 7.21 Marked points on Faces 4 and 5 at Location 2

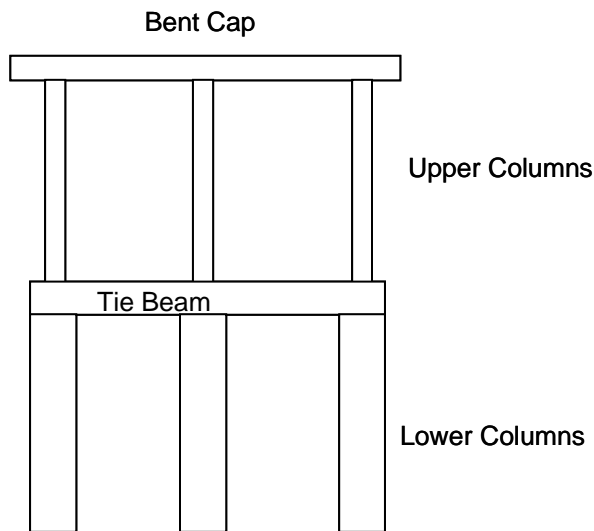
Figure 7.23 Schematic of a bent in FM 1979 structure

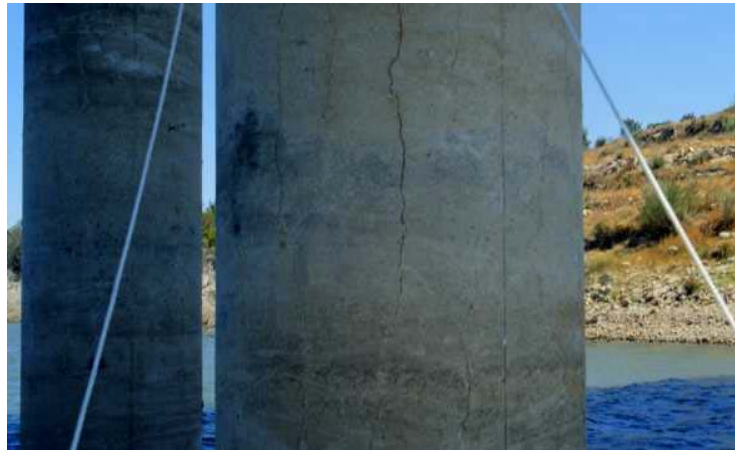
Figure 7.24 Vertical cracking typical of Bents 9, 10 and 11 of FM 1979 structure (Bent 10)

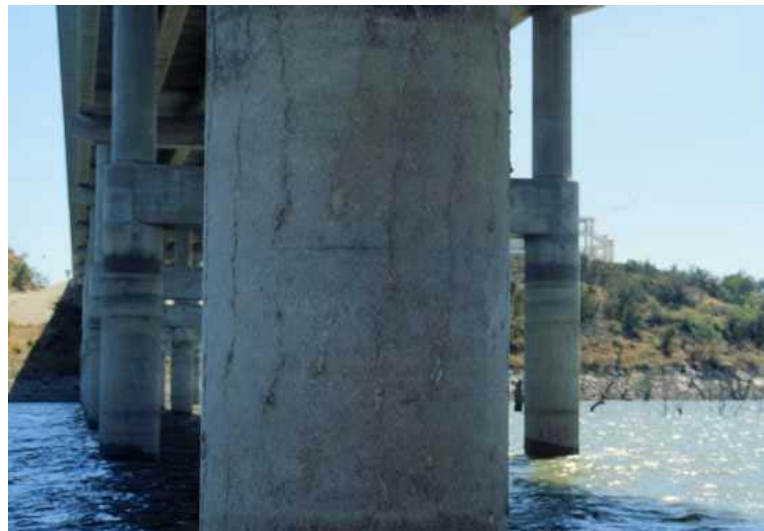
Figure 7.25 Horizontal and vertical cracking in Bent 5 of FM 1979 structure

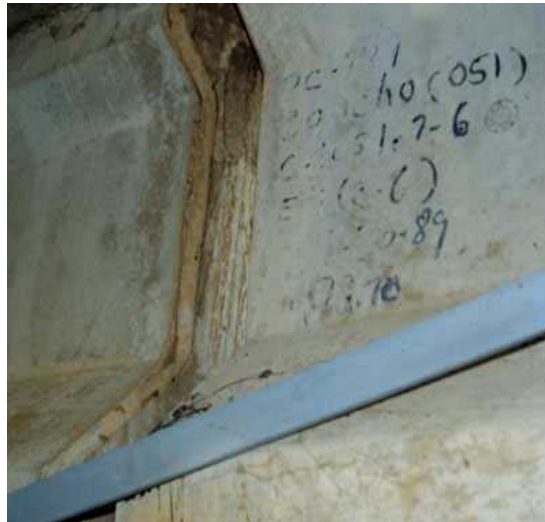
Figure 7.26. Horizontal cracking on bottom flanges of outside girder ends (Bent 5)

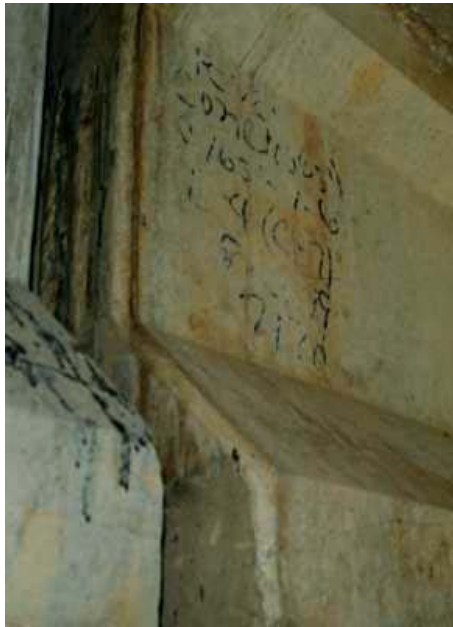
Figure 7.27. Horizontal cracking at bottom flanges of inside girder ends (Bent 5)

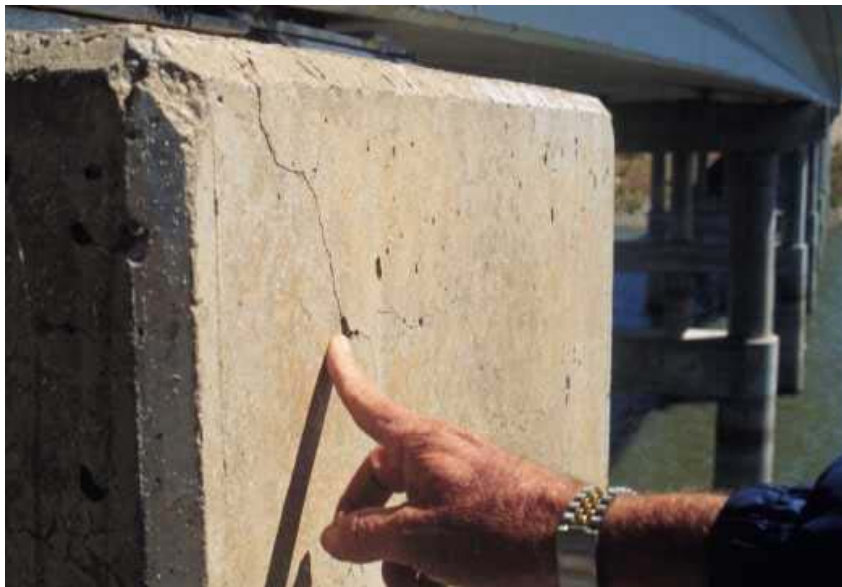
Figure 7.28 Map cracking at ends of bent cap (Bent 5)

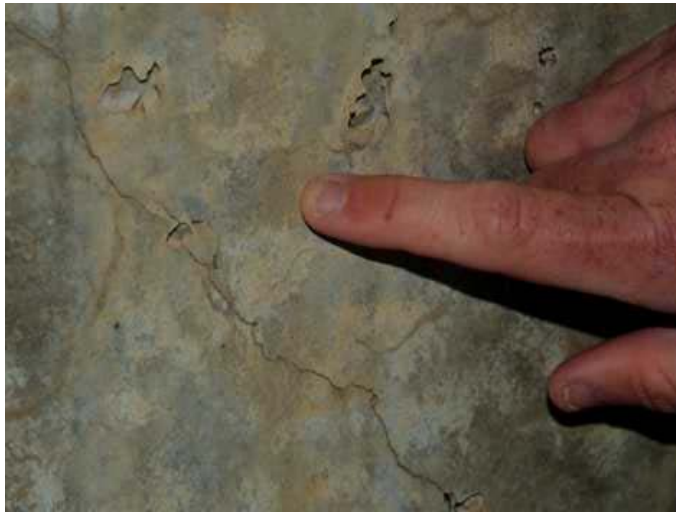
Figure 7.29 Map cracking on side of bent cap (Bent 5)

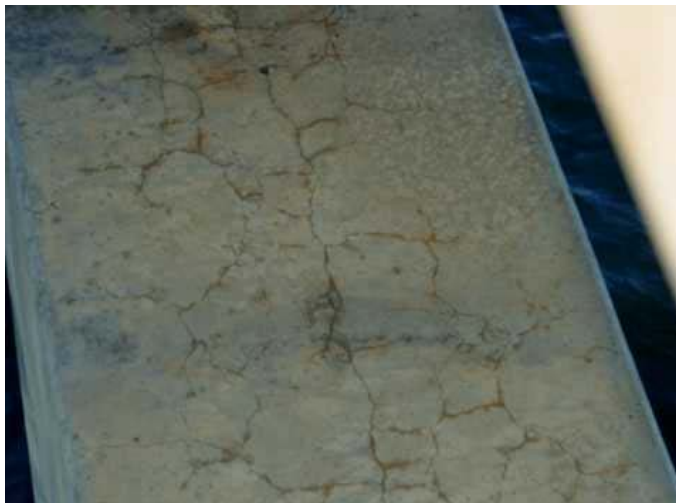
Figure 7.30 Map cracking on upper surface of tie beam (Bent 5)

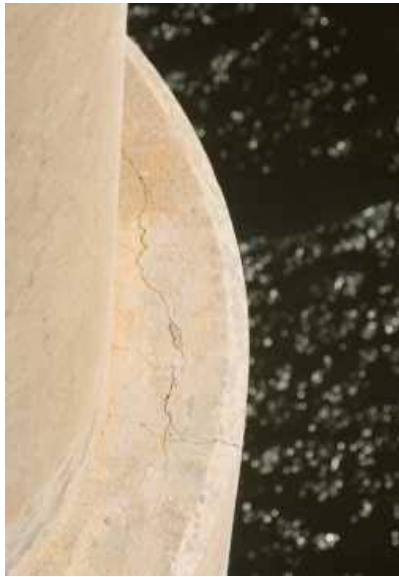
Figure 7.31 Propagation of vertical cracks in lower column to top of tie beam (Bent 5)

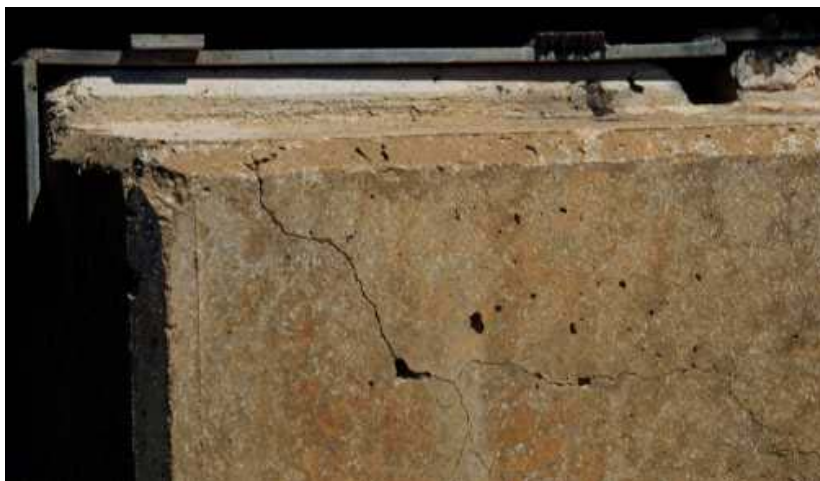
Figure 7.32 Map cracking at ends of bent cap (Bent 9)
