Copyright
by
Anna Boenig
2000

**Bridges with Premature Concrete Deterioration:
Field Observations and Large-Scale Testing**

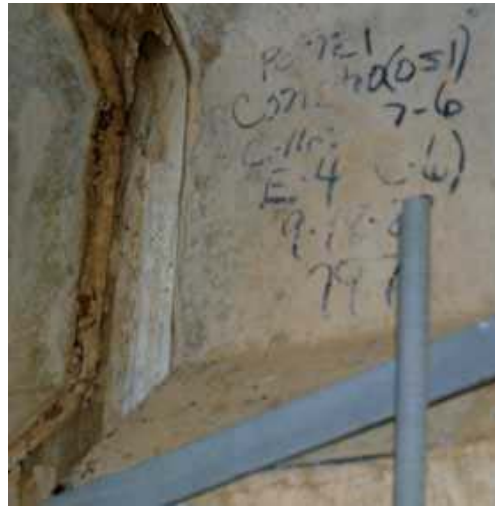
Figure 7.33 Horizontal and map cracking at girder ends (Bent 9)

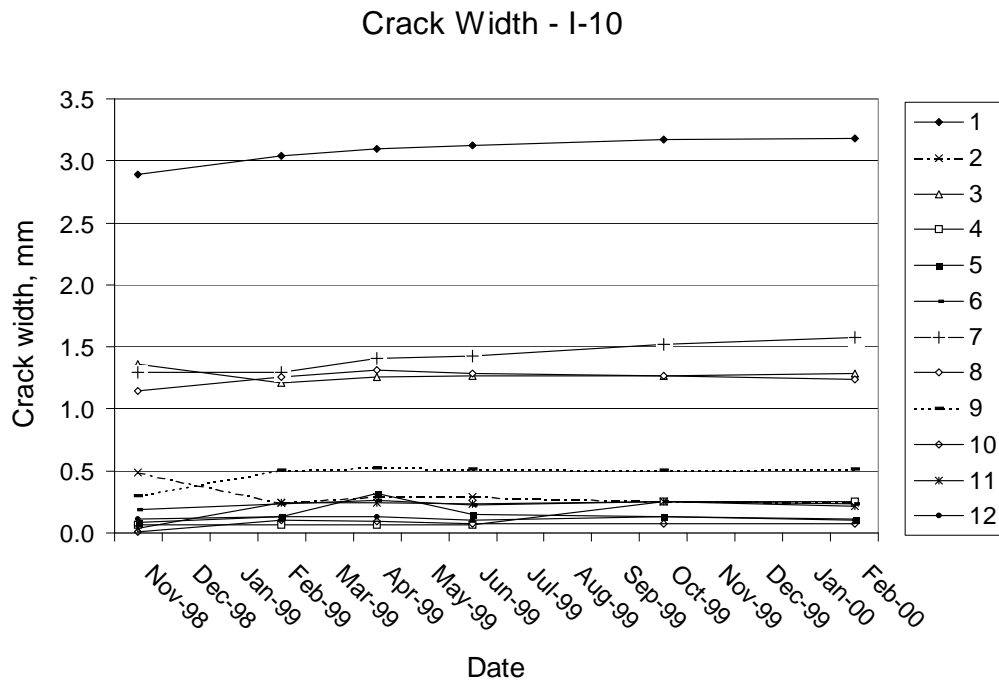
Figure 7.34 Crack width over time for I-10 structure

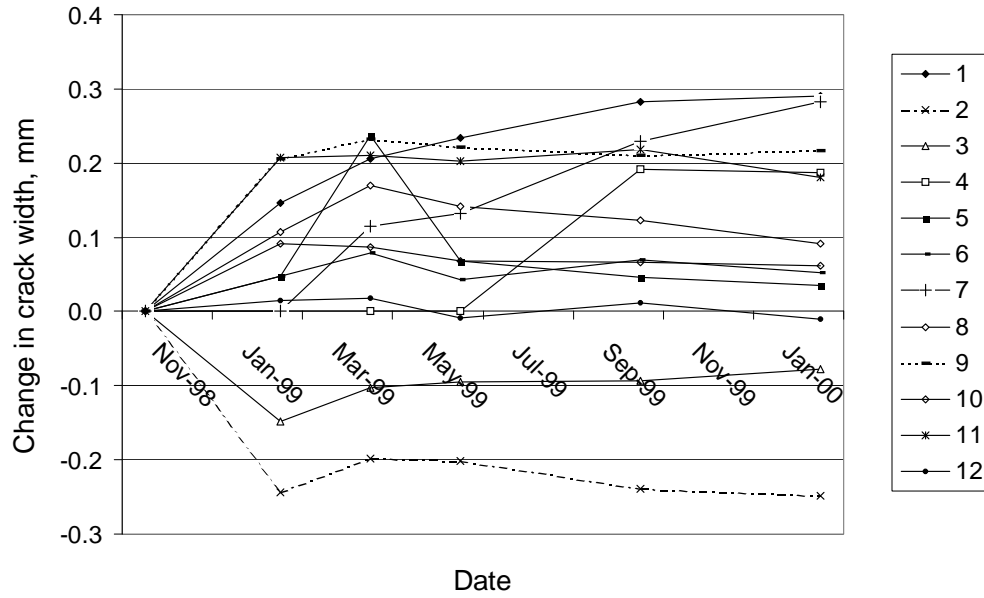
Figure 7.35 Change in crack width over time for I-10 structure

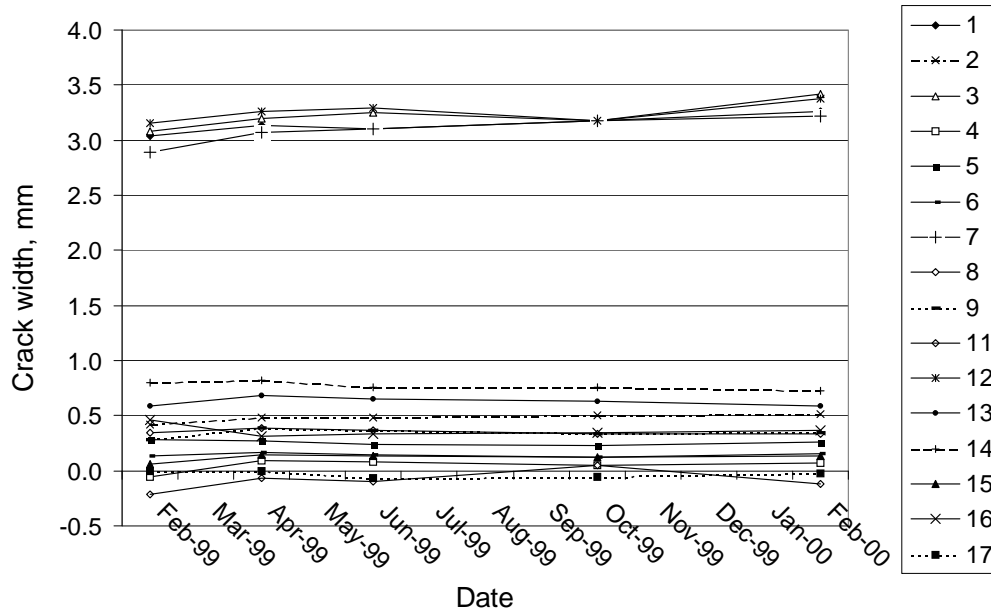
Figure 7.36 Crack width over time for US-90 structure

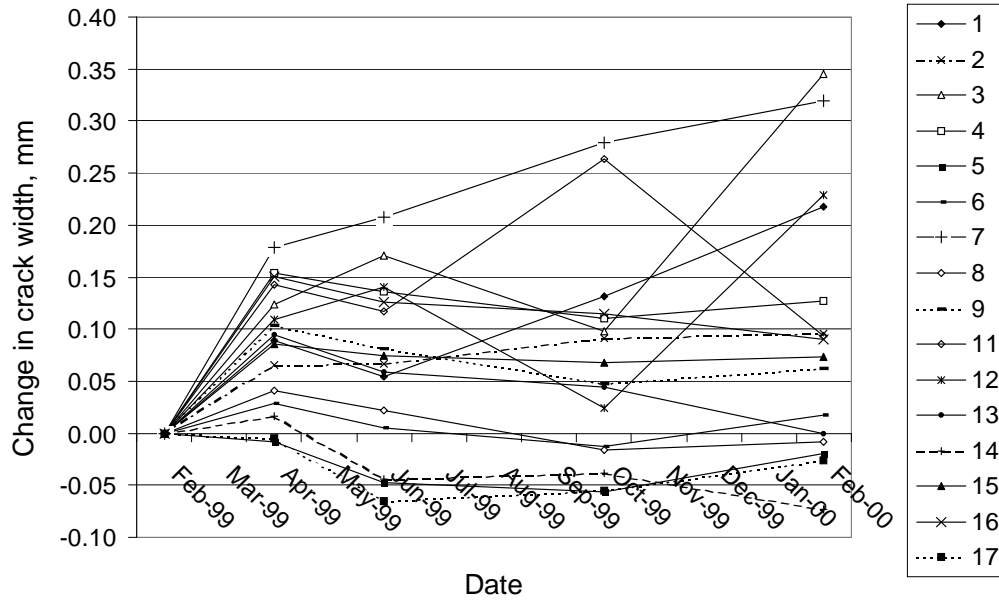
Figure 7.37 Change in crack width over time for US-90 structure

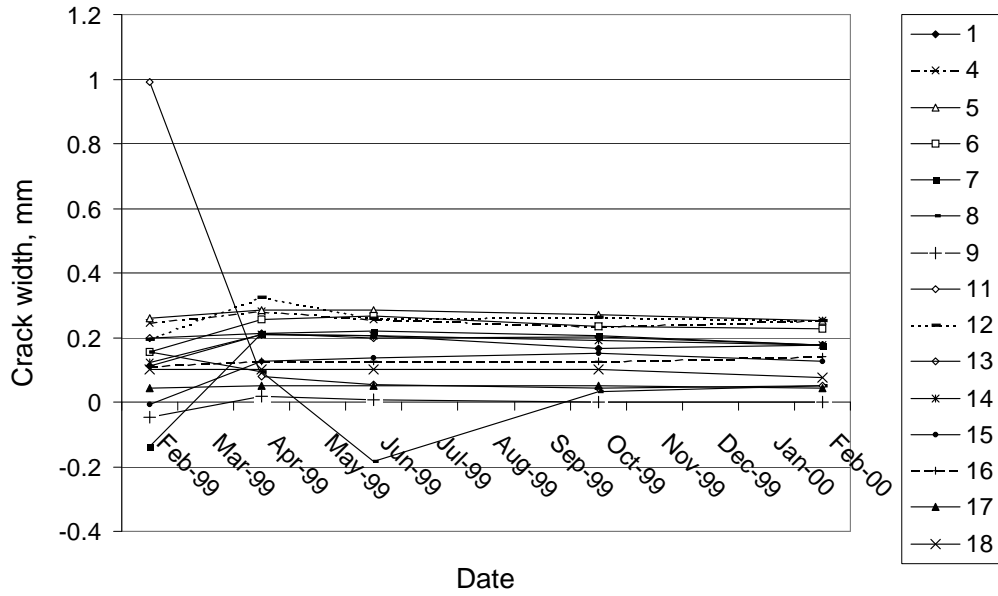
Figure 7.38 Crack width over time for Robinson Road structure

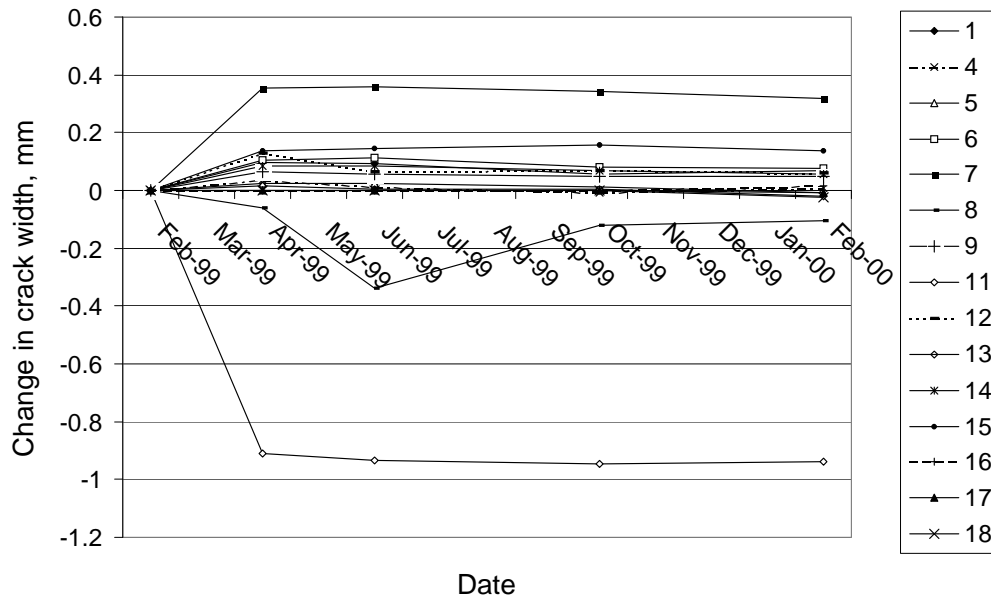
Figure 7.39 Change in crack width over time for Robinson Road structure

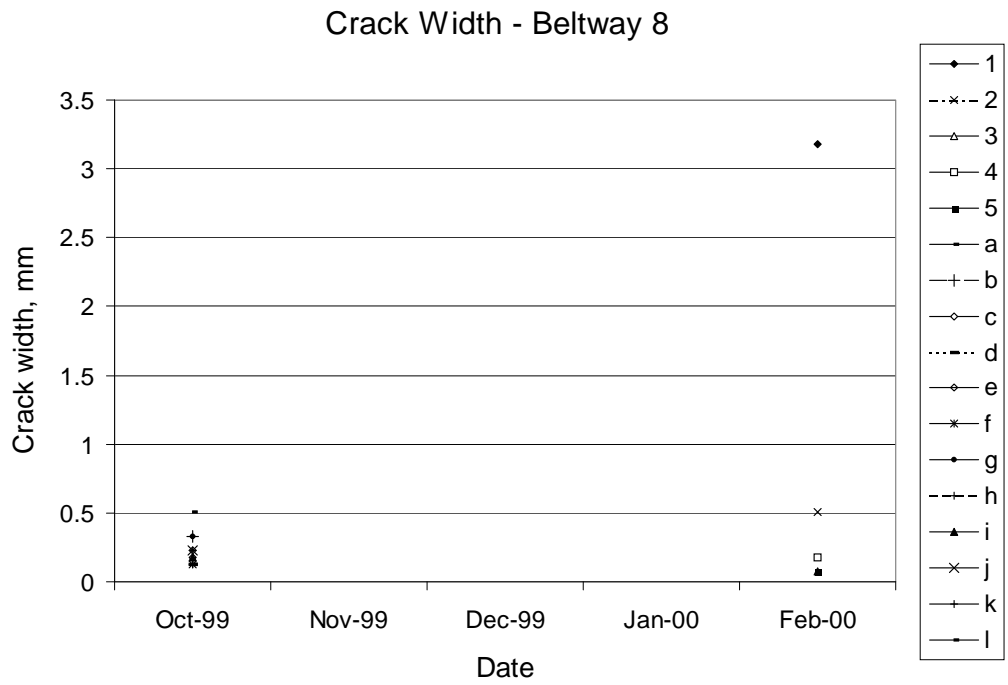
Figure 7.40 Crack width over time for Beltway 8 structure

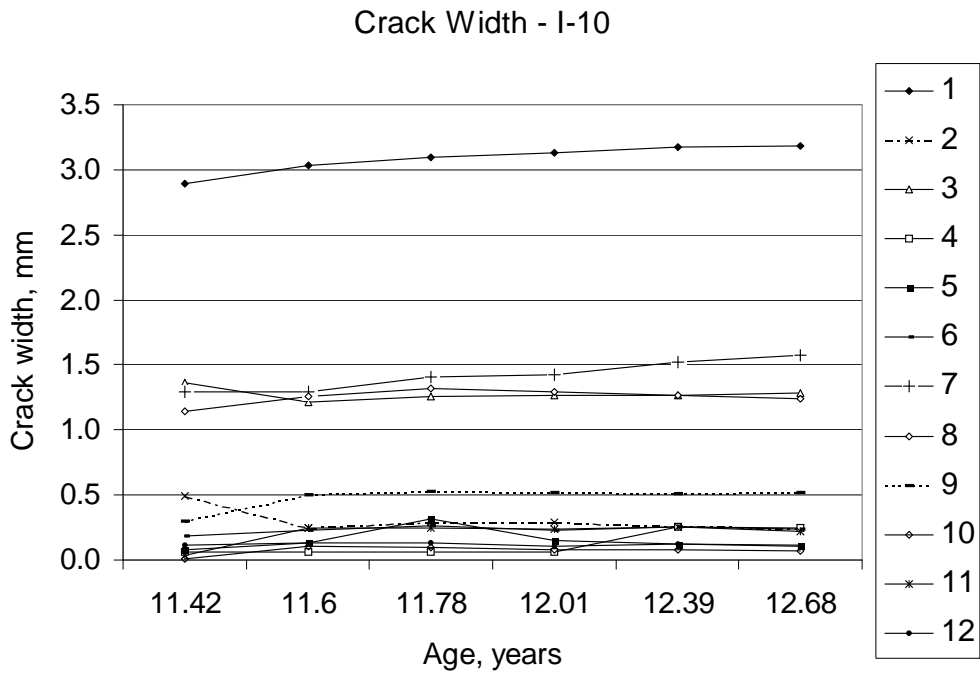
Figure 8.1 Crack width versus age of beam for I-10 structure

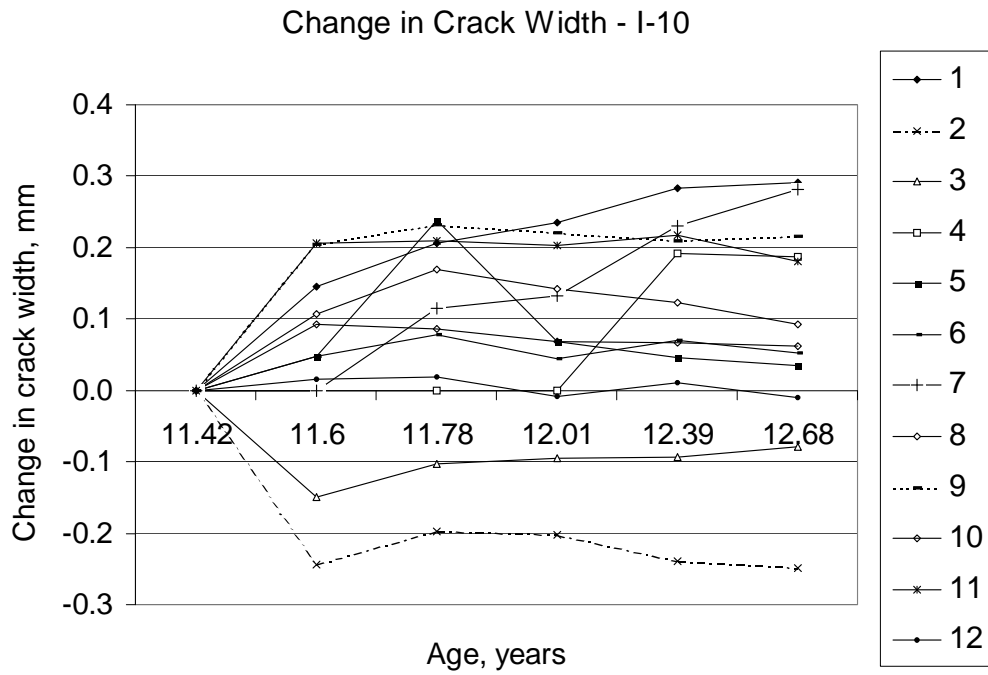
Figure 8.2 Change in crack width versus age of beam for I-10 structure

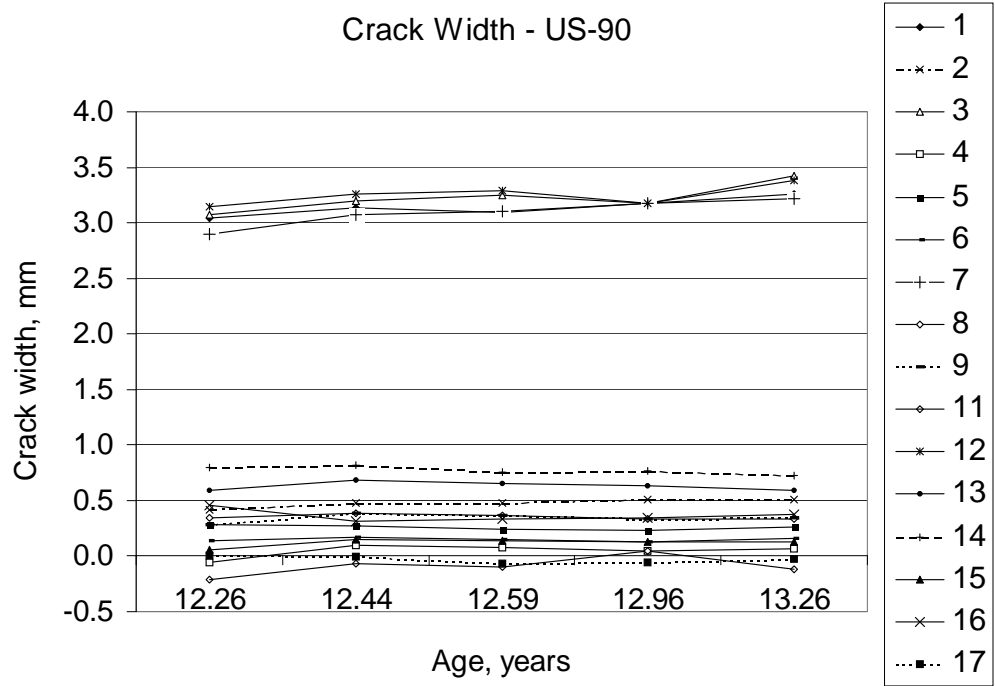
Figure 8.3 Crack width versus age of beam for US-90 structure

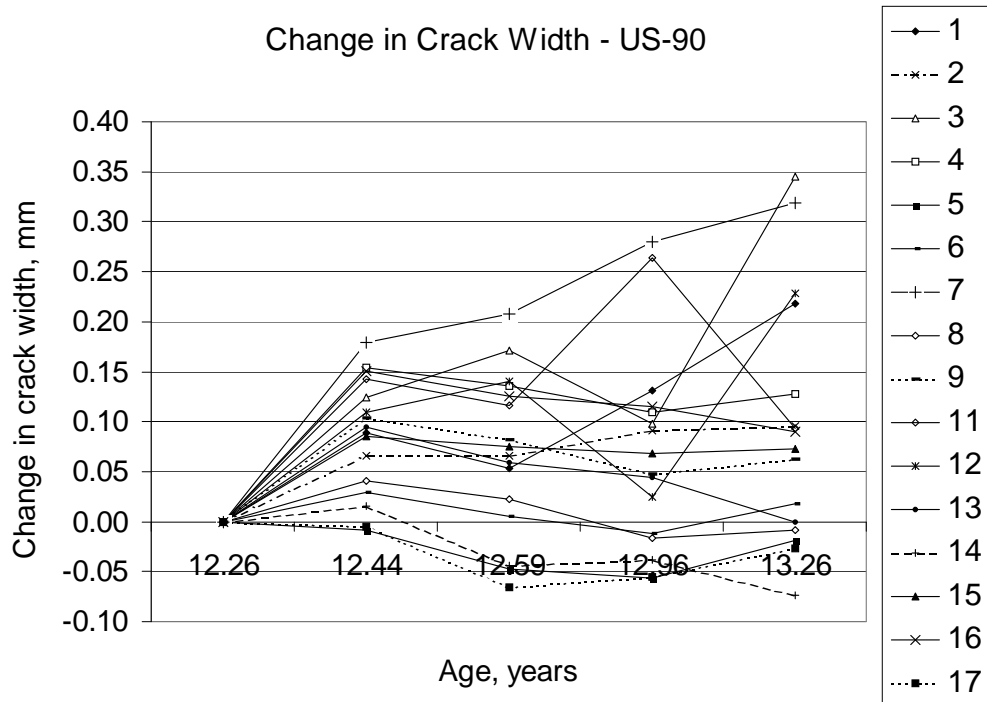
Figure 8.4 Change in crack width versus age of beam for US-90 structure

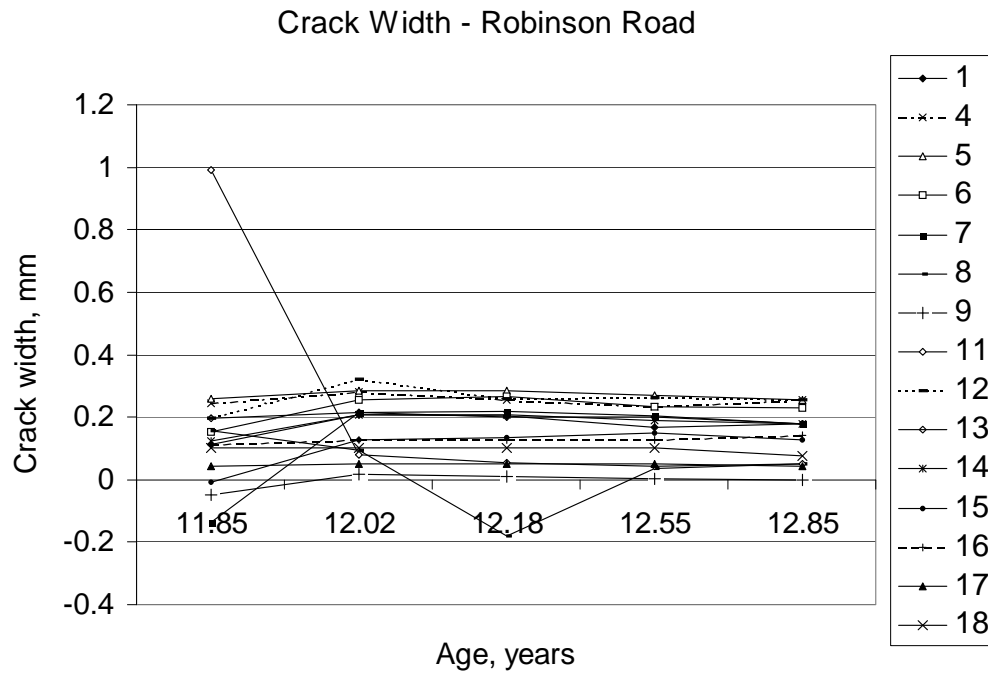
Figure 8.5 Crack width versus age of beam for Robinson Road structure

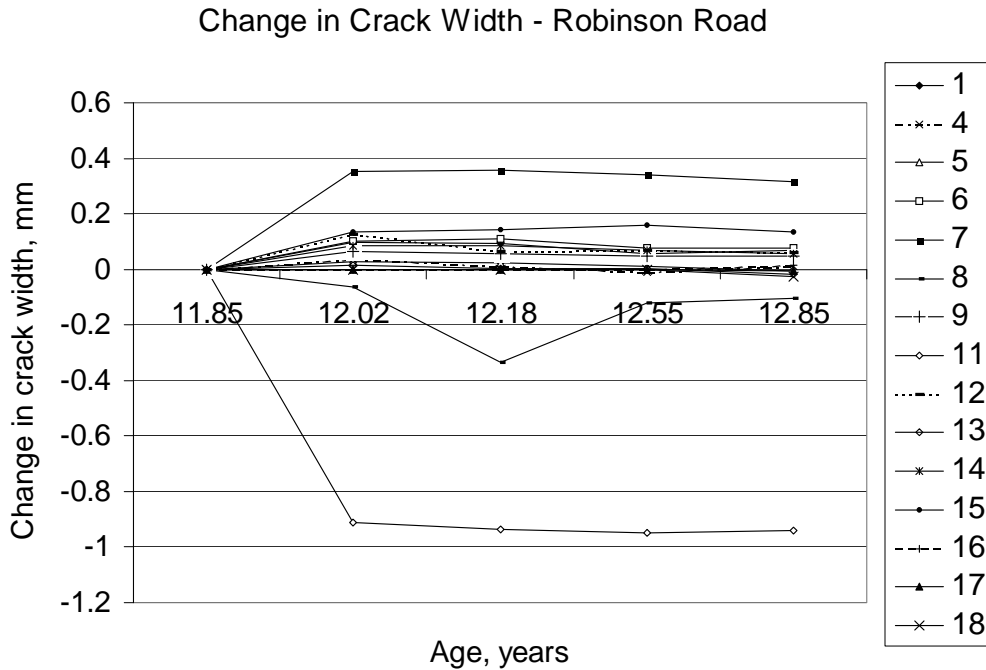
Figure 8.6 Change in crack width versus age of beam for Robinson Road structure

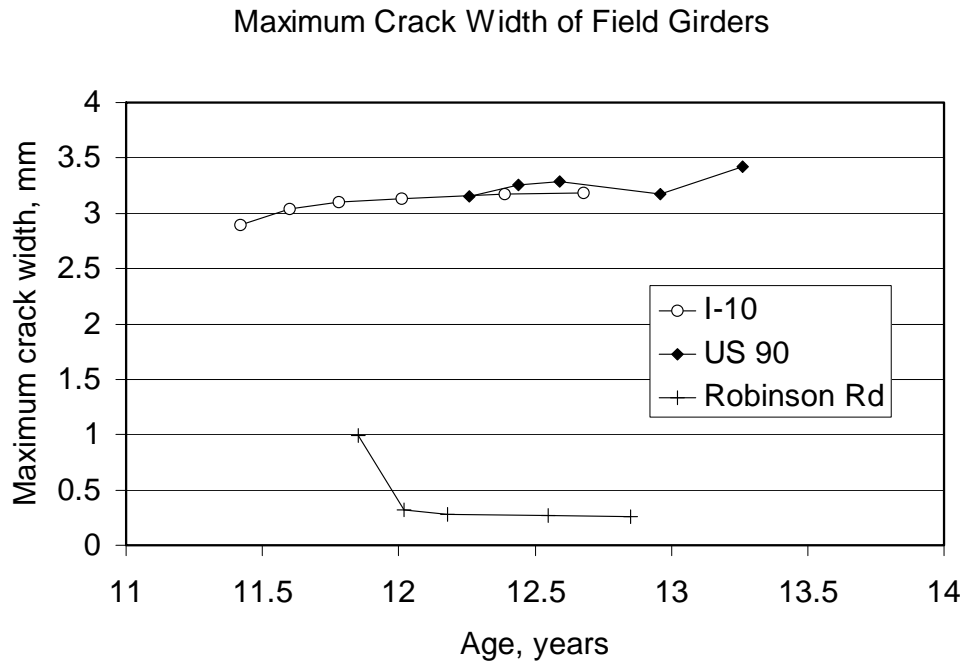
Figure 8.7 Maximum crack width of field girders

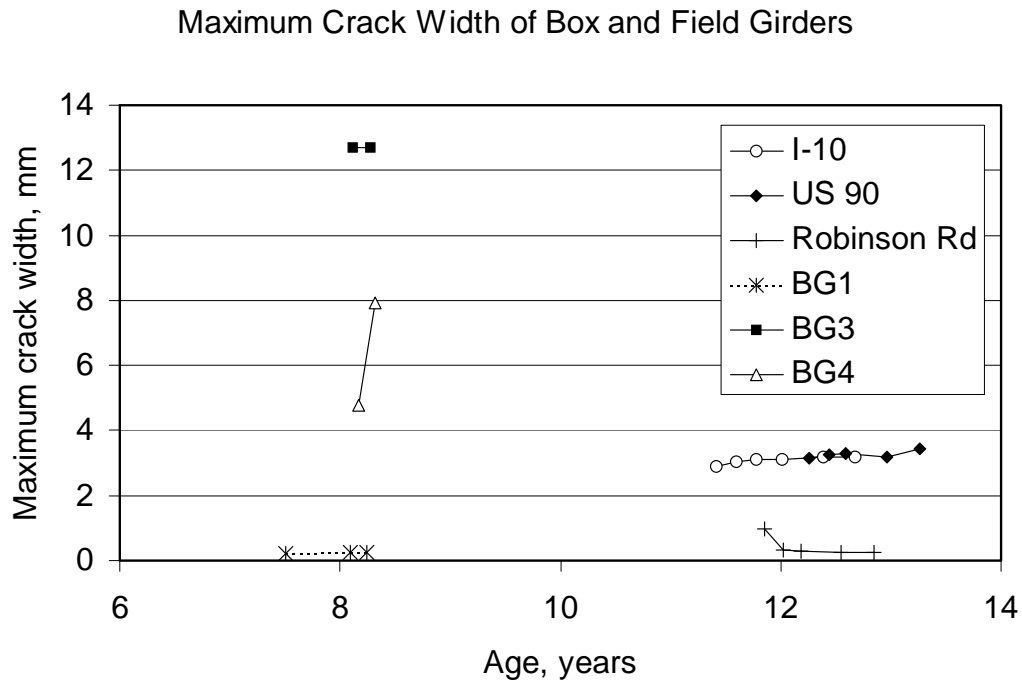
Figure 8.8 Maximum crack width of box and field girders

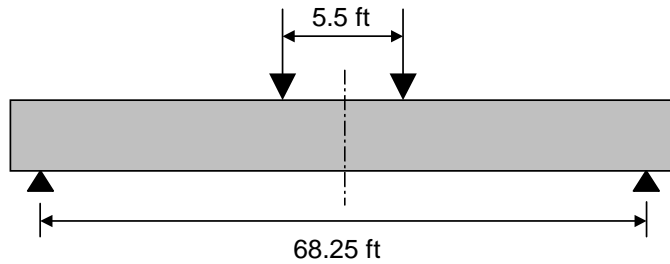
Figure D.2 Simple span of flexure-dominated specimens

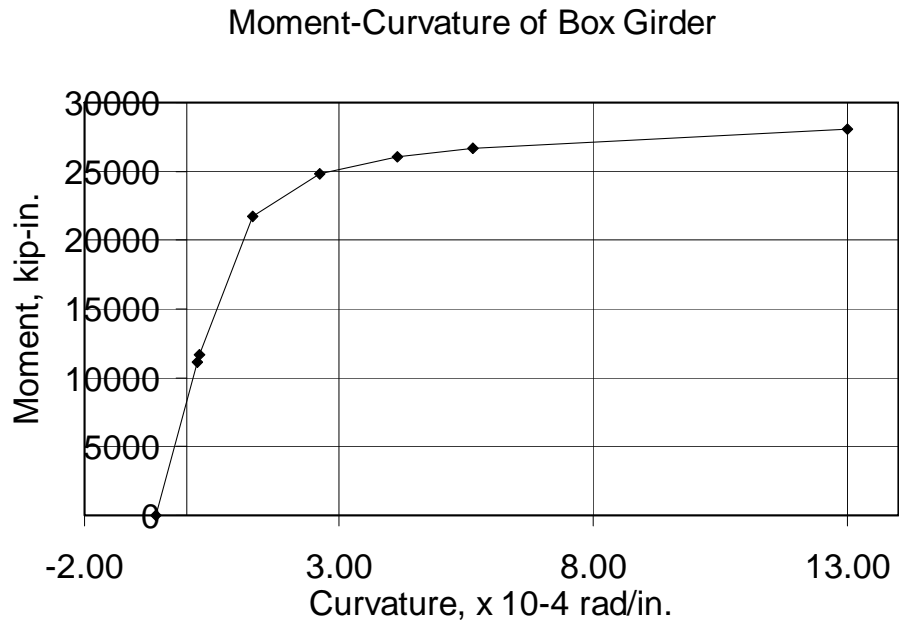
Figure D.4 Moment-curvature of box girders

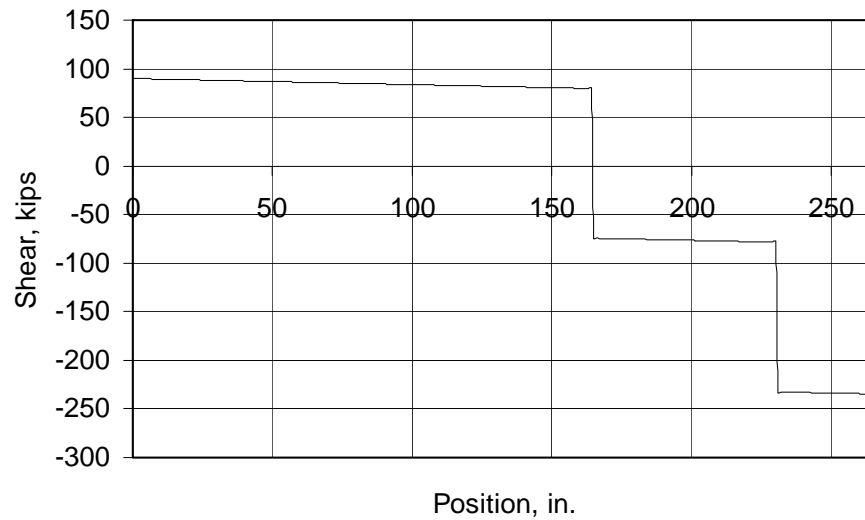
Figure D.19 Shear diagram for Case 1 loading
