**Testing of Emergency Wood Shoring Towers for use in Urban Search  
and Rescue Operations**

**Thesis**

**The University of Texas at Austin**

**May 2012**

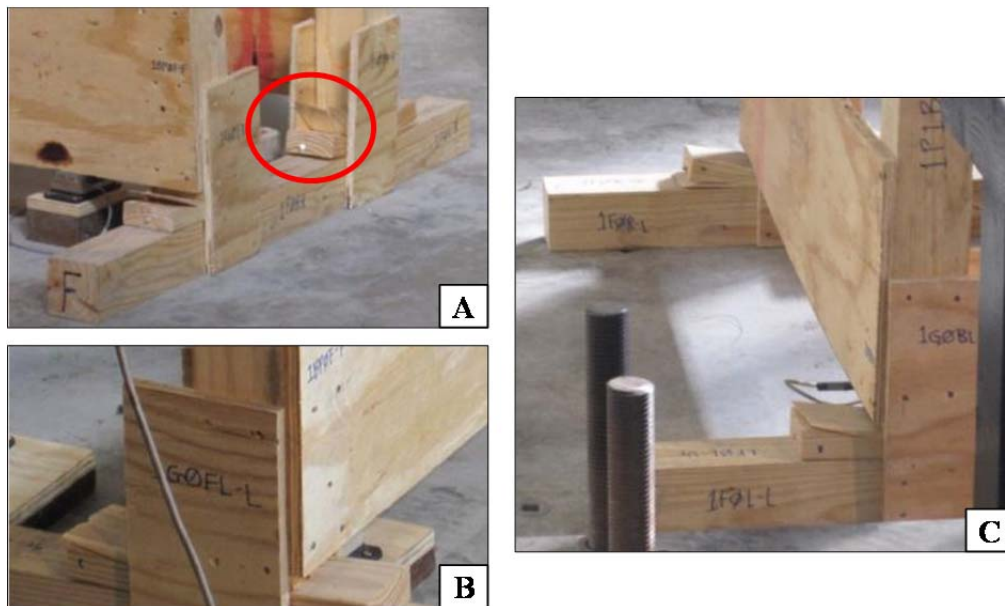
During loading, audible sounds of the wood creaking and cracking were heard from periods of low loads (20-30kips) up to failure. These noises intensified at loads of around 70kips and above. Also visibly noted during testing was the cupping action of some of the wedges. In particular, the two sets of wedges on the right side of the shore cupped to a greater degree than the two sets on the left. This cupping action progressed from approximately 50kips to failure. Figure 5.2 shows the performance of the wedges.

**Figure 5.2** Test 1 Wedge Performance A) Right Side Cupping B) No cupping at Front Left C) Minor Cupping of Back Right

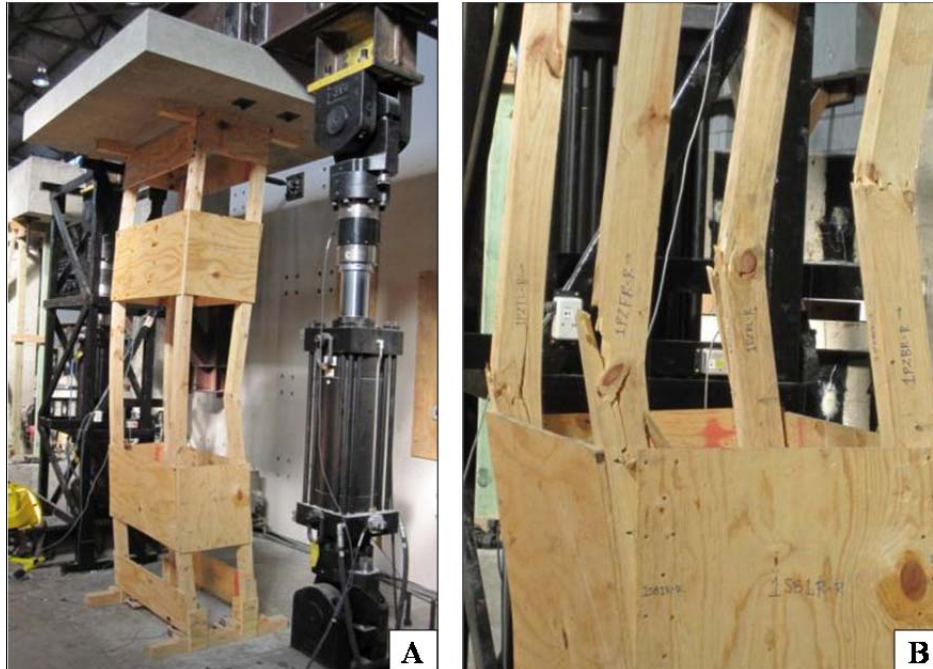
Prior to failure, all four posts began to bow outward towards the front. The first failure occurred at a knot in the back right post at approximately the midpoint between the intermediate braces at a total vertical load of 65kips. The front right post also cracked around a spike knot just above the lower intermediate brace at 65kips and progressively split as loading continued. At approximately 32kips, the two left posts simultaneously failed at knots. This load progression is presented using the load-displacement curve in Figure 5.3. Photographs of the failures are also provided.

**Figure 5.4** Test 1 A) First Failure and Bowing of Posts B) All Post Failures

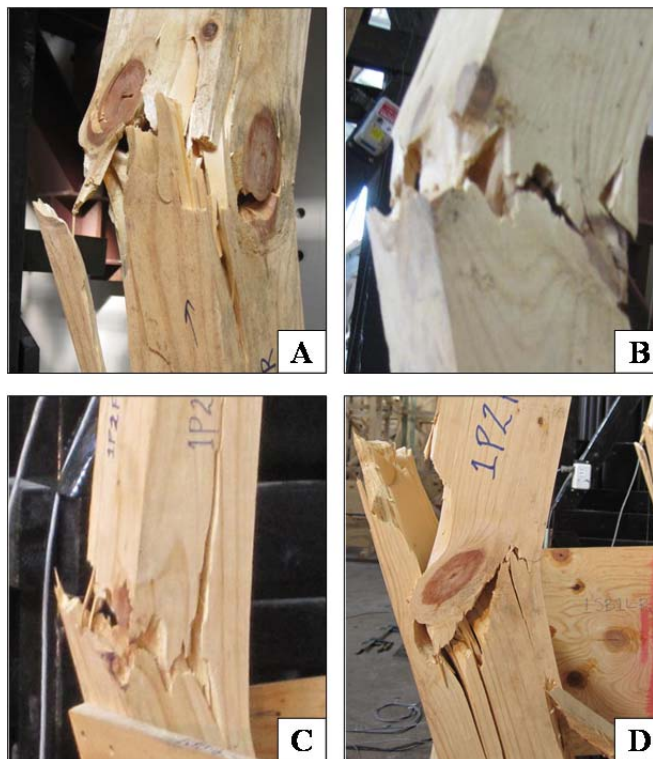
**Figure 5.6** Post Failures A) Back-Left B) Back-Right  
C) Front-Left D) Front-Right

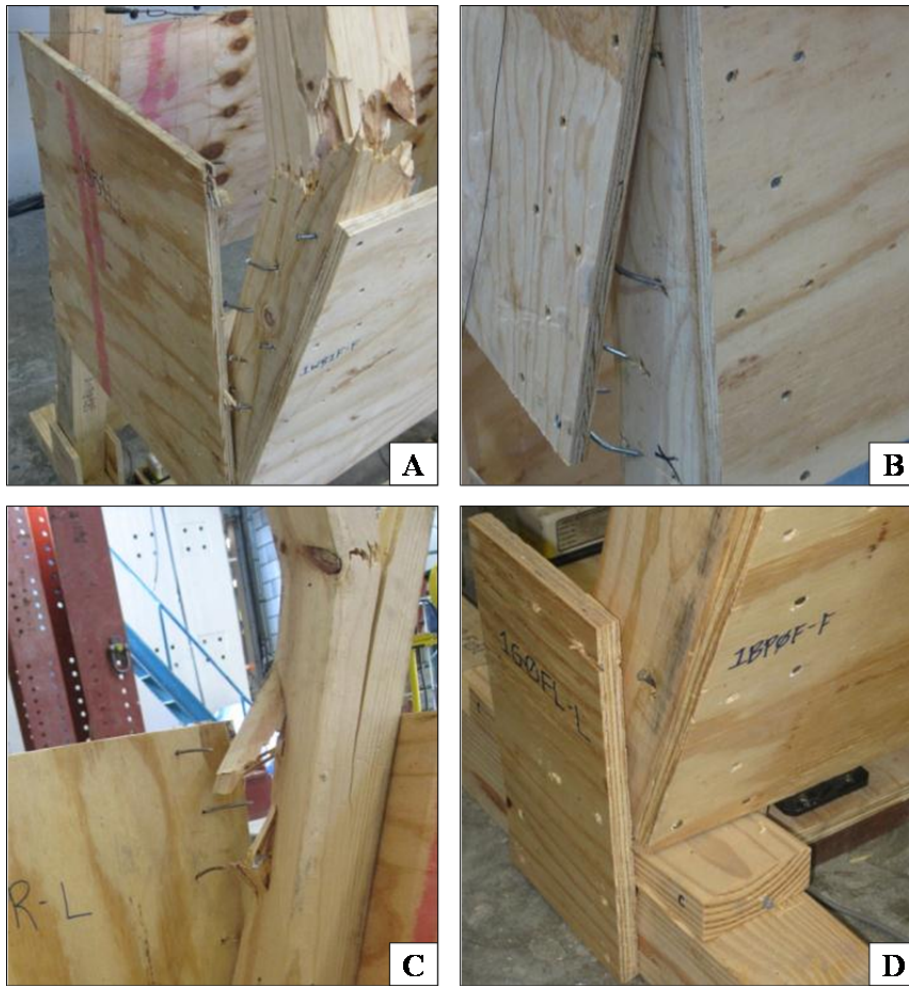
All brace failures were at the connections, not within the plywood section. Failure of the braces consisted of nail withdrawal in the direction of the post bowing. In some cases the nails withdrawal from the posts and in others the nails pulled through the plywood cross-section. Connections of the half-gusset plates also pulled through as the posts rotated about the wedges. Figure 5.7 shows the different types of connection failures in shore 1.

**Figure 5.7** Connection Failures A) Pull Through B) Pullout C) Post Splintering D) Half-Gusset Rotation and Pull Through

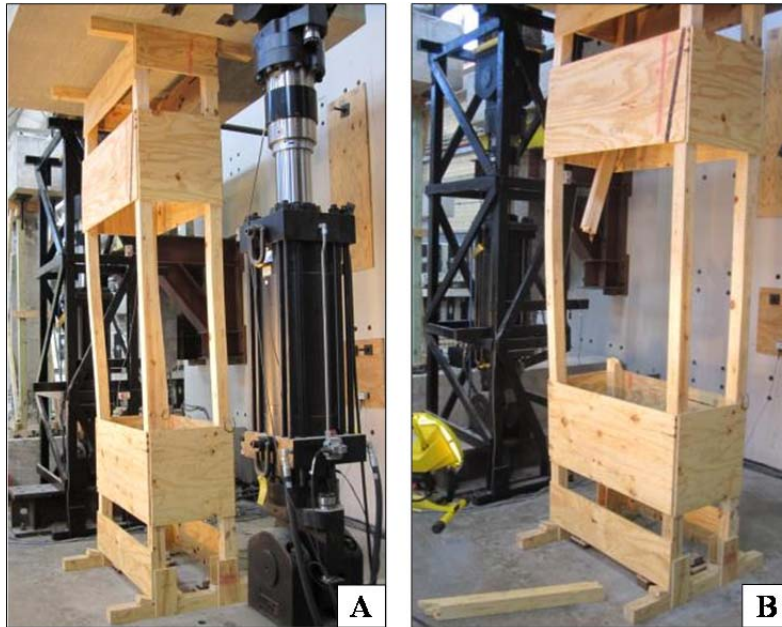
At 85kips, the two left posts were visibly bent in an ‘S’ shape, while the right posts remained relatively vertical. After the peak load of 93.4kips was reached, the back left post failed completely through the cross section in two locations, ejecting a roughly three foot long section. The back right post buckled at approximately 57kips in multiple locations, followed by the front left post at approximately 34kips. The load-displacement response is shown in Figure 5.9.

**Figure 5.10** Specimen 2 A) Left Post Buckling B) First Failure

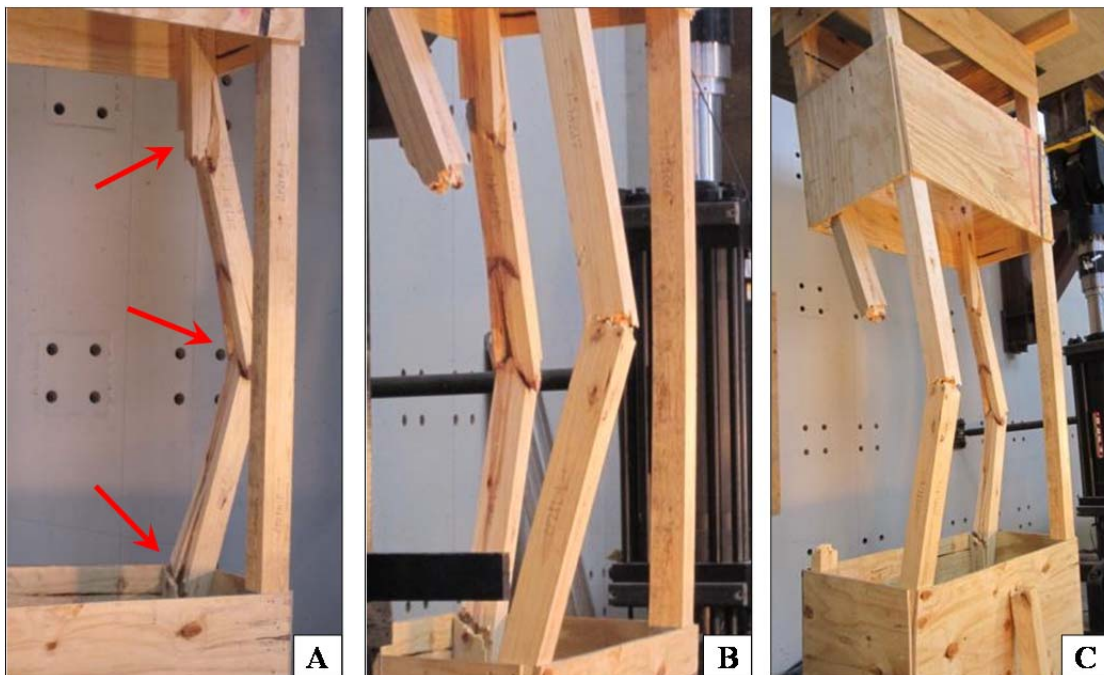
Photographs of each post failure are included in the following figures. It is interesting to note that all three failures were unique and did not follow the same one-directional buckling failure as was seen in test 1. Failures 1 and 2 included multiple points of fracture and the failure planes were 90 degrees from one another.

**Figure 5.11** Specimen 2 A) Second Failure B) Third Failure C) End of Test Condition

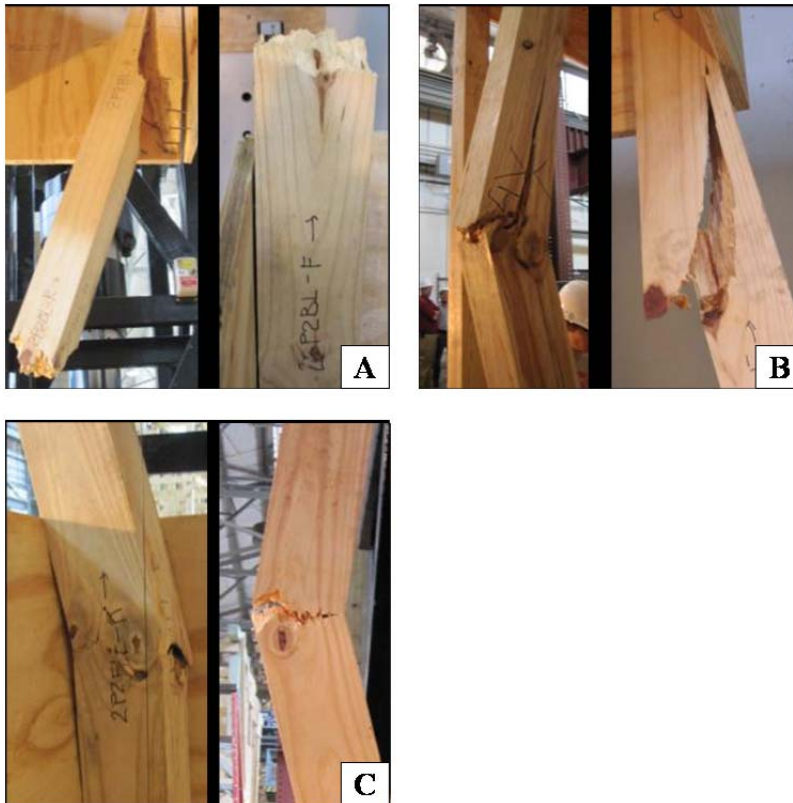
**Figure 5.12** Post Failures A) Back Left B) Back Right C) Front Left

The three failures failed in multiple locations, within the clear spacing of the post between braces, and a secondary failure within the brace region. This displays the presence of high stresses within the interface region of the braces and clear spans of the post. Only minor withdrawal of the 8d nails in the half-gusset plates and plywood braces was documented. These cases are shown in Figure 5.13.

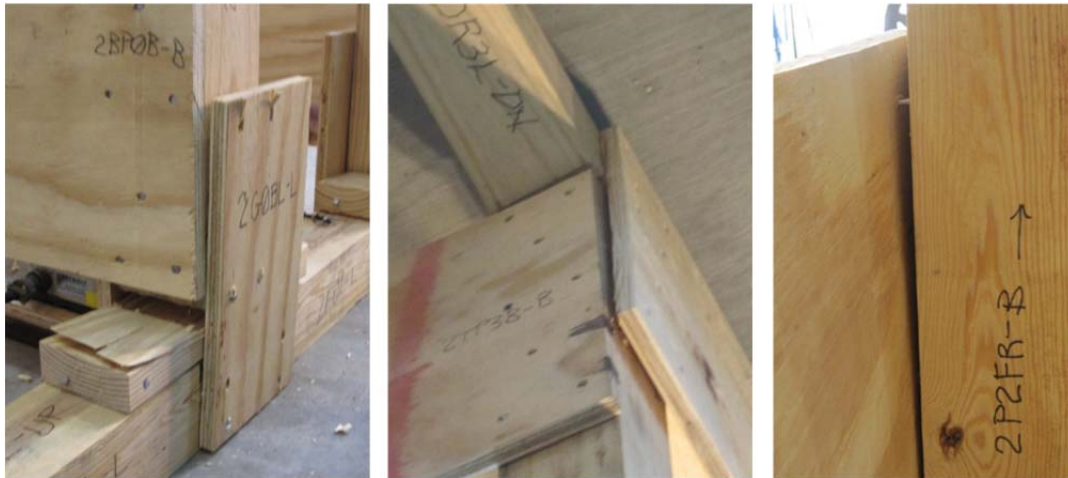
**Figure 5.13** Samples of Minor Pullout from Specimen 2

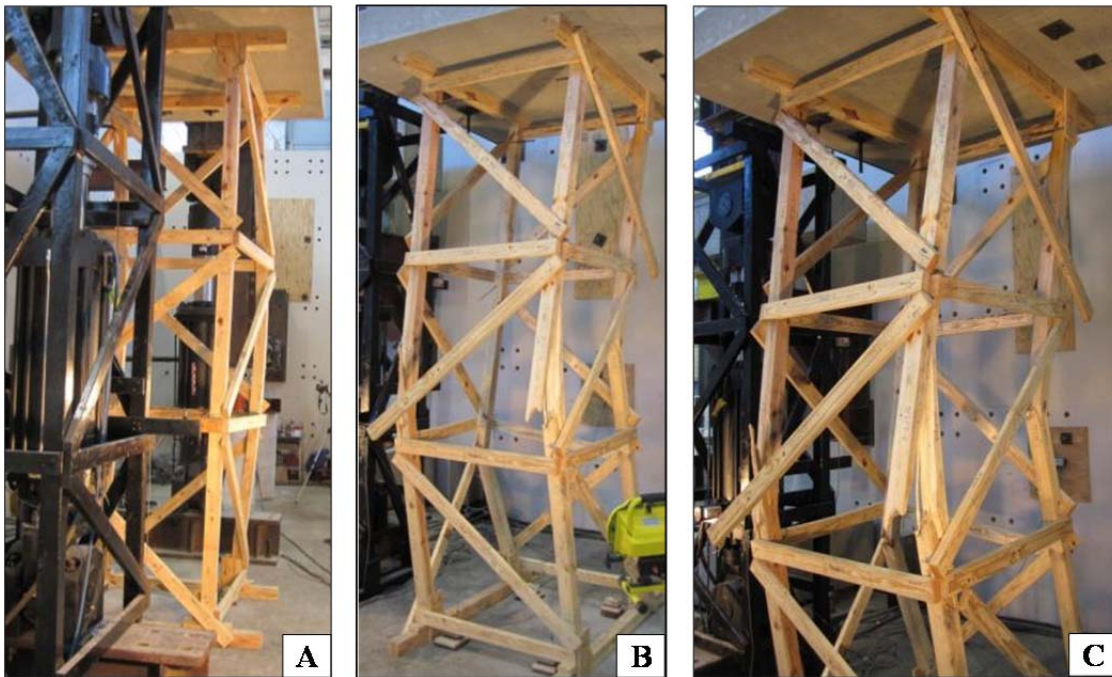
Bowing of the right posts prior to failure and the failures of all four posts are displayed in Figure 5.15. The buckling plane of the third failure (back left) was to the left whereas the buckling planes of the other three posts were towards the front, as seen in Figure 5.15-B.

**Figure 5.15** Specimen 3 A) Bowing of Right Posts before Failure B) End of Test Condition C) Close-up of All Four Post Failures

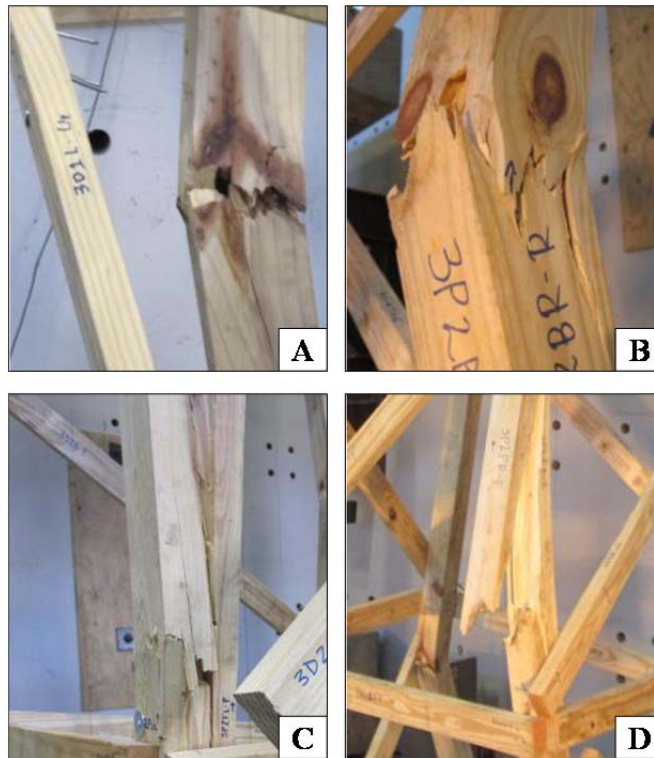
The load-displacement plot is shown in Figure 5.16. Figure 5.17 shows a close-up view of each of the four post failures. Each failure occurred at a knot in the post.

**Figure 5.17** Post Failures A) Back Left B) Back Right C) Front Left D) Front Right

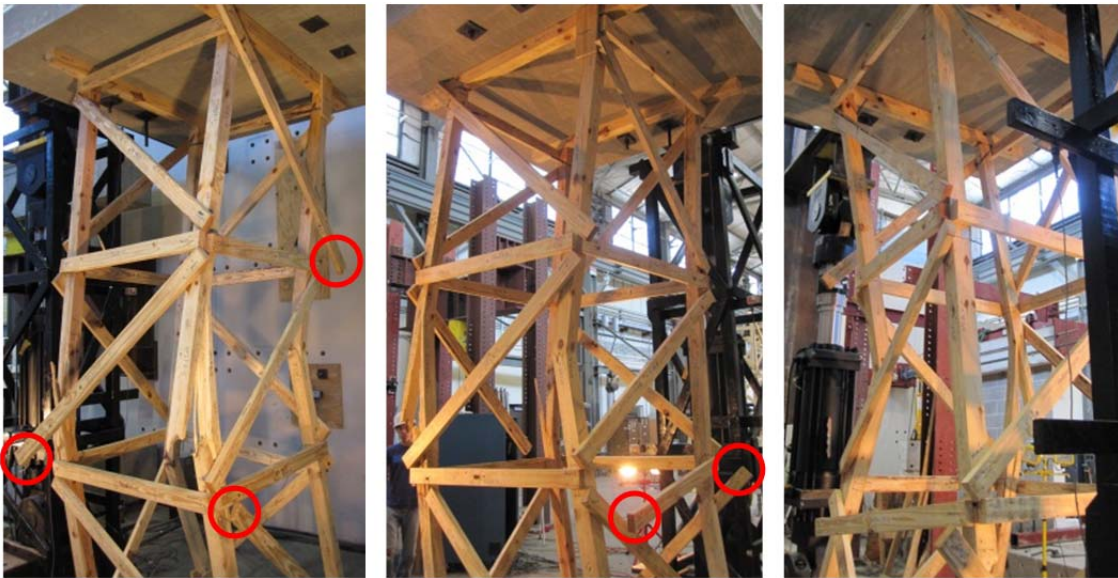
Multiple 2x4 brace connections failed during the extent of the test. Connection failures generally consisted of nail pullout due to splitting of the brace, or nail withdrawal from the post. The five connections that failed were: first level diagonal on left side (3D1L), first level diagonal on right side (3D1R), first level horizontal on back (3Hz1B), second level diagonal on front (3D2F), third level diagonal on right (3D3R). A partial nail withdrawal from the post was also observed on the third level diagonal on the left side (3D3L). The following photographs illustrate the locations of the failed braces and close-up images depicting a typical pullout scenario.

**Figure 5.18** Photographs of the Five Brace Connection Failures at End of Test

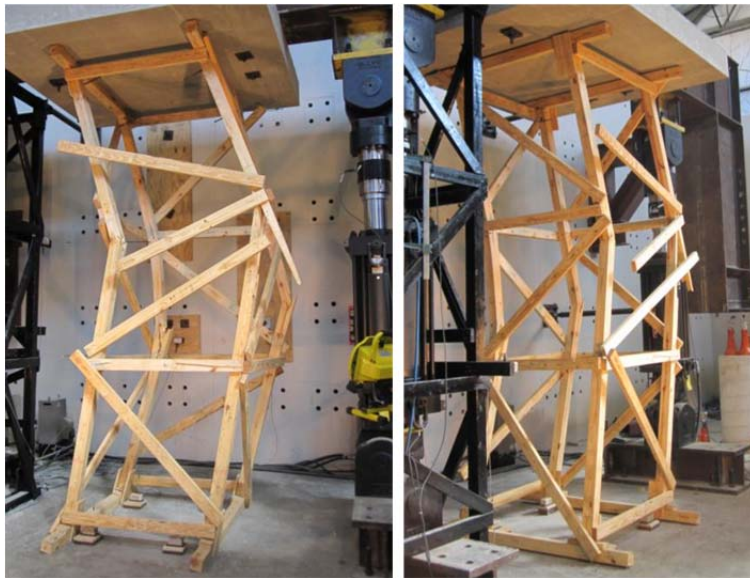
As the peak load was reached, the two back posts buckled to the right, followed closely by the buckling of the front two posts. The failure of all four posts occurred in approximately one second, in contrast to the progressive failures of the displacement-controlled tests. The load-displacement plot and post-failure photographs of test 4 are included in the following figures.

**Figure 5.22** Specimen 4 Failure Photographs at Conclusion of Test

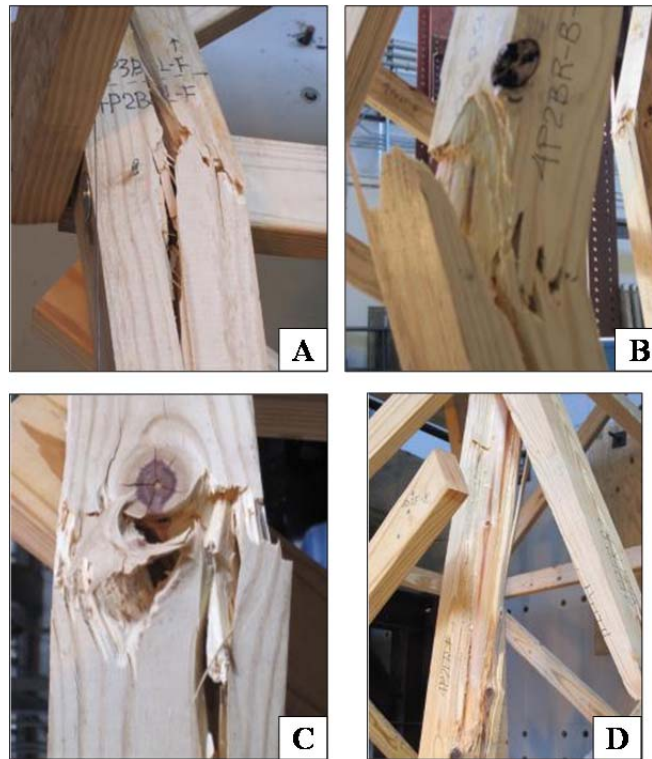
**Figure 5.23** Post Failures A) Back-Left B) Back-Right C) Front-Left D) Front-Right

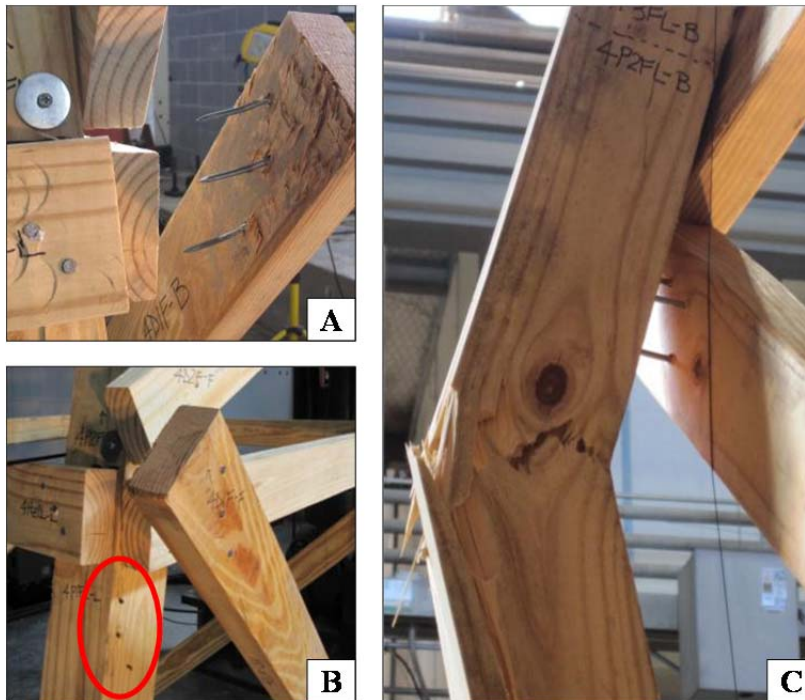
**Figure 5.25** Specimen 4 Connection Failures A) Nail Pullout B) Nail Pullout Holes C) Partial Pullout on Left Side

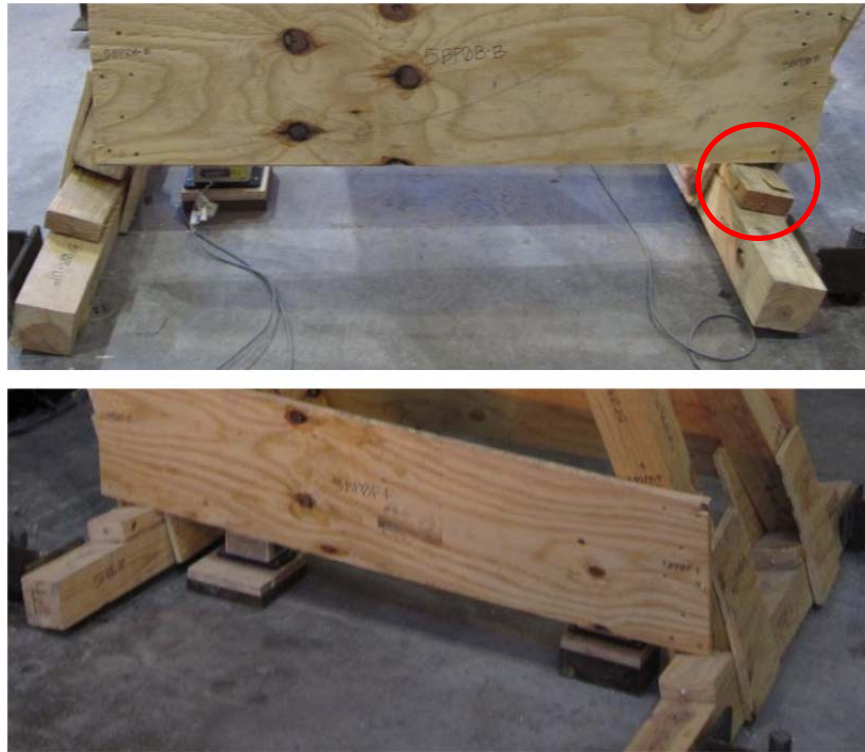
Wedge cupping was relatively absent throughout the entire loading sequence. Longitudinal wedge splitting was observed, but vertical cupping was not witnessed. Figure 5.26 shows the condition of the wedges at the conclusion of the test.

**Figure 5.26** Photographs of Wedges at the End of Test

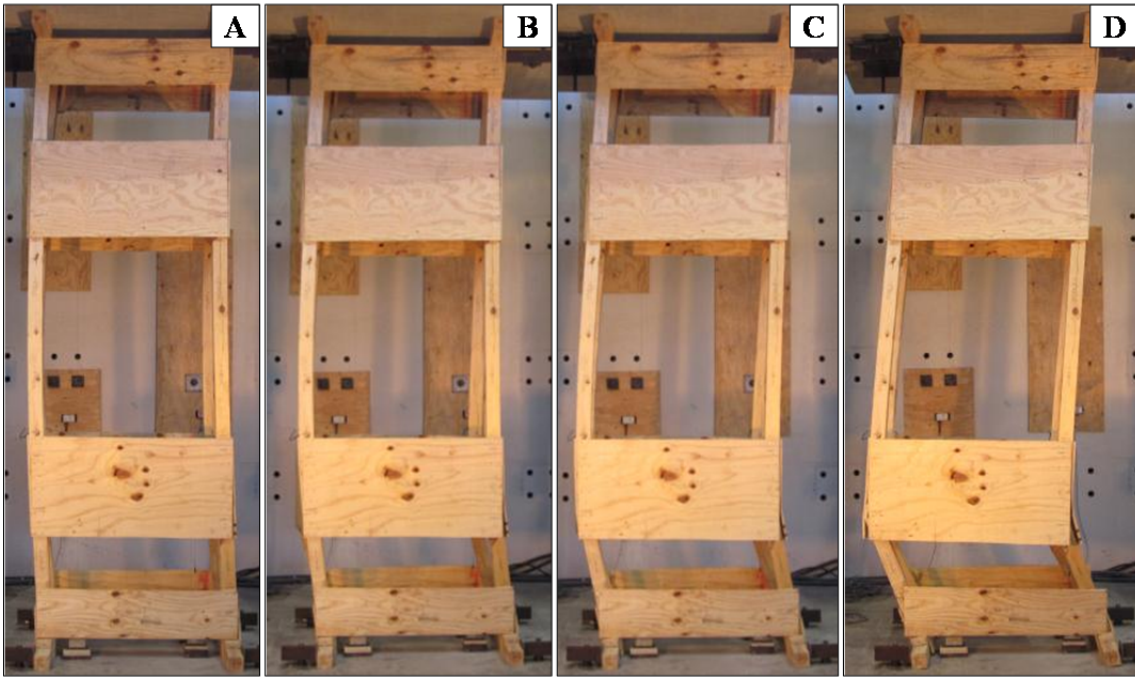
Rather than bending in double curvature as was seen during the lateral displacement phase of the test, the posts buckled in single curvature under the increasing vertical load. At approximately 62kips, both back posts failed at relatively the same time in the region of the lower intermediate plywood brace. The front two posts failed around 26kips in the same direction as the back two posts. Figure 5.32 shows the progressive failure and Figure 5.31 shows the vertical load-displacement plot for the entire duration of the test. Vertical loading conducted after the completion of the cyclic phase is shown to the right of the dashed red line.

**Figure 5.32** Specimen 5 Failure Progression A) Bowing of Posts B) Back Posts Fail C) Front Posts Fail D) Final Condition at End of Test

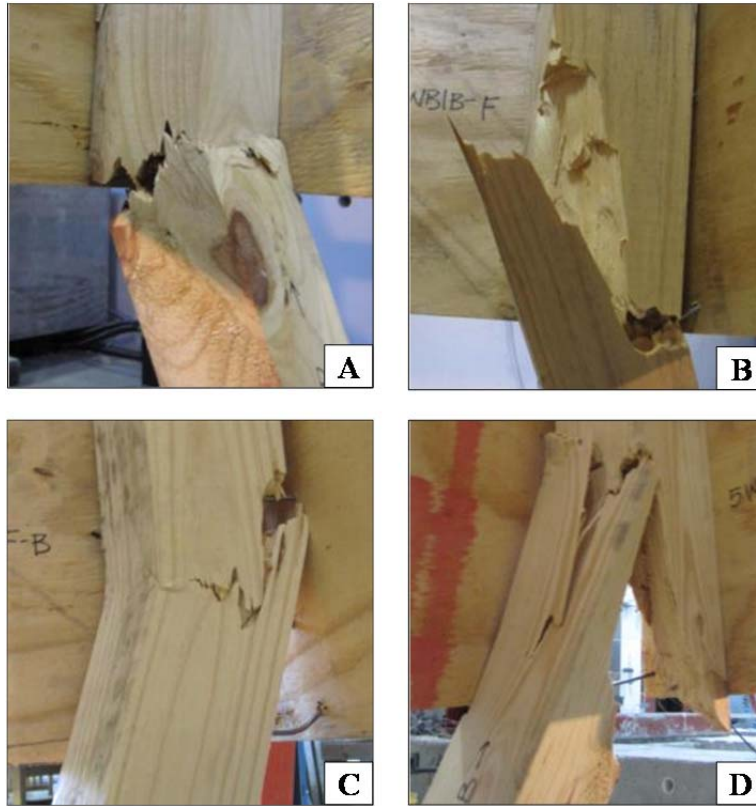
Close-up photographs of the four failures from the interior of the shore are provided in Figure 5.33.

**Figure 5.33** Post Failures A) Back-Left B) Back-Right  
C) Front-Left D) Front-Right

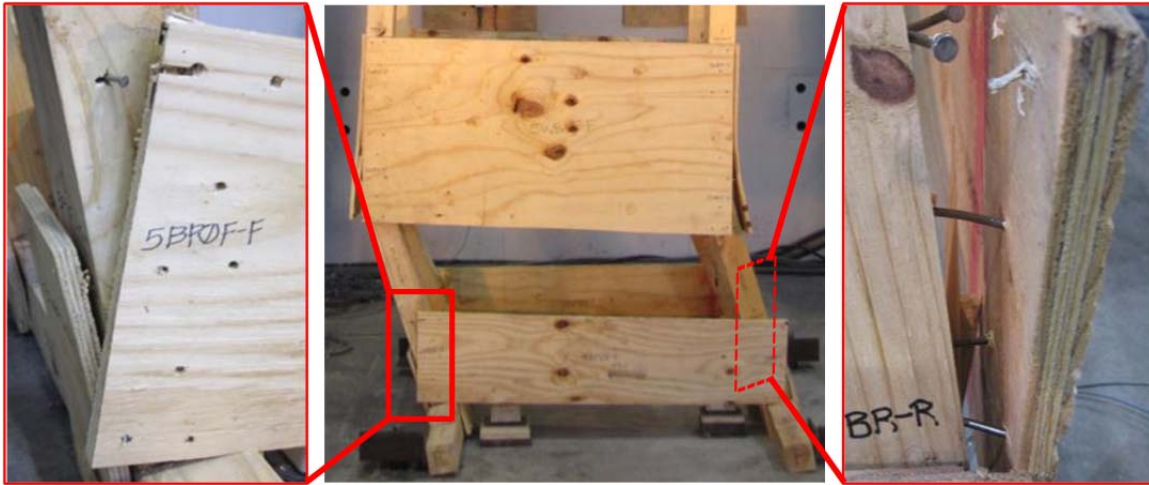
Failure of all four posts occurred in the region of the lower intermediate plywood brace. This caused noticeable connection failures on the lower level, and only minor failures in the upper braces. Connection failures primarily consisted of nail withdrawal from the post, or the nail pulled through the plywood brace. Samples of these connection failures are provided in Figure 5.34.

**Figure 5.34** Connection Failure Examples from Specimen 5

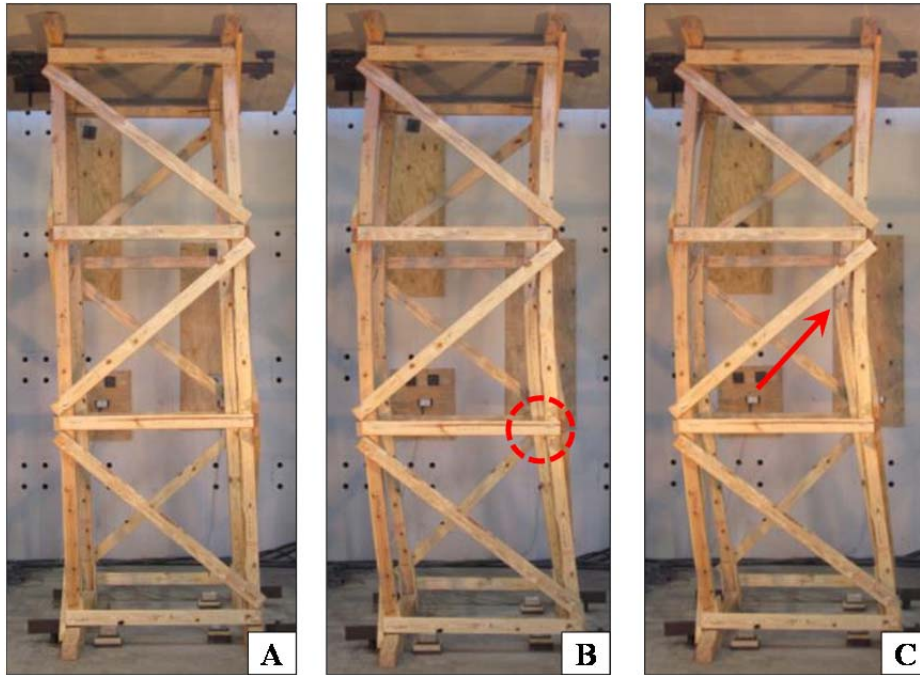
The first failure was a connection failure of the 1<sup>st</sup> level diagonal on the back side at the back right post. As the maximum load was attained, the top end of the diagonal withdrew from the back right post allowing substantial bending deformation of the post to occur. This connection failure and buckling behavior is depicted in Figure 5.37 as the instantaneous loss of capacity followed by a short re-stiffening of the shore between 55 and 65kips. The first buckling failure of a post occurred in the back-right post at approximately 41kips. Both front posts failed simultaneously at approximately 30kips. A pictorial representation of the different phases of testing and initial failures is presented in Figure 5.36 below.

**Figure 5.36** Loading Specimen 6 A) Initial 6in Displacement Prior to Loading B) 1<sup>st</sup> Connection Failure C) Back Right Post Failure

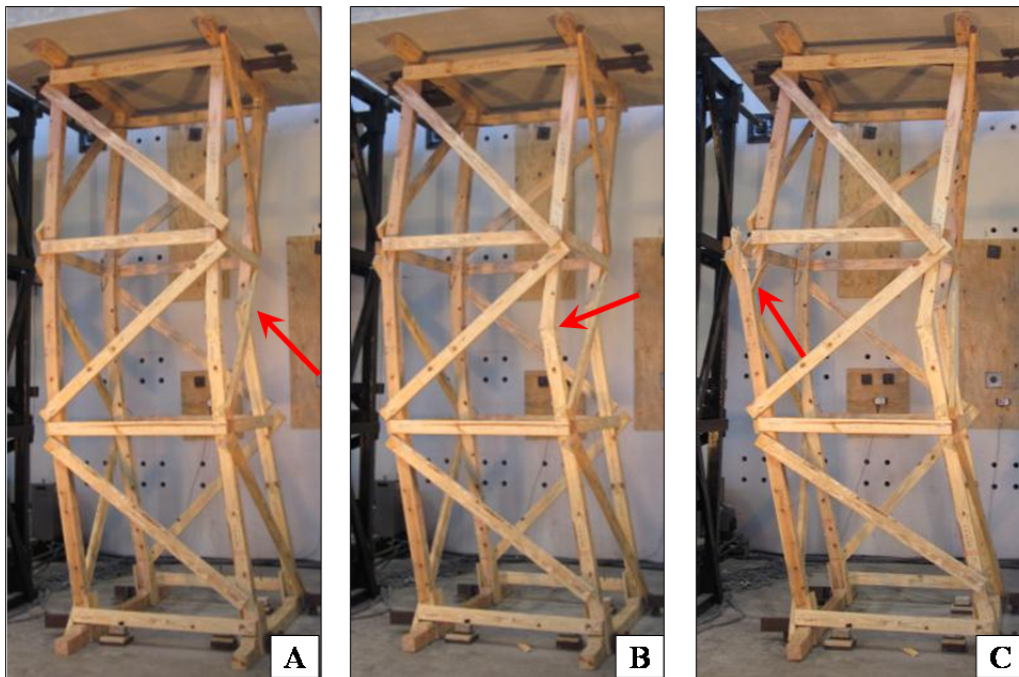
**Figure 5.38** Specimen 6 Failure Sequence A) 1<sup>st</sup> Failure B) Front Right Failure  
C) Front Left Failure

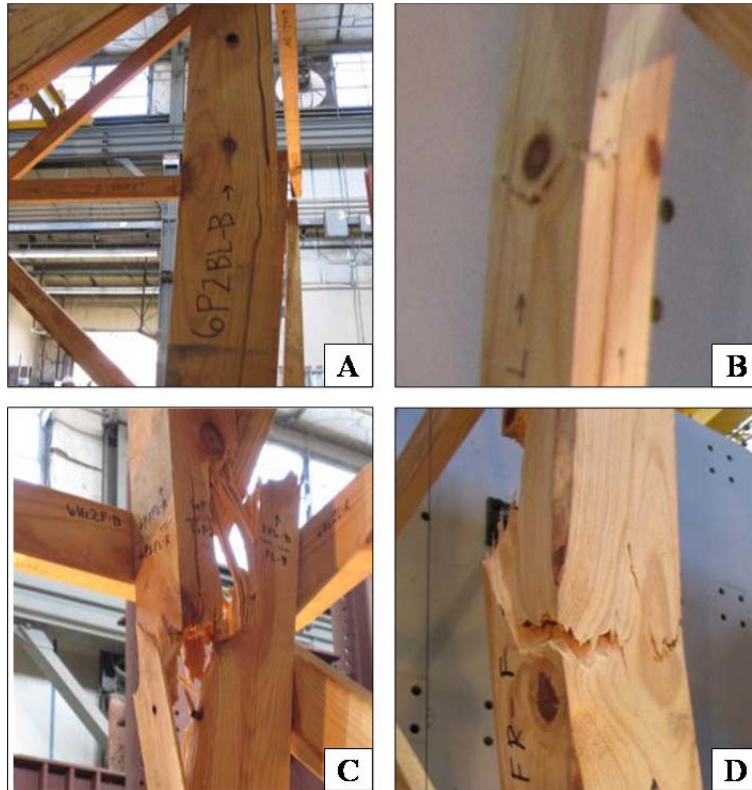
**Figure 5.39** Detailed Photographs of each Post Failure A) Back Left B) Back Right C) Front Left D) Front Right

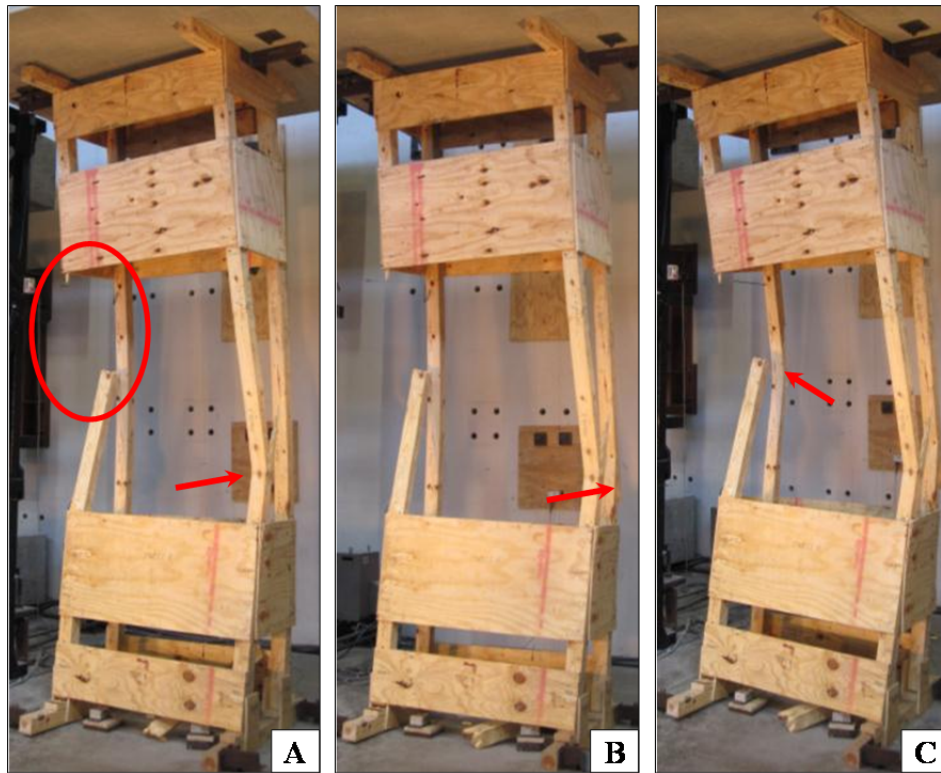
**Figure 5.43** Failure Modes A) Initial Failures B) 3<sup>rd</sup> Failure C) 4<sup>th</sup> Failure

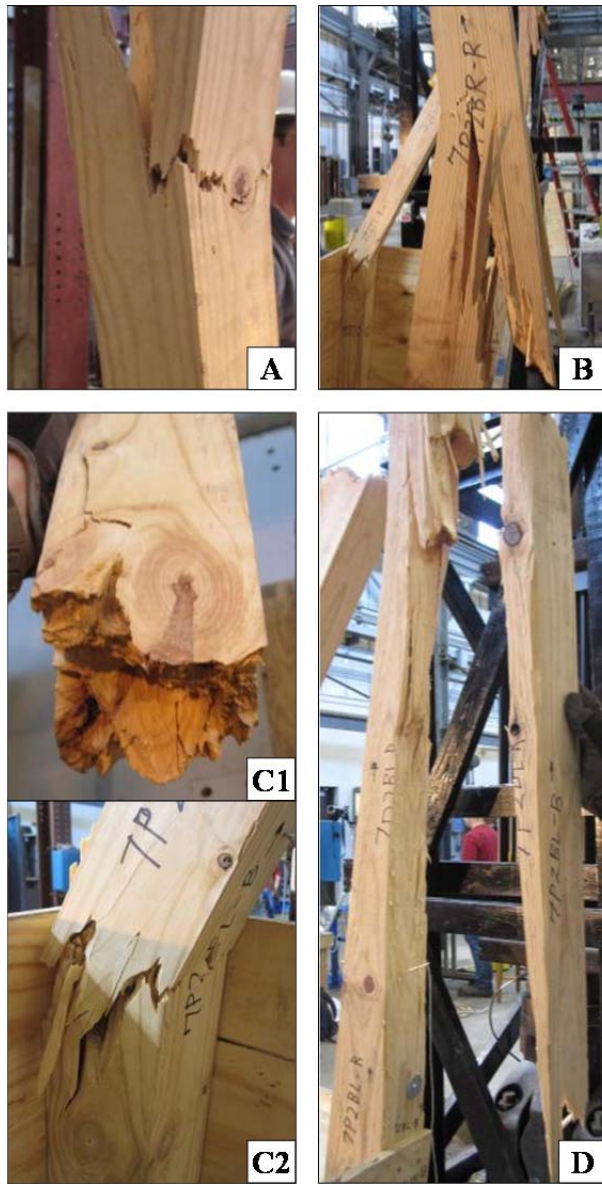
**Figure 5.44** Failure Photographs A) Front-Right Post B) Back-Right Post C1) Top Failure of Front-Left Post C2) Bottom Failure of Front-Left Post D) Back-Left Post

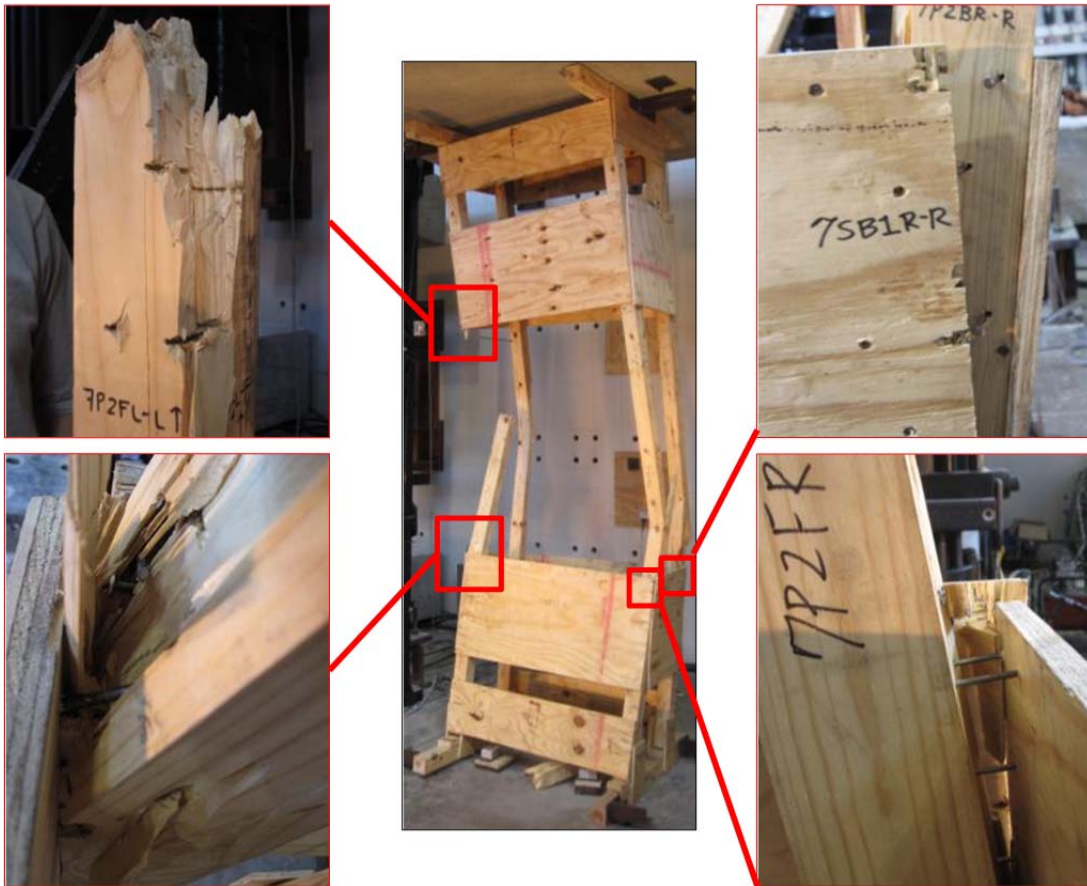
**Figure 5.45** Regions of Significant Brace Connection Failures

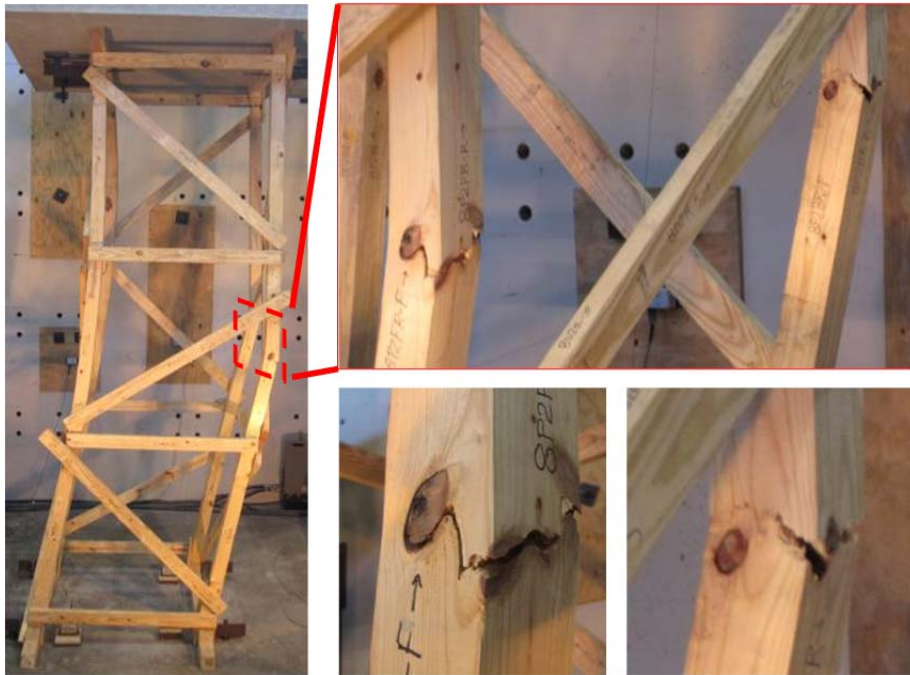
**Figure 5.50** Photographs of Right Side Post Failures

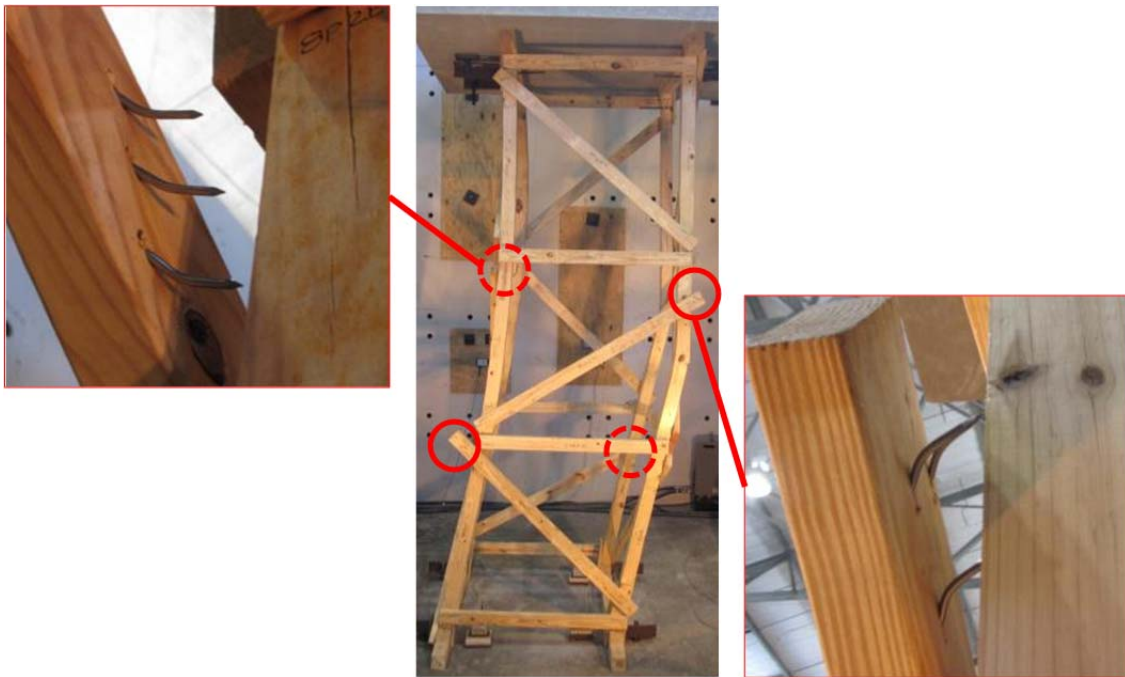
**Figure 5.51** Connection Failures of Braces

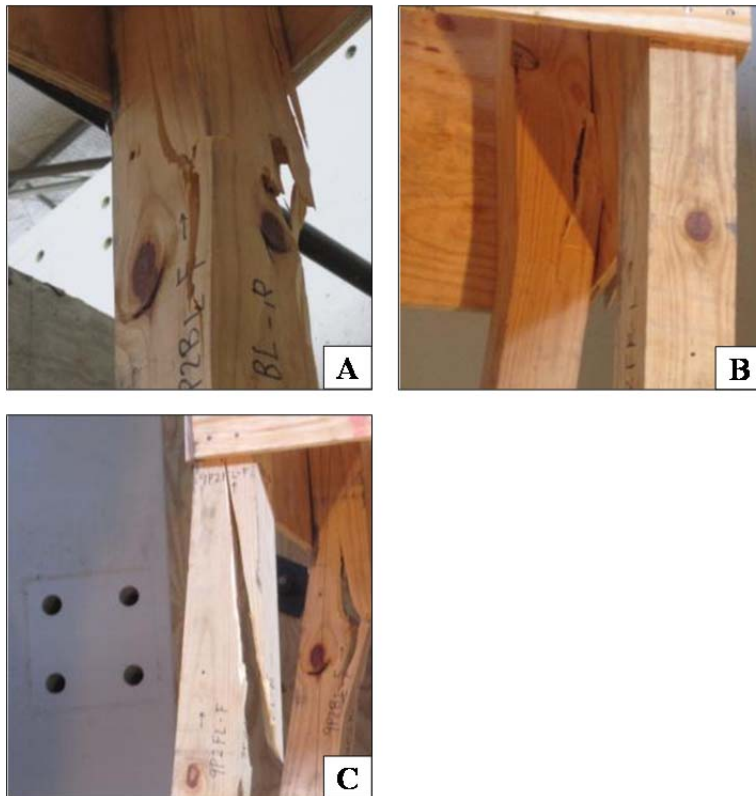
**Figure 5.58** Individual Post Failures A) Back Left Post  
 B) Back Right Post C) Front Left Post

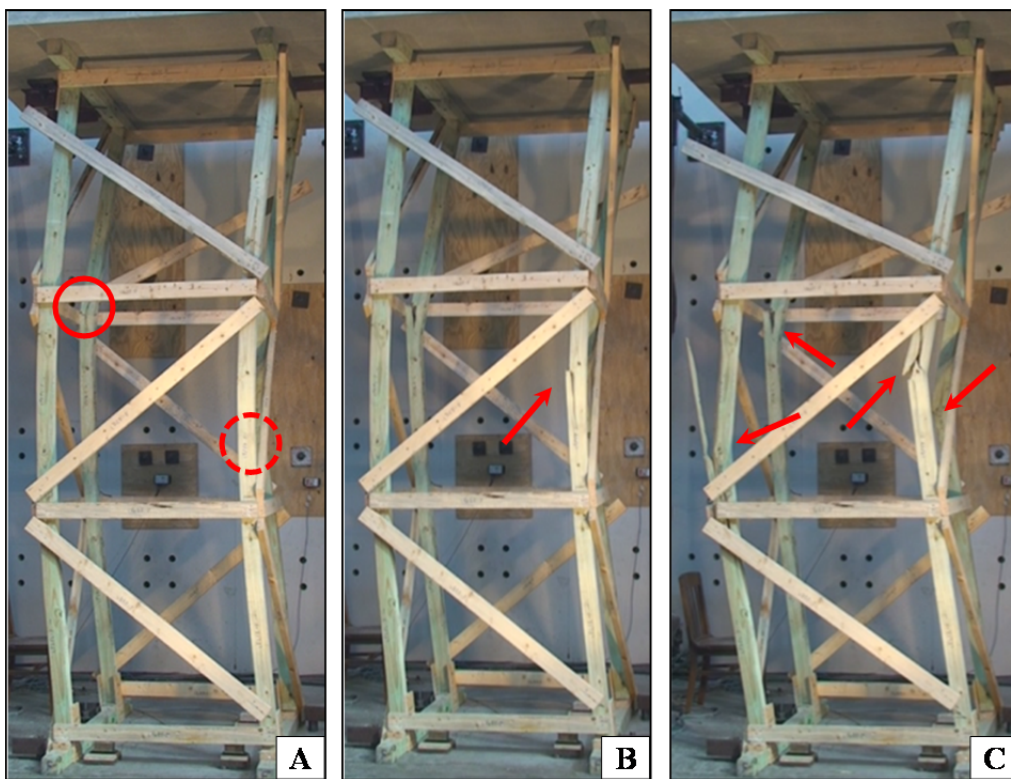
**Figure 5.64** Post Failures A) Initial Failures B) Secondary Failure C) Final State

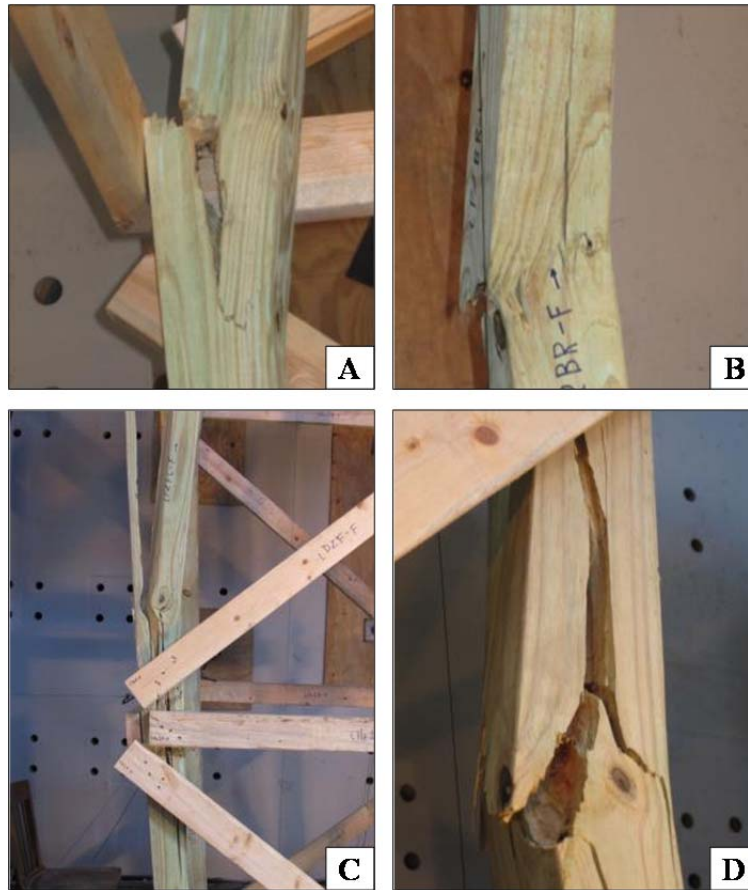
**Figure 5.65** Failure Close-ups A) Back Left Post B) Back Right Post C) Front Left Post D) Front Right Post

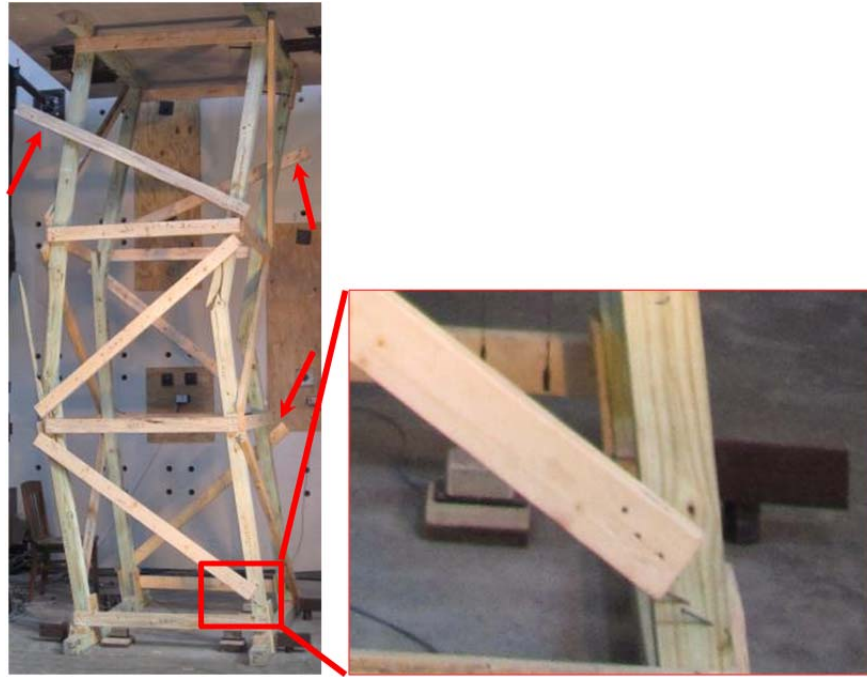
**Figure 5.66** Diagonal Brace Connection Failures

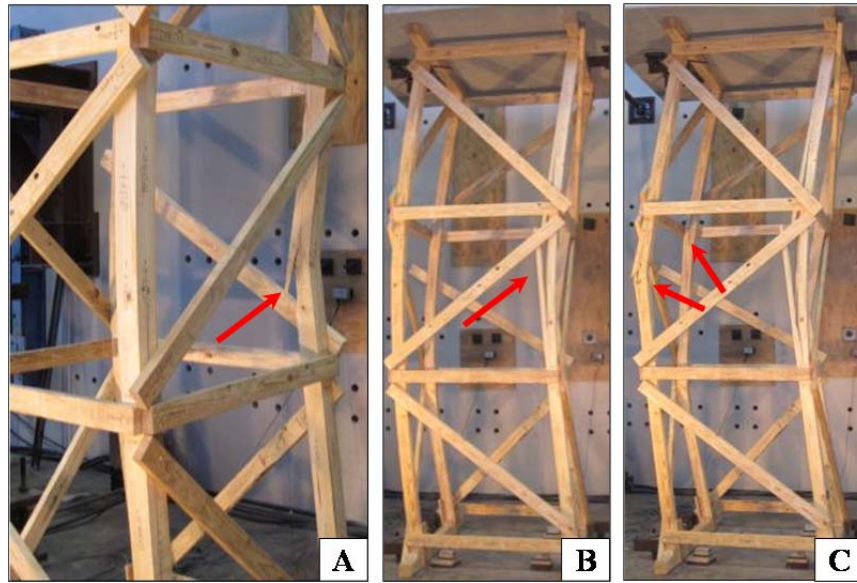
**Figure 5.71** Failure Sequence A) 1<sup>st</sup> Failure B) 2<sup>nd</sup> Failure C) Final Failures

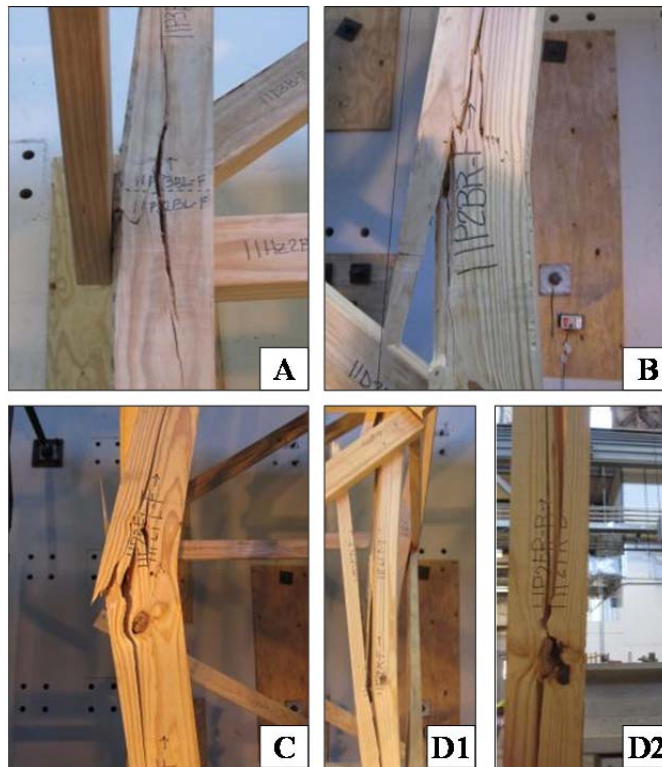
**Figure 5.72** Failures A) Back Left Post B) Back Right Post C) Front Left Post D1) Front Right (Front) D2) Front Right (Back)
