**Testing of Emergency Wood Shoring Towers for use in Urban Search  
and Rescue Operations**

**Thesis**

**The University of Texas at Austin**

**May 2012**

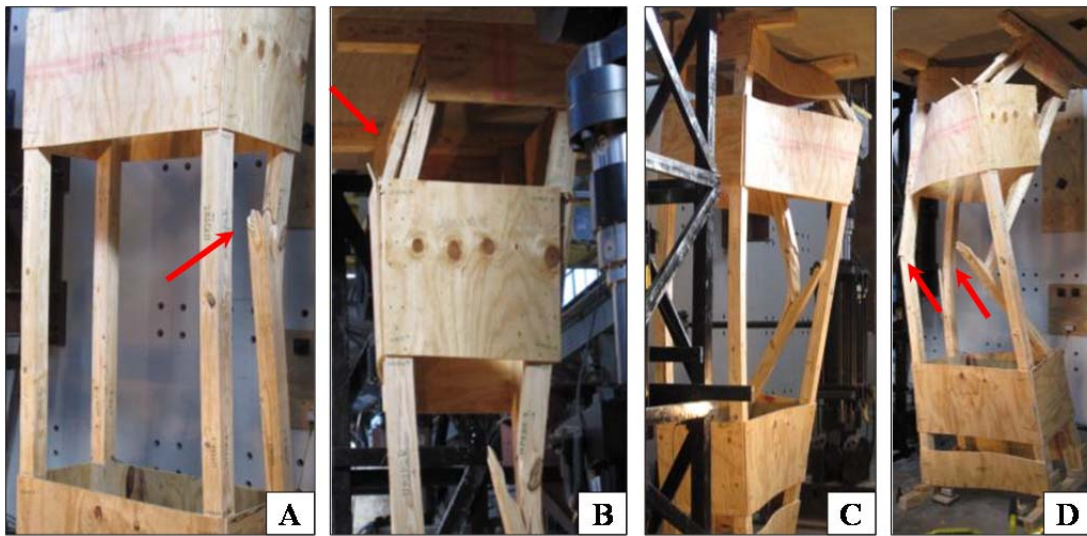
**Figure 5.76** Failures A) 1<sup>st</sup> Failure B) 2<sup>nd</sup> Failure C) Excessive Torsional Buckling of Braces, Excessive Deflection D) Final Failure of Left Posts

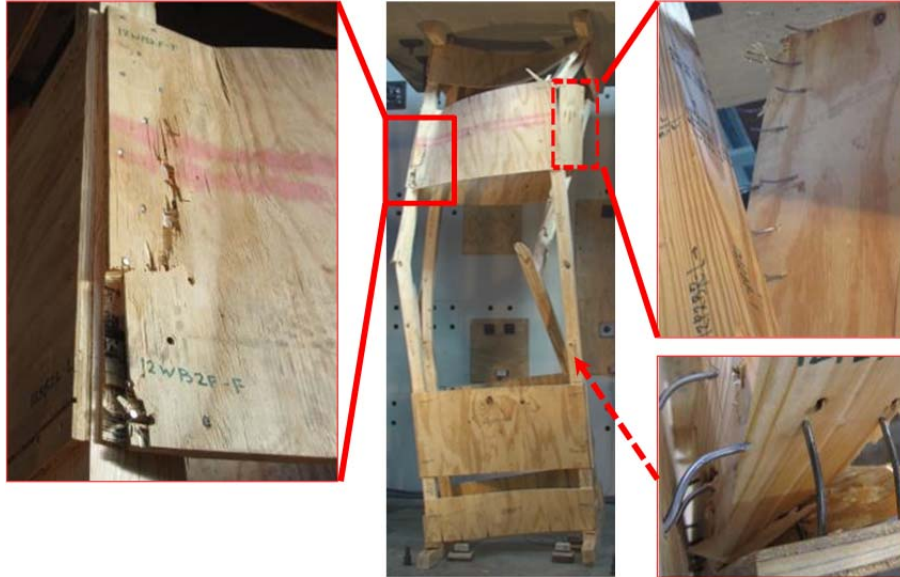
**Figure 5.78** Brace Connection Failures

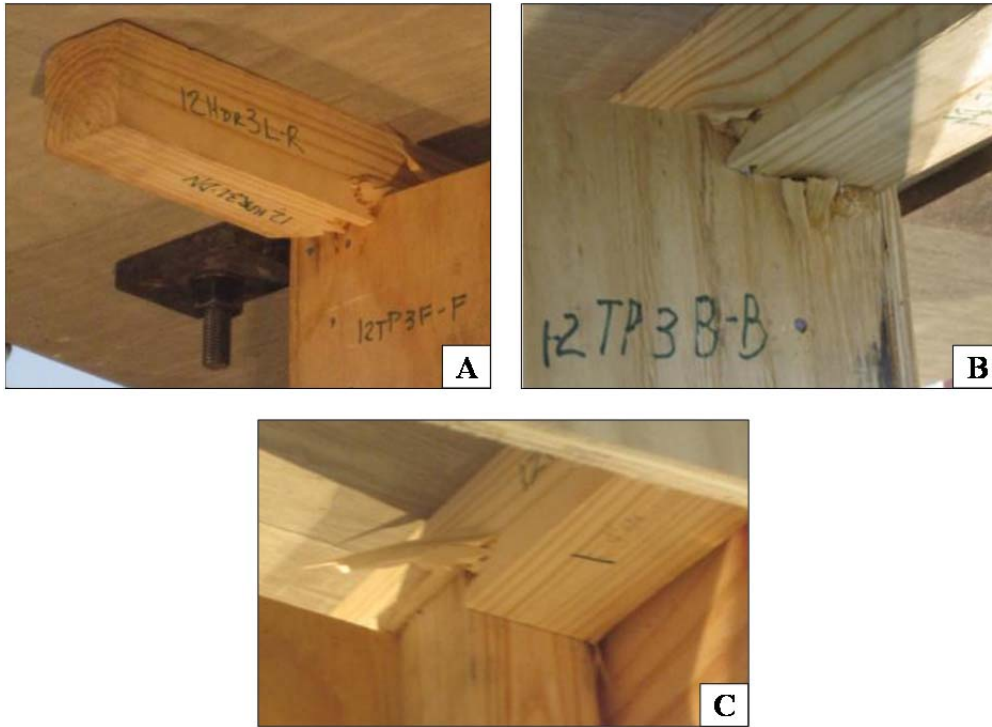
**Figure 5.79** Bearing Into Left Header A) Front Left B) Back Left C) Front Left  
(Interior)

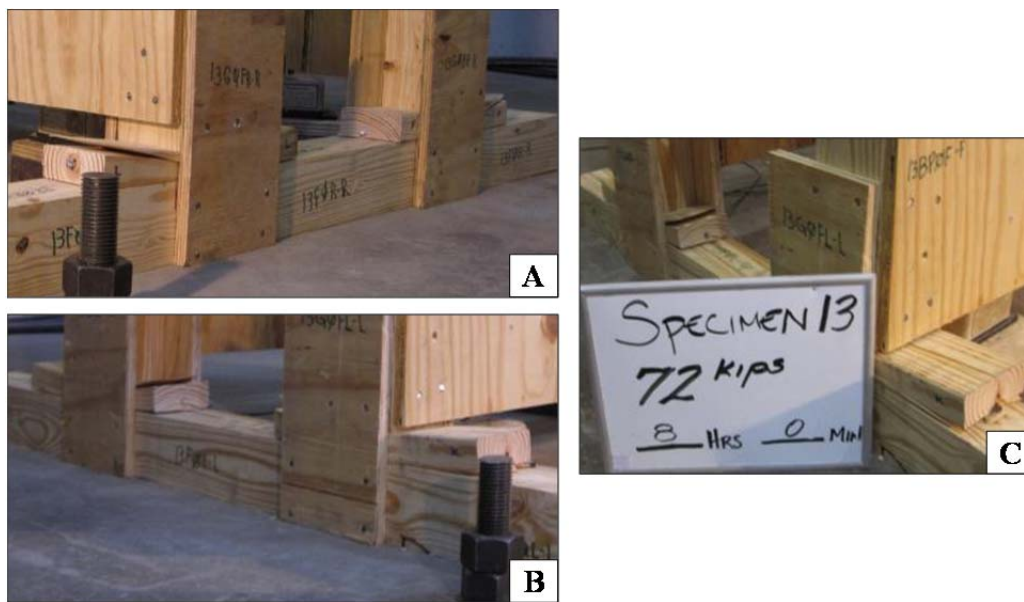
**Figure 5.80** Wedge Performance with 72kip Load A) Right Side at 0.0hrs  
B) Left Side at 0.0hrs C) Left Side at 8.0hrs

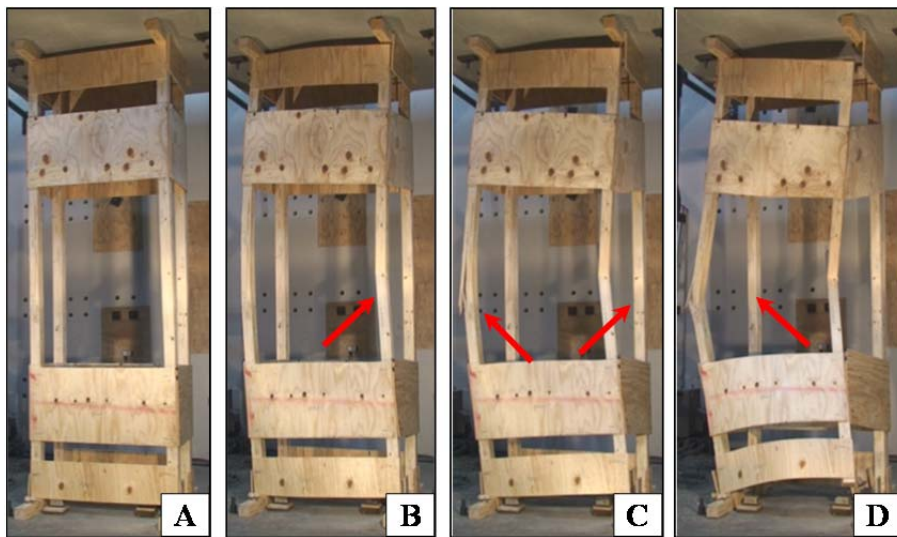
**Figure 5.82** Progressive Failures A) 72kips B) 1<sup>st</sup> Failure C) Front Left and Back Right Posts Fail D) Back Left Post Fails (End of Test)

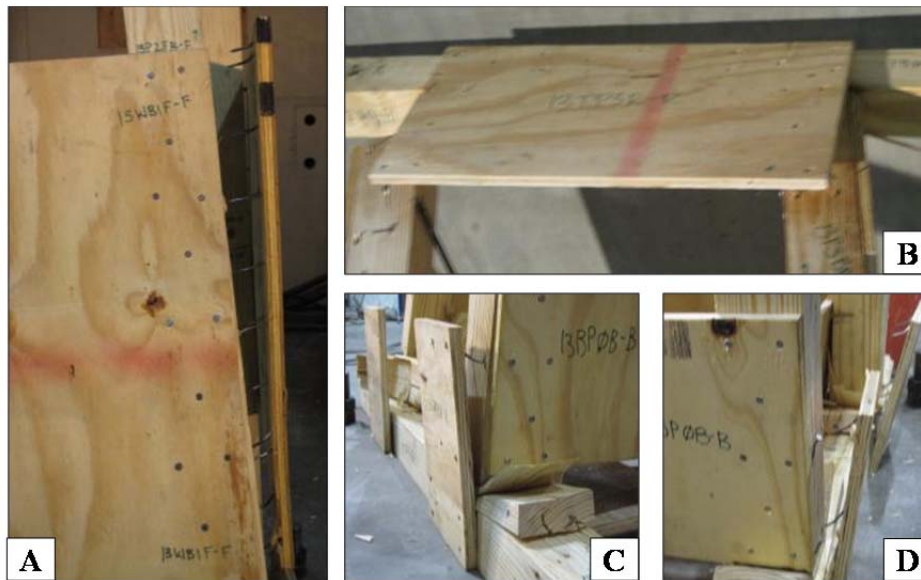
**Figure 5.84** Brace Failures A) 1<sup>st</sup> Level Brace on Right Side B) Top Plate on Right Side C) Gusset Plates on Right Side D) Gusset Plates on Left Side

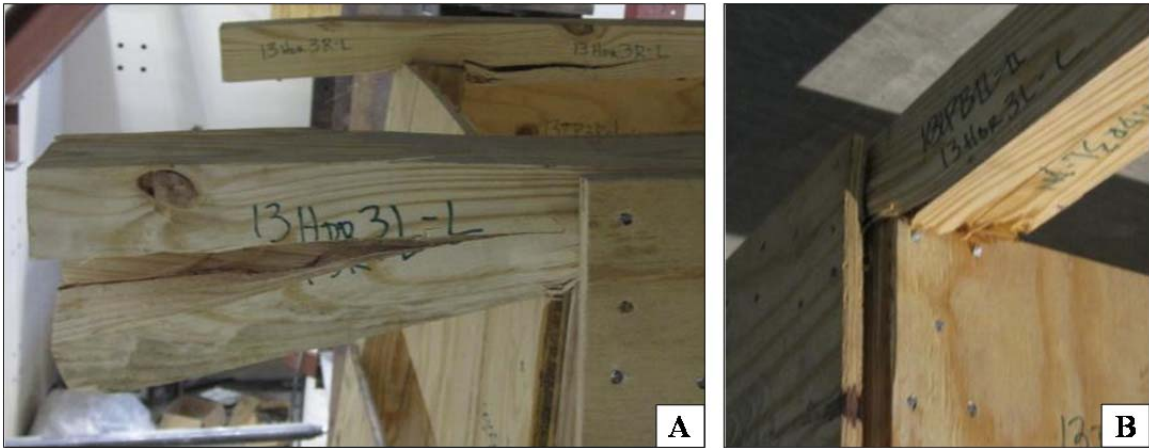
**Figure 5.85** Condition of the Headers A) Split Left Header (foreground) and Split Right Header (background) B) Bearing of Left Front Post into Left Header
