Ferguson Structural Engineering Lab Newsletter

Volume 5, Issue 2

THE UNIVERSITY OF TEXAS AT AUSTIN - STRUCTURAL ENGINEERING

July 30, 2013

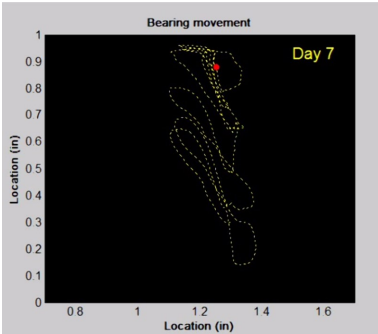
The movement trace of a bearing over a week, not a drunken person's walk...

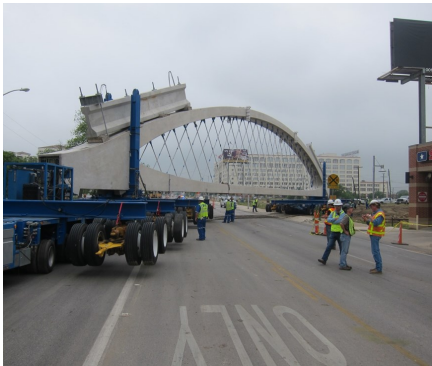
Arch transportation using Self Propelled Modular Transporters (SPMTs)

During the spring semester, the final stages were performed in the precast yard, and all of the arches were made ready for transportation. The 300-ton arches were then transported over a distance of almost half a mile and were installed on new

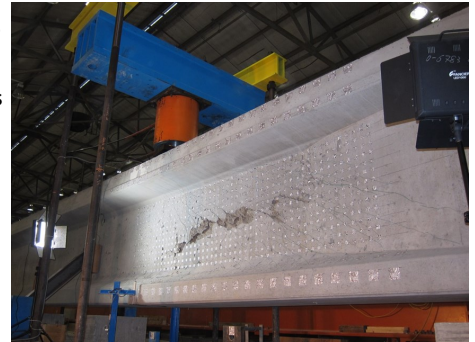
Failure of girder 5 showing vision system targets

The spliced girder team is nearly finished testing the fifth of eight large-scale beam specimens in their investigation of the shear performance of post-tensioned bridge girders. The vision system developed at FSEL was used during a recent test to capture the expansion of the beam web due to the

presence of the post-tensioning duct (see picture). The team hopes to use the data to better understand the shear failure mechanism of the beam specimens.

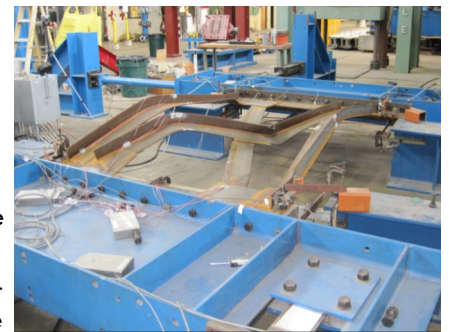
Cross frame stiffness test setup with unequal leg X frame

K frames and X frames offer adequate fatigue performance, and we will be making some recommendations on the width of the gusset plates to improve the life of the details. We have also performed one stiffness test and two fatigue tests on X frames using unequal leg angles, which have a reduced member eccentricity.

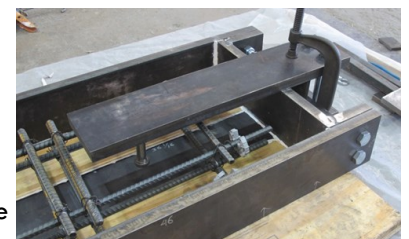
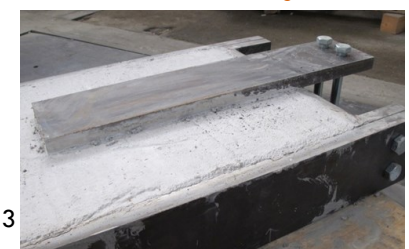
Composite specimen before (above) and after (below) concrete casting

A test setup is being designed and constructed to determine the load-slip behavior of shear connectors at elevated temperatures. Experiments on small steel-concrete composite specimens will be conducted at several temperatures ranging from room temperature up to 800°C. Thermocouples will be installed over the thickness

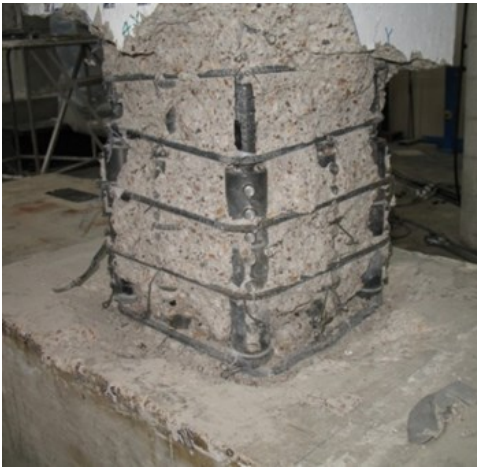
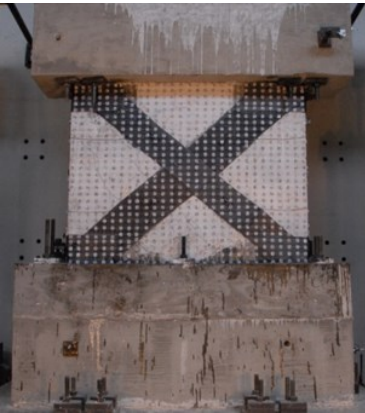
Retrofitted column (above) and masonry wall (below) after testing

Innovative materials and devices can be used to strengthen reinforced concrete members for improved seismic performance. Laboratory tests were conducted on full scale reinforced concrete columns and a masonry wall which were retrofitted using new techniques after suffering severe damage. CFRP sheets and anchors were used to provide additional shear

capacity and ductility. These sheets were applied both as column jackets and as diagonal ties on the masonry walls. Mechanical splices were used to provide continuity to the reinforcement and to replace buckled bars in areas of heavy damage. The performance of the retrofitted members was found to be comparable to that of similar members strengthened using more conventional techniques. The mechanical splices behaved well under the axial load and moments applied through the lateral cy-

lic loading applied to the columns. The CFRP materials confining the hinge region at the column base provided a large amount of ductility. The CFRP sheets and anchors allowed the columns and wall to carry higher shear loads than the original structures. The feasibility of these innovative strengthening methods for a particular case depends on the degree of damage, the cost of replacement, and the performance requirements of the strengthened structure.

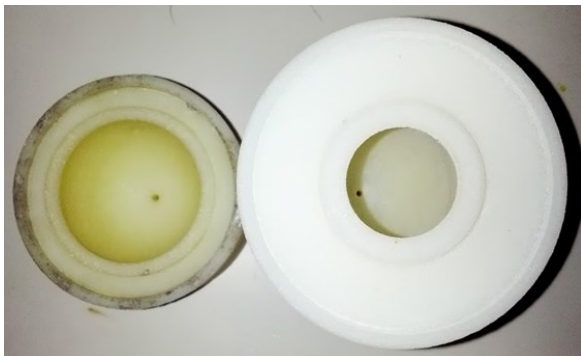
Air-coupled impact-echo testing equipment

The air-coupled impact-echo system works well when employed in through-transmission tests, i.e. when the spark source and the microphone are positioned on opposite sides of the concrete slab test specimen. However, when the source and the receiver are located on the same side of the specimen, the noise generated by the spark tends to overshadow the useful impact-echo signal,

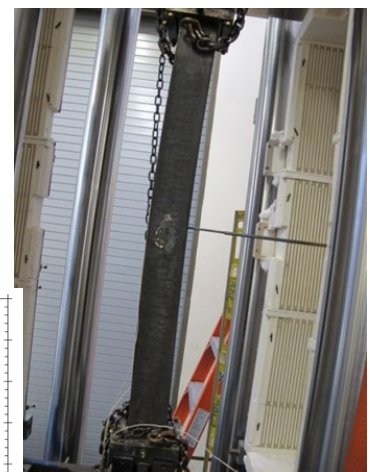
Buckled column at 700°C (above) and corresponding load-deflection plot (left)

vated temperatures. The buckling tests on W4×13 wide flange columns are currently underway and will be continued through summer. As an example, the deformed shape of a pin-ended column following a buckling test at 700°C is shown in the picture. The corresponding load-deflection curve is also shown. As can be seen in the load-deflection plot, a small increase in the crosshead displacement rate has result-

ed in a jump in this curve. This observation further illustrates the time-dependent buckling behavior of steel columns at elevated temperatures.

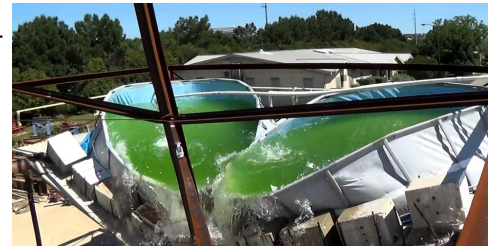
The floor slab at the moment of collapse

A second large-scale test was carried out in May 2013 (see picture). The purpose of the test was to characterize the response of a composite floor slab under a perimeter column loss scenario. The specimen was an isolated portion of a prototype building that was designed and constructed using typical practices found in the US and worldwide. This second test further
