1. Report No. FHWA/TX-06/0-4176-1		2. Government Accession No.		3. Recipient's Catalog No.	
4. Title and Subtitle Anchorage Requirements for Grouted Vertical-Duct Connectors in Precast Bent Cap Systems			5. Report Date May 2006

ANCHORAGE REQUIREMENTS FOR GROUTED VERTICAL-DUCT CONNECTORS IN PRECAST BENT CAP SYSTEMS

CTR Research Report:	4176-1
Report Date:	May 2006
Research Project:	0-4176
Research Project Title:	Development of Precast Bridge Construction Systems
Sponsoring Agency:	Texas Department of Transportation
Performing Agency:	Center for Transportation Research at the University of Texas at Austin

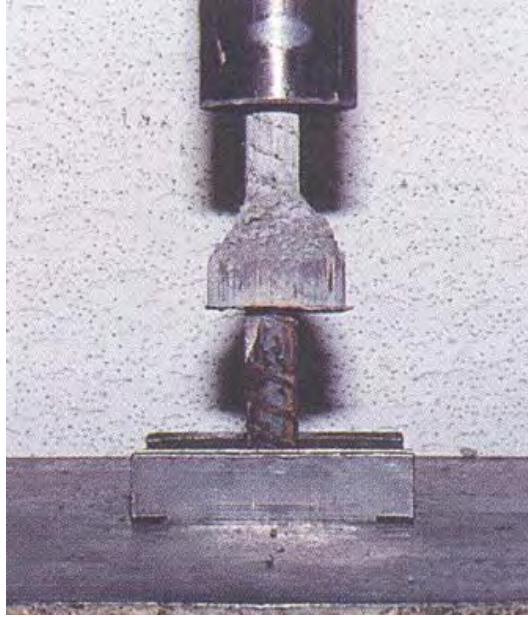
Figure 2.5 Pullout Failure of Generic Grout-Filled Splice Sleeve (Einea et al. 1995)

Einea et al. (1995) tested a series of generic grout-filled reinforcing bar splices monotonically in tension utilizing standard steel pipe as the sleeve material (Figure 2.5). Four different types of splice specimens were tested using both lap splice and butt splice arrangements, and with different steel pipe end details. Details included welding steel rings on the ends of pipes to mobilize confinement action in the grout. Tests involved #5, #6, and #9 bars with embedded lengths between 5 and $11d_b$. Most specimens failed at an axial stress higher than the specified yield strength of the reinforcement.

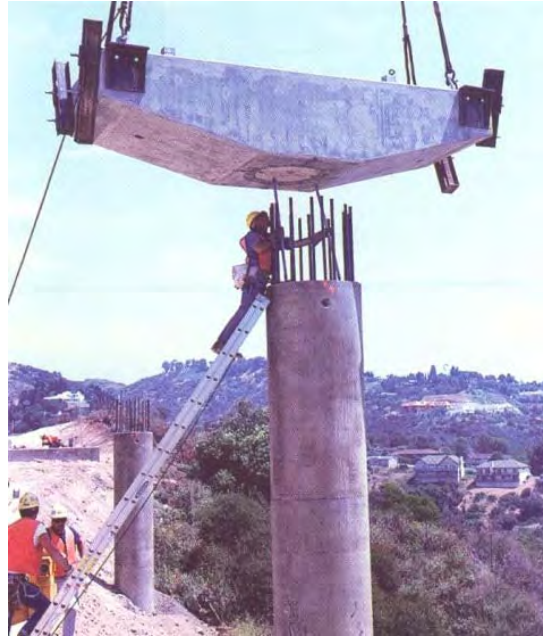
Figure 2.6 Precast Crossheads Used in the Getty Center People-Mover System Project (Josten et al. 1995)

The Getty Center People-Mover System in Los Angeles was built using precast concrete crossheads with grouted vertical-duct connections (Josten et al. 1995). The precast crosshead elements provided an efficient construction system in an environmentally sensitive site along steep hillsides (Figure 2.6). The columns of the tram system were cast-in-place and included a double reinforcing bar template to ensure adequate alignment of the vertical reinforcement that projected above the tops of the columns into the precast crosshead elements. The connection configuration typically consisted of 16 reinforcing bars, as large as #11s, in a 3'-0" diameter circular pattern. The protruding column bars were housed inside 1.5-in. diameter corrugated sleeves cast into the crossheads. High-strength grout was then poured into the sleeves to complete the connections. The sleeve diameter was restricted to 1.5 in. so that it would not interfere with the crosshead reinforcing. Construction of the crosshead elements also made use of templates in the formwork that aligned and maintained the corrugated sleeves at the proper location. Although clearances were extremely tight, all crossheads aligned correctly when erected in the field.

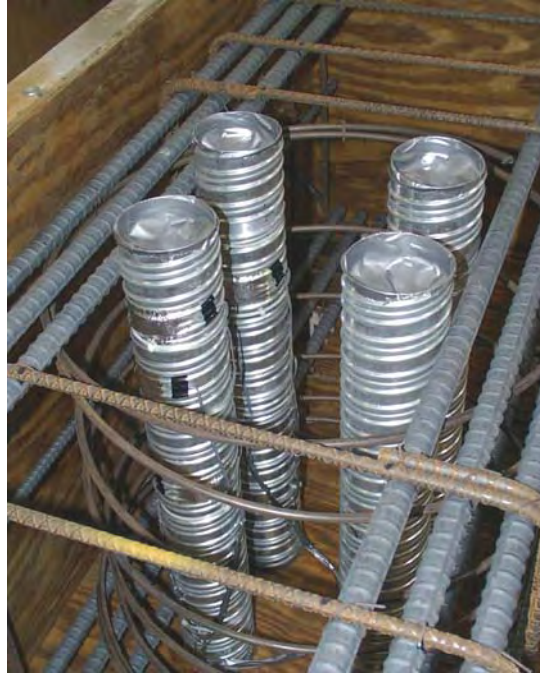
Figure 5.7 Completed Strain Gage Installations on Galvanized Steel Ducts

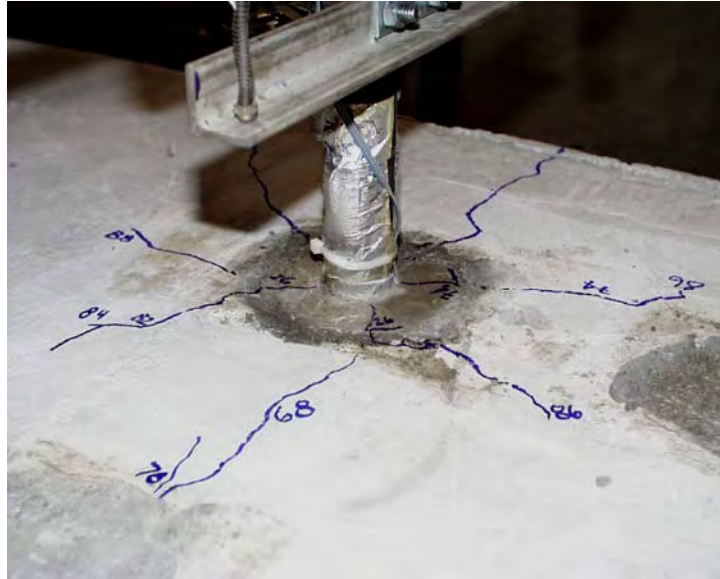
Figure 6.1 Widespread Splitting in Test 10

Crack patterns in specimens constructed using galvanized steel duct are illustrated using Tests 10, 13, and 23. A single, plain bar with an embedded depth of $12d_b$ was loaded during Test 10. The first signs of cracking in the grout were observed at a load of 26 kip (17 ksi). As load increased, radial cracks were observed in the concrete at a load of approximately 68 kip (45 ksi). A widespread pattern of radial splitting (Figure 6.1) formed at a load of approximately 88 kip (57 ksi). The pattern of radial splitting in single connectors was generally axisymmetric, meaning cracks were usually spread equally in all directions. The cracks typically extended over a large portion of the top surface of the specimens.

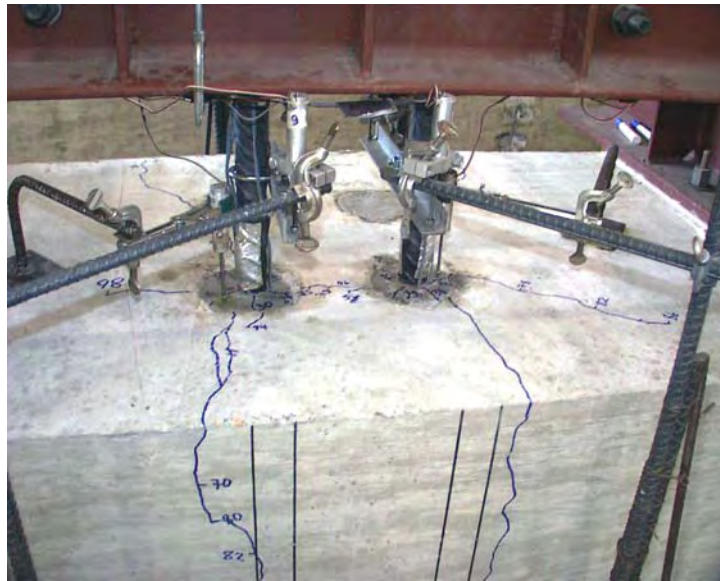
Figure 6.3 Widespread Splitting in Test 13

The crack patterns at failure were similar for tests with multiple connectors. Two, plain bars with embedded depths of $16d_b$, were loaded during Test 13. The first signs of cracking in the grout were observed at a load of 24 kip (16 ksi), and radial cracks in the concrete were observed at a load of 86 kip (57 ksi). The crack patterns around the two connectors were similar throughout the test (Figure 6.3). The close proximity of connectors (clear spacing of $1D$ between ducts) caused extensive interaction between the connectors. Both connectors failed together as a unit at a load of approximately 132 kip (87 ksi) (Figure 6.4).

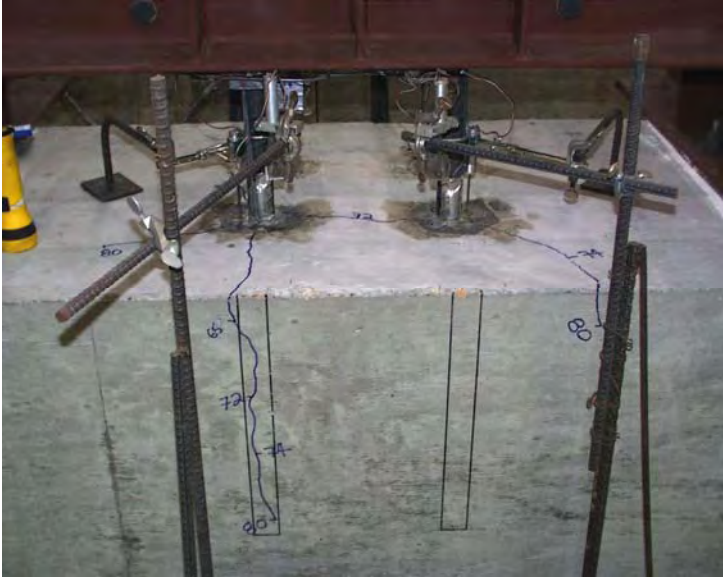
Figure 6.5 Widespread Splitting in Test 23

Two connectors were also tested in Test 23. The connectors were embedded $12d_b$ and the clear spacing between ducts was $2D$. The increased duct clear spacing reduced the interaction between the connectors and different crack patterns were observed for each connector (Figure 6.5). In this test, cracks were first observed in the grout at a load of approximately 19 kip (13 ksi) and widespread splitting was observed at a load of 74 kip (49 ksi). As loading approached failure, the connectors acted as a unit. Figure 6.6 shows the crack pattern at failure, which included V-shaped cracks.

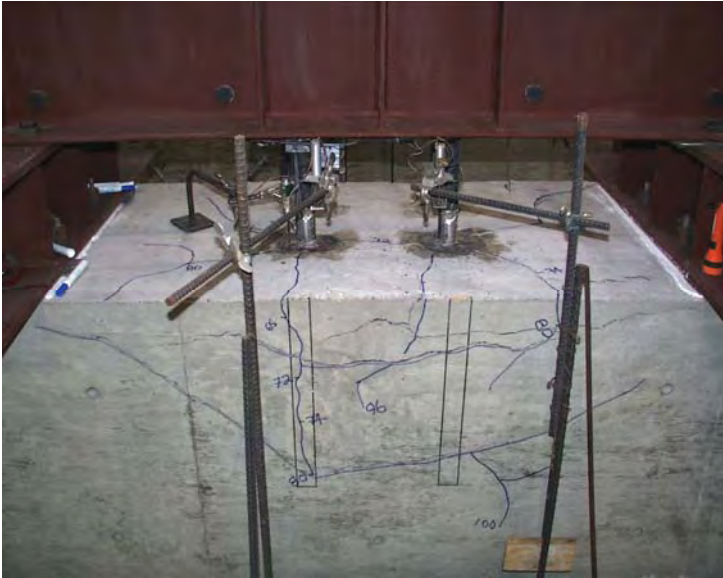
Figure 6.6 Crack Pattern at Failure - Test 23

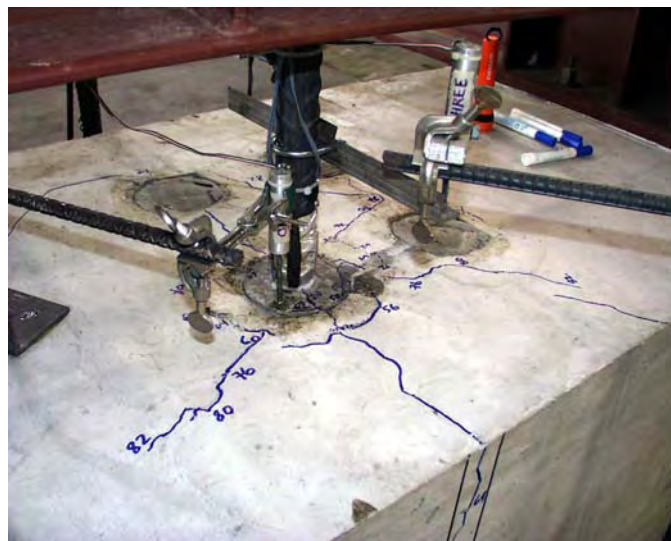
Figure 6.8 Crack Pattern at Failure – Test 9

Crack patterns in specimens constructed using polyethylene duct are illustrated using Tests 9 and 14. A single, plain bar with an embedded depth of $12d_b$ was loading during Test 9. The first signs of cracking in the grout were observed at a load of 20 kip (13 ksi). As load increased, radial cracks were observed in the concrete at a load of approximately 64 kip (42 ksi). Figure 6.7 shows the cracking pattern at a load of 78 kip (51 ksi). Fewer radial cracks were observed in this specimen compared with the specimens constructed using galvanized steel duct. In addition, the cracks occupied a much smaller area on the top surface of the beam. Figure 6.8 shows the crack pattern at failure (82 kip (54 ksi)). V-shaped crack formations did not form in this specimen.

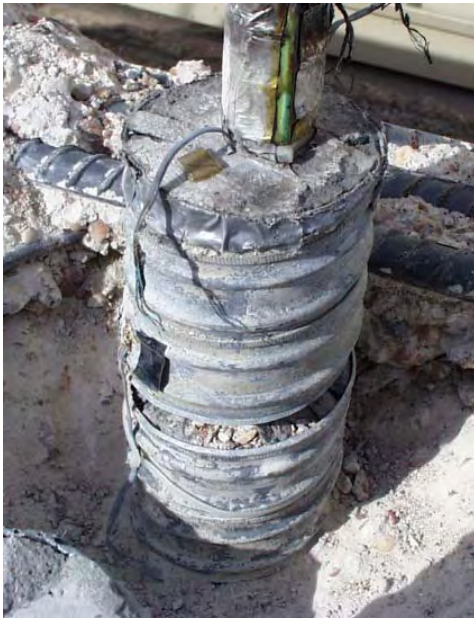
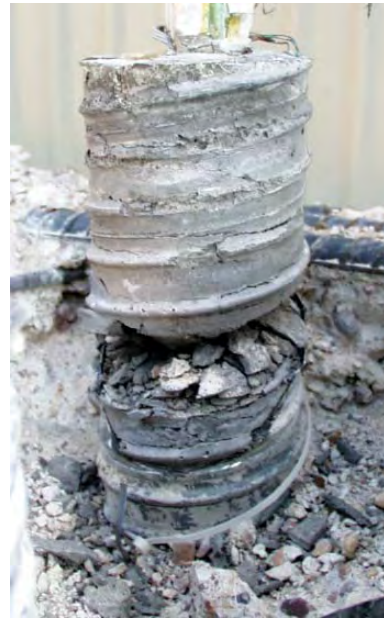
Figure 6.25 Observed Failure of Test 4 (Single Connector, Galvanized Steel Duct)

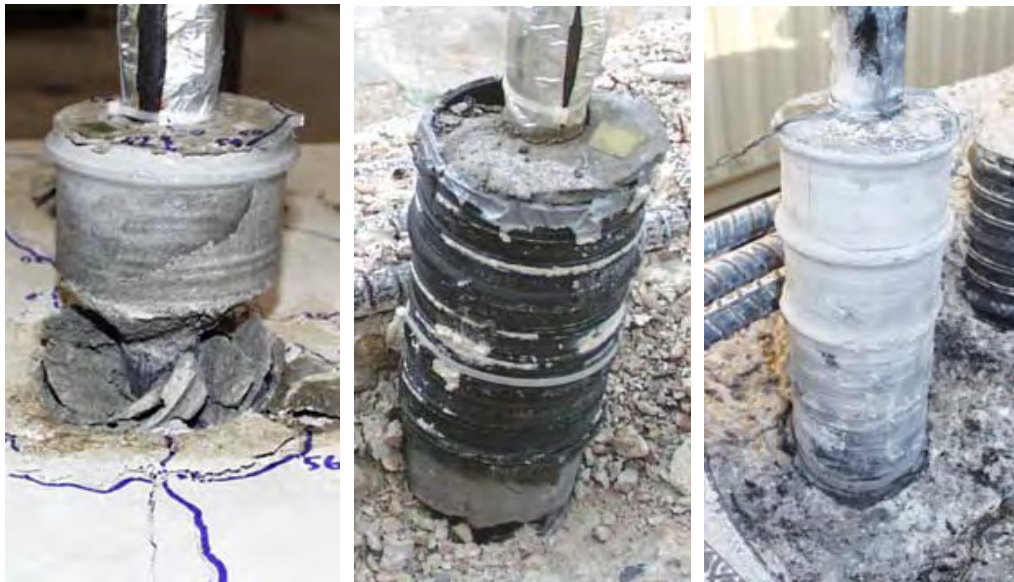
a. Mode 1
Partial Plug Failure
without Duct

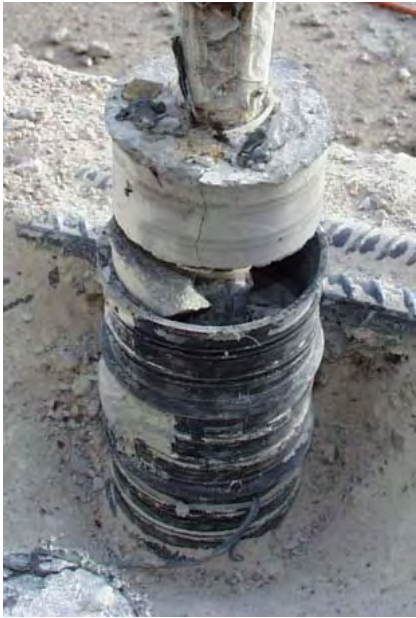
Figure 6.28 Observed Failure of Test 7 (Single Connector, Polyethylene Duct)

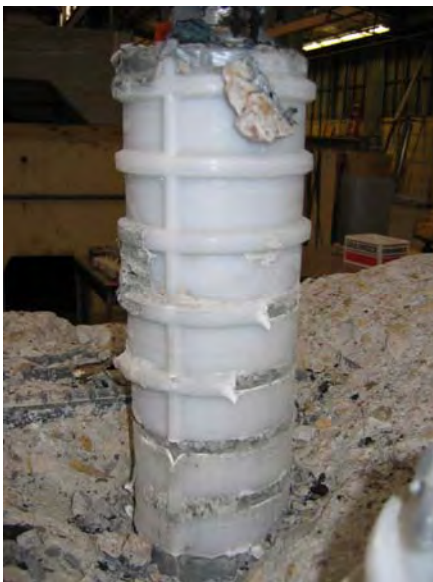
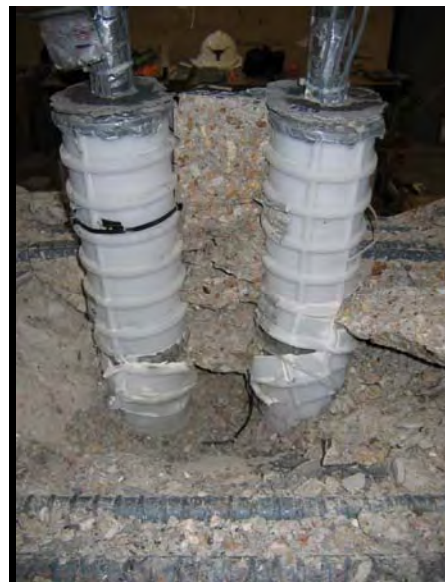
Figure 6.30 Observed Failure of Tests 30 and 28 (Polypropylene Duct)

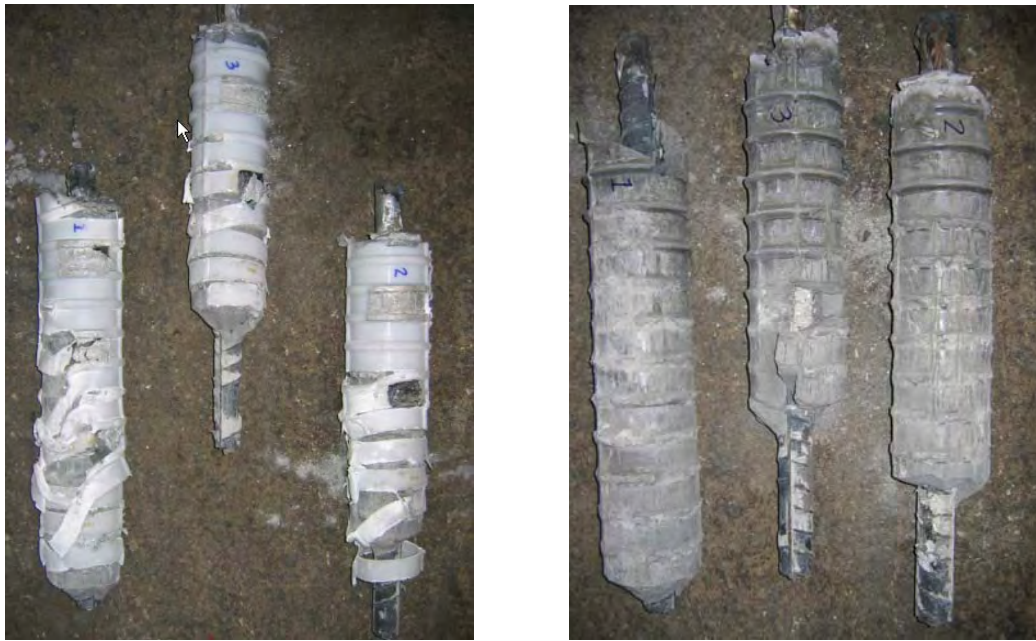
Figure 6.31 Connectors from Test 32 after Pullout (Polypropylene Duct)

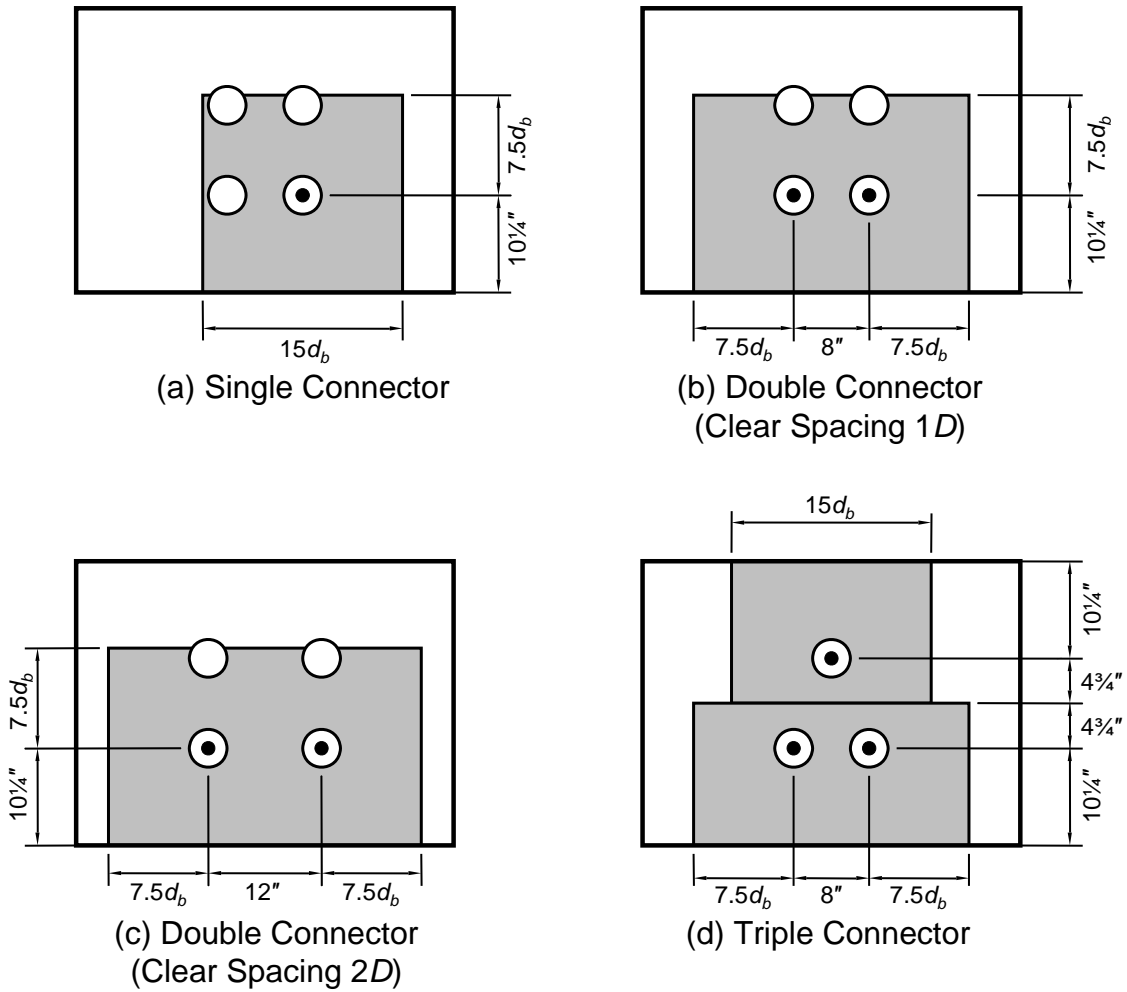
Figure 8.7 Idealized Projected Failure Surfaces for Groups of Connectors
