**FATIGUE STRENGTH OF FILLET-WELDED TRANSVERSE
STIFFENERS WITH UNDERCUTS**

Research Report 0-4178-1

FILLET WELD DETAILING FOR STIFFENER

Texas Department of Transportation

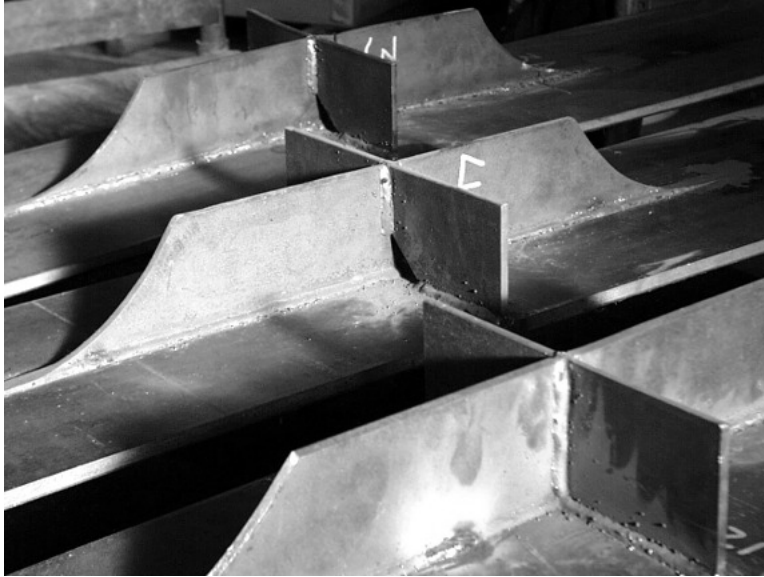
Figure 2-4: Photo Showing Variety of Specimens

Four specimens with different stiffener weld details were used to investigate effects of the undercutting caused by wrapping the fillet welds around the stiffener. These specimens, designated type A through type D, were designed to evaluate the fatigue performance based on undercutting at the interior stiffener clip weld wrap and undercutting at the edge of the stiffener-to-flange weld. Figure 2-3 illustrates the cross-section geometry at the stiffener-to-flange connection. The locations of the undercuts purposely introduced are highlighted with the small circles. The other significant locations are highlighted with the larger circles in the figure. The different specimen types are also shown in Figure 2-4. A type D specimen with a filled clip is in the foreground of Figure 2-4.

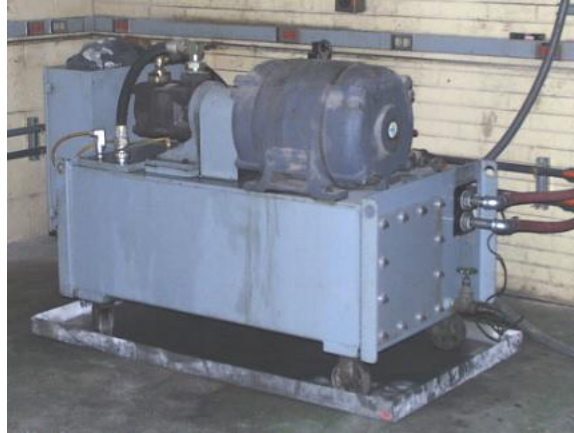
Figure 3-4: MTS Hydraulic Supply Unit

An MTS hydraulic supply unit (model 506.20) was used to maintain pressure to the system throughout testing. The pump, pictured in Figure 3-4, supplies 20 gallons per minute (76 L/min.) at a constant pressure of 3000 psi (20.7 MPa). The pump was water-cooled.
