1. Report No. FHWA/TX-05 / 0-4562-1		2. Government accession No.		3. Recipient's Catalog No.	
4. Title and Subtitle Factors Affecting Bond and Friction Losses in Multi-Strand Post-Tensioning Tendons Including the Effects of Emulsifiable Oils				5. Report Date June 2005

FACTORS AFFECTING BOND AND FRICTION LOSSES IN MULTI-STRAND POST-TENSIONING TENDONS INCLUDING THE EFFECT OF EMULSIFIABLE OILS

CTR Research Report:	0-4562-1
Report Date:	June 2005
Research Project:	0-4562
Research Project Title	Effect Of Emulsifiable Oils Used as Temporary Corrosion Protection in Grouted Post-Tensioned Tendons, and Investigation of Alternate Corrosion-Resistant Post-Tensioning Systems
Sponsoring Agency:	Texas Department of Transportation
Performing Agency:	Center for Transportation Research at The University of Texas at Austin

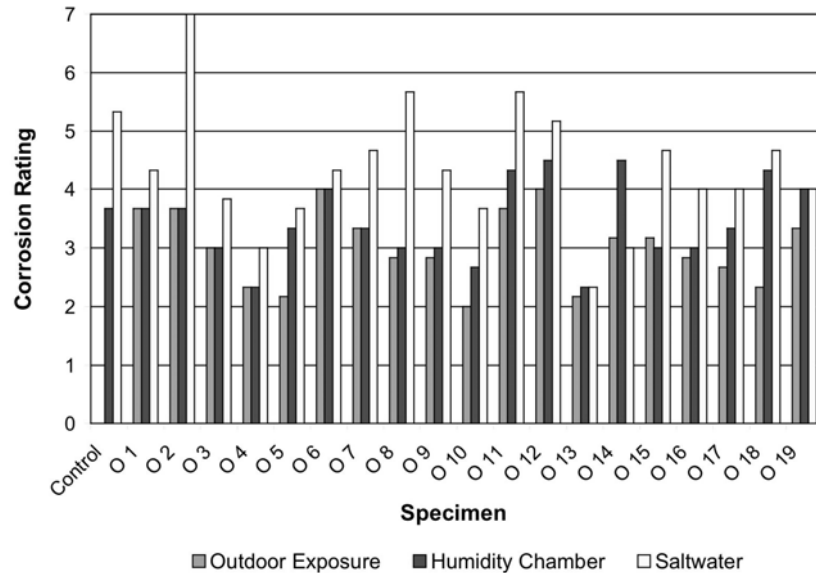
Figure 3-2 Final Corrosion Test Results

Final results for the unstressed strand corrosion tests are presented in Figure 3-2. A corrosion rating of 4 was selected by the researchers as the standard for “adequate” corrosion protection. As shown, seven of the 19 oils tested met this standard in all three environments at the end of the six-month testing period: O3, O4, O5, O10, O13, O16, and O17. More detailed final results, as well as intermediate corrosion ratings for each specimen, can be found in Salcedo (2003).

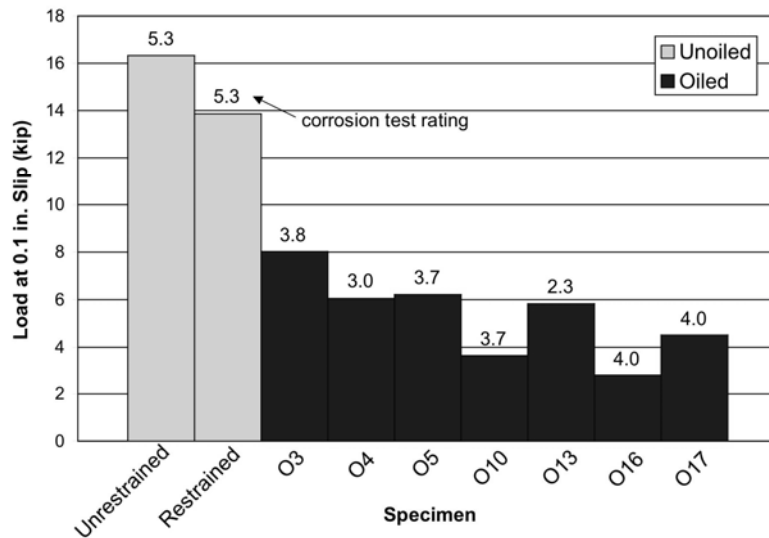
Figure 3-8 Pullout Test Results, Selected Oils with Corrosion Ratings ≤ 4

Final results for all pullout tests are presented in Figure 3-7. Results for only those oils that received a rating of 4 or better in all three environments in the corrosion tests are presented in Figure 3-8 along with control values. A slip value of 0.1 in. was selected by the researchers as the standard for bond failure. This value was determined primarily through phone conversations with members of the North American Strand Producers Association. As shown, average failure loads for oiled specimens were approximately 30–95 percent lower than the average failure load for the restrained control specimens. Average failure loads for the selected oils with favorable corrosion protection ratings shown in Figure 3-8 were approximately 40–80 percent lower than the restrained control. More detailed final results and variability information can be found in Salcedo (2003).

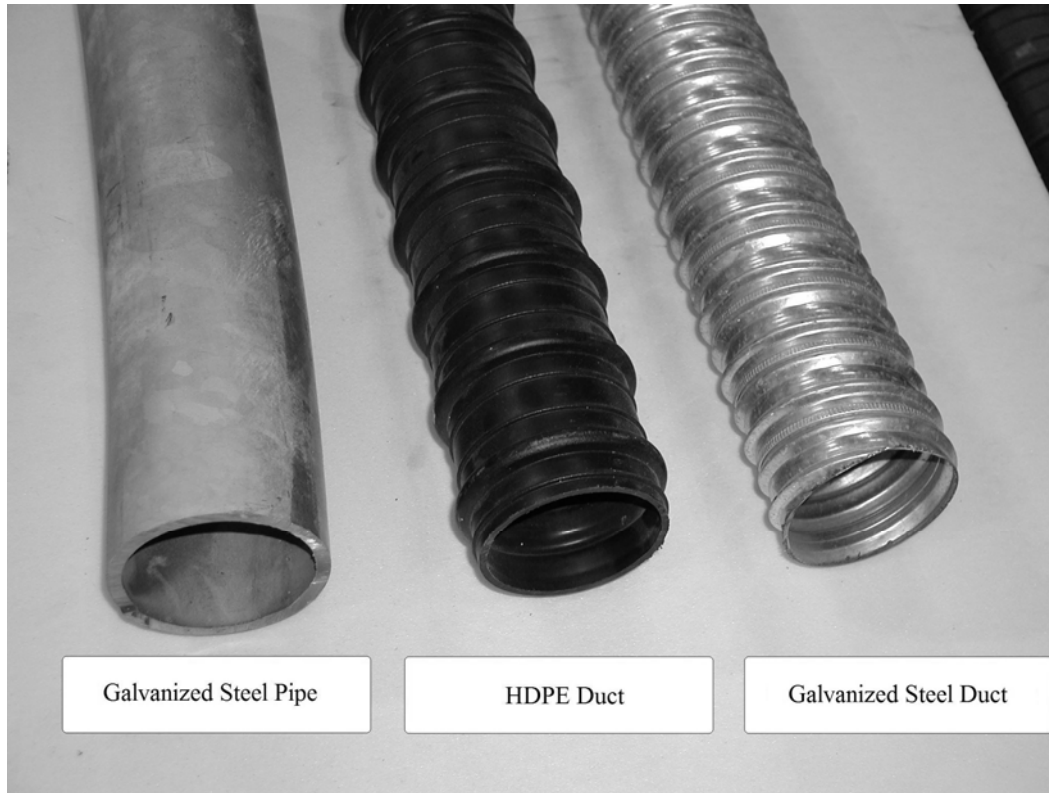
Figure 4-1 Ducts (Icaza 2004)

Semi-rigid galvanized steel ducts, high-density polyethylene (HDPE) ducts, and galvanized rigid steel pipes, all shown in Figure 4-1, were used in both the friction and bond tests. The semi-rigid galvanized steel and HDPE ducts are industry standards for post-tensioned construction and are widely available. Steel pipes are commonly used in deviator blocks, where a large tendon angle change is required over a short distance. All three ducts had a 3-in. nominal diameter, the standard size for a 12-strand tendon with 0.5-in. diameter strand.

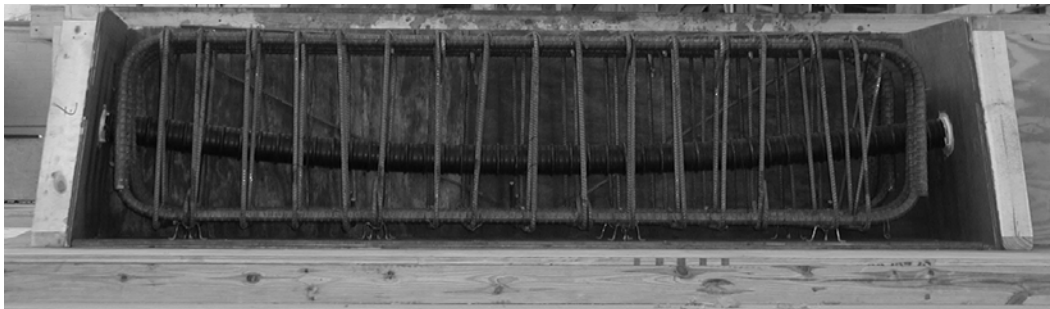
Figure 4-5 Assembled Specimen Cage, Duct, and Formwork

Prior to casting concrete, the reinforcement cage and duct were placed in the formwork as shown in Figure 4-5. This figure shows one of the original specimens built by Diephuis and is not representative of the actual specimen geometry and reinforcement layout used for the bond tests discussed in this report. However, the general process of assembling the cages, ducts, and formwork did not change. The duct was tied to the cage with wire to create the desired profile and to ensure the duct did not move during placement of the concrete.

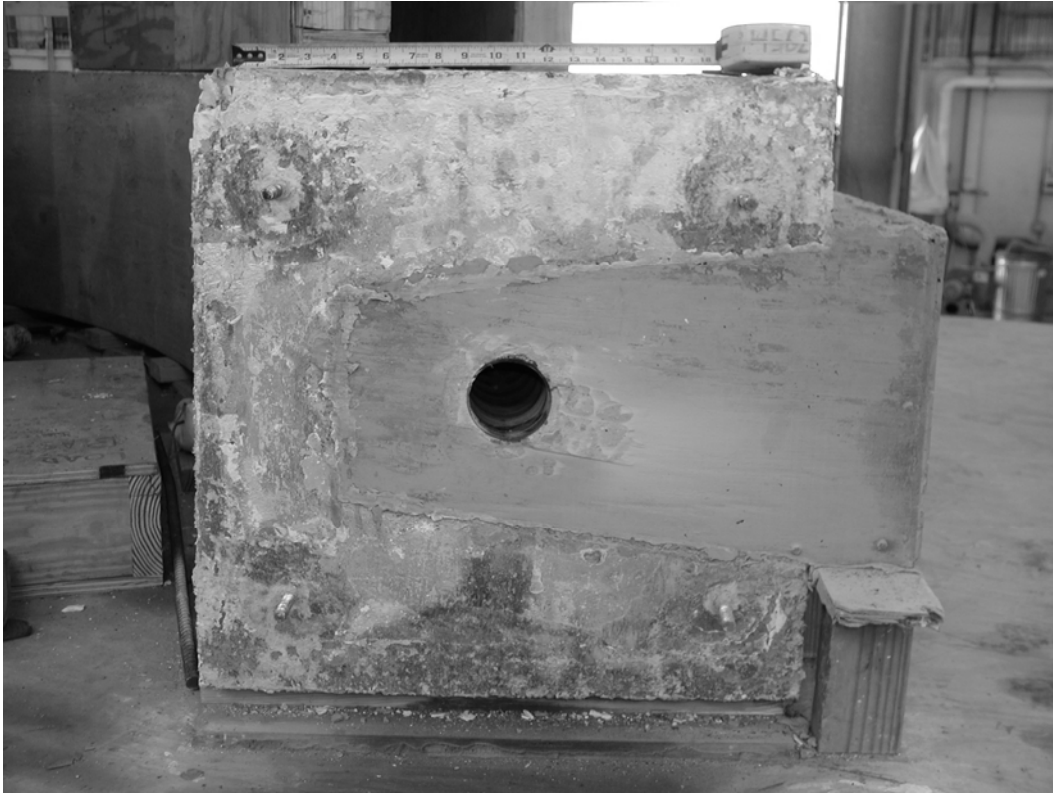
Figure 4-17 Complete Beam Cross Section

Before casting the inner arc, a debonder was applied to the inner surfaces of the permanent reaction beam. The duct was placed inside the reaction beam cavity, held in place by either wooden blocks (in the case of the rigid steel pipe) or pieces of styrofoam cut to fit the inner portion of the cavity (in the case of the HDPE and galvanized ducts). For most specimens, light reinforcement was also placed inside the cavity. After casting, forms were removed, and the ends of the ducts cut flush with the ends of the beam. A photo of the actual completed cross section is shown in Figure 4-17.

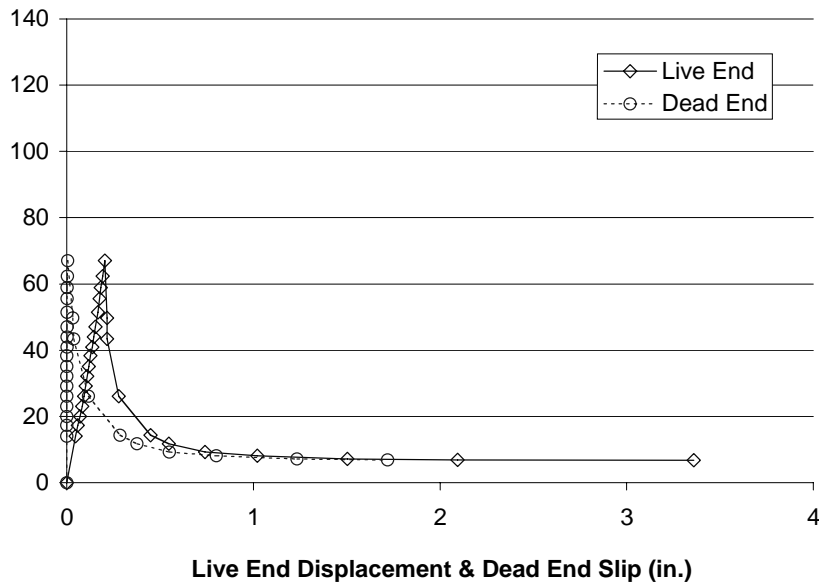
Figure 5-1 Live End Load-Displacement and Dead End Load-Slip Behavior for Specimen 0-SP-7.5^o-1

Failure of this specimen occurred at the duct-concrete interface. Figure 5-3 shows the specimen after testing, with the duct and tendon pulled several inches out of the specimen.

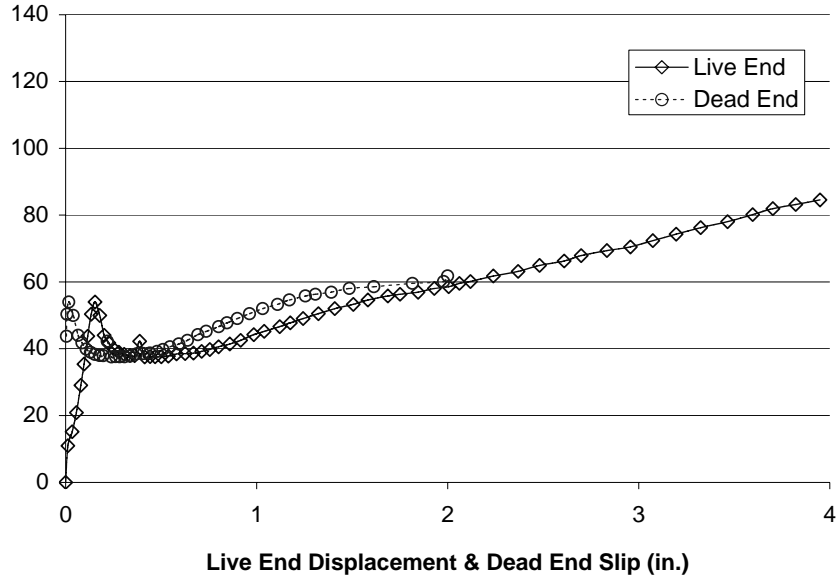
Figure 5-9 Live End Load-Displacement and Dead End Load-Slip Response for Specimen 0-SP-7.5°-4

Failure of this specimen occurred at the grout-duct interface. After the initial peak load was reached, the resistance dropped by about one-third and then began increasing again. This trend was presumably due to the interlock of the grout plug and the duct as described in Section 5.2.1.3. A photograph of this specimen after testing was not available.

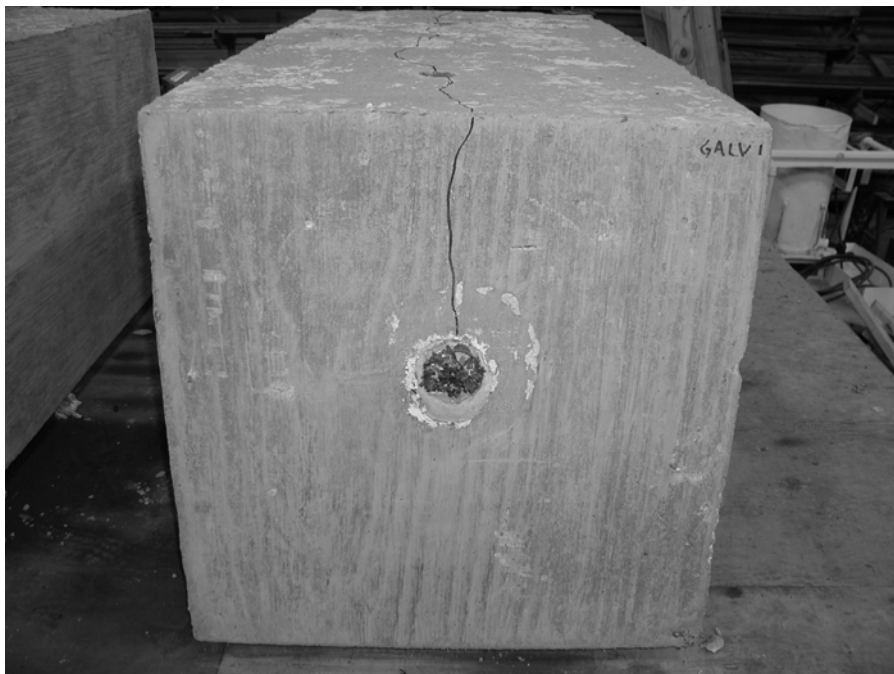
Figure 5-46 Photo of Specimen 2-GD-7.5°-3 after Testing

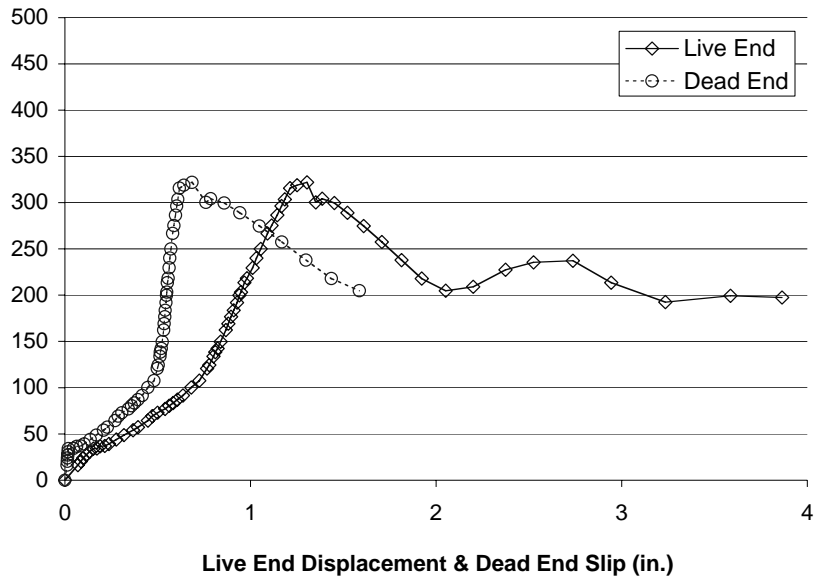
Figure 5-64 Live End Load-Displacement and Dead End Load-Slip Response for Specimen 1-HD-7.5°-1

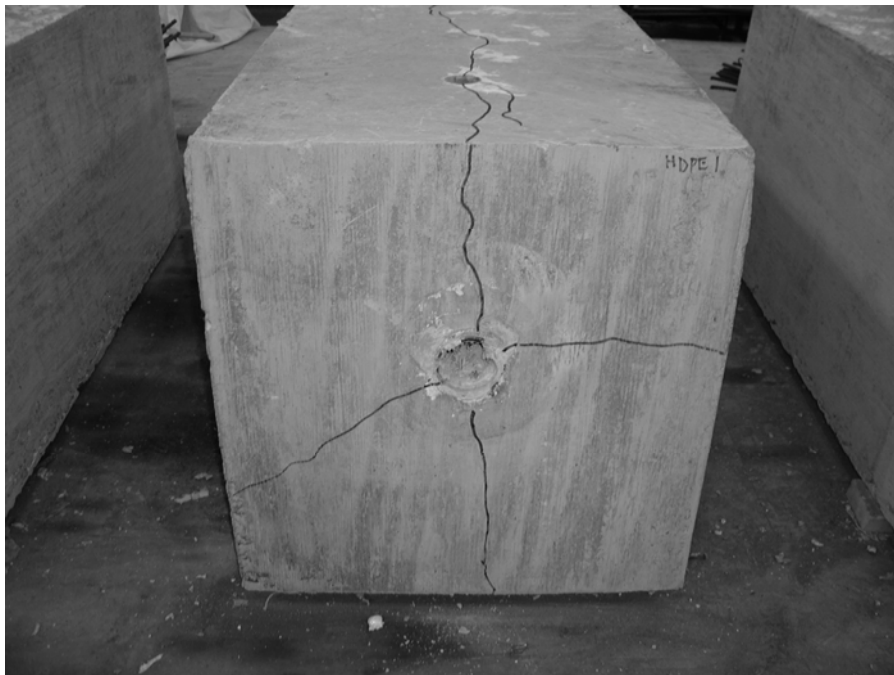
Figure 5-75 Photo of Specimen 2-HD-7.5°-2 after Testing

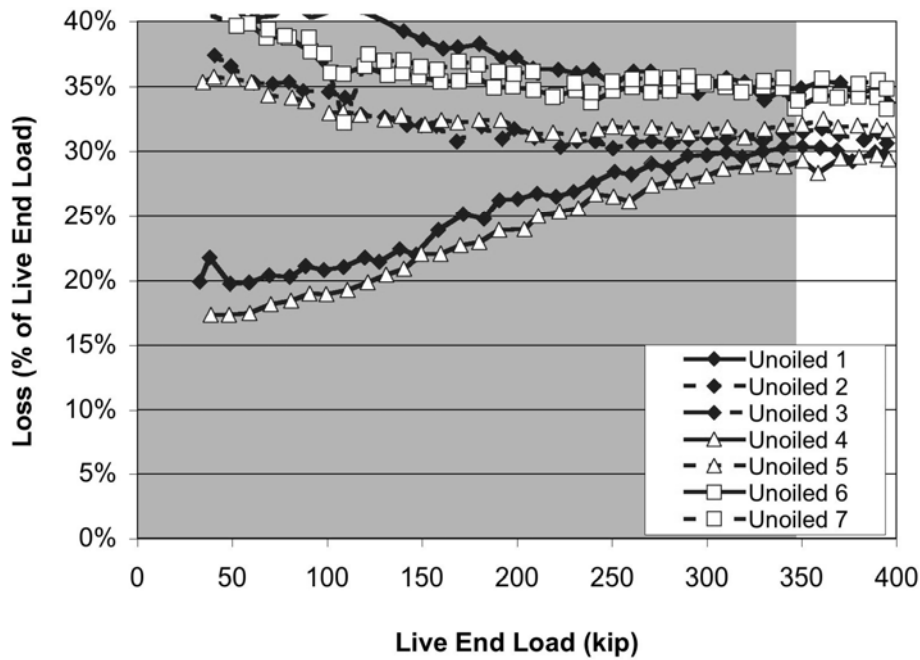
Figure 5-85 Friction Losses for Specimen 0-SP-90°

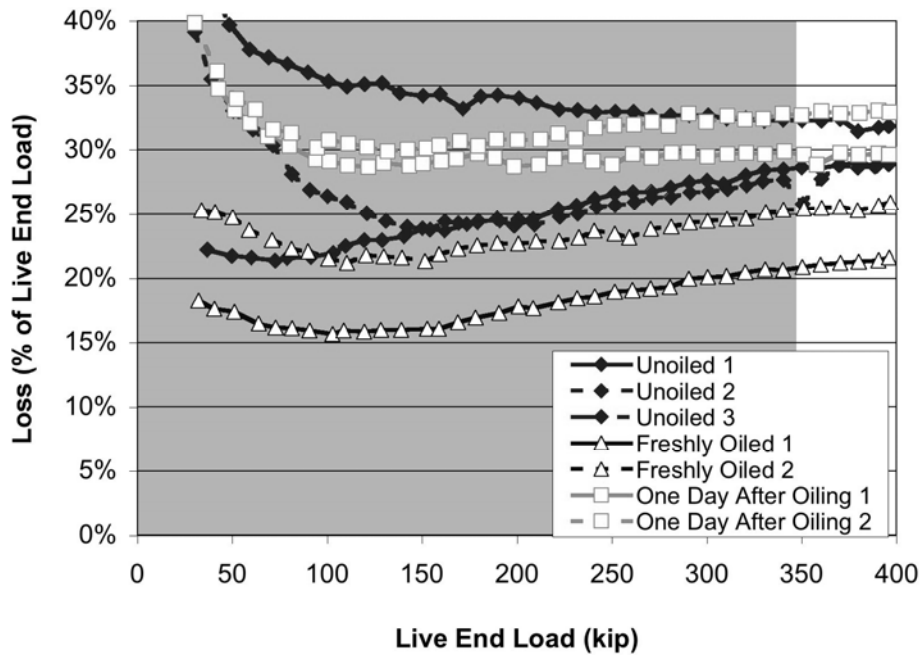
Figure 5-87 Friction Losses for Specimen 2-SP-90°

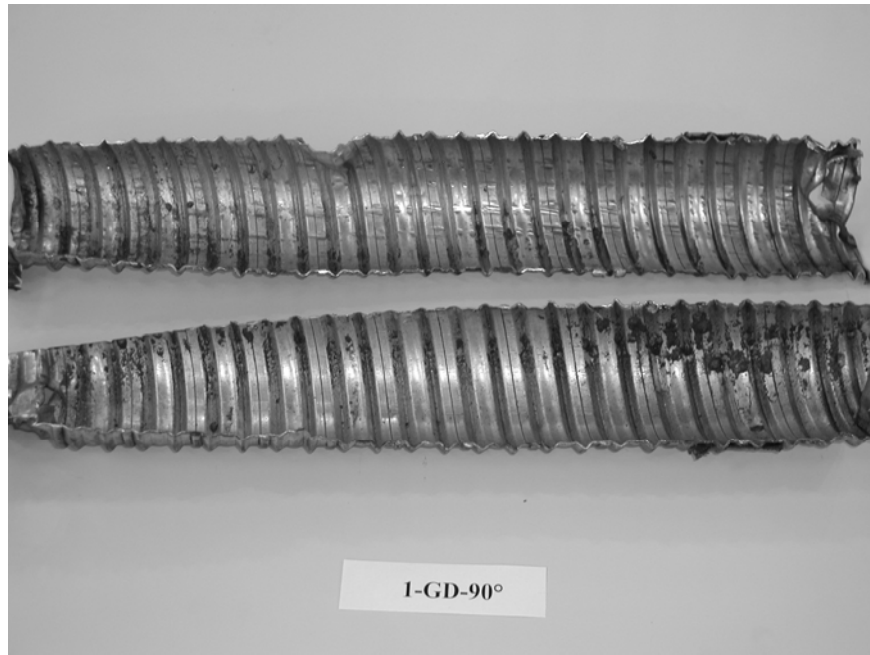
Figure 5-99 Duct from Specimen 1-GD-90° after Testing

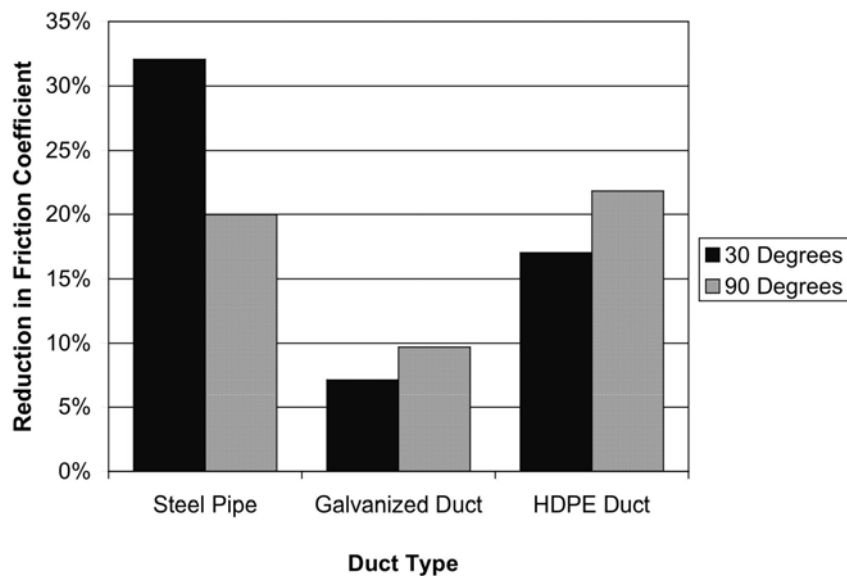
Figure 6-16 Reduction in Friction Coefficient, Freshly Oiled Tendons (Average Reduction for Both Oils)
