1. Report No. <u>PRELIMINARY REVIEW COPY</u>		2. Government Accession No.		3. Recipient's Catalog No.	
4. Title and Subtitle DESIGN GUIDE FOR SHORT ANCHOR BOLTS				5. Report Date October 1990

DESIGN GUIDE FOR SHORT ANCHOR BOLTS

Research Report No. 1208-1F

"Effect of Environmental Cycling
on the Strength of Short Retrofit Anchor Bolts"

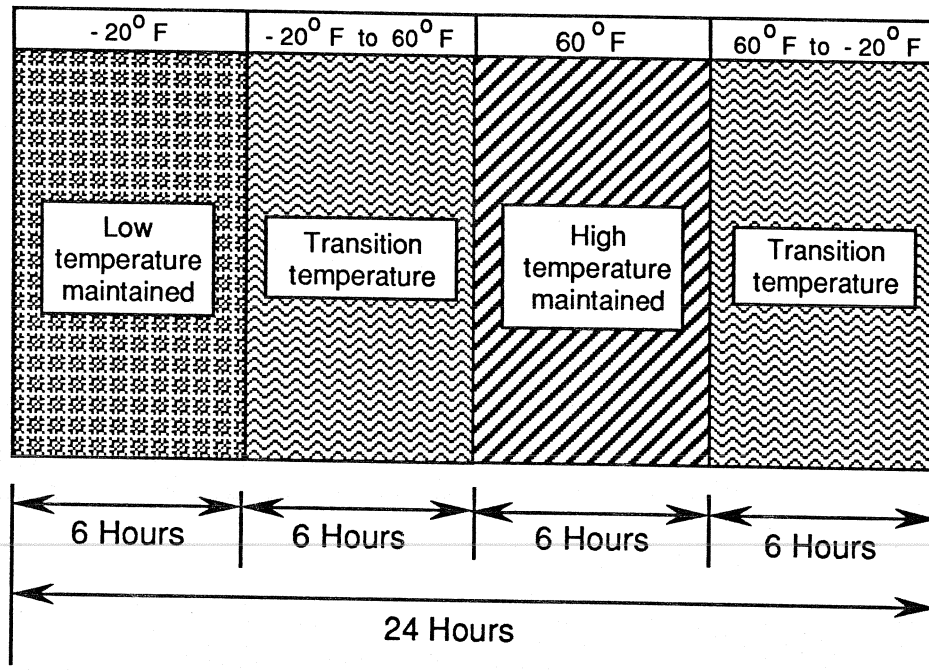
Figure 5.4 Schematic of freezing and thawing exposure.

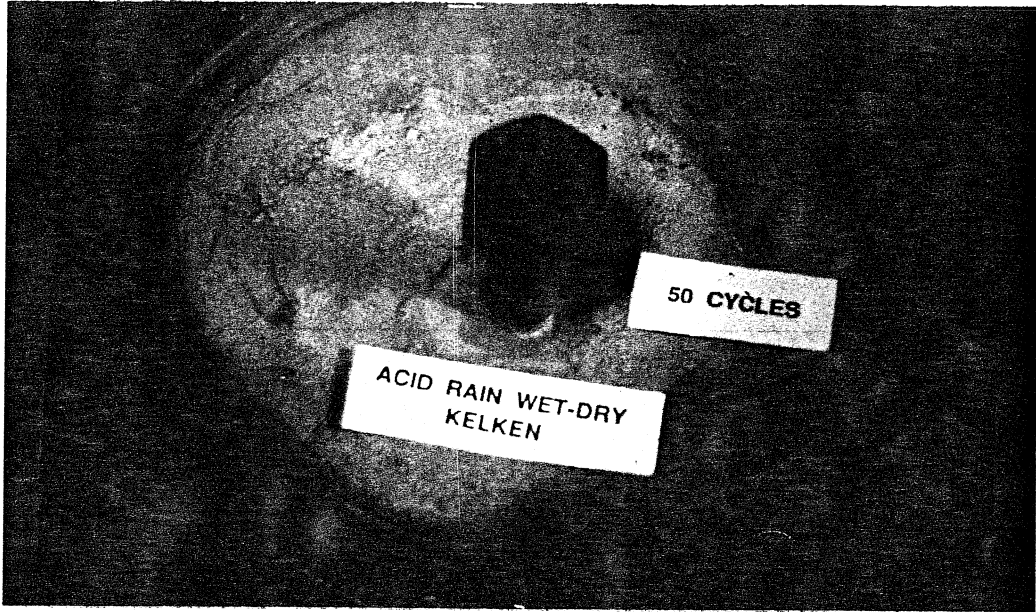
Figure 7.20a Condition of Designation D anchors after 50 cycles of acid rain wetting and drying.

Figure 7.20b Schematic of condition of Designation D anchors after 50 cycles of acid rain wetting and drying.

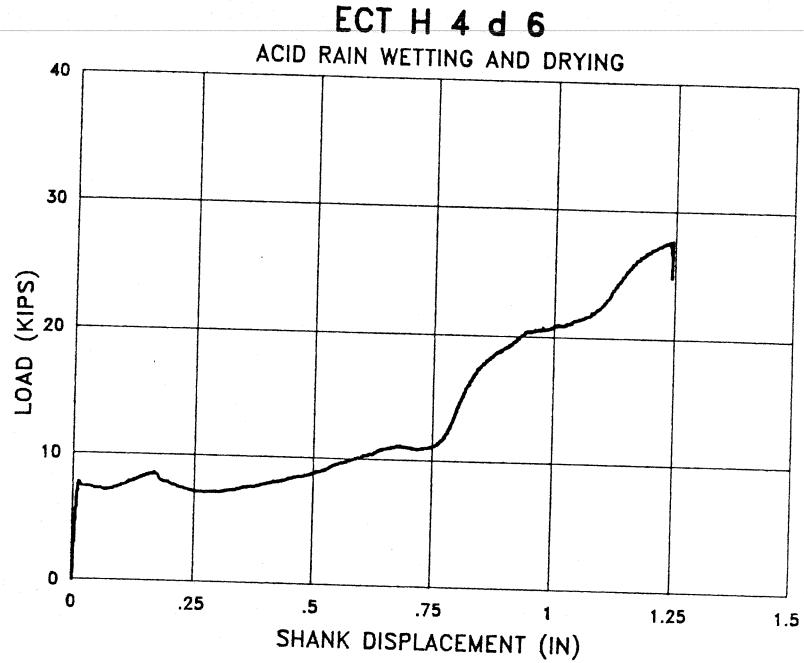
Figure 7.50 Load-deflection plots of pullout failure for Designation H anchors subjected to acid rain wetting and drying.
