**SHEAR STRENGTHENING OF PRETENSIONED PRESTRESSED  
CONCRETE COMPOSITE FLEXURAL MEMBERS**

**Research Report 1210-2**

**Research Project 3-5-89-1210**

**March 1991**

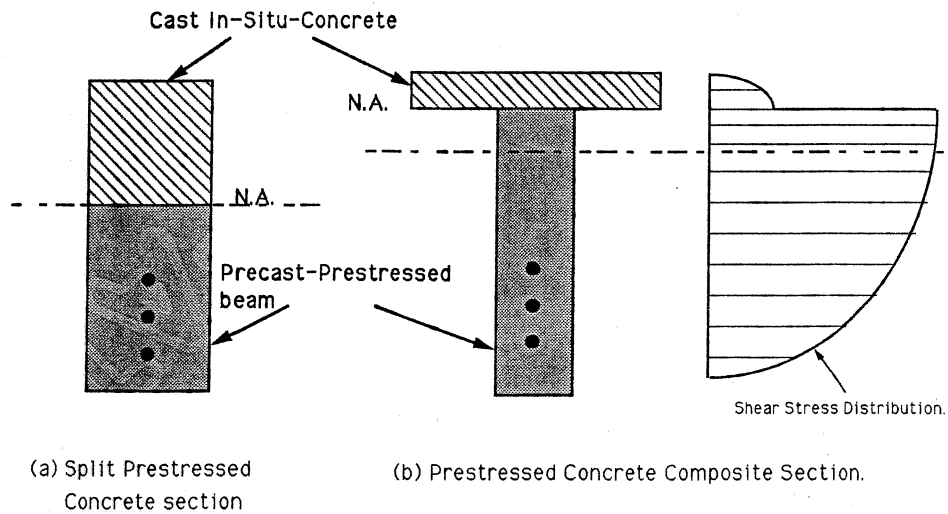
Figure 1.1 Prestressed concrete composite sections.

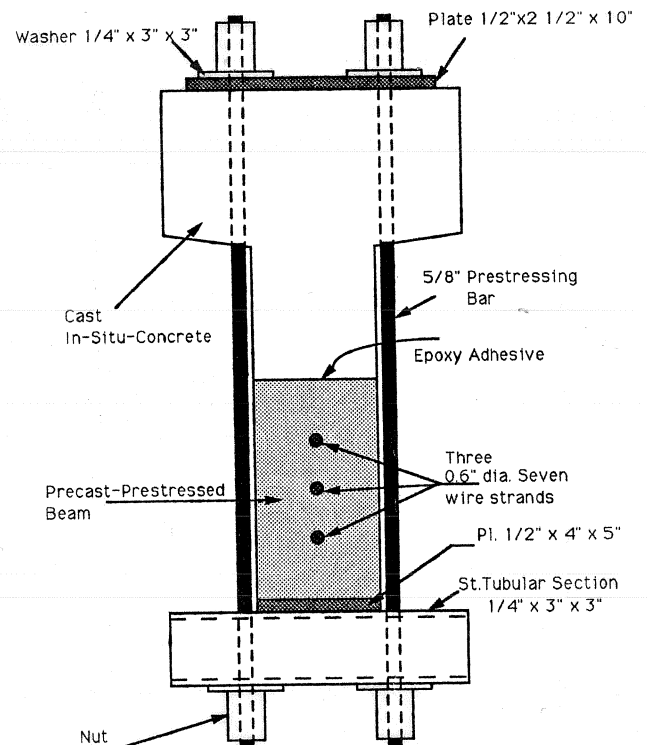
Figure 1.2 Retrofitted prestressed composite section.

and Public Transportation. After the study of transfer length was done it was decided to make use of these beams in a study of development length of prestressing strands, but since no web reinforcement was protruding at the interface, the prestressed composite beams experienced sudden horizontal shear failure before retrofitting. Ductile flexural failure occurred after being retrofitted by external prestressing bars. This research studied how the mode of failure of prestressed composite flexural member could be changed from sudden shear failure to ductile flexural failure by utilizing external prestressing bars, as well as the effect of those prestressing bars on the required development length of the prestressing strands in the bottom portion of the prestressed composite section. Figure 1.2 shows the retrofitted composite section tested in this study.

The scope of this thesis included an experimental test program of 5 beams and analytical study of simply supported beams subjected to different static loads. The level of prestressing force in the external prestressing bars (Fig. 1.2) was considered the principal variable in these tests. Actually this added reinforcement was the major factor in preventing horizontal shear failure and allowing flexural strength of the composite section to be developed.

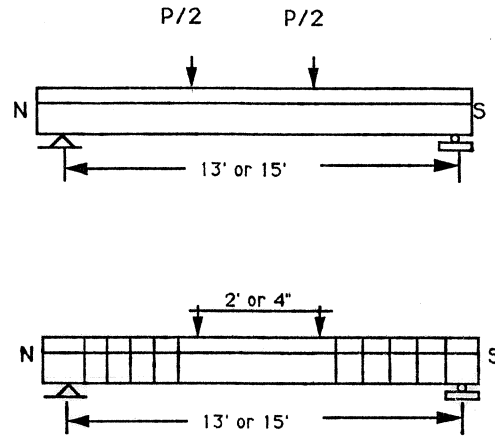
Figure 1.3 Test beam before and after retrofitting.

One beam was tested before retrofitting and four retrofitted beams were tested under two concentrated loads as shown in Fig. 1.3. The provisions in ACI Code 318-89<sup>4</sup> for the design of prestressed concrete composite beams were compared with the test results. Recommendations are made for the use of external prestressing systems as an effective strengthening system.

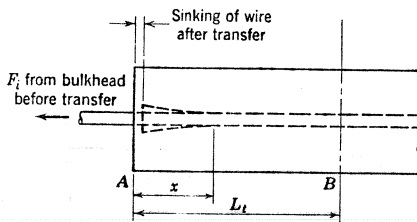
Figure 2.3a Prestress transfer at end of pretensioned beams.

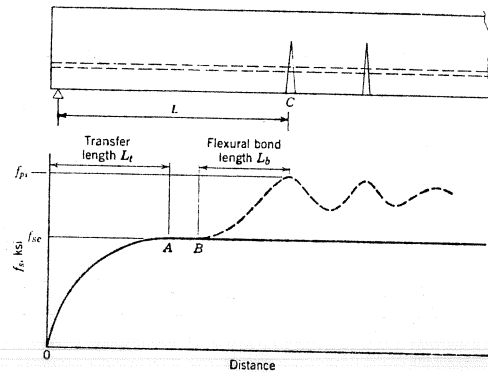
Figure 2.3b Flexural bond overlapping with transfer length, Ref. 14.

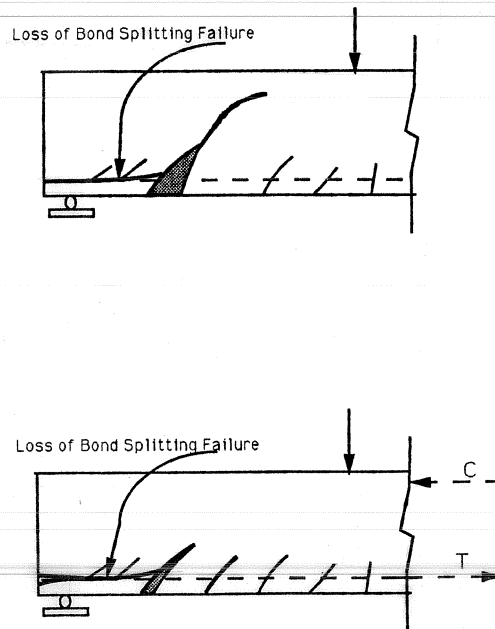
Figure 2.3c Bond failure.

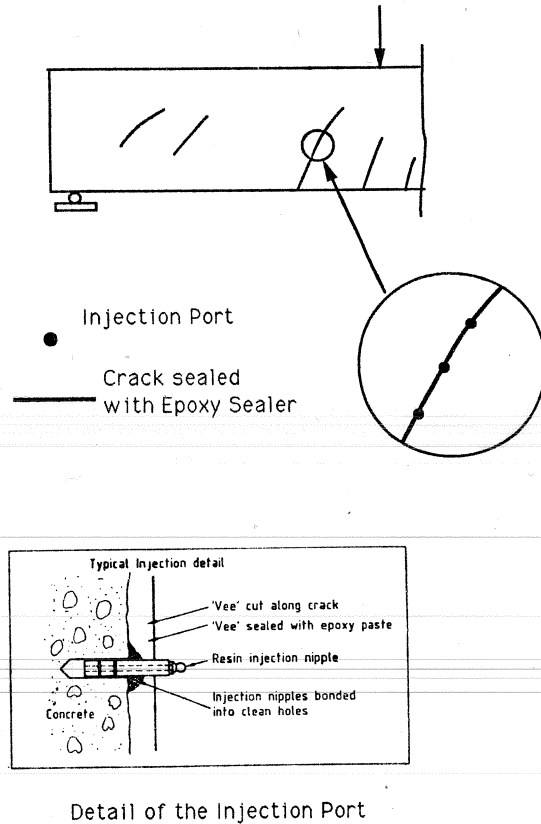
Figure 3.1 Epoxy resin injection technique.

Resin injection as a means of restoring shear cracks has been used successfully on numerous reinforced concrete structures. Restoration of highway bridges subject to shear cracking has been documented by Stratton, Alexander, and Nolting<sup>28</sup>. Success of the resin injection technique for shear repair has been observed for beams as reported, by Brondum-Nielsen.

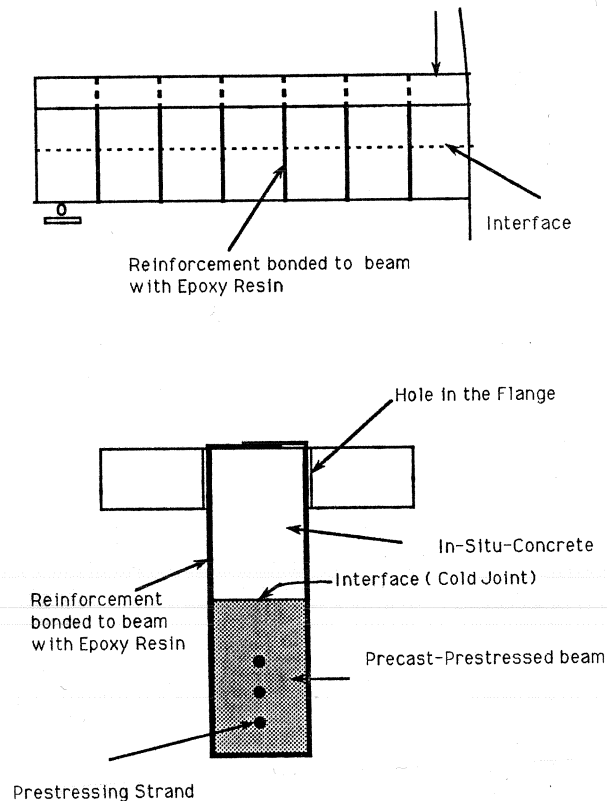
Figure 3.2a Shear strengthening using external bar bonding technique.

**3.2.2 Bonding of External Reinforcement.** Epoxy adhesives have the distinct advantage of being able to bond dissimilar materials. Additional reinforcing bars or steel plates may be bonded externally to the concrete in areas of high shear stress. The main objective in strengthening structures by external reinforcement is to achieve a high shear strength between the steel - resin adhesive interface, and concrete-resin interface. Previous studies have shown that when a thin layer of epoxy resin is used to bond concrete to steel, failure almost always occurs in the concrete adjacent to the concrete-resin interface and, thus, significant increases in live load-bearing capacities of structures can be achieved<sup>29, 30, 31</sup>. Extensive field applications of this method have been documented<sup>32, 33, 34</sup> with external reinforcement bonded as shown in Fig. 3.2a and b.

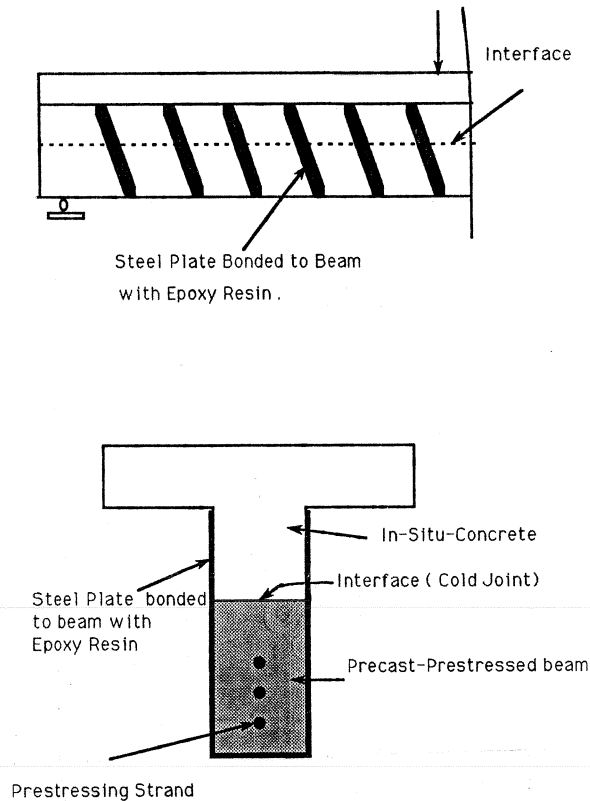
Figure 3.2b Shear strengthening using external steel plate bonding technique.

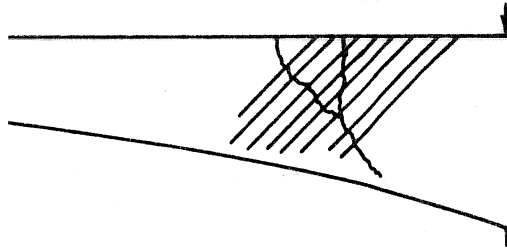
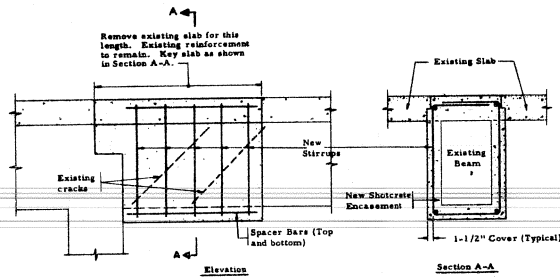
(a) Shear Strengthening using Conventional Reinforcement (Ref. 28)

(b) Shear Strengthening using Conventional Reinforcement and Shotcrete

Figure 3.3 Shear strengthening using conventional reinforcement and shotcrete.

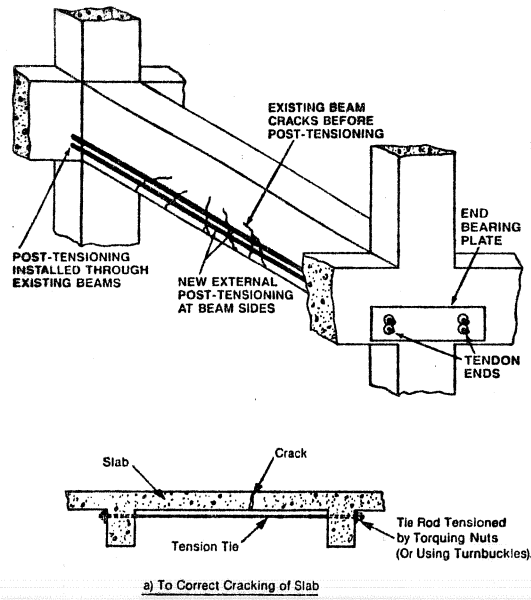
Figure 3.4a Strengthening using external prestressing strands or bars.

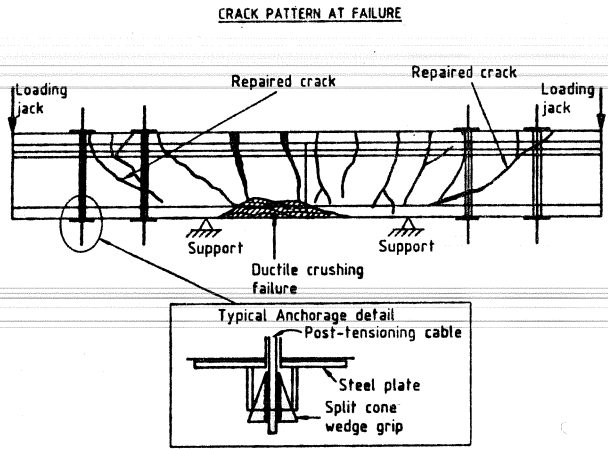
Figure 3.4c Shear strengthening using post-tensioning technique.

the cast in-situ concrete, the horizontal shear failure can be prevented. Application of the external tendons of the type shown in Fig. 3.4c was used in this study to provide both shear strength and horizontal shear strength at a composite interface as described in the following chapter.

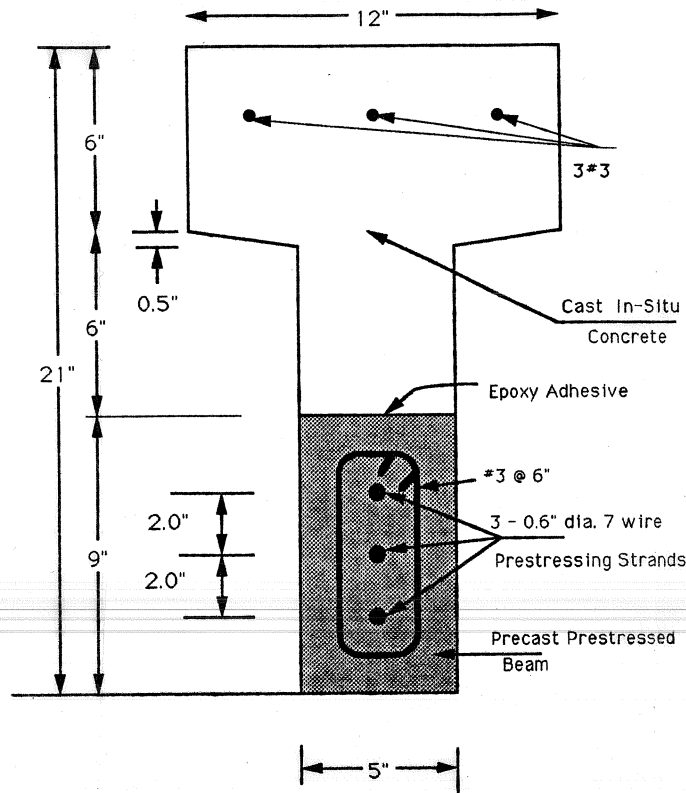
Figure 4.1(a) Prestressed concrete composite beams, Type One (14' long beams).

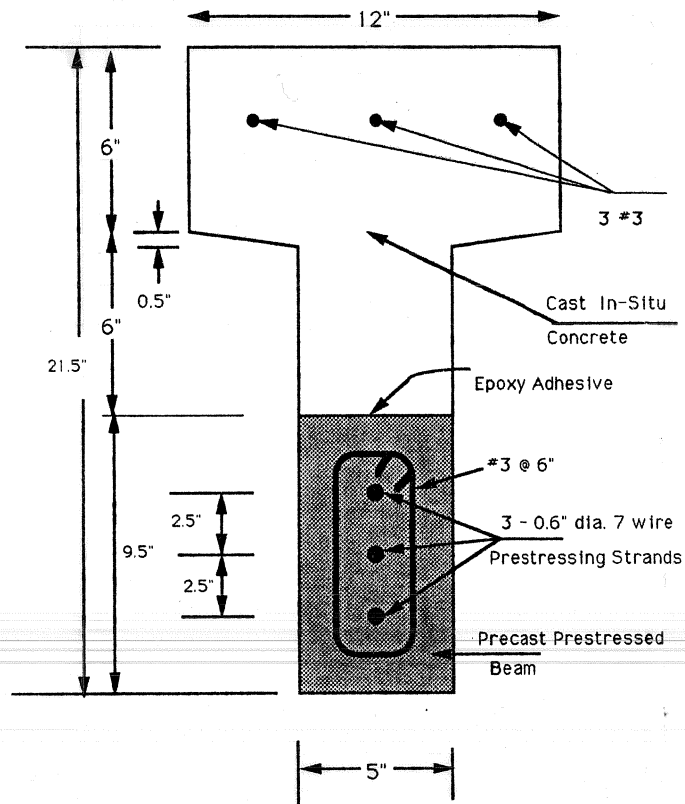
Figure 4.1(b) Prestressed concrete composite beam, Type Two (16' long beams).

*5.2.1 Beam B1 (Type Two - Cross Section, Fig. 4.1b).* Beam B1 was 16 feet long, with a clear span between supports of 15 feet. The precast-prestressed beam was provided with #3 transverse reinforcement at 6.0 inches as shown in Figure 4.1b. No web reinforcement was left protruding from the prestressed beam, across the interface with the cast-in-situ concrete. The beam was loaded with two concentrated loads four feet apart, as shown in Figure 5.1a. Load was applied in five-kip increments. The beam showed elastic behavior before cracking, and deformations were linearly proportional to load. Flexural cracks were first noted at 40 kips applied load. As the load was increased, deformation of the beam began to increase more rapidly than the load, but at a low rate as shown in Fig. 5.1b. After the flexural cracks had formed in the prestressed beam, some cracks started developing in the cast-in-situ portion in addition to the cracks that were extending from the prestressed beam.

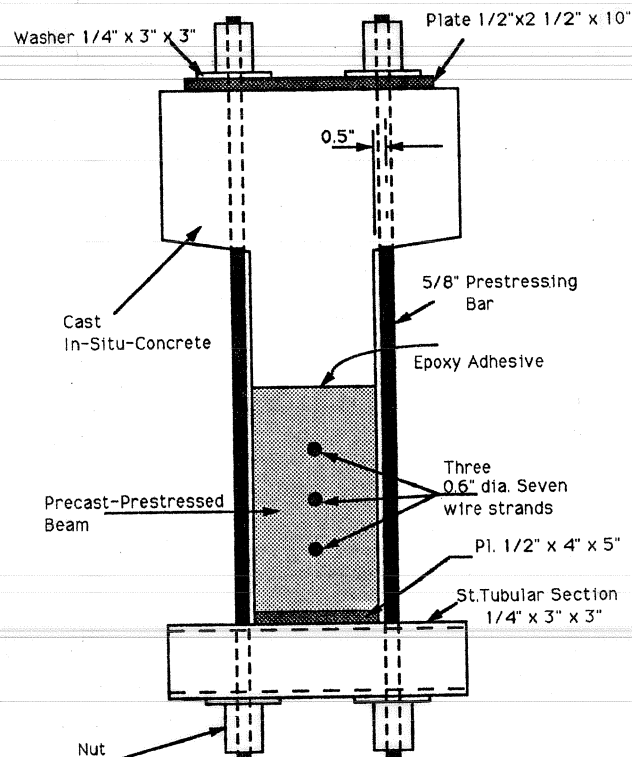
Figure 4.2(a) Retrofitted prestressed composite section.

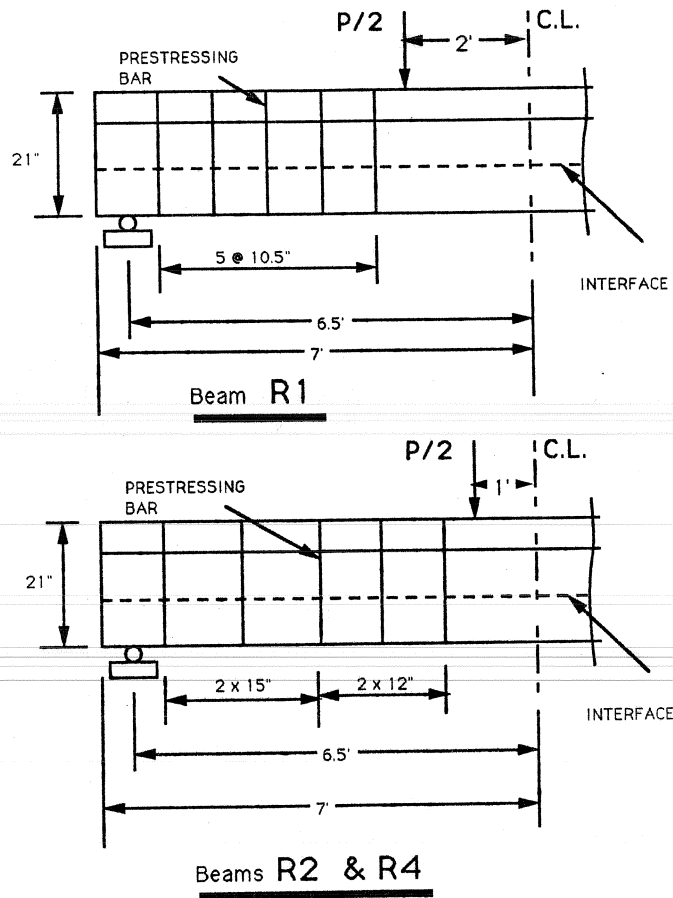
Figure 4.2(b) Locations of prestressing bars for Beams R1, R2 and R4.

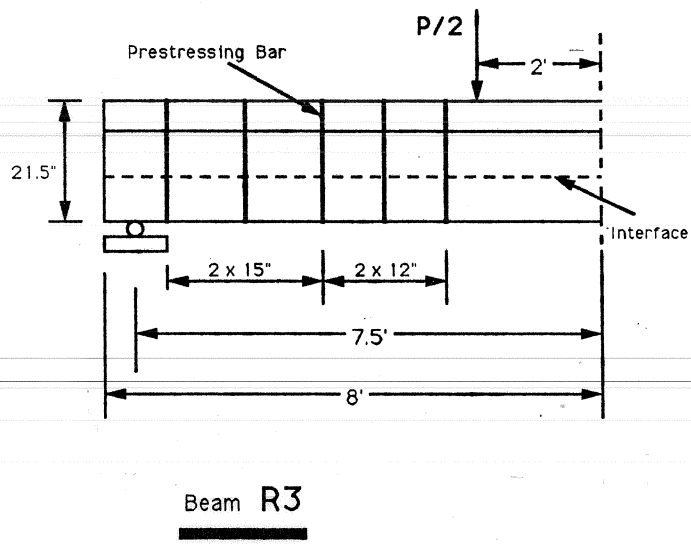
Figure 4.2(c) Locations of prestressing bars for Beam R3.

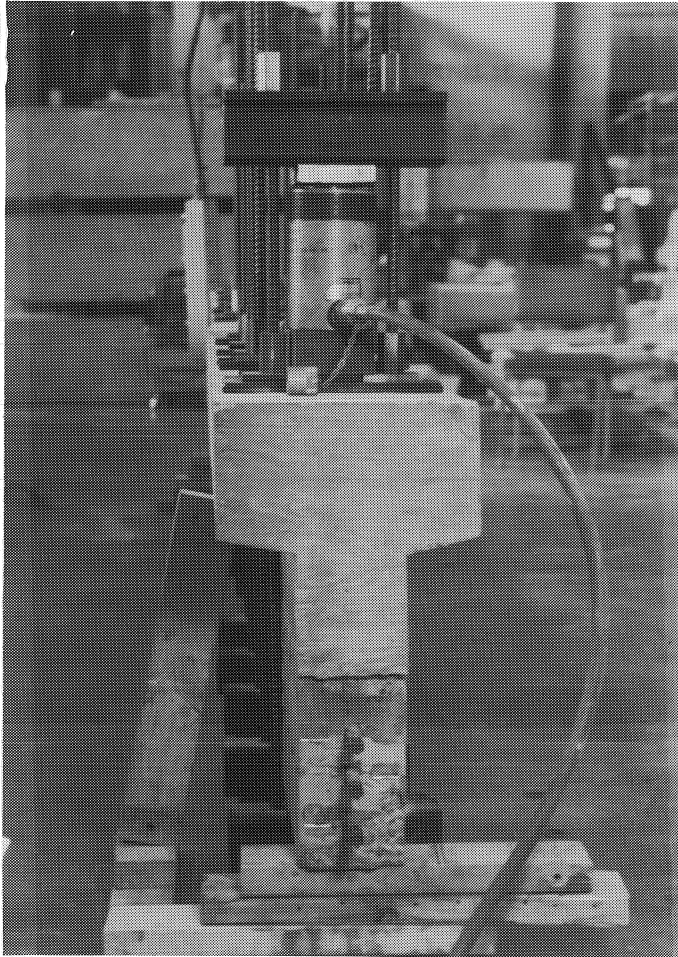
Figure 4.2(d) Tensioning system.

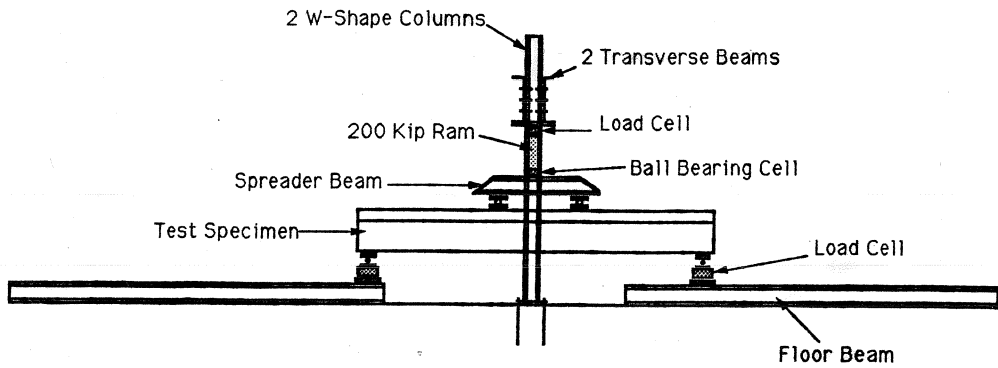
Figure 4.3(a) Test setup.

*4.4.1 Description of Test Setup.* Beams were tested in flexure under two concentrated stationary loads applied to the beam using one hydraulic ram (capacity 200 kips and stroke 10 inches) and a spreader beam. The load was applied against a structural steel frame connected to the floor as shown in Figure 4.3(a). The beam was supported by two structural steel W-shaped beams, to allow testing beams of different lengths and to distribute the reaction load to the test floor. A ball-bearing unit was used under the ram to ensure the transfer of pure axial load to the spreader beam. A pin support was used under the test specimen. Figure 4.3(b) shows a test specimen under load in the testing frame.

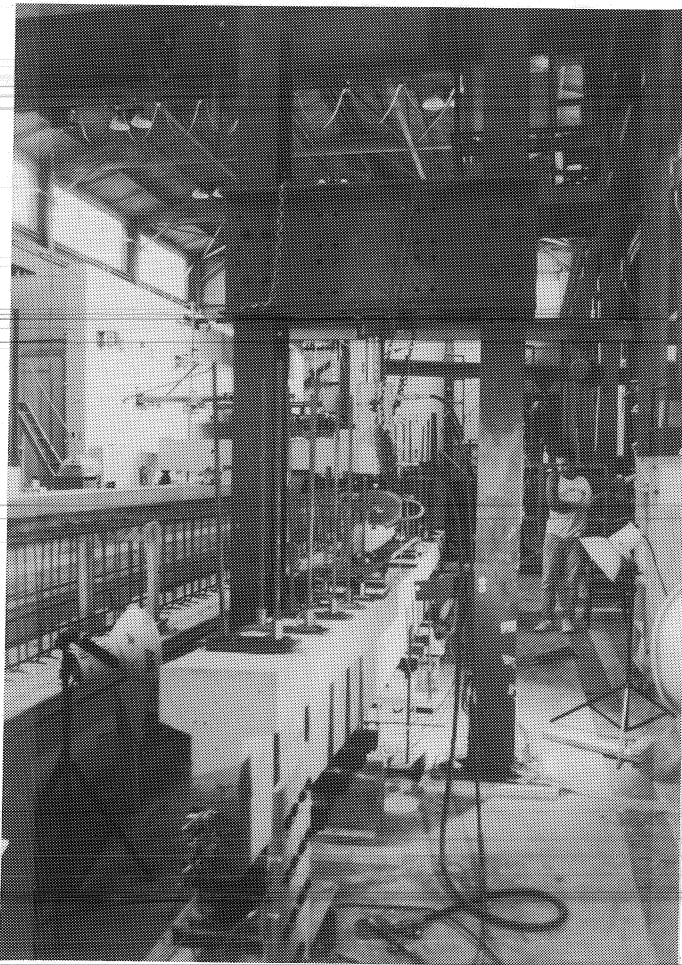
Figure 4.3(b) Test specimen under testing frame.

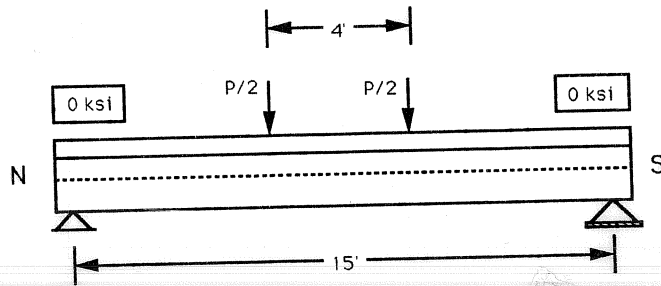
Figure 5.1a Loading pattern, Beam B1.

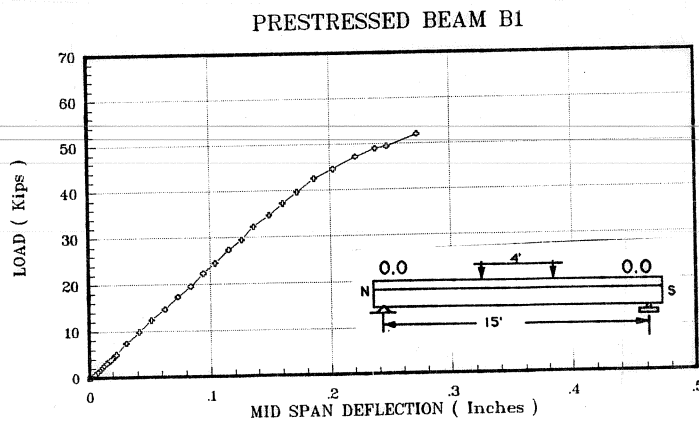
Figure 5.1b Load - Midspan deflection curve.

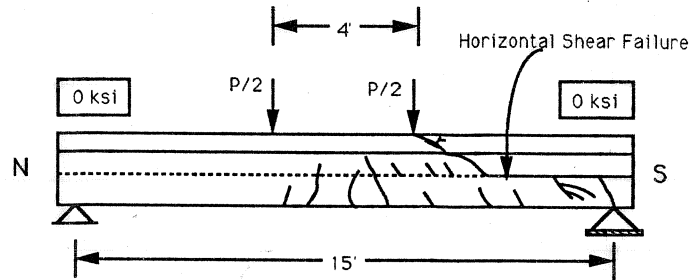
Figure 5.1c Crack pattern, Beam B1.

At a load of 53 kips the beam suddenly failed in shear, the major crack starting from the south load point at an angle of about 45 degrees with the interface as shown in Fig. 5.1c. The bond between the precast-prestressed and the cast-in-situ portion failed from the intercept point of the diagonal crack to the south end. One diagonal crack formed at the

No web shear cracks were observed before failure. Figure 5.1c shows the crack patterns. Since the beam did not develop its flexural capacity, the stresses in the prestressing strands were very low and far from yielding. Figure 5.1d shows load versus additional stress in the strands due to external applied load. Zero additional stress in the strand represents the prestressing stress of the strand. End slips of prestressing strands were almost zero at the time Beam B1 failed in horizontal shear at the north end.

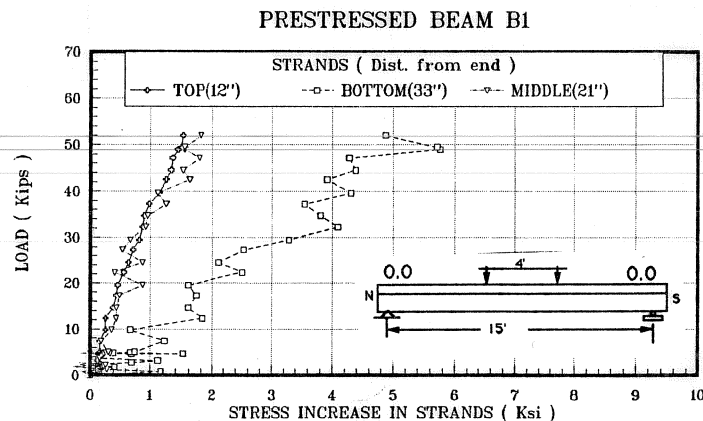
Figure 5.1d Load vs. stresses in strands.

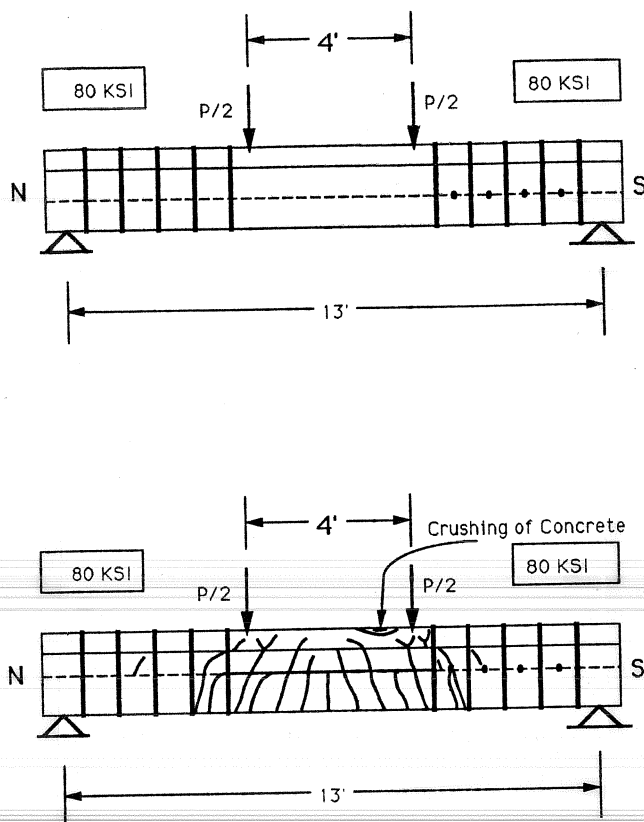
Figure 5.2a Loading and cracking pattern, Beam R1.

**5.2.2 Beam R1 (Type One - Cross Section, Figure 4.1a).** Beam R1 was 14 feet long, with a clear span between supports of 13 feet. This was the first retrofitted beam, and was strengthened by pairs of 5/8-inch external prestressing bars as shown in Figure 5.2a. Ten pairs of prestressing bars were stressed to 80 ksi, to produce a normal pressure at the horizontal shear interface, and distributed along the shear spans as shown in Fig. 5.2a.

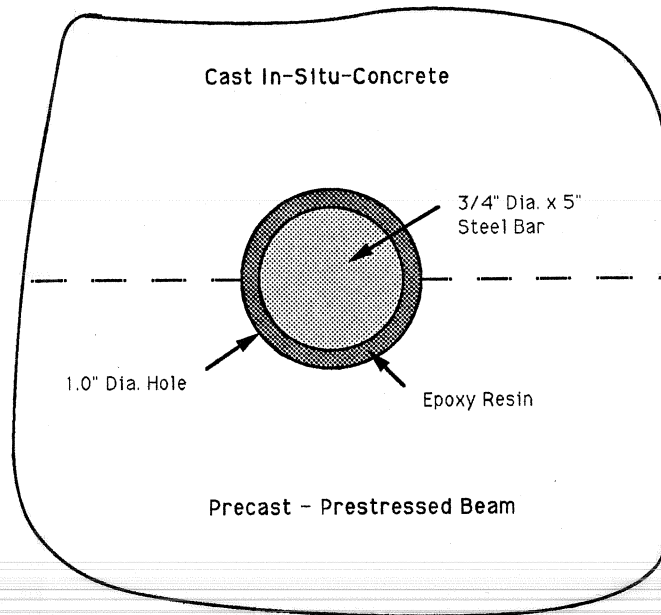
Figure 5.2b Detail of horizontal shear insert.

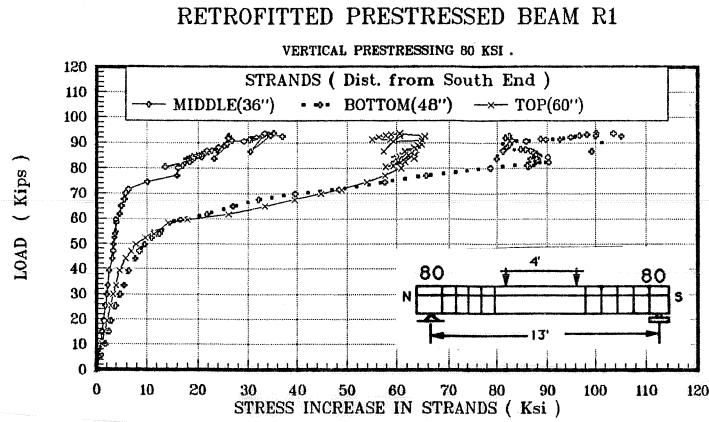
Figure 5.2c Load vs. stresses in strands (south end).

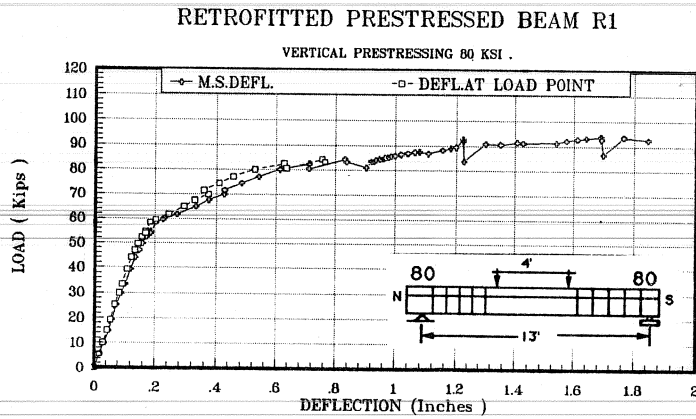
Figure 5.2d Load - deflection curve.

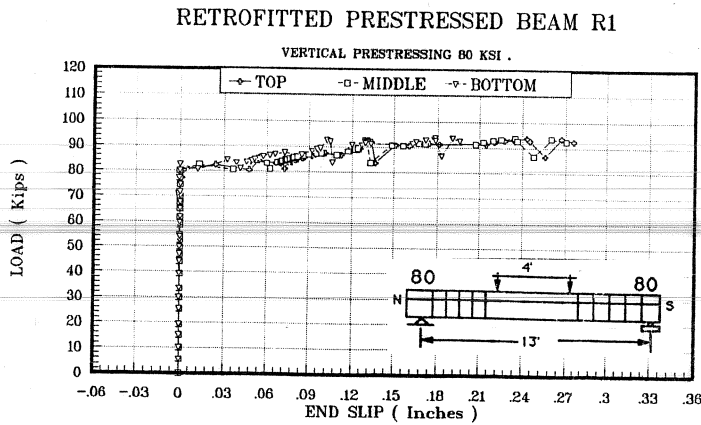
Figure 5.2e Load vs. end slip (south end).

As the load was increased, the cracks continued to extend into the flange until the beam failed in flexure and crushing of concrete occurred next to the south load point within the pure flexure span. Midspan deflection at failure was 1.85 inches. Figure 5.2d shows the load versus deflection of the beam. The flexural failure was accompanied by end slip of the prestressing strands as the load exceeded 80 kips. At the south end the slip was about 0.25 inch and at the north end it was about 0.12 inch, as shown in Figs. 5.2e and f. This end slip at both ends is due to loss of bond between strands and concrete in the shear spans at loads above 80 kips. Damage to the concrete in providing the shear inserts would account for the south end being slightly weaker in resistance to end slip as shown in Figure 5.2e.

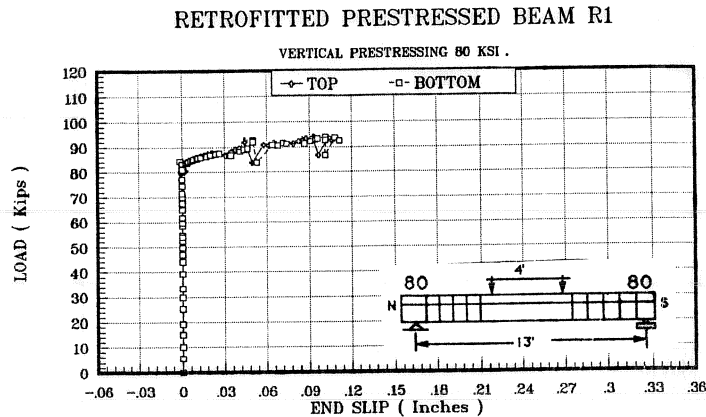
Figure 5.2f Load vs. end slip (north end).

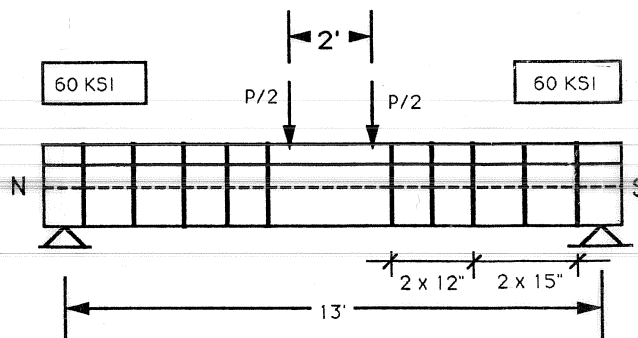
Figure 5.3a Loading pattern.

The beam was loaded with two concentrated loads (Fig. 5.3a) until failure. The spacing between these loads was reduced to two feet, allowing a longer shear span and a larger M/V ratio. The beam showed elastic behavior before cracking, and deformations were linearly proportional to load, as shown in Fig. 5.3b. First cracking developed at a load of 48 kips, and was in the prestressed portion of the beam within the pure flexure span. Five flexural cracks were formed at a spacing of 6 to 8 inches. As the load was increased,

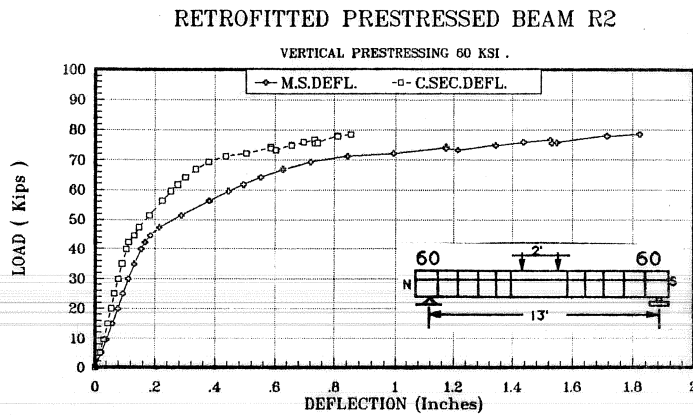
Figure 5.3b Load - deflection curve.

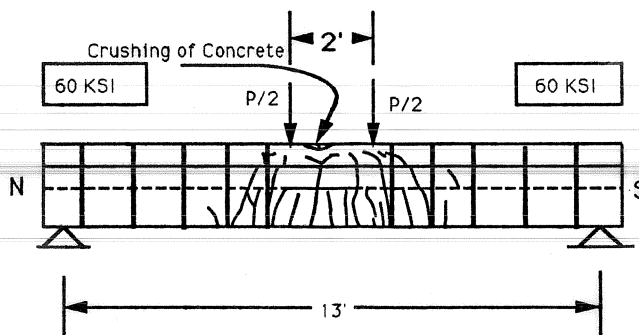
Figure 5.3c Cracking patterns, Beam R2.

The principal cracks were between the point loads and the first two prestressing bars, as shown in Fig. 5.3c. The mode of failure was flexural failure at a load of 78.57 kips. The

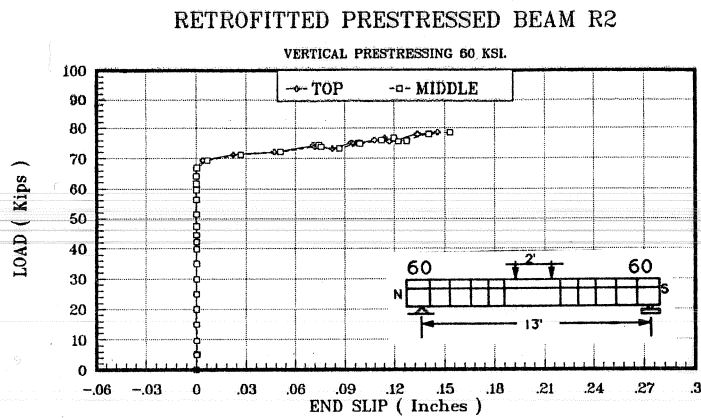
Figure 5.3d Load vs. end slip (south end).

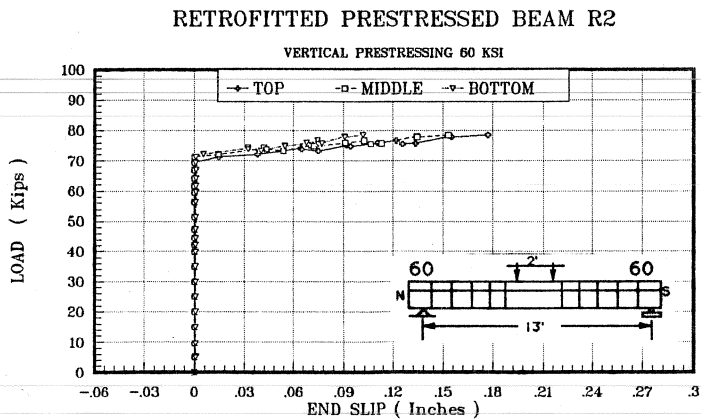
Figure 5.3e Load vs. end slip (north end).

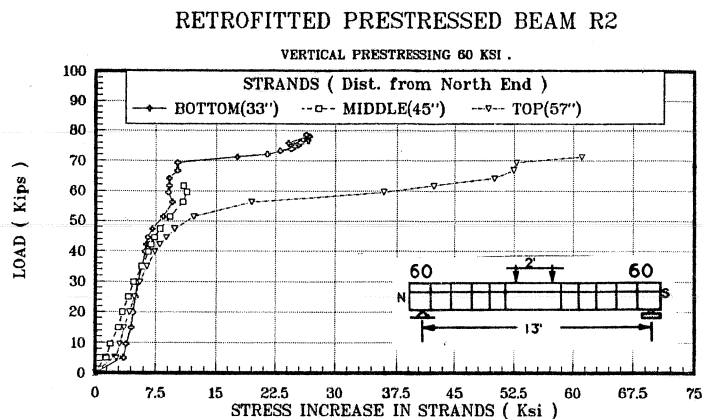
Figure 5.3f Load vs. stresses in strands (north end).

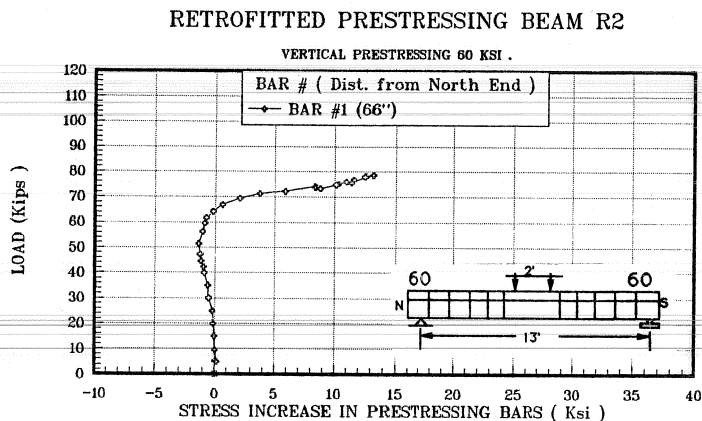
Figure 5.3g Load vs. stresses in prestressing bars (north end).

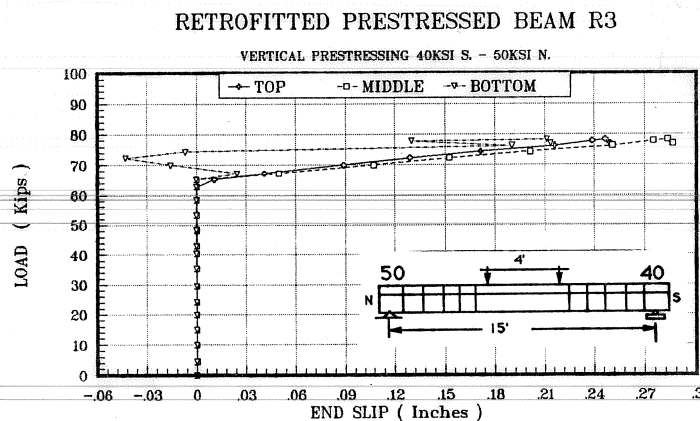
Figure 5.4a Load vs. end slip (south end).

This beam showed very similar behavior to that of Beam R2 with the exception that the end slips at each end approached 0.3 inches, which is nearly twice the end slip of the strands in Beam R2. Figure 5.4a and b show the end slips of the strands at different load levels.

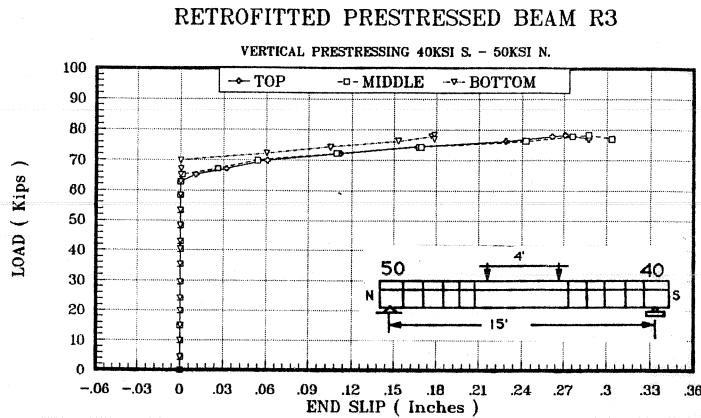
Figure 5.4b Load vs. end slip (north end).

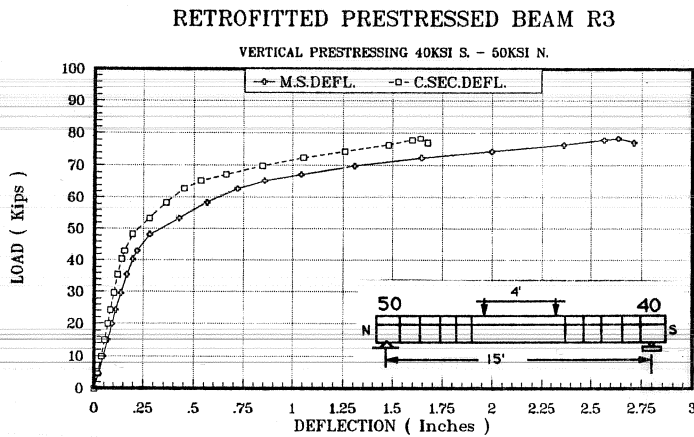
Figure 5.4c Load - Deflection curve.

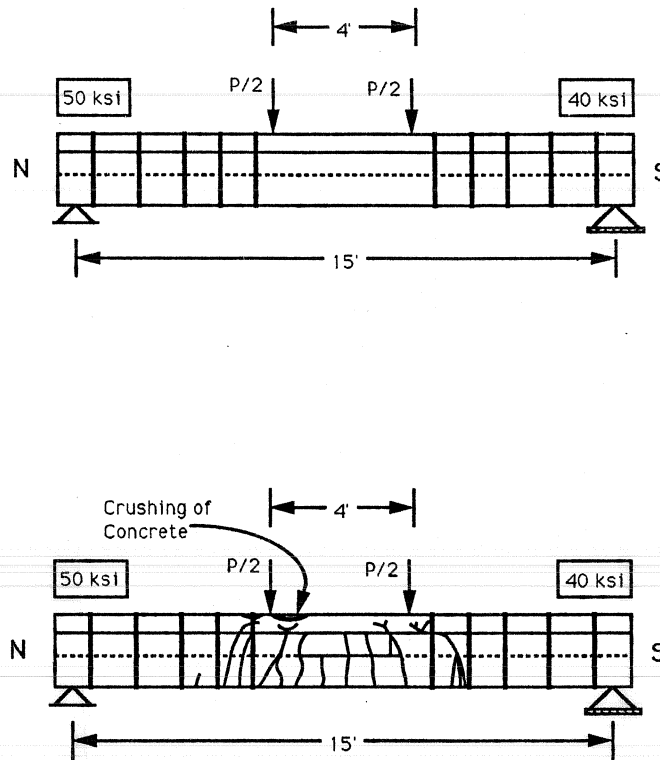
Figure 5.4d Loading and cracking pattern (Beam R3).

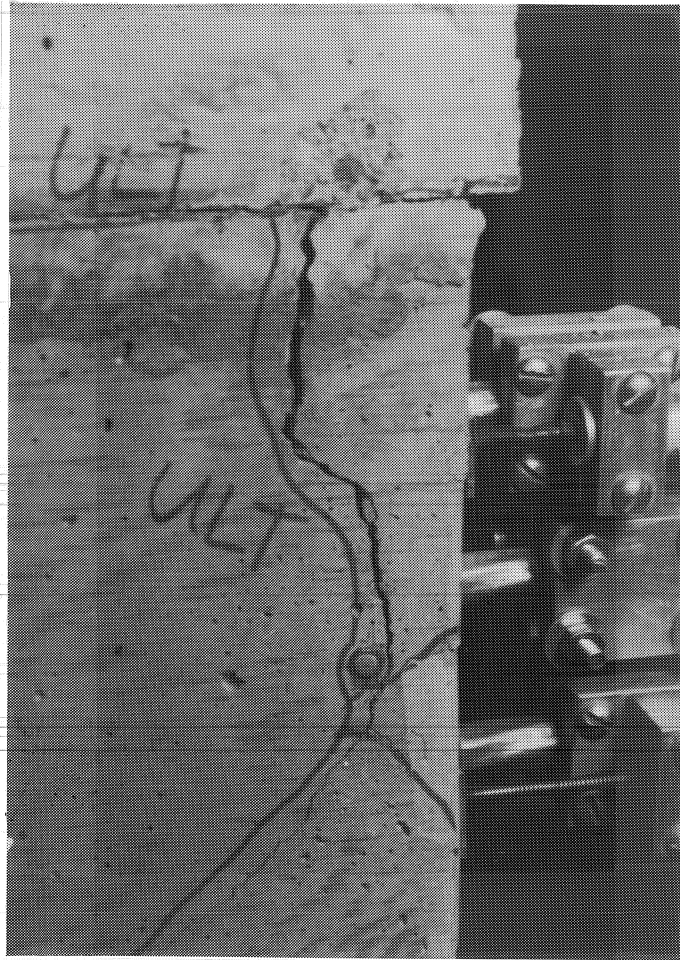
Figure 5.5a Differential movement of the cast-in-situ concrete deck against the prestressed beam due to horizontal shear failure.

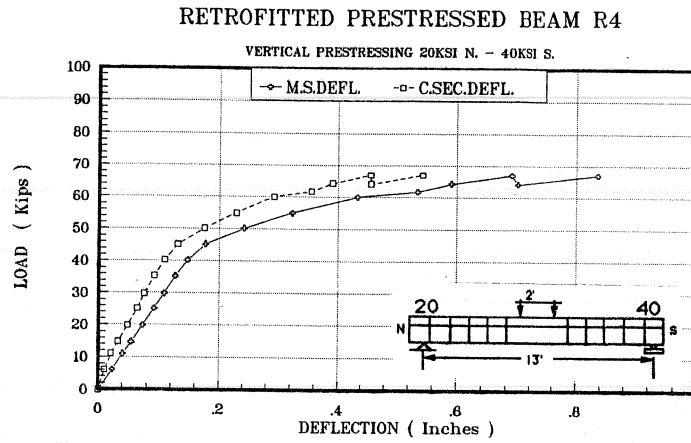
Figure 5.5b Load - Deflection curve.

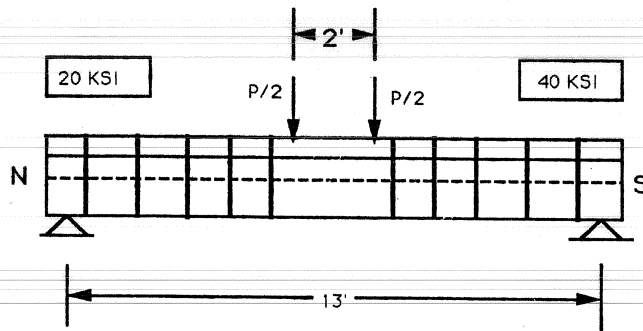
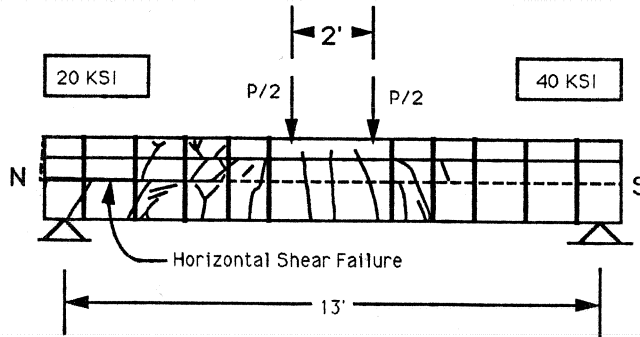
Figure 5.5c Loading and cracking patterns (Beam R4).

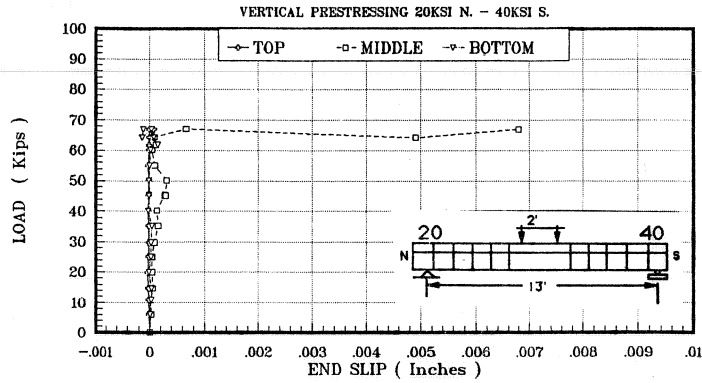
Figure 5.5d Load vs. end slip (south end).

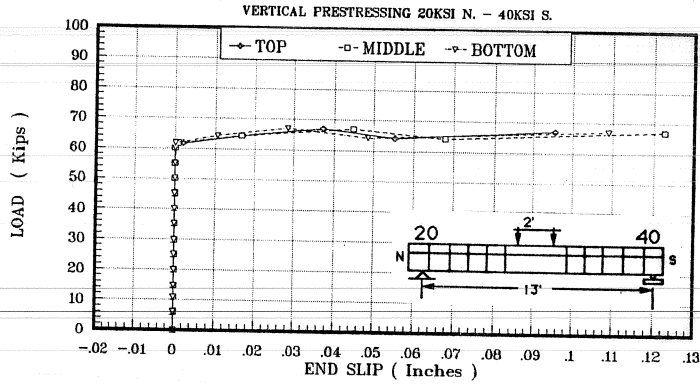
Figure 5.5e Load vs. end slip (north end).

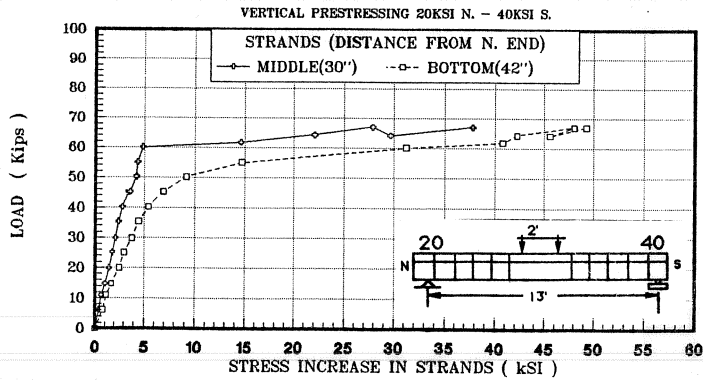
Figure 5.5f Load vs. stresses in strands (north 20 ksi end).

From Figure 5.5f, which shows load versus the increase in stresses in the prestressing strand, it is obvious that the stresses were increasing very slowly until the cracks extended into the cast-in-situ concrete. At this stage the stresses started increasing very rapidly. Although the beam failed in horizontal shear, the strands showed a considerable stress increase. The transverse prestressing bars were stressed to only 20 ksi in the north shear

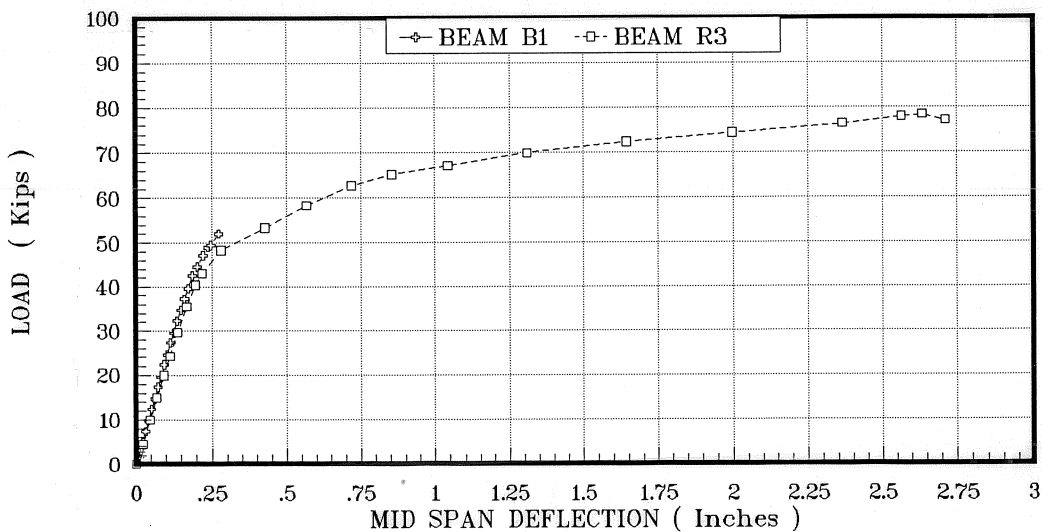
Figure 6.1a Load - Deflection curves, Beams B1 and R3.

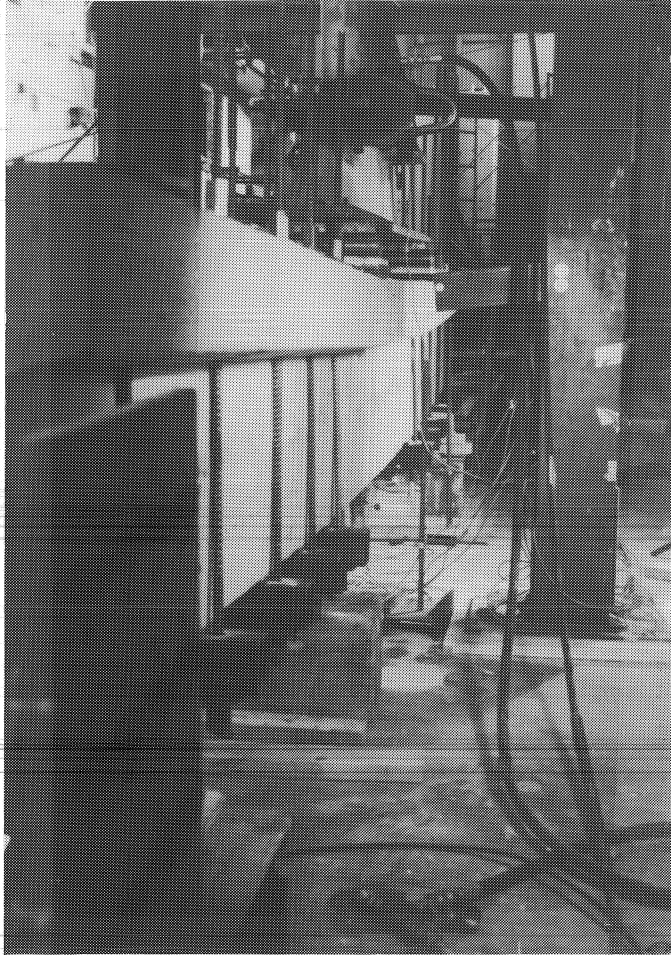
Figure 6.1b Beam R3 under testing frame.

failure. Both beams behaved similarly before cracking. Figure 6.1b shows Beam R3 under testing frame at ultimate load.

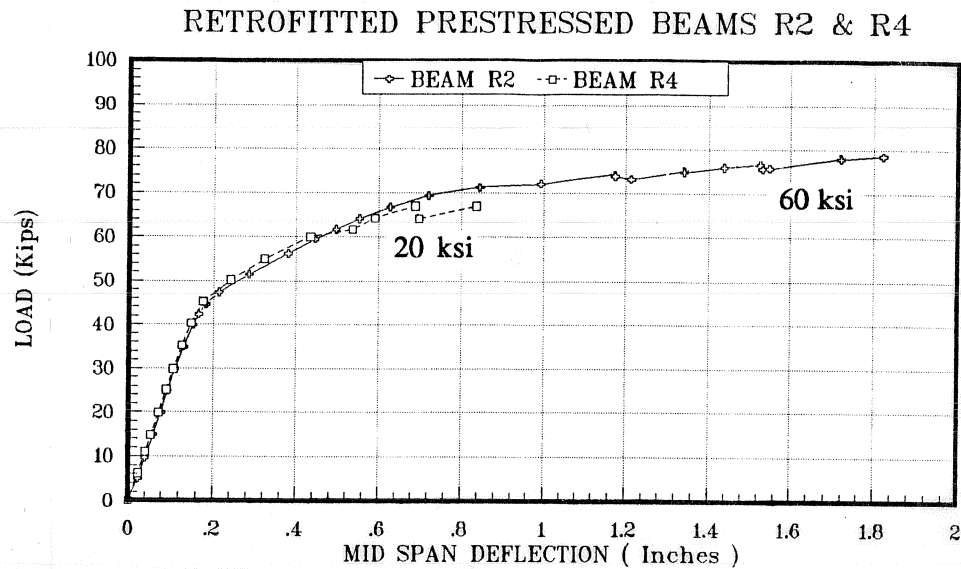
Figure 6.1c Load - Deflection curves, Beams R2 and R4.

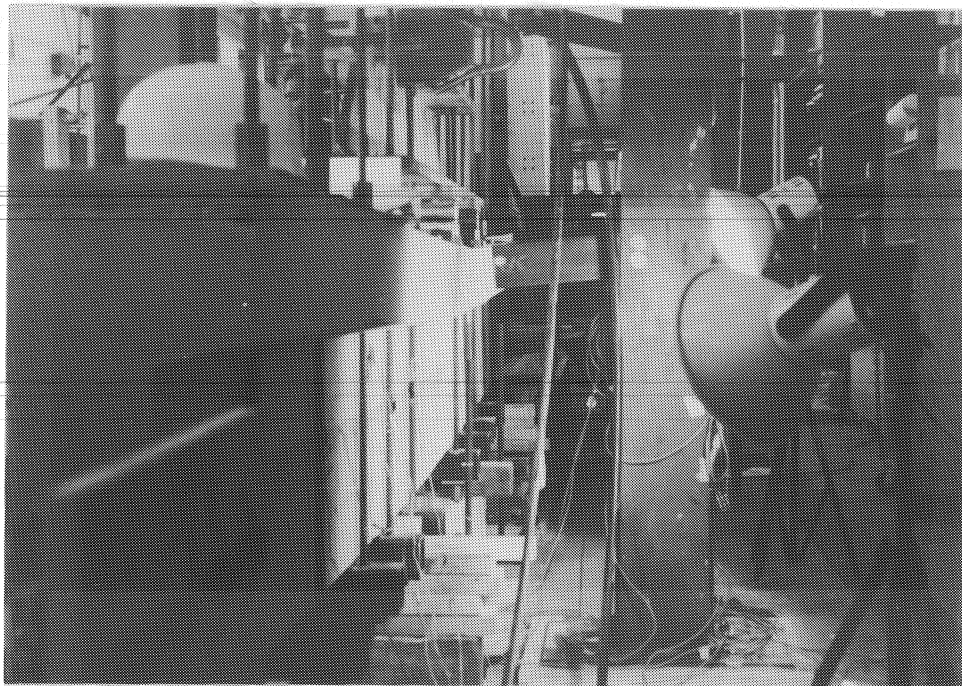
Figure 6.1d Beam R2 under testing frame.
