**SHEAR STRENGTHENING OF PRETENSIONED PRESTRESSED  
CONCRETE COMPOSITE FLEXURAL MEMBERS**

**Research Report 1210-2**

**Research Project 3-5-89-1210**

**March 1991**

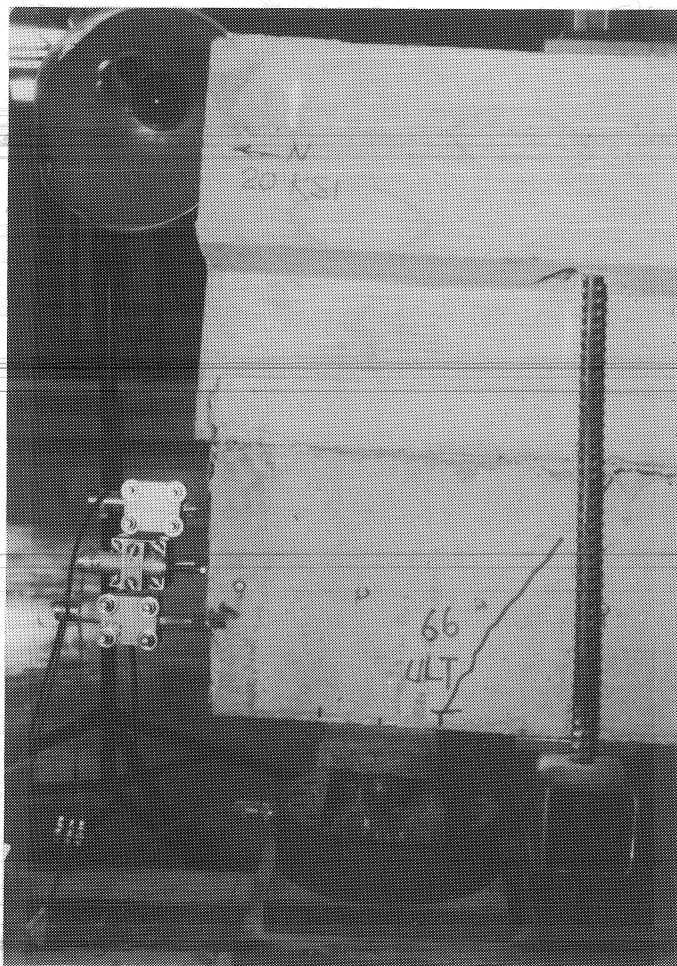
Figure 6.2a North end of Beam R4 at failure.

Beam R4 was retrofitted with a low level of stress (20 ksi) in the prestressing bars; bond at the interface failed. A differential movement of 0.5 inch was observed at the north

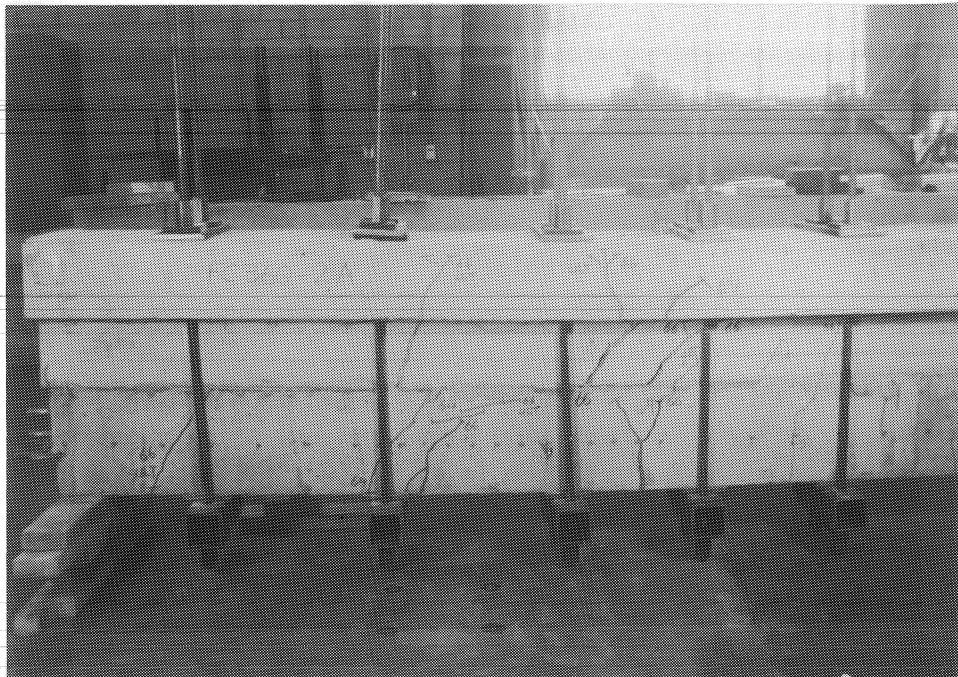
Figure 6.2b Beam R4 before removal of transverse prestressing bars.

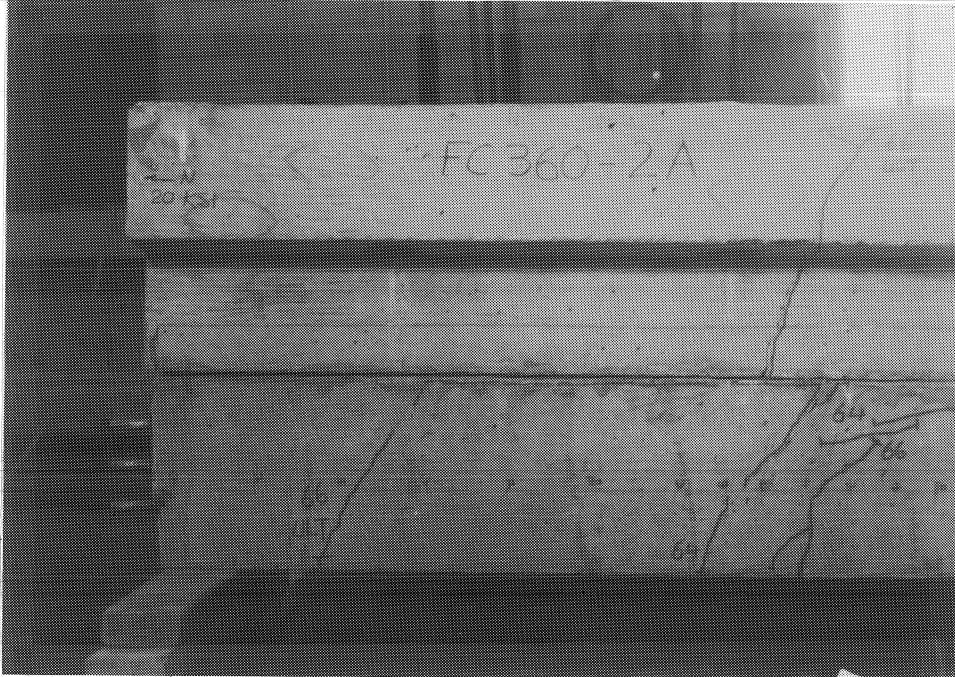
Figure 6.2c Beam R4 after removal of transverse prestressing bars.

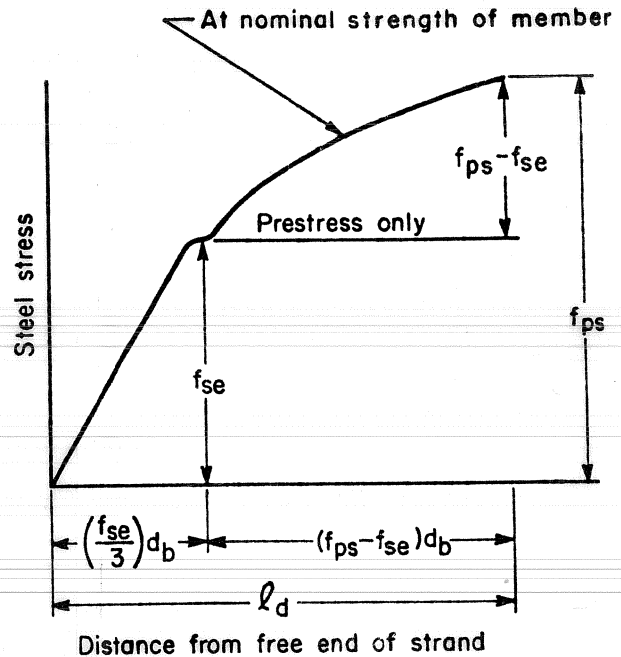
Figure 6.3a Variation of steel stress with distance from free end of strand (Ref. 4.)

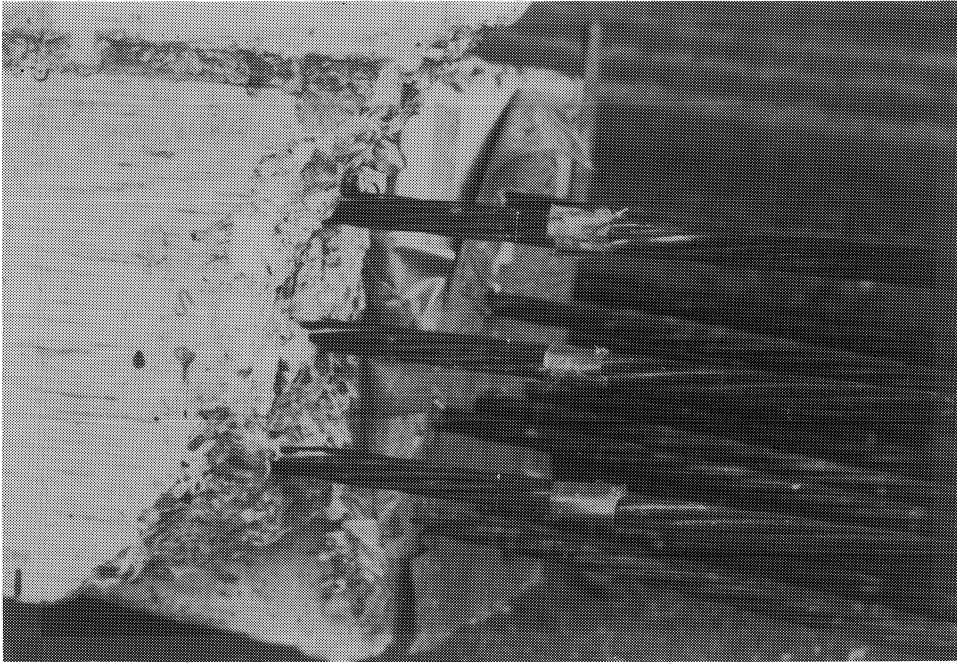
Figure 6.4 Portion of the strands in the transfer zone after removal of concrete.

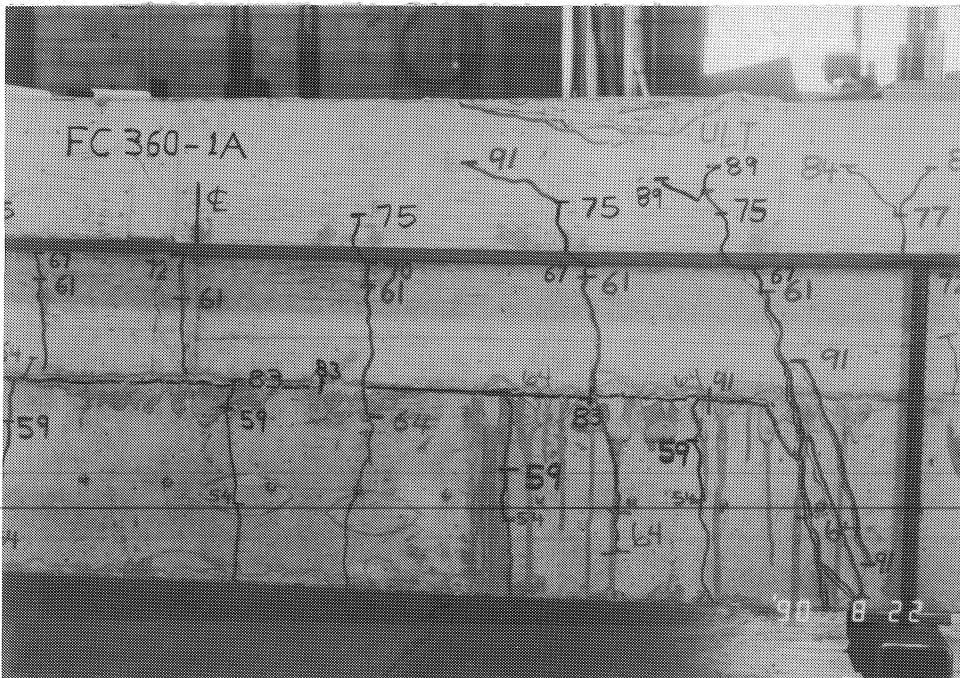
Figure 6.5a Mode of failure of beam R1 (flexural failure - crushing of concrete).

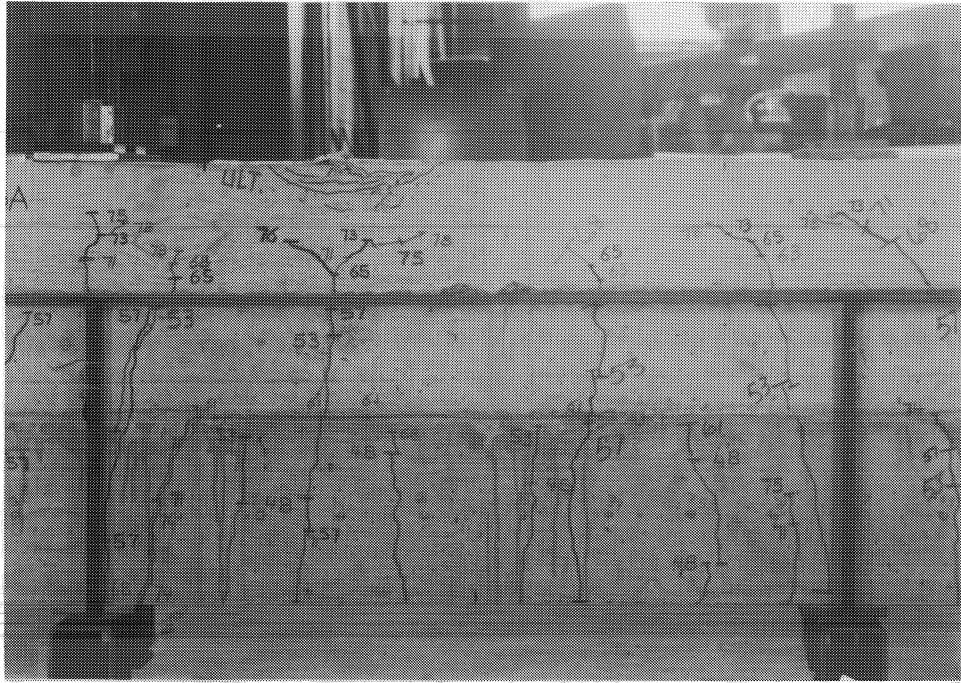
Figure 6.5b Mode of failure of Beam R2 (flexural failure - crushing of concrete).

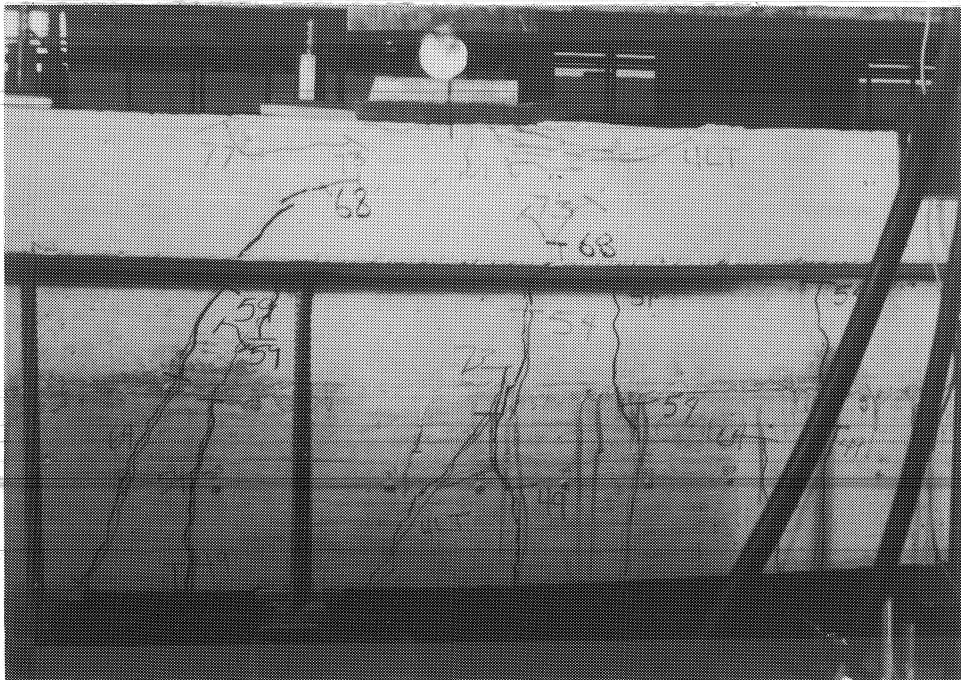
Figure 6.5c Mode of failure of Beam R3 (flexural failure - crushing of concrete).

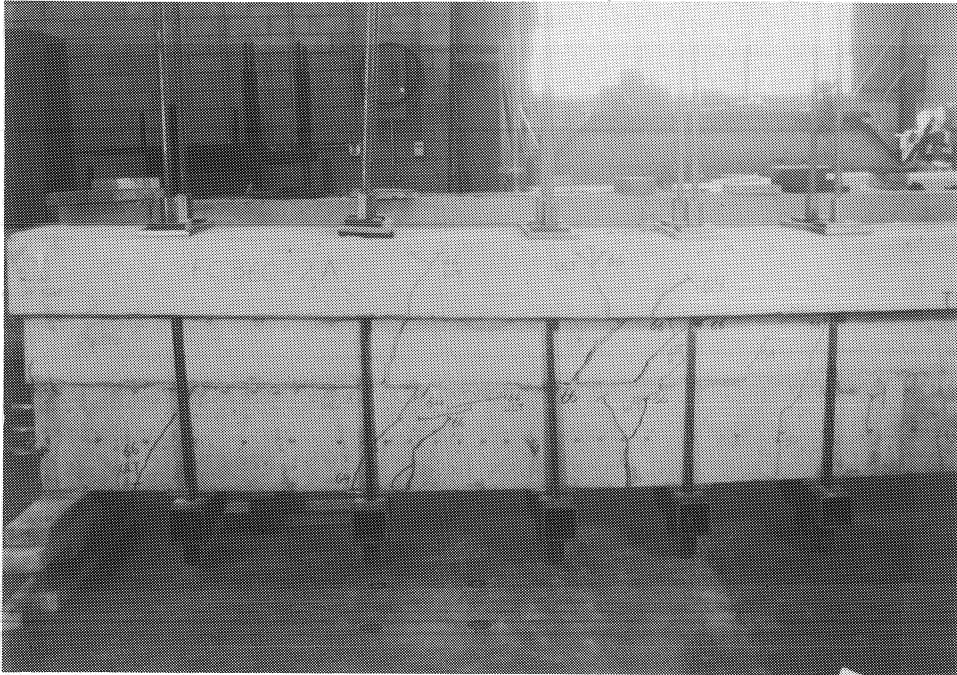
Figure 6.5d Mode of failure of Beam R4 (horizontal shear failure - differential movement).

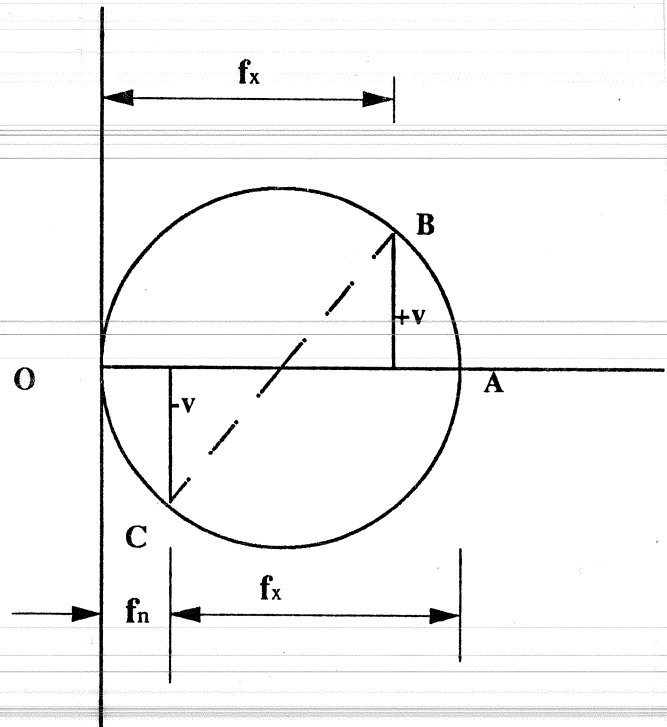
Figure 6.6 MOHR'S Circle for status of principal tensile stresses equal to zero.

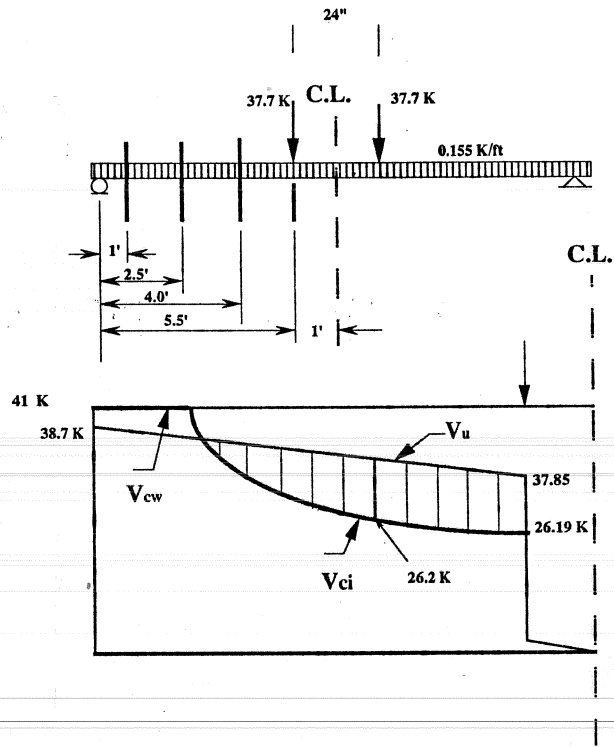
Figure C1. Ultimate shear force and concrete nominal shear strength (Beams R2 & R4).
