**BEHAVIOR OF STATICALLY LOADED
PRETENSIONED CONCRETE BEAMS
WITH 0.5-INCH DIAMETER
DEBONDED STRANDS**

Research Report Number 1210-4

Influence of Debonding of Strands on Behavior of
Composite Prestressed Concrete Bridge Girders

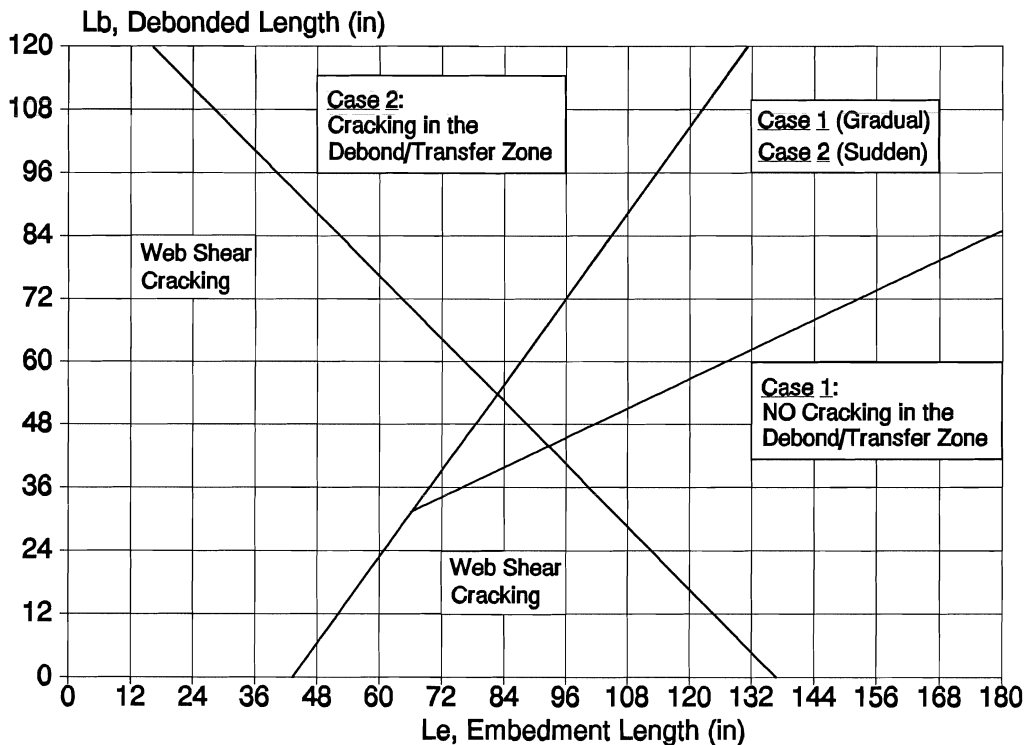
Figure 3.2 Prediction Model of Cracking and Bond Failure

Developed as a design guide (calculations in Appendix D), Figure 3.2 graphically illustrates the expected behavior of a specimen at any given debonded length, L_d , and embedment length, L_e . (The embedment length is the distance from the end of the longest debonded length to the point of maximum moment.) The plot is divided into several different areas. Each area represents a different prediction of behavior. Case 1 areas predict cracking will not occur in the debond/transfer zone and a flexural failure is likely.

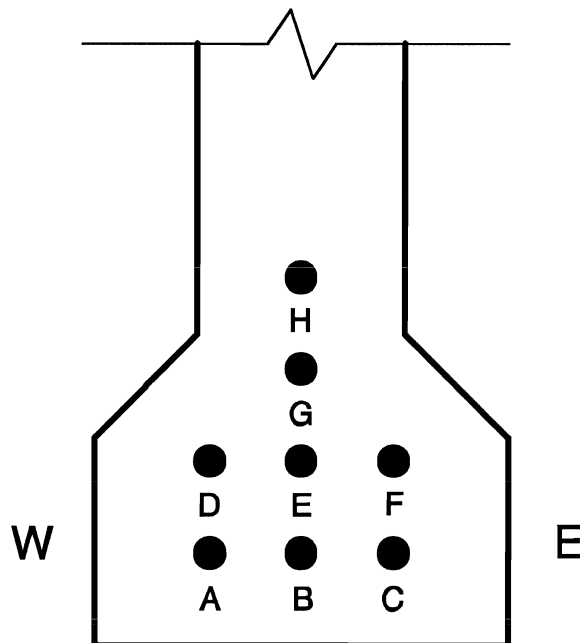
Figure 3.4 Strand Labeling Scheme

DB850 - 1A	
D	Debonded specimen (F = Fully Bonded)
B	Type B cross section (A = Type A)
8	Number of Strands
5	Diameter of Strand (6 = 0.6 inch strand)
0	2 inch spacing grid (2 = 2.25 inch grid)
1	Specimen number in the series
A	First test of specimen (B = second test)

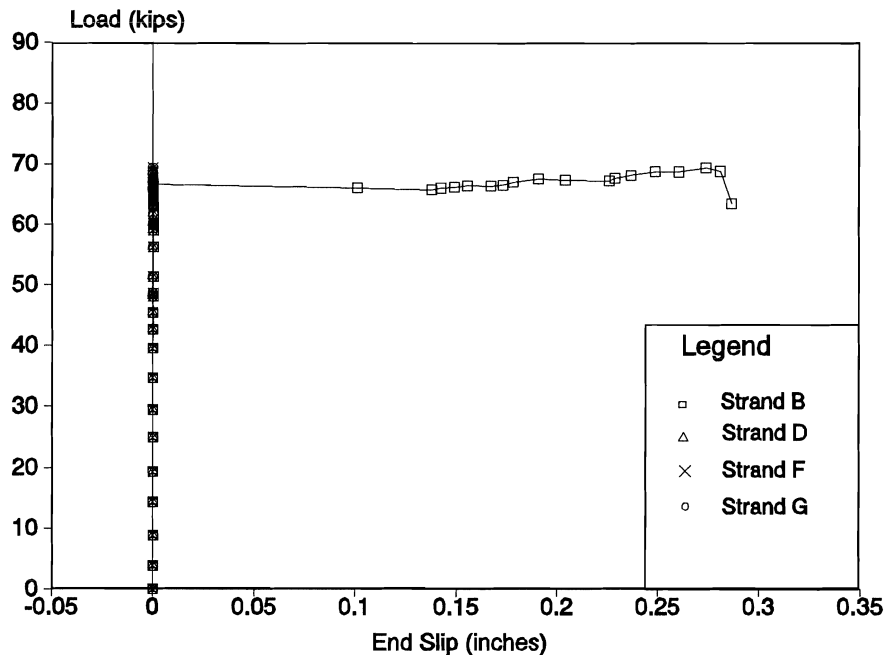
Figure 4.9 Load vs. End Slip, DB850-3B (G)

At a load of 66 kips, the first end slip of 0.101 inches was recorded in strand B (Figure 4.9). Under further loading, increased deformations resulted only in a small
