DESIGN GUIDELINES FOR TRANSFER, DEVELOPMENT AND DEBONDING OF LARGE DIAMETER SEVEN WIRE STRANDS IN PRETENSIONED CONCRETE GIRDERS

Bruce W. Russell and Ned H. Burns

Research Report 1210-5F

January 1993

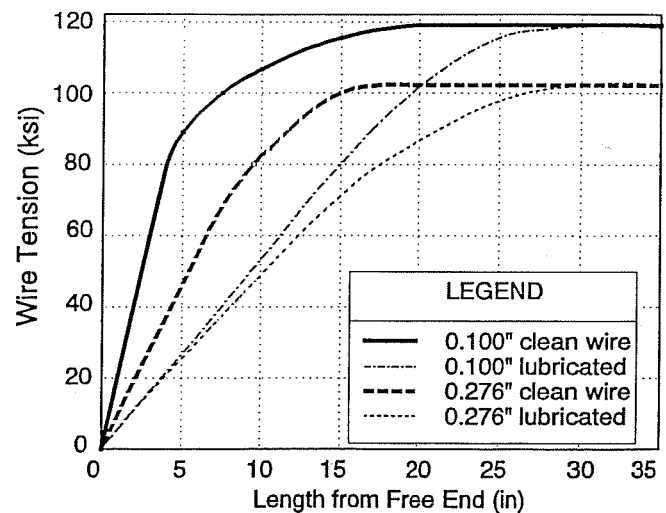
Figure 2.7 Stress Distributions From Clean and Lubricated Wire; Janney 1954

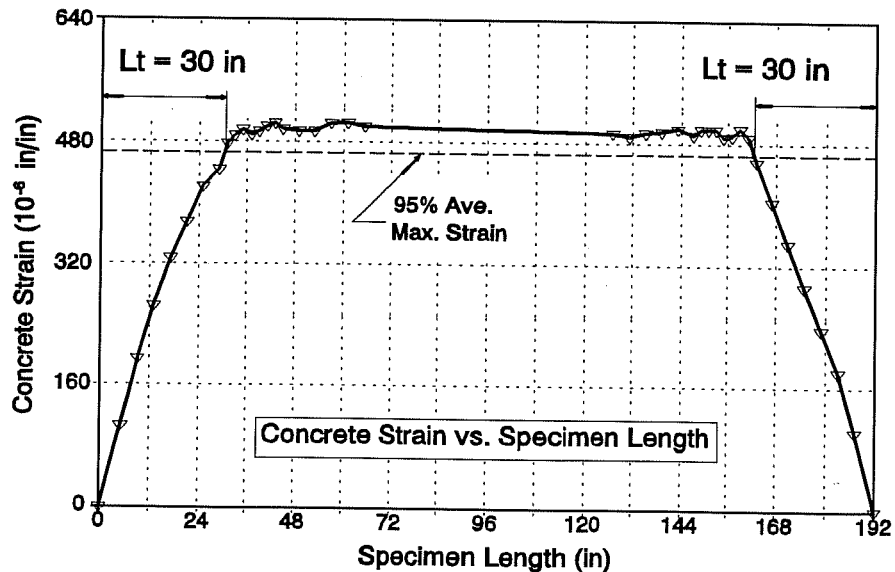
Figure 3.14 FCT350-3, Transfer Length

Figure 3.14 illustrates the strain profile for specimen FCT350-3, which is typical for a fully bonded specimen with 0.5 inch strands. Figure 3.15 is the strain profile for specimen

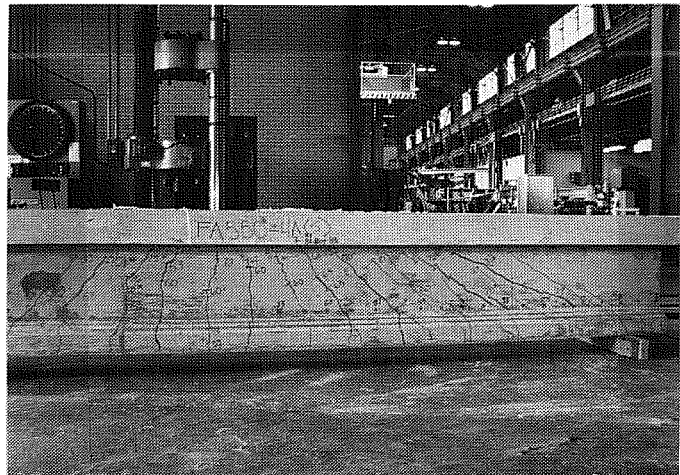
Figure 4.12 Beam FA550-4A: Typical Shear/Bond Failure

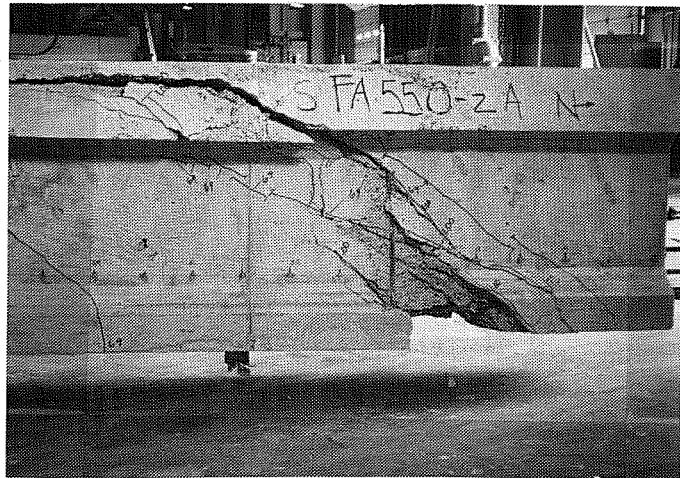
Figure 4.13 Photograph of FA550-2A Explosive Shear Failure

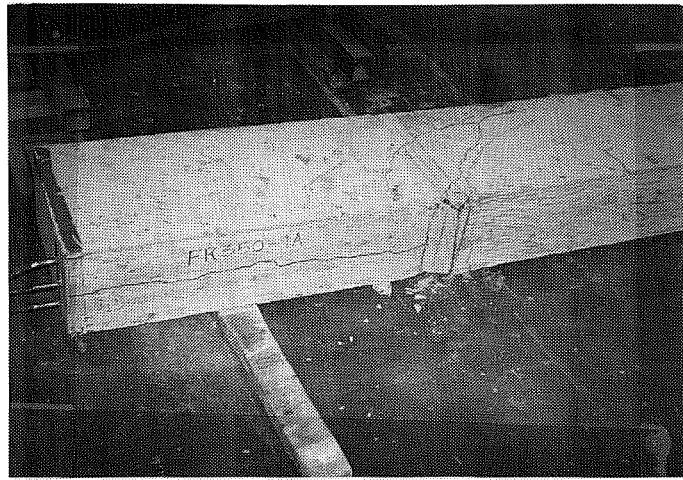
Figure 4.18 Photograph of Cracking at Failure Beam FR350-1 Test A: Bond Failure

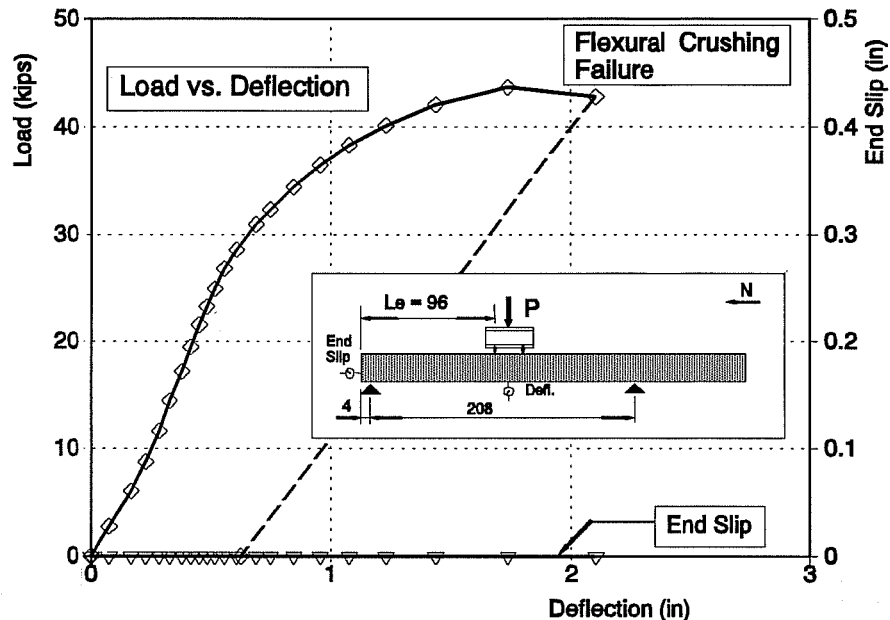
Figure 4.22 Beam FR360-1 Test A: Typical Flexural Failure Rectangular Beams With 0.6 Inch Strands

inches. This corresponds to approximately $1.0 L_d$ as given by the code equations. Also, this was the required development length from the FR350 series. Test FR360-1A failed in flexure with no end slip. In Table 4.5, the concrete strain at failure was 0.003872 in/in and the moment reached 98% of the calculated capacity. The load versus deflection curve shown in Figure 4.22 has the form of a typical flexural failure for a pretensioned beam.

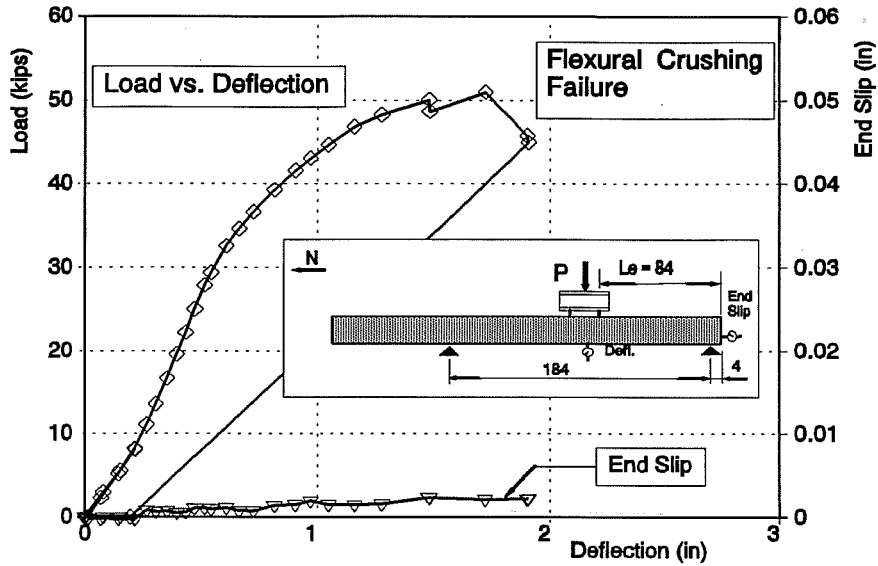
Figure 4.25 Beam FR350-2 Test A: Flexural Failure With Small Strand Slip

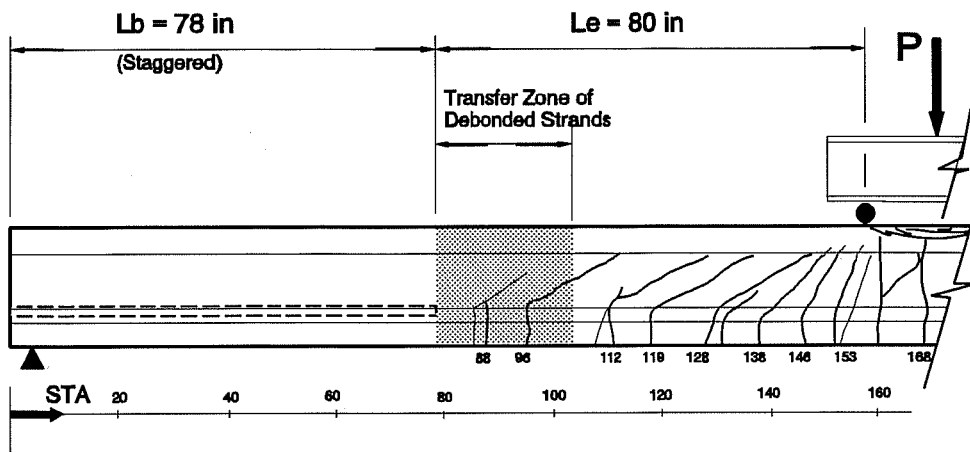
Figure 5.14 Cracking Pattern DB850-3A

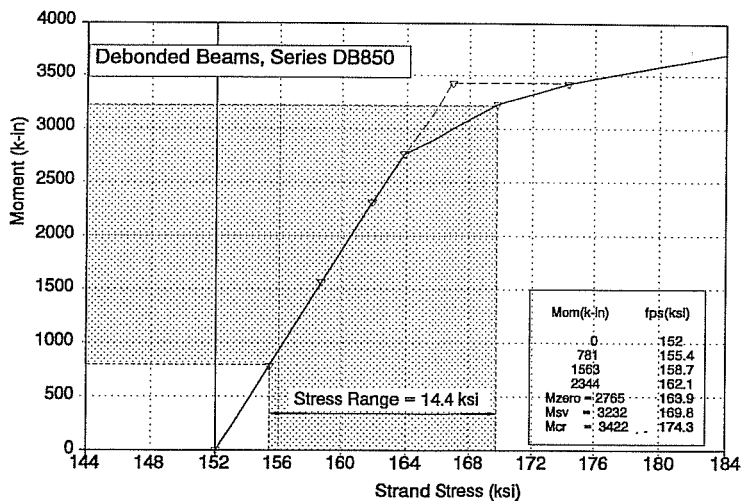
Figure 6.6 Stress Range for Repeated Load Tests

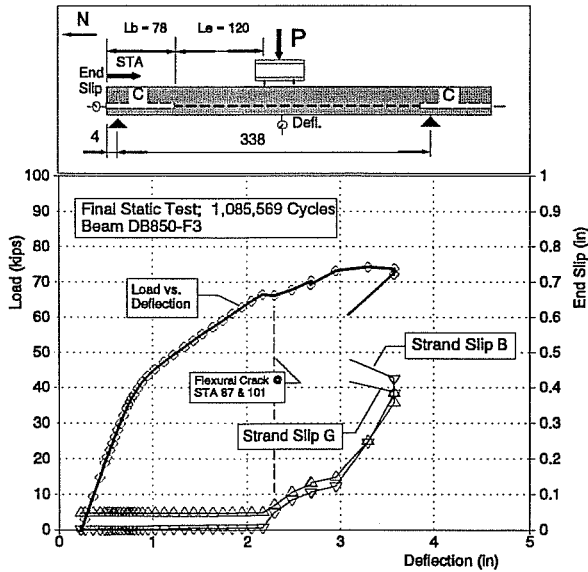
Figure 6.22 Load vs. Deflection and End Slips Beam DB850-F3
