1. Report No. FHWA/TX-92+1239-2		2. Government Accession No.		3. Recipient's Catalog No.	
4. Title and Subtitle AN ULTIMATE LOAD TEST TO STUDY BRACING EFFECTS OF BRIDGE DECKS				5. Report Date May 1992

**AN ULTIMATE LOAD TEST TO STUDY BRACING EFFECTS OF
BRIDGE DECKS**

Research Report No. 1239-2

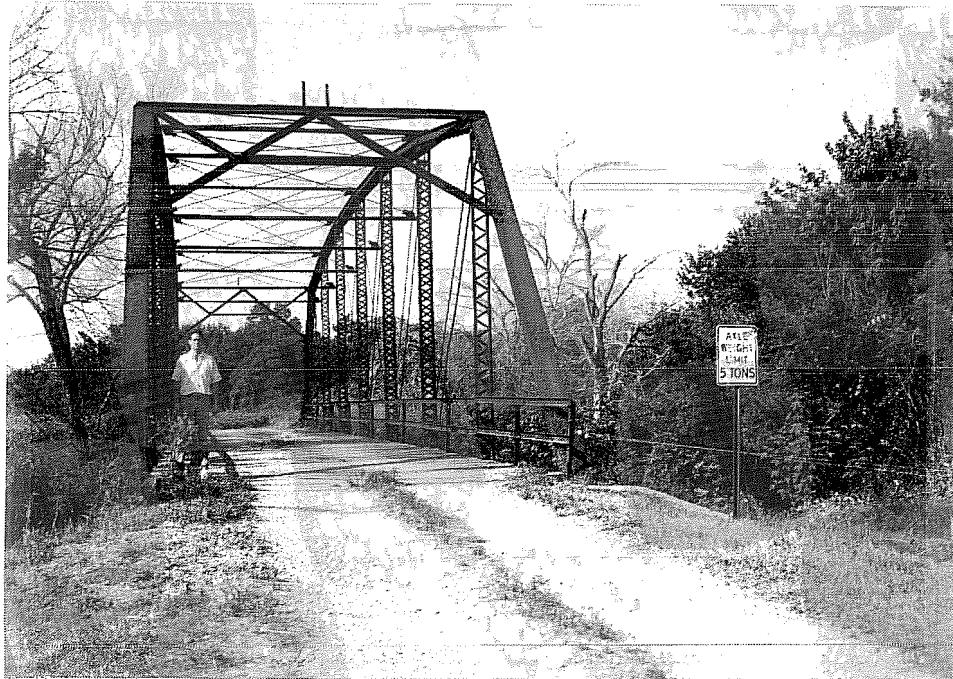
Figure 1.1 Photograph of a typical bridge

The capacities of bridges, constructed with steel stringers supporting a timber plank deck or concrete deck which is not positively attached to all stringers, may be underrated by current AASHTO standards. The lateral buckling formula used in the Texas Bridge Rating Manual, which is the same as that in the AASHTO Bridge Specifications prior to 1990, gives very conservative estimates of strength. When there is no positive connection between the stringers and the deck, the beams may be considered laterally unsupported along the span. This yields a load carrying capacity which is much lower than the loads these bridges are known to support. Figure 1.1 is the photograph of a typical bridge; Figure 1.2 shows the deck-beam connection detail.

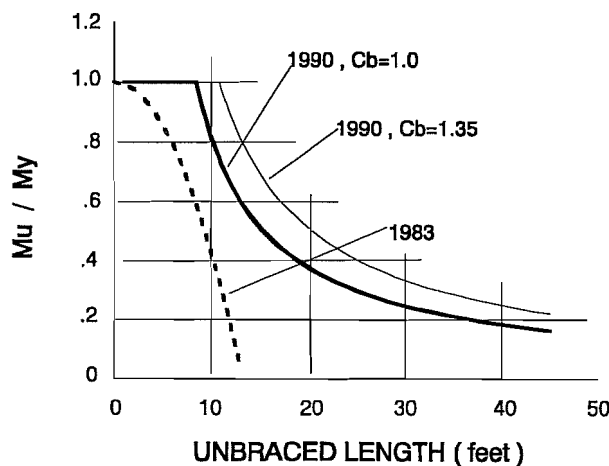
Figure 2.6 AASHTO Beam Buckling Strengths.

Equation (2) gives results very close to the Timoshenko classical lateral buckling formula (Timoshenko, 1960). Figure 2.6 shows values of beam buckling strength given by the 1983 and 1990 AASHTO specifications for a S6x12.5 beam with $F_y = 42$ ksi. As can be seen from the graph, the 1983 AASHTO buckling formula gives very conservative estimates of strength. In cases where the unbraced length is greater than 13 feet, the formula gives negative capacities. For example, for an unbraced length of 13 feet, the 1983 formula gives 0 k-ft, whereas the 1990 formula with $C_b = 1.35$ gives 20.74 k-ft. ($M_y = 25.8$ k-ft)

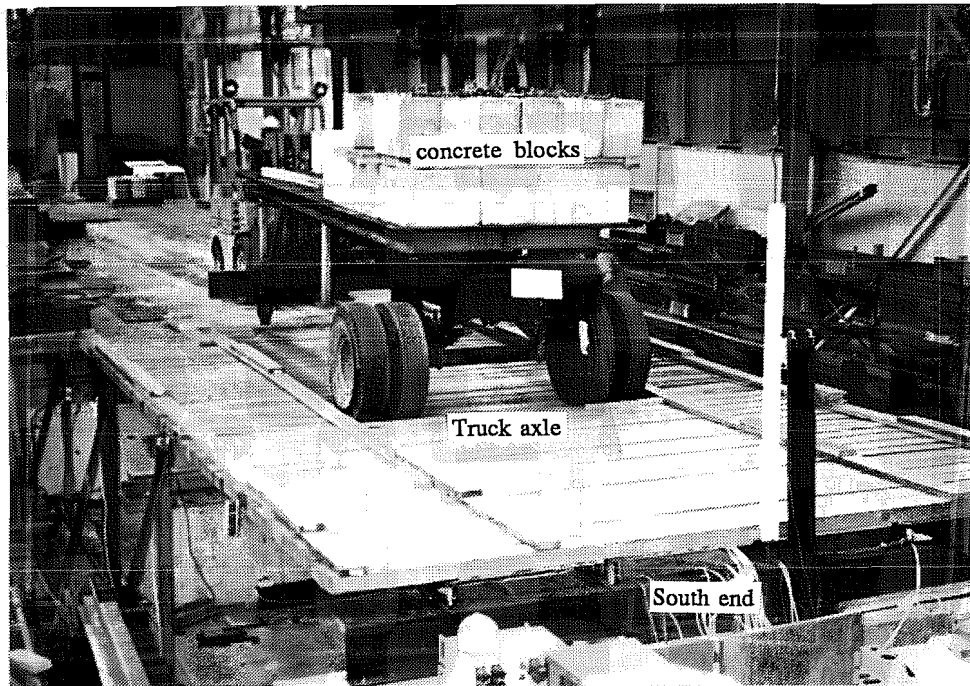
Figure 3.4 Photograph of the bridge and cart.

A steel cart measuring 16-ft x 12-ft and loaded with concrete blocks was used to load the bridge. The cart was fitted with a truck axle (tandem) on one end and rested on castors at the other. The center to center distance between the tires was 6 ft. Only the axle load was applied to the bridge, the castors remained on an elevated slab adjacent to the test bridge. A forklift was used to push the cart on and off the bridge. Figure 3.4 shows a photograph of the cart and the bridge.

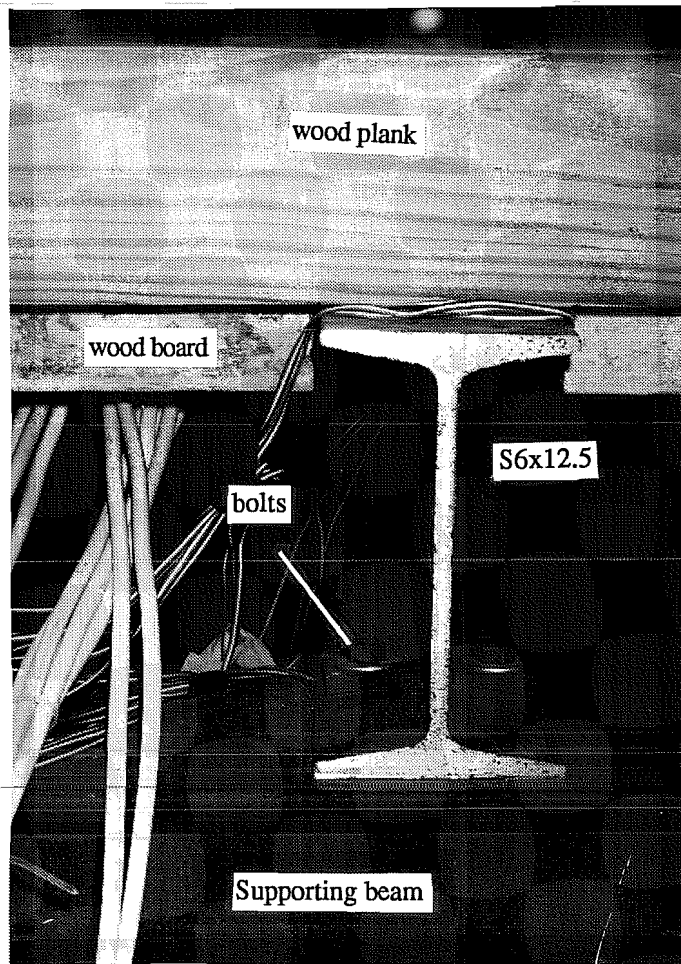
Figure 3.9 Photograph of end support detail.

the fact that the web of the supporting beam bends and provides very little restraint in the x-direction. Hence, for the support arrangement used on the bridge, the support conditions approximate a pin-roller support. Figure 3.9 shows the end support condition for the bridge beams.

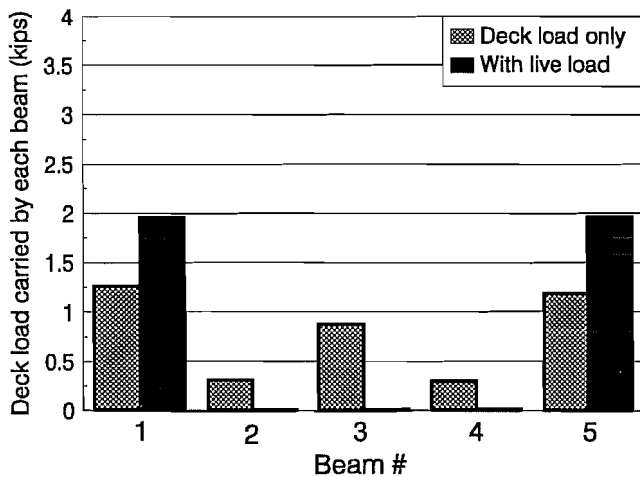
Figure 4.3 Distribution of deck load.

4.2.4 Load Distribution. The loads distributed to each beam were determined from the strain gauge readings. The load distribution is a function of the deck stiffness, beam stiffness, stringer spacing, and initial camber of the stringers and the wood planks. The weight of the deck was determined by measuring the strains before and after the deck was constructed. The distribution of the deck load is shown in Figure 4.3.

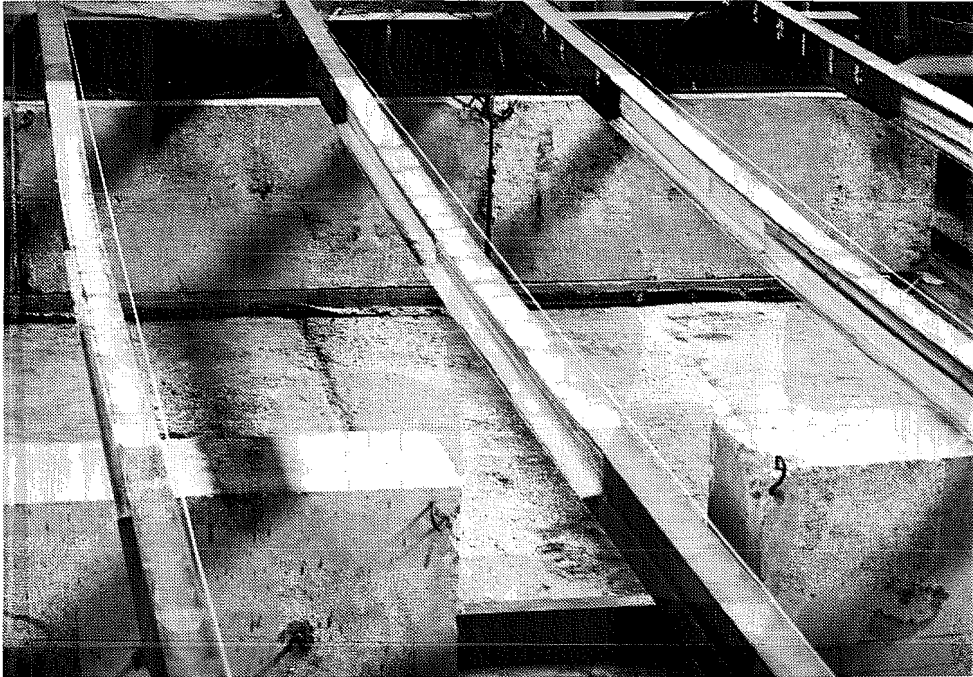
Figure 4.16a Deformed beams after the test.

Figure 4.16a is a photograph of the three interior beams in their buckled configuration after the test was done. The white string marks the original straight position of the beams. Figure 4.16b is a photograph showing the yield lines in the midspan region. The in-plane bending stresses superimposed on the out-of-plane stresses due to lateral torsional buckling cause the top and bottom flange tips on either side to yield.
