1. Report No.	2. Government Accession No.	3. Recipient's Catalog No.	
4. Title and Subtitle Investigation of Corrosion Protection Systems for Bridge Stay Cables		5. Report Date November 1995

**INVESTIGATION OF CORROSION PROTECTION SYSTEMS
FOR BRIDGE STAY CABLES**

Research Report No. 1264-3F

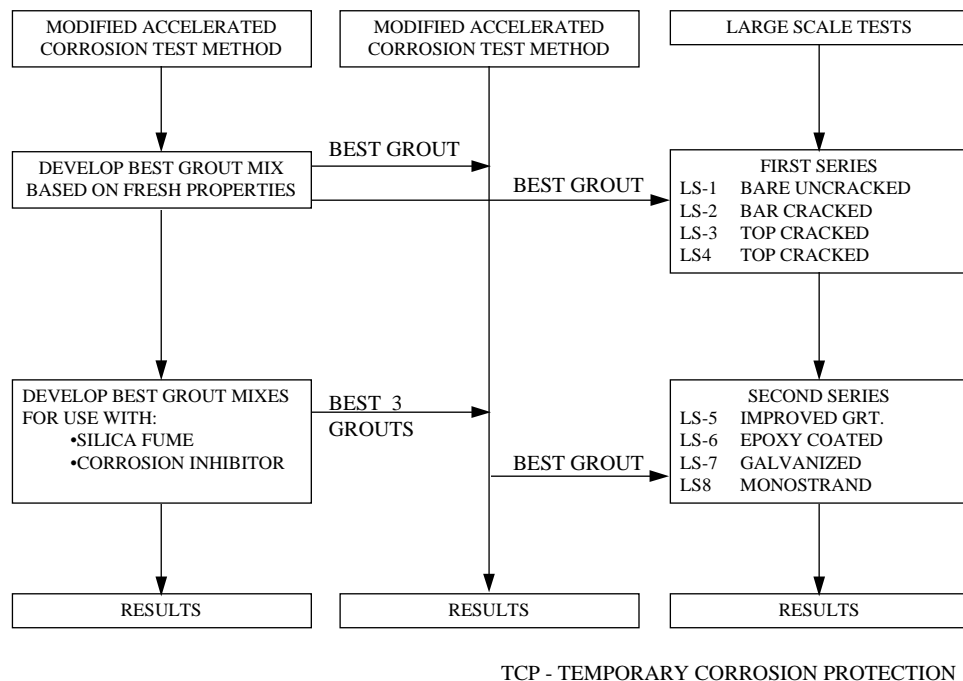
Figure 1-13 Flow chart for experimental program

The research was almost purely experimental and consisted of several test series. The experimental program flow chart is shown in Figure 1-13. The portland cement grout series consisted of selecting trial mix designs and testing the fresh properties of various mixes. The best basic mix was then selected for use in the Modified Accelerated Corrosion Test Method (ACTM) and the first four specimens of the large-scale tests. In addition, the fresh properties of the basic grout mix were tested to determine the effect of adding corrosion inhibitors. A silica fume grout was also developed. The effectiveness of the corrosion protection provided by these “improved” grout mixes was tested with the Modified ACTM. The grout that performed the best in the Modified ACTM was selected for use in Specimen LS-5 in the large-scale test series.

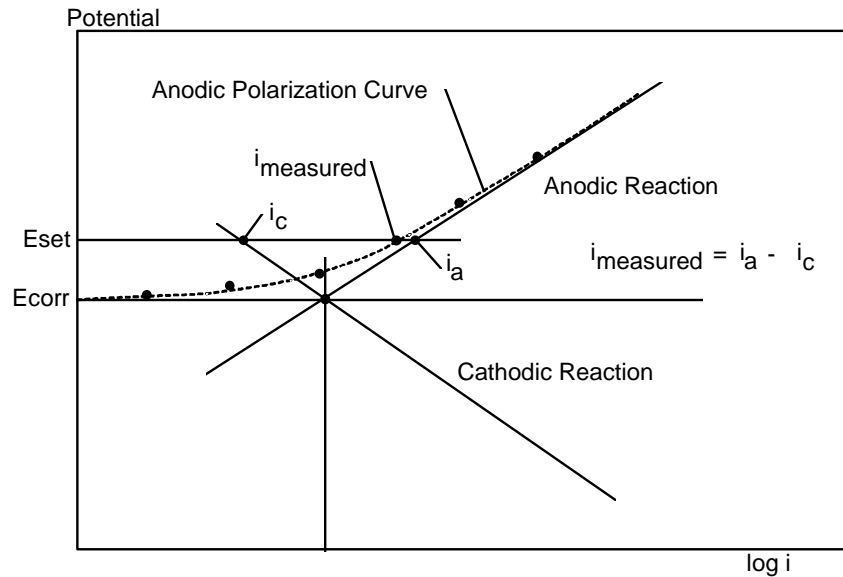
Figure 2- 8 Anodic polarization curve

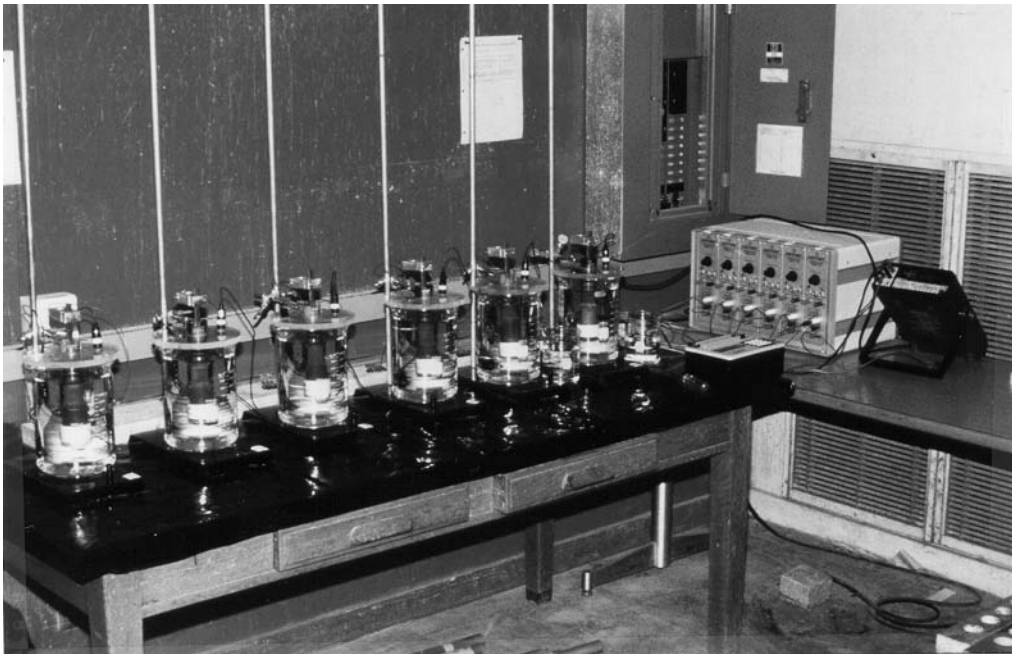
Figure 6-1 Modified accelerated corrosion test method setup

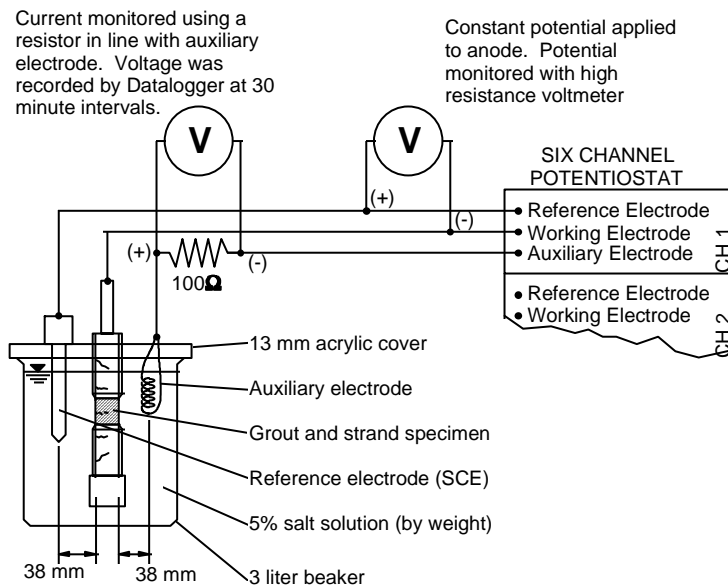
Figure 6-2 Instrumentation for anodic polarization test

There were six corrosion cells, each with the configuration shown in Figure 6-2. The data was recorded with a Campbell Scientific 21X Micrologger portable data acquisition system. Voltage was also monitored with a Fluke 8800A benchtop multimeter

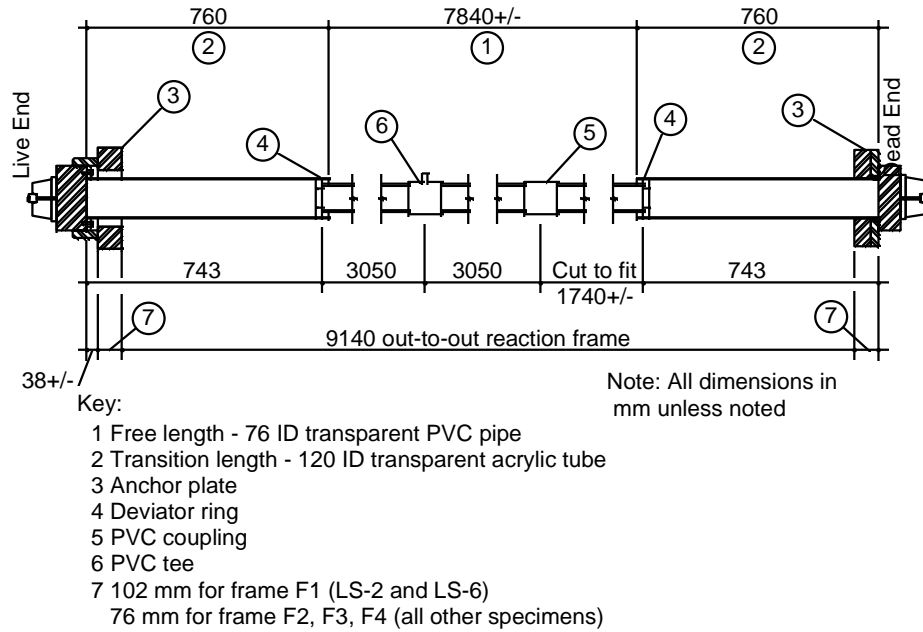
Figure 7- 8 Sheathing details

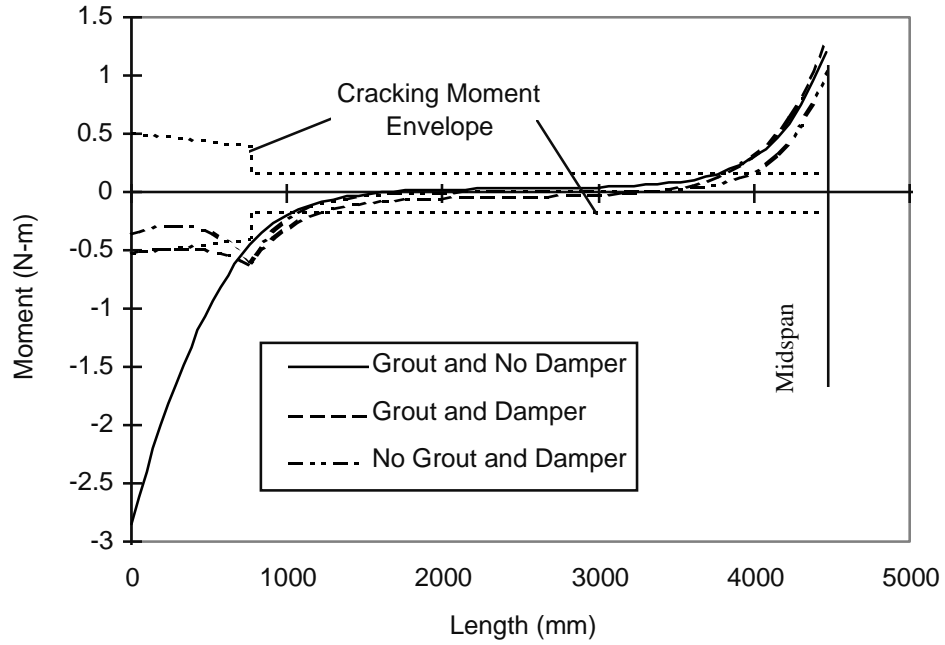
Figure 7-21 Bending moments from analysis of stay cable specimen

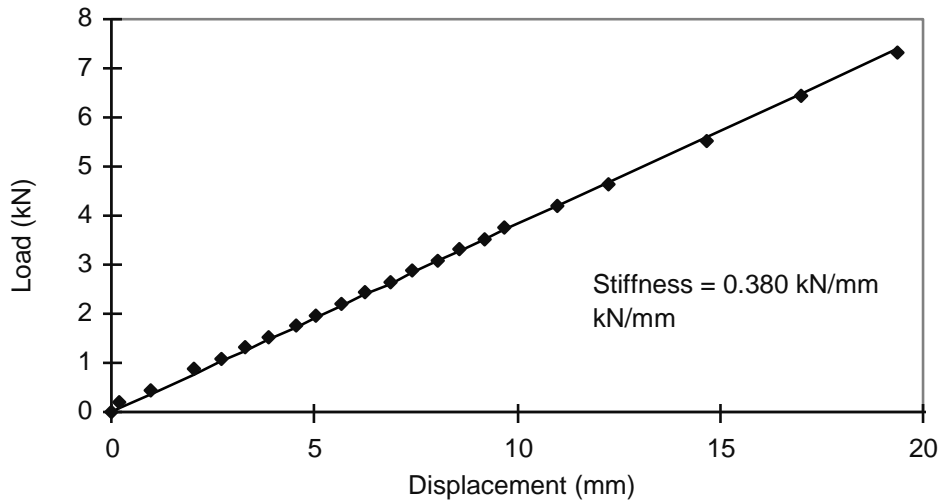
Figure 7- 23 Typical load-displacement relationship from lateral load test

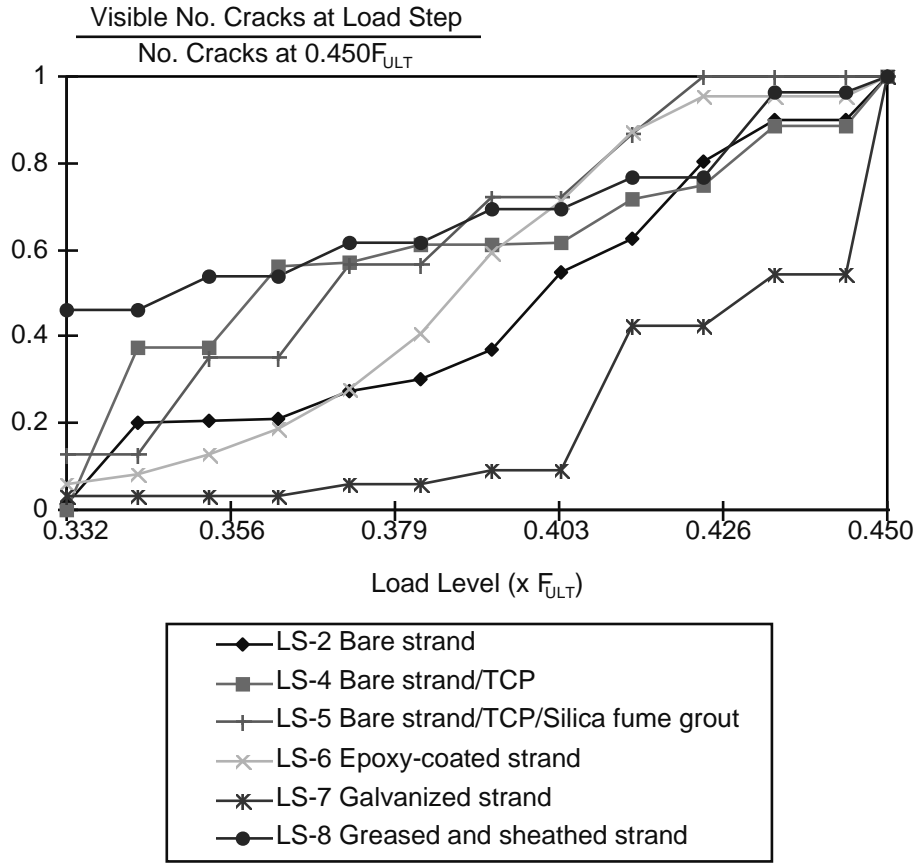
Figure 7-24 Cumulative cracking of specimens

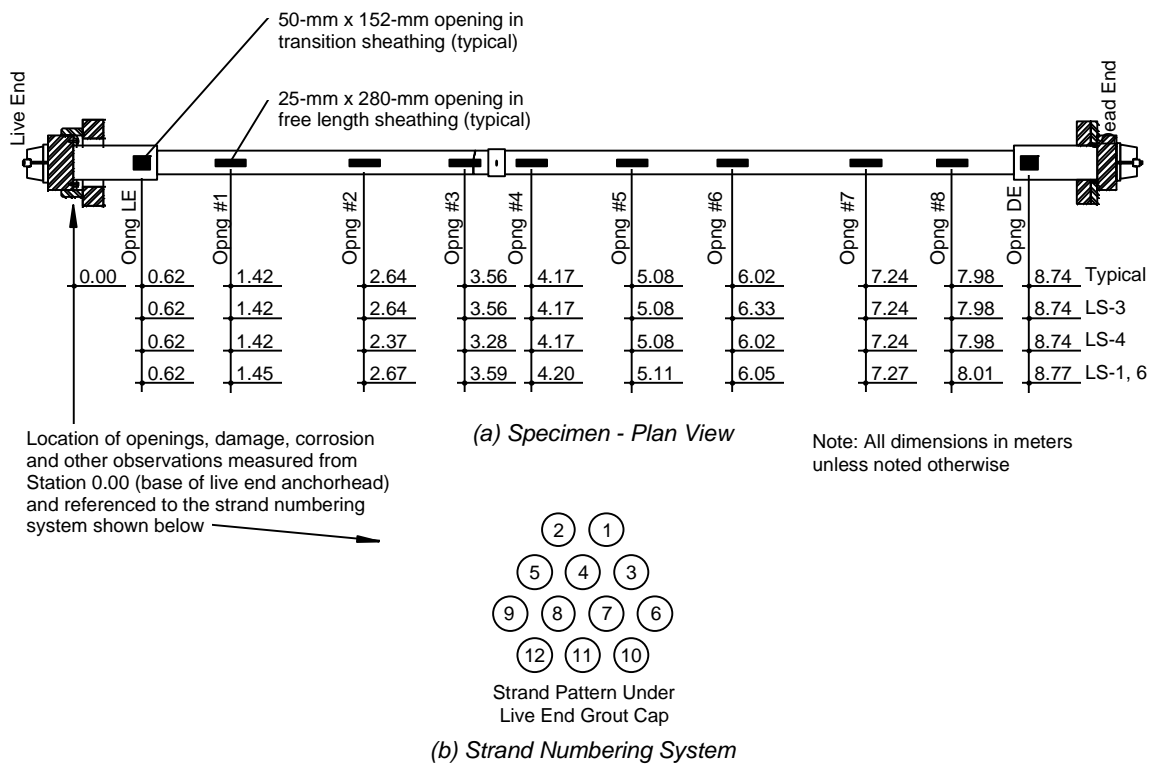
Figure 8-1 Sheathing breaks and standard referencing system for large scale specimens

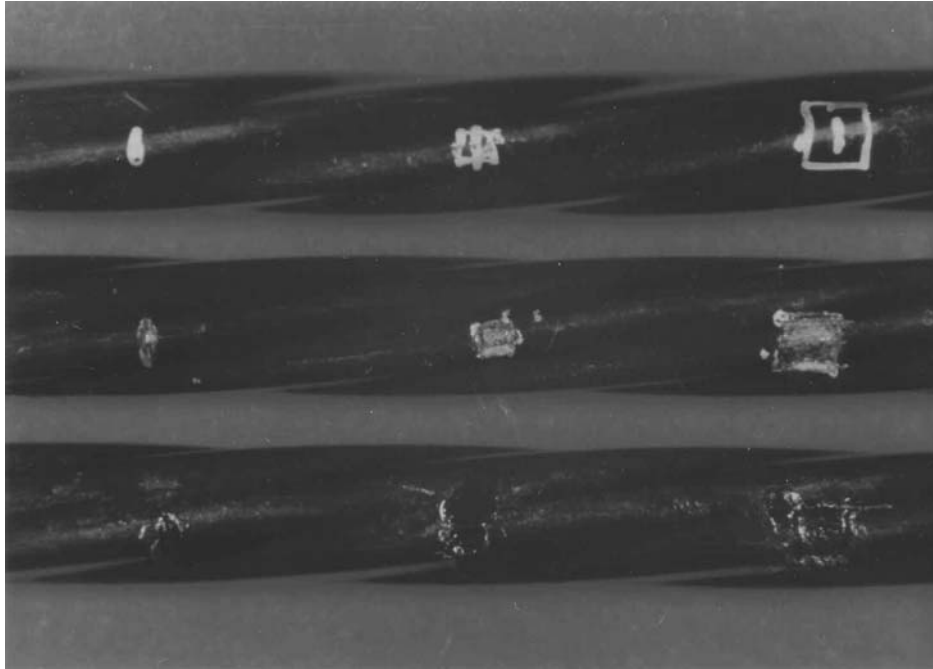
Figure 8- 5 Three sizes of damage made to epoxy coating: Cut, 3.2-mm square and 6.4-mm square (middle). Repaired damages shown at bottom

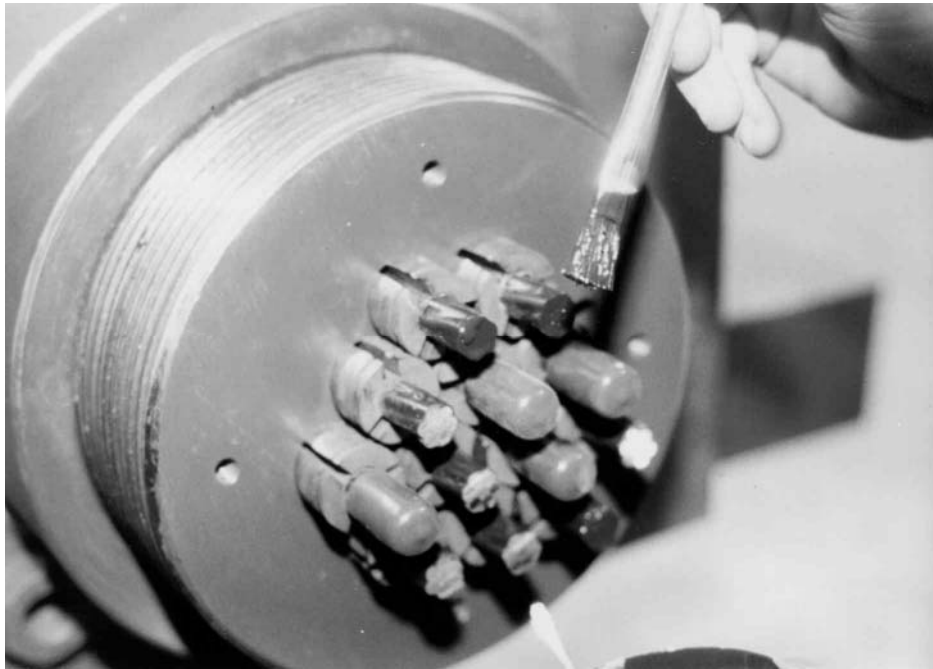
Figure 8-6 Repair of cut ends of epoxy-coated strands

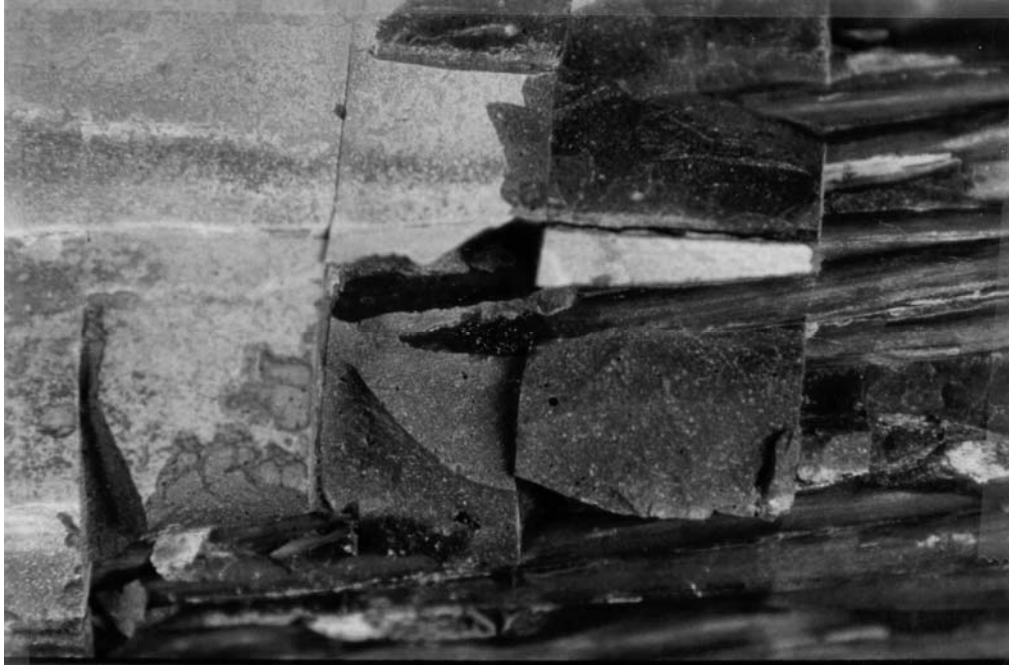
Figure 8- 19 Typical corrosion at base of a grout crack

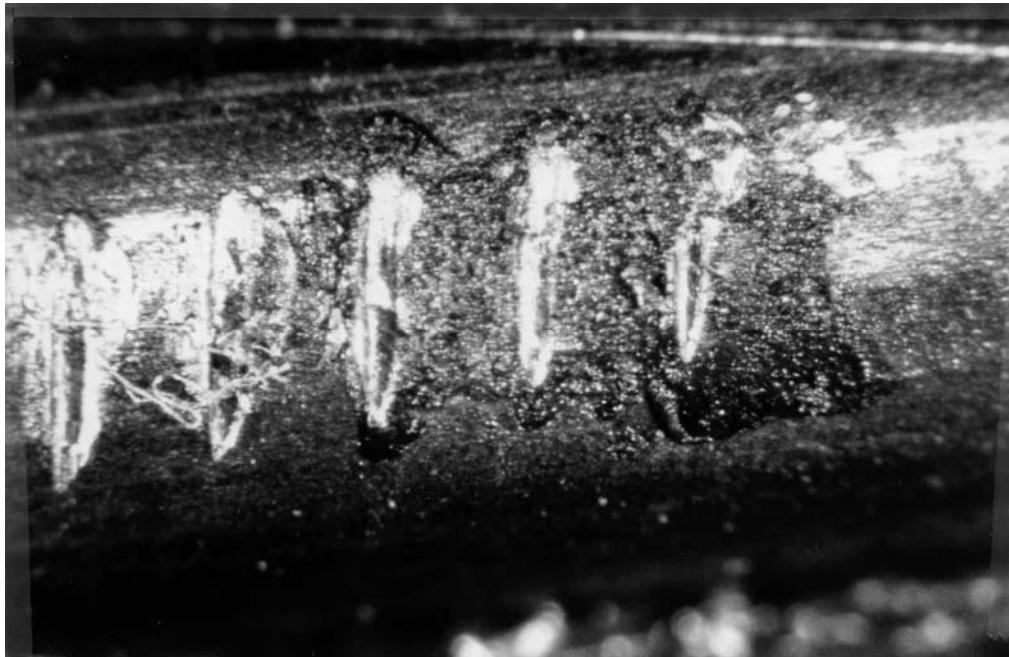
Figure 8- 25 Corrosion between tooth marks on strand

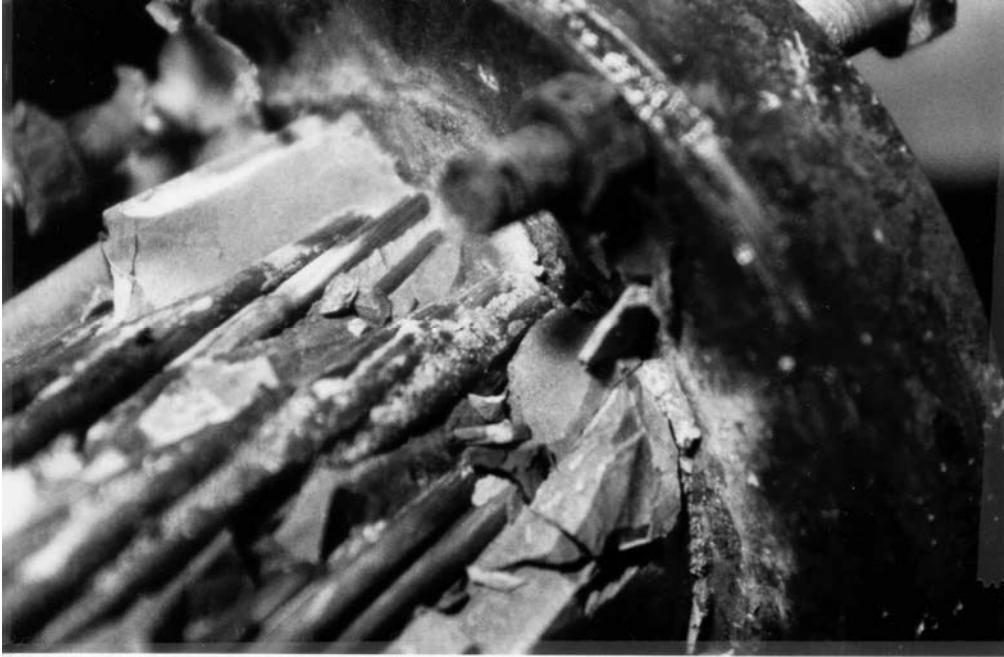
Figure 8- 26 Corrosion of strand adjacent to deviator ring

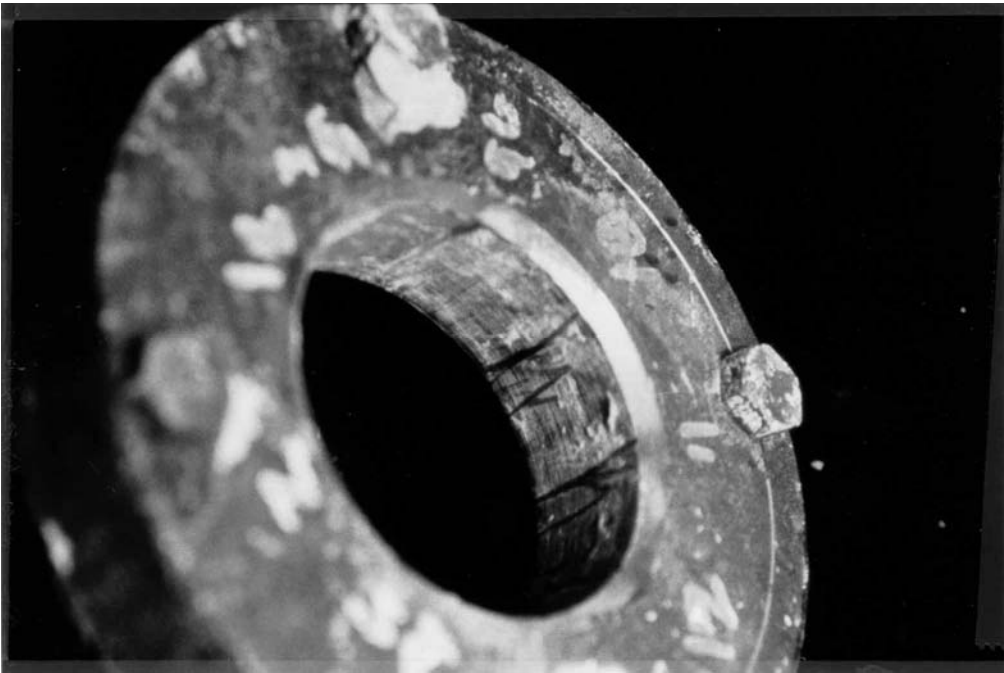
Figure 8- 27 Typical condition of inside face of deviator ring

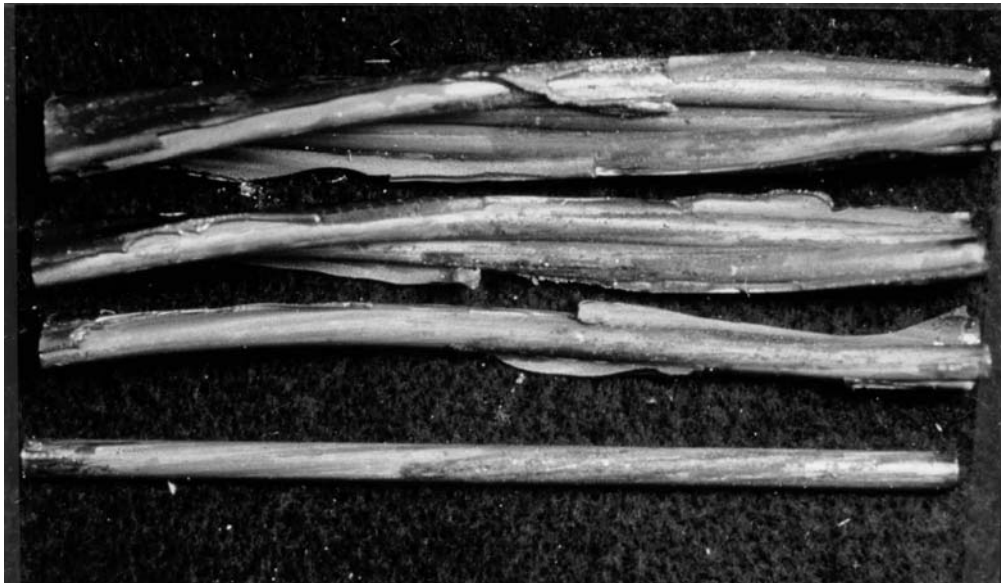
Figure 8-29 Interstitial corrosion of epoxy-coated strand (not filled)

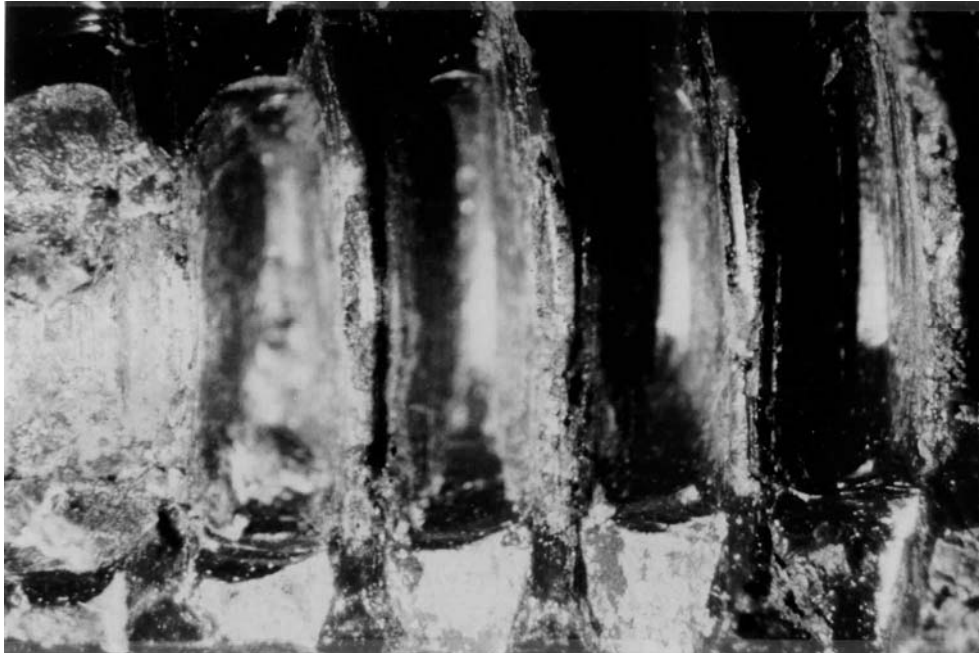
Figure 8-30 Corrosion of strand at tooth mark

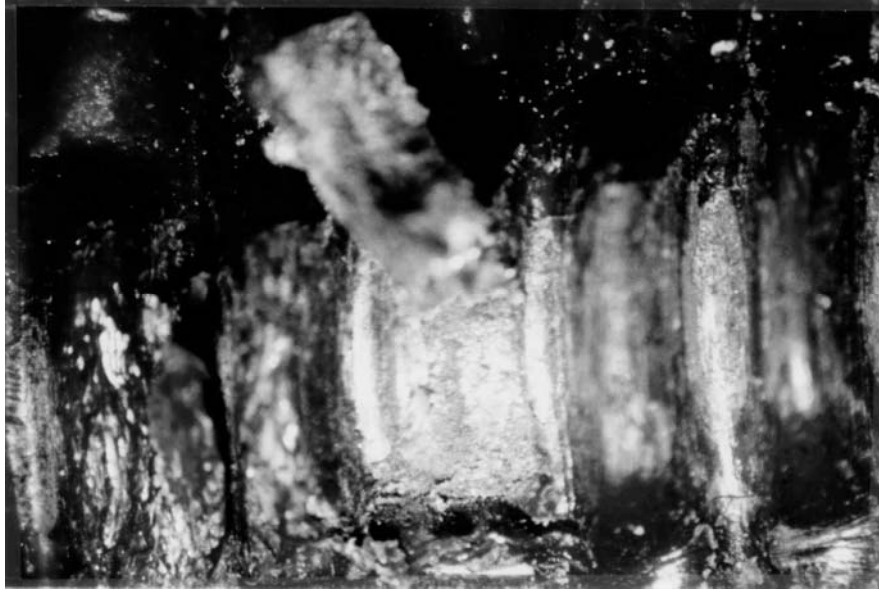
Figure 8- 31 *Corrosion under epoxy coating between tooth marks*

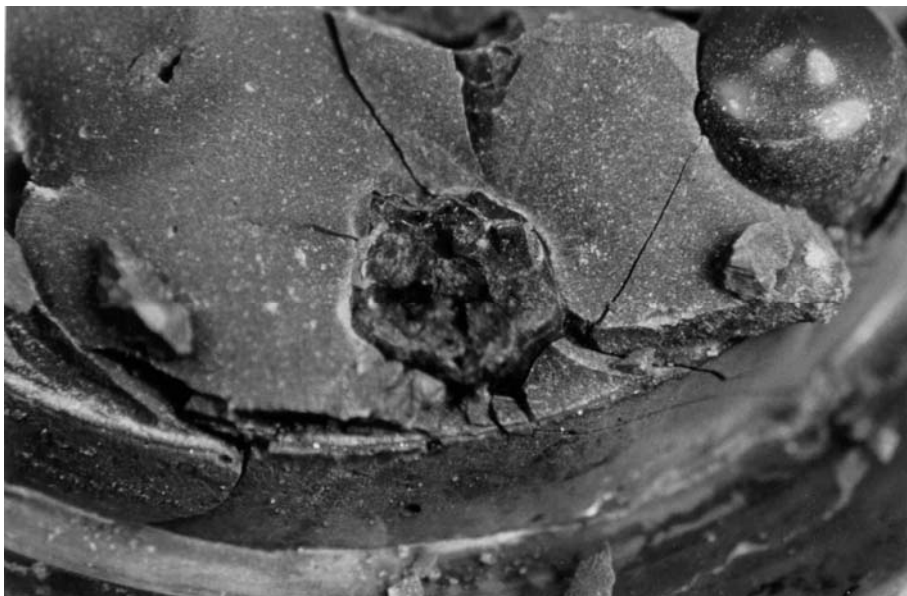
Figure 8- 34 Corroded end of strand repaired with epoxy compound

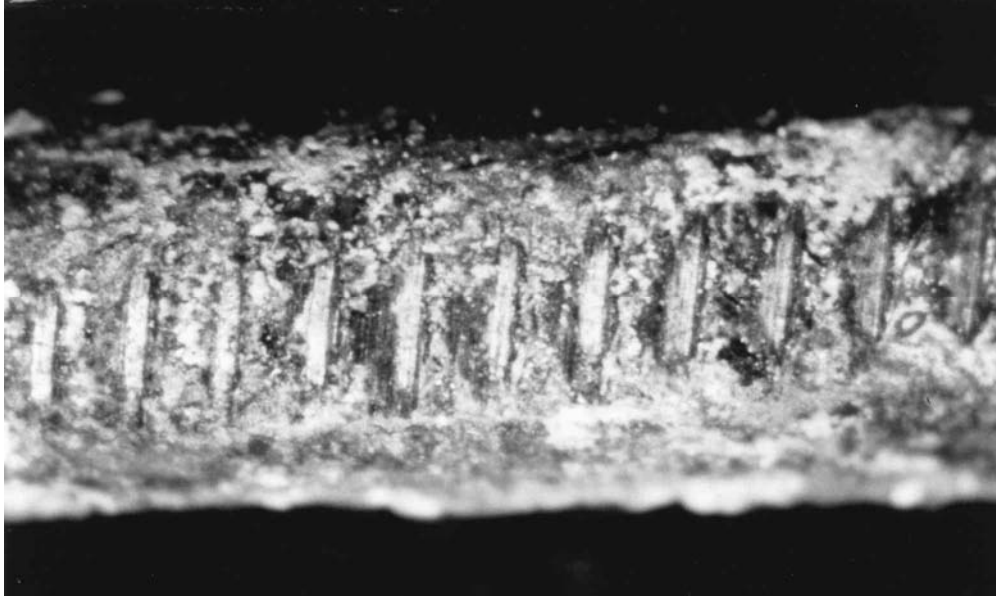
Figure 8- 36 Example of loss of zinc coating

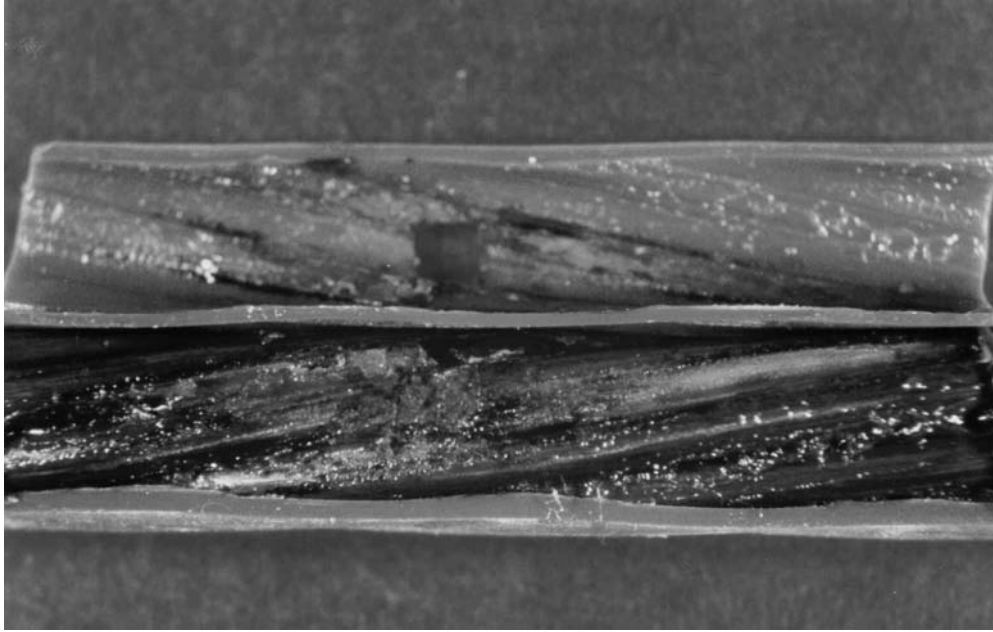
Figure 8- 37 Corrosion under sheathing

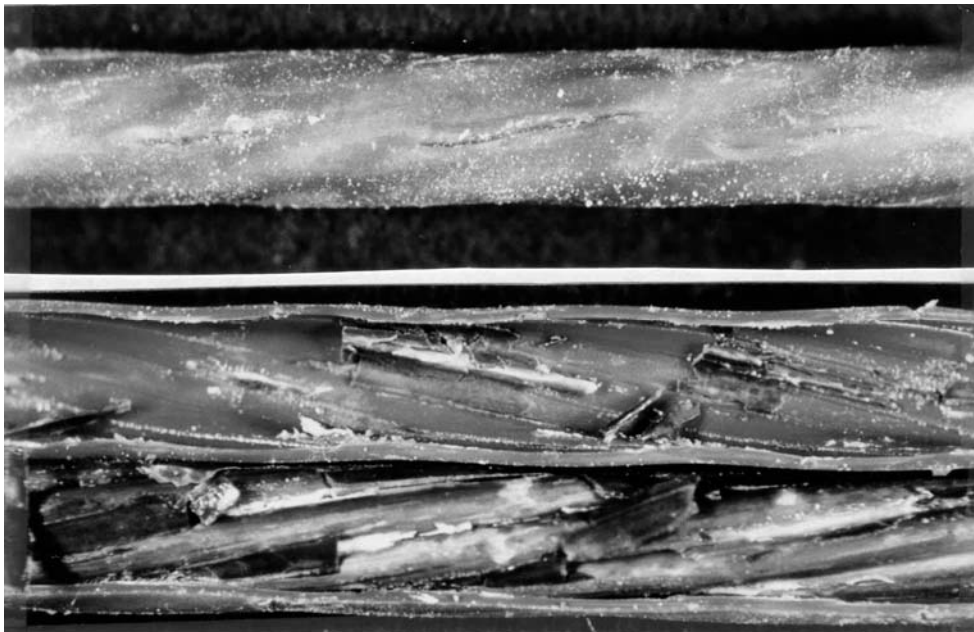
Figure 8- 38 Intrusion of grout into sheathing

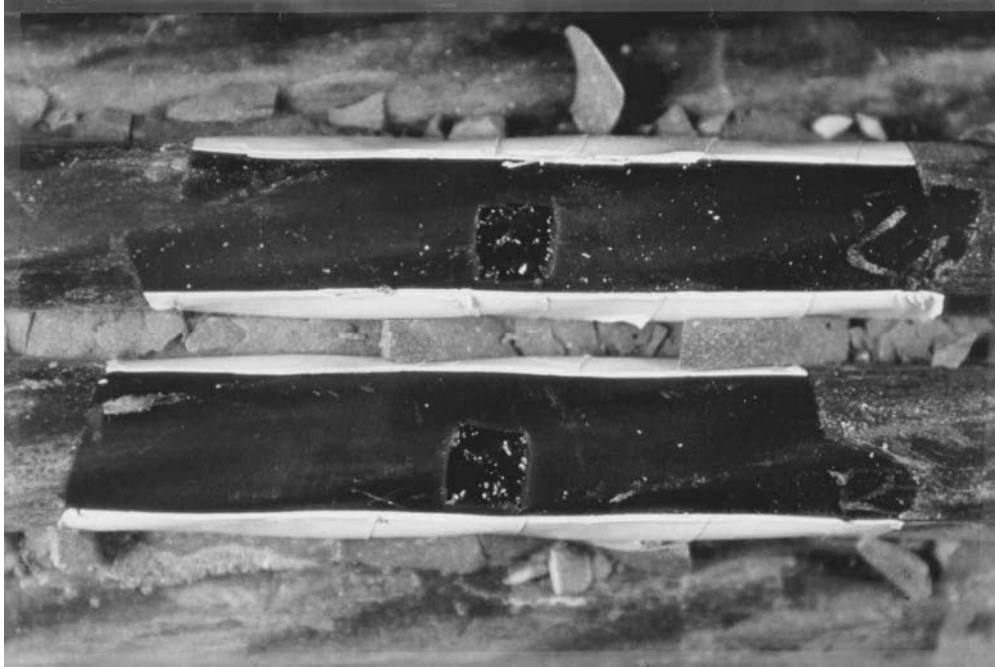
Figure 8- 39 Repaired damage location after completion of corrosion test

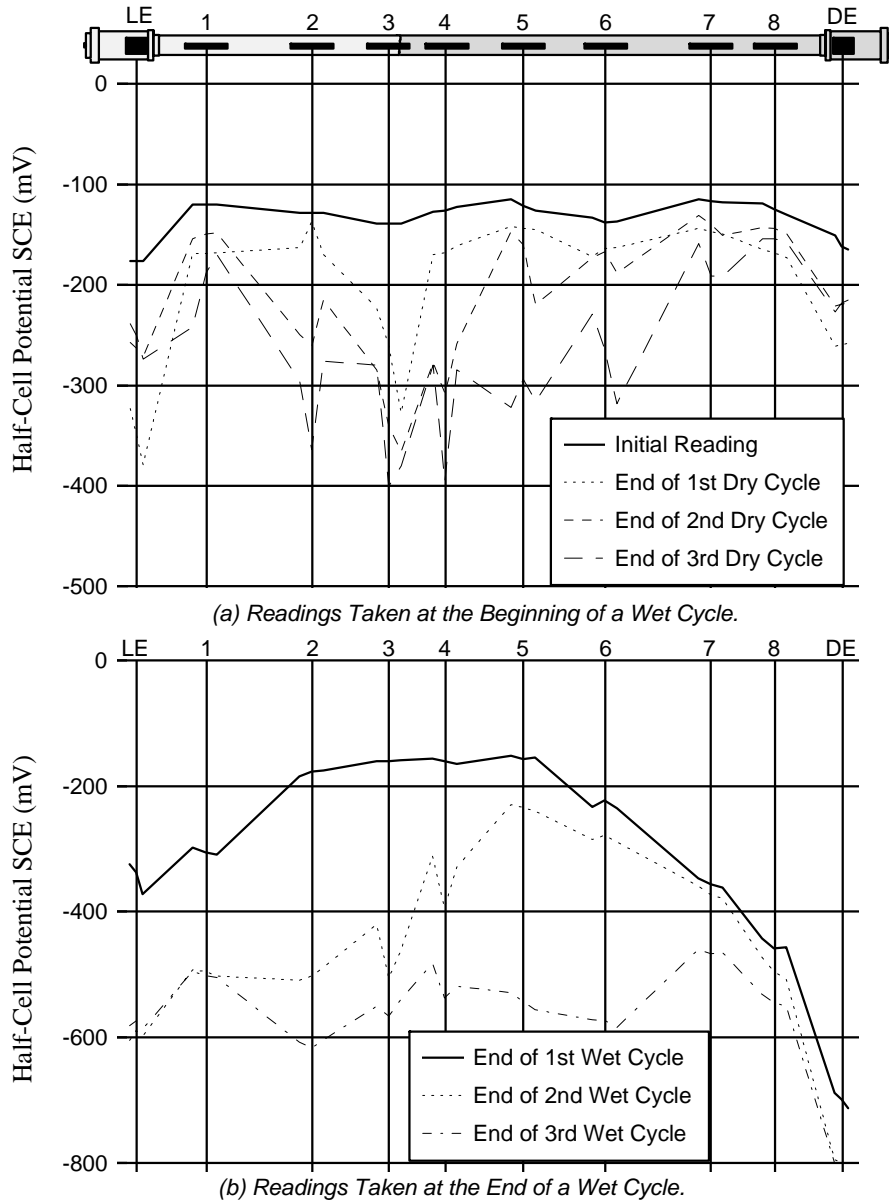
Figure 9-2 Half-cell potentials taken on grout surface for Specimen LS-1

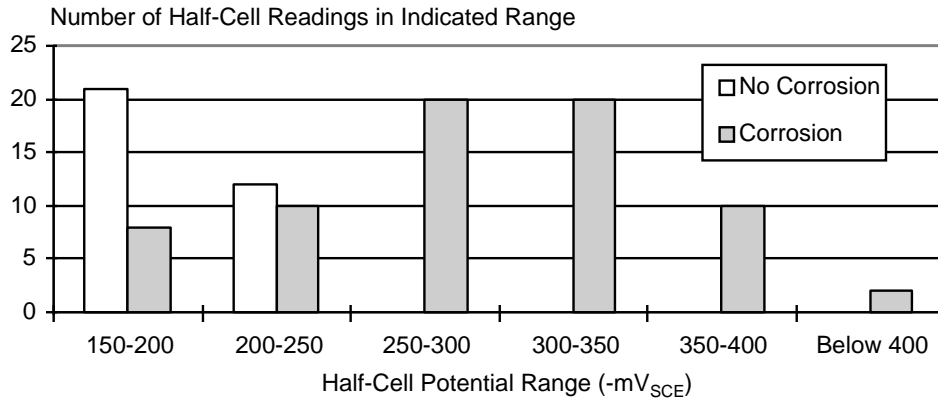
Figure 9- 10 Distribution of half-cell readings after the third dry cycle for LS-1 through LS-4
