CONSOLIDATION OF CONCRETE WITH EPOXY-COATED REINFORCEMENT

Research Report No. 1265-2

Research Project 0-1265

“Structural Integrity of Epoxy-Coated Bars”

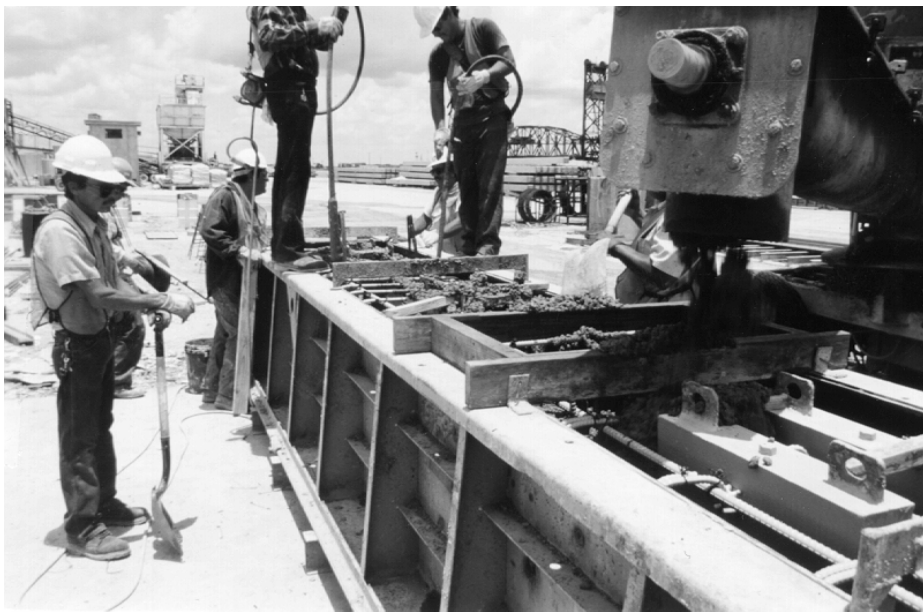
(a) Precast element reinforced with epoxy-coated steel

(b) Vibration of concrete in precast element

Figure 1.2 Concrete placement procedure in precast pier cap

Concrete placement is the last possible procedure during which the coating on reinforcement will be damaged before the rebar is put into service. Any damage during concrete placement cannot be seen nor repaired. Figure 1.2 shows the epoxy-coated reinforcing cage of a precast element bounded by metal formwork, and the same element in the midst of the concrete placement procedure.

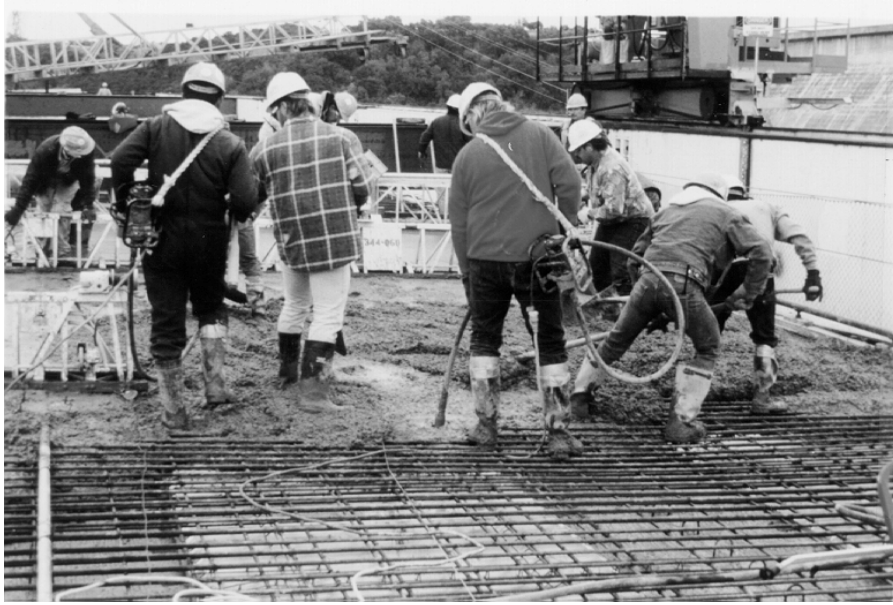
Figure 1.3 Consolidation of concrete in bridge deck

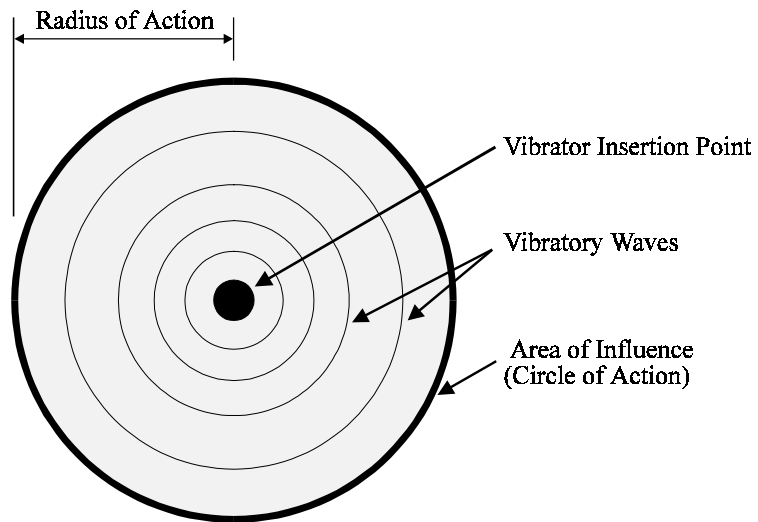
Figure 1.4 Area of influence for concrete vibrator

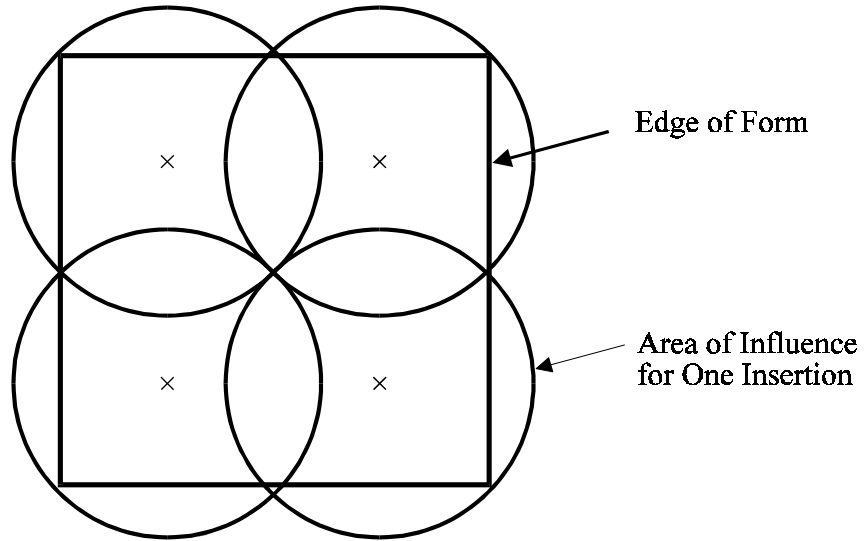
Figure 1.5 *Overlap of areas of influence*

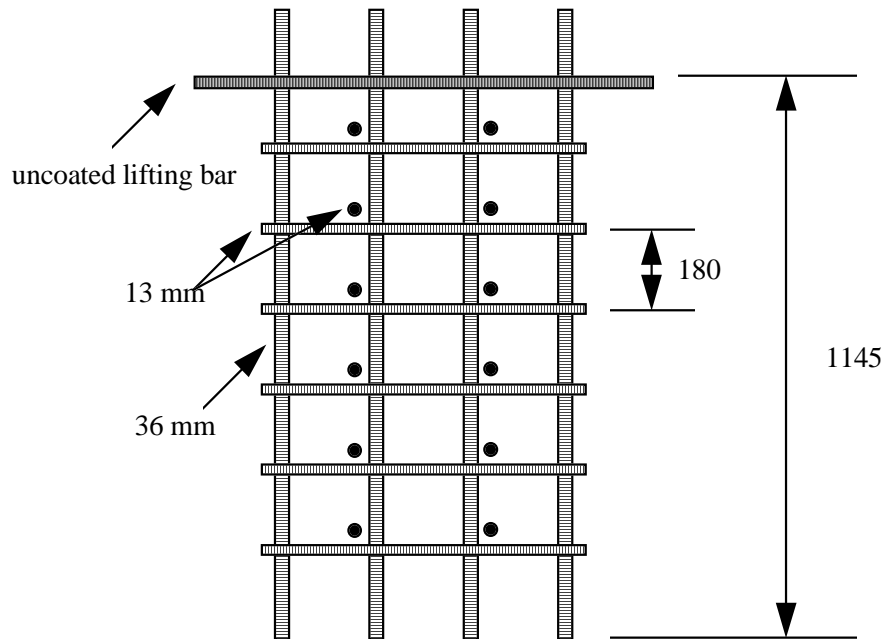
a) Elevation View

b) Plan View

Figure 2.2 Details of column reinforcement

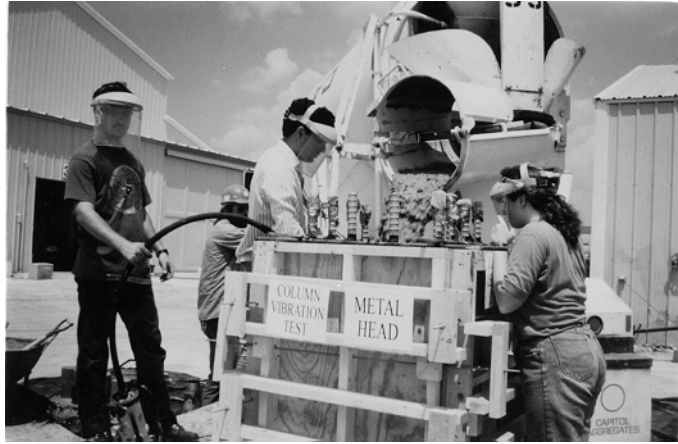
Figure 2.7 Placing concrete in column form

Concrete was placed in the forms directly from the ready-mix truck. Figure 2.7 shows a picture of the concrete placement procedure. The concrete was placed in the form in three equal lifts. A concrete vibrator with a metal head was used to consolidate the first specimen, and one with a rubber head was used to vibrate the second specimen. The metal head used in the column test was 4.4 cm (1 3/4 in) in diameter and 35.5 cm (14 in) in length. The rubber head was 4.8 cm (1 7/8 in) in diameter and 35.5 cm (14 in) in length. The same model of concrete vibrator with an electric 17 amp motor was used in each test. Flexible shafts from the same manufacturer, each 2.1 m (7 ft) in length, were used in the two tests.

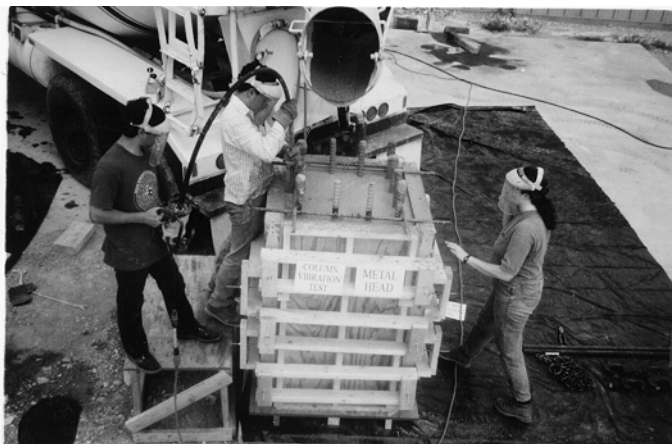
Figure 2.8 Consolidating column specimen

The vibrator was inserted at sixteen points in each lift. A picture of the metal head specimen during vibration is shown in Figure 2.8. During each test, the head of the vibrator was purposely inserted between the formwork and the stirrup at eight locations to simulate the damage that results when the vibrating head is forced to operate in a very confined area. At each insertion point the concrete was vibrated for 4-5 seconds. The same operator consolidated the concrete with both the metal and rubber head vibrators to eliminate differences that might occur between operators. The same procedure and schedule of insertion points was followed with each type of vibrator head.

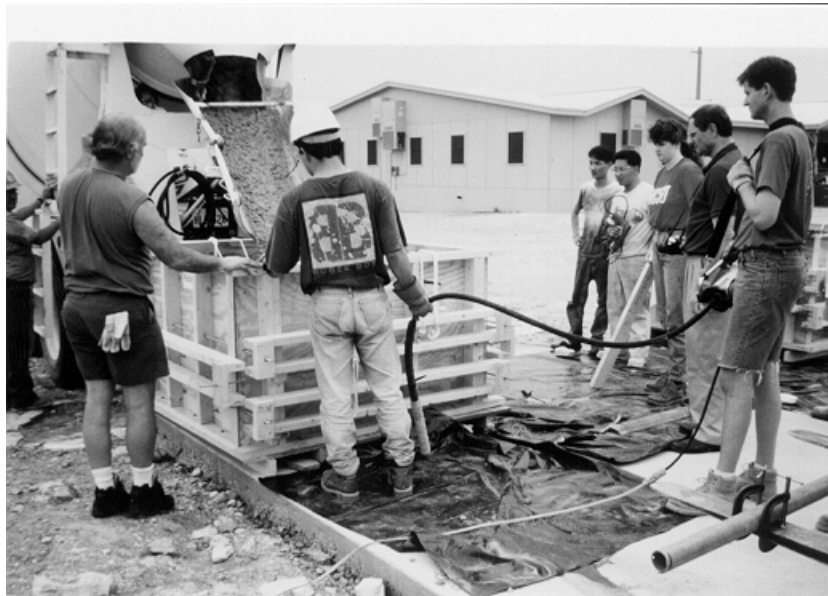
Figure 2. 11 Placing concrete in footing form

Concrete was placed in each footing form directly from the ready-mix truck, as shown in Figure 2.11. The concrete was placed in three equal lifts and the vibrator was inserted at sixteen points in each lift. A concrete vibrator with a metal head was used to consolidate the first specimen, and one with

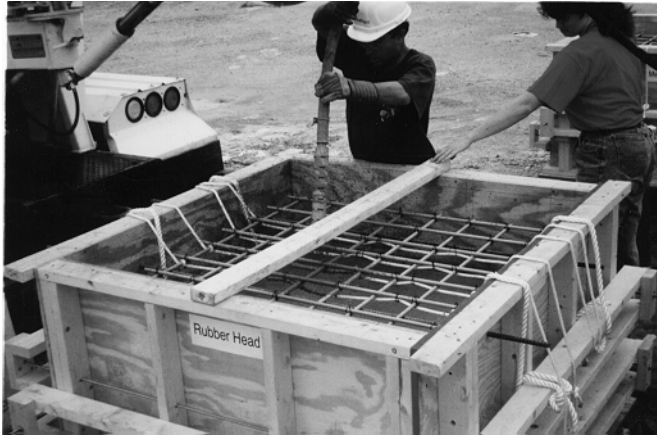
Figure 2.12 Consolidating footing specimen

a rubber head was used to vibrate the second specimen. Figure 2.12 shows a picture of the rubber head specimen during consolidation. The metal head used in the footing test was 4.4 cm (1 3/4 in) in diameter and the rubber head was 4.8 cm (1 7/8 in) in diameter. Both heads were 35.5 cm (14 in) in length. The concrete was vibrated for 4-5 seconds at each insertion point. The same operator conducted the test of each type of vibrator head, and the same procedure was followed with each of the heads.

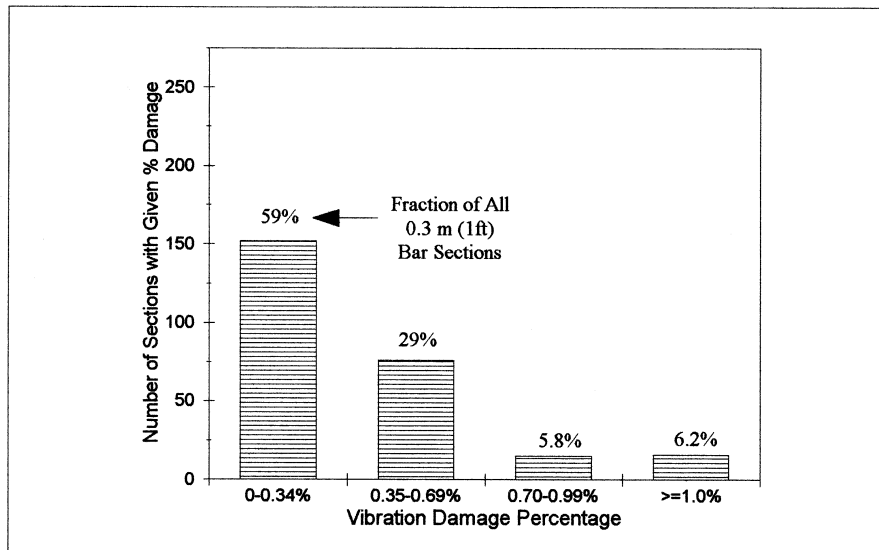
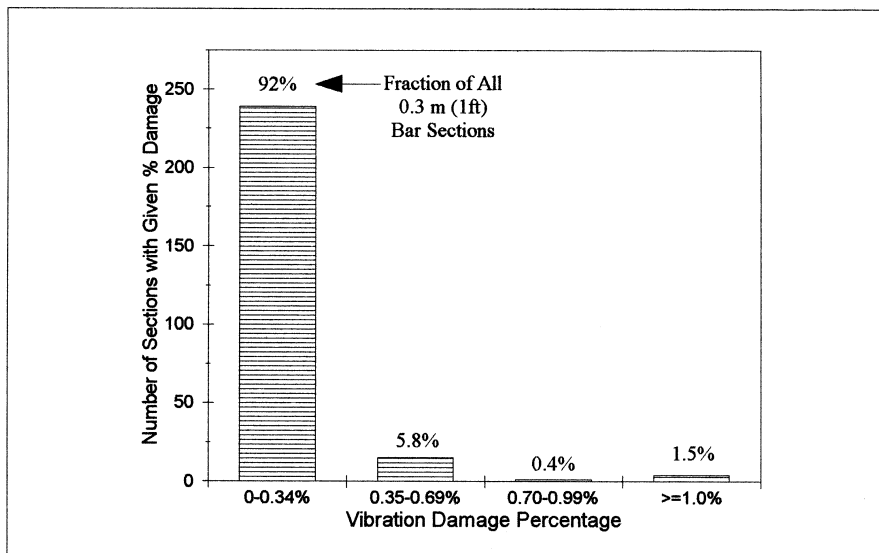
Figure 2. 17 Histogram of damage percentages for 0.3 m (1 ft.) horizontal bar sections from column, footing and slab specimens

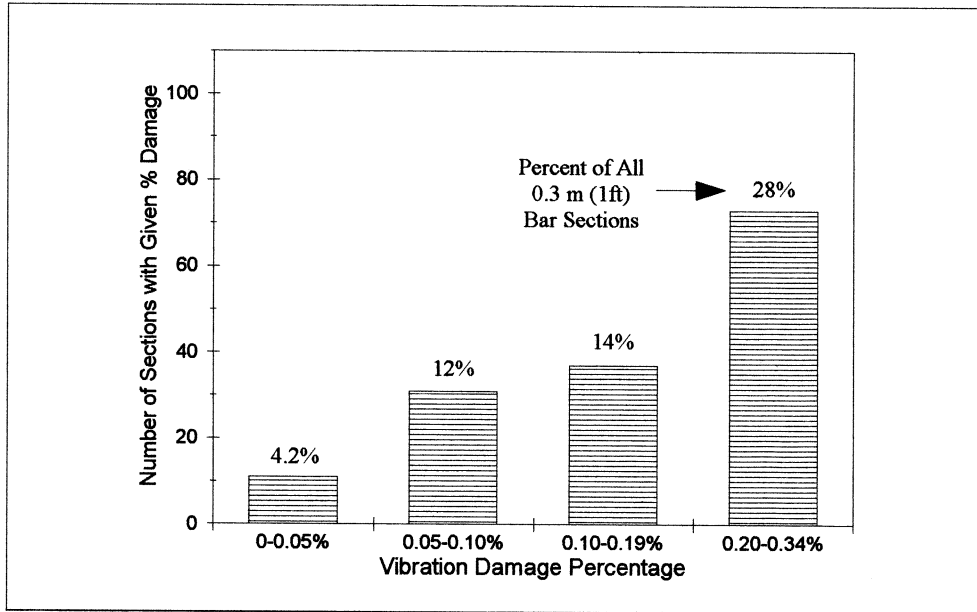
Figure 2. 18 Histogram of damage percentages (0 - 0.34% range)

A further breakdown of damage figures in the 0-0.34% range for the metal and rubber heads is presented in Figure 2.18. As in the other figure, data for all 0.3 m (1 foot) bar sections from the three test specimens is included. The smallest damage group, from 0-0.050% would definitely be considered

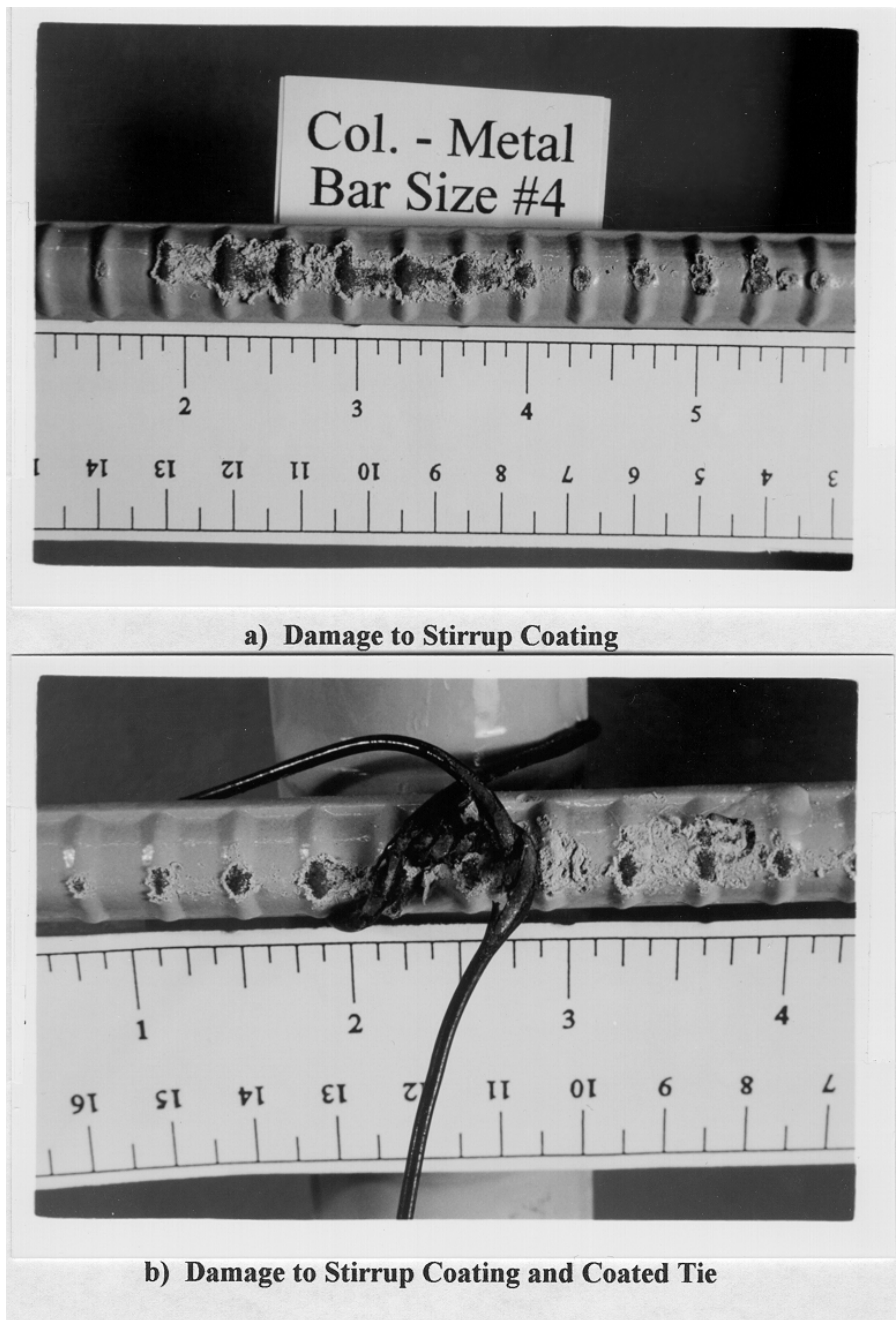
Figure 2. 20 Coating damage with metal vibrator head

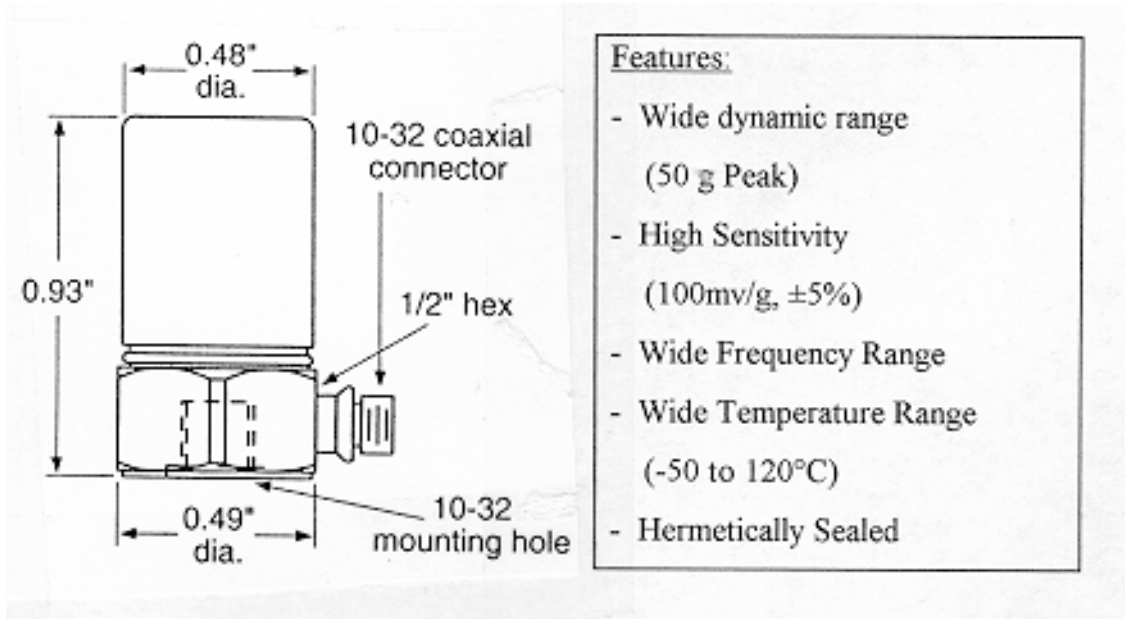
Figure 3. 4 Accelerometer features

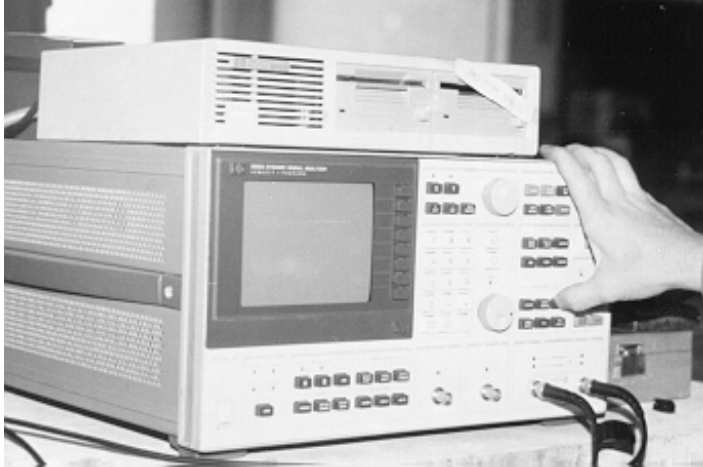
Figure 3.6 Data acquisition system

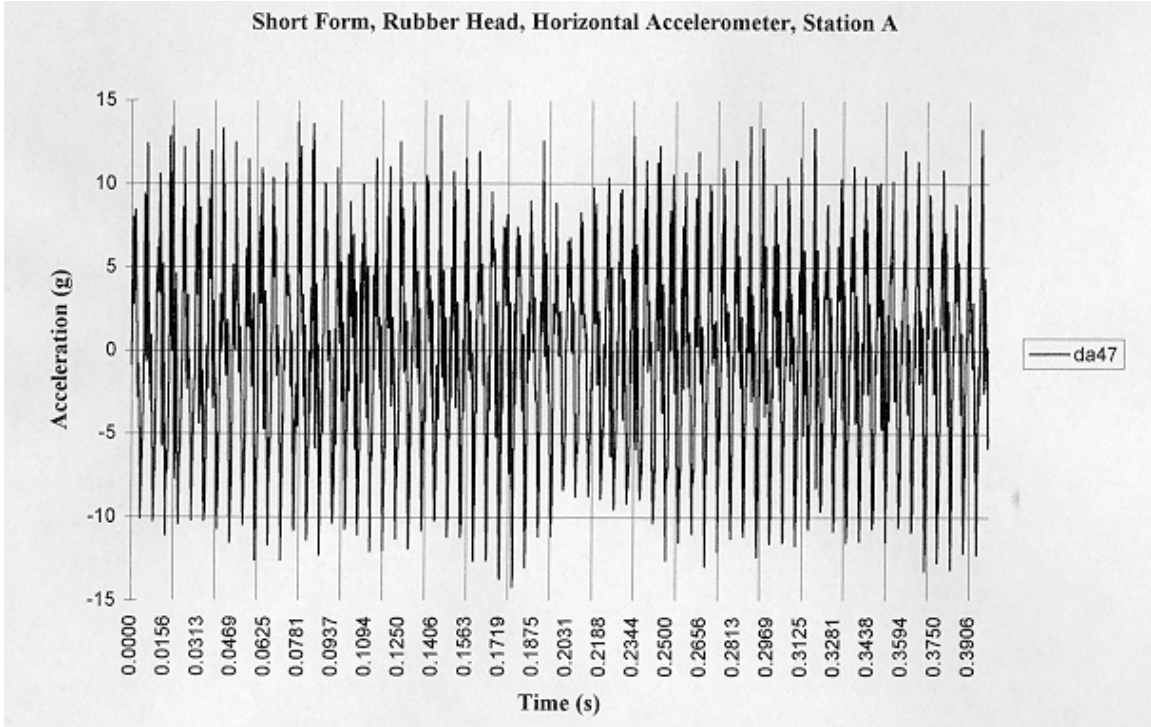
Figure 3. 8 Typical time record

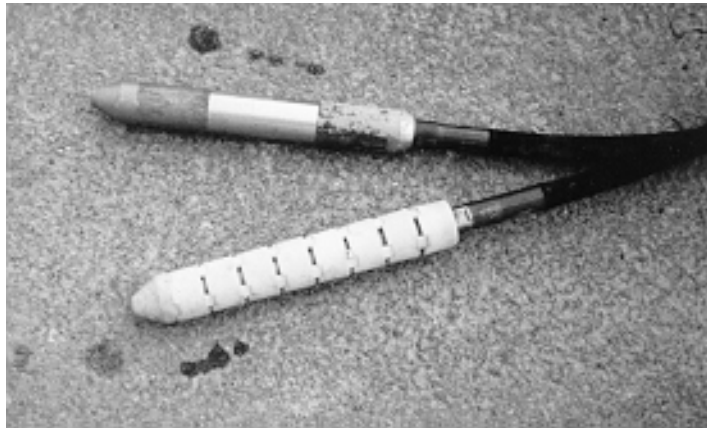
Figure 3.9 Metal (top) and rubber vibrator heads

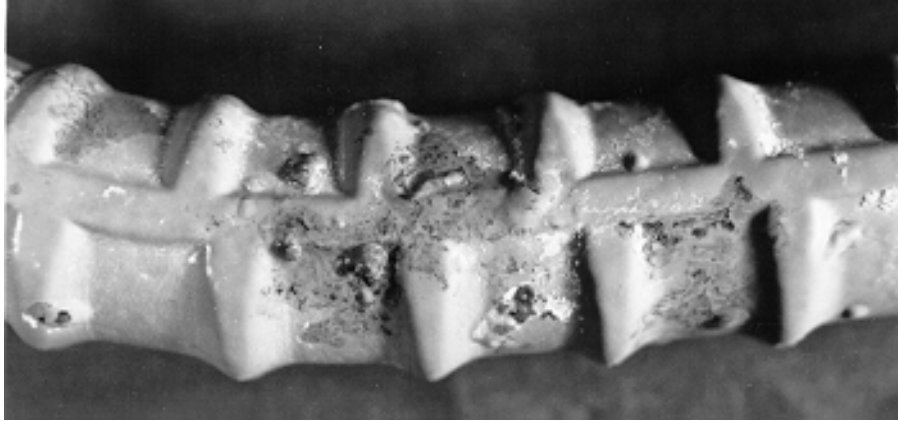
Figure 4.2 Corrosion at blisters on coated bars

Earlier work on this project has shown that corrosion activity does take place where voids in the concrete border the steel. Wetting and drying of voids, as well as the concentration of oxygen and chlorides in voids, promote corrosion at damage spots on the coated bars. When a damaged spot is exposed to corrosive agents, the localized area of steel cannot passivate, and the process of corrosion will progress. Especially at larger damaged spots on the bottom of a coated bar where voids are adjacent to the surface, localized corrosion may be extensive. Large pits were observed where significant areas of coating damage bordered voids in the concrete in corrosion specimens evaluated in earlier work on this project.⁴ A picture of a blister in the epoxy-coating where it was adjacent to a void is shown in Figure 4.1, and an extensively corroded area of reinforcement on the bottom of an epoxy-coated reinforcing bar is shown in Figure 4.2.

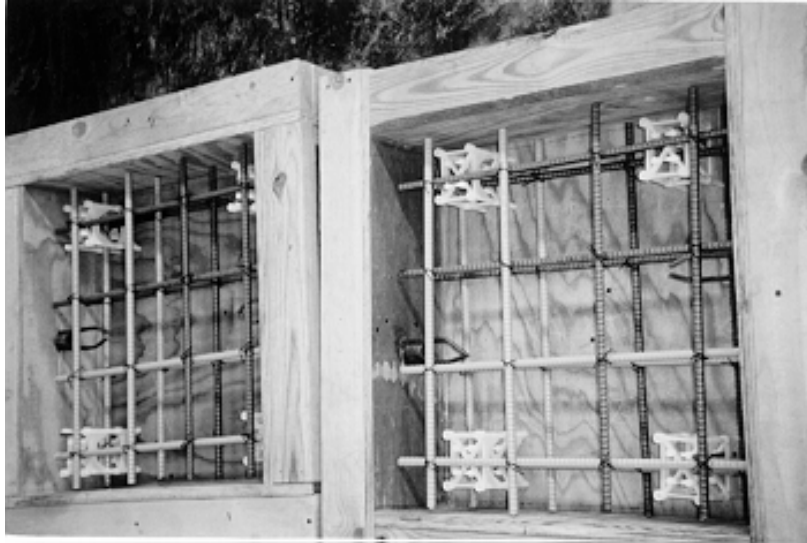
Figure 4.4 Reinforcement of Specimens M8 and R8

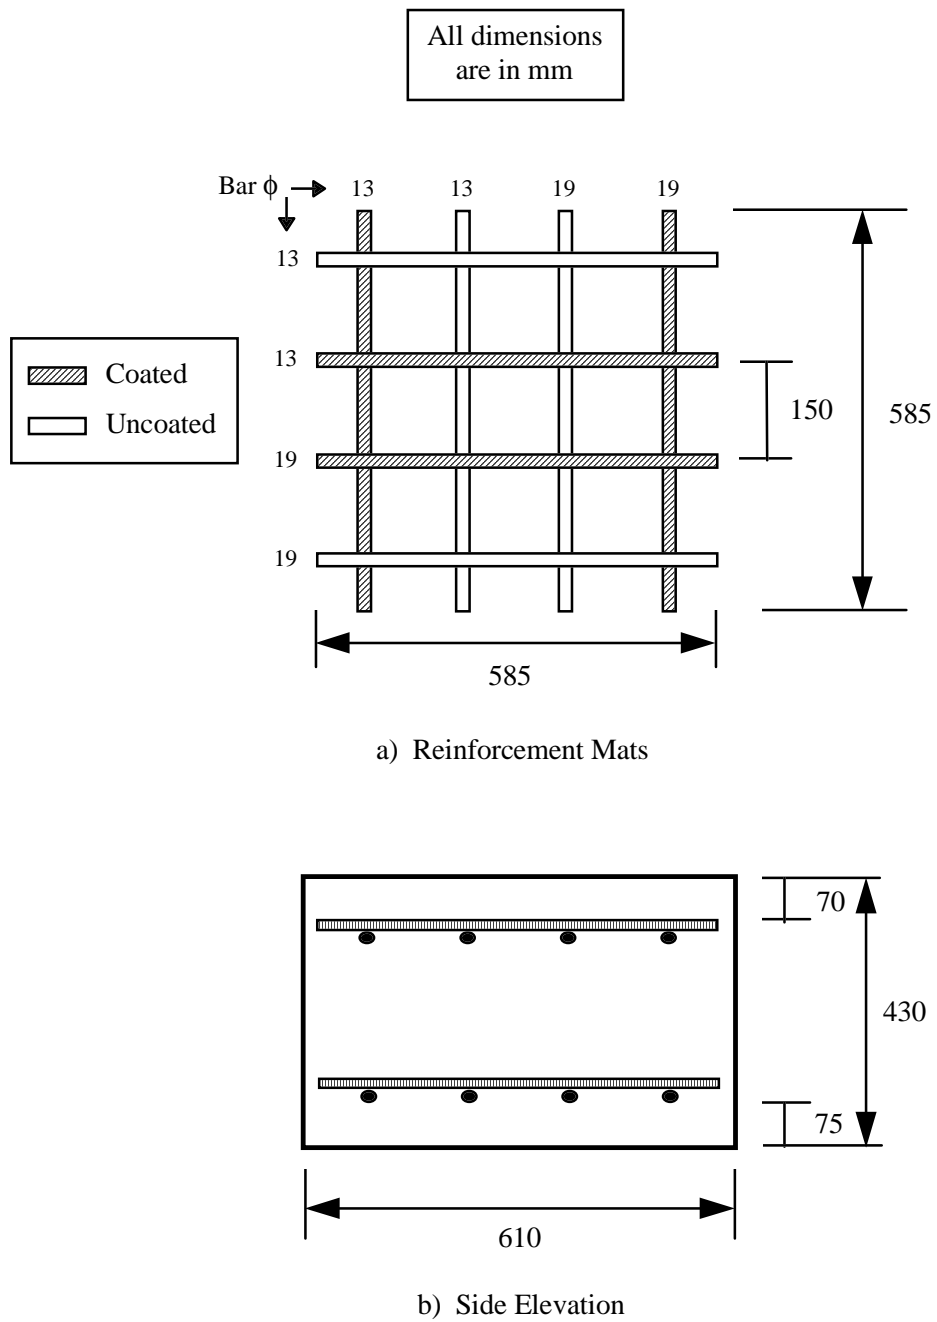
Figure 4. 6 Layout of reinforcement in specimens M17 and R17

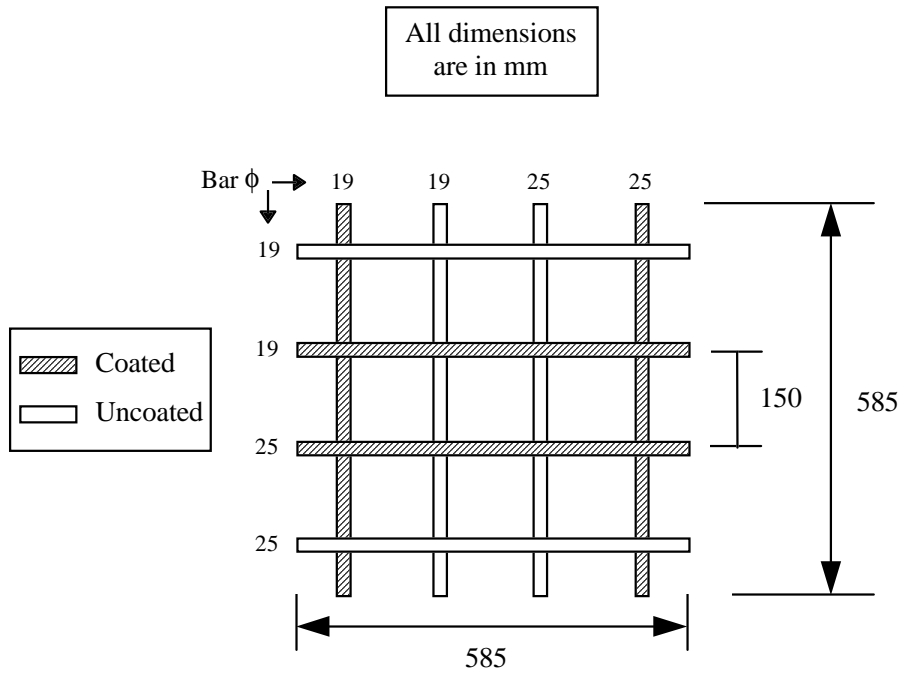
a) Reinforcement Mats

b) Side Elevation

Figure 4.7 Layout of reinforcement in Specimens M28 and R28

The third pair of companion specimens were 710 mm (28 in) in height, and 610 x 610 mm (24 x 24 in) in plan. The layout of reinforcement and specimen dimensions were as shown in Figure 4.7. Both 19 mm

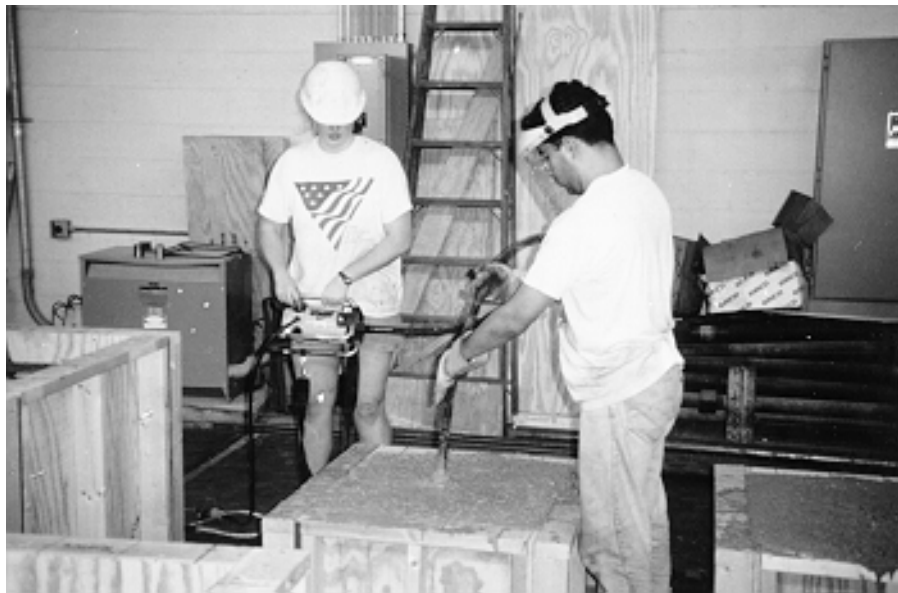
Figure 4. 12 Consolidation of Specimen M17

The second pair of specimens, 430 mm (17 in) in height, were consolidated with vibrator heads 360 mm (14 in) in length. The first specimen was consolidated with a rubber head 48 mm (1 7/8 in) in diameter. The second specimen was vibrated with a metal vibrator head 44 mm (1 3/4 in) in diameter. The concrete was placed in each block in two equal lifts. Both lifts were vibrated for eight seconds with the head positioned at the center insertion point. A picture of the vibration operation is shown in Figure 4.12.

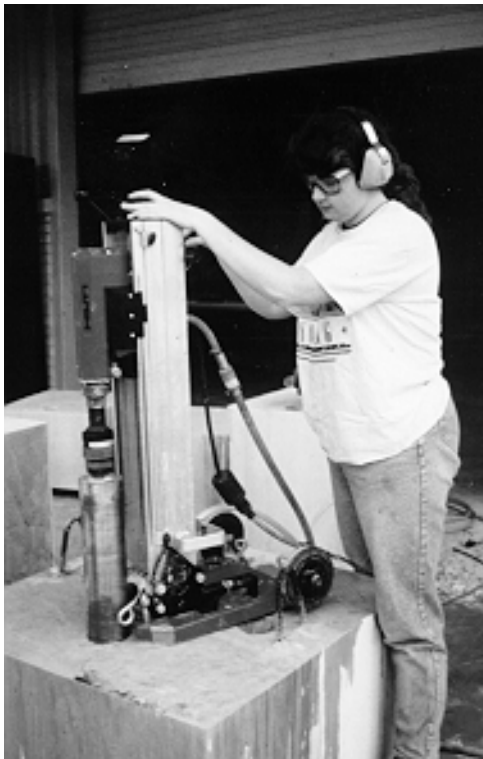
Figure 4. 13 Coring reinforced concrete test specimen

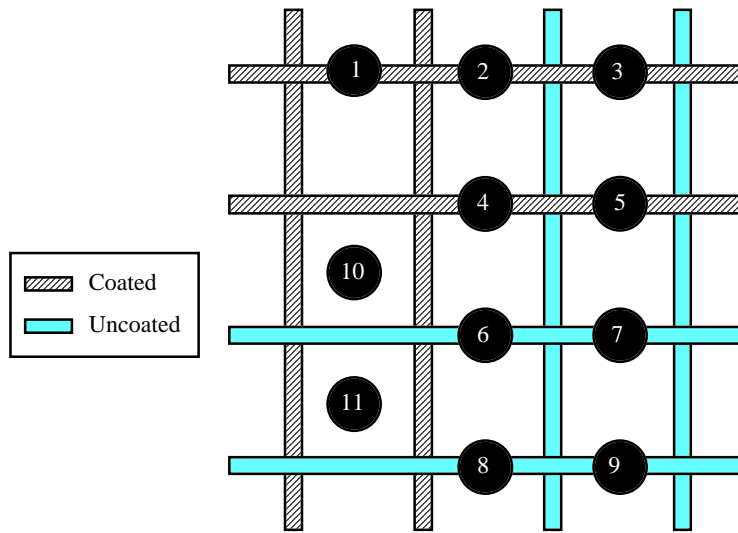
a) Coring Schedule for Specimen R8

a) Coring Schedule for Specimen M8

Figure 4. 16 Core maps for Specimens R8 and M8

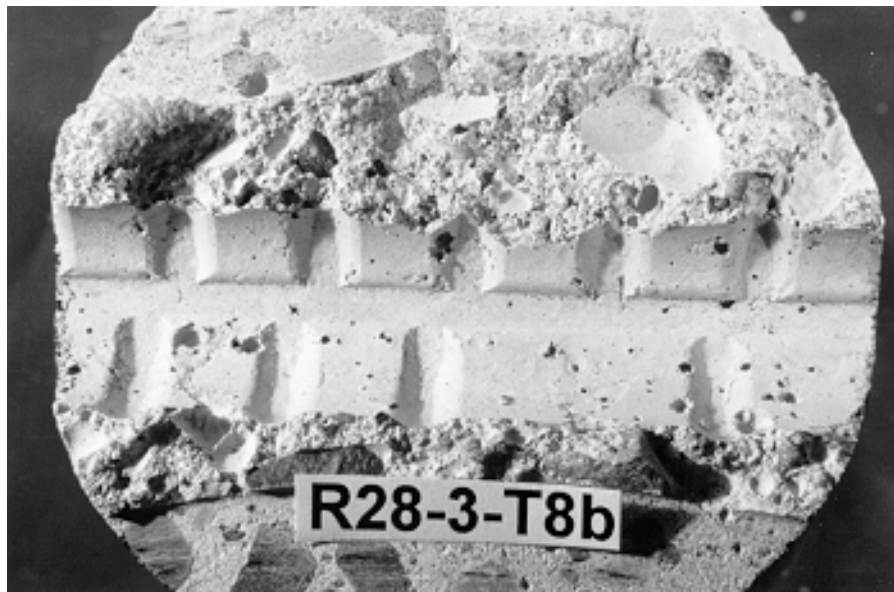
Figure 4. 21 Typical distribution of voids under rebar

In almost all cases, there were no air voids adjacent to the top surface of reinforcing bars. There were voids in the concrete located beside and beneath most of the reinforcing bars, especially those farther from the point of vibrator insertion. Figure 4.21 shows typical small to medium sized voids located below a reinforcing bar. Voids were found at locations adjacent to both the side of the bar nearer the vibrator head and the side farther from the head. At locations where a bar rib was turned at an angle to the horizontal, there were often voids located on both sides of the rib. Figure 4.22 pictorially locates areas where voids were often located.

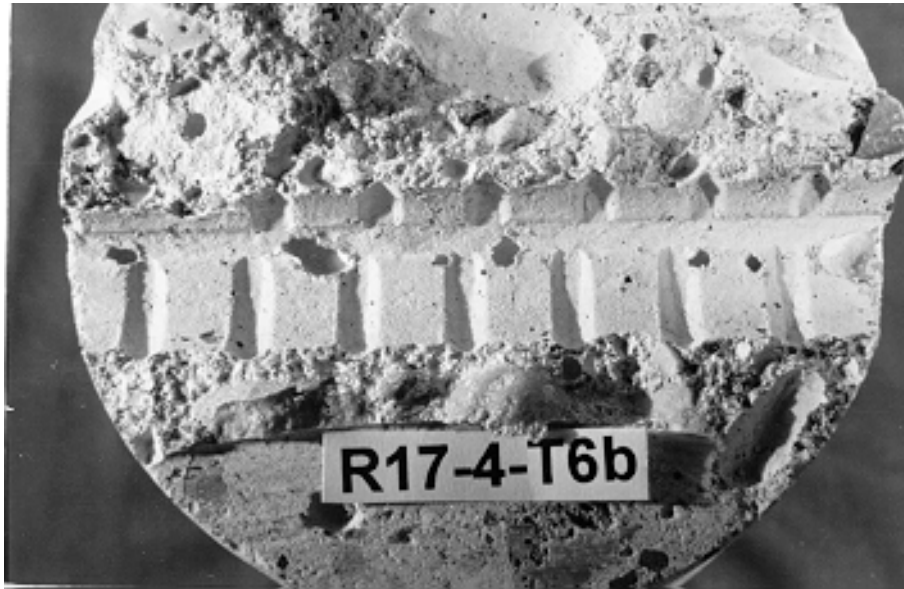
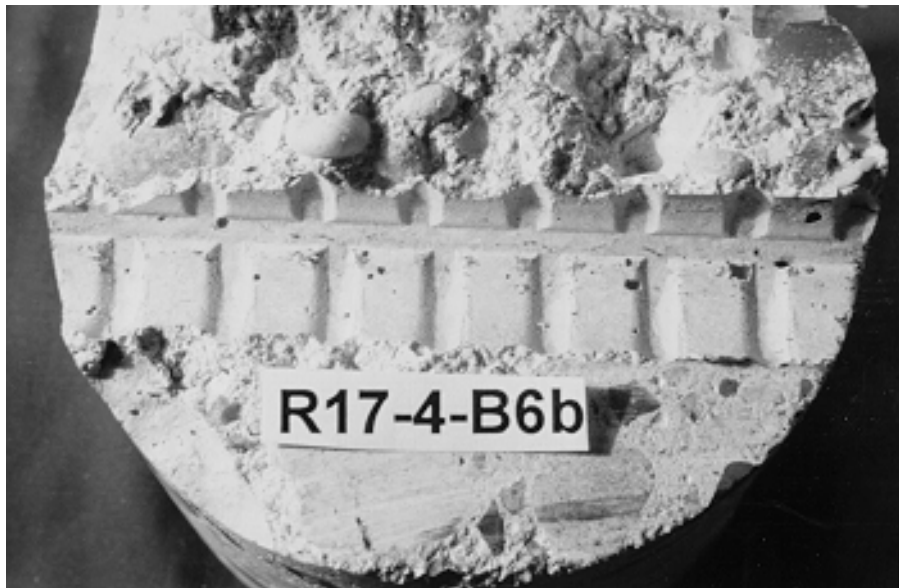
(a) Air voids under top bar

(b) Air voids under bottom bar

Figure 4. 23 Voids under top and bottom bars from Specimen R17
