**WAX BUILD-UP ON THE SURFACES OF
NATURAL RUBBER BRIDGE BEARINGS**

Research Report Number 1304-4

Research Project 0-1304
Elastomeric Bearings

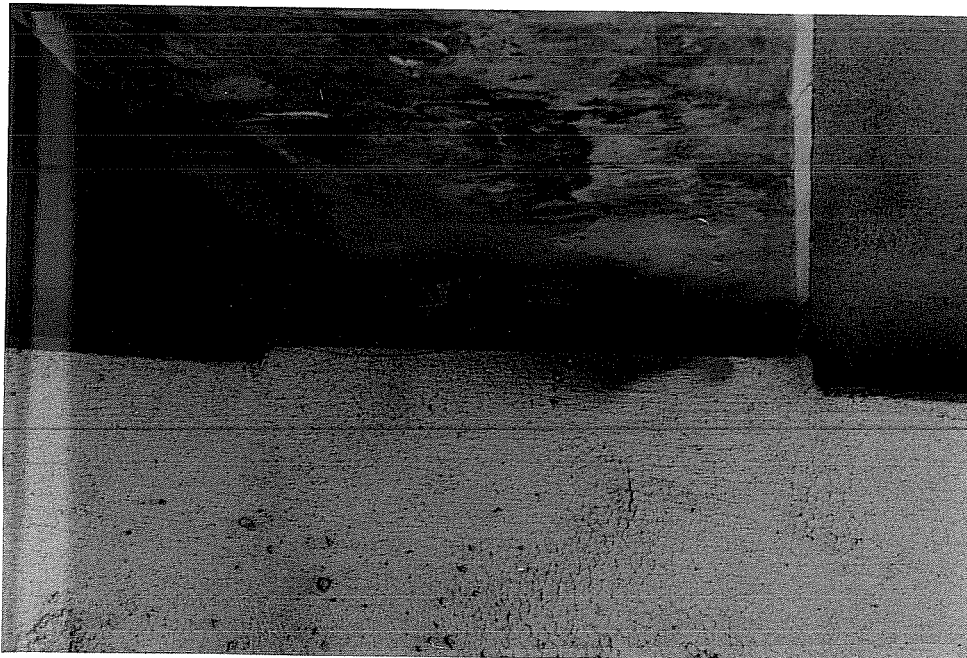
Figure 1- 2 Position of the same bearing from another angle.

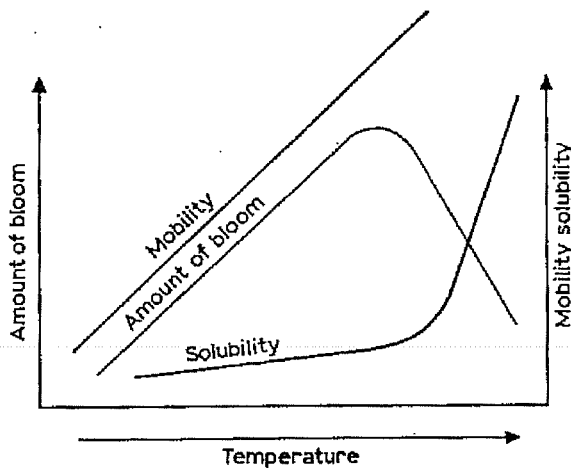
Figure 3-1 Wax bloom as a function of mobility and solubility [25].

Figure 3.1 shows why waxes with melting points above 65°C (149°F) are unsuitable for low temperature uses [28]. Even if a sufficient bloom is formed prior to exposure, thermal contraction or handling, shock and weathering can break the bloom. The bloom will be repaired too slowly to afford adequate protection even if a high level of supersaturation exists [28].

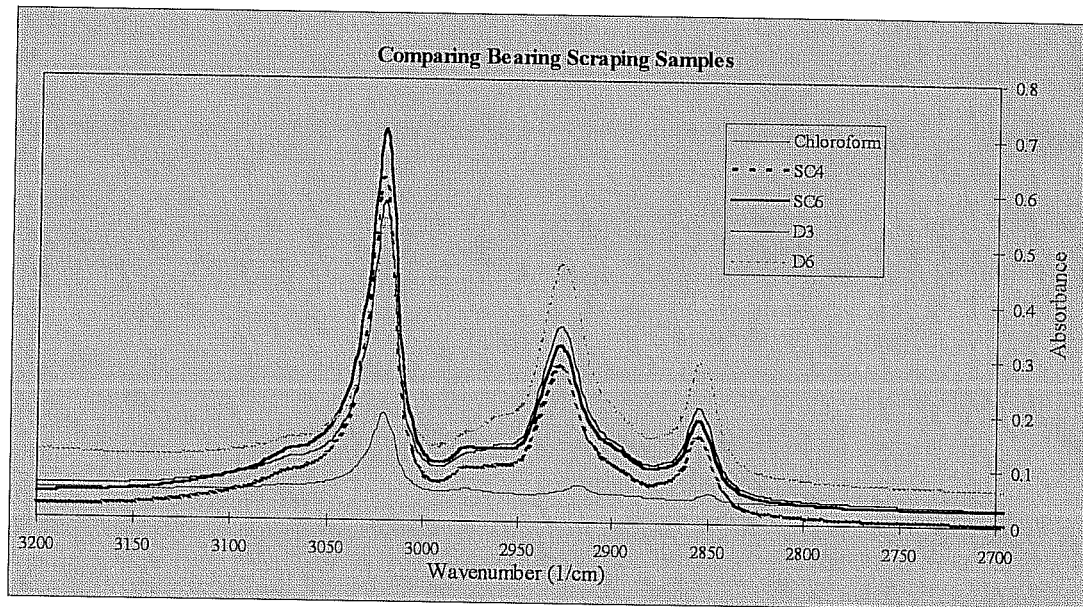
Figure 4-1 Comparing bearing scraping samples

The exact coincidence of these peaks indicate that the four samples are identical substances. Peaks from 600 cm^{-1} to 4000 cm^{-1} were also monitored to see if they contained additional information. These peaks were also checked for coincidence and were found to be equal in all four samples.

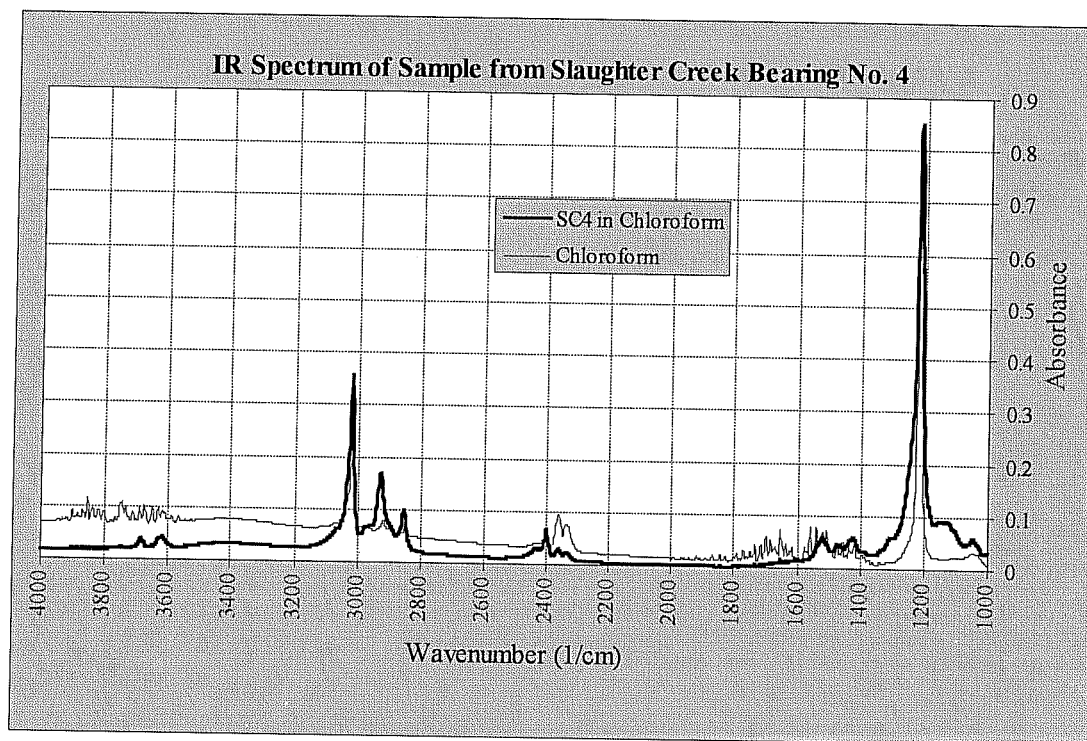
Finding that the samples were identical allowed the rest of the analysis to continue by analyzing just one sample. The sample SC4 was chosen. The full IR spectrum of SC4 in chloroform is shown in Figure 4.2. A plot of the sample SC4 in the solvent trichloroethylene is plotted versus the solvent in Figure 4.3. By examining both Figure 4.2 and Figure 4.3, it was determined that the peaks other than the two near 3000 cm^{-1} were of minor importance. Therefore the IR analysis focused on the two peaks between 3000 and 2800 cm^{-1} though all peaks were considered when the sample spectra was compared to known spectra.

Figure 4-2 IR spectrum of sample from Slaughter Creek Bearing No. 4 in chloroform.

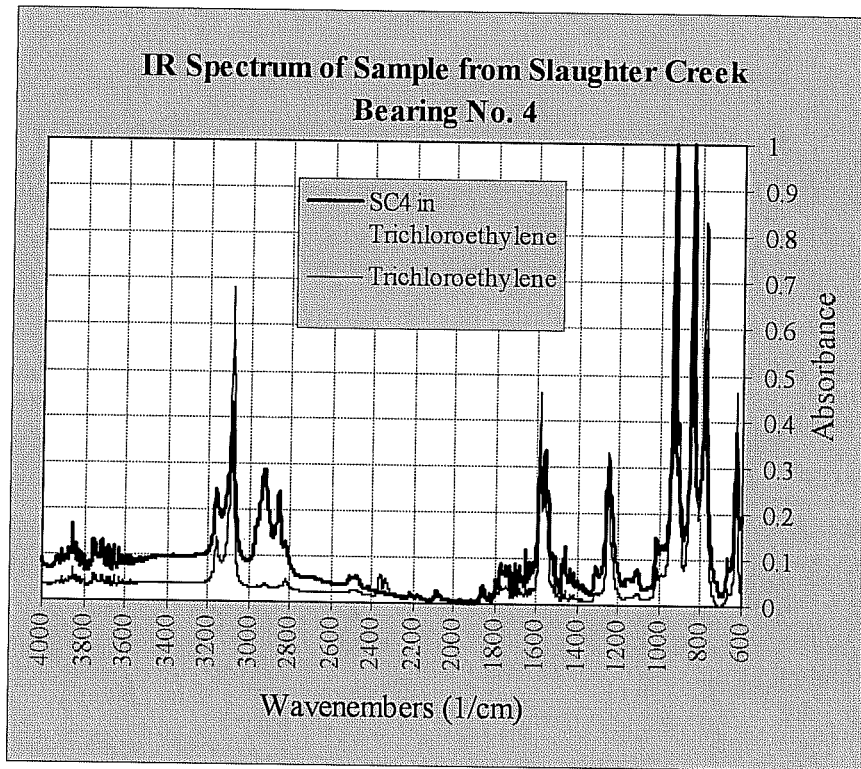
Figure 4-3 IR spectrum of sample from Slaughter Creek Bearing No. 4 in trichloroethylene

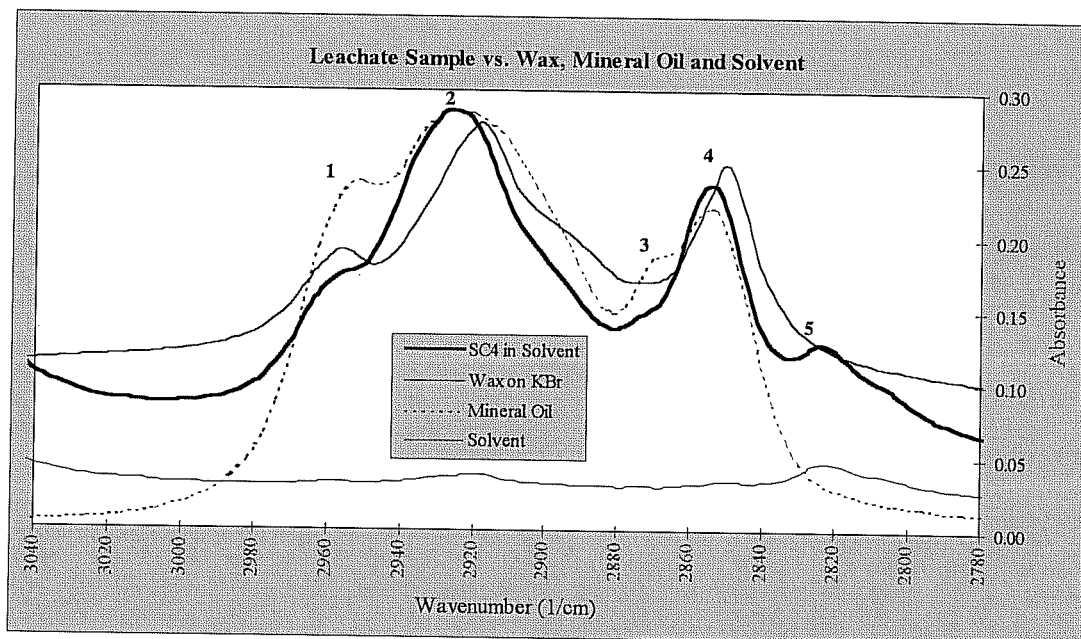
Finally, the wax and mineral oil spectra were compared to the sample's spectra. Both had peaks in the location of interest and no significant peaks elsewhere. A close up of the spectra in this region are shown in Figure 4.4. First note that peak 5 in the sample is caused by the solvent. Peaks 1,2 and 4 are all in the same locations if we allow for the resolution error of up to 4 cm^{-1} of the IR Spectrometer. Peak 2 and 4 are of the same relative height in the sample, the wax and the mineral oil. But peak 1 in the mineral oil has an inconsistent height relative to its other peaks. Also peak

Figure 4- 4 Leachate sample versus wax, mineral oil and solvent

3 exists only in the mineral oil. It is therefore certain that no mineral oil is present. The leachate is thus shown to be almost entirely composed of the wax supplied by the rubber manufacturer.

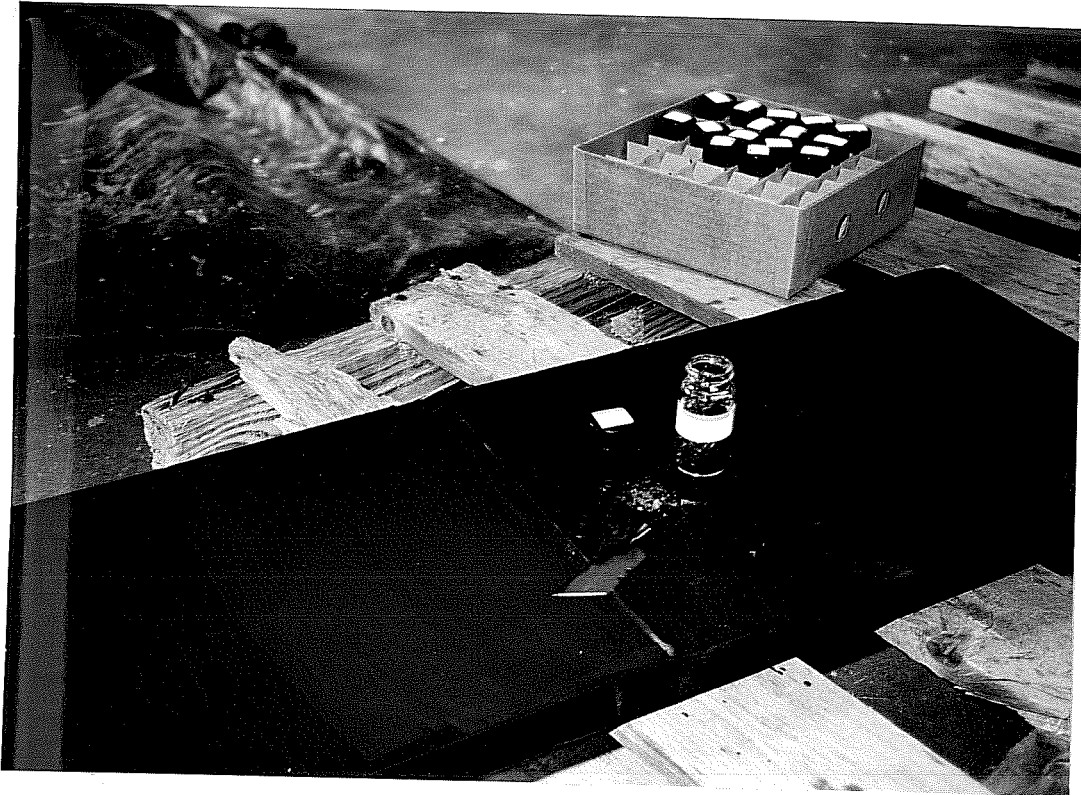
The layer thickness was determined by scraping the top and bottom surfaces of the bearing clean with a steel blade and weighing the scrapings on an electronic scale accurate to the 100th of a gram. See Figure 5.2. Layer thicknesses were determined using a wax specific gravity of 0.92 as suggested by Dimauro *et al.* This seemed to be a reasonable value as typical waxes range from specific gravity of 0.90 to 0.94 [26]. During the time between scrapings, the bearings were stored in a temperature controlled room between 20°C and 25°C (68 and 77 degrees Fahrenheit). The bearings were stored on their sides to ensure the leachate was not transferred from the bearing surface during storage.

Figure 5- 2 Scraping the bearings with a steel blade and collecting the leachate.

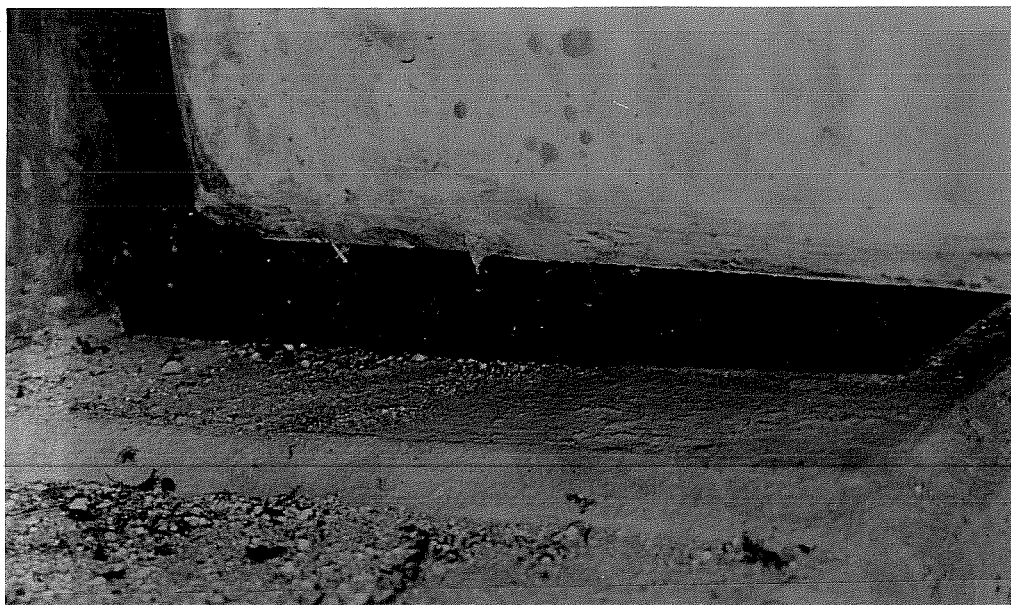
Figure 6- 1 Photo of bearing pad slip in Texas

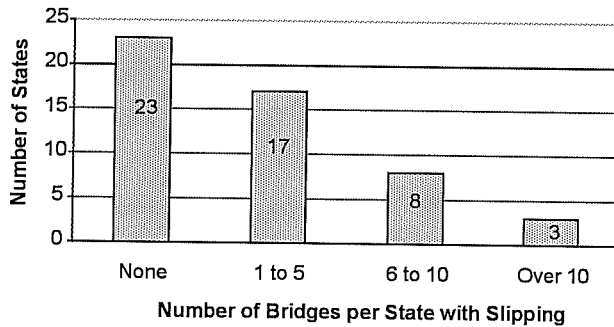
cases of slip. The vast majority of state reporting slipping were only aware of one to three cases.

Figure 6-5 Bearing pad slipping cases per state
