1. Report No. FHWA/TX-99/1364-2		2. Government Accession No.		3. Recipient's Catalog No.	
4. Title and Subtitle <b>AN EVALUATION OF REPAIR METHODS FOR CANTIEVER BRIDGE PIERS</b>				5. Report Date August 1998

# **AN EVALUATION OF REPAIR METHODS FOR CANTILEVER BRIDGE PIERS**

Research Report No. *1364-2*

**“Design of Large Structural Members Utilizing Partial Prestressing”**

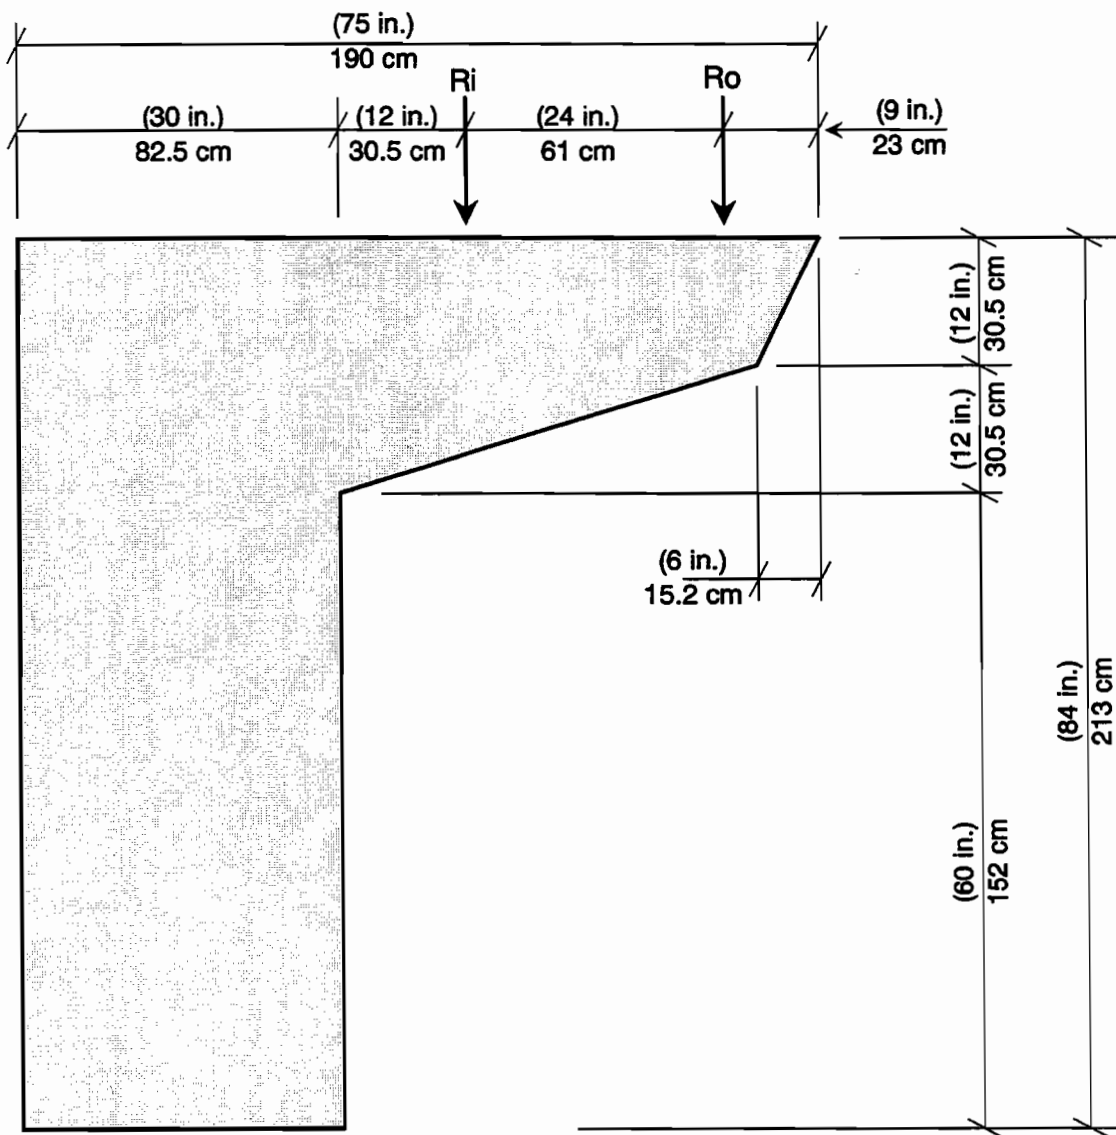
Figure 3. 4 Dimensions of the model bent (from Ref. 3)

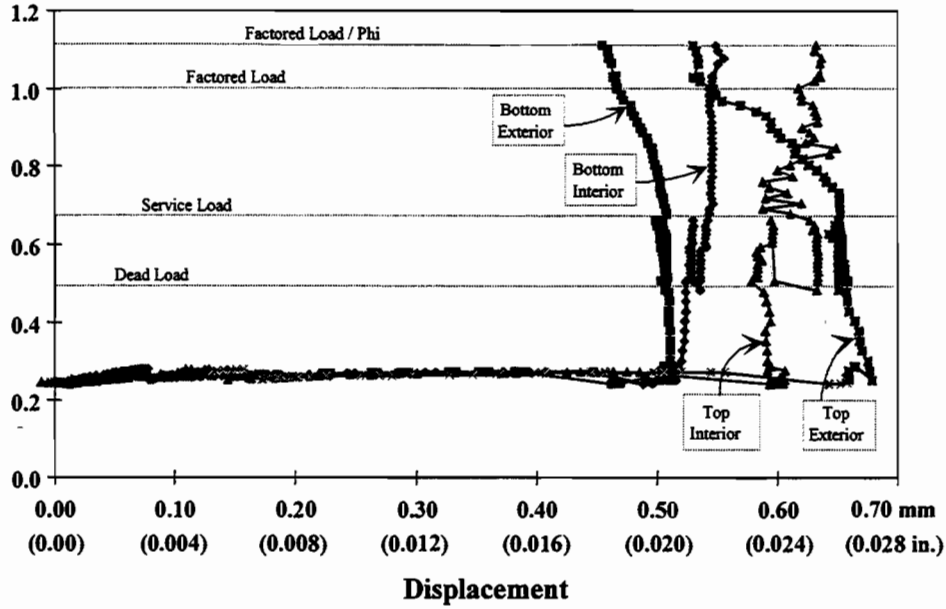
Figure 5.10 Vertical slippage of the side plates on Specimen POJ-PS-100-RP1

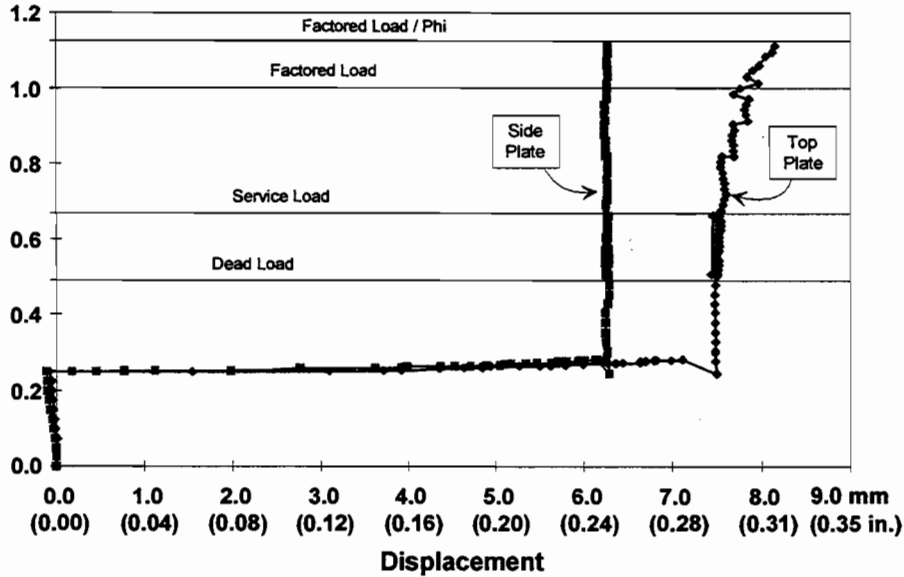
Figure 5.27 Normalized load vs. plate slippage curves for Specimen POJ-RC2-RP1

The readings from strain gauges attached to plates in the repair hardware indicated that the maximum stress was slightly under half of yield stress. Displacements of the plates are shown in Figure 5.27. Initial slippage consisted of approximately 6.4 mm (0.25 in.) for the side plate and approximately 7.6 mm (0.30 in.) for the top plate. During loading, the top plate moved an additional 0.7 mm (0.03 in.), while the extra displacement on the side plate was too small to be measured.

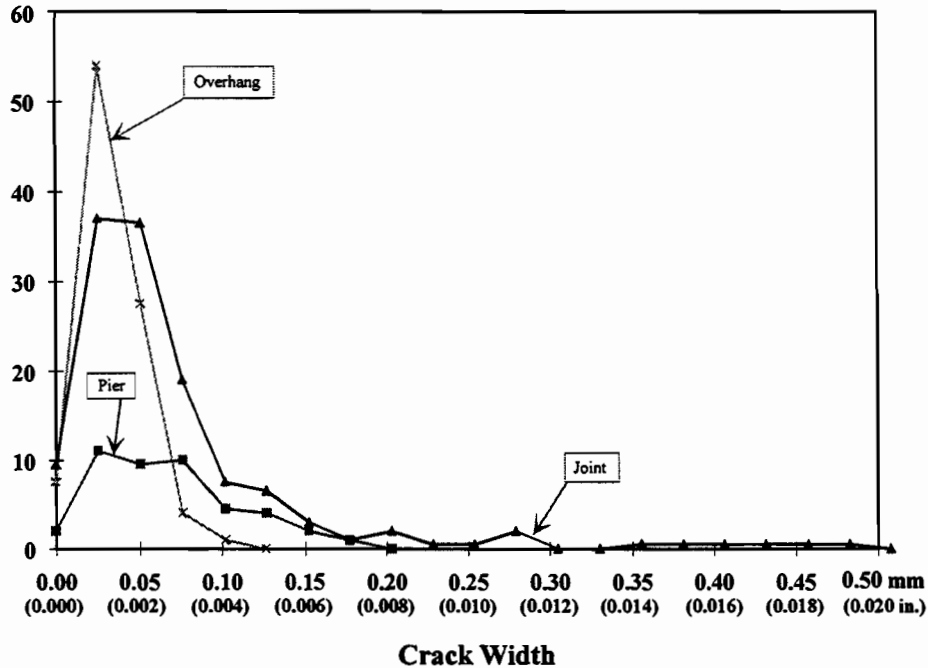
Figure 5.36 Distribution of service load crack widths in each region of Specimen POJ-RC2-RP2a

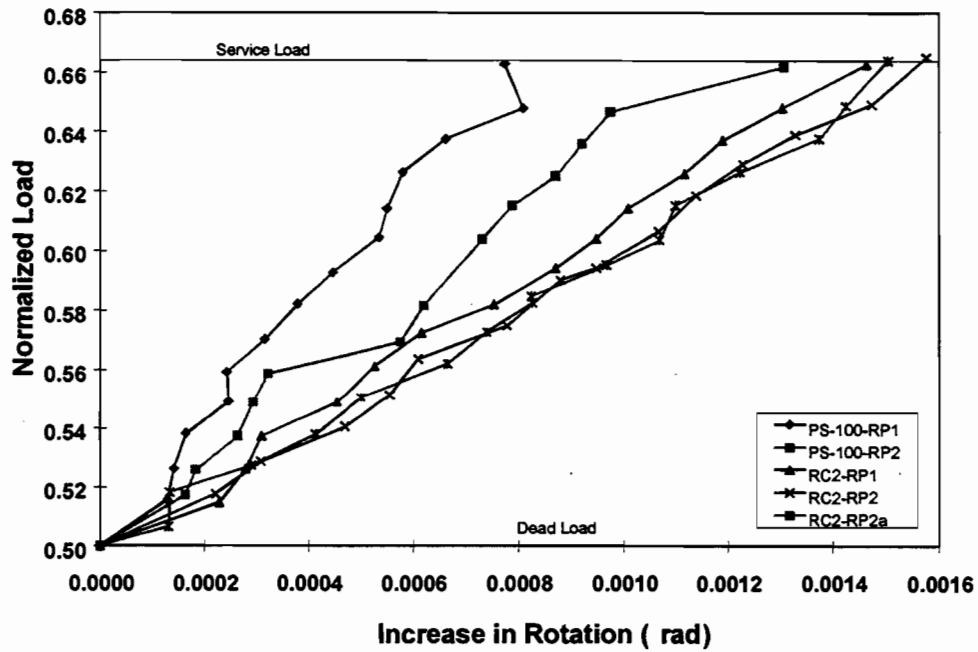
Figure 7.5 Comparison of service level joint rotations for all repaired specimens

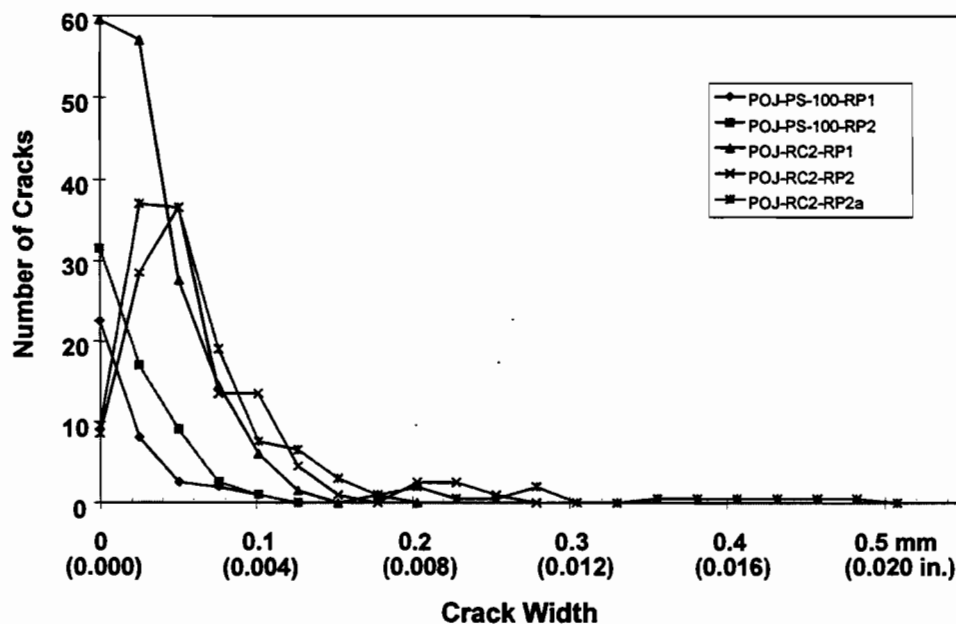
Figure 7. 11 Comparison of adjusted crack width distribution at service load

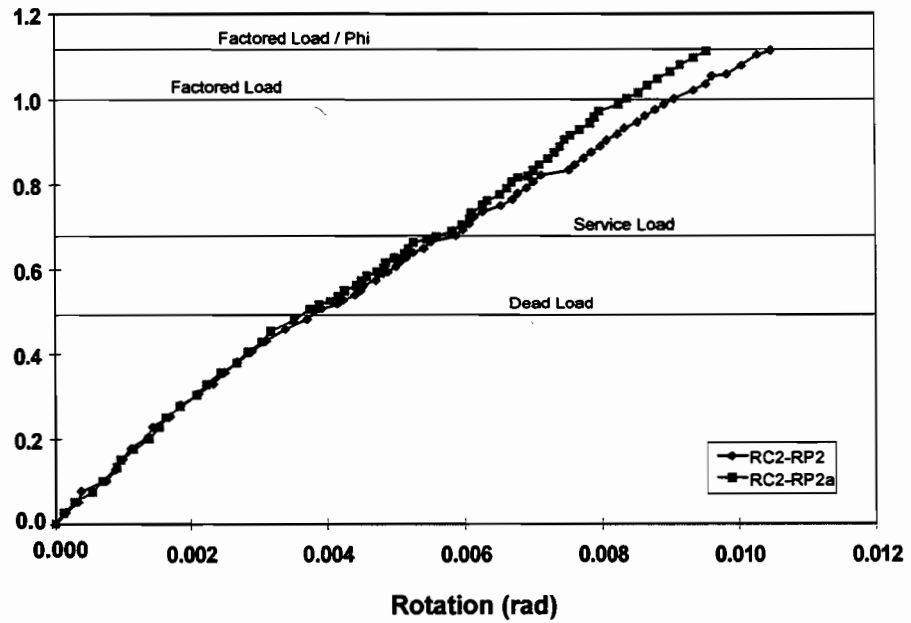
Figure 7.16 Comparison of joint rotations for specimens with internal post-tensioning

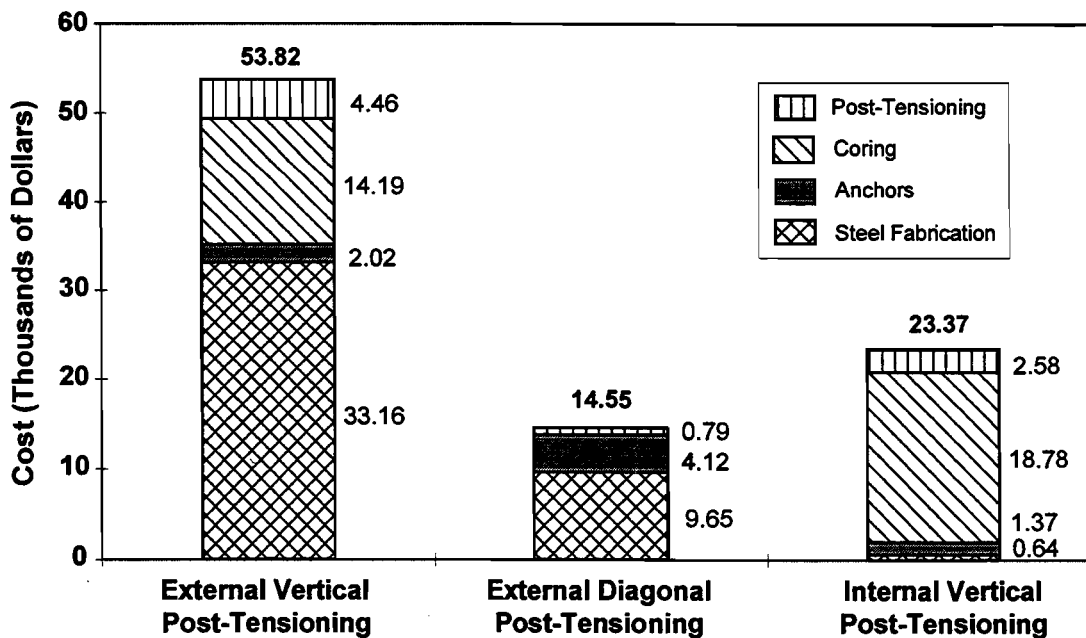
Figure 7.20 Costs of repair options
