**CORROSION PROTECTION FOR BONDED INTERNAL TENDONS
IN PRECAST SEGMENTAL CONSTRUCTION**

J. S. West, R. P. Vignos, J. E. Breen, and M. E. Kreger
Research Report 1405-4

*DURABILITY DESIGN OF POST-TENSIONED
BRIDGE SUBSTRUCTURE ELEMENTS*

by the
CENTER FOR TRANSPORTATION RESEARCH
BUREAU OF ENGINEERING RESEARCH
THE UNIVERSITY OF TEXAS AT AUSTIN

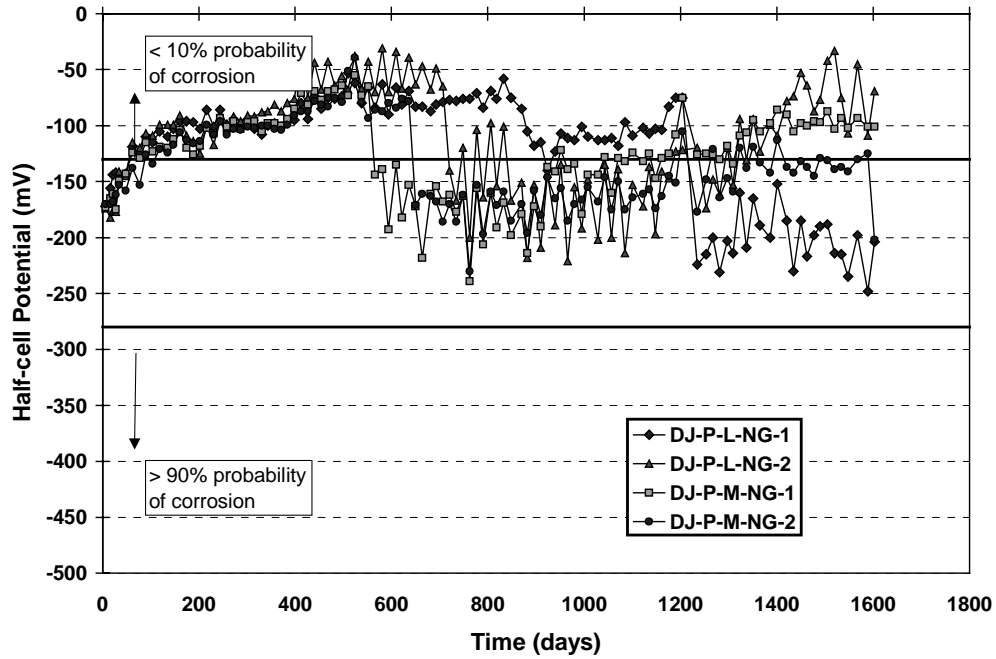
Figure 3.7 – Half-Cell Potentials: Dry Joint, PVC Duct and Normal Grout

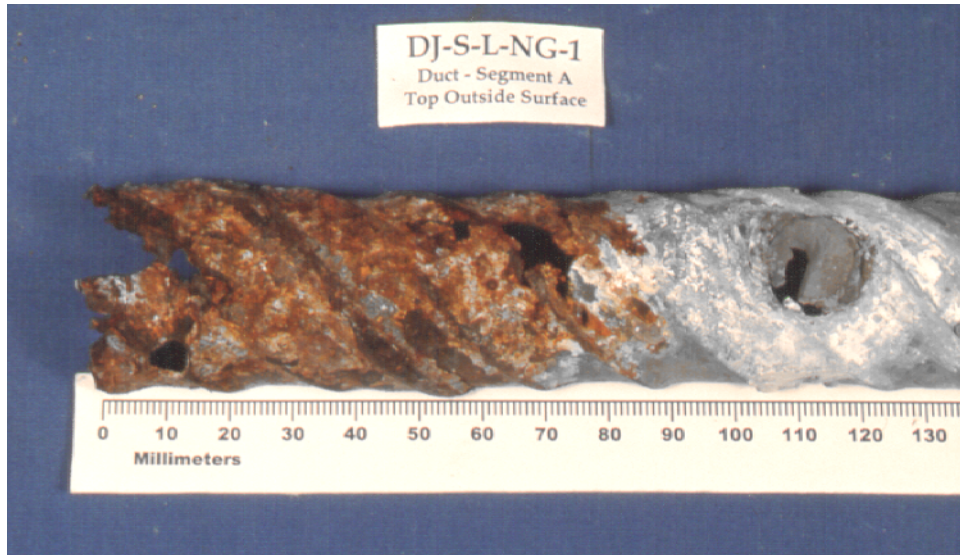
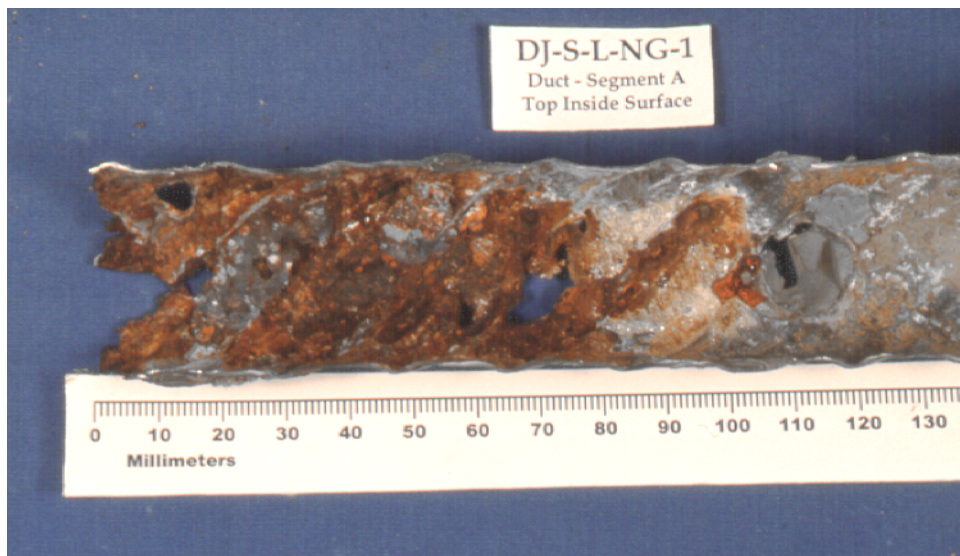
(a) Outside Surface of Duct (joint location at left end)

(b) Inside Surface of Duct (joint location at left end)

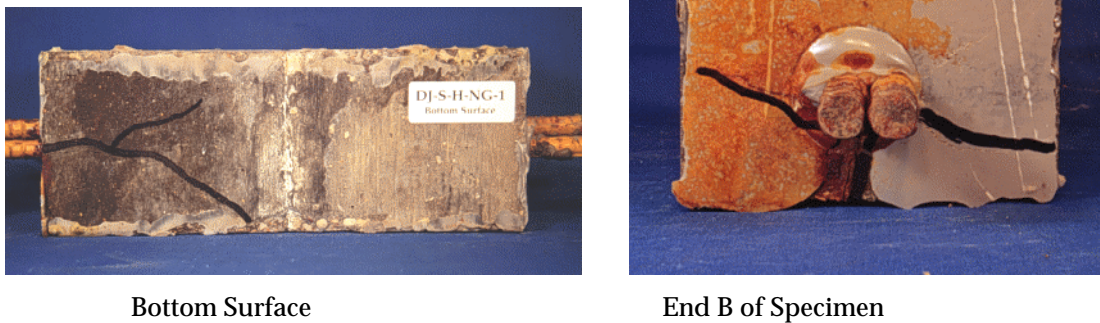
Figure 4.14 – Cracking Due to Rebar Corrosion

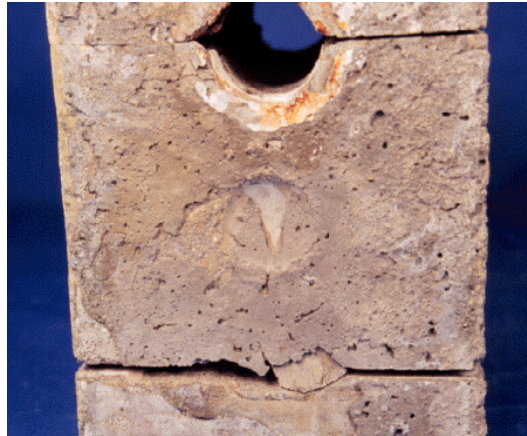
The concrete surface of the match-cast dry joint was intact with no voids or cracks. Significant grout leakage occurred during grouting, and approximately 80% of the joint surface was covered with grout, as shown in Figure 4.15. Rust and salt stains are present on the face of the joint around the duct opening.

Figure 4.15 – Grout Infiltration Into Joint: Specimen DJ-S-L-CI-1

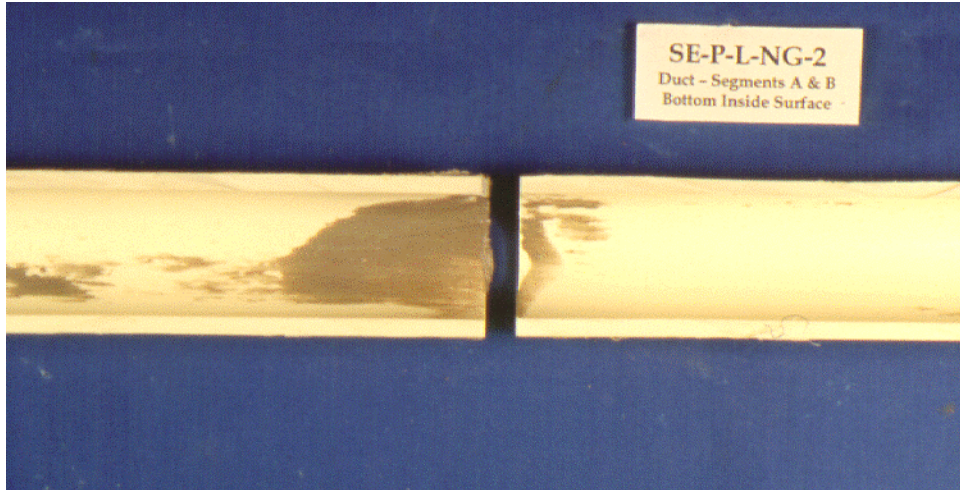
Figure 4.17 – Joint Epoxy Smeared Inside Plastic Duct During Swabbing

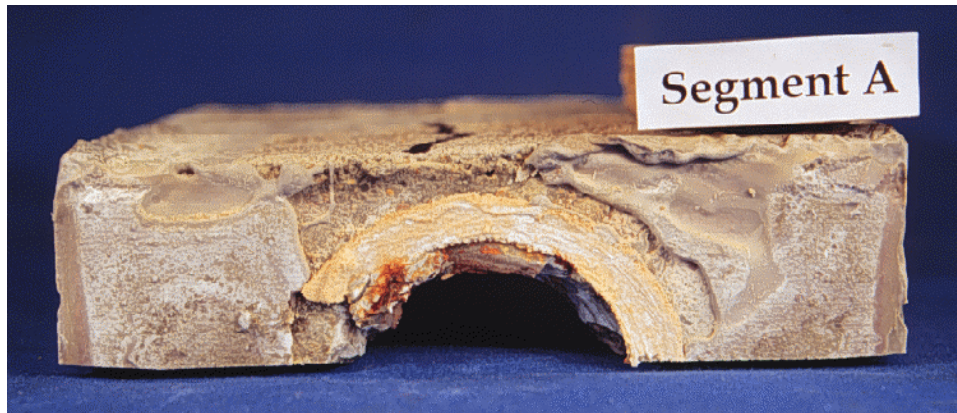
The side and bottom perimeter of the joint were intact and appeared filled with epoxy. A thin void was visible at the joint on the top surface. Sections through the joint at the mid-height, bar cut line and strand cut line showed it to be completely filled with epoxy and free from voids or cracks. However, the gasket appears to have prevented complete bonding of the segments immediately above the duct opening. As a result, the top portion of the specimen above the strand cut line separated at the joint during autopsy. When the face of the joint was examined, incomplete epoxy coverage was revealed as shown in Figure 4.18. Salt and rust stains were visible on the joint.

Figure 4.18 – Incomplete Epoxy Coverage in Epoxy/Gasket Joint (EG-S-M-NG-2)

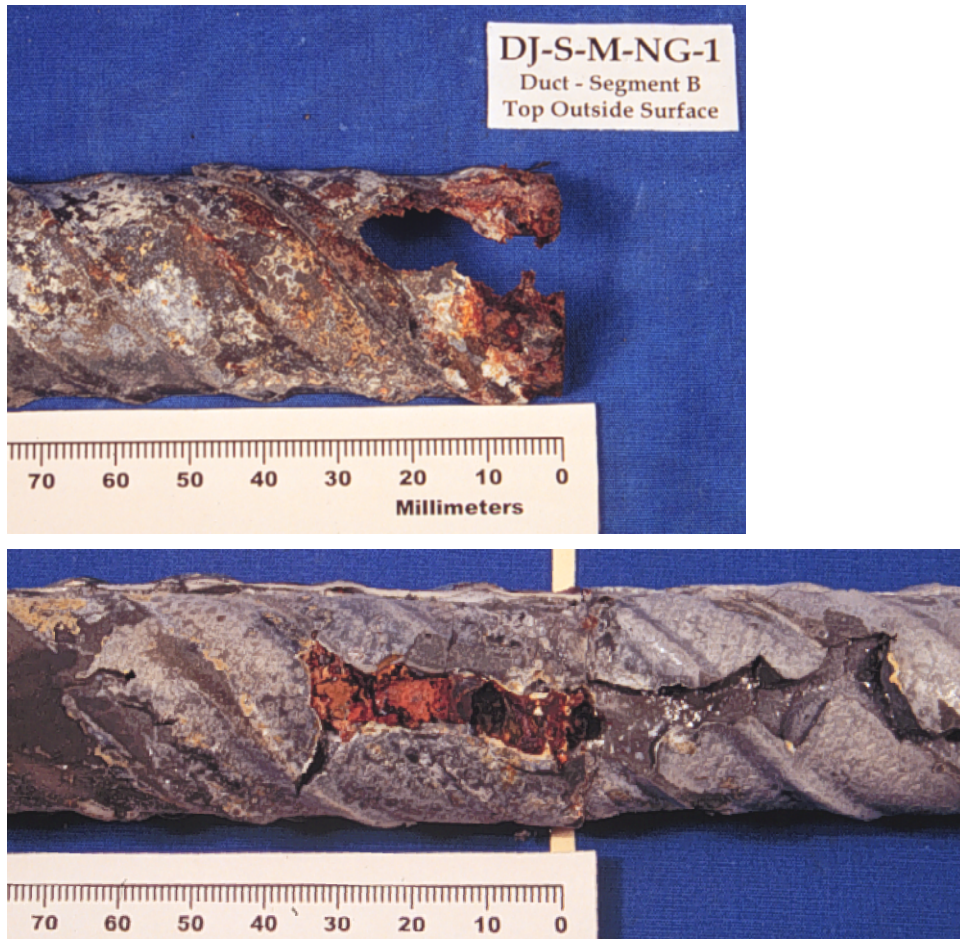
Figure 5.6 – Hole in Duct Corresponding to Grout Void
