RESEARCH REPORT 1405-2

DEVELOPMENT OF HIGH PERFORMANCE GROUTS FOR BONDED POST-TENSIONED STRUCTURES

A. J. Schokker, B. D. Koester, J. E. Breen, and M. E. Kreger

OCTOBER 1999

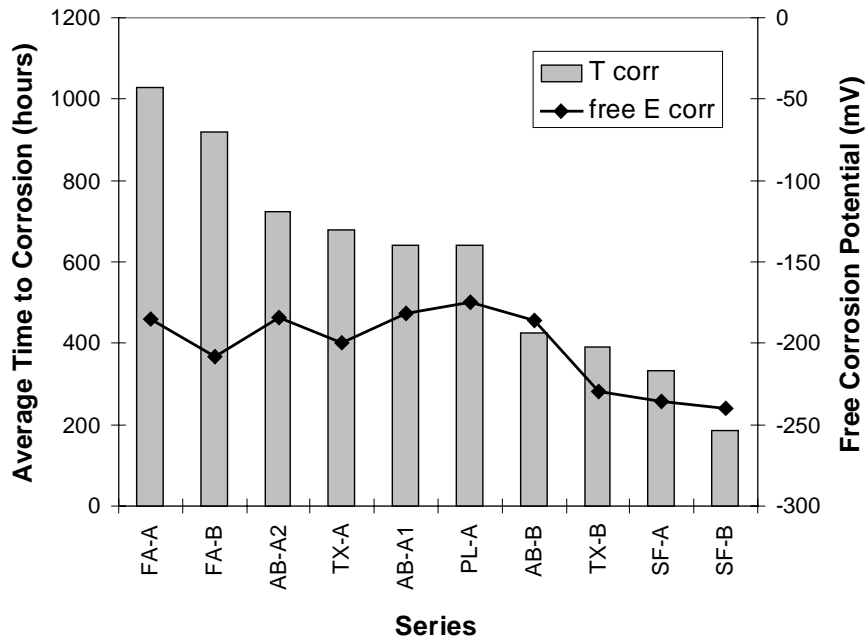
Figure 3.17: Comparison of Free Corrosion Potential and Average Time to Corrosion for All Test Series

Plots of free E_{corr} and the time to corrosion (t_{corr}) are given in Appendix C for each series. A comparison of the average free E_{corr} and average t_{corr} between the test series is shown in Figure 3.17. There appears to be poor correlation between the average free corrosion potential and the average time to corrosion. Koester¹⁷ found some evidence of correlation in his grout studies that may suggest that grouts with more negative average free corrosion potentials will tend to have shorter average times to corrosion. However, the correlation is not strong enough to support comparing grouts solely on their free corrosion potential values. Figure 3.18 more clearly illustrates the lack of correlation between the free corrosion potential and the average time to corrosion.

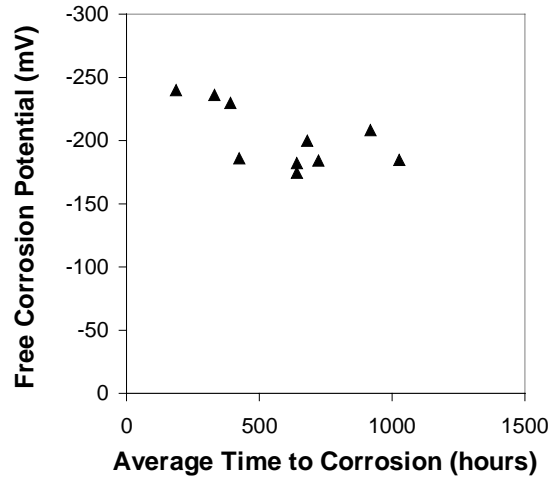
Figure 3.18: Correlation between Free Corrosion Potential and Average Time to Corrosion

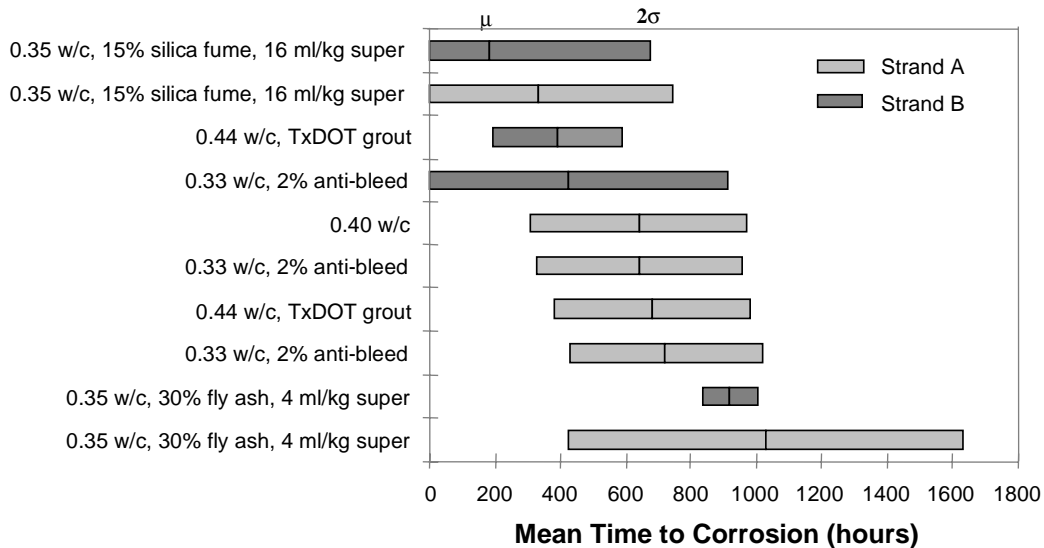
Figure 3.20: ACTM Grout Performance (Summarized Results of Schokker and Koester¹⁷)

The longer bars in the figure indicate longer times to corrosion and therefore better corrosion protection. Strands from the two different reels are included for comparison. The consistently longer values for Strand A show the importance of using the same strand throughout a test series. The addition of fly ash to the mix gave the highest time to corrosion with over 40% improvement in corrosion protection over the next best grout. The mix containing anti-bleed admixture also tested well. Although anti-bleed admixture has been known to reduce time to corrosion,¹⁵ the very low water-cement ratio of 0.33 allowed this mix to perform favorably. This mix was the only grout design from the current tests that passed all of the fresh property tests including the pressurized bleed test. The beneficial effect of lowering water-cement ratio is evident in this plot through comparison of the plain grouts with 0.40, 0.44, and 0.50 water-cement ratios.

A comparison of grout performance is most easily seen in Figure 3.20 that includes data from the present study and from Koester's study¹⁷ with values from the same mix designs averaged together. Since these are the results of an accelerated corrosion test, the actual times shown are not intended to directly relate to actual service life. The test is used as a relative comparison between different grout types.

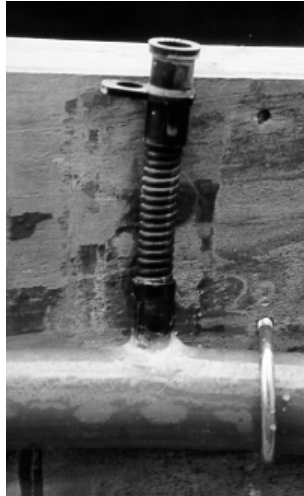
Figure 4.3: Main Crown Vent

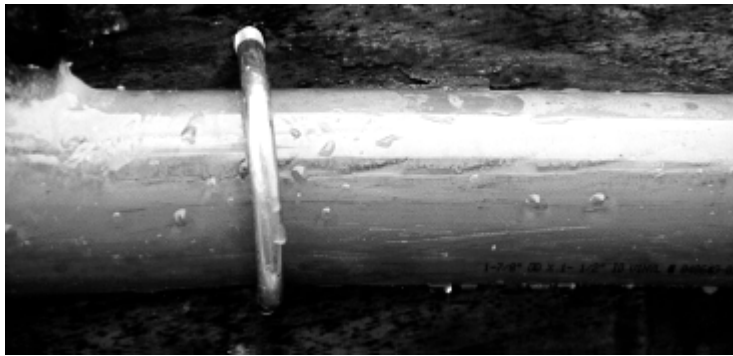
Figure 4.6: Beginning of Void Formation at Intermediate Crest

The standard TxDOT grout was also tested in the parabolic duct as a comparison to the other grouts. The original test of this grout was unusable. Autopsy slices revealed that the grout never fully set and the grout crumbled when touched. The likely cause was use of Intraplast-N admixture that was past its expiration date. The test was successfully rerun with fresh Intraplast-N. The grout was very workable and easy to pump. Immediately after pumping, bleed water was visible in the duct. Bubbles traveled to the intermediate crest where a large void pocket was formed. The bubbles and forming of the void are shown in Figures 4.5 and 4.6. After 24 hours, the bleed water had reabsorbed and a large void remained at the intermediate crest.

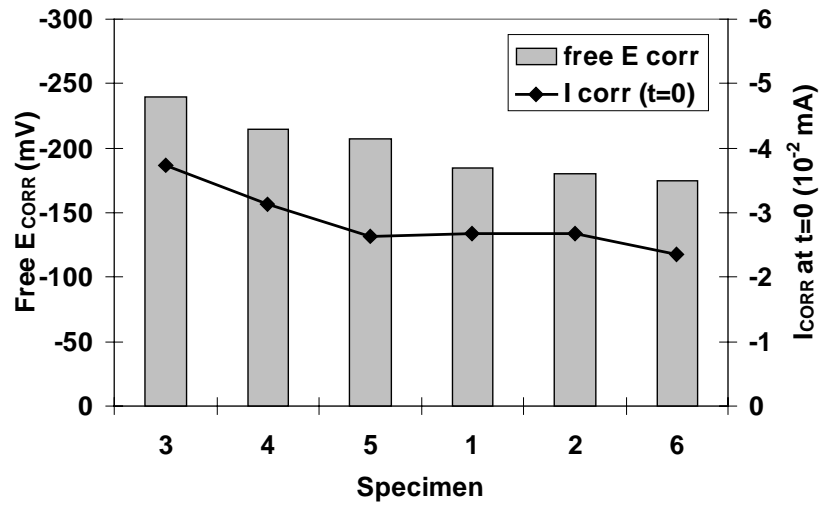
Figure B9: Initial Corrosion Current and Free Corrosion Potential
(Series TX-A – 0.44 w/c, 0.9% expansive admixture)
