**FINAL EVALUATION OF CORROSION PROTECTION
FOR BONDED INTERNAL TENDONS IN PRECAST
SEGMENTAL CONSTRUCTION**

Research Report 1405-6

Research Project 0-1405

*DURABILITY DESIGN OF POST-TENSIONED
BRIDGE SUBSTRUCTURE ELEMENTS*

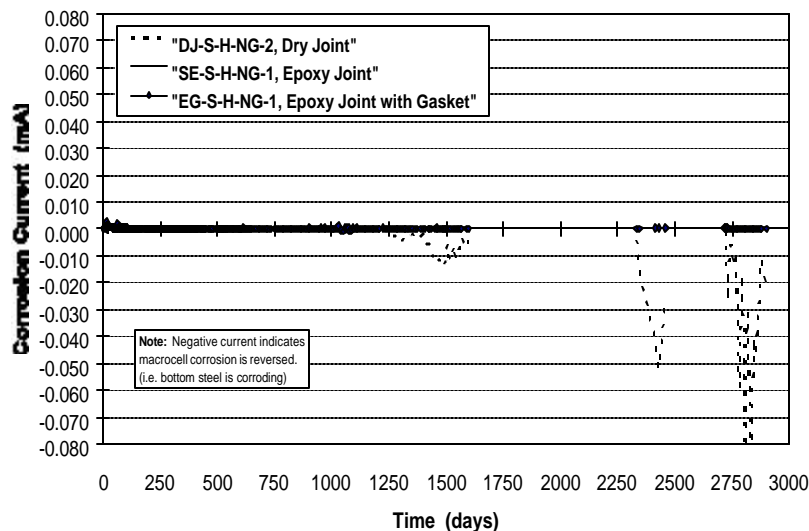
Figure 3.1 Macrocell Corrosion Current: Dry, Epoxy and Epoxy with Gasket Joint, Steel Duct, High Precompression and Normal Grout.

Macrocell corrosion currents over time were plotted for all remaining specimens, after eight years of very aggressive exposure, grouped according to test variables, and are included in Appendix A. Figures 3.1 to 3.4 show examples of corrosion current plots comparing joint type, duct type, joint precompression and grout type, respectively. When examining these plots, the “polarity” of the current is important. As described in Section 2.4.1, the measured voltages and thus the corrosion currents are positive if the assumed macrocell corrosion mechanism (prestressing strand actively corroding) has developed. Negative corrosion currents indicate that a reversed corrosion cell has developed. That is, the prestressing strand is acting as the cathode, while the mild steel reinforcement bars are actively corroding.

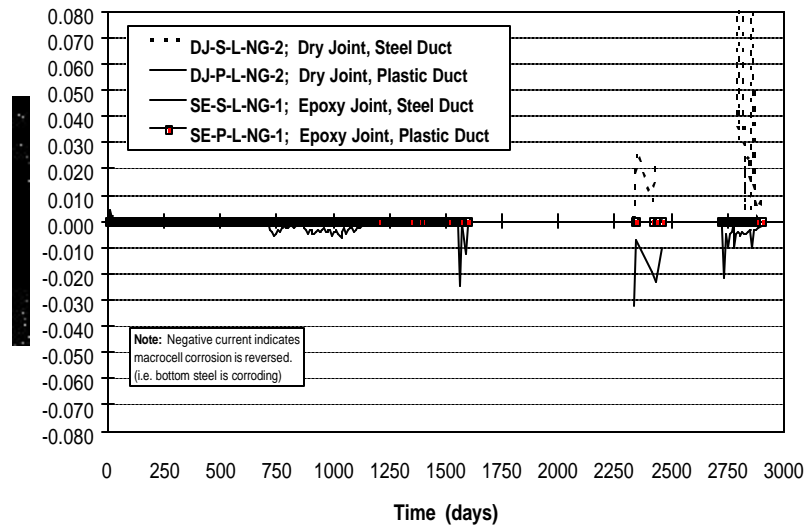
Figure 3.2 Macrocell Corrosion Current: Dry and Epoxy Joint, Steel and Plastic Duct, Low Precompression and Normal Grout.

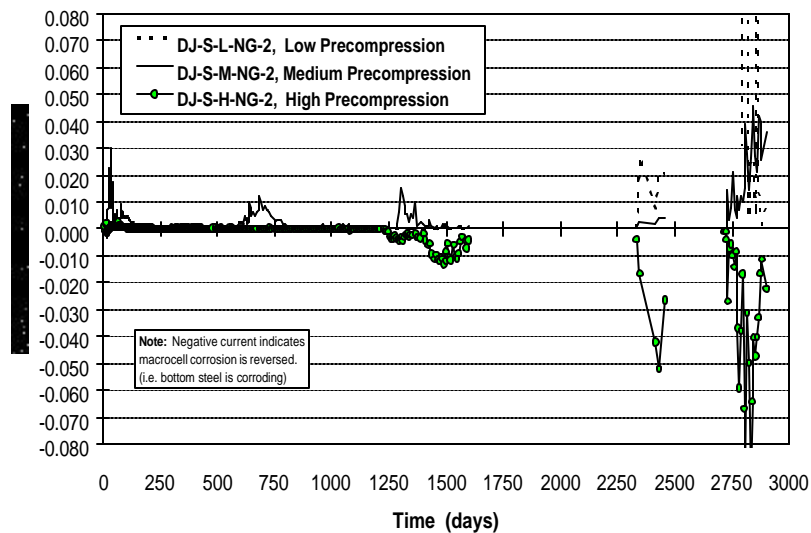
Figure 3.3 Macrocell Corrosion Current: Dry Joint, Steel Duct, Low, Medium and High Precompression and Normal Grout.

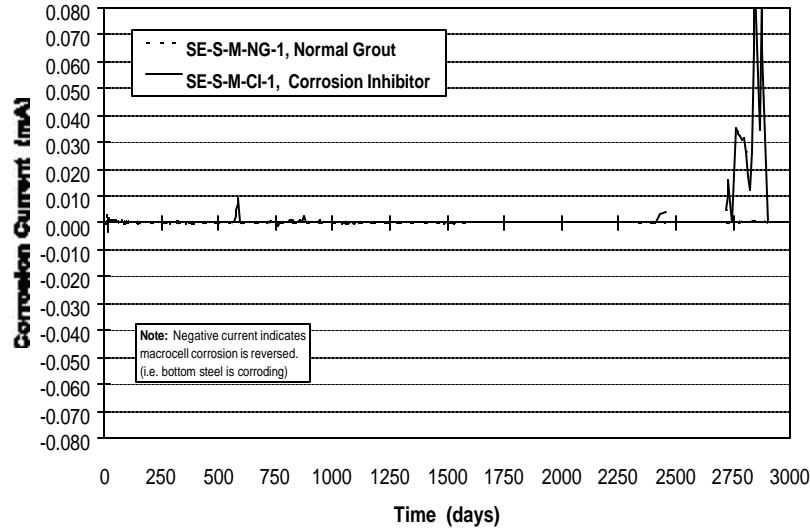
Figure 3.4 Macrocell Corrosion Current: Epoxy Joint, Steel Duct, Medium Precompression and Different Grouts (Normal and Corrosion Inhibitor added).

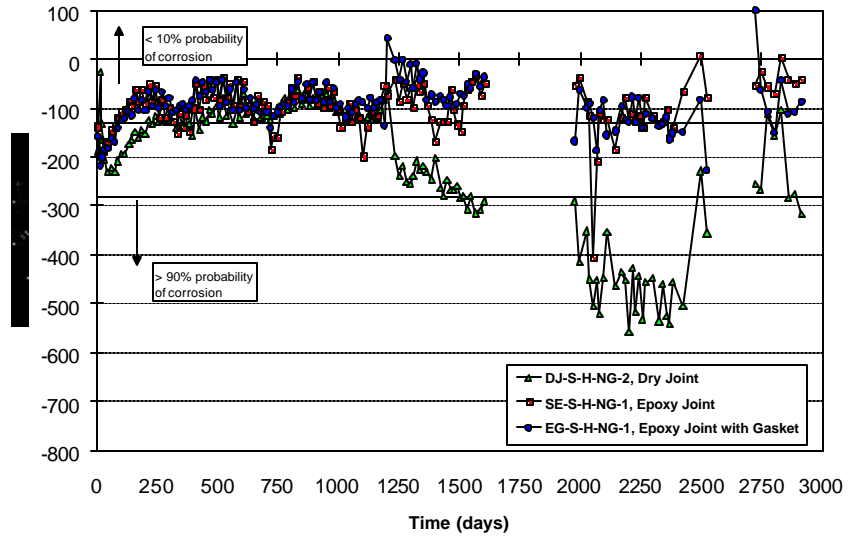
Figure 3.5 Half-Cell Potentials: Dry, Epoxy and Epoxy with Gasket Joints, Steel Duct, High Precompression and Normal Grout.

As with the corrosion current plots, half-cell potential readings over time were plotted for all nineteen specimens after eight years of very aggressive exposure, grouped according to test variables, and included in Appendix A. Figures 3.5 to 3.8 show examples of corrosion current plots comparing joint type, duct type, joint precompression and grout type, respectively. Figures A.14 to A.26 complement those presented herein. The specimens plotted in each figure correspond to the same specimens in Figure 3.1 through Figure 3.4, and Figure A.1 through A.13, respectively. Table 3.2 summarizes the general results based on half-cell readings, according to ASTM C876.

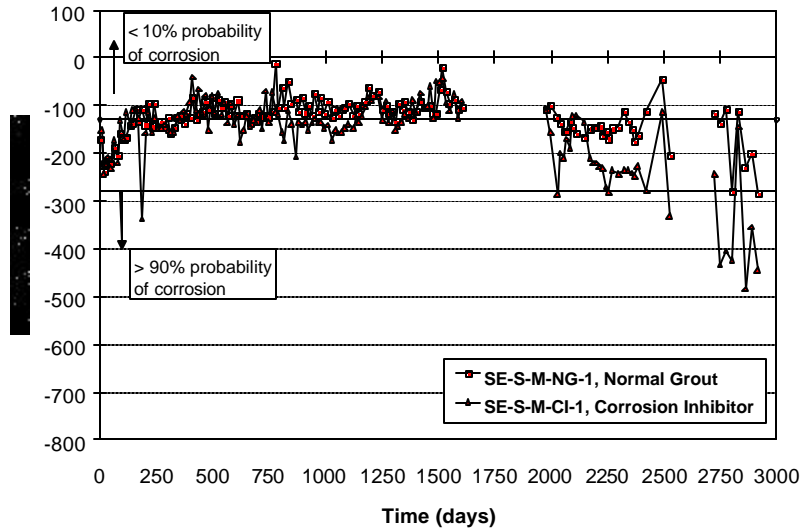
Figure 3.8 Half-Cell Potentials: Epoxy Joint, Steel Duct, Medium Precompression, and Different Grouts (Normal, and Corrosion Inhibitor Added).

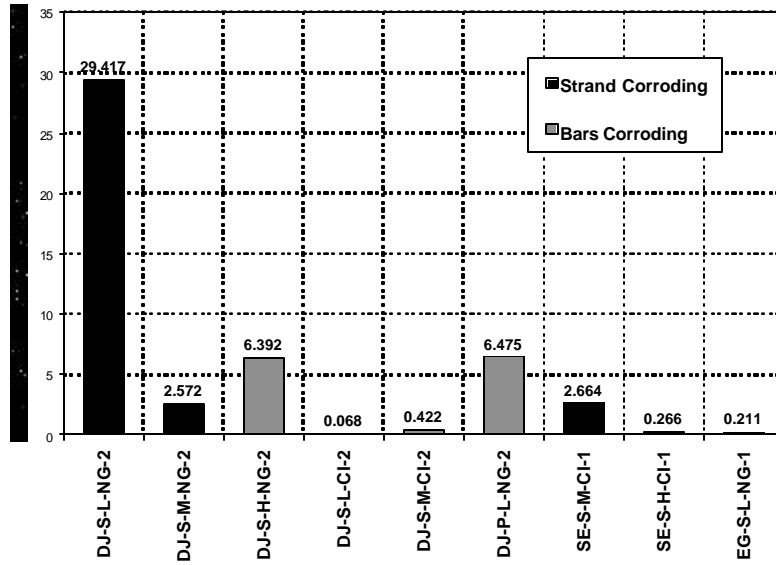
Figure 3.9 Calculated Weighted Average Corrosion Current for Active Specimens after Eight Years of Exposure.

The effect of the different variables (other than joint type) is not clear based on the calculated corrosion rates (Figures 3.9 through Figure 3.11). However, data suggests that a higher level of precompression or protection to the strand (in the case of plastic ducts or corrosion inhibitor in grout), somewhat produces a higher tendency of reversed macrocell behavior, which may relate to lower strand corrosion.

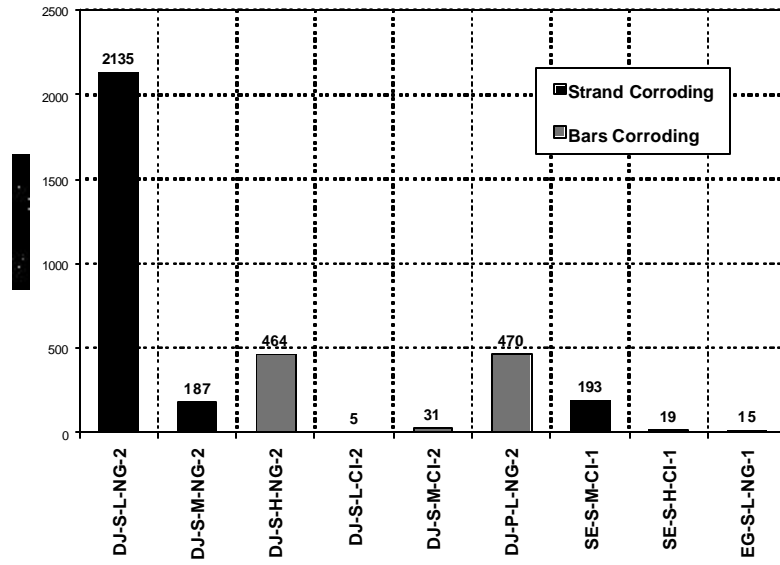
Figure 3.11 Calculated Metal loss for Active Specimens after Eight Years of Exposure.

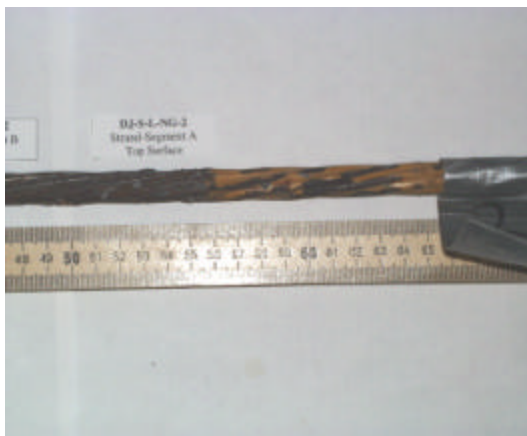
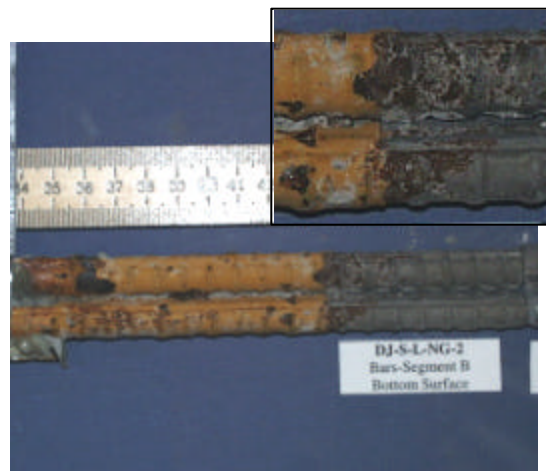
Figure 4.10 Concrete, Duct, Strand and Bar Condition for Specimen DJ-S-L-NG-2.

More than 50% of the duct had been consumed by corrosion, leaving a build up of corrosion products around the surface of the grout. Corrosion products were mixed with a white powder (that was analyzed with X-Ray Diffraction and was found to be Zinc Oxide and Zinc Hydroxide). At the remaining areas of the duct metal, severe uniform corrosion and pitting was found, as shown in Figure 4.10. The duct corrosion rating for this specimen was the maximum of all specimens examined.

Three shallow voids of around 0.016 in.² each, were found in the grout surface, when extracting the remaining duct material. The voids appear to have resulted from insufficient grout fluidity rather than due to trapped air or bleed water collection. The grout was also cracked in the top, corresponding with the crack observed in the concrete cover.

The strand showed one of the highest corrosion rates when compared to the other 18 specimens. Uniform corrosion and pitting extended the complete length of the strand, including those sections where the epoxy paint had peeled off, which represented more than 50% of the painted area

The mild steel showed moderate corrosion away from the joint, in the vicinity of the epoxy paint area, as shown in Figure 4.10. Additionally, light to moderate corrosion was found under the epoxy paint and in all those areas where the epoxy had peeled off, which represented around 15% to 20% of the epoxy area in the bars.

Duct corrosion produced a crack in the top of the concrete specimen extending its whole length, as shown in Figure 4.10. The crack had a maximum top width of 0.12 in., and extended the full depth of cover to the duct, and was clearly visible when the specimen was opened at the strand cut line. Rust staining was visible around the crack.

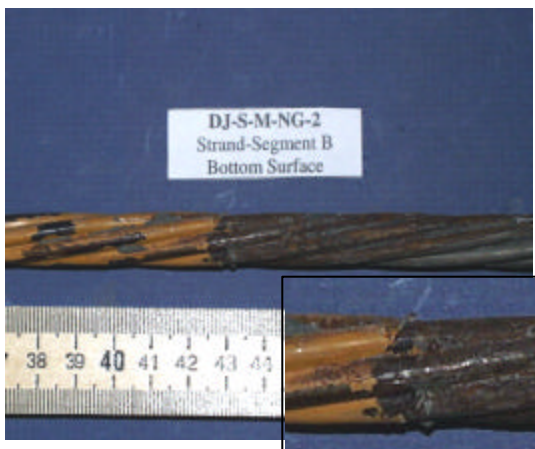
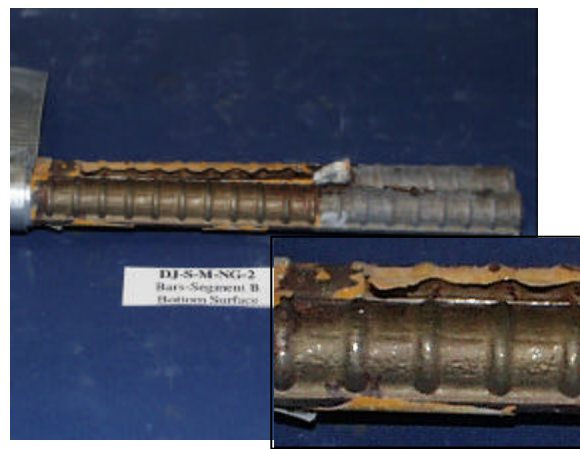
Figure 4.11 Concrete, Duct, Strand and Bar Condition for Specimen DJ-S-M-NG-2.

Discoloration and light to moderate corrosion was found in the reinforcing bars, mainly underneath the epoxy paint, as shown in Figure 4.11. The epoxy paint seemed to have retained moisture, forcing the paint to peel off and triggering corrosion. Few small voids were found in the concrete surface underneath the reinforcing bars.

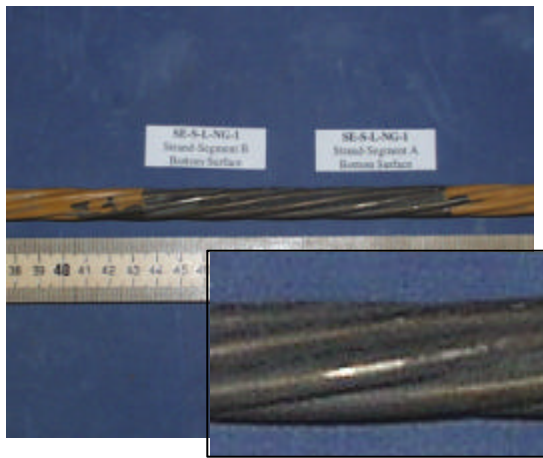
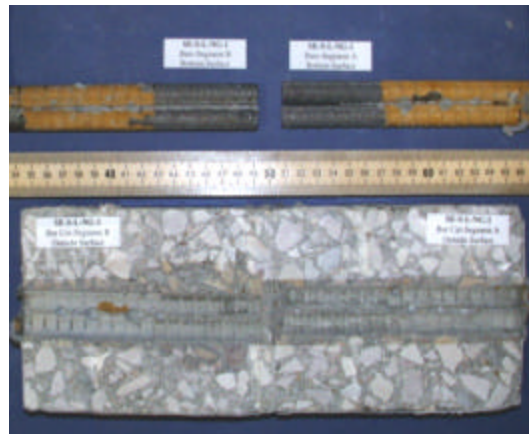
Figure 4.17 Concrete, Duct, Strand and Bar Condition for Specimen SE-S-L-NG-1.

Severe corrosion covered most of the top of the duct in Segment B, as seen in Figure 4.17, and half the top of the duct in Segment A, extending from the joint face. Corrosion in Segment B produced a horizontal crack in the duct of approximately 1.5 in. that lead to another vertical crack of about 0.75 in. in length with a hole of 0.015 in.². The bottom of the duct was covered mostly with a white residue (white powder) with only a few areas of light to moderate corrosion near the joint section.

The mild steel bars showed discoloration in the unpainted areas and light corrosion in the few areas where the epoxy paint had peeled off, as shown in Figure 4.17.

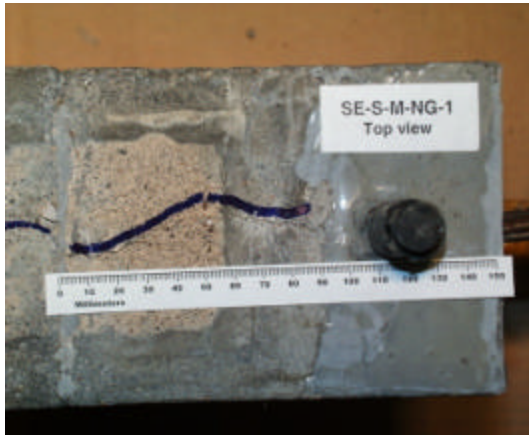
Figure 4.18 Concrete, Duct, Strand and Bar Condition for Specimen SE-S-M-NG-1.

At the duct/strand cut line, severe corrosion was found on the top of the galvanized steel duct, as shown on Figure 4.18. Corrosion produced several small holes through the duct in Segment B. In Segment A, one large longitudinal hole of about 0.55 in.² was centered at approximately 23.6 in. from the joint. White powder was impregnated to the duct metal in various locations, especially in the bottom of the duct in Segment A and in the top of duct in Segments A and B, around the grout vent locations, as shown in Figure 4.18.

Moderate to severe corrosion was found on one of the outer wires of the strand of the unpainted section, in Segment B. The center wire has also moderately corroded at the same place. Light to moderate corrosion was found on the rest of the wires in that segment. Light corrosion and discoloration was found under the epoxy paint.

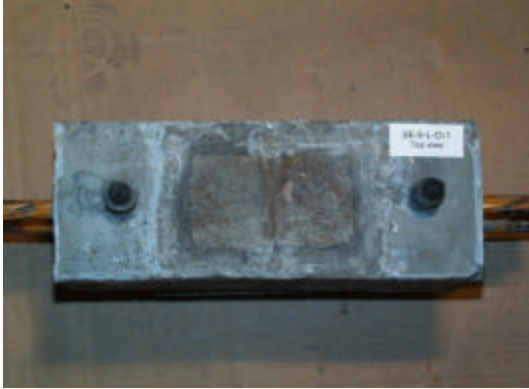
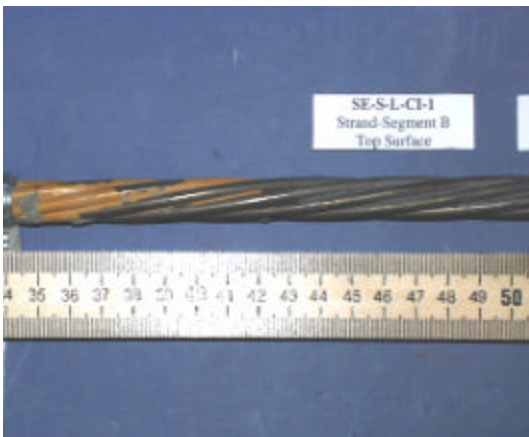
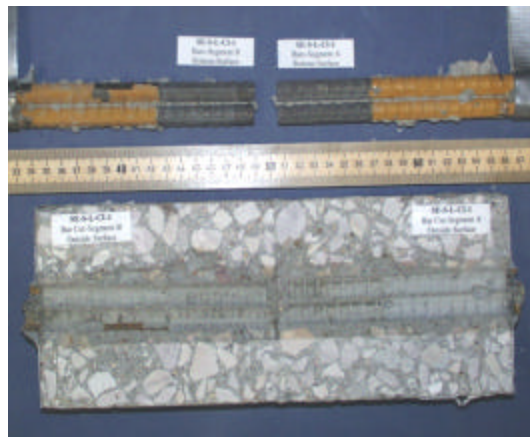
Figure 4.22 Concrete, Duct, Strand and Bar Condition for Specimen SE-S-L-CI-1.

No cracks were found on the top, sides or bottom of the specimen. Severe corrosion was found on the top of the galvanized metal duct in Segment B, extending half of the segment from the joint section, and with the most severe corrosion at 1.75 in. from the joint. Also, moderate to severe corrosion was found on the top of the metal duct in Segment A, centered at 1.75 in. from the joint, as shown in Figure 4.22. White residue (powder) was found mixed with the dark corrosion products. The bottom of the duct showed no signs of corrosion products either in the form of dark or white residues.

Specimen	(2)	(1)
Strand	24	95
Bars	0	28
Duct	85	126

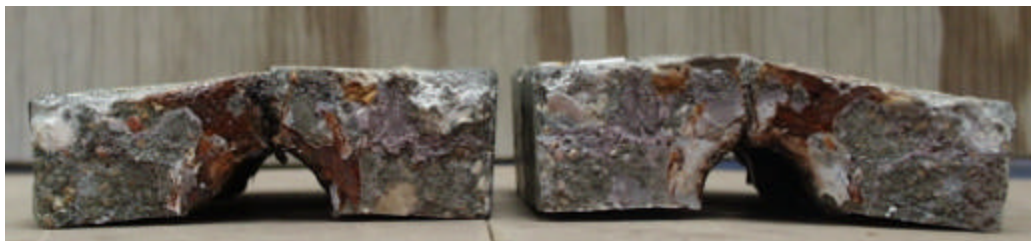
The match-cast epoxy joint was incompletely filled in the top of the strand cut line, allowing water to penetrate to the duct. The joint had corrosion stains from the duct location up to the top of the specimen as shown in Figure 4.24.

Figure 4.24 Incompletely Filled Epoxy Joint (SE-S-M-CI-1).

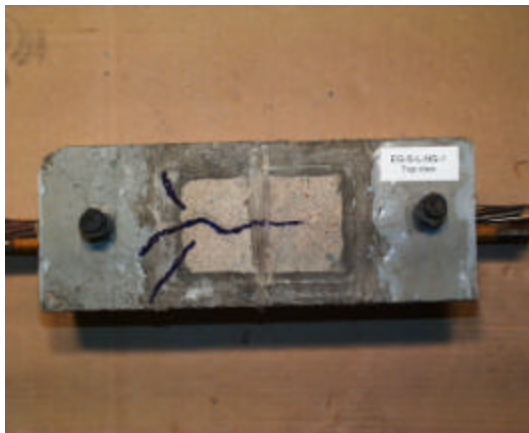
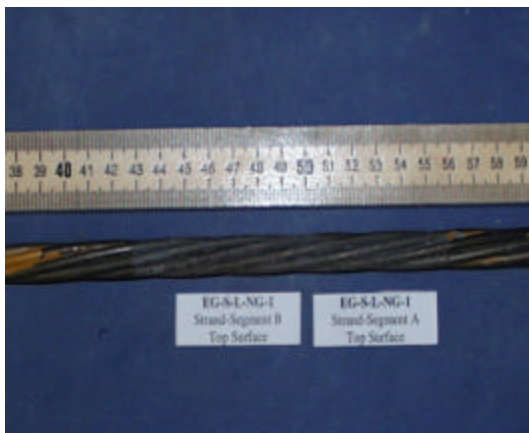
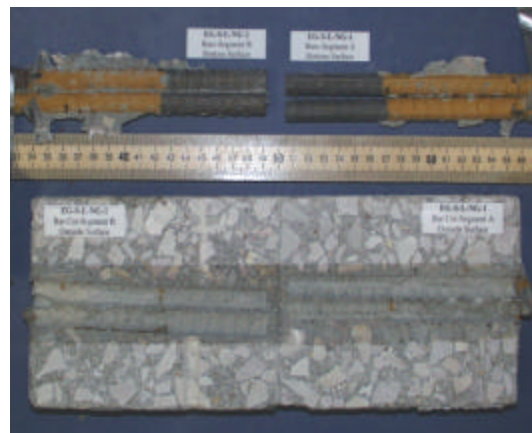
Figure 4.27 Concrete, Duct, Strand and Bar Condition for Specimen EG-S-L-NG-1.

Corrosion in the galvanized metal duct produced a 0.020 in. maximum width longitudinal crack in the top of the specimen, 5.5 in. in length, and two additional hairline cracks of 1.2 in. and 2 in. respectively in the top of Segment B at the border of the ponded region and extending to the sides, as shown in Figure 4.27. No cracks were found in the sides or bottom of the specimen.

Specimen	(2)	(1)
	4.4 yrs	8 yrs
Strand	2	88
Bars	0	25
Duct	54	1096

The epoxy segmental joint was intact with no signs of moisture, salt or rust penetration. Examination of three sections through the joint showed it to be completely filled with epoxy and free from voids or cracks.

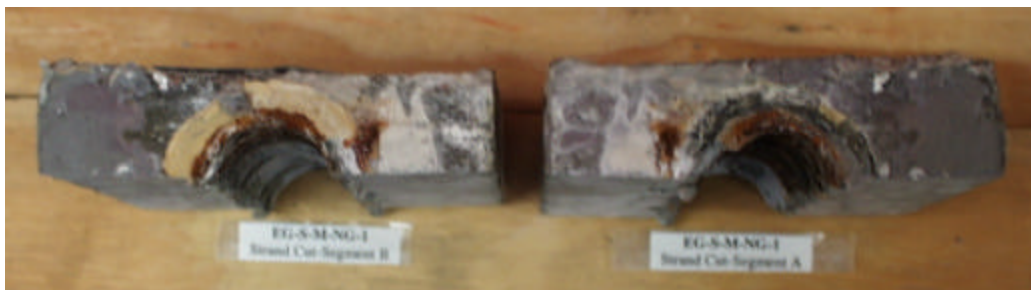
Figure 4.28 Incomplete Epoxy Coverage in Epoxy/Gasket Joint (EG-S-M-NG-1).

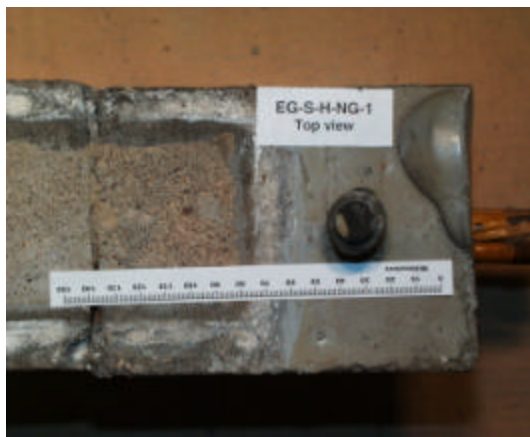
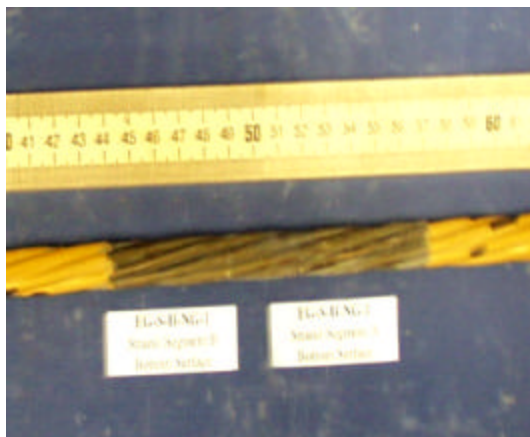
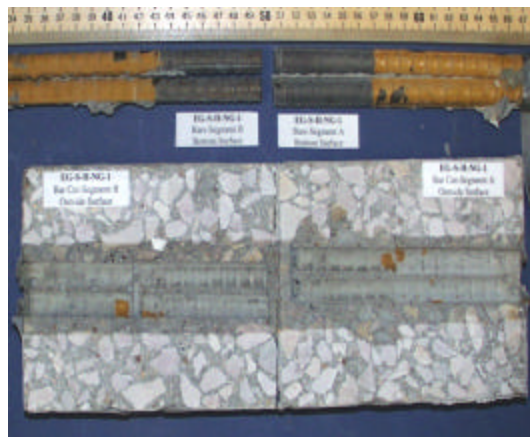
Figure 4.31 Concrete, Duct, Strand and Bar Condition for Specimen EG-S-H-NG-1.

The top of the duct had severe corrosion in Segments A and B, centered in each side at 1.60 in. from the epoxy joint with gasket, as shown in Figure 4.31. Holes in Segment A had 0.016 mm², same as the holes in Segment B. Corrosion products were very dark in color and there was one dark green spot close to the

hole in Segment B. The duct bottom had light to moderate corrosion extending a few millimeters from the joint section at each side, as seen in Figure 4.31. White residue was present around all the corroded areas.

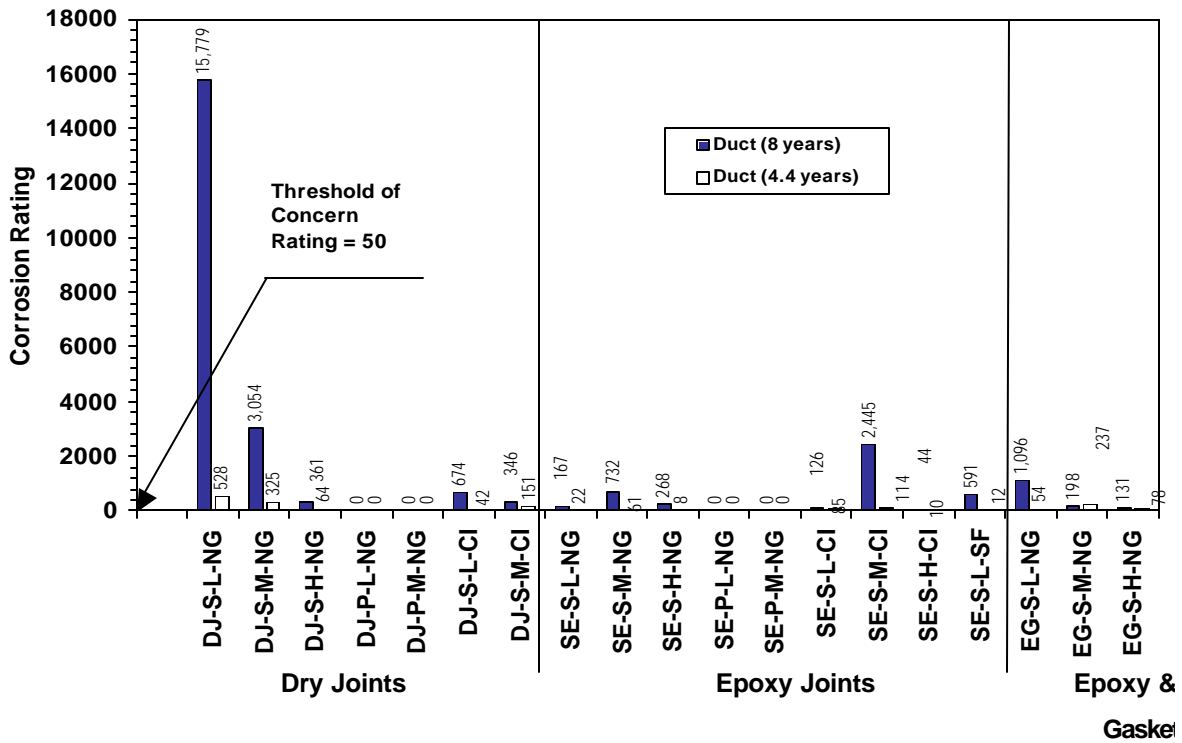
Figure 4.34 Duct Corrosion Ratings for All Specimens.

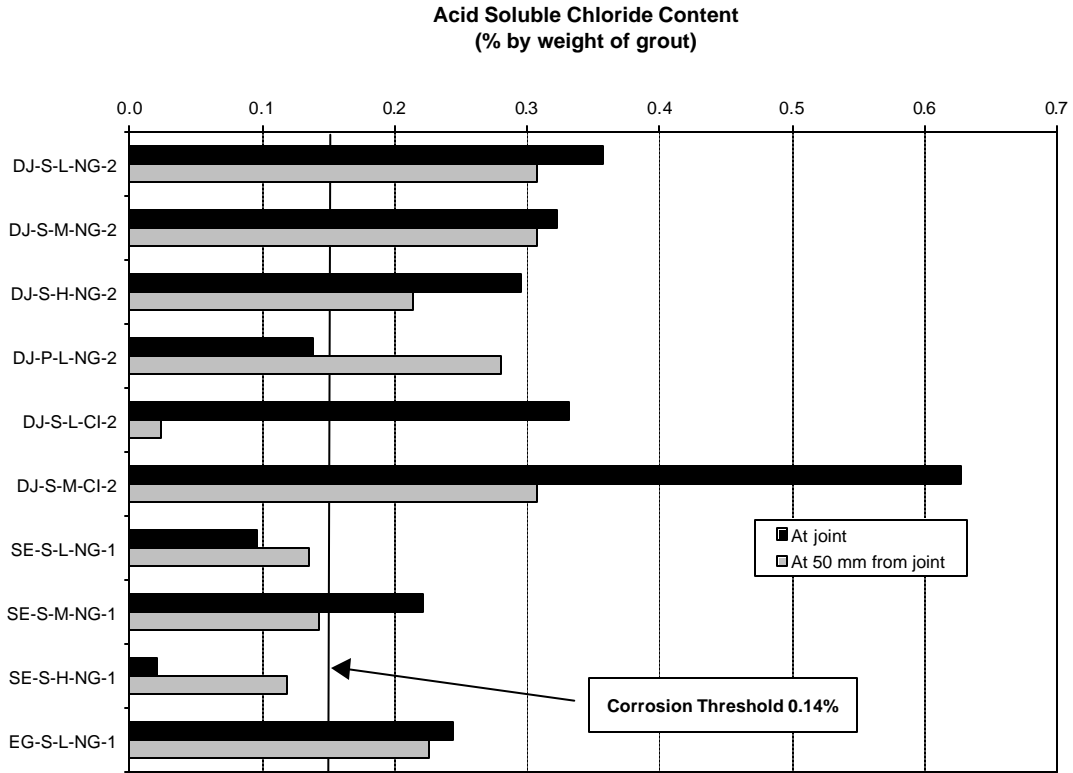
**Figure 4.49 Measured Chloride Contents in Post-tensioning Grout
after about Eight Years of Exposure.**

6. Dry joint specimens with steel duct, and normal grout, show a distinct trend with respect to the level of precompression, having less chloride content with higher levels of precompression. The same trend is observed with epoxy joint specimens with steel duct, normal grout and low and high levels of precompression. The only two exceptions are, Specimen DJ-S-M-CI-2, which has higher chloride content than Specimen DJ-S-L-CI-2; and, Specimen SE-S-M-NG-1, which has higher chloride content than the other epoxy joint specimens. The last case is explained following the same reasoning as in 5 above.

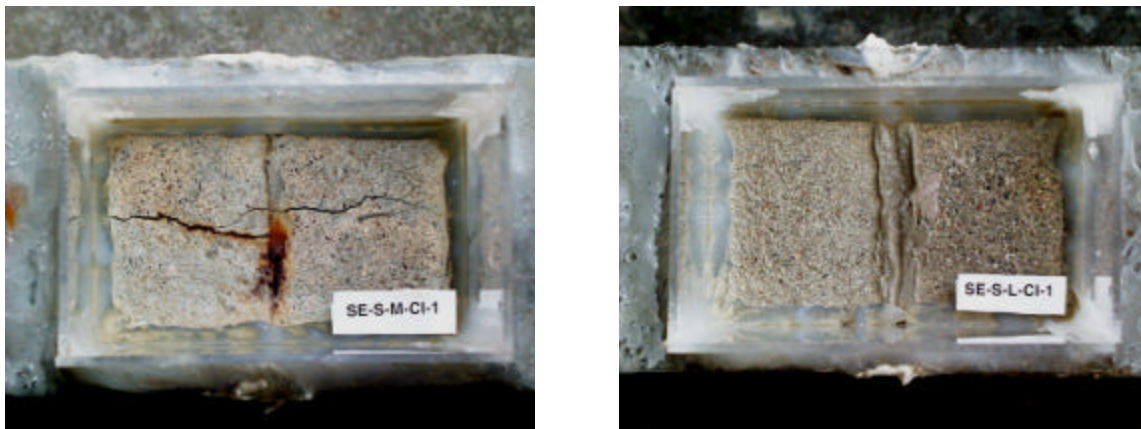
Figure 5.2 Top View of the Effect of a Faulty Epoxy Joint (SE-S-M-CI-1) Compared to a Sound Epoxy Joint (SE-S-L-CI-1).

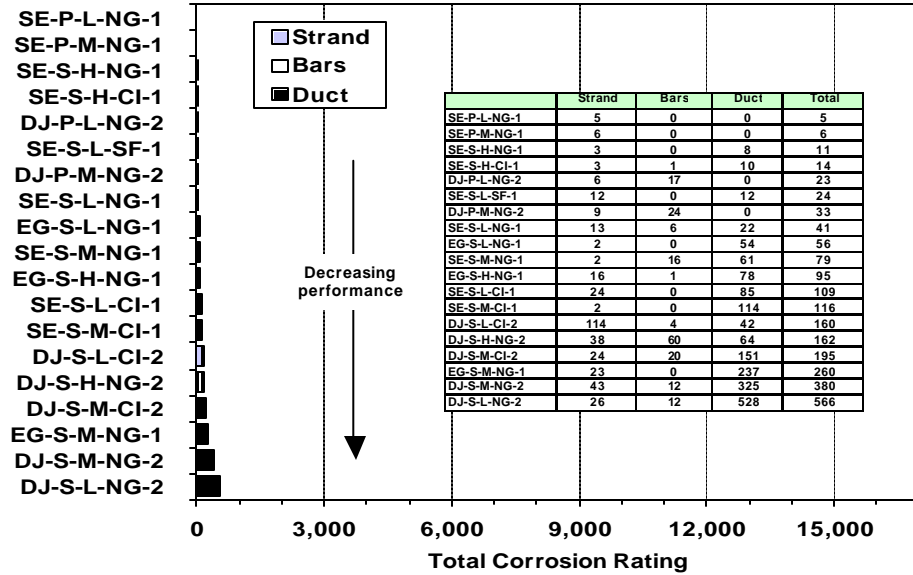
Figure 5.3 Total Corrosion Rating Ordered According to Performance (After Four Years and Five Months of Exposure).

The overall performance of the specimens is better compared by considering the total corrosion rating, obtained by summing the ratings for the strand, bars and duct, as shown in Figure 5.3 and Figure 5.4. Comparison between these two figures showed overall corrosion increased dramatically for most specimens between four and a half years and eight years of exposure. After eight years, the best performance was shown in the plastic duct specimens, while the dry joint specimens with steel ducts and normal grout showed the worst performance. The poor performance observed for specimen SE-S-M-CI-1 clearly shows the detrimental effect of faulty epoxy filling at the joint.

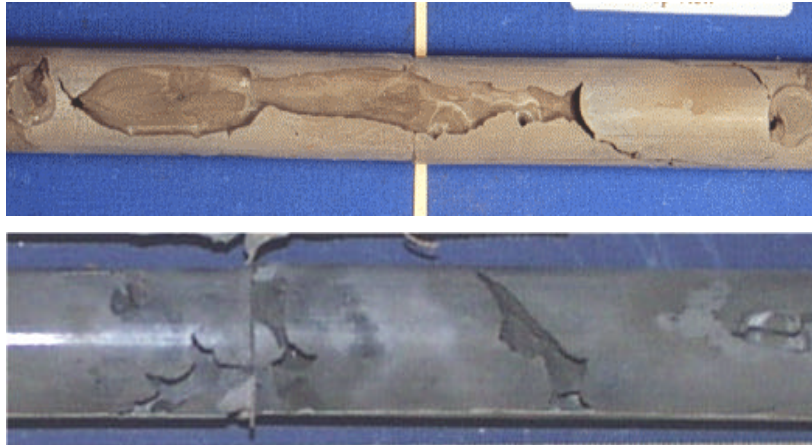
Void caused by entrapped air, bleed water or incomplete filling (from reference 15)
