**ANALYSIS, TESTING, AND LOAD RATING OF
HISTORIC STEEL TRUSS BRIDGE DECKS**

Research Report 1741-2

Research Project 0-1741

*PRESERVATION ALTERNATIVES
FOR HISTORIC TRUSS BRIDGES*

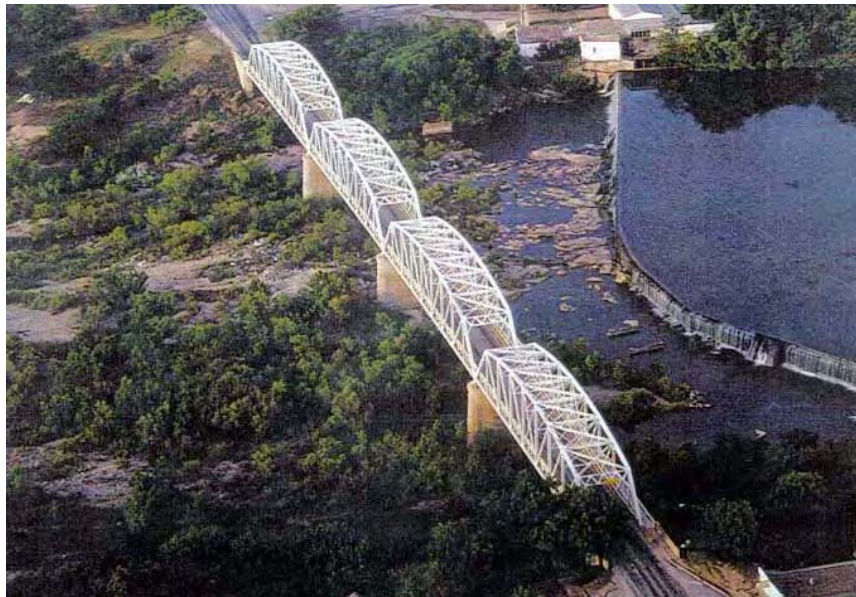
**Figure 2.1 Aerial photo of Roy Inks Bridge
(photo courtesy of Texas Department of Transportation)**

The first of the bridges selected as a case study is a four span bridge in Llano, Texas. Formally known as the Roy Inks Bridge, the main structure spans approximately 800 feet crossing the Llano River. Located near the center of town, it is the main entryway from the north to the downtown area. Figure 2.1 shows an aerial view of the bridge. The location of the bridge is highlighted on the map in Figure 2.2. The 1991 TxDOT estimate of the Average Daily Traffic (ADT) was 9,100 vehicles per day.

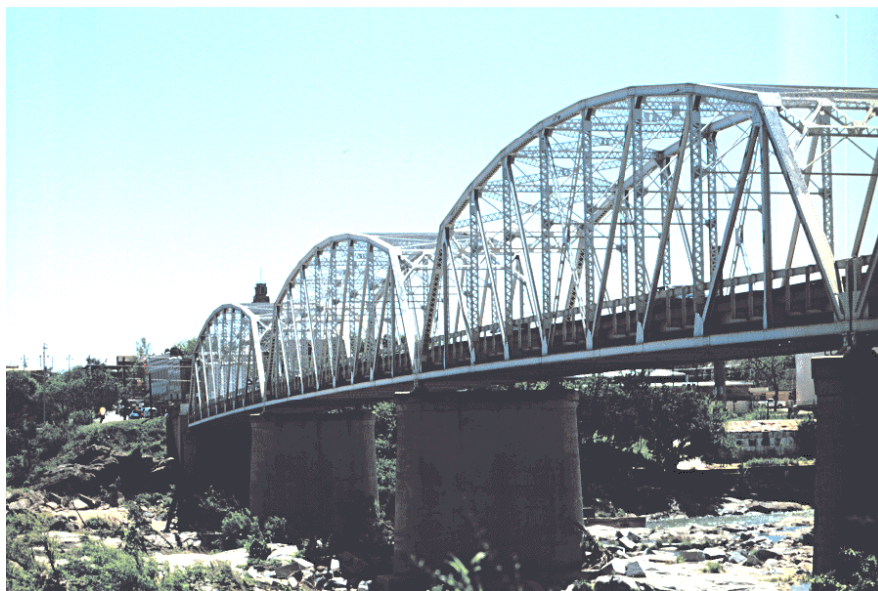
Figure 2.3 Three of the four spans of the Llano Bridge

The overall shape can identify a particular truss. The Llano Bridge is known as a Parker truss. The Parker is basically a Pratt truss with a polygonal top chord, and is distinguished by having diagonal members in tension and vertical members in compression under dead loads. Three of the four spans of the Llano Bridge may be seen in Figure 2.3, and a schematic with dimensions for one span can be seen in Figure 2.4. The Llano configuration is on occasion referred to as a Camelback truss, which is simply a specific type of Parker characterized by exactly five pairs of equal slopes on the top chord.

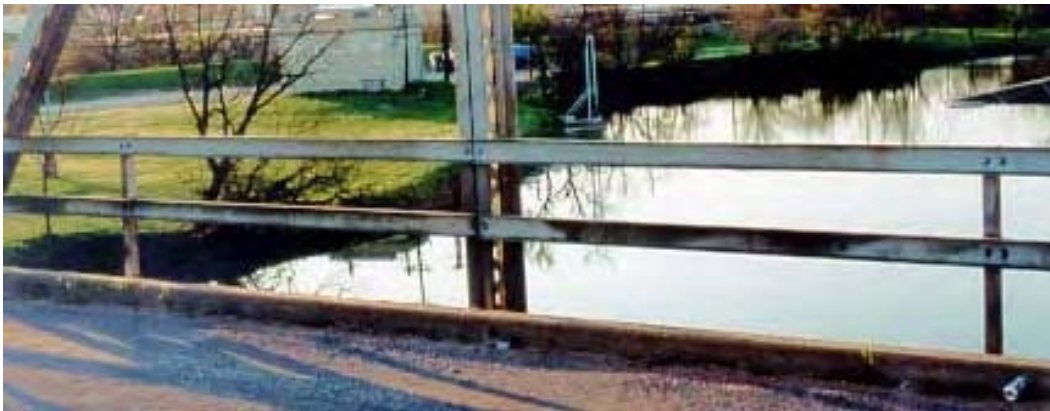
Figure 2.10 Railing attached to vertical and diagonal truss members

The railing of the bridge consisted of channel sections directly connected to the vertical and diagonal members of the truss, as shown in Figure 2.10. In between the verticals and diagonals, rails are attached to the outermost stringers with angles, as shown in Figure 2.11. Because of the relatively small size and relatively flexible connections to the deck, the railing was not considered structurally significant, and not included in the analysis.

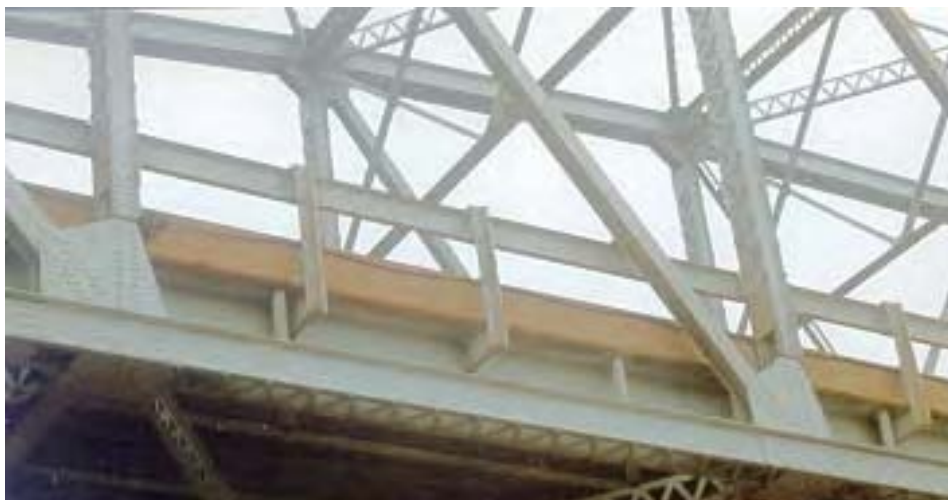
Figure 2.11 Angle attachments of railing to longitudinal stringers

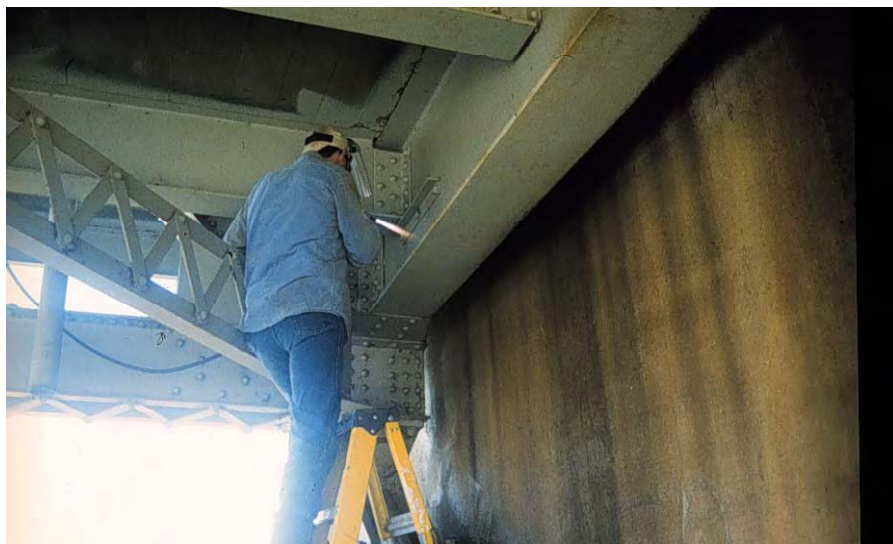
Figure 2.15 Removing the steel sample

To verify the accuracy of these mill certificates, the decision was made to conduct material tests on two samples of steel removed from the bridge. To reduce the possibility of selecting samples from the same heat of steel, the specimens were taken from transverse floor beams at opposite ends of the bridge as shown in Figure 2.13. Figure 2.14 shows the sampling size and location. The samples were taken from areas of the beam subject to very low stress. The samples were cut from the flanges with a torch, and subsequently the area was painted to protect the bare steel (see Figures 2.15 and 2.16).

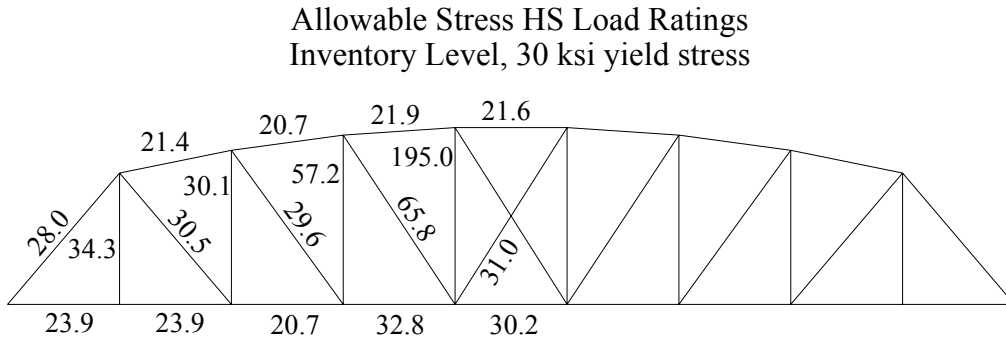
Results of the truss load ratings are shown in Figures 2.19 to 2.26. Since the truss is symmetrical, ratings are shown for only one-half of the truss. Allowable Stress results are shown in Figures 2.19 through 2.22, and Load Factor results follow in Figures 2.23 through 2.26.

Figure 2.19 Allowable stress HS inventory level load rating results based on 30 ksi yield stress

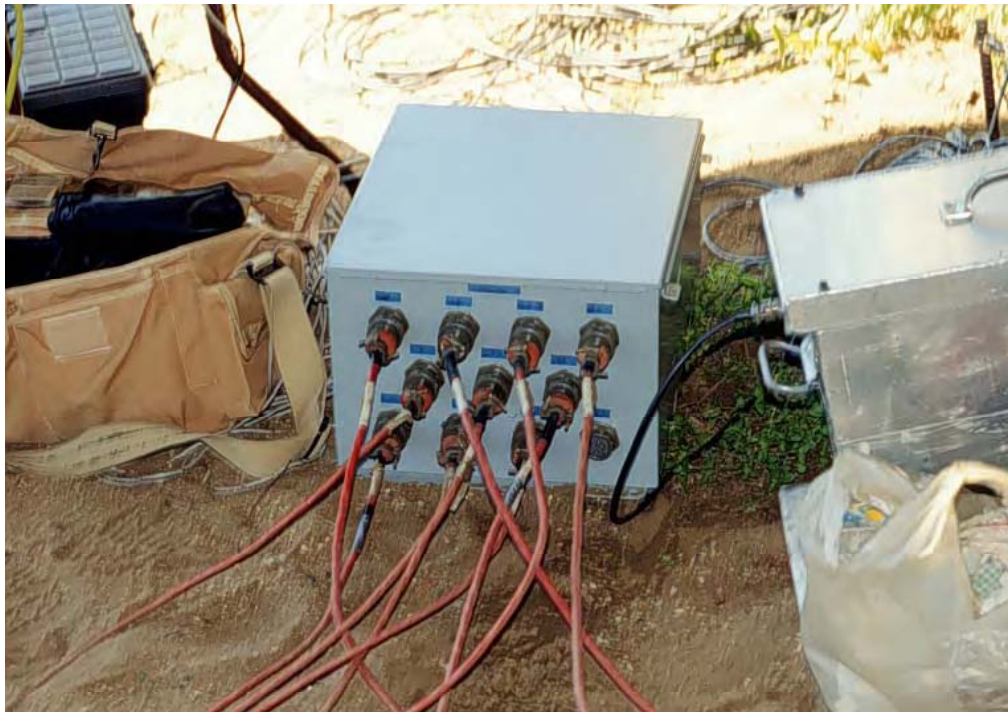
Figure 4.5 CR 9000 data logger

The data acquisition system used was an upgraded model of one developed earlier at the University of Texas at Austin (Jauregui 1999). The core of the system is a Campbell Scientific CR9000 data logger. The logger has a capacity of 55 channels for real time data acquisition. Shunt calibration circuitry is built into the completion boxes for each strain gage. Figure 4.5 shows the CR 9000 data logger.

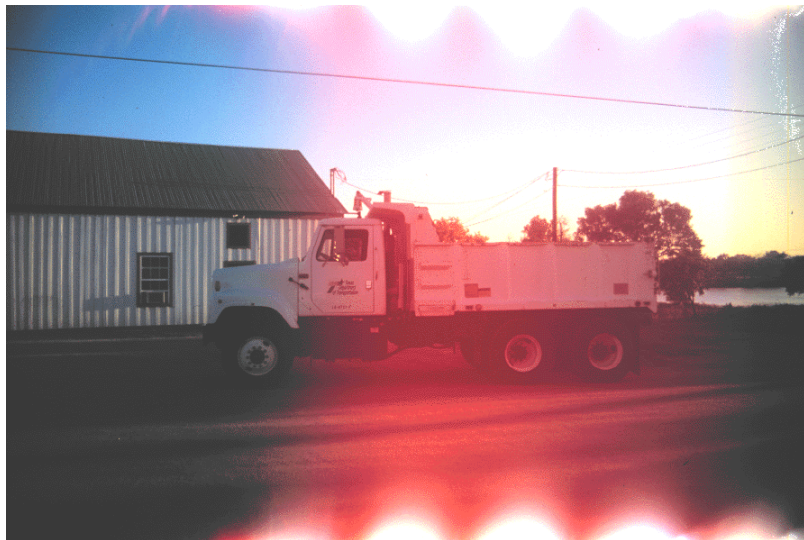
Figure 4.6 Tandem truck used for Llano load tests

Two identical tandem dump trucks provided by TxDOT, arbitrarily labeled Truck A and Truck B, were used to load the bridge for each test. The trucks were loaded with gravel, and the front and tandem axles were weighed with portable scales prior to testing. Figure 4.6 shows a photograph of a truck used for the tests

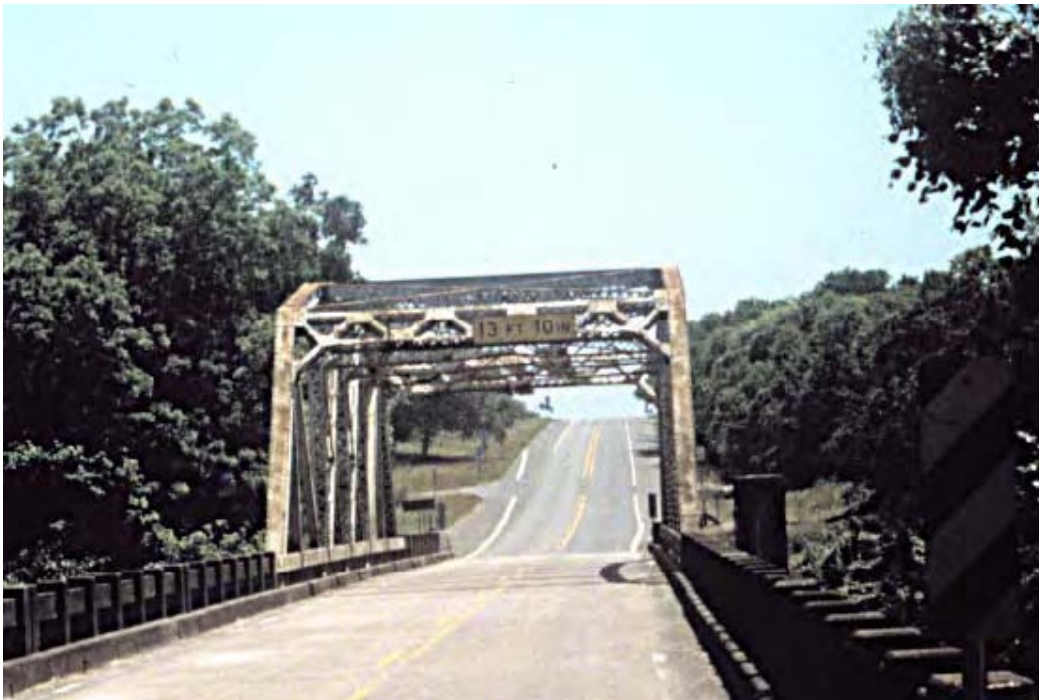
Subsequent to the Llano field tests described in Chapter 4, additional field tests were conducted on a similar bridge located in Goliad, Texas (Figure 5.1). This bridge was scheduled for replacement and demolition, and field load testing was conducted just prior to demolition. Consequently, this bridge was tested at a much higher load than was used for Llano, since a limited amount of yielding could be tolerated.

Figure 5.1 Parker truss bridge in Goliad, Texas

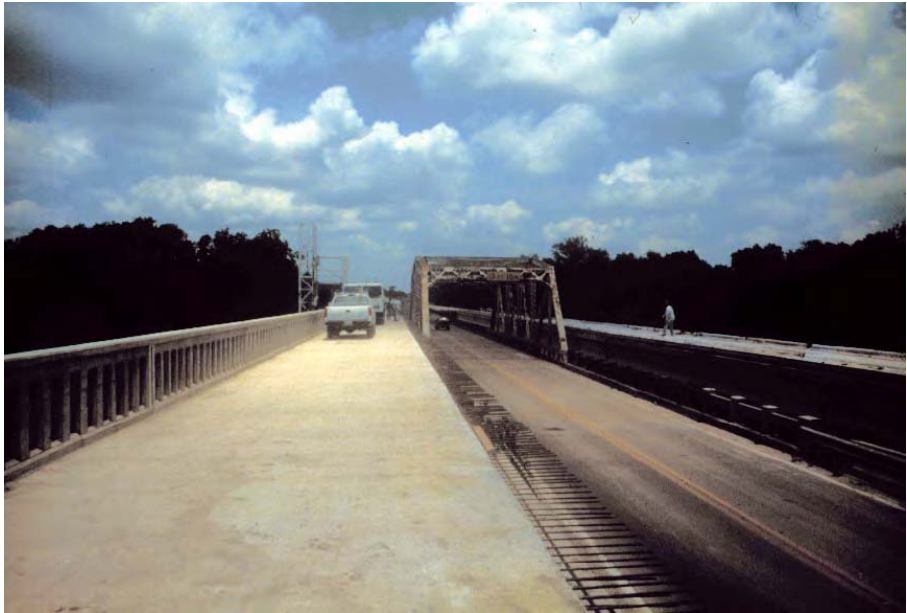
Figures 5.2 and 5.3 show the new bridge during construction and after completion. Reinforcement steel can be seen protruding from the side lanes, ready to tie the future center lanes together. Figures 5.4 and 5.5 show the replacement bridge after completion.

Figure 5.2 Lanes built around the original bridge

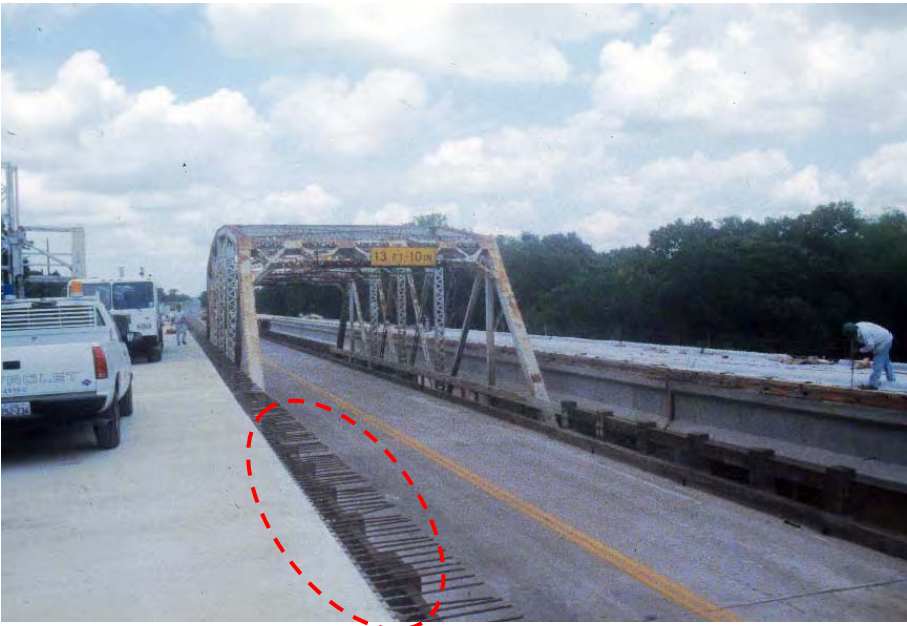
Figure 5.3 Detail showing connecting rebar

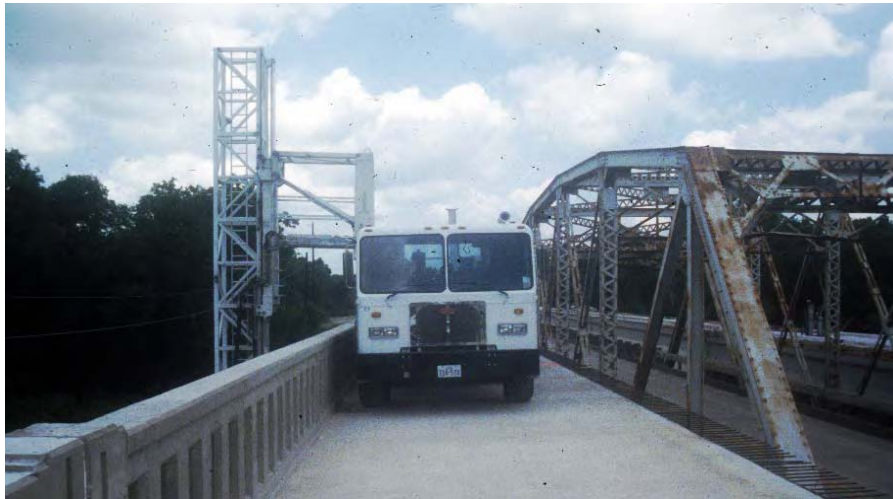
Figure 5.12 TxDOT snooper truck

construction of the new bridge outside the truss bridge, instrumentation was possible using those lanes as a platform. TxDOT supplied a “snooper” truck to allow access to the underside of the bridge. Figures 5.12 through 5.14 show the truck and instrumentation access.

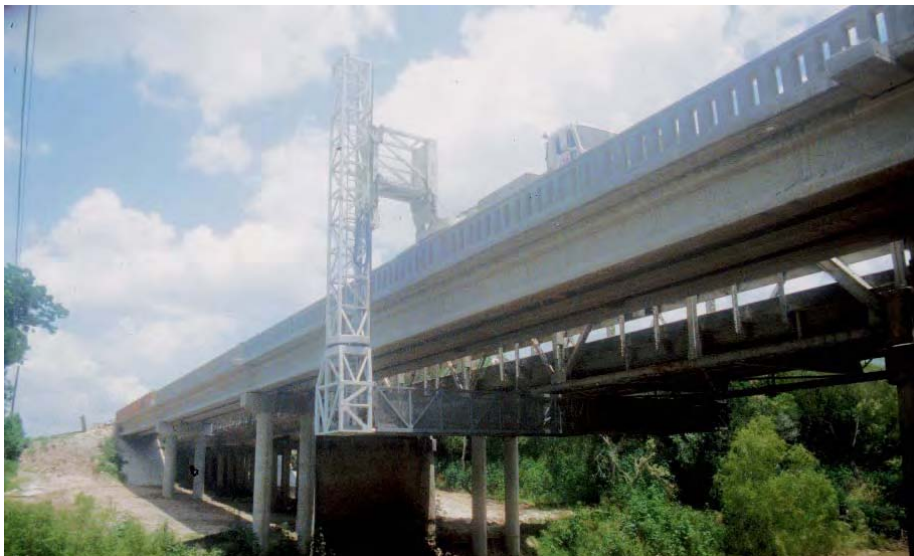
Figure 5.13 Access to bridge deck

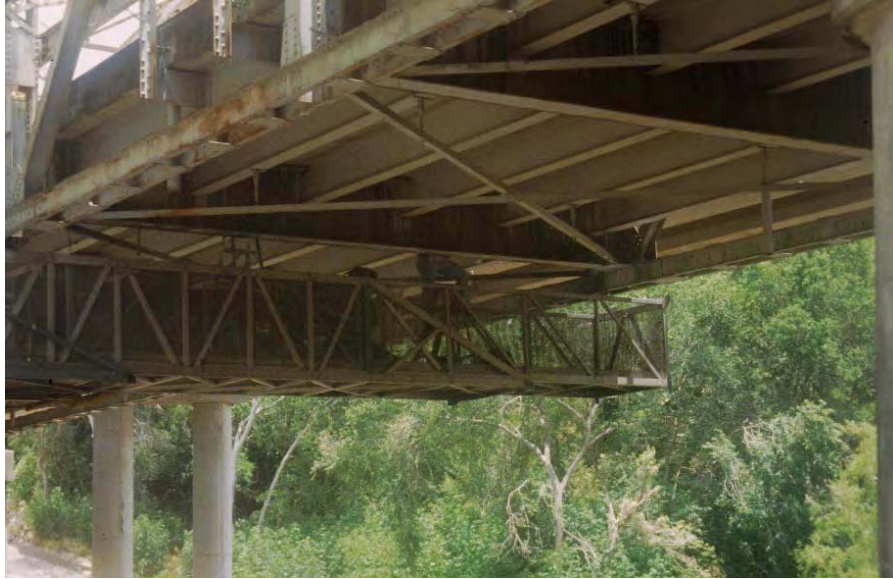
Figure 5.14 Platform extension used to instrument deck

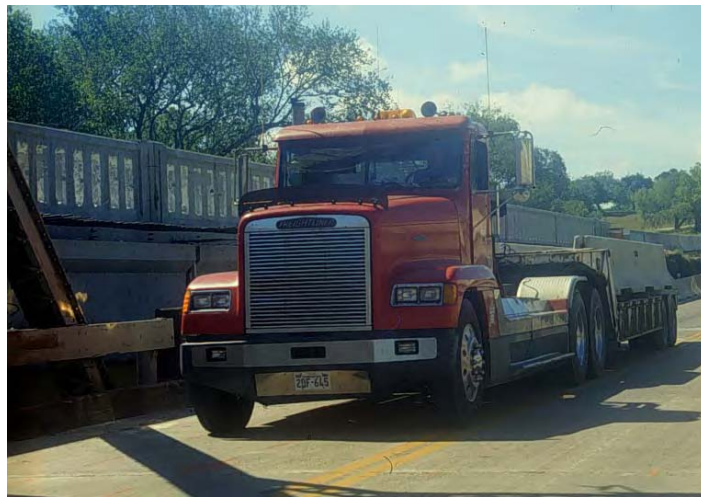
Figure 5.18 Goliad load test truck

Based on availability, the load test vehicle was a “low boy” tractor-trailer loaded with concrete lane dividers. Figure 5.18 shows the tractor-trailer during a load test, and Figure 5.19 shows the truck dimensions.

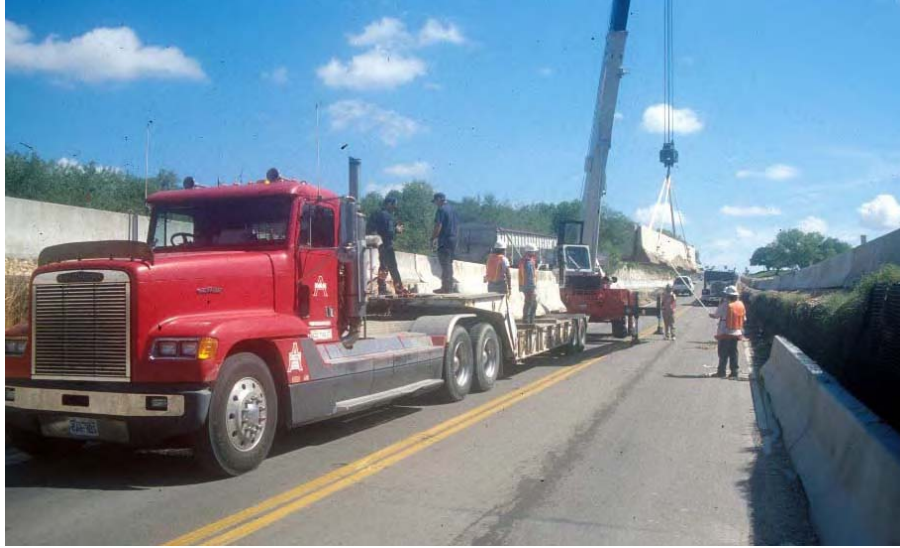
Figure 5.20 Barrier loading to increase axle weight

The number of concrete barriers placed on the truck was varied to permit testing at different load levels. Test runs were made with an empty truck, and with two, three, and finally five barriers loaded onto the truck. Portable scales provided by the Texas Department of Public Safety were used to measure each axle for all load cases. Table 5.3 lists the loadings. In this table, Axle 1 refers to the front axle, Axle 2 to the front tandem, and Axle 3 to the rear tandem. Figure 5.20 shows the loading process, and Figure 5.21 shows the portable scales weighing the trucks.

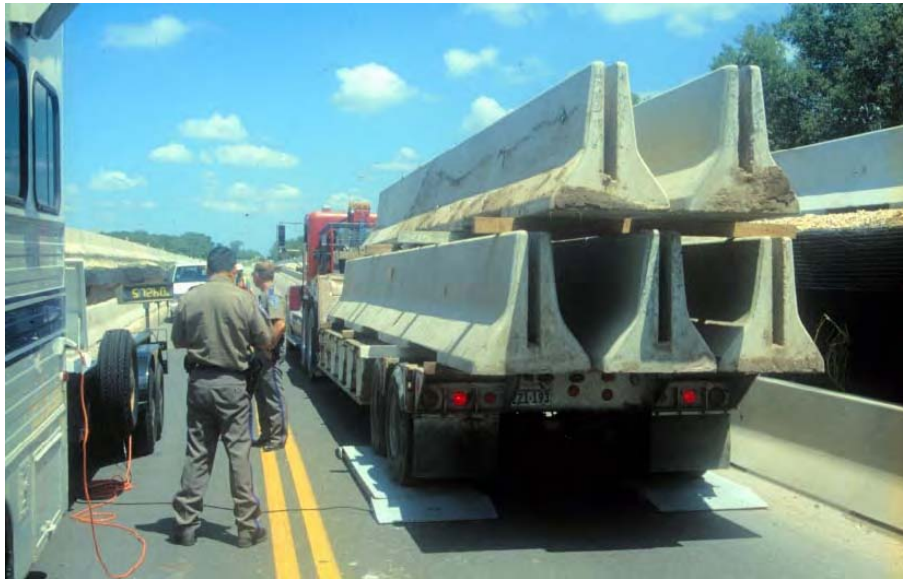
Figure 5.21 Portable scales used to weigh truck

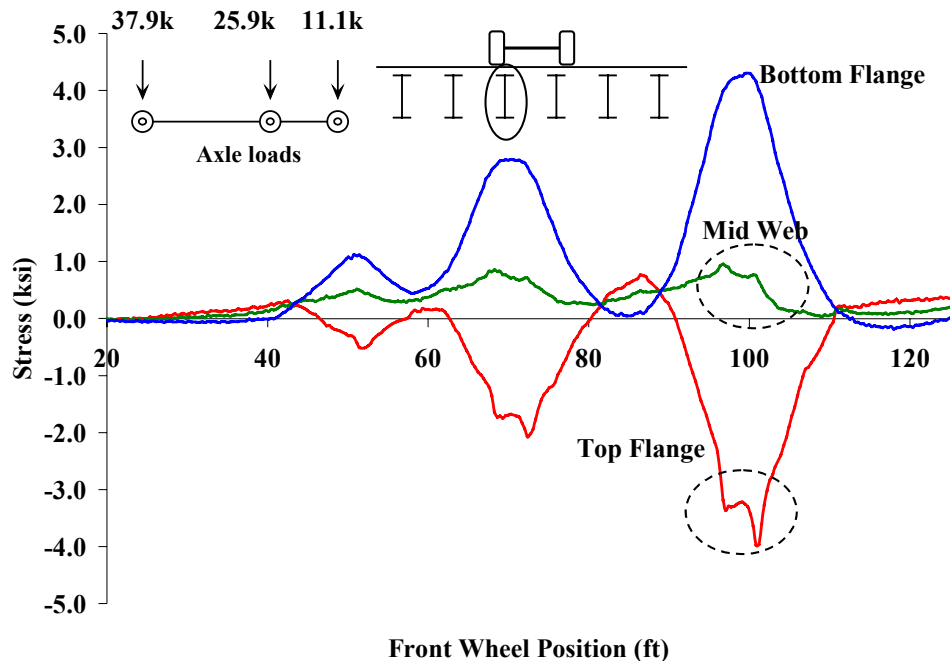
Figure 5.35 Midspan stress in stringer S3: truck loaded with two barriers

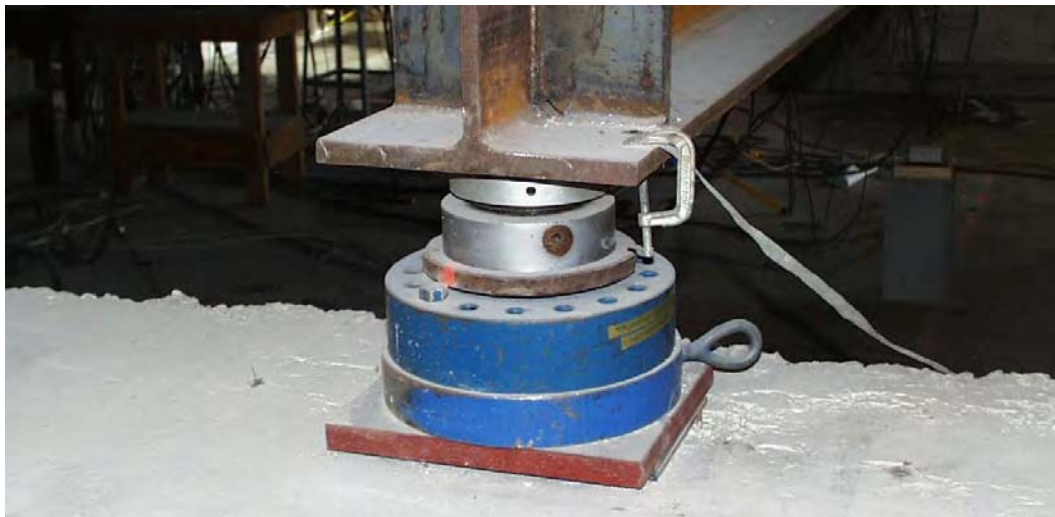
Figure 6.4 Transverse beam placed on (top to bottom) a swivel plate, a load cell, and leveling plates

The W33x130 transverse beams of the laboratory model were placed on spherical bearing base plates to allow end rotation. The base plate was then placed on a load cell, and then, on leveling plates, as shown in Figure 6.4.

Because of the ease of access to the members and a larger capacity data acquisition system, the model could be instrumented to a much larger degree than possible in the field tests. Strain gages were placed on the inside face of both the top and bottom flanges. Typically, flanges were gaged on both sides of the web for a total of four gages per location. Some of the longitudinal stringers were gaged at the quarter points and midspan, and the transverse beams were gaged at the midpoint between longitudinal member attachments. Figure 6.19 shows the gage layout. Additionally, vertical deflections were measured at the midpoint of each member and vertical reactions were measured at the four supports of the laboratory model (Figure 6.4).

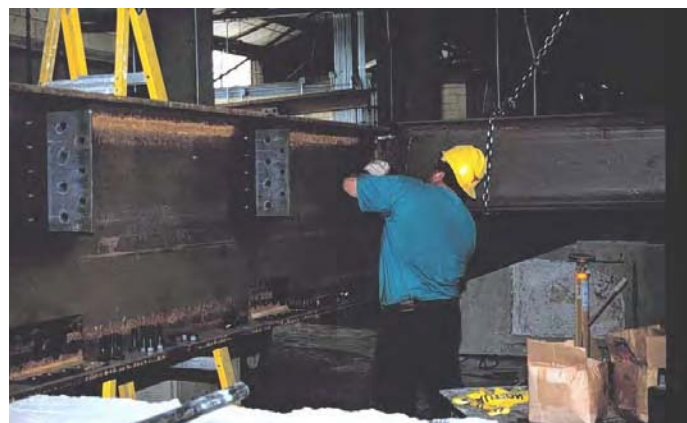
Figure 6.5 Connecting of longitudinal stringer to transverse beam

The steel was fabricated off site and erected in the laboratory. Steel erection is shown in Figure 6.5 and the finished steel is shown in Figure 6.6 prior to the construction of the reinforced concrete slab.

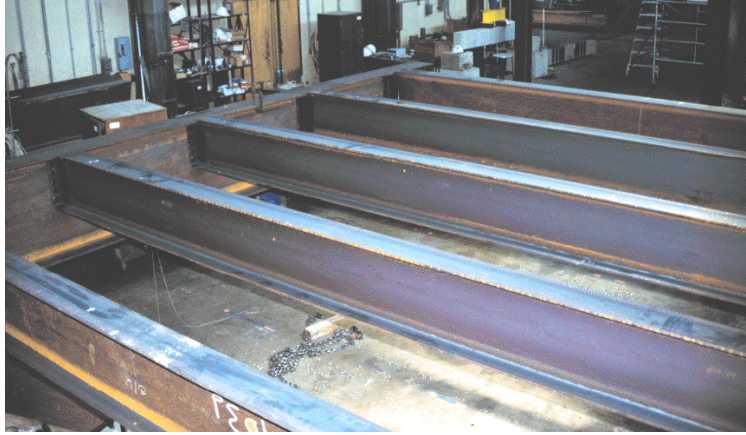
Figure 6.6 Transverse and longitudinal steel beams in laboratory model

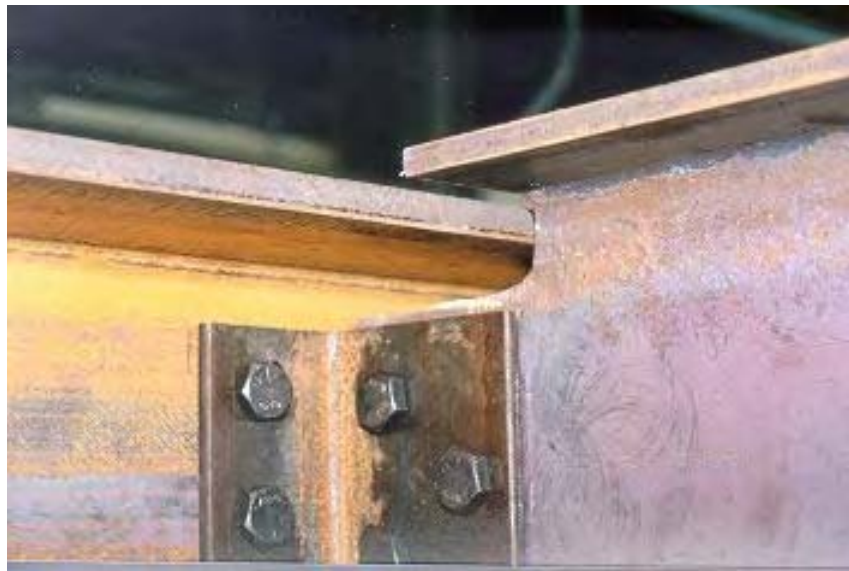
The longitudinal stringers were coped at the ends to fit around the top flange of the transverse beams, and positioned to be 1 in. higher to enable embedment into the slab, similar to the condition found in the actual bridges. Figure 6.7 shows the connection between a stringer and beam.

Figure 6.7 Cope detail showing elevated top flange of longitudinal stringer

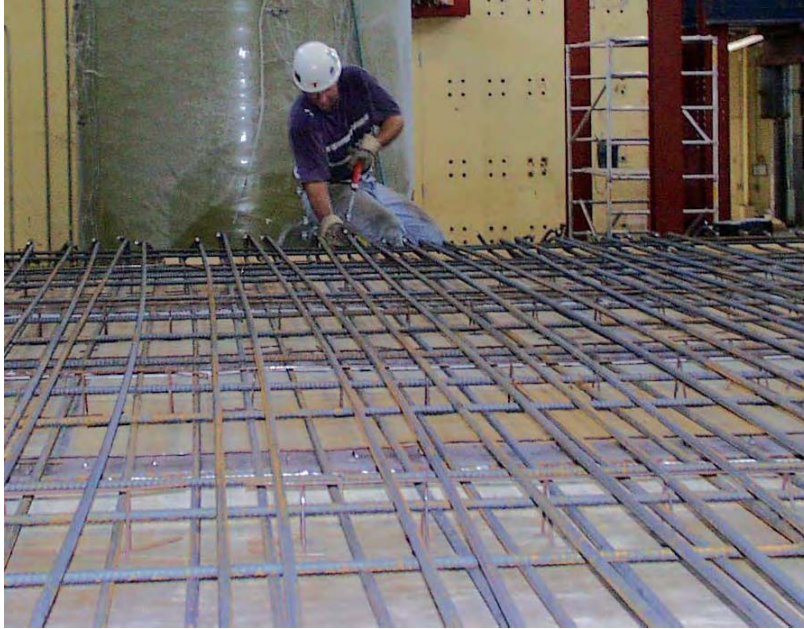
Figure 6.11 Reinforcing bar placement in slab

Photographs of the reinforcing bar placement and concrete pour are shown in Figures 6.11, 6.12, and 6.13.

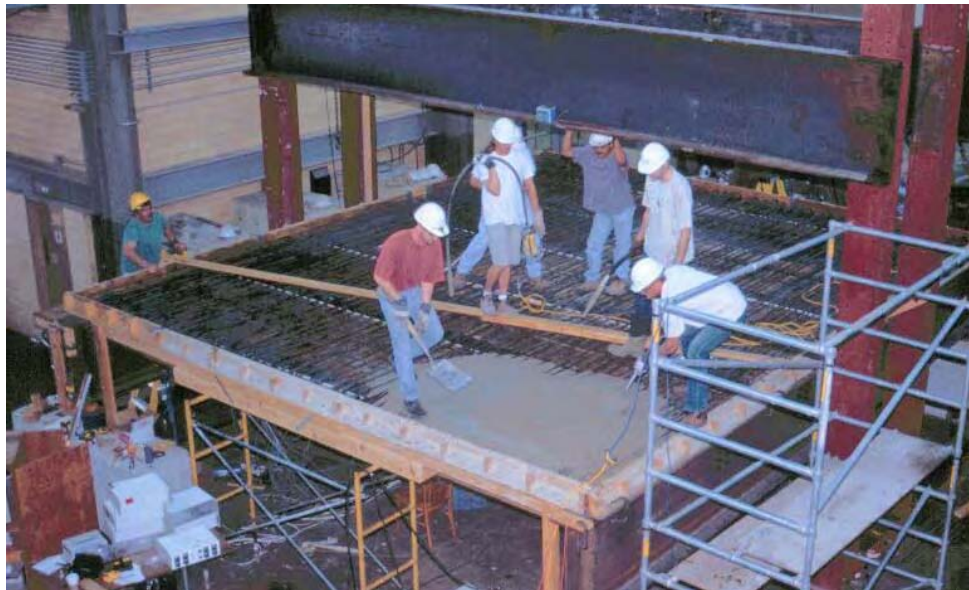
Figure 6.12 Concrete pour and finishing

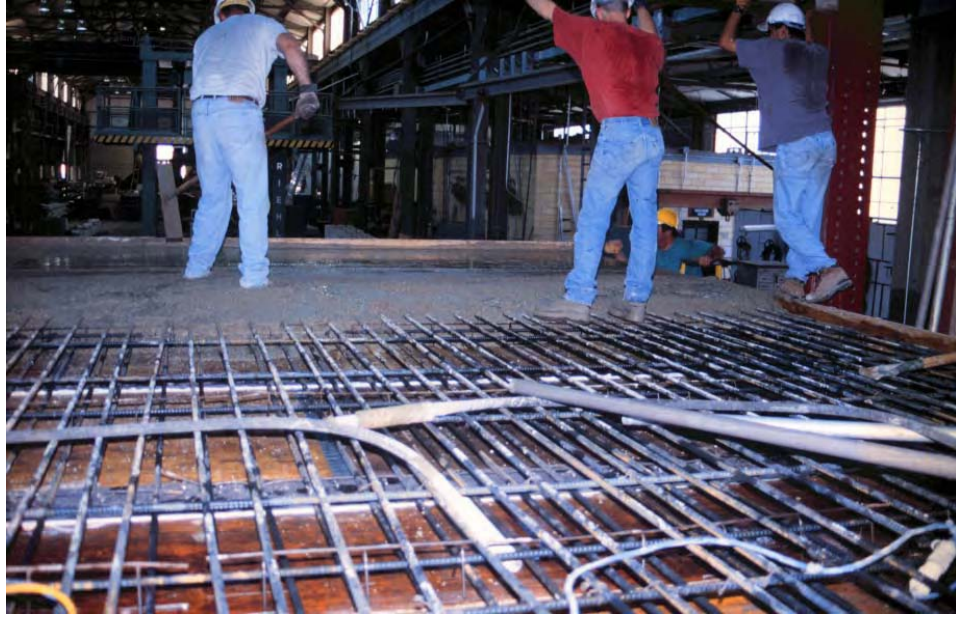
Figure 6.13 Slab construction

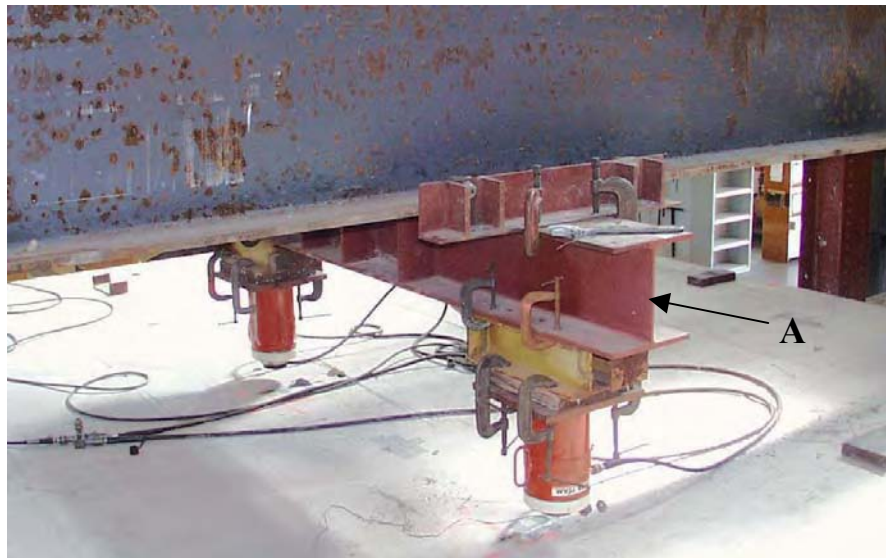
Figure 6.16 Attachment of actuators to load frame

Two deep W sections were bolted to four columns anchored to the floor to serve as a loading frame. These large members were positioned longitudinally in the same direction as the longitudinal stringers of the deck model, as shown in Figure 6.14. A smaller W section (labeled A in Figures 6.15 and 6.16) was placed perpendicular to the deep frame members to support two 200 kip hydraulic actuators spaced 6.5 feet apart transversely.

The smaller transverse member on the loading frame was placed on rollers to allow the actuators to travel longitudinally along the frame and hence load at any desired longitudinal position (Figures 6.16 and 6.17). To approximate the double axle configuration (4 rear wheels) of the load truck tandem, two structural tubes were used to spread the load to four rubber pads. The rubber pads, which are shown in Figure 6.18, were 9 in. wide by 12 in. long and 3 in. thick and were spaced 4 ft. apart longitudinally.

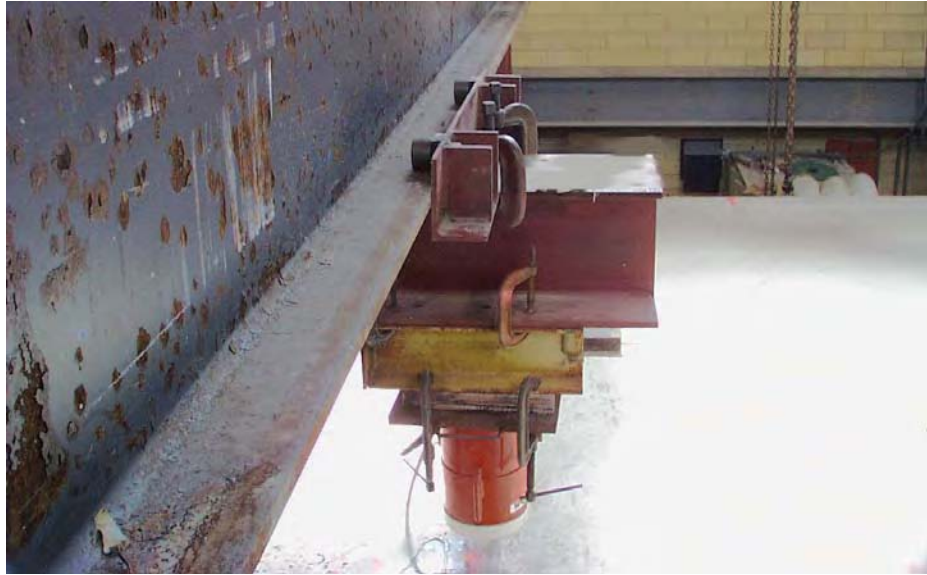
Figure 6.17 Roller attachment of actuators to load frame

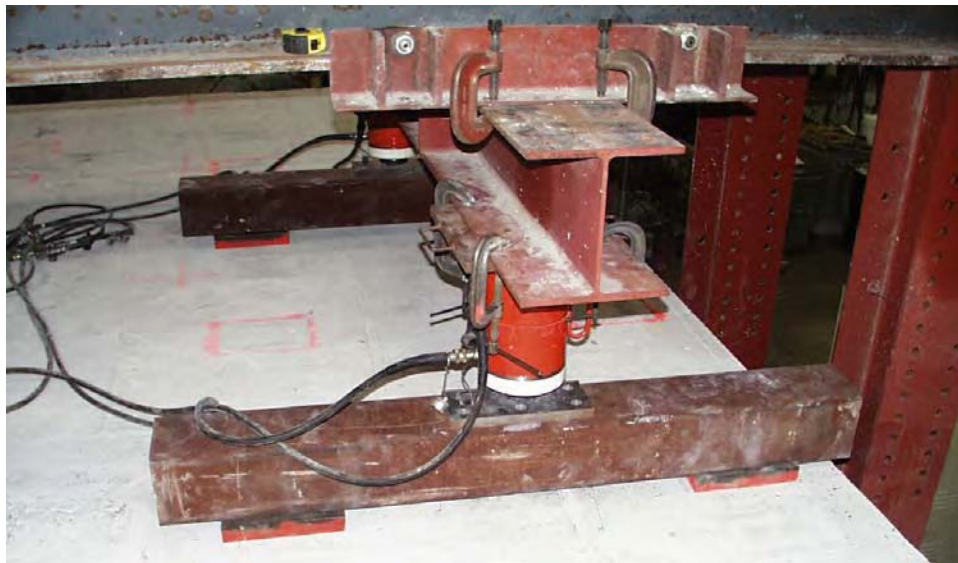
Figure 6.18 Approximation of tandem axle with structural tubing and rubber pads

Longitudinal members were loaded with the double axle configuration shown in Figure 6.18. The load of each of the two actuators was split into two loads, 4 ft. apart so as to approximate a tandem axle loading. This produced four equal point loads on the structure. To reproduce the loading in the field tests and in the finite element analysis, each stringer was loaded with one actuator directly on top of the member, and the second 6.5 ft. towards the center of the deck. Longitudinal stringers were tested with actuators positioned at midspan and quarter-span points. Figure 6.20 shows the positioning for centerline loading of the second longitudinal stringer. Transverse beams were loaded with the actuators located as shown in Figure 6.21.

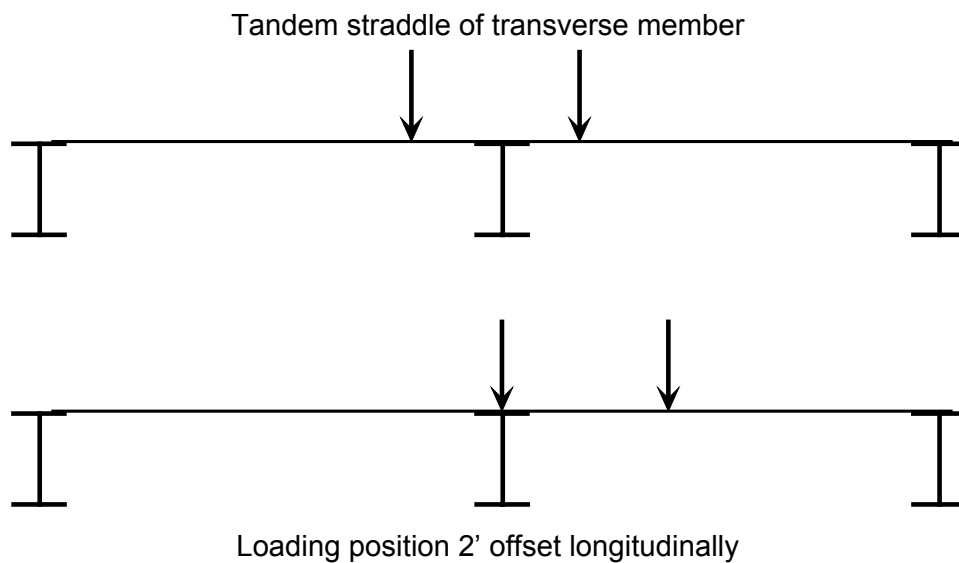
Comparisons are made between centerline (tandem centered transversely) loading cases. Since the laboratory model's transverse loading had the rear most axle of the tandem over the member (Figure 6.21), the same tandem position was used for comparing results in the field test. Given that the maximum response in the field test was due to the rear tandem straddling the transverse member, the response used in the comparisons was lower than the maximum response. In other words, for comparison, the response used was when the truck was 2 ft. further longitudinally than for the maximum response. These positions are shown in Figure 6.62.

Figure 6.62 Loading position for maximum response (top) and loading position used for comparison with laboratory loading (bottom)

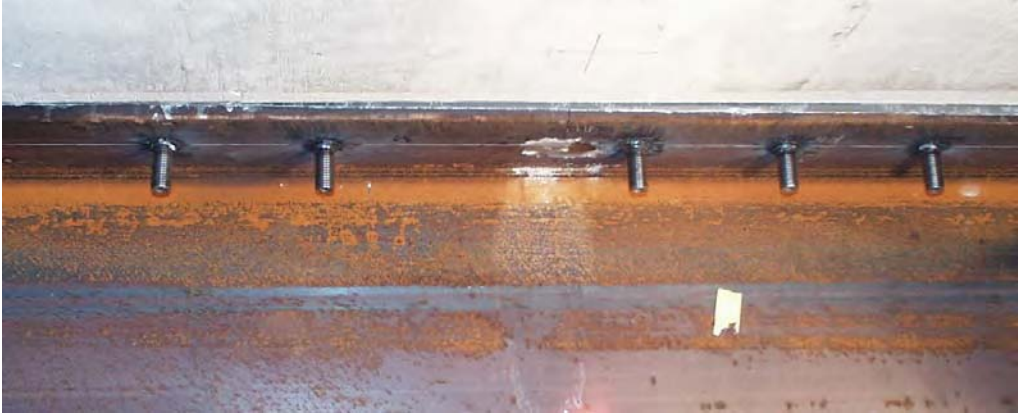
Figure 6.63 Threaded studs welded to the inside top flange of the transverse beam

Threaded studs with a diameter of 3/4-inch were welded to the inside top flange at the end of the transverse beams, between the connections of the two outermost longitudinal members, as shown in Figures 6.63 and 6.64. A 1/2 inch thick steel plate with holes drilled corresponding to the location of the welded threaded studs was then bolted to the flange, with approximately 6 inches of the plate protruding beyond the edge of the flange. To accommodate the weld metal at the base of the threaded stud and any slight misalignment in placing the studs, the holes in the plates were 1-1/4 inch in diameter. Since the plate was bolted to the bottom side of the top flange, and the slab rested on the topside of the top flange, the corresponding gap (equal to the thickness of the top flange, 0.855 inches) between the plate and slab was filled with grout, as shown in Figure 6.65.

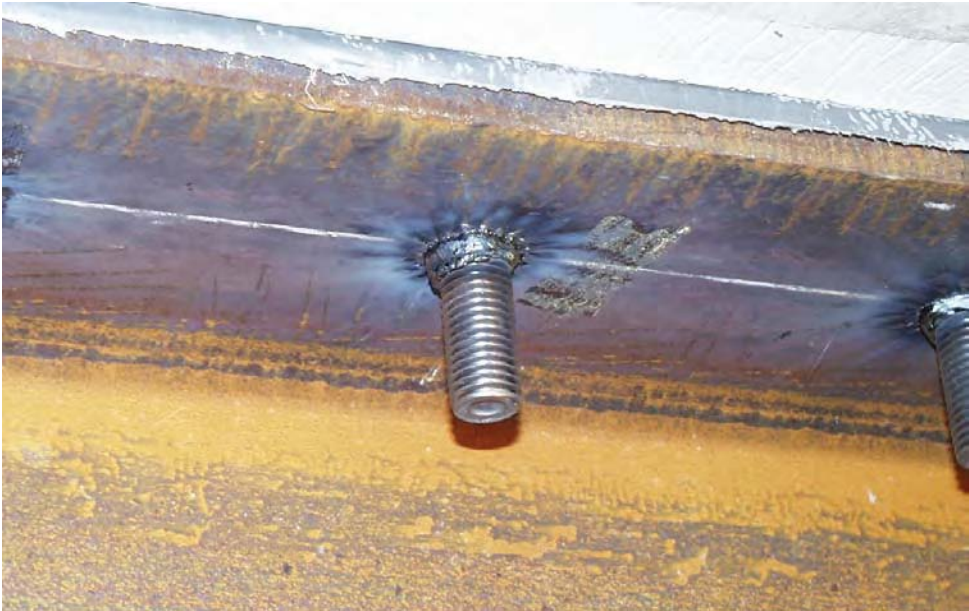
Figure 6.64 Close up view of the threaded stud

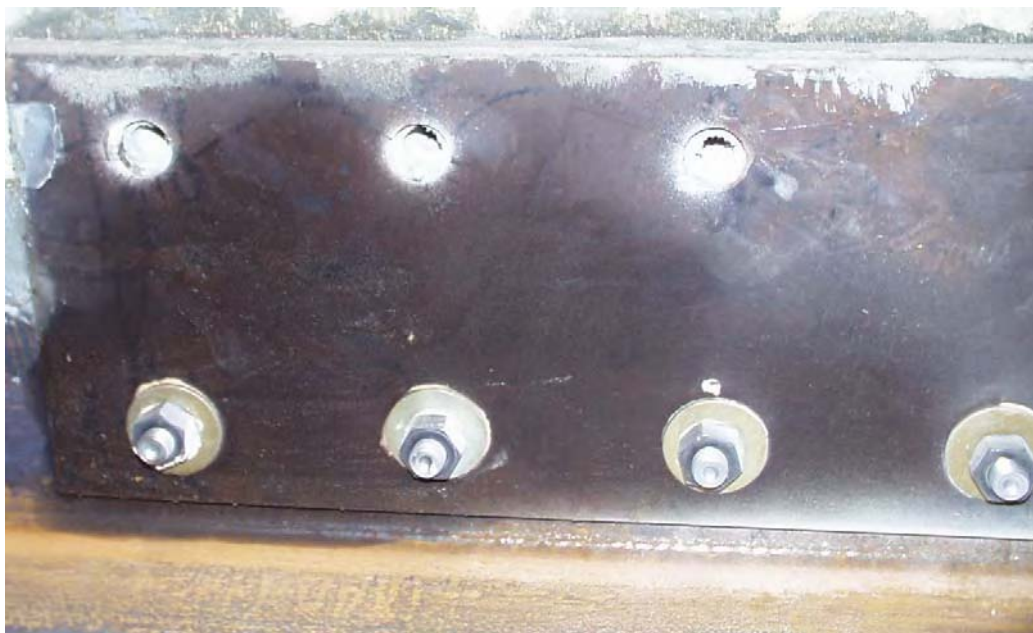
Figure 6.66 Holes drilled up through the plate into the slab

Holes that were 7/8 inch in diameter were drilled upward through the existing holes in the plate into the slab. Threaded rods were then placed in these holes, fastened with epoxy, and then tightened to the plate with nuts, as shown in Figures 6.66 through 6.68.

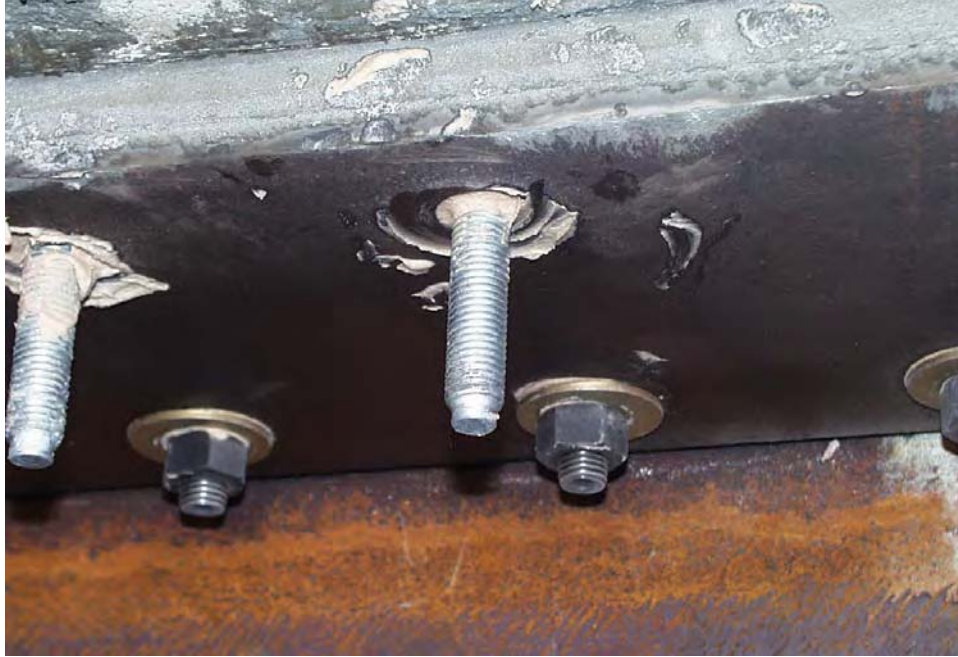
Figure 6.67 Threaded rod installed in slab with epoxy

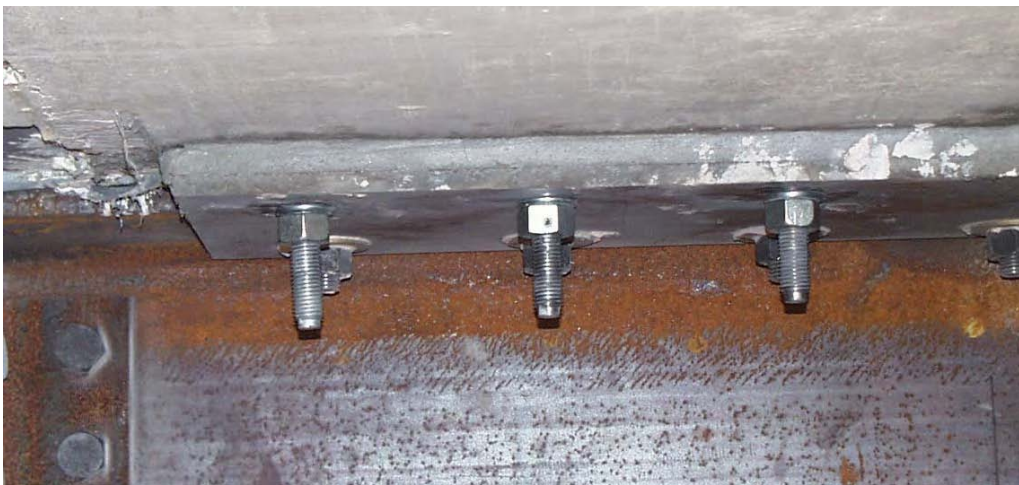
Figure 6.68 Threaded rods bolted to plate

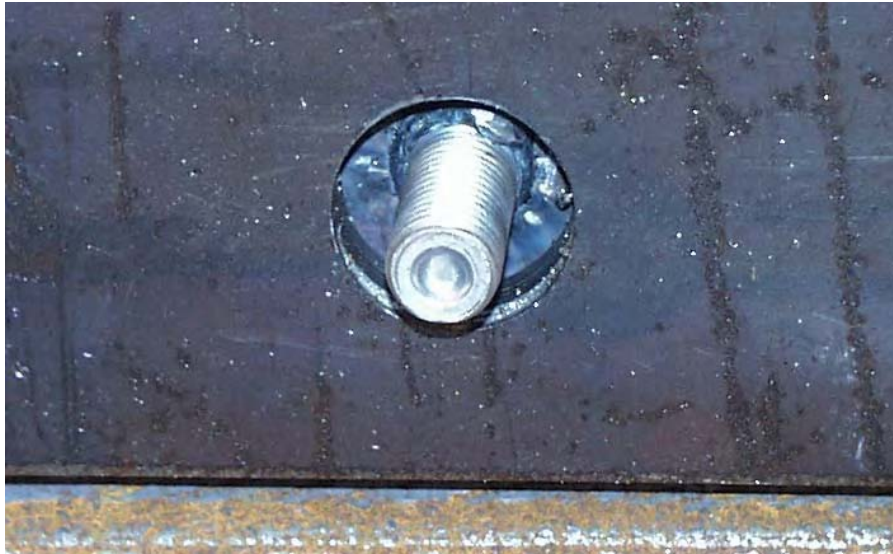
and the plate holes were 1-1/4 inch in diameter. The gap around the welded rod is shown in Figure 6.75. These gaps were filled with epoxy, as shown in Figure 6.76. However, since the gaps were subsequently covered with washers and nuts (Figure 6.77), it was not possible to visually inspect to see if the gaps were fully filled with epoxy. The grout and epoxy were damaged during disassembly, and therefore it was not possible to verify after testing whether the gaps were filled.

Figure 6.75 Gap around threaded stud

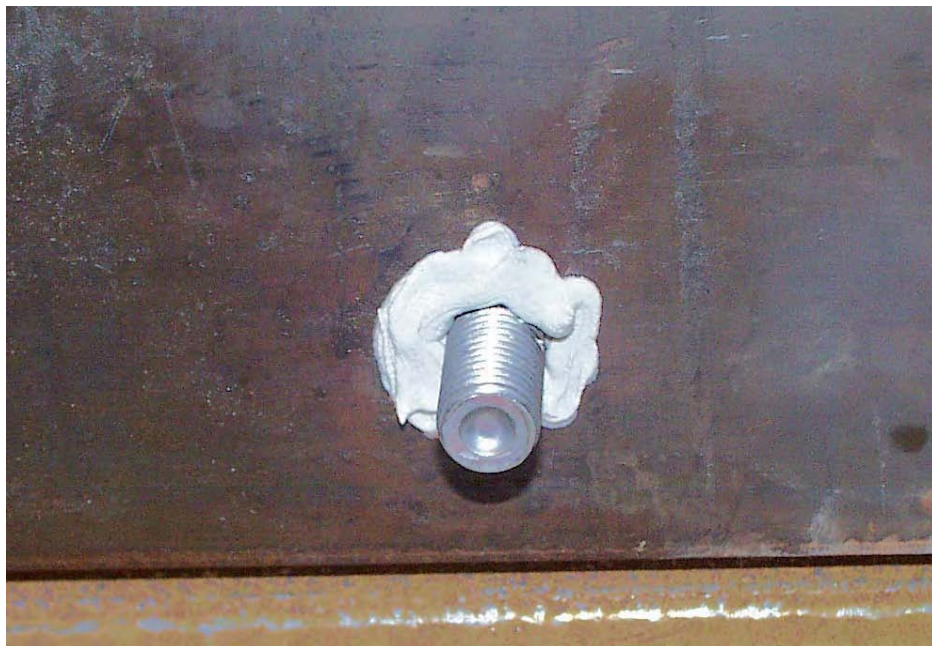
Figure 6.76 Gap filled with HSE 2421 epoxy

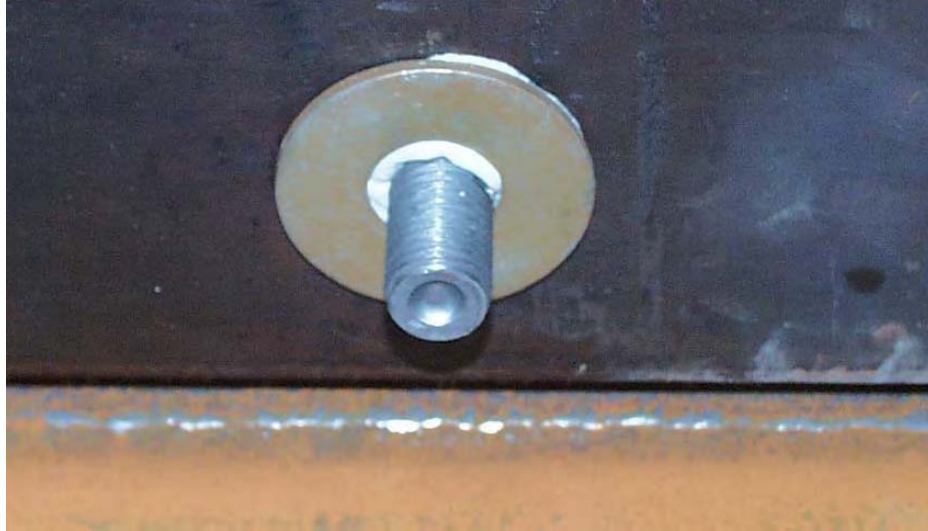
Figure 6.77 Washer covering epoxy filling

The epoxy was inserted overhead, and in some cases difficult to keep in place. The epoxy had a modulus that was 1/100 of steel. Hence, even if the gaps were filled completely, the compressive stiffness of the epoxy was much lower than that of steel. This lower stiffness would allow a greater relative movement between the rod and the plate as compared to the condition if the rods were bearing against the steel plate directly. Additionally, any shrinkage of the epoxy would likely contribute to reduced effectiveness in shear transfer.
