1. Report No. FHWA/TX-03/1741-3	2. Government Accession No.	3. Recipient's Catalog No.	
4. Title and Subtitle <b>Evaluation and Rehabilitation of Historic Metal Truss Bridges: A Case Study of an Off-System Historic Metal Truss Bridge in Shackelford County, Texas</b>		5. Report Date <b>March 2003</b>

**EVALUATION AND REHABILITATION  
OF HISTORIC METAL TRUSS BRIDGES:  
A CASE STUDY OF AN OFF-SYSTEM HISTORIC METAL TRUSS  
BRIDGE IN SHACKELFORD COUNTY, TEXAS**

**D. R. Maniar, M. D. Engelhardt and D.E. Leary  
Research Report 1741-3**

*PRESERVATION ALTERNATIVES  
FOR HISTORIC TRUSS BRIDGES*

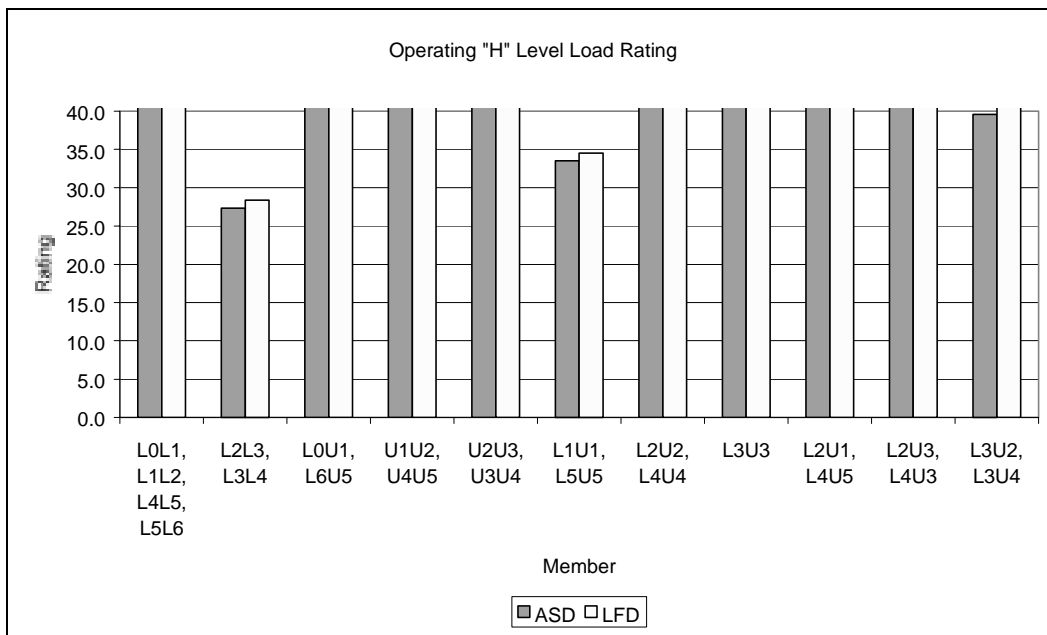
**Figure 4.6: Operating level “H” load rating for truss members**

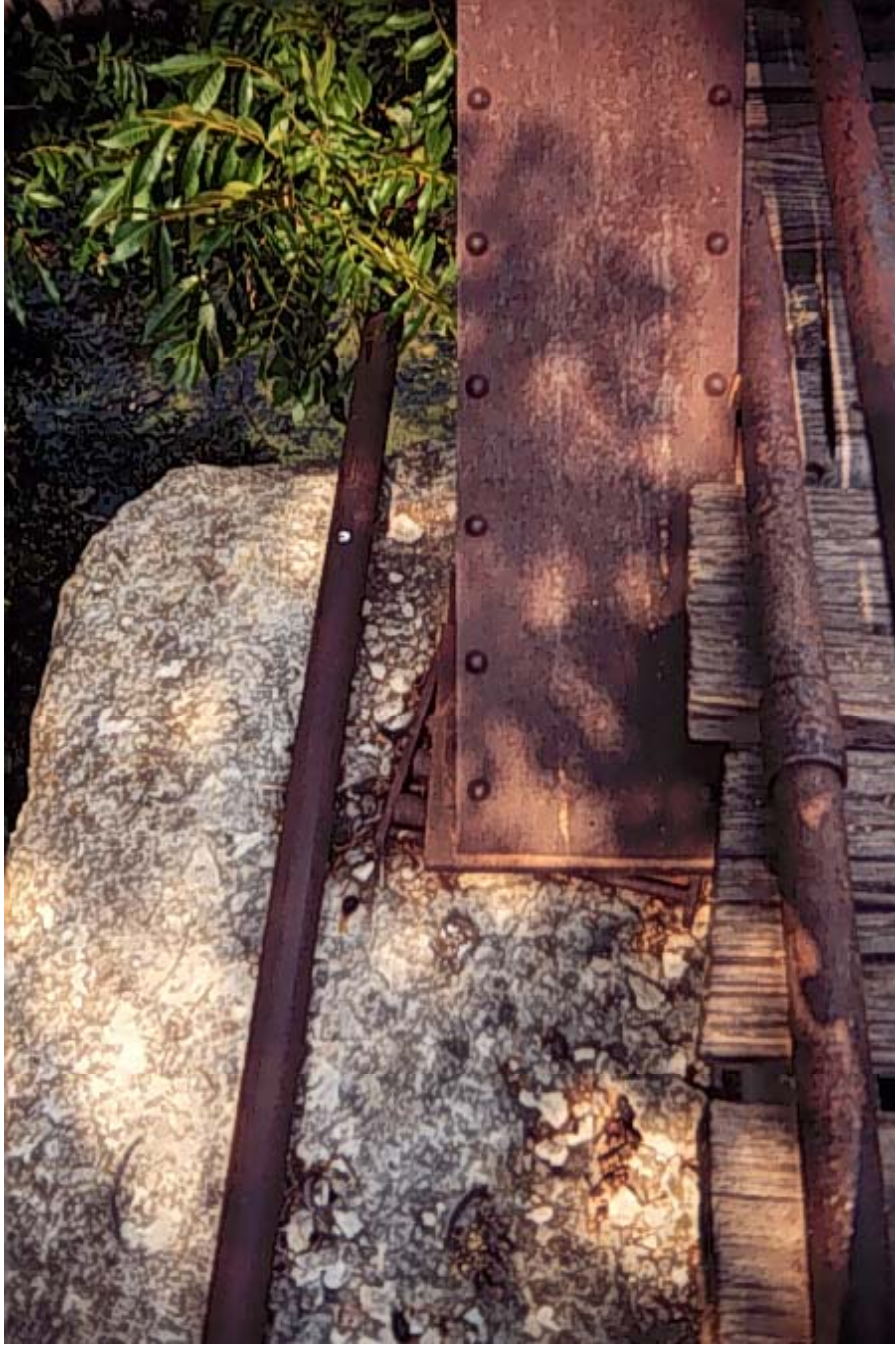
**Figure A.7: Roller support at southwest corner of main truss span**

Metal elements of the main truss span, including the floor beams and truss members showed only minor corrosion, with little or no loss of cross-section. No large displacements, distress or damage was found on truss members except at one hanger. This tension hanger had a kink at the middle. All joints appear in good condition except the southwest roller support. This roller support is dislocated from its original position (Figure A.7).

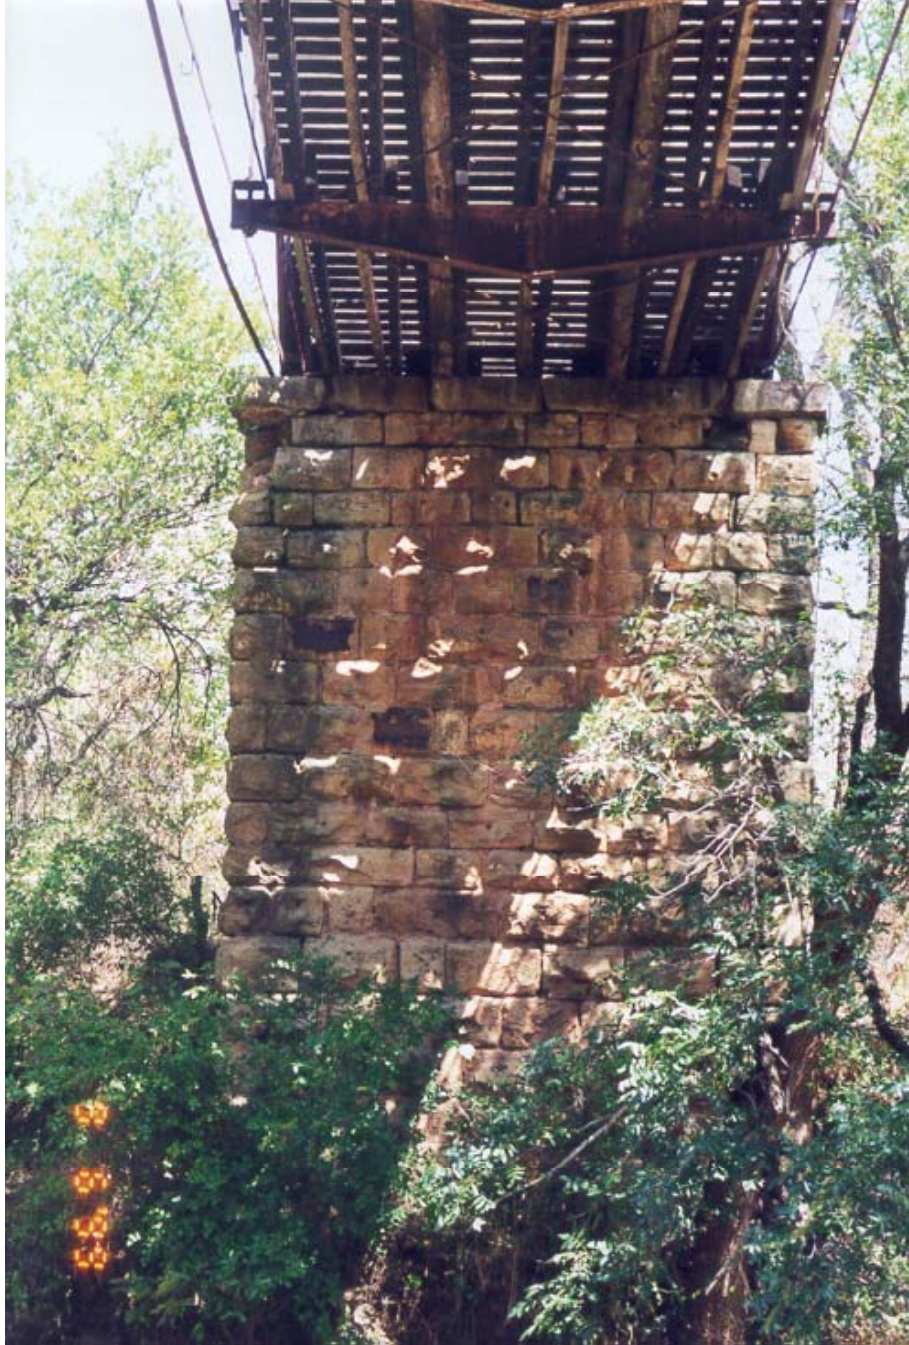
**Figure A.19: North stone masonry pier**

Masonry joints are deteriorated at a number of locations. Scouring near the foundation has made the slope of the ground very steep. Stones from the pier have come out at several places, especially near top of the north pier.

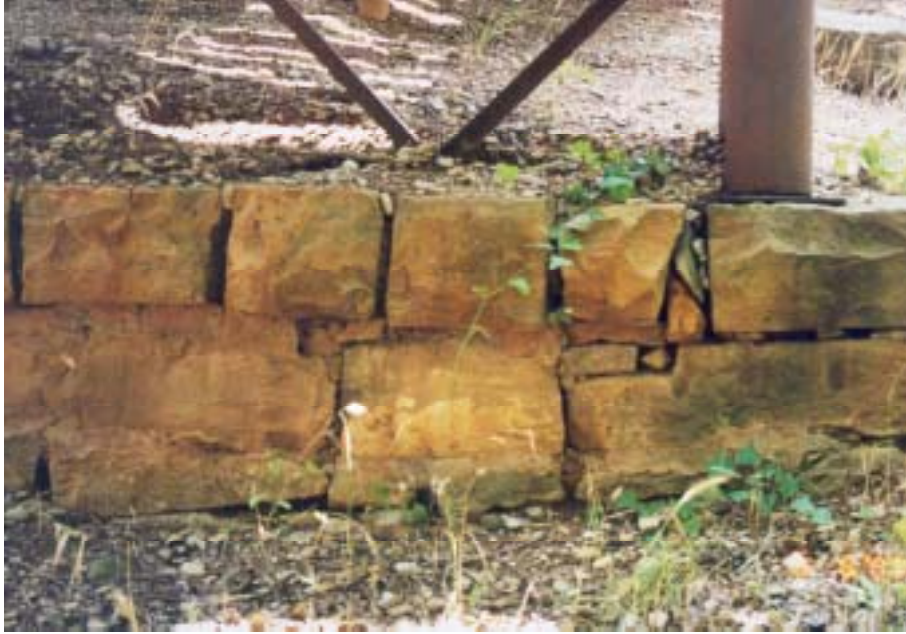
**Figure A.34: Deteriorated foundation of metal bents for north approach span**

Foundations for metal bents are not visible at most locations. At one bent of the north approach, the foundation is visible as it is projecting above the ground. The masonry joints of this foundation are open. This suggests the possibility that the foundations of all bents may have open joints. The south approach span abutment has many stones dislocated from their original positions. All the joints of the abutment are filled with soil. The north approach abutment is not visible due to the metal retaining plate.

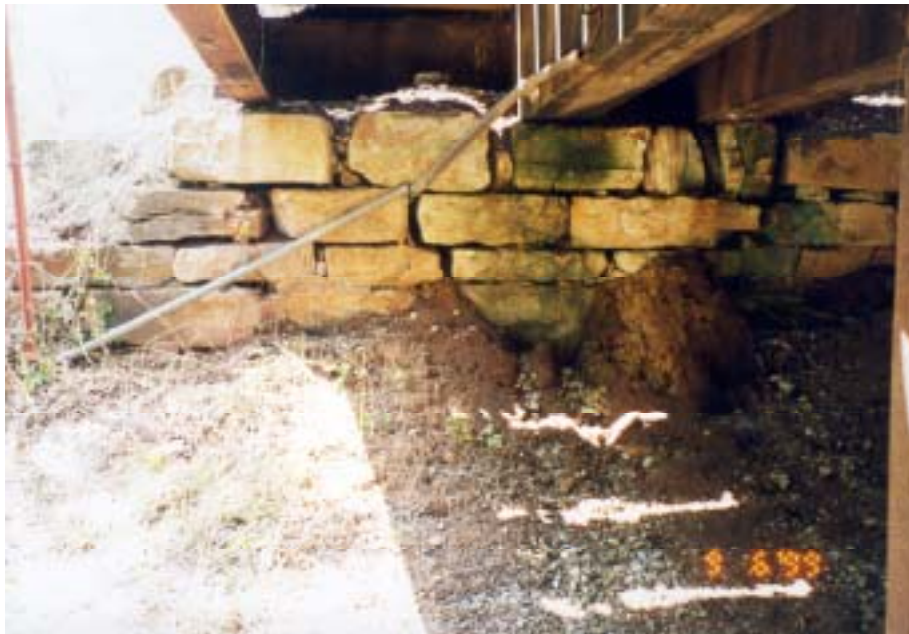
**Figure A.35: Deteriorated abutment at south end of south approach span**

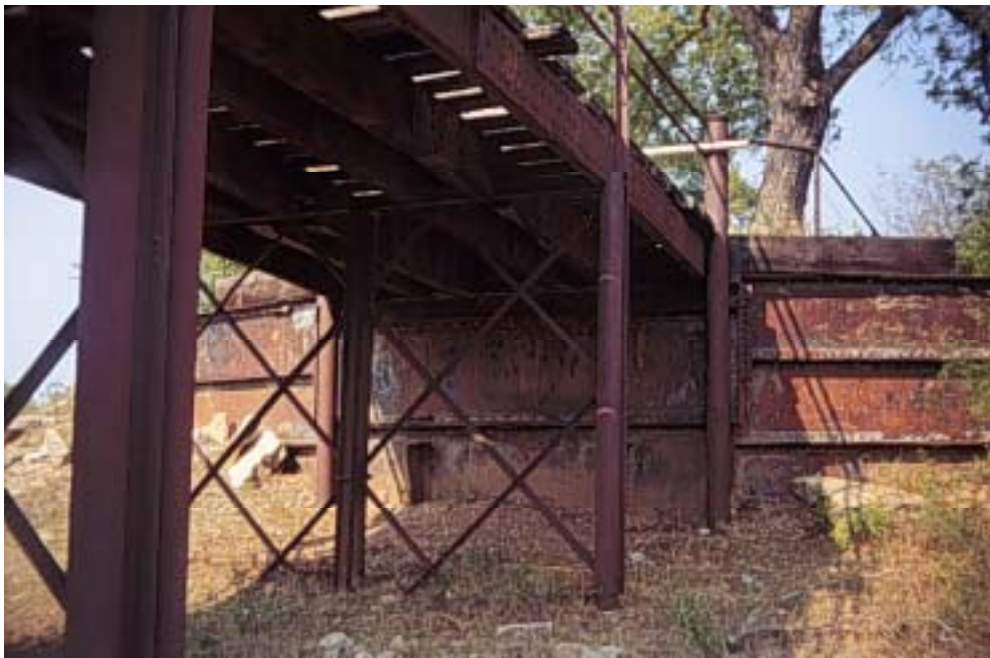
**Figure A.37: Metal retaining wall at the north abutment**

This metal retaining wall is heavily corroded. This plate appears to be taken out from another structure and then added to this bridge.

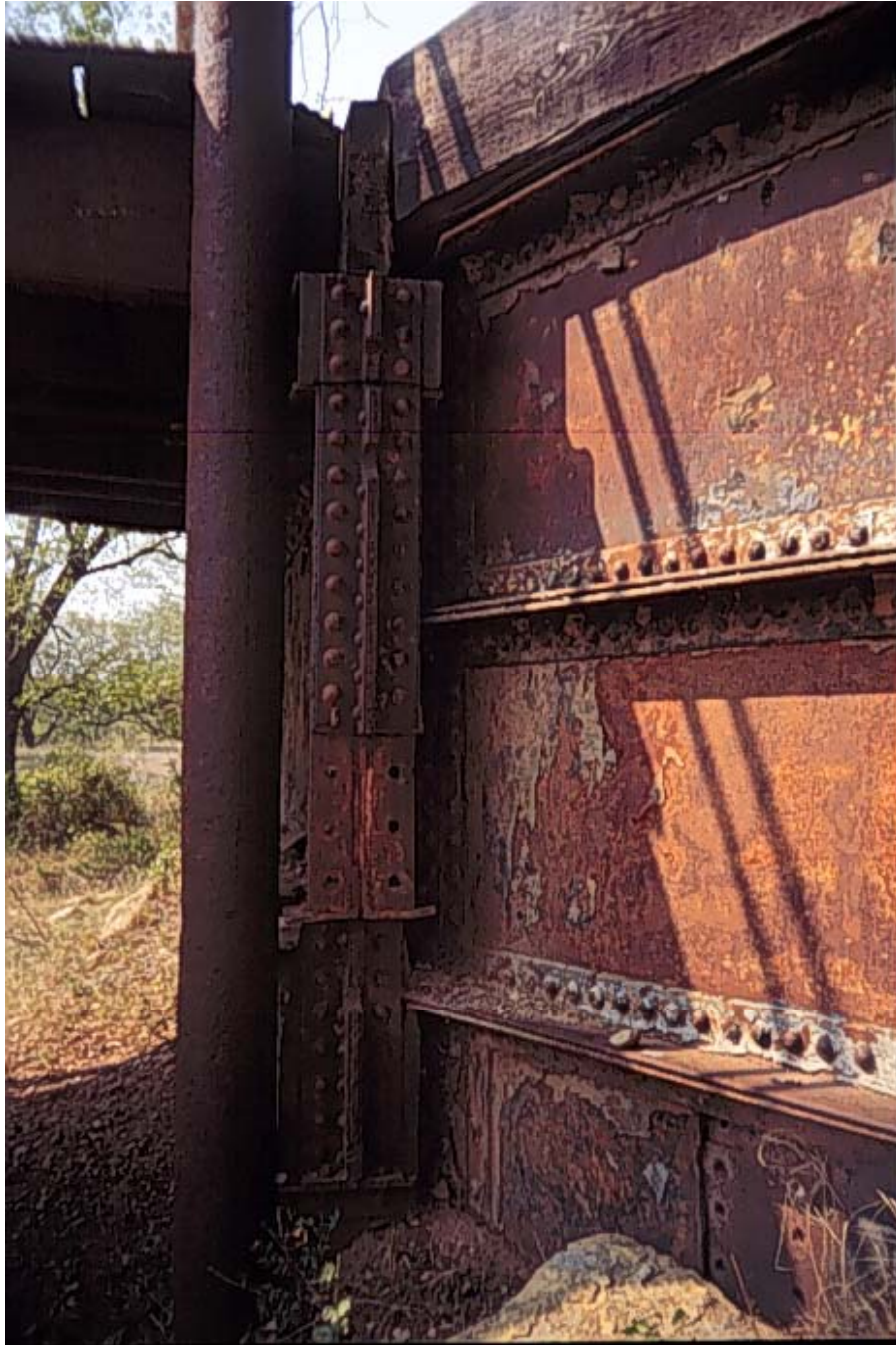
**Figure A.38: Metal retaining wall at the north abutment**

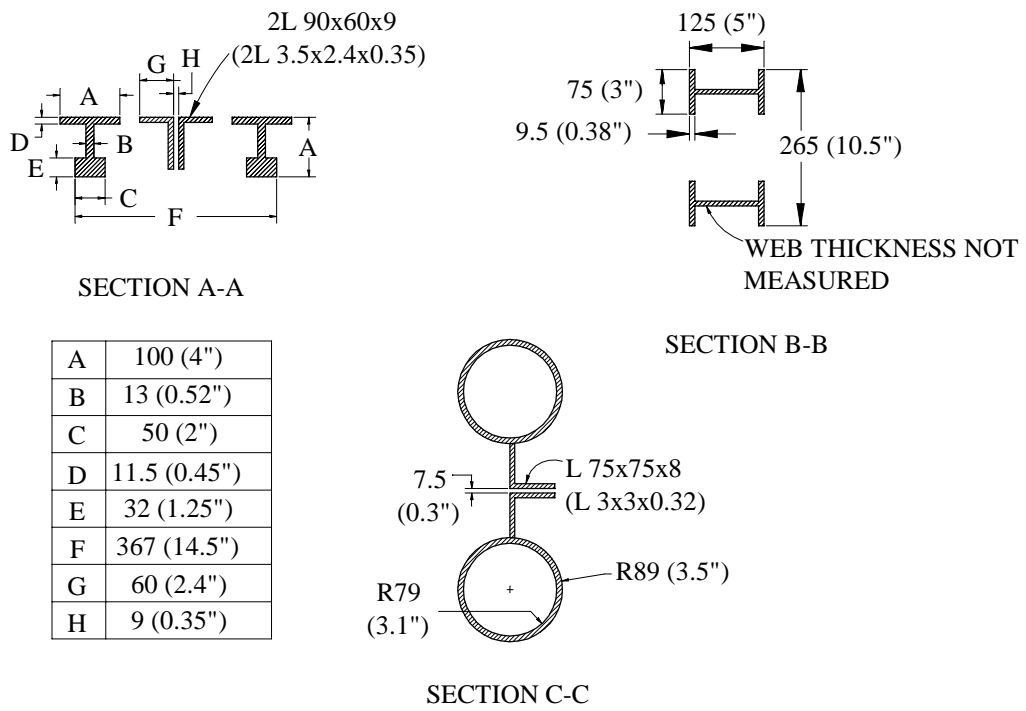
**Figure B.21: Details of metal bent for approach spans**
