1. Report No. <b>FWHA/TX-03/1774-2</b>		2. Government Accession No.		3. Recipient's Catalog No.	
4. Title and Subtitle  Effects of Wrapping Chloride Contaminated Concrete with Fiber Reinforced Plastics				5. Report Date October 2001

# **EFFECTS OF WRAPPING CHLORIDE CONTAMINATED CONCRETE WITH FIBER REINFORCED PLASTICS**

Research Report No. 1774-2

*“Effect of Wrapping Chloride Contaminated Structural Concrete  
with Multiple Layers of Glass Fiber/Composites and Resin”*

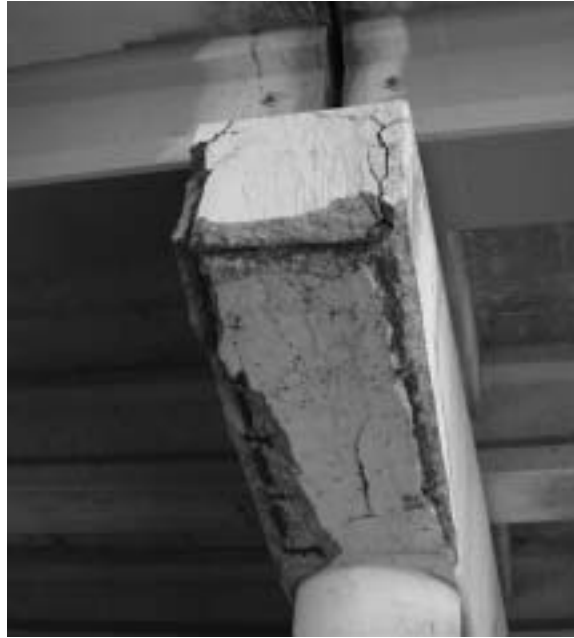
**Figure 1.1 Corrosion damage to a bridge bent**

A recent solution for repairing damage due to corrosion in reinforced concrete is to use fiber reinforced plastic (FRP) composite wrap. In addition to strengthening a concrete member, the FRP wrap is not subject to corrosion and may provide a barrier to protect the concrete from an aggressive environment. A potential concern is that by encapsulating concrete with FRP composites, moisture, chlorides, and oxygen may be trapped and cause the corrosion process to continue undetected. Figures 1.1 and 1.2 show a bridge bent before and after repair.

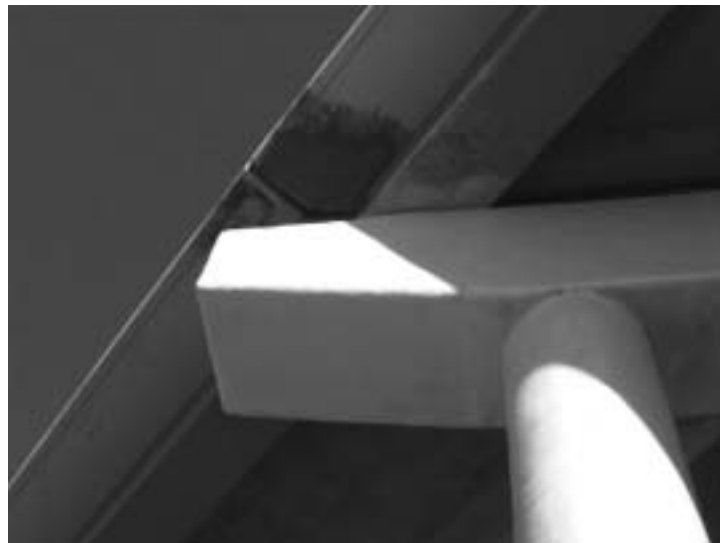
**Figure 1.2 Bridge bent and column wrapped with FRP after repair of corrosion damage**

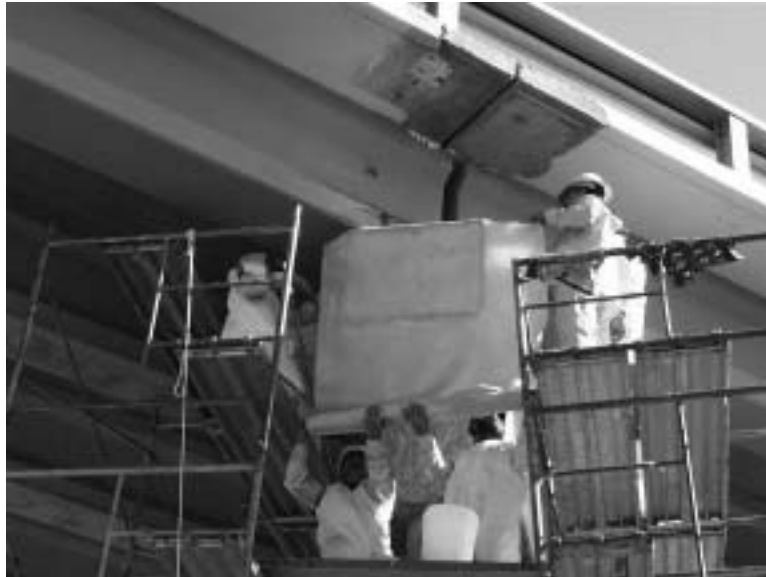
**Figure 3.1 FRP composite wrap being applied to the bent of a bridge**

There are three different methods for manufacturing commercial composite products: pultrusion, filament winding, and hand layup. Pultrusion is the process of pulling fibers through a resin bath and then through a heated die to produce a structural shape with a constant cross section. Pultrusion is used to manufacture rods, beams, and channels. Filament winding is the automated process of winding resin saturated fibers around a mandrel to produce a circular shape. This method is primarily used to manufacture tanks, pipes, and poles, but has also been used as an automated method to encapsulate bridge columns. Hand layup involves saturating sheets of fabric with resin by hand or machine, and then applying them by hand to an existing structure (Ballinger 1991). This method is primarily used to produce laminates and wraps that are used in retrofits. Figure 3.1 is an example of the hand layup method being used in the field.

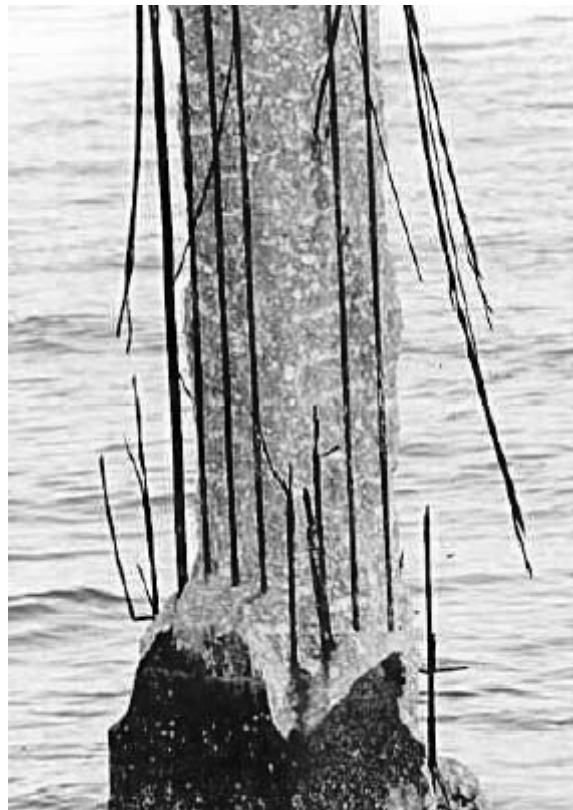
**Figure 3.3 Concrete pile that had previously been repaired with a fiberglass jacket.**

On the Bryant Patton Bridges in Florida, it was found that fiberglass jackets applied to bridge piles in a marine environment had accelerated the corrosion process. Capillary action allowed moisture to rise from the submerged portion of the pile, but the fiberglass jacket prevented the concrete from drying out. The combination of moisture and the high levels of chlorides in the unrepaired portions of the pile resulted in severe damage due to corrosion, as seen in Figure 3.3 (Sohangpurwala and Scannell 1994).

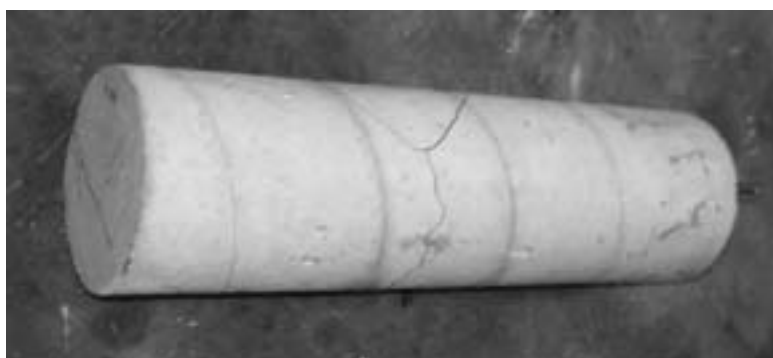
**Figure 5.5 Cracked cylinder specimen**

In order to simulate existing cracks within a structure, some of the specimens were subjected to flexural cracking prior to being wrapped. The cracks were created by applying a point load in the center of the specimen using a Universal Testing Machine. The specimens were loaded until crack widths of 0.01 to 0.013 in. were observed, which is the maximum crack width allowed for exterior exposure by ACI 10.6.4 (ACI 1995). The cylinders were loaded on two sides; the rectangular blocks were only loaded on the topside. Figure 5.5 shows a typical cracked specimen.

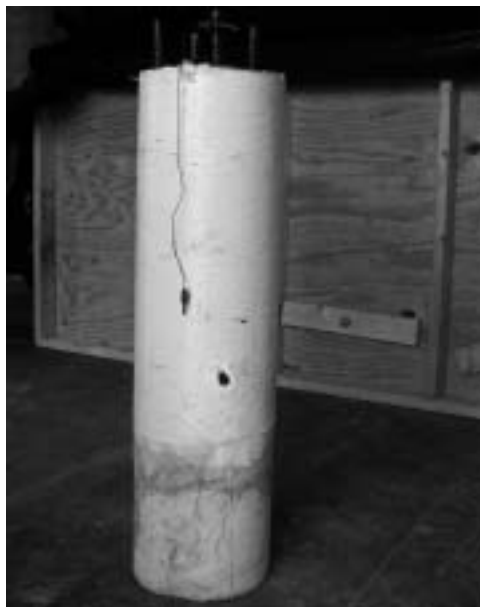
**Figure 5.6** Wrapped cylinder specimen

Access holes, 1 ¼-in. in diameter, were cored into the FRP composite in order to provide access to the concrete surface for the reference electrode. The holes are located at a distance of 16 in. from the bottom of the cylinder specimens, which is 4 in. above the waterline. On the rectangular blocks, the access hole is located on the lower left corner of the downstream end. The access holes are sealed during exposure in order to prevent moisture from infiltrating. Grease was applied to the exposed steel reinforcing in order to protect it from corrosion. Figures 5.6 and 5.7 are typical wrapped specimens. Each specimen is described in detail in Appendix A.

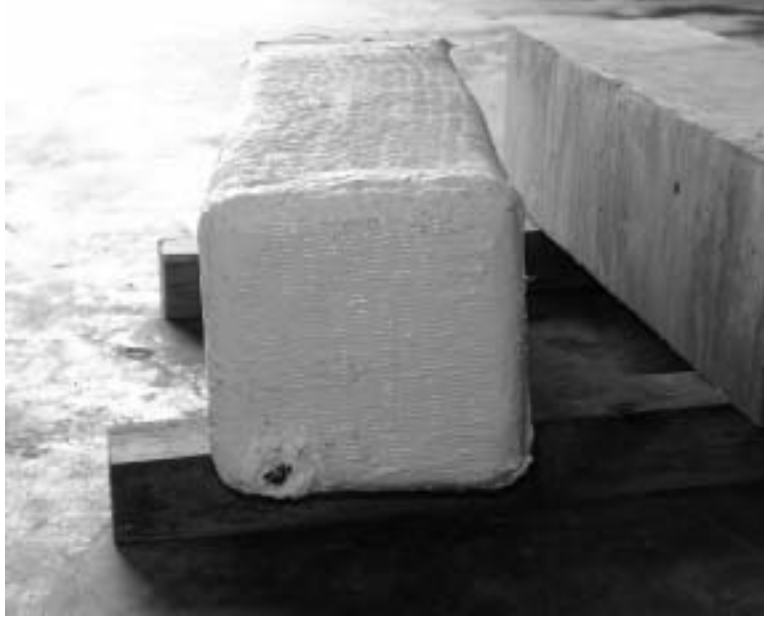
**Figure 5.7** Wrapped rectangular block specimen

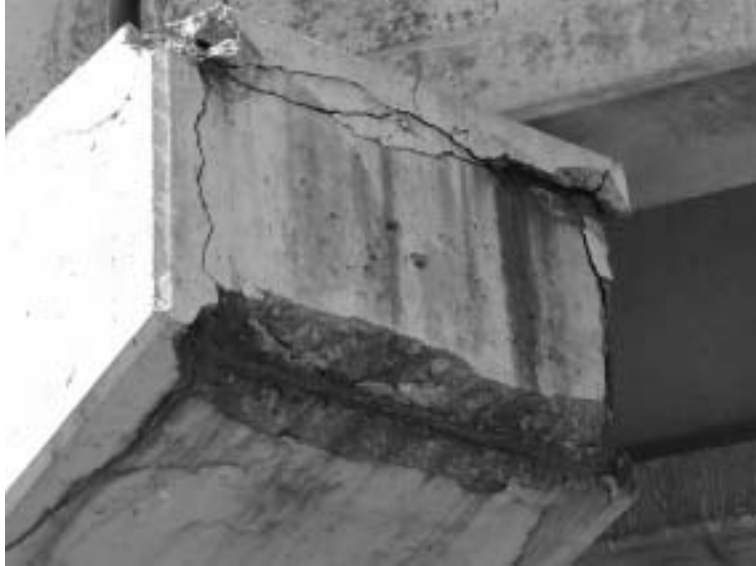
**Figure 5.8** Damage to an endcap of Structure #5

The bridges were experiencing severe damage due to corrosion. The damage consisted of cracking, spalling, and delamination of the concrete cover on the downstream portions of the bents, and also on some of the columns. Figures 5.8 to 5.10 show typical corrosion damage found on the substructure. The damage correlated with the drainage paths for water on the bridge deck. The bents had a slight slope so that water ran to the lower end as shown in Figs. 5.8 and 5.9.

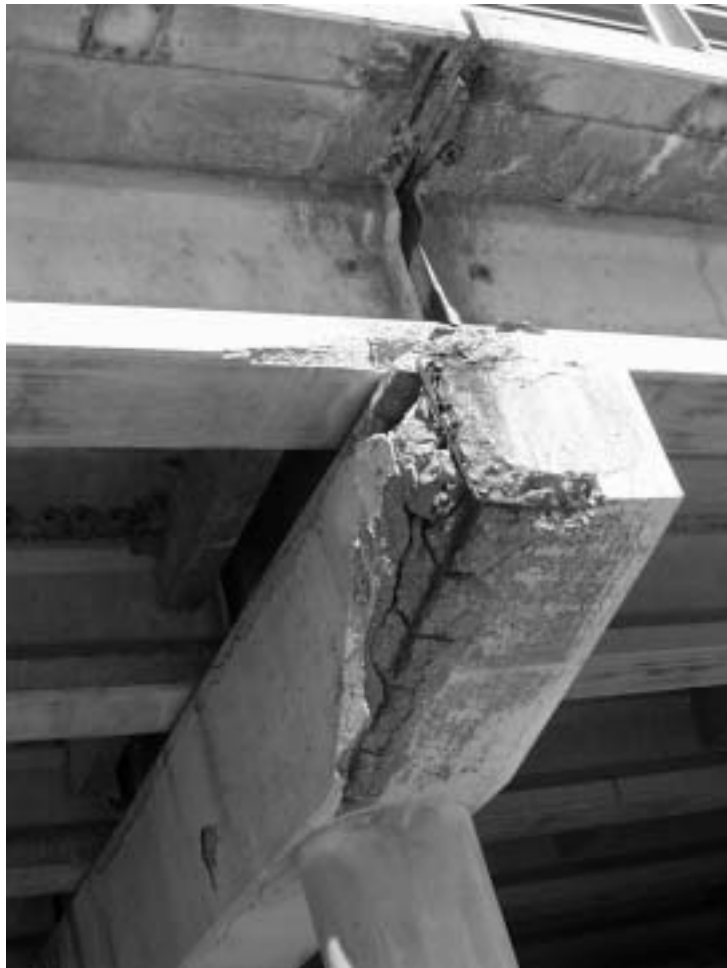
**Figure 5.9** Delamination on an endcap of Structure #8

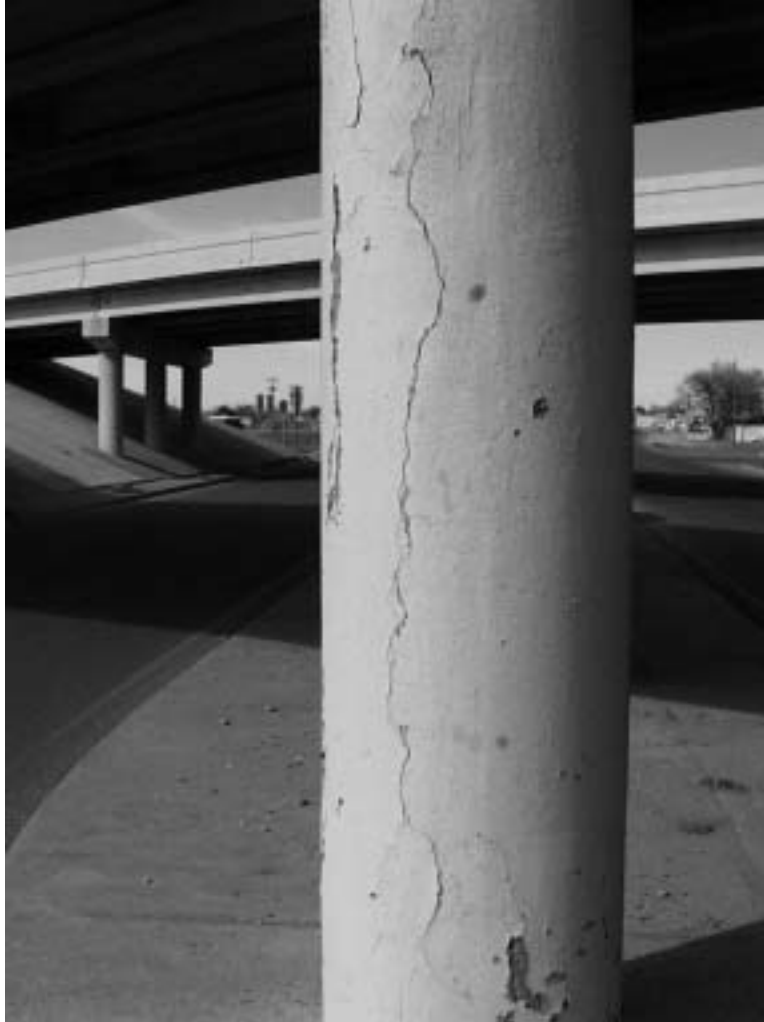
**Figure 5.10 Cracking on column of Structure #12**

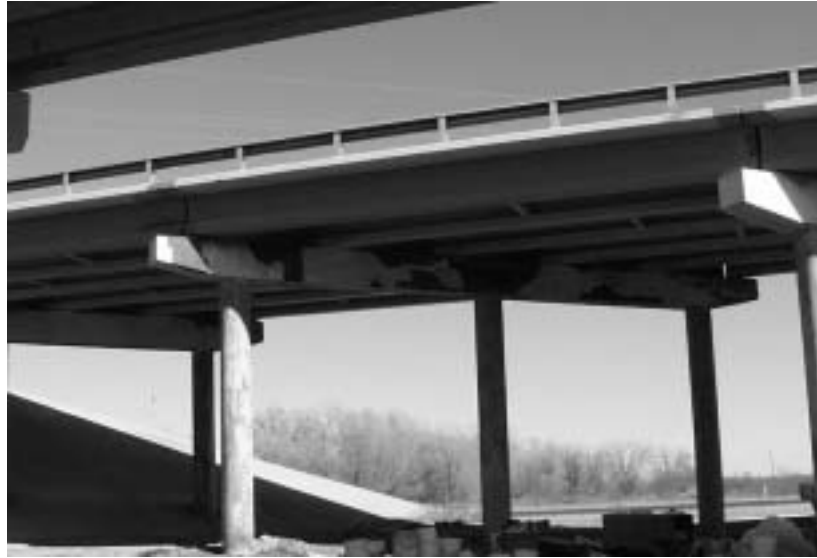
**Figure 5.11 Structure #1 prepared for encapsulation**

The glass fabric was saturated with resin by a saturation machine and then applied to the substructure by the hand layup method. Three layers of FRP wrap were applied in a manner similar to that described in the laboratory phase. Figure 5.11 shows Structure #1 after repairs have been made, and before the FRP composite has been installed. Figure 5.12 shows the parallel structure, Structure #2 after encapsulation.

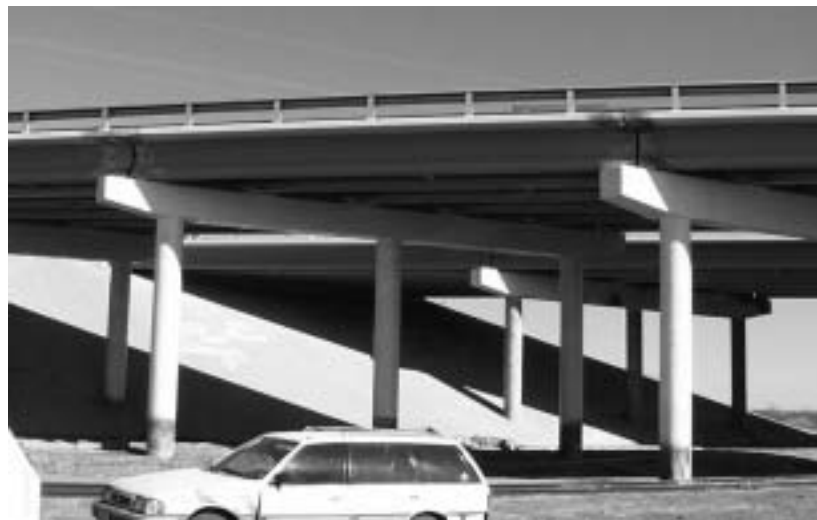
**Figure 5.12 Structure #2 encapsulated with FRP wrap**

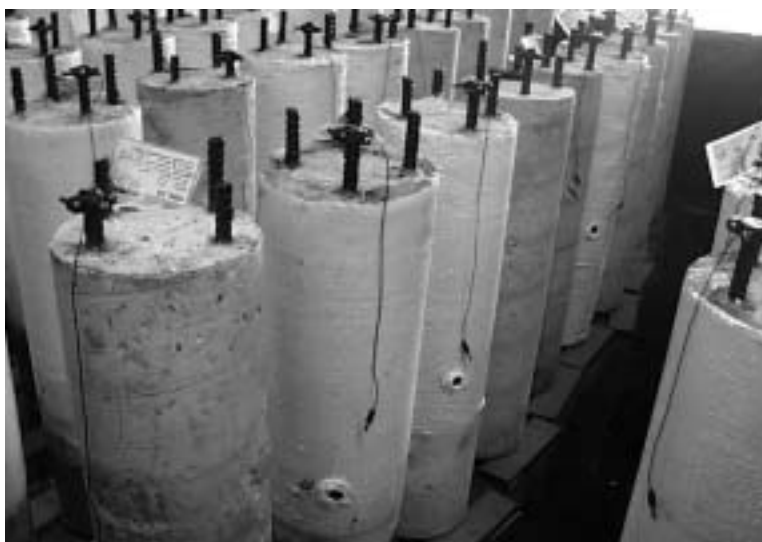
**Figure 6.1 Cylinder specimens in the exposure tank**

The laboratory specimens described in Chapter 5 were monitored from spring 1999 to spring 2001. During that time, the specimens were exposed to wet/dry cycles, in order to accelerate the corrosion process. The wet/dry cycle consisted of a soaking (wet) period of one week in a 3.5% saline solution followed by a two-week drying period. During the wet period, the lower one foot of the cylinders (columns) was immersed in salt water. During the drying cycle, the water was removed to a level below the bottom of the cylinder specimens. This was to create a splash zone effect for the cylinder specimens. The rectangular block specimens (bents) had saline water irrigated over the top surface. Mats were placed over the tops to provide even distribution of the water. The blocks were placed at a slight incline, allowing for the water runoff to flow towards the downstream end. Figure 6.1 is a photograph of the cylinder specimens in the exposure tank.

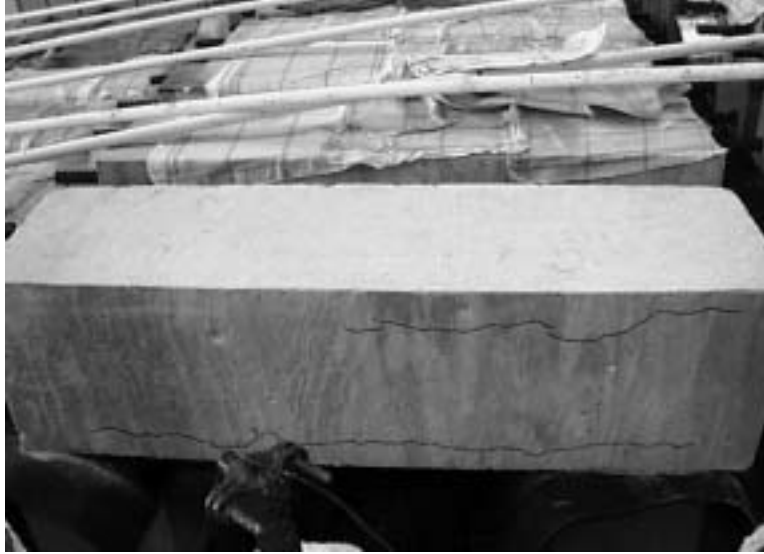
**Figure 6.2** Longitudinal cracks forming on an uncracked specimen

Readings were taken after every four wet/dry cycles for the wrapped specimens during the exposure period. Readings were taken after every cycle for the unwrapped specimens for the first year and a half of monitoring. After eighteen months of exposure, it was well established that corrosion was taking place in the unwrapped specimens. The readings indicated a high probability that corrosion was taking place. In addition, cracks were forming parallel to the reinforcing in specimens that were not cracked prior to exposure, as illustrated in Figure 6.2. After eighteen months of exposure, readings were taken after every four cycles on all of the specimens. Linear polarization testing was performed on the cylinders in Group B in order to compare results with the amount of corrosion activity found in the specimen after it was opened.

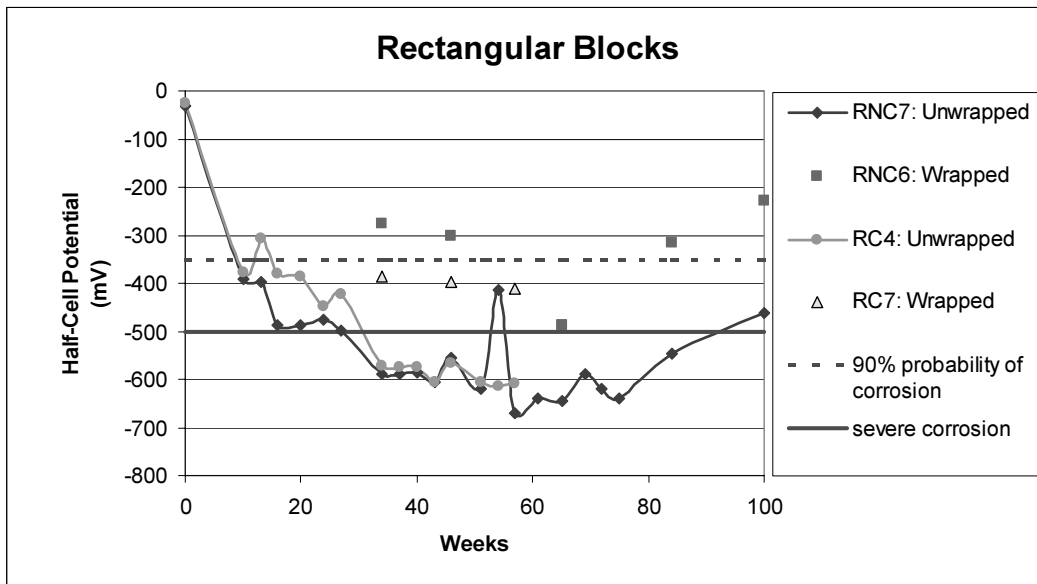
**Figure 6.7 Half-cell potential vs. time for rectangular blocks**

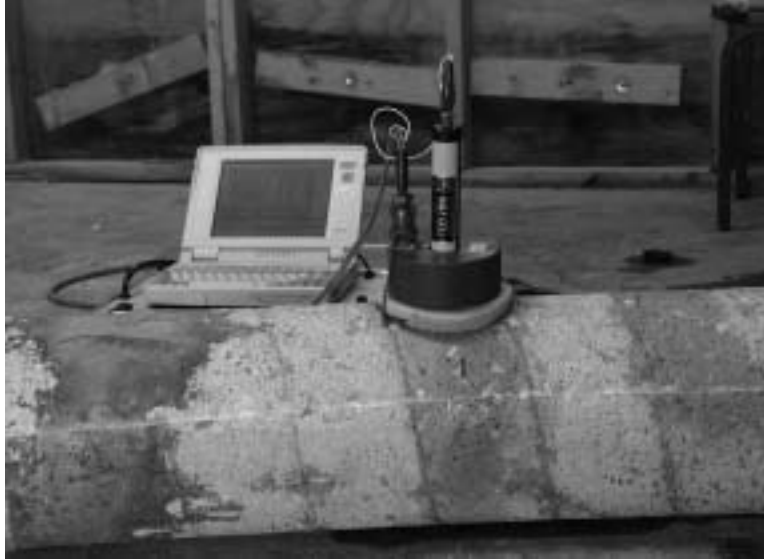
**Figure 6.8 PR-Monitor test setup on specimen CC5**

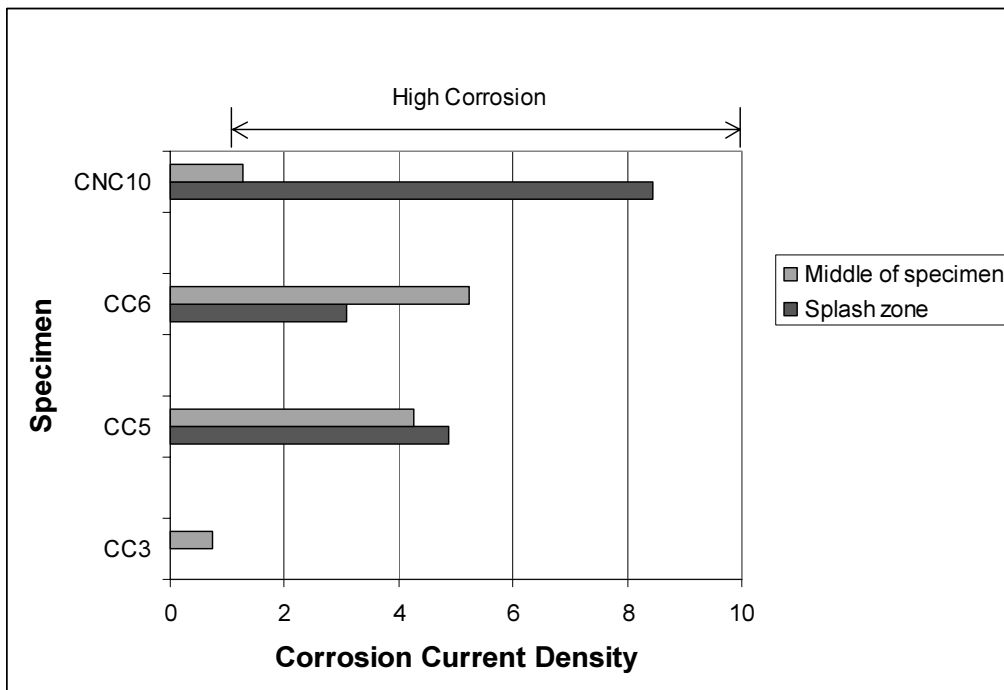
**Figure 6.9 Corrosion current density ( $\mu\text{A}/\text{cm}^2$ ) values for Group B**

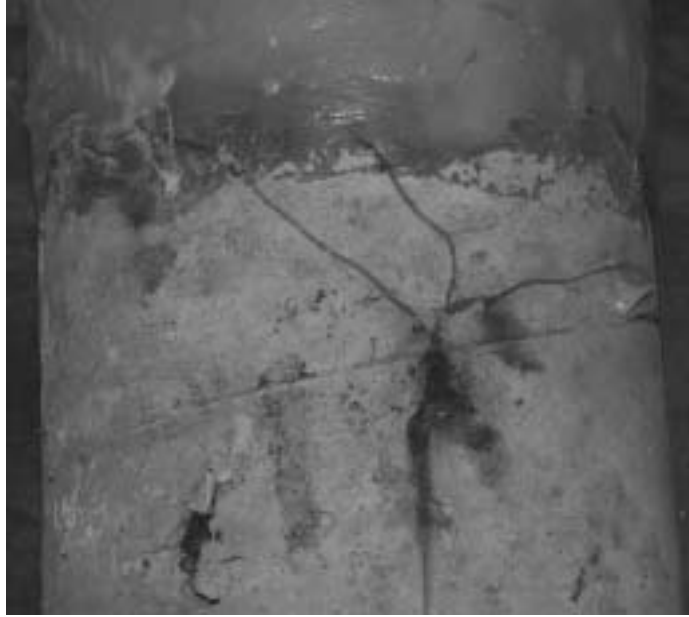
**Figure 6.10 Evidence of corrosion activity in the splash zone of specimen CNC10**

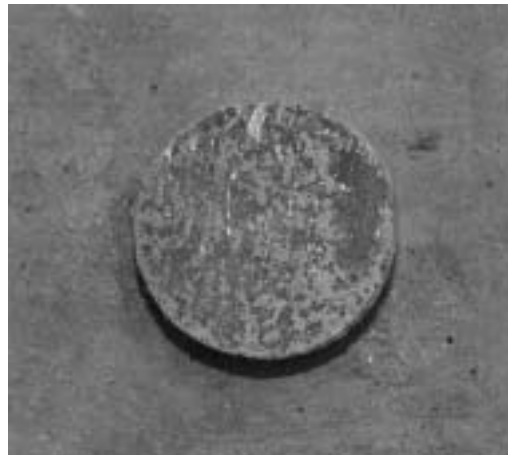
**Figure 6.12 Failure at the epoxy/concrete interface on Test #2**

All of the tests failed in the substrate except for test #2, which failed at the bond between the wrap and the concrete surface, as shown in Figure 6.12. This indicates that the bond strength was stronger than the concrete tensile strength for most of the specimen. The top face had the most severe exposure, so it is reasonable that the tensile strength was lower. The upstream end was most likely to have moisture seep under the wrap, which may have resulted in the failure at the epoxy bond in that location. The differences in failure strength are also possibly due to the fact that concrete is not an isotropic material. In addition, the low failure strength in the substrate during test #1 may have also been caused by cracks in the specimens. The difference in values of failure stress does indicate that there is some variation in the adhesion of the FRP wrap to the concrete surface.

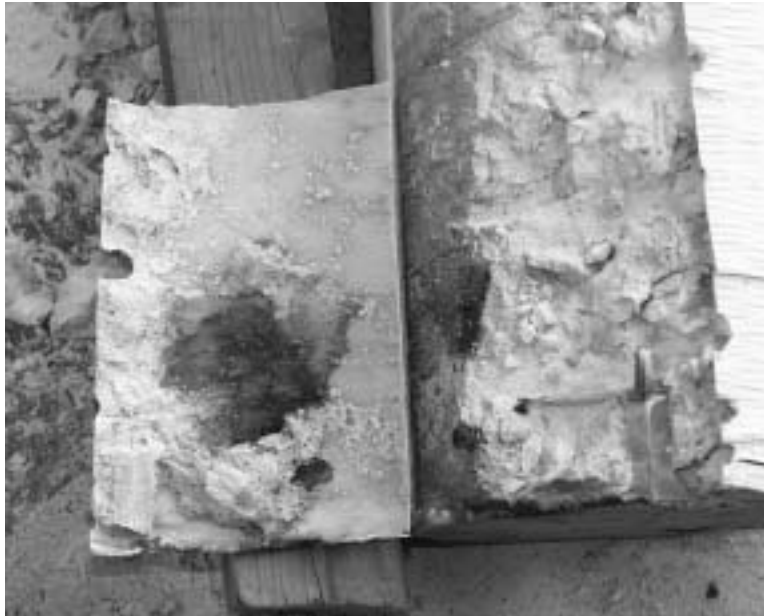
**Figure 6.13** Moisture trapped beneath the surface in the splash zone of specimen CNC14

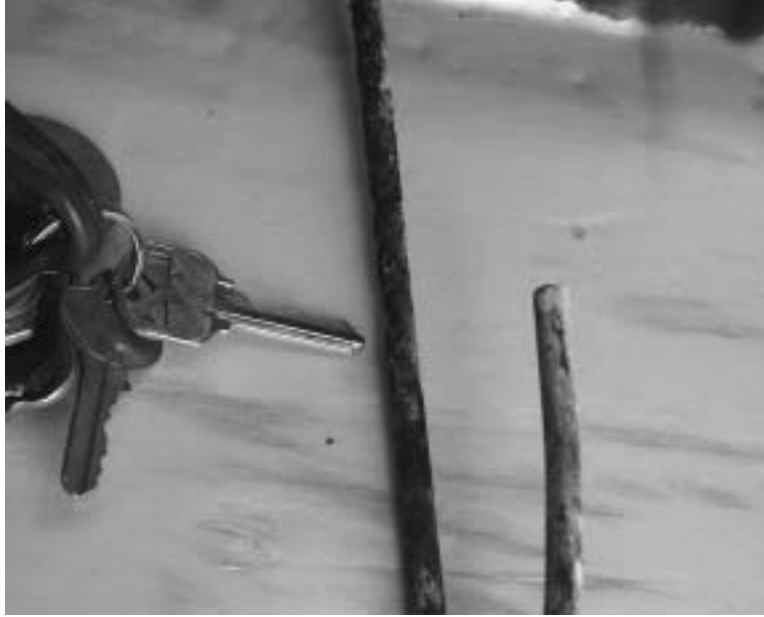
**Figure 6.14** Section loss on the upstream stirrup of specimen RNC6

Unlike Group A, corrosion activity was also found in the upper half of the cylinder specimens. Heavy corrosion was found at the patches in the chloride contaminated concrete indicating that macrocells had formed between the concrete and the uncontaminated repair material for the cylinder specimens. The macrocells were found both in the splash zone and several feet above the splash zone in encapsulated concrete. Figure 6.15 shows the corrosion activity found in the top portion of specimen CC5. A macrocell also formed between the uncontaminated concrete and the repair material in RNC6, but the corrosion activity was not as extensive. This was most likely due to fact that the existing concrete did not contain chlorides.

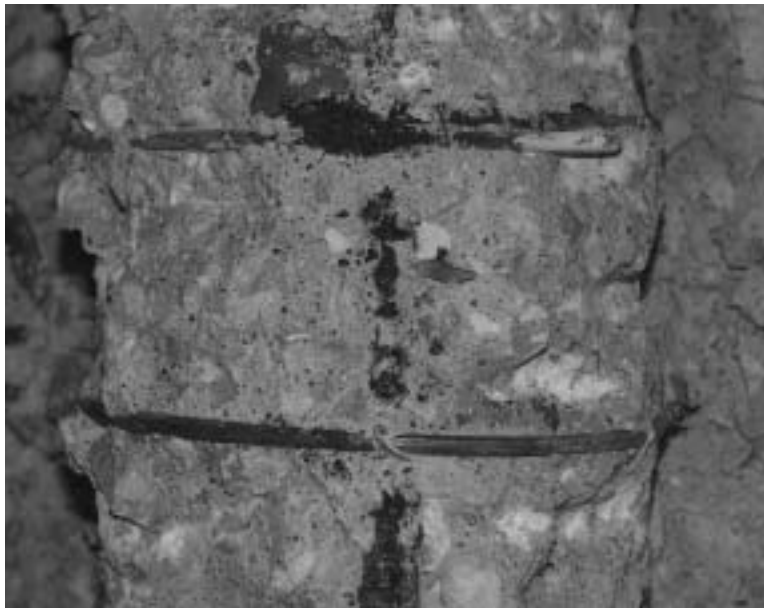
**Figure 6.15** Macrocell formation in the top portion of specimen CC5

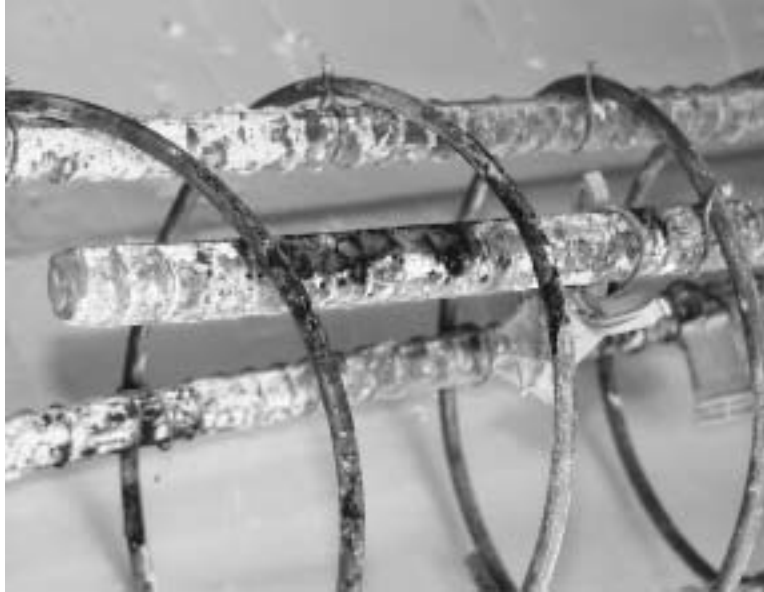
**Figure 6.16** Steel reinforcing of CNC10 with a corrosion rate of 3.86 mpy

The following figures help to quantify the corrosion rate measurements taken from the linear polarization testing. Figure 6.16 shows the steel reinforcing that was polarized in the splash zone of CNC10. It had the highest corrosion rate measurement, 3.86 mpy. The concrete was not wrapped with FRP composite in that area. Figure 6.17 shows the steel reinforcing that was polarized in the splash zone of CC6. The concrete was wrapped with FRP composite in that area. The corrosion rate was 1.41 mpy. Figure 6.18 shows the steel reinforcing that was polarized in the middle portion of CC3. It had the lowest corrosion rate measurement, 0.34 mpy, and the only measurement that was in the moderate corrosion rate level. The concrete was wrapped with FRP composite in that area. As shown in the following figures, the corrosion rate was consistent with the extent of corrosion activity. Photographs of the steel reinforcing cage for each specimen in both groups may be found in Appendix C.

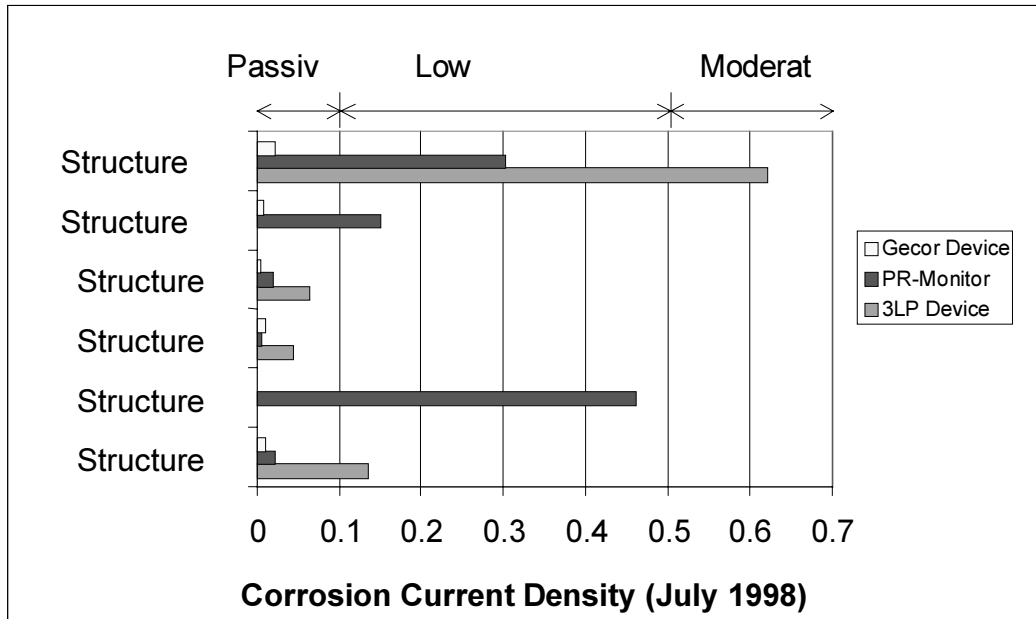
**Figure 7.1** Corrosion current density ( $\mu\text{A}/\text{cm}^2$ ) values from different equipment

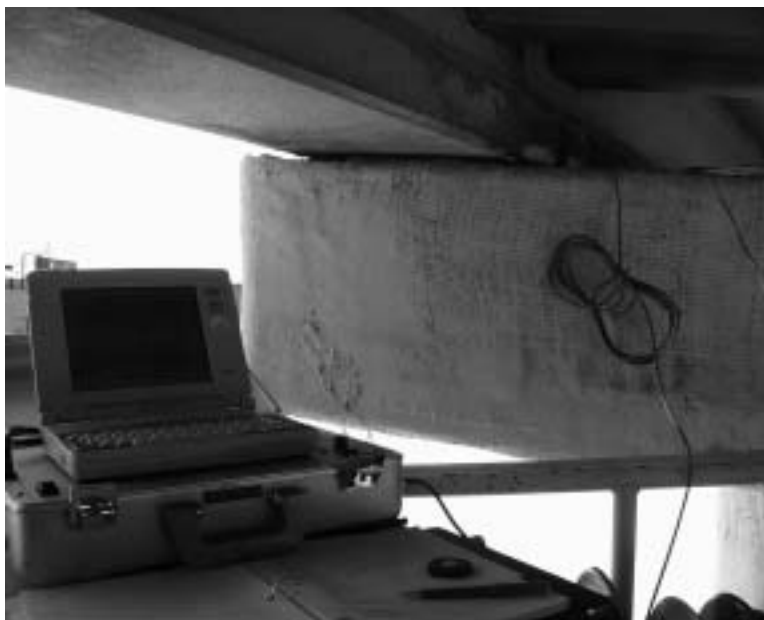
**Figure 7.2 PR-Monitor test setup for Structure #12**

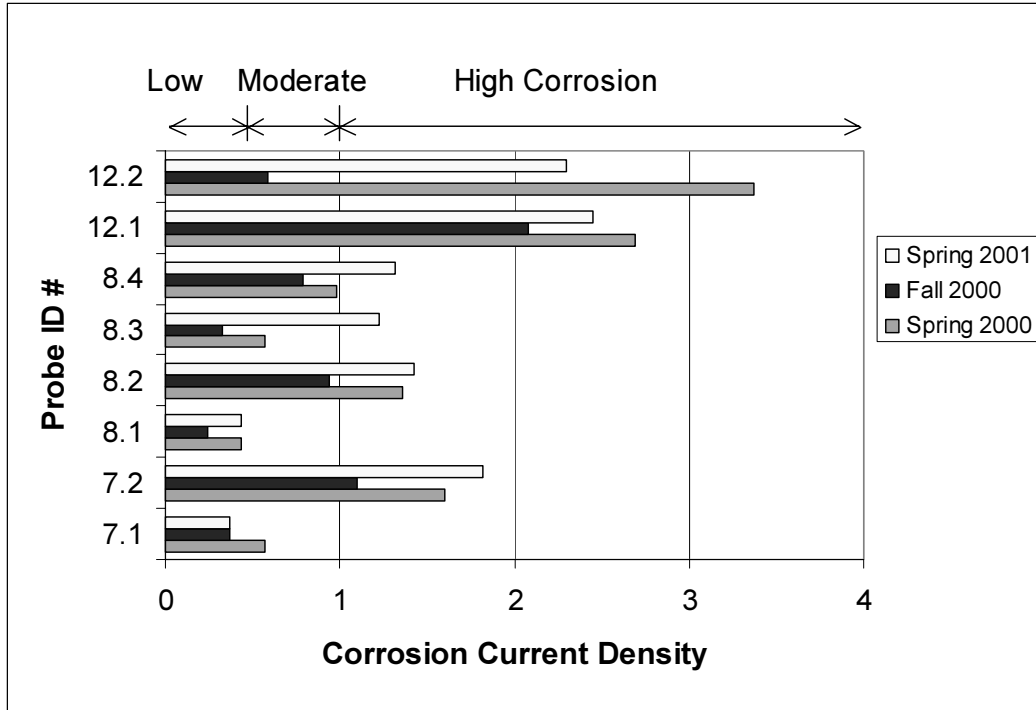
**Figure 7.3 Corrosion current density ( $\mu\text{A}/\text{cm}^2$ ) for corrosion monitoring**

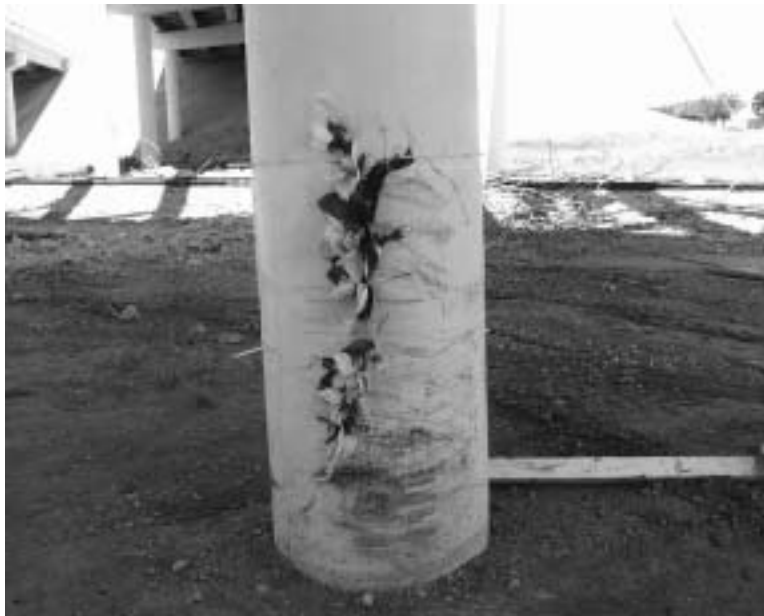
**Figure 7.7 Vehicular collision damage on column of Structure #2**

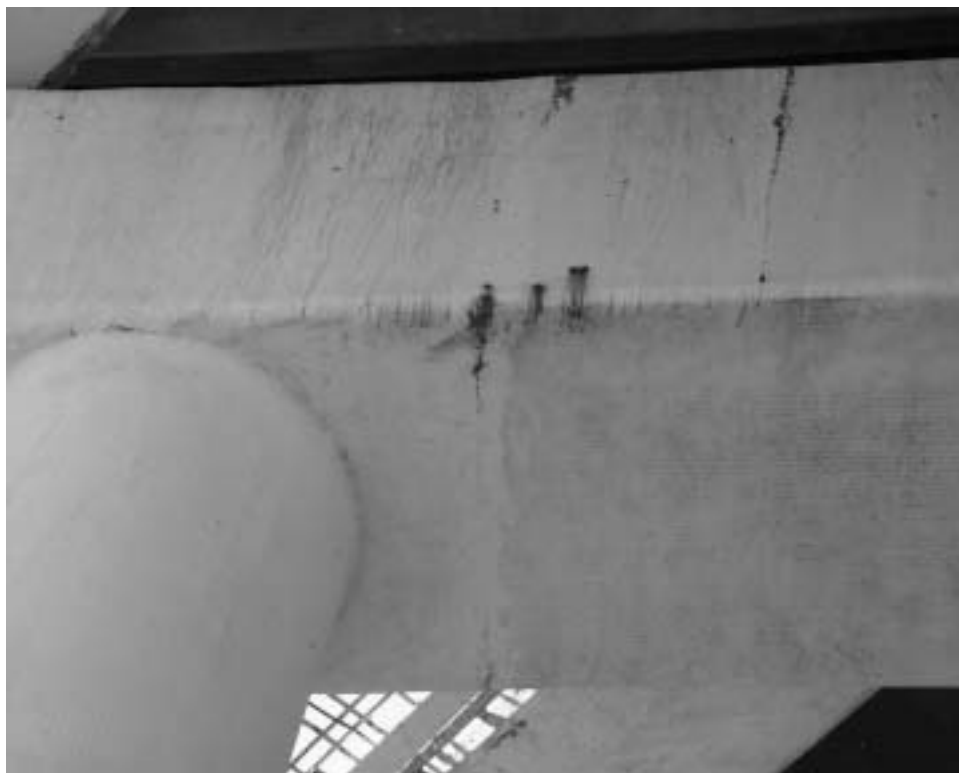
**Figure 7.8 Rust stains on bent of Structure #1**

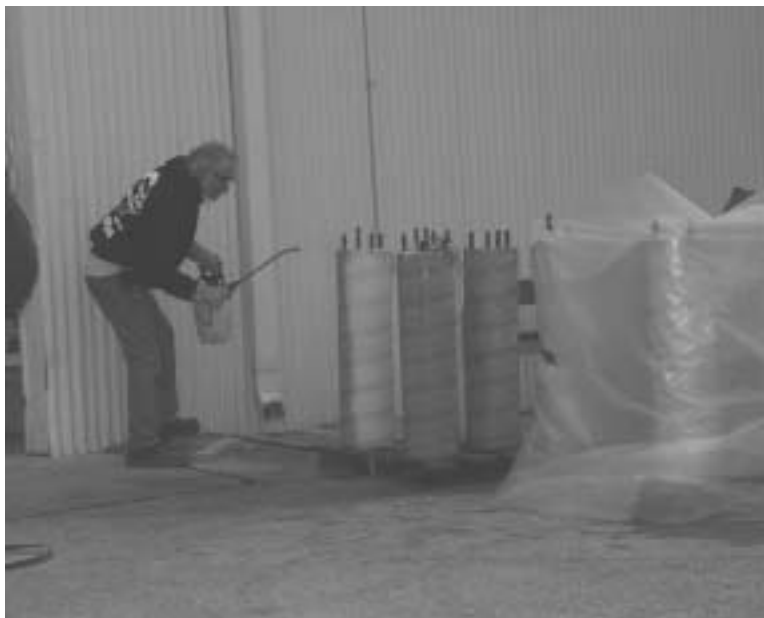
**Figure 8.1 Application of a surface applied corrosion inhibitor to the specimens**

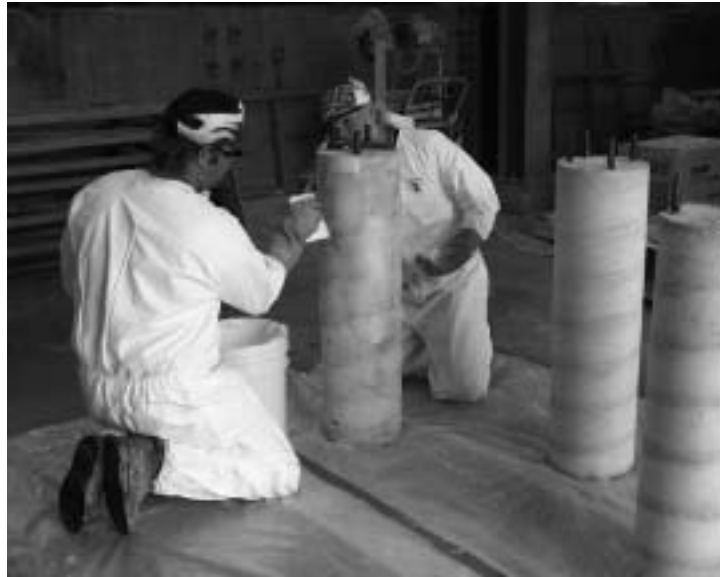
**Figure 8.2 Filling voids with a thickened epoxy filler**

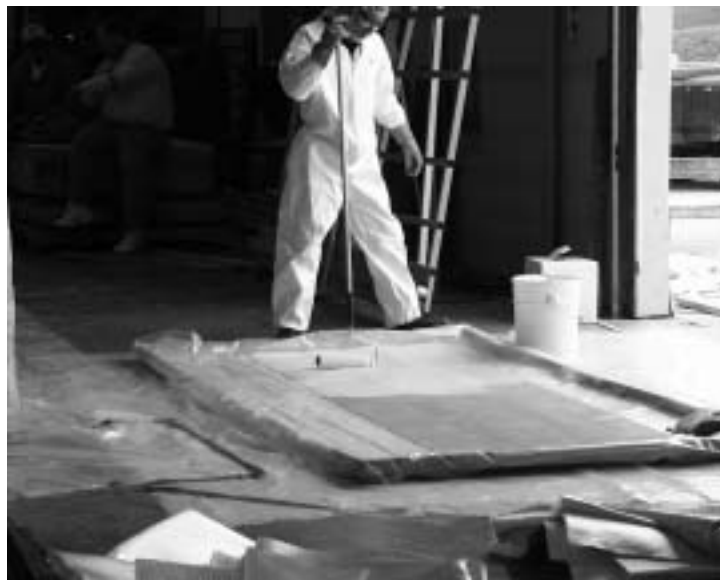
**Figure 8.3 Saturating glass fabric with epoxy resin**

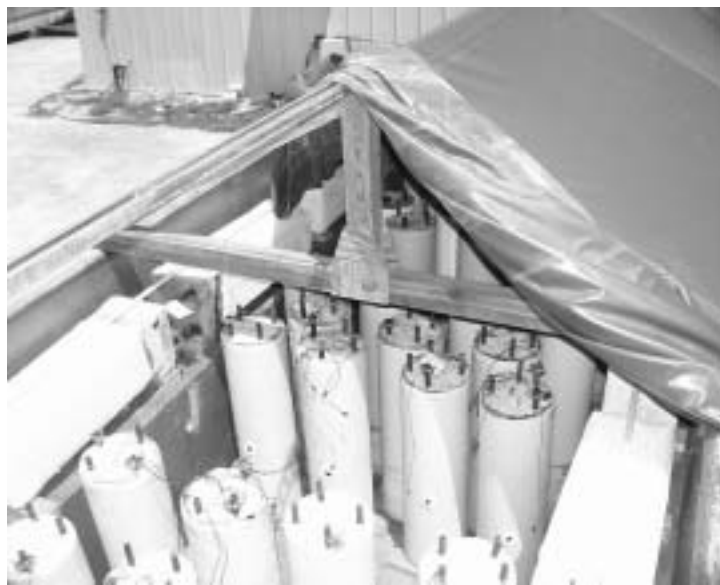
**Figure 8.8 Specimens in the exposure tank.**
